Report on Geotechnical Pavement Investigation

# **Larson Middle School** 2222 East Long Lake Road Troy, Michigan 48085

G2 Project No. 220949 December 27, 2022

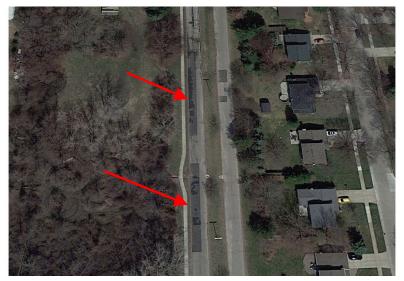
The northbound drive (east drive) is in fair condition with moderately severity block and edge cracking (Photograph Nos. 1 through 4). Toward the southern half of the drive, more extensive fatigue cracking is also present (Photograph No. 5). The southbound drive (west drive) is in poor condition with high severity fatigue and edge cracking throughout (Photograph Nos. 6 through 12). It appears patching was performed along both sides of the southbound drive between 2010 and 2015 with more significant areas on the west side show with red arrows below.

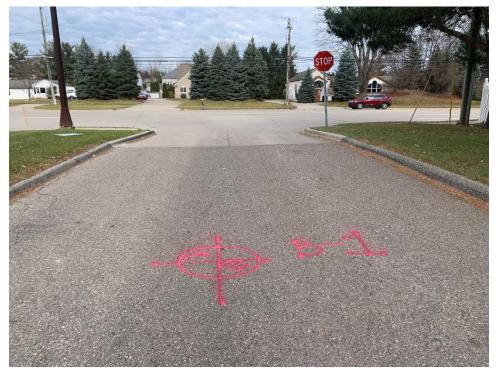
Photograph No. 1: Moderate severity edge cracking at exit to E. Long Lake Road.

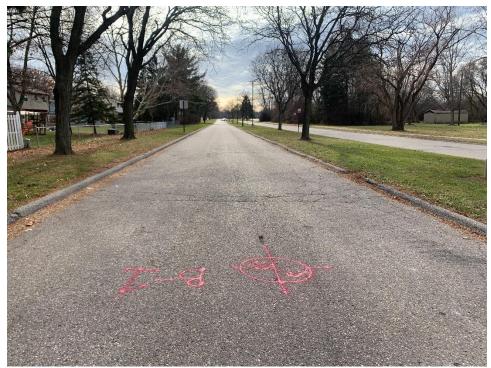
Photograph No. 2: Looking south from B-1, moderate severity transverse cracking.

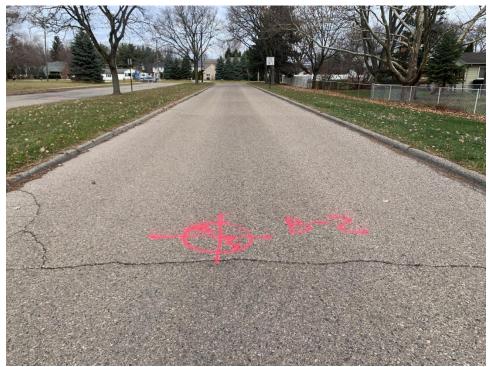
Photograph No. 3: Moderate severity transverse and edge cracking near B-2. Bituminous curb along drive.

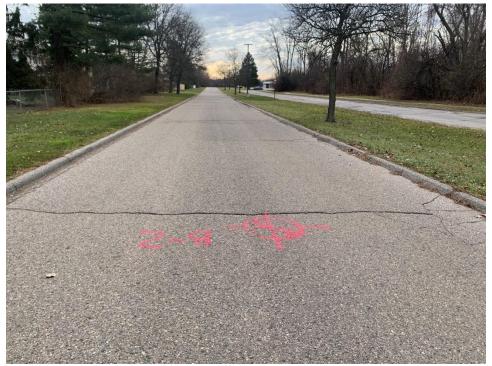
Photograph No. 4: Looking south from B-2, moderate severity block cracking along entire alignment.

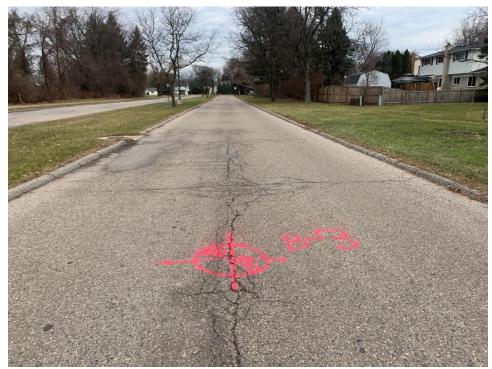
Photograph No. 5: Moderate to high severity block cracking near B-3. Patch noted on west side of drive.

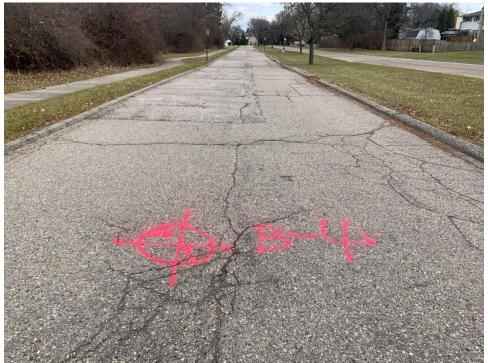
Photograph No. 6: High severity block and edge cracking. Patch noted on west side of drive.

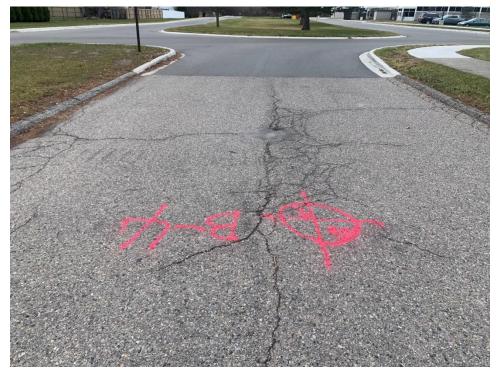
Photograph No. 7: High severity block and edge cracking. Note previous site work.

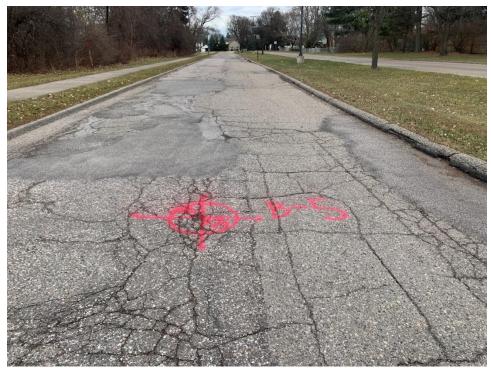
Photograph No. 8: High severity fatigue cracking near B-5. Patching throughout drive.

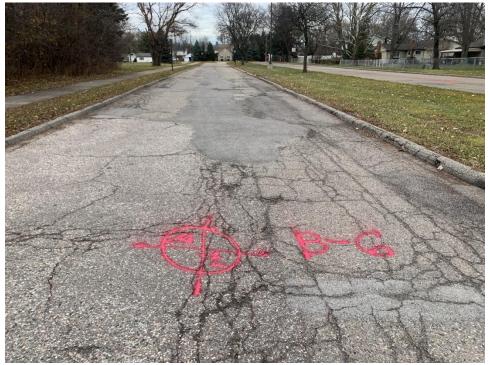
Photograph No. 9: High severity block and edge cracking and patching throughout.

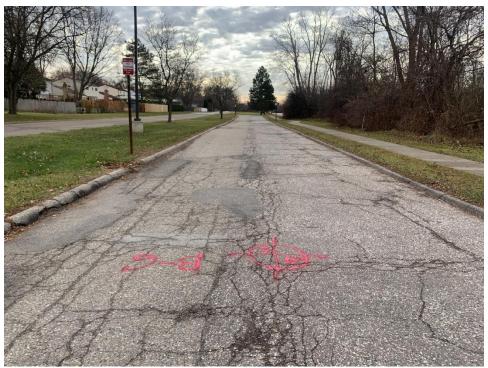
Photograph No. 10: High severity fatigue cracking and previous patching near B-6.

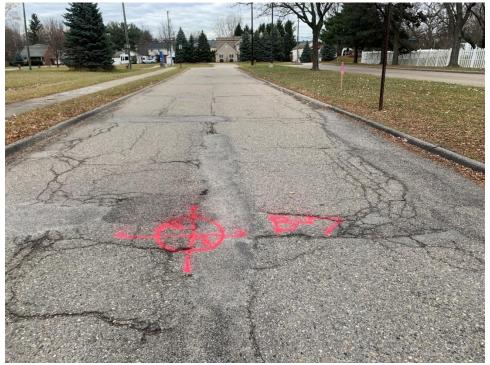
Photograph No. 11: High severity block and edge cracking. Previous patching.

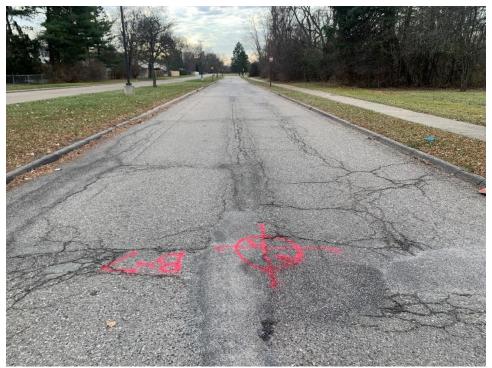
Photograph No. 12: High severity block and fatigue cracking looking south from B-7.

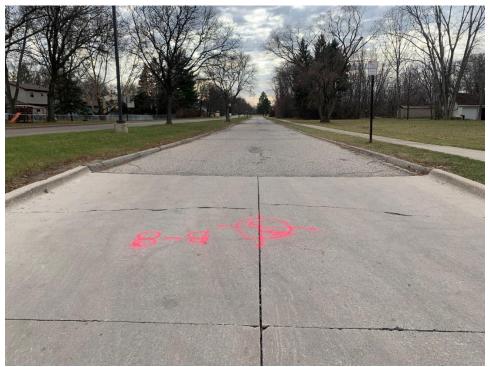
Photograph No. 13: Concrete entrance apron along East Long Lake Road, transverse cracking.

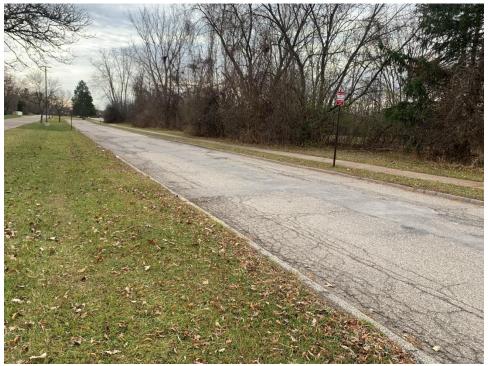
Photograph No. 14: Overall view of entrance drive. Note high severity edge cracking throughout and previous patching.

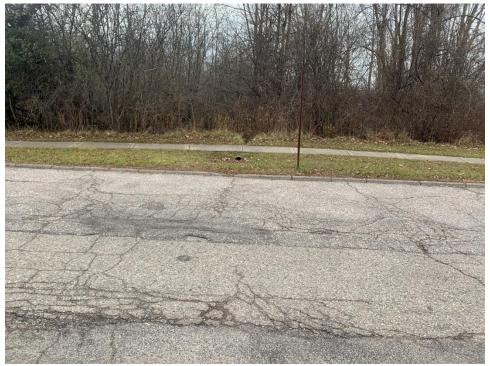
Photograph No. 15: Drains along east side of drive leading into wooded area.

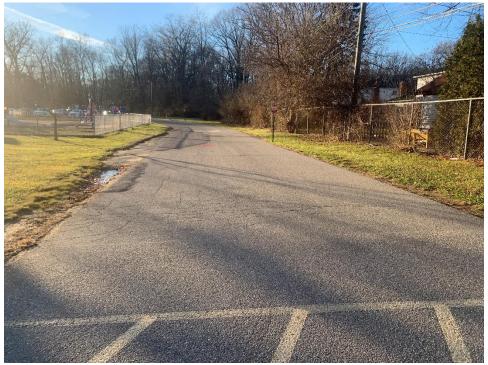
Photograph No. 1: Low to moderate severity edge and fatigue cracking east of B-1.

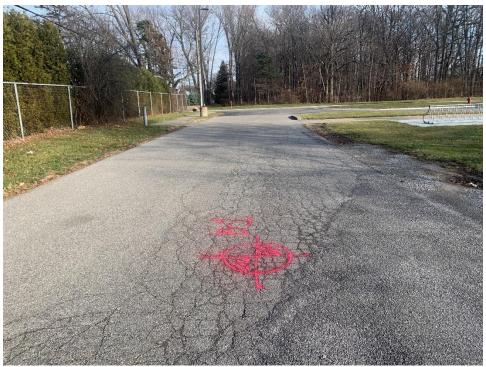
Photograph No. 2: High severity fatigue cracking near B-1, previous patching and lack of vegetation on south side of drive.

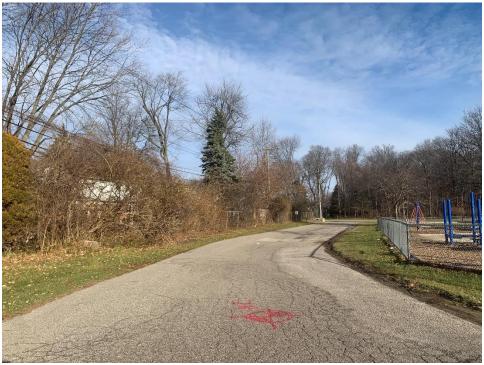
Photograph No. 3: High severity fatigue cracking near B-2. Concrete collar around catch basin east of B-2.

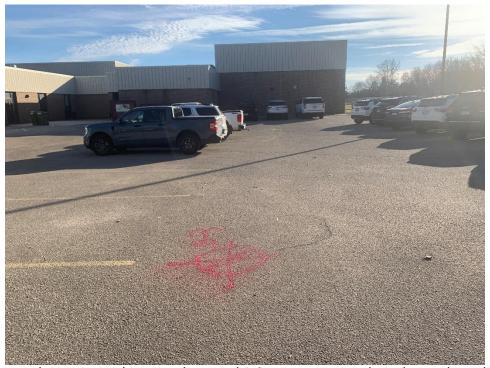
Photograph No. 4: Looking south toward B-3, pavement is relatively good condition.

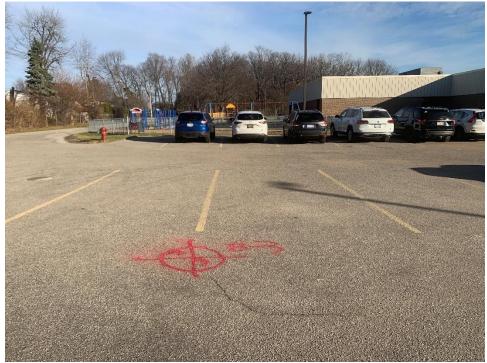
Photograph No. 5: Pavement in relatively good condition near B-3.

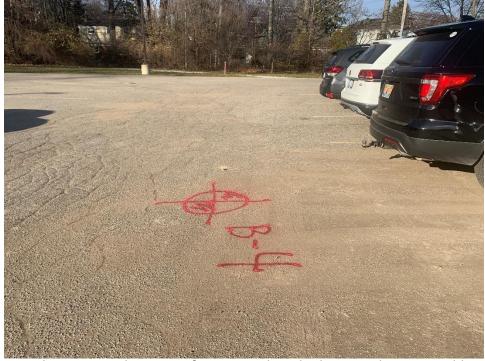
Photograph No. 6: High severity fatigue cracking looking north at B-4 and beyond.

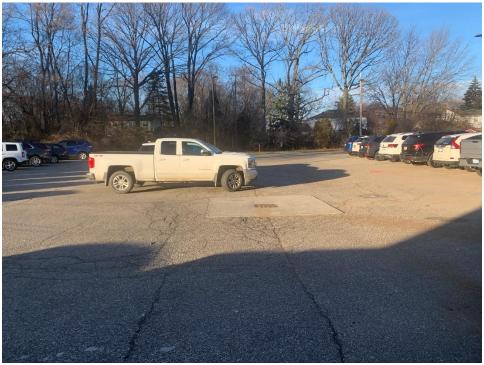
Photograph No. 7: Moderate to high severity fatigue and block cracking, looking north toward B-4.

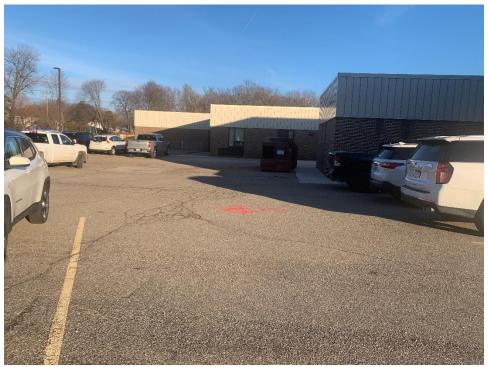
Photograph No. 8: Moderate severity block and fatigue cracking near B-5. Settlement noted in areas of heavy fatigue.

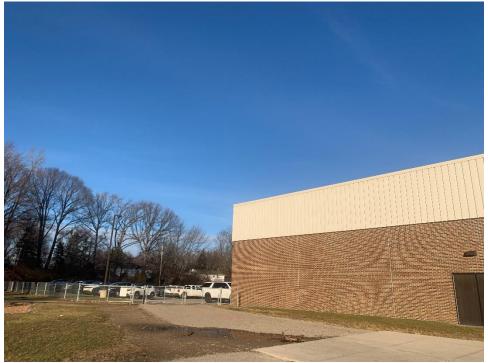
Photograph No. 9: Note lack of vegetation along west drive near B-6, indicative of poor drainage.

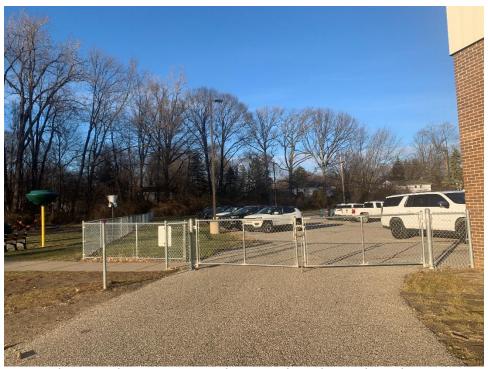
Photograph No. 10: West drive in relatively good condition.

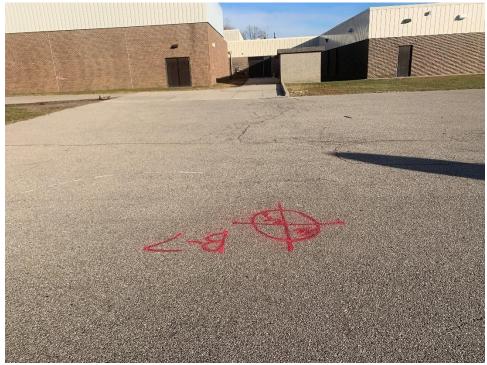
Photograph No. 11: Low to moderate severity block cracking near B-7.

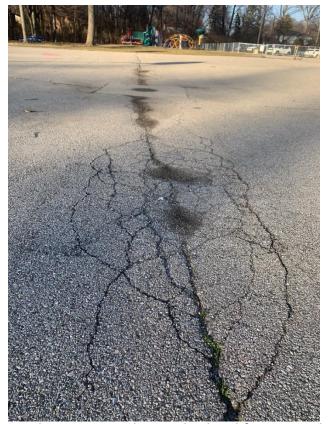
Photograph No. 12: Moderate severity longitudinal and fatigue cracking along center of play surface, in line with drainage lines.

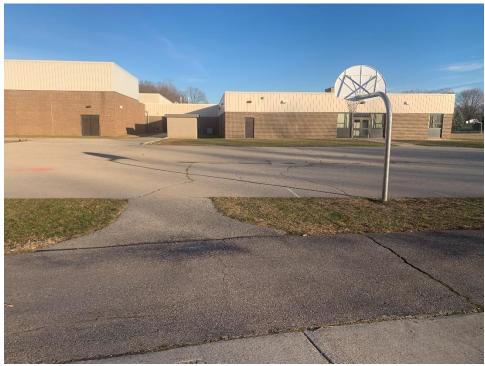
Photograph No. 13: Low to moderate severity longitudinal and fatigue cracking along center of play surface.

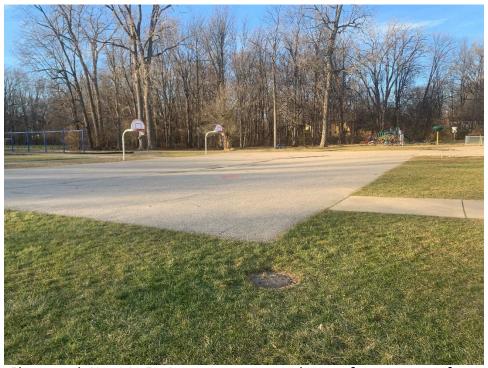
Photograph No. 14: Drainage structure southwest of pavement surface.

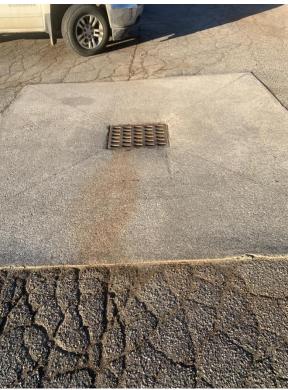
Photograph No. 16: Catch basin with concrete collar southwest of B-4, high severity fatigue cracking around collar.

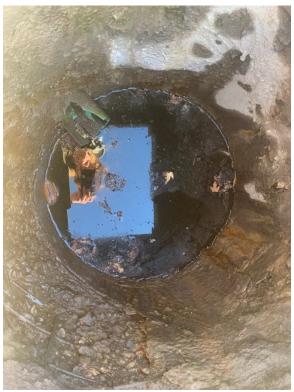
Photograph No. 17: Interior of precast structure near B-4, holding water.

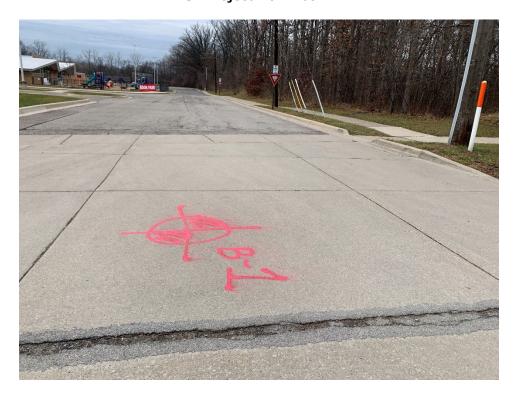
Photograph No. 1: Low to moderate severity edge and fatigue cracking east of B-1.

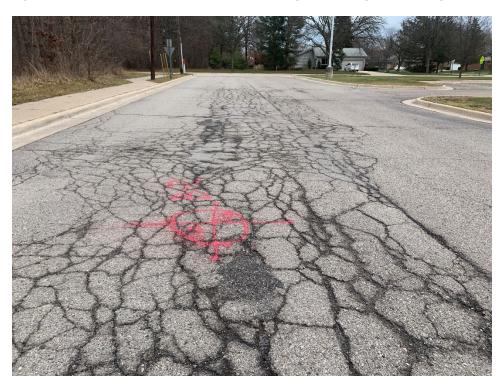
Photograph No. 2: High severity fatigue cracking near B-2, water infiltration through distress evident.

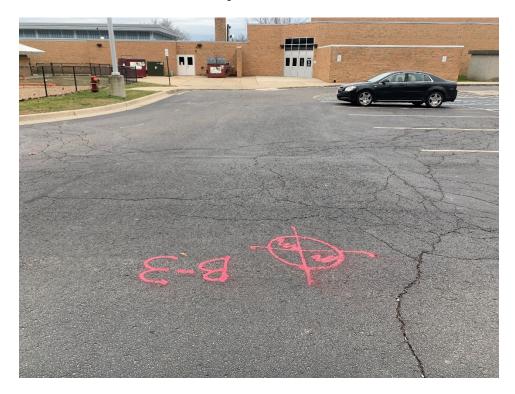
Photograph No. 3: Moderate severity fatigue cracking near B-3.

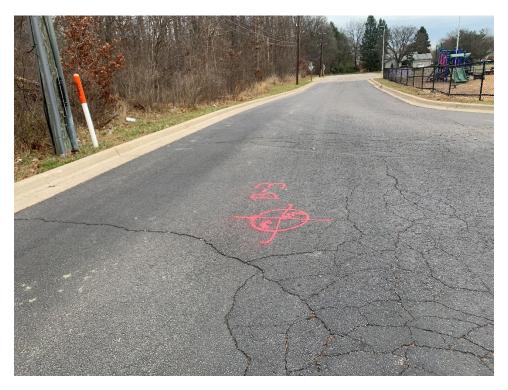
Photograph No. 4: Looking east toward B-3, moderate severity fatigue and block cracking.

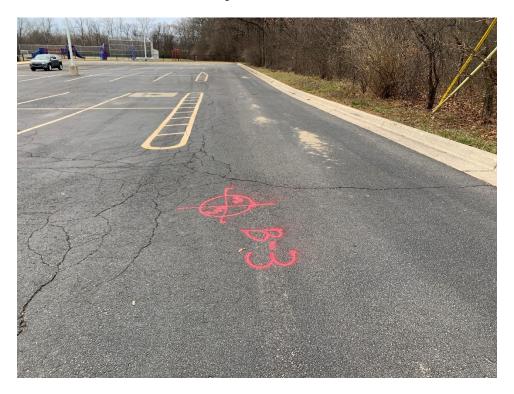
Photograph No. 5: Low to moderate severity fatigue cracking looking west toward B-3.

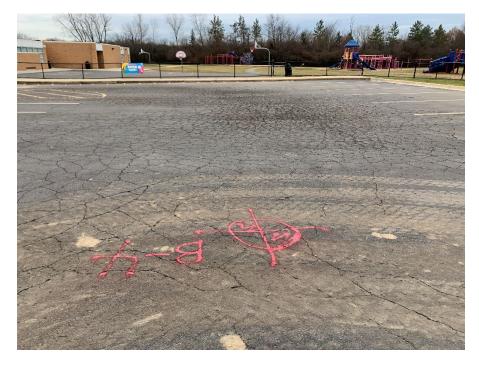
Photograph No. 6: High severity fatigue cracking looking south at B-4 and beyond.

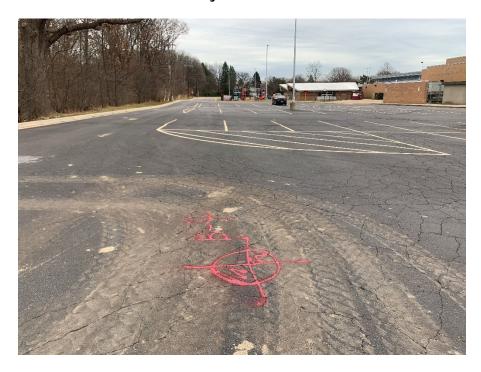
Photograph No. 7: Moderate severity fatigue east of B-4.

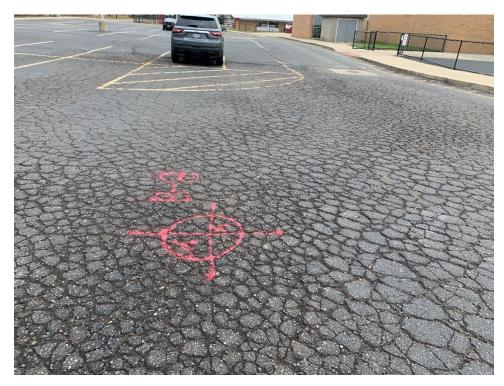
Photograph No. 8: High severity fatigue cracking and pavement raveling, looking east toward B-8.

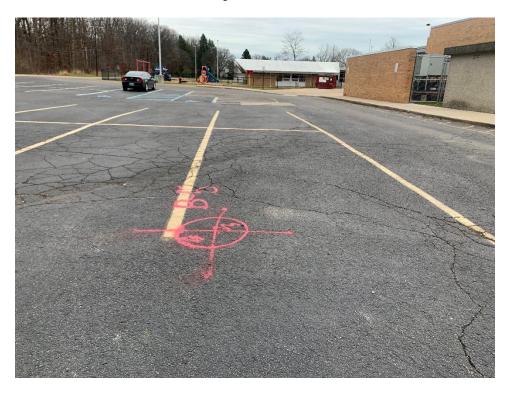
Photograph No. 9: Low to moderate severity fatigue cracking near B-5. Settlement noted in areas of heavy fatigue.

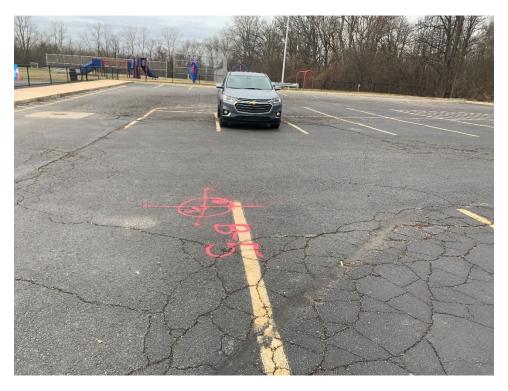
Photograph No. 10: Moderate severity fatigue cracking near B-5.

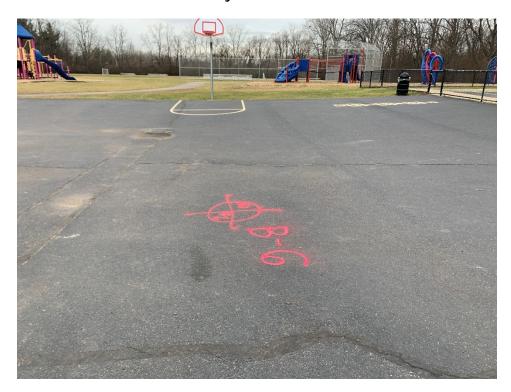
Photograph No. 11: Low severity block cracking near B-6. Evidence of sediment from ponding.

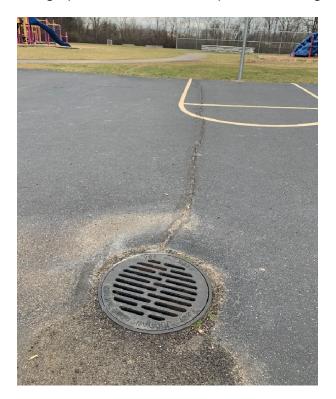
Photograph No. 12: Catch basin with sediment around structure. Note previous sawcut patch south of B-6, in east/west direction.

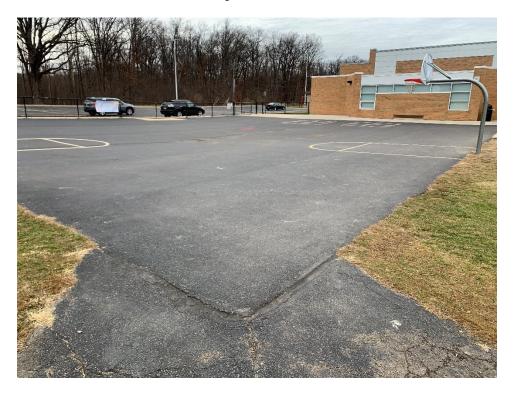
Photograph No. 13: Looking northeast across Lot B. Lot is in relatively good condition.

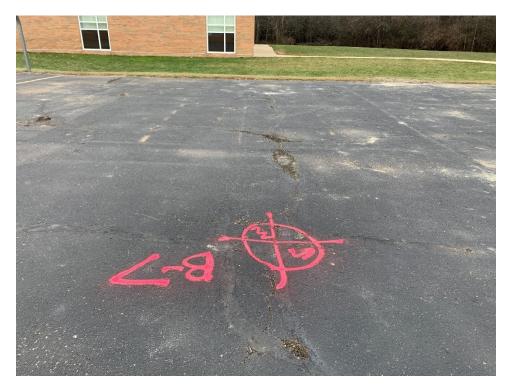
Photograph No. 14: Low severity block cracking throughout Lot C.

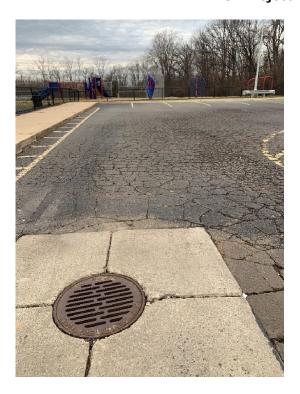
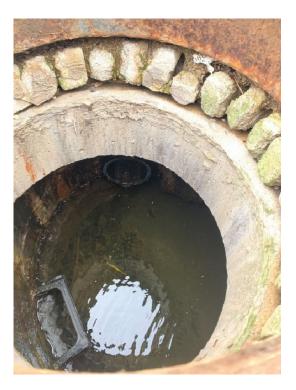
Photograph No. 15: Precast concrete catch basin with block around top and concrete collar at surface.

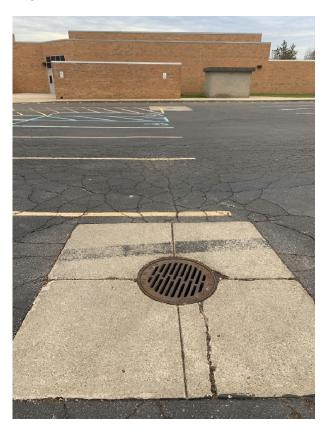
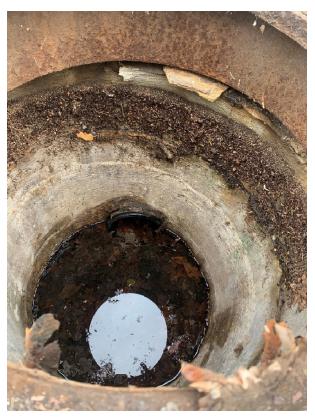
Photograph No. 16: Concrete collar around catch basin in fair condition. Precast basin structure.

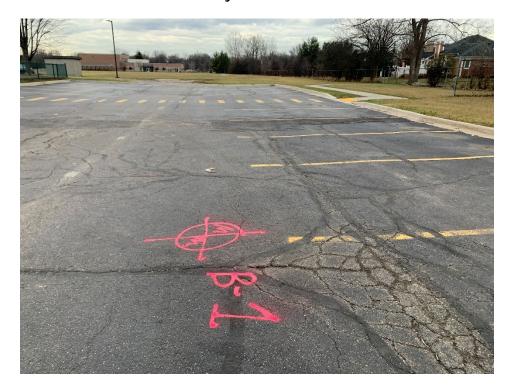
Photograph No. 1: Moderate to high severity block and fatigue cracking looking west toward B-1 and beyond.

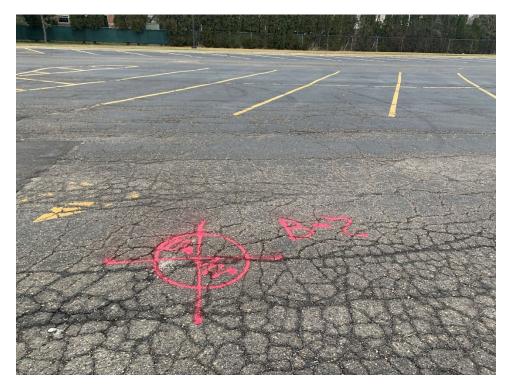
Photograph No. 2: Looking north toward B-2, high severity fatigue cracking.

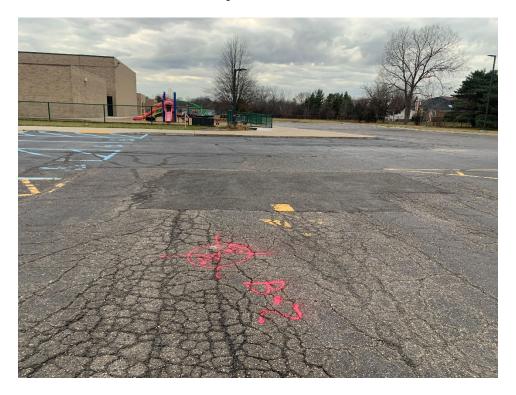
Photograph No. 3: High severity fatigue cracking near B-2 looking west. Note patch in pavement.

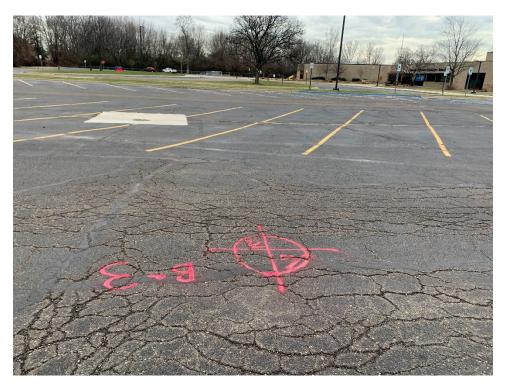
Photograph No. 4: Looking south from B-3, high severity fatigue cracking. Note new concrete collar around catch basin.

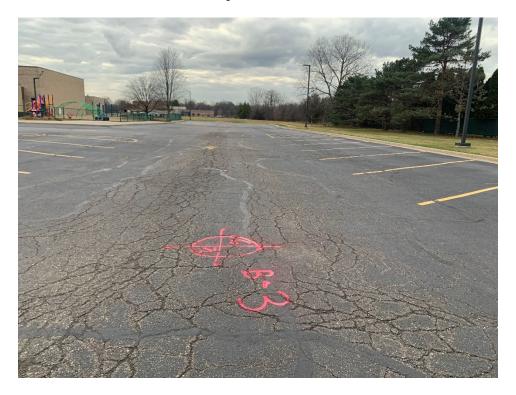
Photograph No. 5: High severity fatigue cracking near B-3, looking west across lot.

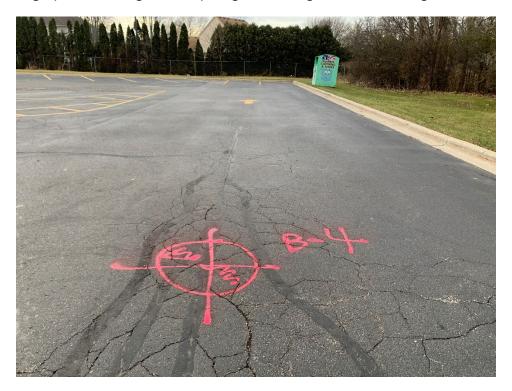
Photograph No. 6: Low to moderate severity block and fatigue cracking. Looking north at B-4 and beyond.

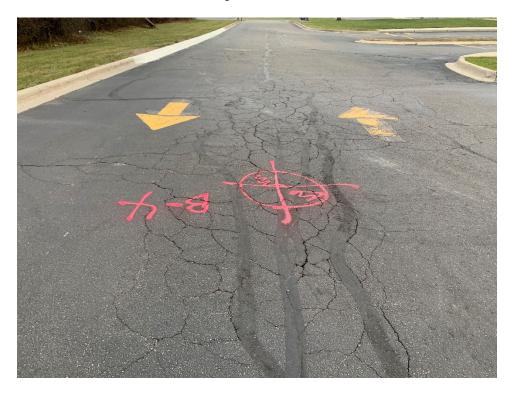
Photograph No. 7: Moderate severity block and fatigue cracking looking at B-4 and beyond.

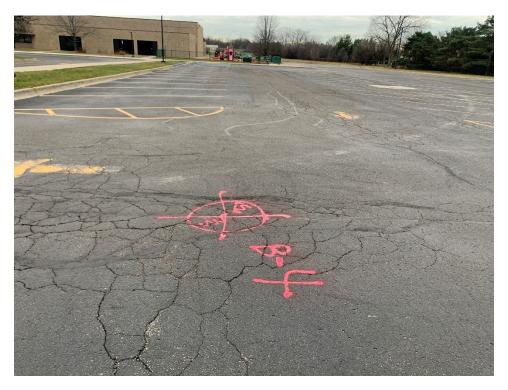
Photograph No. 8: Moderate severity fatigue cracking looking at B-4 and beyond. Moderate to high severity distress visible across entire lot.

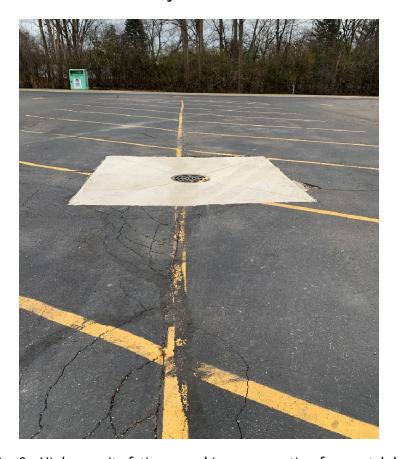
Photograph No. 9: High severity fatigue cracking propagating from catch basin near B-3.

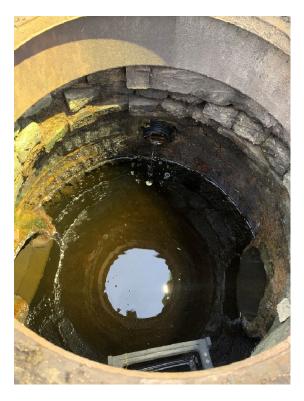
Photograph No. 10: Interior of catch basin.

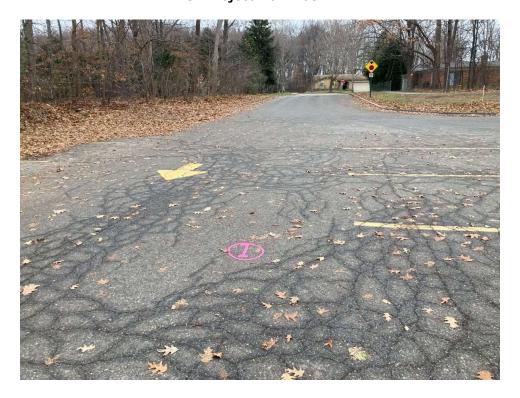
Photograph No. 1: High severity block and fatigue cracking near boring B-1. View to the north.

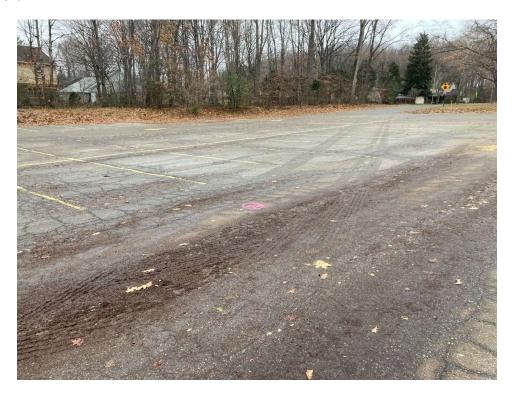
Photograph No. 2: High severity block and fatigue cracking near boring B-2. View to the northwest.

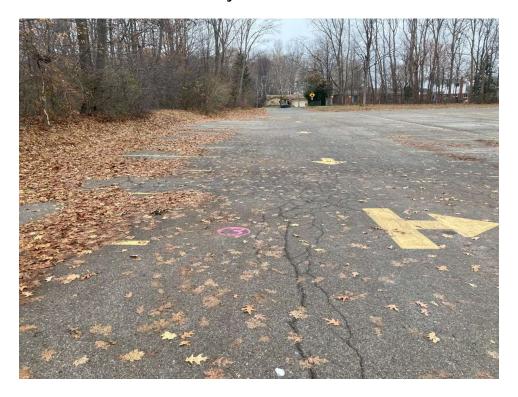
Photograph No. 3: Moderate to high severity block and fatigue cracking near boring B-3. View to the north.

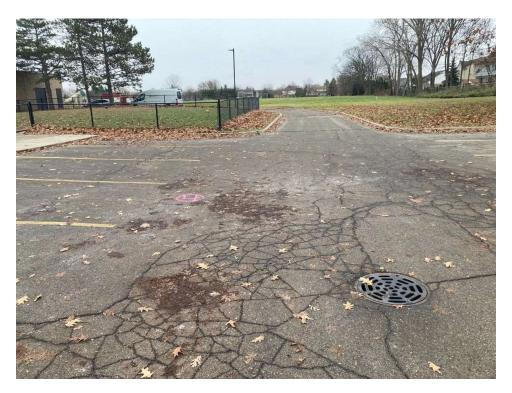
Photograph No. 4: Moderate to high severity block and fatigue cracking near boring B-4. View to the south.

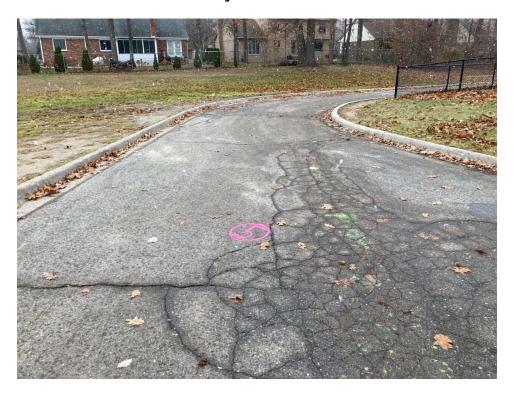
Photograph No. 5: Moderate to high severity block and fatigue cracking near boring B-5. View to the northwest.

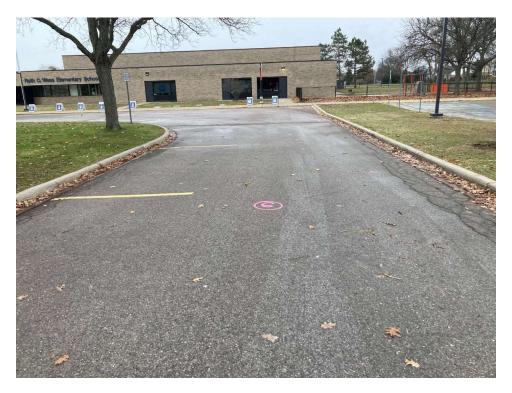
Photograph No. 6: Low severity edge cracking near boring B-6 View to the south.

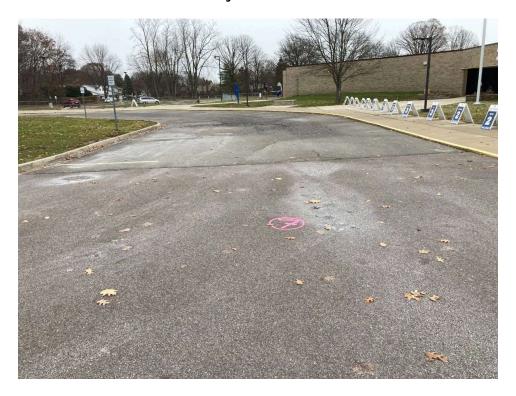
Photograph No. 7: Low severity transverse cracking near boring B-7. View to the east.

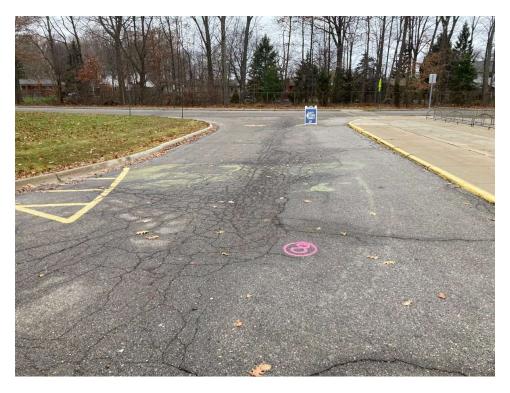
Photograph No. 8: Moderate to high severity block and fatigue cracking near boring B-8. View to the north.
