Piedmont Unified School District

FACILITIES ASSESSMENT

February 10, 2016

QUATTROCCHI KWOK
ARCHITECTS

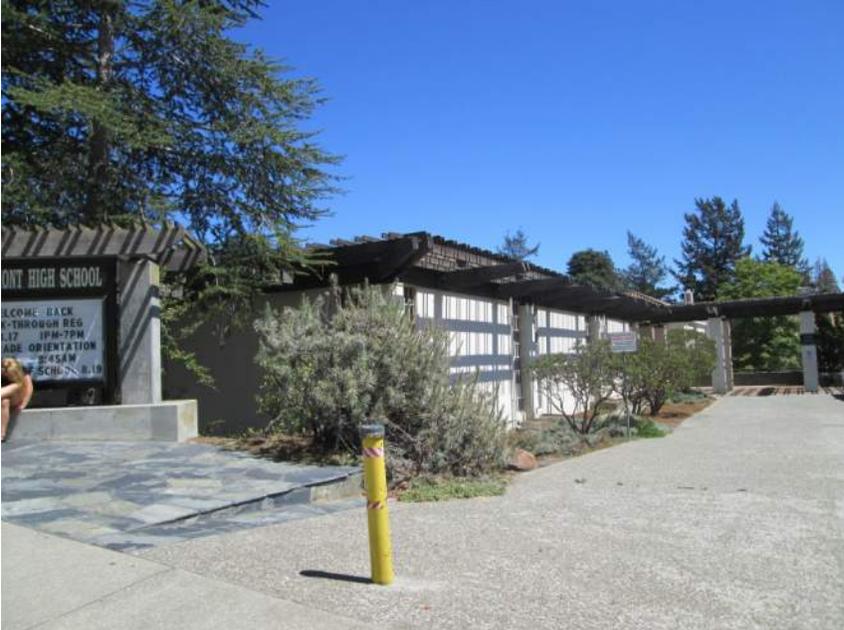
PHS Entry at Magnolia

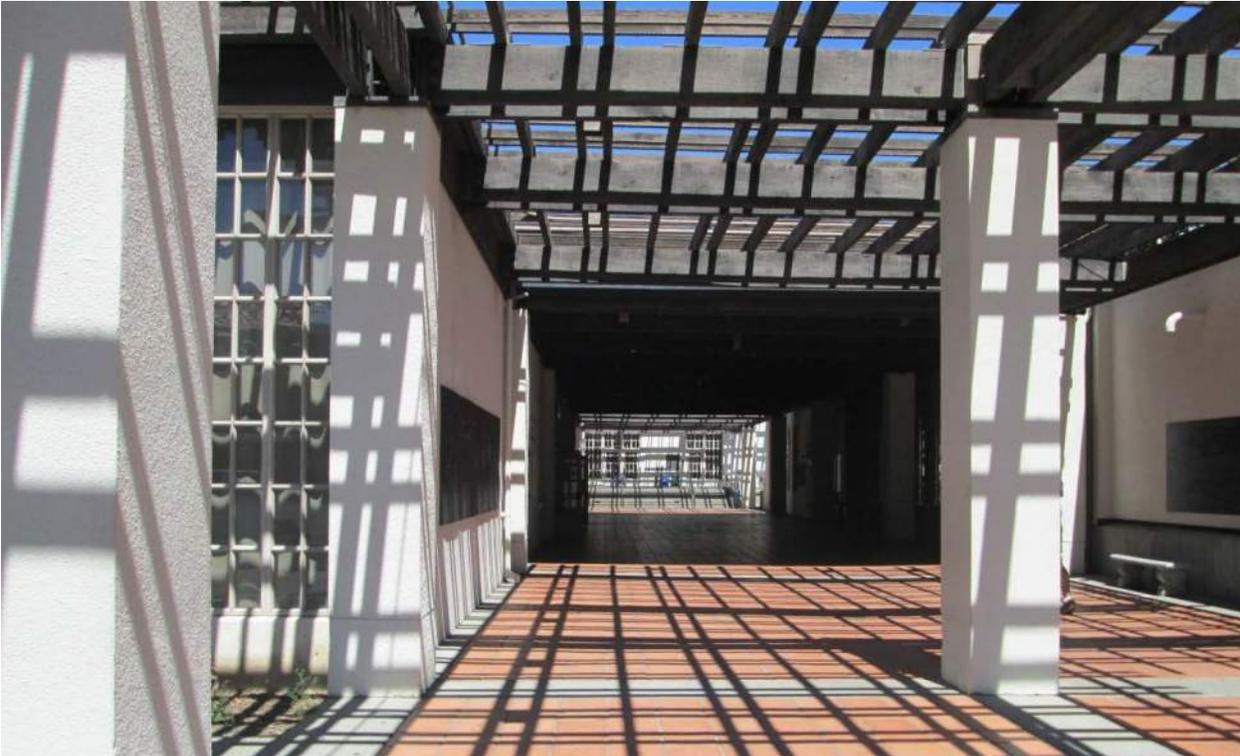
Looking towards Administration

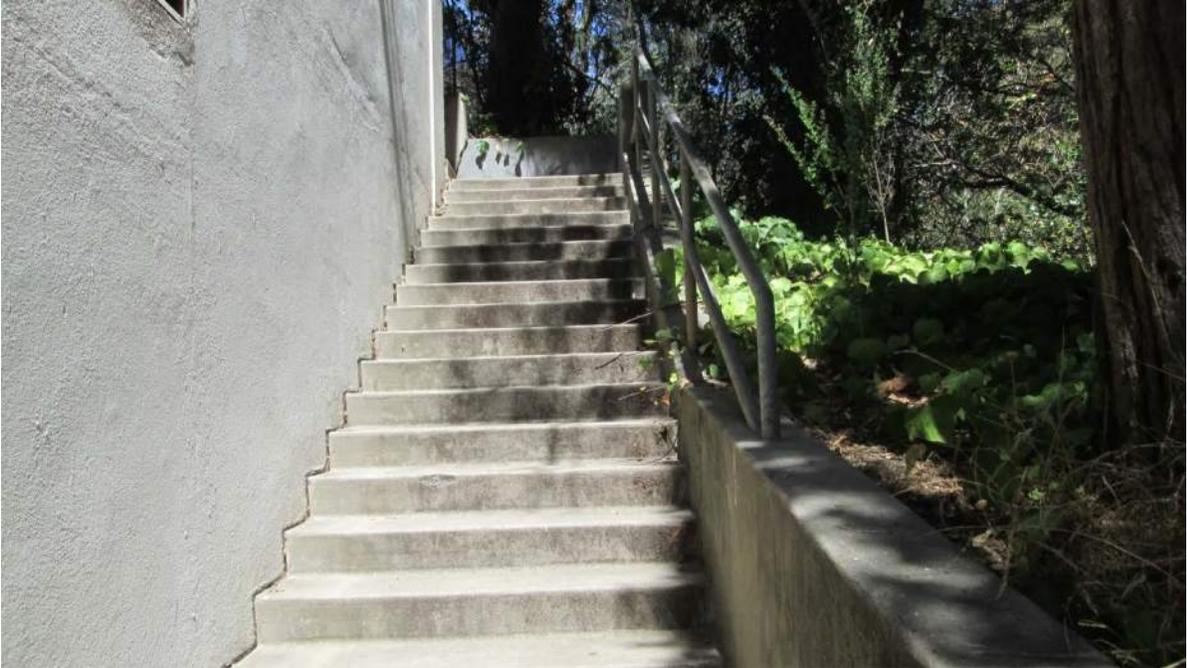
Stair at Park side of 30's building

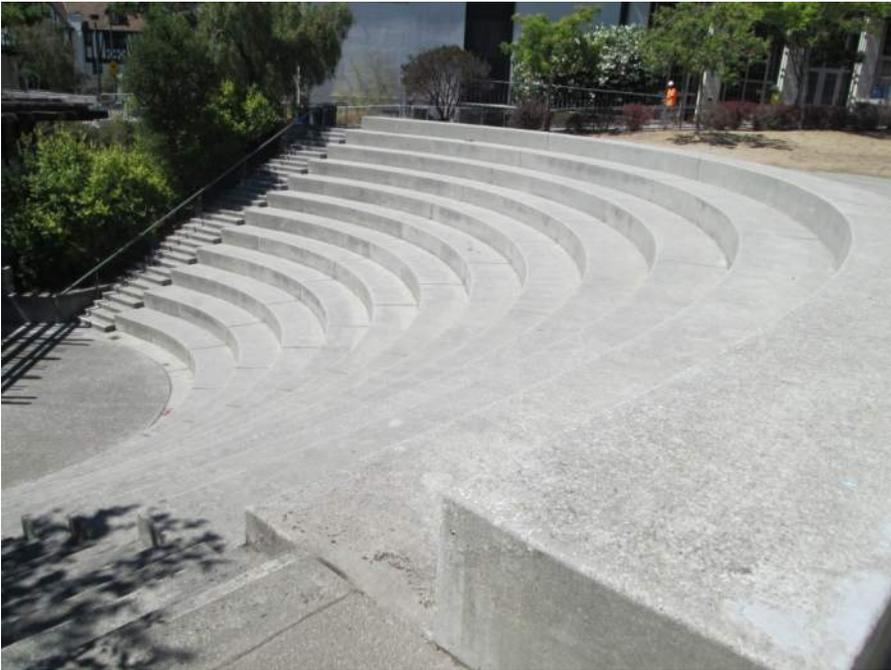
Amphitheater

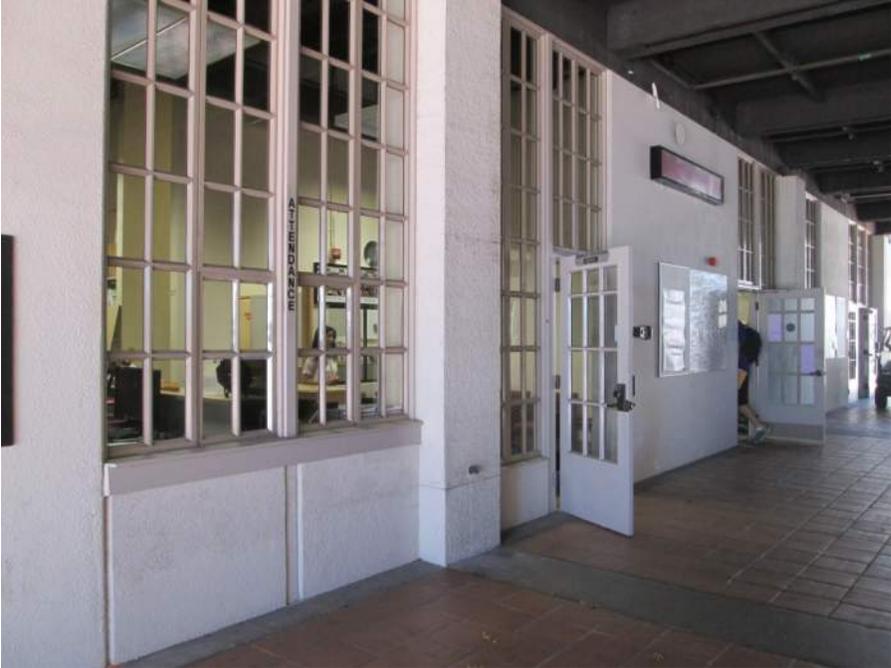
Entry to Administration

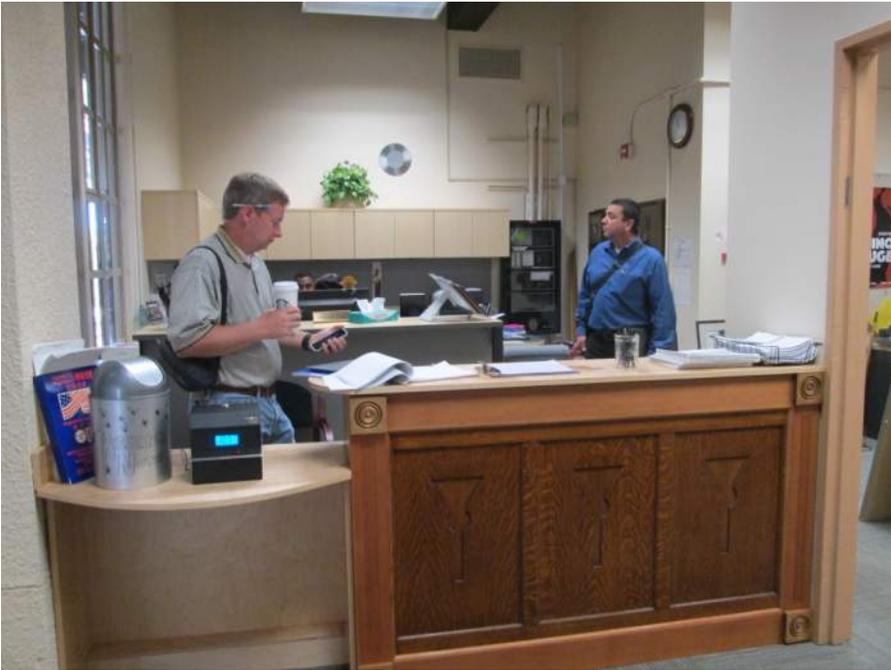
Administration Entry

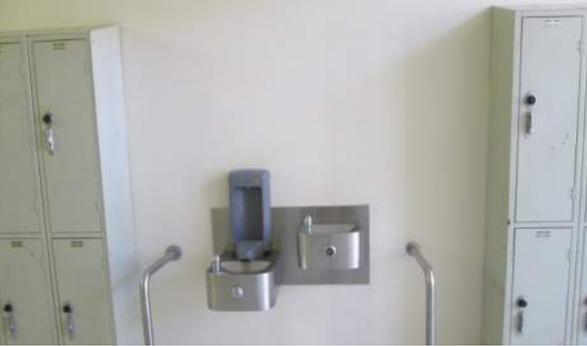
Drinking Fountains

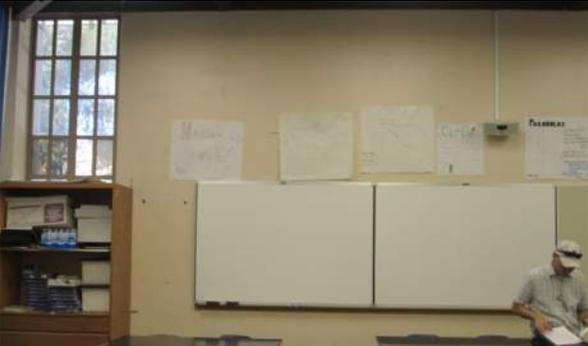
Typical Classroom Interior

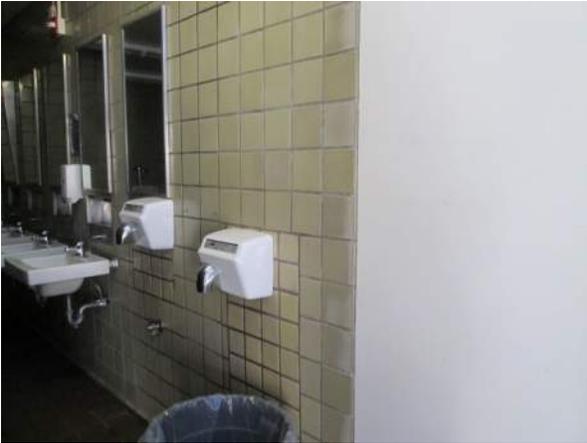
Boys' Restroom 1

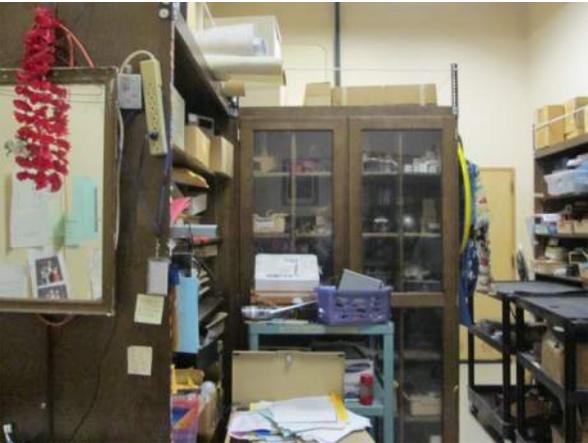
Storage and Office

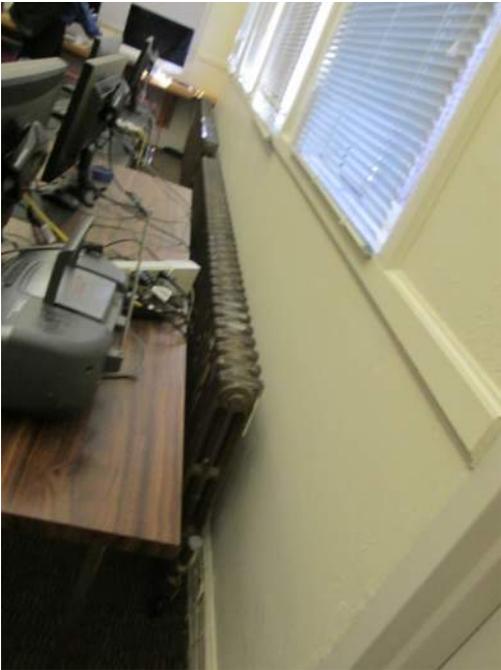
Older heating systems

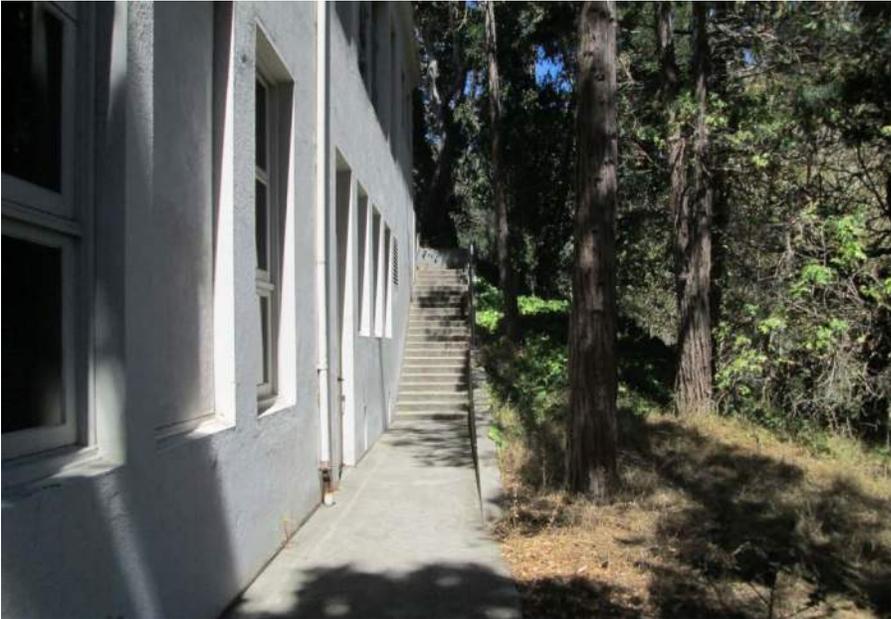
Building adjacent to park

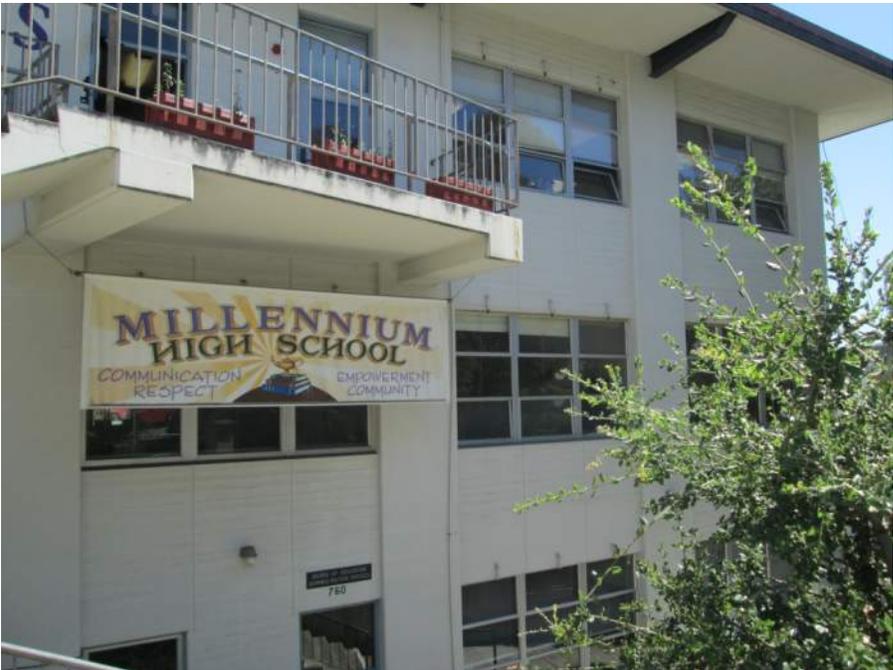
Millennium Entry

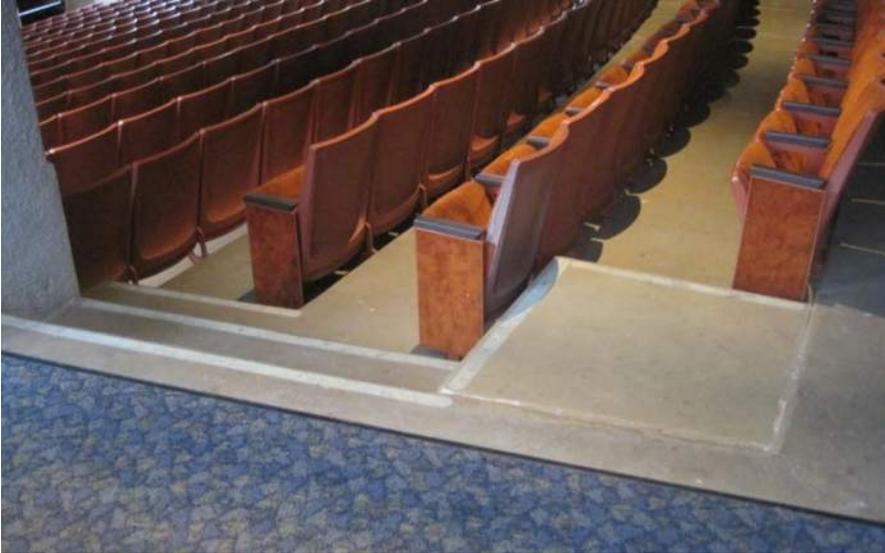
Aisle ends

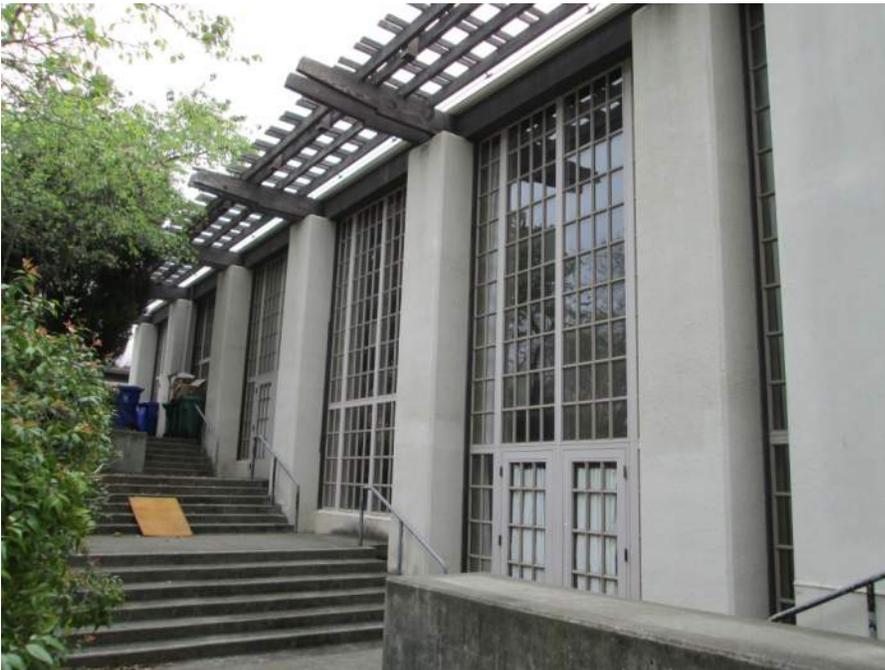
Stepped exterior pathway

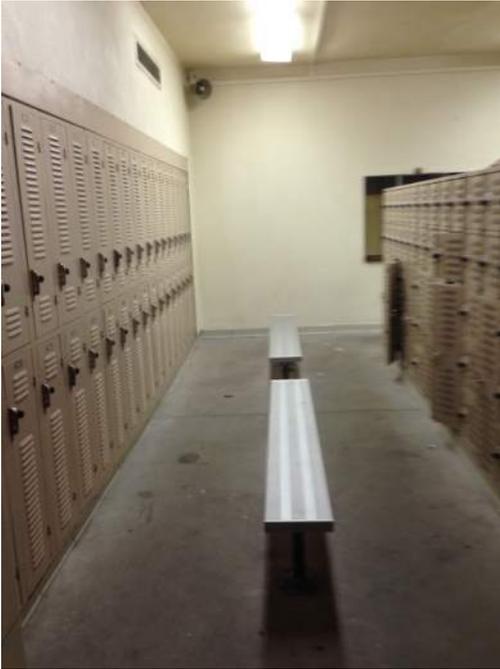
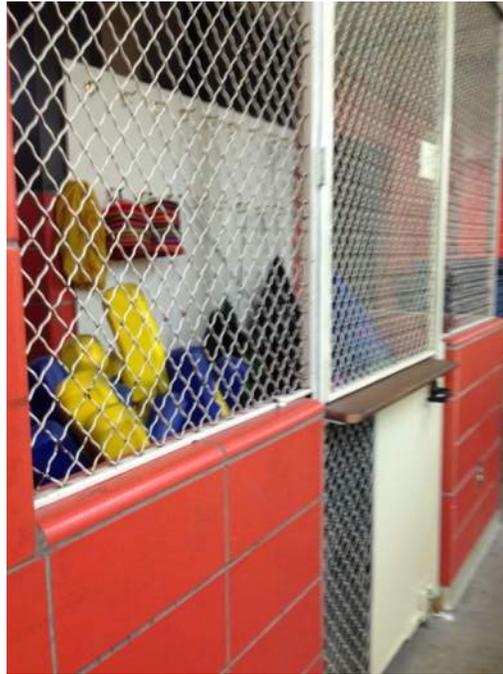
Locker Rooms

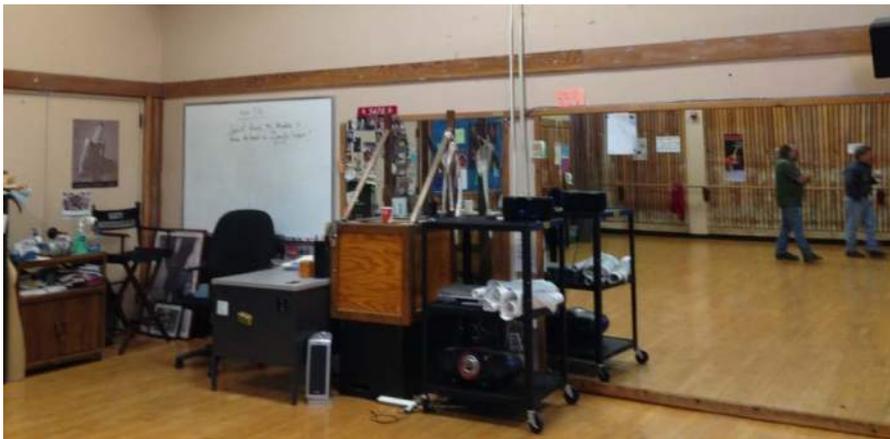
Dance Room
