# FACILITY ASSESSMENTS

# PIEDMONT HIGH SCHOOL

# 10'S AND 20'S BUILDINGS

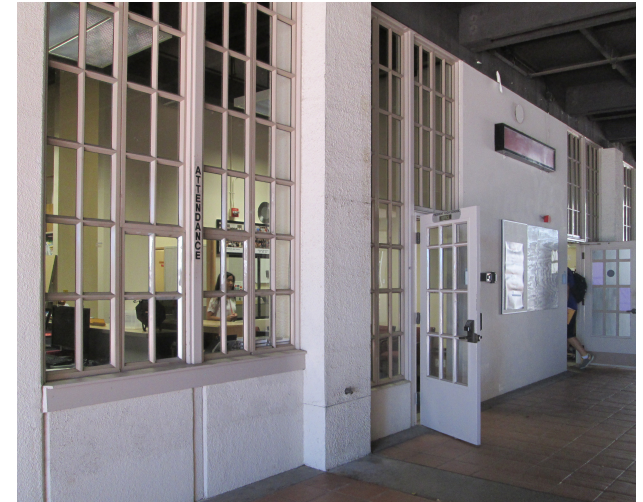
Administration Entry

- Administration has no oversight of school entry
- Administration crowded
- Under-sized classrooms
- Non-accessible restrooms and support spaces
- Outdated and inefficient mechanical systems
- Lighting and glare in classrooms

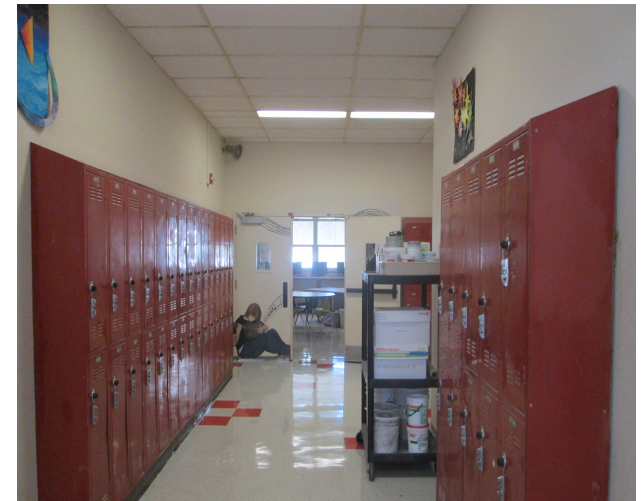
Corridor

- Multiple levels and entry points
- Multiple Accessibility issues
- Noise transfer between rooms

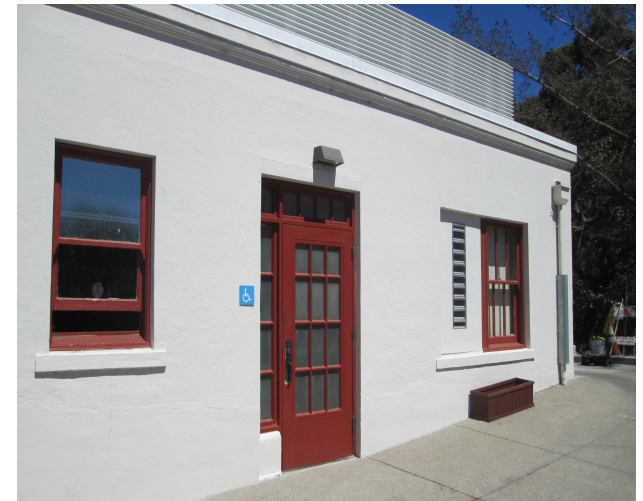
Special Education Offices

- Acoustic issues in cafeteria during presentation
- Special Education wing somewhat isolated
- Culinary Arts currently uses cafeteria as classroom

- Building in very good condition, needing minimal improvements
- Upgrade cafeteria interior for presentation
- Relocate Special Ed and repurpose wing to large classroom

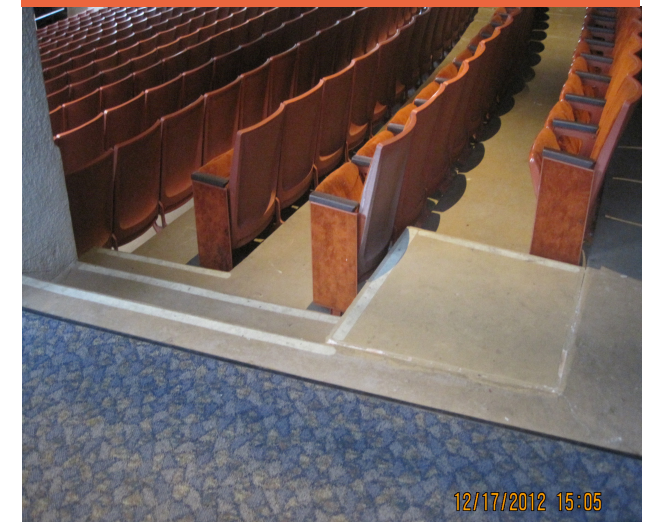
Seating

- A day-lit auditorium, not ideal as a theatrical performance space, including lack of sound or light locks
- Many issues of non-compliant accessibility POT including in-house
- Undersized lobby and restrooms
- Lack of adequate back stage support spaces
- Does not support instruction in set design, sound, lighting or stage management
- Use as a drama classroom complicates scheduling and increases wear and tear
- Electrical panel must be replaced
- Minor structural system upgrade, but major dry rot at exterior trellis

- Good location for public access
- Slope can work with stepped seating

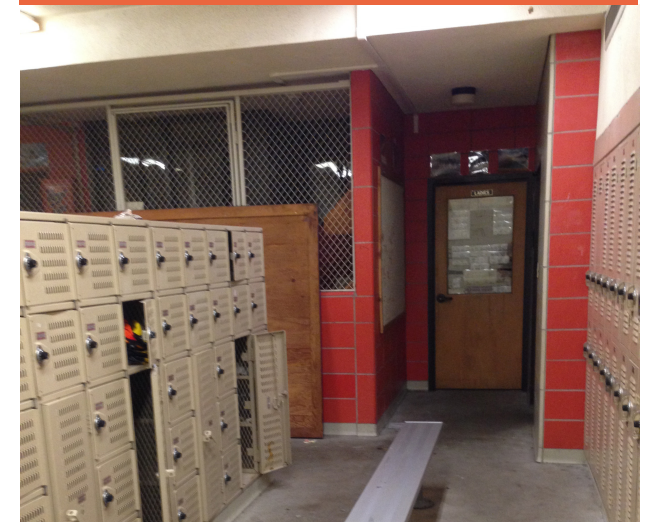
Locker Room

- Accessibility and maintenance issues at locker rooms
- Bleachers are not accessible
- Lighting needs to be upgraded
- Gym acoustics
- Circuitous accessible path of travel

- Limited area of modernization at locker rooms
- Upgraded lighting
- Upgraded sound reinforcement for presentation
- Identified as possible location for roof top solar
- Upgraded water heating more efficient

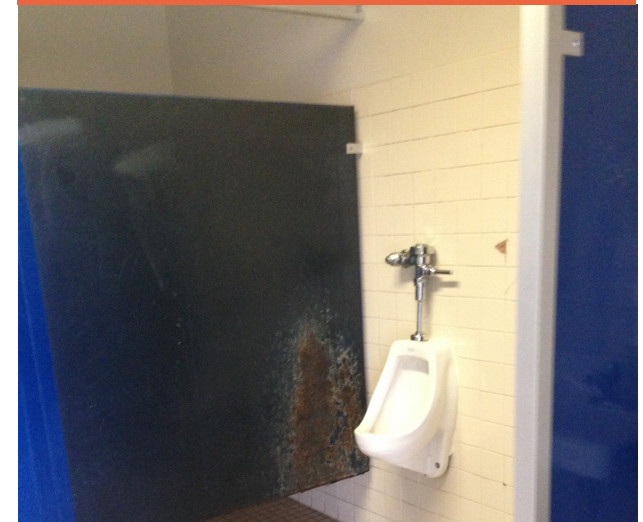
Public Restroom

- Worn finishes at the public restrooms
- Accessible path of travel issues

- Minor accessibility upgrades required
- Fully functional and appropriate as it is

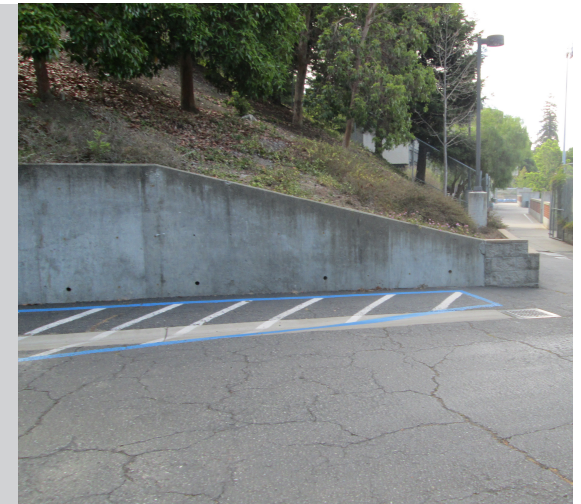
Accessible Parking

- No accessible parking or path of travel to bleachers
- Circuitous accessible route to field
- Sub-surface drainage requires investigation for solution
- Worn artificial turf field
- Bleachers do not meet current requirement for disbursed seating
- Existing "tennis" lights inadequate

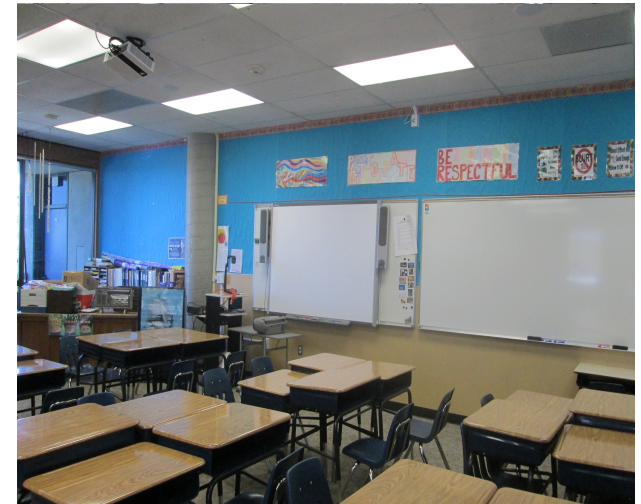
Classroom

- No administrative oversight of entry
- Multiple accessibility issues including restrooms, doors, and path of travel
- Undersized classrooms
- Operable walls don't work, limit electrical outlets
- Poor acoustic isolation from adjacent classrooms
- No operable windows or easy ability to ventilate

- Multiple opportunities for outdoor educational spaces to be created
- Structural system allows flexible configuration
- Building structure is sound
- Re-use of existing mechanical systems is possible
- Identified as possible location for roof top solar

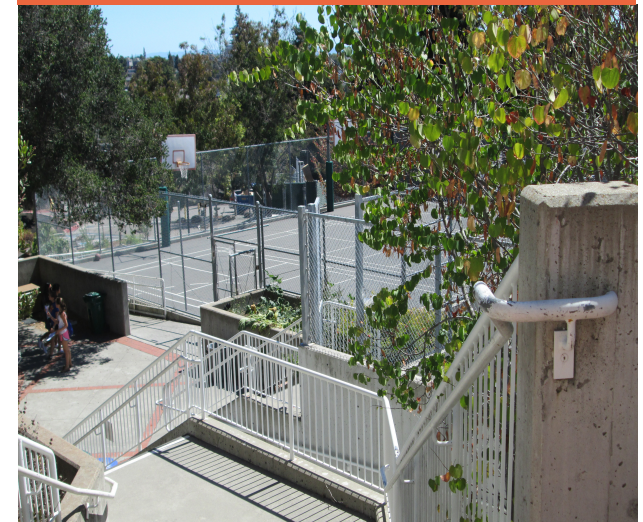
Courtyard / Stair Access

- Circuitous accessible route
- Multi-Use Room acoustics
- West facing glazing
- Computer Room heating / ventilation

- Enhanced landscape and courtyards
- MUR acoustic improvements
- Exterior shading and upgraded ventilation
- Identified as possible location for roof top solar

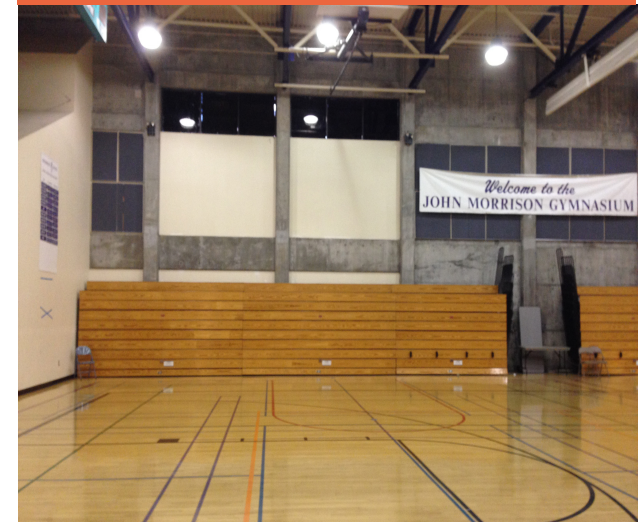
Basketball Courts

- Few issues of concern other than storage
- Minor upgrades at locker rooms required
- Accessible pathway circuitous
- Acoustic issues at gym

- Improve acoustic for presentation at gym
- Shared facility with high school
- Identified as possible location for roof top solar
