Project Observation Report

Project Name:	Tri Tech East Building	Project No.	2208
Report #:	14		
Observation Date:	1-11-23	Last Report:	1-4-23
Prepared By:	Steve Mallory, AIA	Contractor:	Banlin

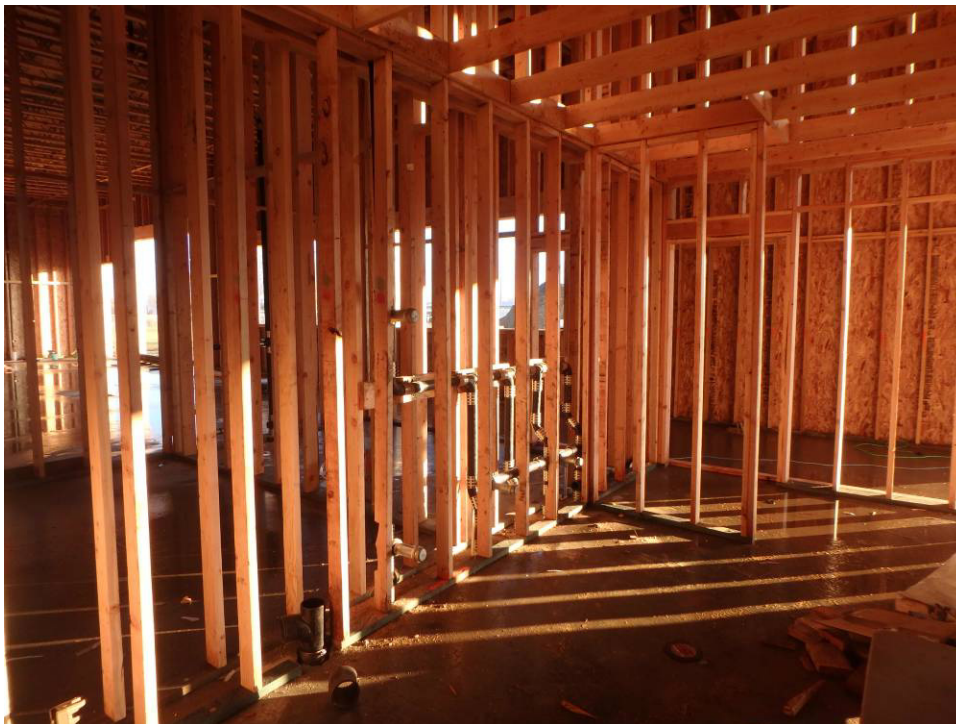
Restroom plumbing

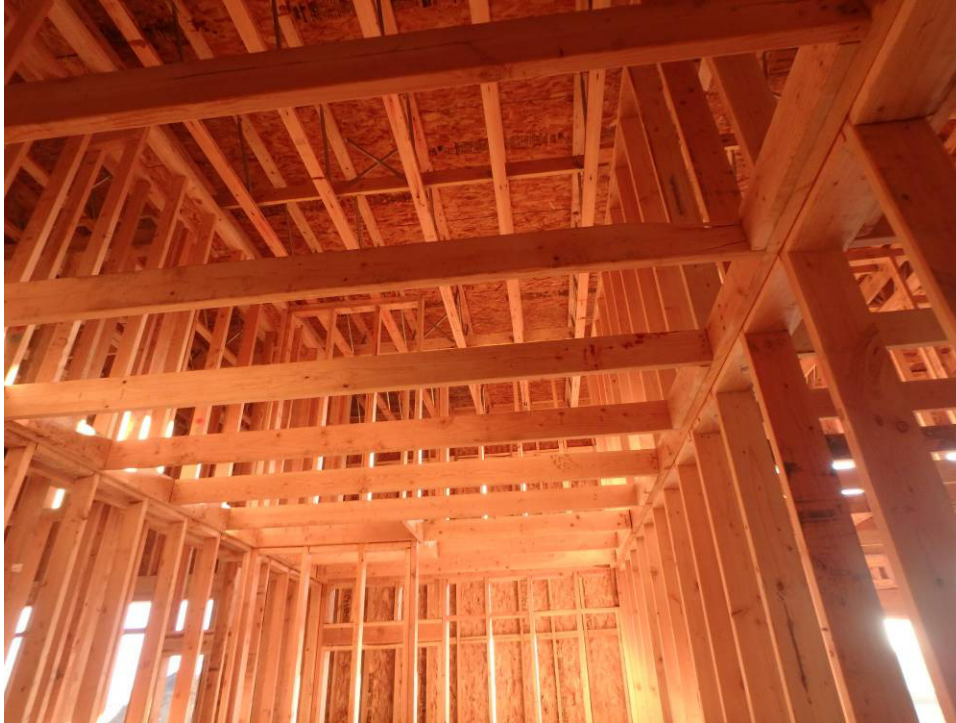
Restroom dropped ceiling framing

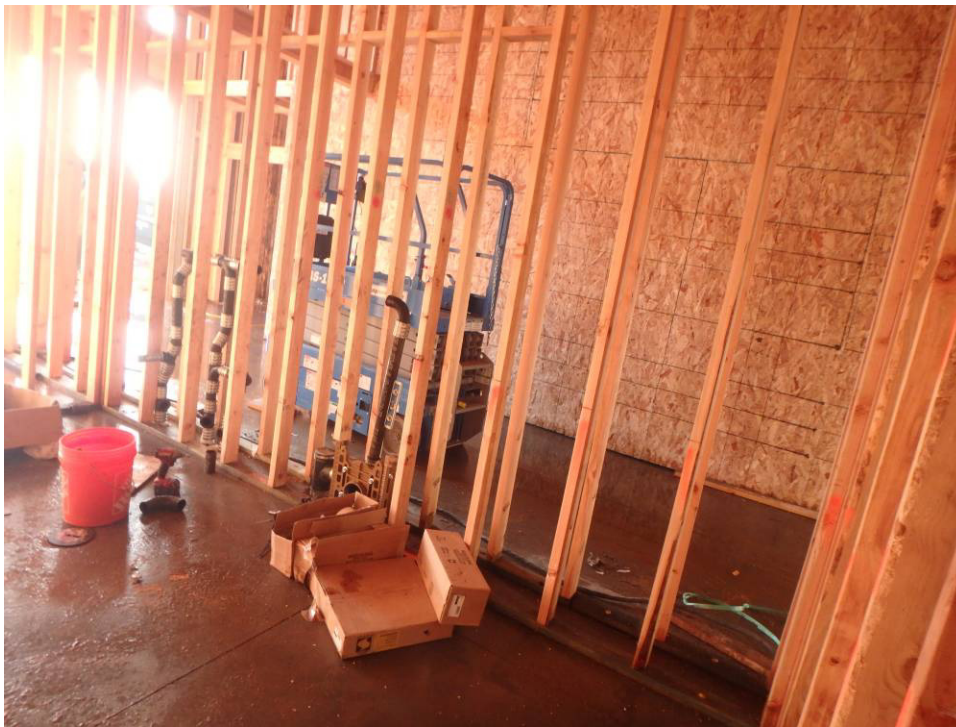
South Restroom rough-in and framing

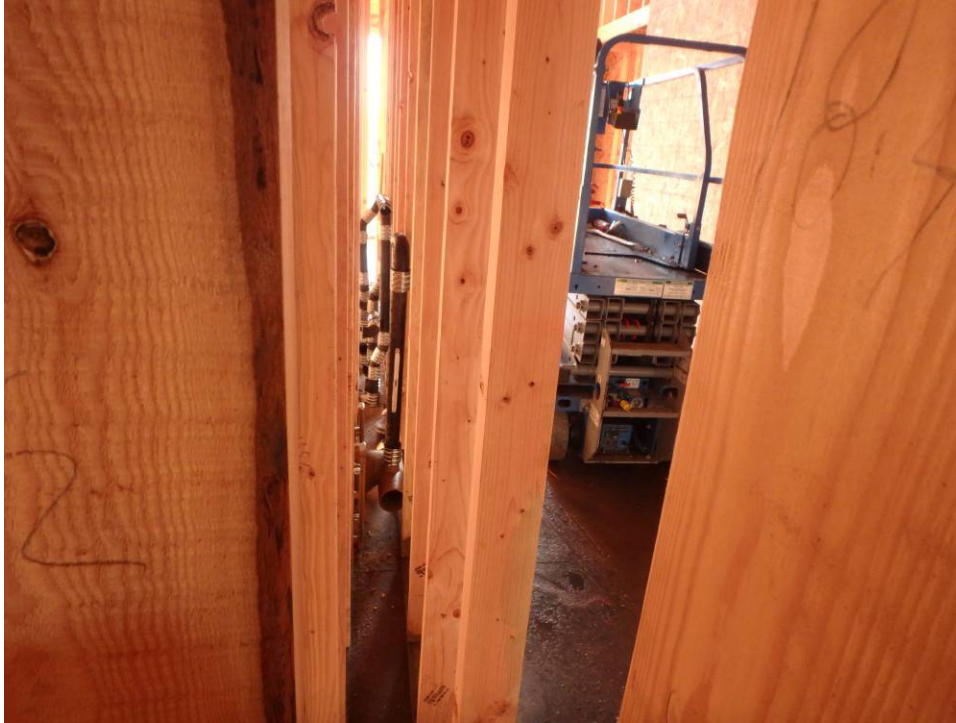
Plumbing chase

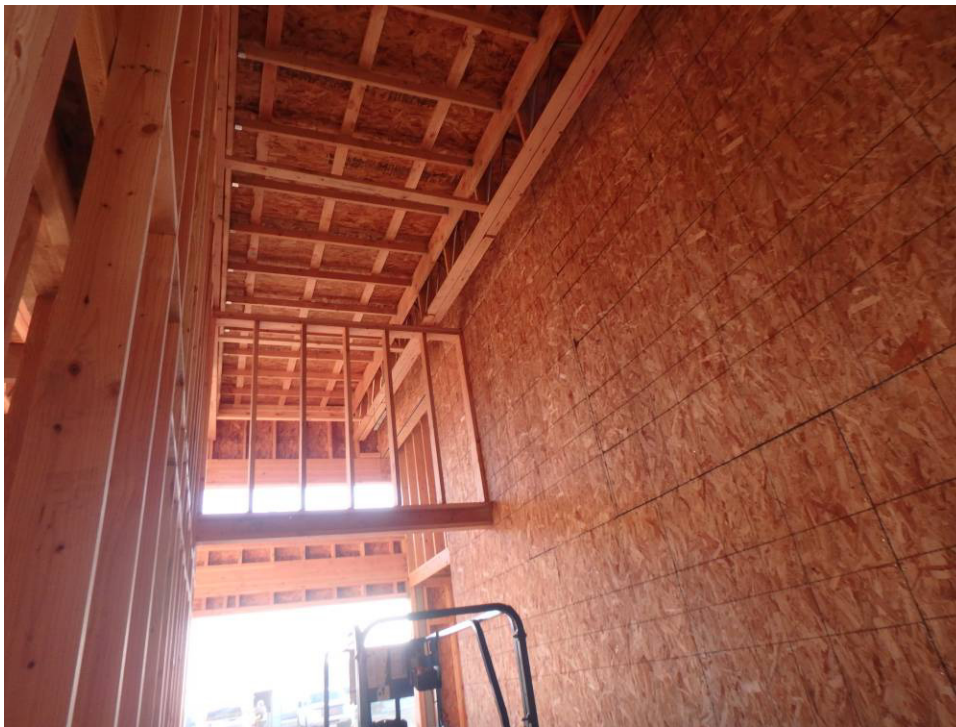
New roof and framing over the entry

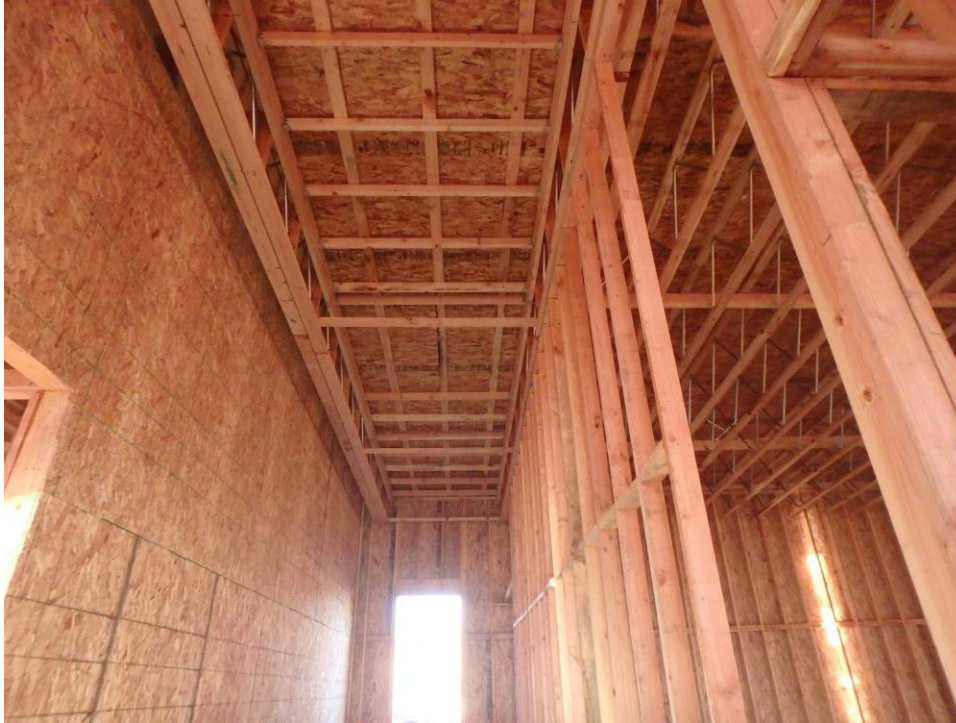
New roof and framing as viewed from the entry

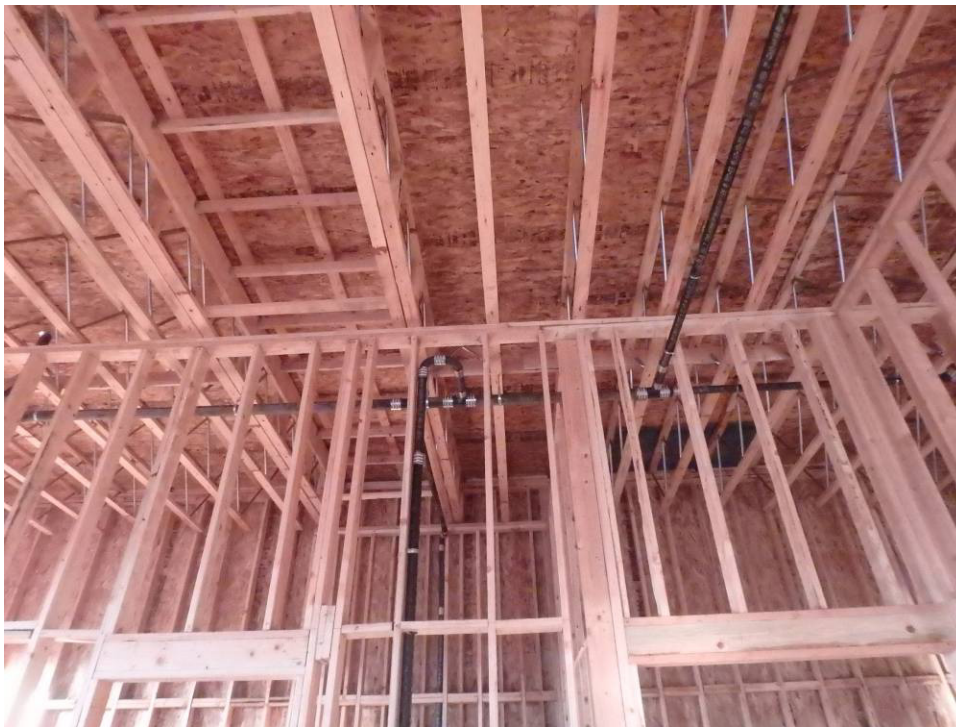
Looking west at the northwest corner of the lab – framing above

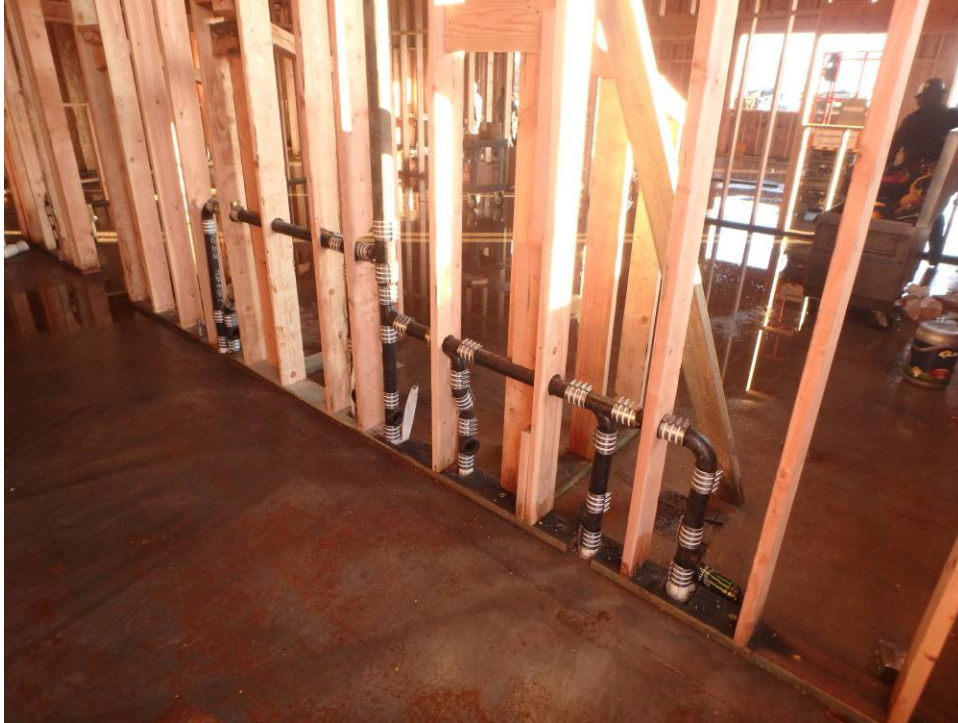
Plumbing stub-ups for the dog washes from the kennel side

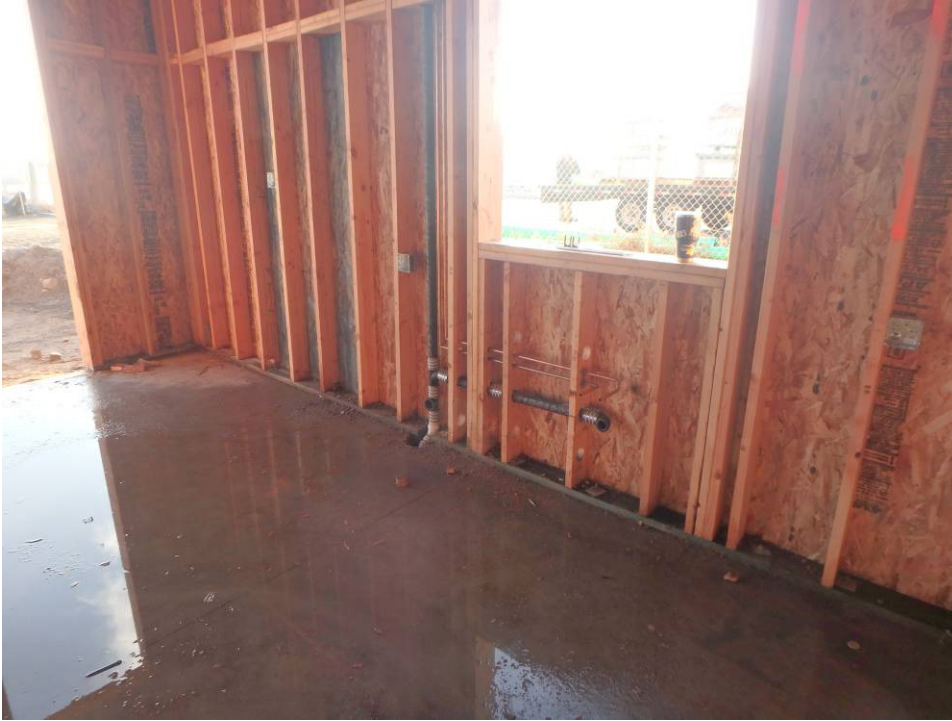
Looking at the southeast corner of the SE classroom framing, sheathing and plumbing

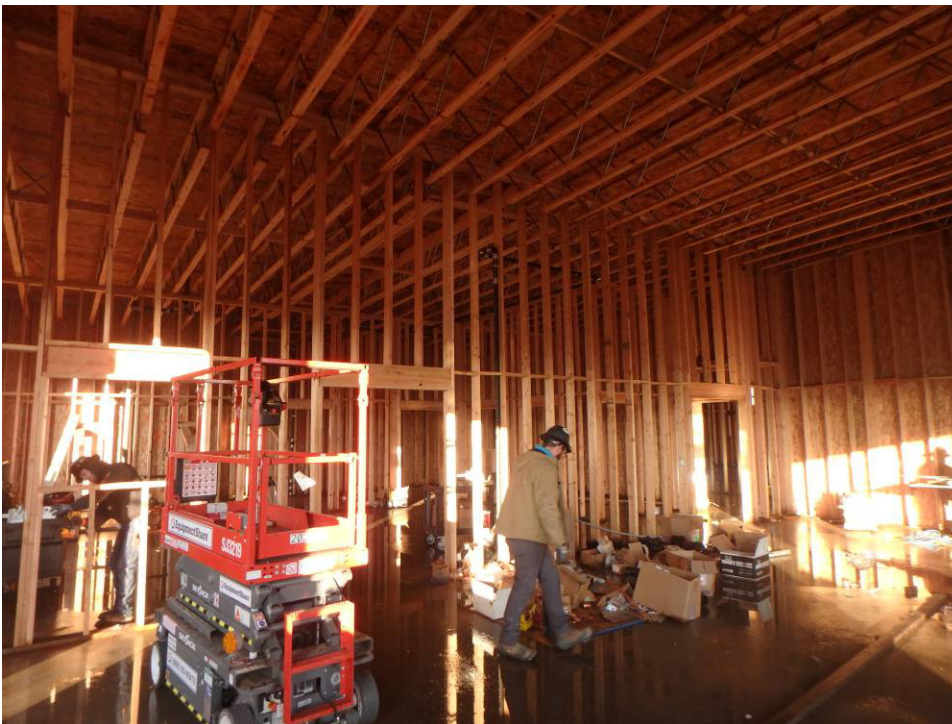
Looking north at the classroom (southeast room) framing, sheathing and roof framing

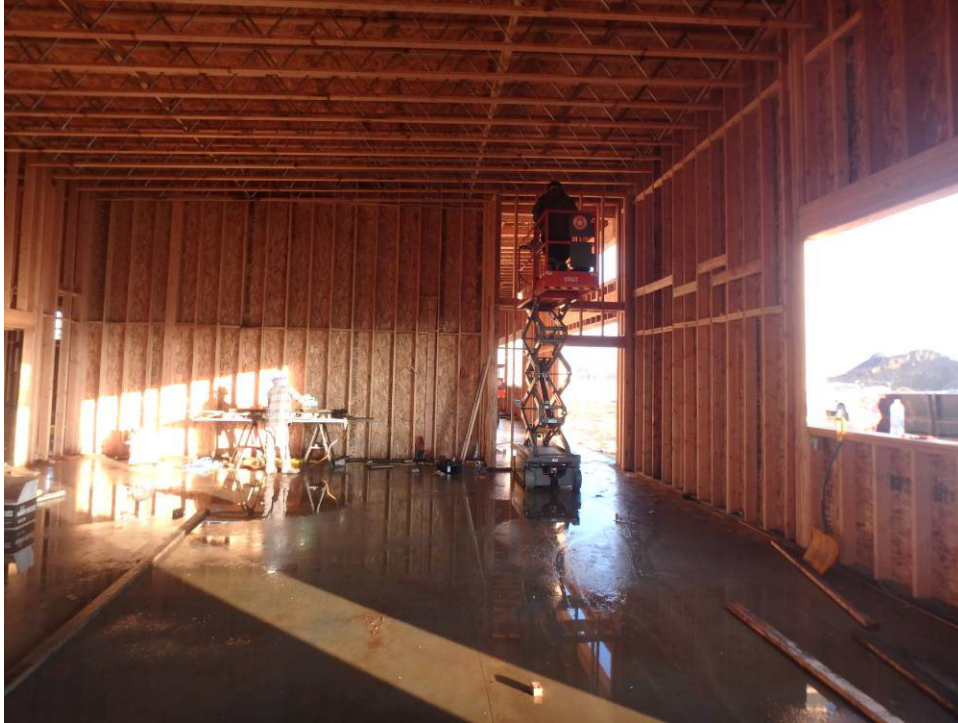
Looking north at the classroom entrance framing, sheathing and roof trusses

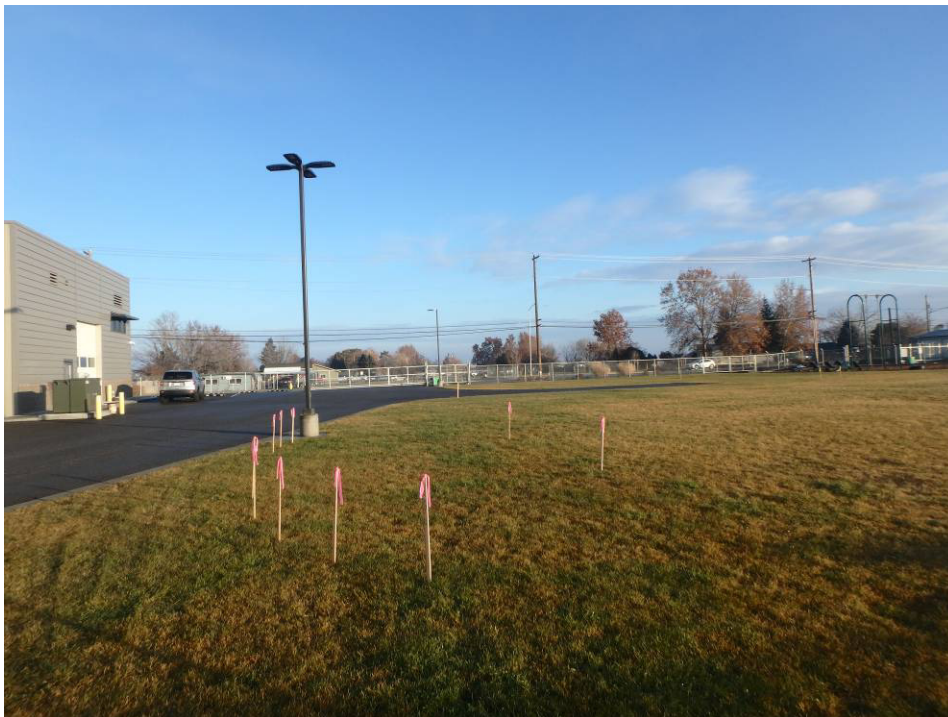
Looking north from the north property line to the newly surveyed curbing layout
