Project Observation Report

Project Name:	Tri Tech East Building	Project No.	2208
Report #:	17		
Observation Date:	2-1-23	Last Report:	1-25-23
Prepared By:	Steve Mallory, AIA	Contractor:	Banlin

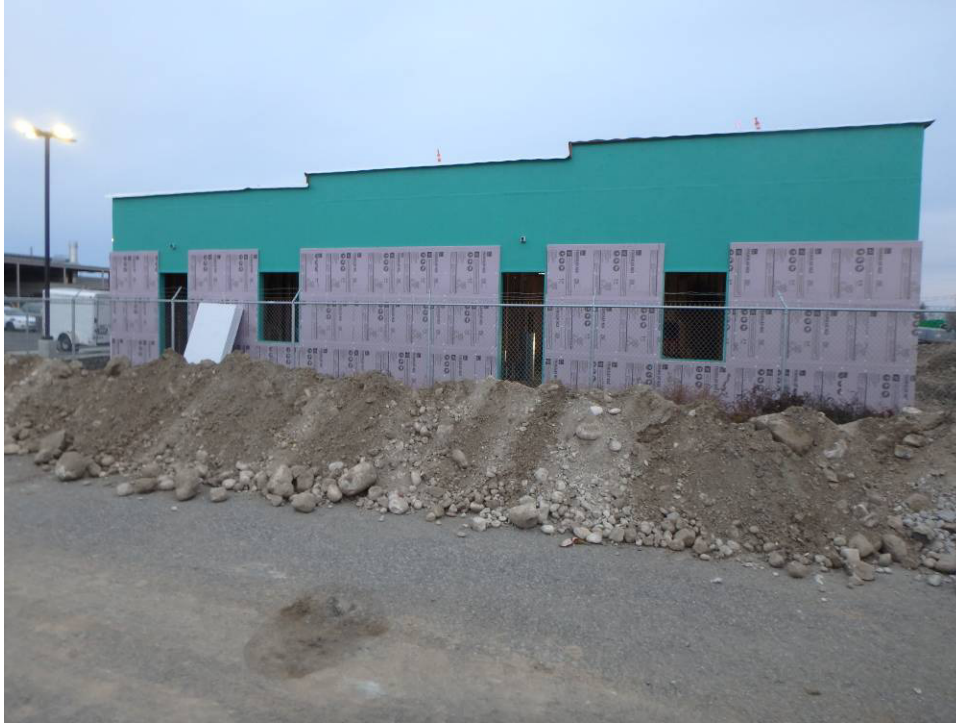
South elevation insulation board and liquid-applied

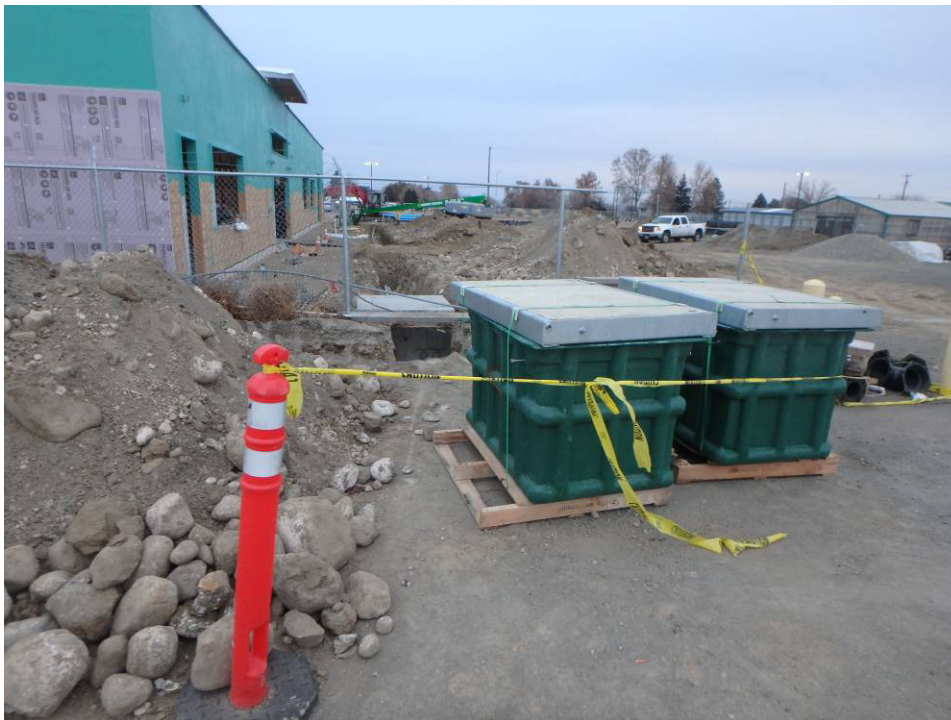
Two of the three Fiber vaults

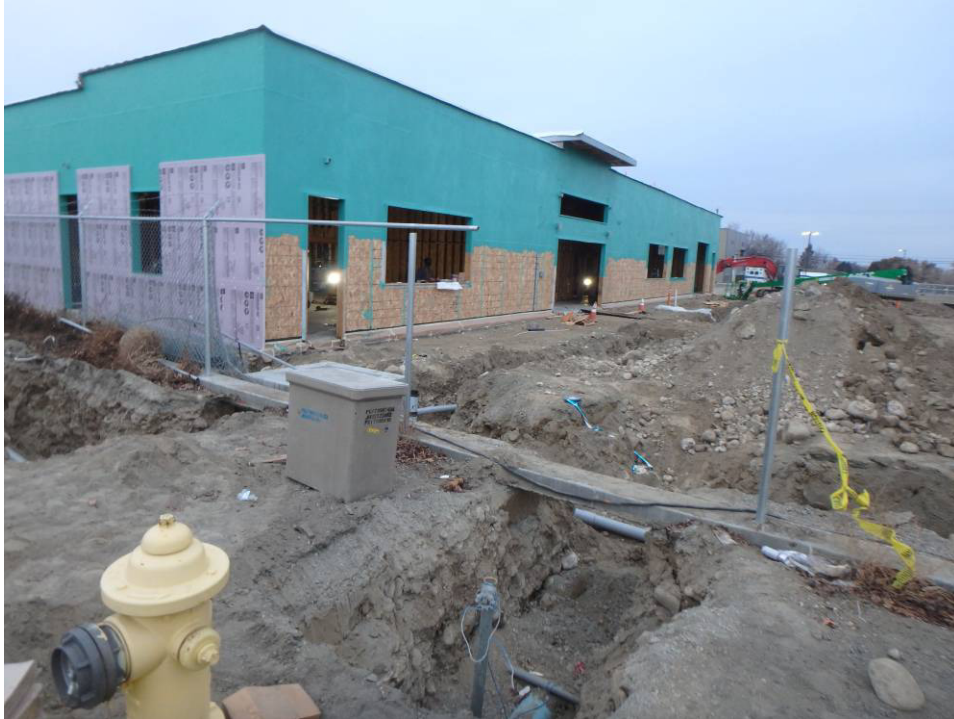
Trenching at the southeast fire hydrant and the east elevation

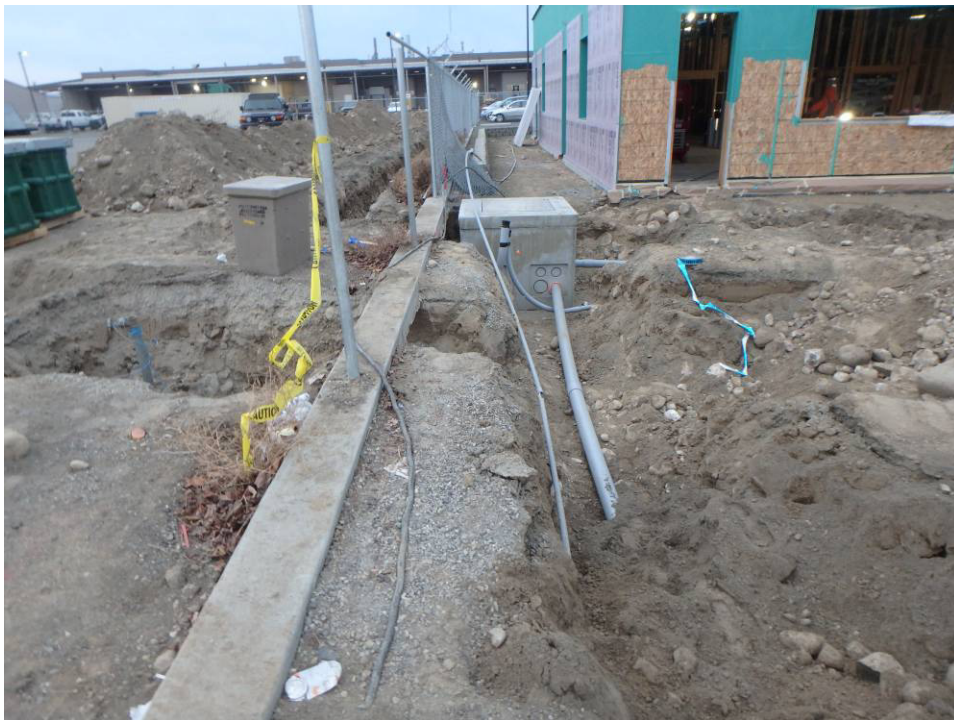
Looking west at the SE electrical vault

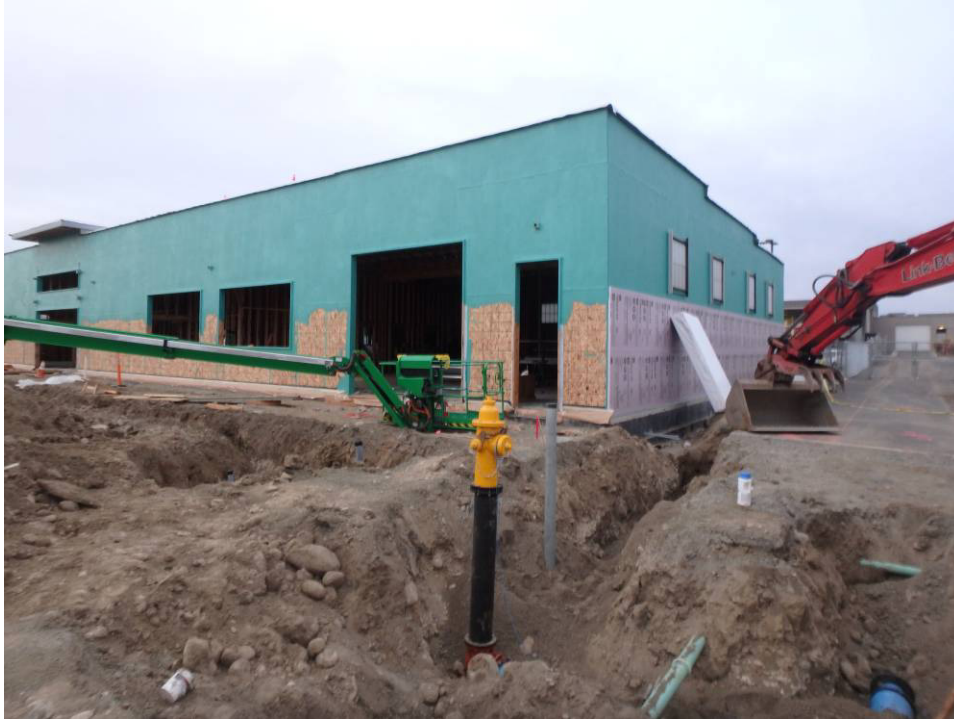
Field Discussions: The PUD electrical vault is set at the SE corner of the building. The sanitary line to the north has been backfilled. The FDC and the fire hydrant are in on the NE corner of the building. The fire water line at the NE fire hydrant trench is open and you can see a 2" irrigation line, a 2" conduit for 1 cat6 line going east. The east wall of the building has 50% of the fluid-applied membrane installed. Lights have now been delivered and are stored. The TPO and roof curbs are installed. Electrical on-going on the south half of the building. HVAC install has started in the south half. The north Kalwall window openings not have the Kalwall installed. Gas line work schedule late morning the 8th. The existing asphalt is cut to the west fire hydrant and also to the north. The west half of the main corridor ceiling to be raised 6" and wall section at the electrical panel to be built out to 6" depth. Also discussed the SE end of the retaining wall and how that should be terminated.

Northeast corner of the building and fire hydrant

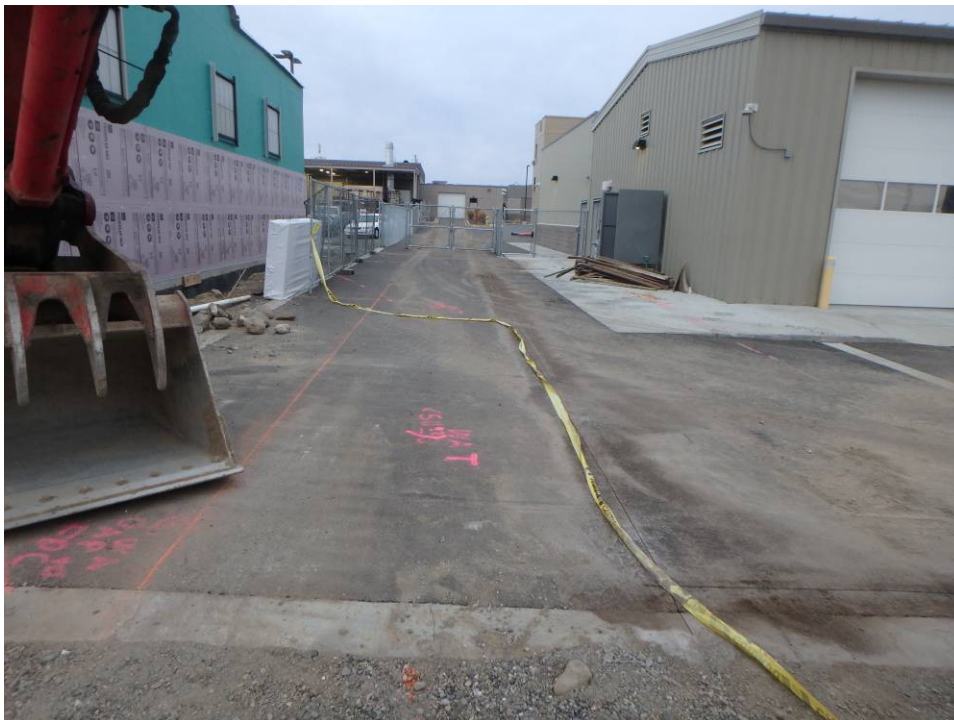
Looking west at the saw cuts to the northwest fire hydrant between the buildings.

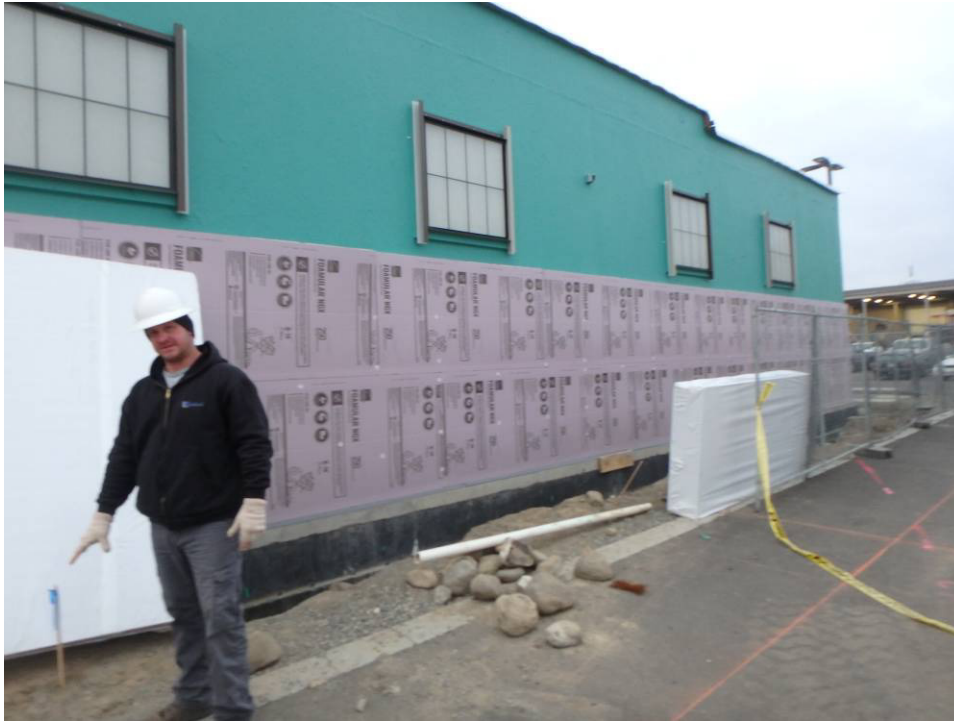
North elevation insulation and translucent windows

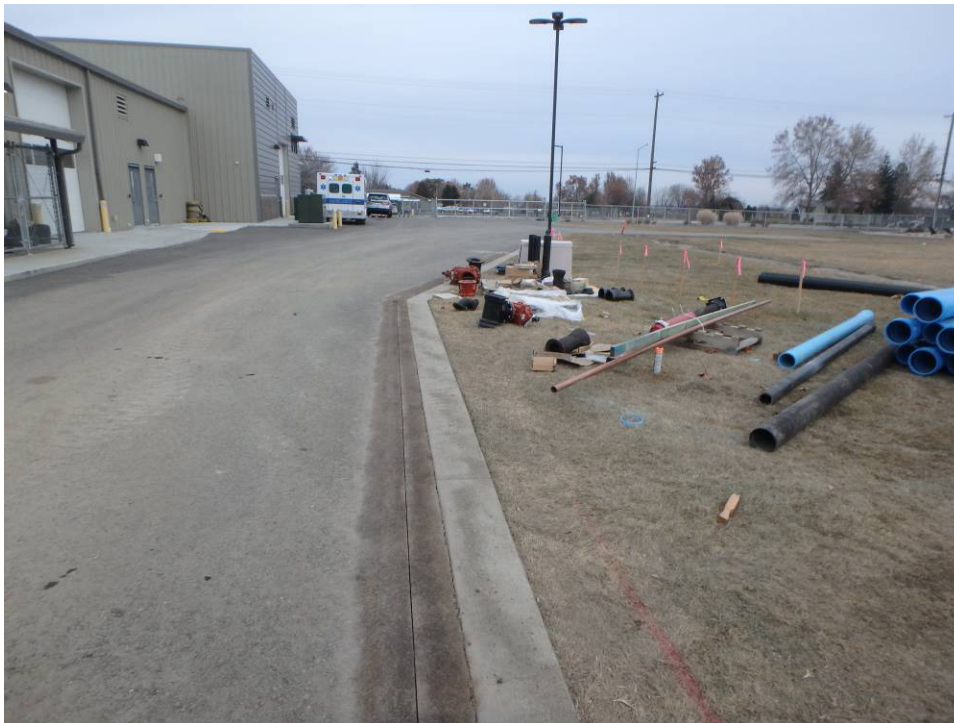
Looking north at the new sawcuts

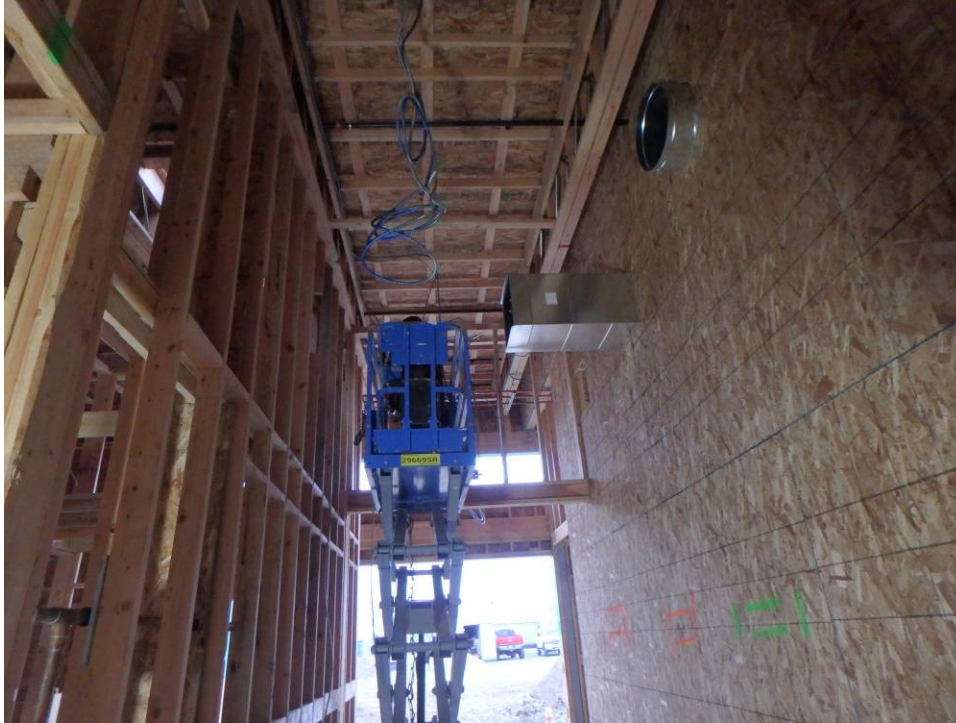
Looking east at the main entry, new ductwork

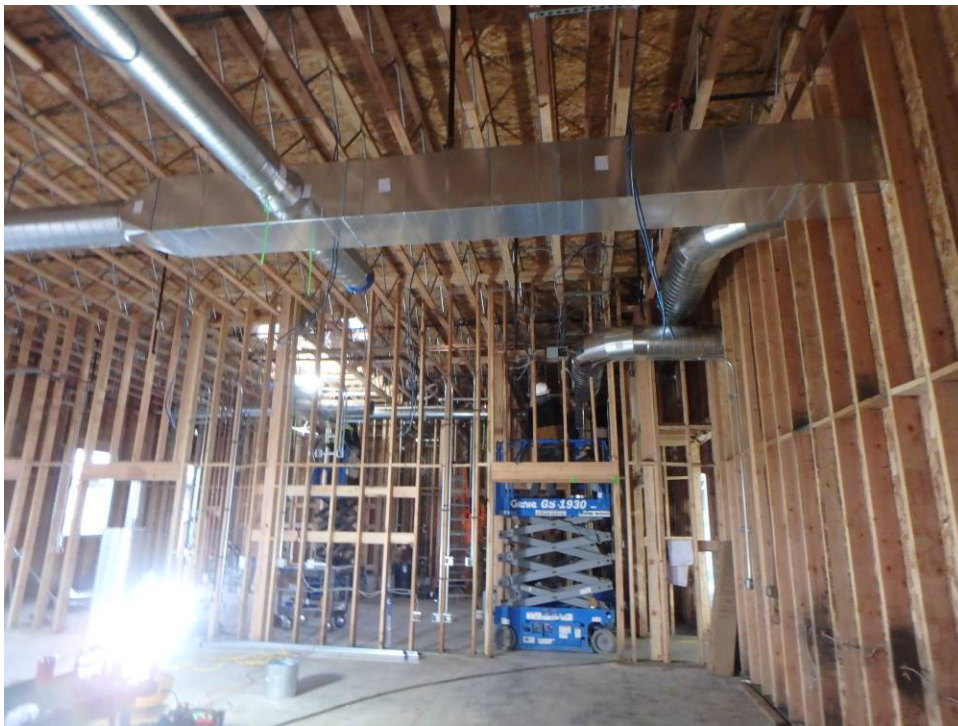
Looking west along the north wall of the south classroom at the duct crossing from the main corridor

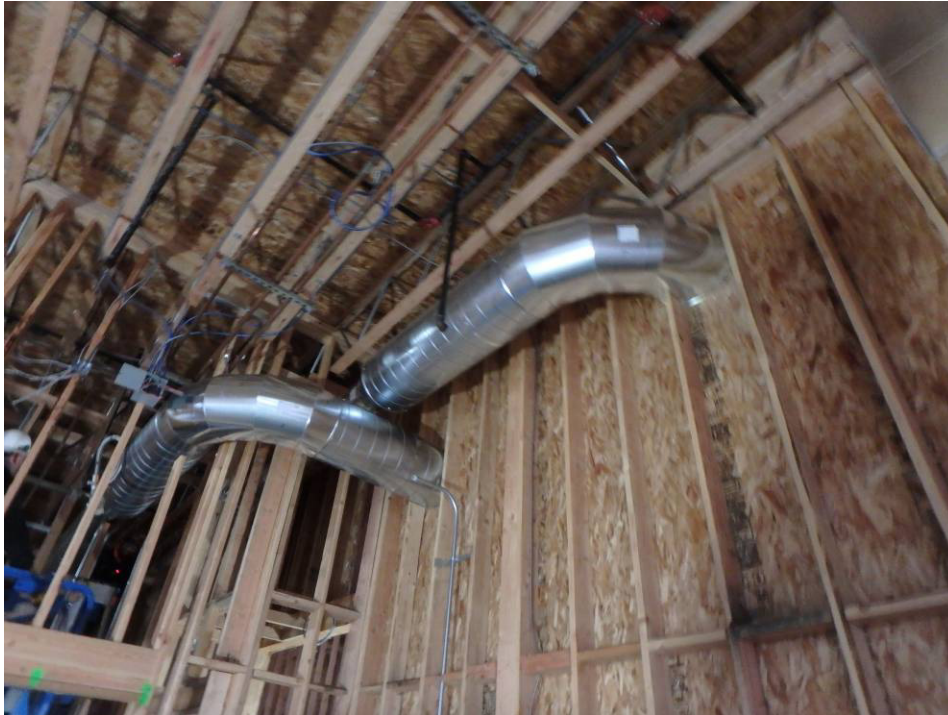
Looking west along the north wall of the south classroom ductwork

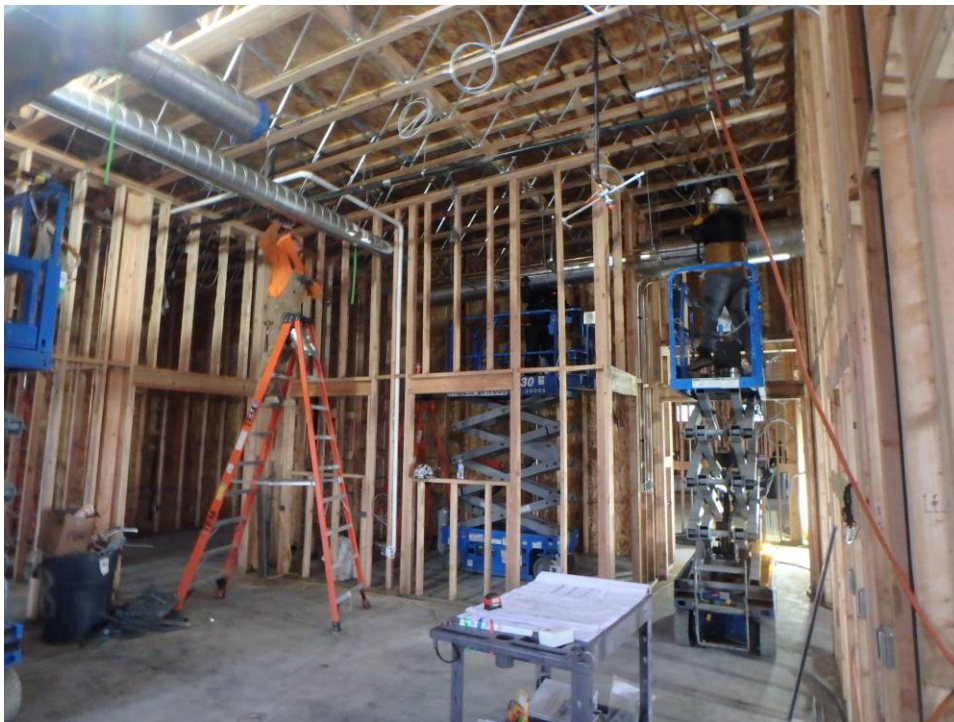
Office framing and ductwork

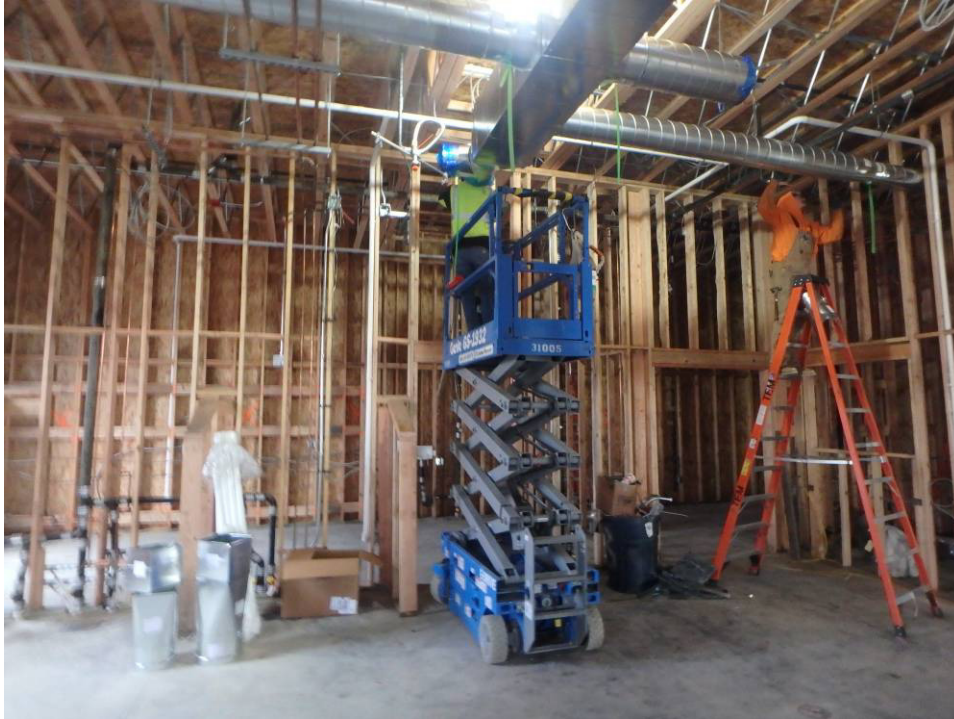
West wall of the lab, framing and ductwork

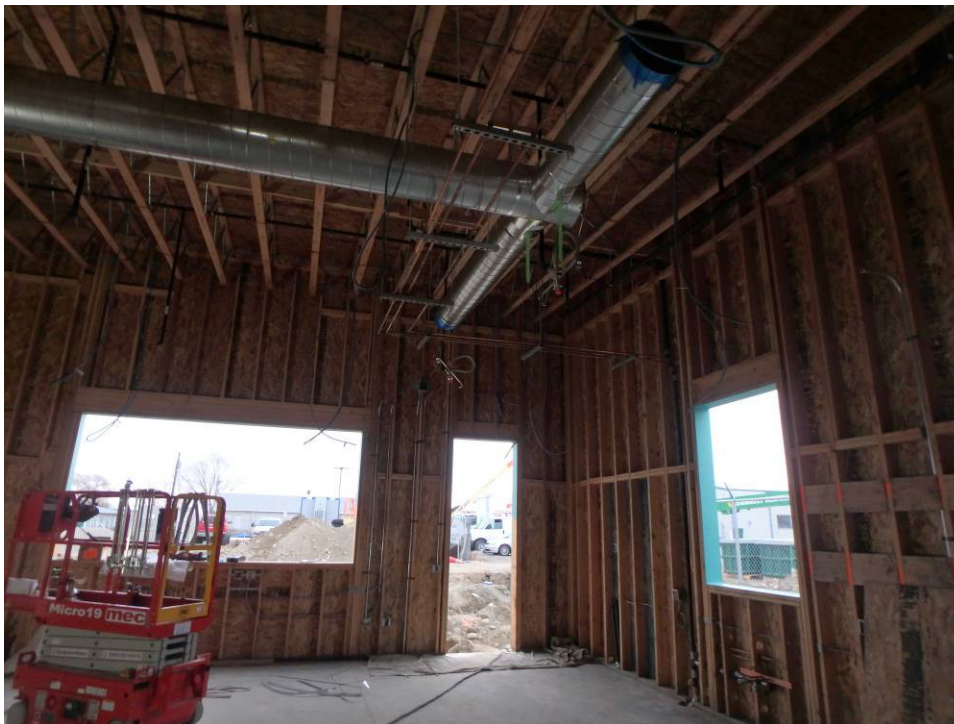
Looking southeast at the ductwork and framing

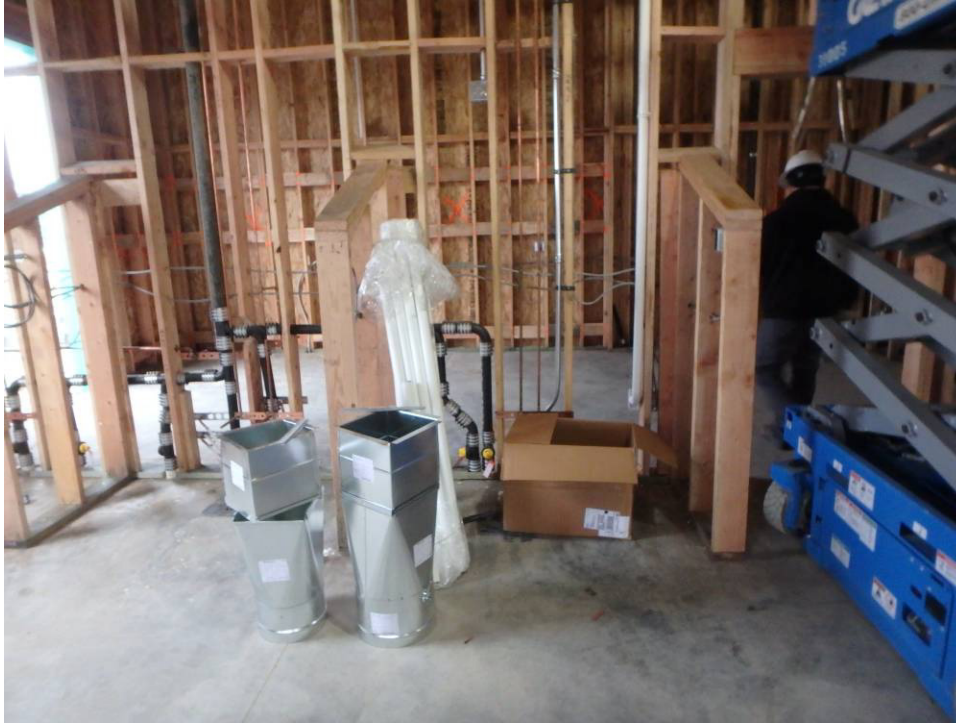
Vacuum lines (white) behind the dog wash stations

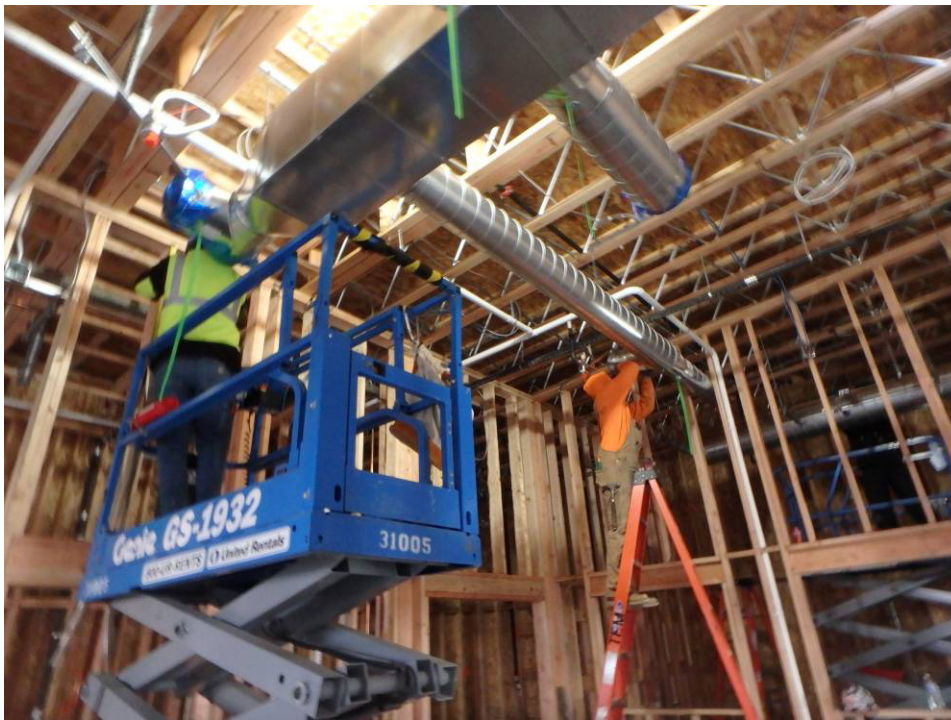
Vacuum lines above the dog wash stations
