**GT Management Consultants LLC**  
When Experience Counts

July 7, 2019

Report of CM Visits on 7/01-05/2019

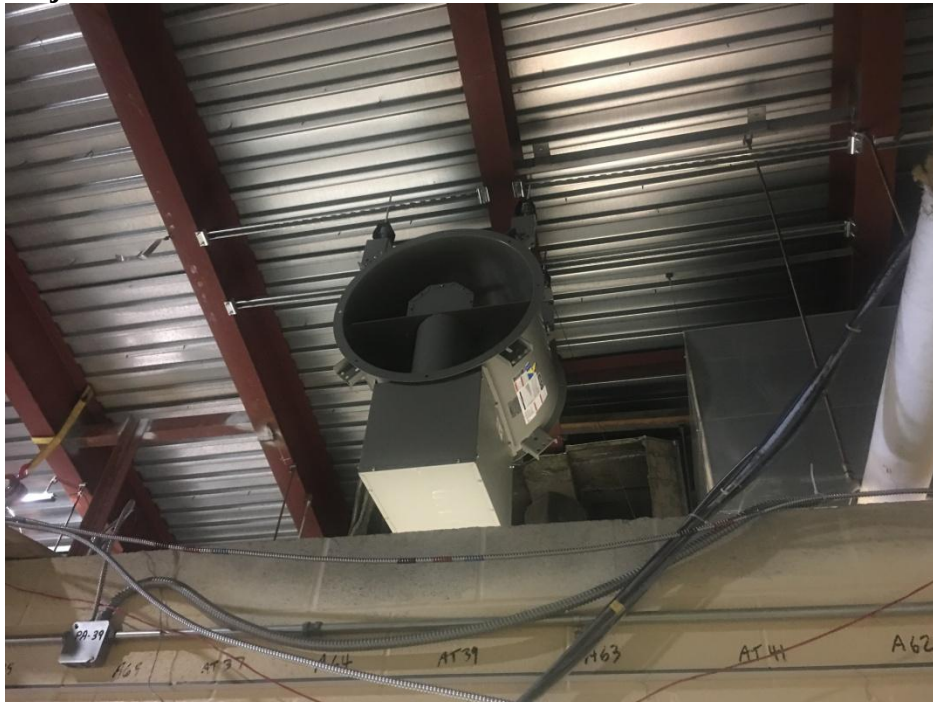
- Piping and ductwork installation is ongoing.
- The new axial return fan (RF1) has been installed for AHU1.

View of new Axial Return Fan RF-1 at BES.

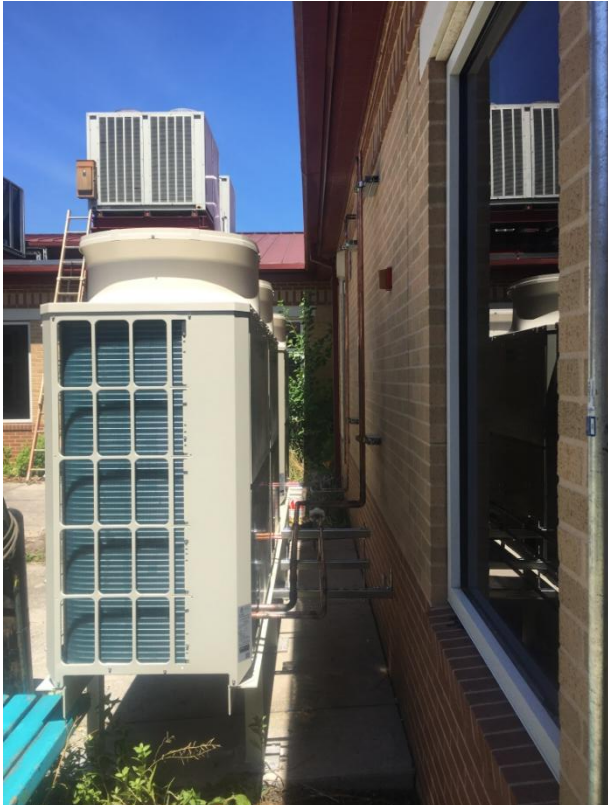
View of new condensing units at BES.

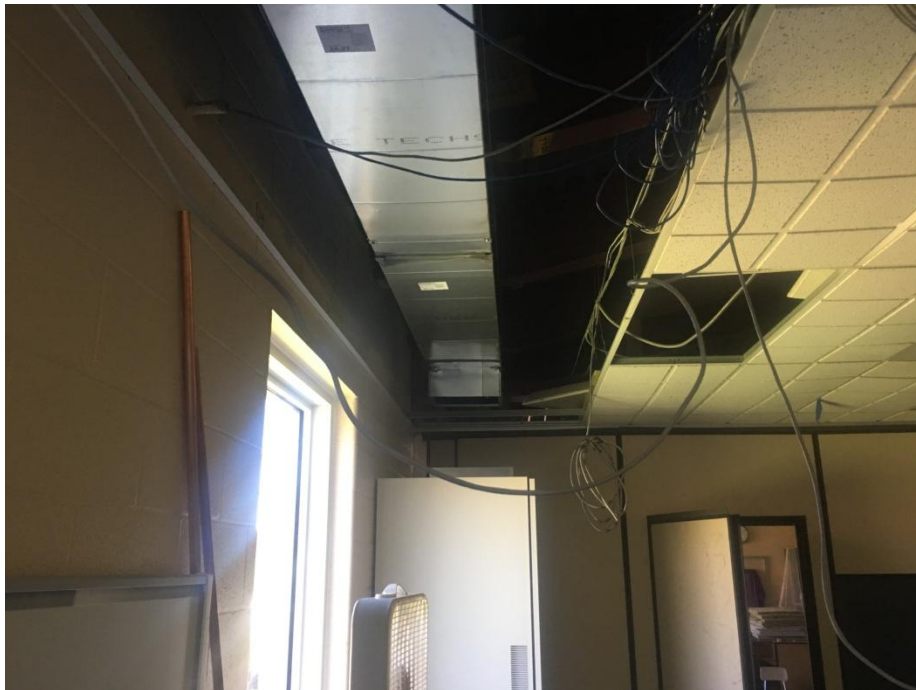
View of ductwork being run to new VUV unit.

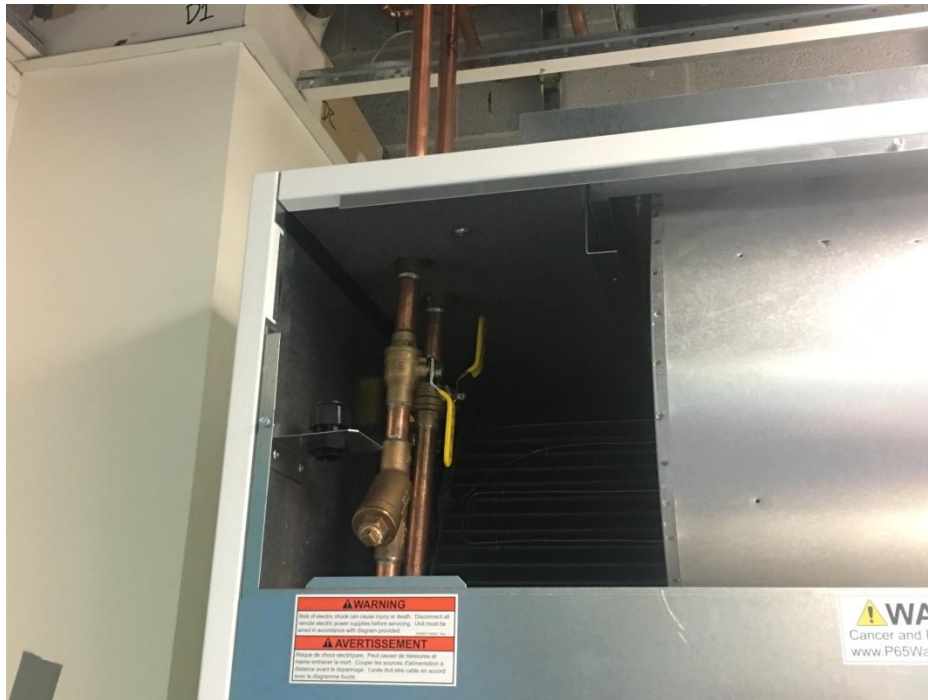
View of plumbing connections to VUV unit at AES.

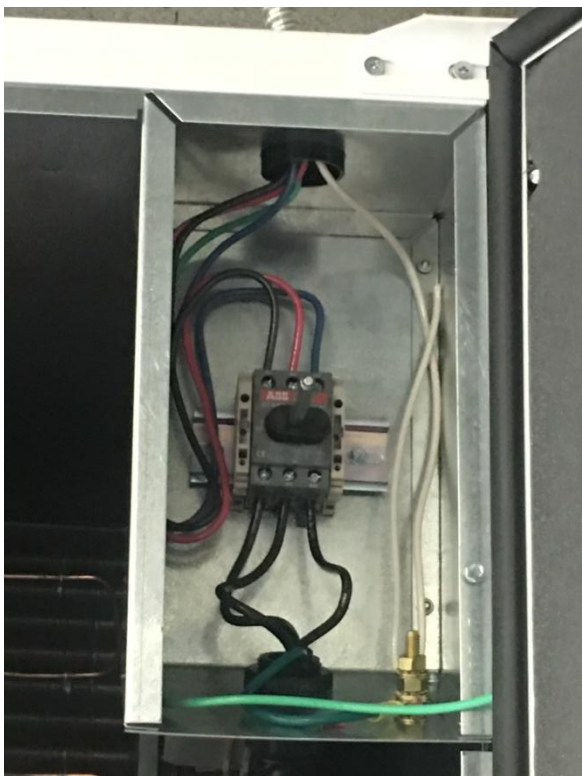
View of electrical connections to VUV at AES.
