**GT Management Consultants LLC**  
When Experience Counts

November 10, 2019

Report of CM Visits on 11/04-11/08/19

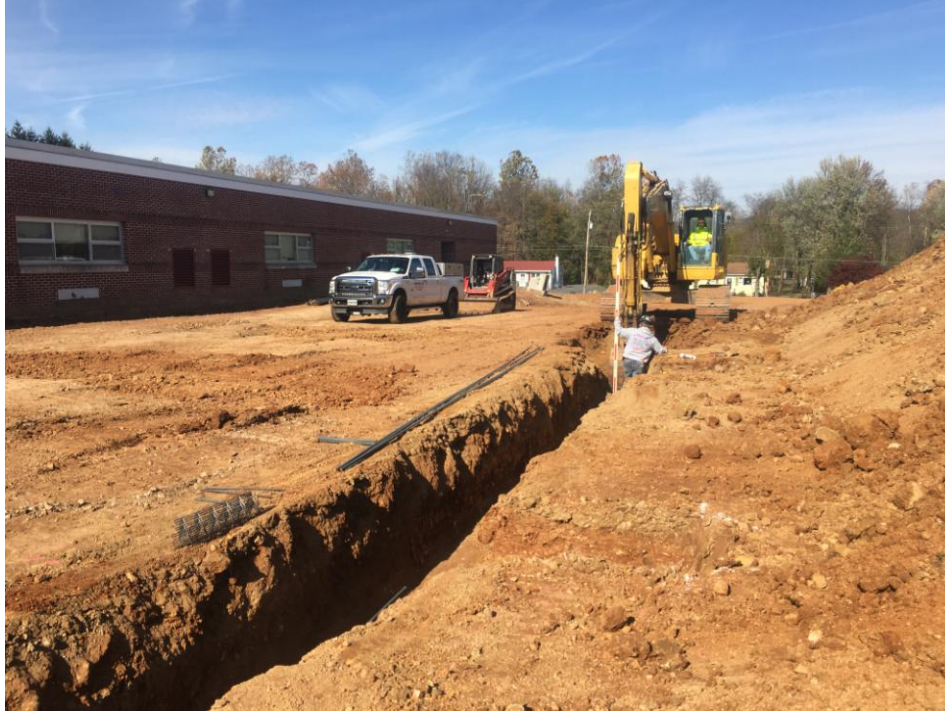
Footer trench being dug.

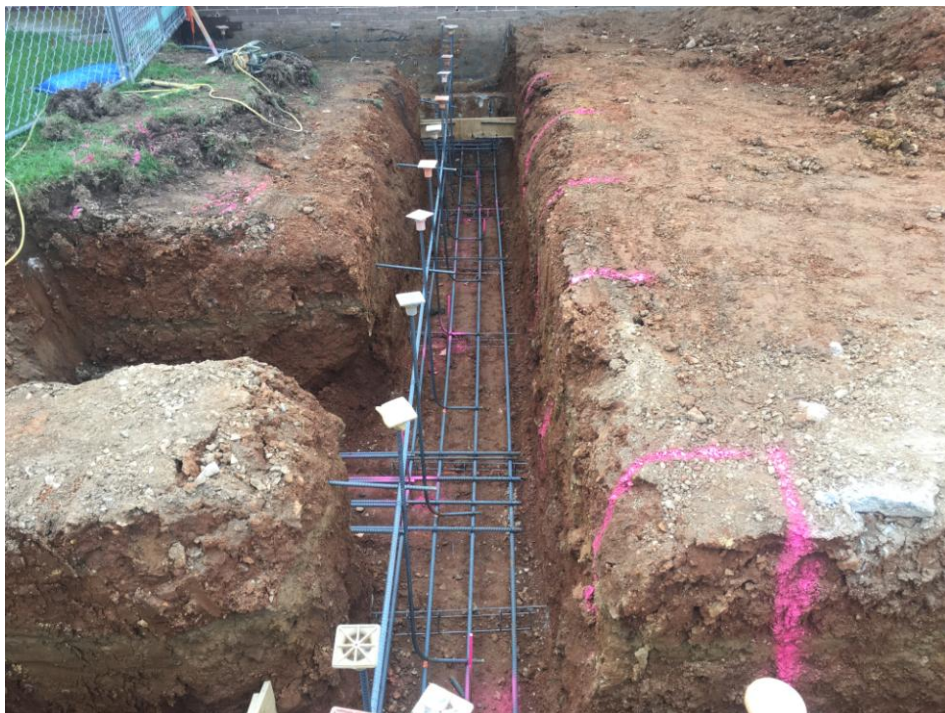
Rebar being installed in footer trench.

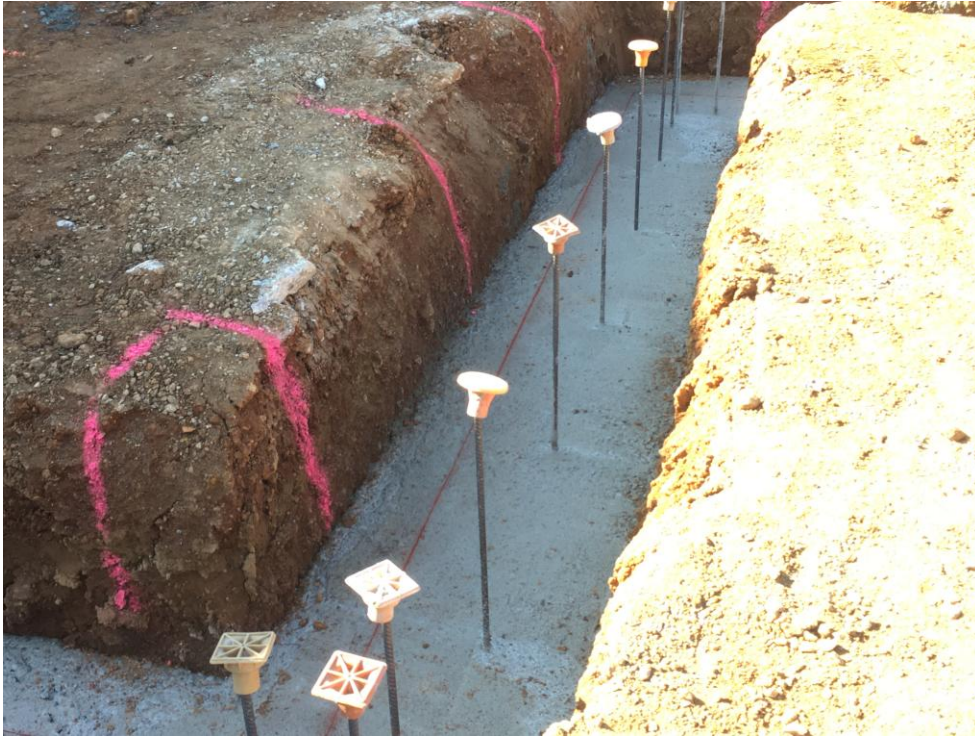
Footers after pouring.

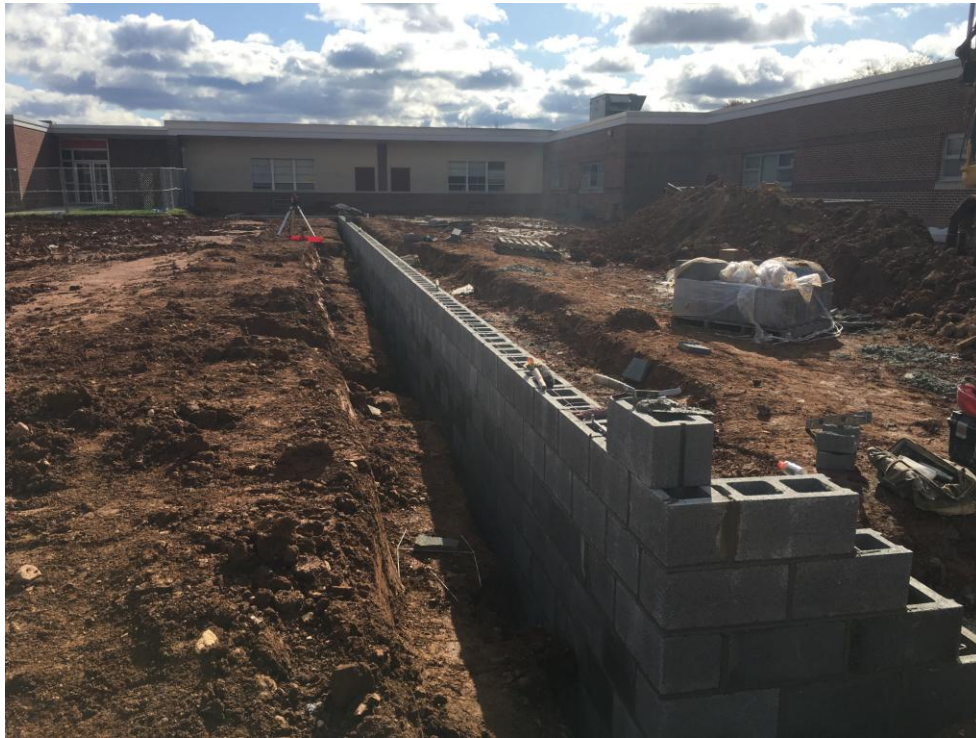
Foundation wall being laid.

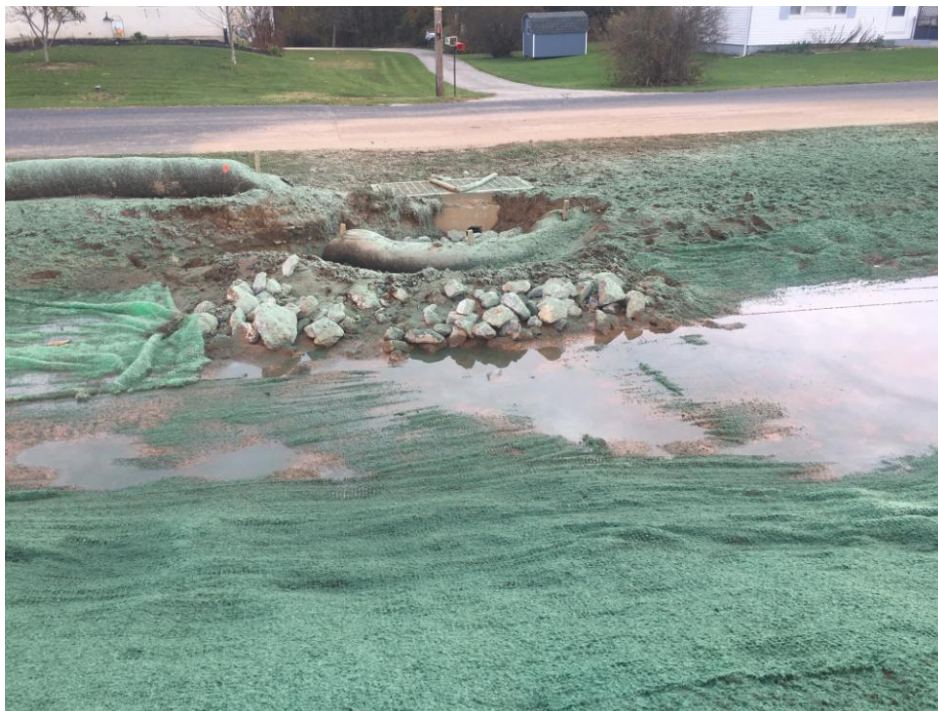
Stabilization matting and seeding at Conewago St drain.

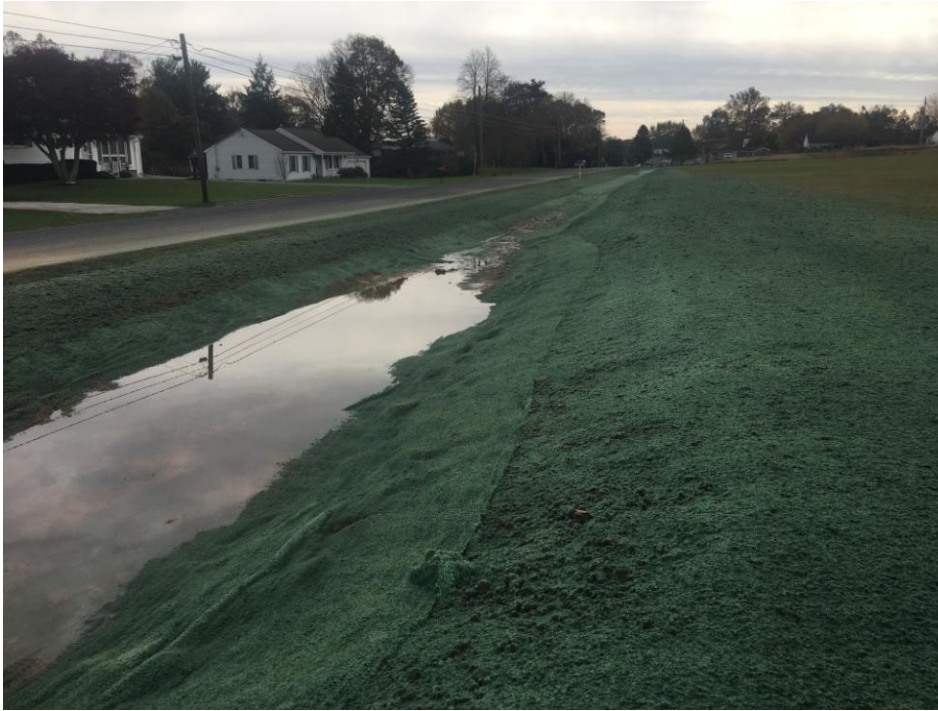
Stabilization matting and seeding along Conewago St.

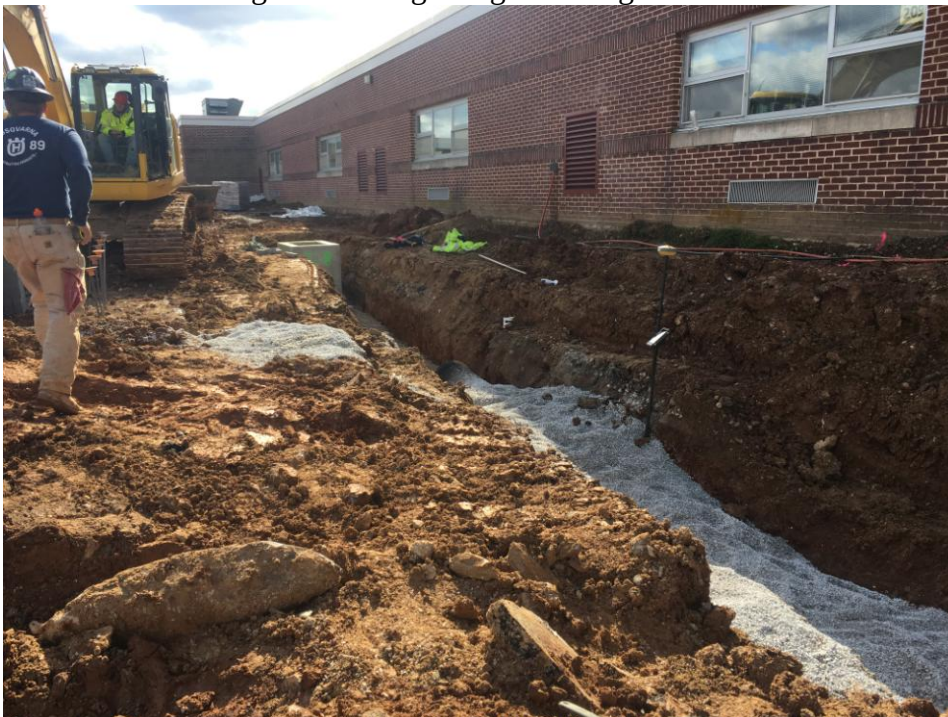
New catch basin and storm line being installed.

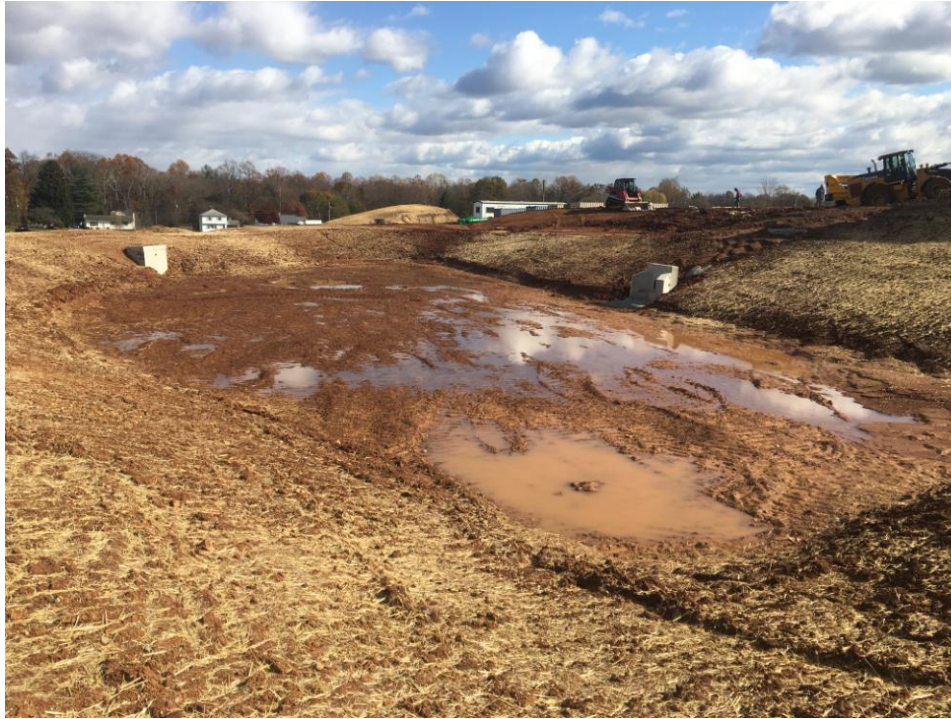
- The elevations shown on the drawings along Queen Street look off. K&W needs to tell us what happens between the swale and the street.
- K&W needs to have more contact with Lobar and Remcon in order to avoid further confusion on the E&S provisions.

Detention Pond along Queen St showing new drain headwall on right.

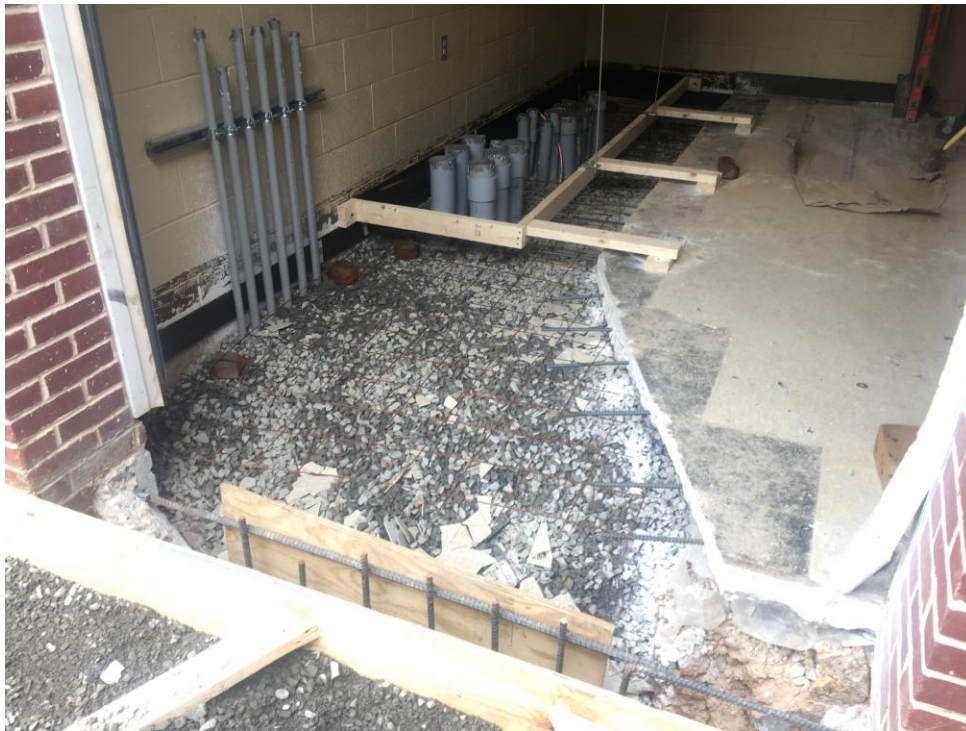
New switchgear area ready for concrete pour.

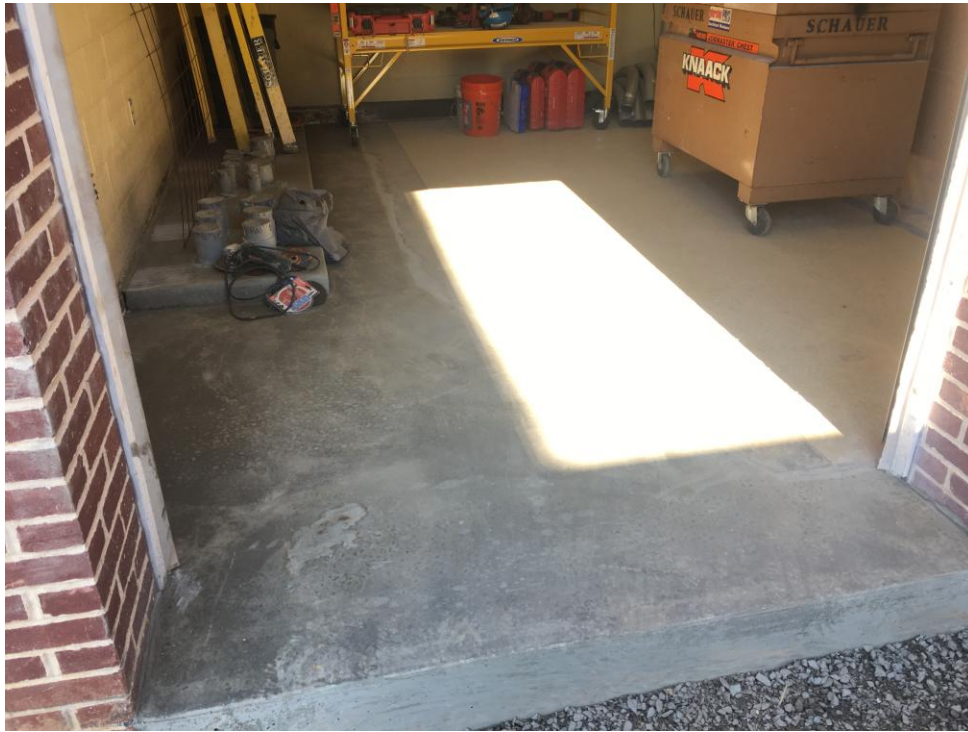
New switchgear area after floor was poured.

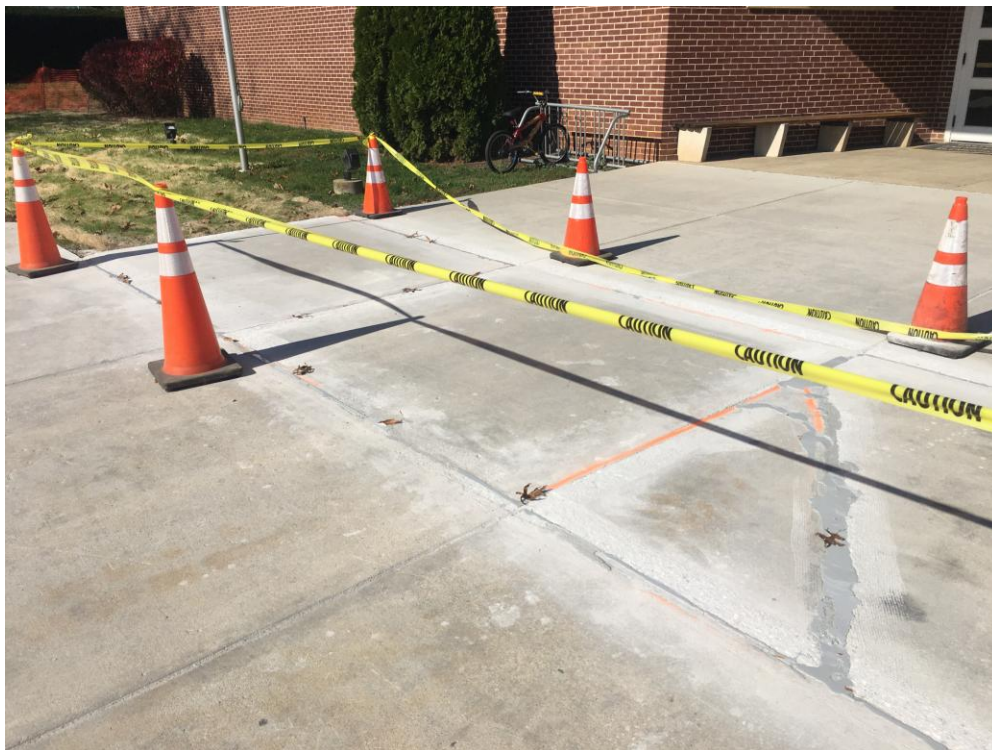
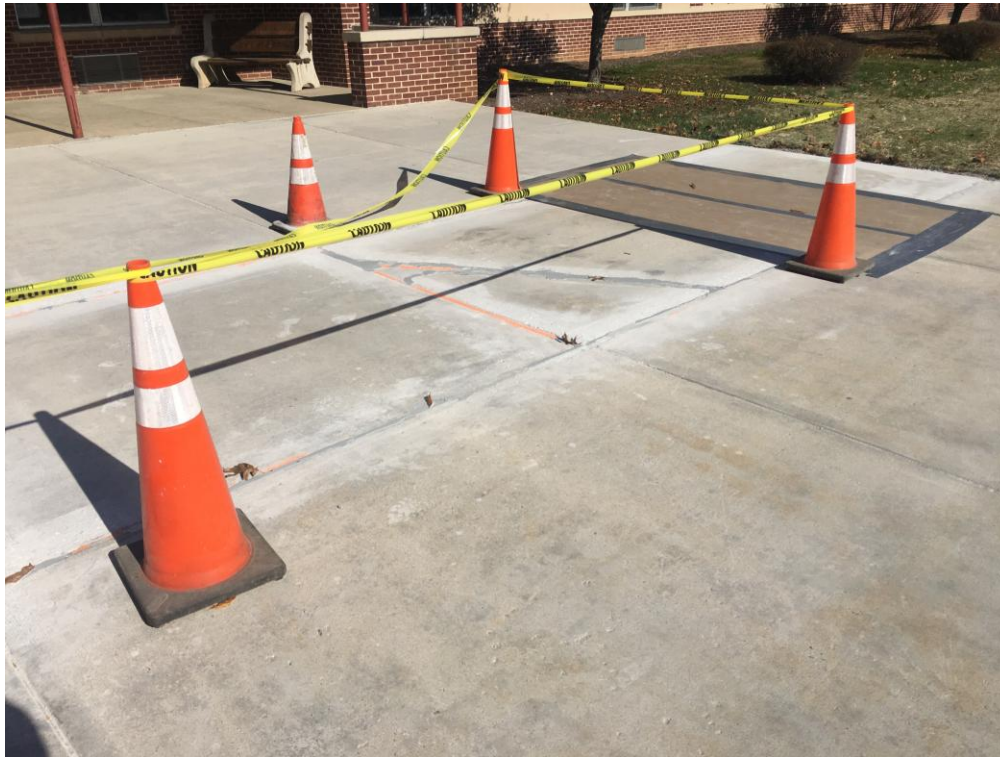
- Footer excavation and rebar installation is continuing.
- A person fell on the front walk where the concrete sidewalk slabs were remove and replaced. Schauer Electric is grinding the edges and will provide marking and cones.

- Footers are being poured. There should be approximately 300 feet of footer poured by the end of the day.
- Rebar is continuing to be installed.
- The uneven slabs at the front entrance have been ground down and caulked.

Area of sidewalk that heaved after grinding.

Same area, different angle.

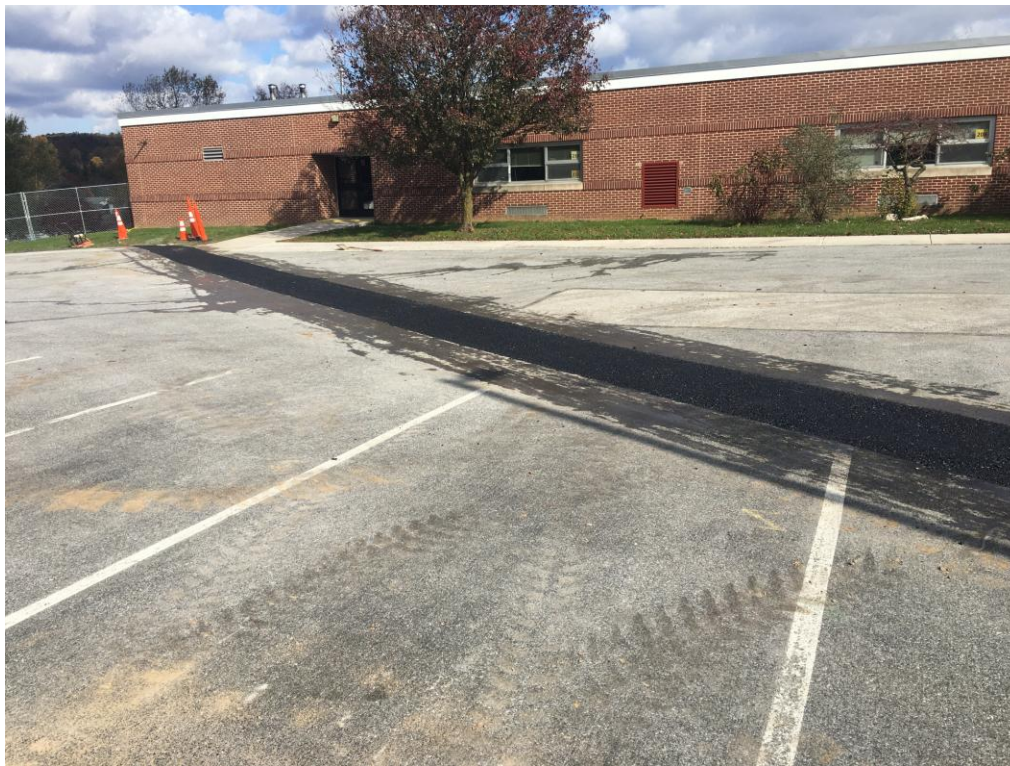
Trench for electrical duct bank has been paved across rear parking lot.
