**GT Management Consultants LLC**  
When Experience Counts

January 26, 2020

Report of CM Visits on 1/20-24/20

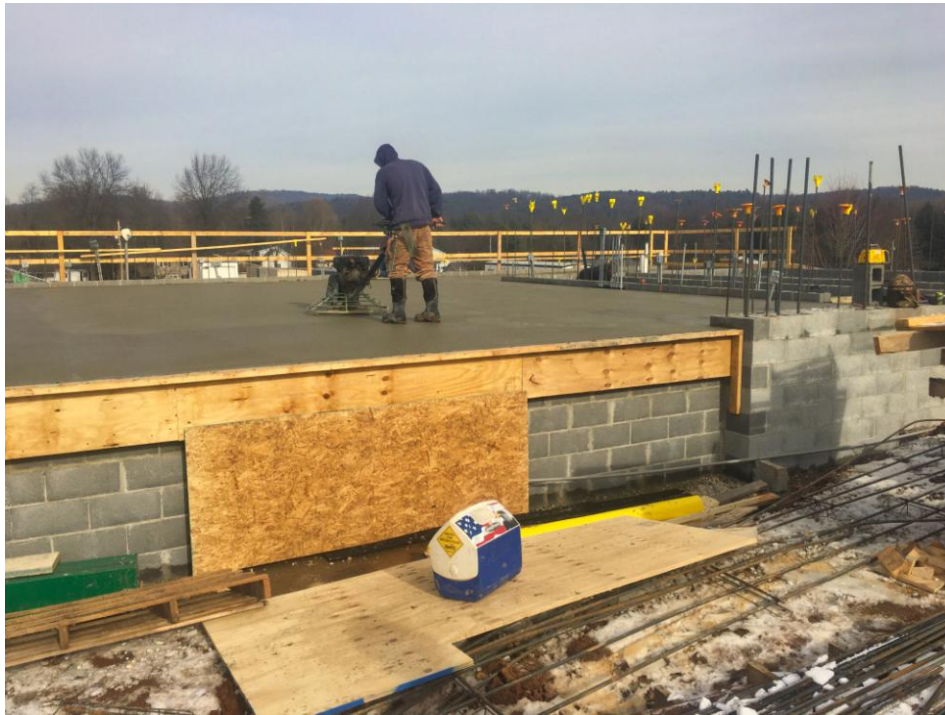
Platform slab being finished in Gym.

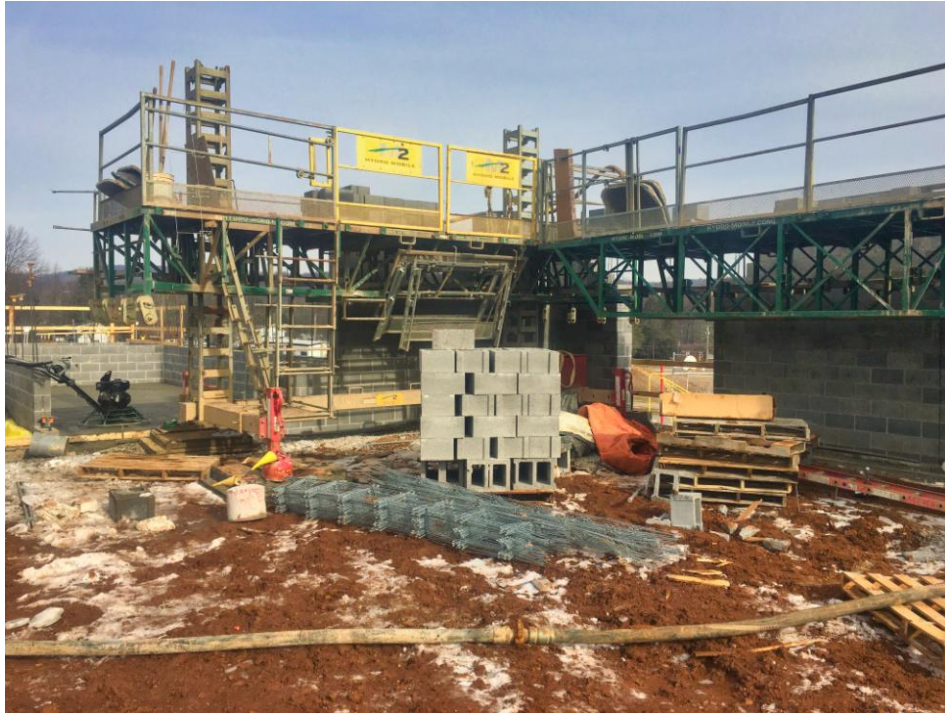
Exterior walls being worked on in Gym.

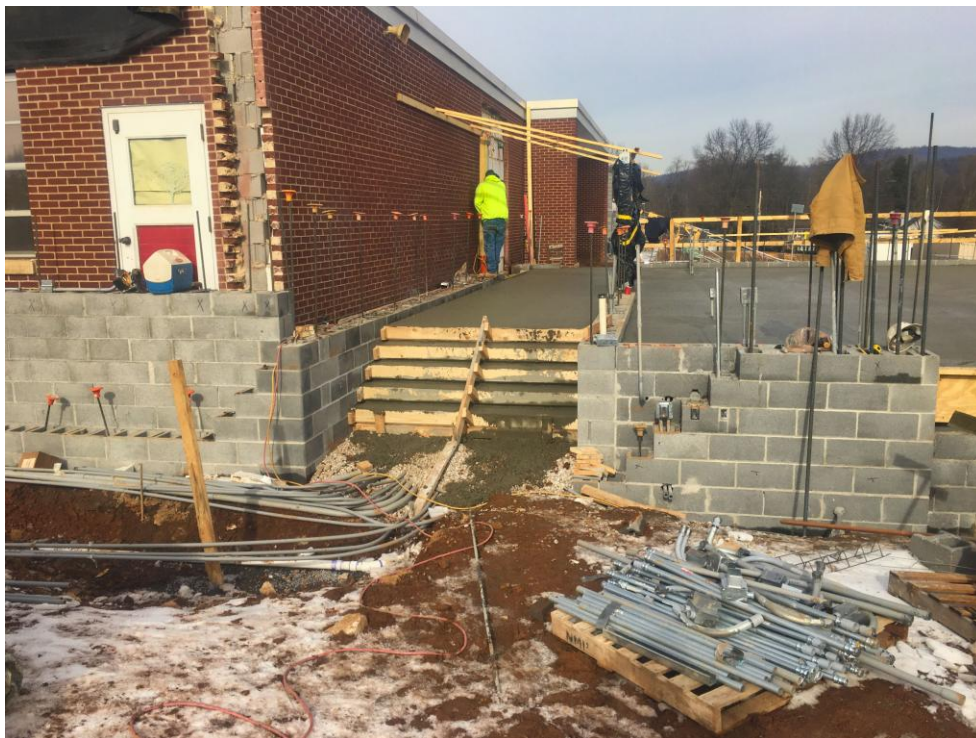
View of steps to Platform in Gym.

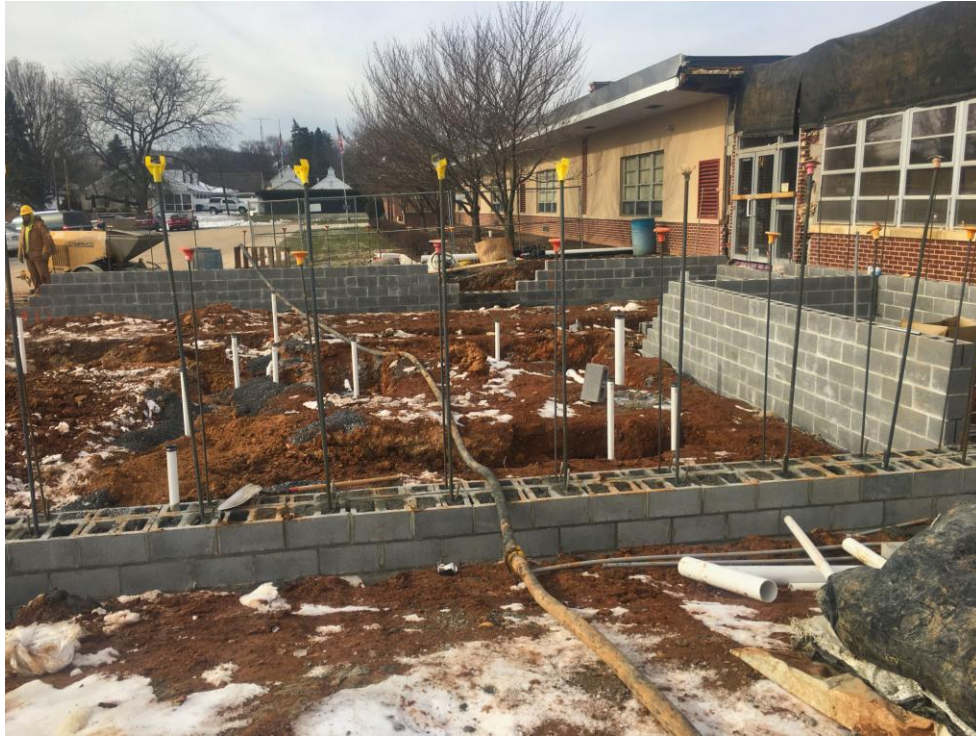
View of walls and plumbing rough-ins at Gym Bathrooms.

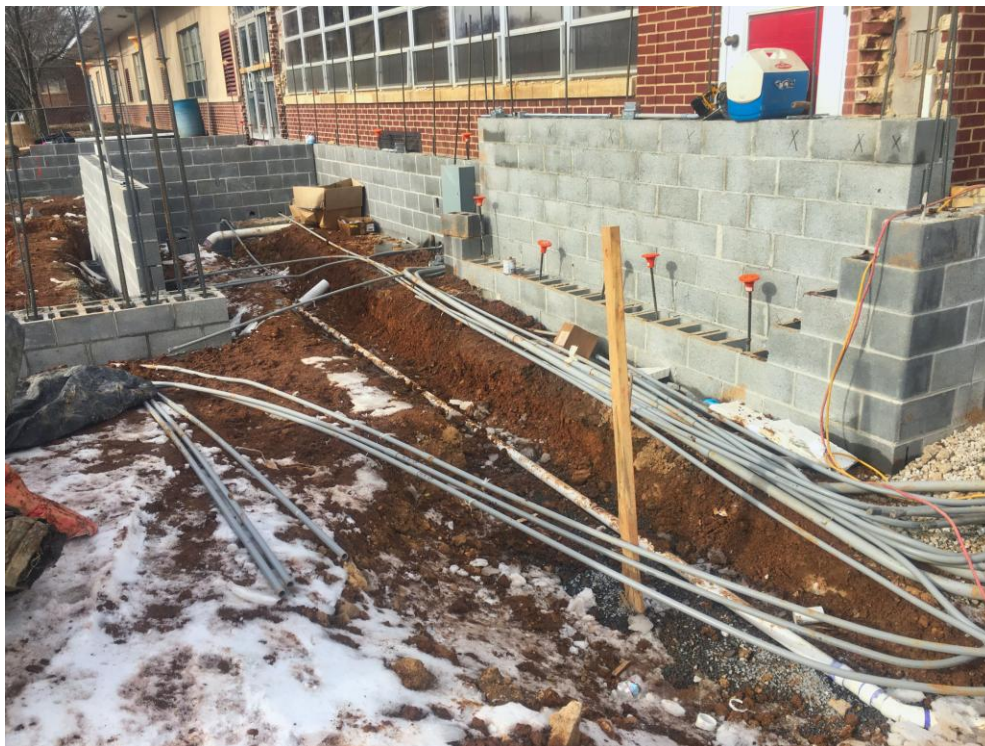
View of under slab electrical rough-ins in Gym Addition.

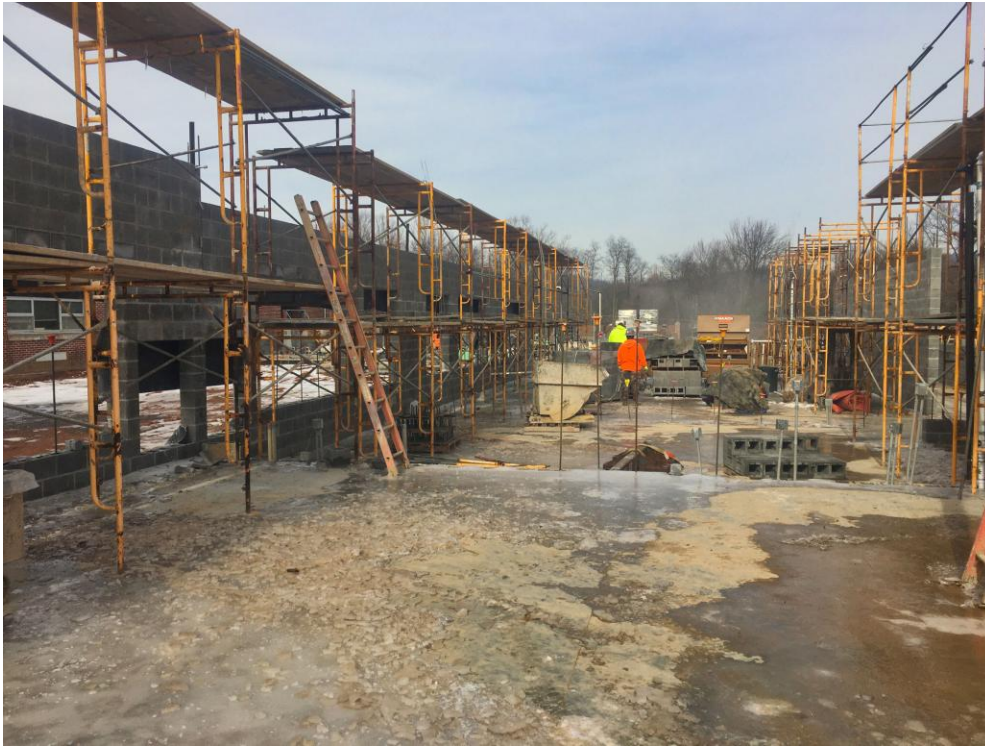
View of walls being erected in Classroom Addition.

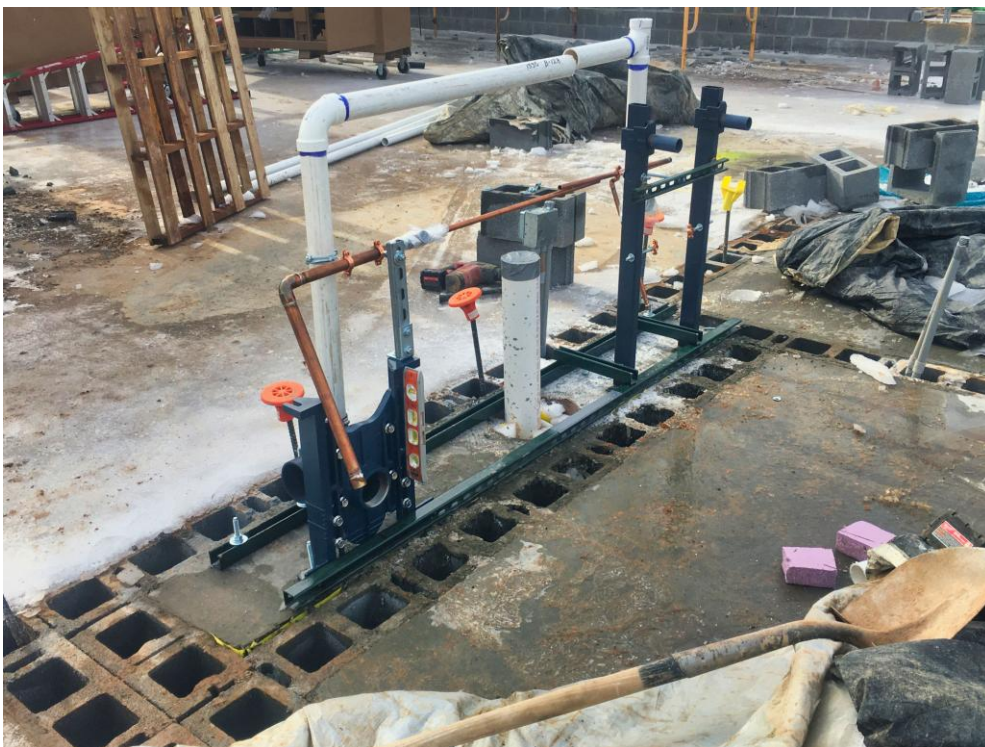
View of plumbing rough-ins in Classroom Addition Bathrooms.

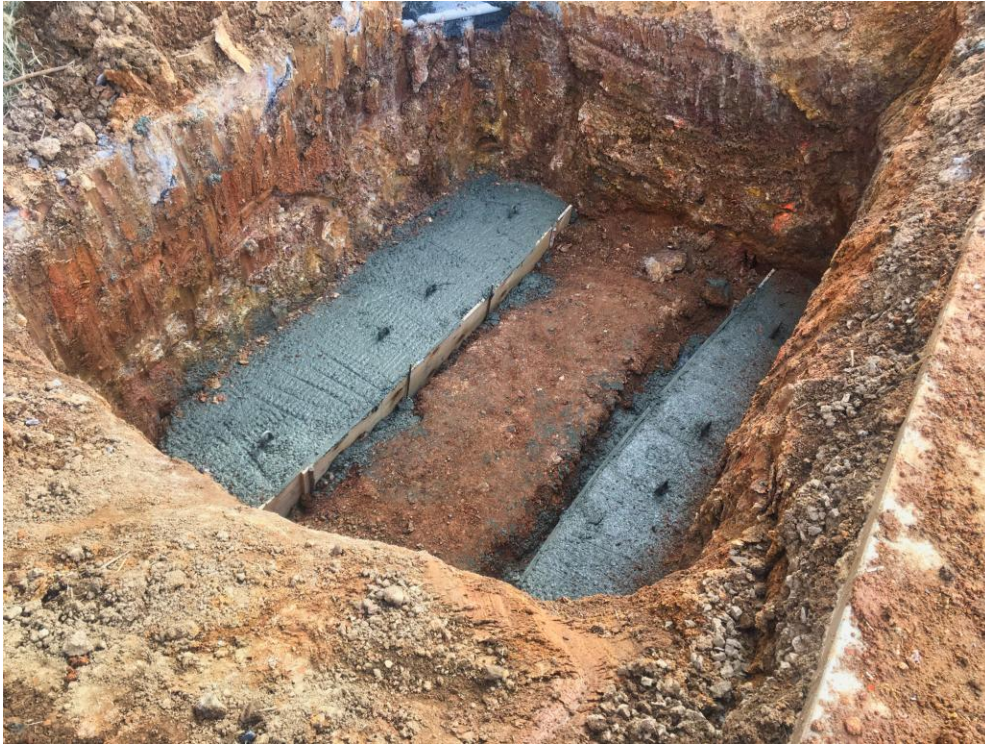
View of foundation for Grease Trap behind Kitchen.
