**GT Management Consultants LLC**  
When Experience Counts

February 9, 2020

Report of CM Visits on 2/03-07/20

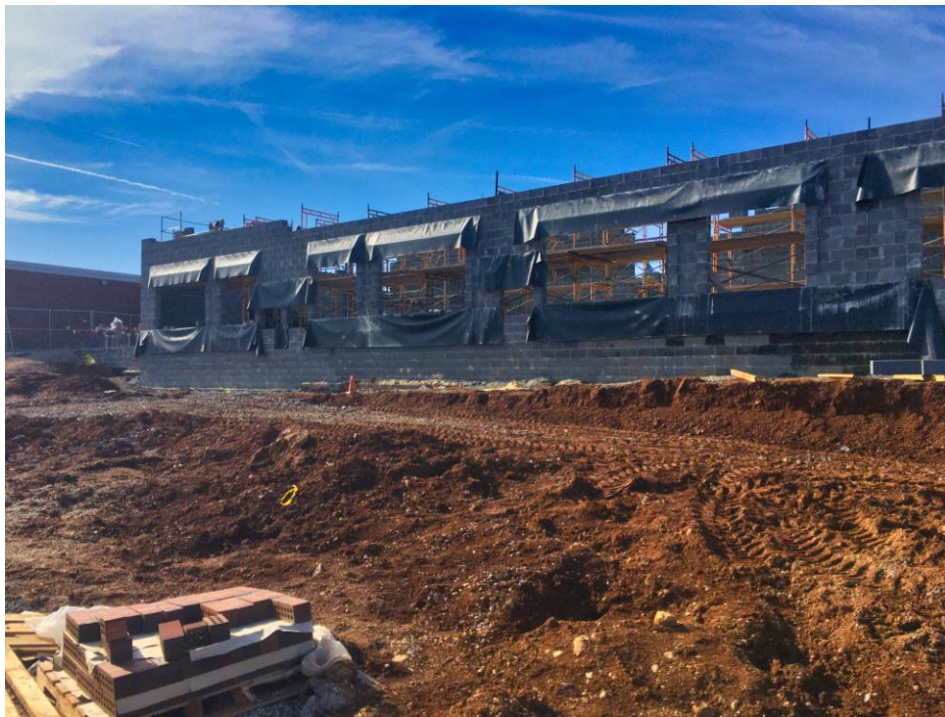
Exterior view of east wall of Classroom Addition.

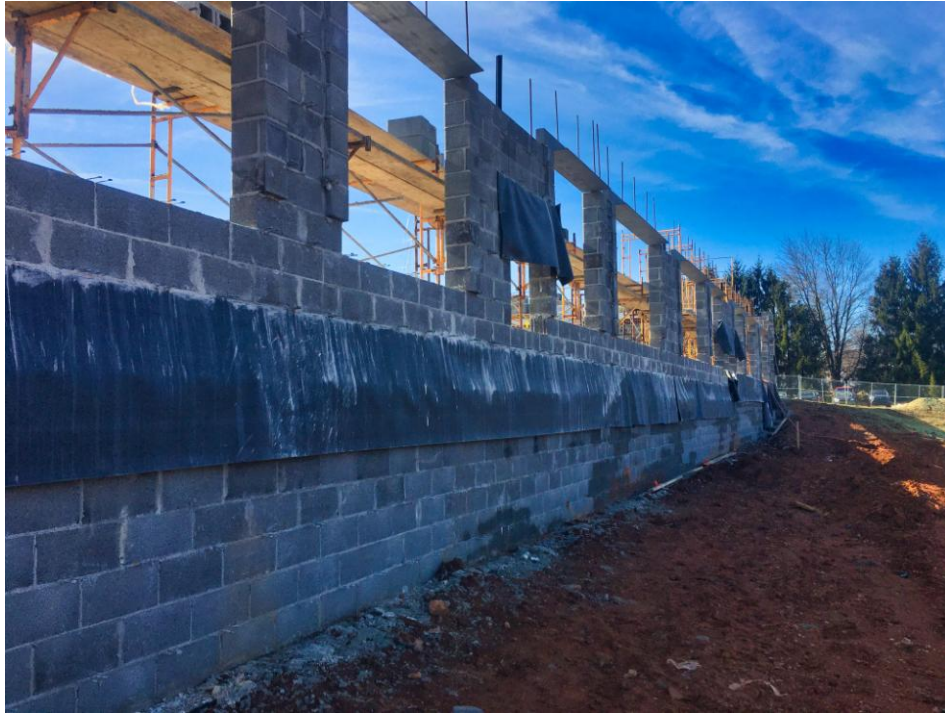
Exterior view of east wall of Classroom Addition facing North.

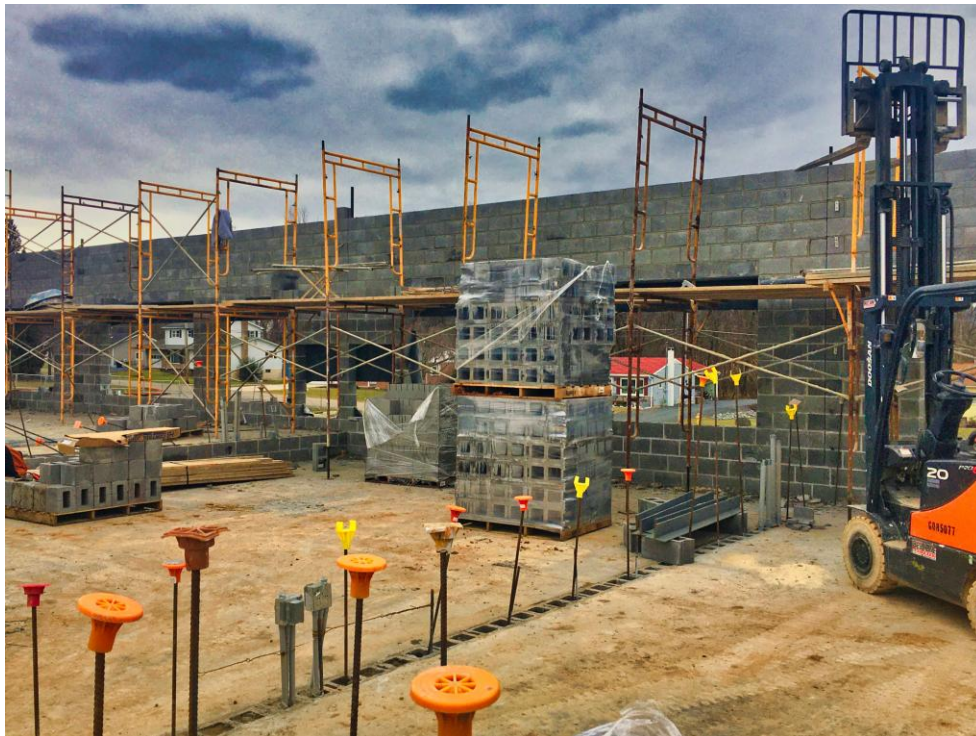
Interior view of east wall of Classroom Addition facing East.

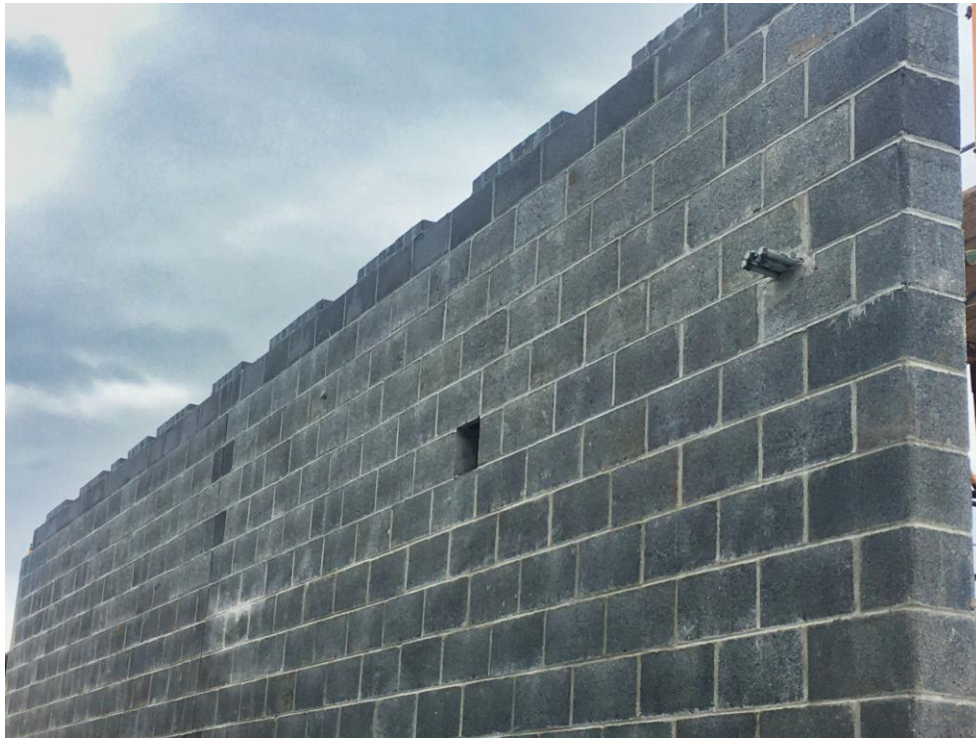
Interior view of corridor wall showing pipe penetrations and joist bearing plate notches.

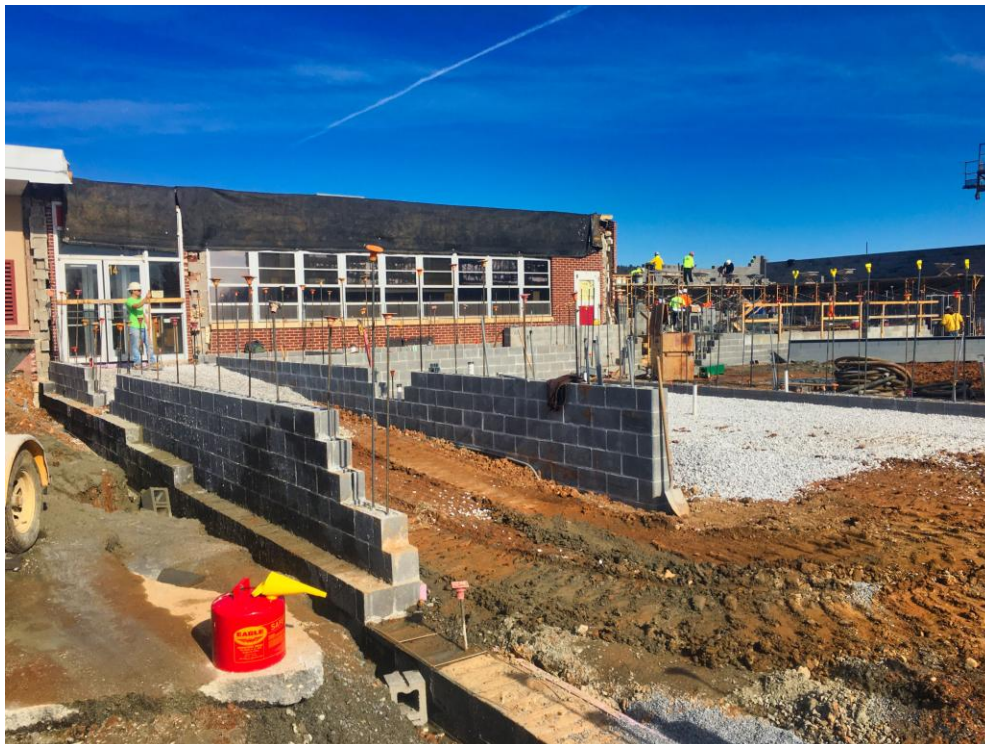
View of connection to Gym addition at southeast corner of existing building.

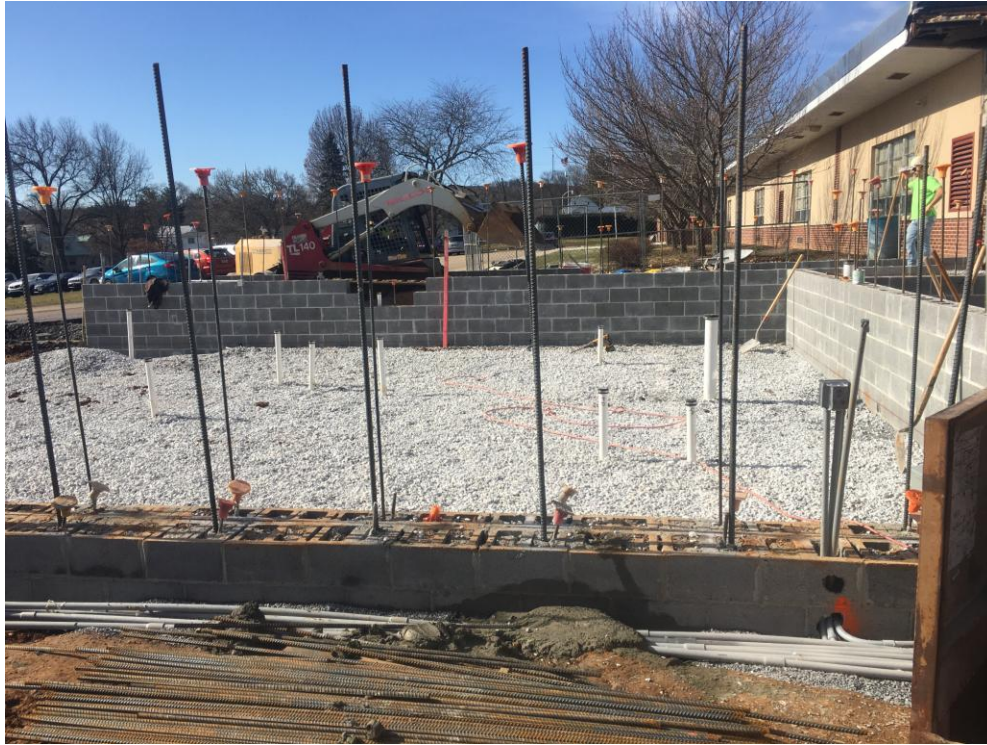
View of Gym Bathrooms being prepped for pouring of floor slab.

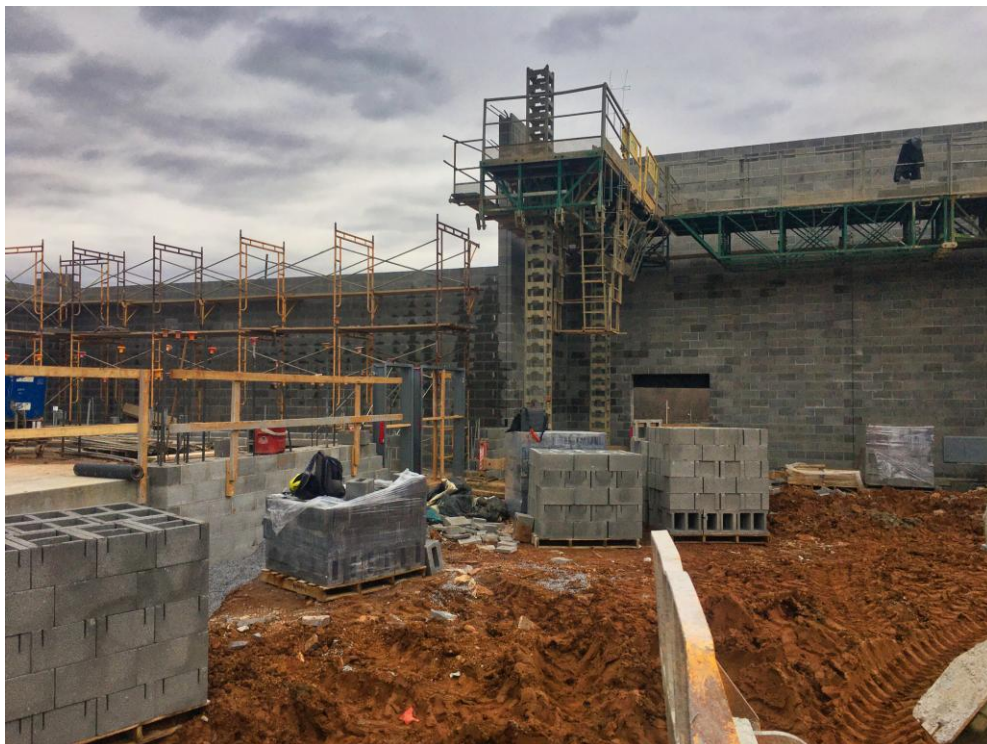
Interior view of east wall of Gym.

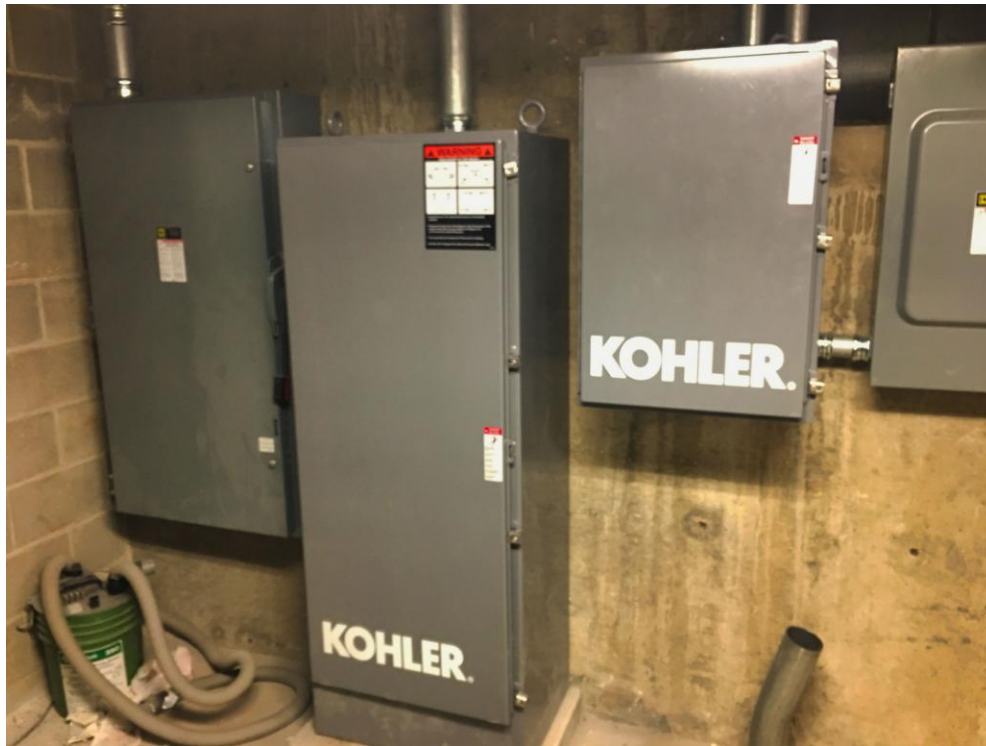
View of new Emergency Transfer Switch in existing basement.
