**GT Management Consultants LLC**  
When Experience Counts

March 1, 2020

Report of CM Visits on 2/24-28/20

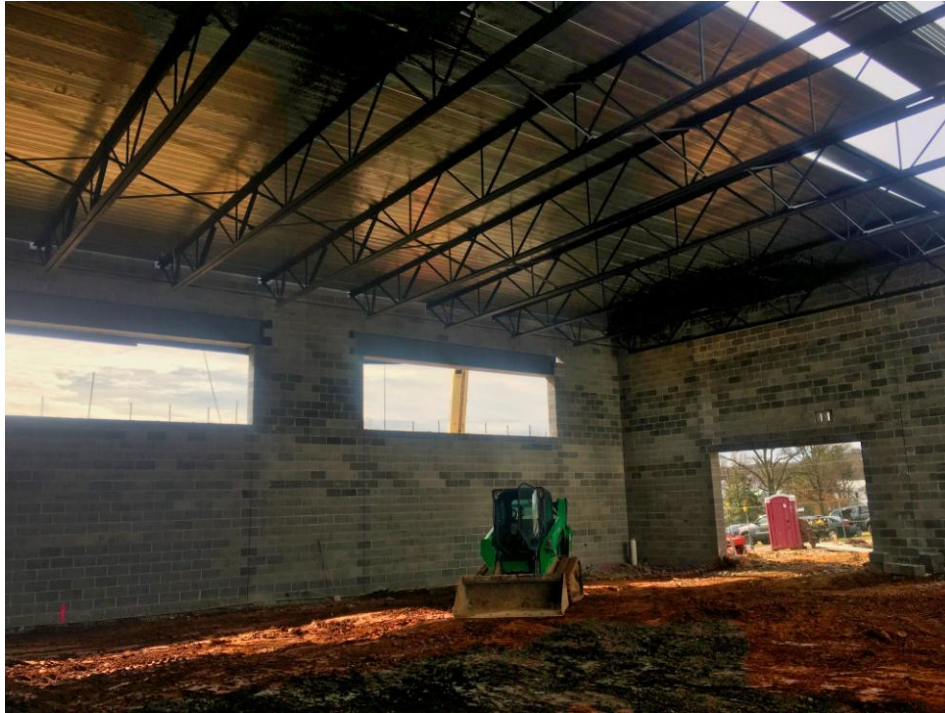
View of Gym facing entrance on West side.

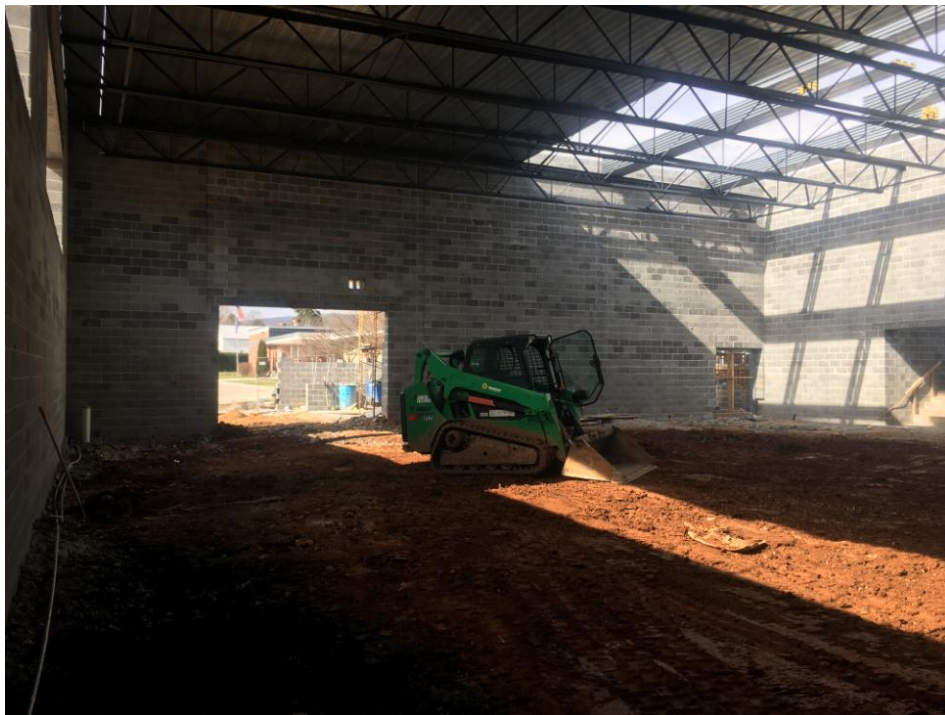
Same view as above at different angle.

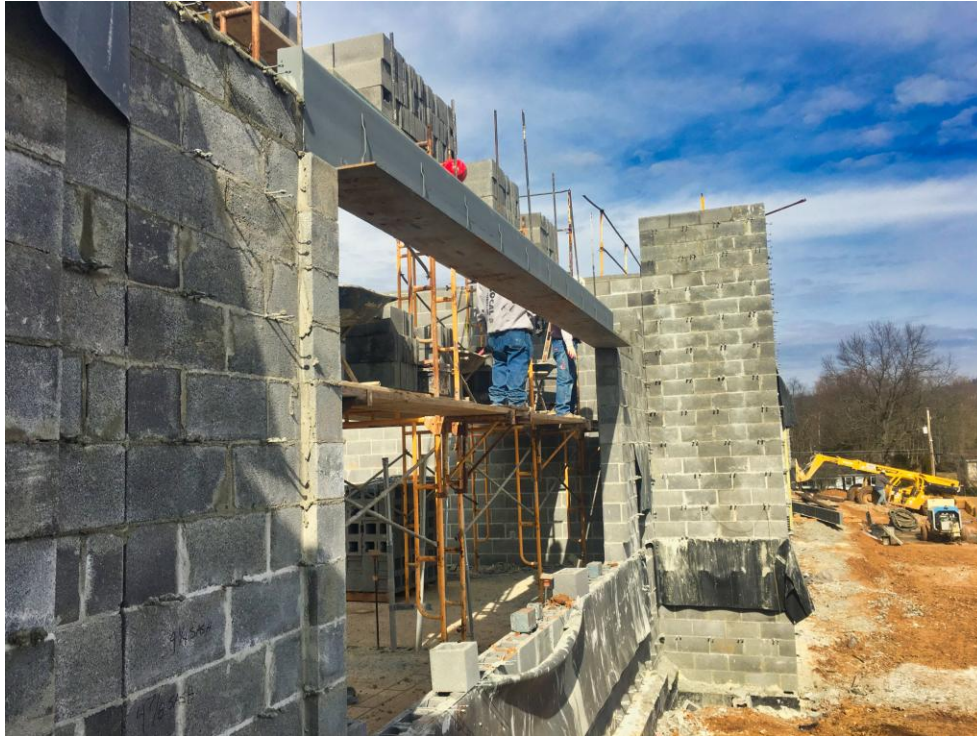
View along East wall of Classroom Addition showing steel lintel.

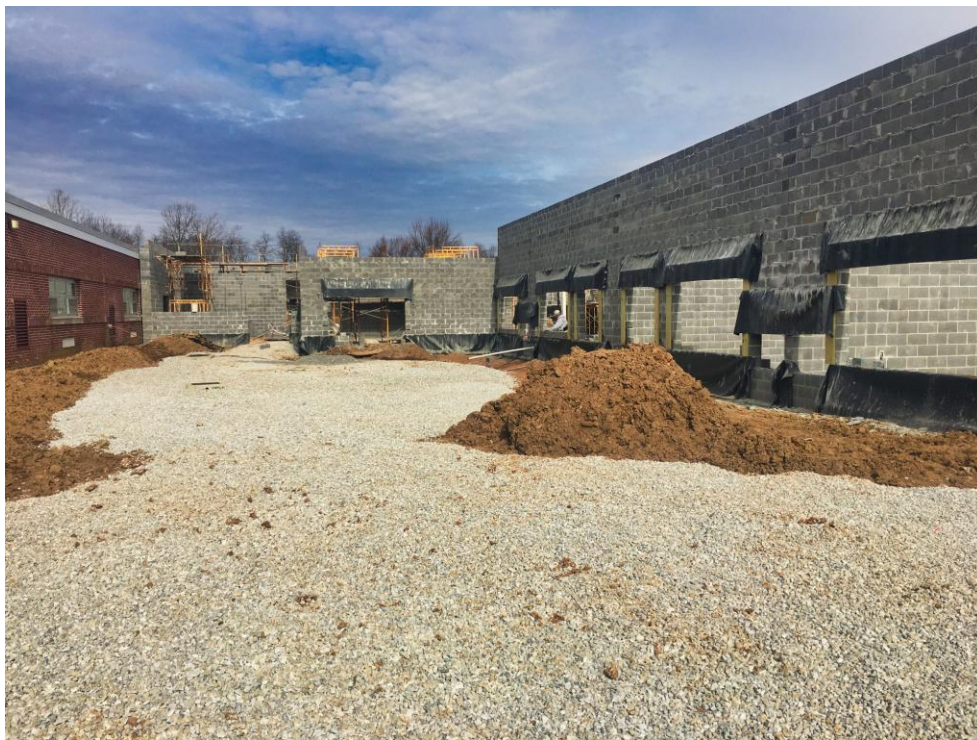
View of Courtyard between Existing Building and Classroom Addition..

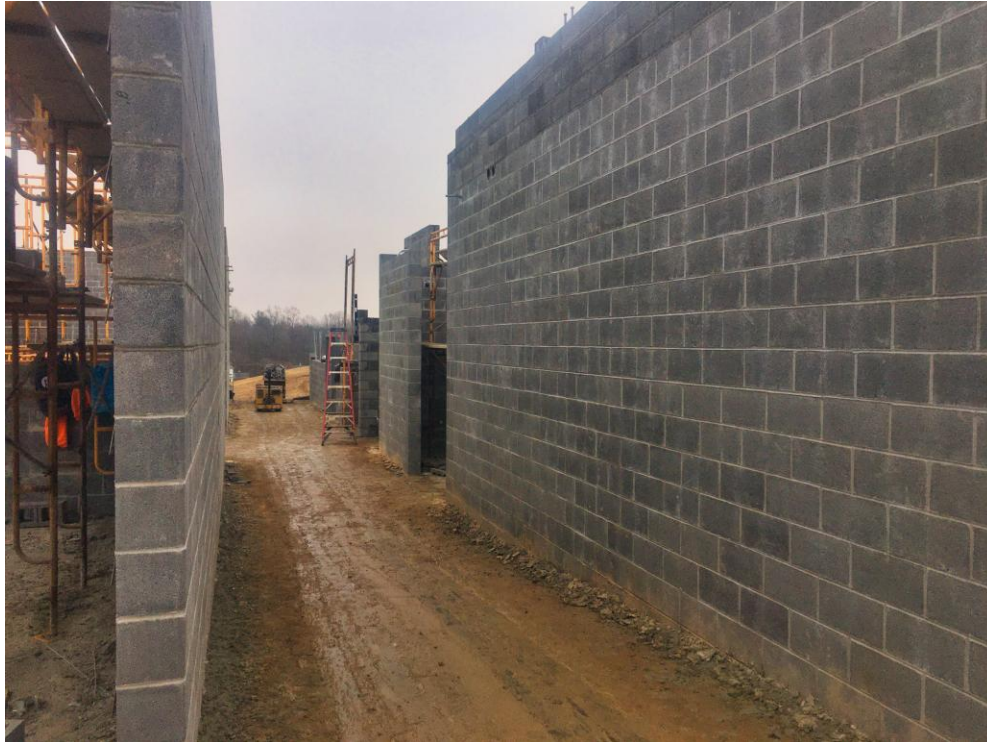
View of East/West corridor in Classroom Addition facing East.

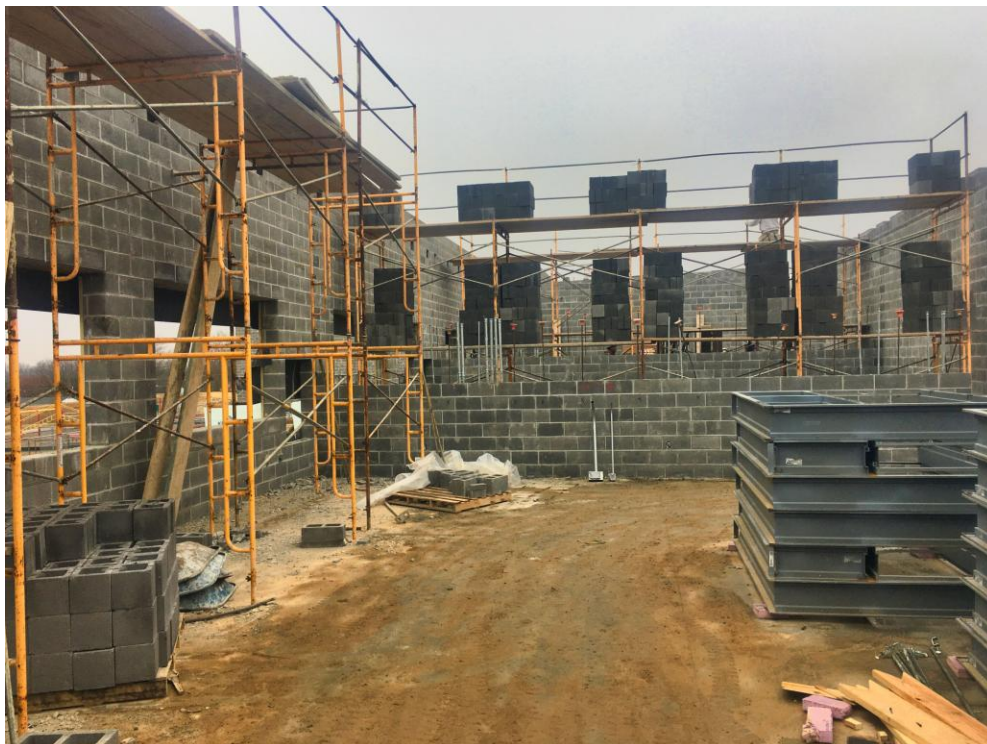
View of Classroom Addition interior facing South.

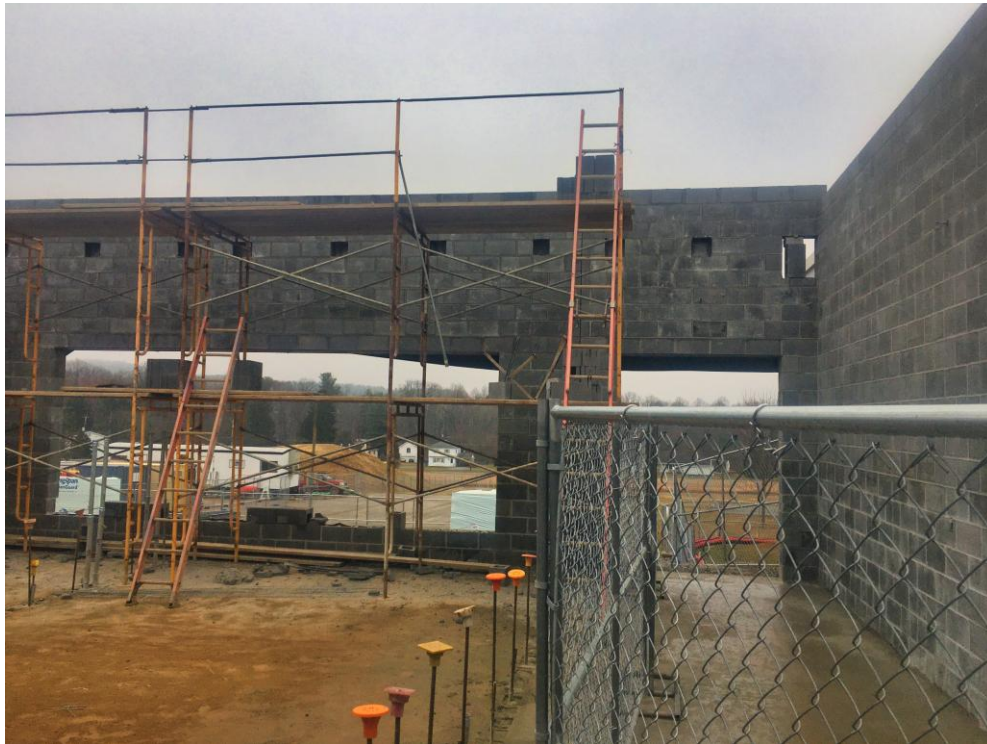
View of new corridor to Playground steps.

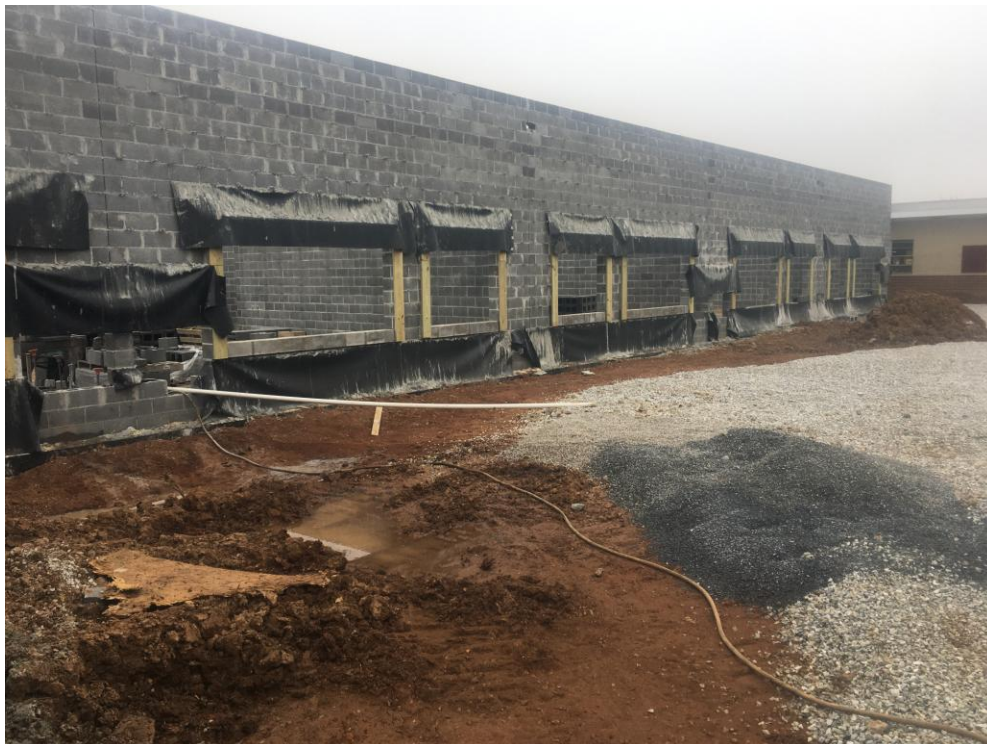
View of West exterior wall of Classroom Addition.
