**GT Management Consultants LLC**  
When Experience Counts

June 21, 2020

Report of CM Visits on 6/15-6/19/20

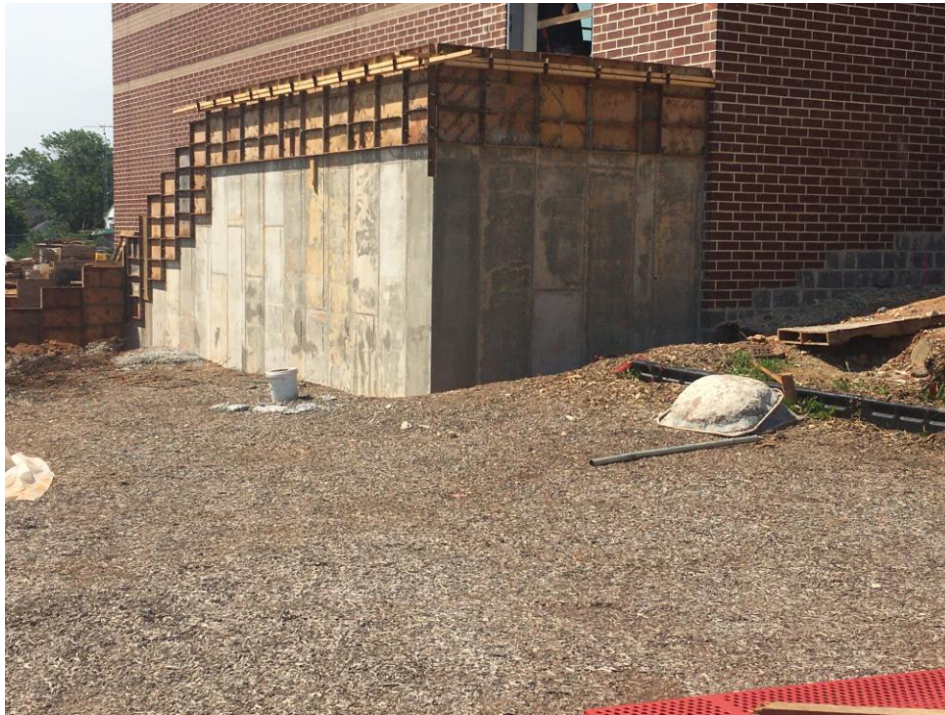
View of exterior Gym stairs being formed.

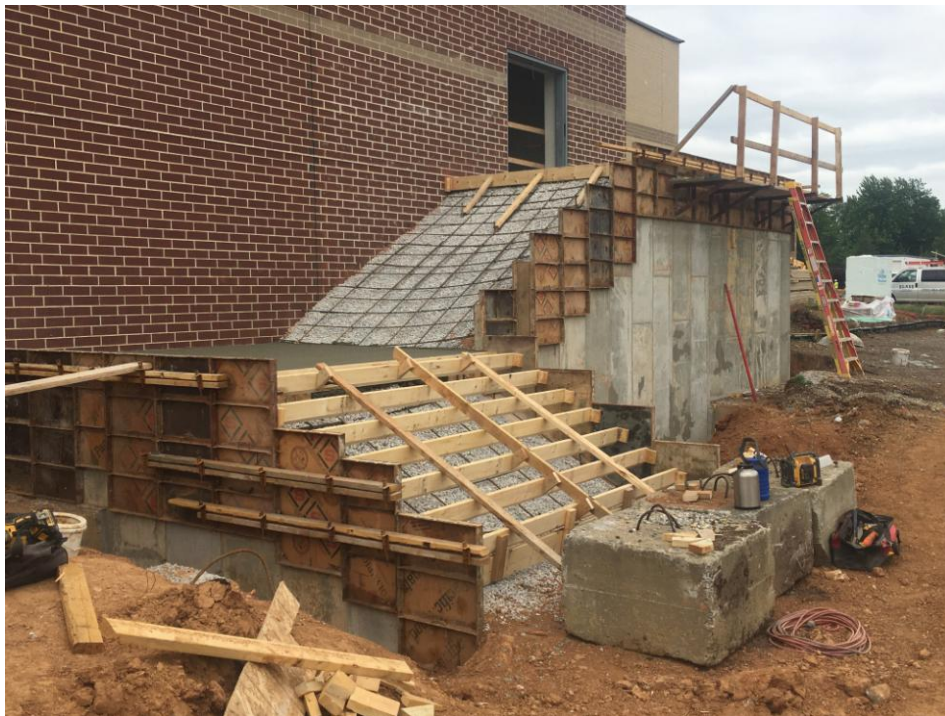
View of exterior Gym stair risers being formed.

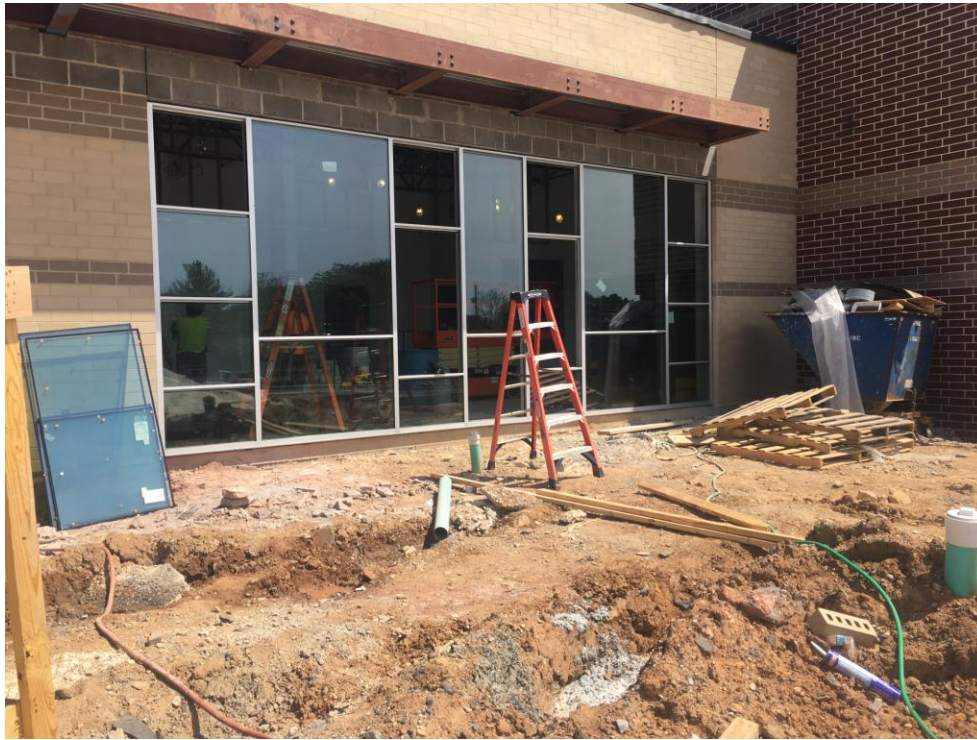
View of installation of storefront glass at Gym entrance.

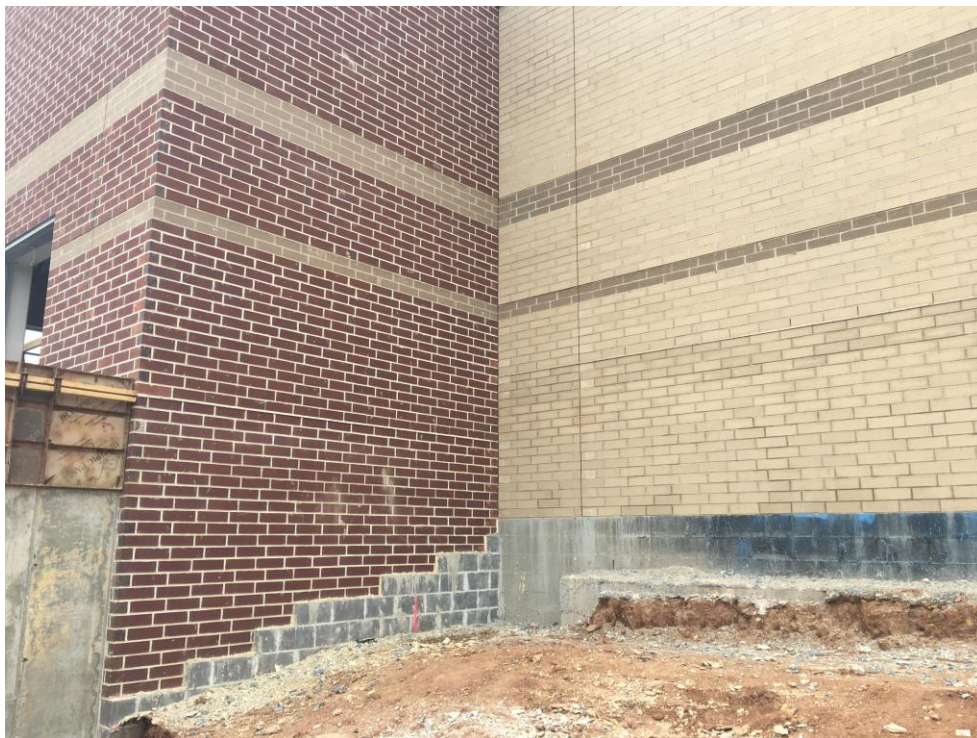
View of NE corner of Gym wall at color change of brick.

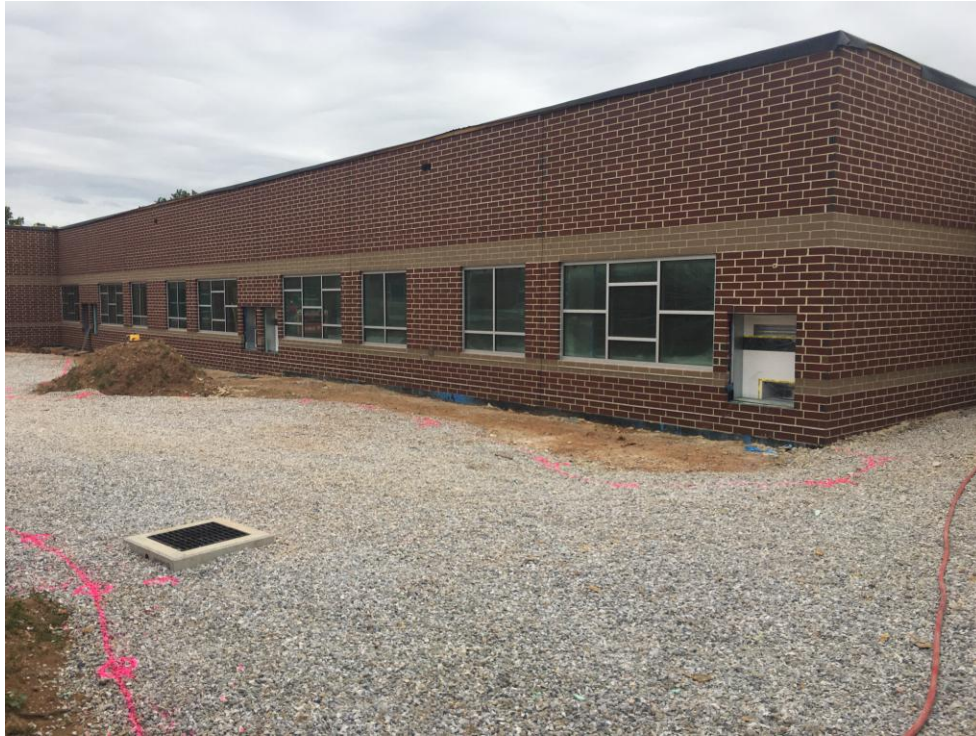
View of new Classrooms from new Courtyard.

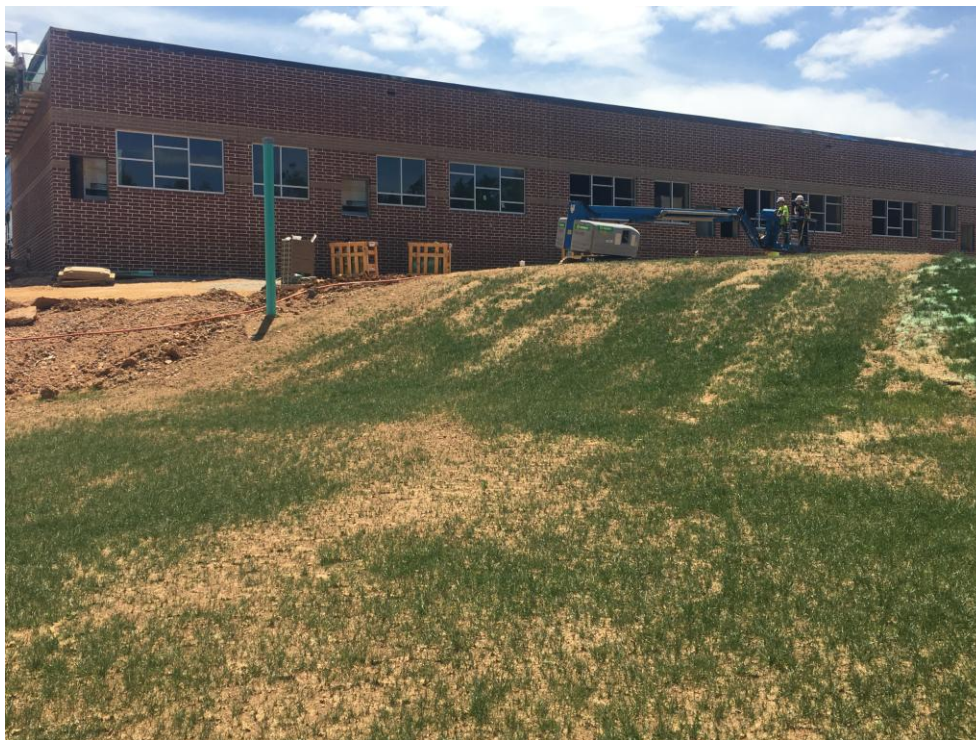
View of new Classrooms from North side.

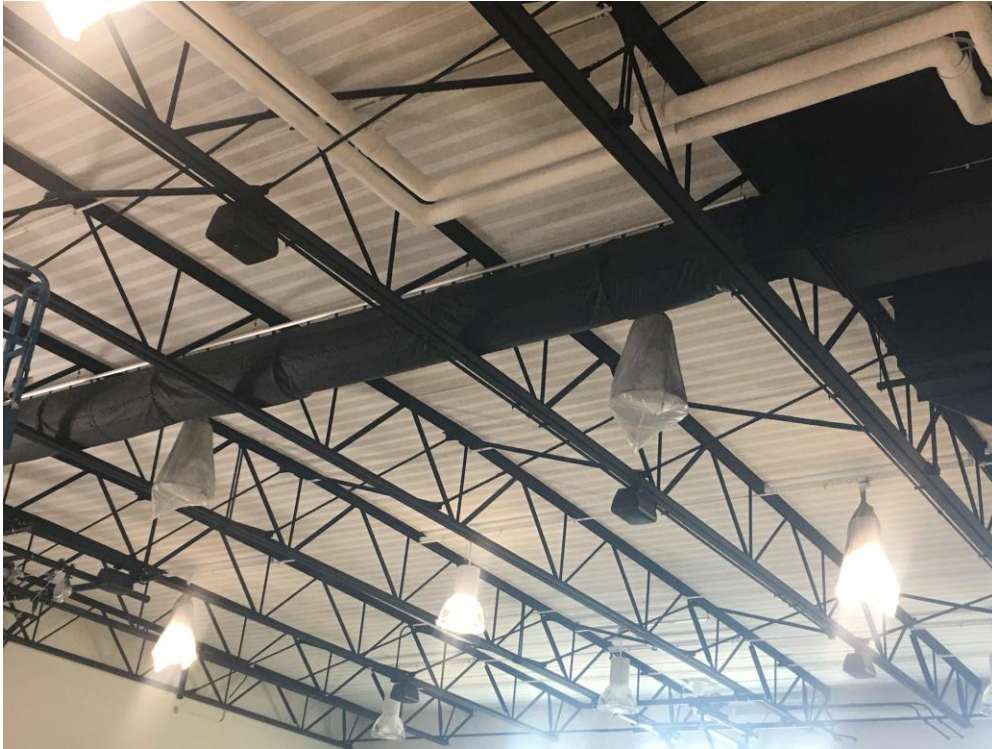
View of Gym ceiling and joists after painting with duct sock in place.

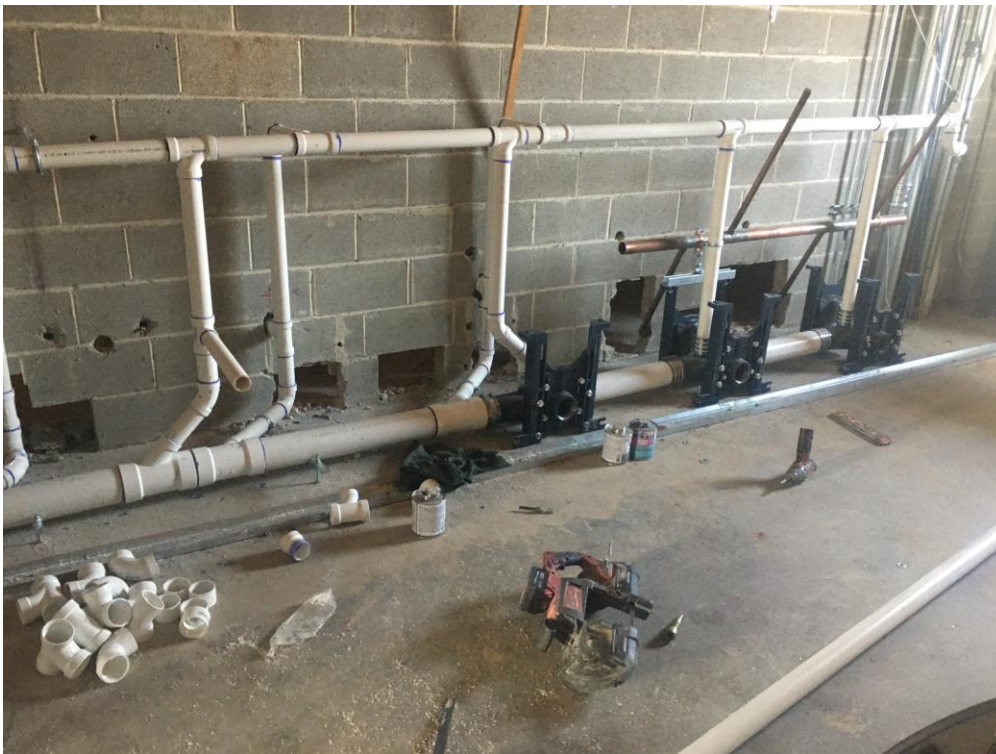
View of piping for renovated Bathrooms across from Admin Suite.

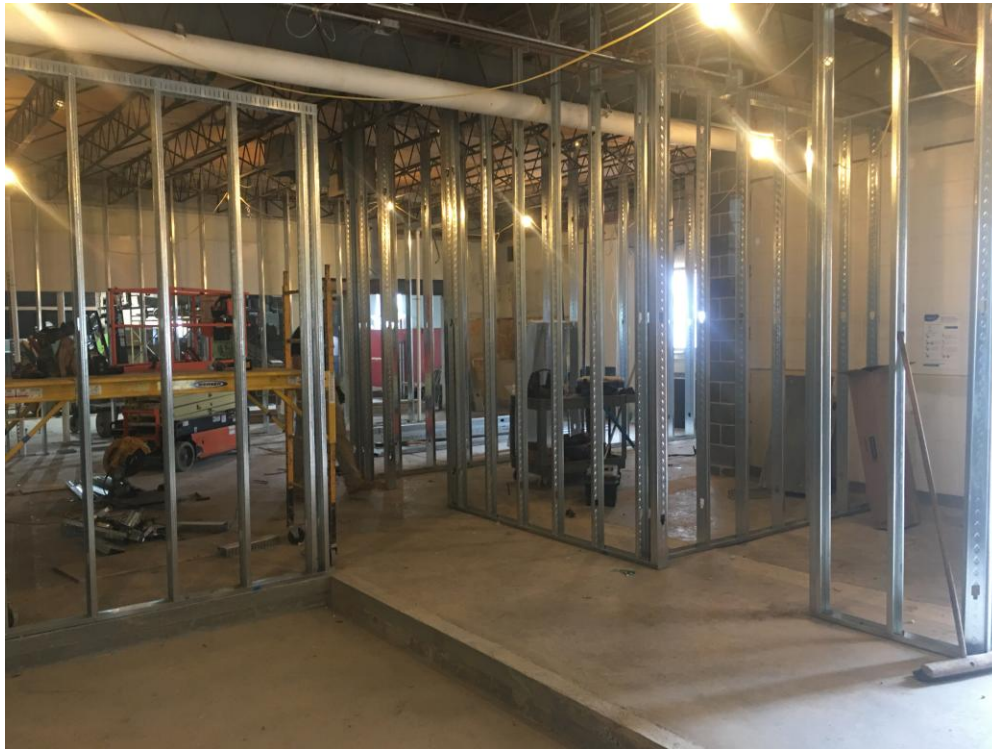
View of framing for new Kitchen offices and Slab for Walk-In Coolers.

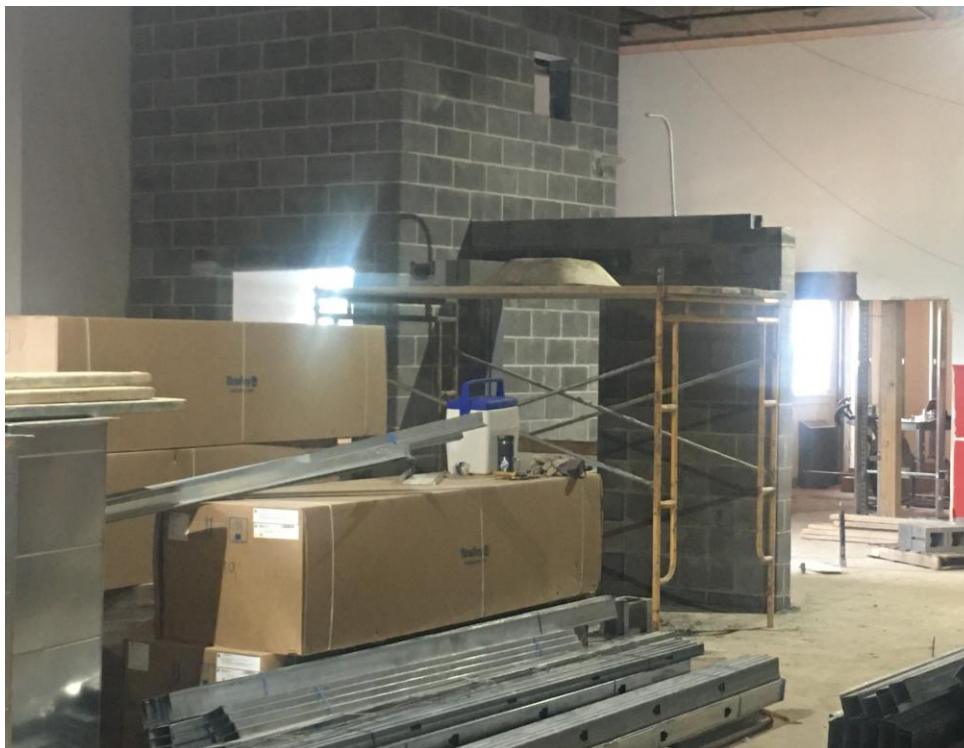
View of masonry walls being erected in Cafeteria/Kitchen area.

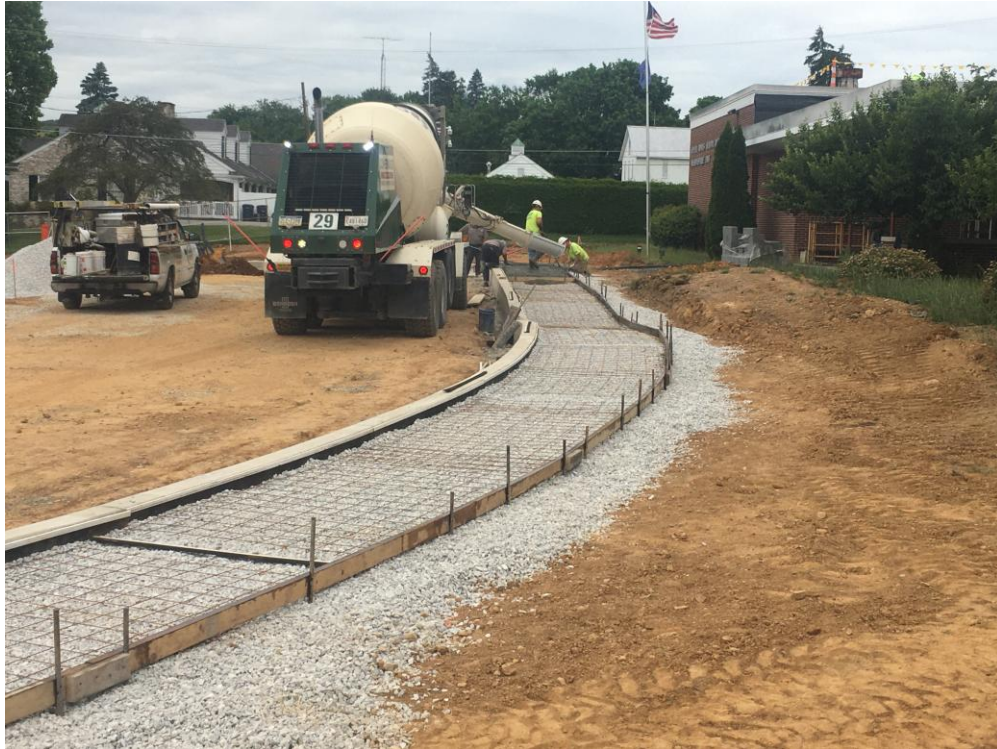
View of new sidewalk being poured at front entrance.
