**GT Management Consultants LLC**  
When Experience Counts

July 26, 2020

Report of CM Visits on 7/13-7/24/20

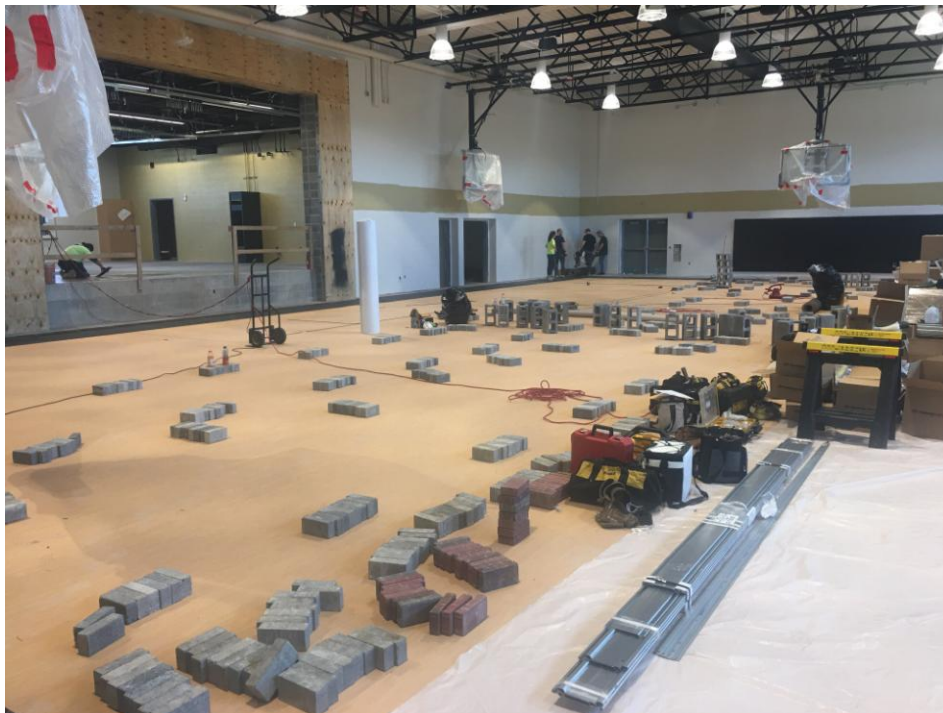
View of new Gym floor being laid. Note weights to keep it flat while gluing.

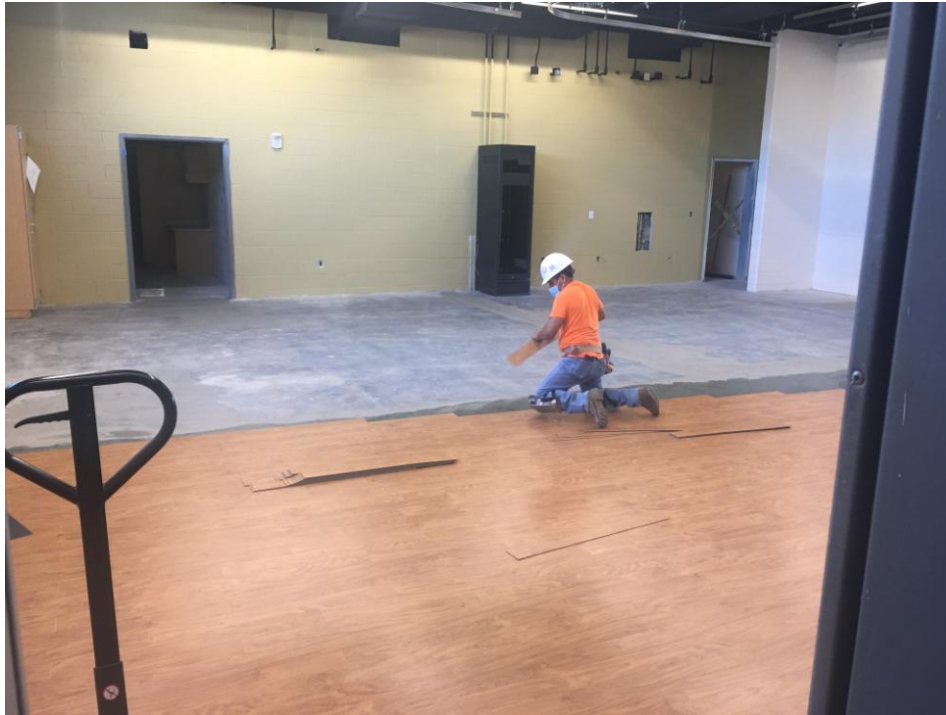
View of new floor being laid on the Platform/Music Classroom.

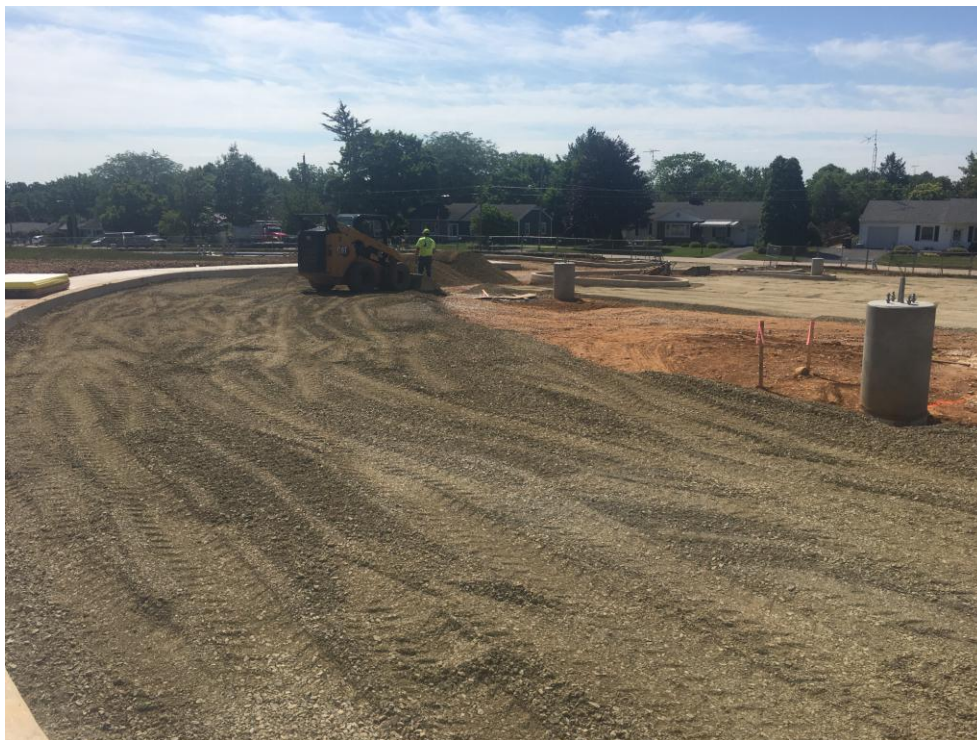
View of stone being spread on Front Parking Lot.

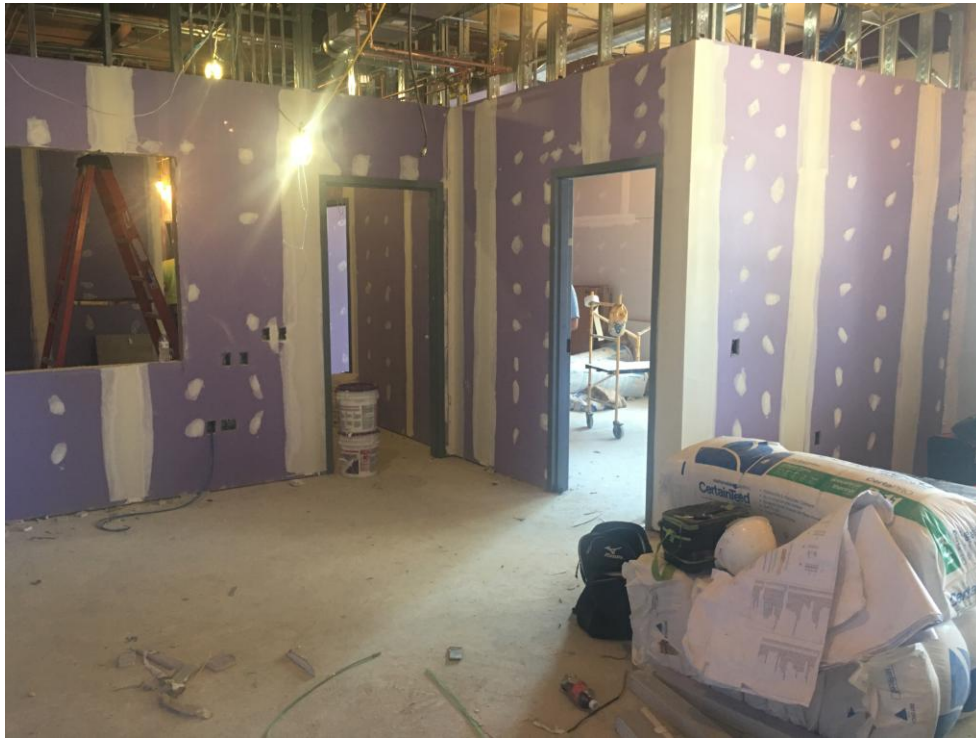
View of new Admin area.

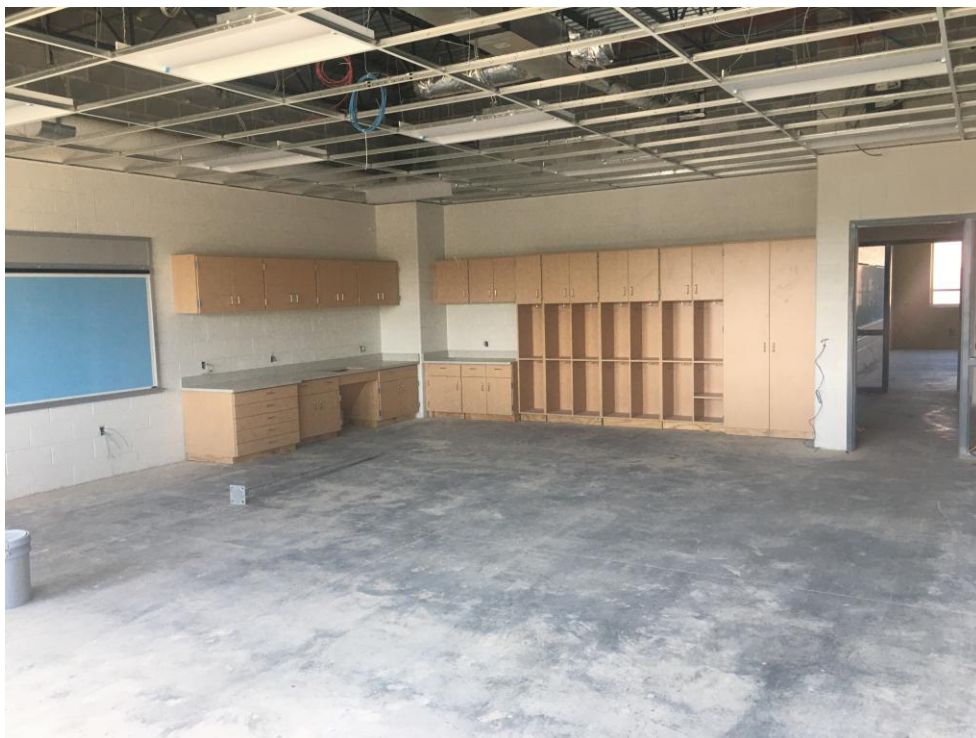
View of classroom in new wing.

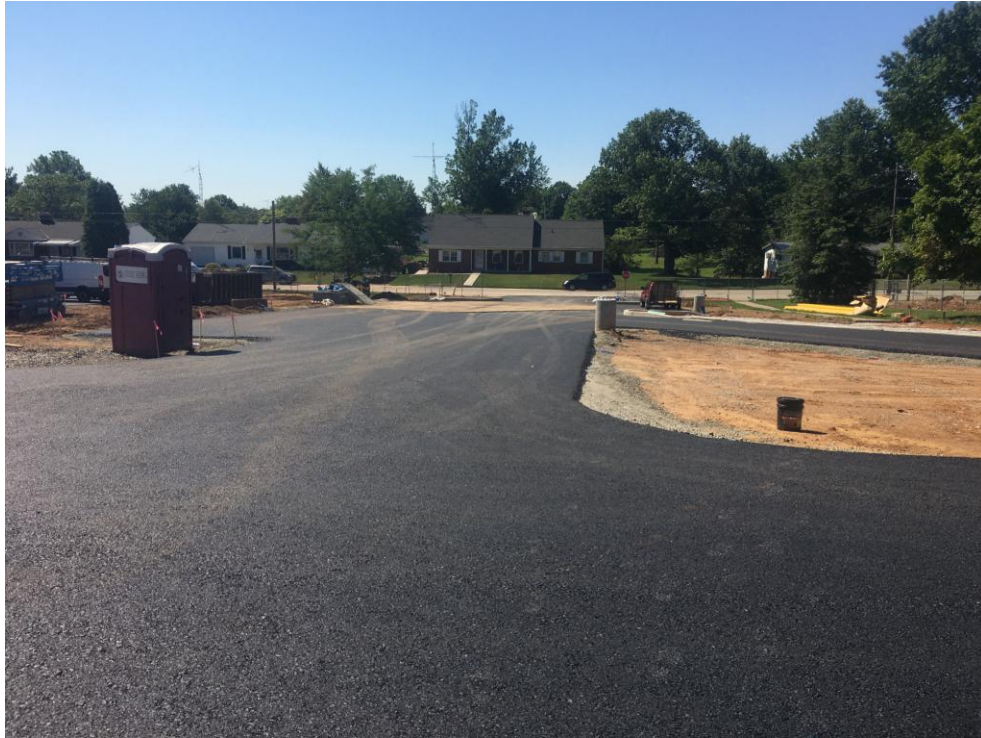
View of Front Parking lot after asphalt base was laid.

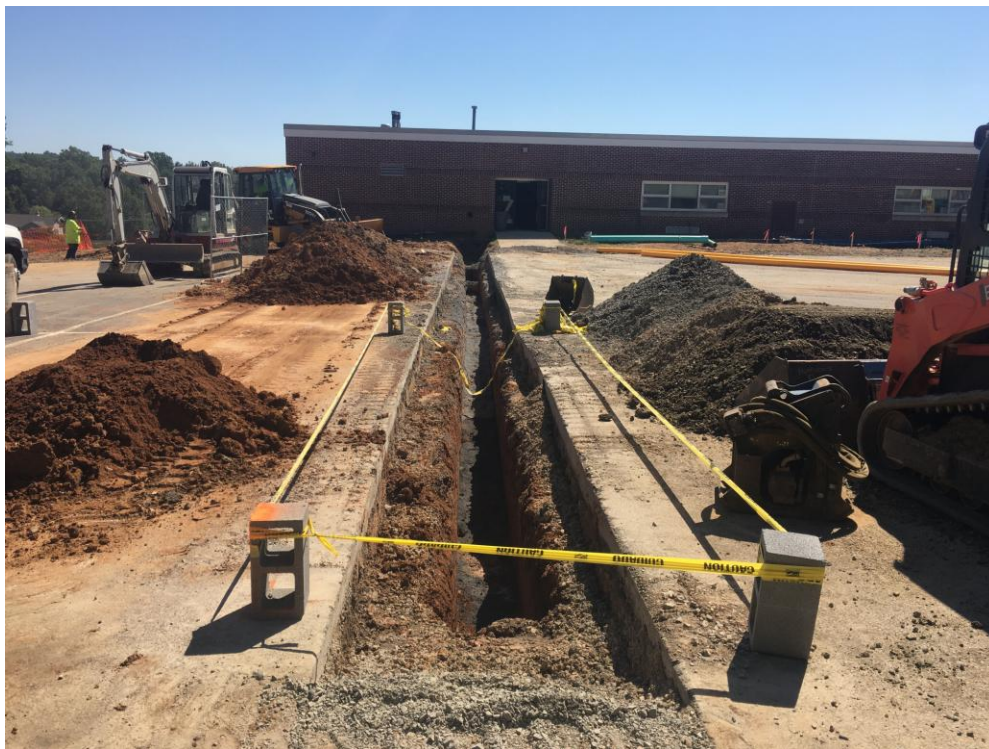
View of excavation for new gas line.

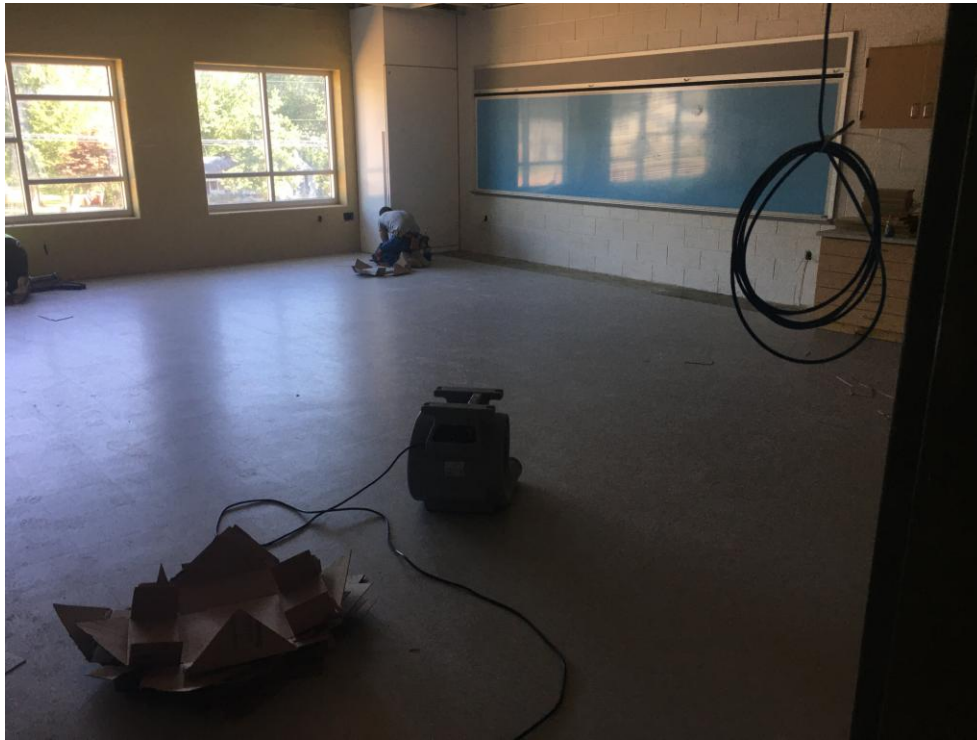
View of new classroom with flooring laid.

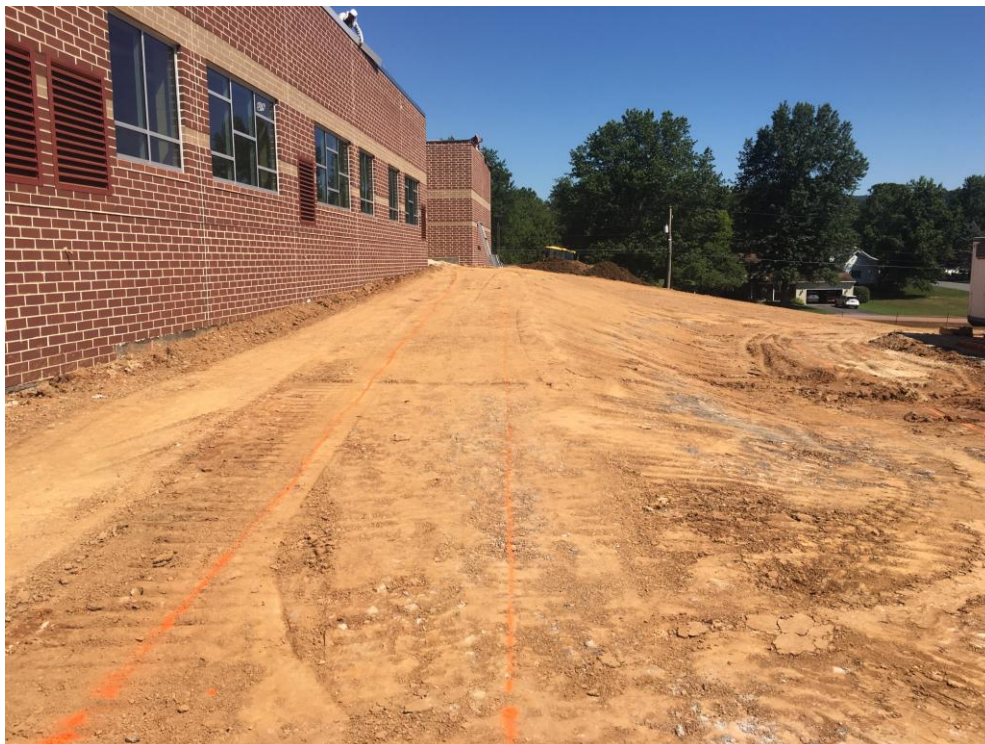
View of grading for ramp at rear of new Classroom Addition.

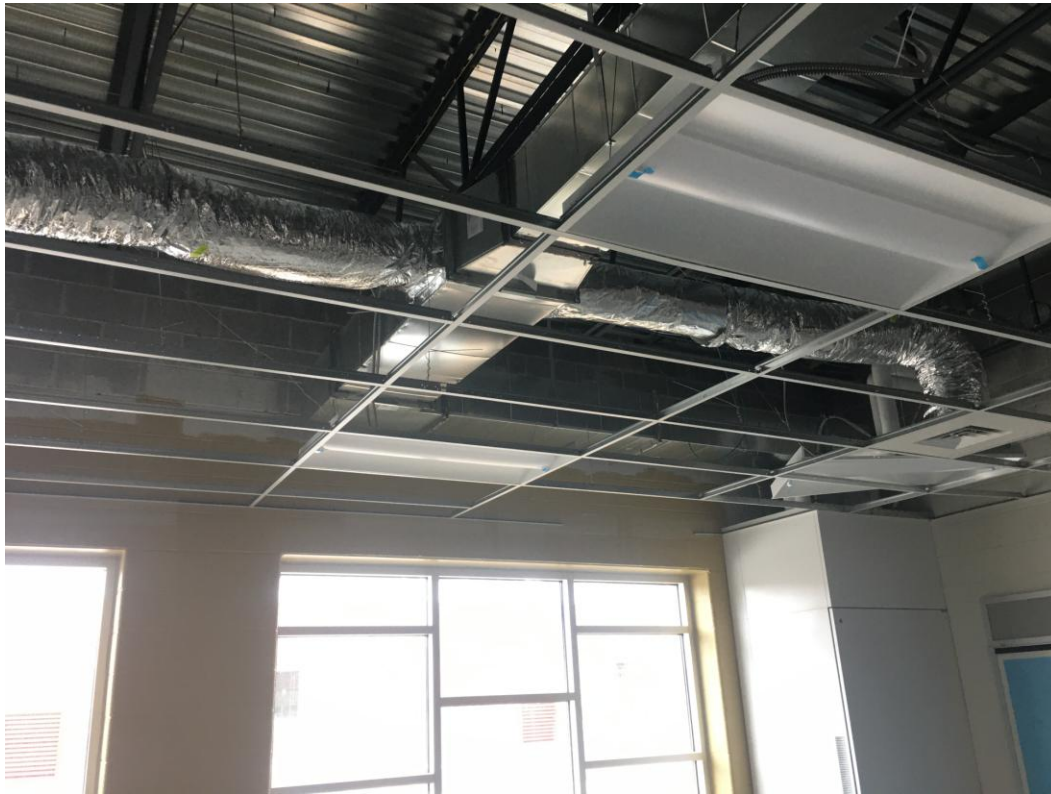
View of new light s and ceiling grid in Classroom Addition.

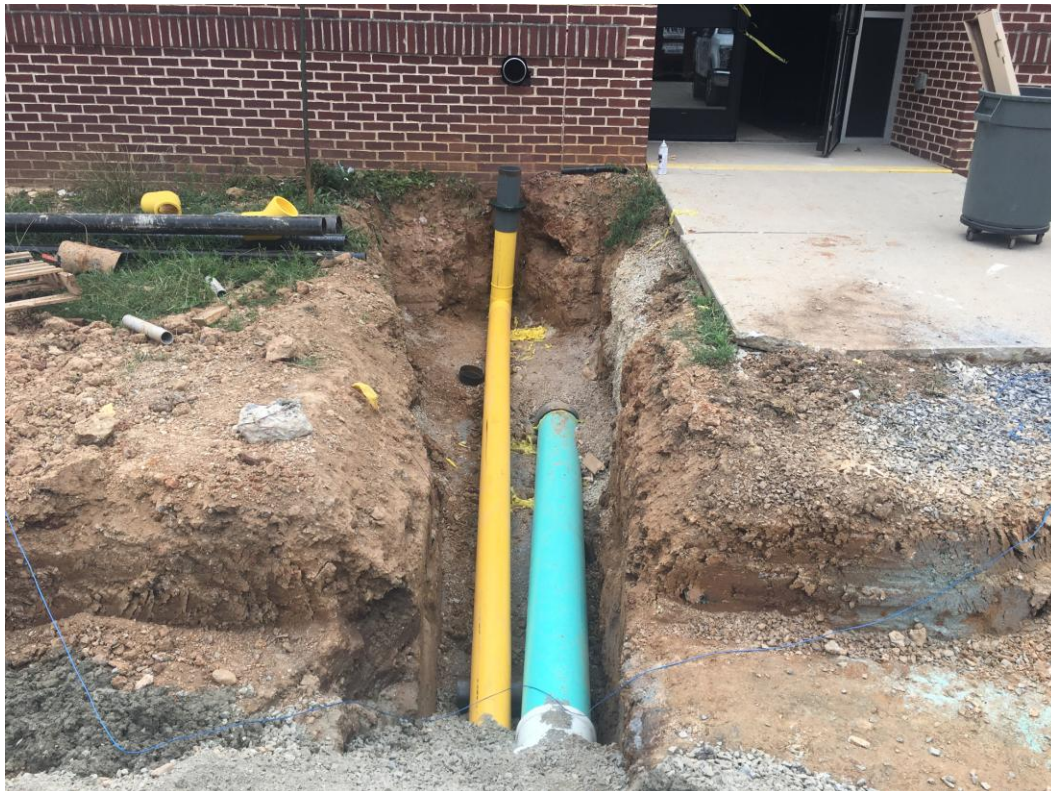
View of new gas line and repaired roof drain/storm sewer connection.

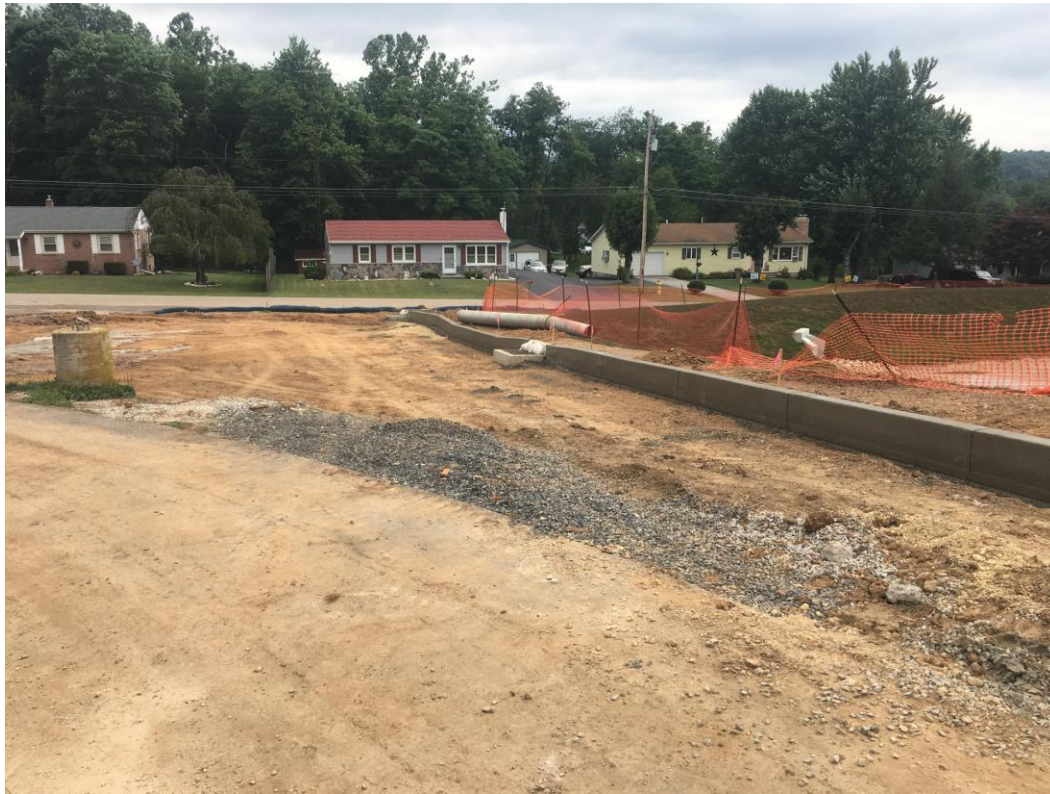
View of curb being poured at Rear Parking Lot.

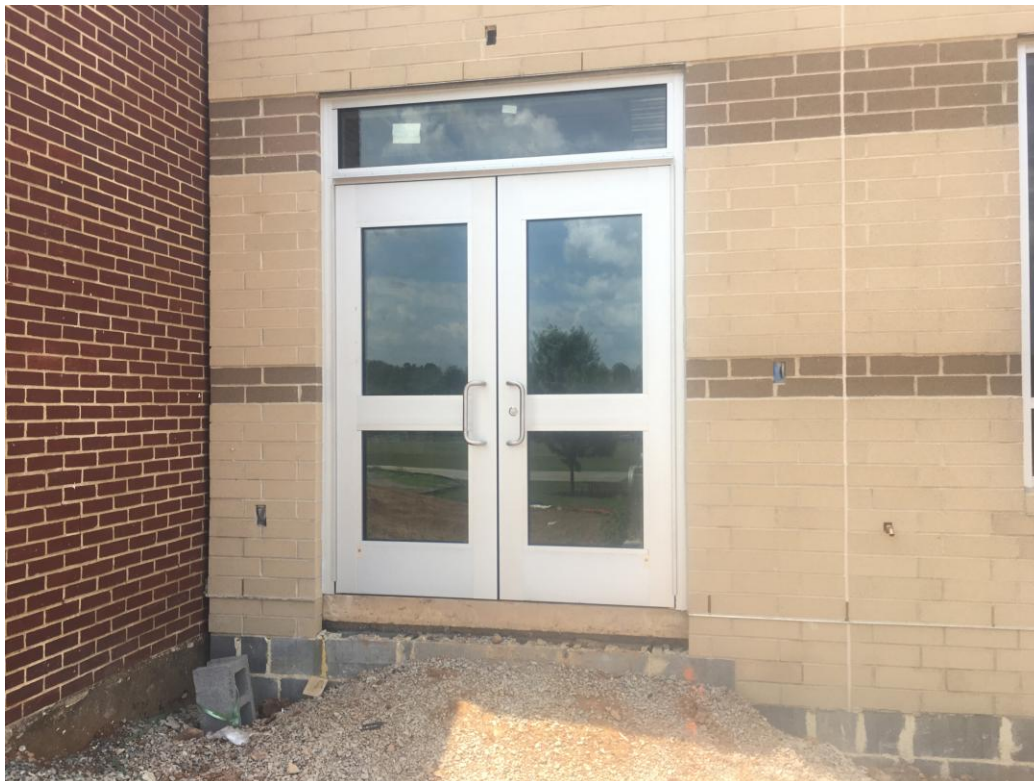
View of new doors at playground exit.

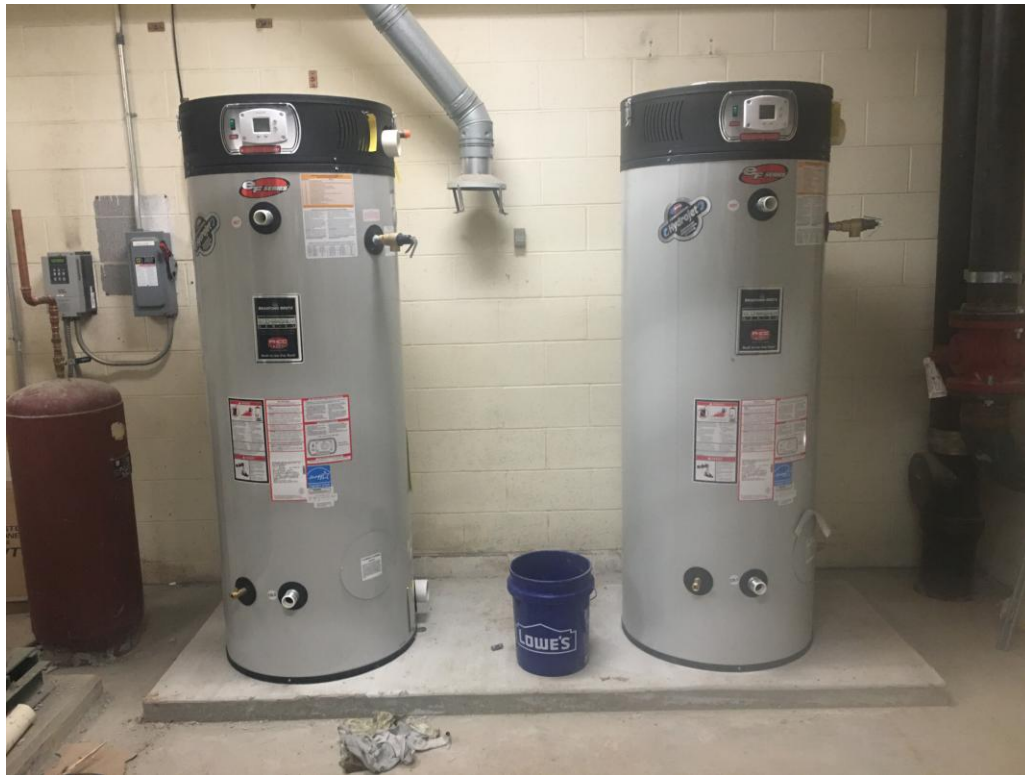
View of new Hot Water Heaters.

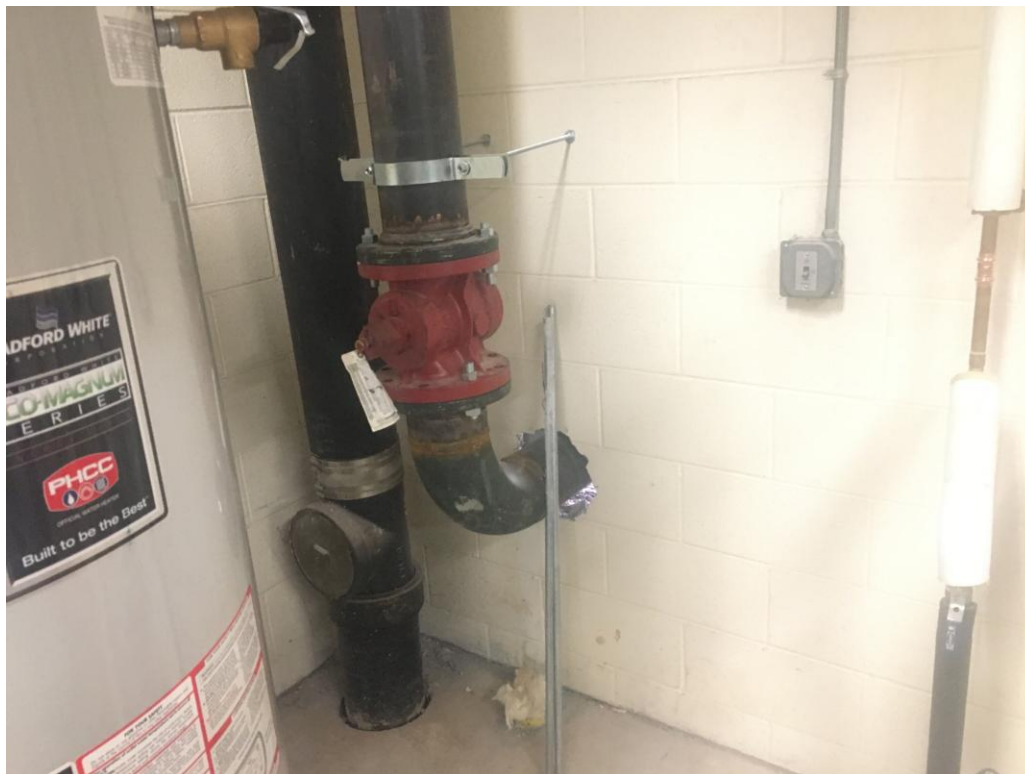
View of new gas connection.

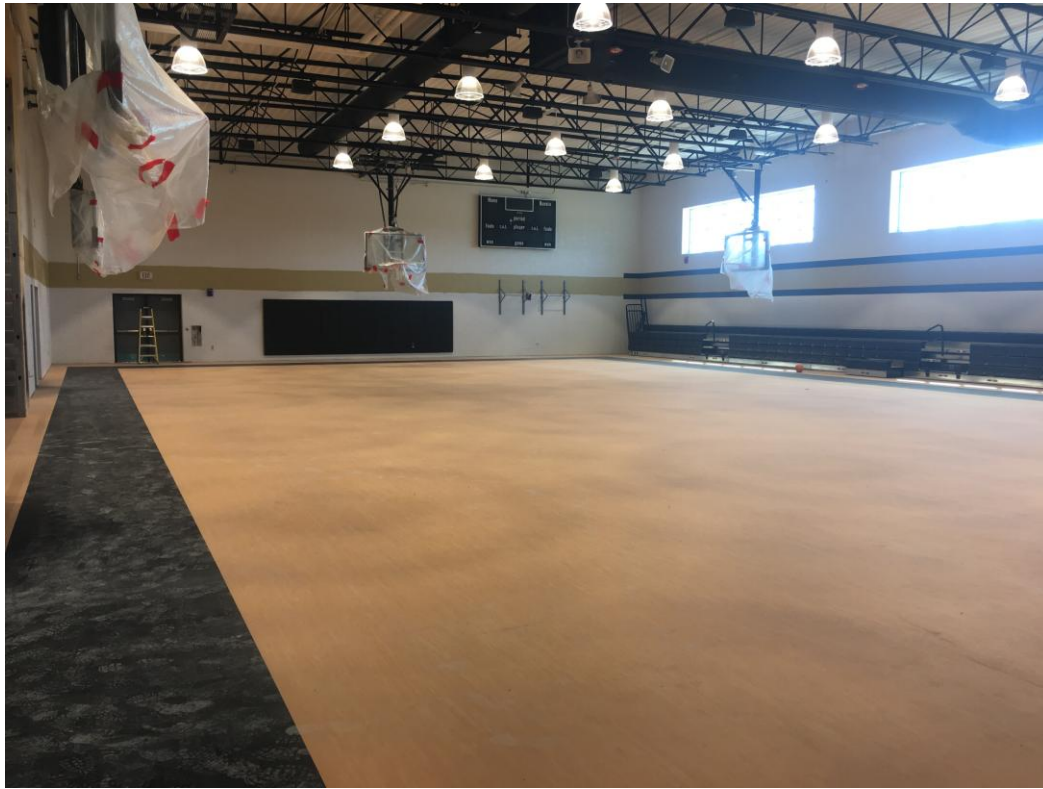
View of New Gym with flooring.

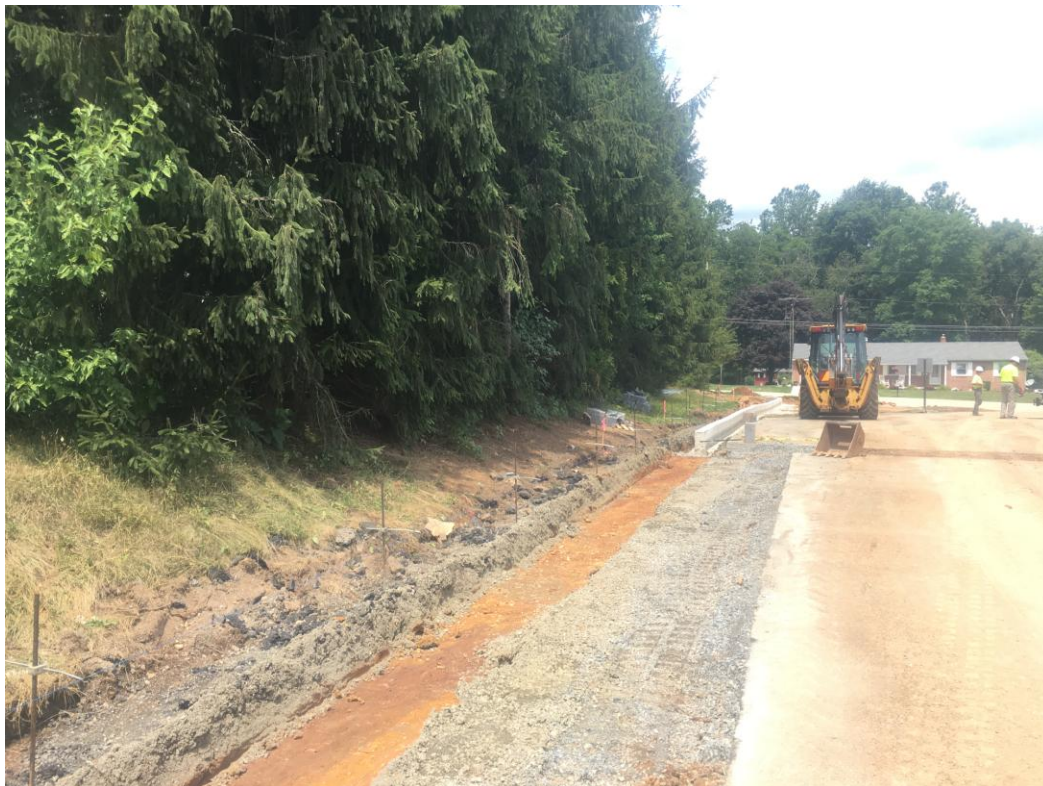
View of pine trees along Rear Parking Lot after trimming back.

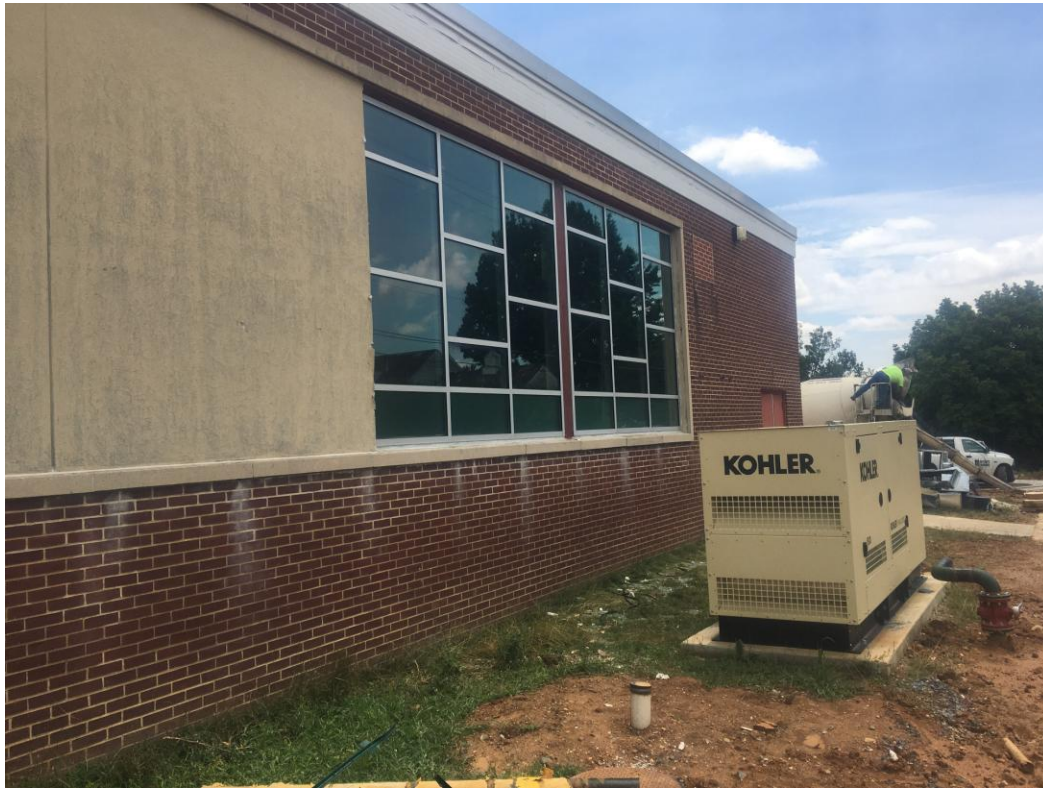
View of new Cafeteria windows.
