**Building Information - Canfield Local (48314) - C.H. Campbell Elementary**

| Assessment Name | 2022 - C.H. Campbell Elementary School (TDA/OFCC Validation Update - 9/2021) |
| Assessment Date (on-site; non-EEA) | 2018-10-09 |

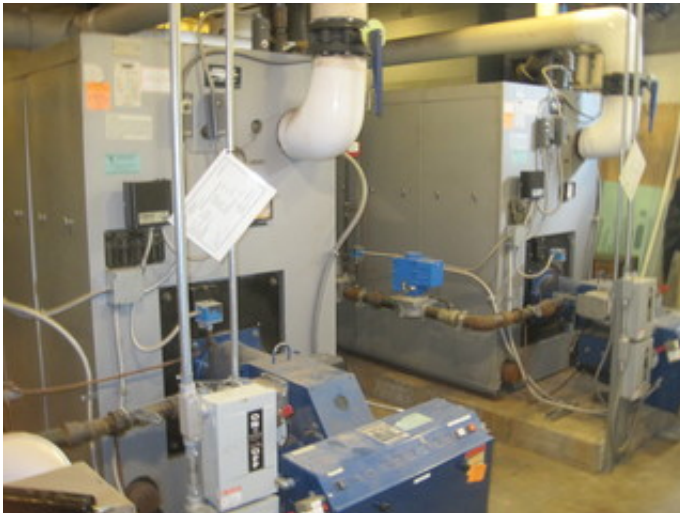
**Description:** The existing system for the overall structure consists of two Peerless gas-fired boilers installed around 2003 and (3) base-mounted pumps which are in good condition. The boilers supply water to unit ventilators (UVs) in each classroom, and unit heaters/cabinet unit heaters and finned radiation in various locations in the building. The boilers and UVs are in fair condition. The classrooms are not air conditioned. The gymnasium is heated and ventilated by a separate air handler. There are (7) rooftop units (RTUs) that serve various areas of the building. These are described further in Item C. The HVAC system does not provide the required CFM as per OSDM design standards. The system temperature controls for the UVs are pneumatic. Controls for the rooftop HVAC units are individual programmable thermostats. There is a Honeywell direct digital control (DDC) system that controls time-of-day function for each RTU.

**Rating:** 3 Needs Replacement

Heating water boilers

**Recommendations:** Provide new overall HVAC System and ductwork to meet OSDM guidelines including full air conditioning.

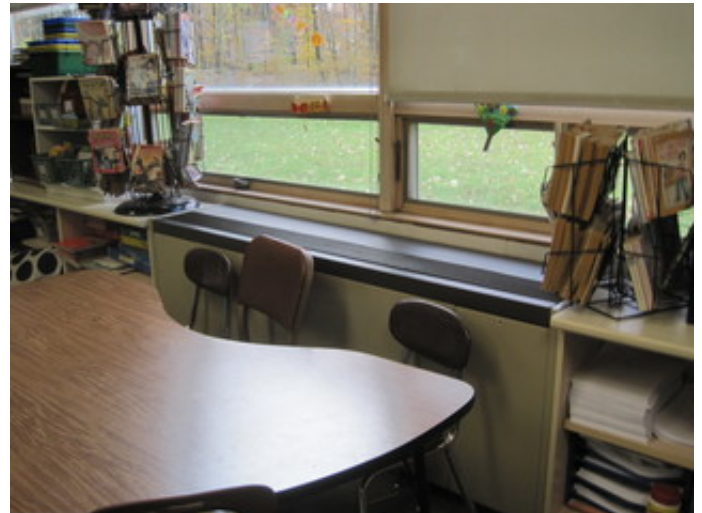
Classroom Univ Ventilator

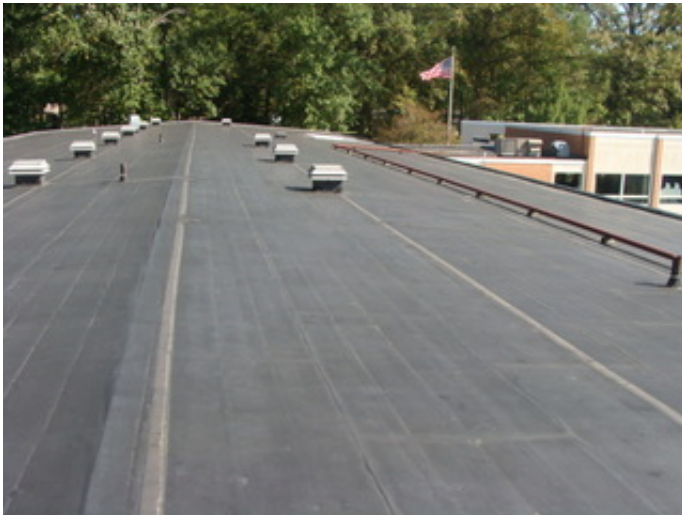
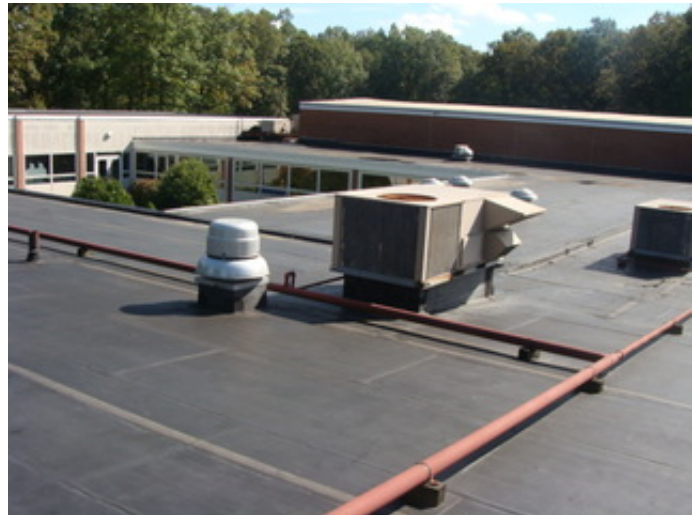
**Description:** The roof over the overall facility is a adhered EPDM system that is in fair condition. There are no District reports of current leaking. No signs of past leaking were observed during the physical assessment. Access to the roof was gained by a ladder. There were no observations of standing water on the roof. Metal cap flashings are in fair condition. Roof storm drainage is addressed through a system of roof drains, which are properly located, and in fair condition. The roof is not equipped with overflow roof drains through they will be required in areas of roof replacement. No problems requiring attention were encountered with any roof penetrations. There is a covered walkway attached to this structure.

**Rating:** 3 Needs Replacement

Existing EPDM Roofing

**Recommendations:** The roof over the overall requires replacement to meet Ohio School Design Manual guidelines for age of system and due to condition. Provide overflow roof drains as well.

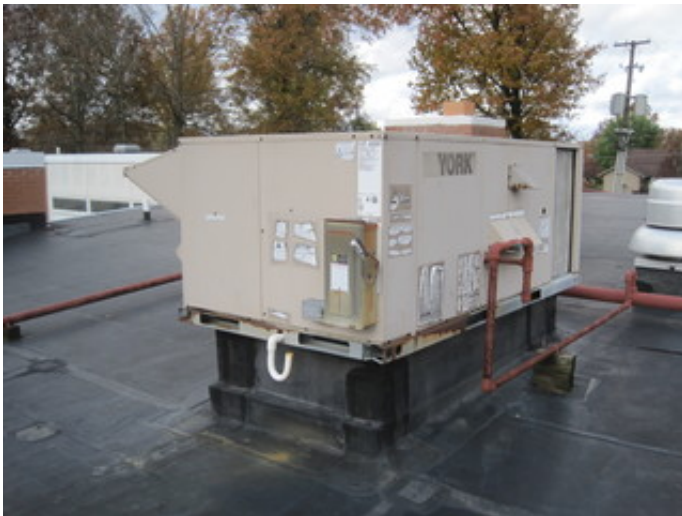
**Description:** The building is partially air conditioned by (7) gas-fired RTUs. (3) serve the library, (1) serves the computer lab, (1) serves the school office and lobby, and (2) serve the cafeteria/kitchen. Most of the RTUs were manufactured in 1999 and are in fair condition. There appears to be adequate space above ceilings for ductwork. It was not determined if the RTU's supply the required minimum outdoor ventilation to the spaces served. The UVs do not supply sufficient outdoor air to the classrooms; however, there are operable windows.

Library RTU

**Recommendations:** Due to the age of the rooftop units and duct distribution systems, and the condition of some air distribution devices, provide a new air conditioning system throughout that meets OSDM design standards. Cost for replacement included in Plate A - Heating System.

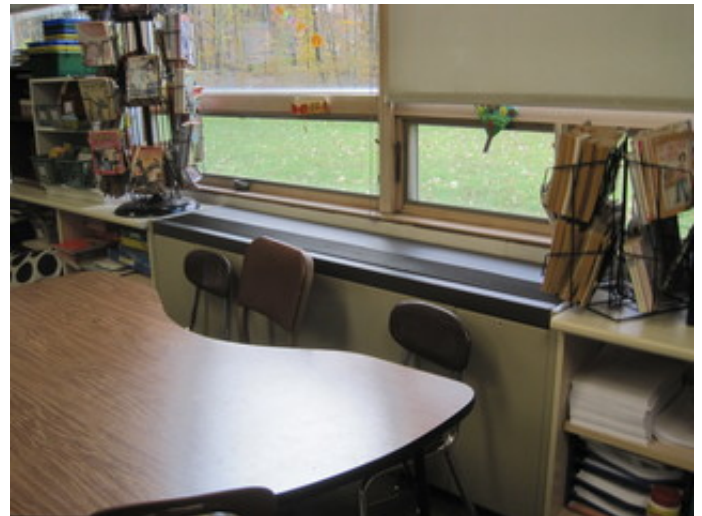
Classroom Univ Ventilator

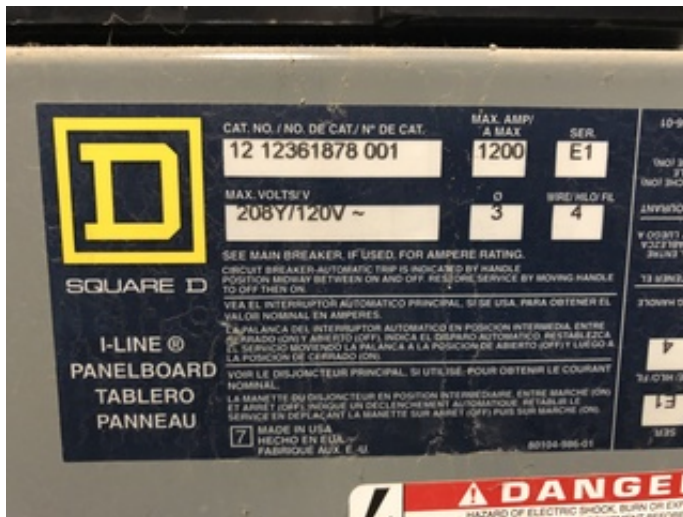
**Description:** The electrical system provided to the C.H. Campbell is a 1200 amp, 208/120 volt, 3 phase, 4 wire system is 1200 amp, 298/120 volt, 3 phase, 4 wire installed in 1999 and is in good condition. Power is provided to the school by a multiple utility owned, pole-mounted transformers located behind building, and in fair condition. The panel system, installed in 1999 is in good condition, and can be expanded to add additional capacity. The Classrooms are not equipped with adequate electrical outlets. The typical Classroom contains 7 general purpose outlets, 1 dedicated outlet for each Classroom computer, and 0 dedicated outlets for each Classroom television. Some Classrooms are equipped with as many as 6 general purpose outlets, while others are equipped with as few as 5 general purpose outlets. There are not any spaces that have no electrical outlets. The Corridors are not equipped with adequate electrical outlets for servicing. Adequate GFI protected exterior outlets are not provided around the perimeter of the building. The facility is not equipped with an emergency generator. Adequate lightning protection safeguards are not provided. The existing facility is not equipped with stage power or lighting system. The overall electrical system does not meet Ohio School Design Manual requirements in supporting the current needs of the school and will be inadequate to meet the facility's future needs.

**Rating:** 3 Needs Replacement

Switchgear

**Recommendations:** The entire electrical system requires replacement to meet Ohio School Design Manual guidelines due to condition and age and to accommodate the addition of an air conditioning system.

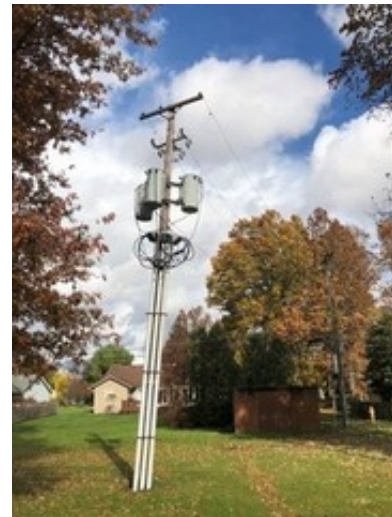
Pole mounted transformer

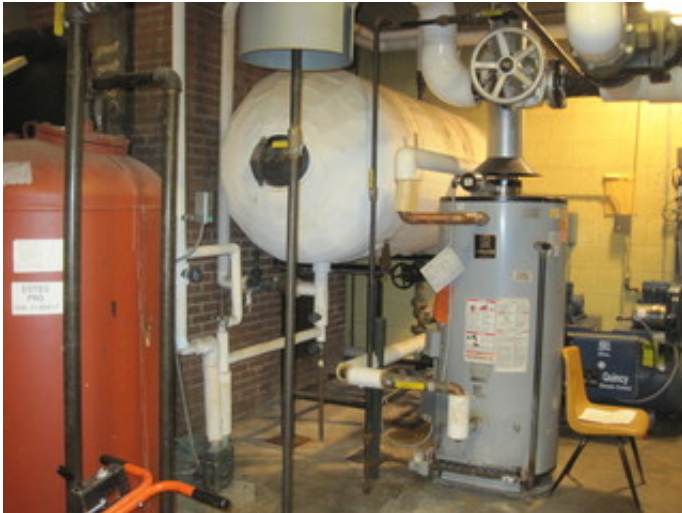
**Description:** All visible domestic water piping appears to be copper. Sanitary piping is cast iron. There is (1) domestic water heater and storage tank located in the mechanical room. It is a State Industries, atmospheric gas-fired, 360 MBH input, 70 gallon tank, manufactured in 1999. Water heater is in fair condition and the storage tank is in good condition. The domestic hot water system has a recirculating pump, but no thermostatic mixing valve. There are (3) single occupancy restrooms, each with a water closet and lavatory. There are (3) boys and (3) girls group toilet rooms. Fixtures are both floor-mounted and wall-hung and appear to be in good-to-fair condition, but out dated. Flush valves and lavatory faucets are manual operation.

**Rating:** 3 Needs Replacement

Domestic Water Heater & Storage Tank

**Recommendations:** Provide new toilets to replace existing wall/floor mounted toilets. Provide new urinals to replace existing wall/floor mounted urinals. Provide two new water heaters to replace existing gas-fired heater.

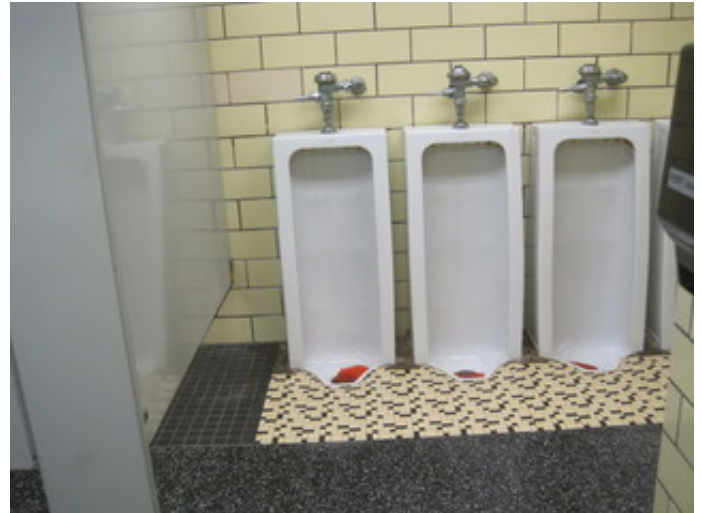
Floor-mounted urinals w/manual flush vales

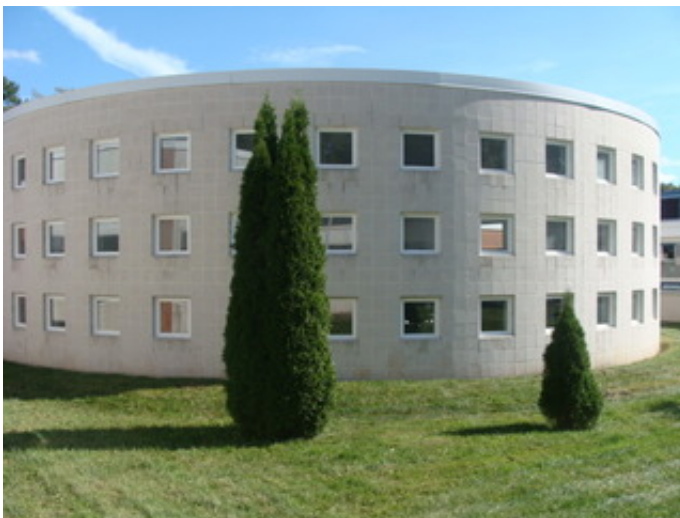
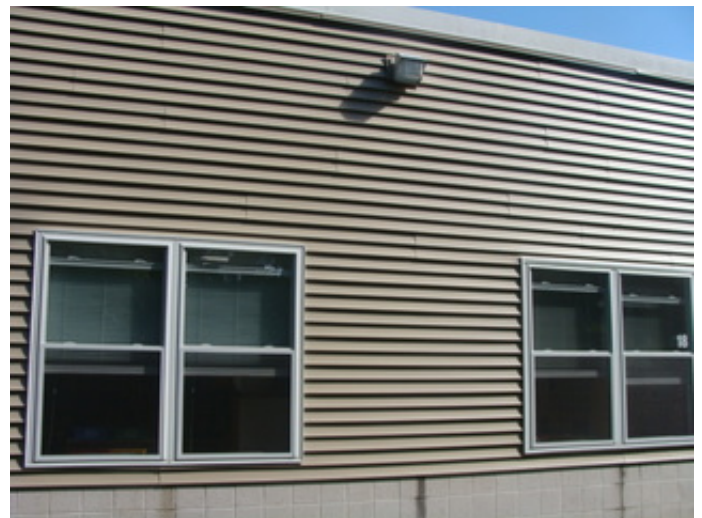
**Description:** The overall facility is equipped with poor Anderson thermally broken vinyl frame windows, double glazed insulated glazing windows. They are in very poor condition. Window system seals are in poor condition, with frequent air and water infiltration being experienced. Window system hardware is in poor condition. The window system features surface mounted blinds.

**Rating:** 3 Needs Replacement

Media Center Windows

Typical Classroom Windows

**Recommendations:** Provide a new insulated window system with integral blinds to meet with Ohio School Design Manual requirements. 2021 UPDATE: Adjust area of window replacement. Add shades to newly replaced windows. 10-13-2022: Per Then Design's assessment validation, updated the cost of the window blinds from \$1800/each to \$2100/each.

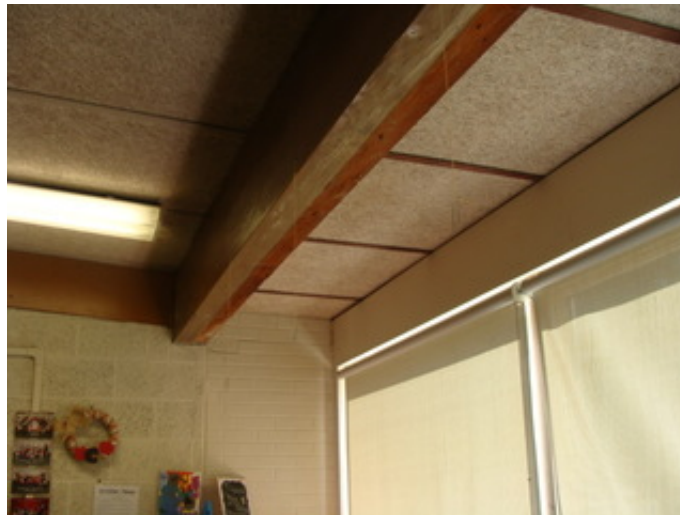
| Description: | The overall facility is equipped with concrete masonry unit foundation walls on concrete footings, which now displayed no locations of significant differential settlement, cracking, or leaking, and are in good condition. A structural settlement issue was repaired a number of years ago. The District reports that there have been no past leaking. No grading or site drainage deficiencies were noted around the perimeter of the structure that are contributing or could contribute to foundation/wall structural deterioration. |

| Item | Cost | Unit | Whole Building | Original Building (1961) | First Addition (1999) | Sum | Comments |
|---|---|---|---|---|---|---|---|
| Sum: | | | \$885,255.00 | \$0.00 | \$885,255.00 | | Evidence of cracking at wall/floor. A potential solution was estimated for a budget. Further analysis is required. |

Area Where Exterior Wall Needed To Be Relocated

| Recommendations: | Existing conditions require no renovation or replacement at the present time. 2021 UPDATE: Evidence of cracking at wall/floor. A potential solution was estimated for a budget. Further analysis is required. 10-13-2022: Per Then Design's assessment validation, updated the cost of the crack repair to \$885,255. |

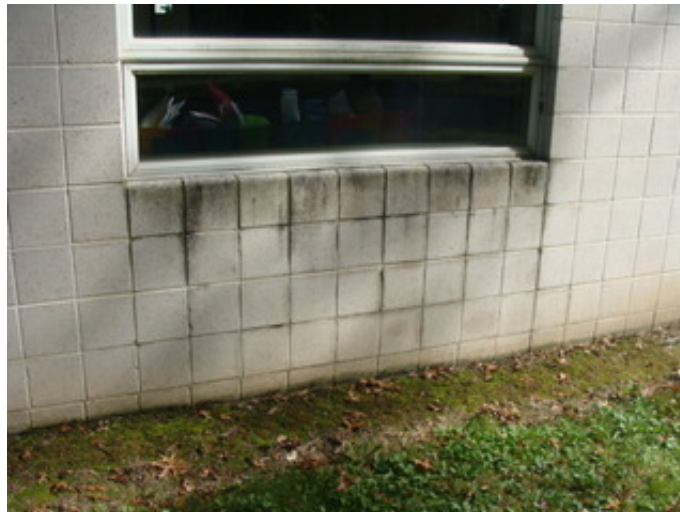
**Description:** The overall facility has a brick veneer on a masonry bearing wall system, which displayed minor locations of deterioration, and is in fair condition. The exterior masonry appears to have appropriately spaced and adequately caulked control joints in fair condition. The exterior masonry has not been cleaned and sealed in recent years, and shows evidence of very minor mortar deterioration. Architectural exterior accent materials consist of stone, which are in fair condition. The window sills are an element of the aluminum window system and are in fair condition. The exterior lintels are steel and are in fair condition.

**Rating:** 2 Needs Repair

Exterior CMU That Needs To Be Cleaned

**Recommendations:** Provide tuckpointing in all areas of mortar deterioration as required through the overall facility. Also provide masonry cleaning, sealing, caulking as required through the overall facility. 2021 UPDATE: Repair/paint fascia and overhang. 10-13-2022: Per Then Design's assessment validation, updated the cost of the infill vents from \$45/SF to \$60/SF and the fascia repair from \$6000 LS to \$7000 LS

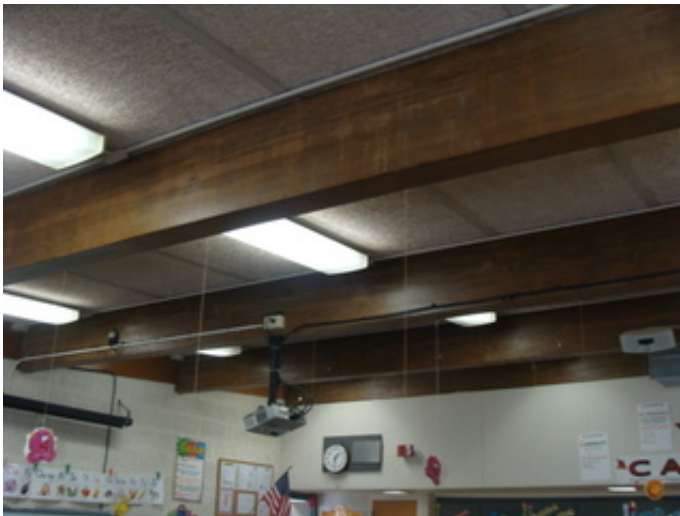
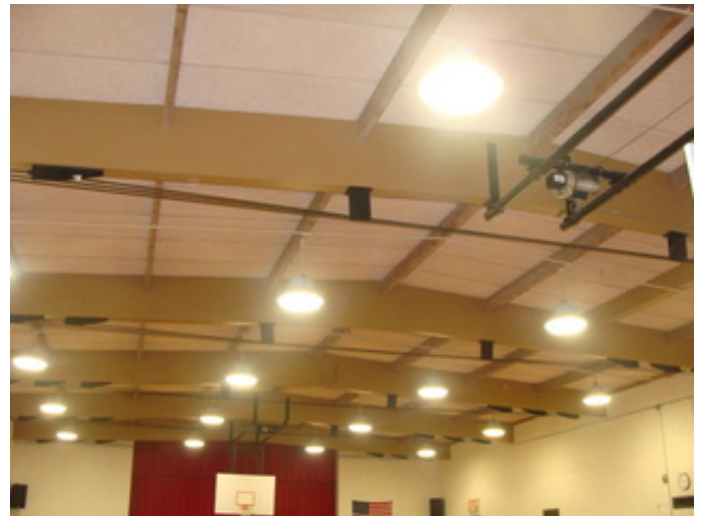
**Description:** The floor construction of the base floor of the overall facility is concrete slab on grade construction, and is in good condition. There is no crawl space. Ceiling to structural deck spaces are insufficient to accommodate HVAC, electrical, and plumbing scopes of work required in renovations. The roof construction of the original building is tectum over a structural wood framing system.

**Rating:** 3 Needs Replacement

Wood Roof Beams in Classroom

Wood Roof Trusses in Gymnasium

**Recommendations:** Provide fire separation assembly for wood roof structure in the original building.

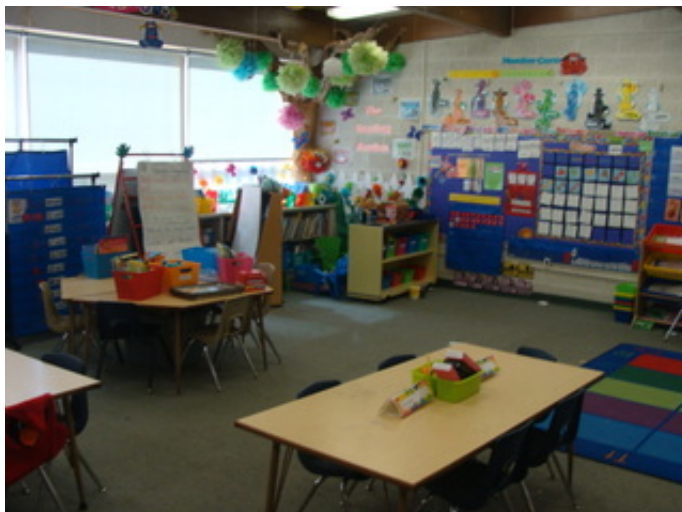
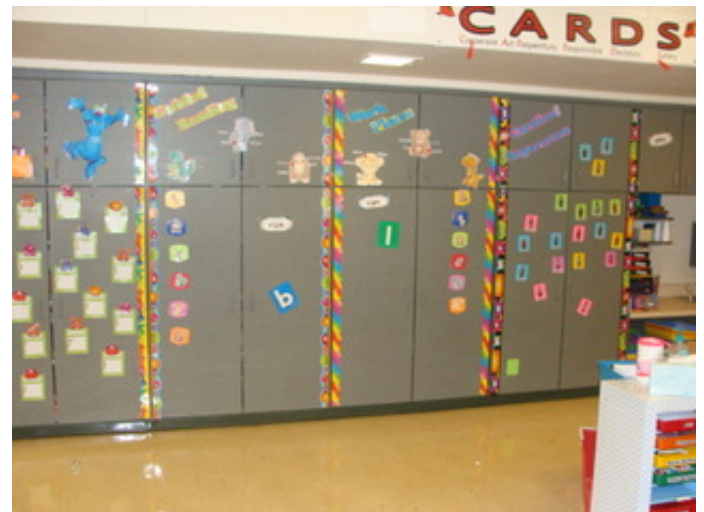
**Description:** The overall facility features conventionally partitioned Classrooms with carpet flooring, tectum/suspended ceilings, as well as tile/painted wall finishes, and they are in fair condition. The overall facility has Corridors with tile flooring, suspended ceilings, as well as tile/CMU wall finishes, and they are in fair condition. The overall facility has Restrooms with tile flooring, suspended ceilings, as well as tile wall finishes, and they are in fair condition. Toilet partitions are metal and plastic, and are in fair condition. Classroom casework in the overall facility is wood construction with plastic laminate tops, is in adequately provided, and in fair condition. The facility is equipped with wood louvered and non-louvered interior doors that are recessed and partially recessed with and without proper ADA hardware and clearances and in fair condition. The Gymnasium space has wood flooring, open ceilings, as well as painted wall finishes, and they are in fair condition. Gymnasium basketball backboards are fixed type, and are in fair condition. The Media Center has carpet flooring, suspended ceilings, as well as painted type wall finishes, and they are in fair condition. Student Dining has VCT flooring, suspended ceilings, as well as painted wall finishes, and they are in fair condition. The existing Kitchen is a Warming Kitchen only, is undersized based on current enrollment, and the existing Kitchen equipment, is in fair condition.

**Rating:** 3 Needs Replacement

Typical Classroom Arrangement

Typical Classroom Storage

**Recommendations:** Provide complete replacement of finishes and casework due to installation of systems outlined in Items A, C, D, E, I, K, L, M, N, T, and U. Also provide new warming Kitchen equipment. 2021 UPDATE: 1961 wing: Replace damaged terrazzo floor area; add exterior wall insulation; replace resilient wood flooring; replace BB backboards; add wall padding in gymnasium. 10-13-2022: Per Then Design's assessment validation, updated the cost of the gym wall padding from \$13/SF to \$14.50/SF

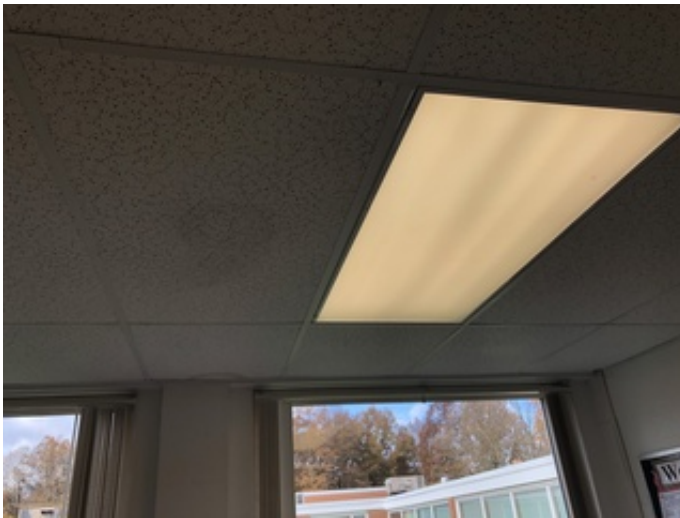
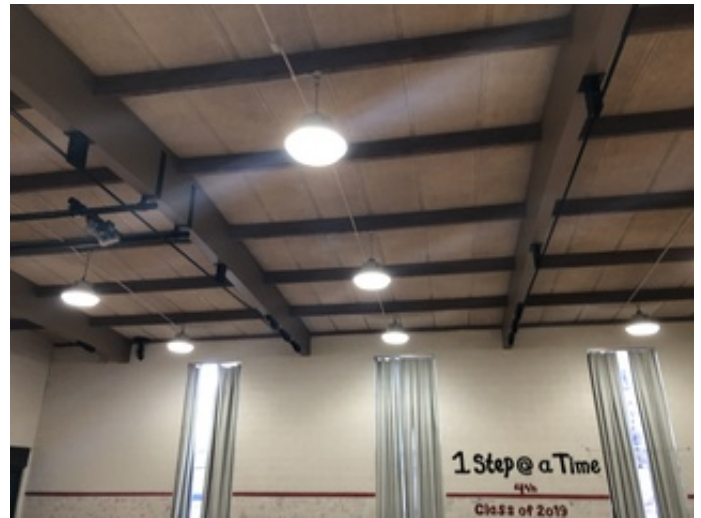
The typical Classrooms in the CH Campbell are equipped with T-8 1x4 surface mount fluorescent fixtures with dual level switching. Classroom fixtures are in fair condition, providing an average illumination of 20 FC, which is less than the 50 FC recommended by the OSDM. The 1999 Addition has 2x4 lay-in T-8 with dual level switching and average illumination of 40-60 FC. The typical Corridors in the CH Campbell are equipped with T-8 2x2 and 2x4 lay-in fluorescent fixtures with single level switching. Corridor fixtures are in good condition, providing an average illumination of 35 FC, thus complying with the 20 FC recommended by the OSDM. The Gymnasium spaces are equipped with pendant LED type fixtures, in good condition, providing an average illumination of 20 FC, which is less than the 50 (ES) FC recommended by the OSDM. The Media Center is equipped with 2x4 lay-in T8 fluorescent fixture type lighting in good condition, providing an average illumination of 30 FC, which is less than the 50 FC recommended by the OSDM. The Media Center Addition is equipped with 1x4 lay-in T8 fixtures in good condition and providing an average of 75-80 FC. The Student Dining spaces are equipped with 1x4 lay-in T8 fluorescent fixture type lighting with multi level switching. Student Dining fixtures are in good condition, providing an average illumination of 55 FC, thus complying with the 50 FC recommended by the OSDM. The Kitchen spaces are equipped with 2x4 lay-in T8 fluorescent fixture type lighting with multi level switching. Kitchen fixtures are in good condition, providing an average illumination of 100 FC, thus complying with the 75-80 FC recommended by the OSDM. The Service Areas in the CH Campbell are equipped with 1x4 surface mount T8 fluorescent fixture and CFL type lighting in fair condition. The typical Administrative spaces in the CH Campbell are equipped with 2x4 lay-in T8 fluorescent fixture type lighting in good condition, providing adequate illumination of 55 FC based on OSDM requirements. The overall lighting systems of the facility are not fully compliant with Ohio School Design Manual requirements due to age and condition, inadequate lighting levels, and lack of multi-level switching.

3 Needs Replacement

2X4 lay-in

Gym Pendant LED

Provide complete replacement of lighting system due to condition, lighting levels, lack of multilevel switching and installation of new fire suppression and air conditioning systems.

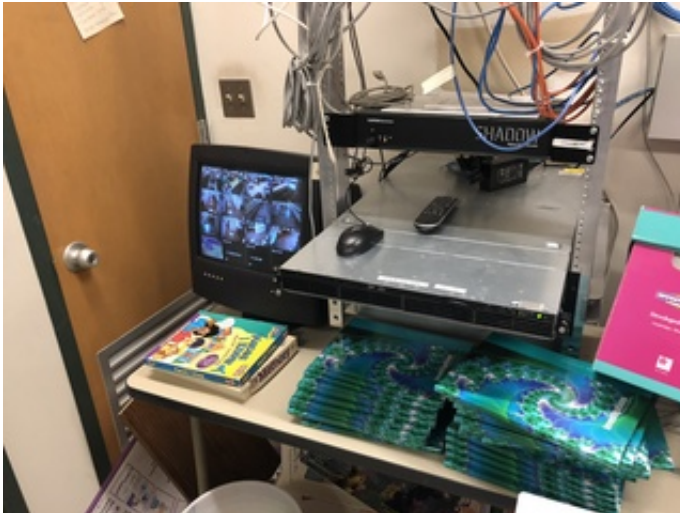
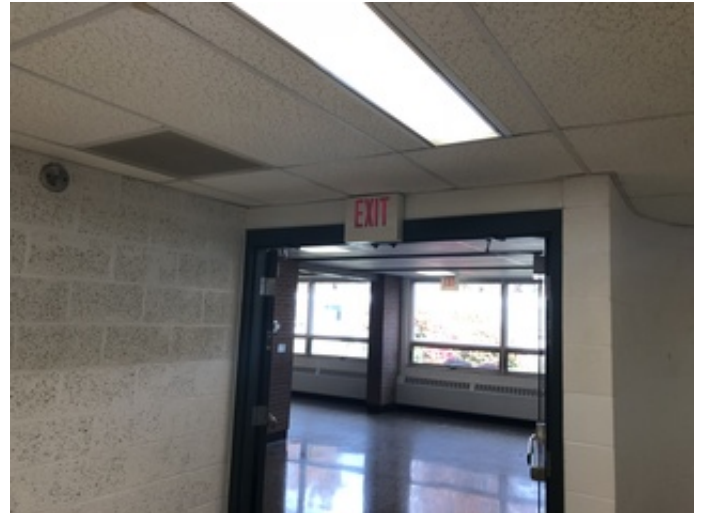
**Description:** The CH Campbell contains a CCTV type security system in good condition. Motion detectors are adequately provided in main entries, central gathering areas, offices, main Corridors, and spaces where 6 or more computers are located. Exterior doors are not equipped with door contacts. An automatic visitor control system is not provided. Compliant color CCTV cameras are provided at main entry areas, parking lots, central gathering areas, and main Corridors. CCTV is monitored in Administrative Area with the use of TV, recording device and multiplexer. The system is not equipped with card / biometric readers. The security system is not adequately provided throughout, and the system is not fully compliant with Ohio School Design Manual guidelines. The exterior site lighting system is equipped with HID metal halide entry lights in fair condition. Parking and bus pick-up / drop off areas are illuminated by wall pack HID and pole mounted flood lights in good condition. The exterior site lighting system provides adequate coverage.

**Rating:** 3 Needs Replacement

Security Monitor

Exterior flood lights

**Recommendations:** Provide a full security system upgrade, consisting of additional door controls, cameras to meet Ohio School Design Manual guidelines due to the extensive renovations that will take place. Provide enhancement of exterior site lighting system, consisting of LED fixtures to meet Ohio School Design Manual guidelines. 2021 UPDATE: Provide Secure Vestibule; change security replacement to full replacement. 10-13-2022: Per Then Design's assessment validation, updated the cost of the secure vestibule from \$250,000 to \$292,500.

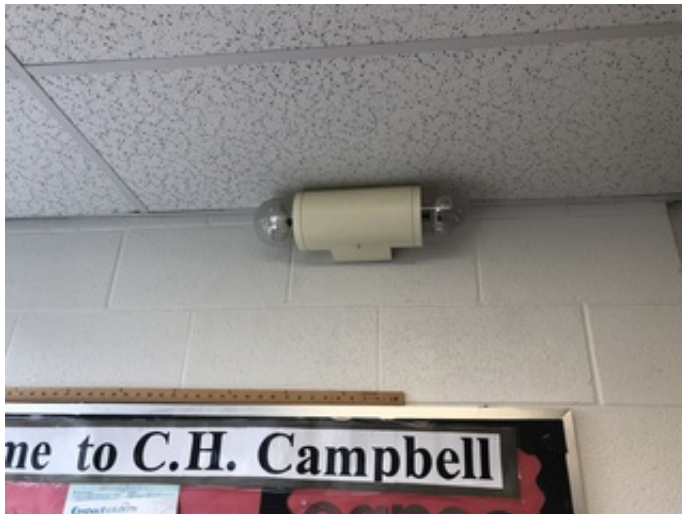
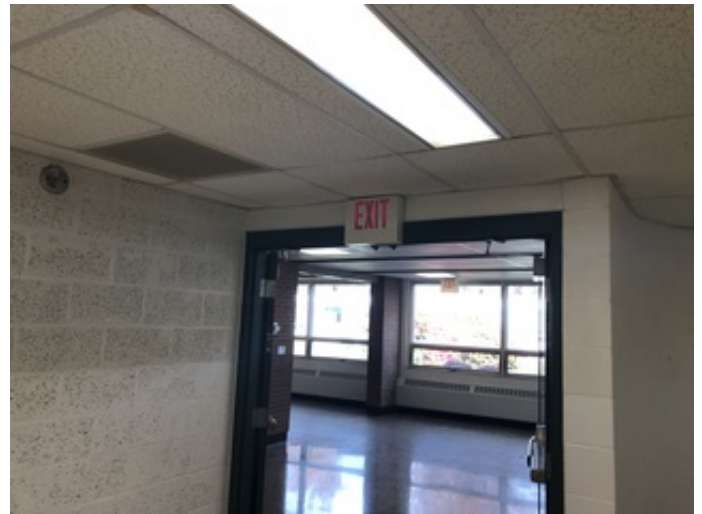
**Description:** The CH Campbell is equipped with an emergency egress lighting system consisting of OSDM compliant red lettered, cast aluminum construction, LED illuminated exit signs and emergency floodlighting. The system is in fair condition, and is provided with appropriate battery backup. The system is not adequately provided throughout, and does not meet Ohio School Design Manual and Ohio Building Code requirements.

**Rating:** 3 Needs Replacement

Typical emergency fixture

Typical exit fixture

**Recommendations:** Provide complete replacement of emergency / egress lighting system to meet Ohio School Design Manual guidelines.

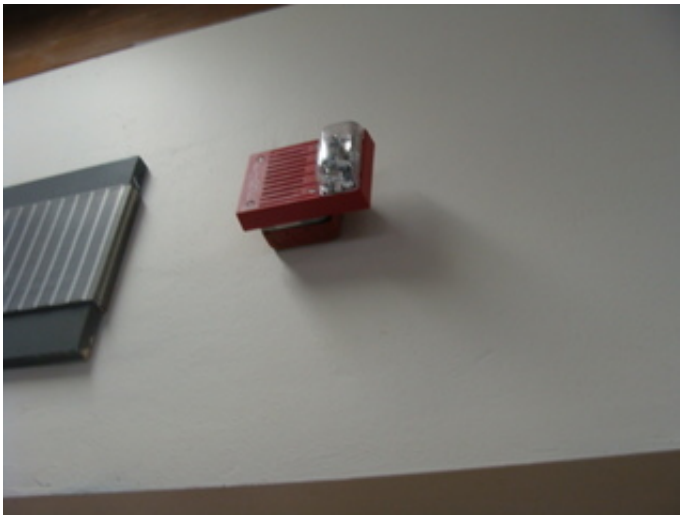
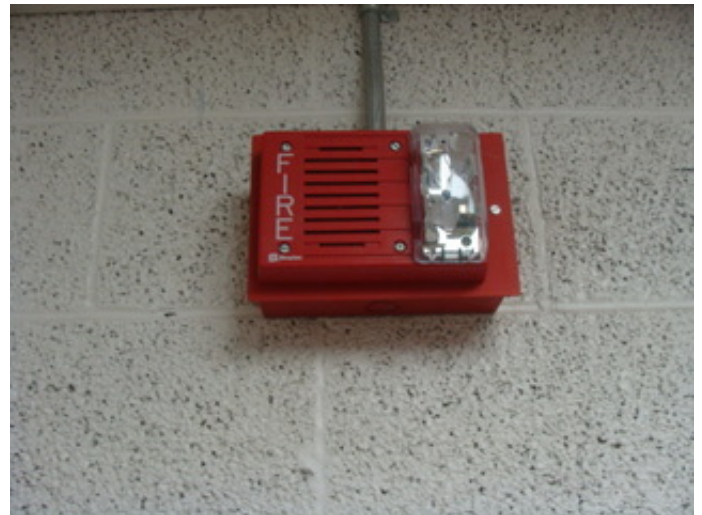
**Description:** The overall facility is equipped with a Simplex Addressable fire alarm system, installed in 1999, and in good condition, consisting of manual pull stations, bells, horn and strobe indicating devices. The system is automatic and is monitored by a third party. The system is not equipped with sufficient audible horns and strobe indicating devices. The system thus will not support future fire suppression systems. The system is not adequately provided throughout and does not have additional zone capabilities. The system is not fully compliant with Ohio Building Code, NFPA, and Ohio School Design Manual requirements.

**Rating:** 3 Needs Replacement

Horn strobe

**Recommendations:** Provide complete replacement of fire alarm system to meet OBC, NFPA, and Ohio School Design Manual guidelines.

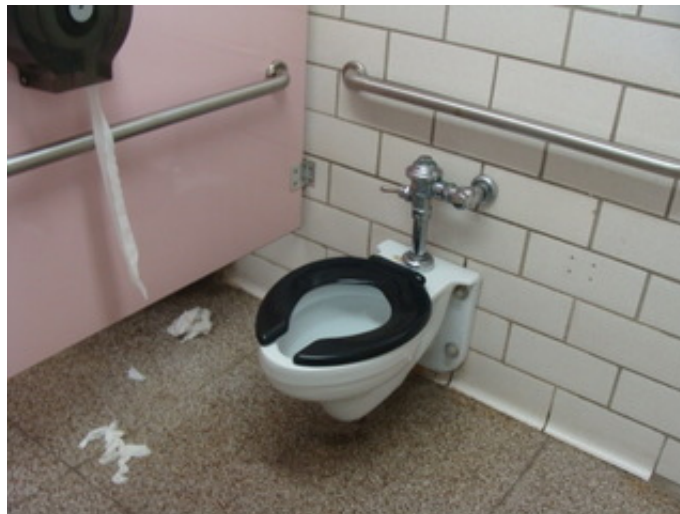
**Rating:** 3 Needs Replacement

ADA wall-mounted toilet

**Recommendations:** Provide ADA-compliant signage, power assist door opener, chair lifts, electric water coolers, toilets, sinks, urinals, toilet partitions, toilet accessories, doors and frames and door hardware in the overall facility to facilitate the school's meeting of ADA requirements.

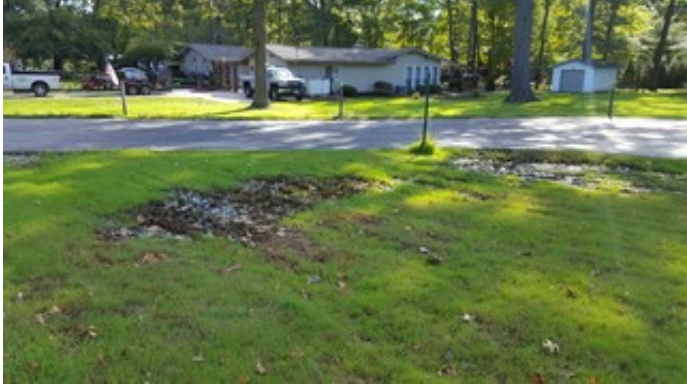
3 Needs Replacement

Ponding near Pavement Approach

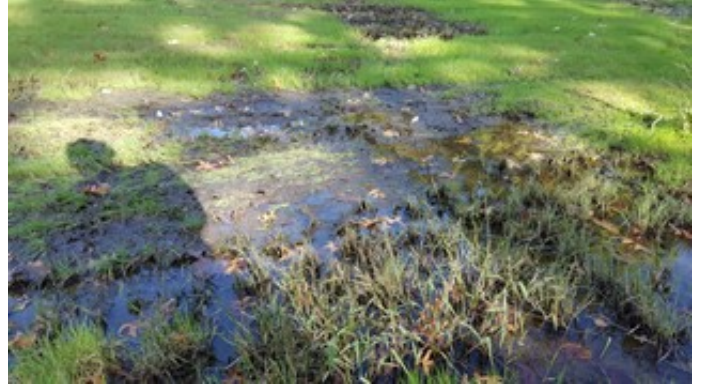
Severe Ponding Areas Behind Building

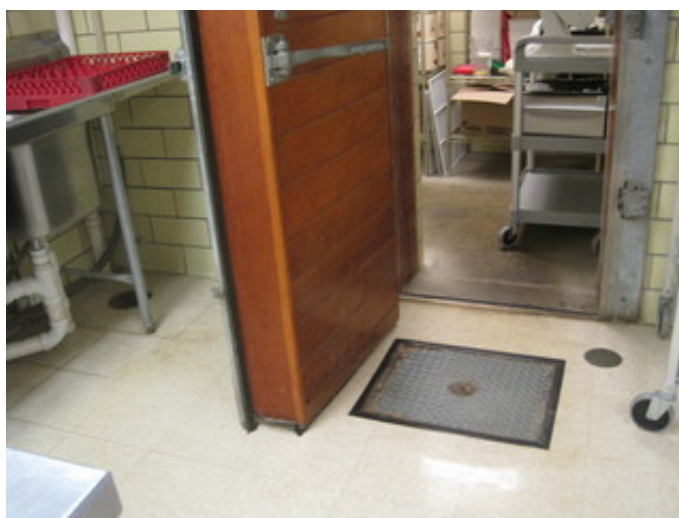
Rating: 3 Needs Replacement

Grease Waste Interceptor Below Dishwasher

Recommendations: Provide for a new sanitary sewer main from the building to the municipal system.

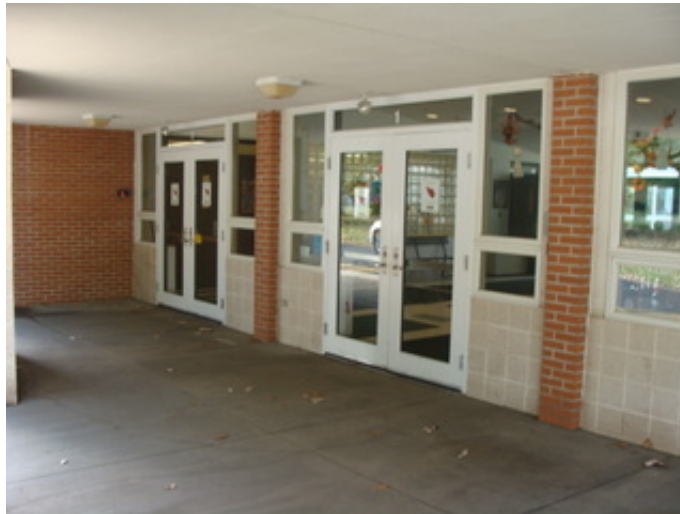
**Description:** Typical exterior doors in the overall facility are aluminum construction, installed on aluminum frames, and in fair condition. Typical exterior doors feature insulated vision panels.

**Rating:** 3 Needs Replacement

Main Entry Doors

**Recommendations:** Replace all exterior doors to comply with Ohio Building Code, ADA, and Ohio School Design Manual guidelines. 2021 UPDATE: Adjust door counts.

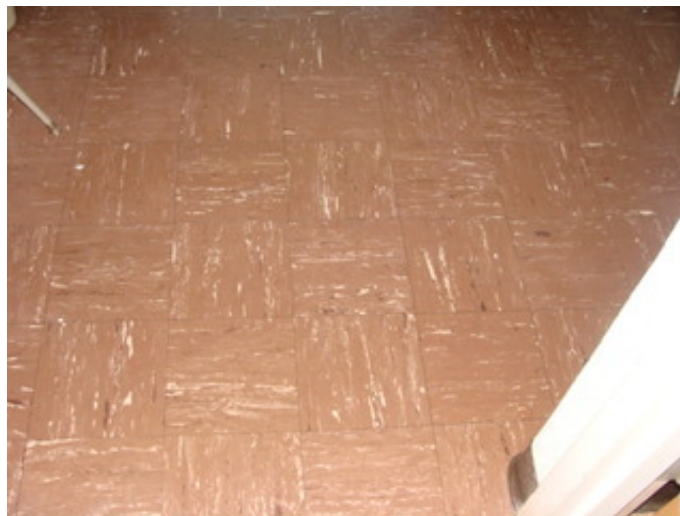
- Description:** The School District provided the AHERA three year reinspection reports, prepared by AGX and dated January 2018, documenting known and assumed locations of asbestos and other hazardous materials.
- Rating:** 3 Needs Replacement
- Recommendations:** Remove all hazardous materials, inclusive of asbestos-containing materials in the overall facility, as noted in the attached Environmental Hazards Assessment. An Enhanced Environmental Assessment (EEA) will need to be performed by OFCC EEA Consultant to establish scope and budget.

VAT in a Classroom

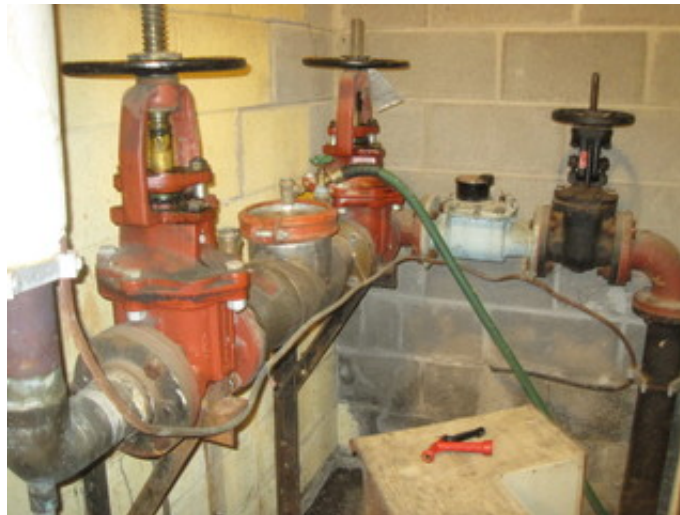
**Description:** The overall facility is not equipped with an automated fire suppression system. The Kitchen hood is in good condition and is equipped with the required UL 300 compliant wet chemical fire suppression system. The cooking equipment is interlocked to shut down in the event of discharge of the fire suppression system. The existing water supply is provided by tie into the city system and is not sufficient to meet the future fire suppression needs of the school.

**Rating:** 3 Needs Replacement

Existing water service

**Recommendations:** Provide new automated fire suppression system to meet Ohio School Design Manual guidelines and provide additional service capacity for this new system. 2021 UPDATE: Add FE cabinet replacement and handrail replacement. 10-13-2022: Per Then Design's assessment validation, updated the cost of the backflow preventer to \$5863.50 and the ADA fire extinguisher cabinet from \$100/each to \$1200/each.

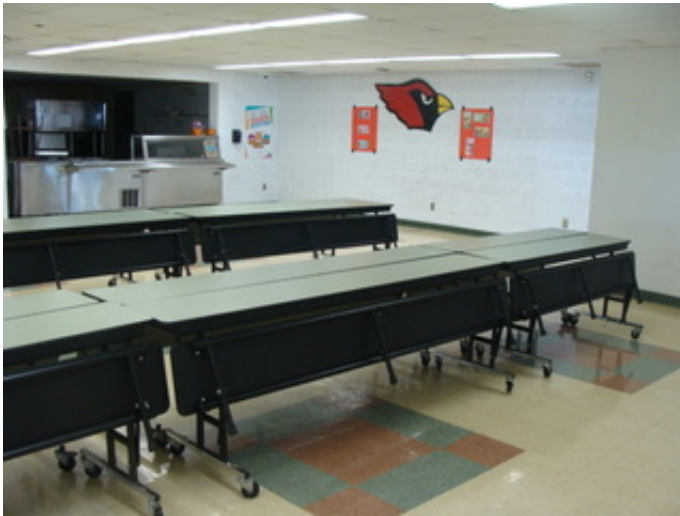
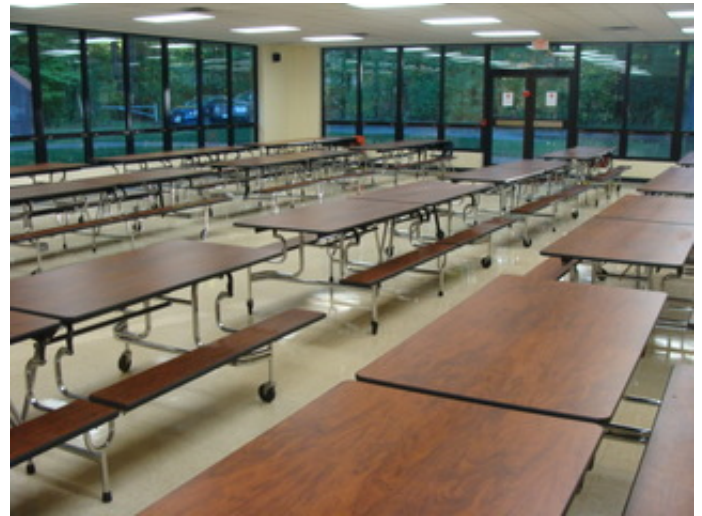
**Rating:** 3 Needs Replacement

A Few Newer Cafeteria Tables

Older Cafeteria Tables

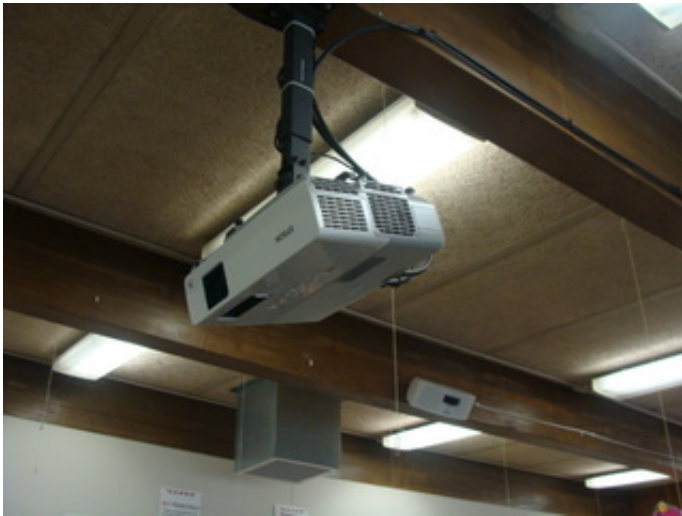
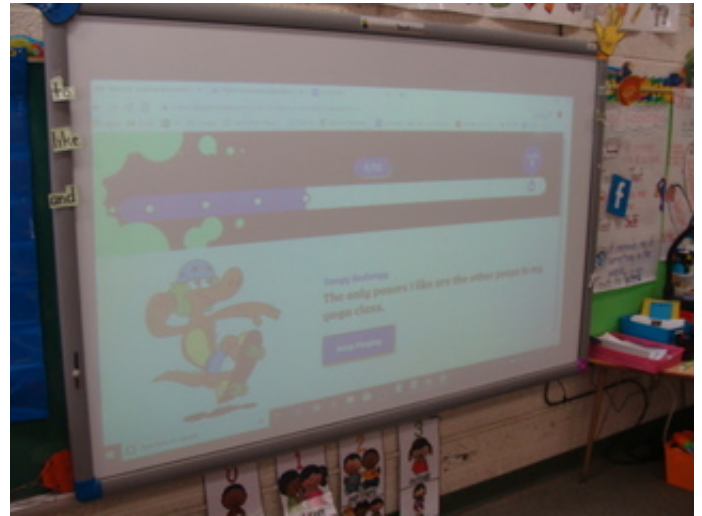
**Rating:** 3 Needs Replacement

Ceiling Mounted Projector

SMART Board
