Building Information - Canfield Local (48314) - Canfield Village Middle School

Program Type	Expedited Local Partnership Program (ELPP)
Setting	Small City
Assessment Name	2022 - Canfield Village Middle School(TDA/OFCC Validation Assessment - 9/2021)
Assessment Date (on-site; non-EEA)	2018-10-09
Kitchen Type	Warming Kitchen
Cost Set:	2022
Building Name	Canfield Village Middle School
Building IRN	70417
Building Address	100 Wadsworth St
Building City	Canfield
Building Zipcode	44406
Building Phone	330-533-4019
Acreage	9.19
Current Grades:	5-8
Teaching Stations	69
Number of Floors	2
Student Capacity	1141
Current Enrollment	783
Enrollment Date	2018-10-09
Enrollment Date is the date in which the current enrollment was taken.	
Number of Classrooms	62
Historical Register	NO
Building's Principal	Judd Rubin
Building Type	Middle

Building Pictures - Canfield Local(48314) - Canfield Village Middle School(70417)

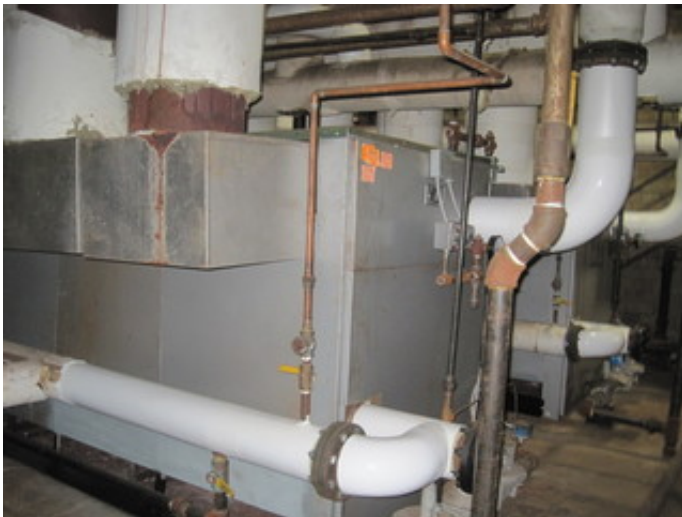
Description: The school is predominately heated with (3) low-pressure, gas-fired steam boilers installed around 2004-2005. The boilers, feedwater system, condensate return units, and other components are in fair-to-poor condition. Steam and condensate return piping is routed throughout the building and serves cast iron radiators, unit ventilators, fan coil units, and heating & ventilating AHUs. Portions of this steam heating system are original to the 1922 building, and some of the units are not operational. There are (19) rooftop HVAC units (RTUs) in the building. Some have gas-fired heat exchangers while others are cooling-only. These will be further addressed in Item C., Air Conditioning, below. The HVAC system does not provide the required outdoor air per OSDM design standards and ASHRAE 62.1. The system temperature controls are pneumatic; however, RTUs are controlled by individual programmable thermostats. There is a Honeywell direct digital Control (DDC) system that controls time-of-day function for the RTUs.

Rating: 3 Needs Replacement

Steam heating boilers

Recommendations: Replace the steam heating system and most of the packaged rooftop equipment since these systems are not compliant with current OSDM guidelines.

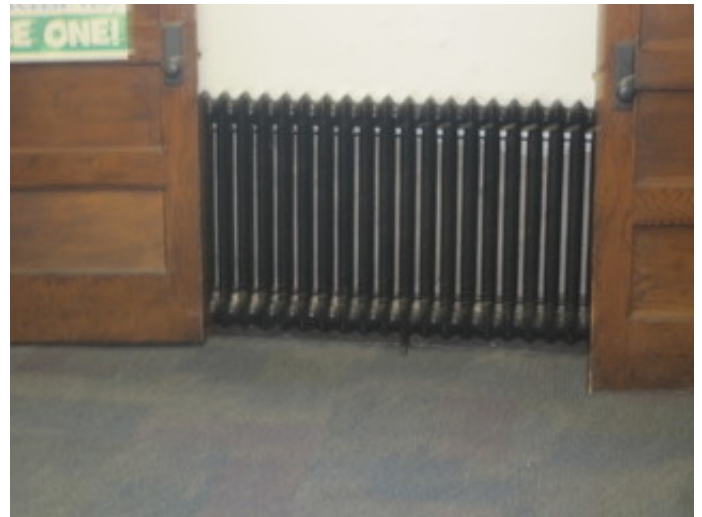
Steam cast iron radiator

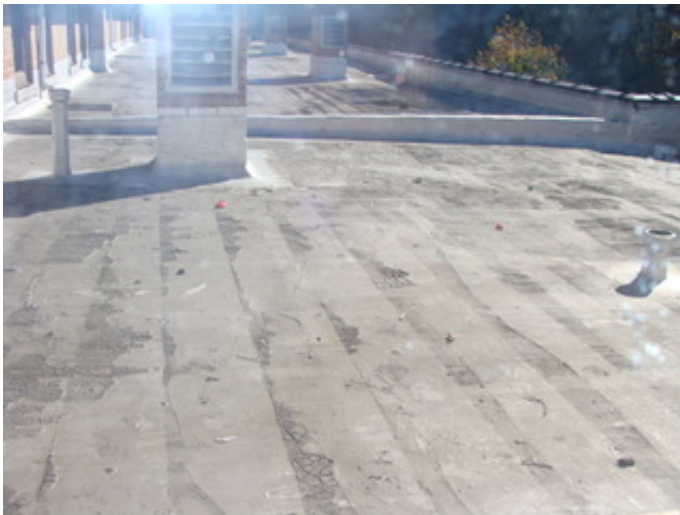
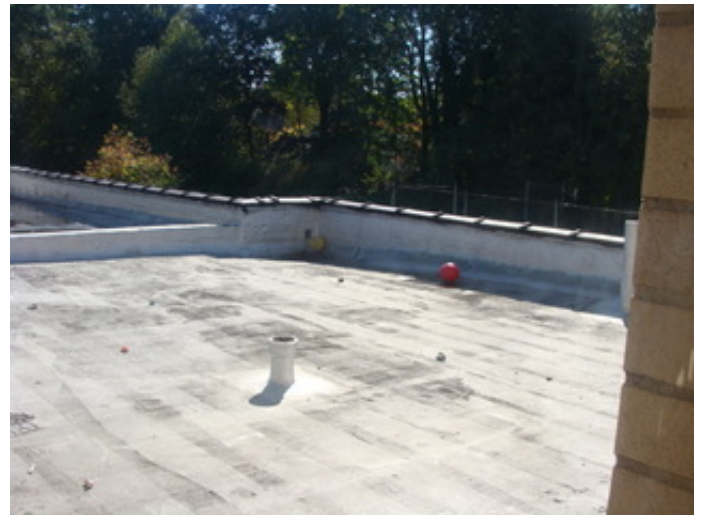
Description: The roof over the overall facility is a EPDM and ballasted membrane system that is in poor condition. There are District reports of current leaking. Signs of past leaking were observed during the physical assessment. Access to the roof was gained by access hatch and ladder that is in fair condition. Fall safety protection cages have not been provided. There were no observations of standing water on the roof. Metal cap flashings and stone copings are in fair condition. Roof storm drainage is addressed through a system of roof drains, which are properly located, and in fair condition. There are gutters and downspouts on the original 1922 building. The roof is not equipped with overflow roof drains, though they are needed on this building. No problems requiring attention were encountered with any roof penetrations. There are not any covered walkways attached to this structure.

Rating: 3 Needs Replacement

Existing Roof

Recommendations: The roof over the overall facility requires replacement to meet Ohio School Design Manual guidelines for age of system and due to condition. Add gutters, downspouts and overflow drains as required. 2021 UPDATE: Significant update (compare to original).

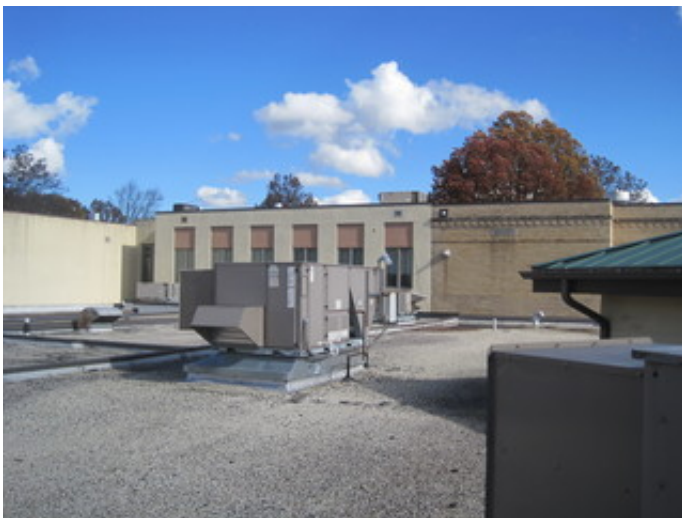
Gas-fired RTU

Recommendations: Due to the age of the duct distribution systems and condition of some air distribution devices, provide a new air conditioning system throughout that meets OSDM design standards. Cost for replacement included in A. Heating System, above.

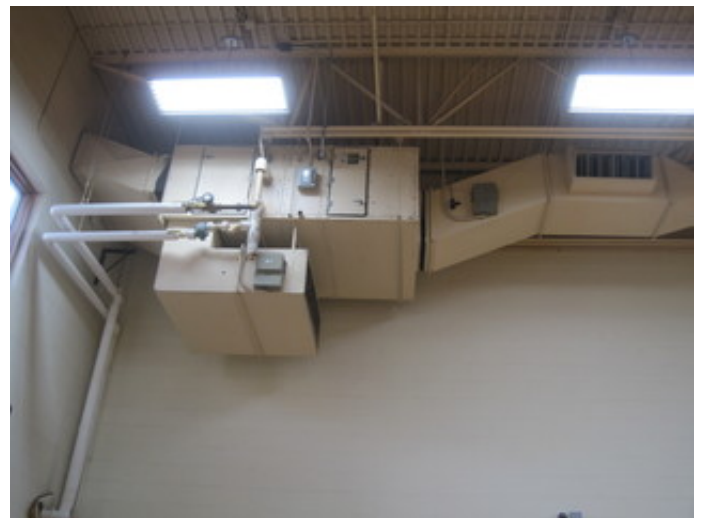
Gymnasium heating & ventilating AHU

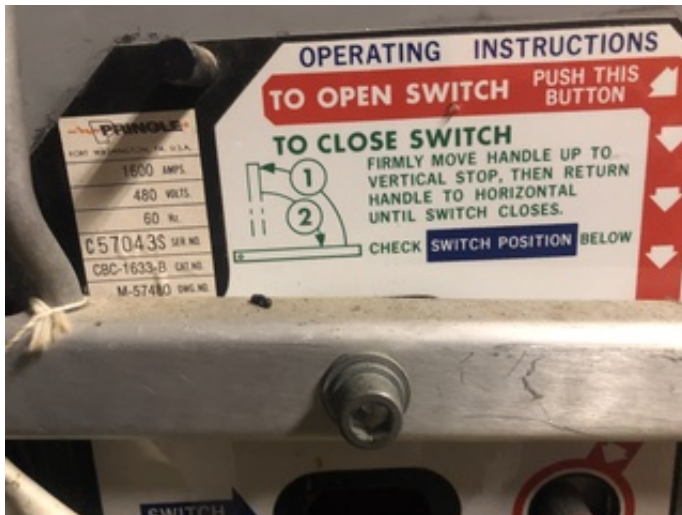
Description: The electrical system provided to the Middle School is (2) systems is installed in 1955 and 1992. The original system installed in 1955 is a 13,200 volt, with internal transformer, (1) main switch. The 1992 system is a 1600 amp, 208/120 volt, 3 phase, 4 wire and is in good condition. Power is provided to the school by a multiple district owned, pad-mounted transformers located in building vault, and in fair condition. The panel system, installed in 1974 is in good condition, and can be expanded to add additional capacity. Several 480 volt/208/120 transformers are located in various locations. The Classrooms are not equipped with adequate electrical outlets. The typical Classroom contains 6 general purpose outlets, 1 dedicated outlet for each Classroom computer, and 0 dedicated outlets for each Classroom television. Some Classrooms are equipped with as many as 7 general purpose outlets, while others are equipped with as few as 4 general purpose outlets. There are not any spaces that have no electrical outlets. The Corridors are not equipped with adequate electrical outlets for servicing. Adequate GFI protected exterior outlets are not provided around the perimeter of the building. The facility is not equipped with an emergency generator. (Refer to item U for specific emergency generator information.) Adequate lightning protection safeguards are not provided. The existing facility is not equipped with stage power or lighting system. The overall electrical system does not meet Ohio School Design Manual requirements in supporting the current needs of the school and will be inadequate to meet the facility's future needs.

Rating: 3 Needs Replacement

1600 amp main switch

Recommendations: The entire electrical system requires replacement to meet Ohio School Design Manual guidelines due to condition and age and to accommodate the addition of an air conditioning system.

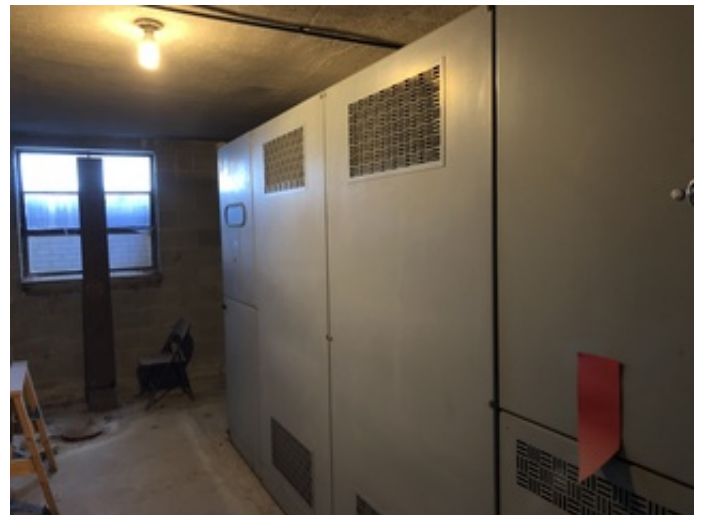
13200 volt system

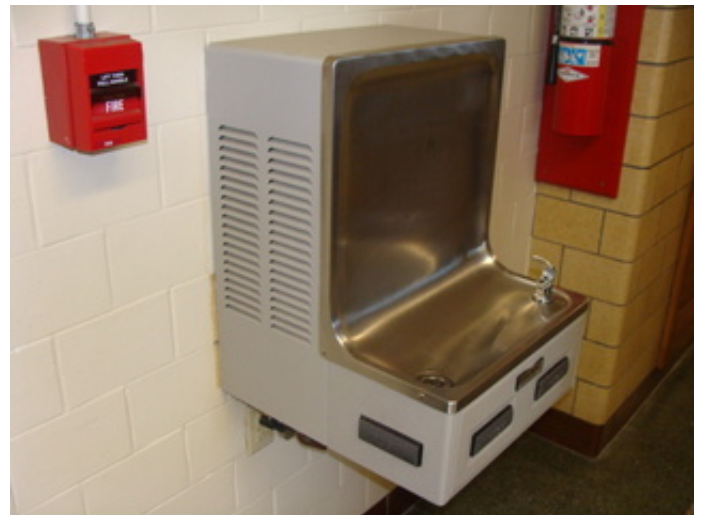
Typical Water Fountain

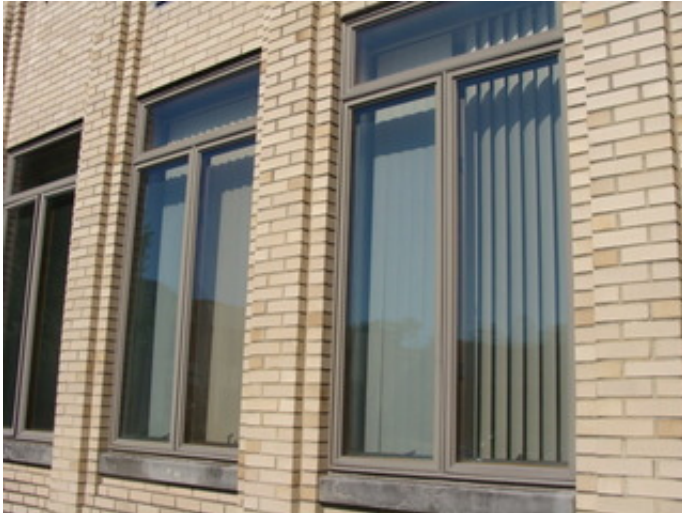
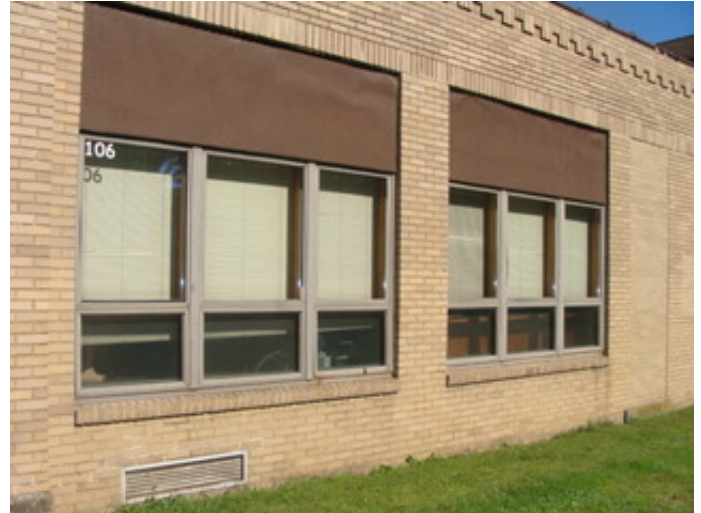
Description:	The overall facility is equipped with Anderson thermally broken vinyl clad wood windows with double glazed insulated glazing window system, which is in very poor condition. Window system seals are in poor condition, with frequent air and water infiltration being experienced. Window system hardware is in poor condition. The window system features surface mounted blinds, which are in poor condition. There is a greenhouse attached to a 1992 classroom. It was noted to be in a good condition.										
Rating:	3 Needs Replacement										
Recommendations:	Provide a new insulated window system with integral blinds to meet with Ohio School Design Manual requirements. 2021 UPDATE: Replace skylights due to condition.

Typical Classroom Window

Typical Classroom Windows

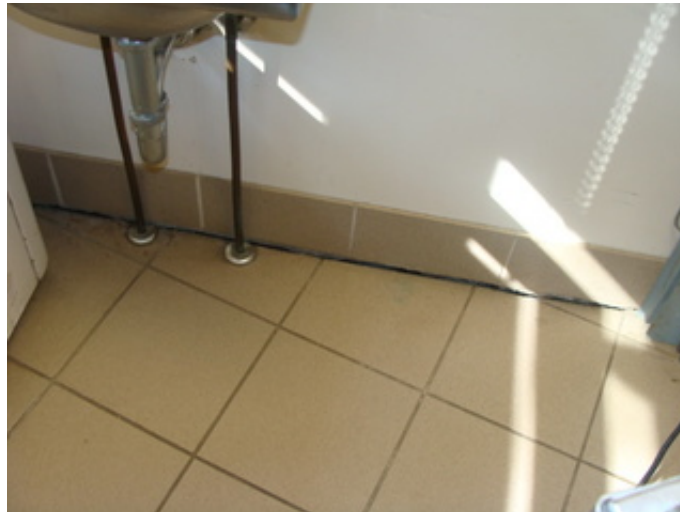
Description: The overall facility is equipped with concrete masonry unit foundation walls on concrete footings, which displayed no locations of significant differential settlement, cracking, or leaking, and are in good condition. The District reports that there has been no past leaking. No grading or site drainage deficiencies were noted around the perimeter of the structure that are contributing or could contribute to foundation/wall structural deterioration.

Interior Floor Settlement Issue That Is Currently Being Repaired

Recommendations: Existing conditions require no renovation or replacement at the present time. 2021 UPDATE: Provide waterproofing & drain tile for 1922 wing.

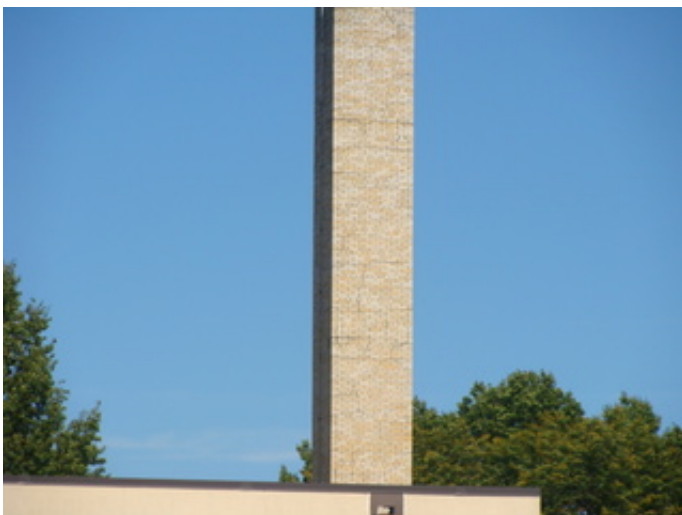
Description:	The overall facility has a brick veneer on a masonry bearing wall system and a stone veneer at the 1937 addition, which displayed locations of deterioration, and is in fair condition. The exterior masonry appears to have appropriately spaced and adequately caulked control joints in fair condition. Control joints are not provided at lintel locations at doors and windows. The exterior masonry has not been cleaned and sealed in recent years, and shows evidence of mortar deterioration. The exterior lintels are steel and are in fair condition. Chimneys are in poor condition.
Rating:	2 Needs Repair
Recommendations:	Provide tuckpointing in all areas of mortar deterioration as required through the overall facility. Provide masonry cleaning, sealing, caulking as required through the overall facility. 2021 UPDATE: Replace damaged brick area, parapet & coping where needed. 10-13-2022: Per Then Design's assessment validation, updated the cost of infill vents from \$45/SF to \$60/SF

Existing Chimney That Needs Repair

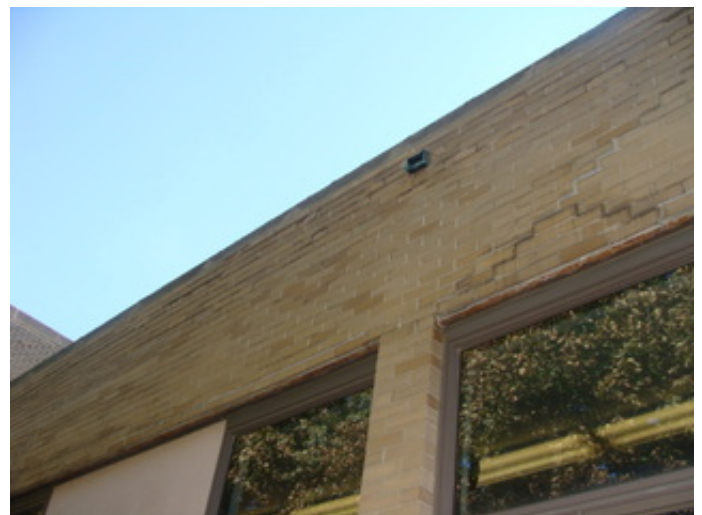
Exterior Brick Issues

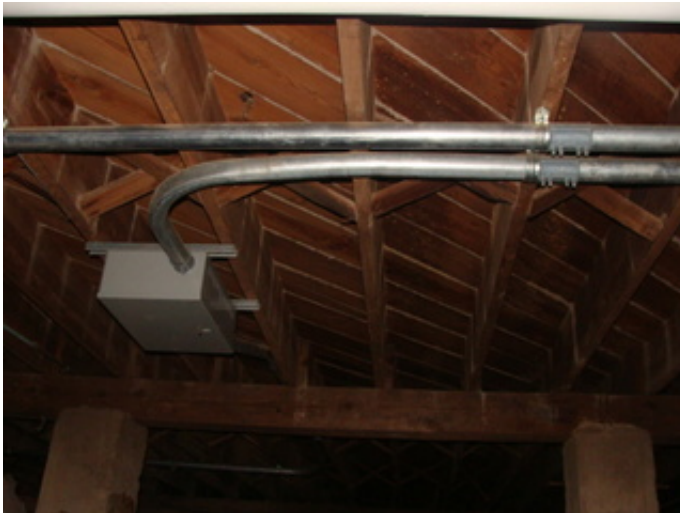
Description: The floor and roof construction of the original construction is wood framing construction, and is in fair condition. The floor framing in all other locations is concrete. Ceiling to structural deck spaces are insufficient to accommodate HVAC, electrical, and plumbing scopes of work in required renovations. The roof construction of the overall facility is steel deck on steel joist, and is in fair condition.

Rating: 2 Needs Repair

Wood Structural Framing Under Cafeteria

Recommendations: Provide fire separation assembly for wood roof structure in the original building.

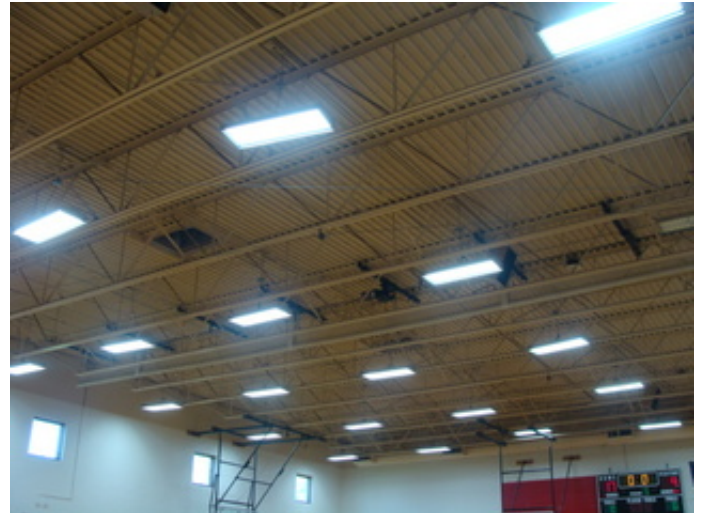
Steel Joists over Gym

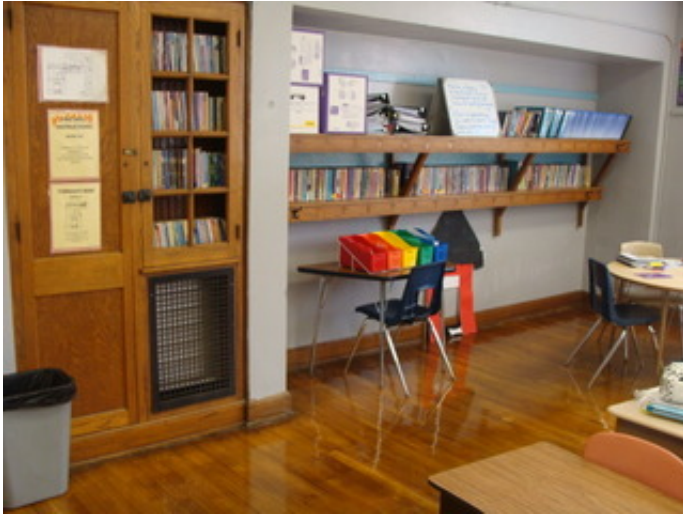
Description: The overall facility features conventionally partitioned Classrooms with various types of flooring, suspended ceilings, as well as painted wall finishes, and they are in fair condition. The overall facility has Corridors with terrazzo flooring, suspended ceilings, as well as tile/CMU wall finishes, and they are in fair condition. The overall facility has Restrooms with tile flooring, plaster/suspended ceilings, as well as tile wall finishes, and they are in fair condition. Toilet partitions are metal and plastic and are in fair condition. Classroom casework in the overall facility is wood construction with plastic laminate tops, is inadequately provided, and in fair condition. The facility is equipped with wood louvered and non-louvered interior doors that are recessed and partially recessed without proper ADA hardware clearances, and in fair condition. The Gymnasium spaces have wood flooring, open ceilings, as well as painted wall finishes, and they are in fair condition. Gymnasium telescoping and concrete fixed stands are in fair condition. Gymnasium basketball backboards are electrically operated type, and are in fair condition. The Media Center, located in the 1992 Addition, has carpet flooring, open ceilings, as well as painted wall finishes, and they are in good condition. Student Dining, located in the original 1922 building has VCT flooring, plaster ceilings, as well as painted wall finishes, and they are in fair condition. The existing Kitchen is a Warming Kitchen only and is undersized based on current enrollment, and the existing Kitchen equipment, is in fair condition. The Kitchen hood is in fair condition, and is not equipped with the required UL 300 compliant wet chemical fire suppression system.

Rating: 3 Needs Replacement

Typical Classroom Casework

Recommendations: Provide complete replacement of finishes and casework due to installation of systems outlined in Items A, C, D, E, I, K, L, M, N, T, U. Also provide new Warming Kitchen equipment. 2021 UPDATE: Add exterior wall insulation; change to full kitchen replacement; replace wood floor and stage curtain; add plaster re-finishing. 10-13-2022: Per Then Design's assessment validation, updated the cost of the stage curtain replacement from \$85,000 to \$100,000.

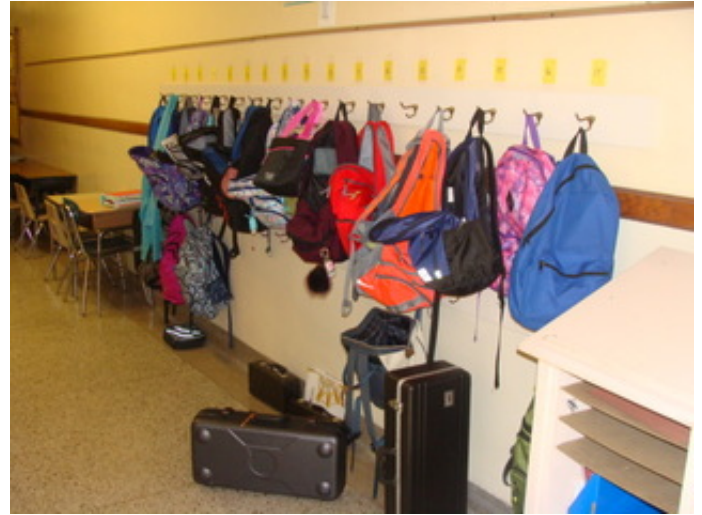
Corridor Mounted Coat Storage

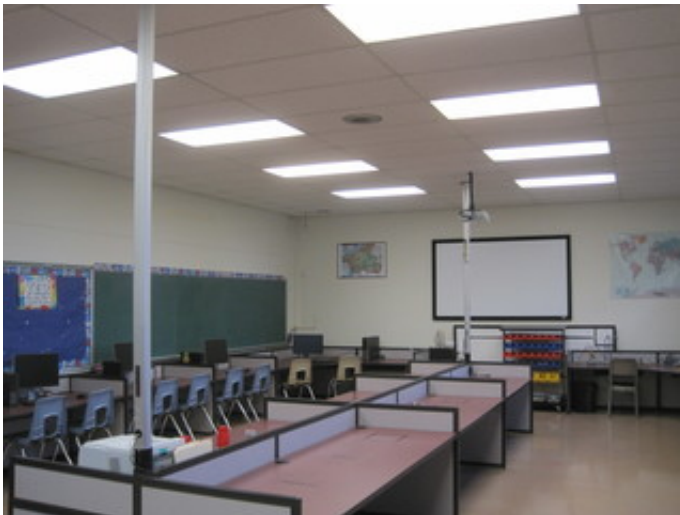
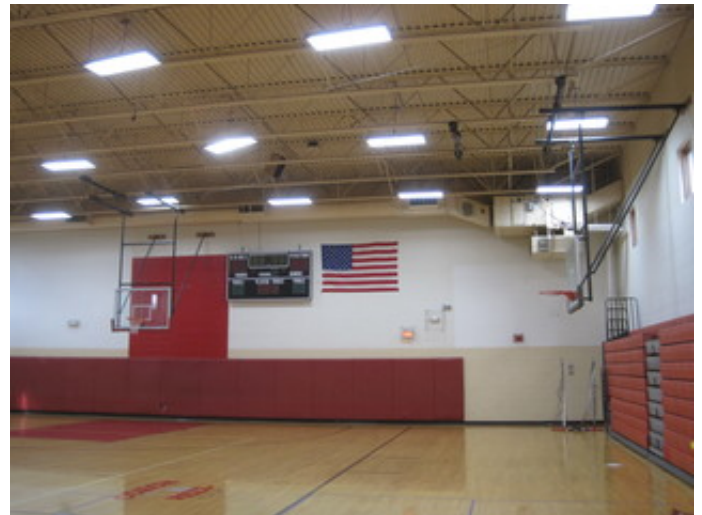
3 Needs Replacement

Typical CR lighting

Gym Lighting

Provide complete replacement of lighting system due to condition, lighting levels, lack of multilevel switching and installation of new fire suppression and air conditioning systems.

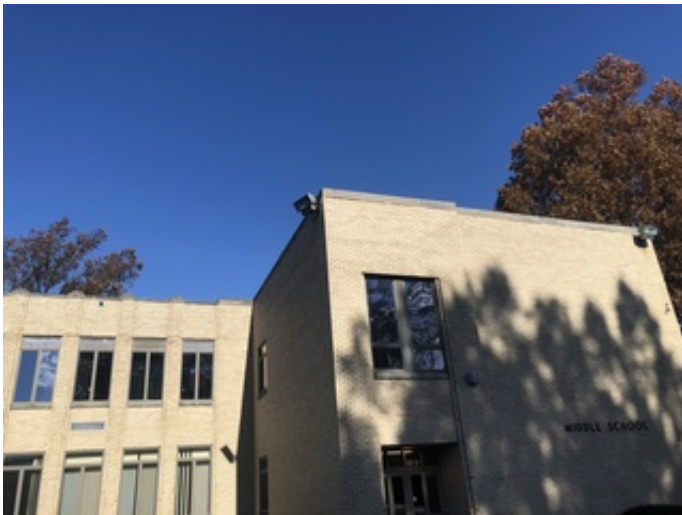
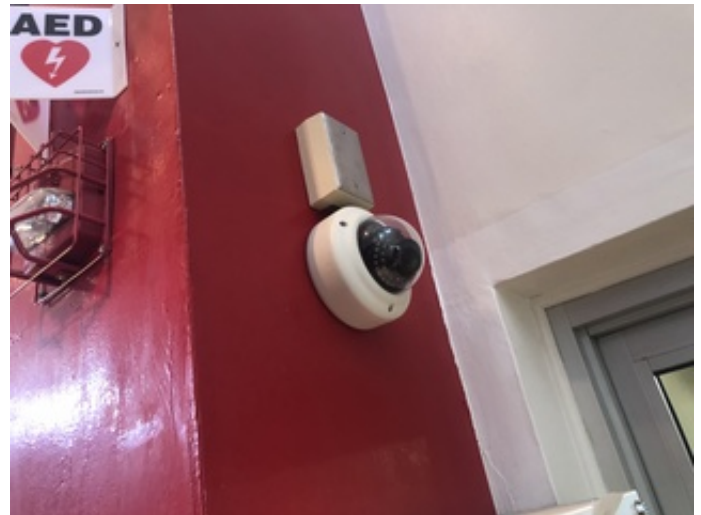
Building flood light

Security camera

Recommendations: Provide a full security system upgrade, consisting of additional door controls, cameras to meet Ohio School Design Manual guidelines. Provide enhancement of exterior site lighting system, consisting of LED fixtures to meet Ohio School Design Manual guidelines.

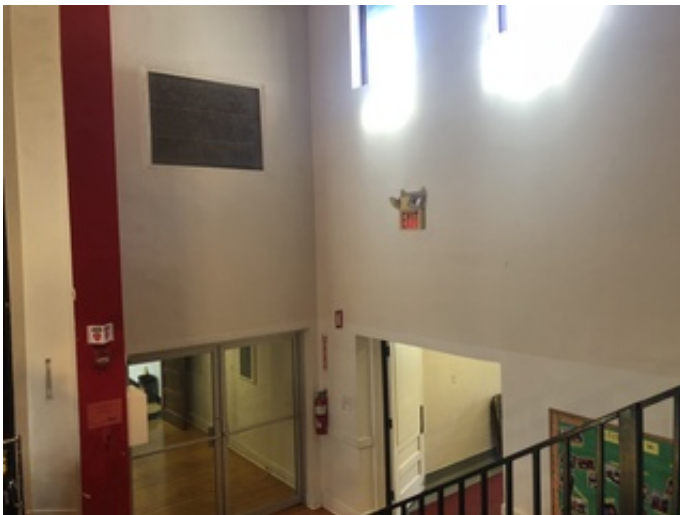
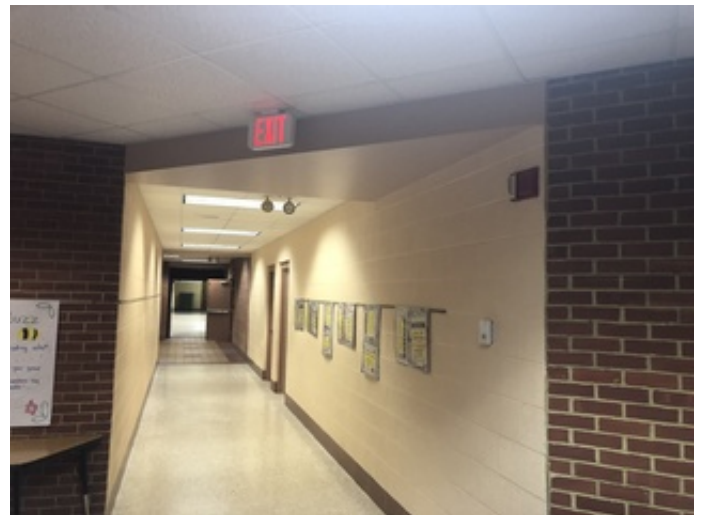
Combo emergency/egress/exit light

exit light/emergency heads

Recommendations: Provide complete replacement of emergency / egress lighting system to meet Ohio School Design Manual guidelines. 2021 UPDTE: Add EE Lighting for 3,514 sf of "Un-usable" attic space. 10-13-2022: Per Then Design's assessment validation, updated the cost of attic space lighting from \$1.00/SF to \$1.17/SF

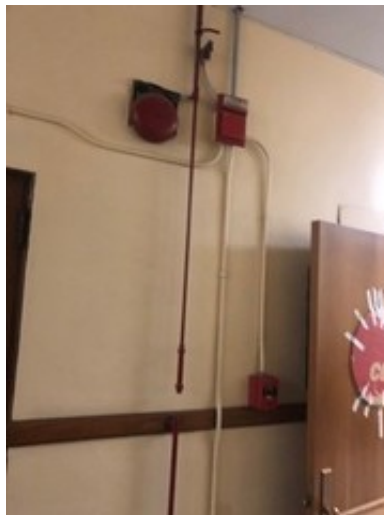
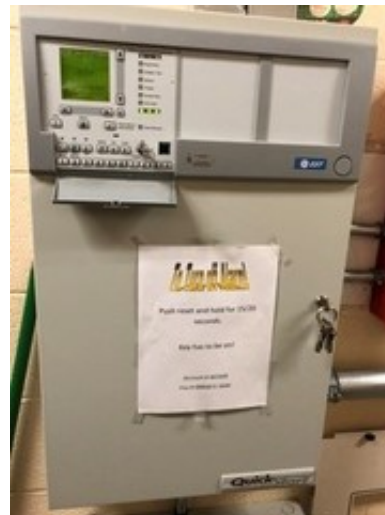
Audio/visual strobe

Main fire alarm

Recommendations: Provide complete replacement of fire alarm system to meet OBC, NFPA, and Ohio School Design Manual guidelines. 2021 UPDATE: Provide fire alarm for 3,514 sf of "Un-usable" attic space. 10-13-2022: Per Then Design's assessment validation, updated the cost of the attic space fire alarm from \$2.45/SF to \$3.52/SF.

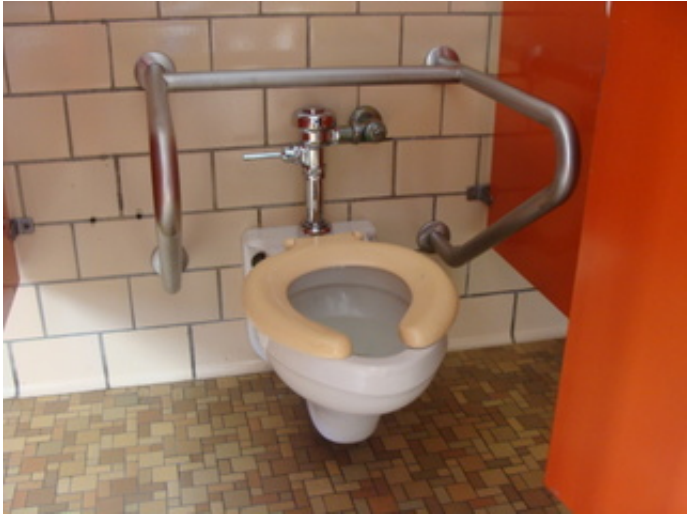
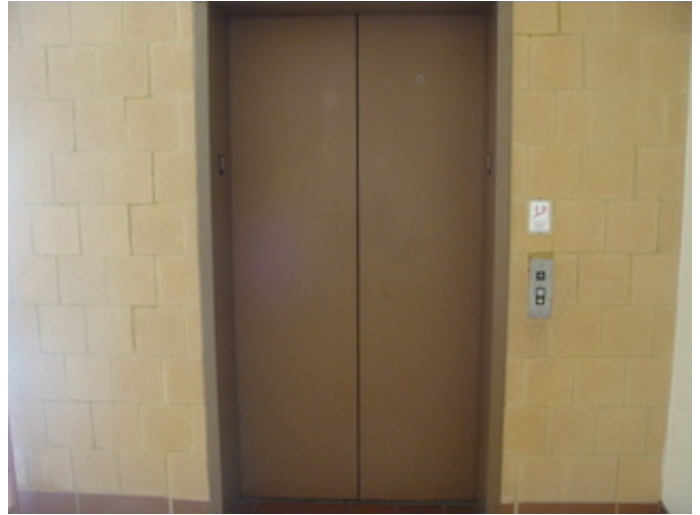
ADA wall-mounted toilet

Elevator

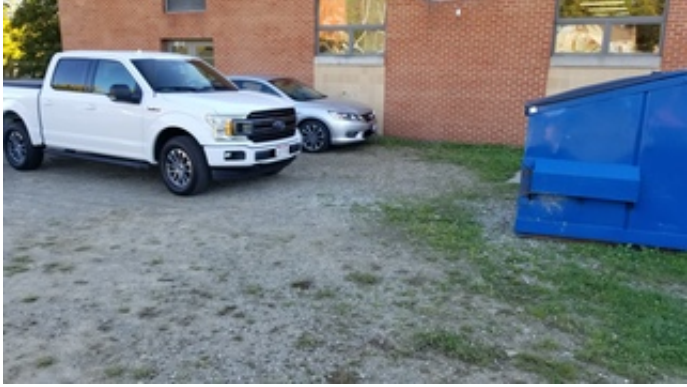
Existing Dumpsters Location

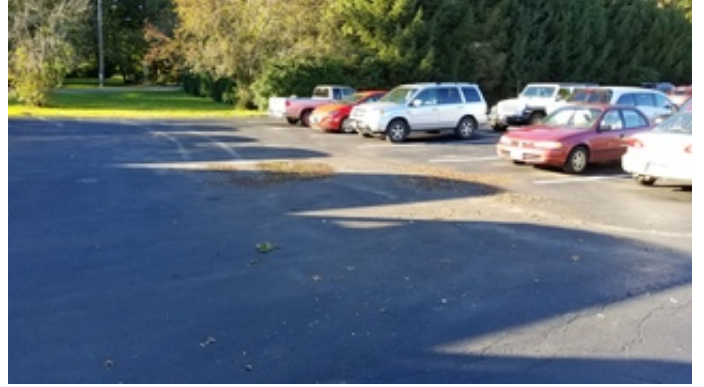
Typical Pavement Condition

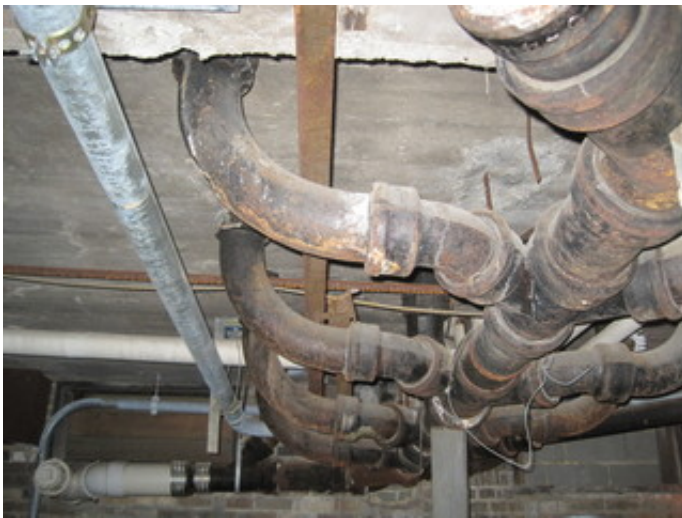
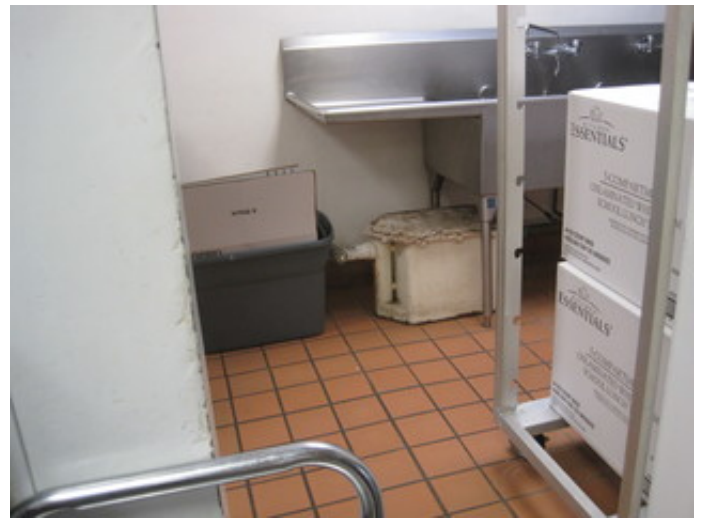
Cast iron sanitary piping

Grease Waste Interceptor

Recommendations: Provide new sanitary piping from all toilet room fixtures. Priced under Item E- Plumbing and Fixtures. 2021 UPDATE: Replace sewage main due to history of problems.

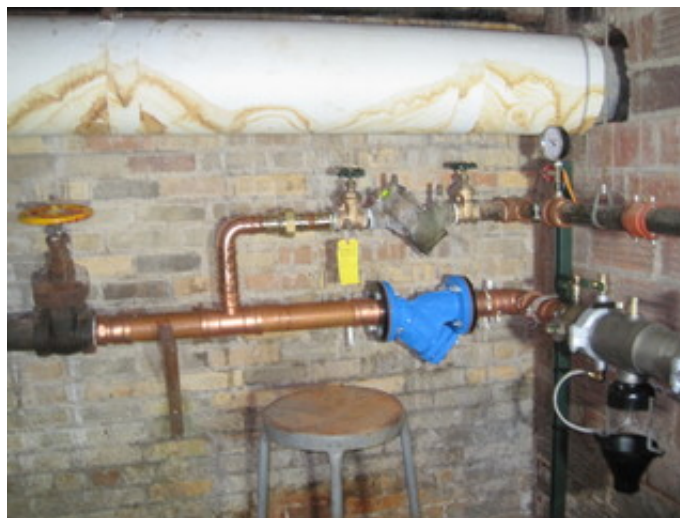
Incoming domestic water service

Recommendations: No work required.

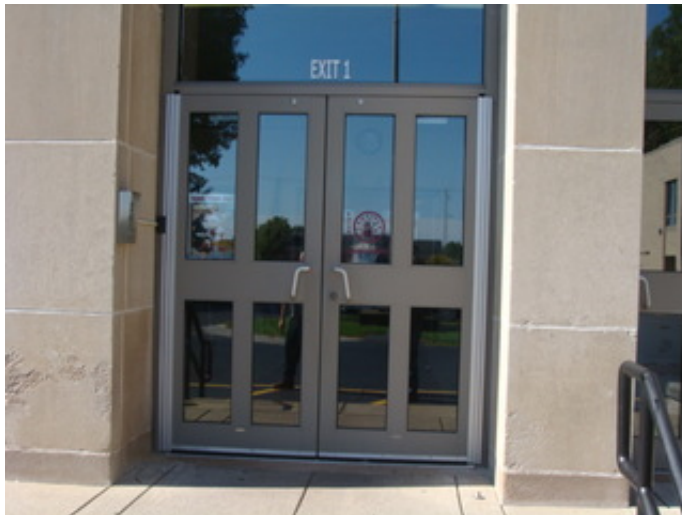
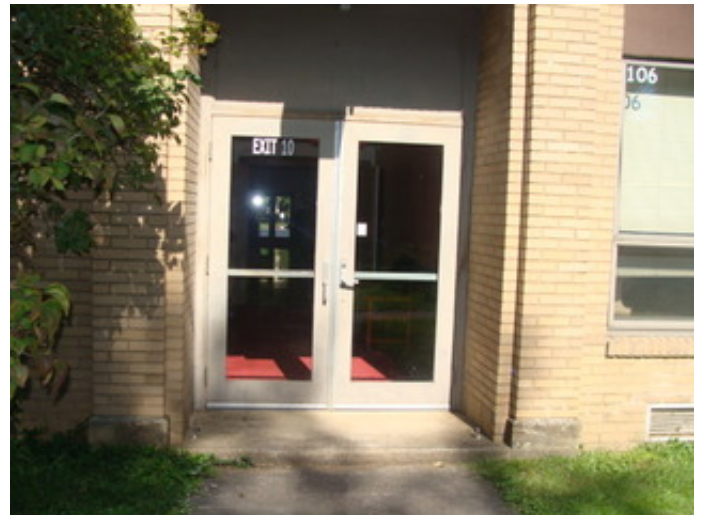
Main Entry Doors

Entry Doors To Board Offices

Recommendations: Replace all exterior doors to comply with Ohio Building Code, ADA, and Ohio School Design Manual guidelines.

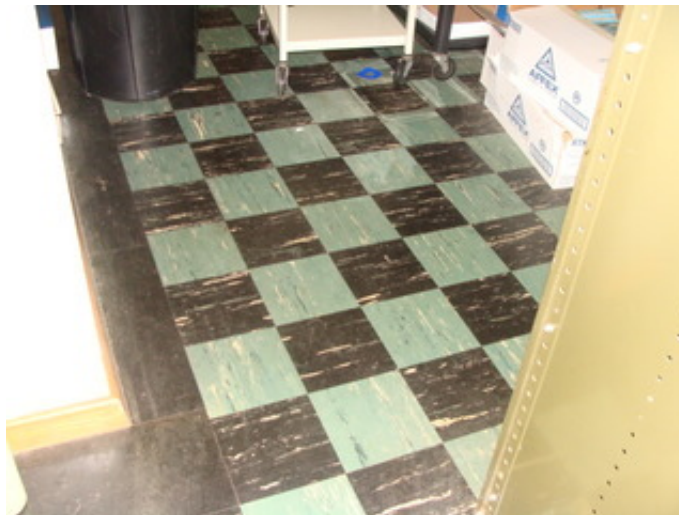
VAT in a Classroom

Recommendations: Remove all hazardous materials, inclusive of asbestos-containing materials in the overall facility, as noted in the attached Environmental Hazards Assessment. An Enhanced Environmental Assessment (EEA) will need to be performed by OFCC EEA Consultant to establish scope and budget.

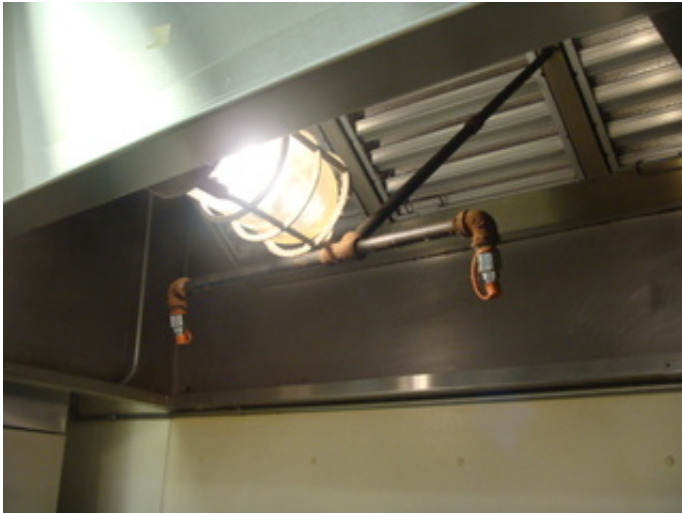
Kitchen Hood

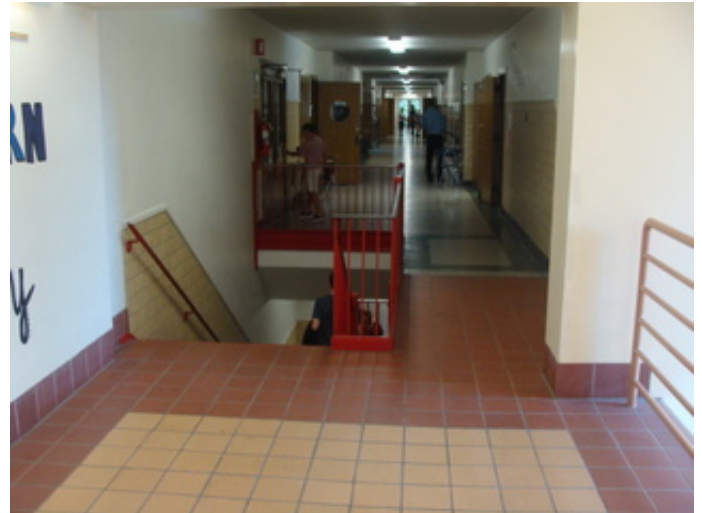
Very Narrow & Open Stairs

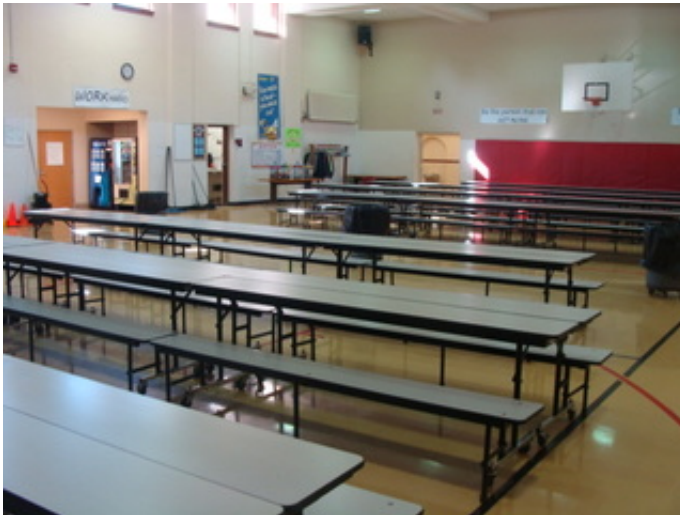
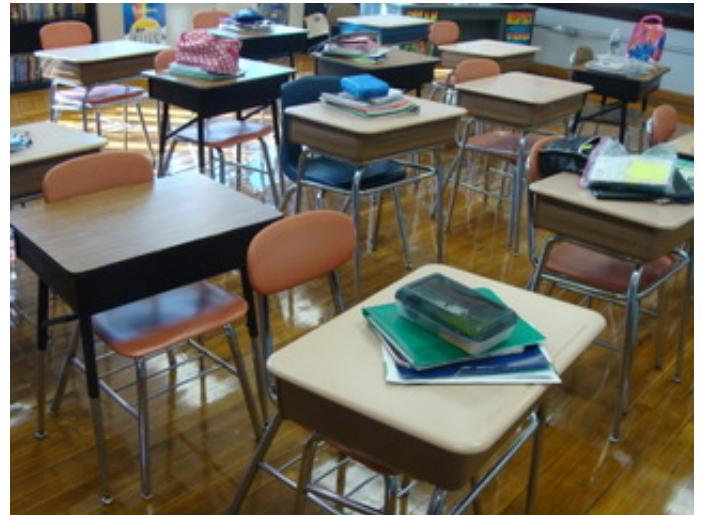
Cafeteria Tables

Classroom Desks

Recommendations: Provide for replacement of outdated or inadequate furniture.

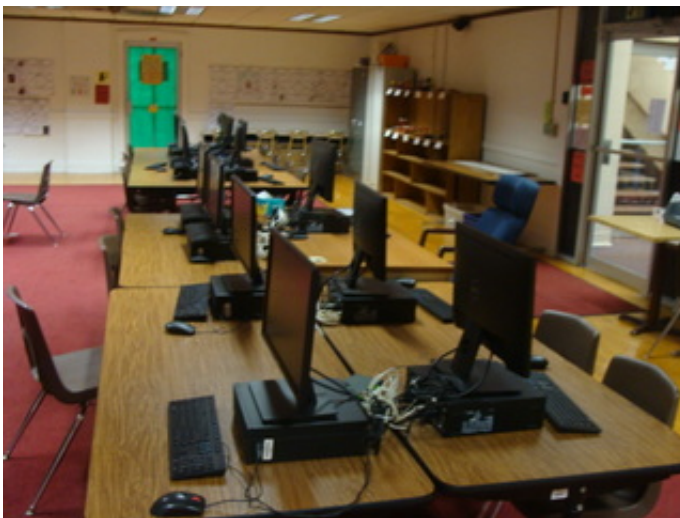
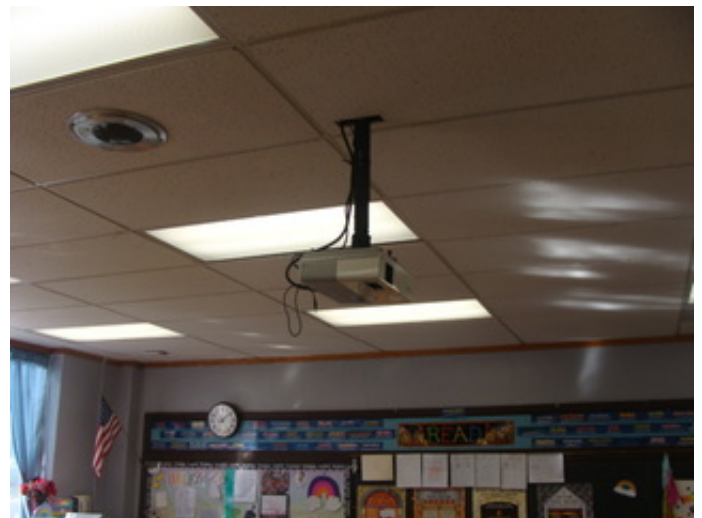
Small Computer Lab

Ceiling Mounted Projector
