Building Information - Canfield Local (48314) - Canfield High

Program Type	Expedited Local Partnership Program (ELPP)
Setting	Small City
Assessment Name	2022 - Canfield High School (TDA/OFCC Validation Update - Sept 2021)
Assessment Date (on-site; non-EEA)	2018-10-16
Kitchen Type	Full Kitchen
Cost Set:	2022
Building Name	Canfield High
Building IRN	4796
Building Address	100 Cardinal Dr
Building City	Canfield
Building Zipcode	44406
Building Phone	330-533-5507
Acreage	29.51
Current Grades:	9-12
Teaching Stations	63
Number of Floors	1
Student Capacity	987
Current Enrollment	871
Enrollment Date	2018-10-16
Enrollment Date is the date in which the current enrollment was taken.	
Number of Classrooms	57
Historical Register	NO
Building's Principal	Michael Moldovan
Building Type	High

Building Pictures - Canfield Local(48314) - Canfield High(4796)

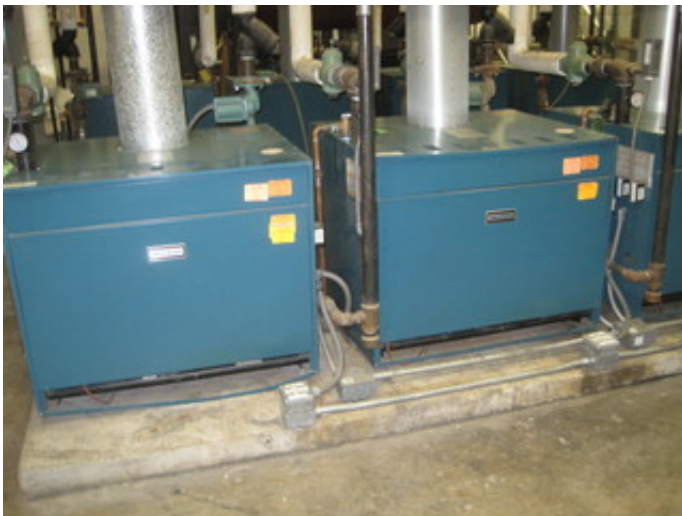
Heating Water Boilers

Description: The school is heated and cooled by a total of (30) rooftop packaged HVAC units. All are natural gas fired. Units serving classrooms, offices, and other multi-use spaces are variable air volume units, while the gymnasium and cafeteria units are single-zone units. Most units were reportedly installed around 1999. They are in fair condition but approaching the end of a useful life. Gas piping is routed above the roof to each unit and assumed to be low pressure (7-14 in H₂O). There is a central heating system in the building, consisting of (10) Burnham boilers with an input of 594 MBH each. The boilers were manufactured in 1999 and are in fair-to-good condition. The temperature controls are pneumatic for reheat valves and dampers throughout the building. Controls for the rooftop HVAC units are individual programmable thermostats. There is a Honeywell DDC system that controls time-of-day function for each RTU.

Rating: 3 Needs Replacement

Recommendations: Replace all of the packaged rooftop equipment since these systems are not compliant with current OSDM guidelines. 2021 UPDATE: 1 units have been replaced in 2021 and more is scheduled, however, since these are not OSDM compliant, a new system is budgeted.

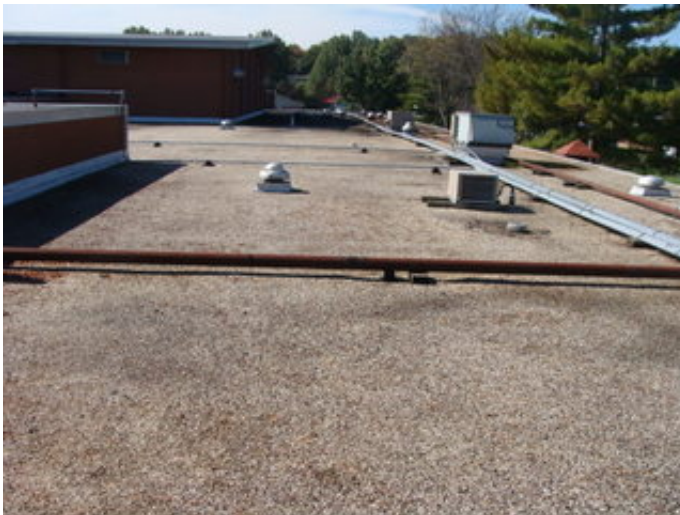
Typical Roof Membrane

Description: The roofs over the overall facility are EPDM and ballasted membrane systems in poor to fair condition. A new EPDM roof was installed 2 years ago over the Music Area. There are District reports of current leaking. Signs of past leaking were observed during the physical assessment. Access to the roof was gained by a ladder. Fall safety protection cages are not provided. There were observations of standing water on the roof. Metal cap flashings are in fair condition. Roof storm drainage is addressed through a system of roof drains, which are located properly, and in fair condition. The roof is not equipped with overflow roof drains, though they are needed on this building. No problems requiring attention were encountered with any roof penetrations.

Rating: 3 Needs Replacement

Recommendations: The roof over the overall facility requires replacement to meet Ohio School Design Manual guidelines for age of system and due to condition. Also, overflow drains need to be installed. 2021 UPDATE: Add replacement of soffits and fascia due to condition. Add partial roof deck replacement due to rust.

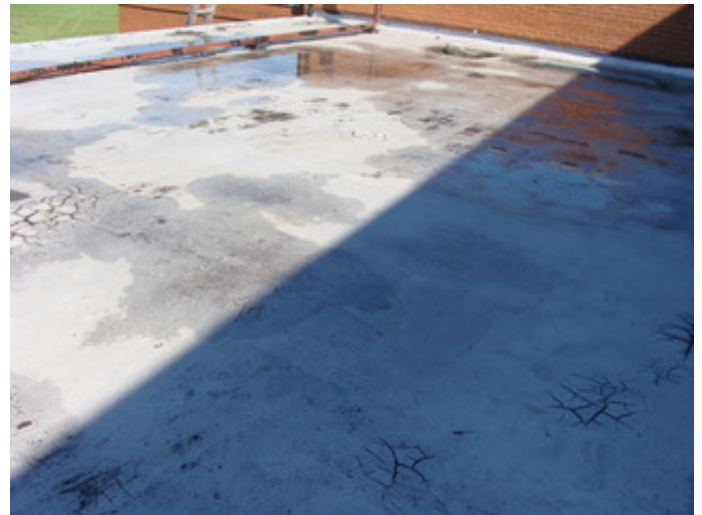
Standing Water on Adhered Membrane

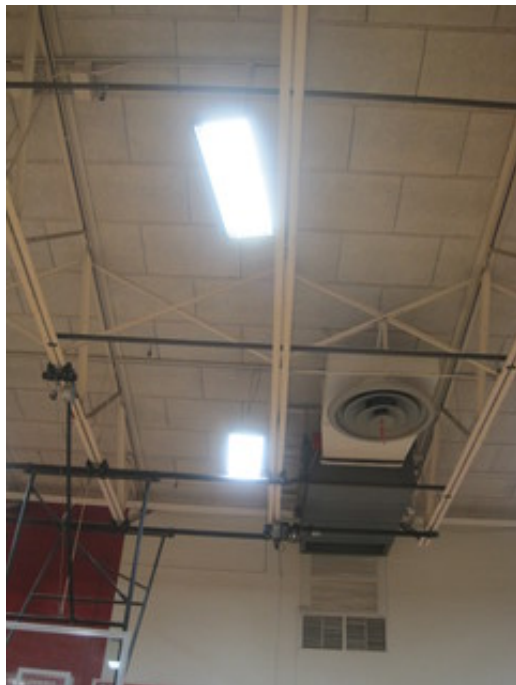
Gymnasium H&V unit

Description: The building is fully air conditioned. The air distribution supply and return is fully ducted to the respective rooftop units from classrooms, gymnasium, cafeteria, and other areas of the building. Many of the rooftop units are variable air volume units, supplying variable air reheat terminals in the classrooms and other zones. The RTU's do not have variable frequency drives but vary the air volume through inlet vanes on the fans. This is not an energy efficient method for fan control. It was not determined if the air-handling systems supply the required minimum outside ventilation air to the spaces. Most classrooms have operable windows. The dust collection system in the Wood Shop is not fully functional. The dust collector is in fair condition; however, ductwork is not fully extended to individual pieces of shop equipment.

Rating: 2 Needs Repair

Recommendations: Provide for new OSDM compliant air conditioning. Costs are included in Plate A. Provide for a new dust collection system in the wood shop area.

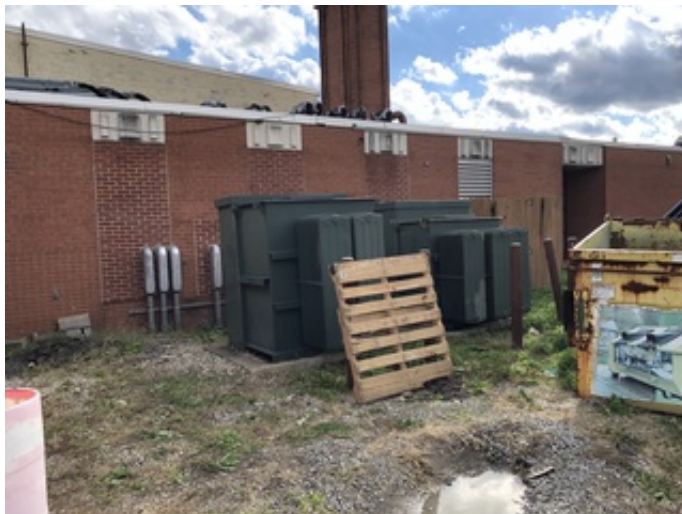
Two pad mounted transformers

Description: The electrical system provided to the High School system installed in 1999 and is in good condition. The service has (6) switches (3) 480/277/3 switches and (3) 208/120/3 switches. Power is provided to the school by two district owned, pad-mounted transformers located outside on grade and in good condition. The panel system, installed in 1999 is in good condition, and can be expanded to add additional capacity. Several 1966 panels are located throughout the building. The Classrooms are not equipped with adequate electrical outlets. The typical Classroom contains 6 general purpose outlets, 1 dedicated outlet for each Classroom computer, and 0 dedicated outlets for Classroom television. Some Classrooms are equipped with as many as 6 general purpose outlets, while others are equipped with as few as 4 general purpose outlets. There are not any spaces that have no electrical outlets. The Corridors are not equipped with adequate electrical outlets for servicing. Adequate GFI protected exterior outlets are not provided around the perimeter of the building. The facility is not equipped with an emergency generator. Adequate lightning protection safeguards are not provided. The existing facility is equipped with stage lighting in fair condition. The overall electrical system does not meet Ohio School Design Manual requirements in supporting the current needs of the school and will be inadequate to meet the facility's future needs.

Rating: 3 Needs Replacement

Recommendations: The entire electrical system requires replacement to meet Ohio School Design Manual guidelines due to condition and age and to accommodate the addition of an air conditioning system. Provide adequate lightning protection safeguards in the overall facility, including associated grounding system, with funding included in the electrical system replacement.

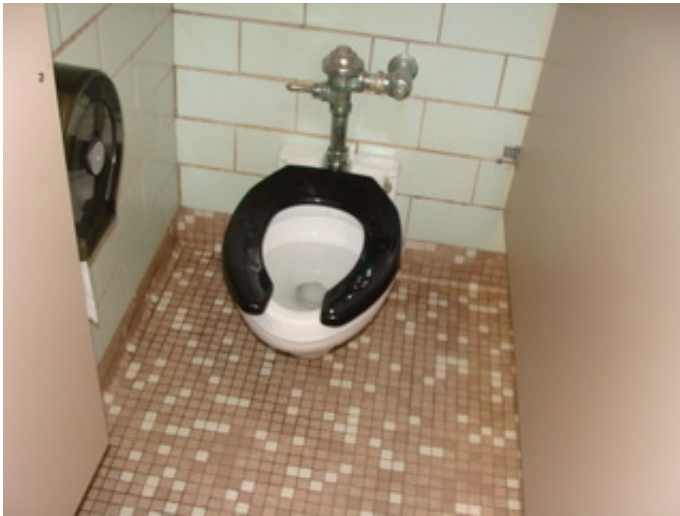
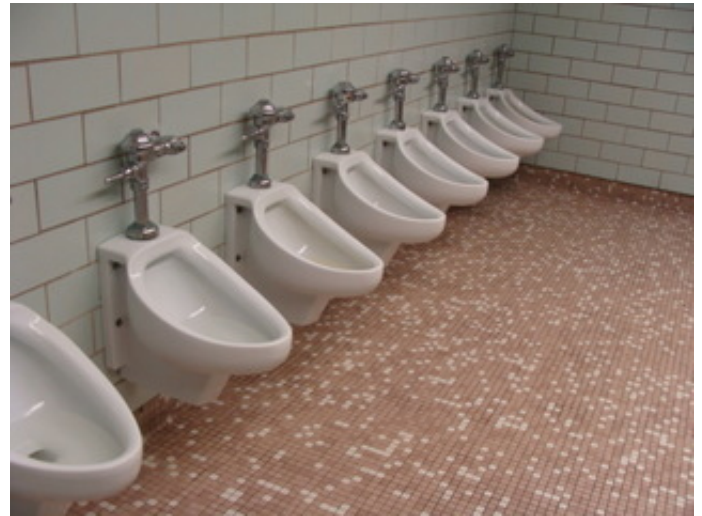
Description: All visible domestic water piping appears to be copper. Sanitary piping is cast iron. There are (2) domestic water heaters and a storage tank. The water heaters are Bradford-White gas-fired units, each with 199 MBH input and 100 gallon storage. The heaters were installed around 2016 and are in good condition. The storage tank is much older and is in poor condition. There are (14) single occupancy restrooms, with water closet and lavatory. There are (10) boys and girls group toilet rooms, plus (4) locker room toilet rooms. All fixtures are wall-hung and appear to be in good condition but outdated. Flush valve and lavatory faucet are manual operation.

Rating: 3 Needs Replacement

Recommendations: Replace the domestic hot water system. Replace plumbing fixtures with low water consumption fixtures that comply with OSDM guidelines. Replace domestic water and sanitary piping. 2021 UPDATE: Add replacement of shower fixtures due to condition. 10-12-2022: Per Then Design's assessment validation, updated the cost of shower fixture replacement from \$600/unit to \$700/unit.

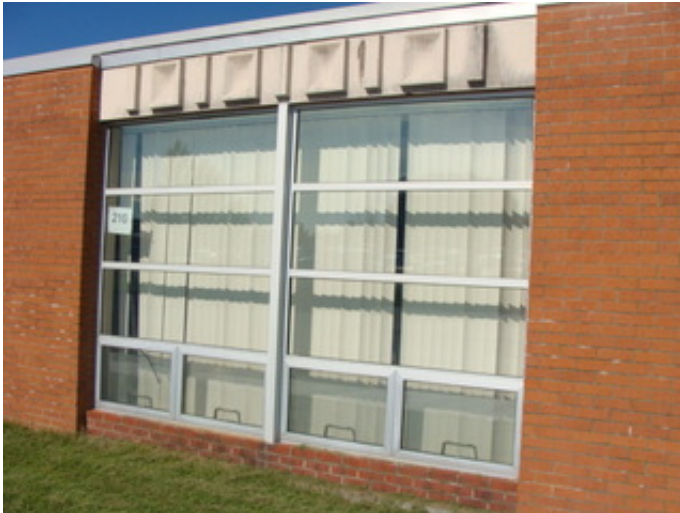
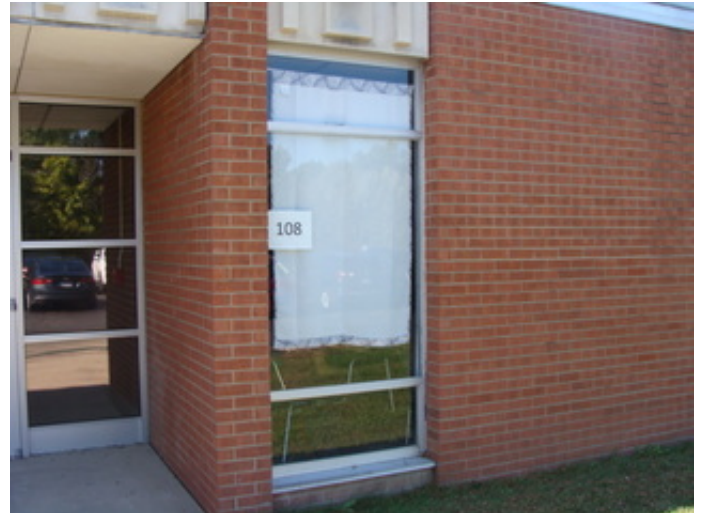
Typical Classroom Window

Description: The overall facility is equipped with thermally broken aluminum with double glazed insulated glazing window system, which was installed in over 20 years ago. These units are in fair condition. Window system seals are in fair condition, with minimal air infiltration being experienced. Window system hardware is in fair condition. The window system features no blinds.

Rating: 3 Needs Replacement

Recommendations: Provide a new insulated window system with integral blinds to meet with Ohio School Design Manual requirements due to age of the windows. 2021: Adjust sf amounts for window replacement & add skylight replacements.

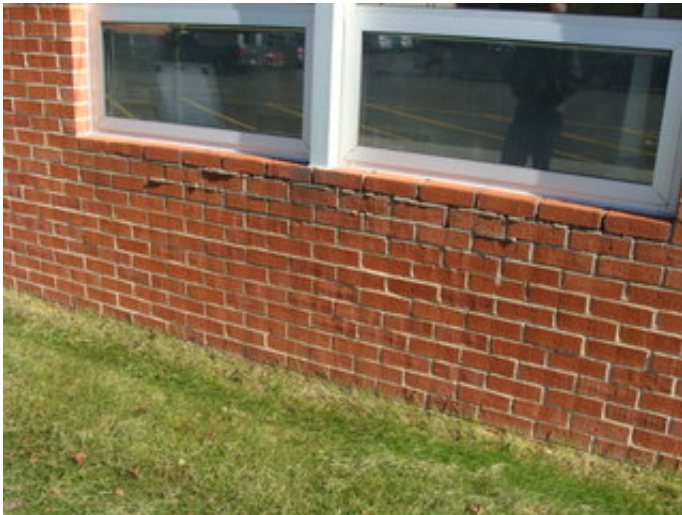
Description: The overall facility has a brick veneer on a masonry bearing wall system, which displayed very few locations of deterioration, and is in good condition. The exterior masonry appears to have appropriately spaced and adequately caulked control joints in good condition. The exterior masonry has not been cleaned and sealed in recent years, and shows very little evidence of mortar deterioration. Interior walls are concrete masonry units and glazed block and are in good condition. Interior masonry appears to have adequately spaced and caulked control joints in good condition. The window sills are brick and are in good condition. The exterior lintels are steel, and are in fair condition.

Rating: 2 Needs Repair

Brick Wall To Be Cleaned

Recommendations: Provide tuckpointing in all areas of mortar deterioration as required through the overall facility. Provide masonry cleaning, sealing, caulking as required through the overall facility. Provide brick infill where unit ventilators louvers are removed. 10-12-2022: Per Then Design's assessment validation, updated the cost of infill vents from \$45/SF to \$60/SF.

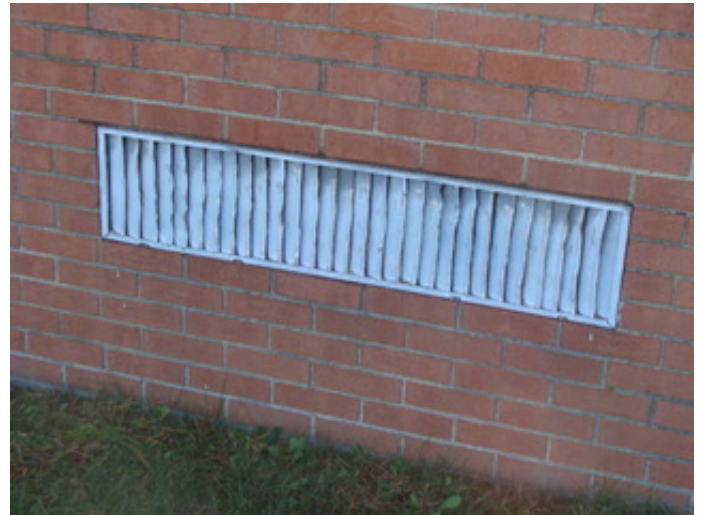
Unit Ventilator to Be Filled In

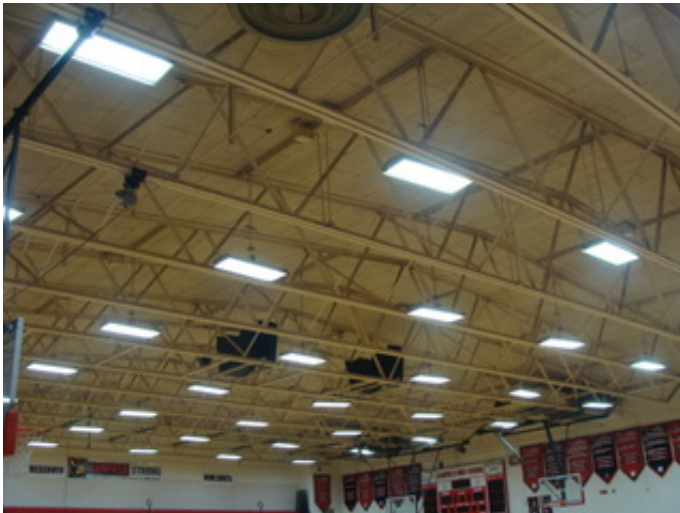
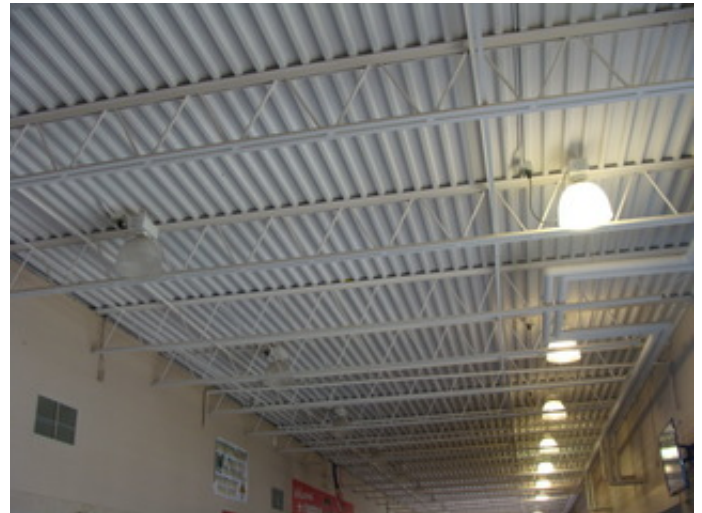
Description: The floor construction of the base floor of the overall facility is concrete slab on grade construction, and is in good condition. There is no crawl space. There are no intermediate floors in this single story structure. Ceiling to structural deck spaces are insufficient to accommodate HVAC, electrical, and plumbing scopes of work in required renovations. The roof construction of the overall facility is steel deck on steel joist, and is in good condition.

Recommendations: Existing conditions require no renovation or replacement at the present time. 2021 UPDATE: There are two areas that are observed to have cracking and what appears to be foundation settlement. It is recommended that a structural analysis be conducted to investigate the cause of these conditions. A potential solution has been developed an a cost estimate/budget provided. 10-12-2022: Per Then Design's assessment validation, updated the cost of the cracked wall repairs from \$1,546,167 to \$1,809,015.39

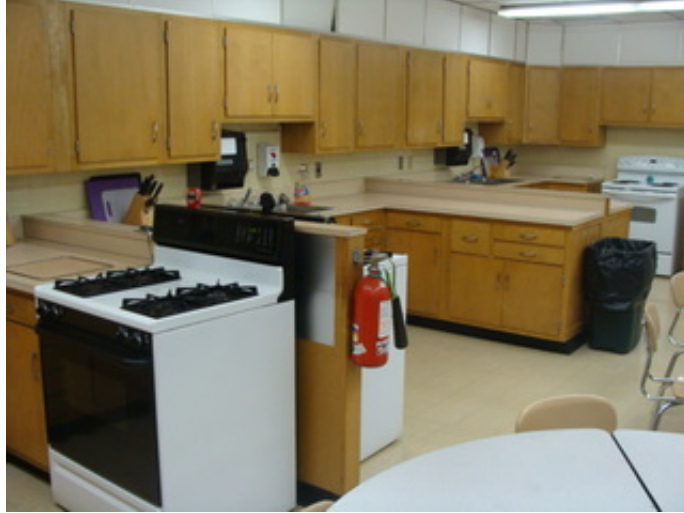
Typical Classroom Casework

Description: The overall facility features conventionally partitioned Classrooms with VCT/VAT flooring, suspended ceilings, as well as painted wall finishes, and they are in fair condition. The overall facility has Corridors with terrazzo flooring, suspended ceilings, as well as glazed tile wall finishes, and they are in good condition. The overall facility has Restrooms with ceramic tile flooring, plaster ceilings, as well as tile wall finishes, and they are in fair condition. Toilet partitions are metal and plastic, and are in fair condition. Classroom casework in the overall facility is wood construction with plastic laminate tops, is inadequately provided, and is in fair condition. The lockers located in the Corridors are in poor to fair condition. The Art program is equipped with a kiln in good condition, and existing kiln ventilation is adequate. The facility is equipped with wood louvered and non-louvered interior doors that are partially recessed without proper ADA hardware and clearances, and in fair condition. The Gymnasium space has a wood floor, open ceilings, as well as painted wall finishes, and they are in good condition. Gymnasium telescoping stands are plastic type construction in good condition. Gymnasium basketball backboards are electrically operated type, and are in good condition. The Media Center has carpeted flooring, suspended ceilings, as well as painted wall finishes, and they are in good condition. Student Dining has VCT flooring, suspended ceilings, as well as painted wall finishes, and they are in good condition. The existing Kitchen which serves all four schools in the District is full service, is undersized based on current enrollment, and the existing Kitchen equipment, installed in 1966, is in fair condition. The Kitchen hood is in fair condition, and is not equipped with the required UL 300 compliant wet chemical fire suppression system. Walk-in coolers/freezers are located within the Kitchen spaces and are in fair condition.

Rating: 3 Needs Replacement

Recommendations: Provide complete replacement of finishes and casework due to installation of systems outlined in Items A, C, D, E, I, K, L, M, N, T, and U. Also, provide all new Kitchen equipment. 2021 UPDATE: Replace stage curtain due to condition; replace damaged terrazzo floor areas; adjust door count and toilet partition count. Add exterior wall insulation. 10-12-2022: Per Then Design's assessment validation, updated the cost of the stage curtain replacement from \$100,000 to \$120,000

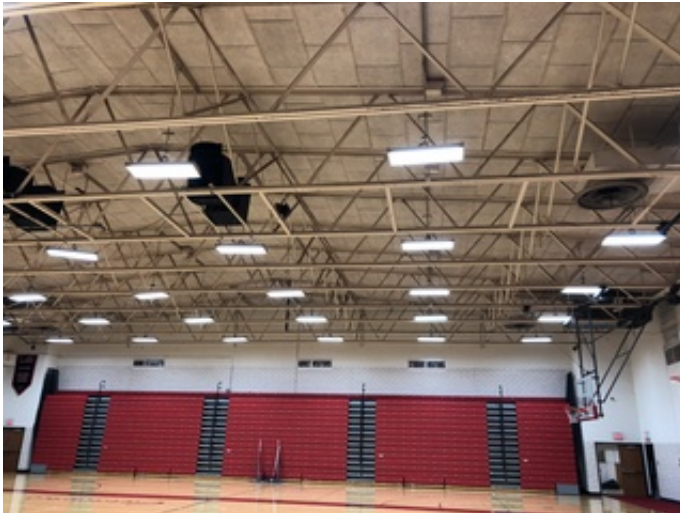
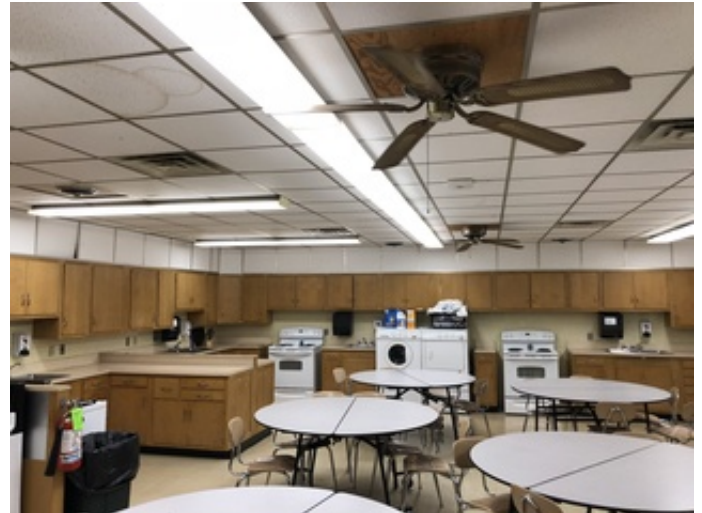
The typical Classrooms in the High School are equipped with T-8 1x4 surface mount fluorescent fixtures with dual level switching. Classroom fixtures are in good condition, providing an average illumination of 40-60 FC, thus complying with the 50 FC recommended by the OSDM. The typical Corridors in the High School are equipped with T-8 2x4 lay-in and 1x4 surface mount fluorescent fixtures with single level switching. Corridor fixtures are in good condition, providing an average illumination of 20 FC, thus complying with the 20 FC recommended by the OSDM. The Gymnasium spaces are equipped with T8 pendant mounted fluorescent fixtures type lighting, in good condition, providing an average illumination of 55 FC, thus complying with the 50 (HS) FC recommended by the OSDM. The Media Center is equipped with 2x4 surface mounted fluorescent fixture type lighting in good condition, providing an average illumination of 50 FC thus complying with the 50 FC recommended by the OSDM. The Student Dining spaces are equipped with 2x2 lay-in LED fixture type lighting with single level switching. Student Dining fixtures are in good condition, providing an average illumination of 30-40 FC, which is less than the 50 FC recommended by the OSDM. The Kitchen spaces are equipped with 2x2 lay-in LED fixture type lighting with single level switching. Kitchen fixtures are in good condition, providing an average illumination of 70 FC, which is less than the 75-80 FC recommended by the OSDM. The Service Areas High School are equipped with 1x4 surface mount T8 fluorescent fixture type lighting in good condition, providing an average illumination of 10-15 FC. The typical Administrative spaces in the High School are equipped with 2x4 lay-in T8 fluorescent fixture type lighting in good condition, providing adequate illumination of 40-55 FC. The overall lighting systems of the facility are not fully compliant with Ohio School Design Manual requirements due to age and condition, inadequate lighting levels, and lack of multi-level switching.

3 Needs Replacement

Provide complete replacement of lighting system due to condition, lighting levels, lack of multilevel switching and installation of new fire suppression and air conditioning systems.

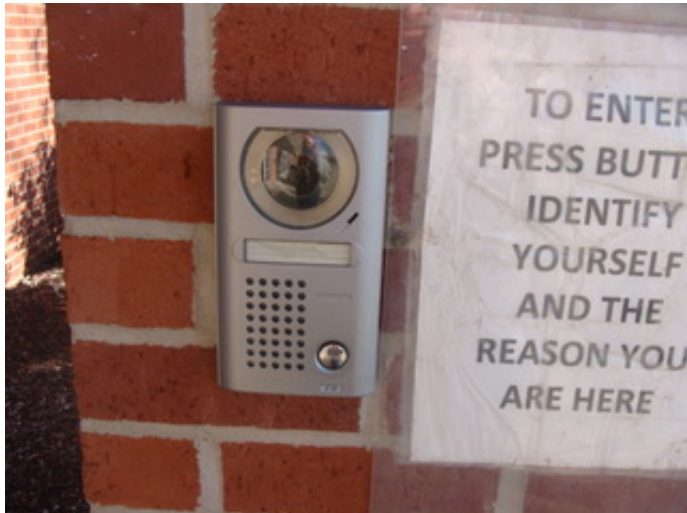
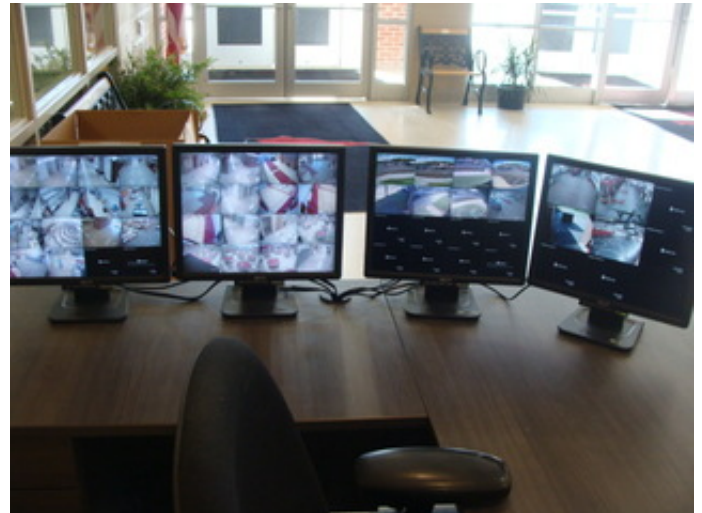
Description:	The High School contains a CCTV type security system in good condition. Motion detectors are adequately provided in main entries, central gathering areas, offices, main Corridors, and spaces where 6 or more computers are located. Three exterior doors are equipped with door contacts. Compliant color CCTV cameras are provided at main entry areas, parking lots, central gathering areas, and main Corridors. CCTV is monitored in Administrative Area with the use of TV, recording device, and multiplexer. The system is equipped with card / biometric readers for (3) exterior doors. The security system is not adequately provided throughout, and the system is not fully compliant with Ohio School Design Manual guidelines. The exterior site lighting system is equipped with HID metal halide wall packs in fair condition. Parking and bus pick-up / drop off areas are illuminated by pole mounted HID in good condition. The exterior site lighting system provides adequate coverage.

Rating:	3 Needs Replacement							
Recommendations:	Provide a full security system upgrade, consisting of additional door controls, cameras to meet Ohio School Design Manual guidelines. Provide enhancement of exterior site lighting system, consisting of LED fixtures to meet Ohio School Design Manual guidelines.

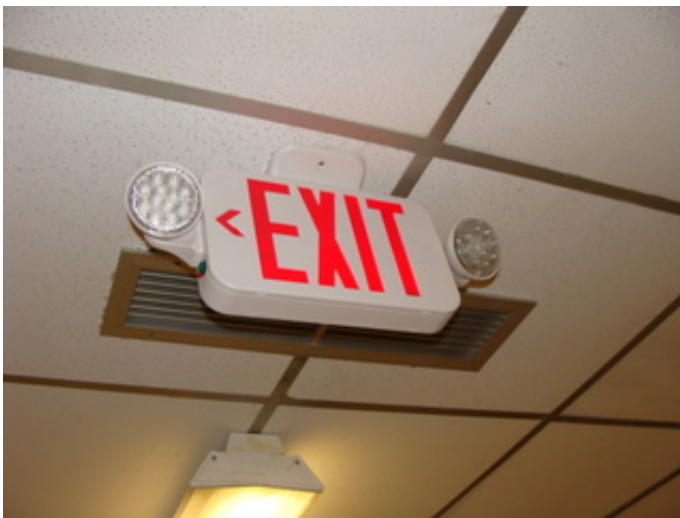
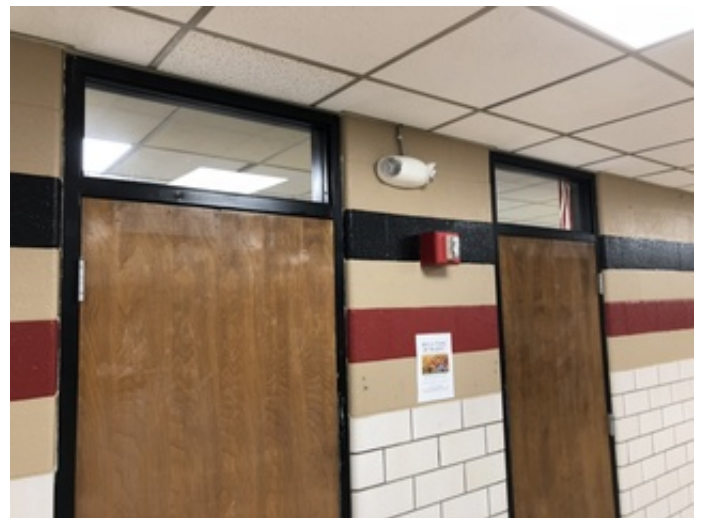
Description: The High School is equipped with an emergency egress lighting system consisting of OSDM compliant red lettered, cast aluminum construction, LED illuminated exit signs and emergency floodlighting. The system is in fair condition and is provided with appropriate battery backup. The system is not adequately provided throughout and does not meet Ohio School Design Manual and Ohio Building Code requirements.

Rating: 3 Needs Replacement

Recommendations: Provide complete replacement of emergency / egress lighting system to meet Ohio School Design Manual guidelines.

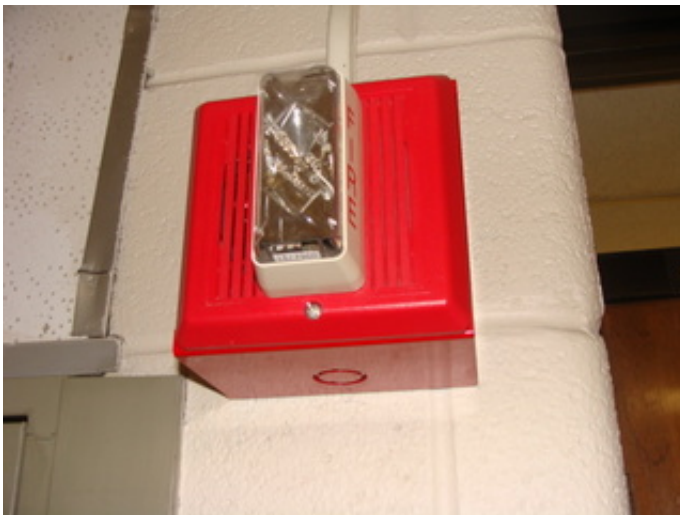
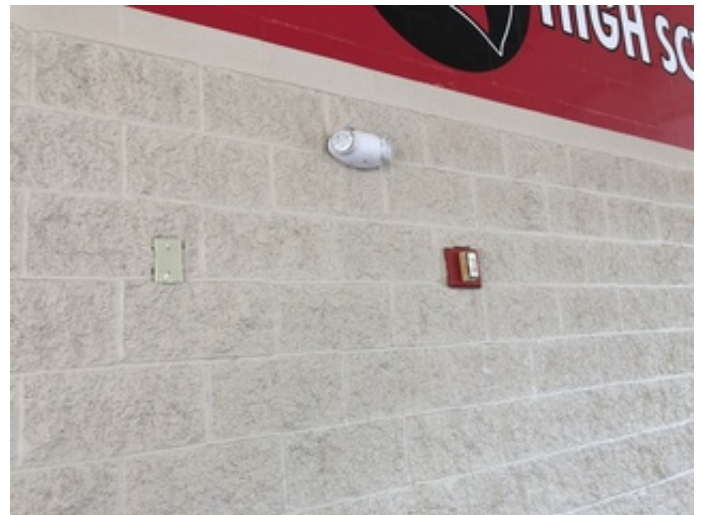
Description: The overall facility is equipped with a EST Addressable fire alarm system in good condition, consisting of manual pull stations, bells, horn and strobe indicating devices. The system is automatic and is monitored by a third party. The system is not equipped with sufficient audible horns and strobe indicating devices. The system thus will not support future fire suppression systems. The system is not adequately provided throughout and does not have additional zone capabilities. The system is not fully compliant with Ohio Building Code, NFPA, and Ohio School Design Manual requirements.

Rating: 3 Needs Replacement

Recommendations: Provide complete replacement of fire alarm system to meet OBC, NFPA, and Ohio School Design Manual guidelines.

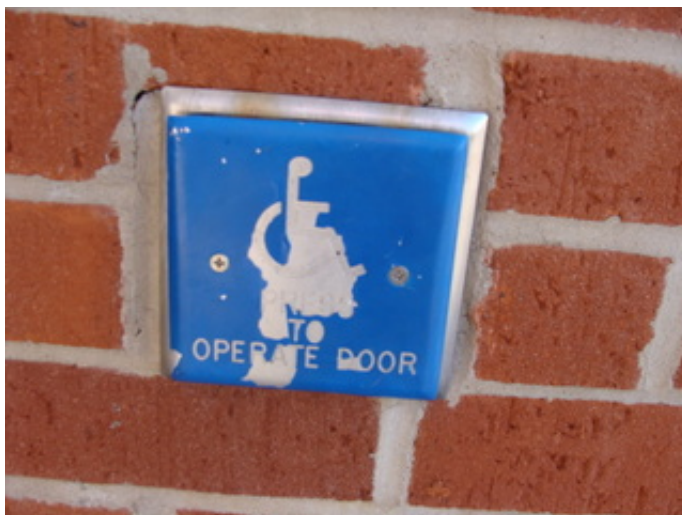
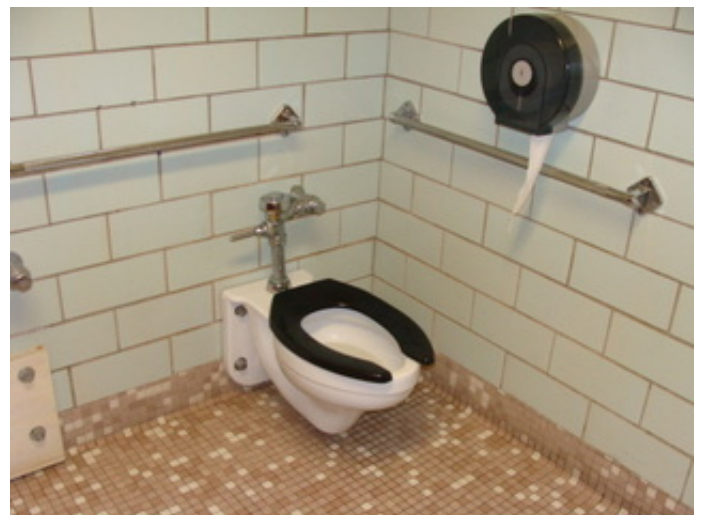
Description: At the site, there is an accessible route provided from the public right-of-way, the accessible parking areas, and from the passenger unloading zone to the main entrance of the school. There is an accessible route connecting all or most areas of the site. The exterior entrances are not fully ADA accessible due to steps. Access from the parking/drop-off area to the main building entry is not compromised by steps or steep ramps. Adequate handicap parking is provided. The main entry is equipped with an ADA power assist door, which is in fair condition. On the interior of the building, space allowances and reach ranges are mostly not compliant. There is an accessible route through the building which does not include protruding objects. Ground and floor surfaces are generally compliant. Ramps and stairs do meet all ADA requirements. Elevation changes within the overall facility are facilitated by ramps in good condition. Access to the Stage is not facilitated by a chair lift or ramp. Interior doors are partially recessed, are generally not provided with adequate clearances, and are generally not provided with ADA-compliant hardware. ADA-compliant toilets have been installed as required but will need to be upgraded. Toilet partitions are metal and plastic and do provide appropriate ADA clearances. ADA-compliant accessories are not adequately provided and mounted. Mirrors do not meet ADA requirements for mounting heights. ADA signage is not provided on both the interior or the exterior of the building.

Rating: 3 Needs Replacement

Recommendations: Provide ADA-compliant signage, chair lifts, electric water coolers, toilets, sinks, urinals, toilet partitions, toilet accessories, doors and frames, door hardware in the overall facility to facilitate the school's meeting of ADA requirements. 2021 UPDATE: Adjusted Toilet Partition count.

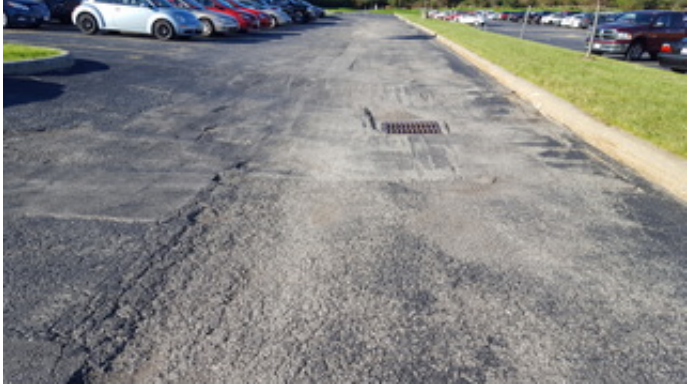
Typical Pavement Condition

3 Needs Replacement

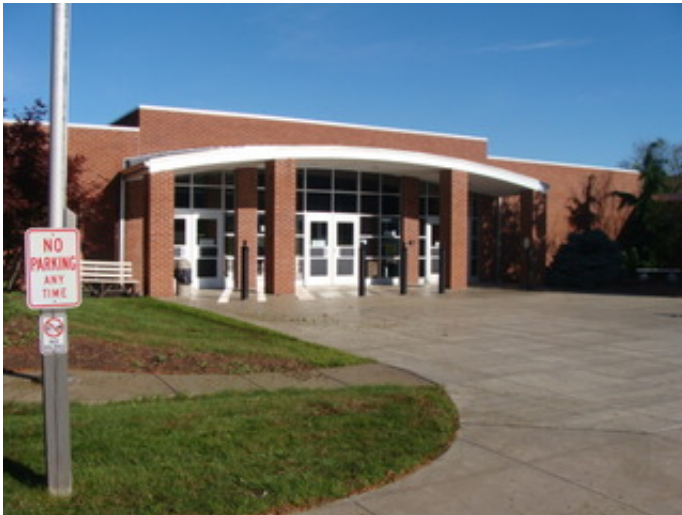
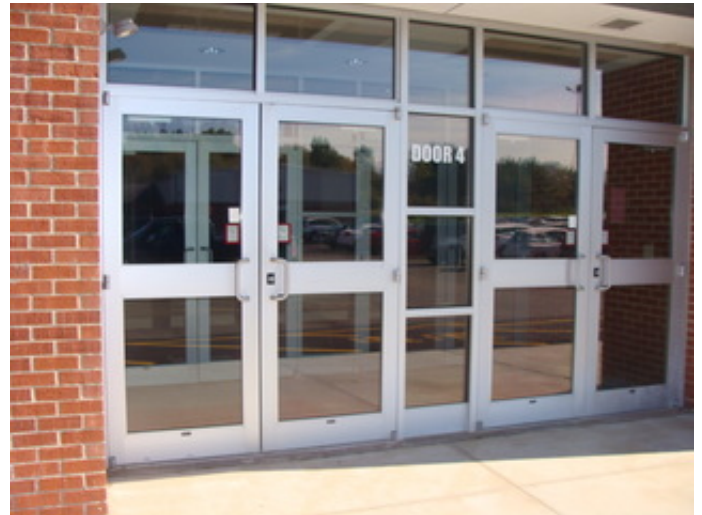
Rating: 3 Needs Replacement

Recommendations: Replace exterior doors as noted below to comply with Ohio Building Code, ADA, and Ohio School Design Manual guidelines. 2021 UPDATE:
Adjusted man-door count

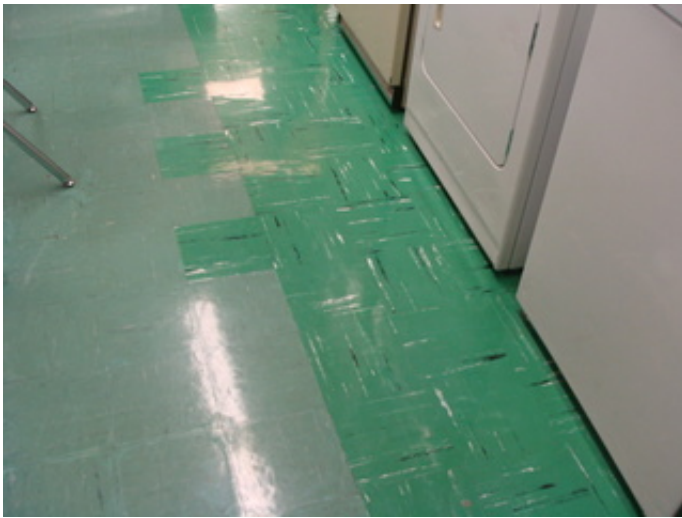
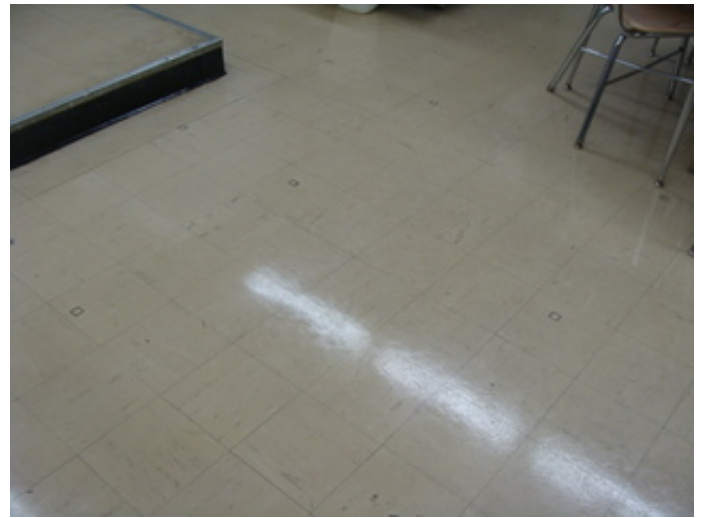
Description:	The School District provided their AHERA three year reinspection reports, prepared by AGX and dated January 2018, documenting known and assumed locations of asbestos and other hazardous materials.
Rating:	2 Needs Repair
Recommendations:	Remove all hazardous materials, inclusive of asbestos-containing materials in the overall facility, as noted in the attached Environmental Hazards Assessment. Enhanced Environmental Assessment (EEA) will need to be performed by OFCC EEA Consultant to establish scope and budget.

VAT in a Classroom

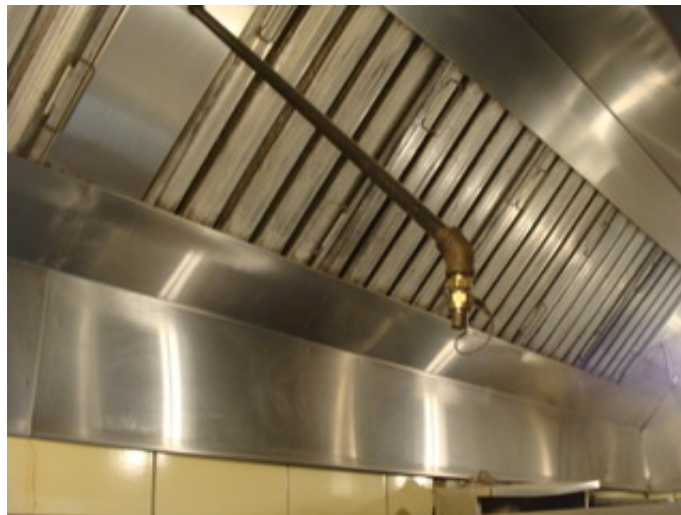
Kitchen Hood

Rating: 3 Needs Replacement

Recommendations: Provide new automated fire suppression system to meet Ohio School Design Manual guidelines. Provide increased water service of capacity sufficient to support the fire suppression system. 2021 UPDATE: Provide ADA fire extinguishers & cabinets. 10-12-2022: Per Then Design's assessment validation, updated the cost of ADA fire extinguisher cabinet from \$1000/each to \$1200/each and the backflow preventer to \$5,863.50

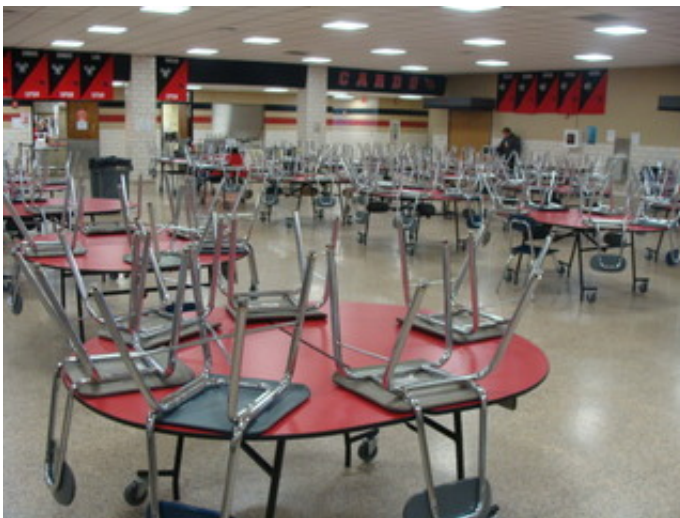
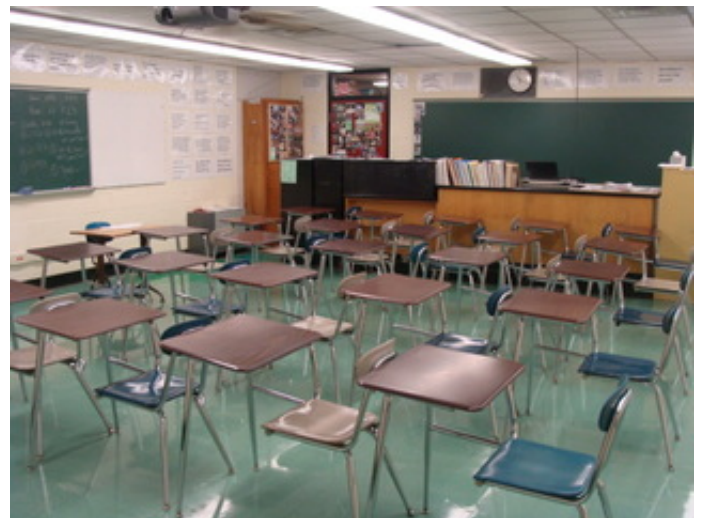
Rating: 3 Needs Replacement

Recommendations: Provide for replacement of outdated or inadequate furniture.
