Project Observation Report

Project Name:	Tri Tech East Building C 1.5	Project No.	2208
Report #:	19		
Observation Date:	2-15-23	Last Report:	2-8-23
Prepared By:	Steve Mallory, AIA	Contractor:	Banlin

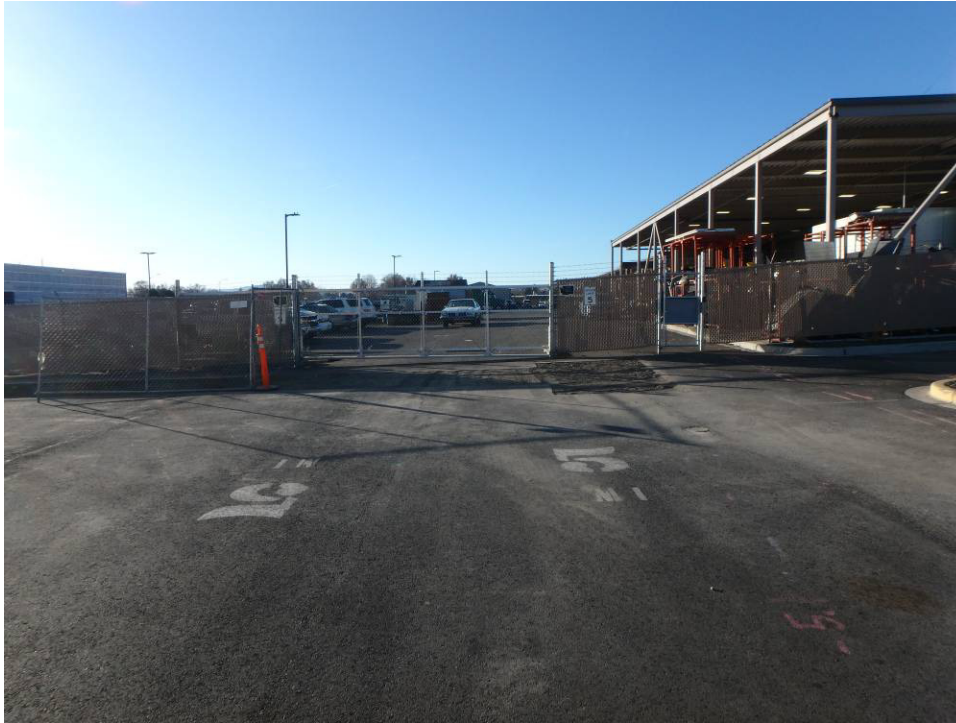
Tri Tech gate (working on the control wiring) waterline trench – west end

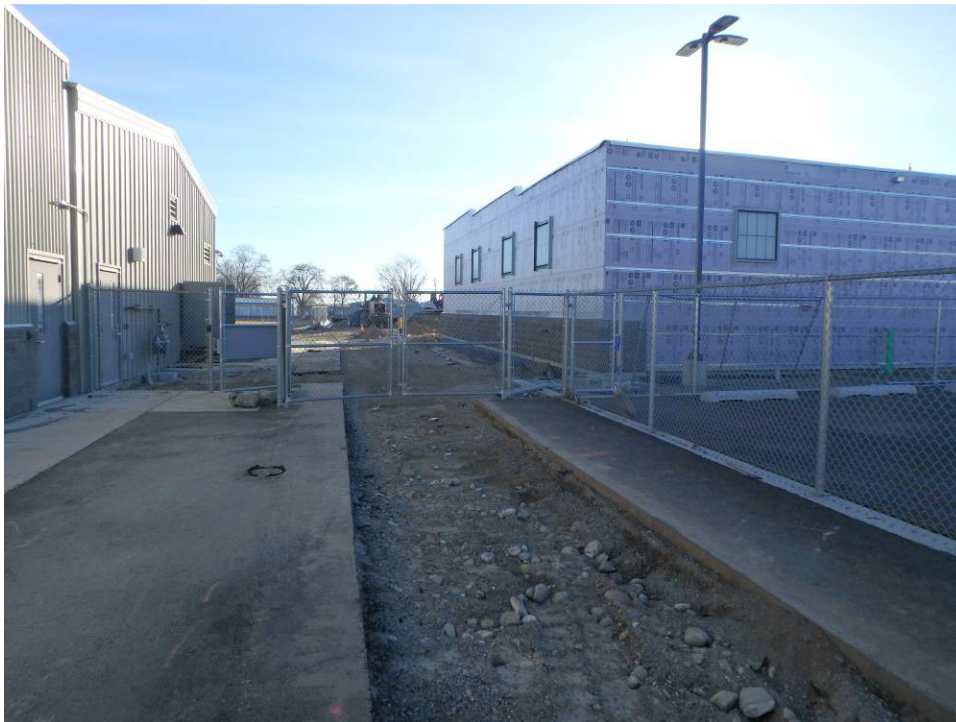
Looking east at the west end of the water line tie-in trench

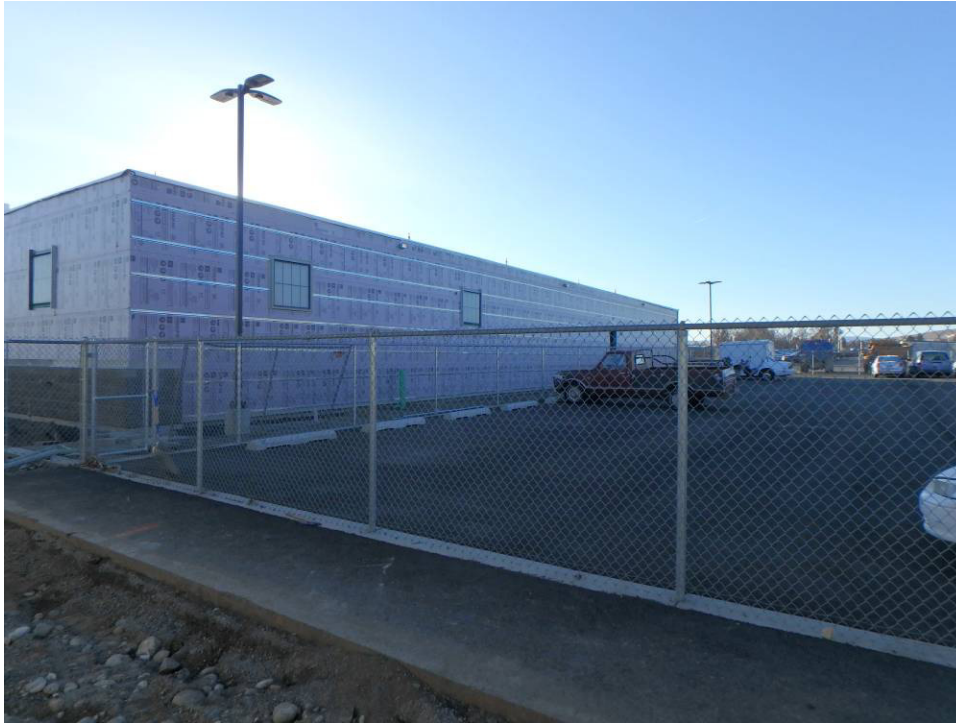
West elevation insulation board and siding furring

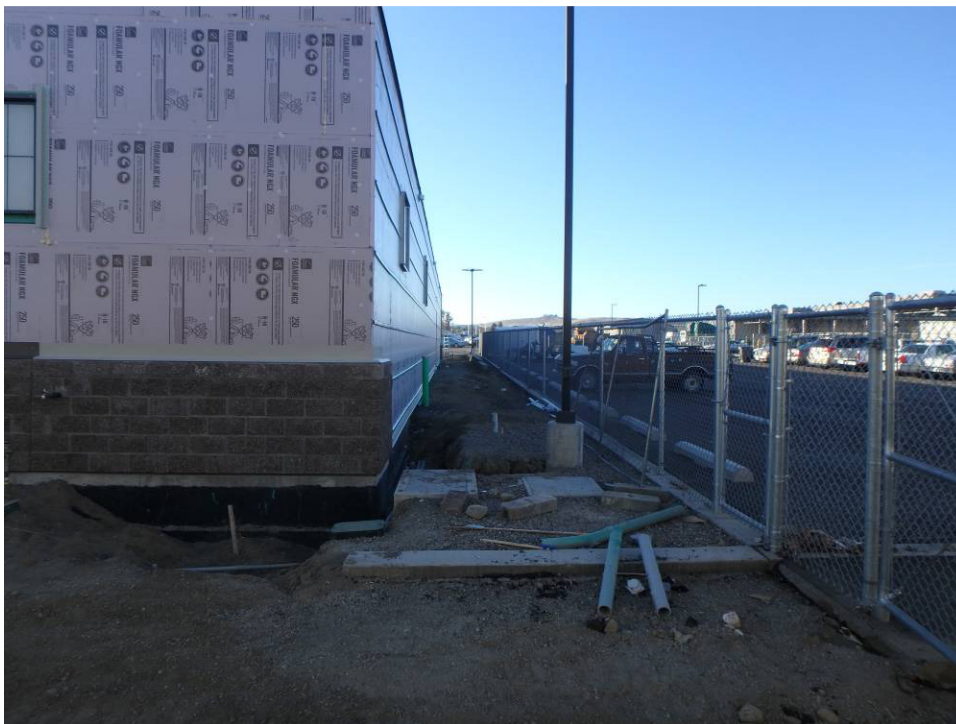
Looking south at the northwest corner of the building and CMU wainscot and the west property line

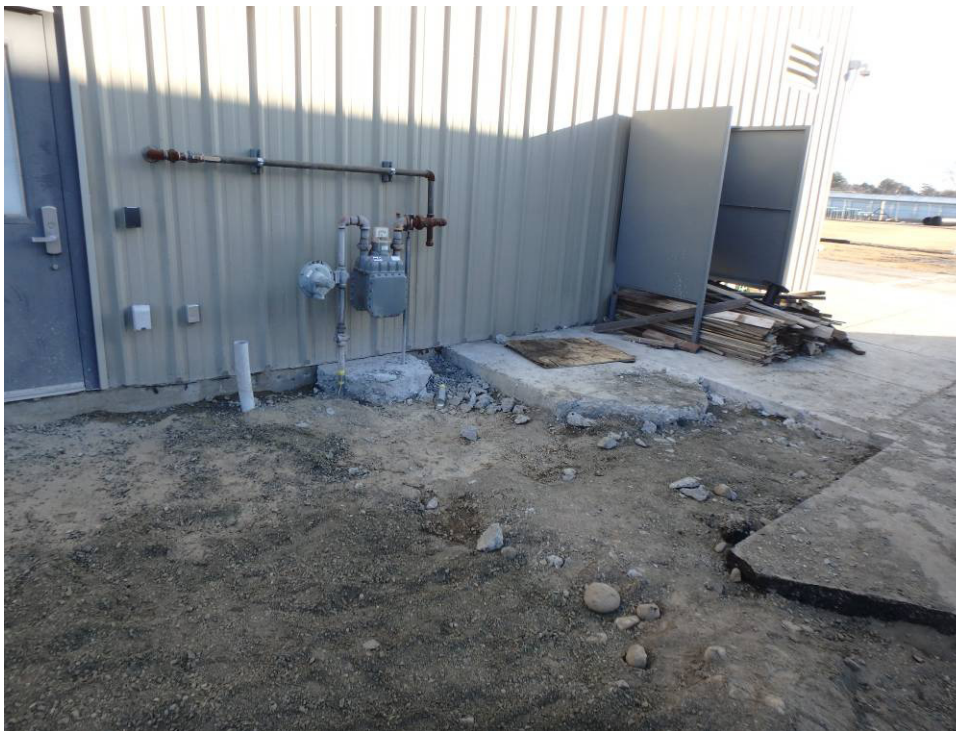
Tri Tech east gas meter

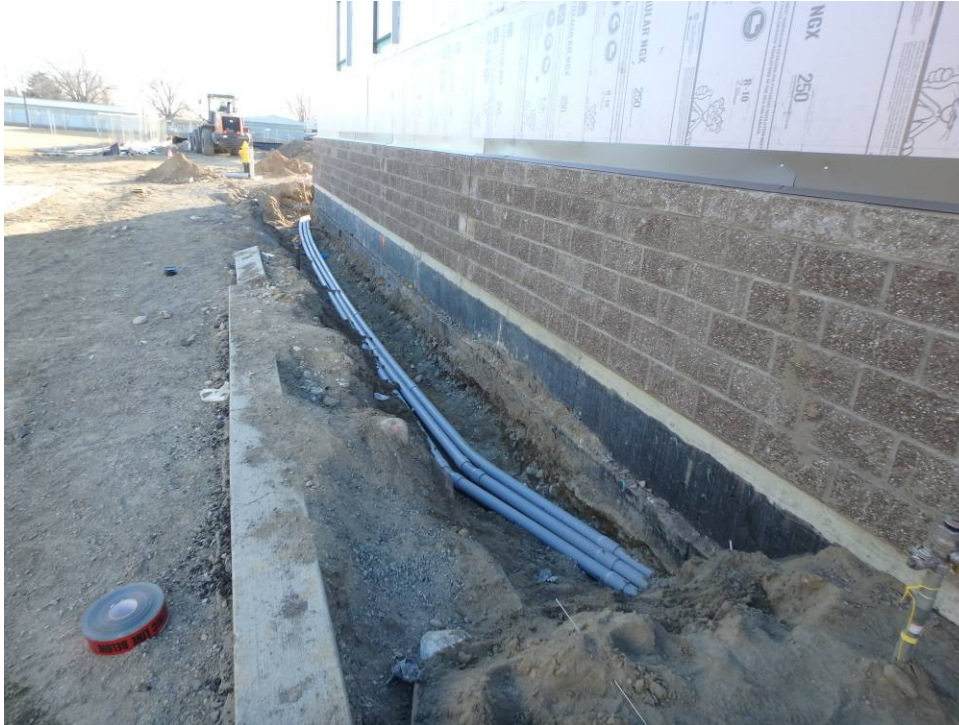
North conduits

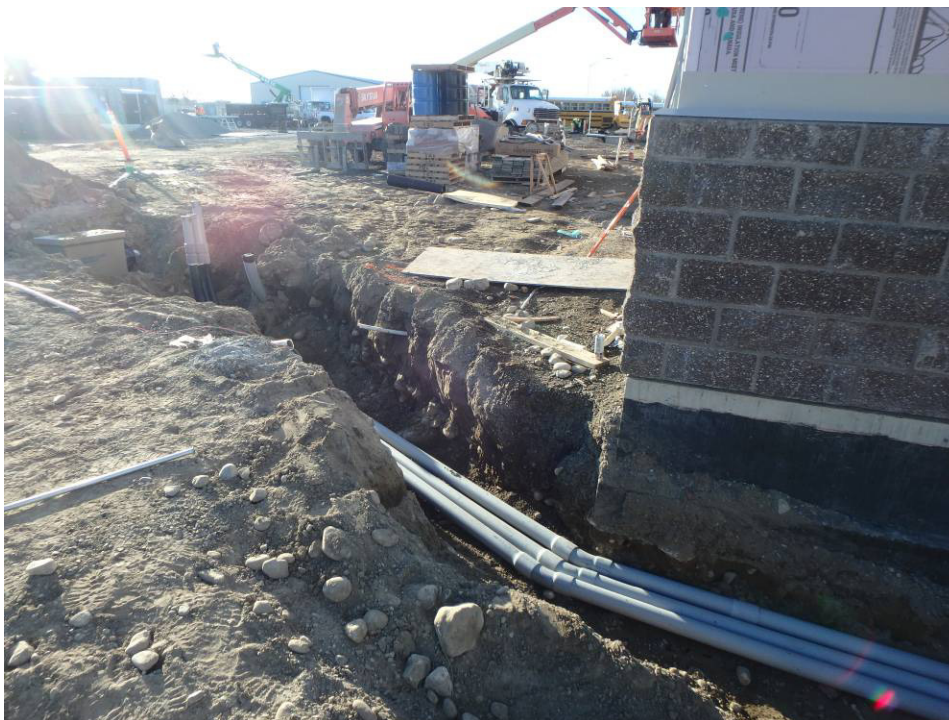
Northeast fire hydrant, and electrical conduits in the NE building island

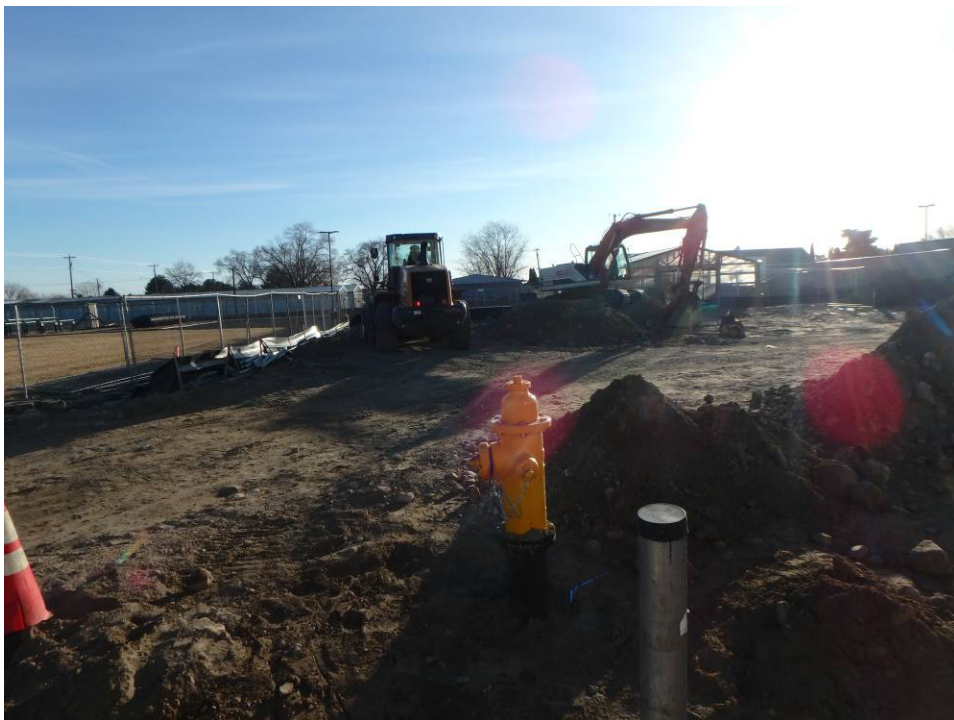
Looking east along the north property line

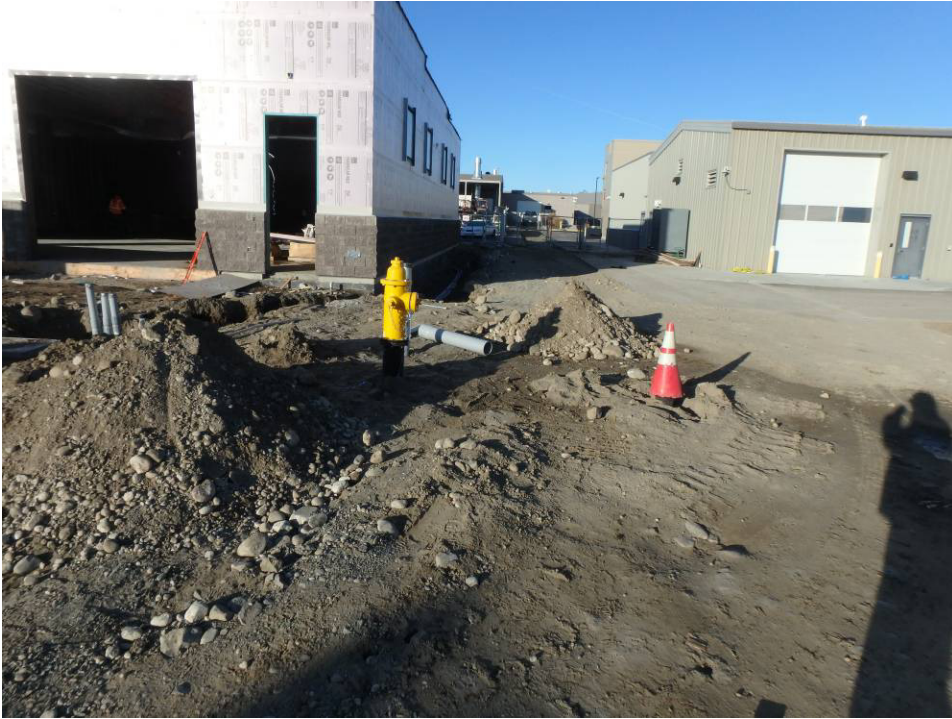
Looking west at the northeast corner of the building and NE island area and waterline backfill

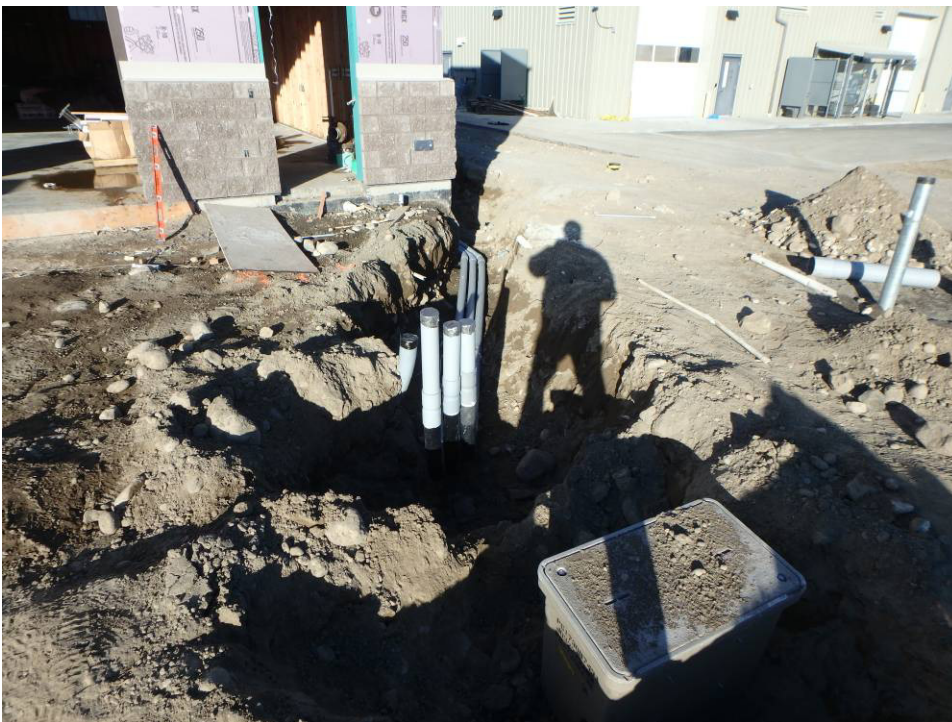
Conduit stub-ups in the NE landscape island

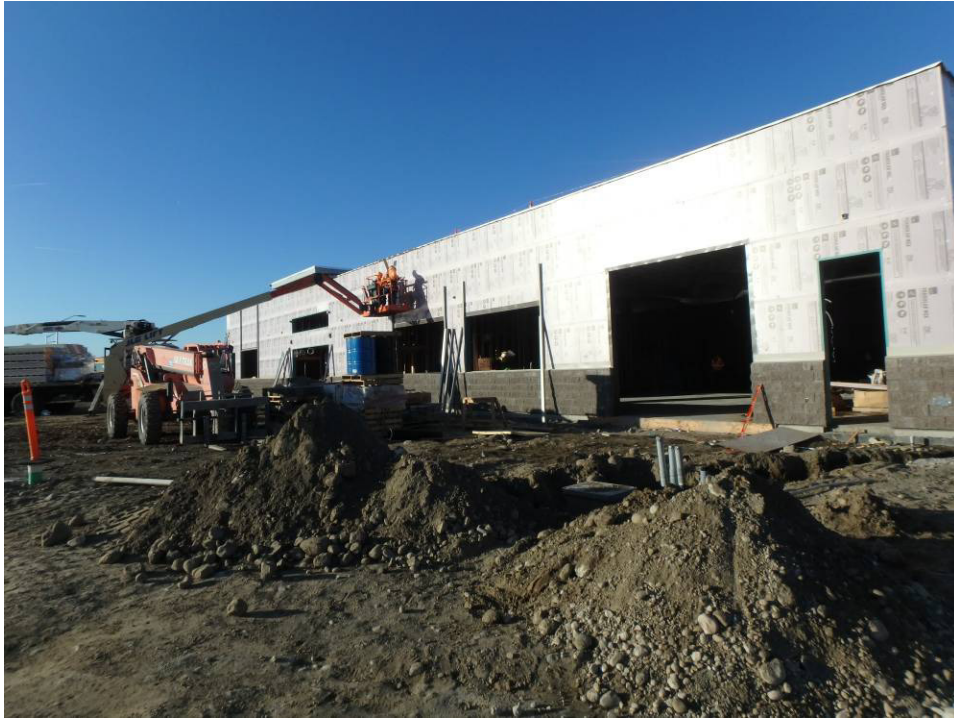
East elevation, installing trim parts for the siding

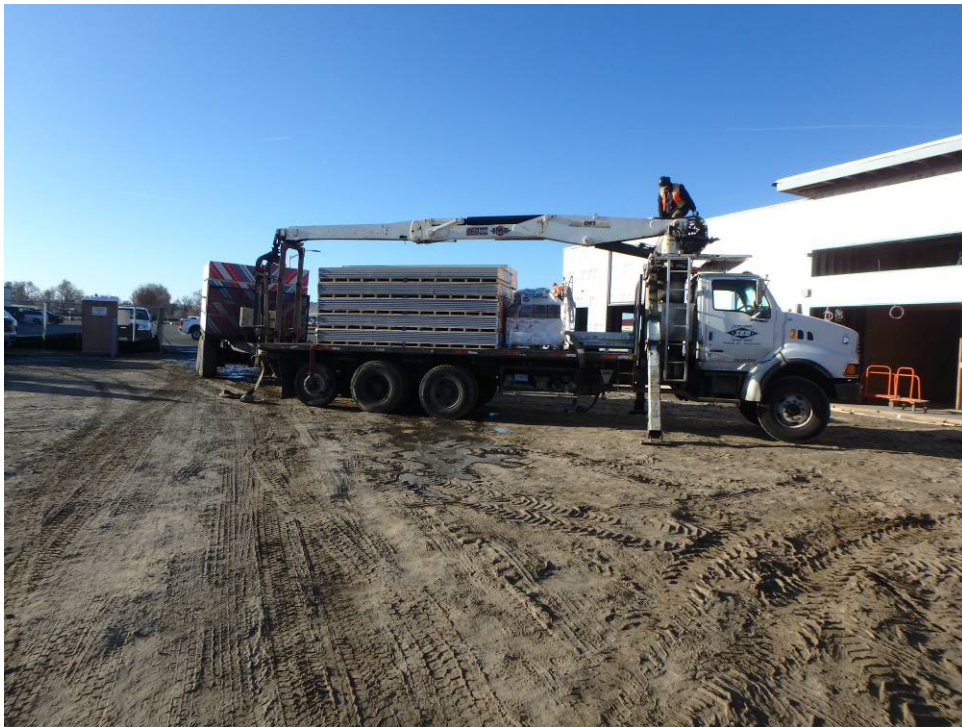
Unloading gypsum wallboard

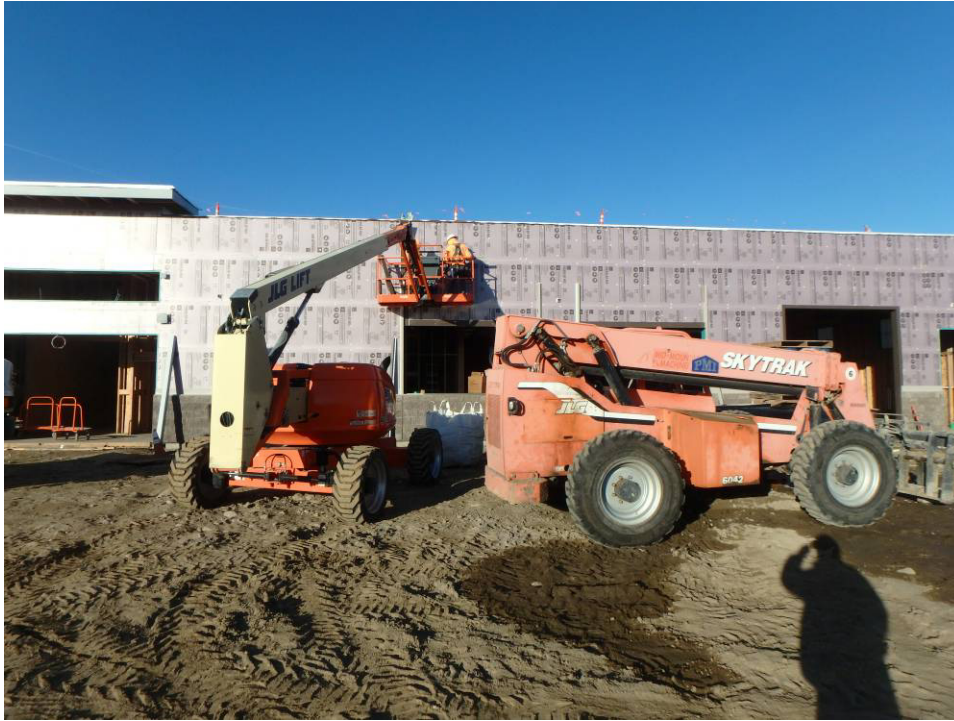
Installing siding trim on the east elevation

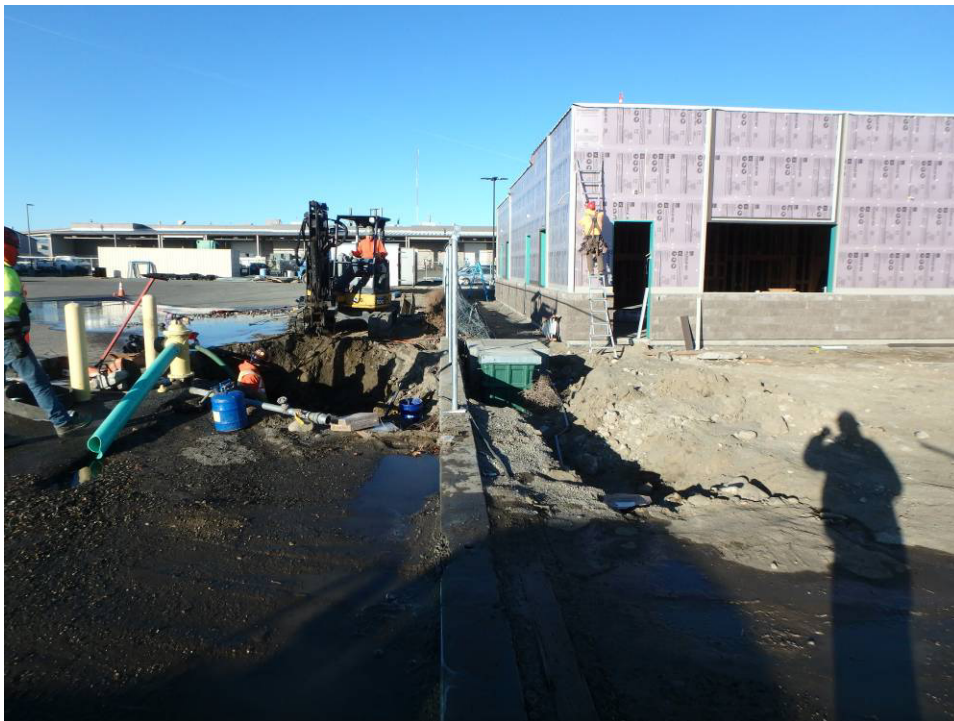
Southeast corner of the building, insulation board and masonry

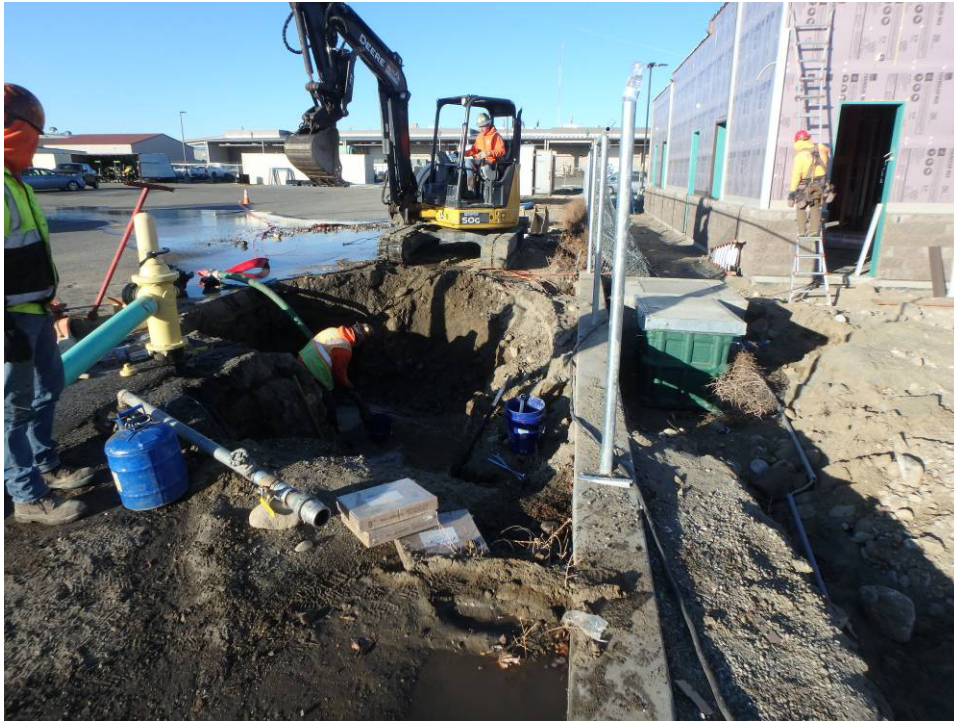
Trenching for the SE water line tie-in

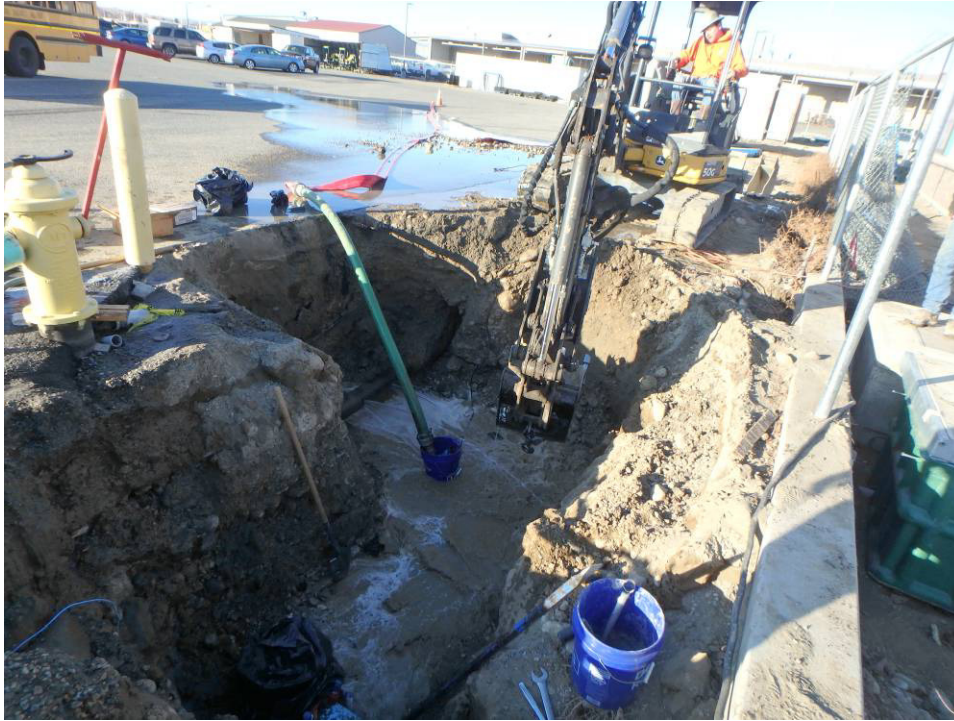
Waterline tie-in

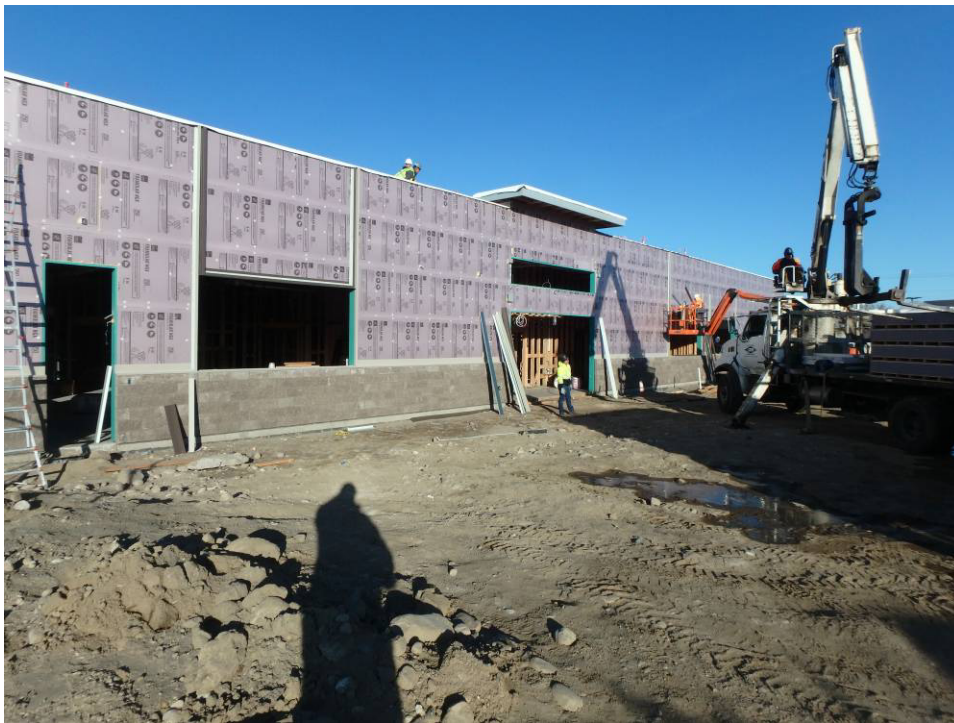
East elevation and the main entry

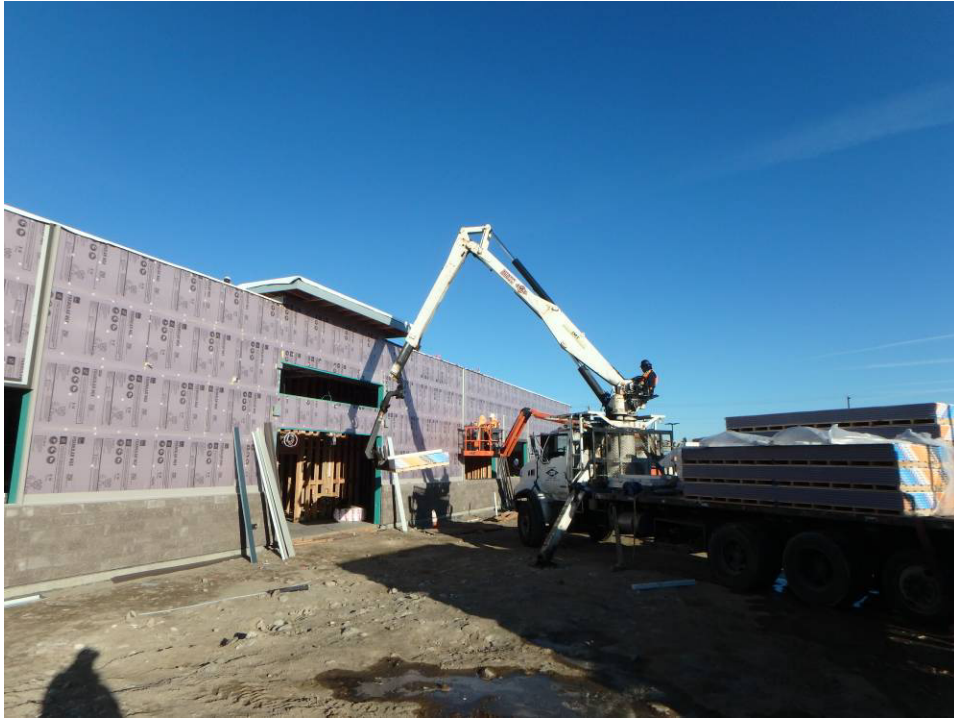
Loading GWB

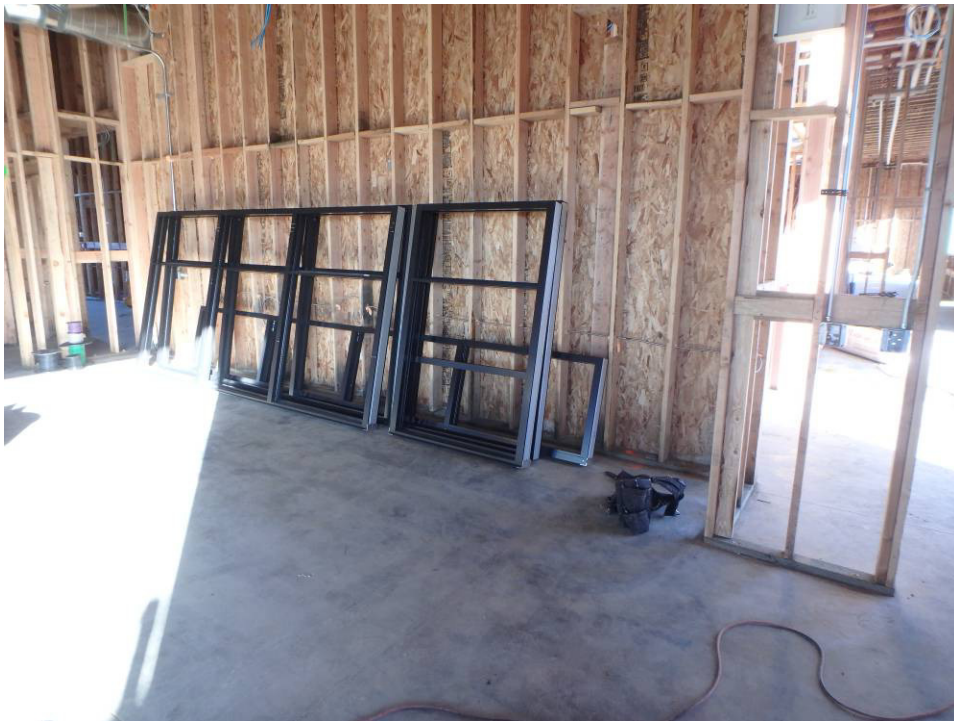
Delivered storefront frames

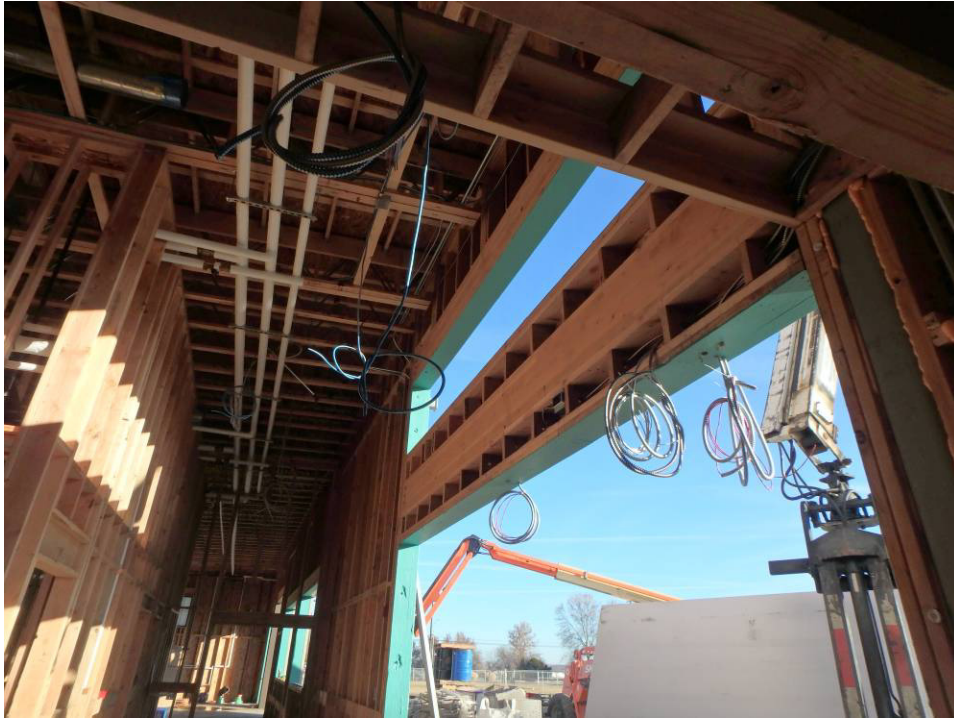
Entry framing and wiring

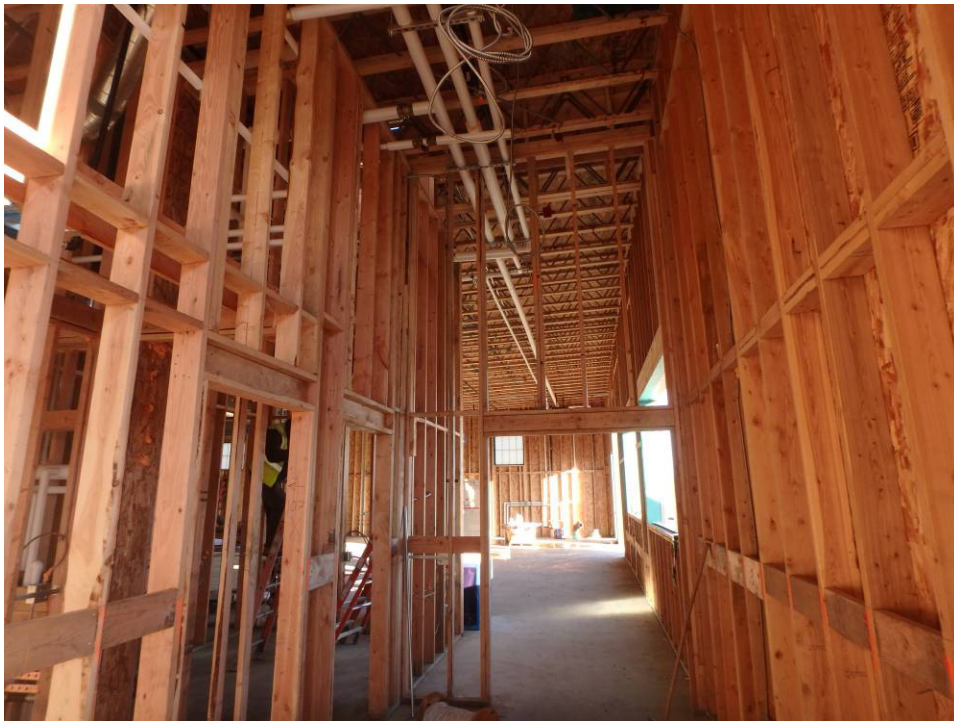
Looking north from the main entry

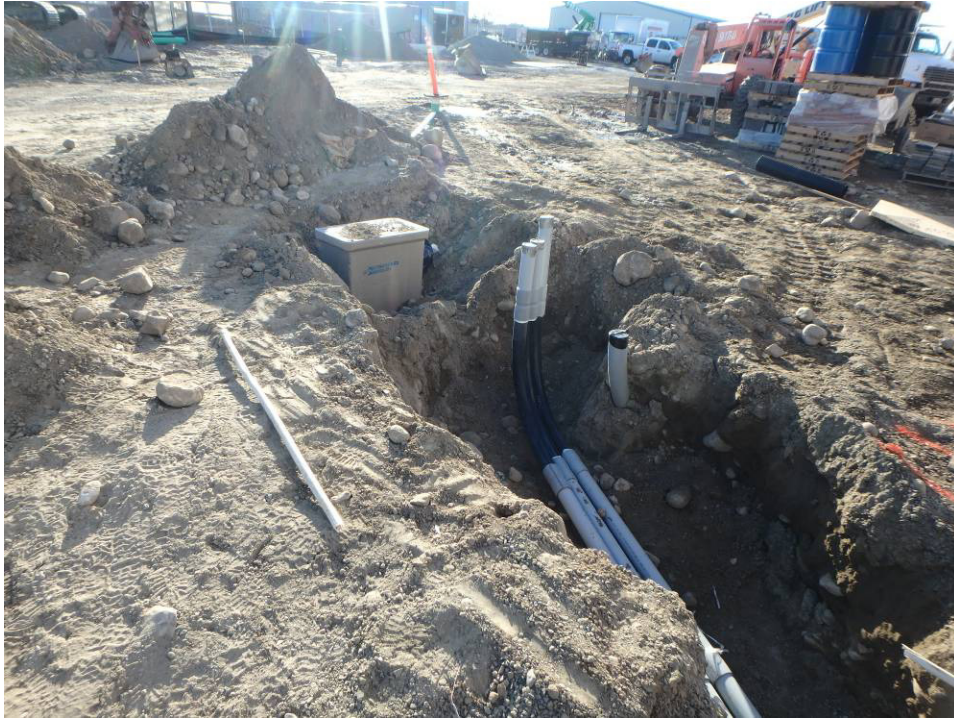
SE Conduits

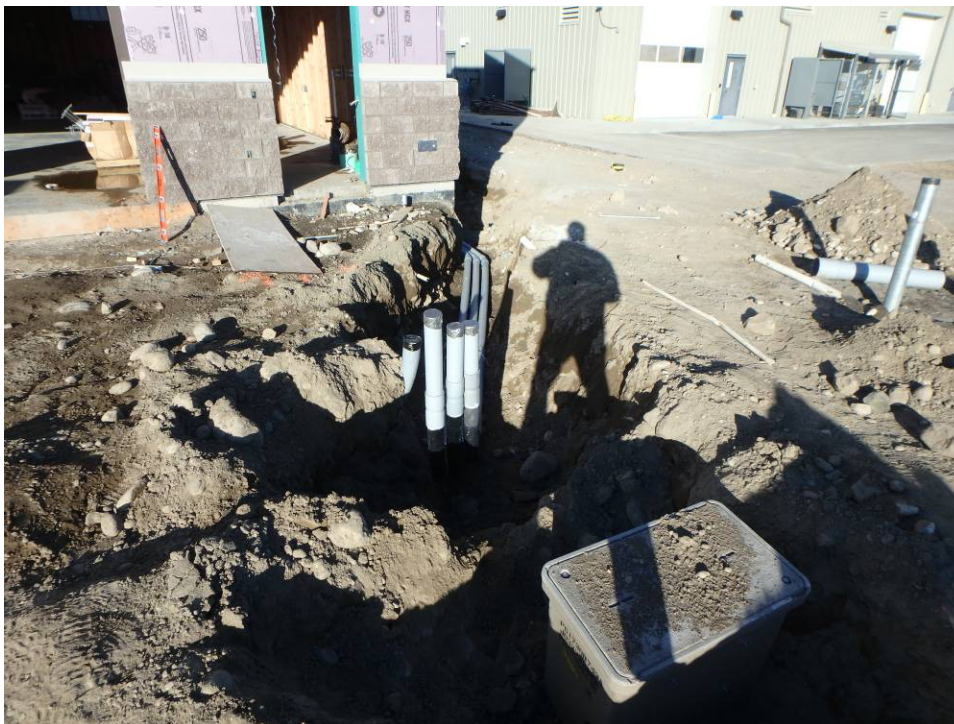
Conduits stubbed up in the NE corner of the building

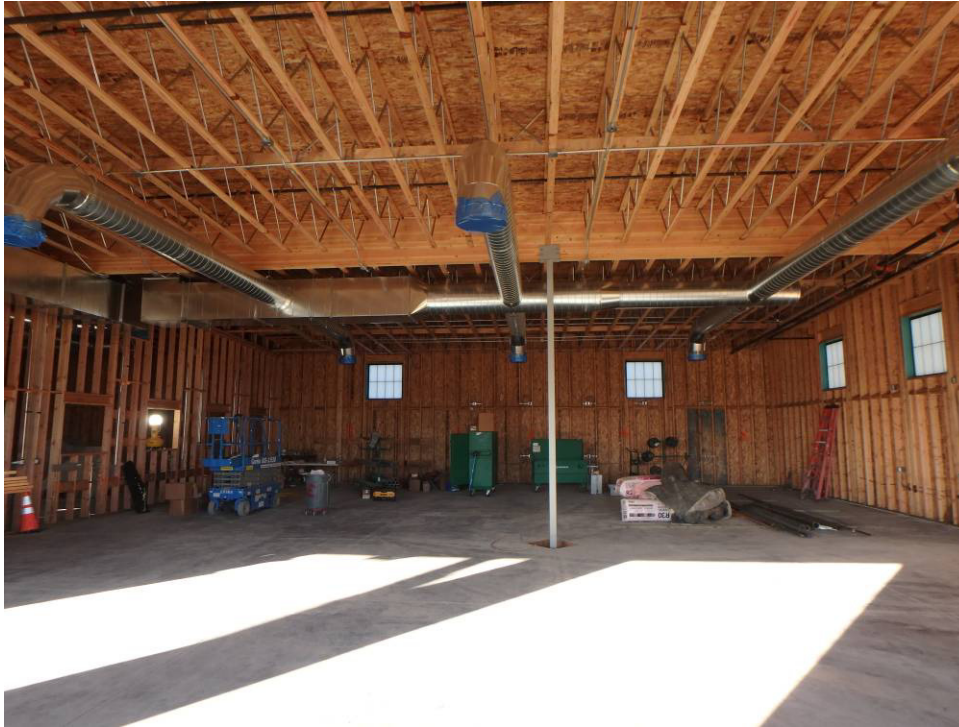
Looking west at the west wall of the shop and the ductwork

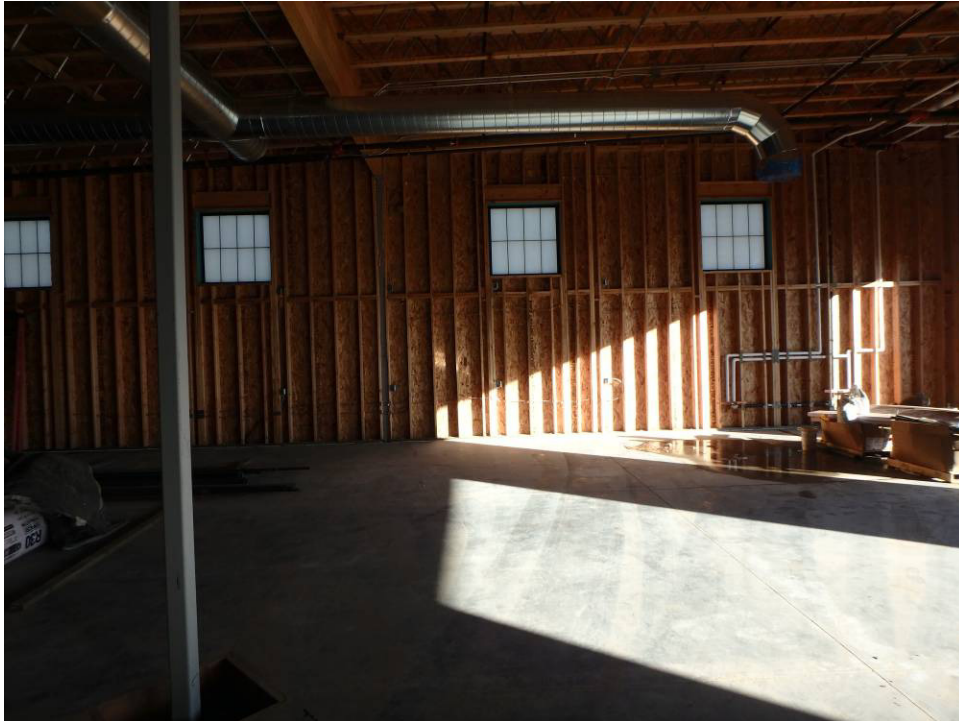
Ductwork above the north wall of the shop

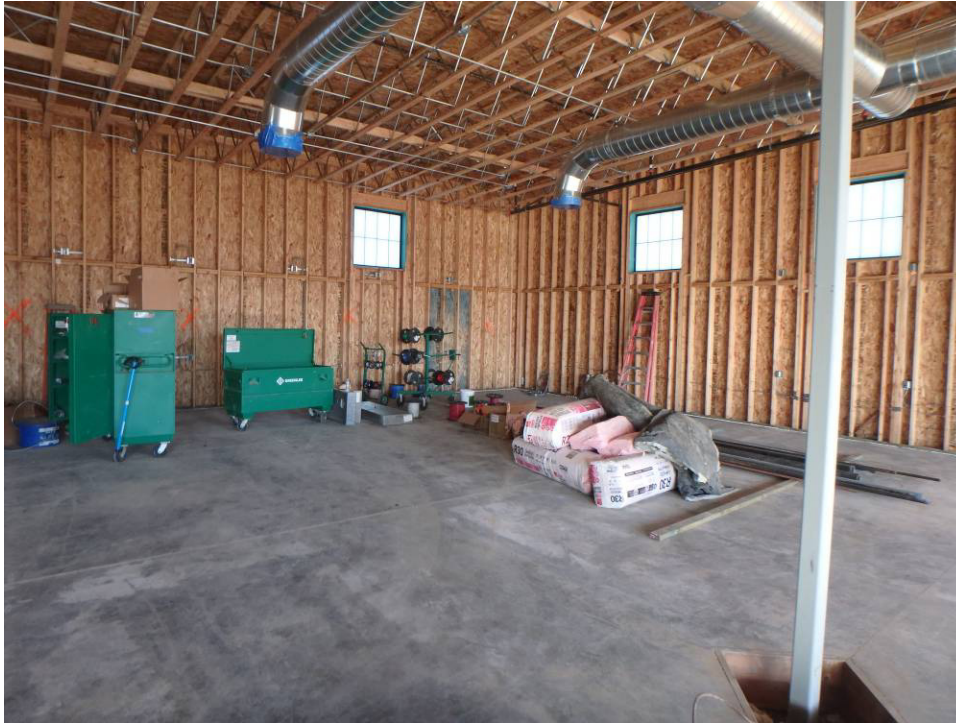
Looking at the northwest corner of the shop

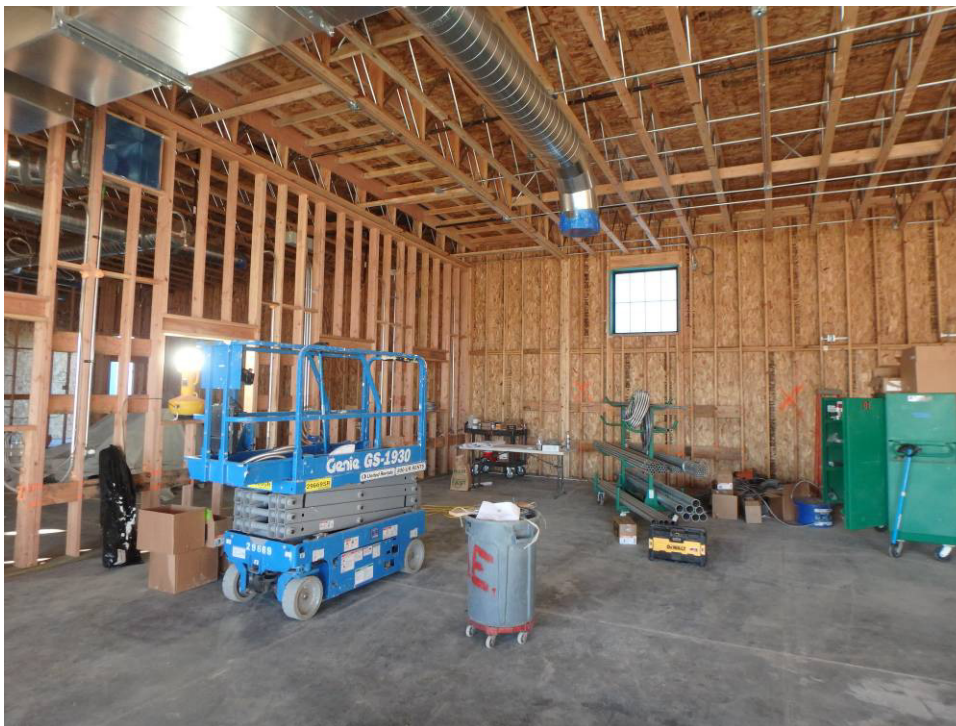
Looking southwest across the shop

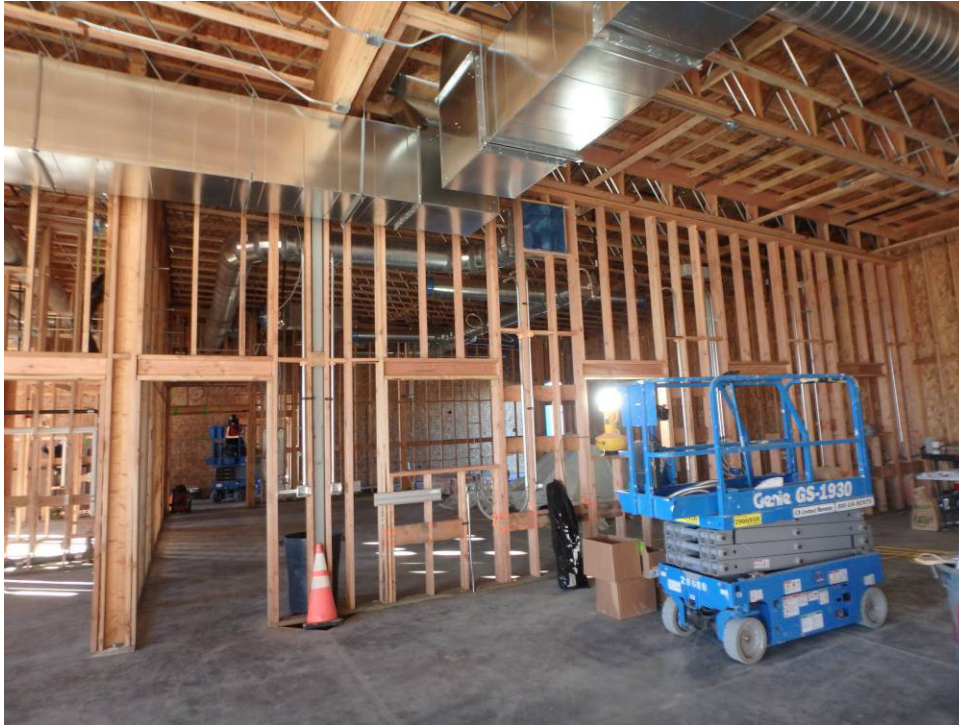
Looking at the south wall of the shop

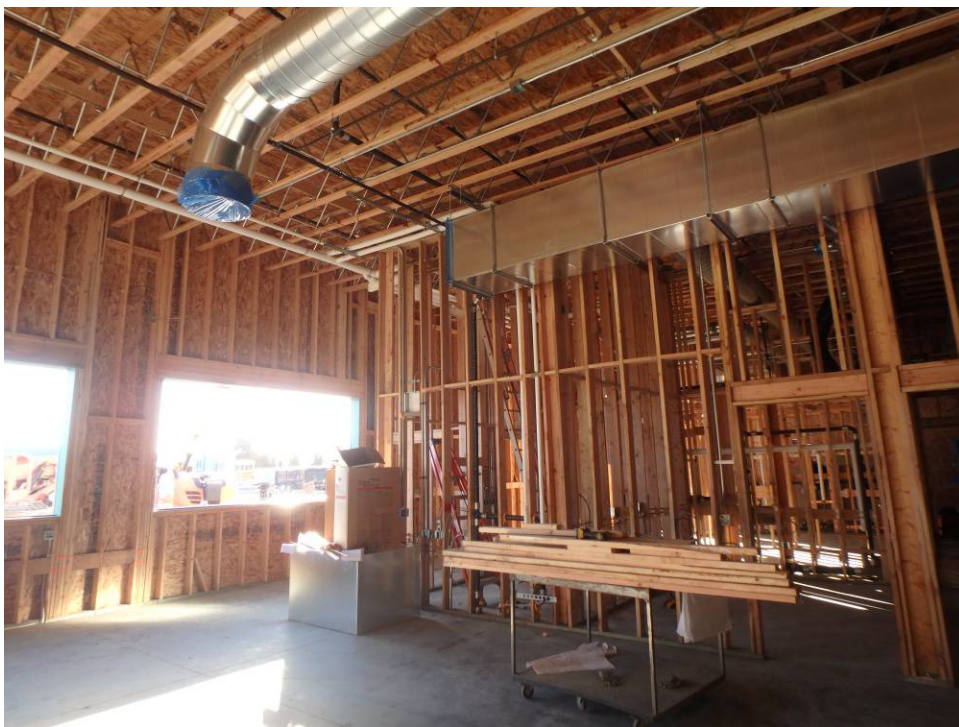
Looking at the southeast corner of the shop

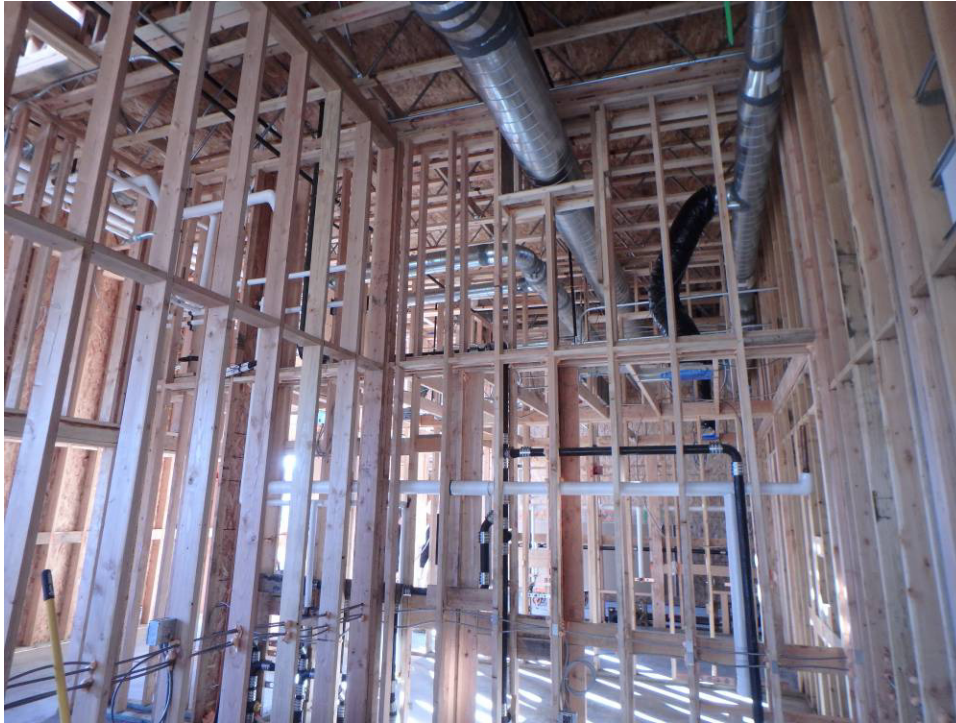
Looking south at the ductwork in the restrooms

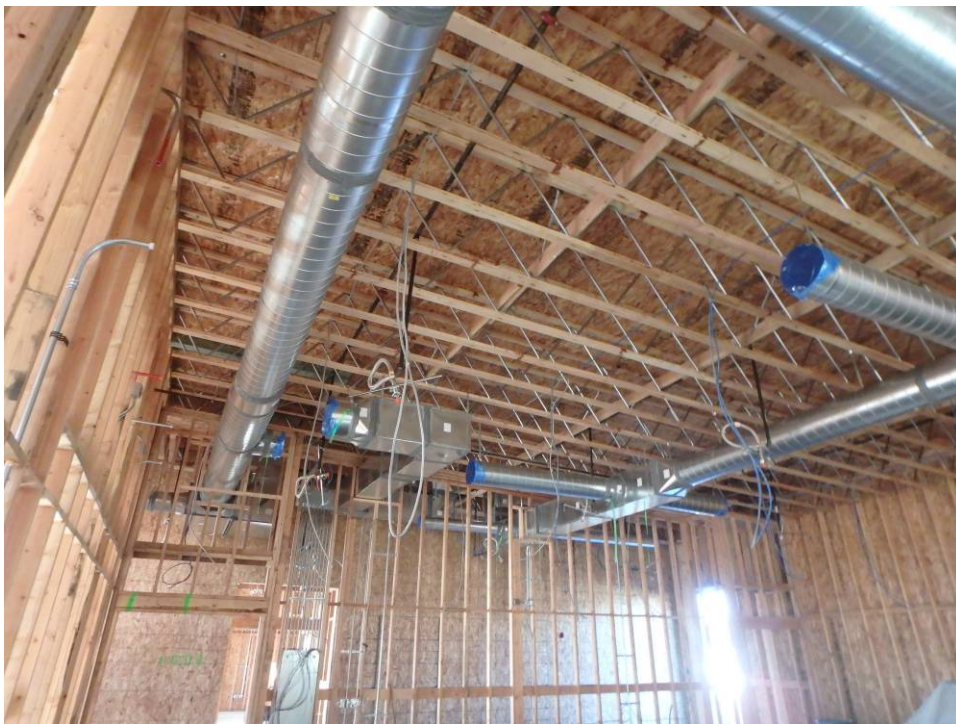
Looking south at the ductwork in the North Classroom

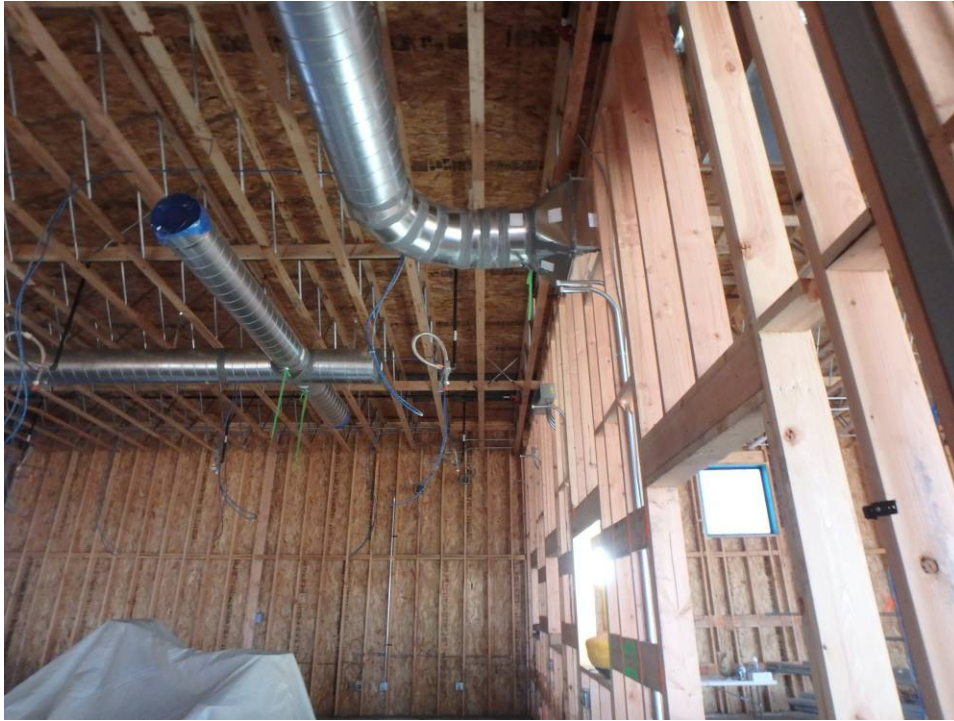
Looking west at the ductwork in the North Classroom

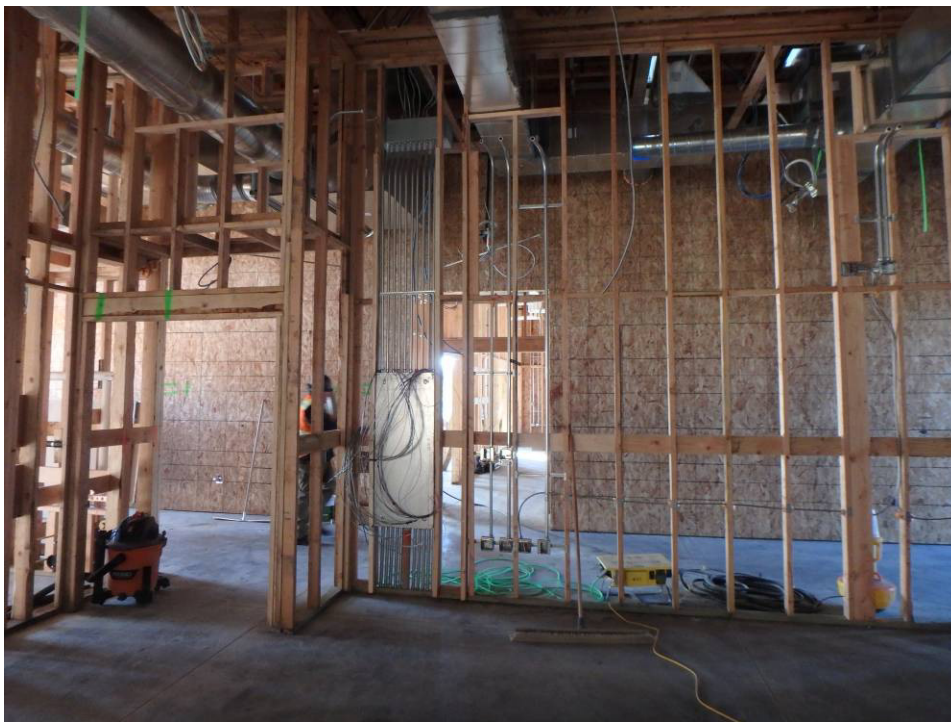
Area above the electrical panel
