Project Observation Report

Project Name:	Tri Tech East Building C 1.5	Project No.	2208
Report #:	19		
Observation Date:	2-15-23	Last Report:	2-8-23
Prepared By:	Steve Mallory, AIA	Contractor:	Banlin

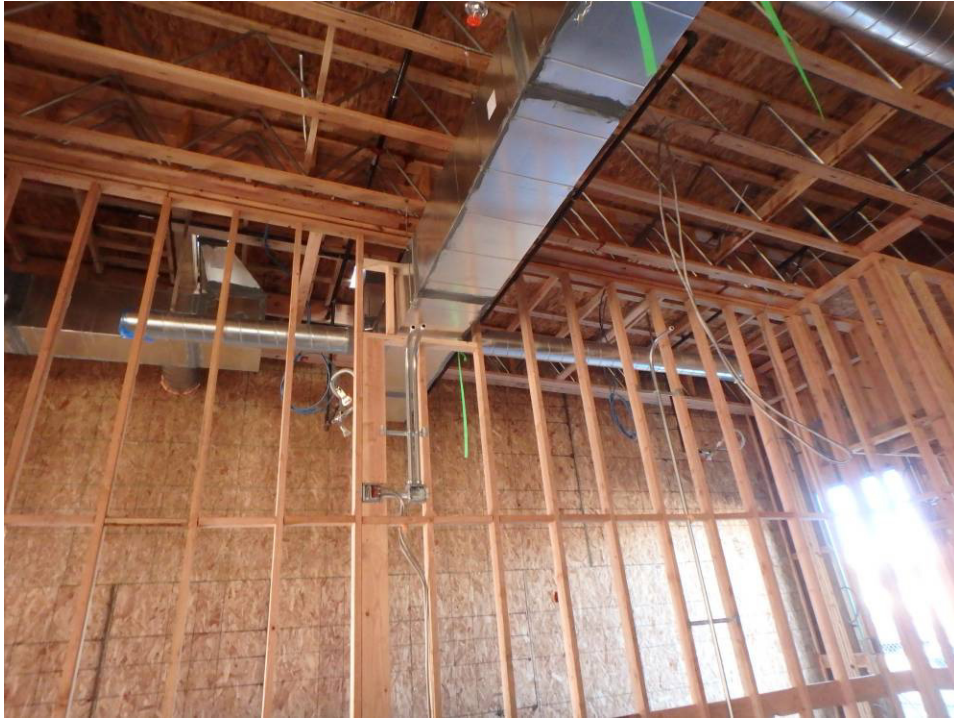
Looking south at the ductwork in the North Classroom

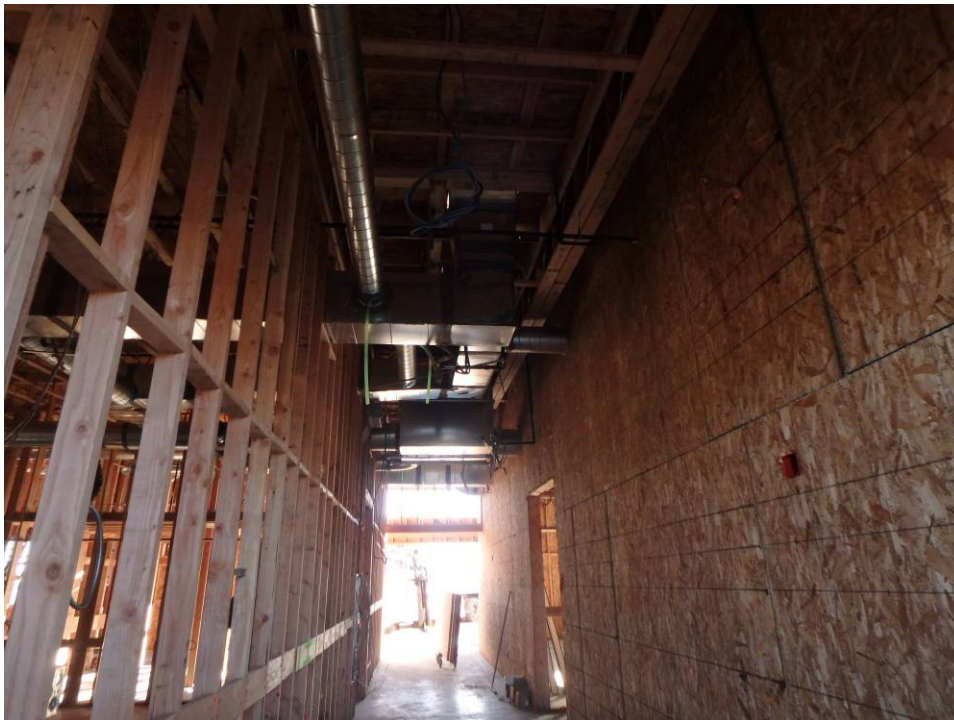
Looking east towards the main entry, new ductwork

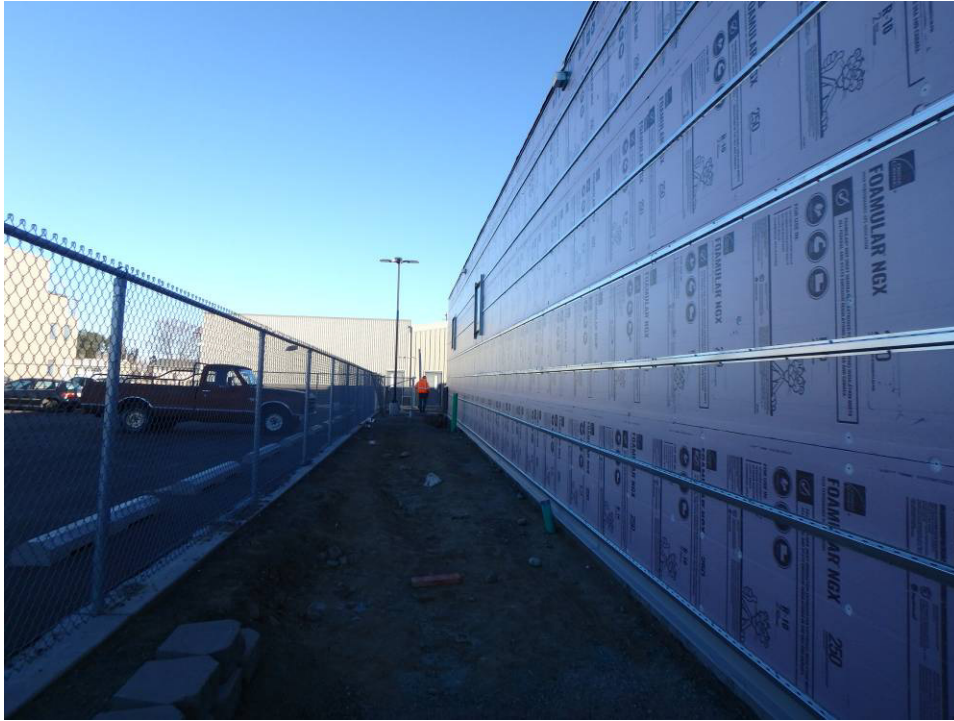
Looking north at the west elevation insulation board

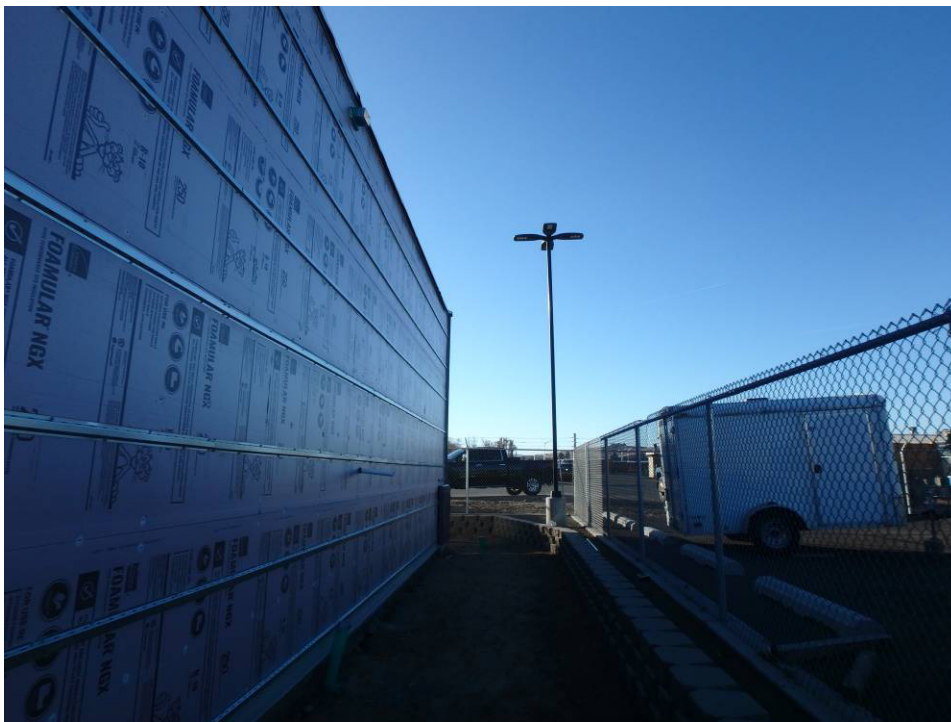
Looking north at the west elevation insulation board

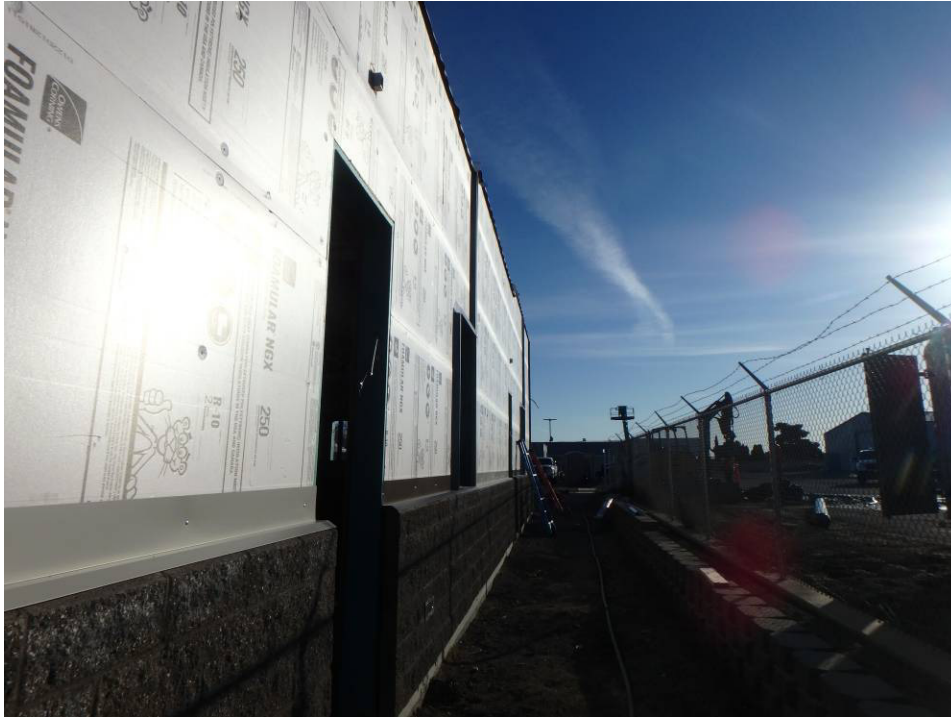
Looking east at the masonry work on the south elevation

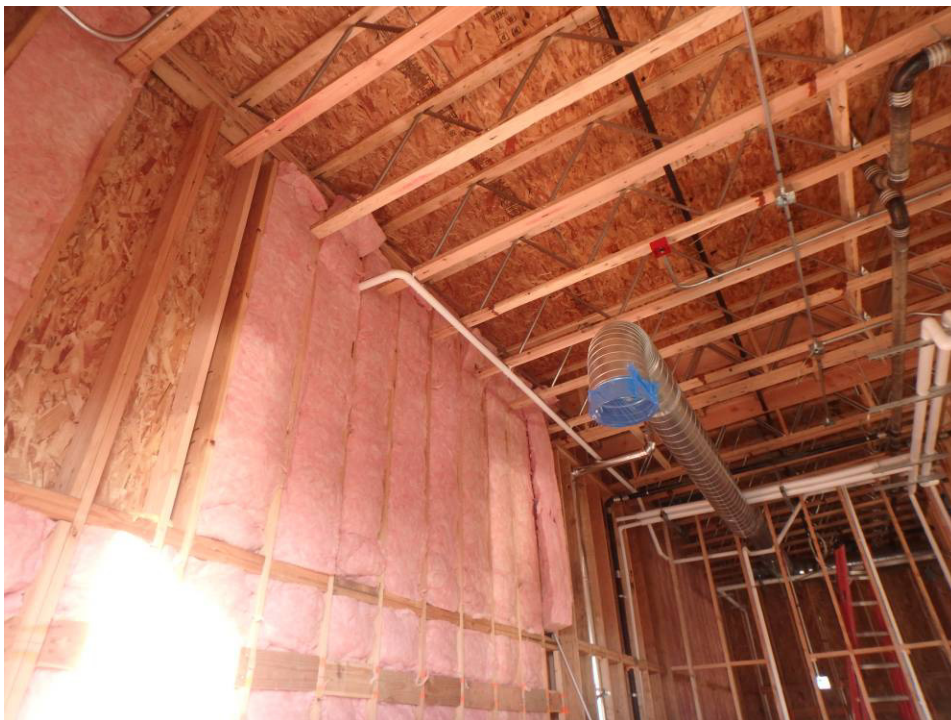
Wall insulation in the south end of the west wall

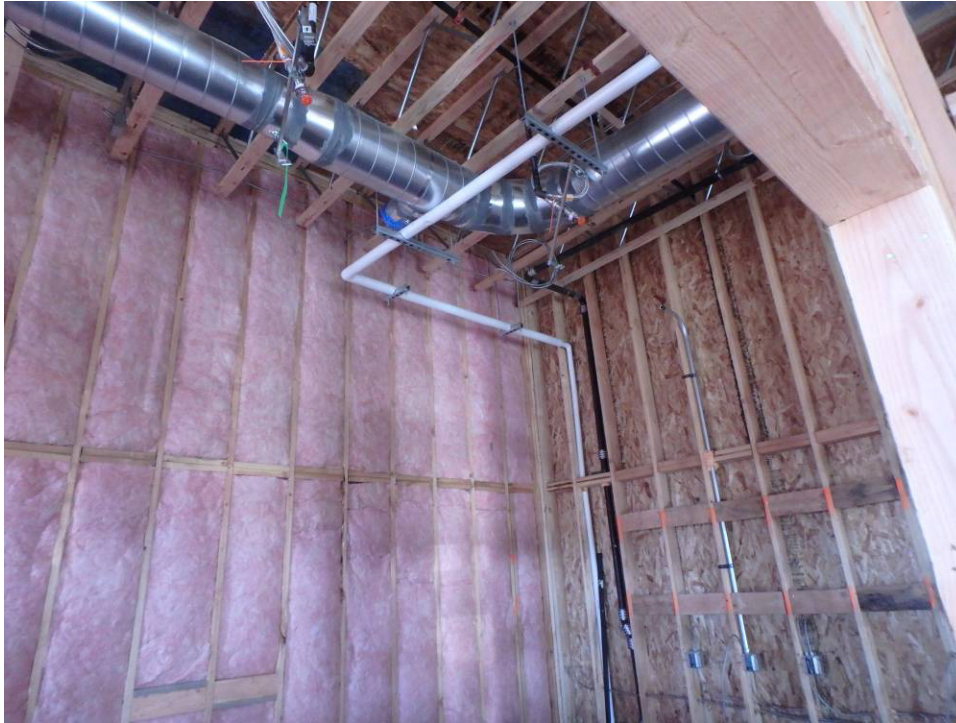
Wall insulation in the south end of the west wall and behind the dryer vent

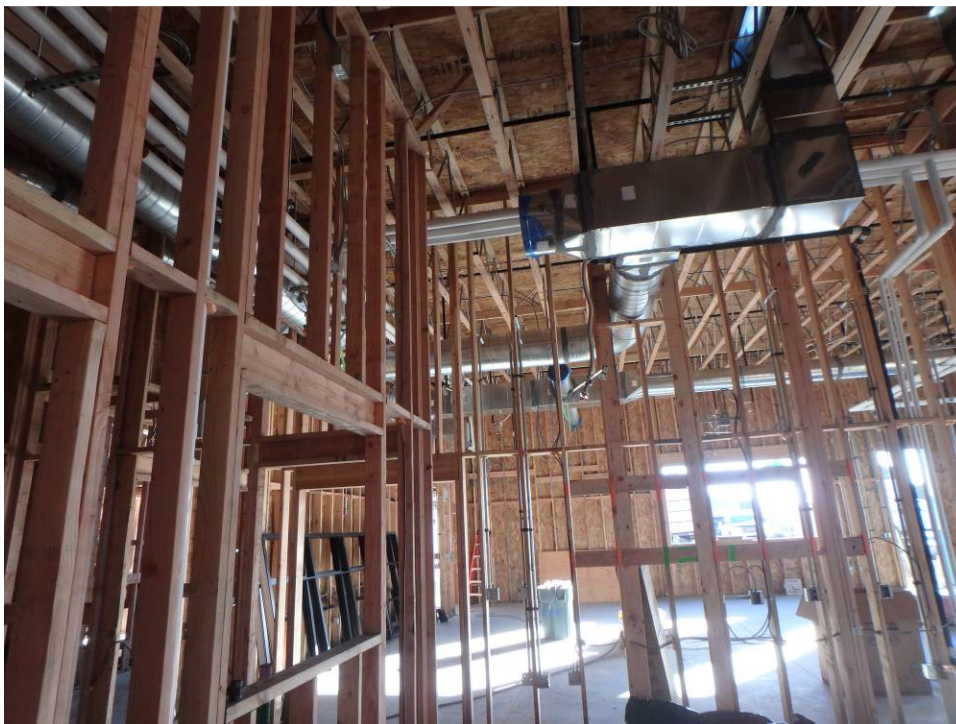
Ductwork over the NW corner of the south classroom

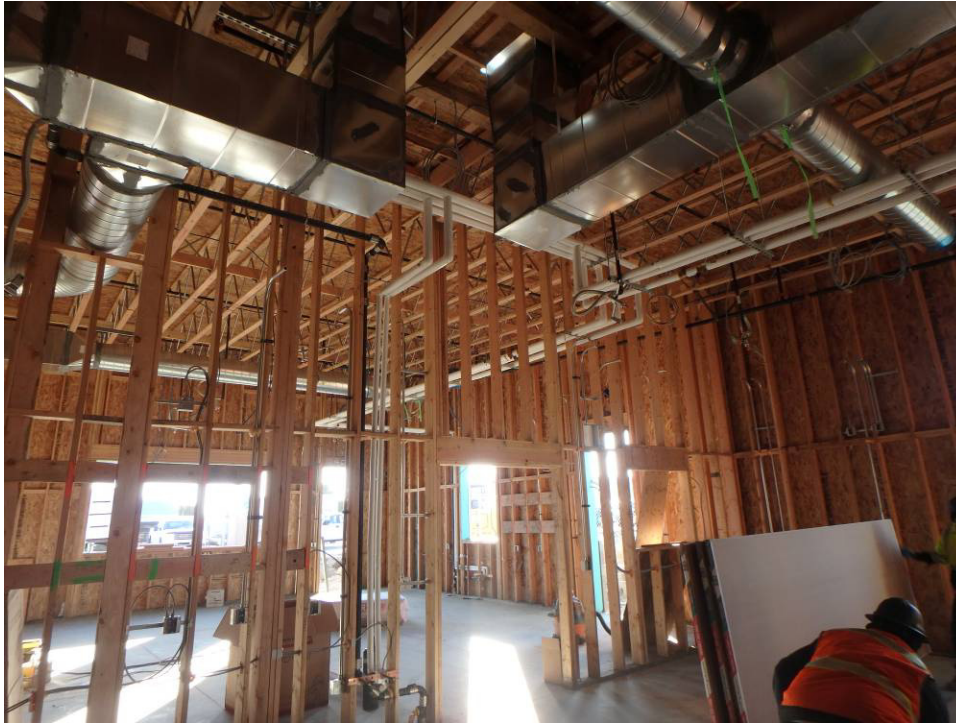
Ductwork over the south classroom

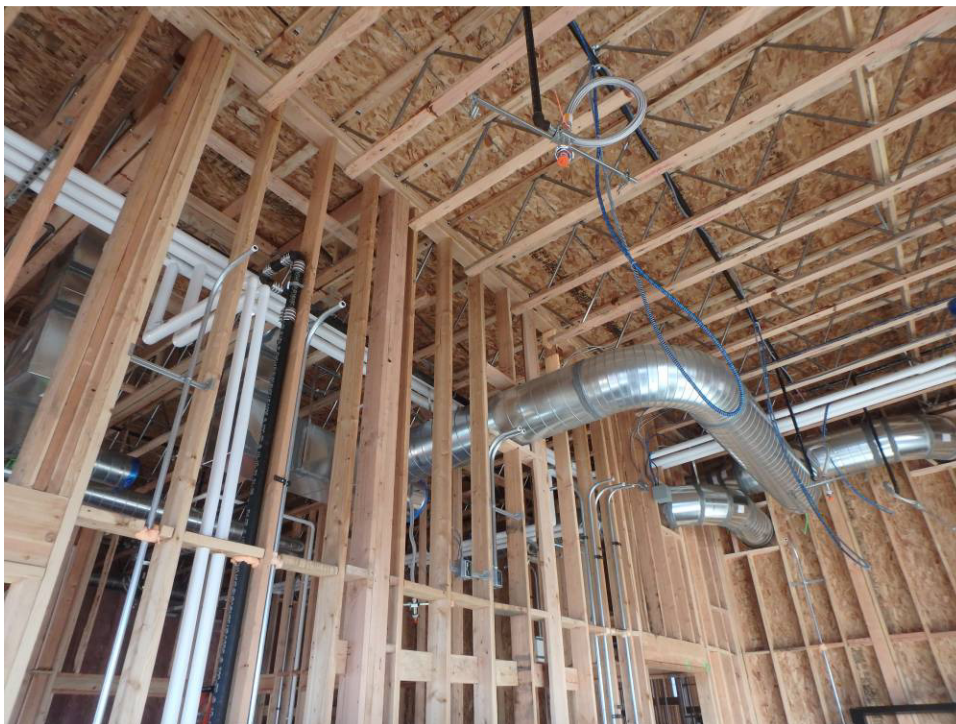
Ductwork over the south classroom Northwest corner of the lab, ductwork, framing and electrical

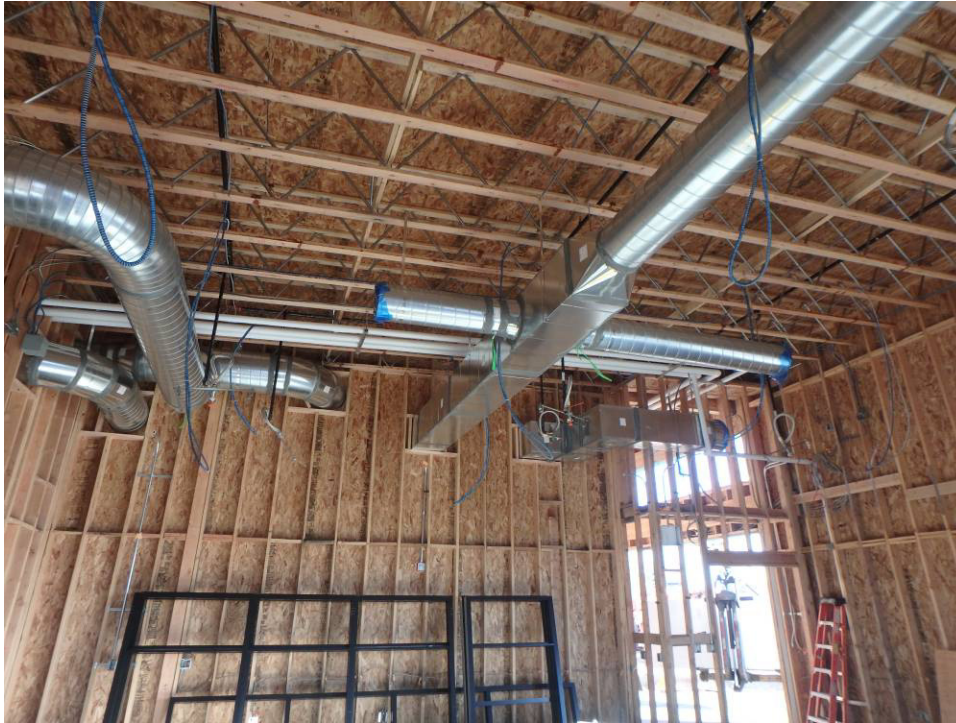
Framing and ductwork above the north wall and entry of the south classroom

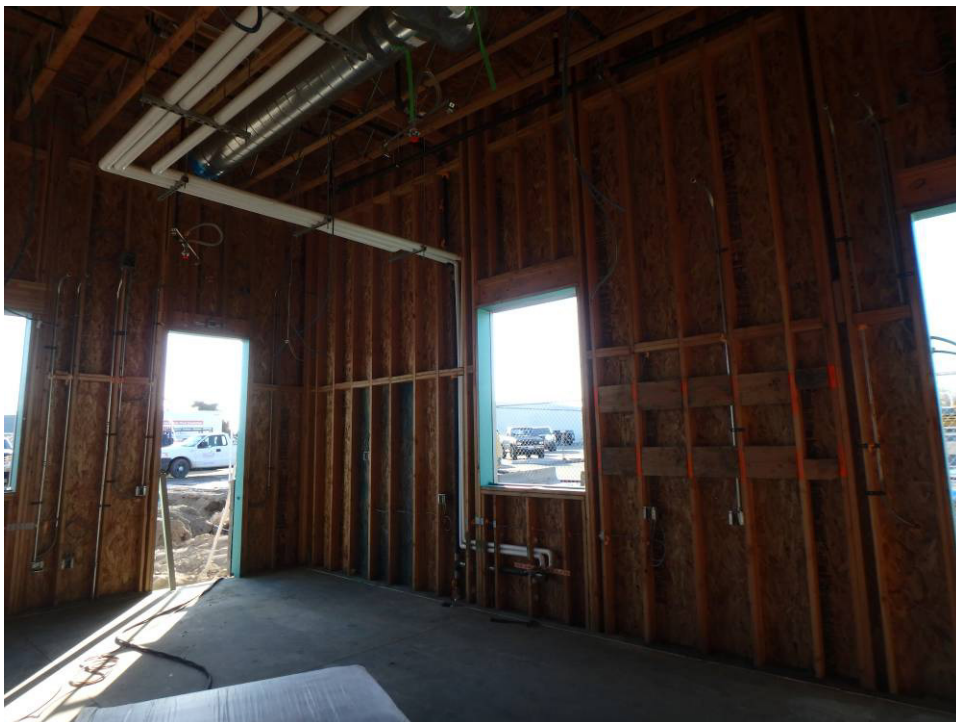
Looking west at the southeast corner and ductwork of the south classroom

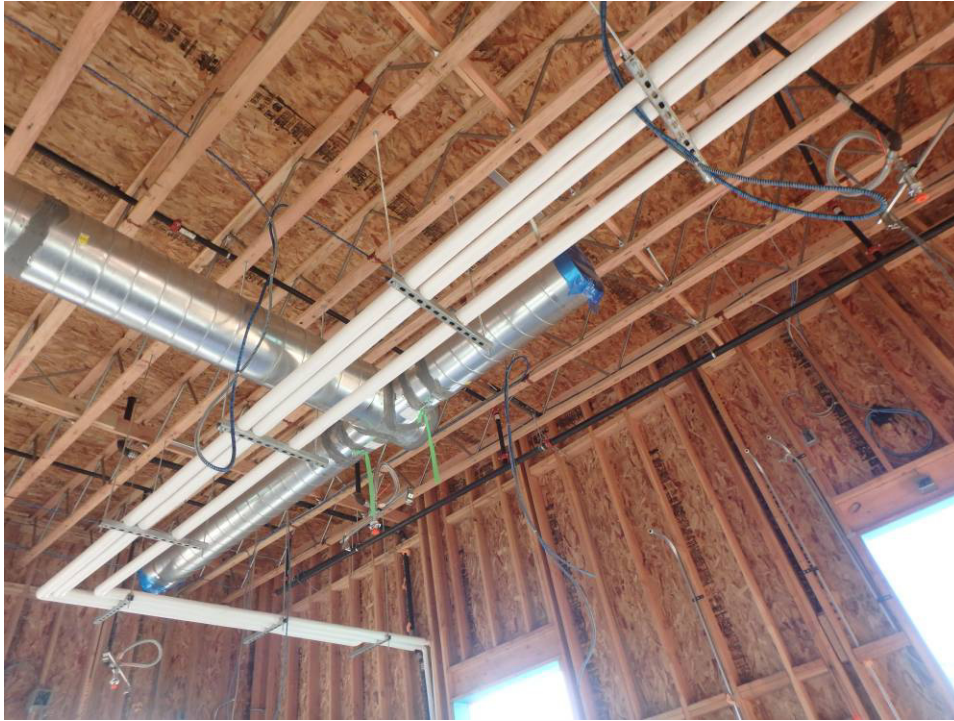
Ductwork over the south wall of the south classroom

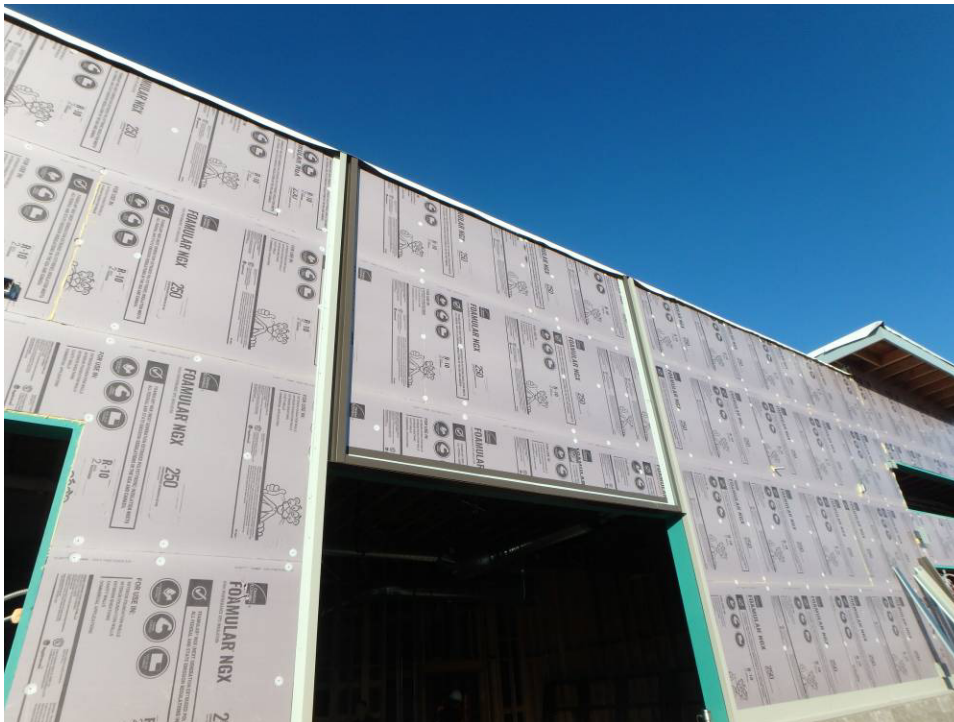
Siding trimwork over the east window of the south classroom
