**AHERA 3-Year Re-Inspection
Penn Hills Area School District
Penn Hills, Pennsylvania 15235**

**Conducted on:
August 18, 2022**

Re: Penn Hills Area School District
AHERA 3-Year Re-Inspection

**AHERA 3-YEAR RE-INSPECTION REPORT
FOR
PENN HILLS AREA SCHOOL DISTRICT
LINTON MIDDLE SCHOOL
250 ASTER STREET
PENN HILLS, PENNSYLVANIA 15235**

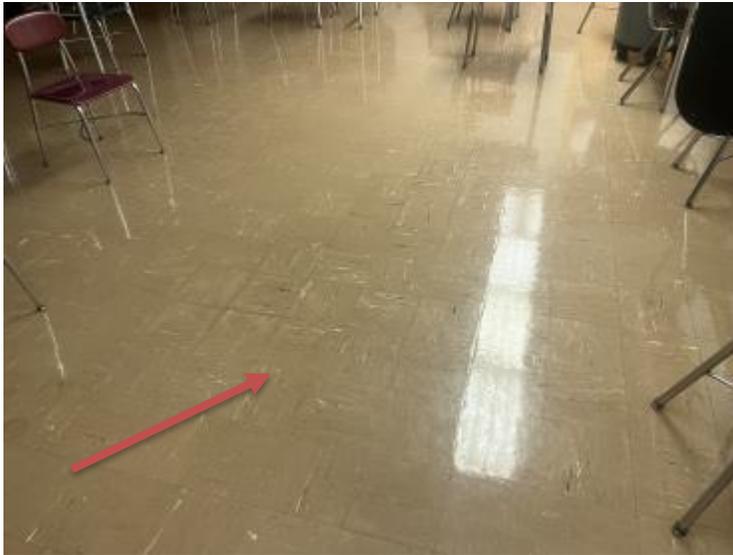
Photo 1 9"x9" Cream Floor Tile (ACM)

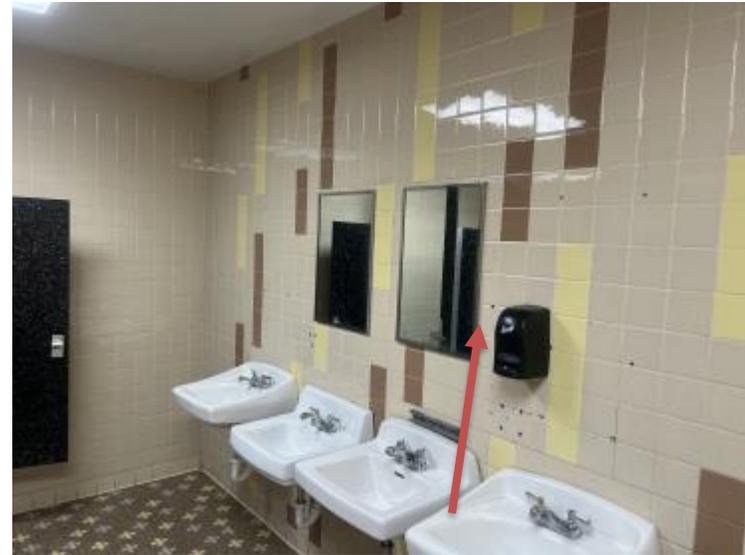
Photo 2 Mirror Mastic (Assumed ACM)

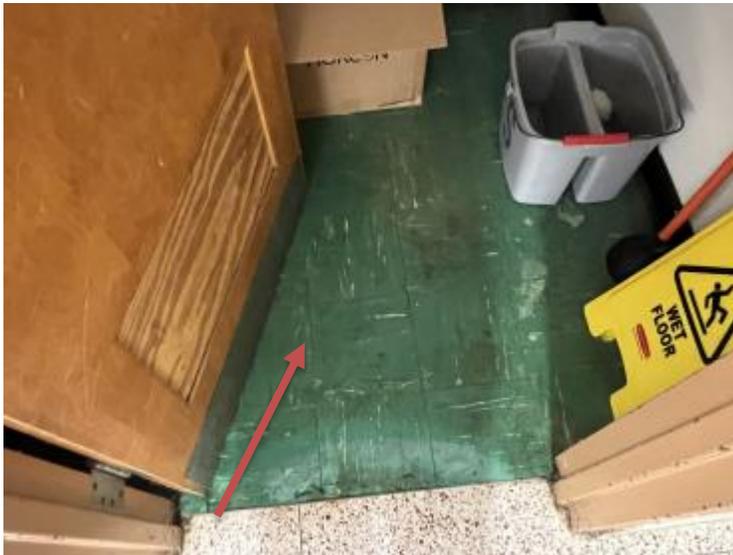
Photo 3 9"x9" Green Floor Tile (ACM)

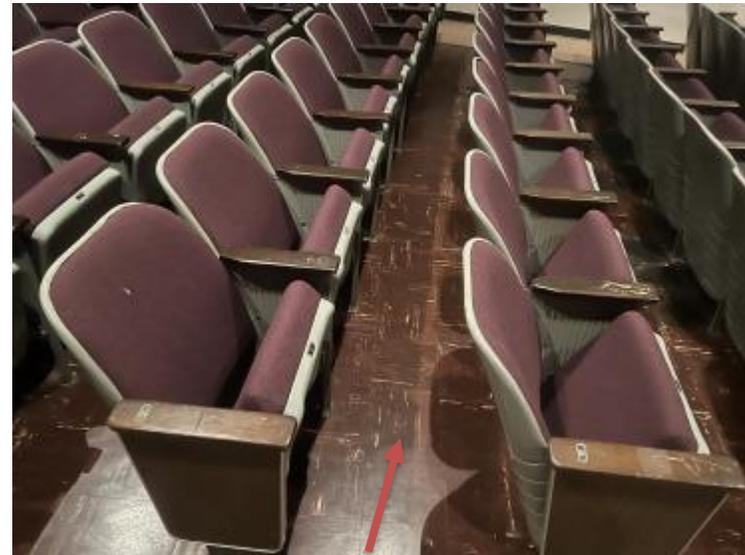
Photo 4 9"x9" Dark Brown Floor Tile (ACM)

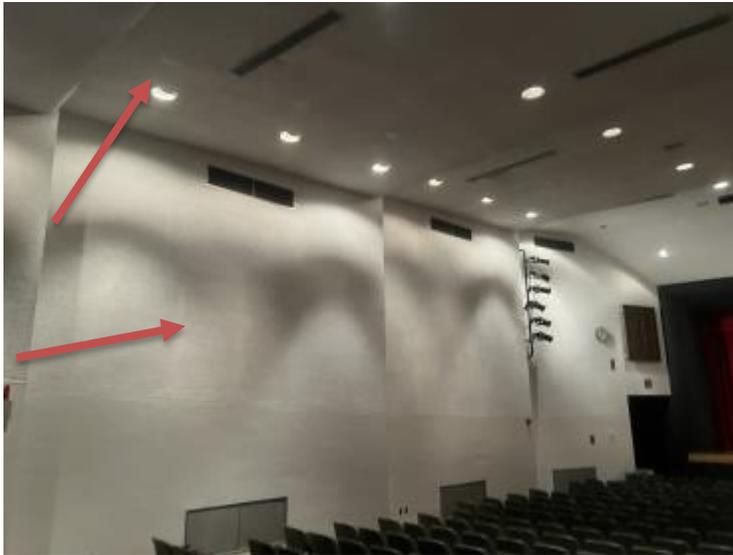
Photo 5 Acoustical Plaster (ACM)

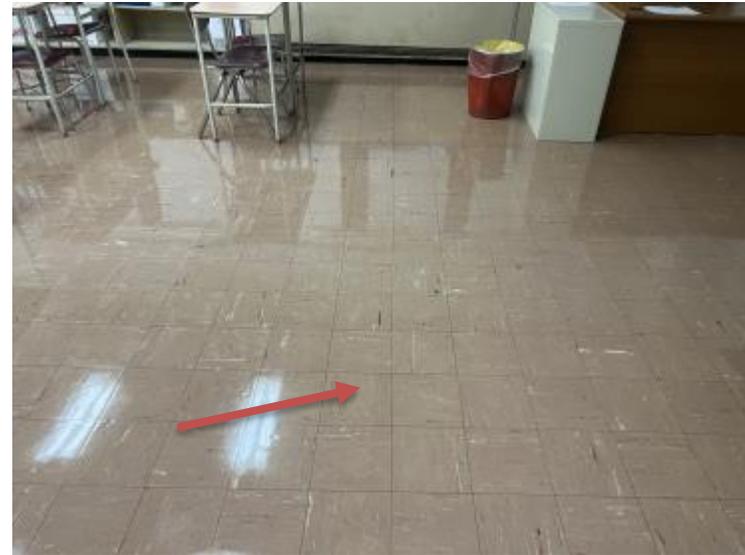
Photo 6 9"x9" Gray Floor Tile (ACM)

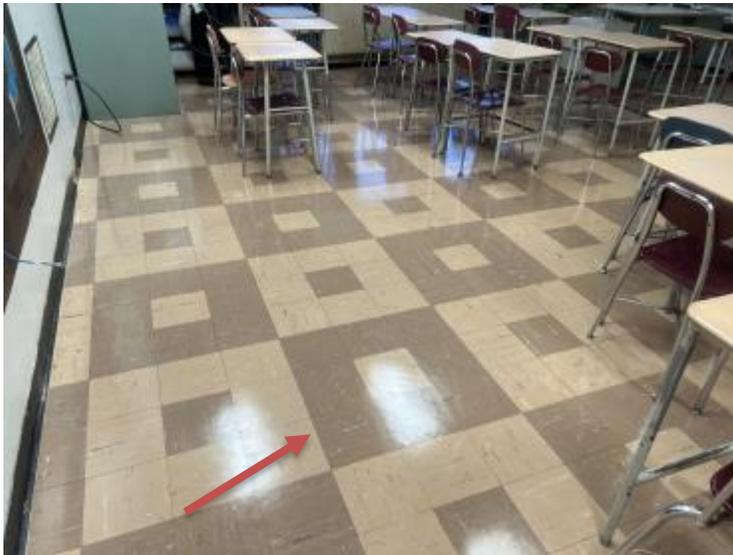
Photo 7 9"x9" Brown Floor Tile (ACM)

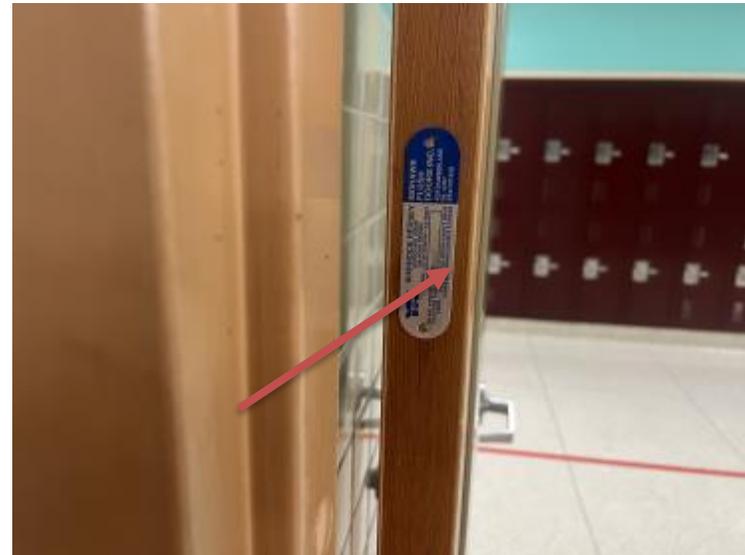
Photo 8 Fire Door (Assumed ACM)

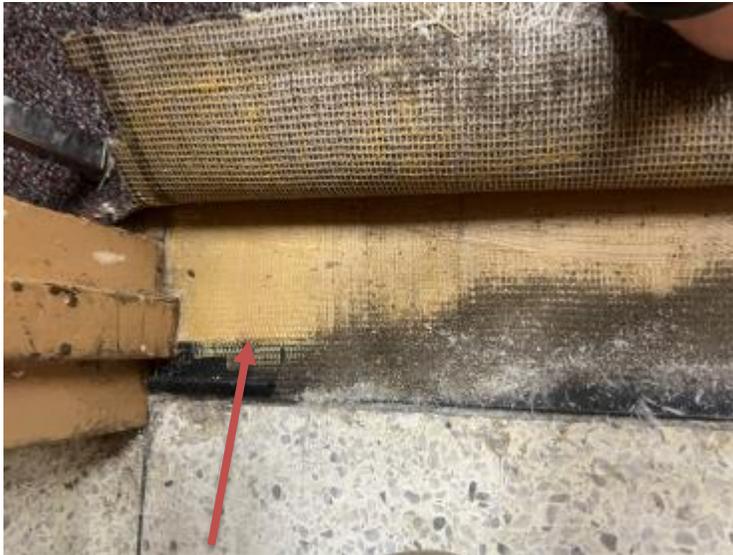
Photo 9 9"x9" Floor Tile (ACM) Under Carpet

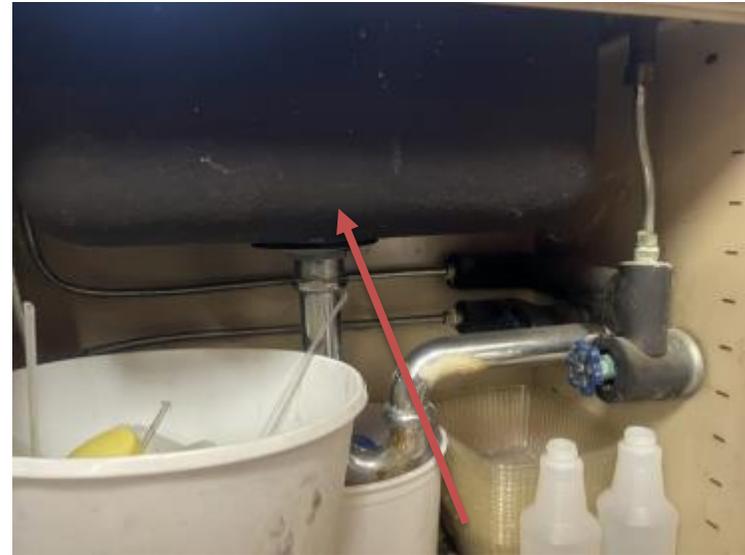
Photo 10 Black Sink Mastic (ACM)

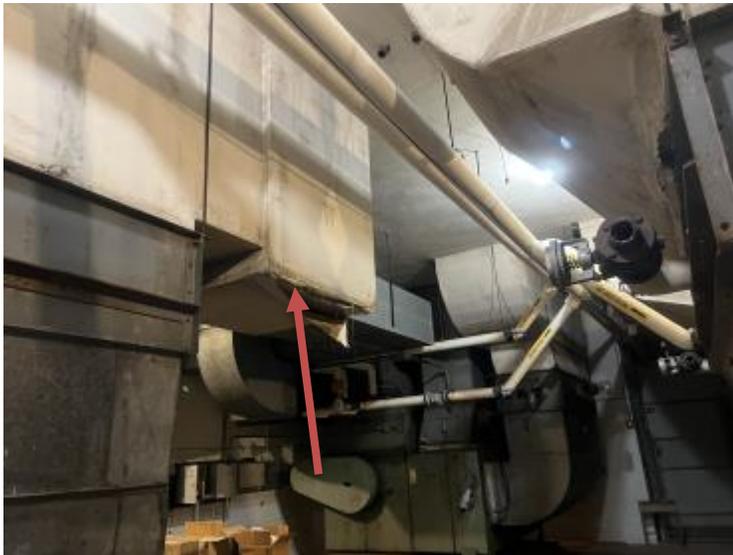
Photo 11 Duct Pin Mastic (Assumed ACM)

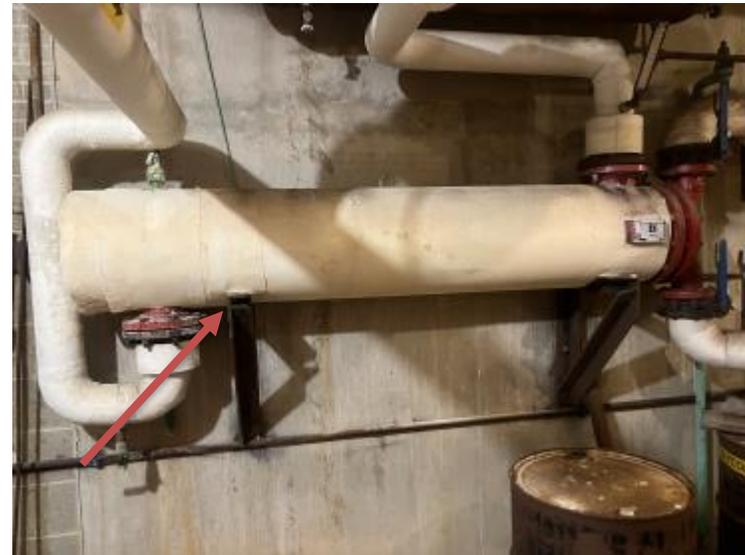
Photo 12 Insulated Tank (ACM)

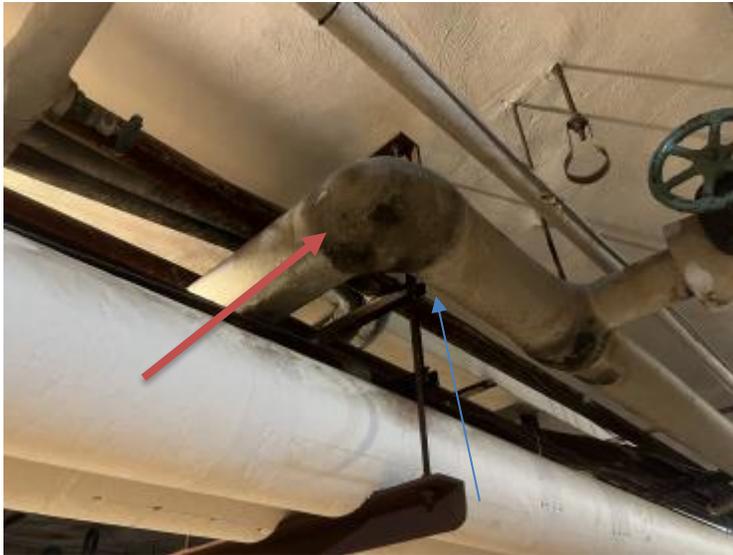
Photo 13 Thermal System Insulation (ACM)

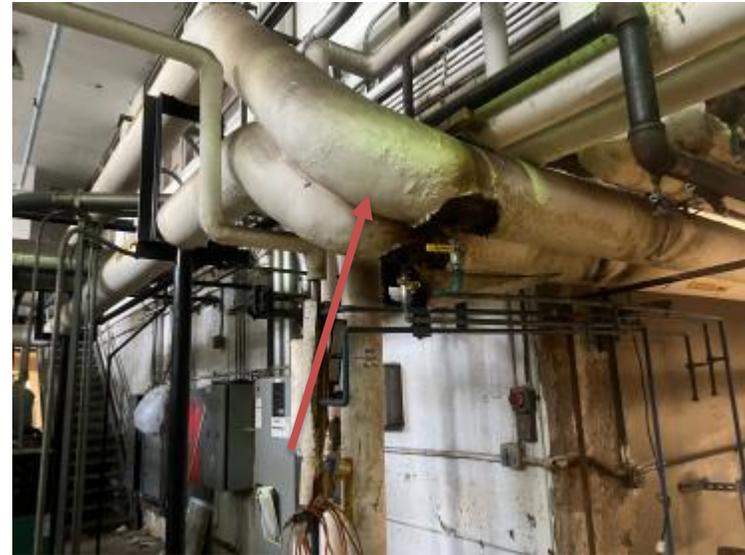
Photo 14 Thermal System Insulation (ACM)

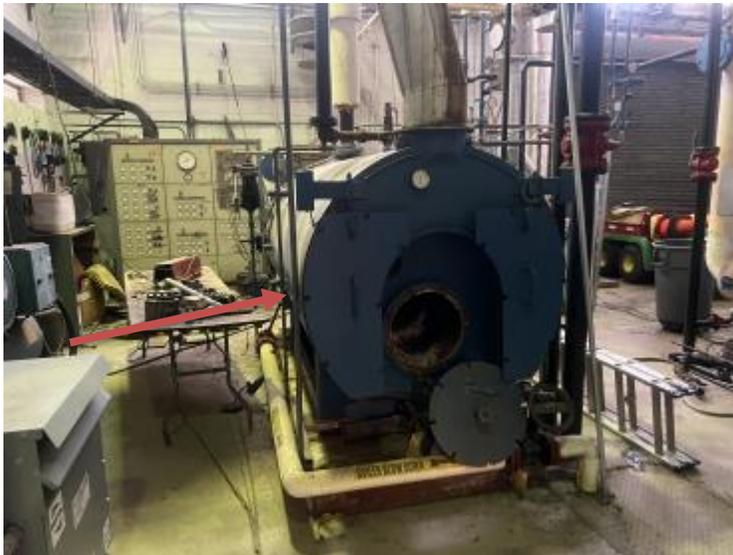
Photo 15 Interior Boiler Components (Assumed ACM)

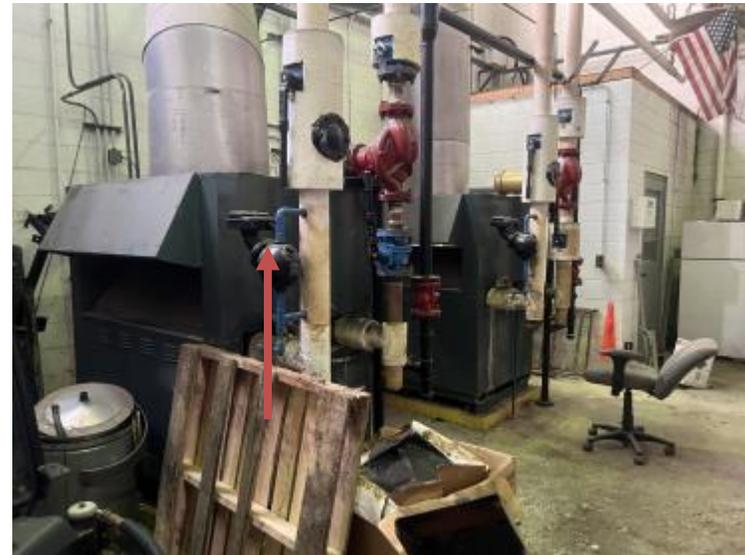
Photo 16 Interior Boiler Components (Assumed ACM)

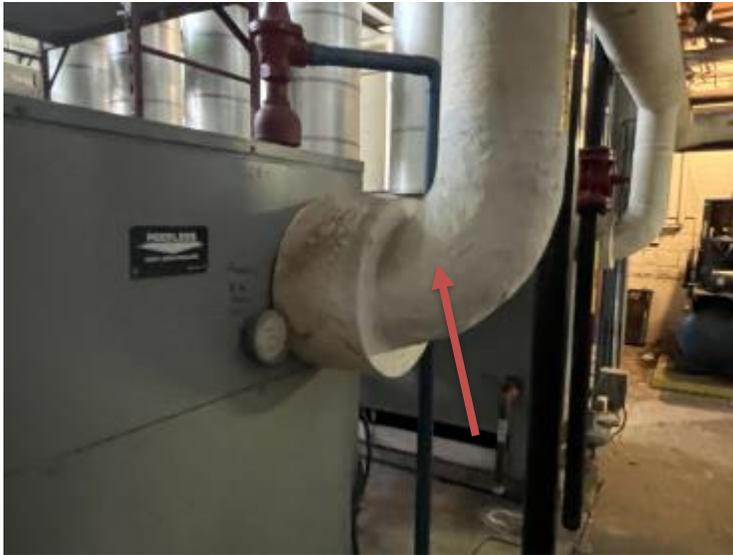
Photo 17 Boiler Breaching (ACM)

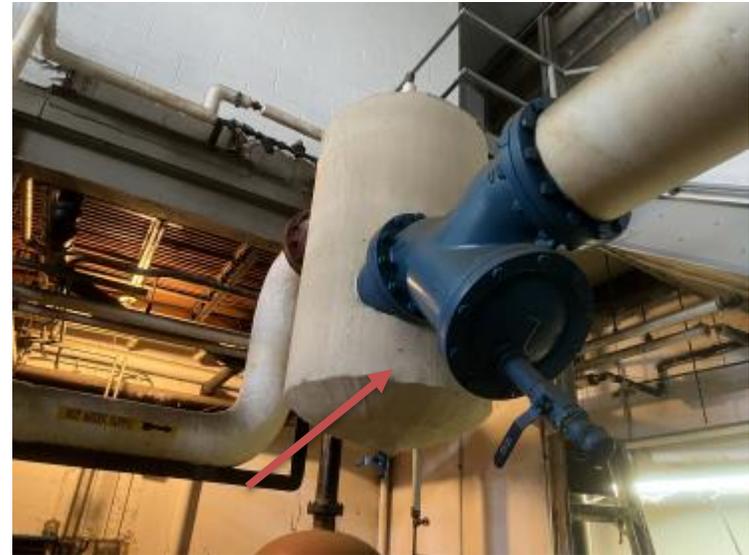
Photo 18 Insulated Tank (ACM)

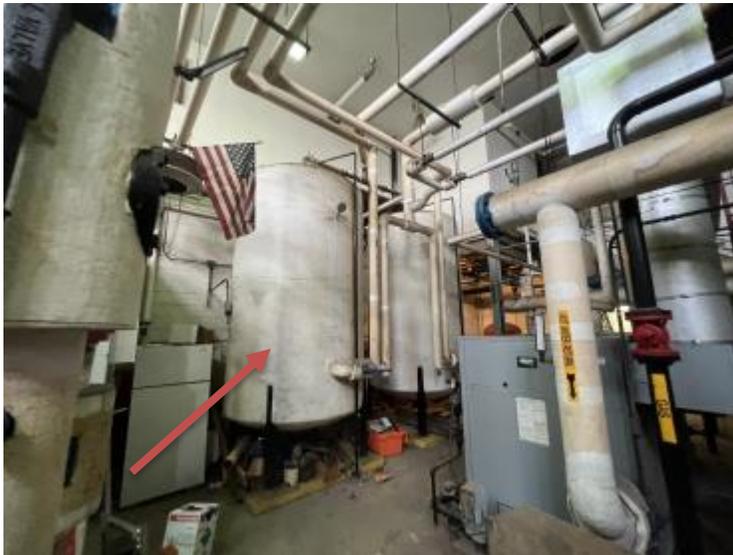
Photo 19 Insulated Tanks (ACM)

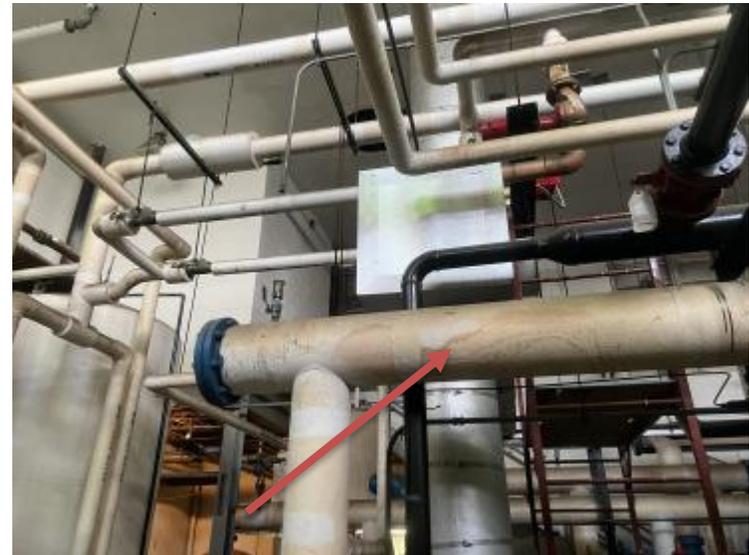
Photo 20 Boiler Breaching (ACM)

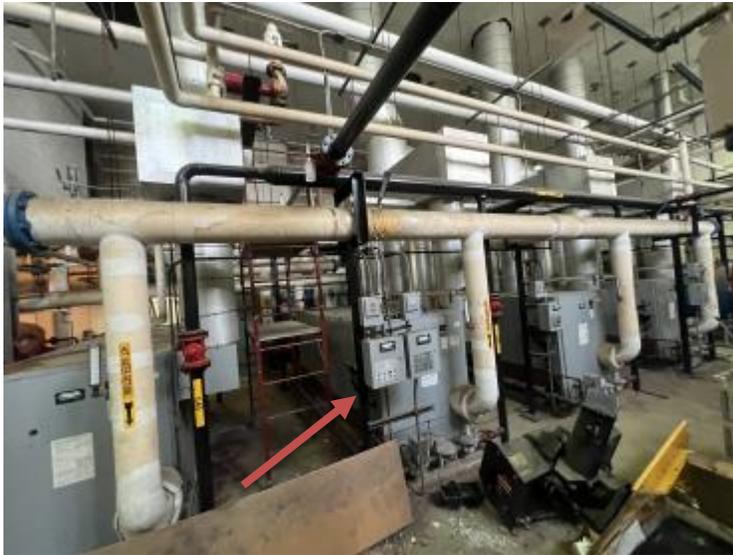
Photo 21 Interior Boiler Components (Assumed ACM)

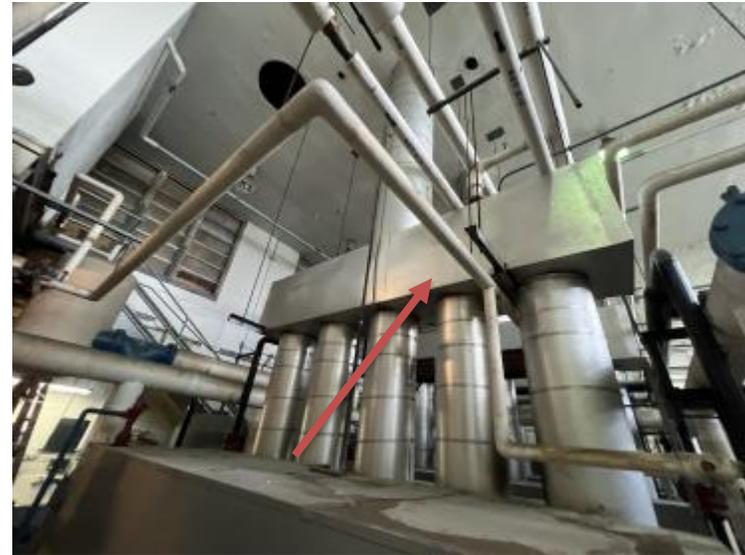
Photo 22 Boiler Breaching (ACM)

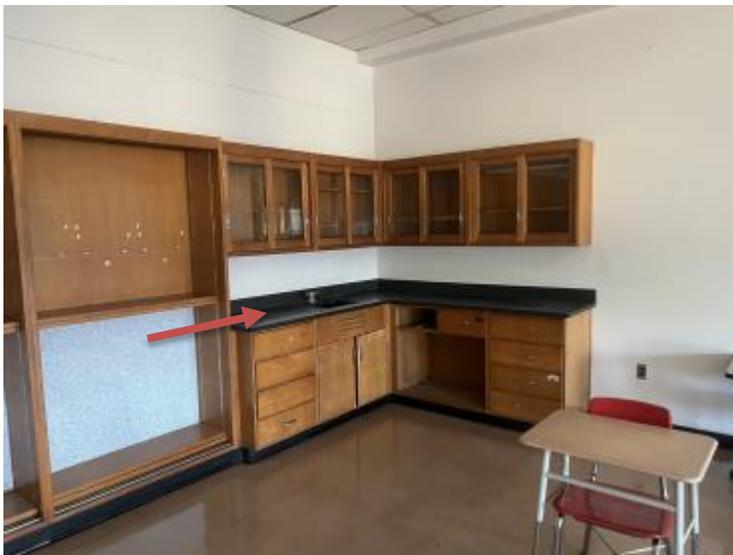
Photo 23 Black Tabletops (Assumed ACM)

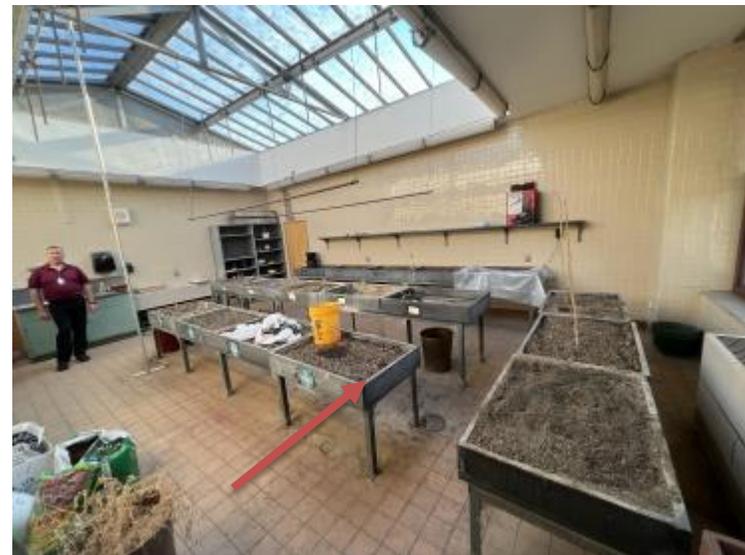
Photo 24 Asbestos Cement Garden Beds (ACM)

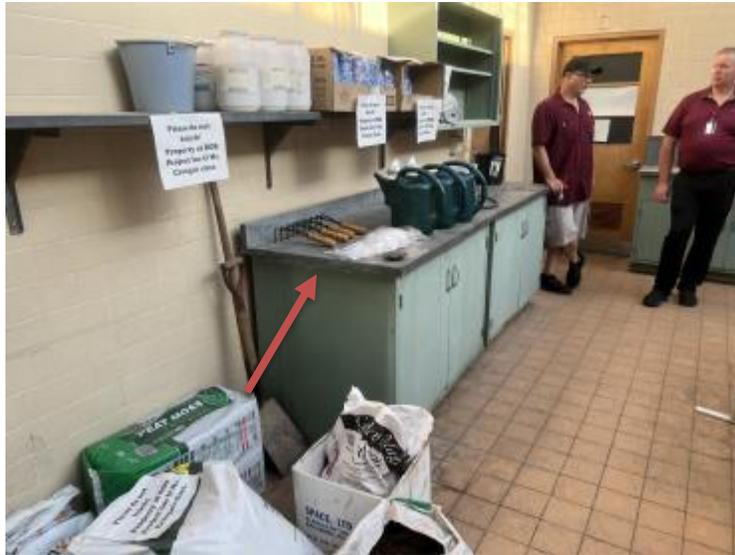
Photo 25 Asbestos Cement Tabletop (ACM)

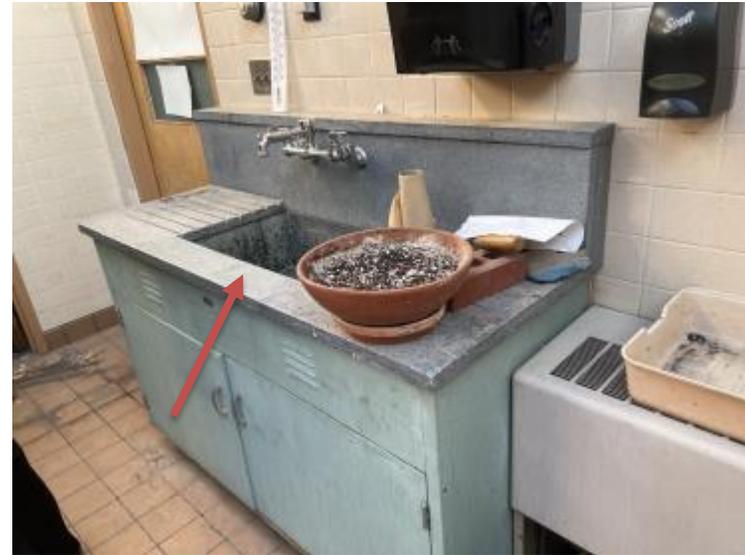
Photo 26 Asbestos Cement Tabletops (ACM)

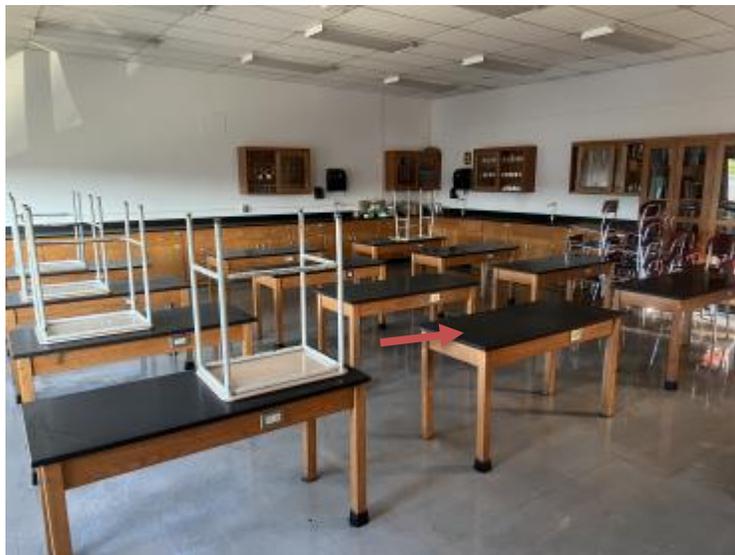
Photo 27 Black Tabletops (Assumed ACM)

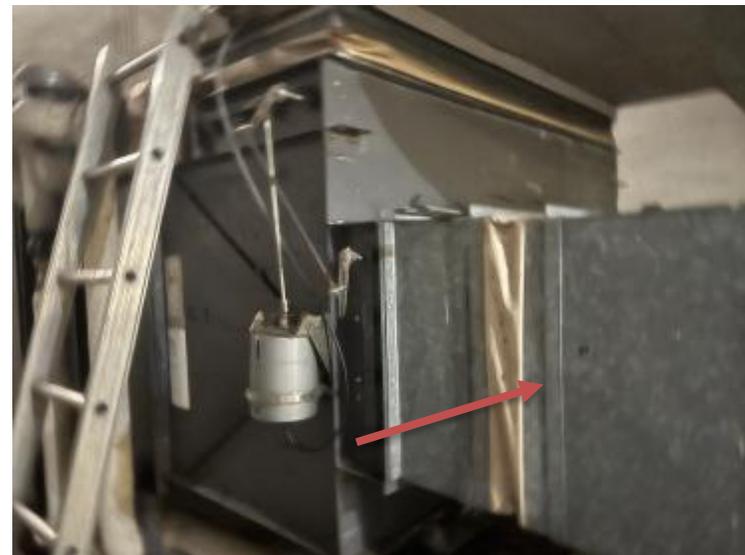
Photo 28 Vibration Dampener (Assumed ACM)

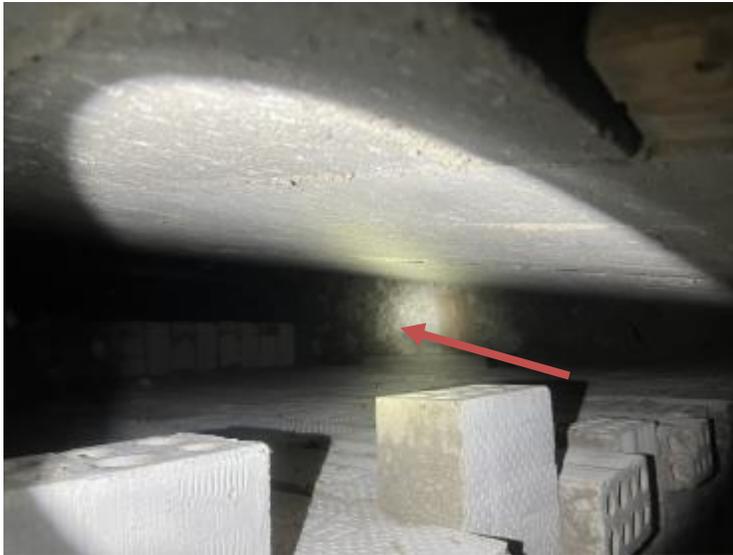
Photo 29 Acoustical Plaster Debris Below Catwalk (Assumed ACM)

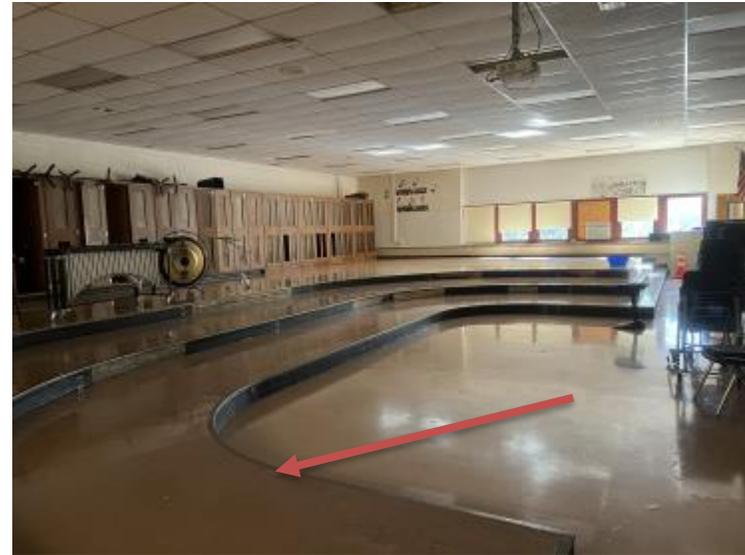
Photo 30 9"x9" Brown Floor Tile (ACM)

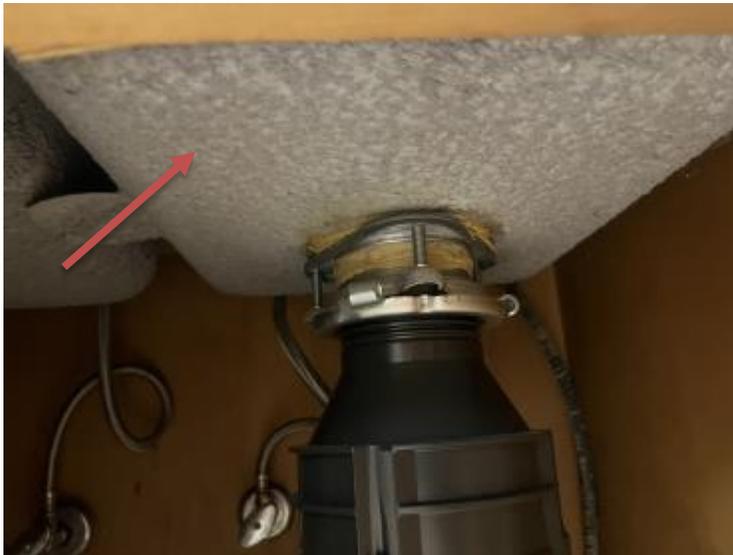
Photo 31 Gray Sink Mastic (ACM)

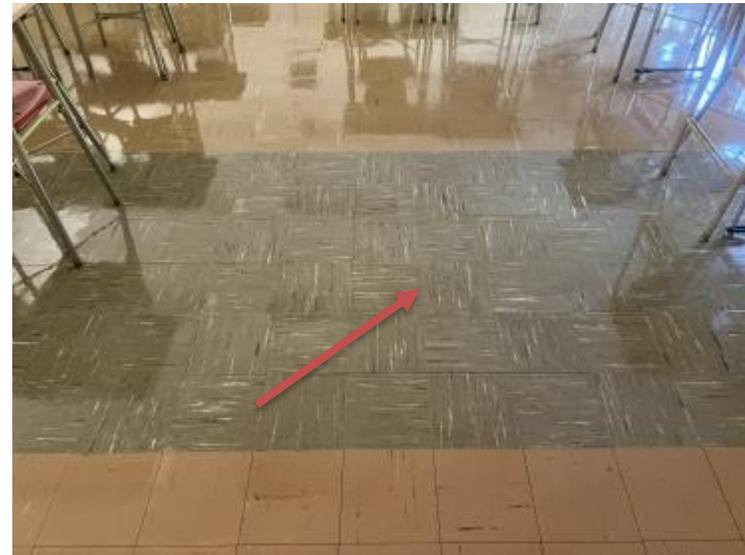
Photo 32 9"x9" Dark Gray Floor Tile (ACM)

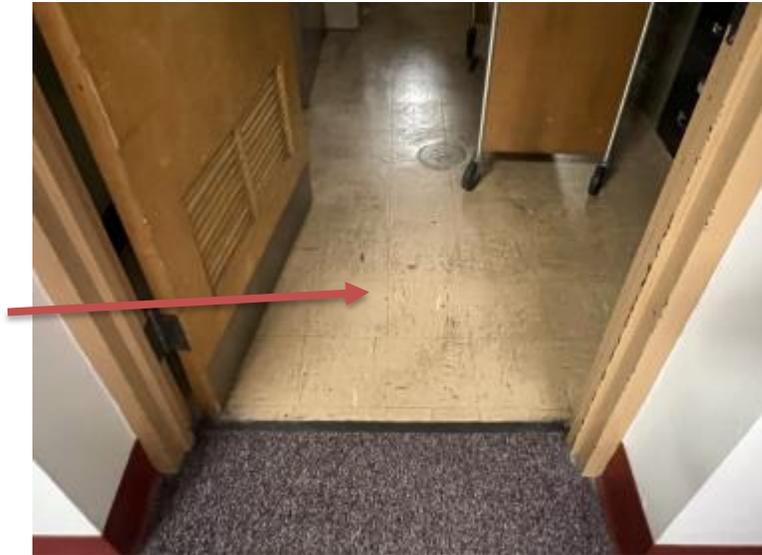
Photo 33 9"x9" Floor Tile (ACM)
