Project Observation Report

Project Name:	Tri Tech East Building C 1.5	Project No.	2208
Report #:	22		
Observation Date:	3-8-23	Last Report:	3-1-23
Prepared By:	Steve Mallory, AIA	Contractor:	Banlin

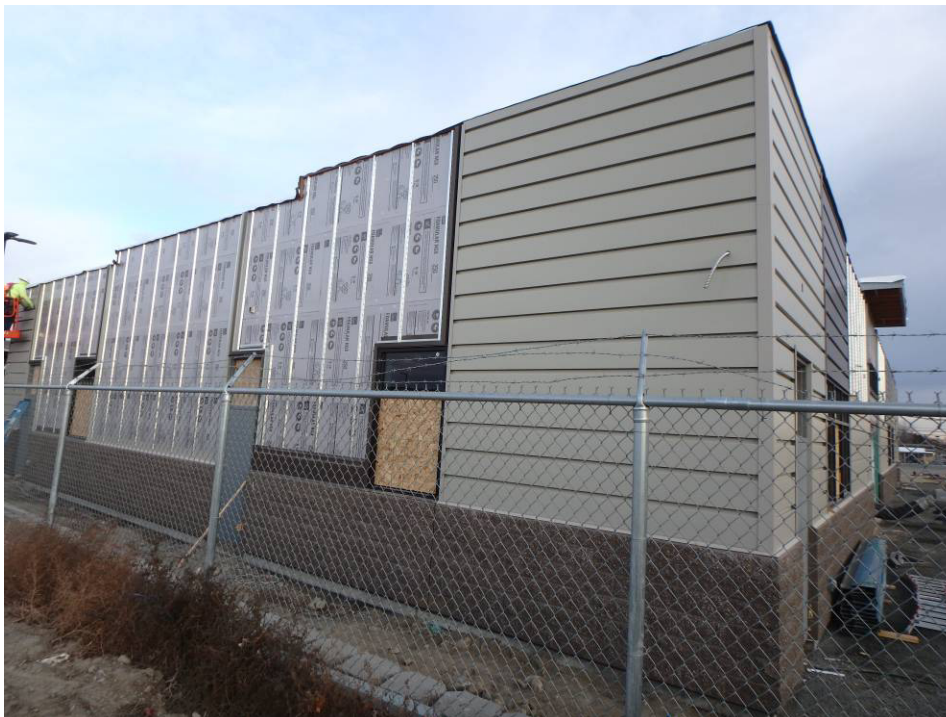
Southeast corner siding

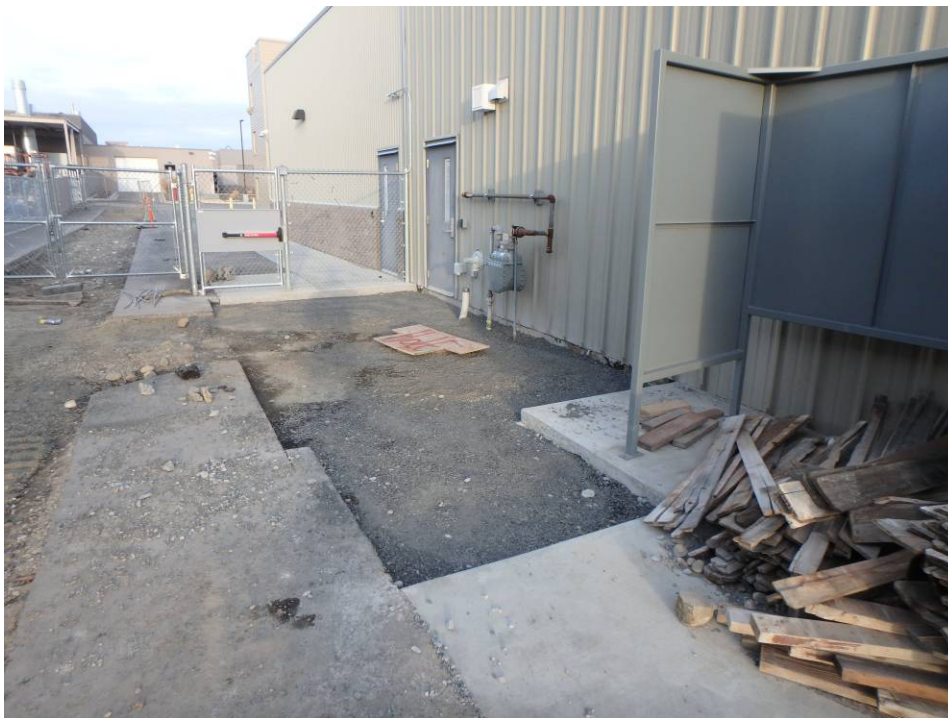
The gas meter at the East Building

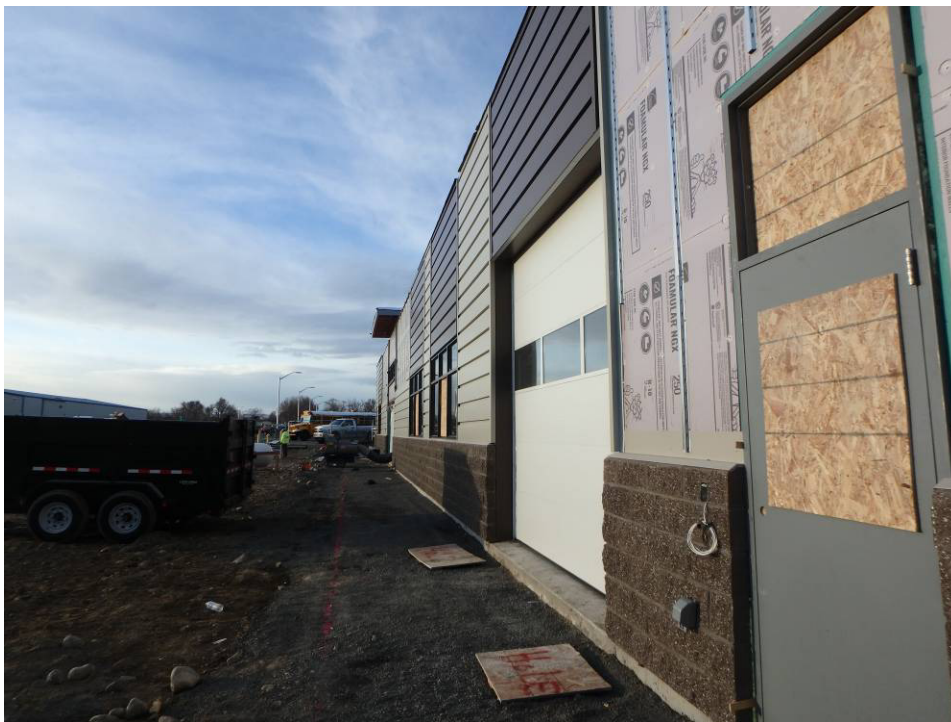
East Elevation siding

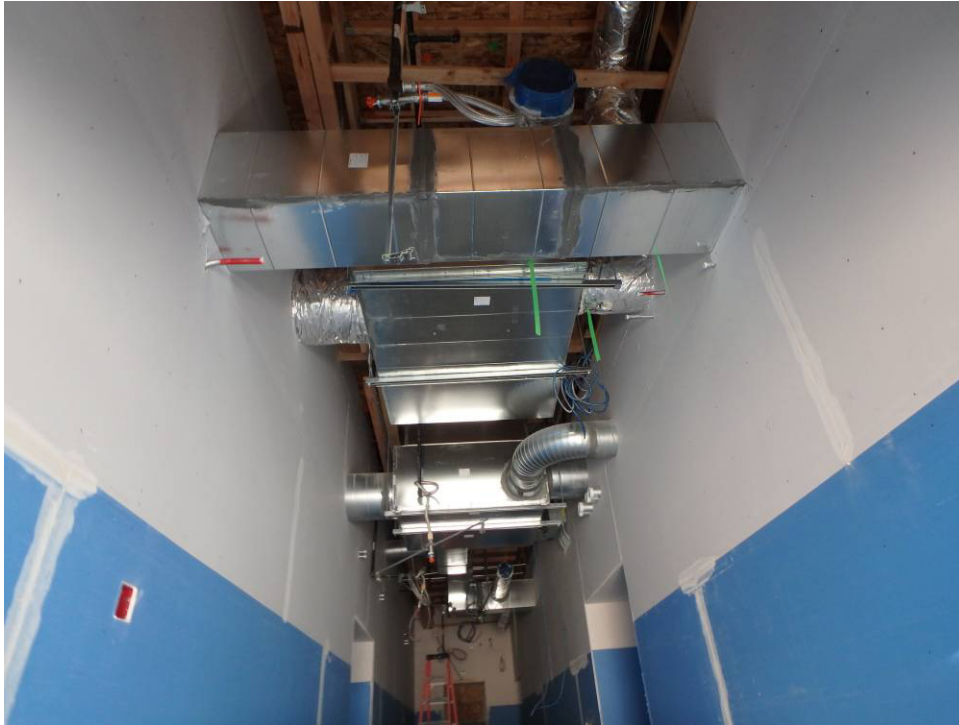
Ducting cross the main corridor

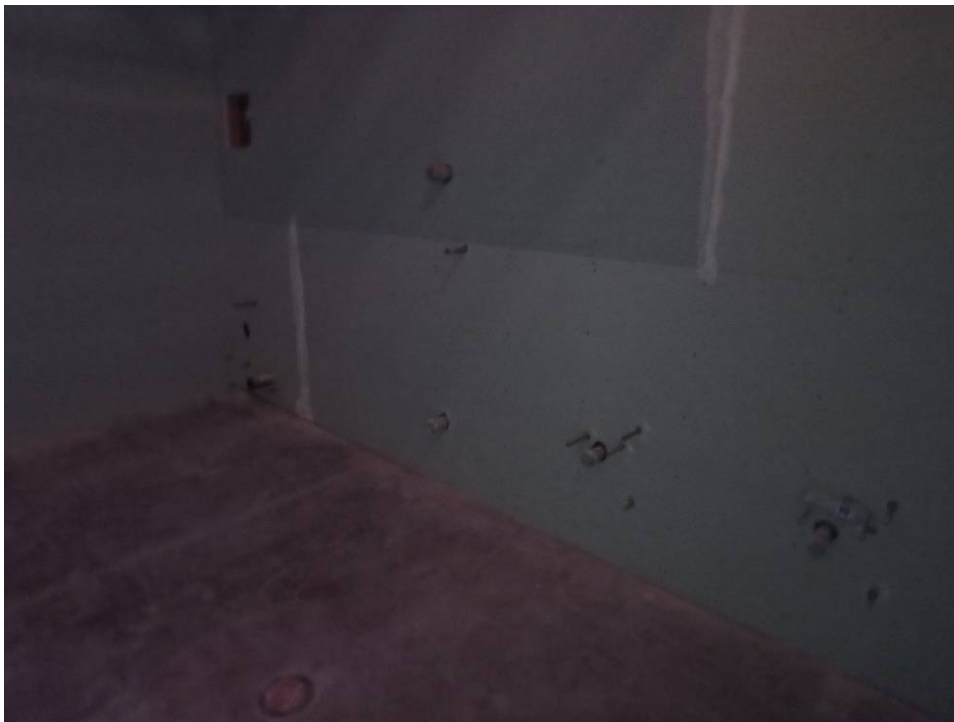
Typical Restroom wallboard

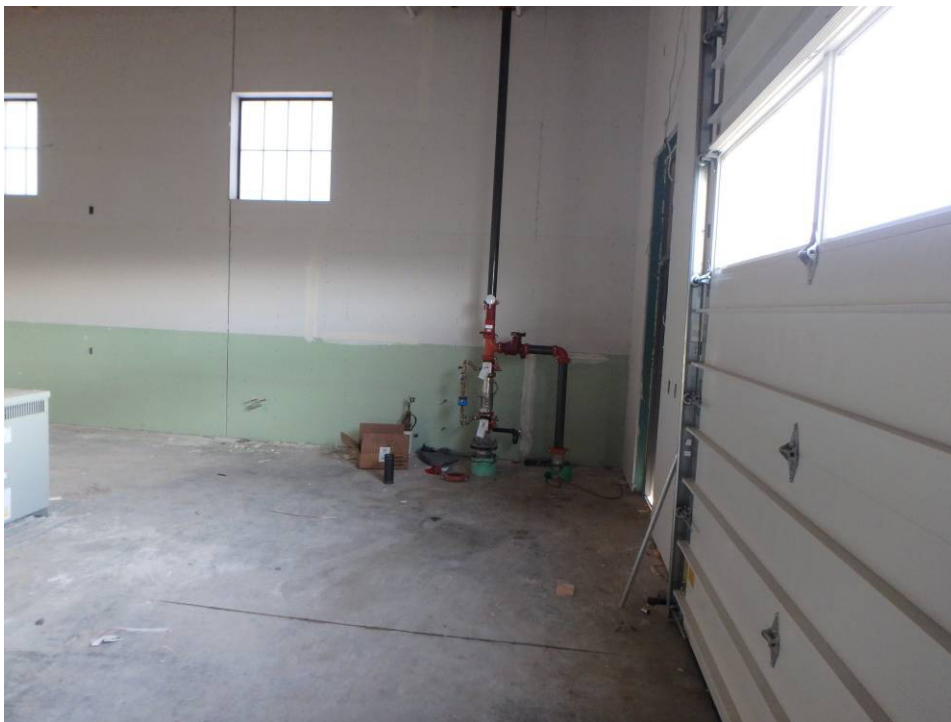
Standpipe and the northeast corner of the shop

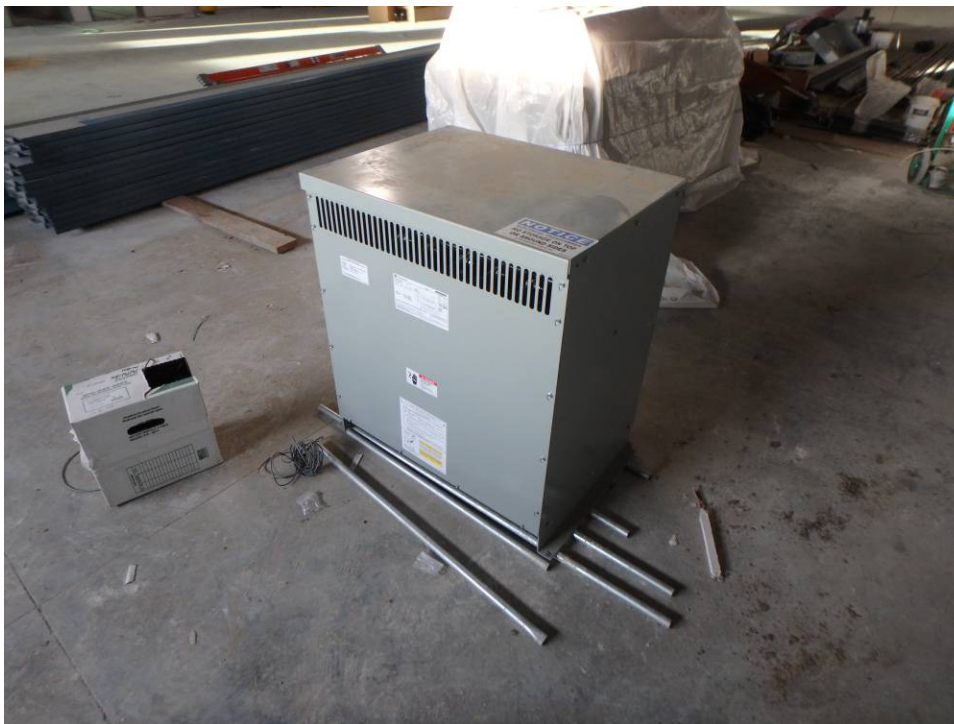
Shop transformer

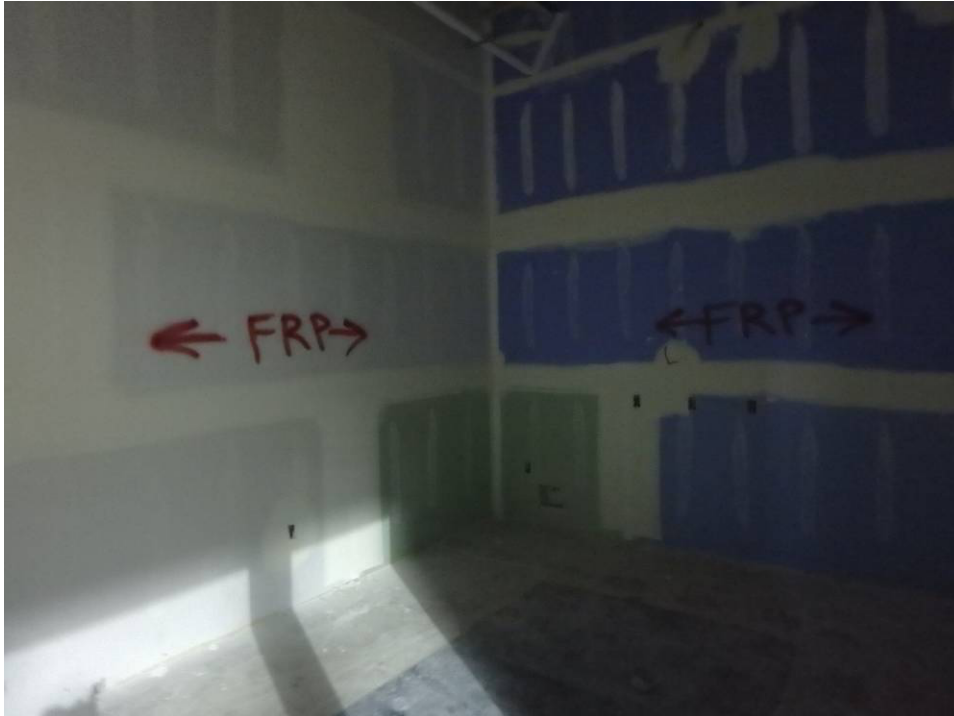
FRP Fiberglass Reinforced Plastic wall panels

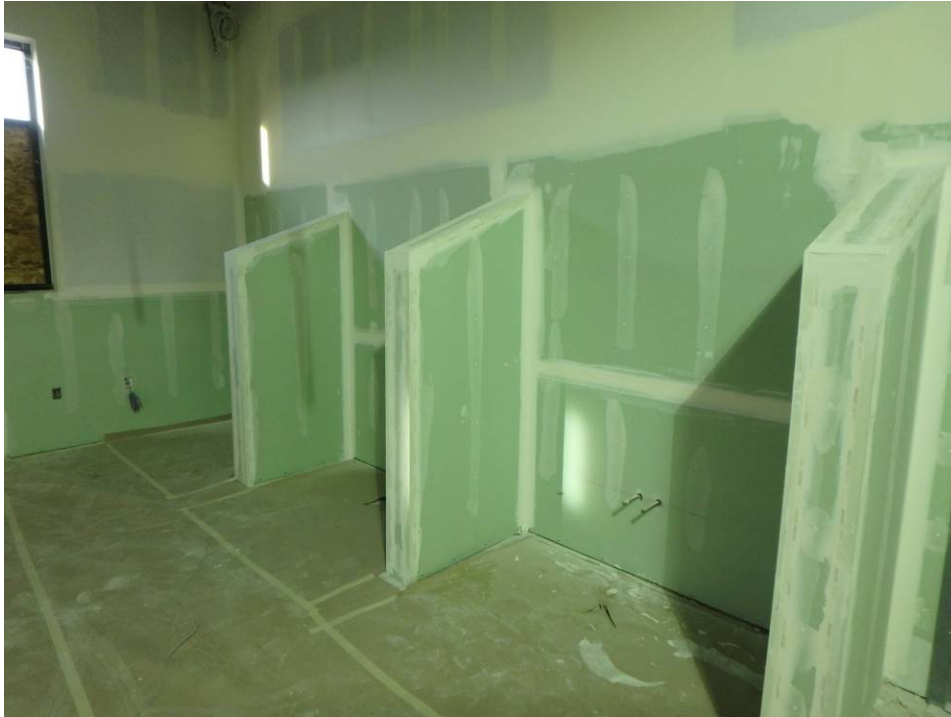
Lab – dog wash stations
