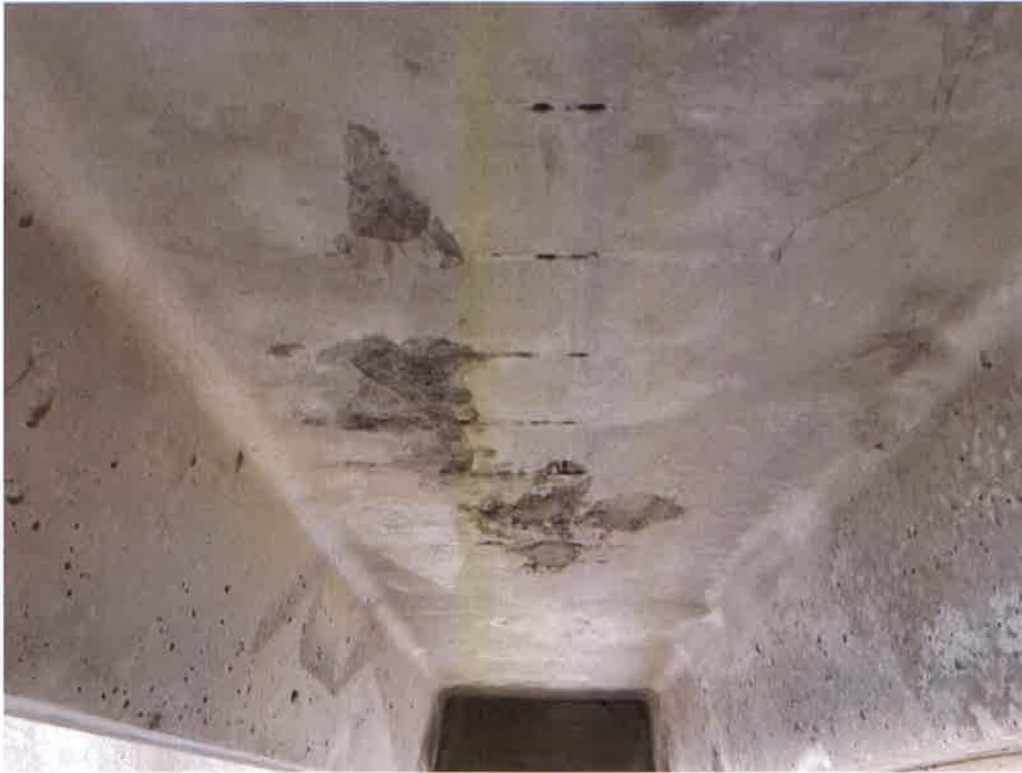
Photo 26: Spalling of Concrete Under Slab

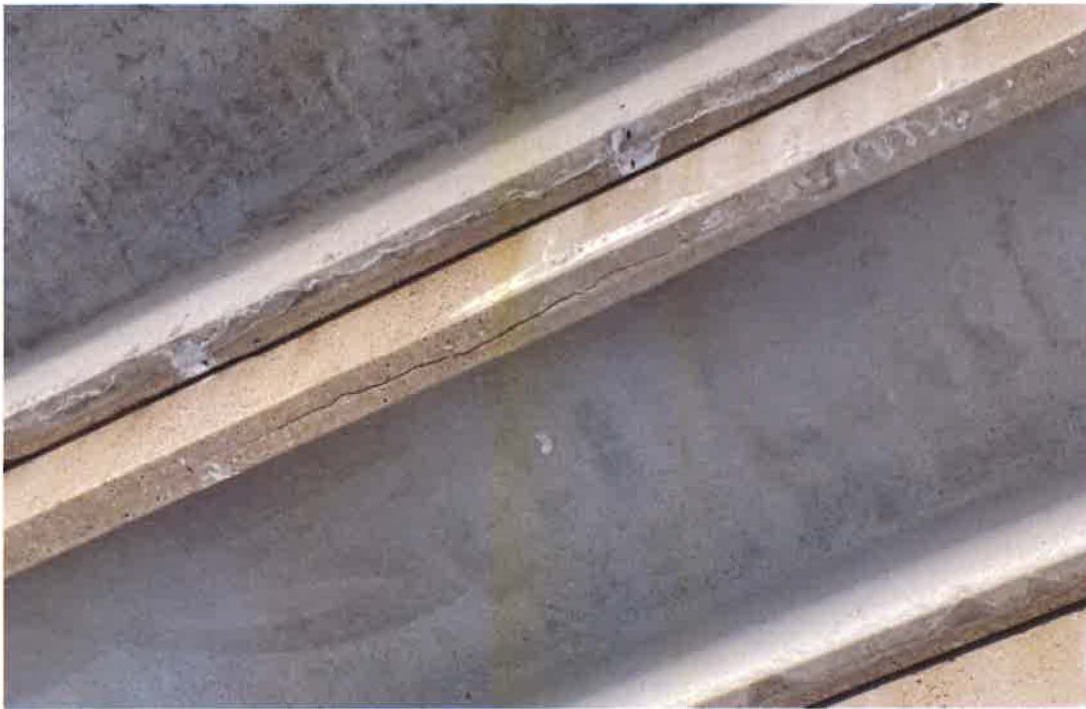
Photo 27: Crack on Joist Web

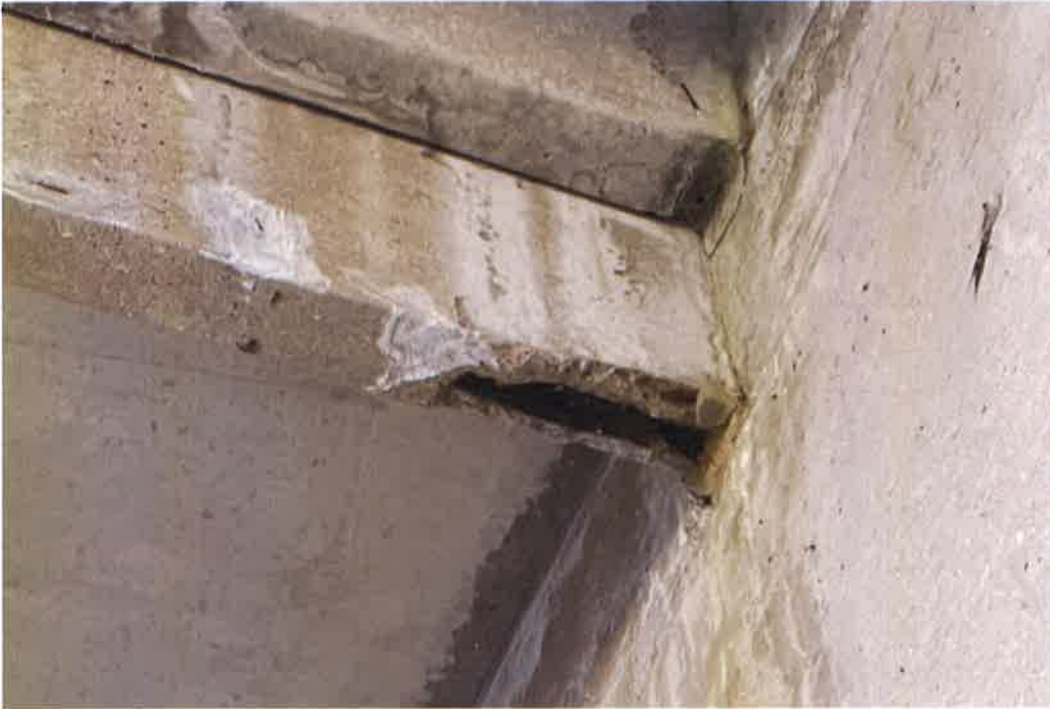
Photo 28: Spalling/Exposed Rebar at Joist Web

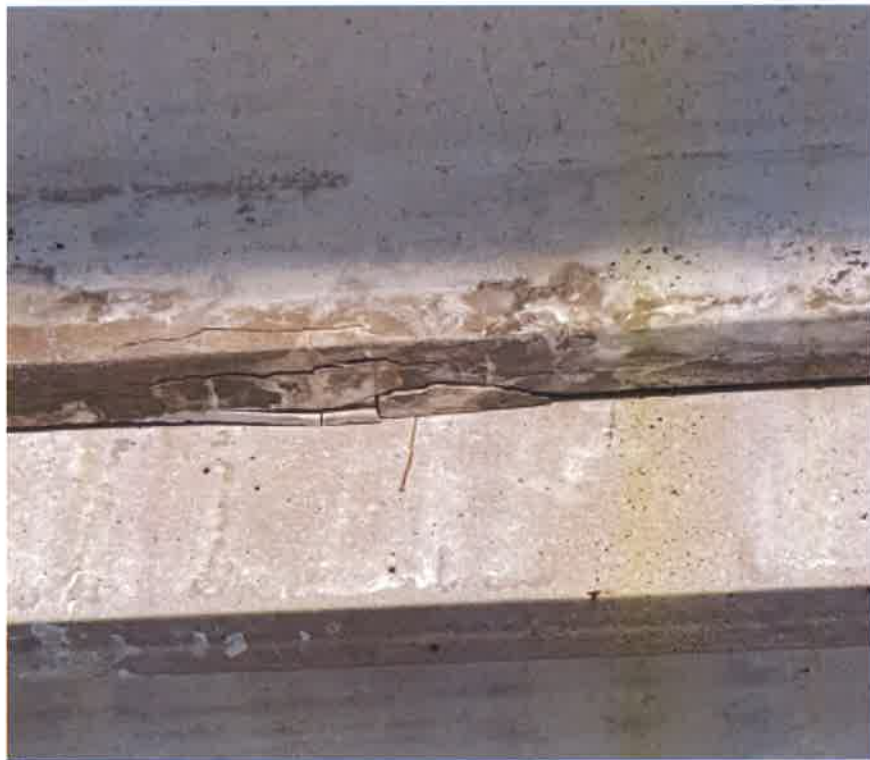
Photo 29: Significant Joist Cracking

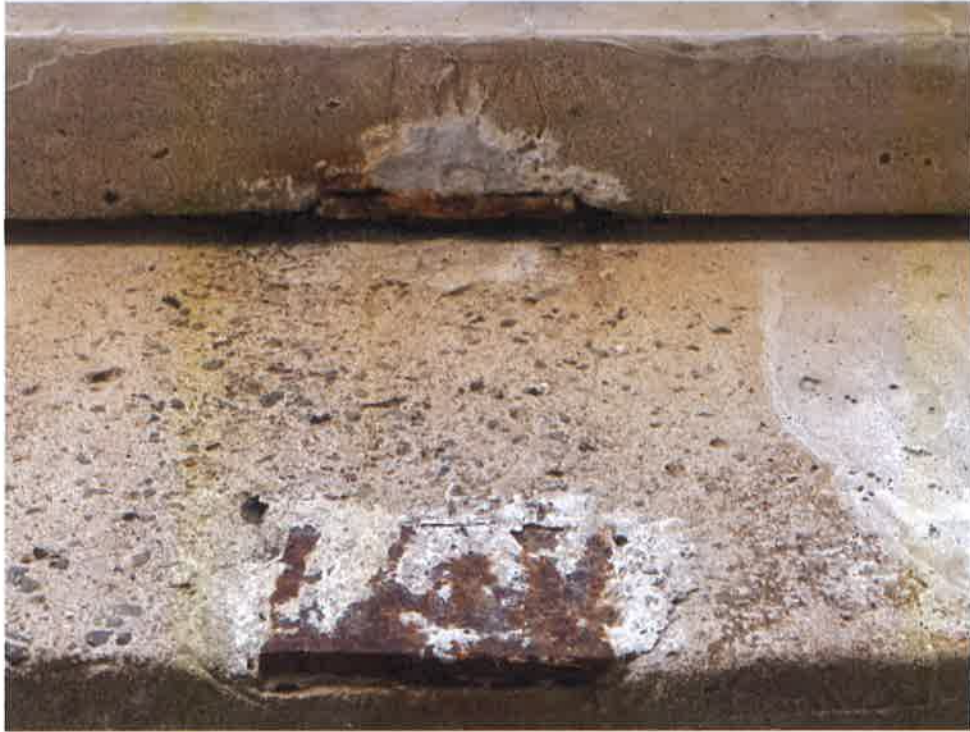
Photo 30: Rusted Diaphragm Tie Plate

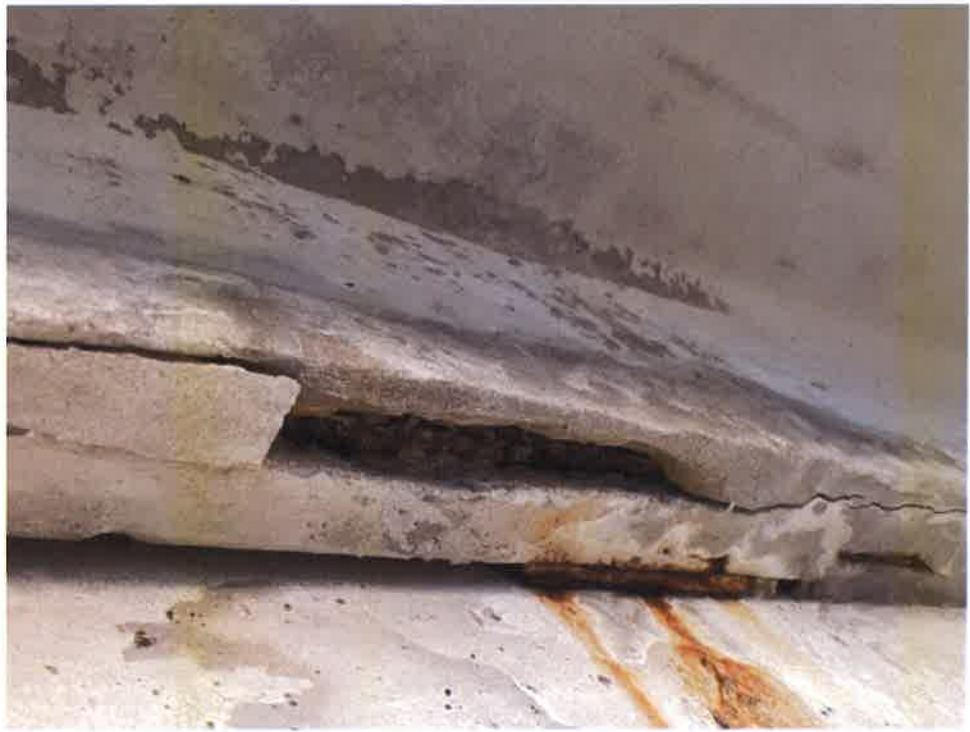
Photo 31: Rusted Diaphragm Tie Plate Causing Deterioration of Surrounding Concrete

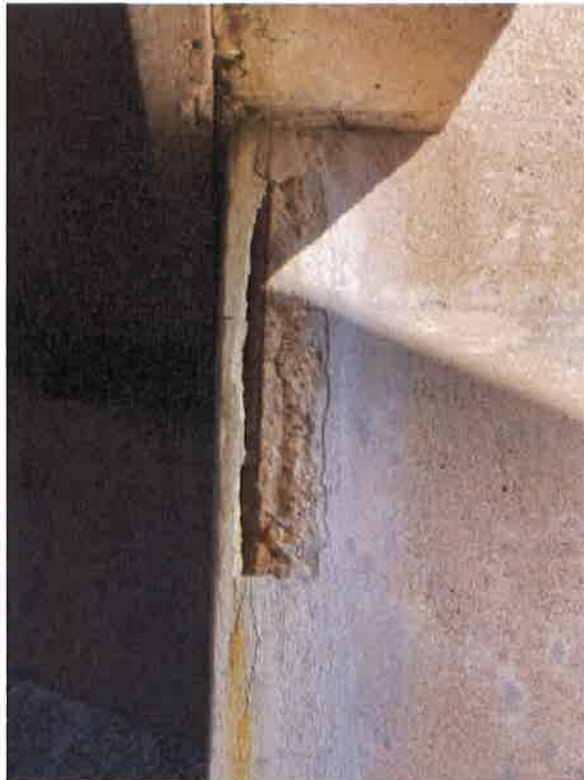
Photo 32: Exposed Rusted Rebar After Spalling of Repair on Ramp Sidewall

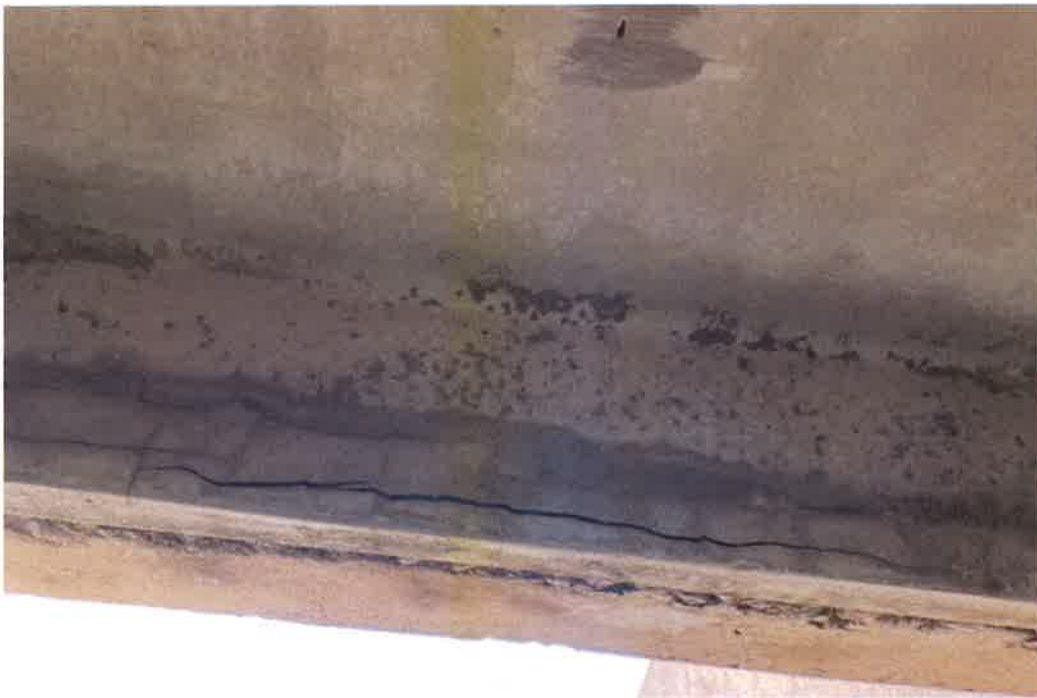
Photo 33: Exposed Rusted Rebar After Spalling of Repair on Ramp Sidewall

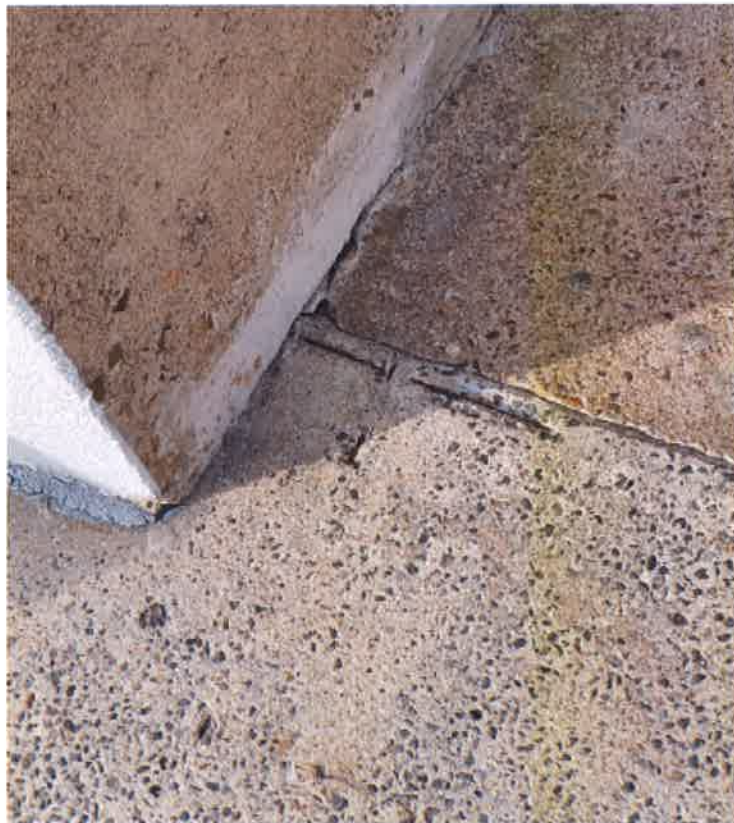
Photo 35: Exposed Welded Wire Mesh Where Ramp Meets Landing

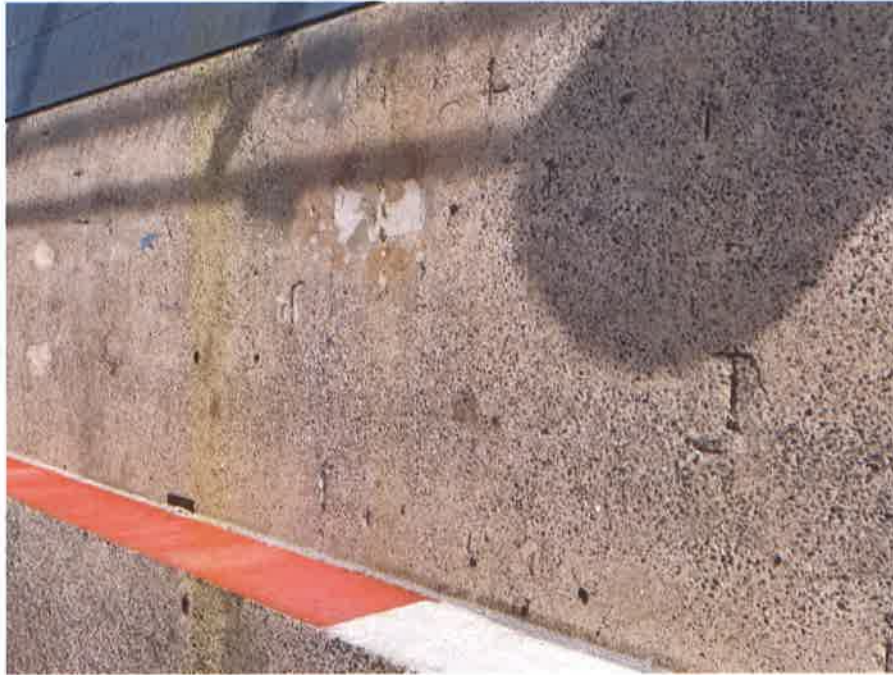
Photo 36: Deteriorated Top Slab

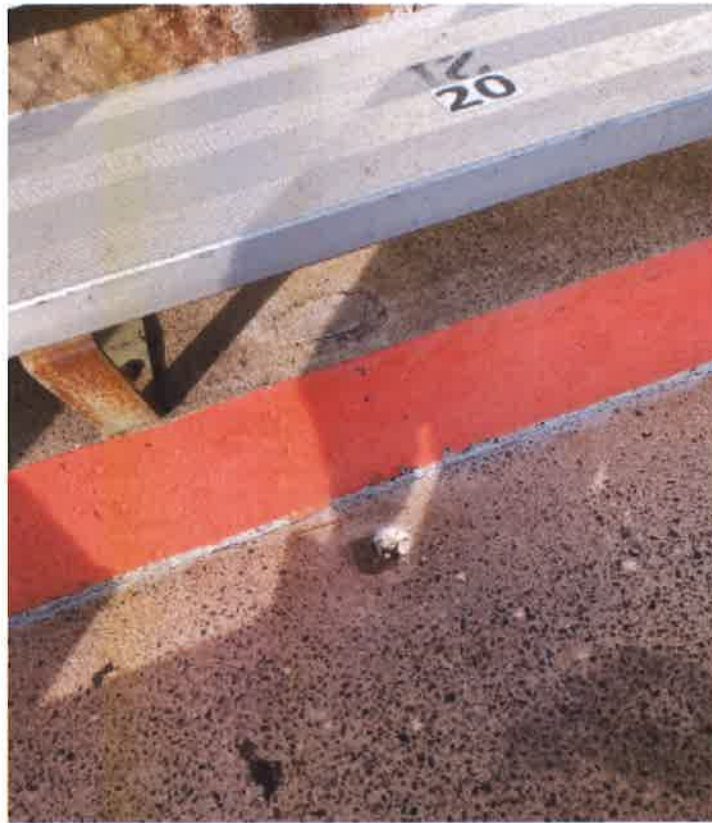
Photo 37: Delamination at Pot Holes

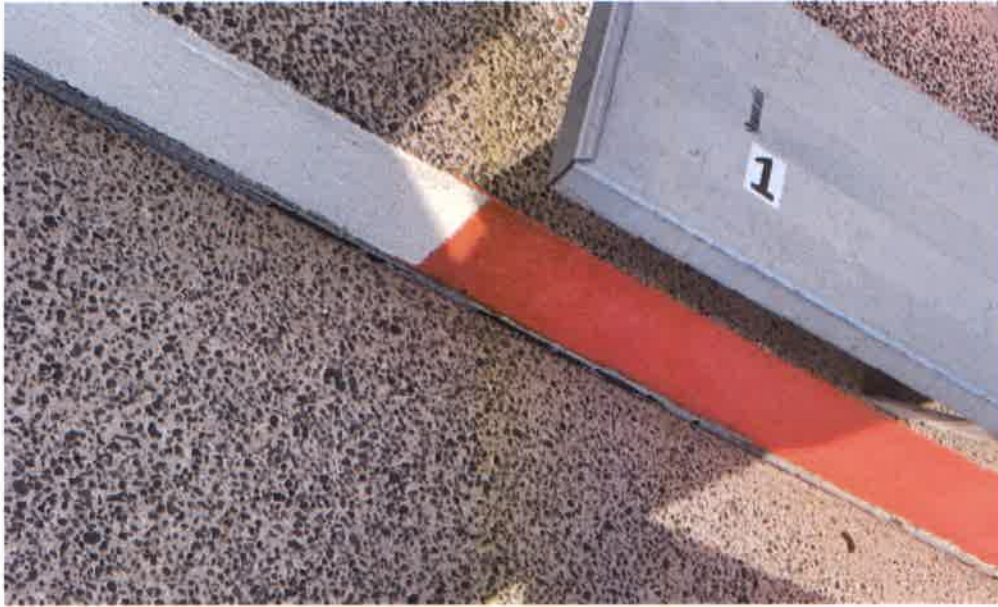
Photo 38: Deterioration of Sealant

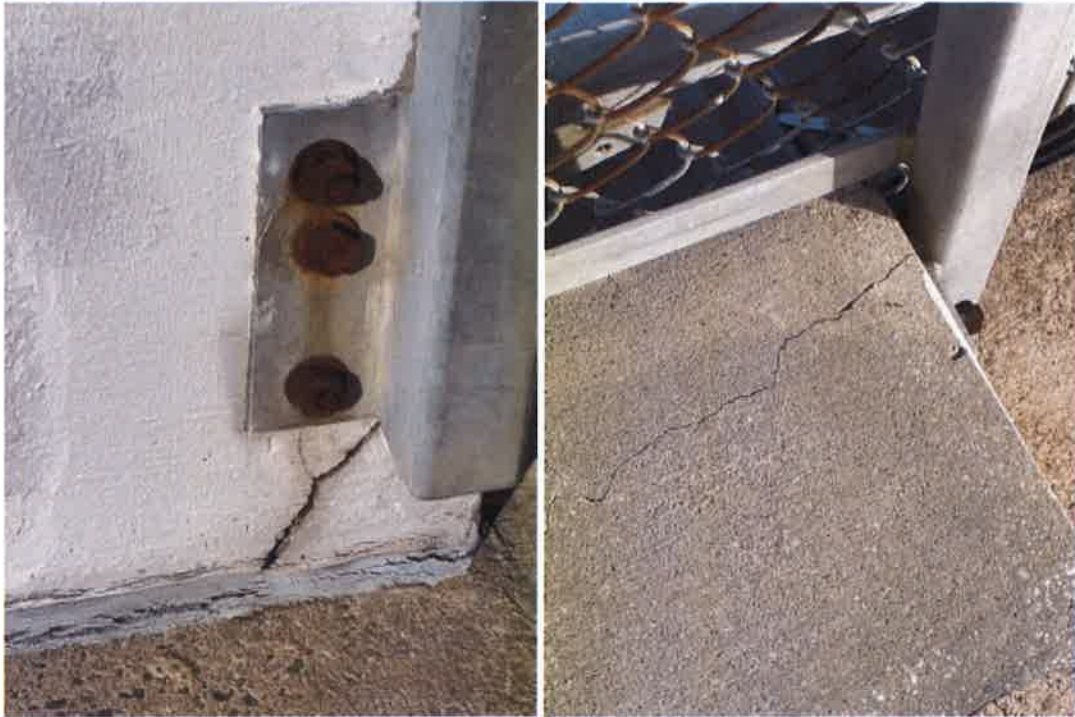
Photo 39: Rusted Anchor of Handrail with Crack in Concrete

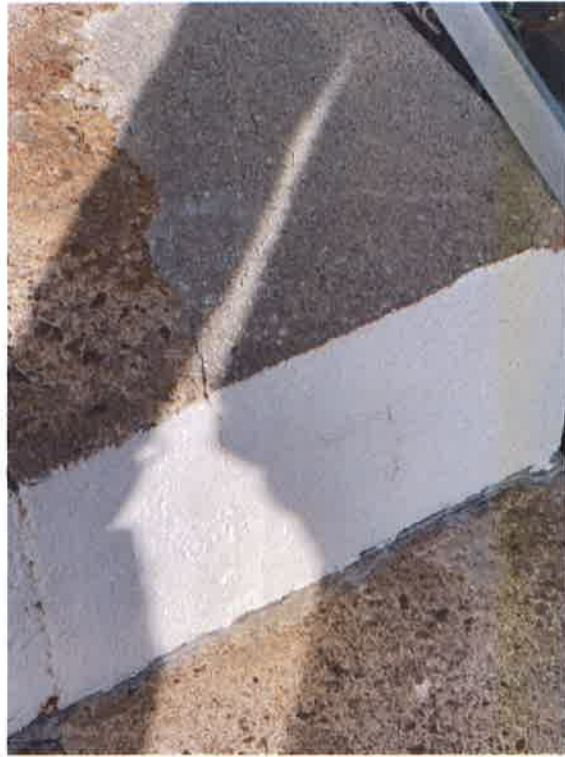
Photo 40: Crack at Repaired Patch of Concrete

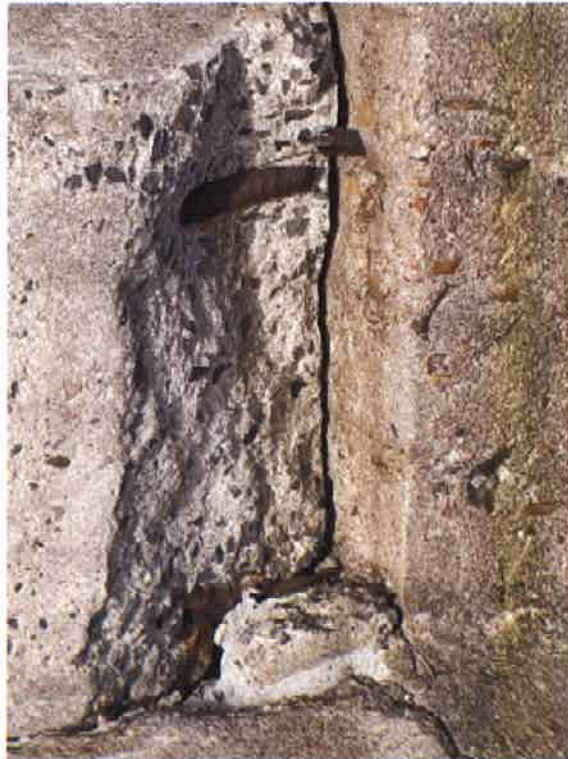
Photo 41: Spalling of Concrete with Exposed Broken rebar on Step "U"

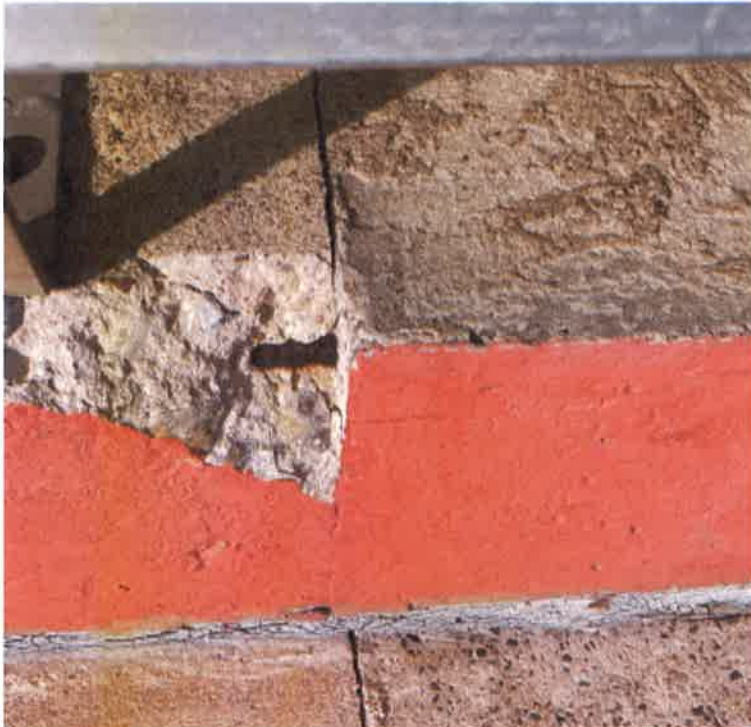
Photo 42: Spalling of Concrete with Exposed Rebar on Step "U"

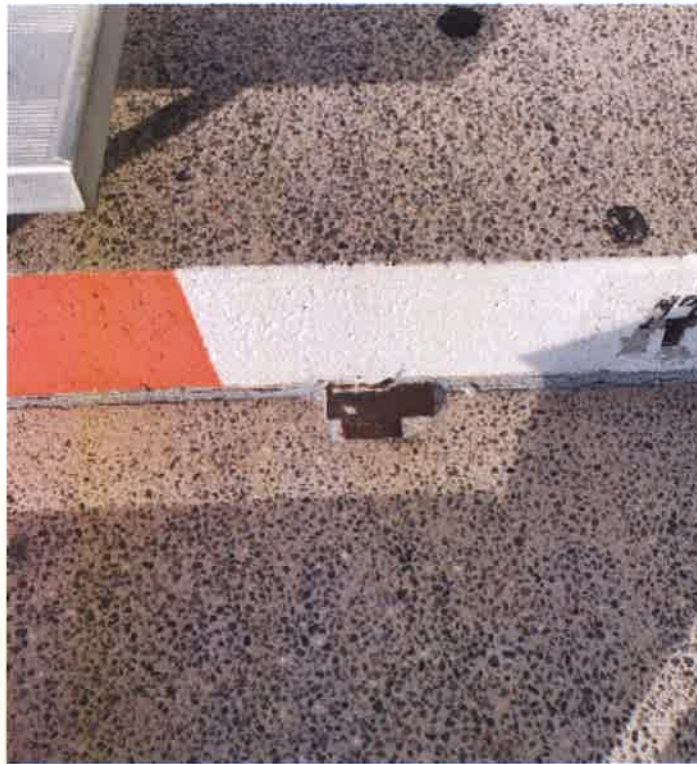
Photo 43: Protruding Rusted Diaphragm Tie Plate

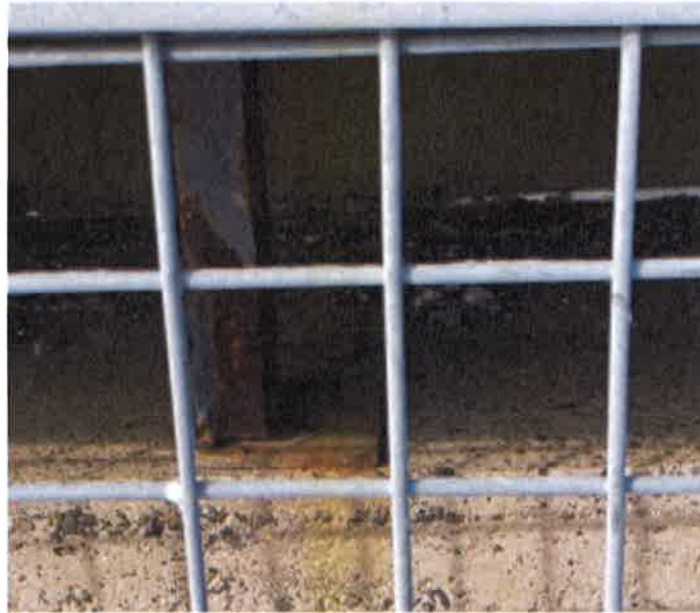
Photo 44: Rusted Support to Press-Box without Anchor bolt

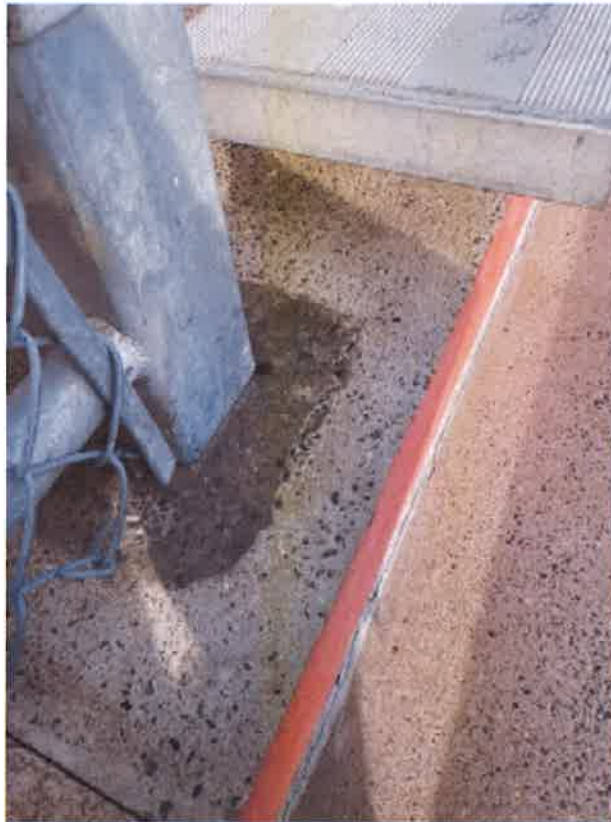
Photo 45: Concrete Crack and Delamination at Posts

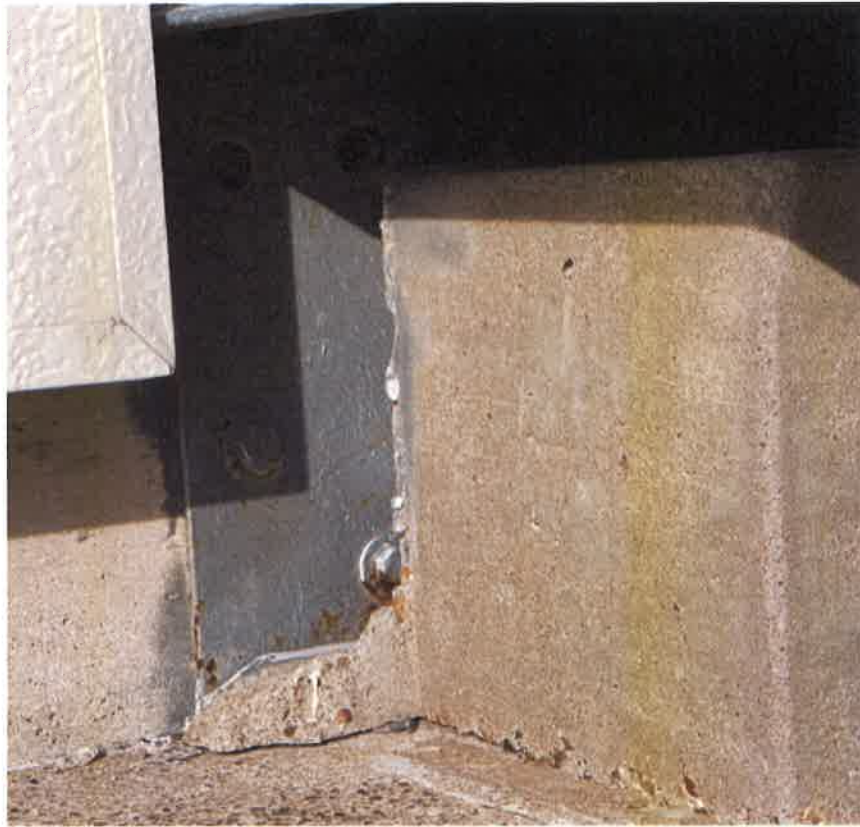
Photo 46: Bearing Plate Missing Anchor bolts

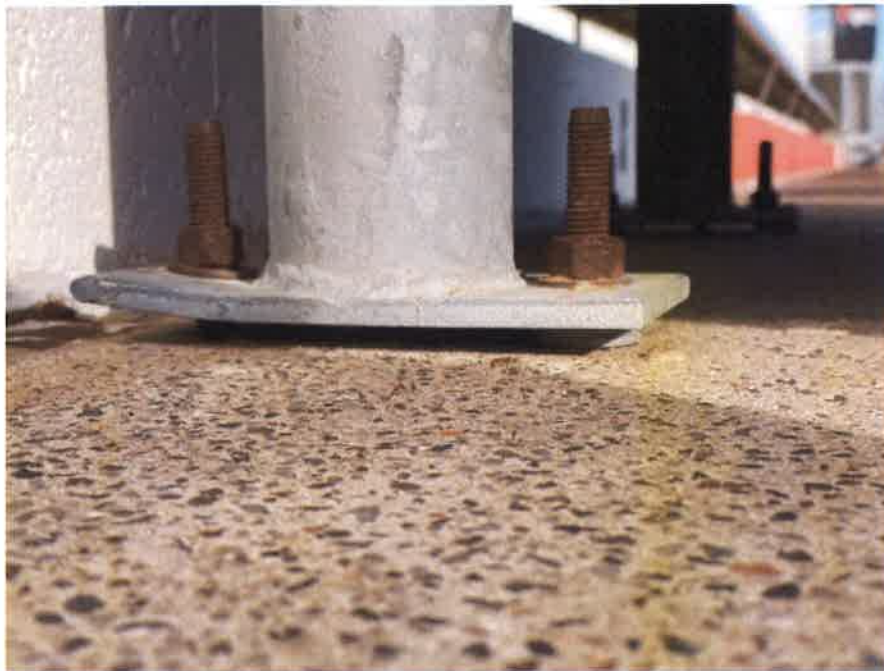
Photo 47: Rusted Anchor Bolts Sitting on Multiple Washers

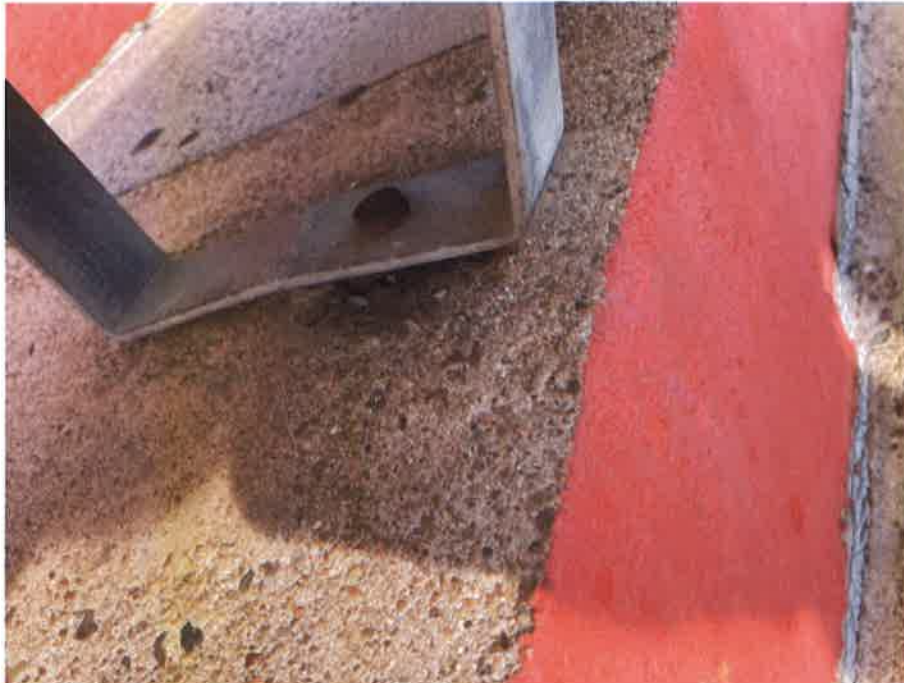
Photo 48: Rusted Anchor Bolts Sitting on Pothole with Dirt

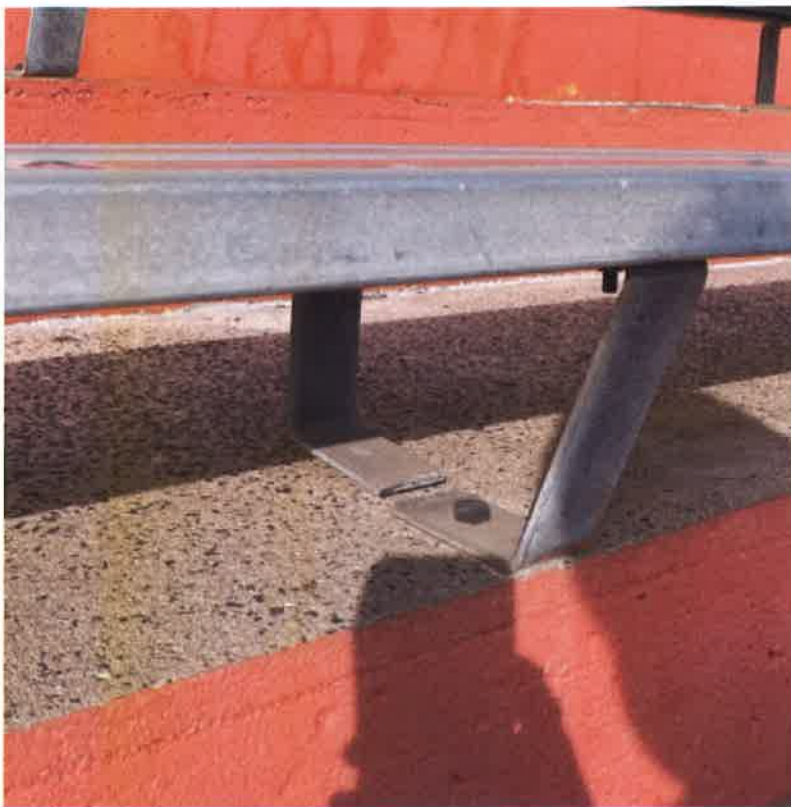
Photo 49: Broken Seating Arrangement

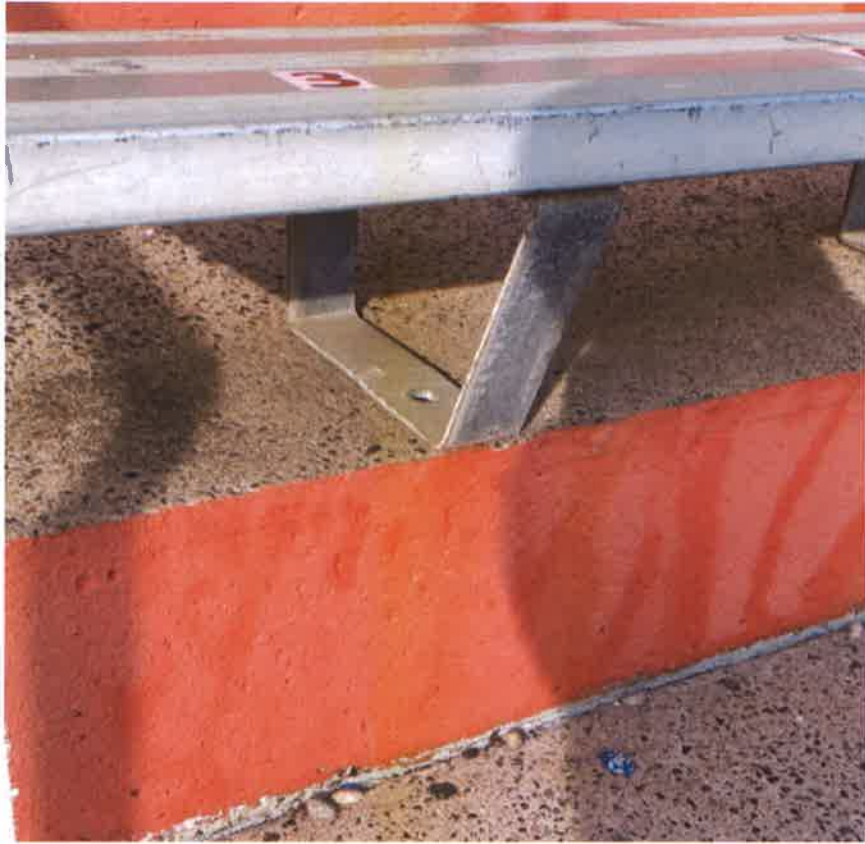
Photo 50: Missing Anchor for Seating Arrangement

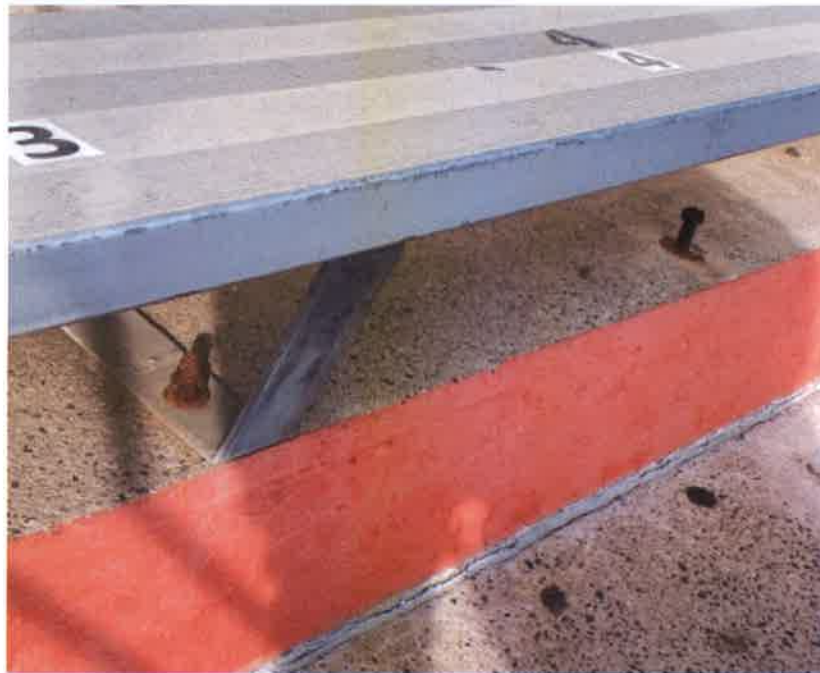
Photo 51: Rusted Anchor Protruding (Source of Hazard)

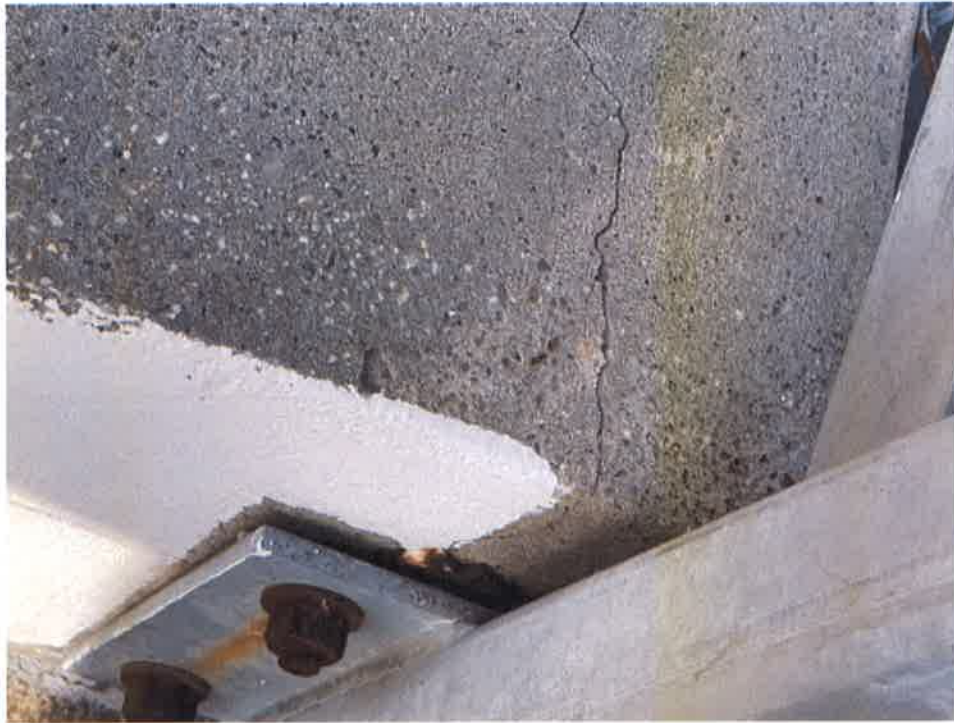
Photo 52: Handrail Support With Rusted Anchor Radiating Crack Across the Topping slab

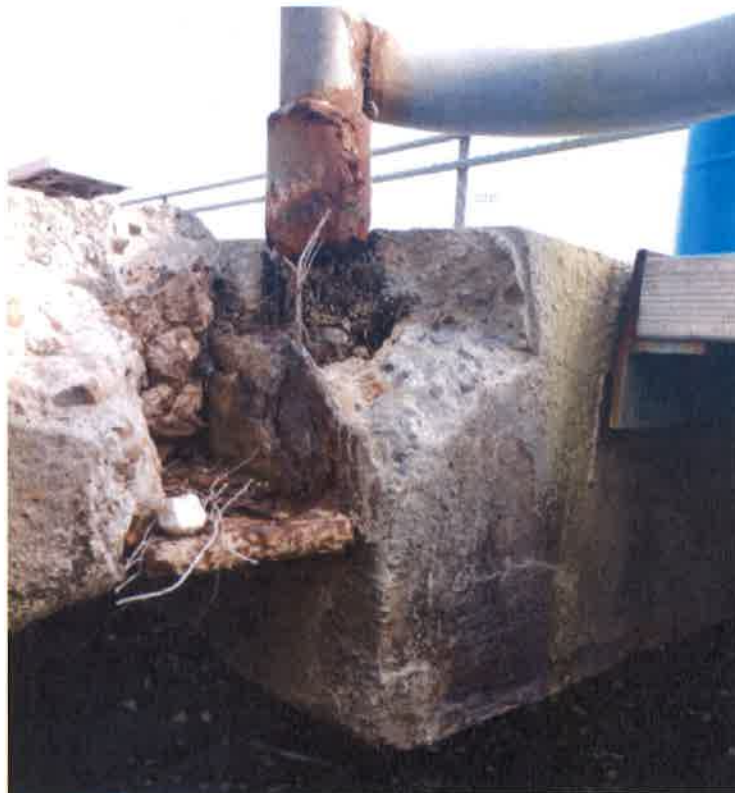
Photo 53: Deteriorated Handrail Support on Top of Rusted Lintel with Spalling of Concrete

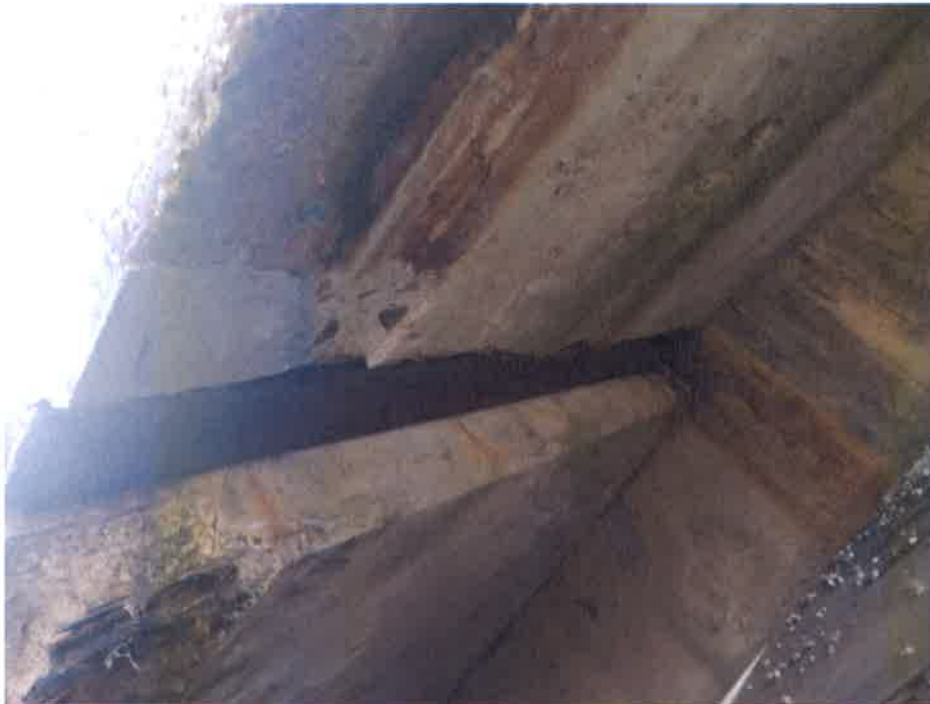
Photo 54: Rusted Lintel with Exposed Rebar After Spalling of Concrete

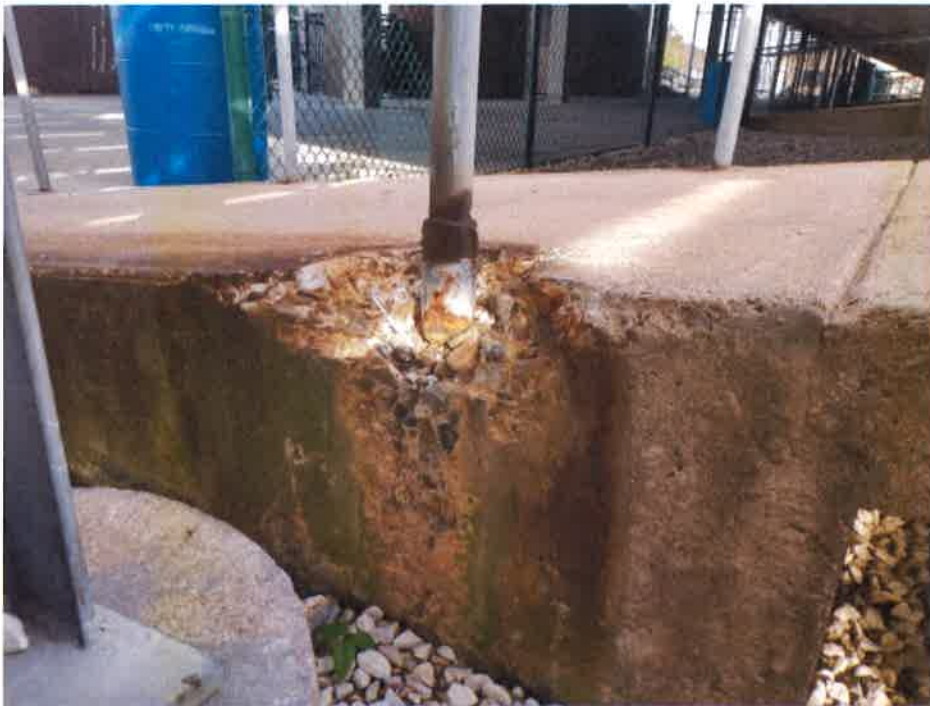
Photo 55: Rusted Handrail with Concrete Damage

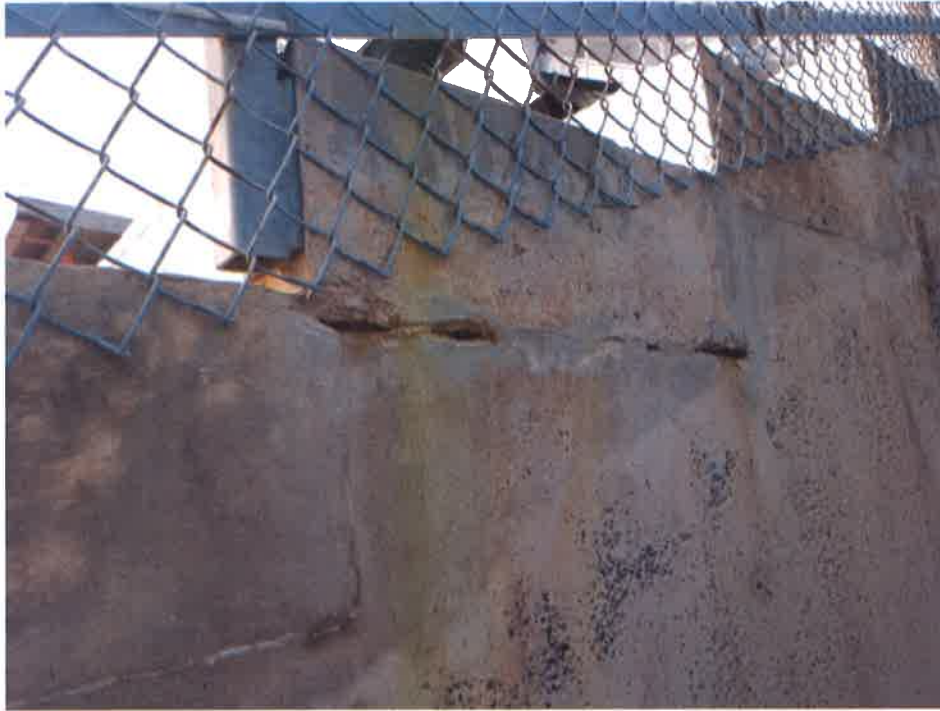
Photo 56: Exposed Rusted Rebar on Top of Raker beam

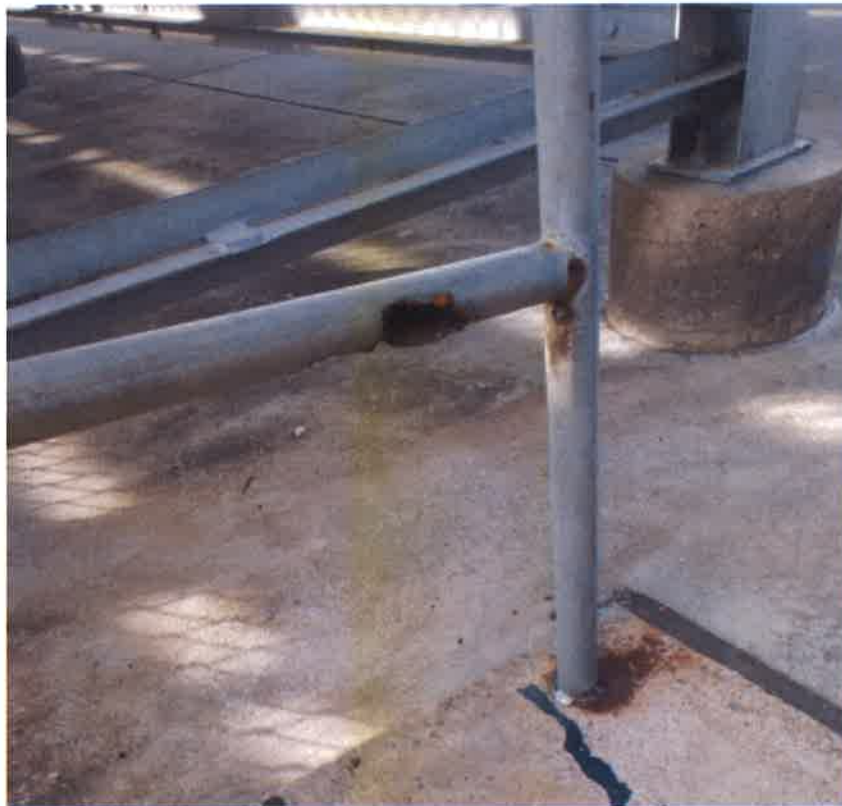
Photo 57: Deteriorated Handrail

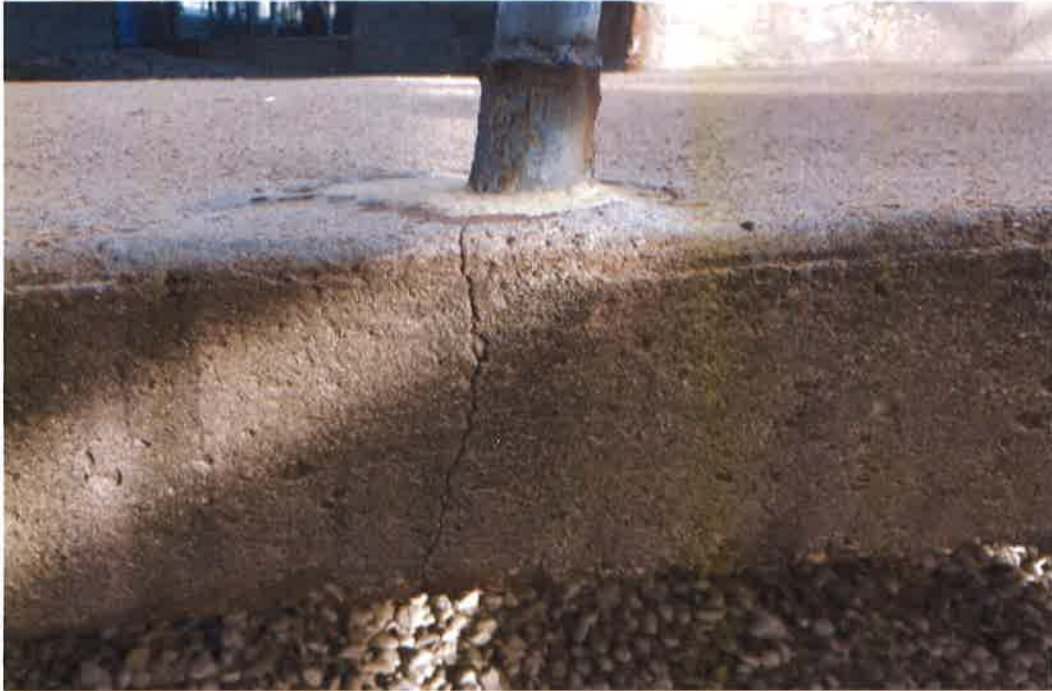
Photo 58: Radiating Crack form Repaired Handrail Post

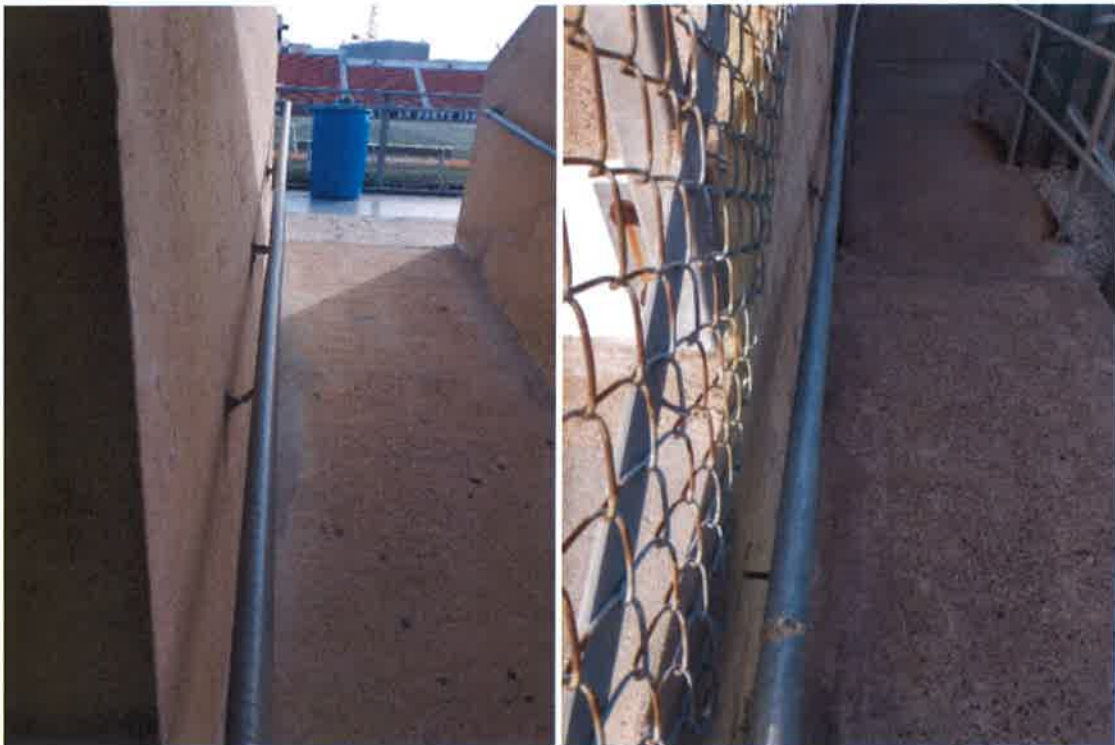
Photo 59: Broken Handrail Embed to Sidewall

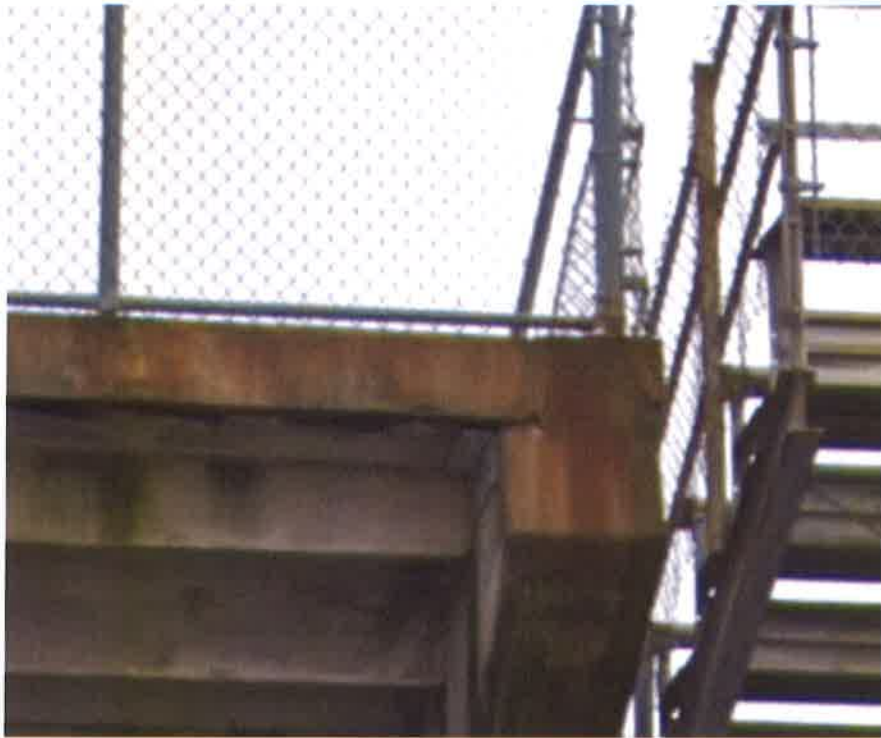
Photo 60: Fence Post Deforming the Concrete Corner

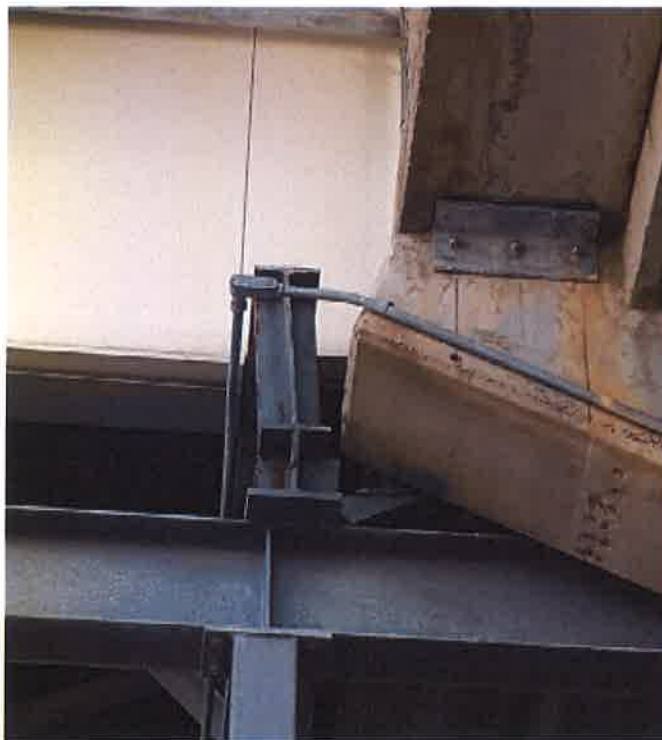
Photo 61: Non-Plumb Steel Beam Supporting Press-box

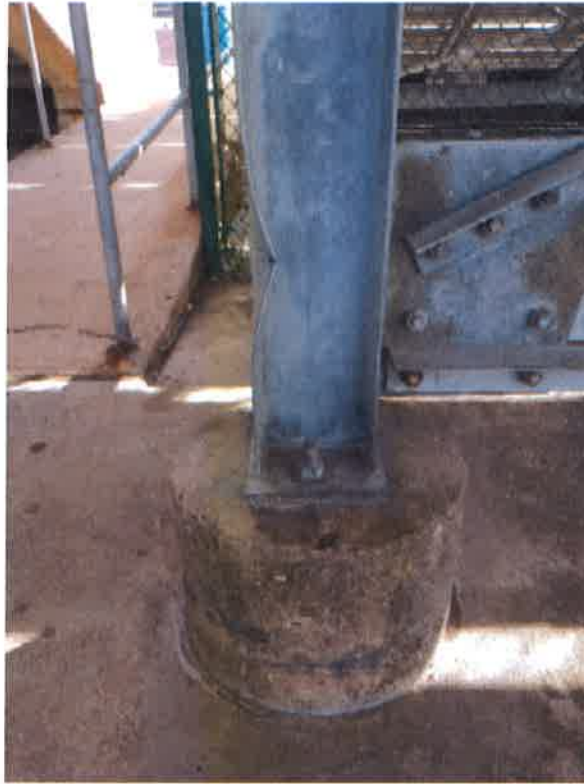
Photo 62: Steel Bleacher Column Deformation
