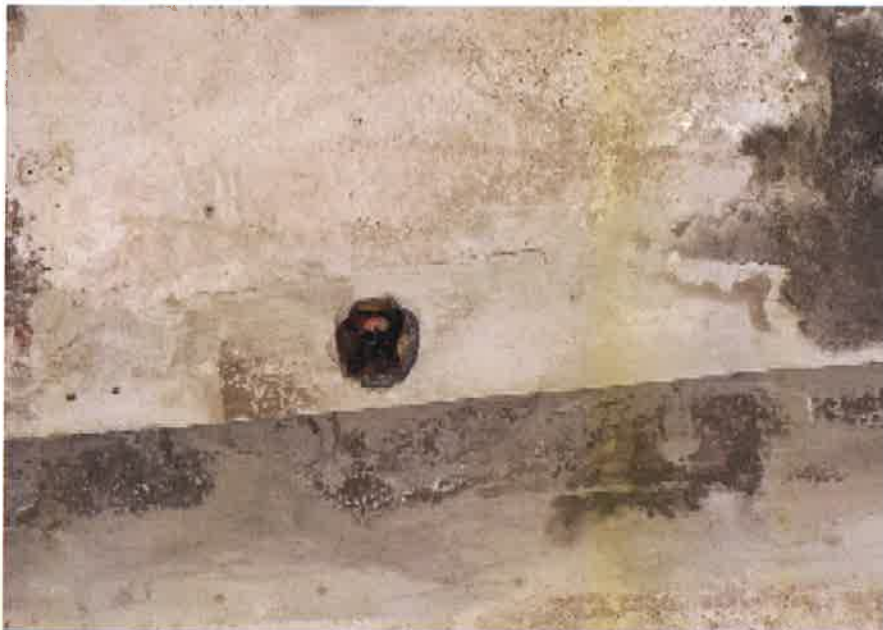
Photo 64: Rusted Duct Inside Stadium Riser

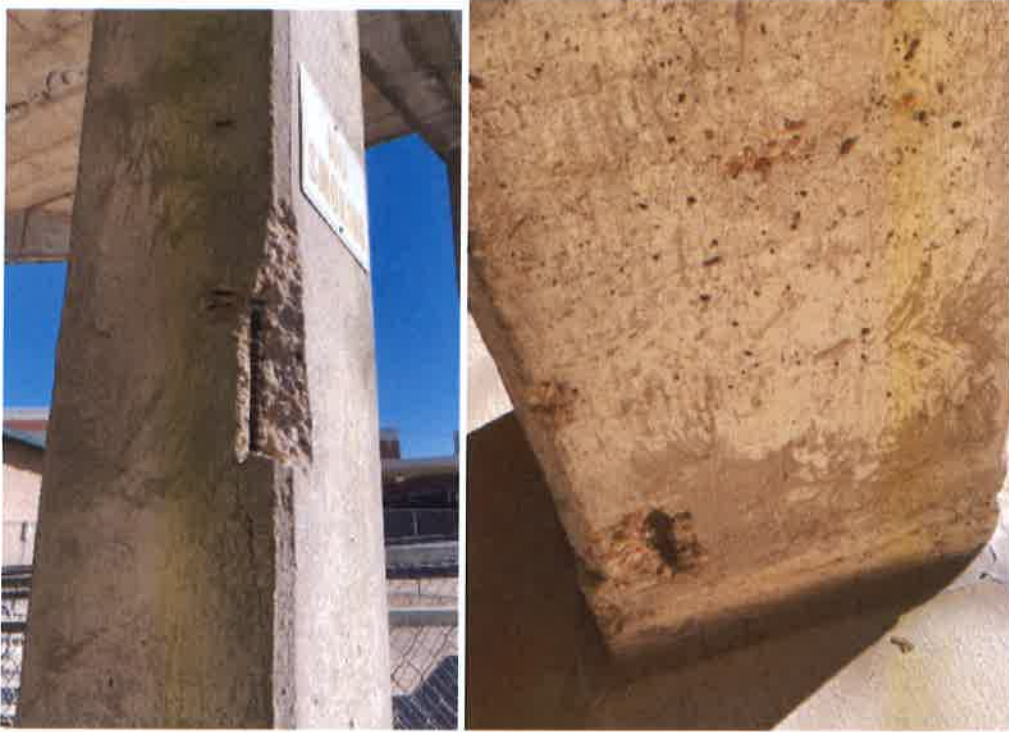
Photo 65: Exposed Rusted Rebar After Spalling of Concrete

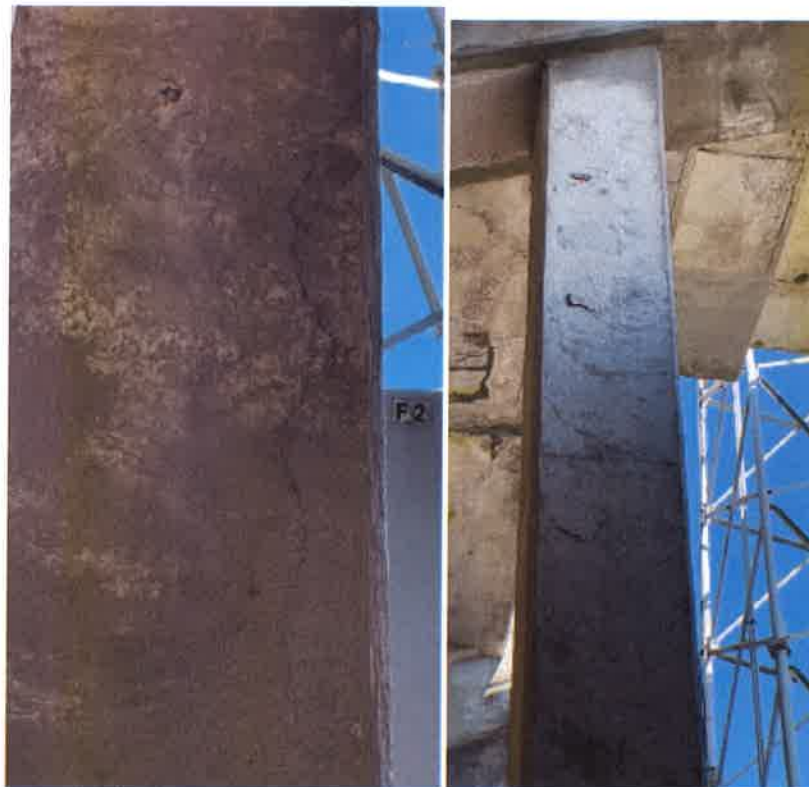
Photo 66: Crack and Delamination in Concrete Column

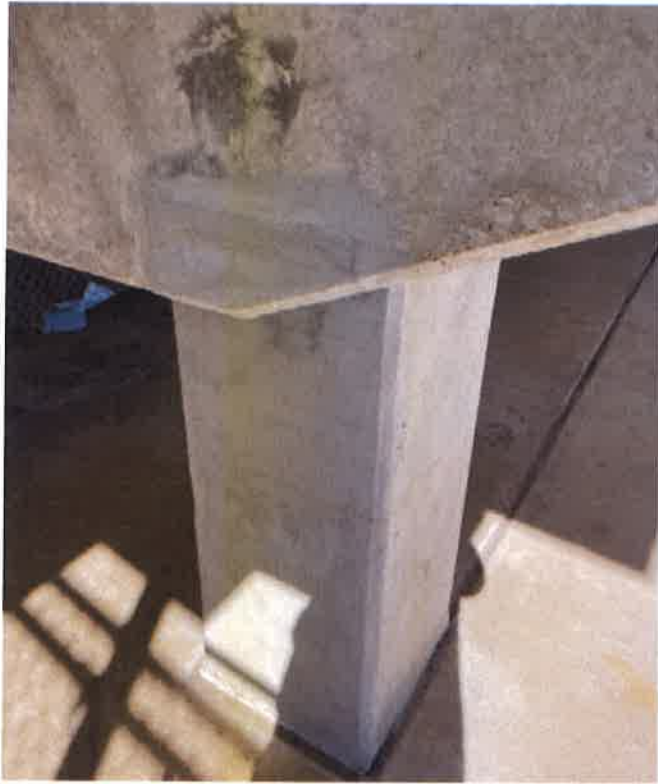
Photo 67: Crack Radiating from Repaired Beam

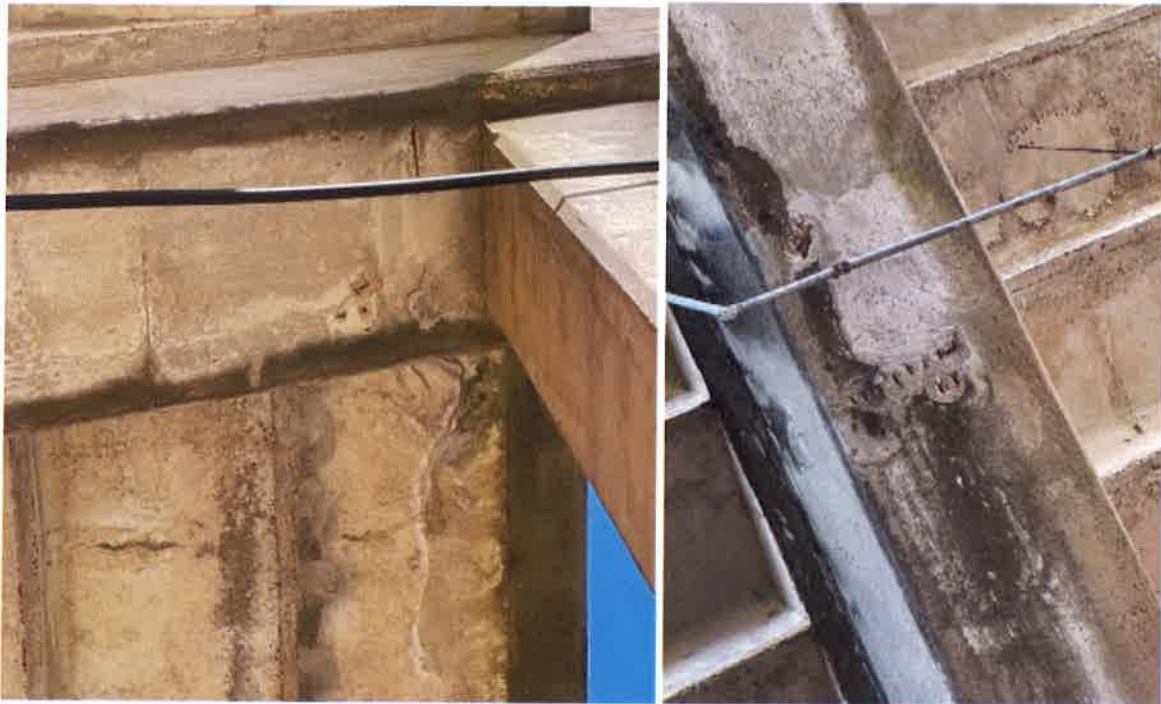
Photo 68: Concrete Spalling with Exposed Rebar in Primary Beams

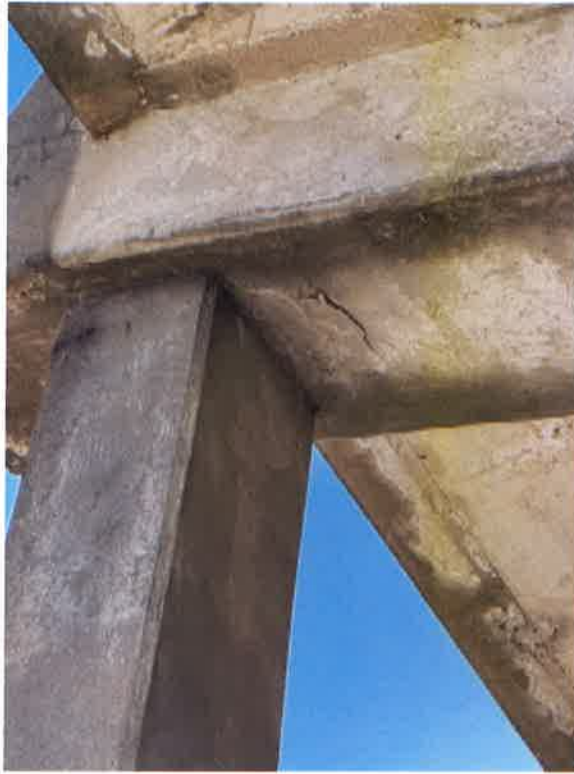
Photo 69: Concrete Delamination in Primary Beams

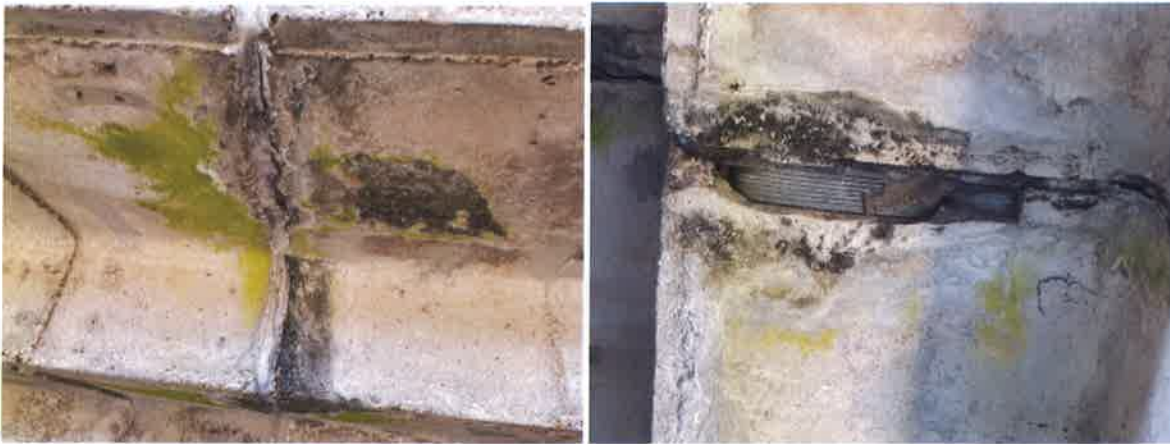
Photo 70: Water Seepage from Deteriorated Cold Joint Sealant

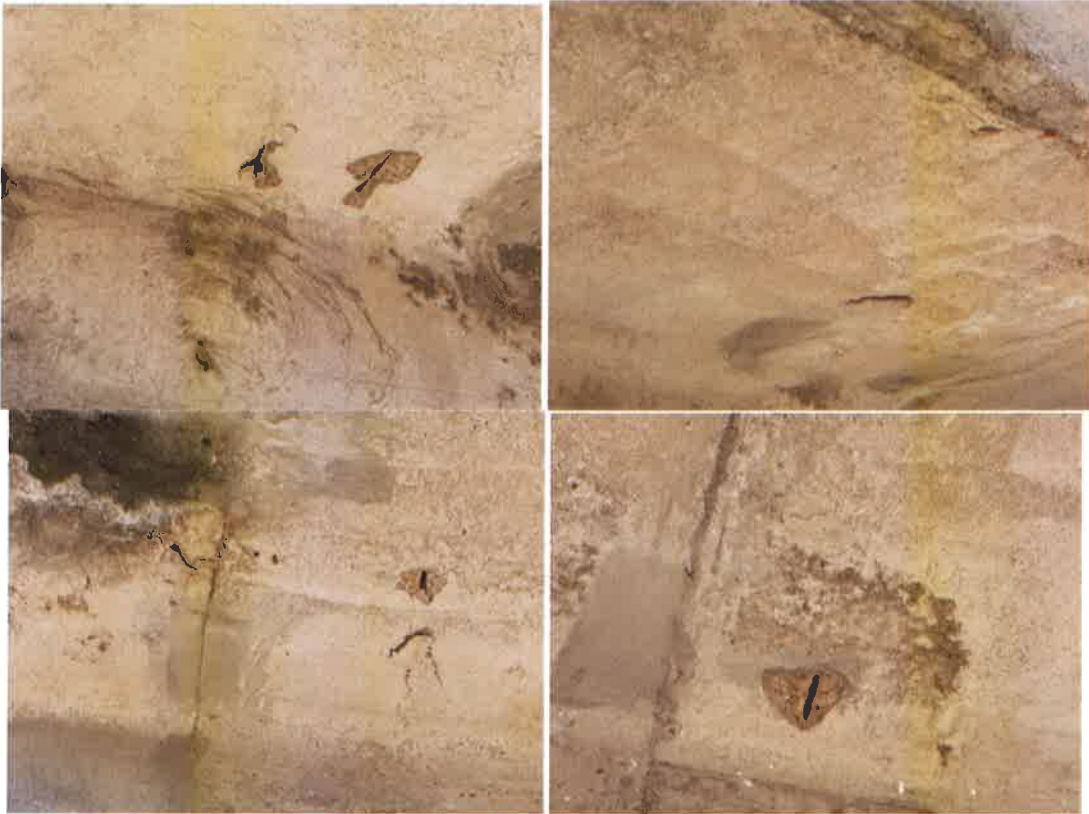
Photo 71: Spot Spalling and Delamination of Secondary Beams

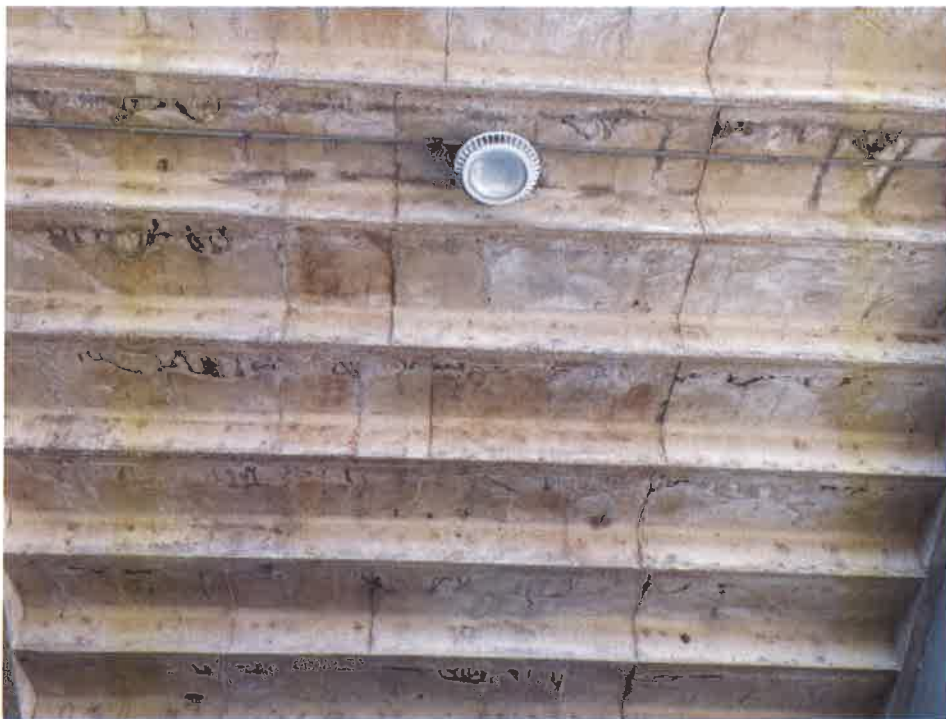
Photo 72: Horizontal Cracks in Secondary Beams Leading to Seepage

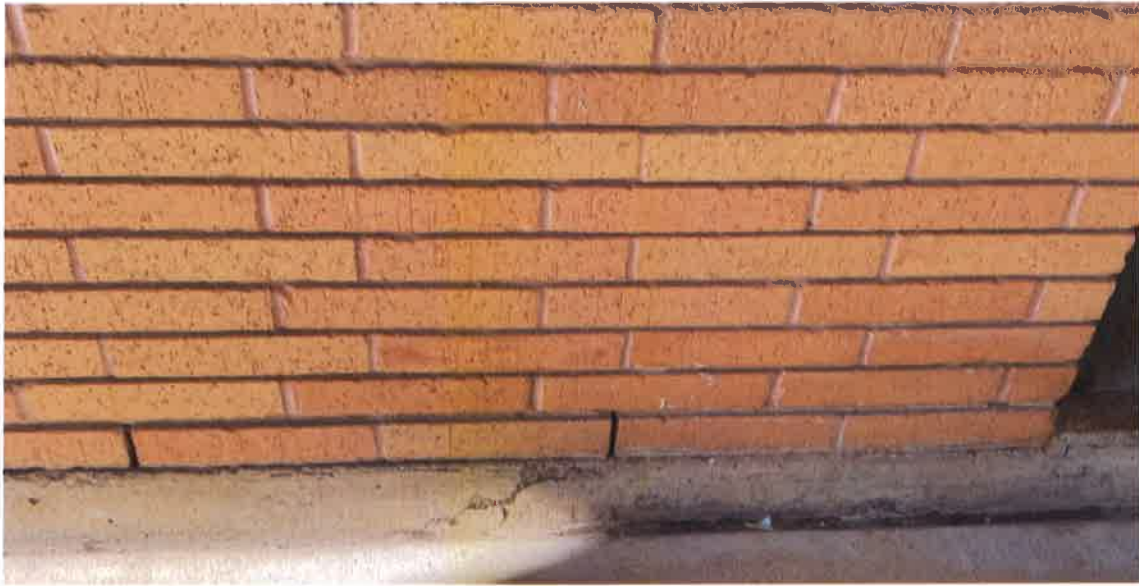
Photo 73: Crack in Brick Ledge of Wall

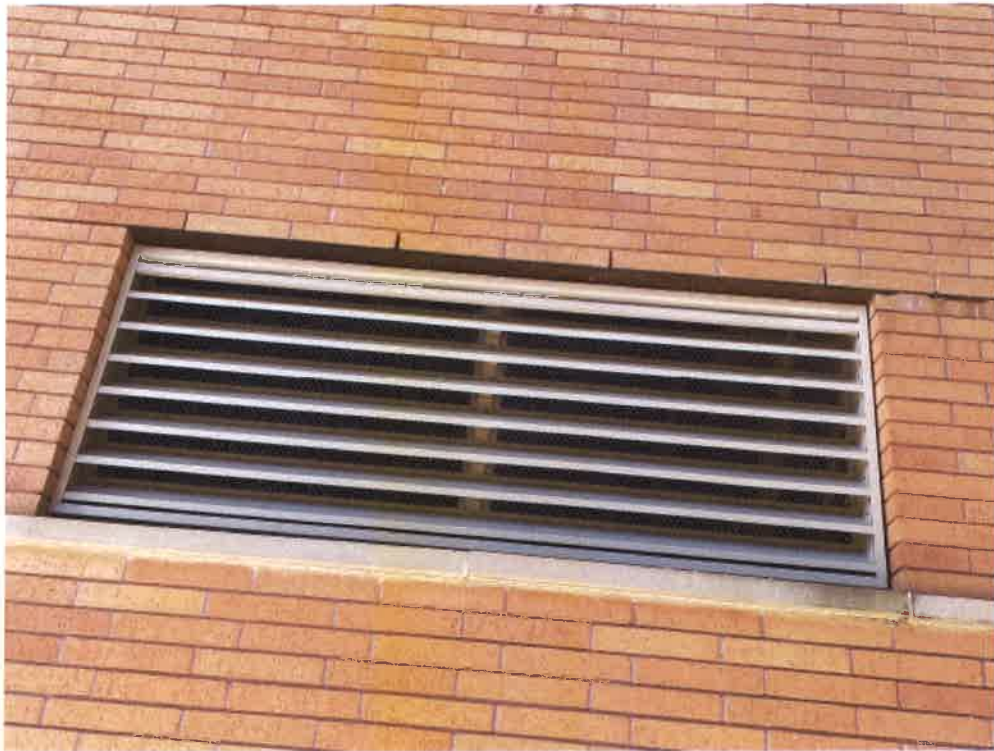
Photo 74: Rusted Lintel for Wall Opening

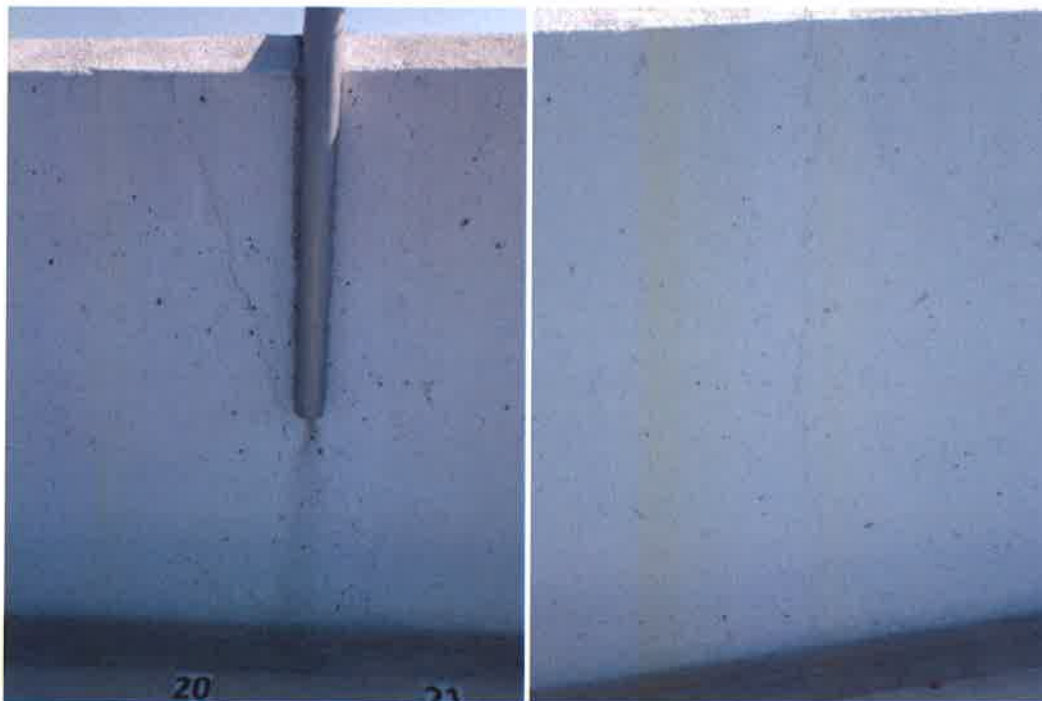
Photo 76: Hairline Cracks on Sidewalls

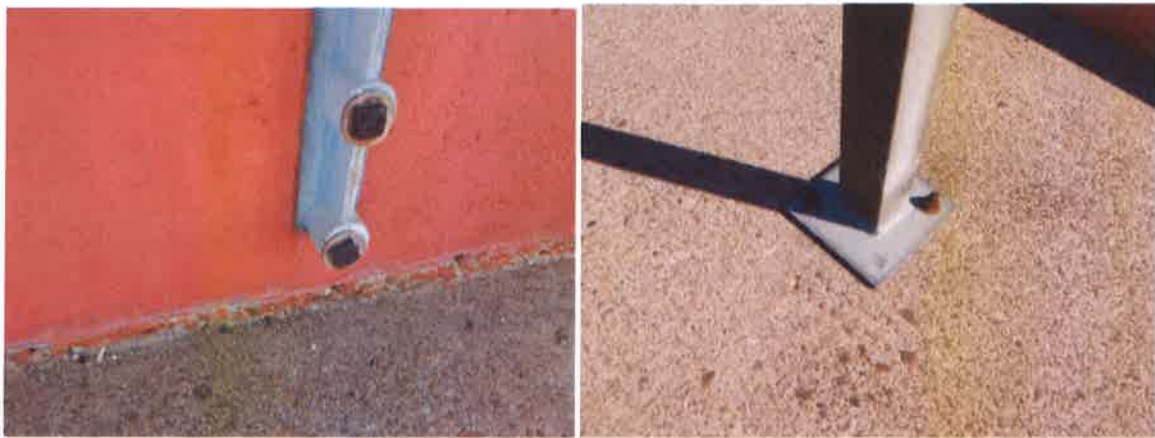
Photo 77: Rusted Anchor for Seating Arrangement

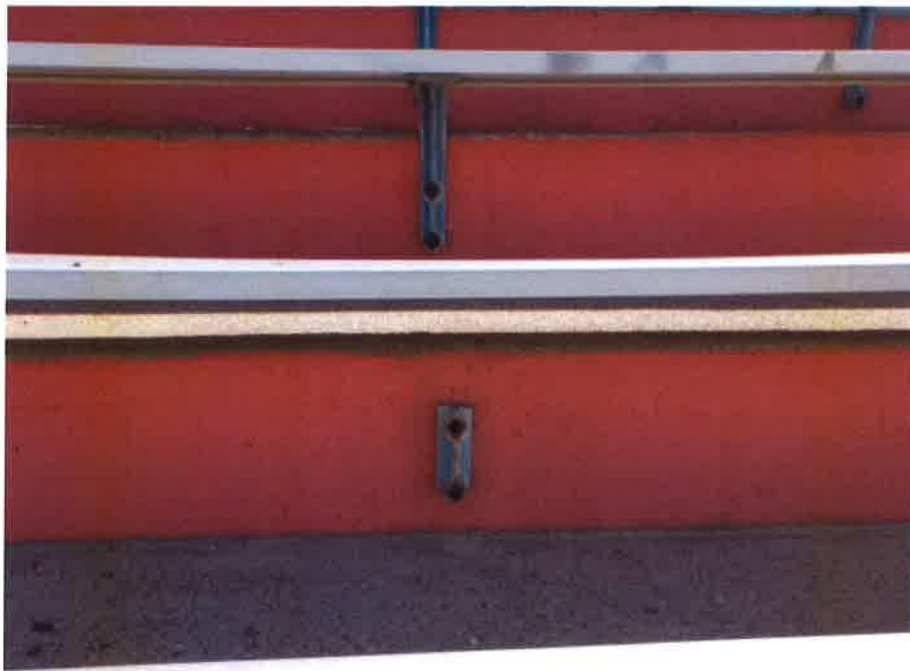
Photo 78: Broken Seating Support

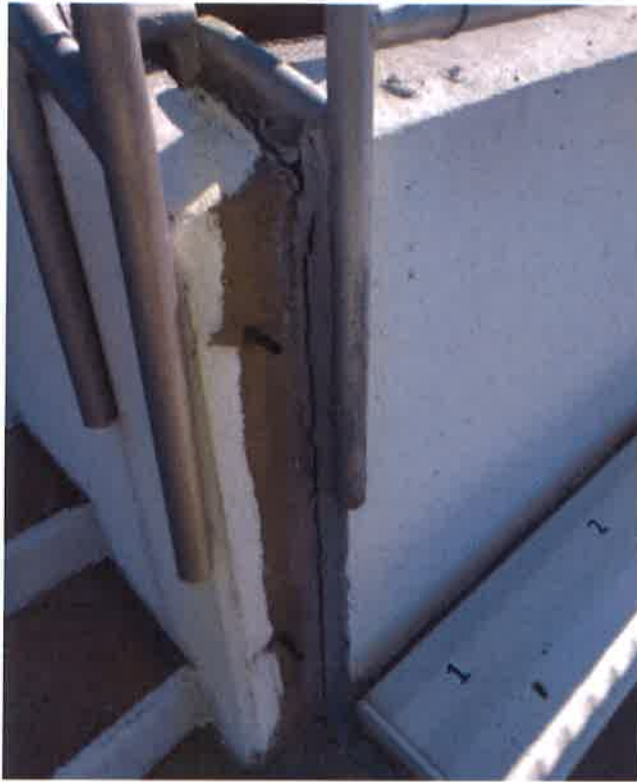
Photo 79: Anchor Rods Protruding from Sidewall (Source of Hazard)

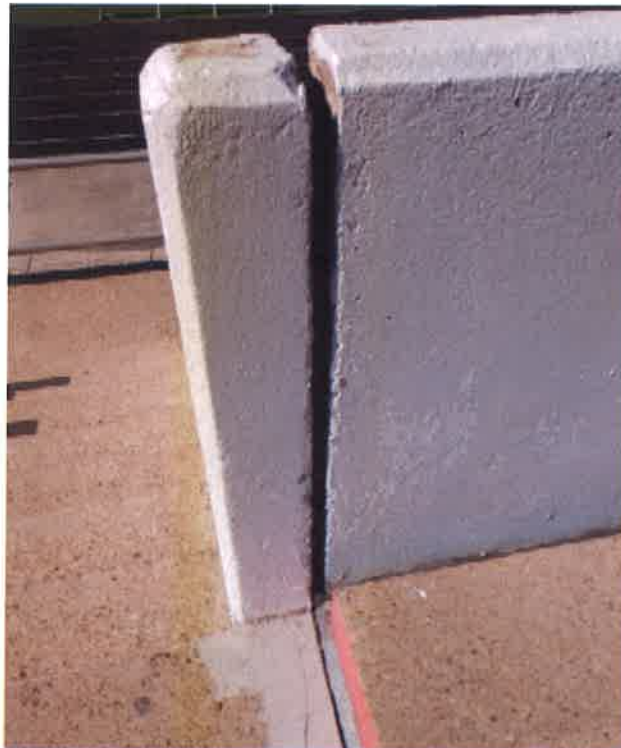
Photo 80: Wide Sidewall Cold Joint (source of Hazard)

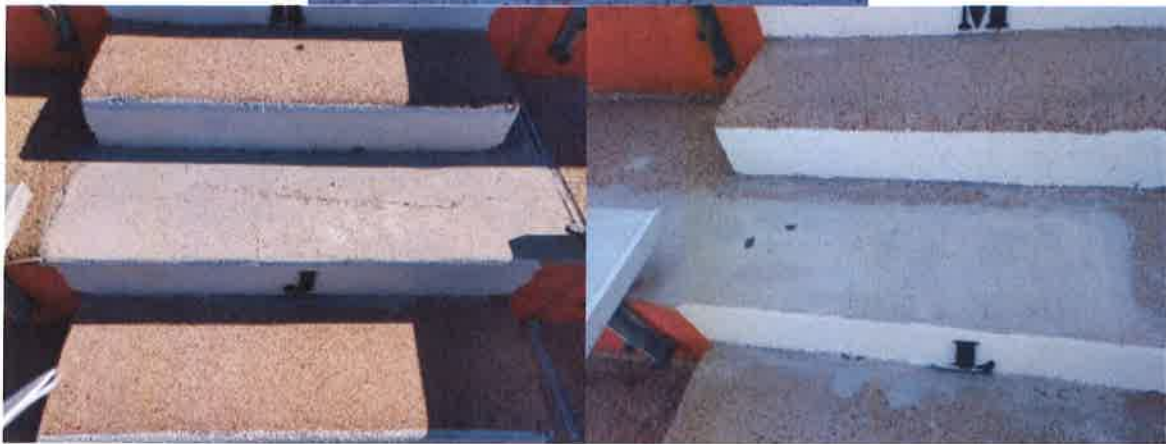
Photo 81: Crack on Repaired Steps on Southern Side

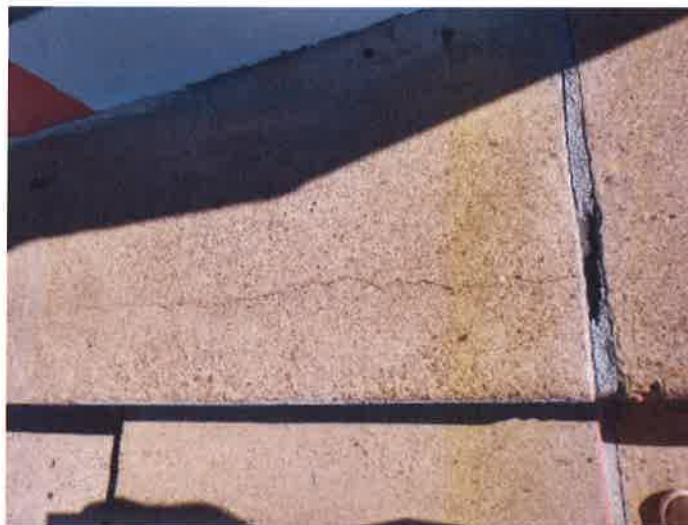
Photo 82: Worn Sealant with Horizontal Crack on Slab

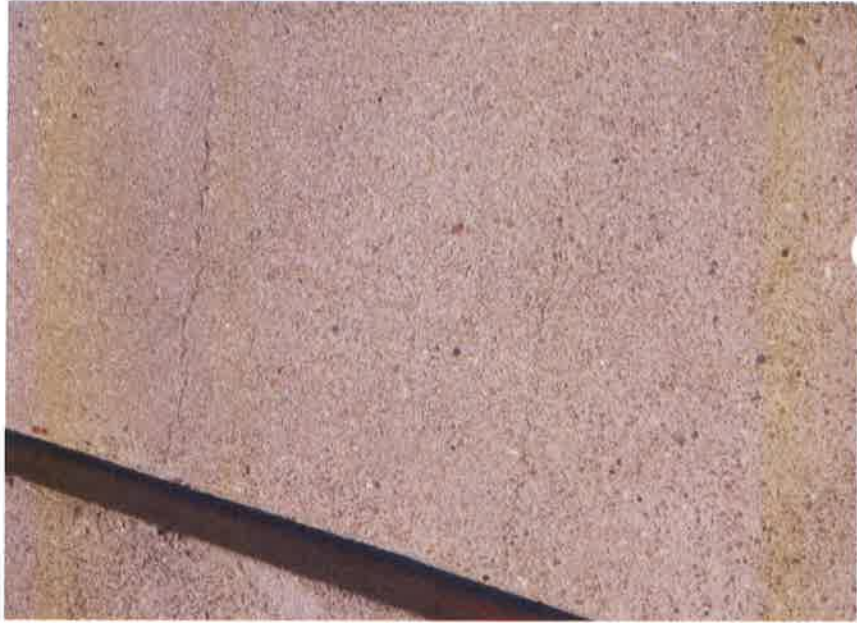
Photo 83: Typical Crack on Slab on Either side of Raker Beam Underneath

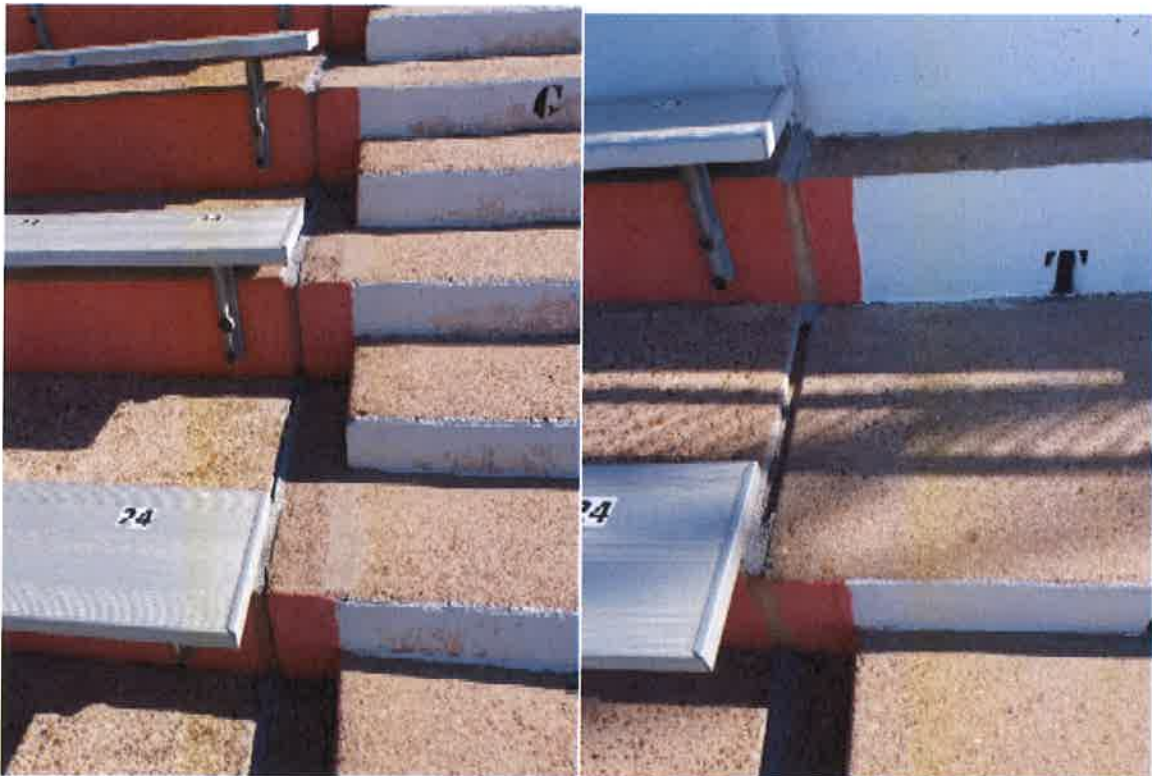
Photo 84: Worn Sealant At All Cold Joint

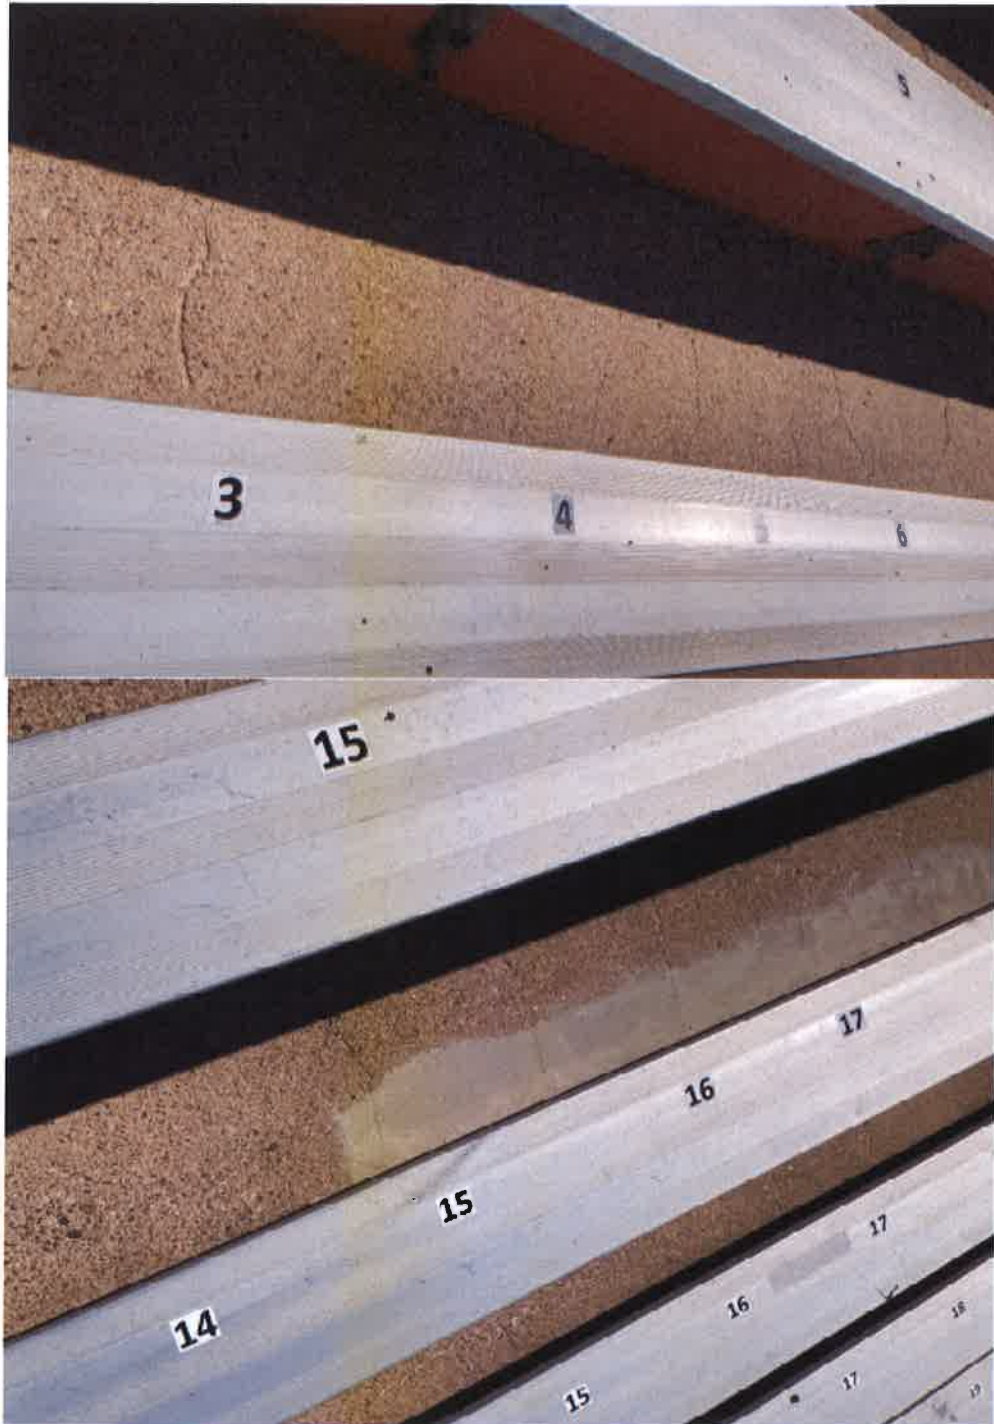
Photo 85: Typical Cracks at Uniformly Distributed For Entire Span on Each Beam

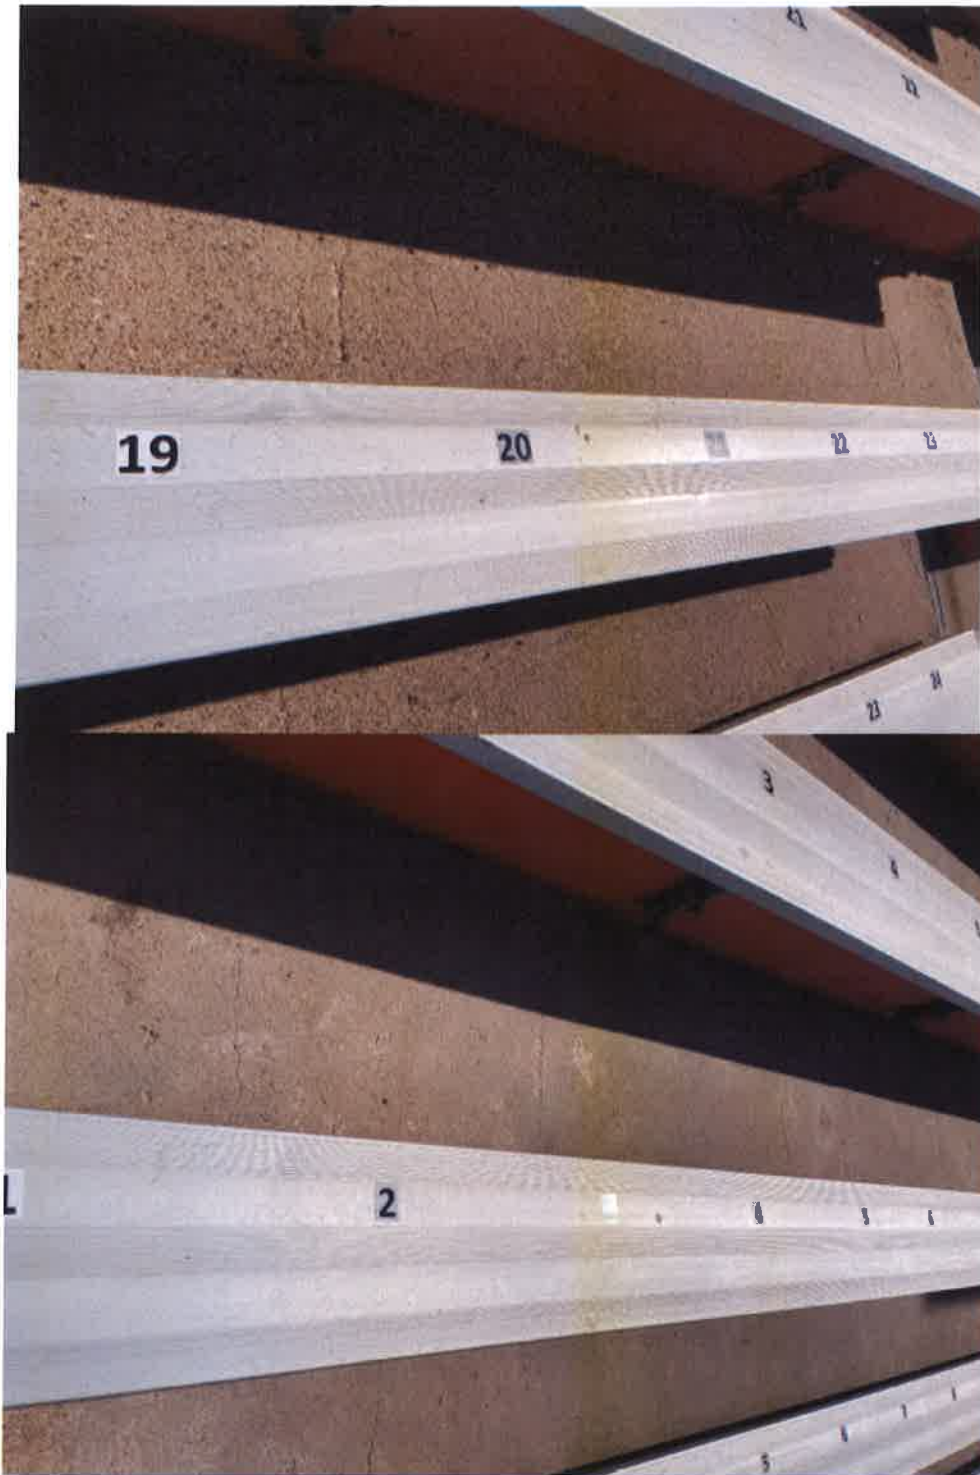
Photo 86: Typical Cracks at Uniformly Distributed For Entire Span on Each Beam

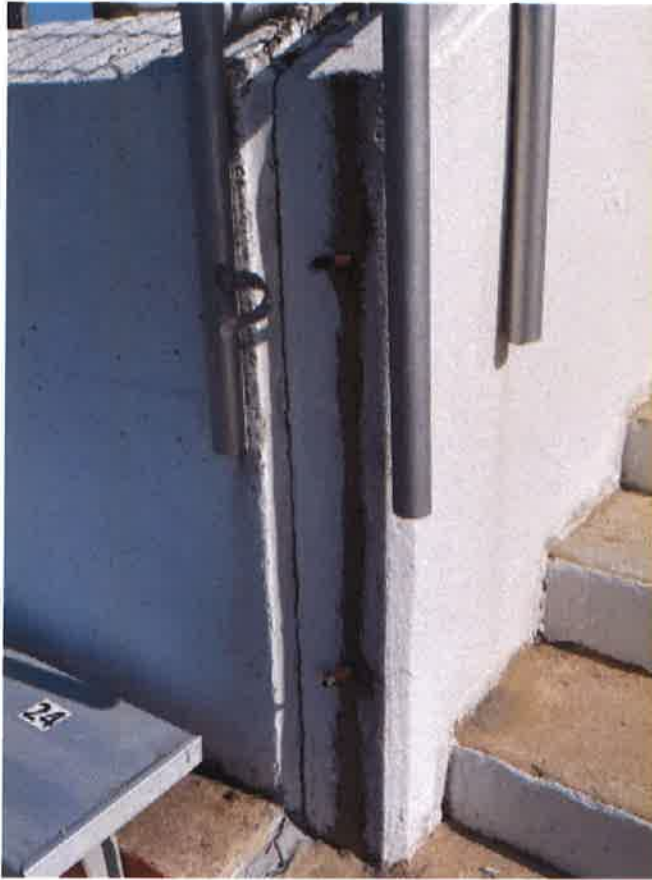
Photo 87: Protruding Rusted Anchor Bolt (Source of Hazard)

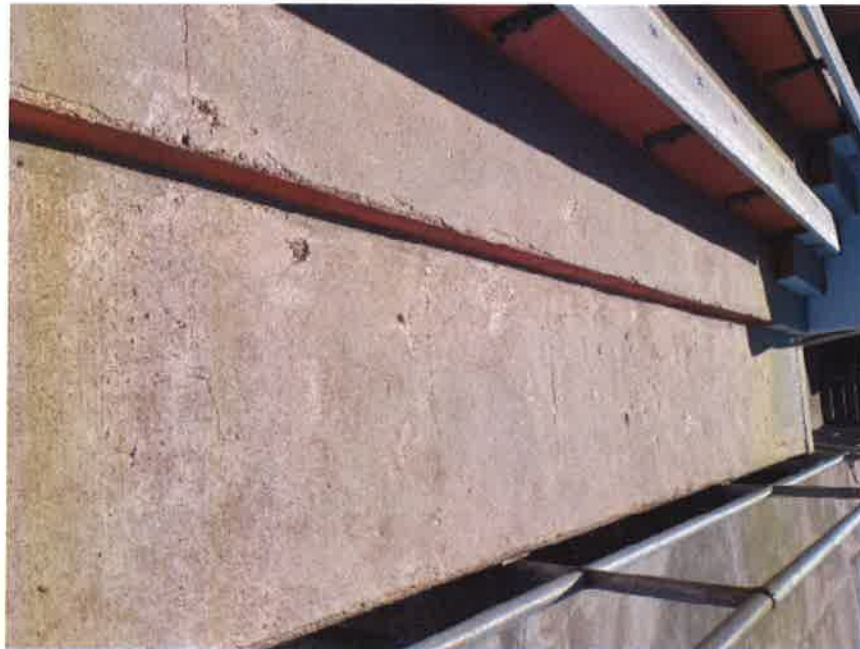
Photo 88: Delamination of Slab with Uniform Cracks for Entire Span

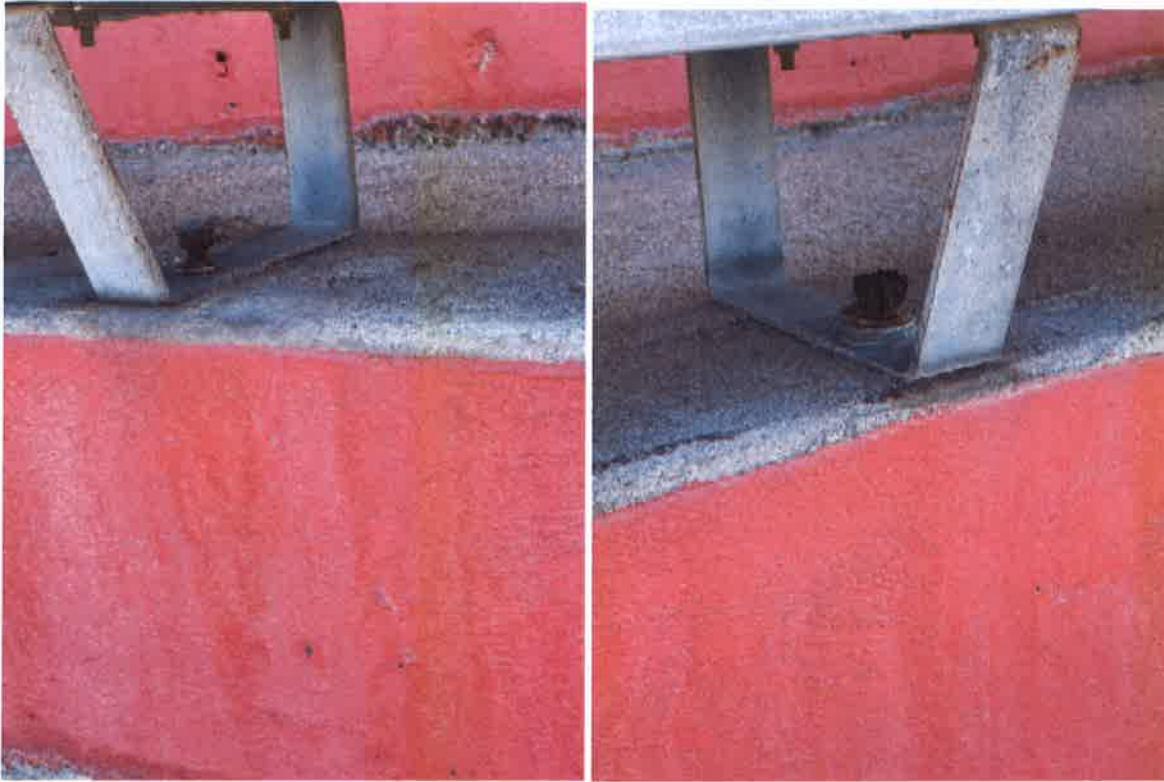
Photo 89: Improper Arrangement of Rusted Anchor Bolts

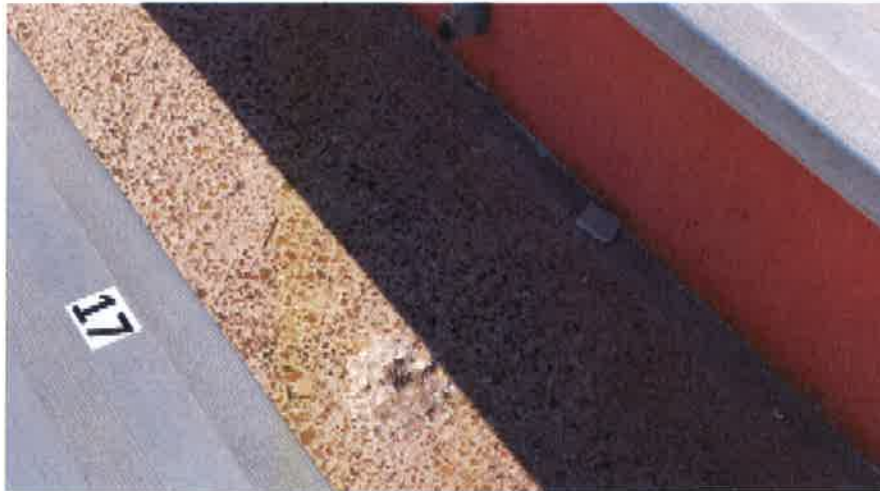
Photo 90: Potholes on Top of Secondary Beams
