Building Information - Wadsworth City (44974) - Central Intermediate School

Central Intermediate School is a four (4) story structure totaling 111,421 sf. The original facility of 37,162 sf was constructed in 1907. An Auditorium/Student Dining/Classroom wing addition of 44,635 sf was constructed in 1927. A second classroom wing addition, consisting of two (2) classroom area additions that were consecutively constructed in 1962 and 1966, totaling 6,925 sf was added to the complex in the 1960's. Recent renovations rendered the 1960's additions undistinguishable from each other and for the convenience of this report, are accounted under one addition. A gymnasium addition of 5,613 sf was constructed in 1973. A third classroom addition of 17,086 sf was constructed in 1990. The complex underwent extensive interior renovations in 2001 and currently contains one (1) gymnasium of 5,613 sf, one (1) student dining of 4,149 sf, one (1) kitchen of 1,358 sf, one (1) media center of 1,554 sf, and one (1) auditorium of 7,897 sf. Central Intermediate School currently provides space for grades 5-6. The 2001 facility renovations provided accessible accommodations but renovations do not fully conform

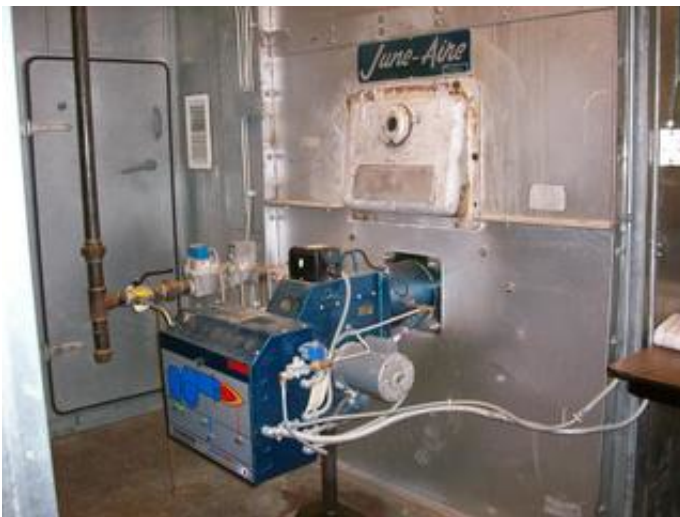
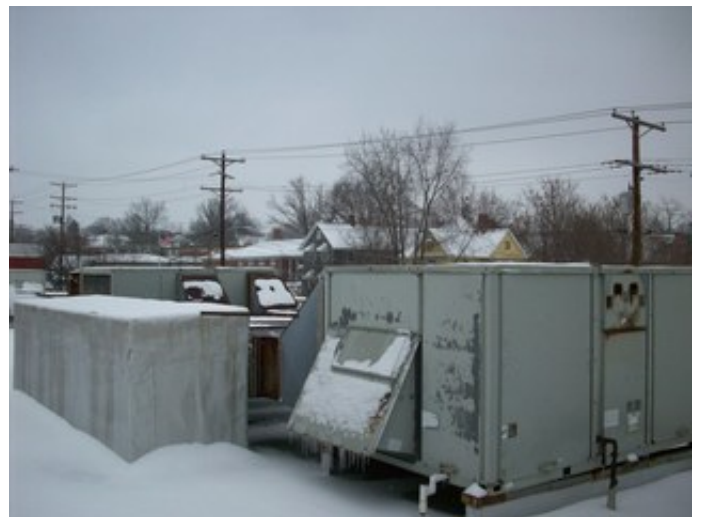
Rating: 3 Needs Replacement

Recommendations: Provide for complete replacement of the entire heating and cooling system and conversion of ductwork. Provide an OSDM compliant system throughout the entire complex.

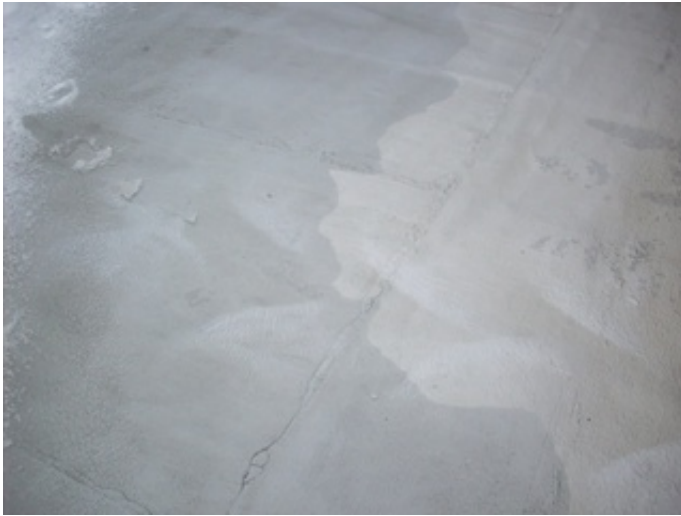
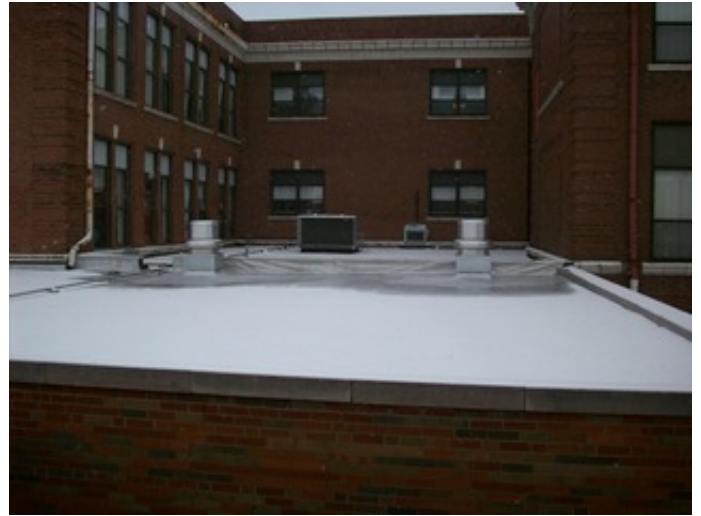
B. Roofing

Rating: 3 Needs Replacement

Recommendations: Provide for replacement of dated roof installations throughout the complex with an OSDM compliant membrane system.

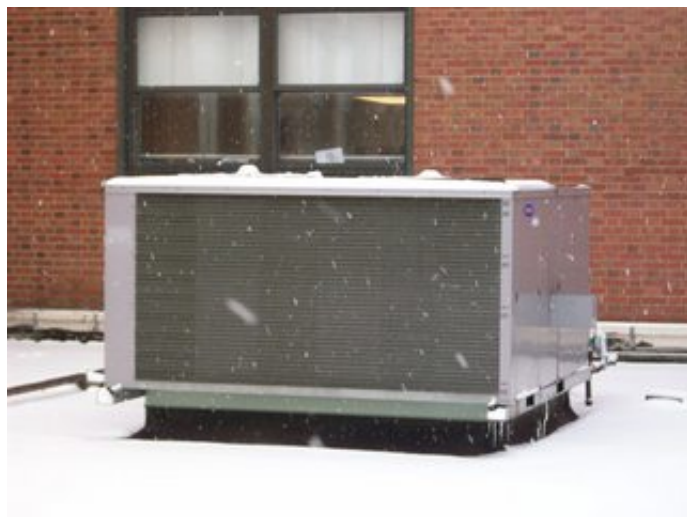
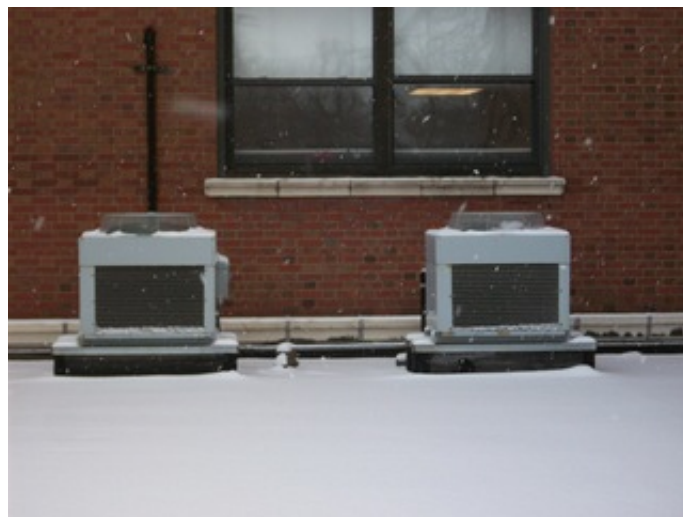
C. Ventilation / Air Conditioning

Description: The complex is equipped with forced air HVAC systems providing air conditioning throughout the entire facility. Cooling is provided by packaged roof top units and condensing units.

Recommendations: Provide for complete replacement of the air conditioning system throughout the entire complex to conform to OSDM requirement. Provision identified in Plate A.

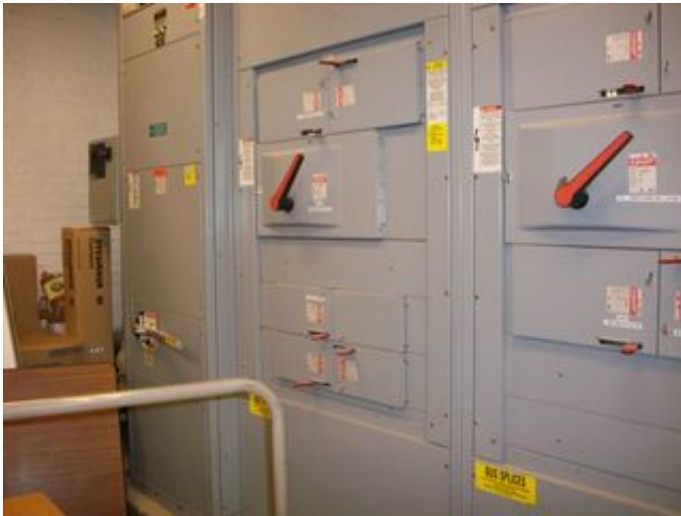
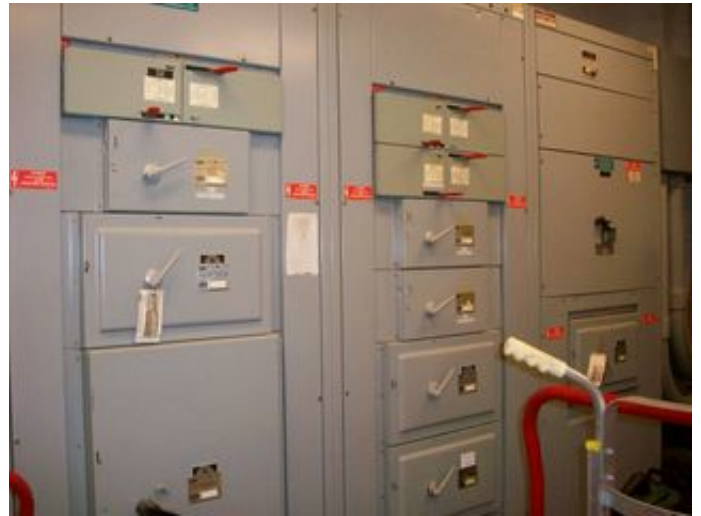
D. Electrical Systems

Description: The existing electrical system for the complex is a 480/277 volt service updated in 2001. The system installations increased capacity and district officials noted renovations included system distribution improvements of dated installations throughout the complex. The system is in satisfactory condition. The original 1907 building is constructed with wood framed floor assemblies. Renovation of this structure will impact system installations throughout the building.

Rating: 3 Needs Replacement

Recommendations: Provide for complete replacement of the electrical system at the 1907 building. System installations at the 1927, 1962, 1973, and 1990 additions are satisfactory.

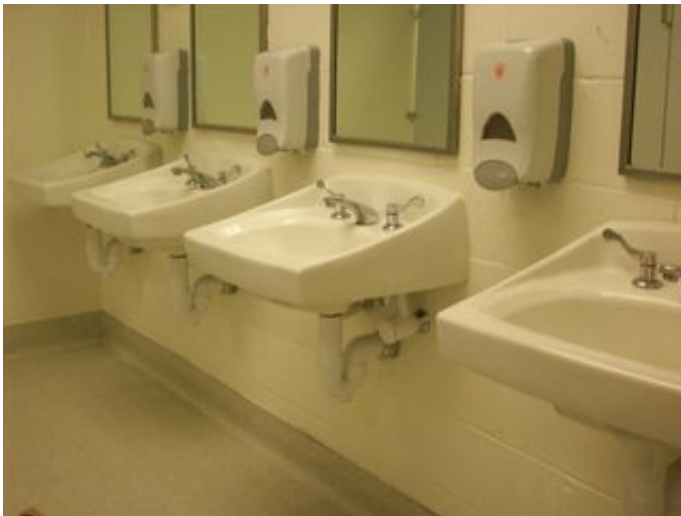
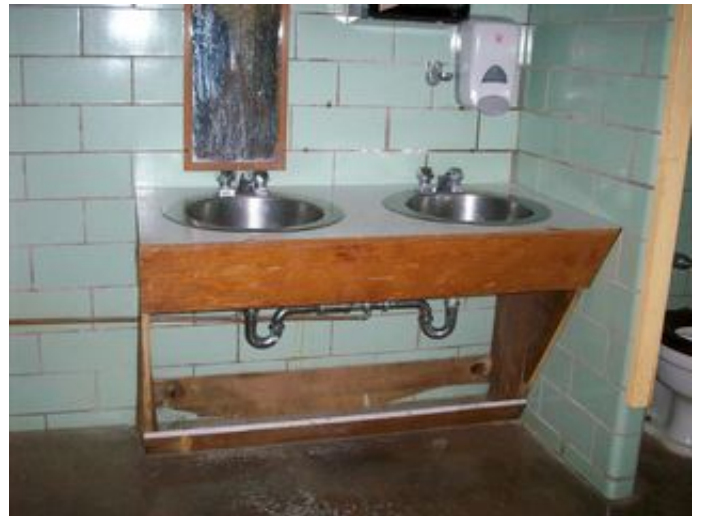
E. Plumbing and Fixtures

Description: The complex contains 8 large group restrooms (4 girls, 4 boys), 1 locker toilet (boys), 1 clinic toilet room with a shower and 6 staff and single occupancy toilet rooms. Fixtures are a combination of floor and wall mounted assemblies. The 1907 building houses the majority of the complex's toilet facilities. The majority of the installations were renovated to provide accessible accommodations, but will require replacement due to replacement of floor structures. Typical restrooms at the 1990 addition provide partial accessible accommodations, but do not fully conform to the provisions of the ADA guidelines. District officials noted recent plumbing renovations included replacement of dated piping installations with new copper pipe.

Rating: 3 Needs Replacement

Recommendations: Provide for replacement of all restrooms/toiletrooms and plumbing installations in the 1907 building. Replace dated floor and wall mounted fixtures and provide for full accessibility throughout the remaining portions of the complex. Additional provisions identified in Plate O.

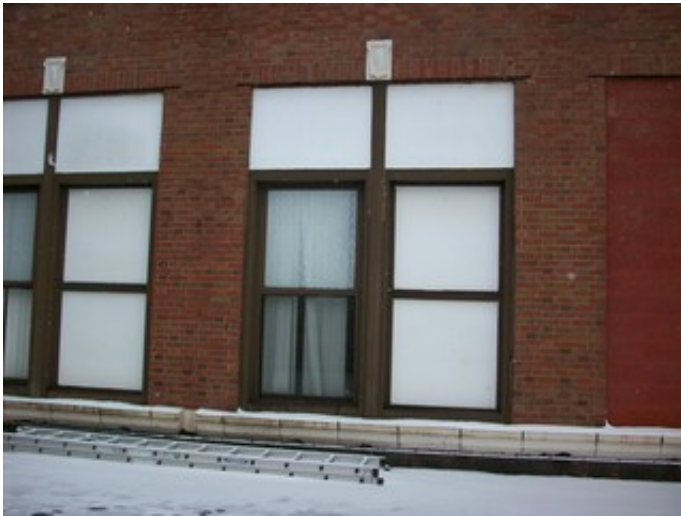
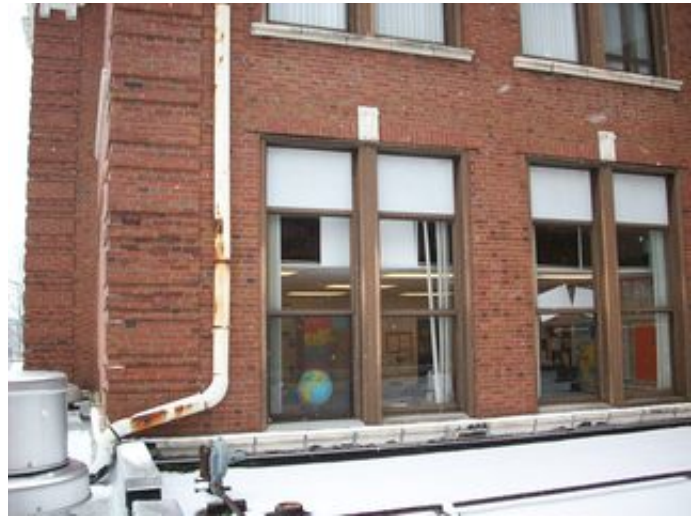
F. Windows

Description: The existing window assemblies at the 1907 building and the 1927 addition were updated in the distant past. The installations are deteriorated in some areas. A portion of the assemblies are equipped with single pane glazing. The 1990 addition is outfitted with operable window assemblies without integral blinds. The installations are original to the date of construction. District officials noted the operation of the units has been an issue of concern.

Rating: 3 Needs Replacement

Recommendations: Provide for complete replacement of all window assemblies to conform to OSDM standards and include integral blinds.

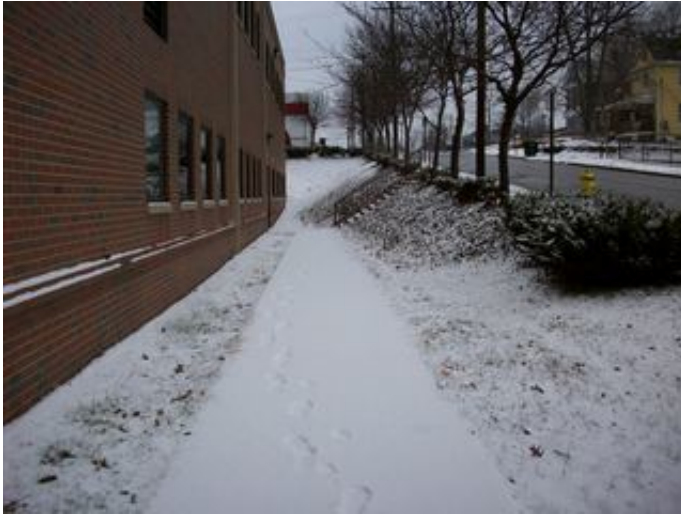
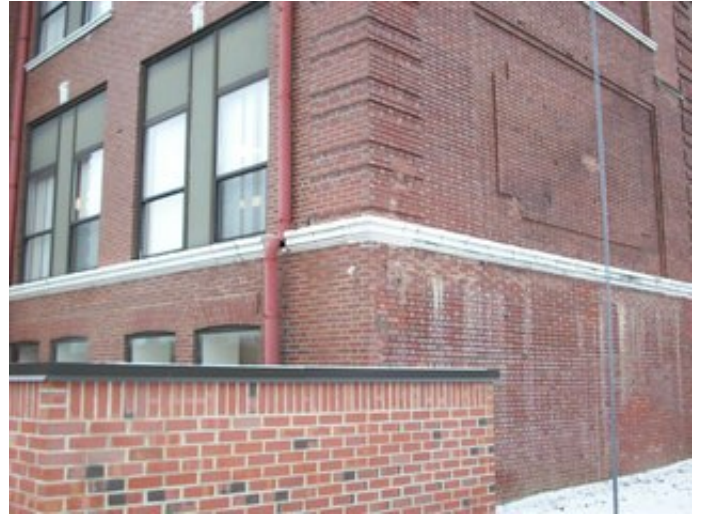
G. Structure: Foundation

Description: The existing complex contains a masonry/concrete foundation system. There were no significant areas of deterioration, cracking, or settlement.

Recommendations: No work is required at this time.

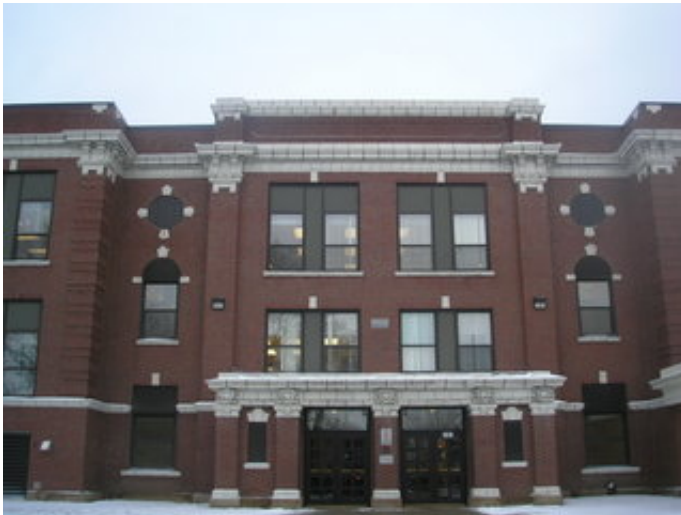
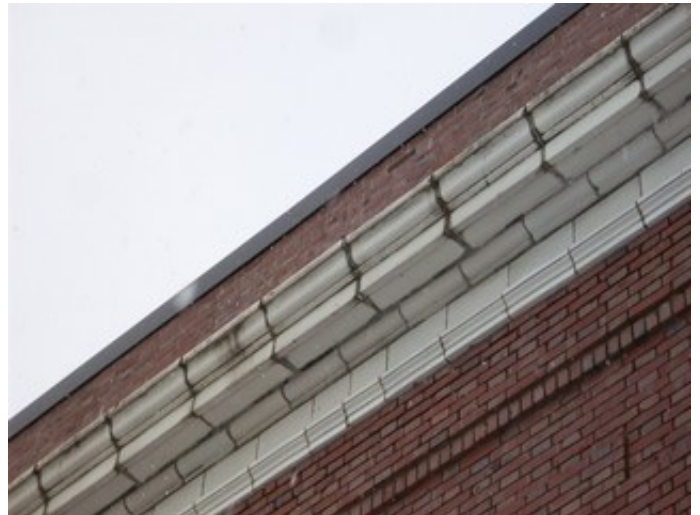
H. Structure: Walls and Chimneys

Description: The existing structures are constructed with masonry walls with brick exteriors. There are several areas of deterioration, especially at older portions of the complex. The 1907 building requires extensive tuckpointing over nearly 100% of the wall surfaces. The decorative masonry cornice and gutter system and masonry watertable require repair/restoration.

Rating: 3 Needs Replacement

Recommendations: Provide masonry cleaning, tuckpointing, masonry repairs, and sealing. Restore deteriorated cornice and watertable assemblies. Replace the deteriorated gutter and downspout systems.

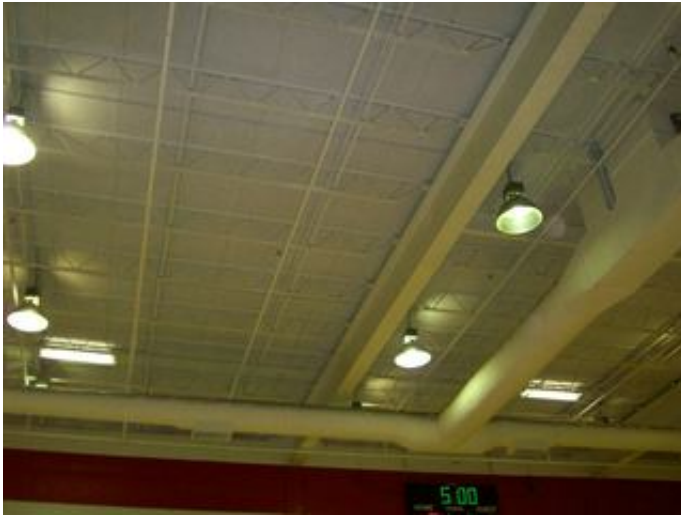
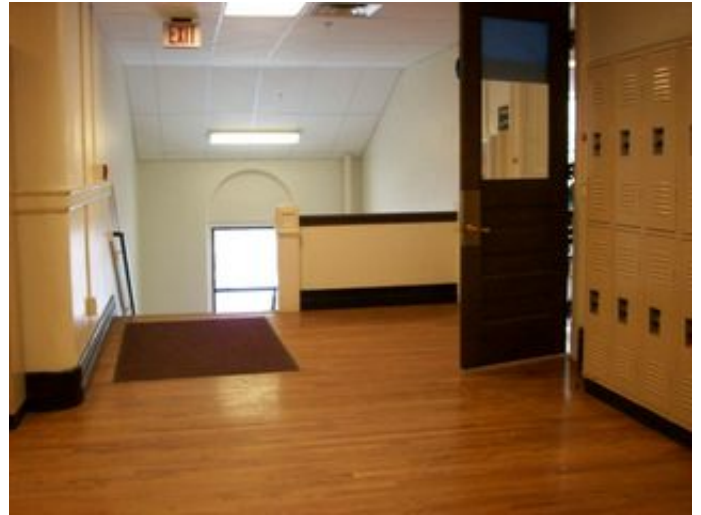
I. Structure: Floors and Roofs

Description: The floor construction for the 1927, 1962, 1973, and 1990 additions are slab-on-grade construction, a steel joist system, and concrete decking. The roof system for the structures are a steel joist system. The 1907 building is constructed with wood floor structures. There was no significant evidence of deterioration.

Recommendations: District architect reported 1907 building had drywall installed from a previous renovation to provide fire rating on wood structures and in compliance with OBBC.

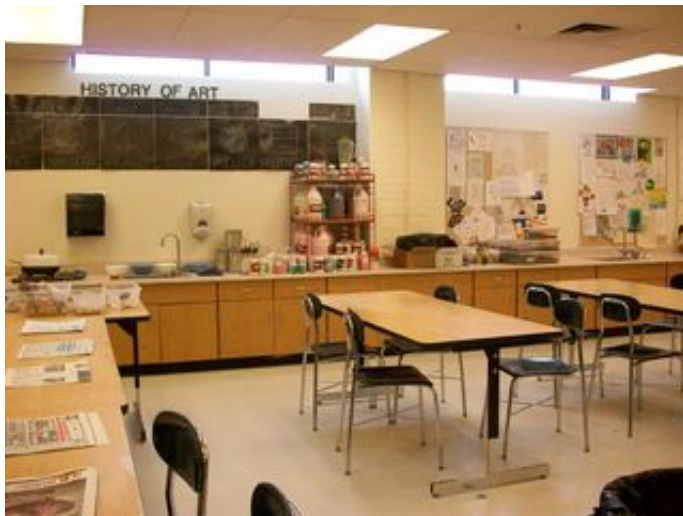
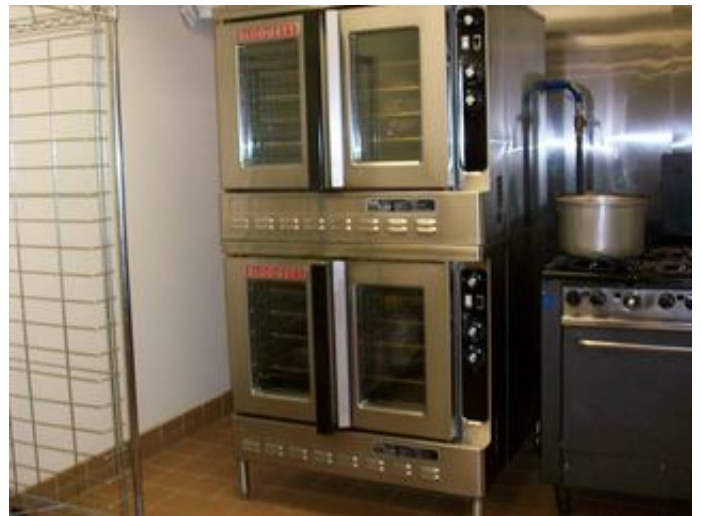
J. General Finishes

Description: The complex was recently renovated and the majority of finishes, casework, and locker installations were updated with new assemblies. The majority of door assemblies were equipped with lever hardware. Renovation work did not include complete replacement dated door assemblies. The ground floor of the 1927 addition was not updated with recent renovations. Tackboards/chalkboards were not replaced and dated assemblies remain at the older portions of the complex. Recent work included renovation of the kitchen and an update of the equipment. The gymnasium at the 1973 addition was equipped with wood bleachers and the gymnasium flooring requires refurbishing.

Rating: 3 Needs Replacement

Recommendations: Replace dated door and chalkboard/tackboard assemblies and classroom VCT and carpet flooring in 1907 original building. Update gymnasium flooring and bleacher seating. Replace all finishes at the ground floor of the 1927 addition and repair all finishes disturbed by proposed HVAC system replacement.

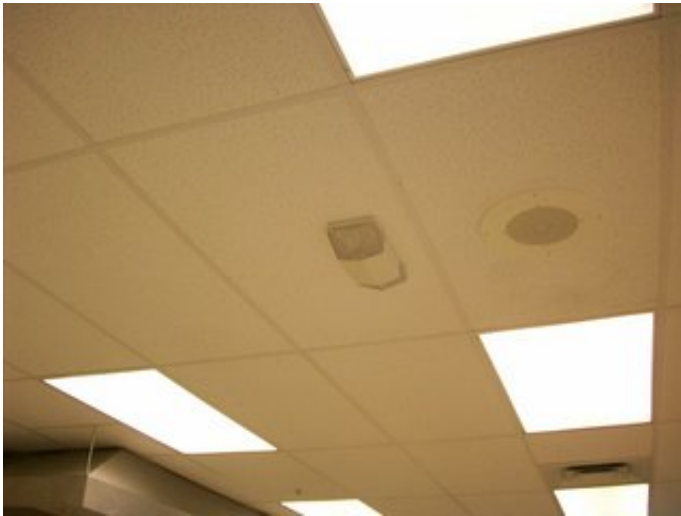
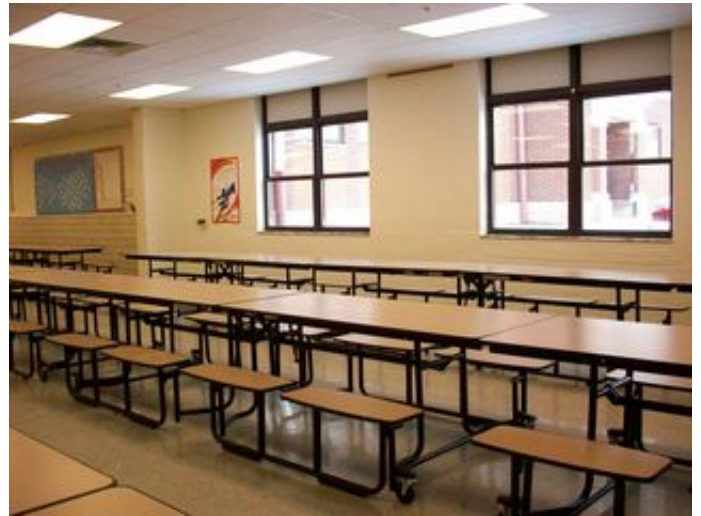
K. Interior Lighting

Description: The entire complex contains fluorescent and incandescent lighting. Lighting levels are: art room- 84/64 fc, band room- 84/64 fc, choir room- 51 fc, media center- 74.1 fc, kitchen- 63 fc, typical classroom 1907/1927 additions 83-95.9 fc, and typical classroom 1990 addition-39.6-51.6 fc. The 1907 and 1927 structures are equipped with dual level lighting.

Rating: 3 Needs Replacement

Recommendations: Provide complete replacement of lighting due to addition of an HVAC system.

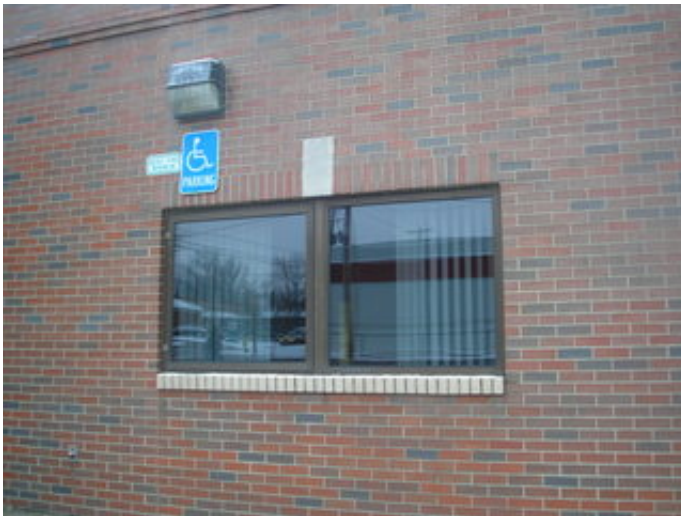
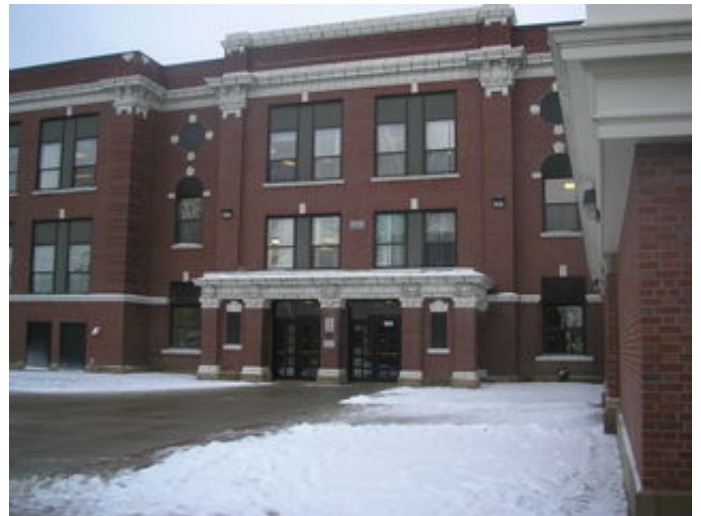
L. Security Systems

Rating: 3 Needs Replacement

Recommendations: Provide upgrade of the security system and site lighting to conform to OSDM standards.

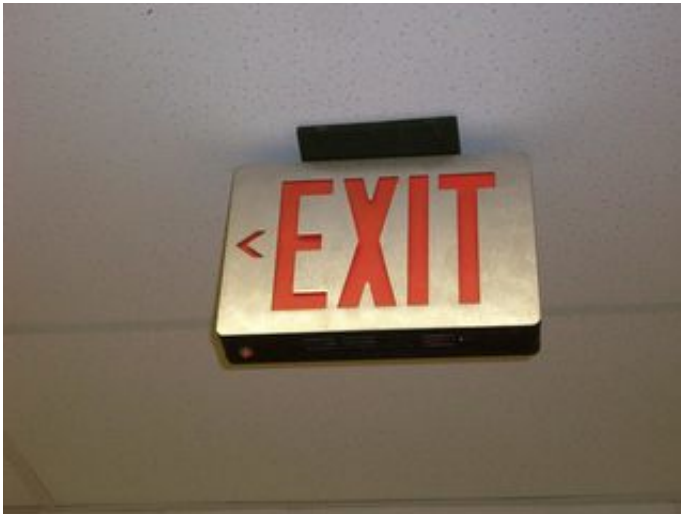
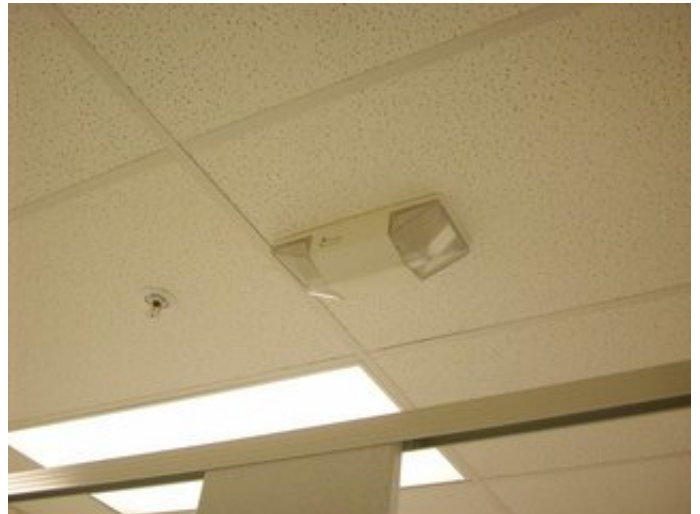
M. Emergency/Egress Lighting

Rating: 3 Needs Replacement

Recommendations: Provide complete replacement of the emergency/egress lighting system due to addition of an HVAC system.

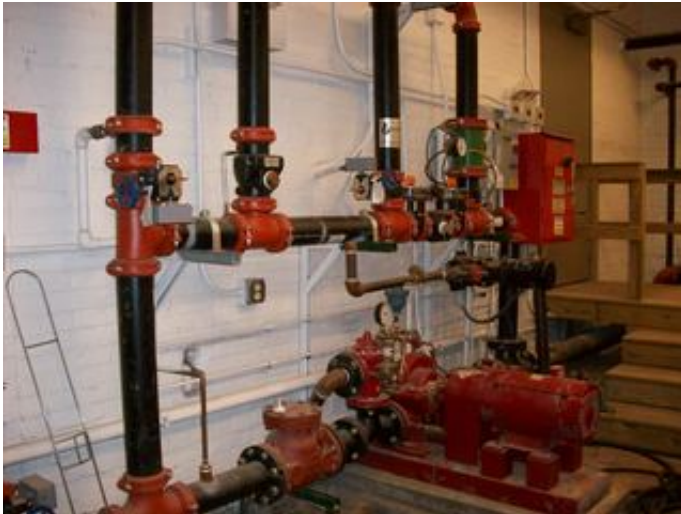
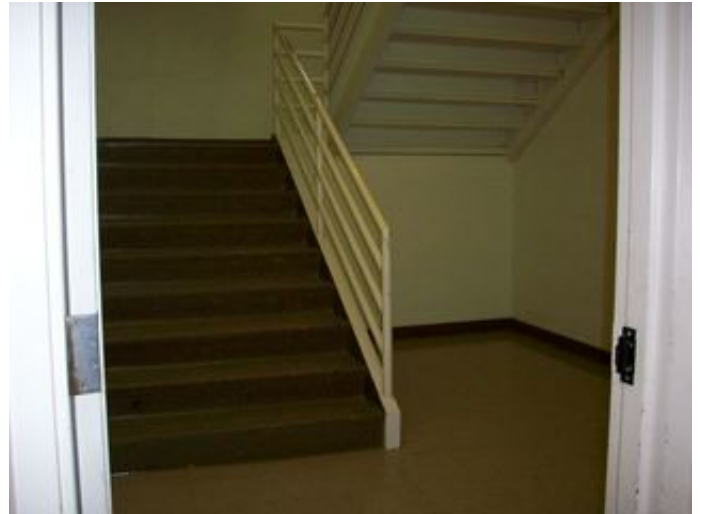
- Description:** The complex is equipped with an automated suppression system. The sprinkler control room is located in the 1907 building. The proposed renovation of the existing HVAC system is likely to require modification of the existing system. A portion of the egress stairs are unenclosed. The majority of the interior handrail/guardrail systems do not conform to current code provisions or ADA guidelines.
- Rating:** 3 Needs Replacement
- Recommendations:** Provide for replacement/modification of the existing fire suppression system throughout. A portion of the existing system may be reuseable. Provide handrail/guardrail systems to conform to OSDM standards and enclose open stair assemblies.
