Name of Appraiser	Tony Schorr	Date of Appraisal	2008-02-07
Building Name	Central Intermediate School		
Street Address	151 Main Street		
City/Town, State, Zip Code	Wadsworth, Ohio, OH 44281		
Telephone Number(s)	330-335-1480		
School District	Wadsworth City SD

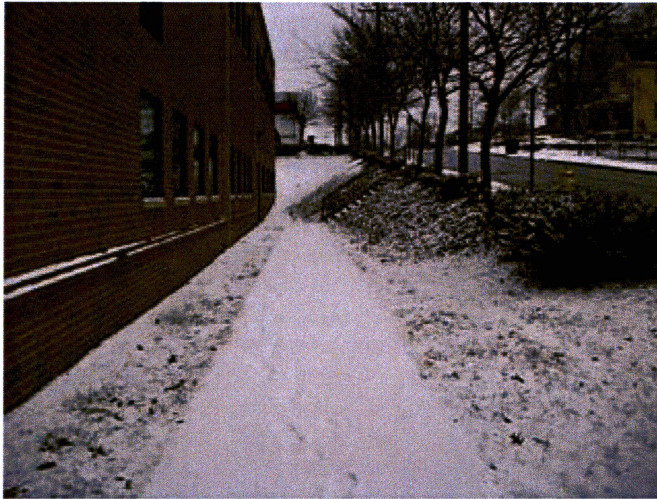
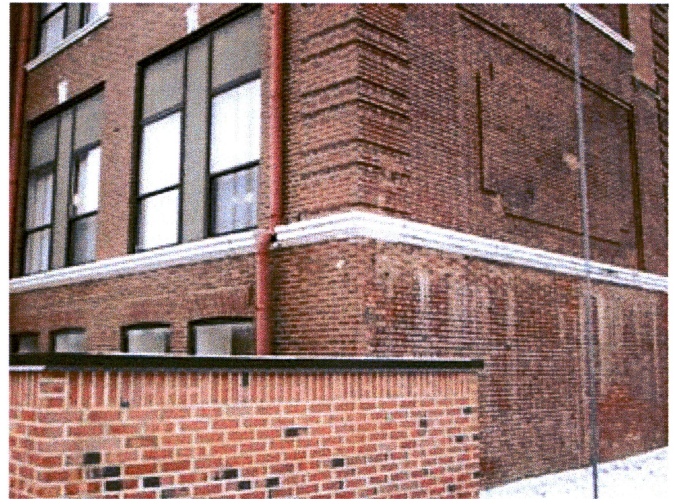
G. Structure: Foundation

Description: The existing complex contains a masonry/concrete foundation system. There were no significant areas of deterioration, cracking, or settlement.

Rating: 1 Satisfactory

Recommendations: No work is required at this time.

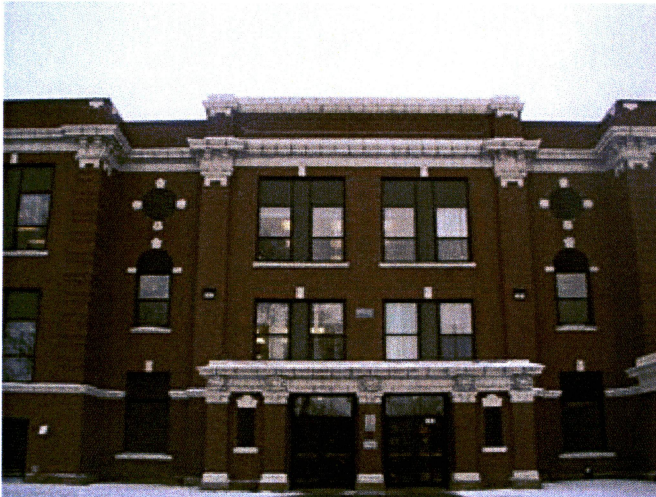
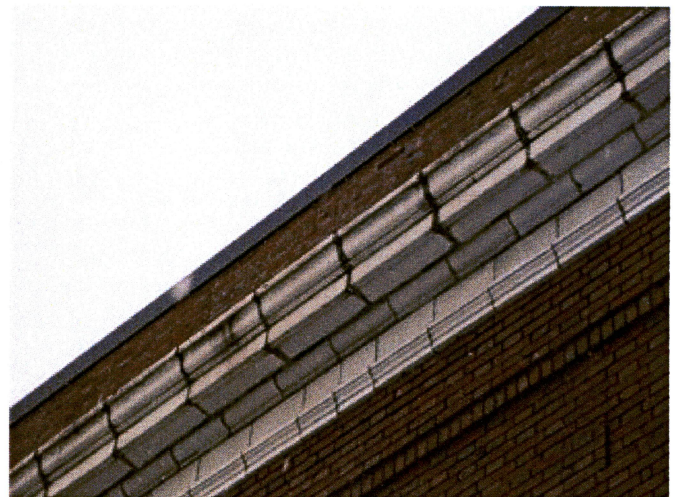
H. Structure: Walls and Chimneys

Description: The existing structures are constructed with masonry walls with brick exteriors. There are several areas of deterioration, especially at older portions of the complex. The 1907 building requires extensive tuckpointing over nearly 100% of the wall surfaces. The decorative masonry cornice and gutter system and masonry watertable require repair/restoration.

Rating: 3 Needs Replacement

Recommendations: Provide masonry cleaning, tuckpointing, masonry repairs, and sealing. Restore deteriorated cornice and watertable assemblies. Replace the deteriorated gutter and downspout systems.

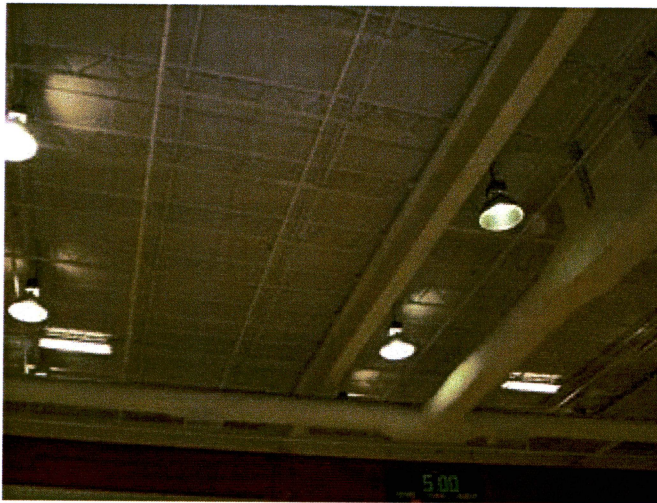
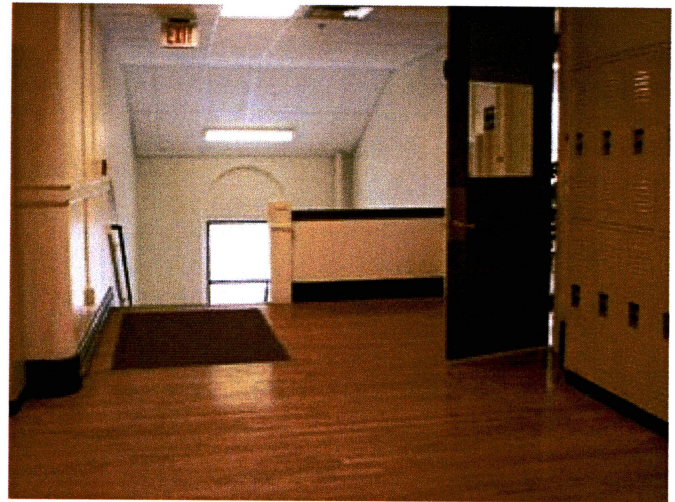
I. Structure: Floors and Roofs

Description: The floor construction for the 1927, 1962, 1973, and 1990 additions are slab-on-grade construction, a steel joist system, and concrete decking. The roof system for the structures are a steel joist system. The 1907 building is constructed with wood floor structures. There was no significant evidence of deterioration.

Rating: 3 Needs Replacement

Recommendations: Provide for complete replacement of the wood structures at the 1907 building to conform to OSDM standards.

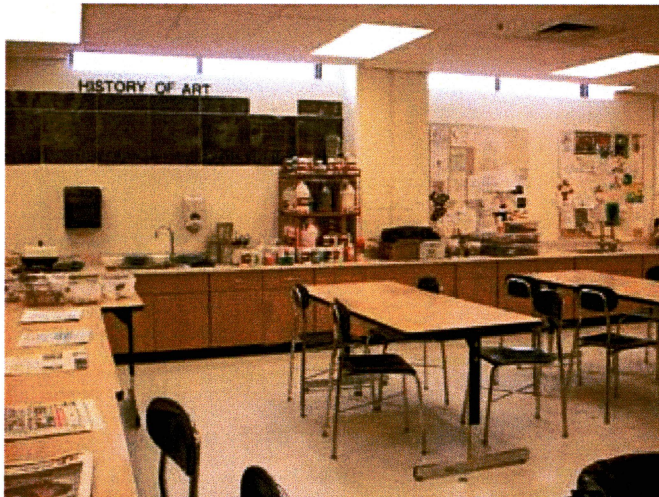
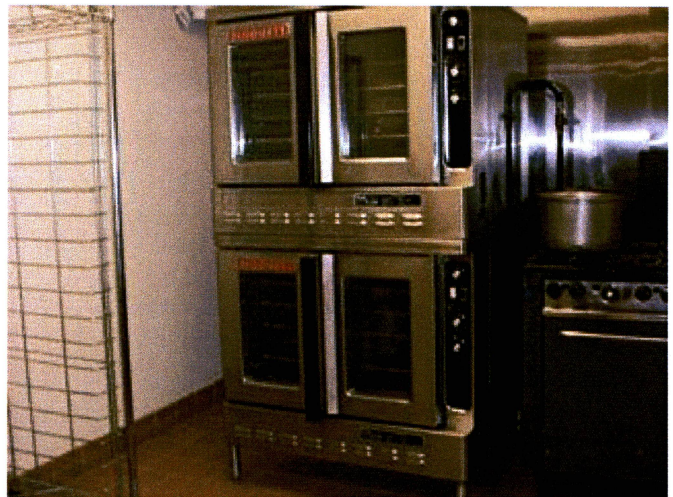
J. General Finishes

Description: The complex was recently renovated and the majority of finishes, casework, and locker installations were updated with new assemblies. The majority of door assemblies were equipped with lever hardware. Renovation work did not include complete replacement dated door assemblies. The ground floor of the 1927 addition was not updated with recent renovations. Tackboards/chalkboards were not replaced and dated assemblies remain at the older portions of the complex. Recent work included renovation of the kitchen and an update of the equipment. The gymnasium at the 1973 addition was equipped with wood bleachers and the gymnasium flooring requires refurbishing.

Rating: 3 Needs Replacement

Recommendations: Provide for complete replacement of all finishes and casework at the 1907 building due to structure replacement. Replace dated door and chalkboard/tackboard assemblies. Update gymnasium flooring and bleacher seating. Replace all finishes at the ground floor of the 1927 addition and repair all finishes disturbed by proposed HVAC system replacement.

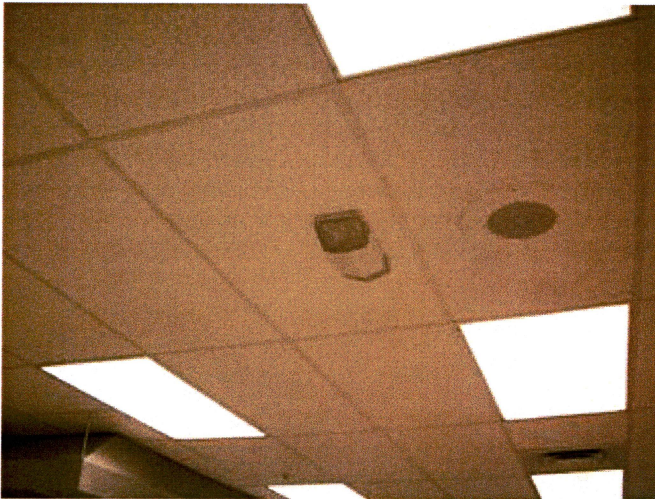
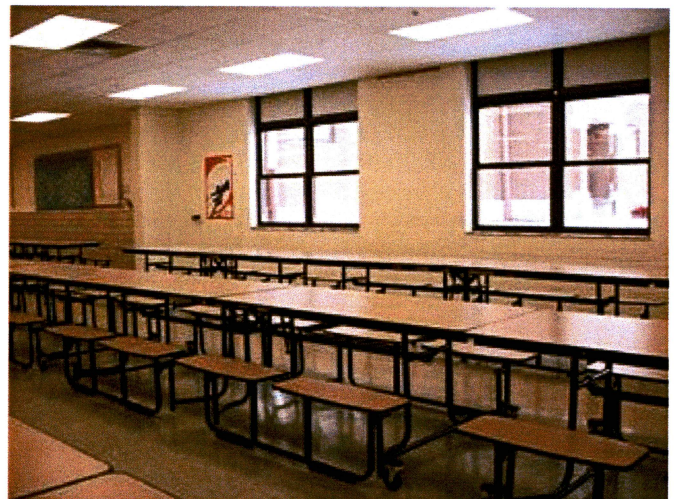
K. Interior Lighting

Description: The entire complex contains fluorescent and incandescent lighting. Lighting levels are: art room- 84/64 fc, band room- 84/64 fc, choir room- 51 fc, media center- 74.1 fc, kitchen- 63 fc, typical classroom 1907/1927 additions 83-95.9 fc, and typical classroom 1990 addition-39.6-51.6 fc. The 1907 and 1927 structures are equipped with dual level lighting.

Rating: 3 Needs Replacement

Recommendations: Provide complete replacement of lighting due to addition of an HVAC system.

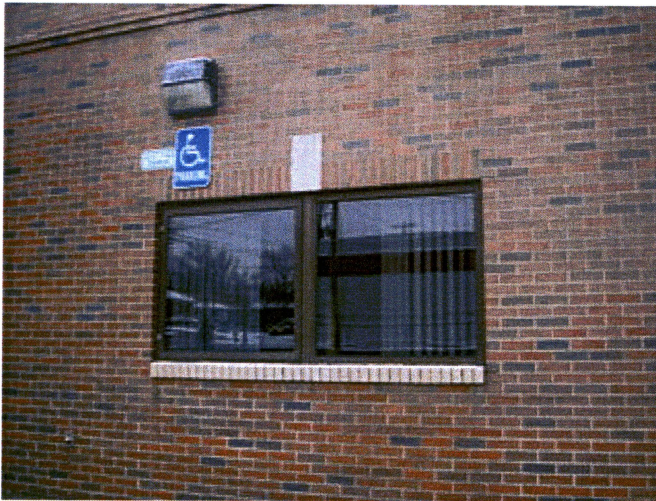
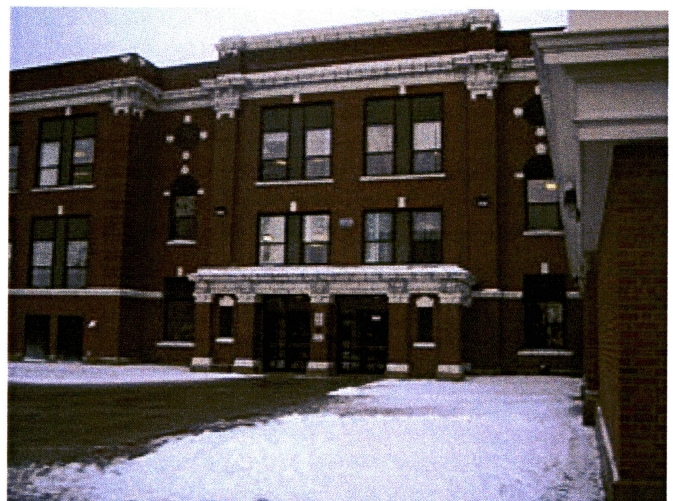
L. Security Systems

Description: The current security system is a camera and motion sensor security system. A portion of entrances are equipped with control access. District officials noted the system did not provide adequate coverage of the complex. Site lighting is provided by building mounted fixtures. The system provided limited illumination of the exterior site.

Rating: 3 Needs Replacement

Recommendations: Provide upgrade of the security system and site lighting to conform to OSDM standards.

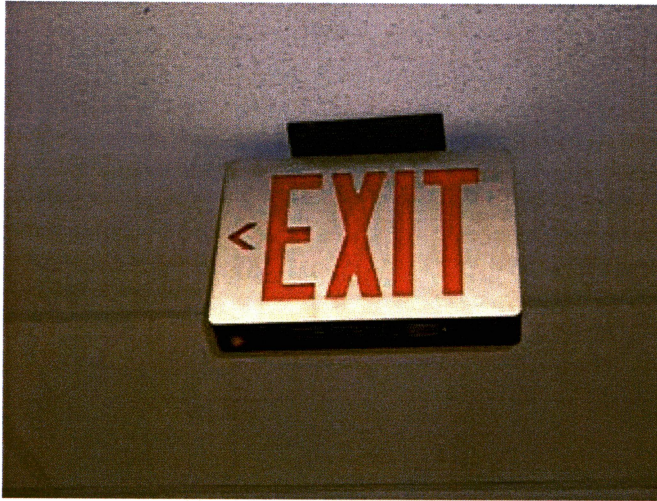
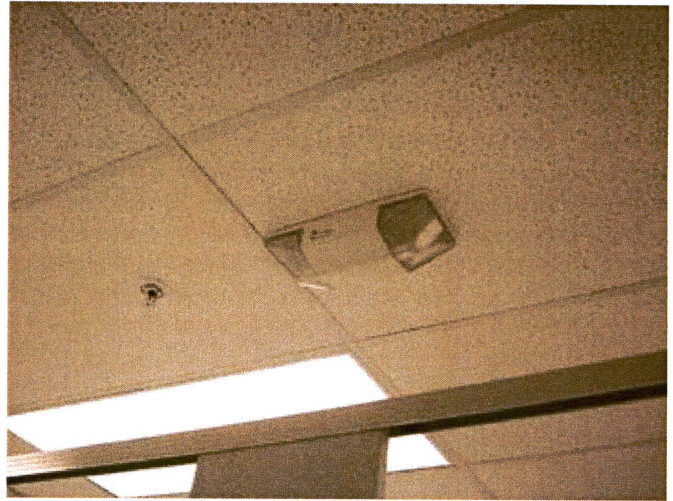
M. Emergency/Egress Lighting

Description: The facility is equipped with an updated emergency egress lighting system and exit signs. Existing fixture installations are likely to be disturbed by proposed renovation work.

Rating: 3 Needs Replacement

Recommendations: Provide complete replacement of the emergency/egress lighting system due to addition of an HVAC system.

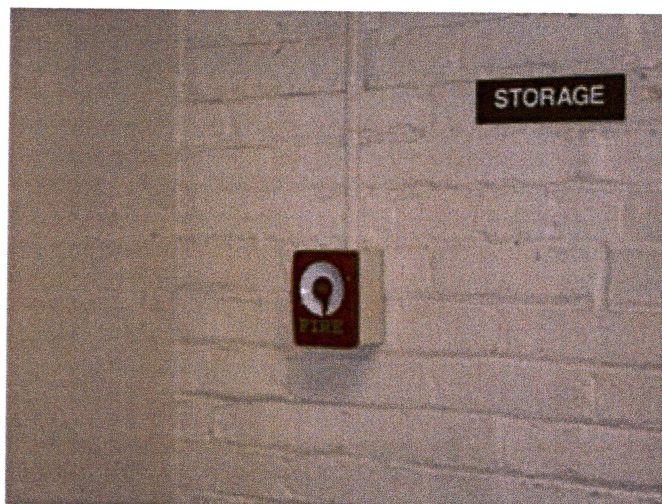
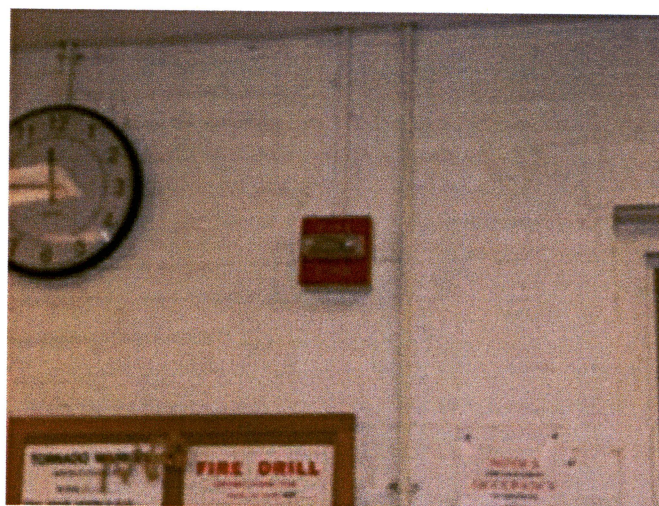
N. Fire Alarm

Description: The facility is equipped with an updated fire alarm system with manual pull stations and horn/strobe signals. The system is satisfactory.

Rating: 3 Needs Replacement

Recommendations: Provide for system replacement at the 1907 building due to structure renovation. The system installations at the 1927, 1962, 1973, and 1990 additions are satisfactory.

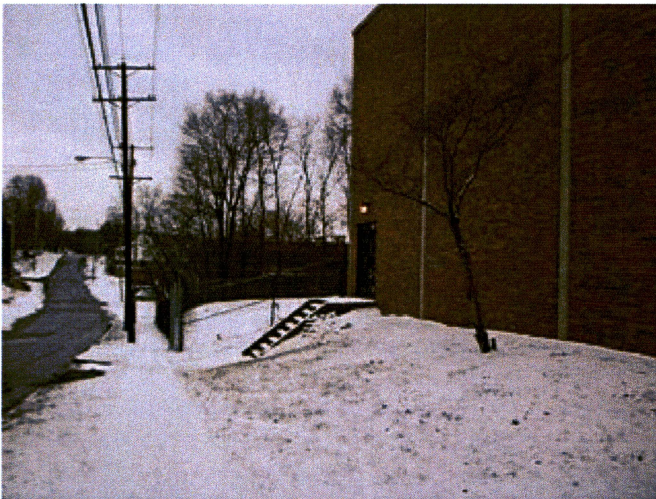
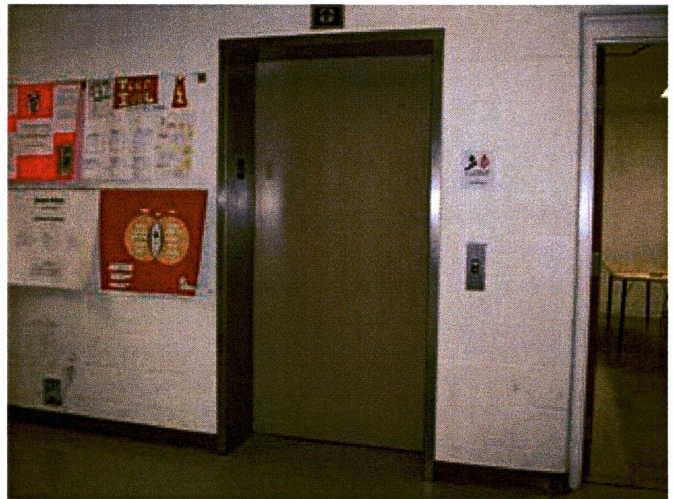
O. Handicapped Access

The complex was recently renovated to provide accessible accommodations throughout the majority of the complex. Renovation work included installation of multiple elevators and ramps to provide access to all interior levels of the complex. The majority of door assemblies were equipped with lever hardware but improvements did not include replacement of dated door assemblies. A portion of the existing door installations do not provide the required maneuvering clearances. A portion of entrances are elevated and are not accessible. The street grade along the east facade exceeds accessible grade parameters, hindering access to the facility from Lyman Street. A portion of the existing toilet rooms/restrooms are not fully accessible. The majority of drinking fountains were updated with accessible fixtures, but a portion of these did not provide required maneuvering or multi-height accommodations.

3 Needs Replacement

Provide for full accessibility throughout the entire complex in conformance with the provisions of the ADA and OSDM requirements.

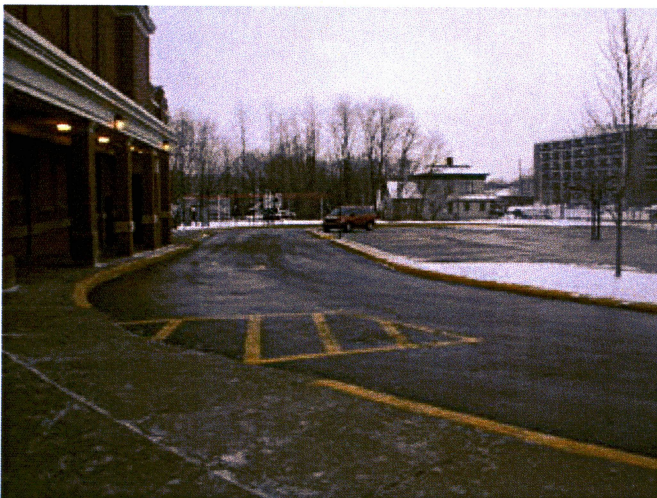
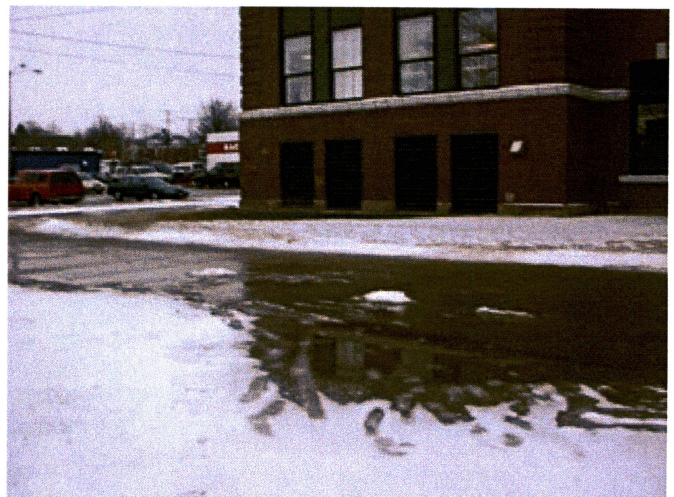
P. Site Condition

Buses load/unload along a separated drive which circulates through a gated dual purpose hard surface play area/parking area. The drive is separated from the adjoining area with curbing. District officials noted parking was not adequate to serve the needs of the school. Pavements are deteriorated in a few areas. A portion of the site's walks are poorly graded and ponding water. A portion of the pavements were covered with snow, hindering full assessment of the area at the time of the visit. The exterior stair assemblies are deteriorated in a few areas. The exterior handrails/guardrails do not conform to current code provisions or are non-existent.

3 Needs Replacement

Replace deteriorated walks and pavements. Replace deteriorated stair assemblies and provide a code compliant handrail/guardrail system at all locations. Provide additional parking.

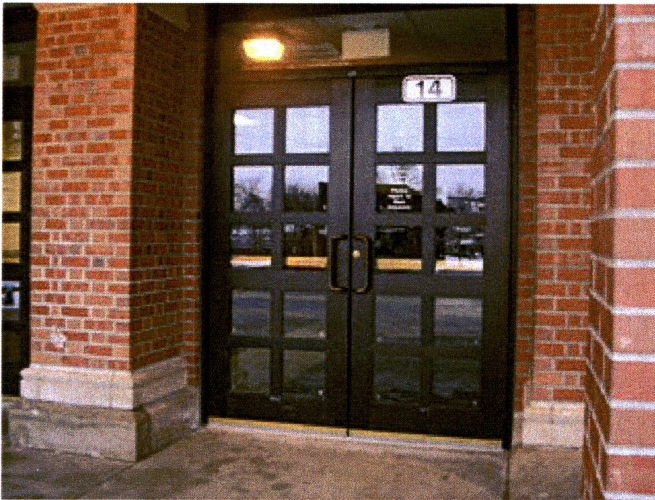
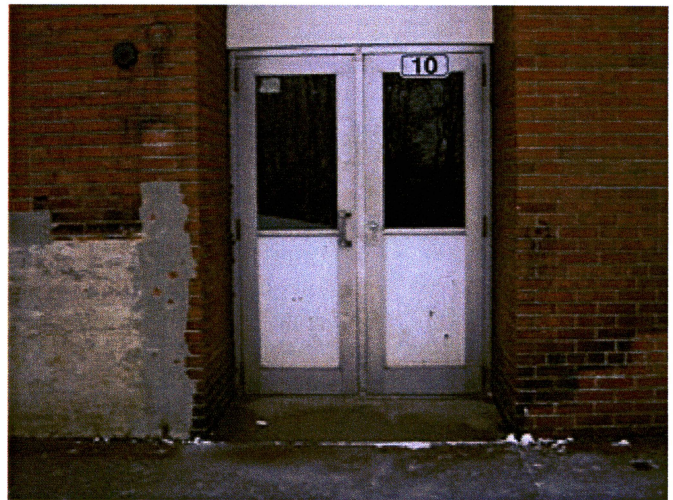
S. Exterior Doors

Description: The majority of the existing door assemblies for the entire complex were updated with new installations. A portion of the units were equipped with single pane glazing. Dated door assemblies remain in a few areas.

Rating: 3 Needs Replacement

Recommendations: Provide for replacement of dated door assemblies. Replace door assemblies, equipped with single pane glazing, with thermally efficient installations.

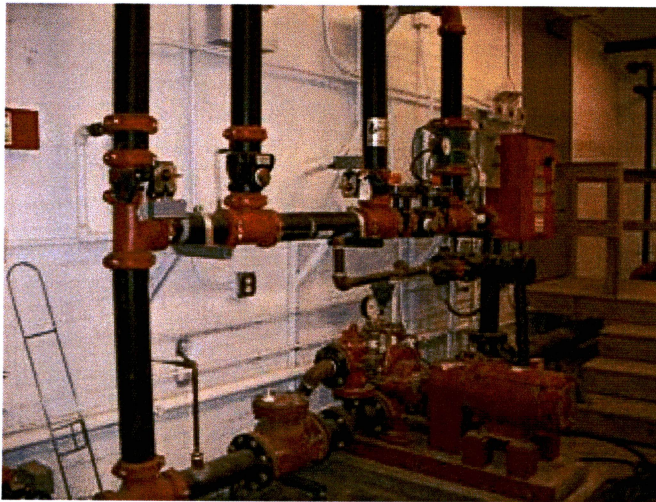
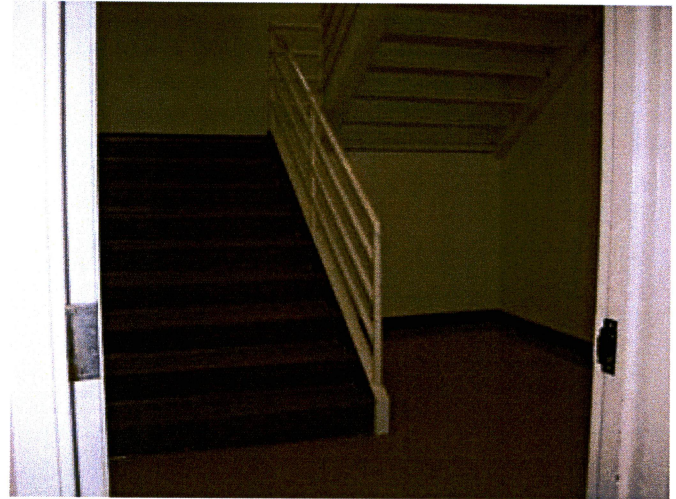
U. Life Safety

The complex is equipped with an automated suppression system. The sprinkler control room is located in the 1907 building. The proposed renovation of the existing HVAC system is likely to require modification of the existing system. A portion of the egress stairs are unenclosed. The majority of the interior handrail/guardrail systems do not conform to current code provisions or ADA guidelines.

3 Needs Replacement

Provide for replacement/modification of the existing fire suppression system throughout. A portion of the existing system may be reuseable. Provide handrail/guardrail systems to conform to OSDM standards and enclose open stair assemblies.

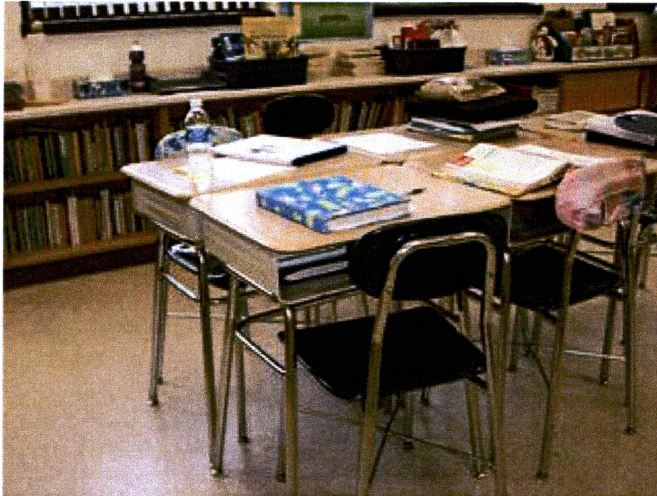
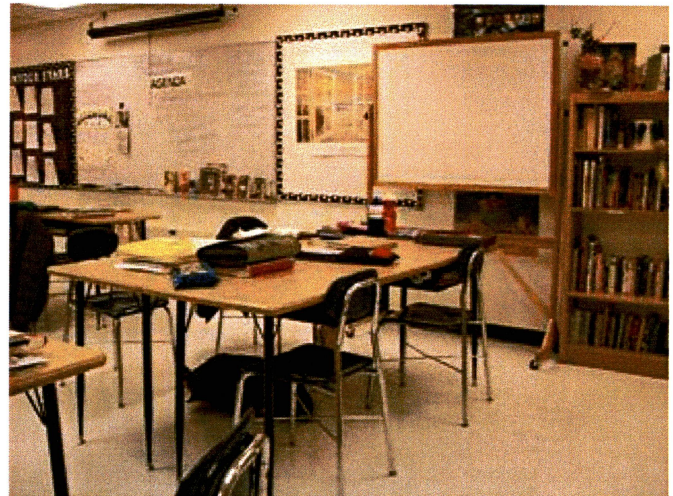
V. Loose Furnishings

Description: A portion of the existing furnishings were updated with newer installations.

Rating: 3 Needs Replacement

Recommendations: Provide for furnishing replacement based upon the rating of 7 given for item 6.17 of the attached CEFPI rating.

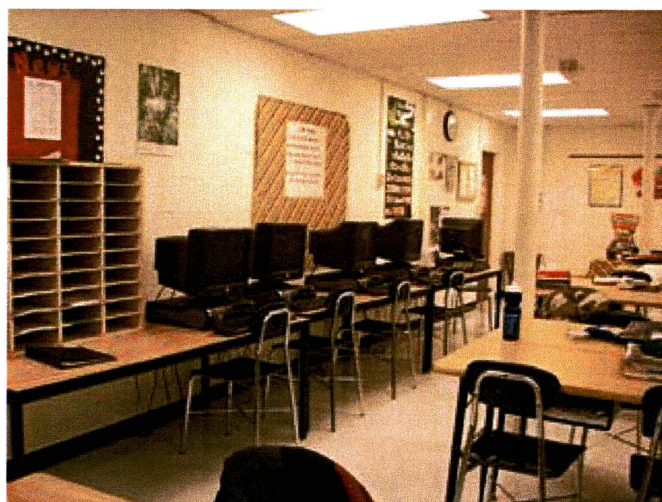
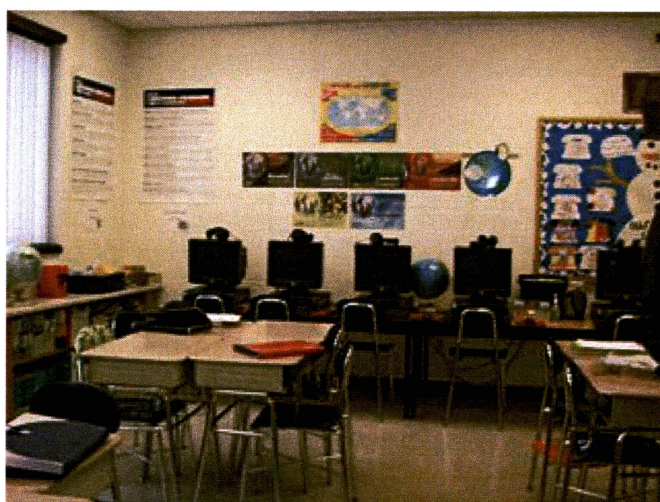
W. Technology

Description: Typical classrooms are equipped with 5-7 data ports for teacher and student use and telephones. Classrooms are not equipped with projection provisions.

Rating: 3 Needs Replacement

Recommendations: Replace all wiring due to renovation to be undertaken and to fully conform to OSDM standards.
