Central Intermediate School

CIS Committee Recommendations

November 20, 2017

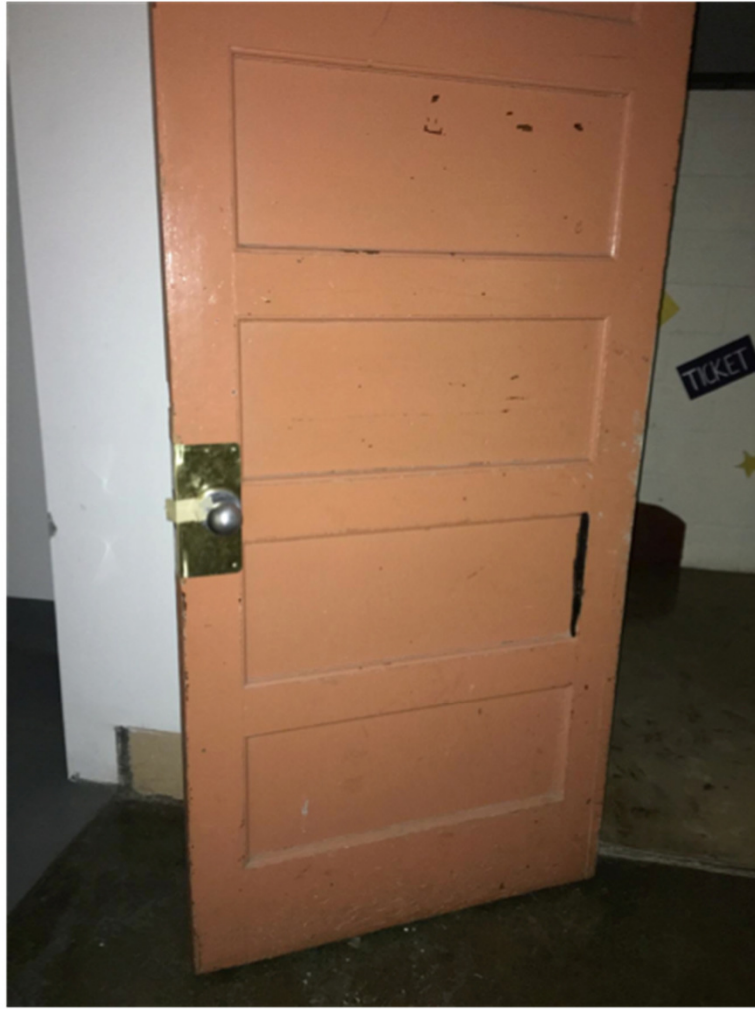
Figure 2-9

Interior Conditions

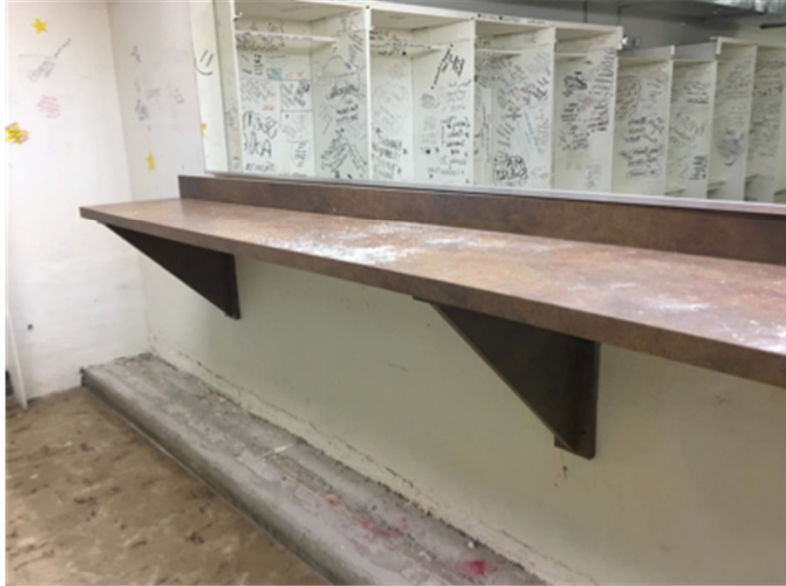
Figure 5-7

Interior Conditions

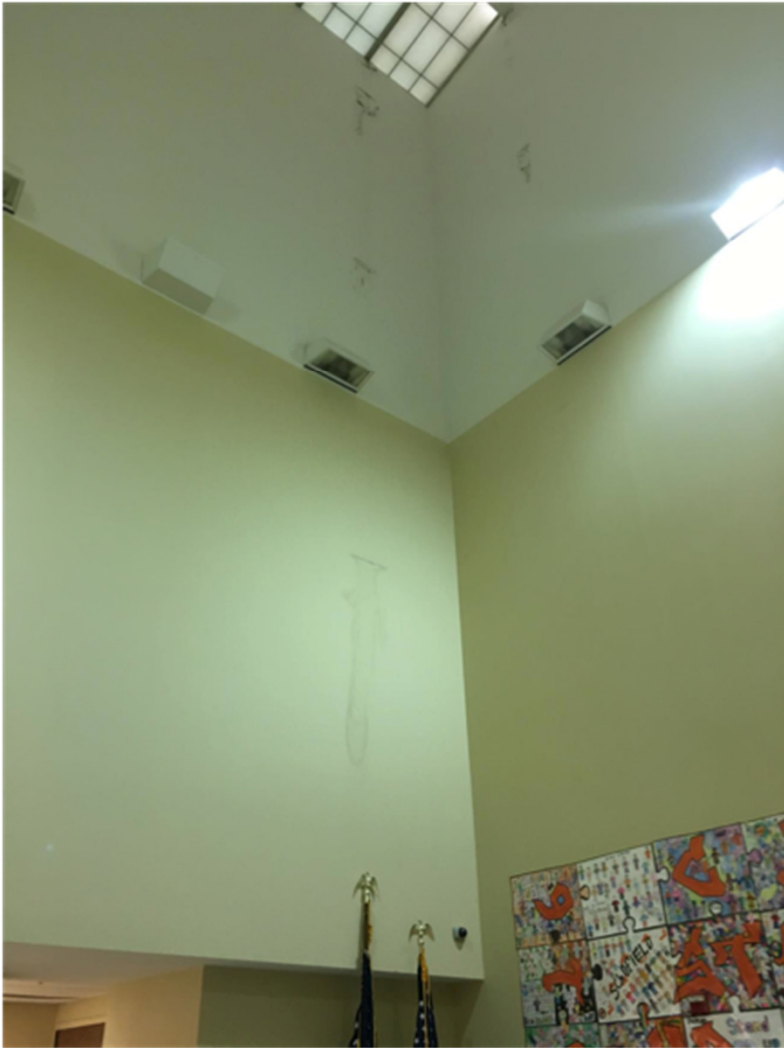
Figure 6-7

Interior Water Damage

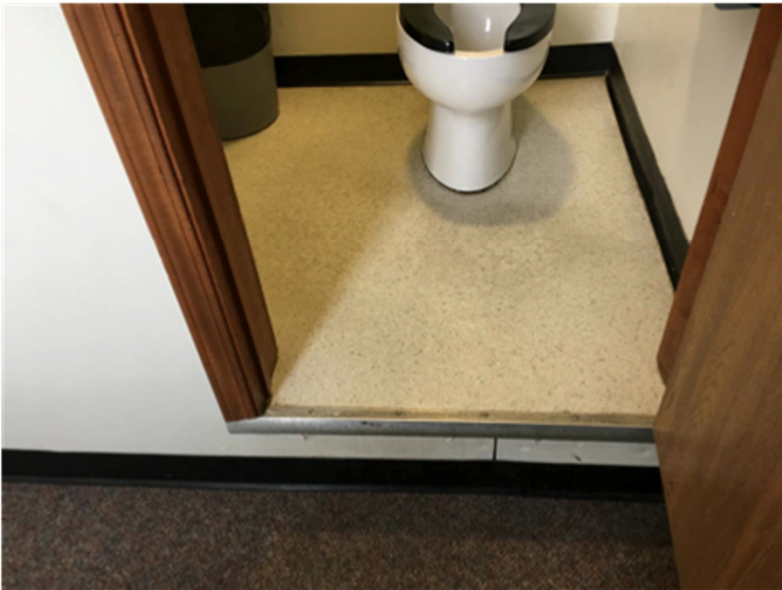
Figure 2-17

ADA Compliance Issues

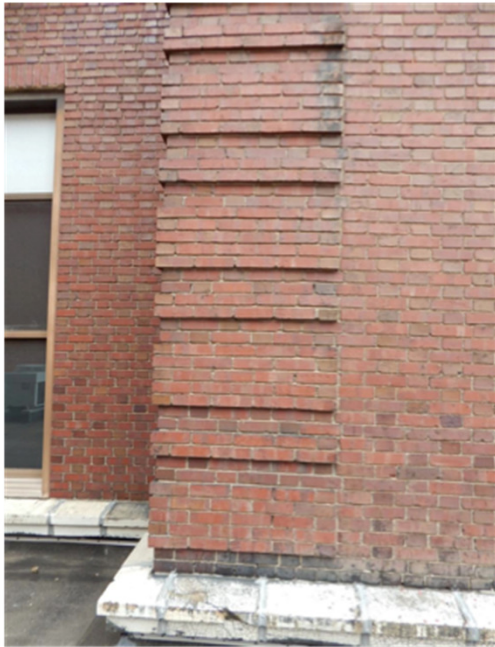
Figure 3-1

Exterior Deterioration

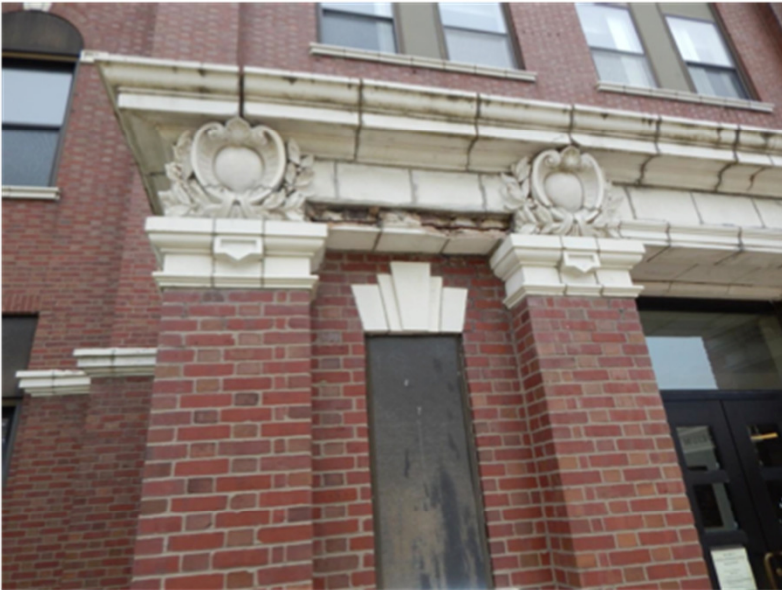
Figure 3-8

The terra cotta detail is cracked and damaged and many of the mortar joints are missing or cracked. (Figs. 3-8, 3-9, 3-10, 3-11)

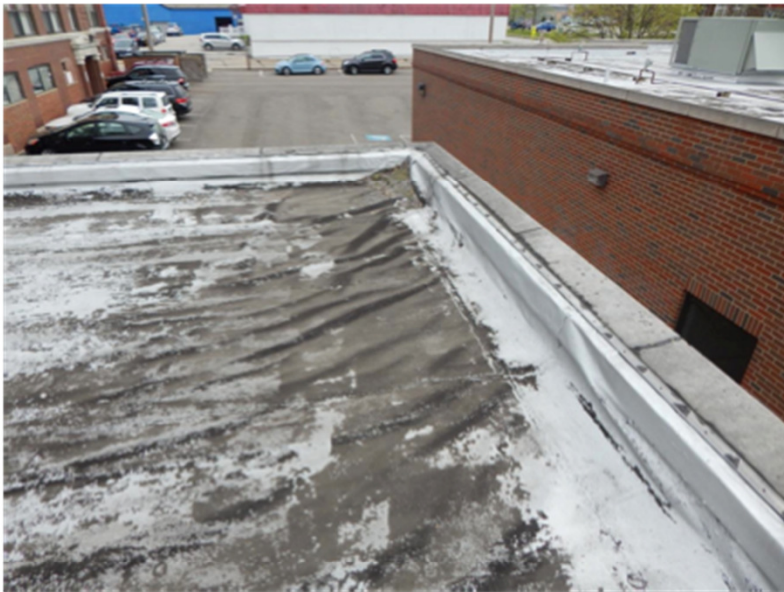
Figure 13-5

Some of the cap sheet is detached. (Fig. 13-5)

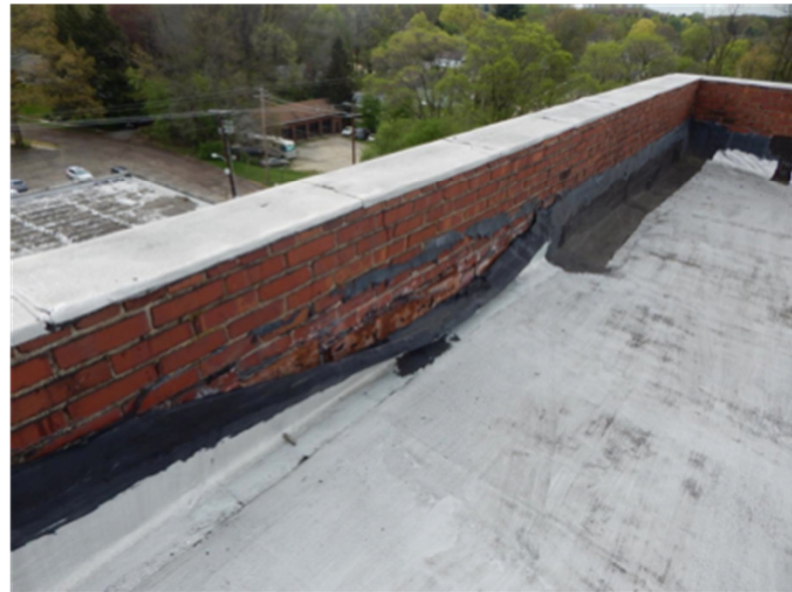
Figure 13-7

Some terminations are open. (Fig. 13-7, 13-8)
