Menlo Park City School District

Lower Laurel School

Tree Risk Assessment Report

April 25, 2017

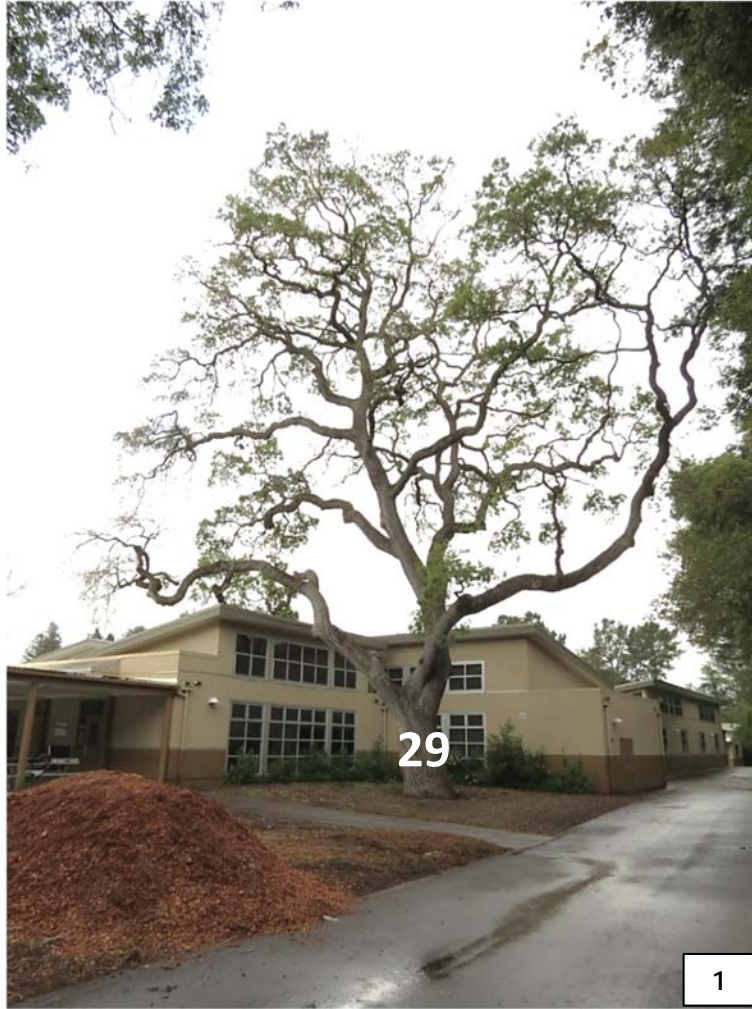
Tree 29 displayed a sparse canopy with occasional branch dieback. Two cables extended from the central leader to opposite elongated limbs. One elongated limb was over the classroom structure and appeared to be in significant decline. The other limb was over the service roadway and was in fair condition. (Photos 1 and 2) Both limbs exhibited poor diameter taper.

Photo 1. Tree 29 (formerly 13) a valley oak, is located between the classroom and roadway. Photo taken of east side of tree.

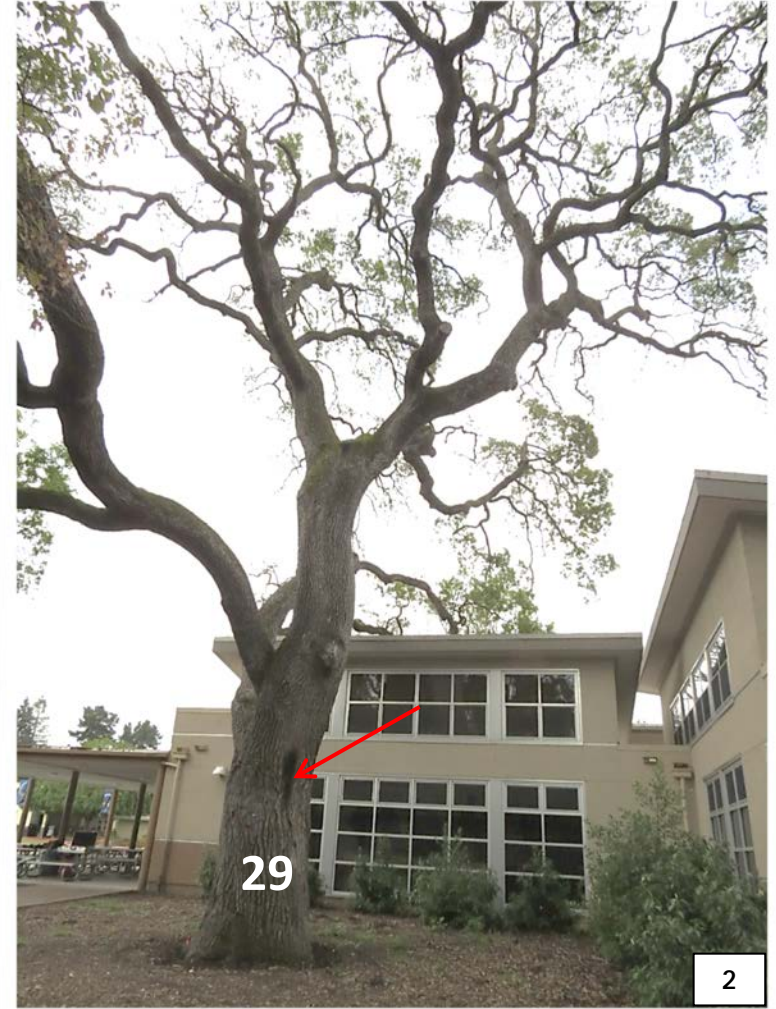
The trunk exhibited three active cankers. These cankers emitted an odorless dark viscous fluid that stained the bark. (Photos 2 and 7)

Photo 2. A closer view of tree 29 and its proximity to classrooms. An arrow points to an active canker exuding a dark fluid. (Refer to photo 7.)

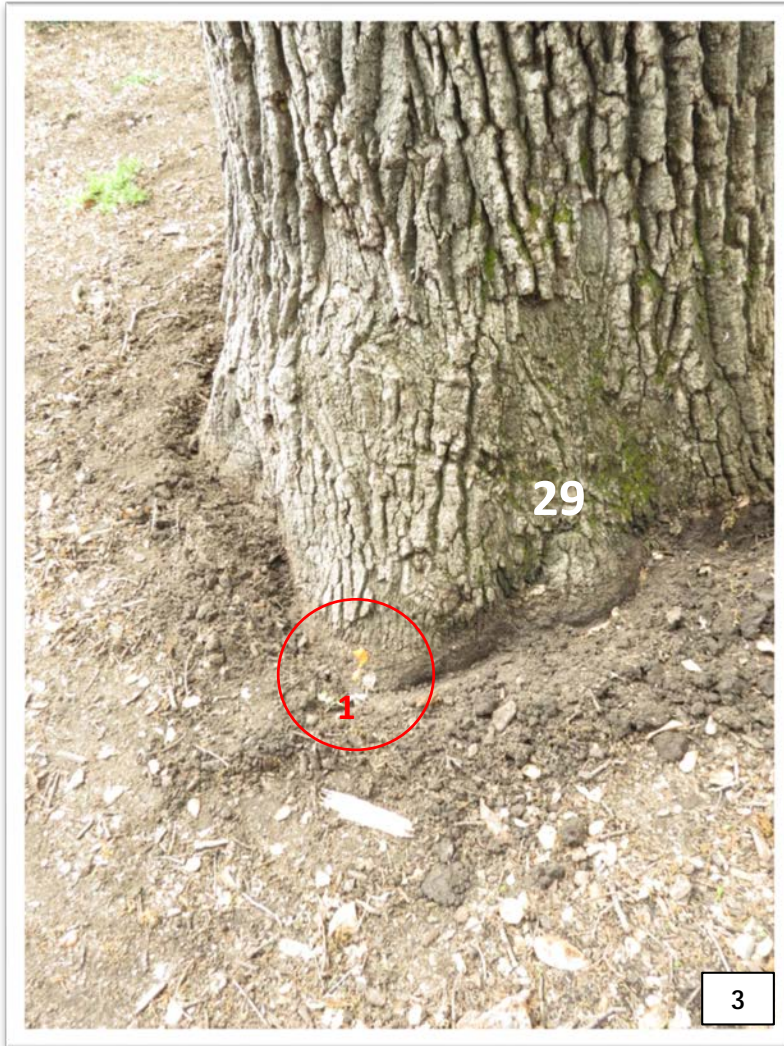
Sample site 1 was taken at top of buttress root and downward at approximately 45 degrees.

After three and a half inches of sound wood, decayed wood or soil was encountered.

Results from RRD samples 1 and 2 indicate decay issues at the soil line and probable root damage. Sample 1 of the buttress root with three and a half inches of sound wood suggests the presence of decay beneath the buttress root.

Photo 3. Circled is the orange flag marking RRD sample 1. This was the top of a buttress root.

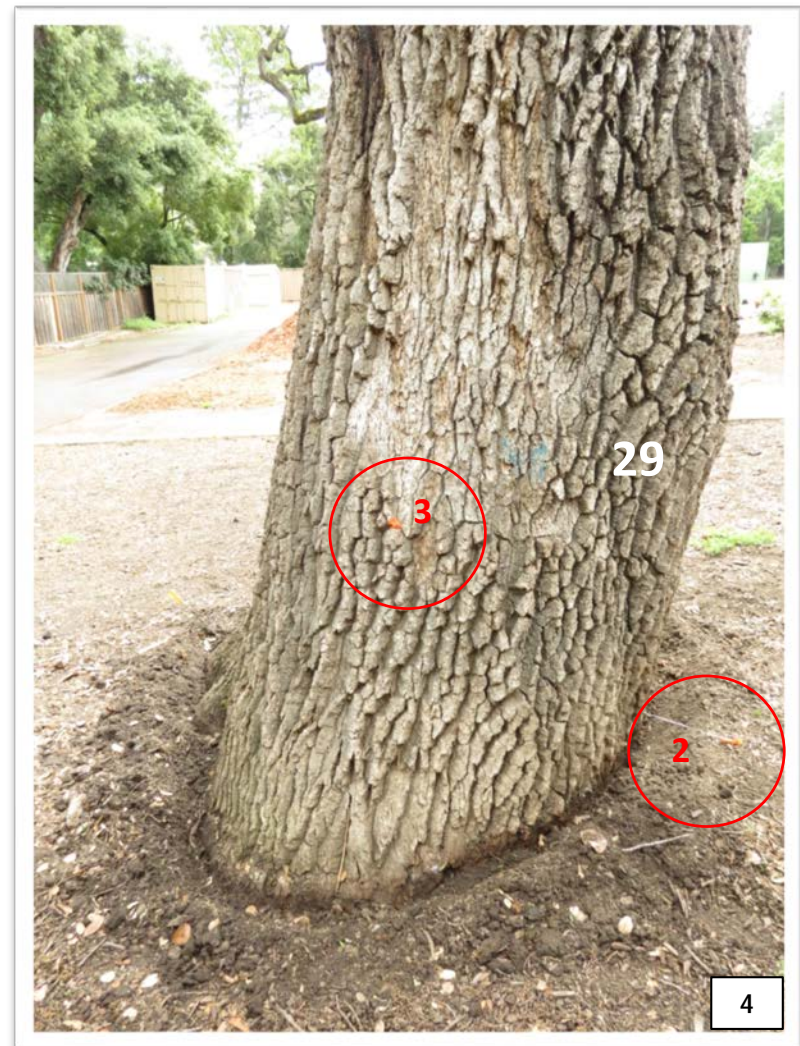
Sample site 2 was taken just above an observed site of decay just below the soil line. An inch and a half of decayed wood followed by five inches of sound wood was encountered. Possible incipient decayed wood or transitional wood was then encountered.

Sample site 3 was taken on the west side. Approximately three inches of transitional wood was encountered followed by very dense sound wood that resulted in a broken drill shaft.

Result from RRD sample 3 indicates the upper trunk is likely sound. The dense wood resulting from the wind sail effect on its upper canopy.

Photo 4. Circled are orange flags marking RRD sample sites 2 and 3. Note soil was removed to partially expose the root collar (base of tree).

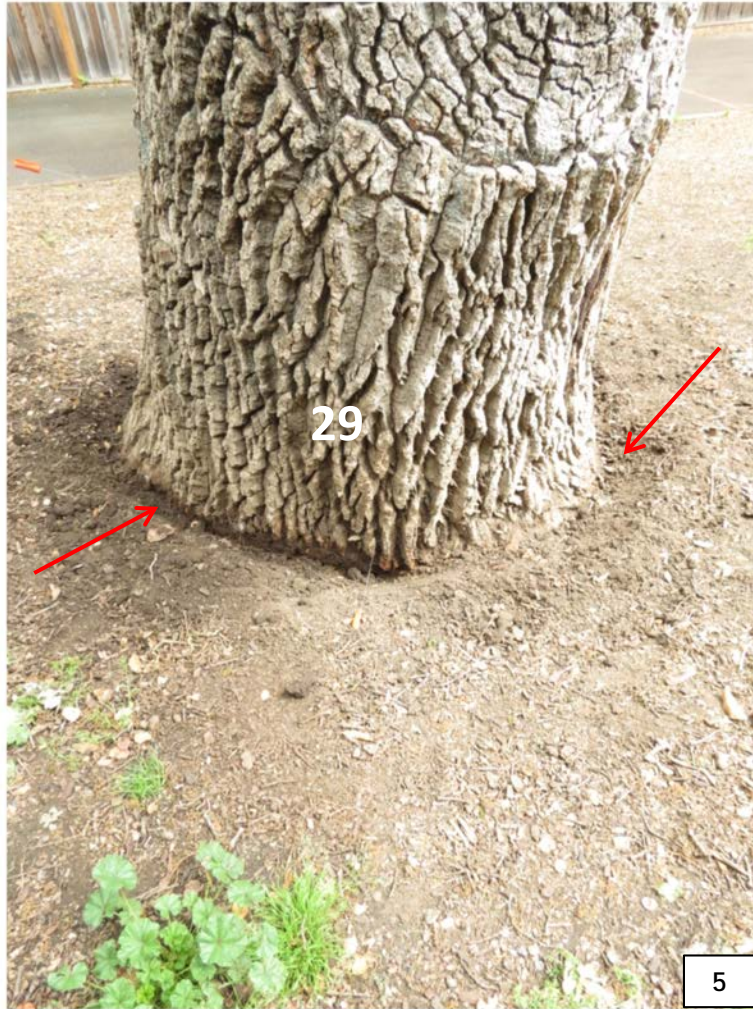
Approximately two to three inches of soil was removed from around the lower trunk by the Consultant. This cursory inspection revealed a patch of decay extending behind the layer of bark. (Photos 5 and 6) The actual root collar (base of tree) was not exposed.

Photo 5. Arrows point to approximately two to three inches of soil that the consultant removed from around the lower trunk.

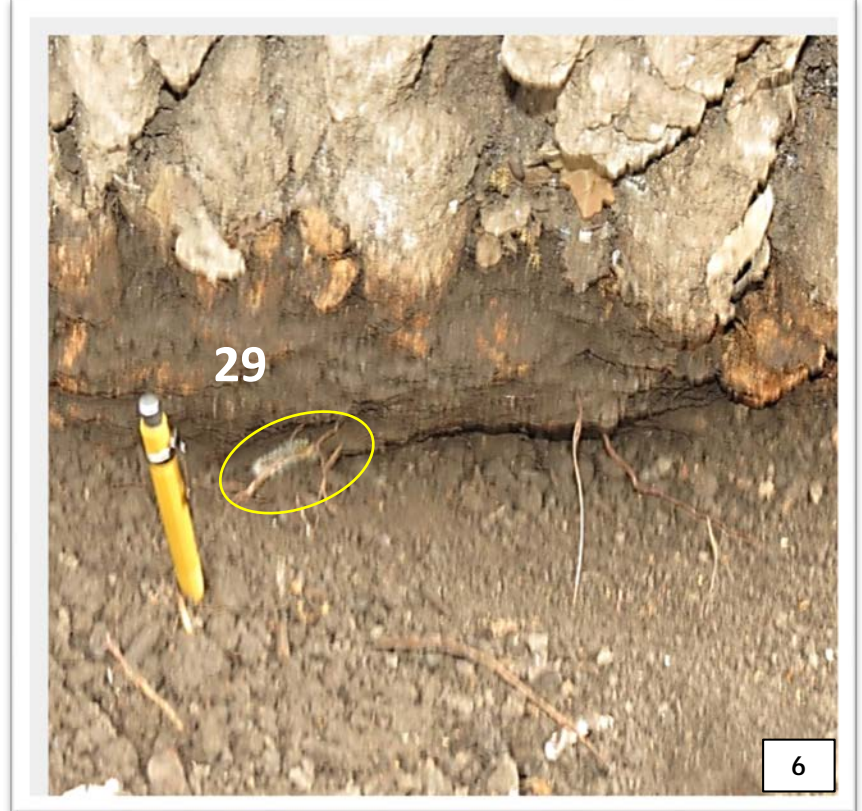
Tussock moth larva (*Orgyia vetusta*) were observed on the trunk and on buildings. (Photo 6) In early spring larva feed on foliage and later pupate in hairy brown cocoons.

Photo 6. Pencil is placed near a site of decayed wood just below the surface of the soil. A Tussock moth is circled in yellow.

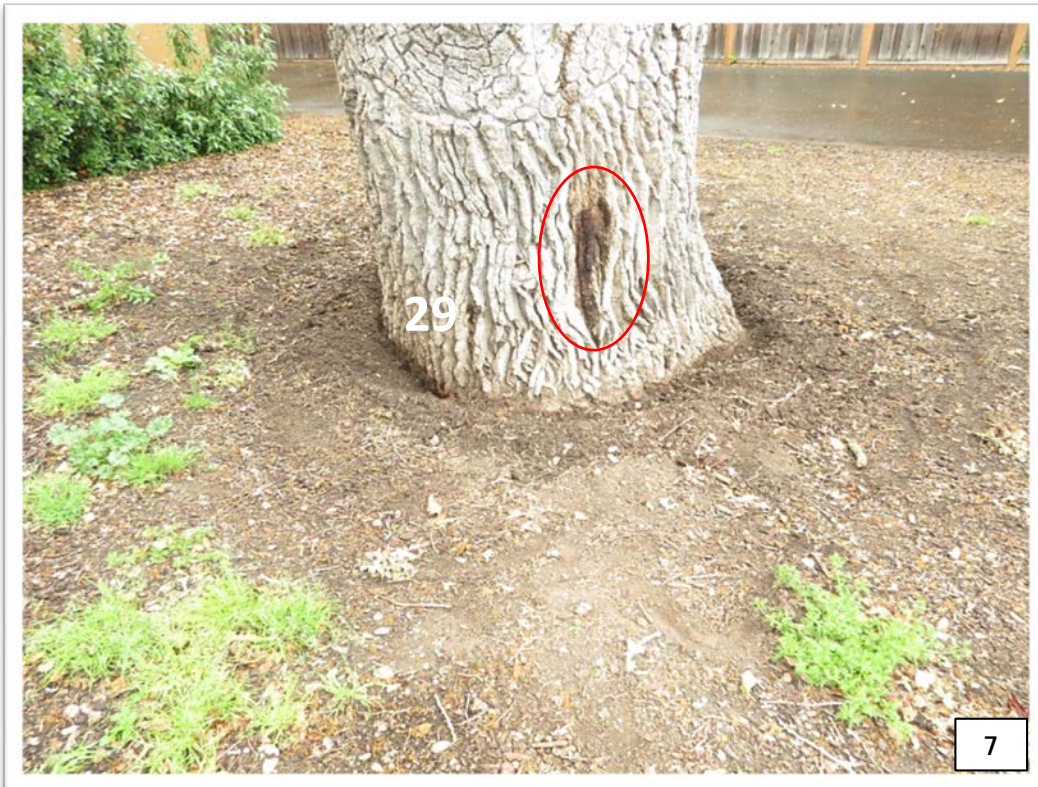
The active trunk cankers described earlier are generally symptomatic of a root disease such as root rot (*Phytophthora spp.*) or oak root fungus (*Armillaria mellea*). Bacterial wetwood, a more benign infection, will emit a foul odor which these cankers do not emit.

Photo 7. Circled is an active canker exuding a dark, odorless viscous fluid. Symptom suggests internal and/or root pathogen infection. A bacterial infection is generally accompanied by an unpleasant odor.

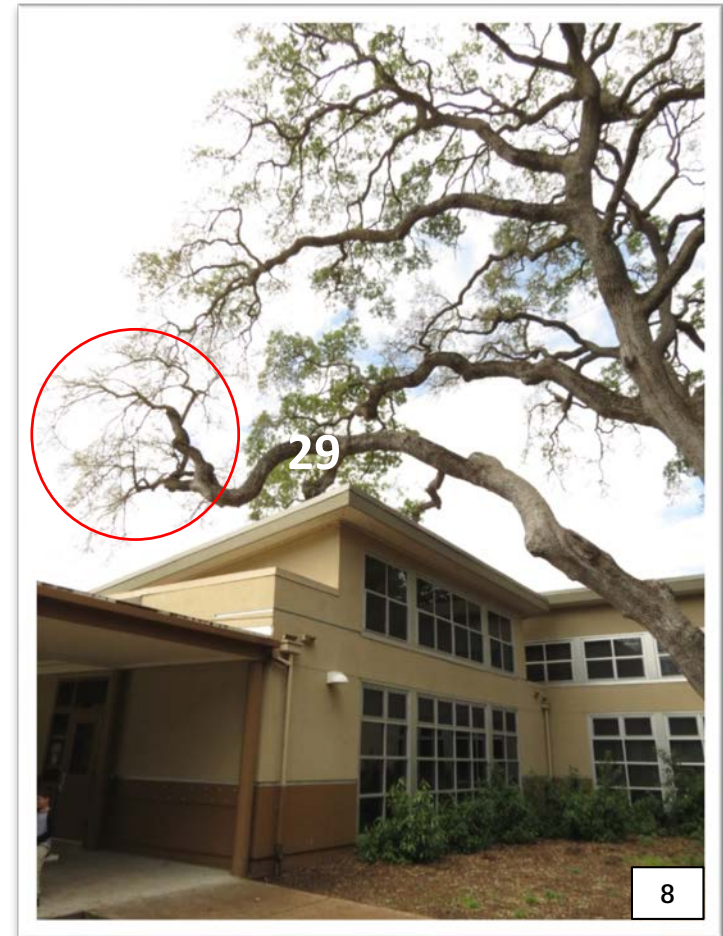
The limb extending over the classroom is in significant decline. Its poor taper and end weight compromises its strength. Decay is present from an old wound that has not closed. (Photos 8, 9 and 10)

The chance of limb failure increases during severe weather events. Under normal weather conditions and considering the frequency of human activity, this limb presents a moderate to high risk to the building, students, staff and visitors within the target area.

Photo 8. This lower limb is partially supported by one metal cable. A closer view of the end of the limb is pictured in photo 9.

4. If Tree 29 is to be preserved, the stressed limb over the class room should be reduced by half or be removed at its attachment. Mitigation work should be completed at the earliest possible date.
5. Should results from the RCX determine that the buttress roots are severely compromised, Tree 29 should be removed at the earliest possible date.

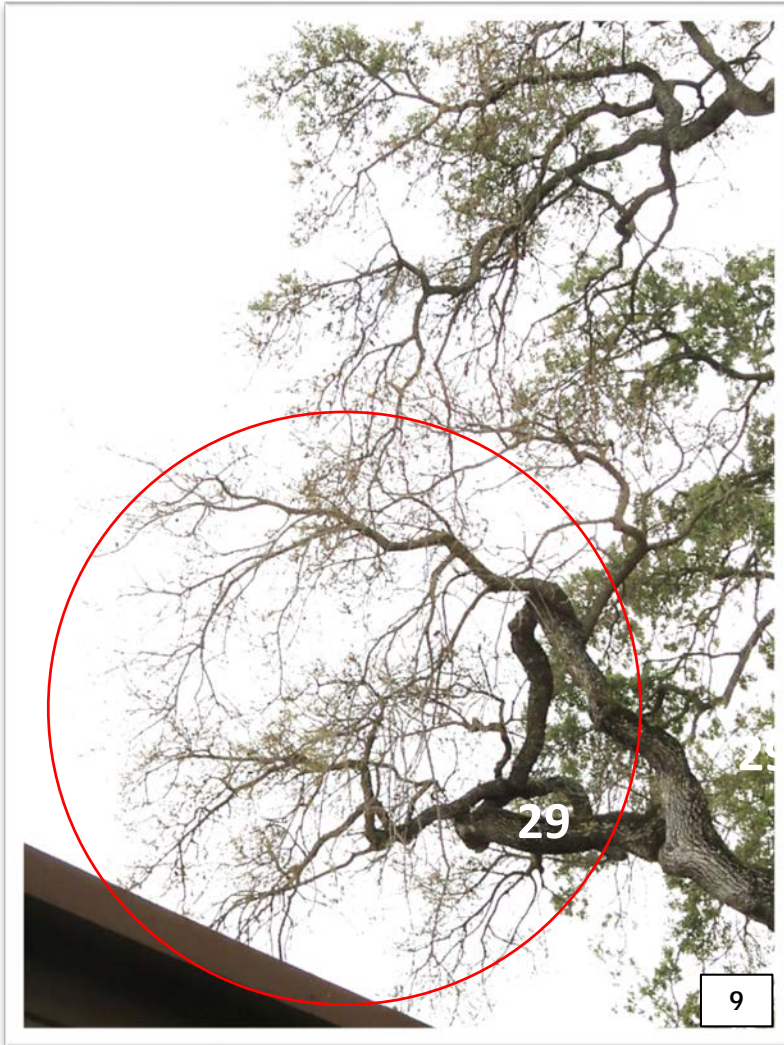
Photo 9. A closer view of the end of the lower limb pictured in photo 8 is shown. Note the lack of foliage.

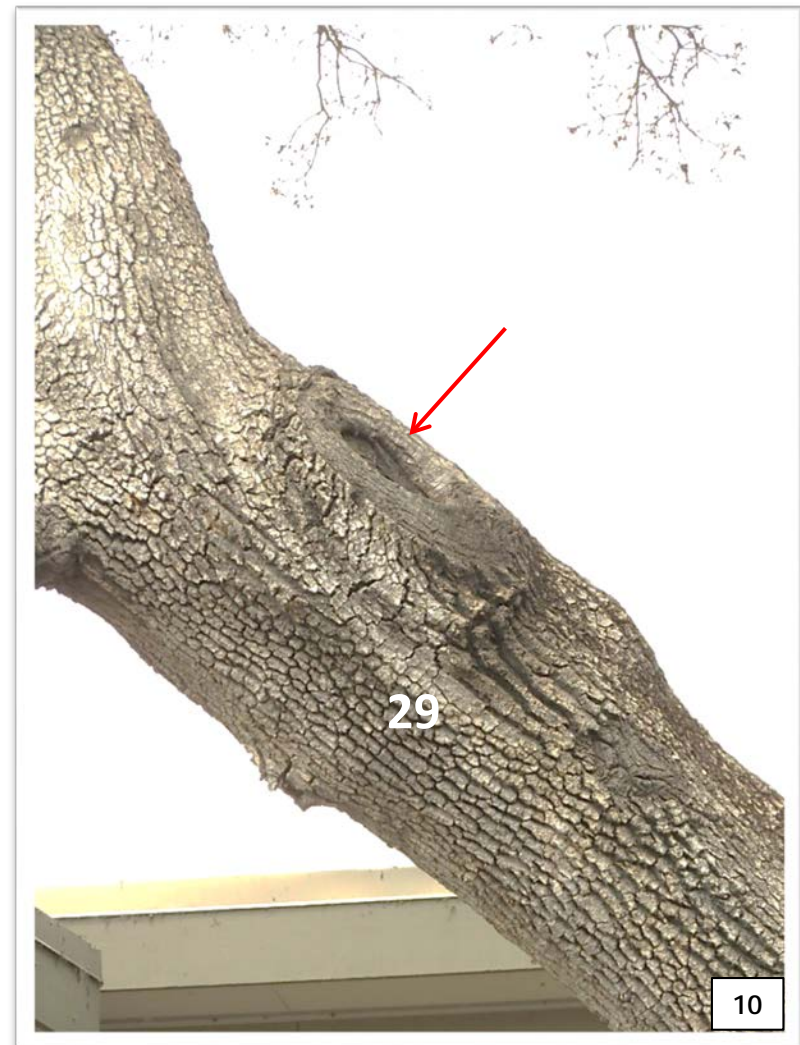
Photo 10. An arrow points to an old wound that has not fully closed. The concave bark suggests internal decay.

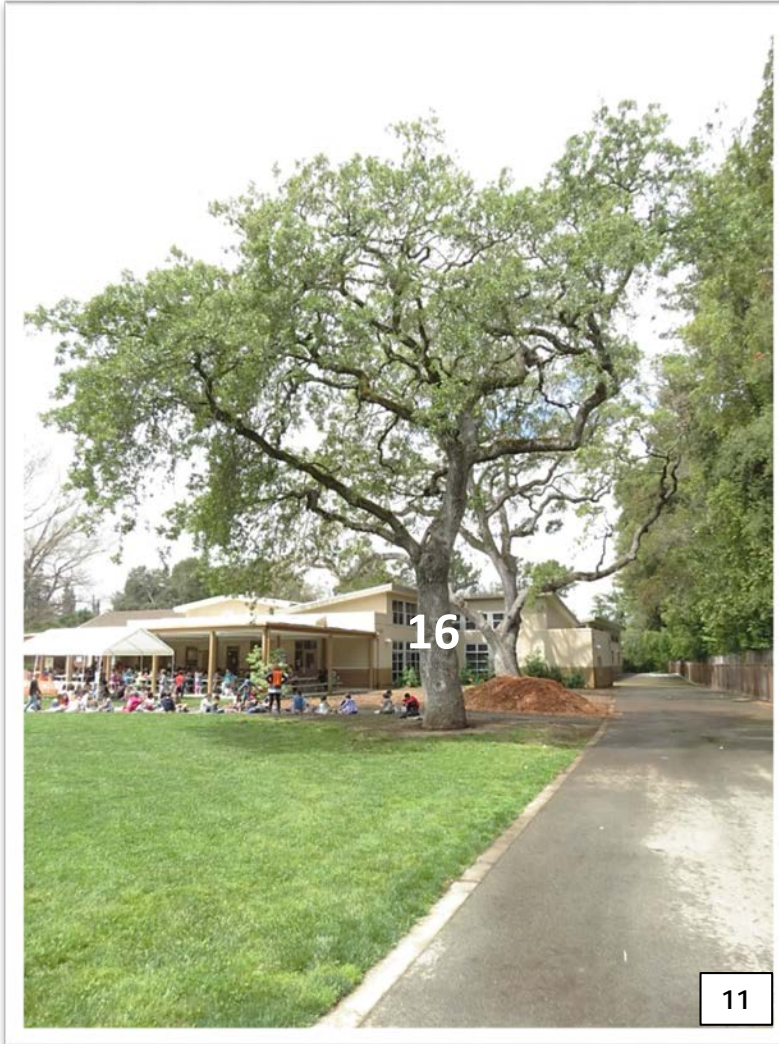
This valley oak is located west of Tree 29 where a soft path and service roadway intersect. Bare soil extended out approximately 15 feet from the trunk to where the turf play area begins. (Photo 11)

At the time of the Consultant's site visit, students were playing around the tree and having lunch under its canopy. (Photo 11)

Based on results of the sounding and RRD sampling, Tree 16 is at possible risk for failing under normal weather conditions and at probable risk for failing during a severe weather event within the next two years. Student activity within the vicinity of Tree 16 is sporadic however it is somewhat likely that a student can be injured in the event of a tree failure. Therefore Tree 16 presents a moderate to high risk to the students, staff and visitors.

Photo 11. Tree 16, a valley oak, is shown when viewed from the east. Students are having lunch on the path that is partially beneath the canopy of tree 16.

1. Remove Tree 16 at the earliest possible date.
2. A temporary barrier should be placed around the tree until the tree is safely removed.

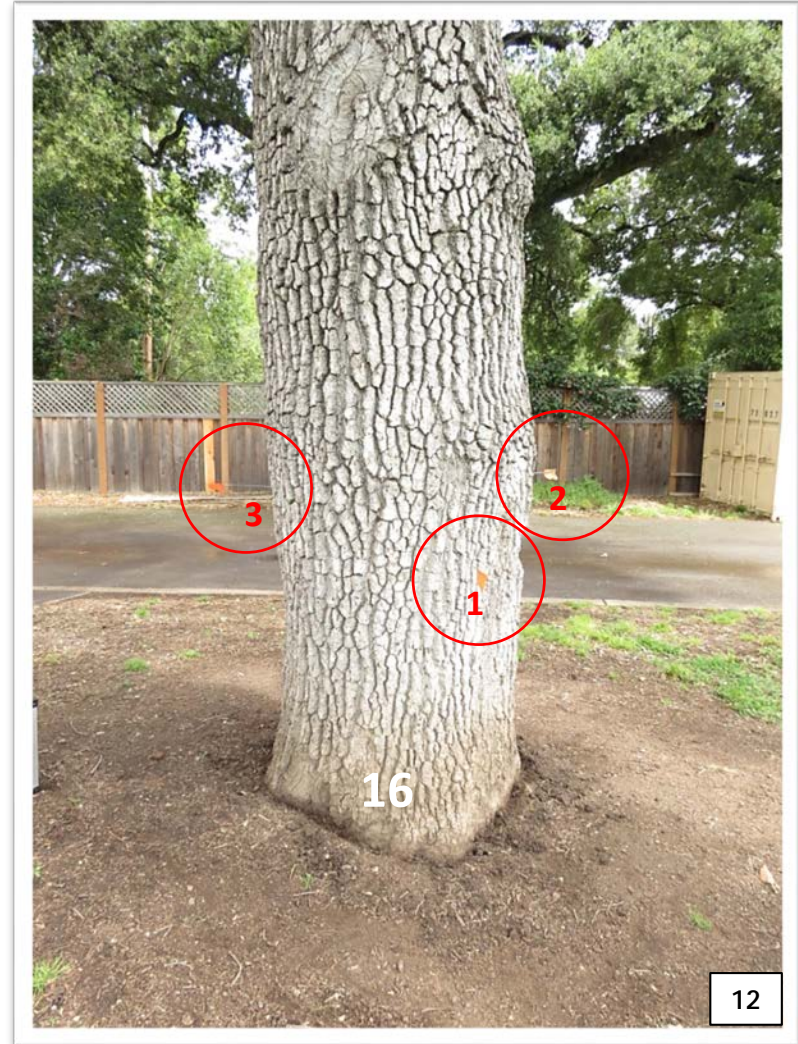
The Consultant struck the trunk with a plastic head hammer as a means to locate possible hollows or cavities. Soundings were distinctly hollow and occurred consistently around the trunk. To provide a visual record of the extent of sound wood the Consultant employed a Resistance Recording Drill (RRD). (Photos 12 and 13)

Results from the RRD sampling describe a fairly well centered column of decay within the tree. The recorded amount of sound wood encountered by the RRD is less than the 35 percent threshold considered sufficient for structural stability. (C. Mattheck, 1993)

Photo 12. Circled are orange flags indicating the RRD sampling sites, 1, 2 and 3.

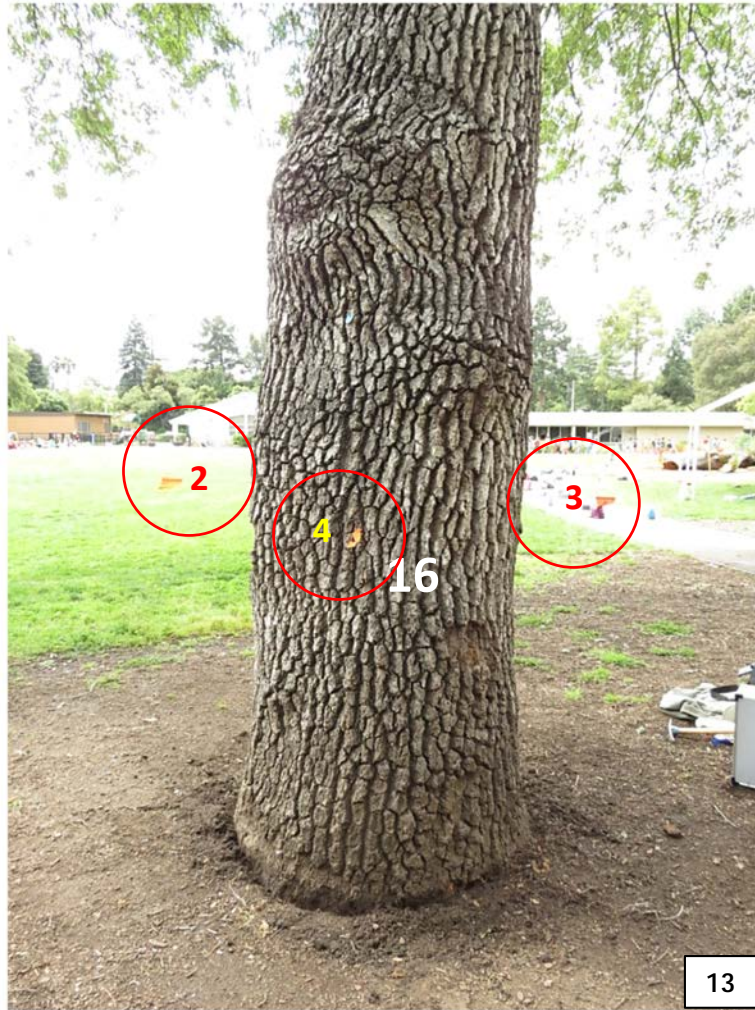
Approximately two to three inches of soil was removed from around the lower trunk by the Consultant. This cursory inspection revealed a site of decay extending beyond the layer of bark. (Photos 13 and 14) The actual root collar (base of tree) was not exposed. (Photo 14)

Photo 13. Circled are orange flags indicating the RRD sampling sites, 4, 3 and 2. Note that the Consultant only partially exposed the lower trunk.

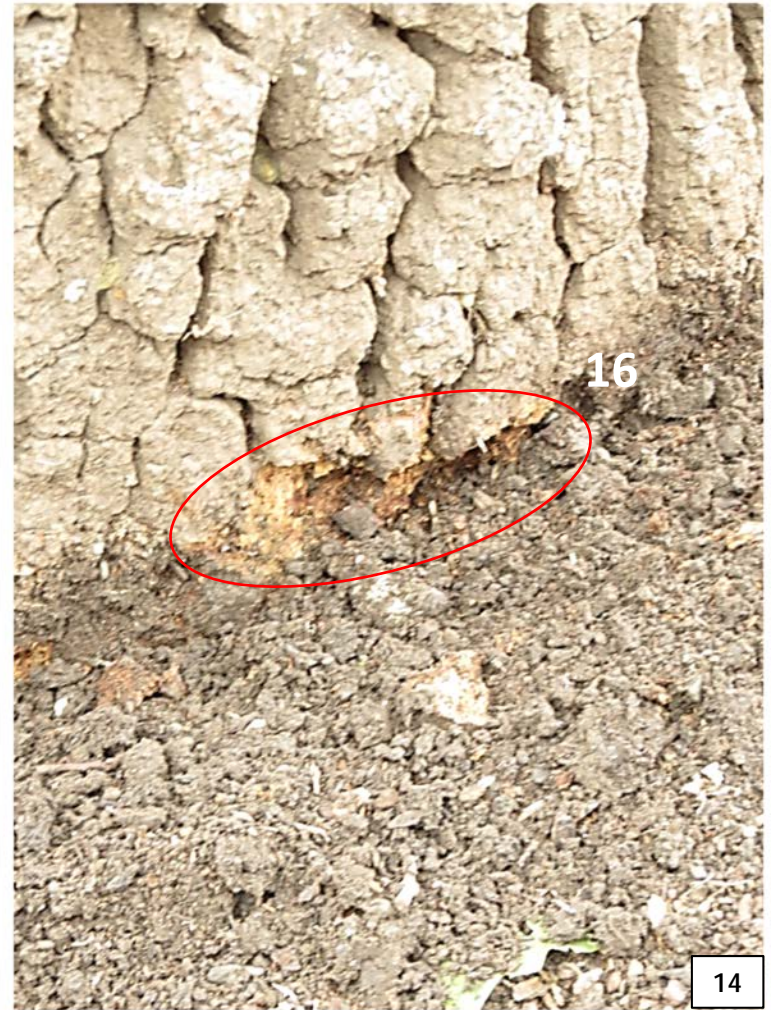
14

Photo 14. Two to three inches of soil was removed to provide a cursory look at the covered root collar. Decayed wood, circled in red, was clearly visible at one site.

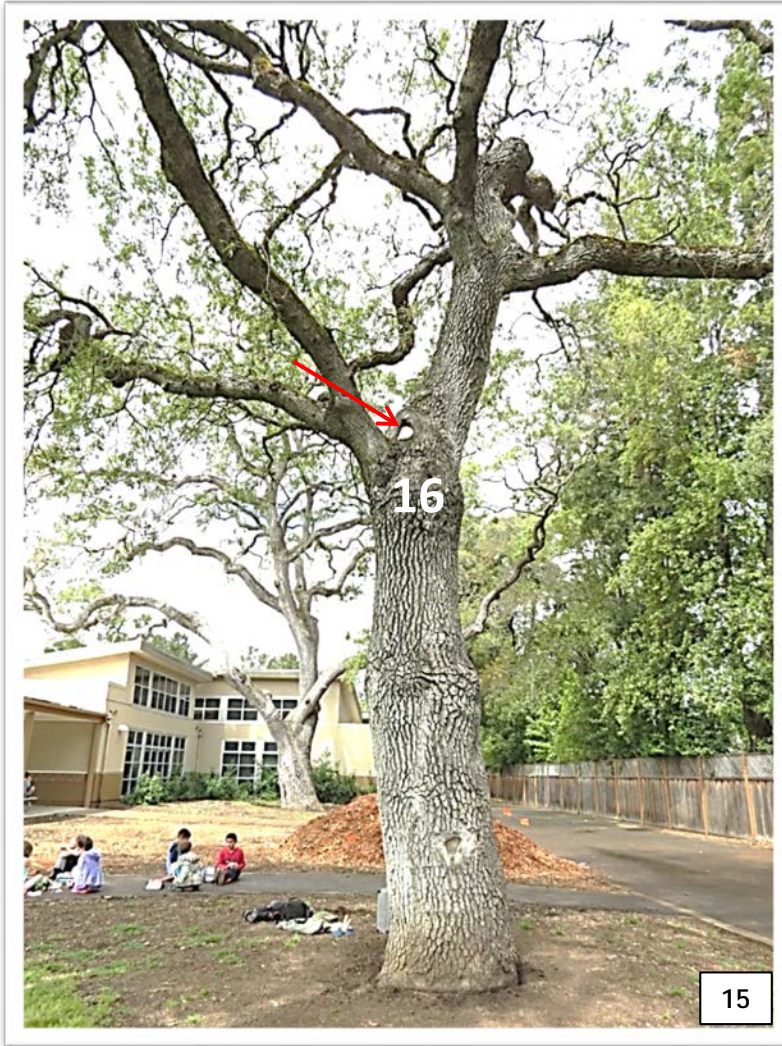
The trunk begins vertical and then shifts to provide a counter lever profile. An old wound was observed at the site where the stem deviated to the east. This wound was filled with concrete. In the early days of Arboriculture, filling cavities with concrete was practiced as a means to strengthen and preserve a tree. (Photos 15 and 16)

Photo 15. The very straight trunk is typical of the valley oak. A red arrow points to an old wound that was filled with concrete as a means of preservation.

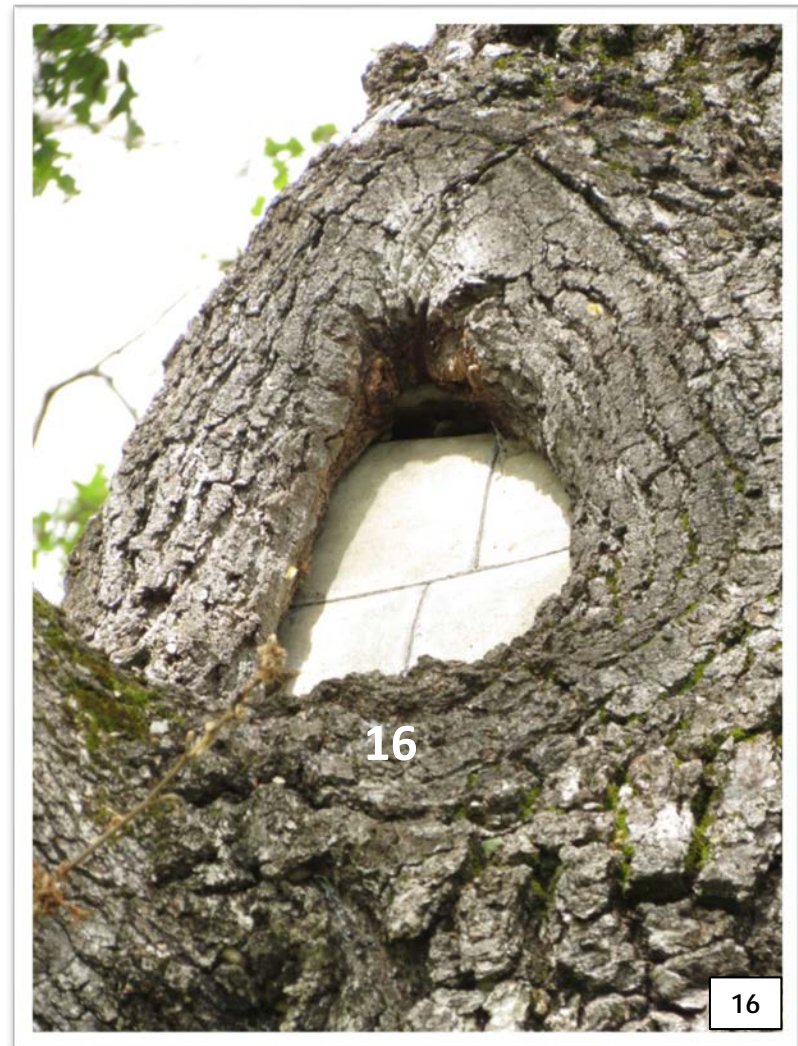
Photo 16. A closer view of the concrete reveals the inscribed lines on the surface of the fill. This was once state of the art in tree work.

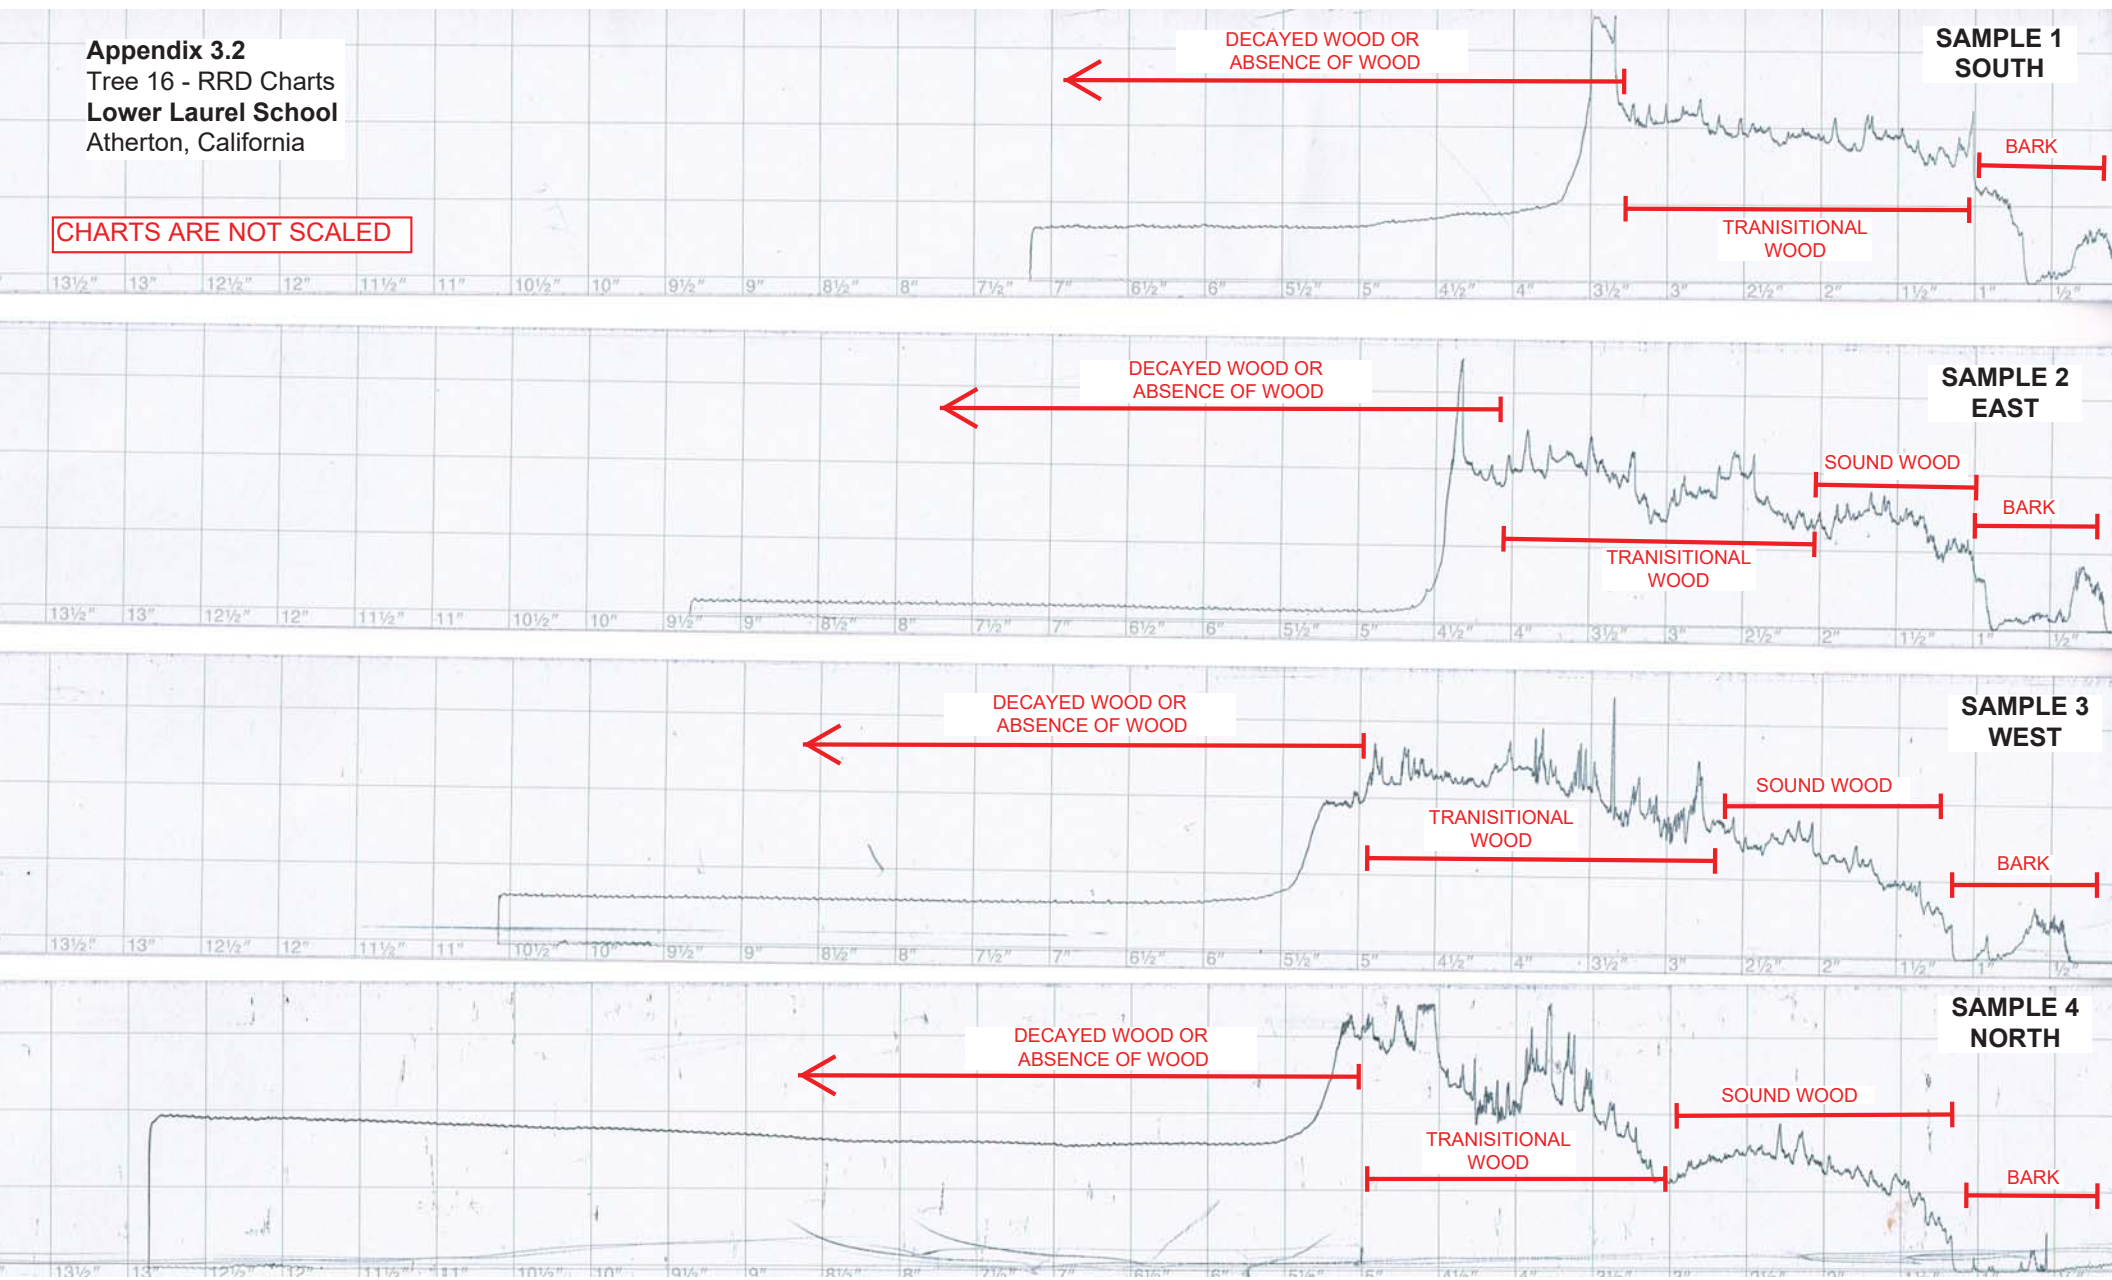
Appendix 3.2
Tree 16 - RRD Charts
Lower Laurel School
Atherton, California

Sample site 1, approximately two and a half inches of transitional wood was encountered after which a continuous hollow was recorded.

Sample site 2, approximately one inch of sound wood and two inches of transitional wood was encountered after which a continuous hollow was recorded.

Sample site 3, approximately one and a half inches of sound wood and approximately two and a half of transitional wood was encountered after which a continuous hollow was recorded.

Sample site 4, approximately one and three quarters inches of sound wood and two inches of transitional wood was encountered after which a continuous hollow was recorded.
