May 22, 2017

Re: Lower Laurel School – Tree 29
Letter of Addendum to Arborist Report of April 25, 2017

Appendix 2.1.1
Tree 29 Diagram v2
Lower Laurel School
Atherton, California

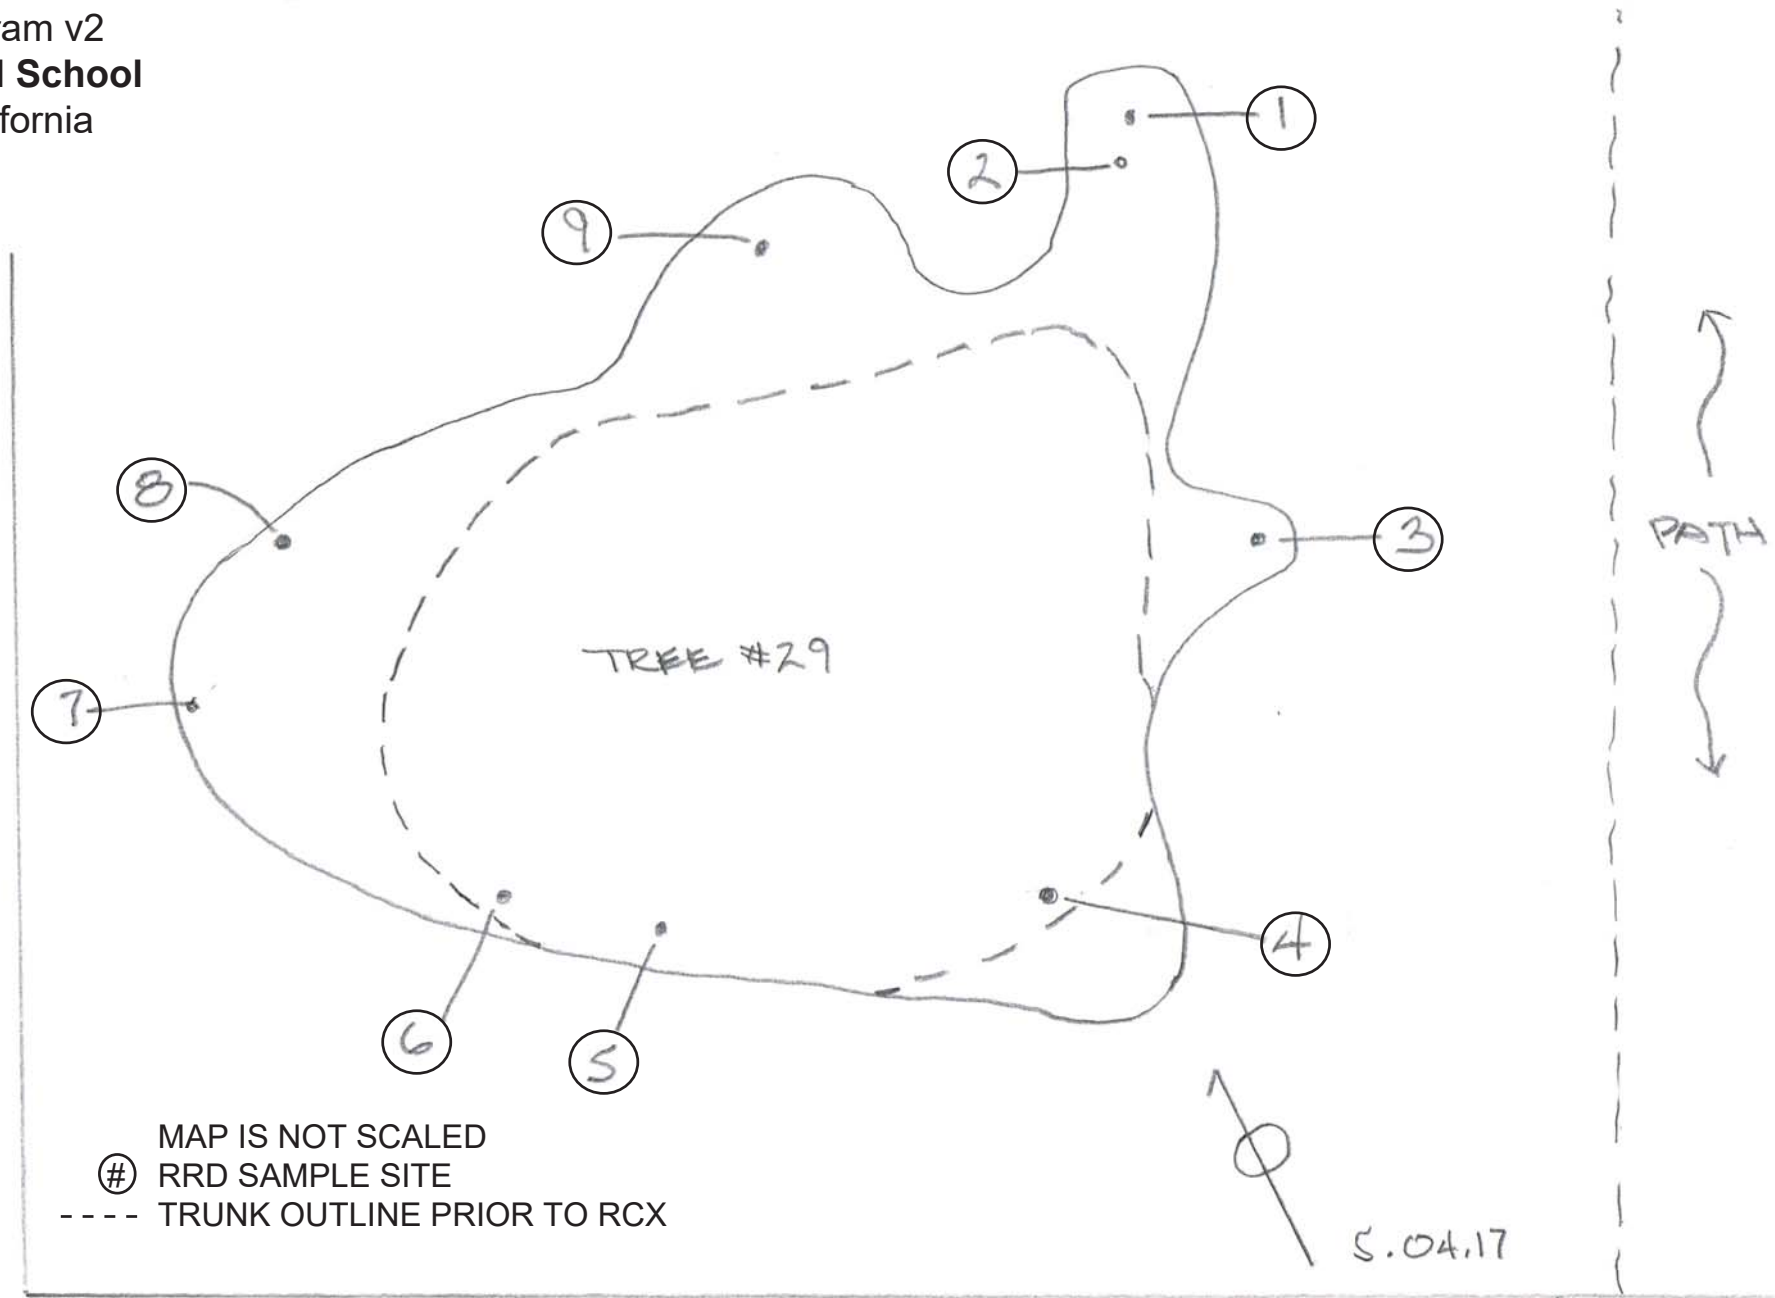
Nine sites were sampled by use of a resistance recording drill (RRD). (Refer to Appendix 2.1.1 – Tree 29 Diagram) The presence of sound wood was strongest on the north trunk side based on sampling from two sites. (Photo 7) The remaining seven sites were determined to be a mix of limited sound wood, insipient decay and decayed wood. (Photos 8 through 14)

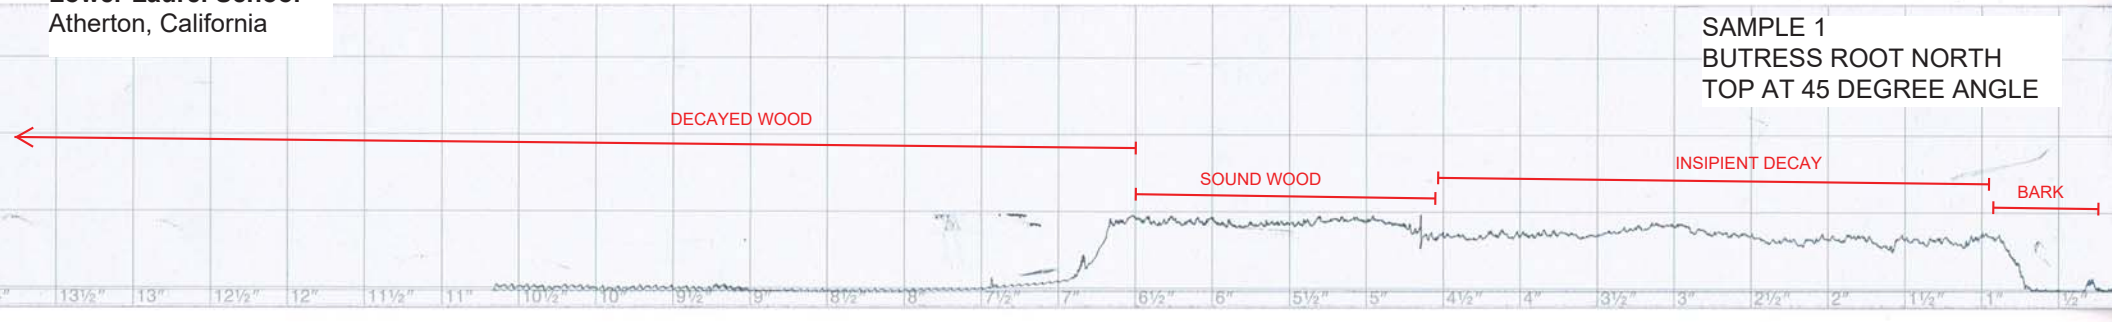
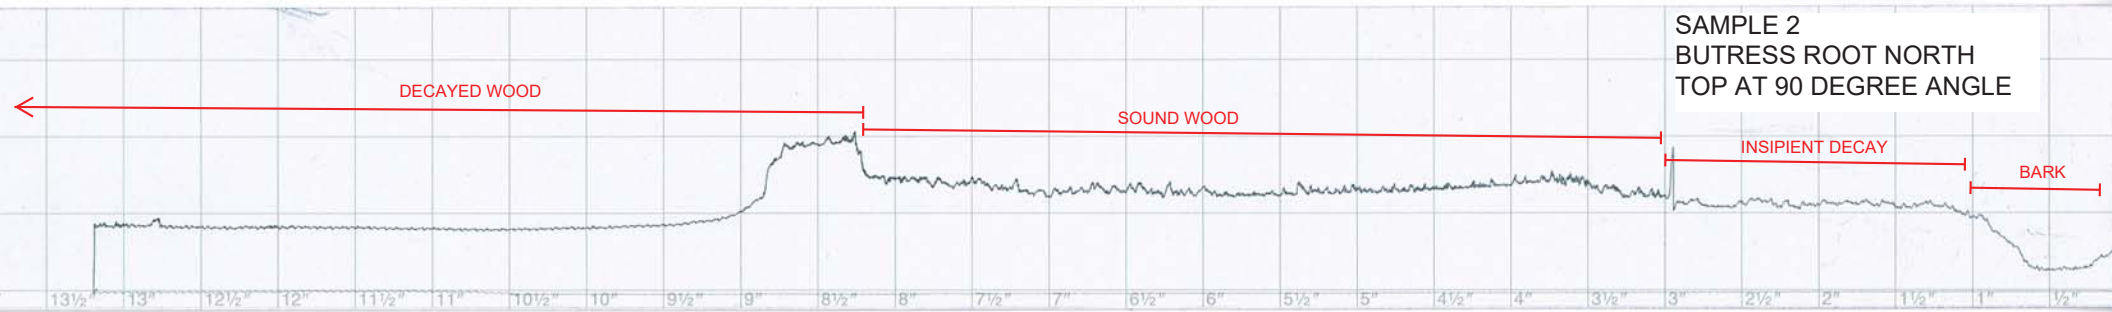
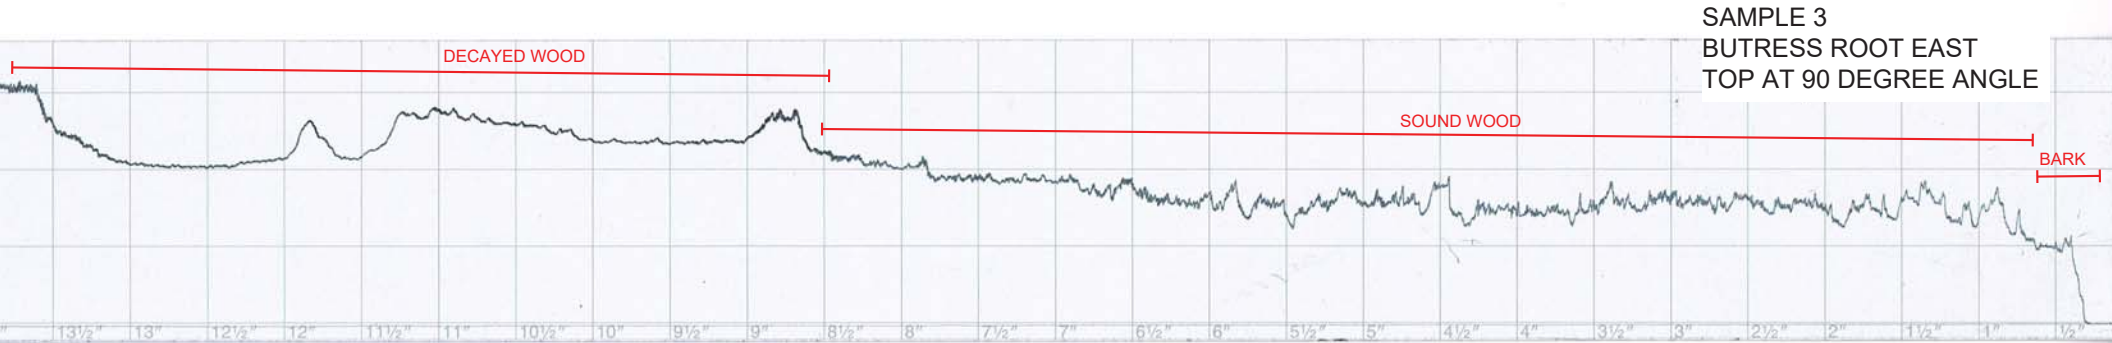
DATE OF SAMPLES: MAY 4, 2017
CHARTS 1, 2 AND 3

Sample sites 1 through 7 were of mixed wood densities and quality. (Appendices 3.1.1, 3.1.2 and 3.1.3) These inconsistent wood density samplings determined by the RRD are indicative of root damage that has moved into the lower trunk.

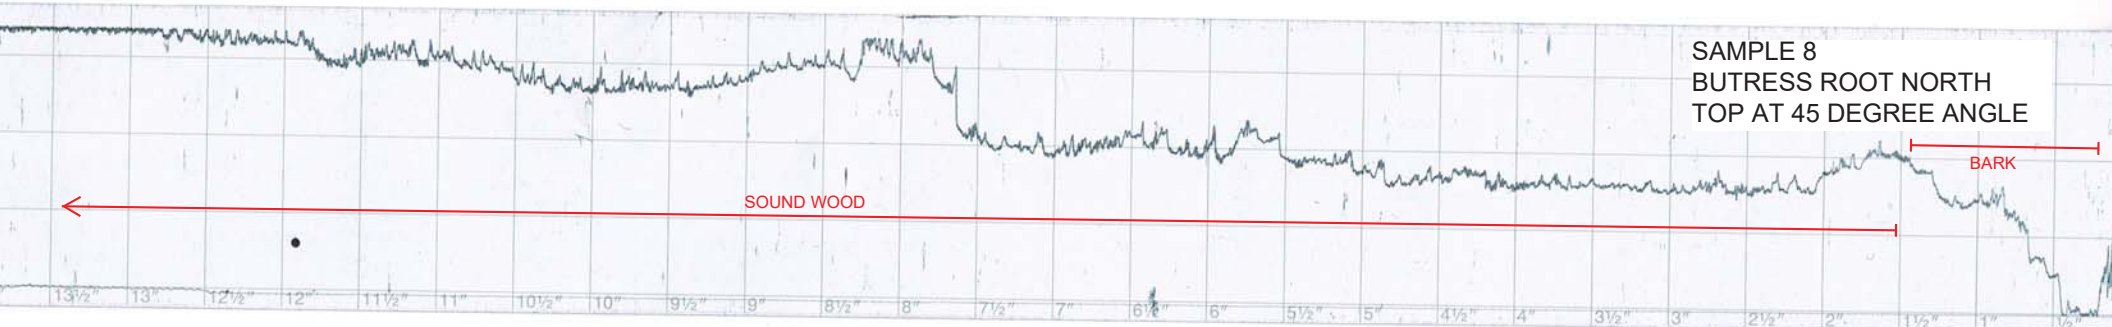
SAMPLE 8
BUTRESS ROOT NORTH
TOP AT 45 DEGREE ANGLE

Sample sites 8 and 9 taken from the north side of trunk produced charts of consistently sound wood. (Appendix 3.1.3 – Samples 8 and 9)
