# **Arborist Tree Assessment Report**

Lower Laurel School Menlo Park, California

March 6, 2017

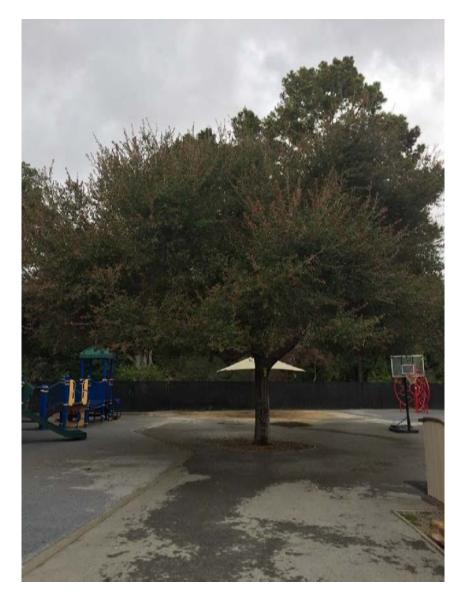
## 1. Live oak in Play Ground

Good health and condition. Young tree structurally pruned a couple of years ago. Putting on a lot of new growth.

Lighten canopy throughout taking weight off lower longer limbs

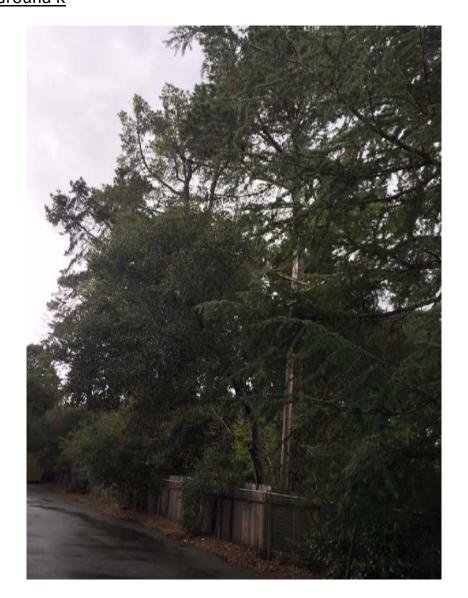
## 2. <u>Pines, oaks and cedars on neighbor's property adjacent to Play</u> <u>Ground K</u>

Fair health and condition. Unmaintained for many years. One large dead pine branch over play area; heavy one sided oak over play area; long heavy cedar branches over play area.

Tree #s 2, 6 and 19 are on the north and east neighbor's property lines. The trees need maintenance including removing large dead wood and lightening canopies and branches to prevent the possibility of failure.

Remove dead limbs, lighten heavier limbs, prune back oak.

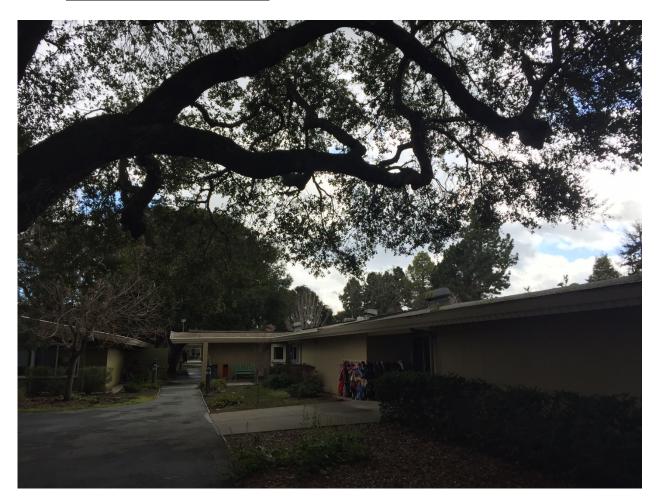
## 3. Live oak over Lunch Area B

Good health and condition. Recently maintained.

Lighten low long limbs over building further with larger (>4") diameter cuts

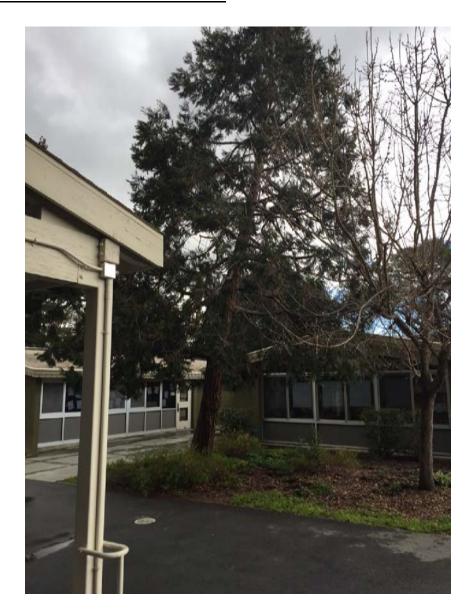
## 4. Incense cedar at Lunch Area B

Fair health and condition. Significant lean, some dead wood, thinning canopy.

Remove dead wood and lighten canopy

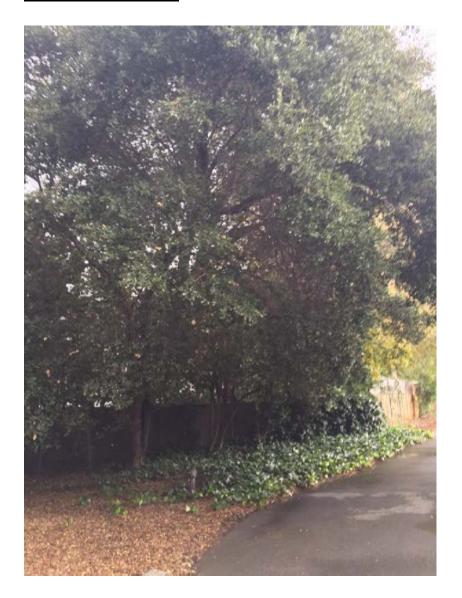
## 5. Oak at F2 Classroom

Good health and fair condition. Co-dominant trunks and a lot of dead wood. Not been maintained for some time.

Remove dead wood and lighten canopy throughout

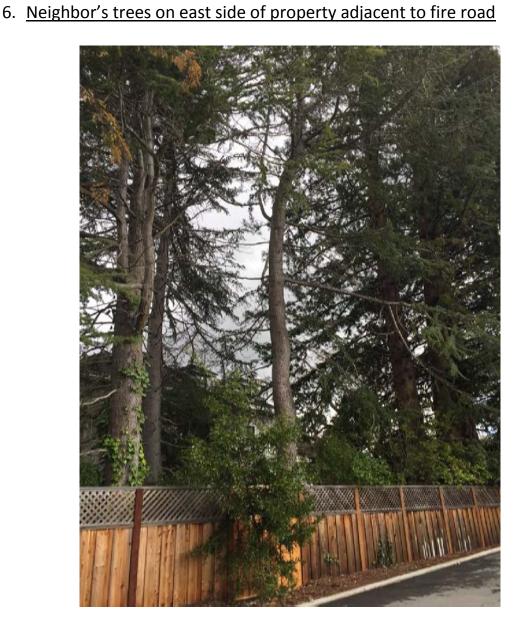
Good health and fair condition. Co-dominant trunks and a lot of dead wood. Not been maintained for some time.

Remove dead wood and lighten canopy throughout

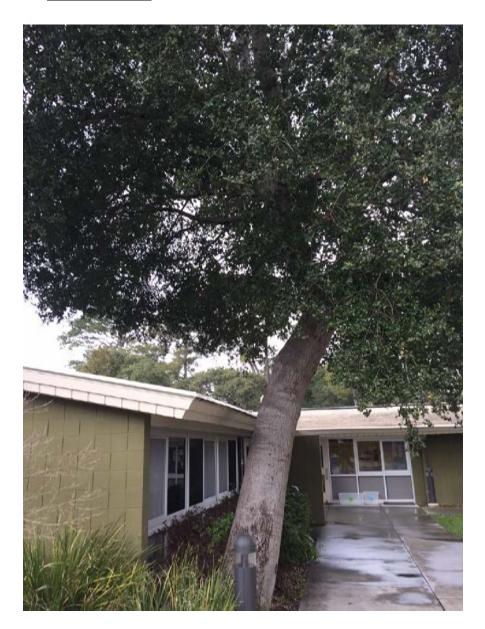
## 7. Live oak at C2

Good health and fair condition. Significant lean. Expecting a lot of growth this year.

Remove dead wood and lighten canopy throughout

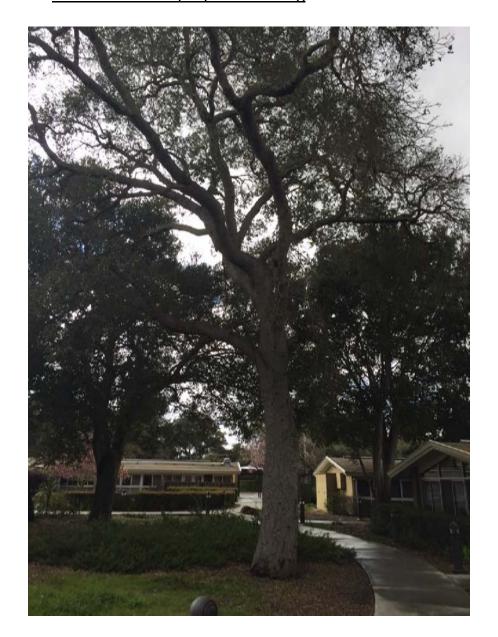
## 8. Live oak at Multipurpose Building

Poor health and condition. No improvement from previous year. Evidence of *phytophthora* at base of tree suggesting potential root decay and root loss.

Tree #8 8 and 9 are growing in the area close to and over the top of the Multipurpose Building. Tree #8 has had a thinning canopy for many years perhaps from the impacts of construction. I suspect there is some root loss caused by **phytophthora** resulting in a weakened tree and perhaps instability. Tree #9 also has a thinning canopy and probably for the same reasons. It is also leaning over the building. Both trees should be removed.

Cut to ground level.

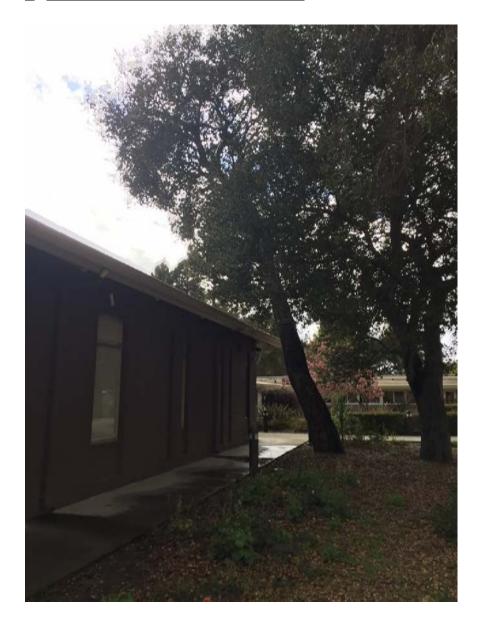
# 9. 2<sup>nd</sup> Live oak at Multipurpose Building

Fair health and condition. Thinning canopy and evidence of *phytophthora* at base of tree suggesting root decay and root loss. Significant lean over building.

Cut to ground level.

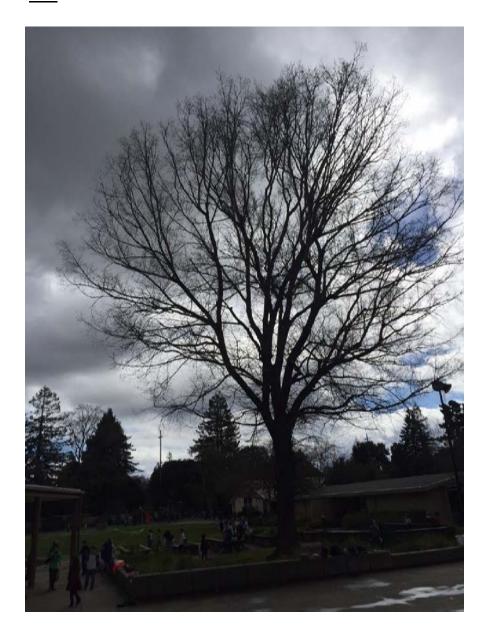
## 10. <u>Elm</u>

Health and condition difficult to determine at this time of year. Some large visible dead wood. Expecting a lot of new growth this year after the rain. Some long heavy branches.

Thin, lighten and remove dead wood throughout.

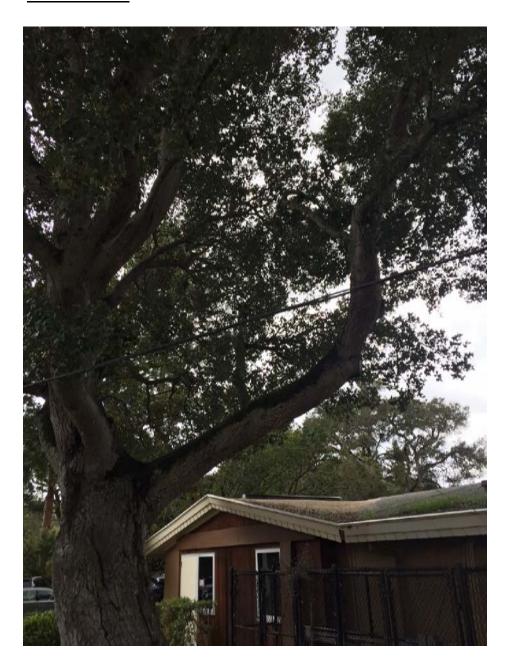
## 11. Oak over A26

Good health and condition. Recently maintained. One heavy branch over building.

Lighten heavy branch over building.

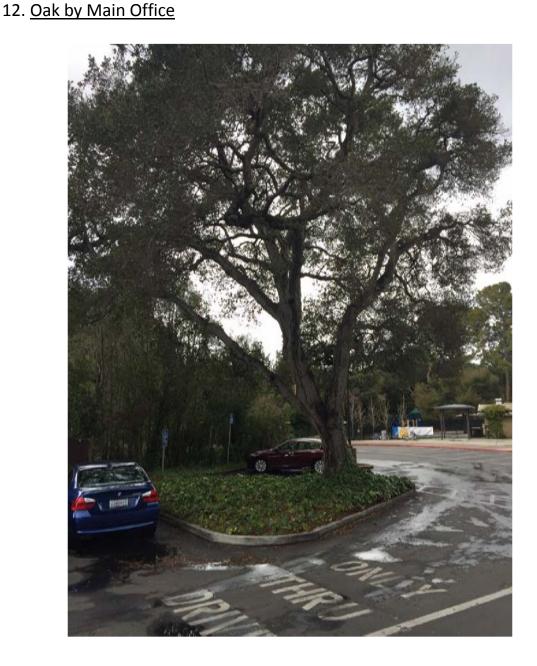
Fair health and condition. Some decay and cavities on larger limbs.

Recently maintained, lighten one or two select heavier limbs.

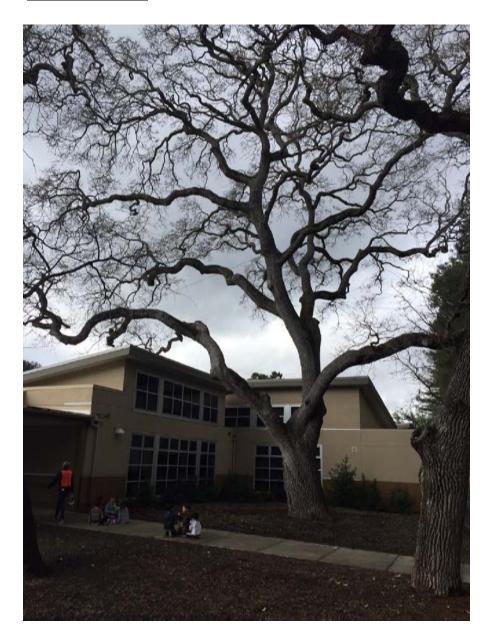
## 13. Large valley oak

Good health and condition. No signs of disease or decay at base of trunk. Canopy thick and healthy

Tree #s 13 and 16 are large valley oaks on the east side of the school. They appear to be in good health and condition. These trees are frequently used as shade during the summer. As a precaution, I would recommend further investigation with a **resistograph** to determine if there is any decay in the trunks or root crown. If there is no significant decay, the trees should be thinned and lightened throughout.

**Resistograph** trunk and root crown to detect for decay or cavities at base of tree. If all well, then lighten tree throughout, reducing the 2 lower limbs back to their first lateral. Remove and replace cable over building if deemed necessary.

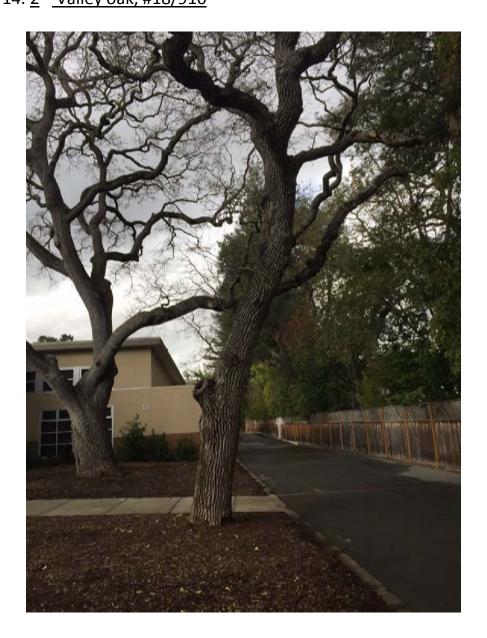
# 14. 2<sup>nd</sup> Valley oak, #18/910

Good health but poor condition. Healthy canopy but several large cavities on the main trunk

Tree #s 14, 15, and 17 all have significant decay in their main structural limbs, trunk or root crown. These trees should be removed.

An area of high use, particularly in the summer when this species is at a higher risk of failure. Cut to ground level.

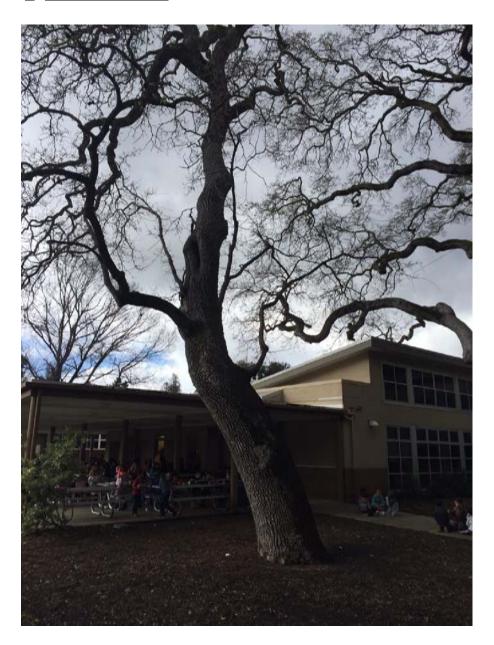
## 15. <u>3<sup>rd</sup> Valley oak, #17</u>

Good health but poor condition. Healthy canopy but several large cavities on the main trunk

An area of high use, particularly in the summer when this species is at a higher risk of failure. Cut to ground level.

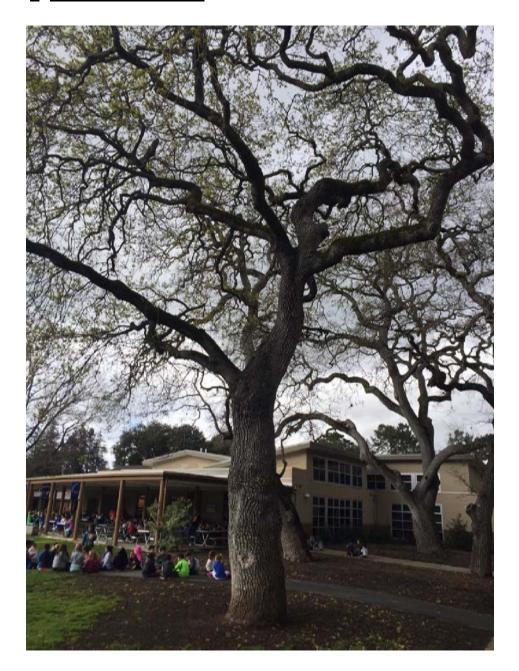
## 16. 4<sup>th</sup> Valley oak, #16/909

Good health and fair condition. Healthy canopy well balanced canopy.

**Resistograph** trunk and root crown to detect for decay or cavities at base of tree. If all well, then lighten tree throughout.

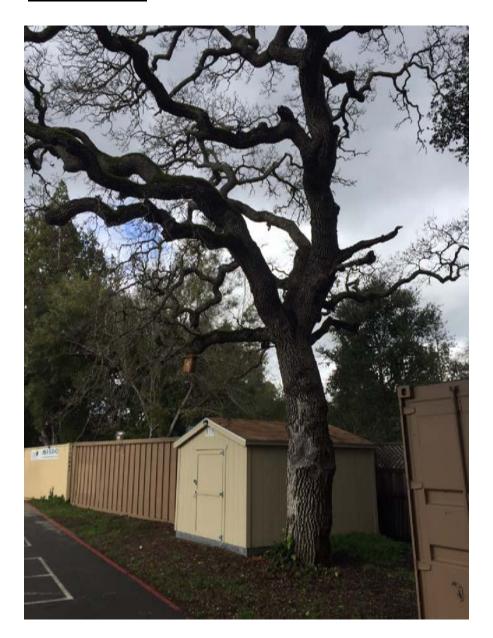
## 17. Valley oak, #14

Fair health but poor condition. Healthy canopy but several large cavities on the main trunk. Significant root decay at base of tree.

An area of high use, particularly in the summer when this species is at a higher risk of failure. Cut to ground level.

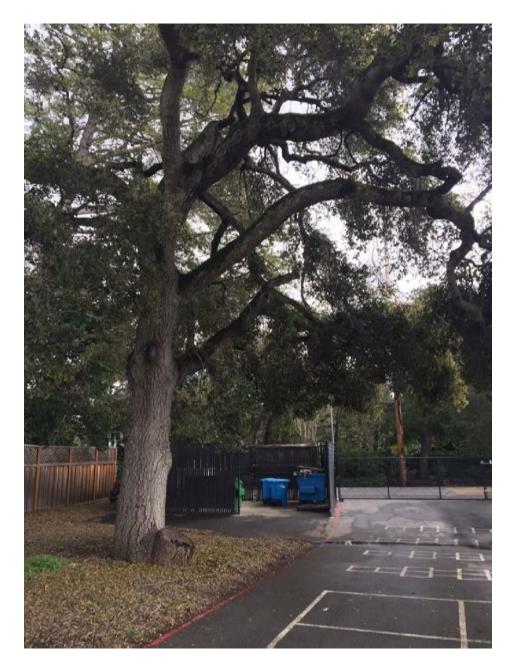
## 18. Coast live oak at entry on Ringwood

Fair health and condition. Not been maintained for some time. Large amount of dead wood throughout canopy and heavy limbs.

Thin and lighten throughout, remove dead wood.

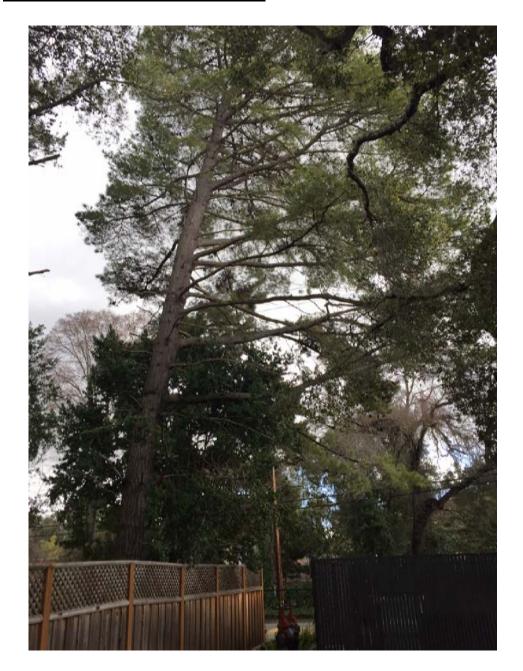
## 19. Neighbor's pine over debris boxes

Fair health and condition. Not been maintained for some time. Large amount of dead wood throughout canopy over school property.

Remove dead wood over school property.

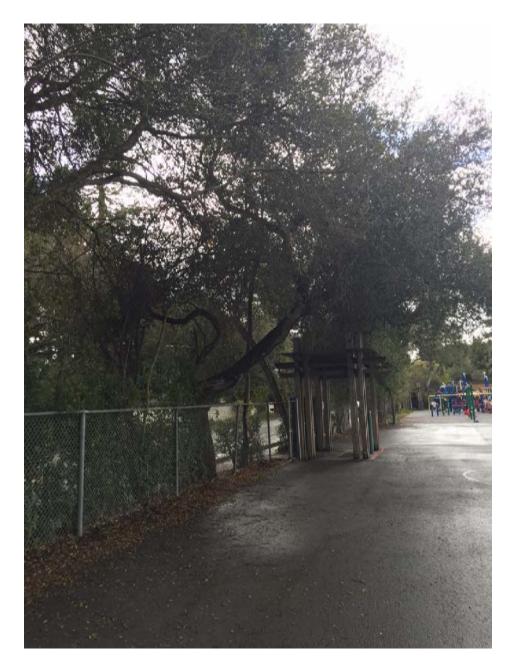
## 20. Live oak over pedestrian gate on Ringwood

Fair health and condition. Perhaps a City tree. Not been maintained for some time. Large amount of dead wood throughout. One sided canopy with large limb growing over play area

Remove dead wood lighten limb over school property.

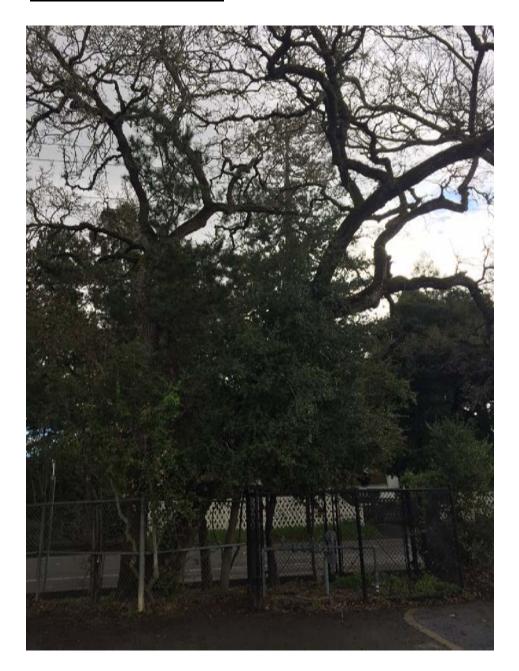
# 21. Valley oak over play area

Fair health and condition. Perhaps a City tree. Not been maintained for some time. Large, heavy limb over play area.

Remove large, heavy limb over play area.

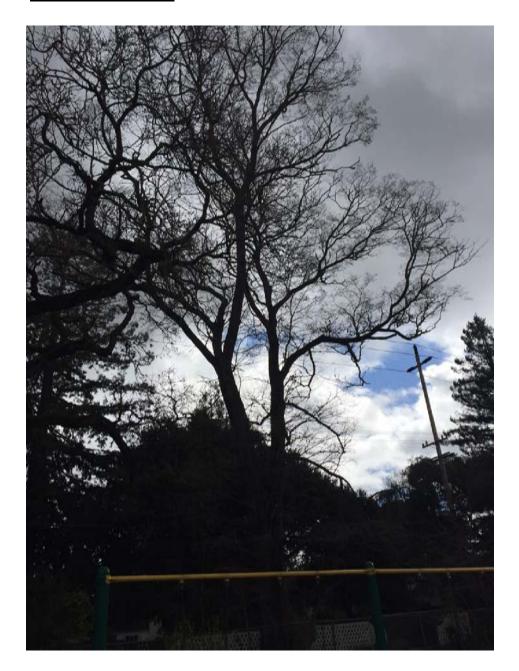
## 22. Elm over play area

Fair health and condition. Perhaps a City tree. Not been maintained for some time. Large, dead wood in canopy over play area.

Remove large dead wood over play area.

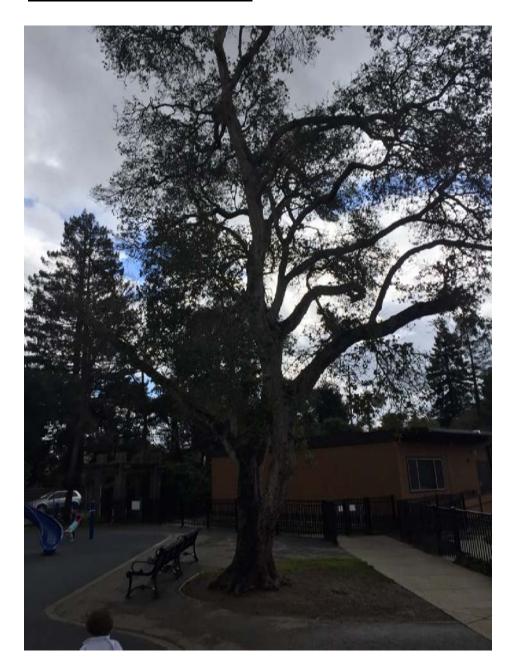
## 23. Live oak over play area, #903

Poor health and condition. Been slowly declining for many years. Has been lightened and maintained but continues to decline.

Tree # 23 has been slowly declining for many years. I do not see any signs of disease or insect infestation, however a thinning canopy suggests a problem in the root system. Since this area has a lot of activity during the school day, I recommend removal and replacement of this tree.

Cut to ground level

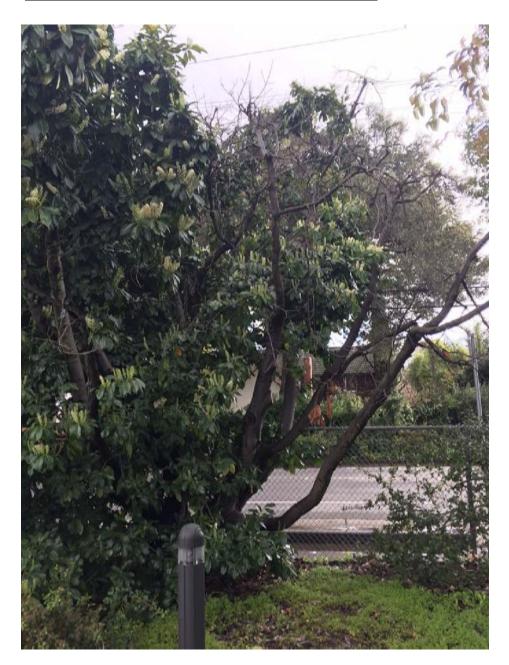
## 24. English laurel at corner of Edge and Ringwood

Poor health and condition. New growth on part of tree, rest of canopy is dead.

Remove large dead trunks

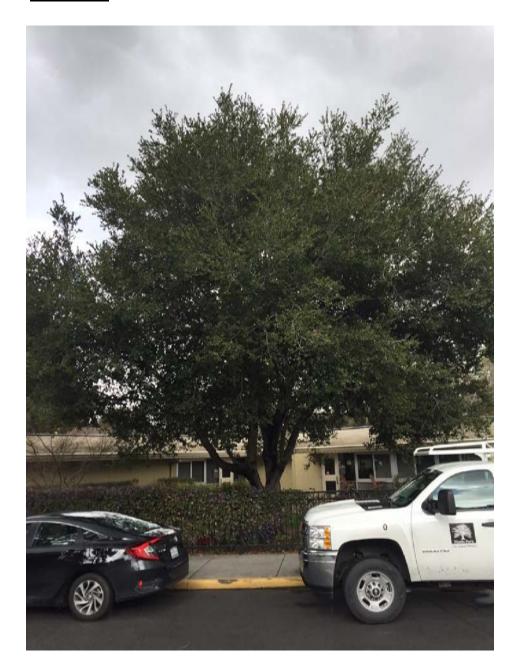
## 25. Oak at G2

Good health and condition. Not been maintained for some time.

Thin and lighten canopy throughout
