Project Observation Report

Project Name: Tri Tech East Building C 1.5 Project No. 2208
 Report #: 26
 Observation Date: 4-5-23 Last Report: 3-29-23
 Prepared By: Steve Mallory, AIA Contractor: Banlin

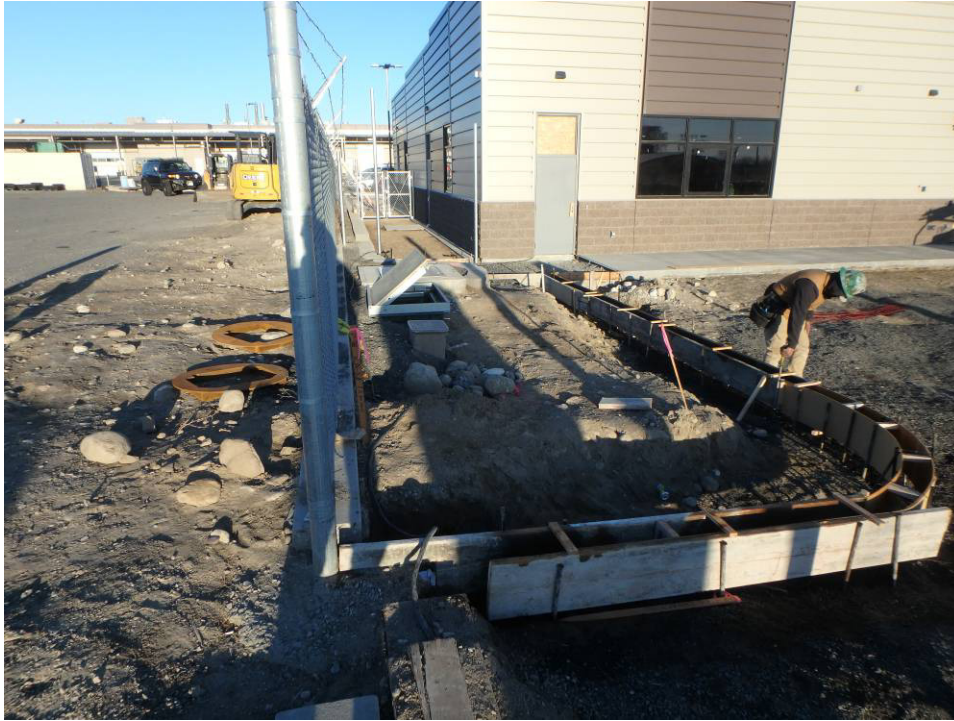
Southeast curb forms

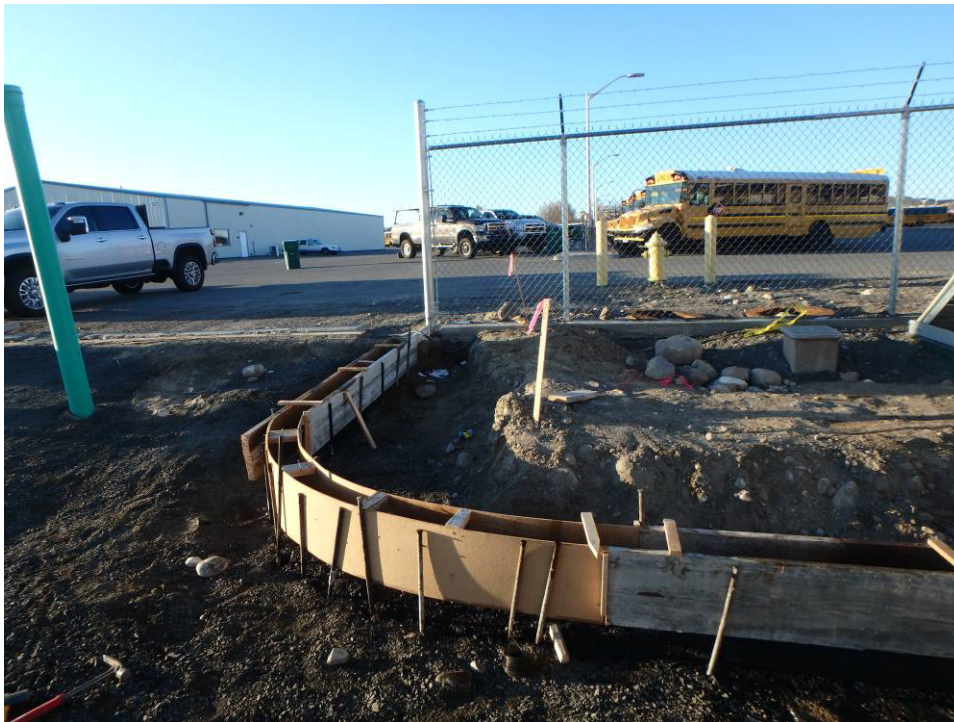
Entry formwork west half

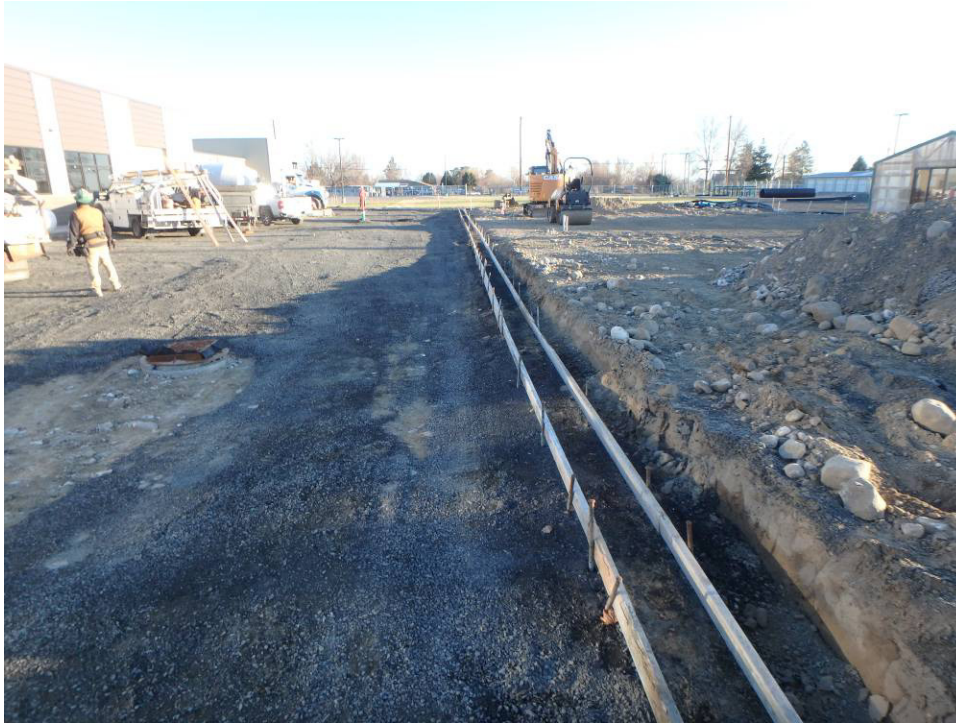
Looking north at the central curb forming

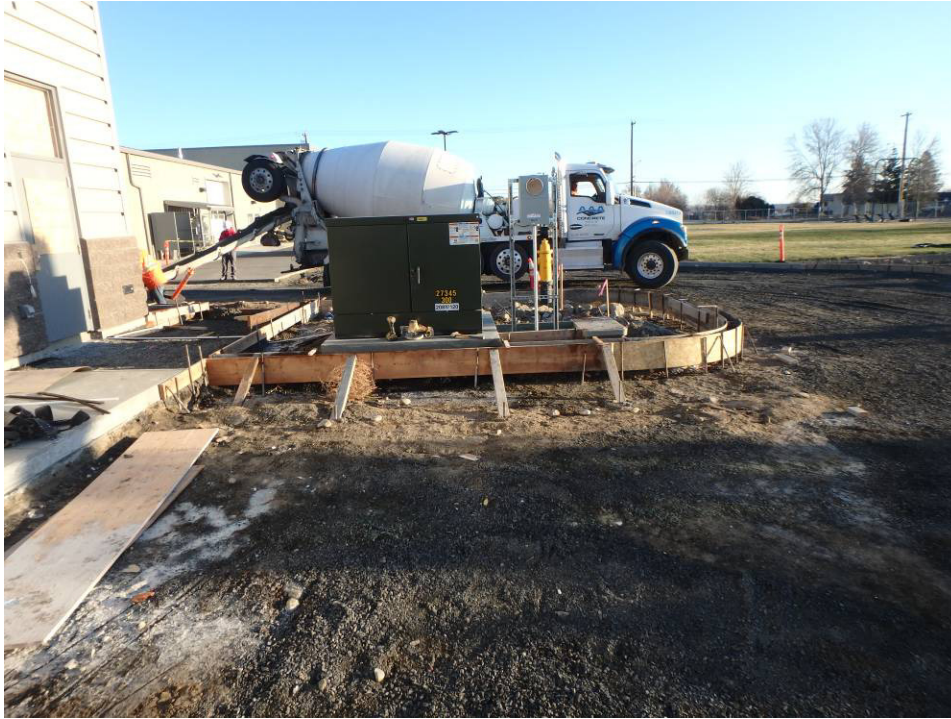
Northeast peninsula formwork

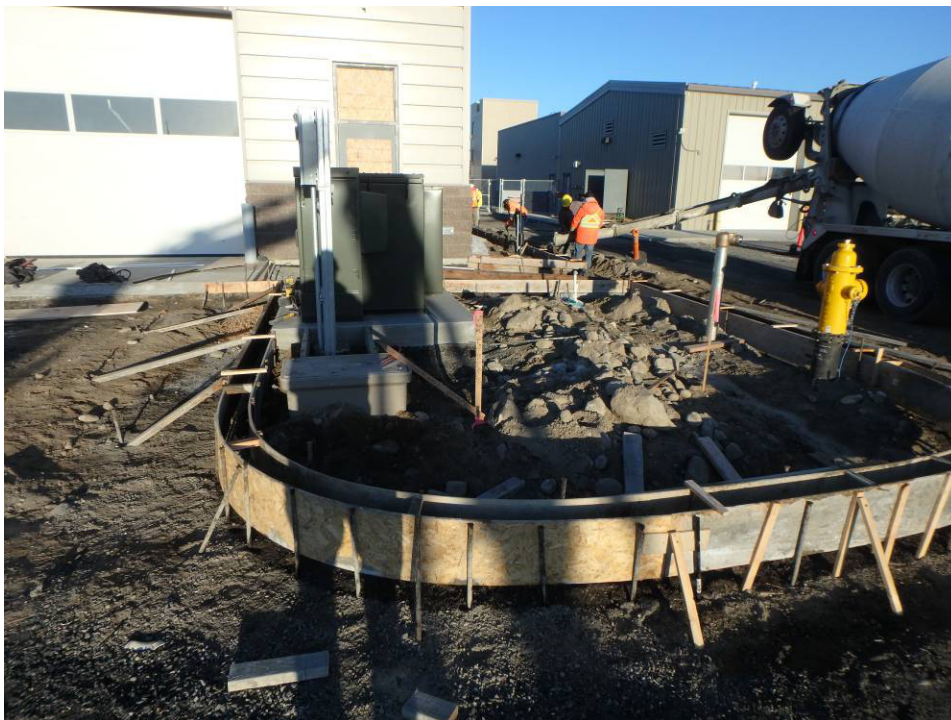
Northeast peninsula formwork

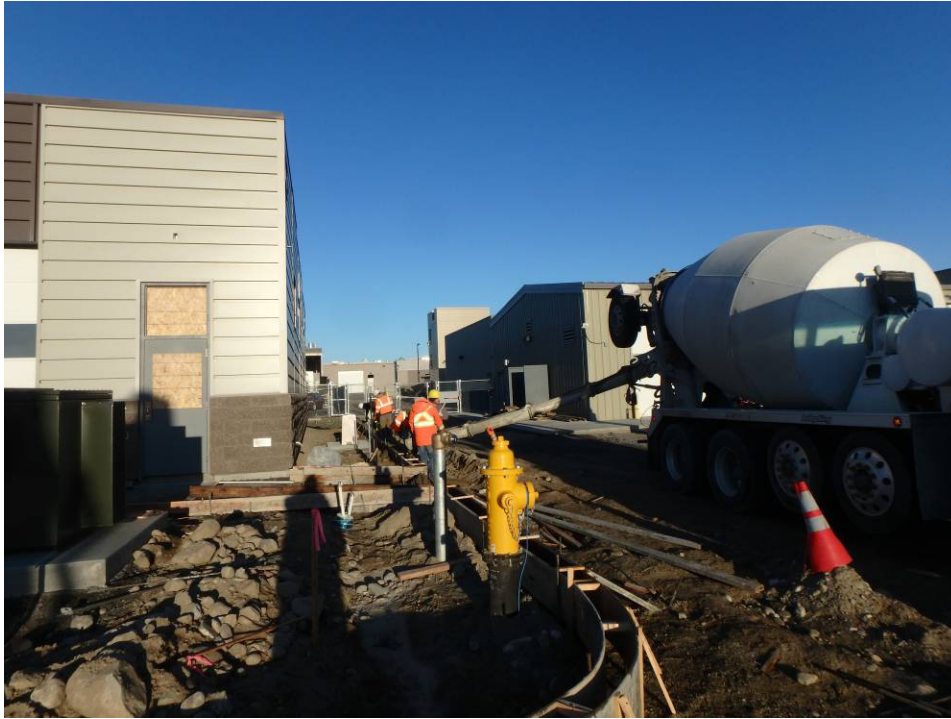
North side of building placing concrete curb

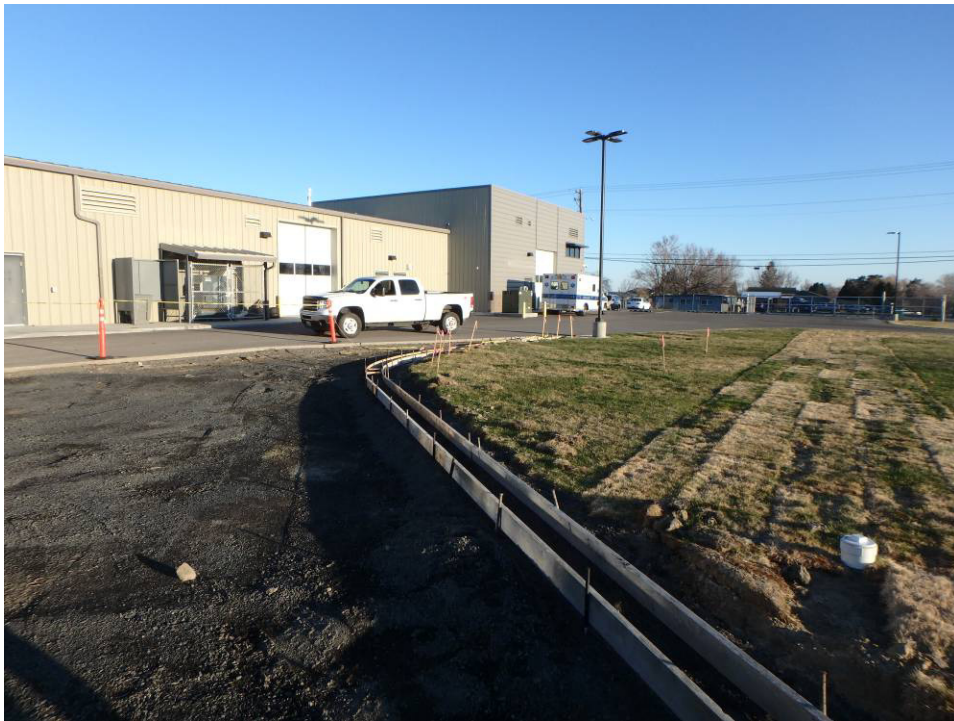
North central site curb forms

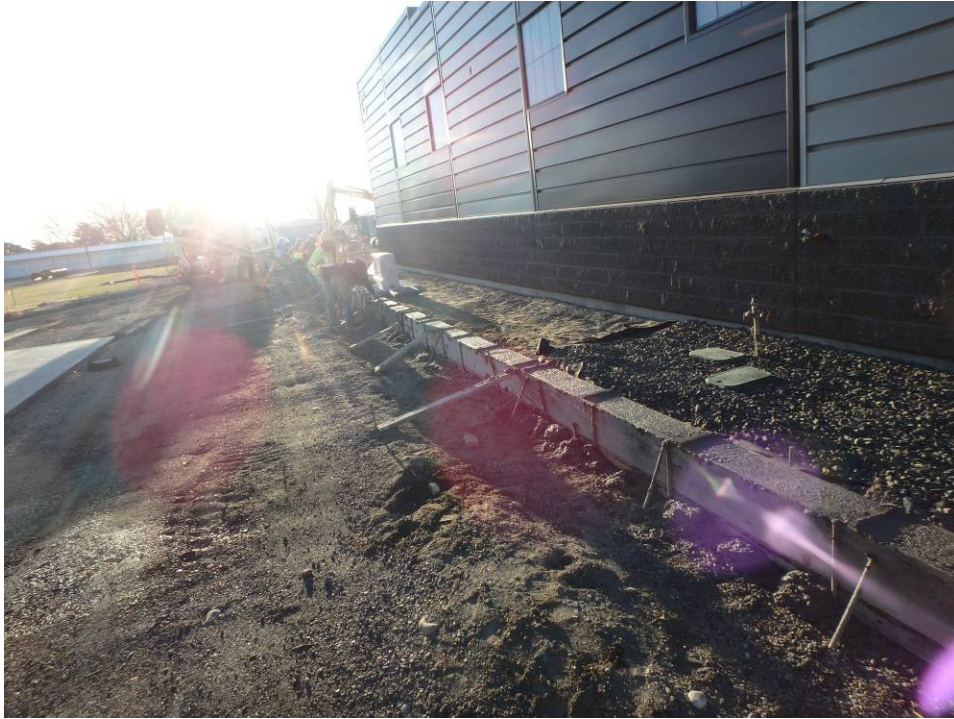
Looking east at the north curb forms and concrete

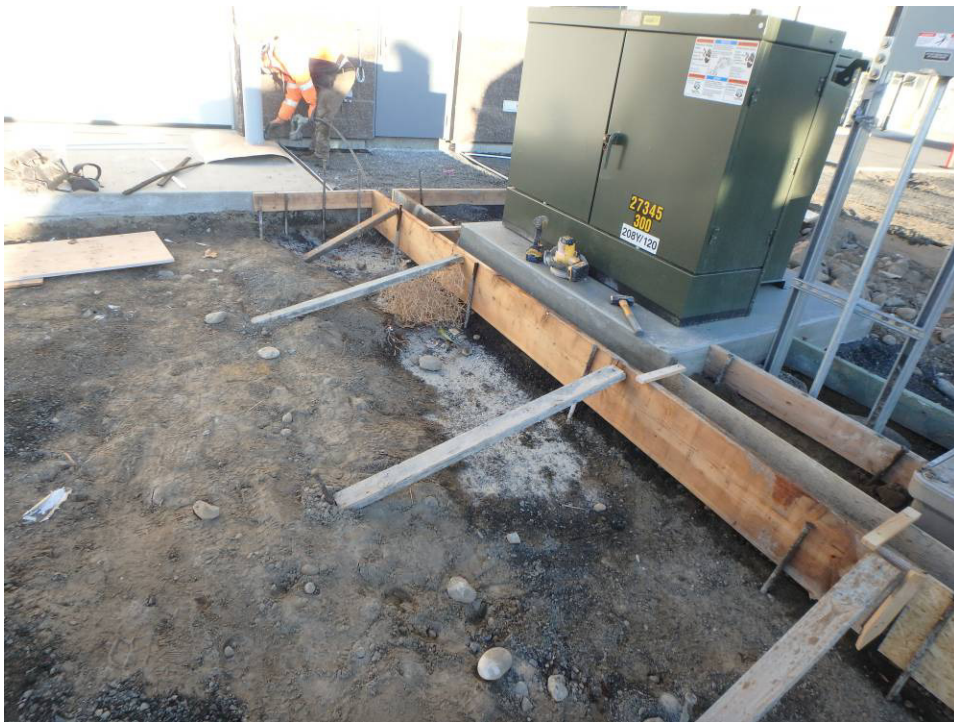
Curb formwork at transformer

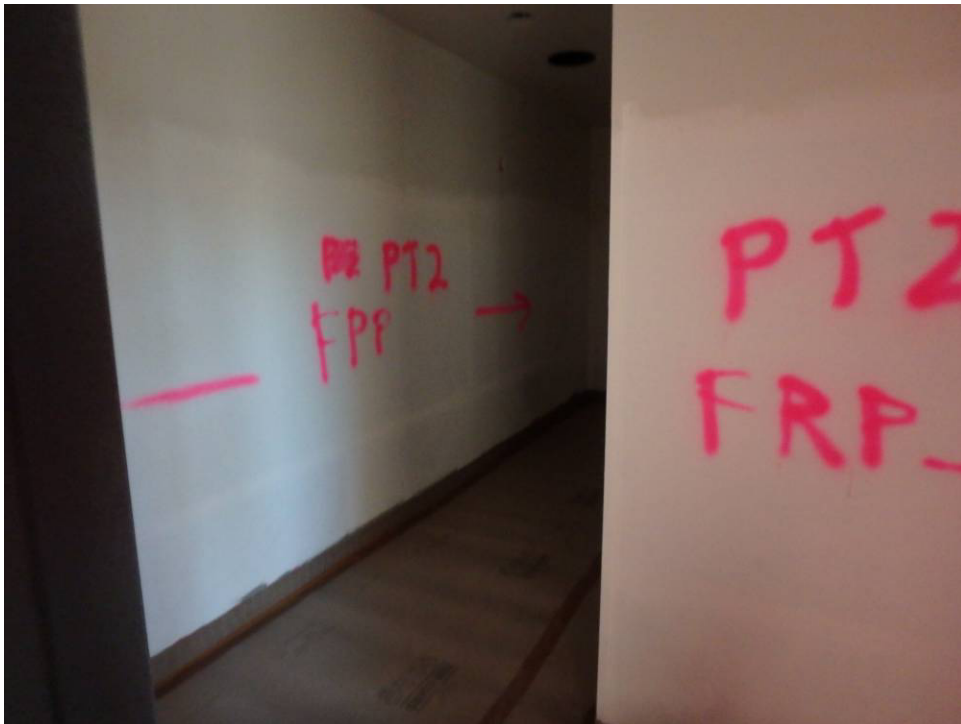
Typical restroom tiling protected

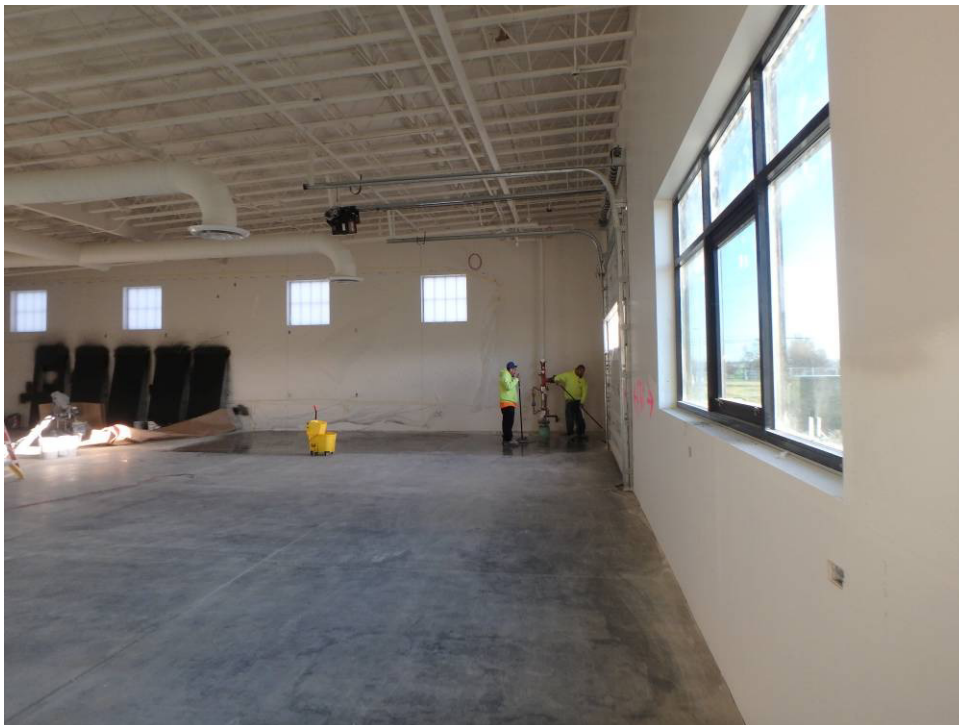
Looking north at the shop east wall, cleaning floors

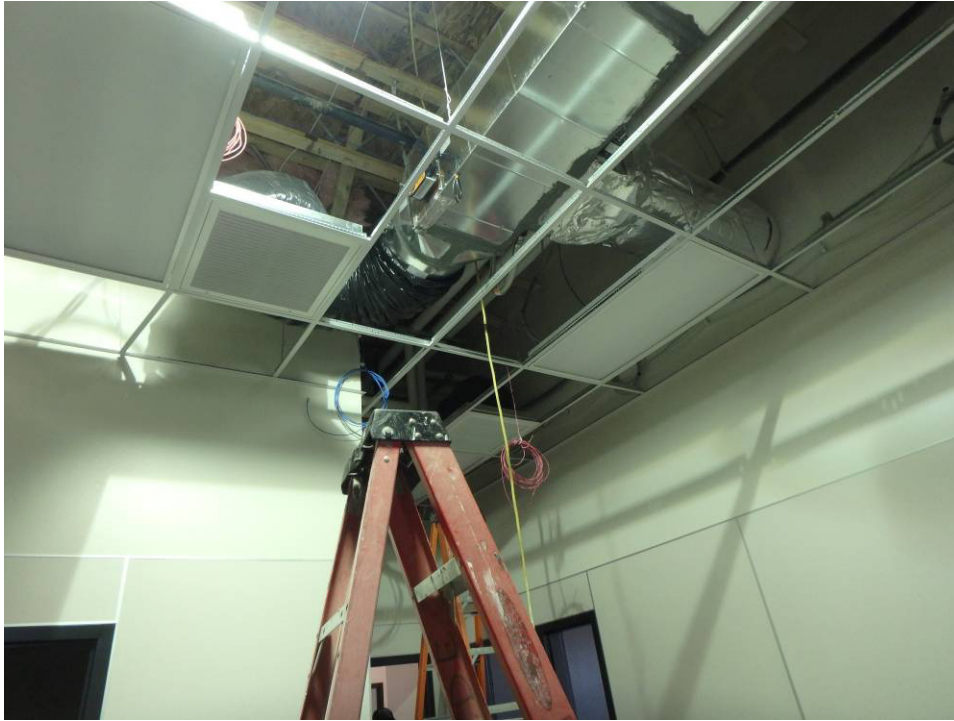
Lab northeast entry and FRP

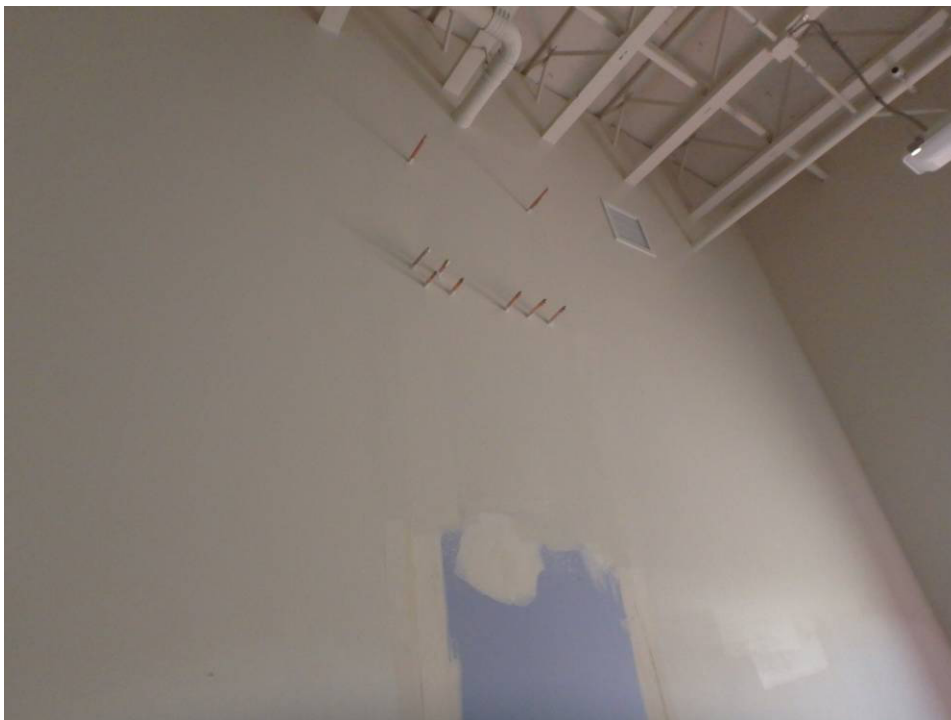
Field Discussions: Concrete curbs are currently being placed on the north and south. Windows installed except the bulletproof glazing at the entry doors, painting complete except for the metal doors. The GWB has been replaced at the trap manifold in the kennel room, ready for prep and paint. Fencing and gates installed. Autobody gate in operation. . Tiling and ceiling grid is installed and they are currently installing lights. The electrical panel “guts” are expected on site on Monday nad the can is expected May 2nd. FRP work is on-going in the north classroom and they will be finished this week. Low voltage is wired. The roof curb termination detail is complete. Building letters mounted to the building. Casework starting tomorrow with lockers being delivered and installed on Monday. TEM to install trim with vacuum remaining. Plumbers here in two weeks.

Wallboard repair at the manifold to be relocated in the Kennel Room

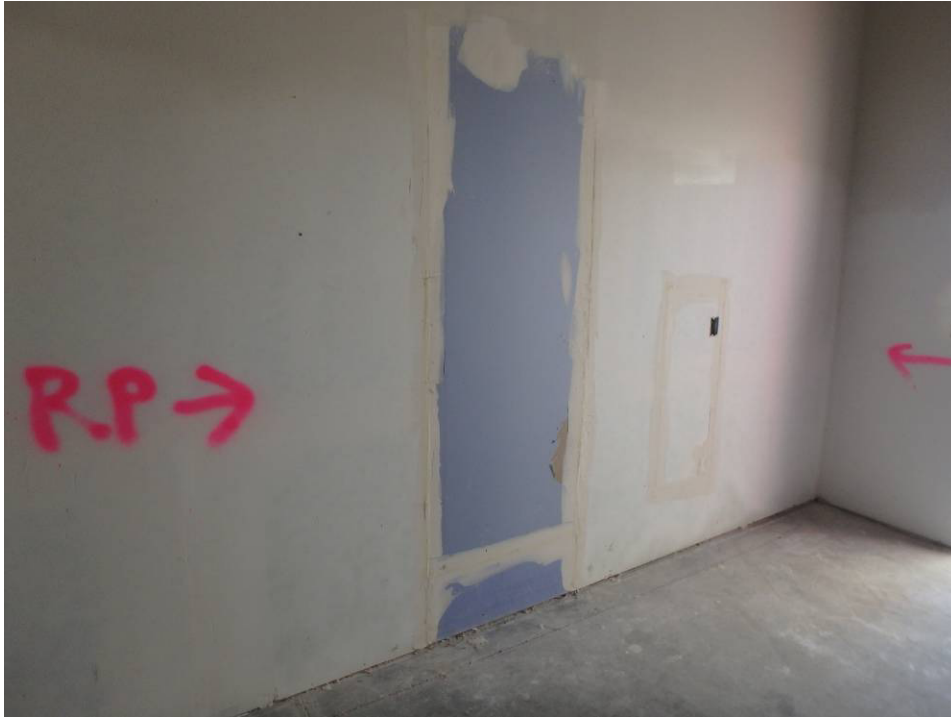
Wallboard repair at the manifold to be relocated in the Kennel Room - lower

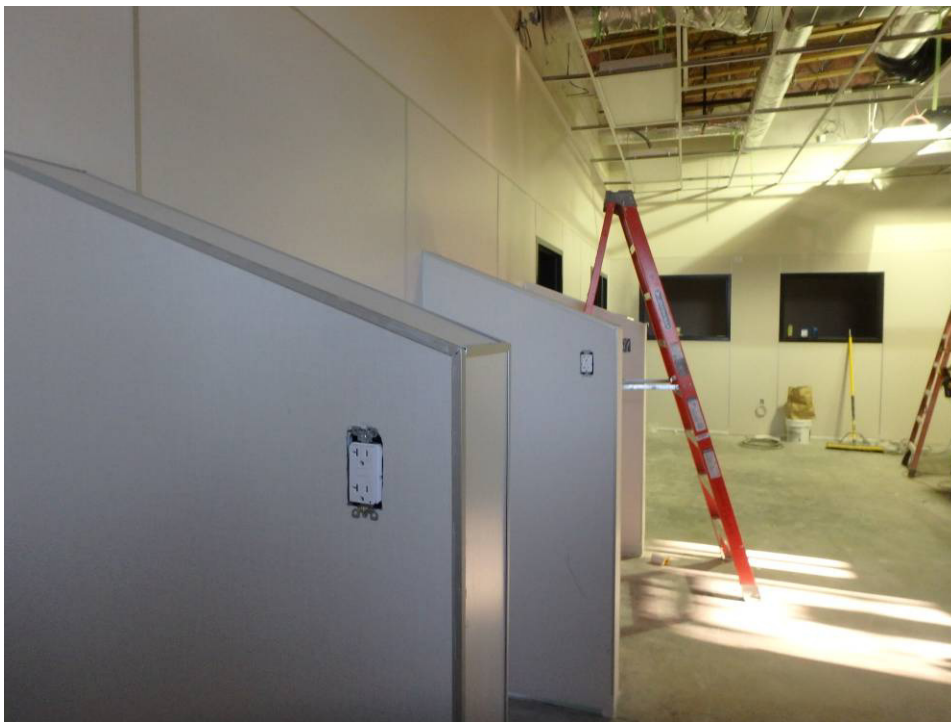
Dog wash dividers with FRP

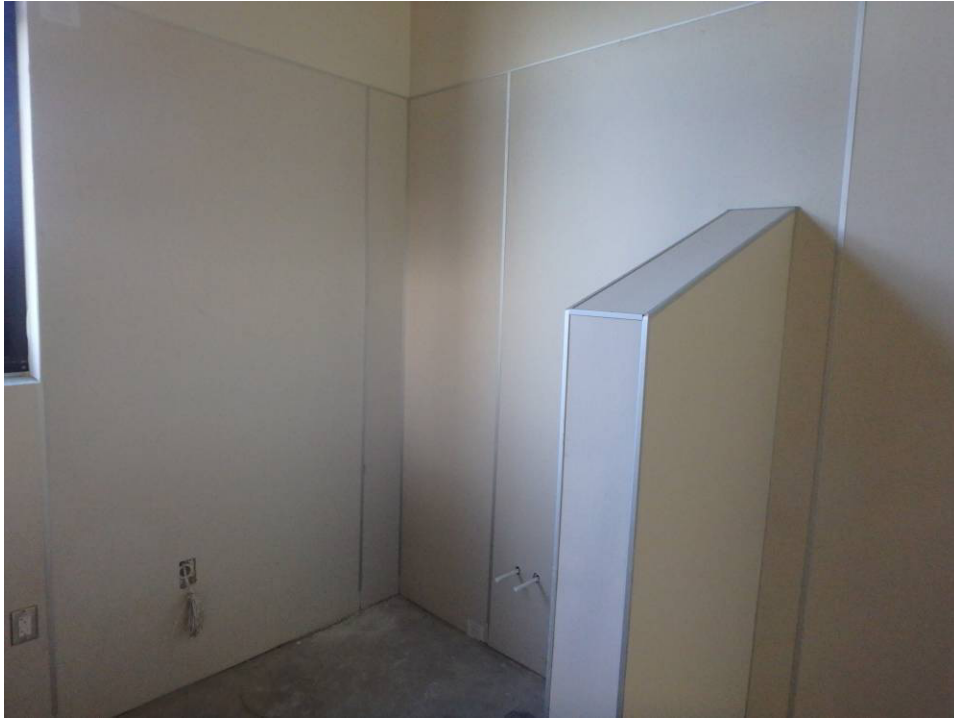
Dog wash divider with FRP
