# Issue Paper 4: Existing Facility Condition

07 APRIL 2023

## EXISTING FACILITIES

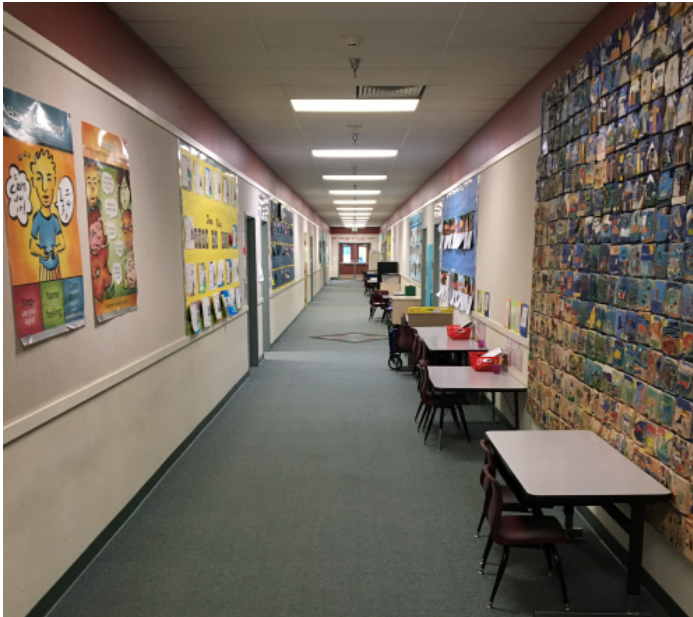
Lakeridge ES: Hallway use for pull-out activities / lack of natural light

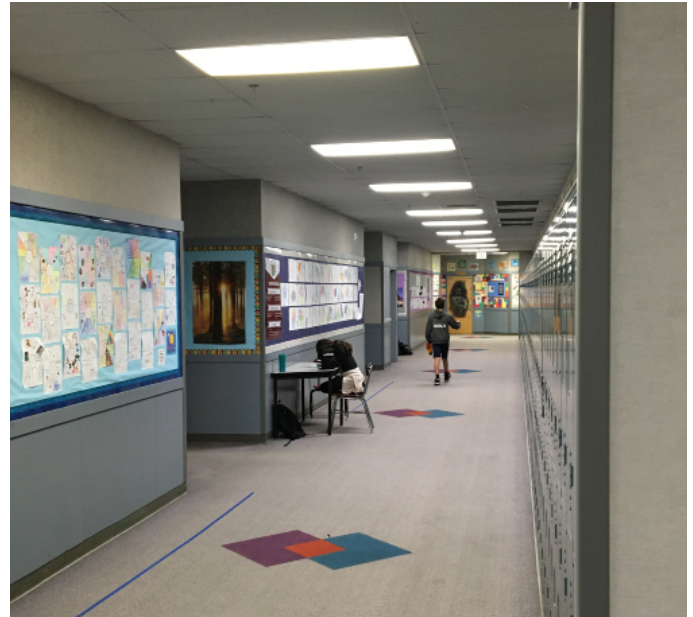
Islander MS: Hallway use for pull-out activities / lack of natural light

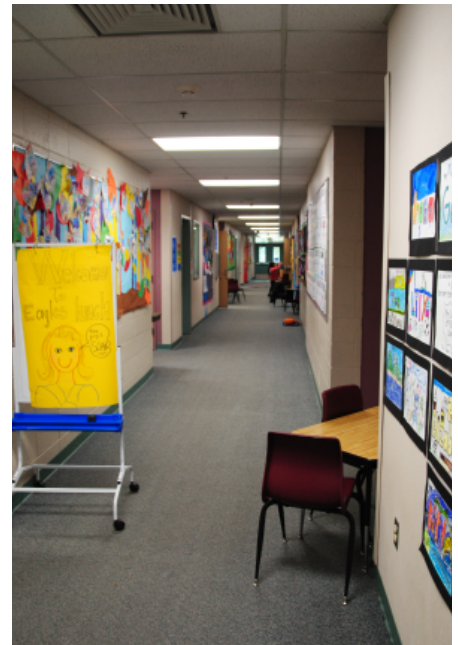
Island Park Elementary: Pull-out areas in hallway

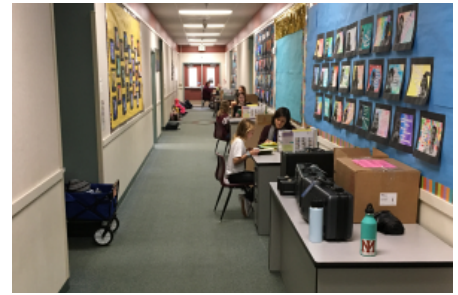
Lakeridge Elementary: Pull-out areas in hallway

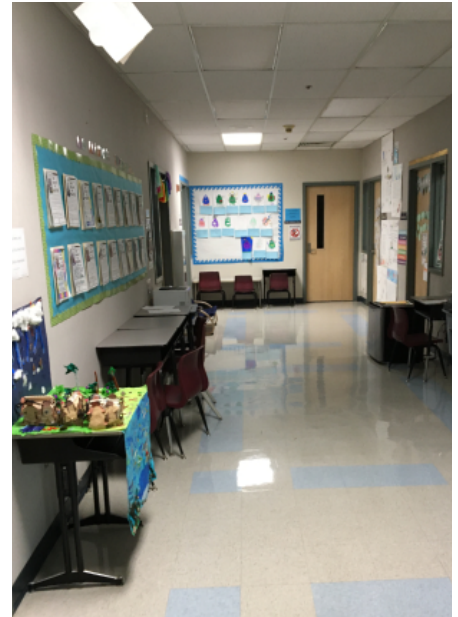
West Mercer Elementary: Pull-out areas in hallway

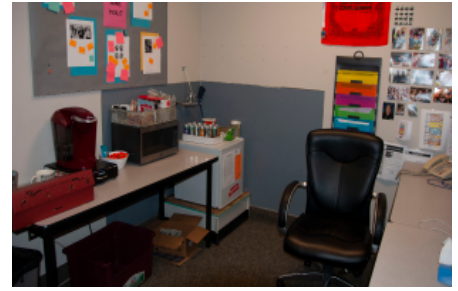
IMS 100/200 Building: Office in custodial closet

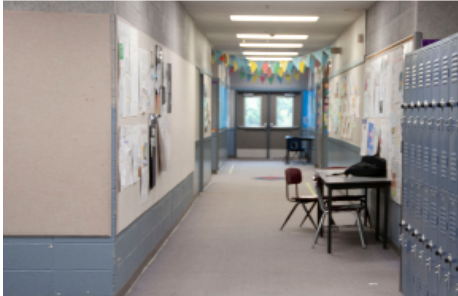
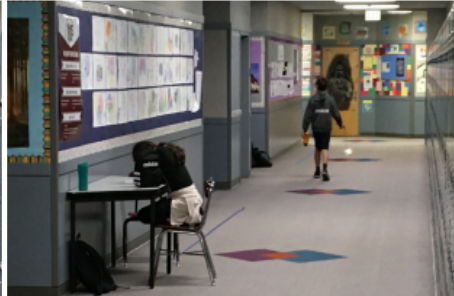
IMS 100/200 Building: Small group learning / pull-out areas in hallways

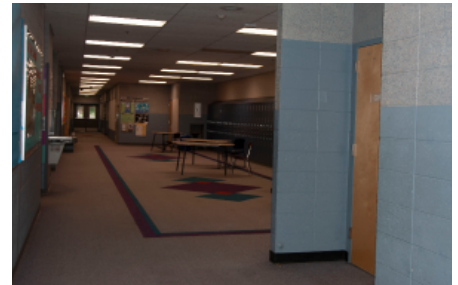
IMS 100/200 Building: Lack of natural light

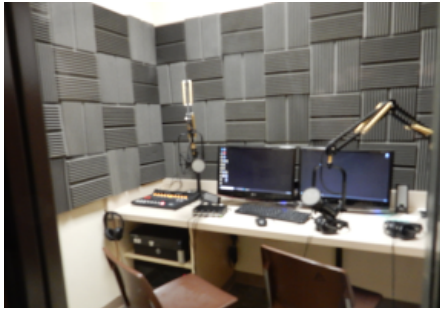
Mercer Island HS: Undersized broadcast program

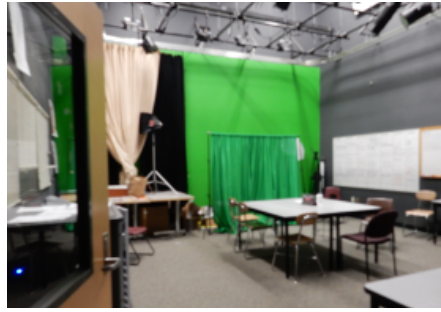
Mercer Island HS: Robotics classroom in old shop

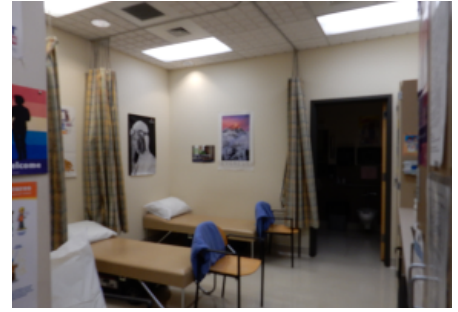
Mercer Island HS: Inadequate health/counseling
