**Project Observation Report**

Project Name:	Tri Tech East Building C 1.5	Project No.	2208
Report #:	27		
Observation Date:	4-12-23	Last Report:	4-5-23
Prepared By:	Steve Mallory, AIA	Contractor:	Banlin

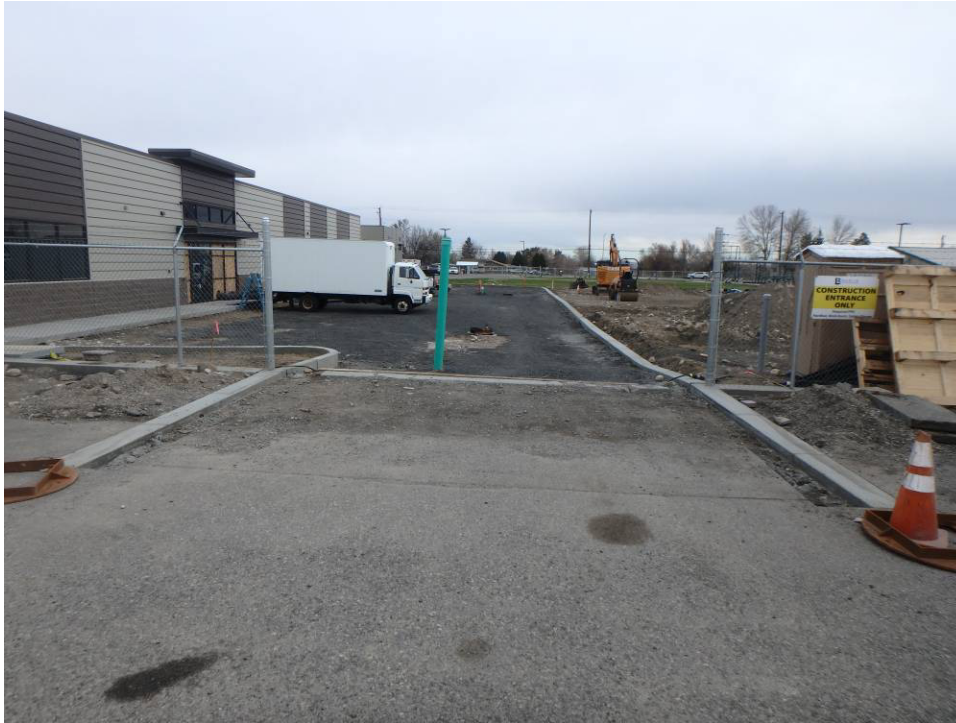
South site entrance and new curbs

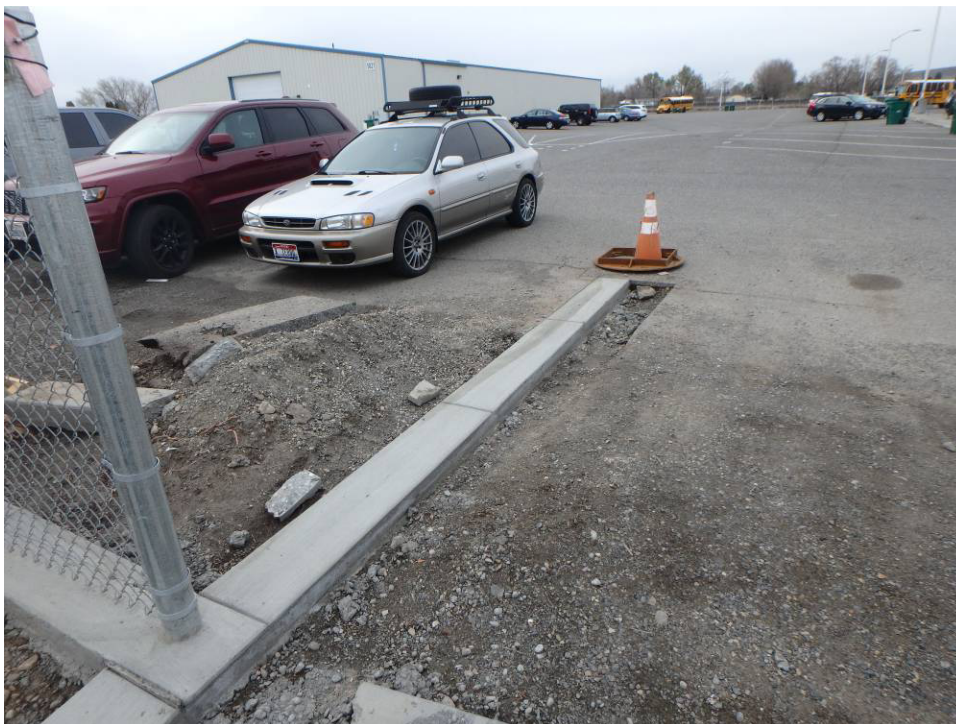
Southeast curb at site entry

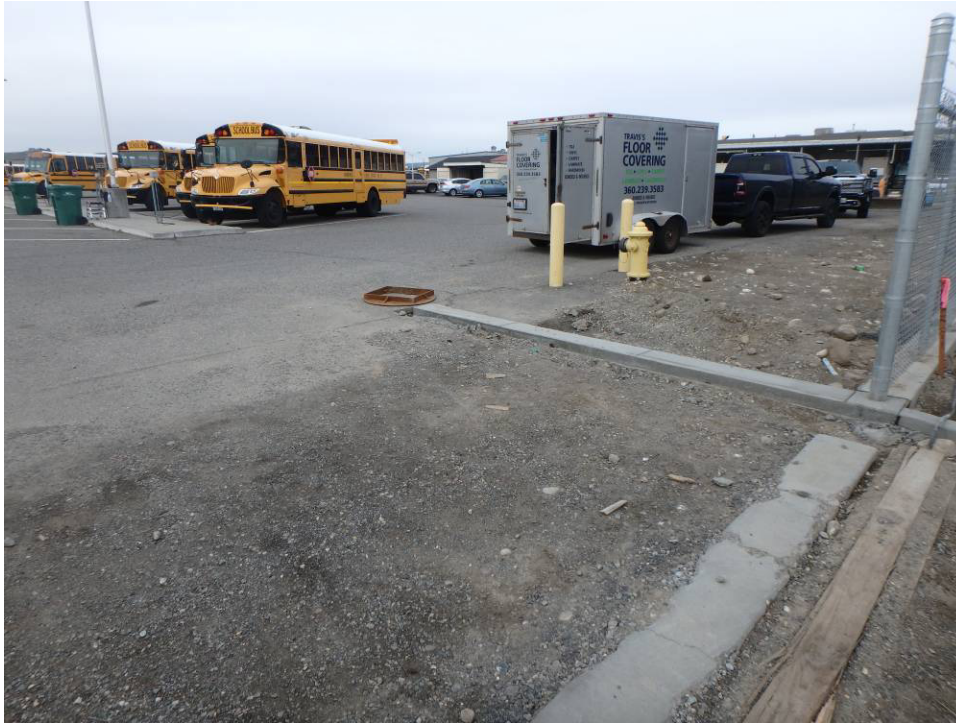
Southwest curb at site entry

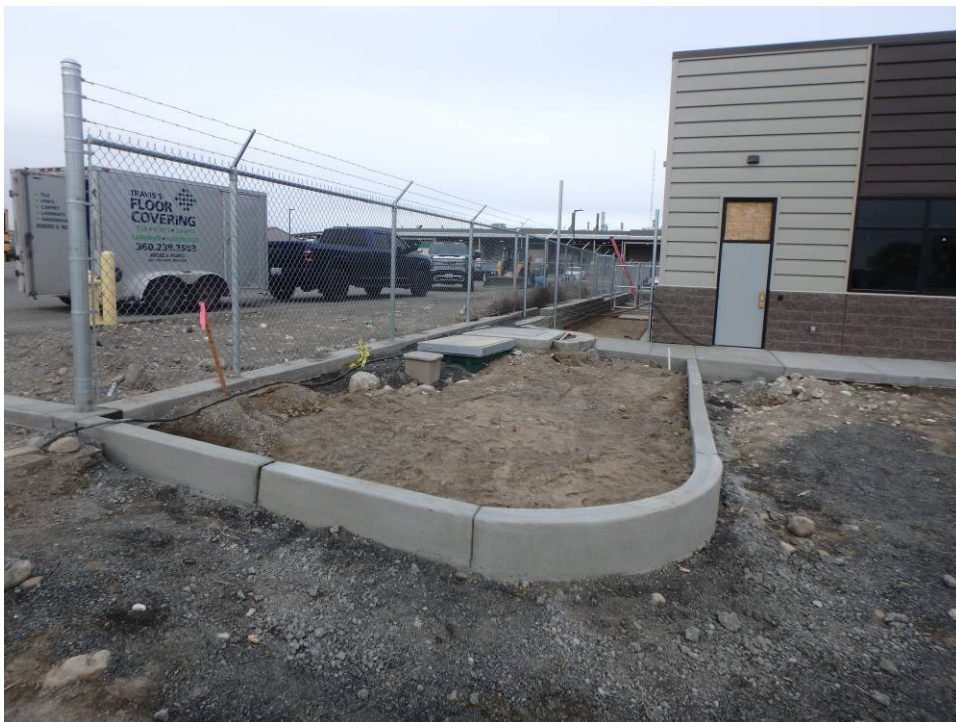
Southwest peninsula and the southeast corner of the building and south property line fence

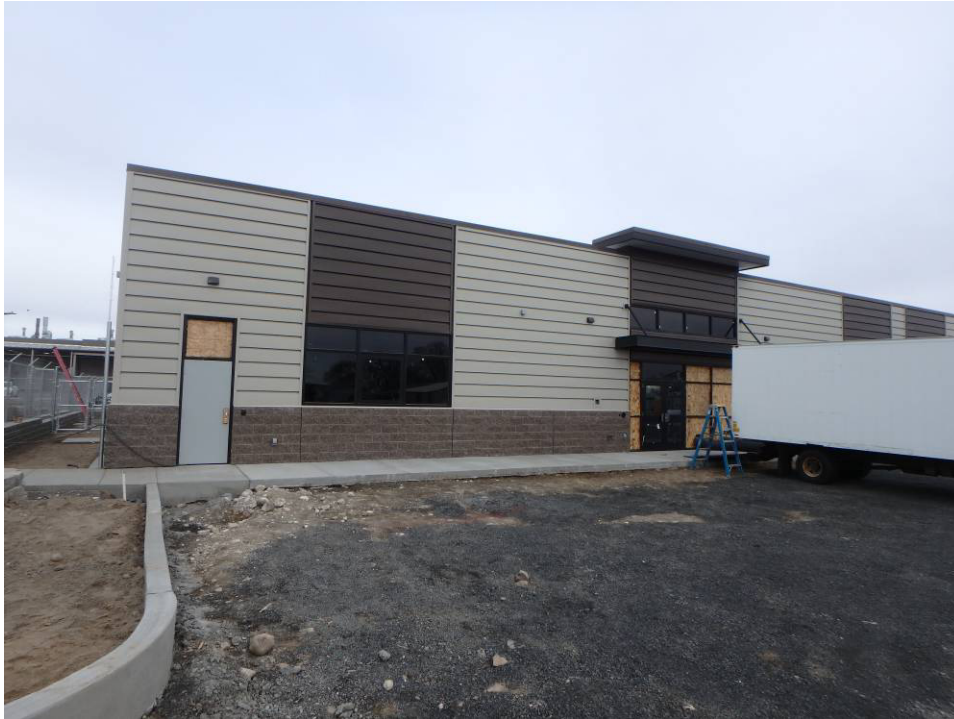
Southeast corner of the building

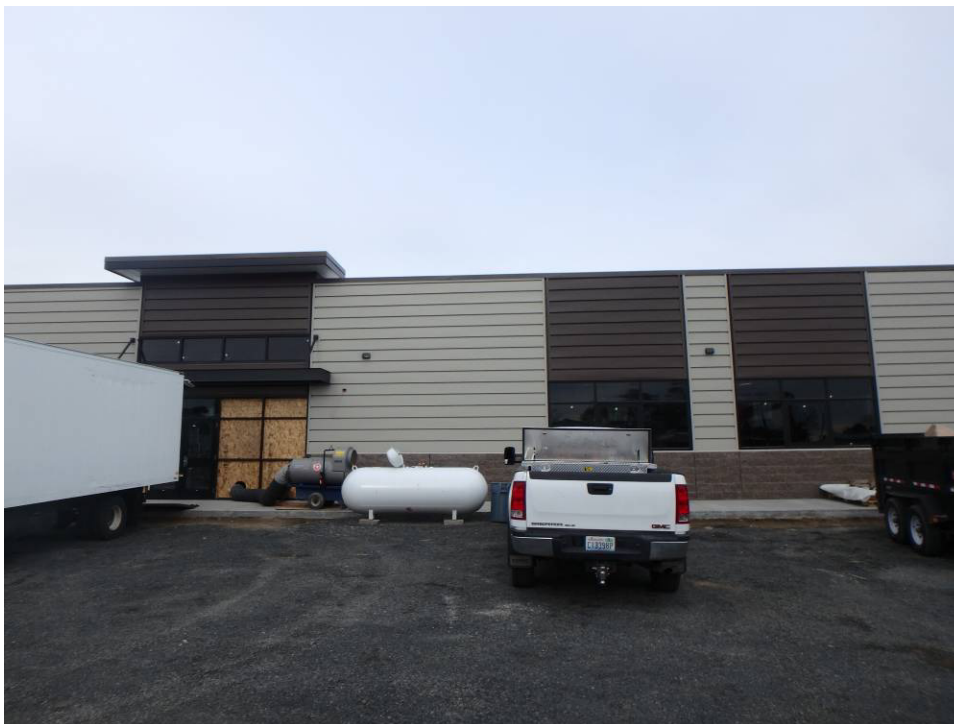
Main entry and central portion of the east elevation

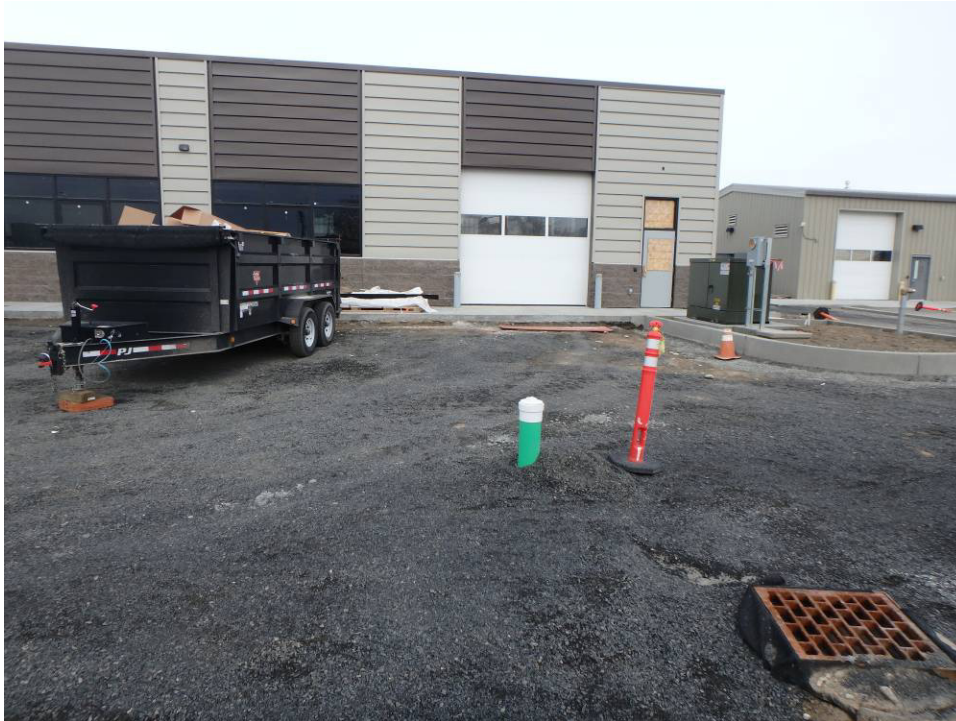
Northeast peninsula and north end of the east elevation

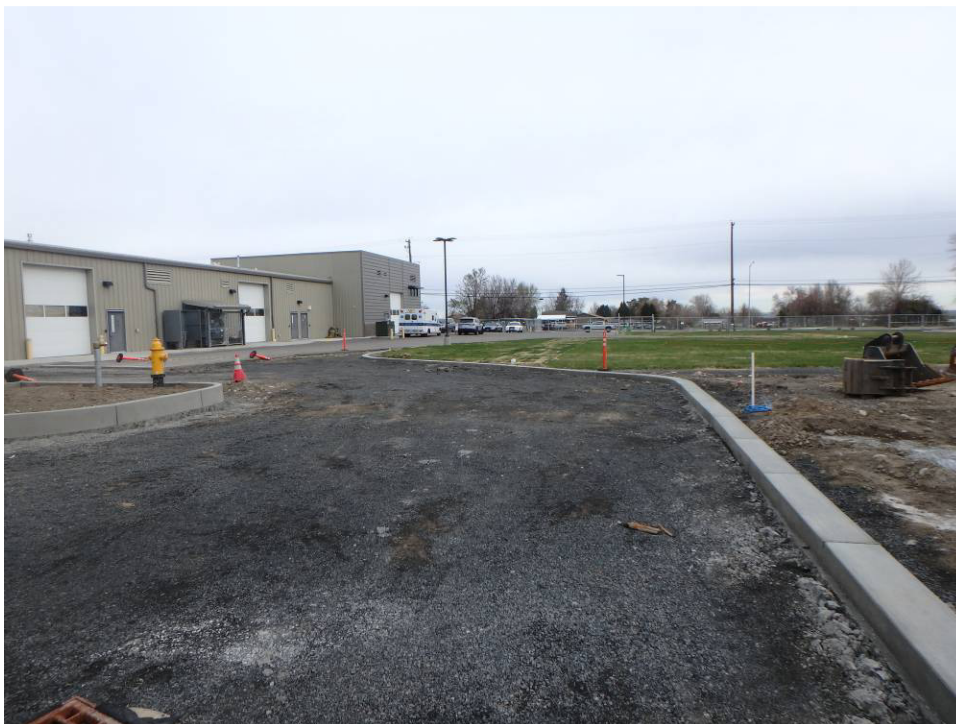
Looking north at the central curb

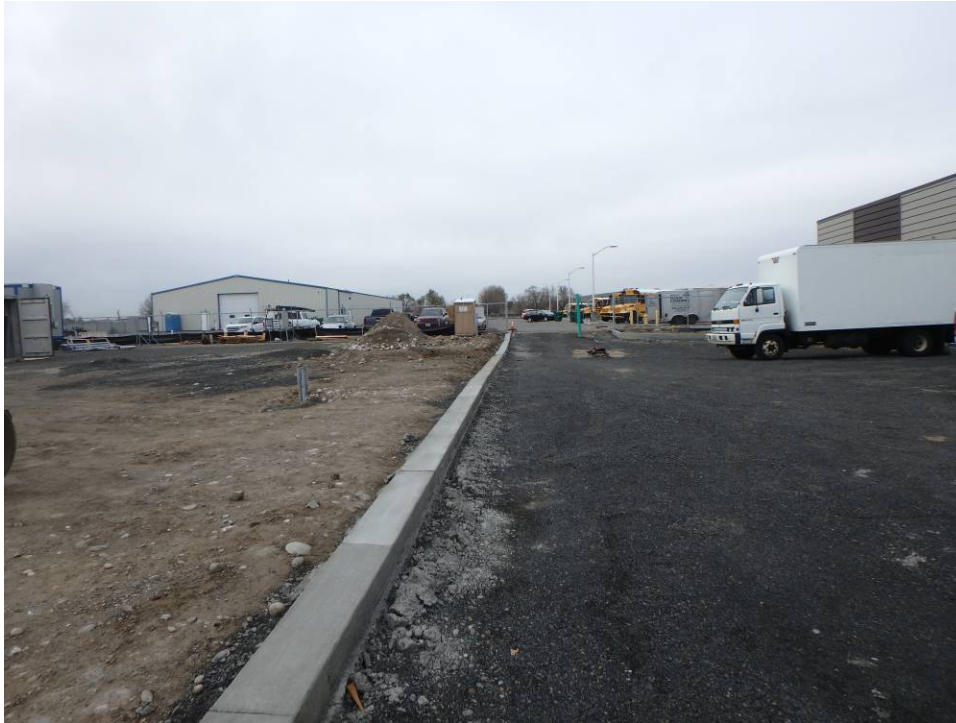
Looking south at the central curb

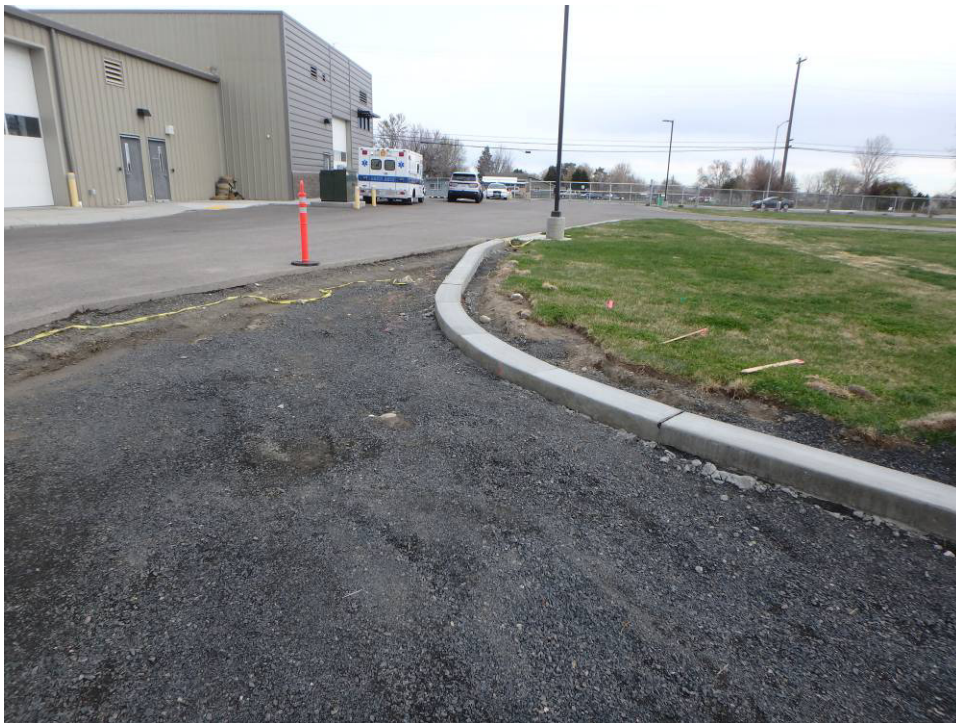
North curb

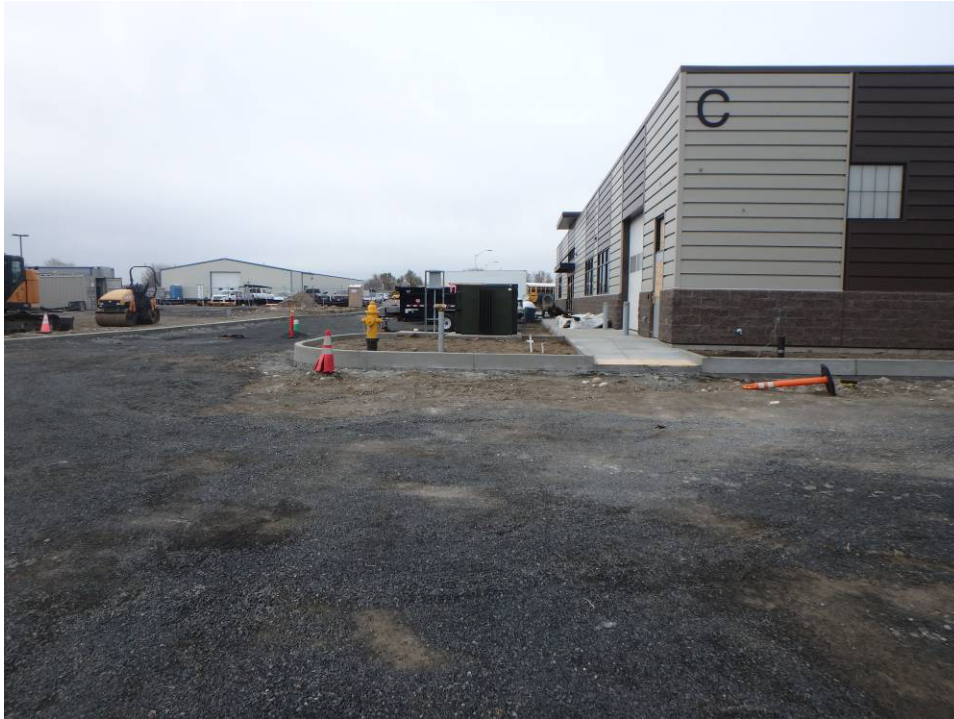
Looking south at the Northeast corner of the building

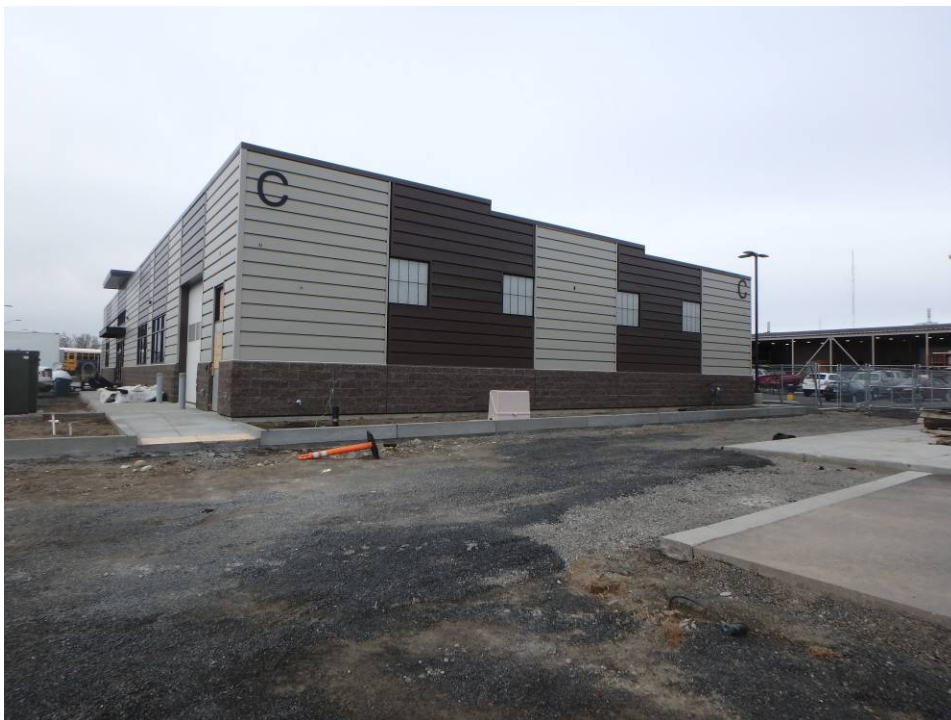
North elevation

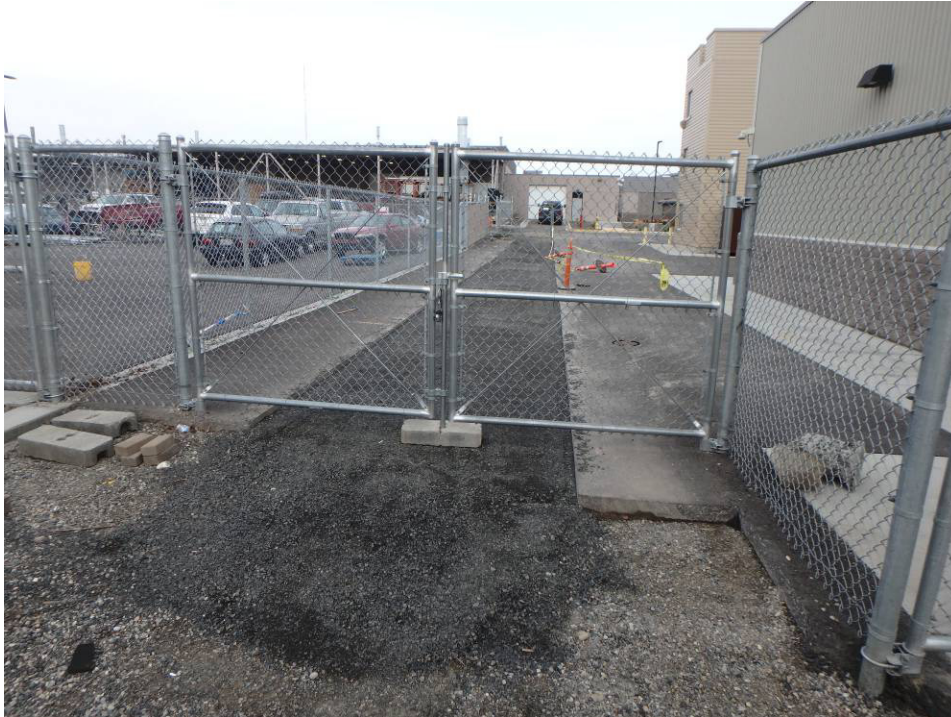
Alleyway – looking west

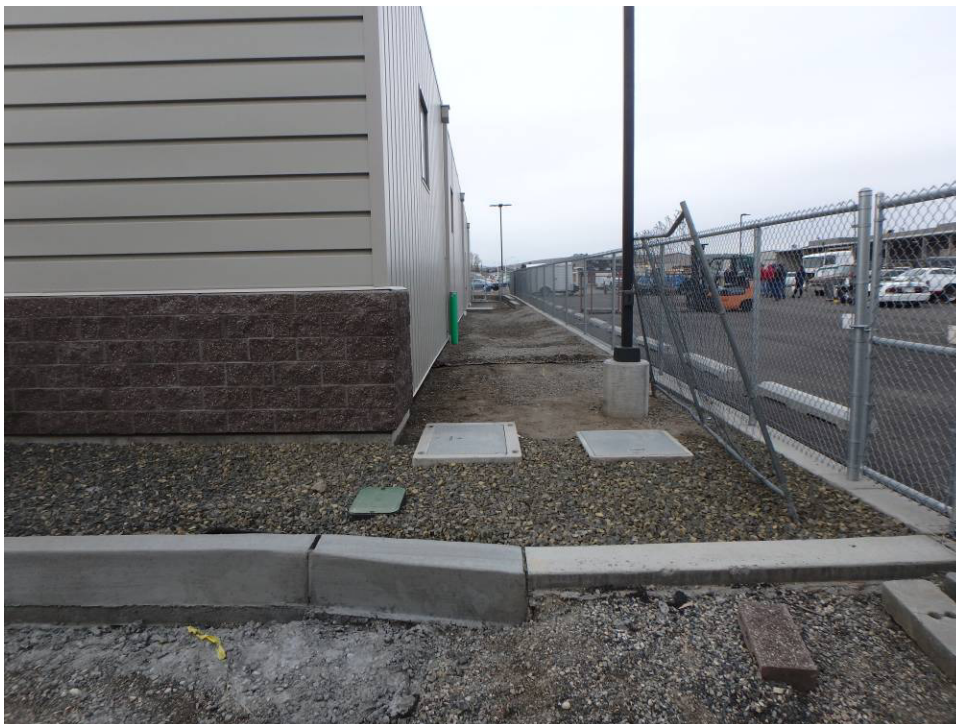
Looking south at the west property line and back of building

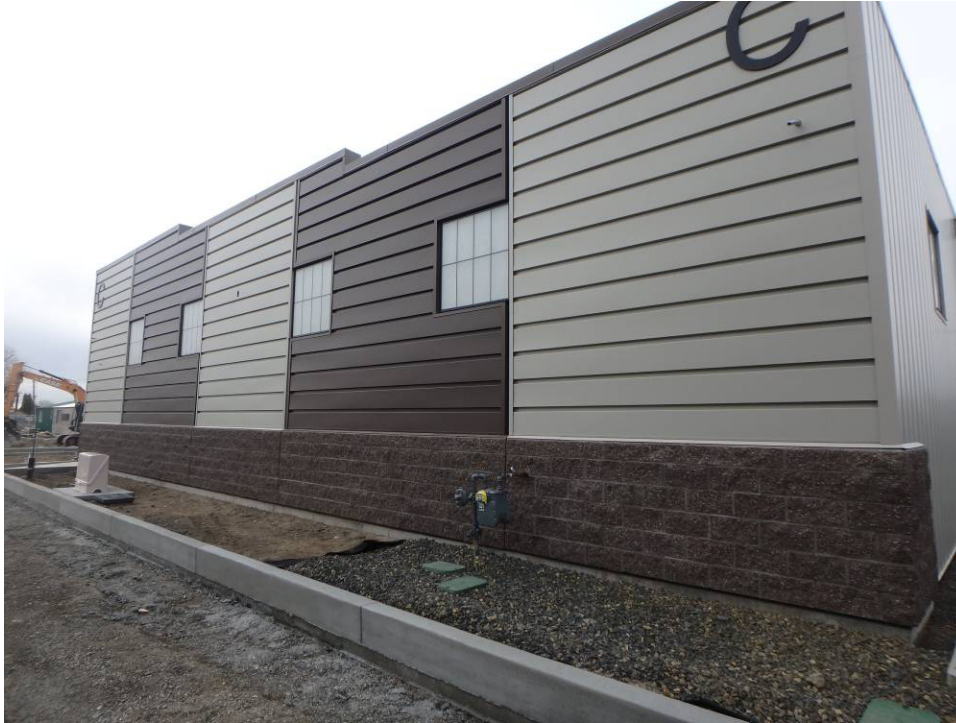
Looking east at the north curb and gas meter

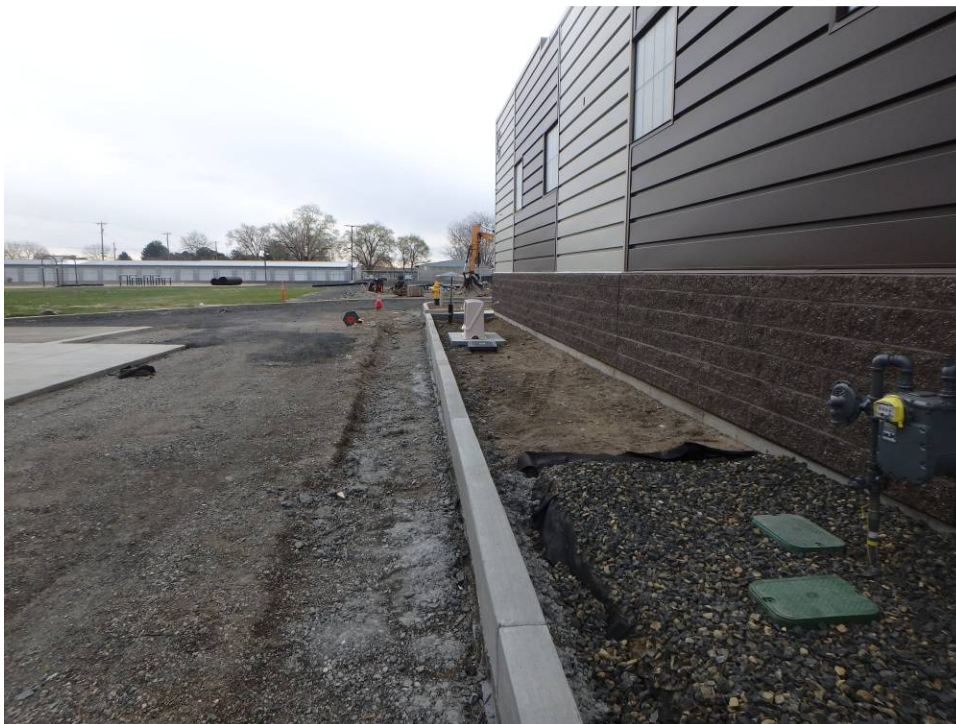
Curb at north end of building – looking east

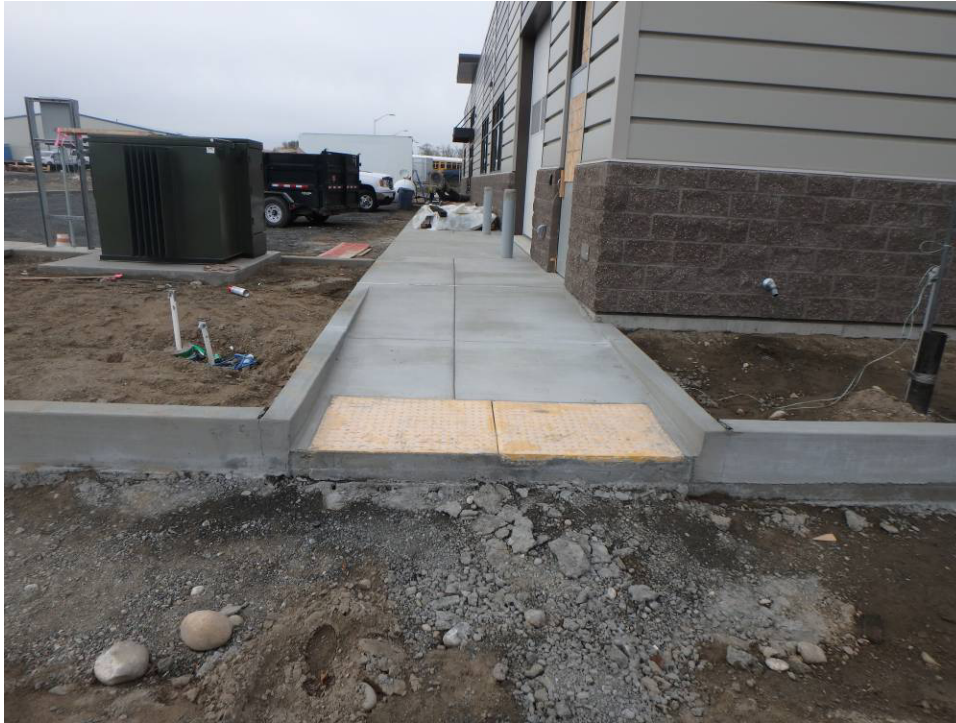
Looking south along the front sidewalk

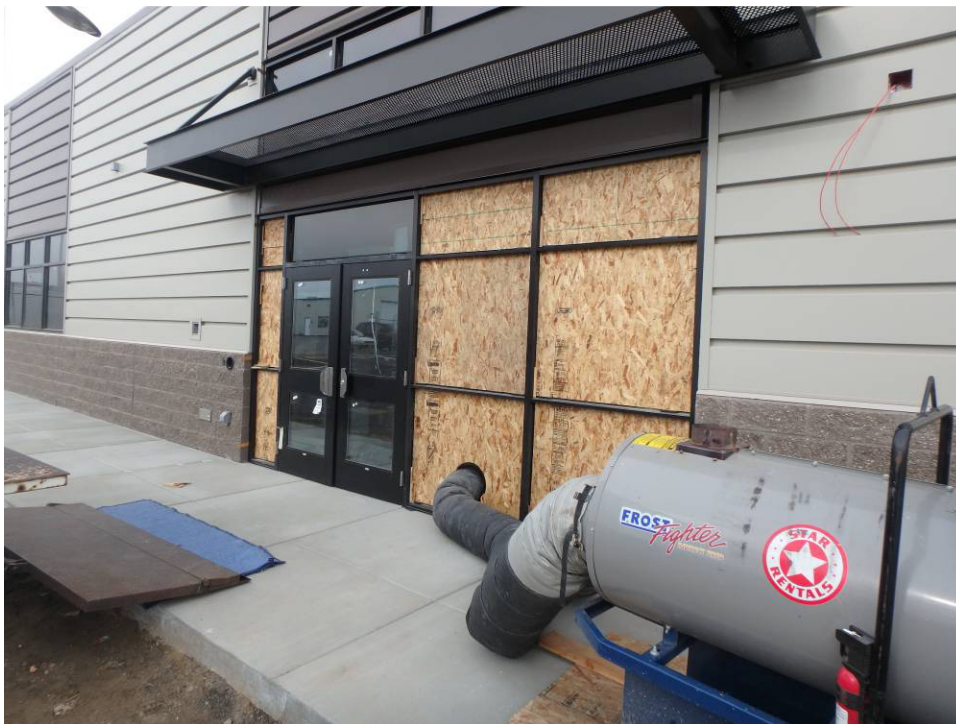
Main entry

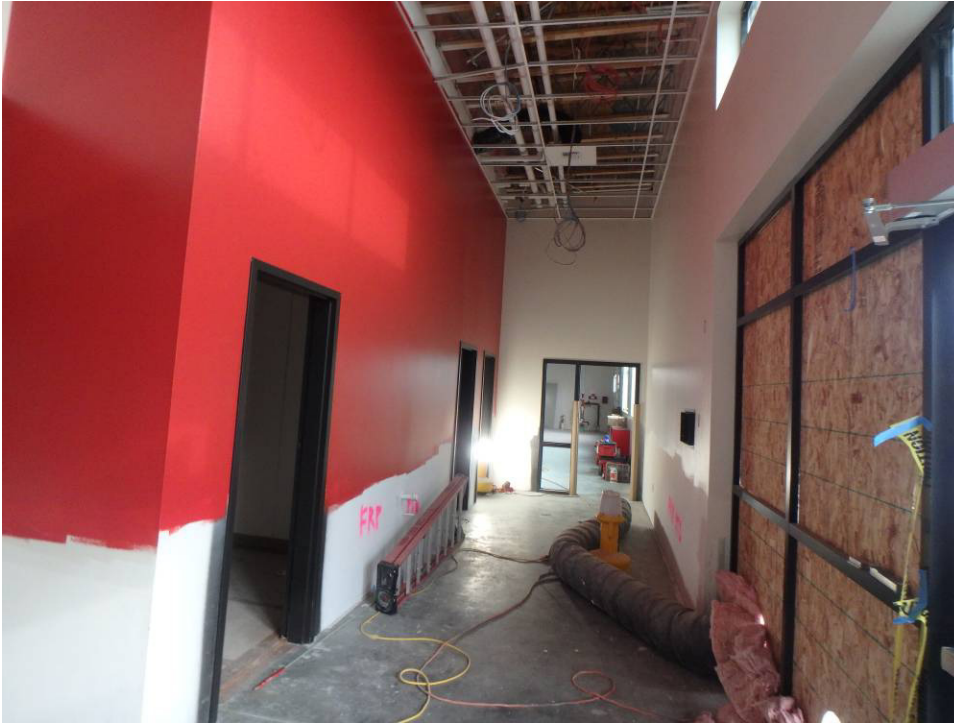
East corridor looking north

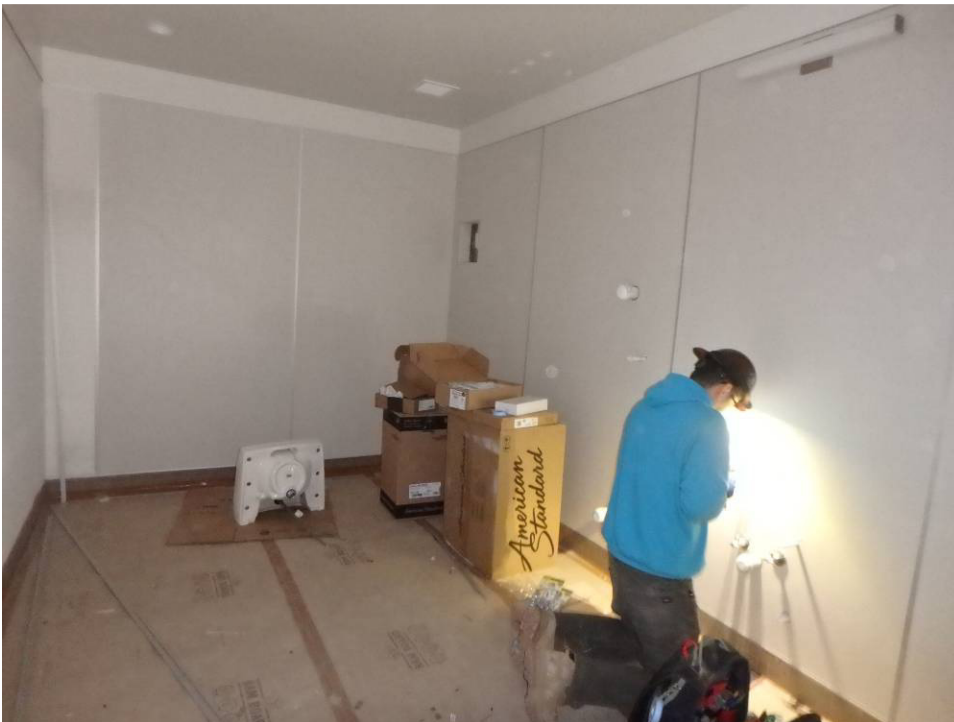
Typical restroom FRP walls

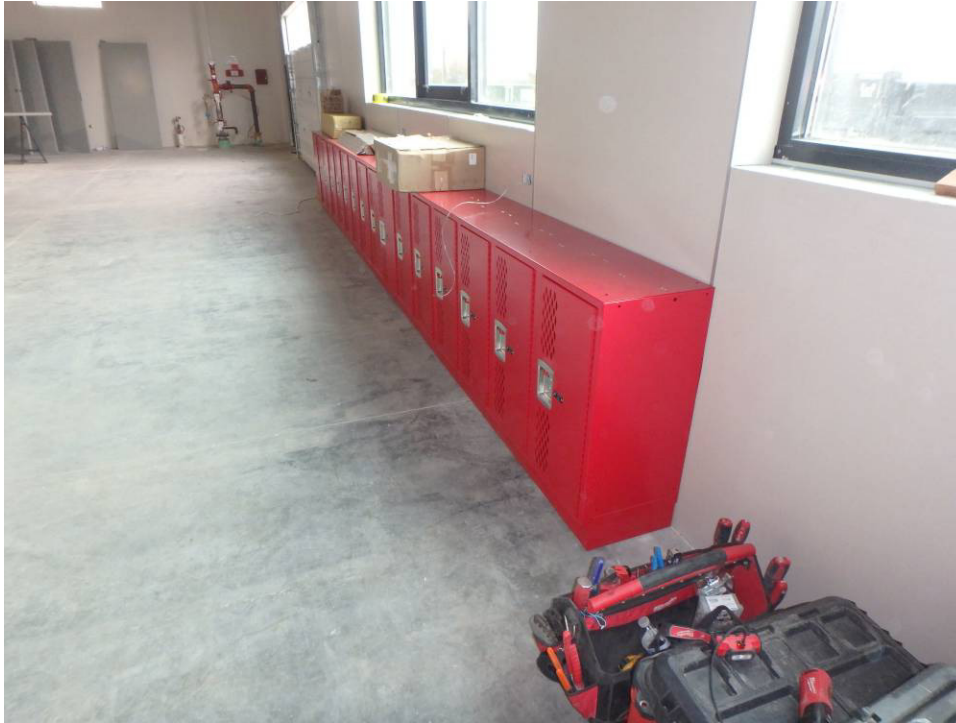
Looking north along the shop's east wall and lockers

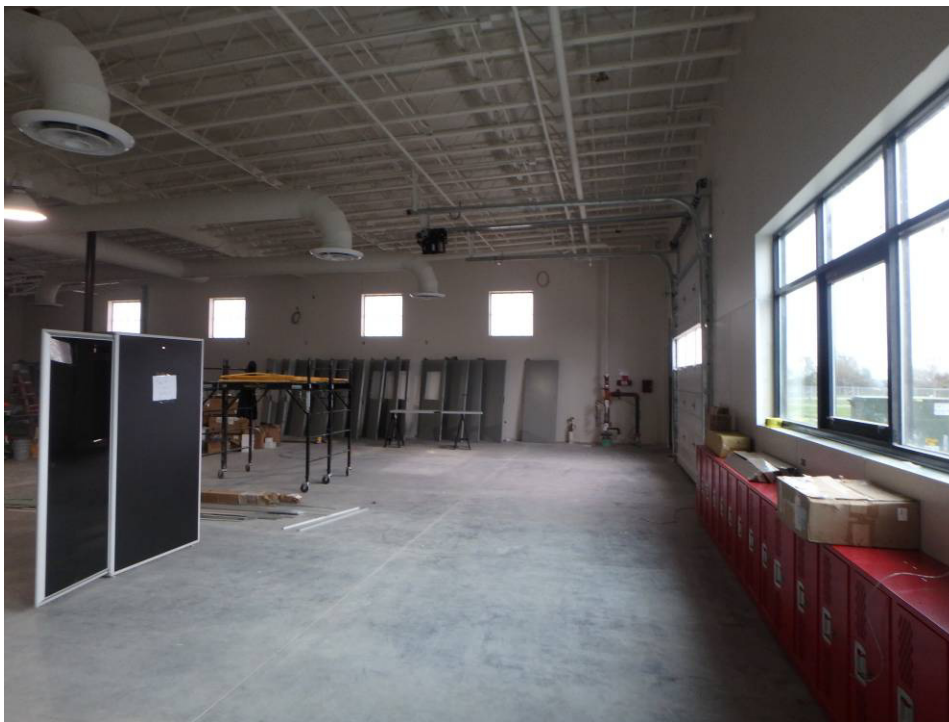
Looking north at the shop's north wall

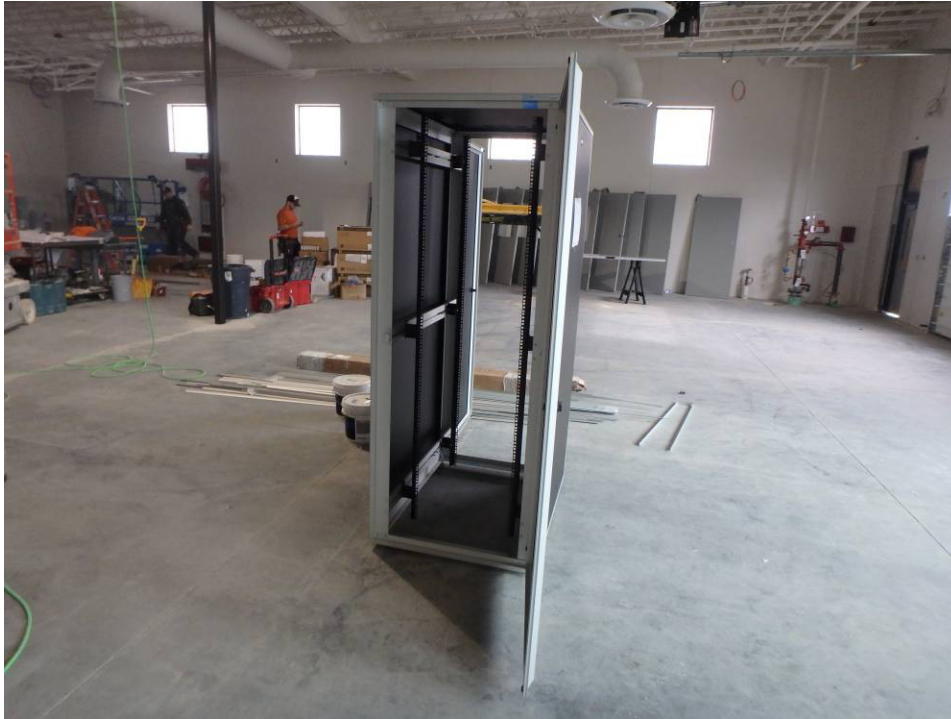
Sever cabinet

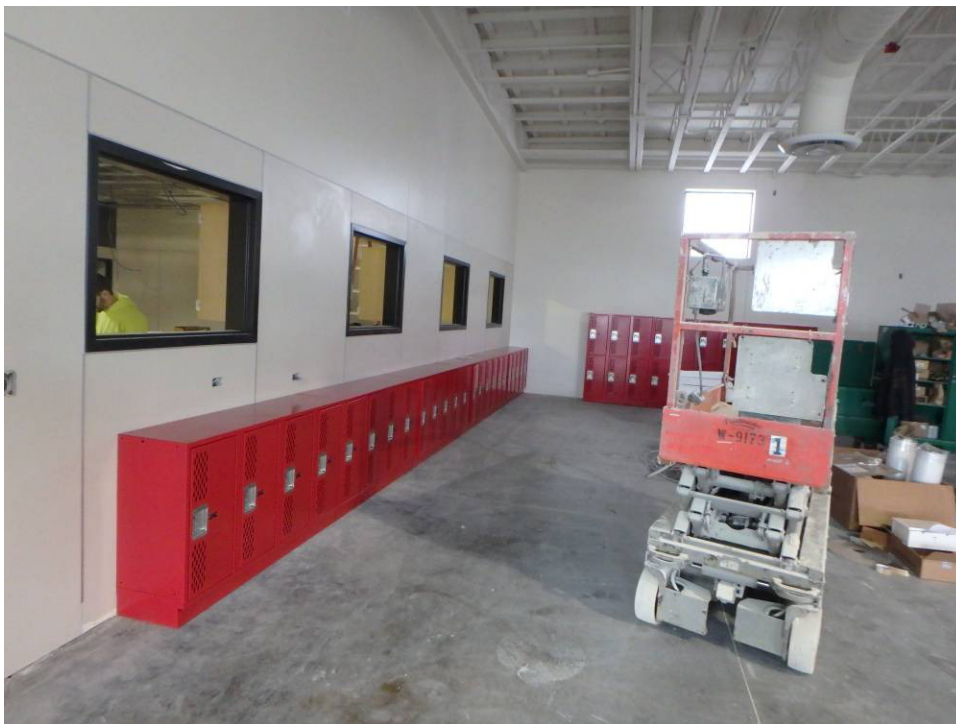
Looking west across the shop along the south wall and lockers

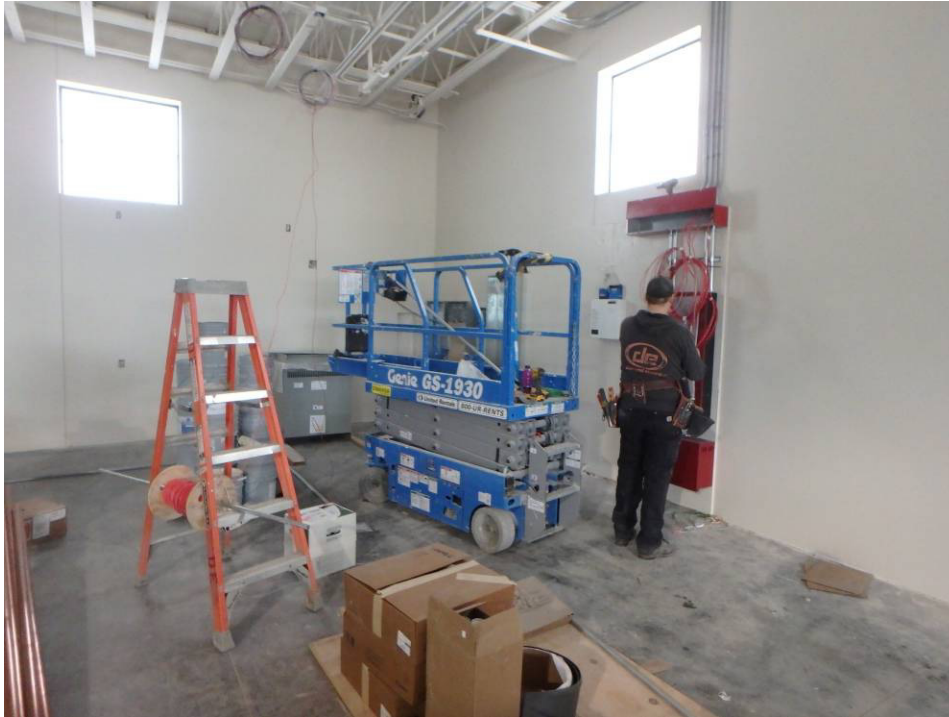
Wiring the fire alarm panel

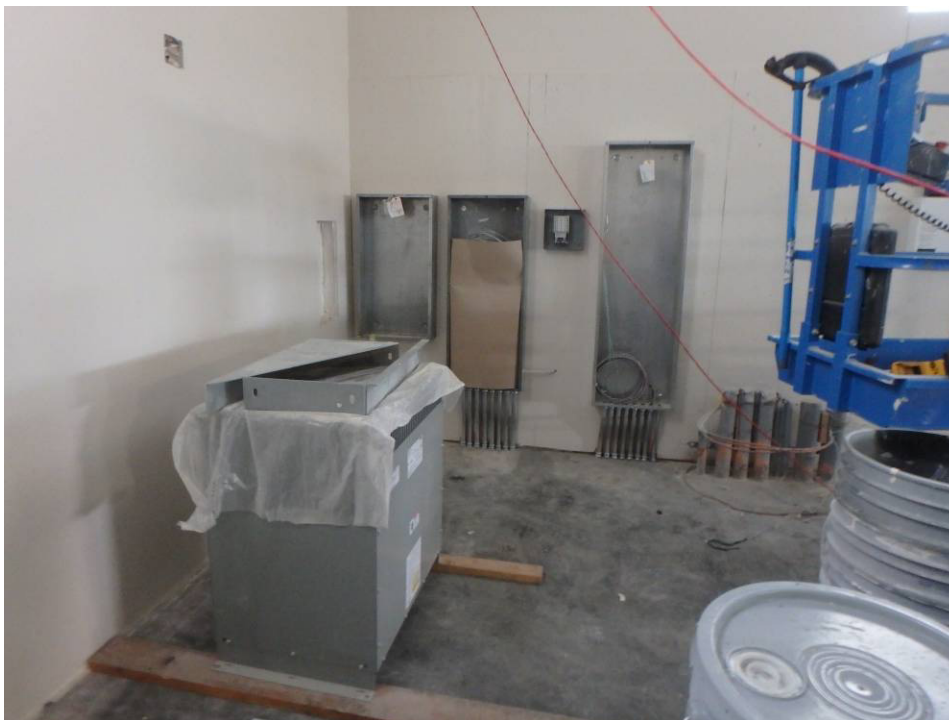
Electrical panels and transformer

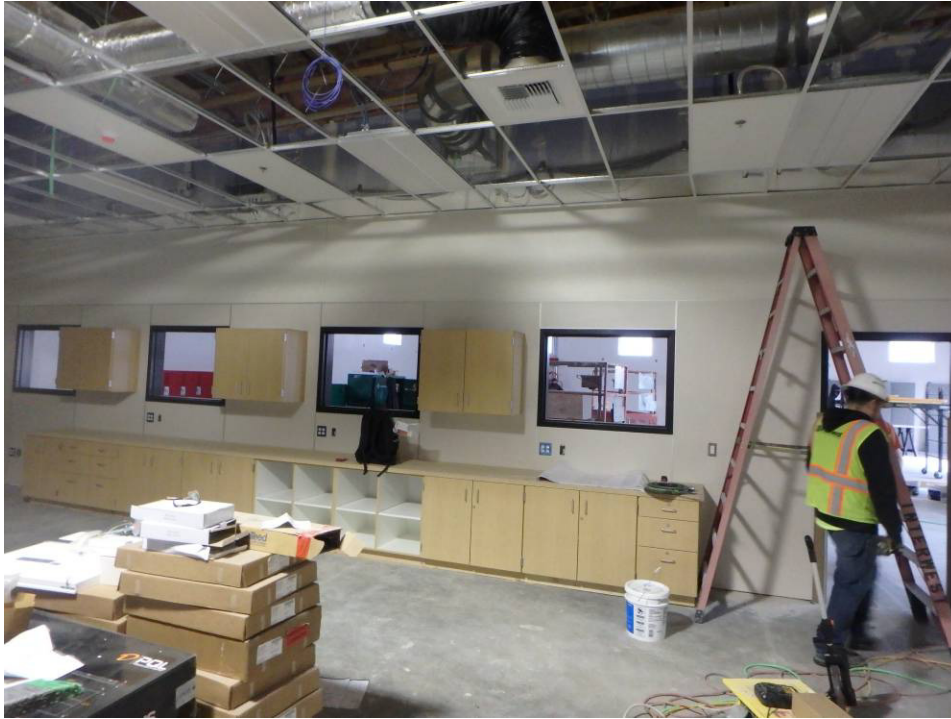
Looking at the north wall of the north classroom and casework

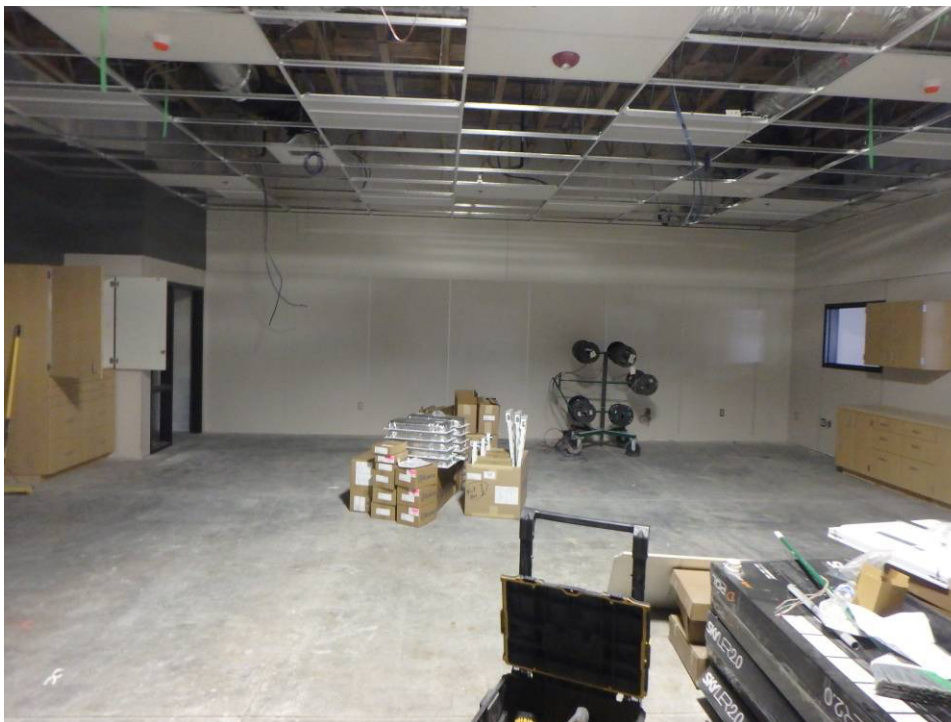
Looking west at the west wall of the north classroom and ceiling grid

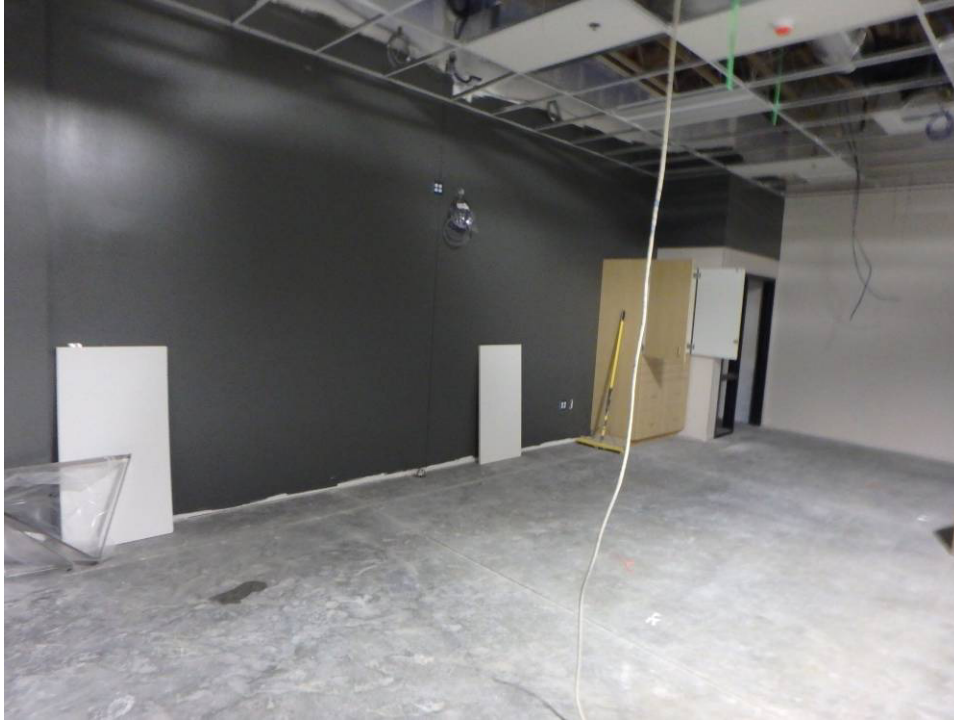
Looking southwest across the north classroom at the ceiling grid and accent wall

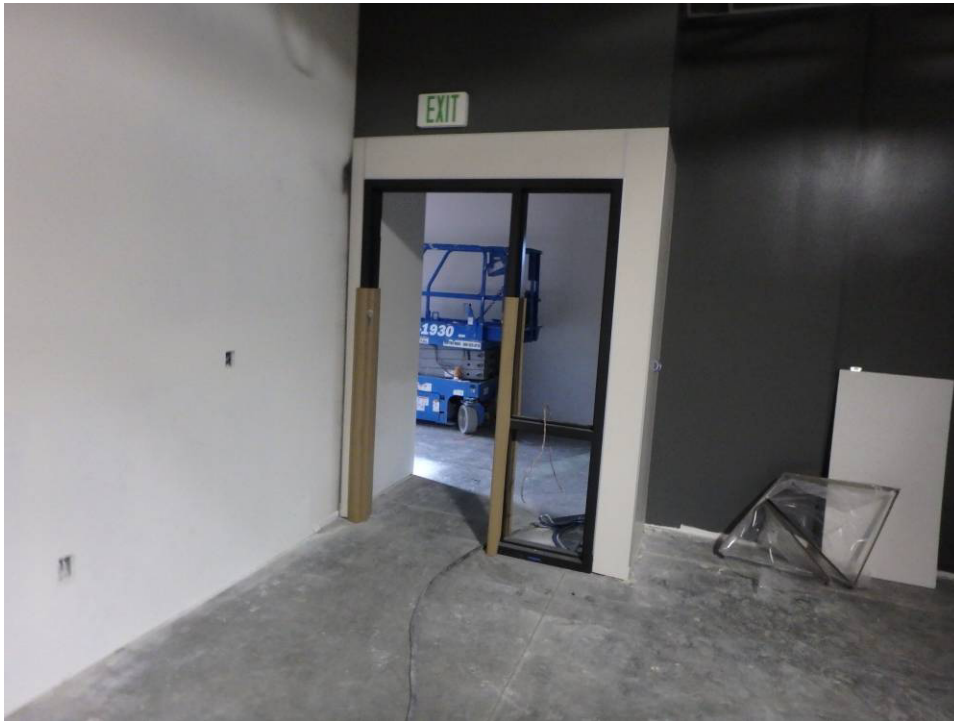
North classroom southeast entry door

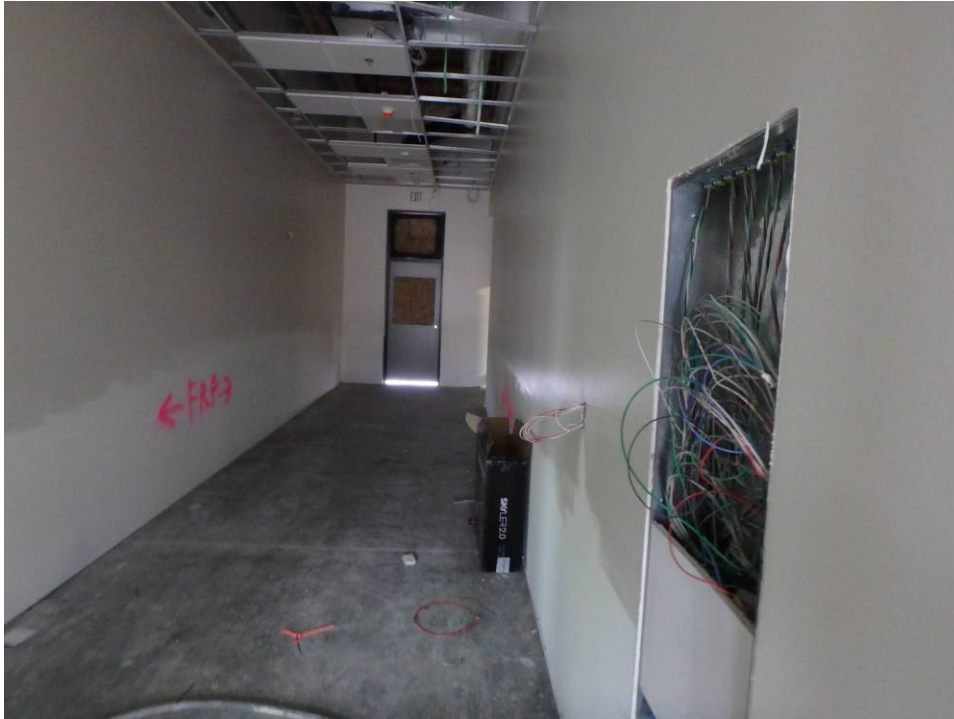
Looking west at the west end of the east-west (main) corridor

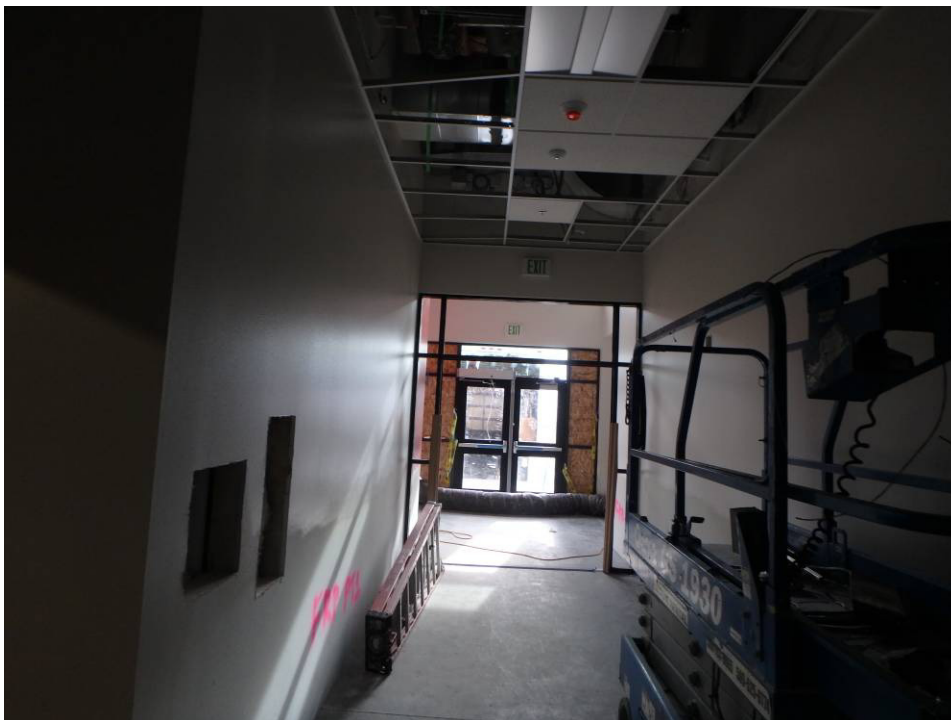
Looking east towards the entry from the west end of the main corridor

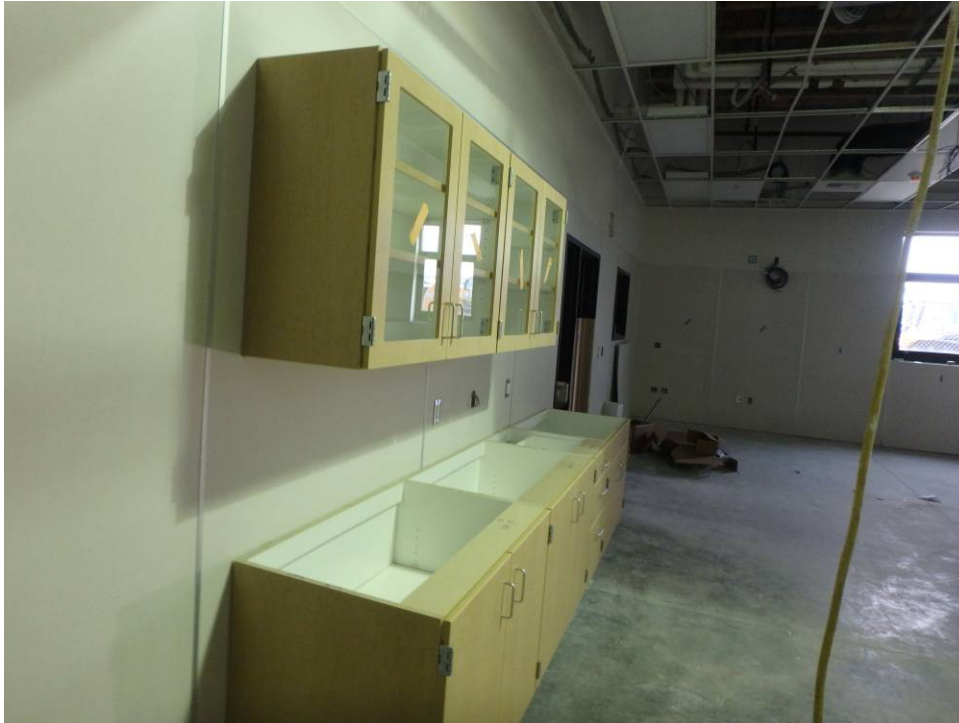
Looking south at the Lab's east wall's FRP and casework
