**Project Observation Report**

Project Name:	Tri Tech East Building C 1.5	Project No.	2208
Report #:	27		
Observation Date:	4-12-23	Last Report:	4-5-23
Prepared By:	Steve Mallory, AIA	Contractor:	Banlin

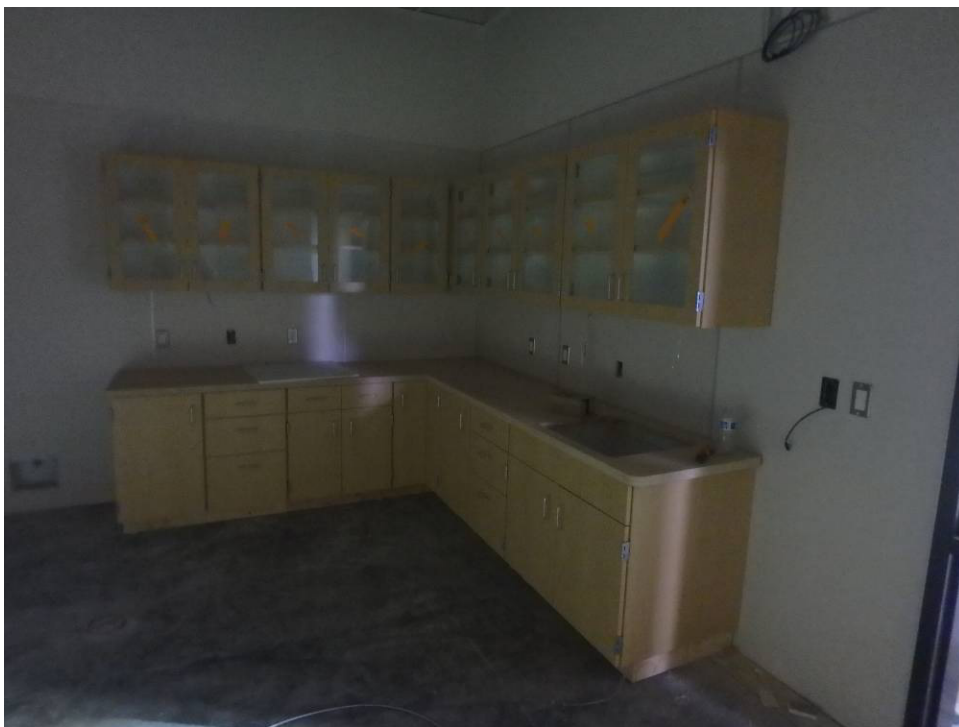
Casework in the Exam room

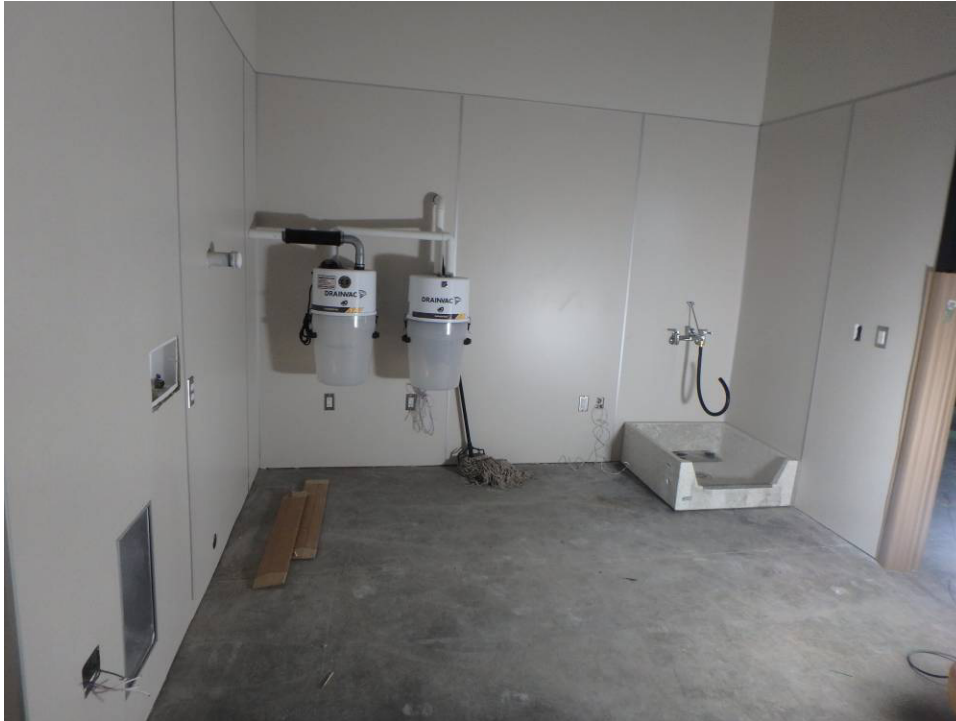
Kennel – vacuum and janitor's sink

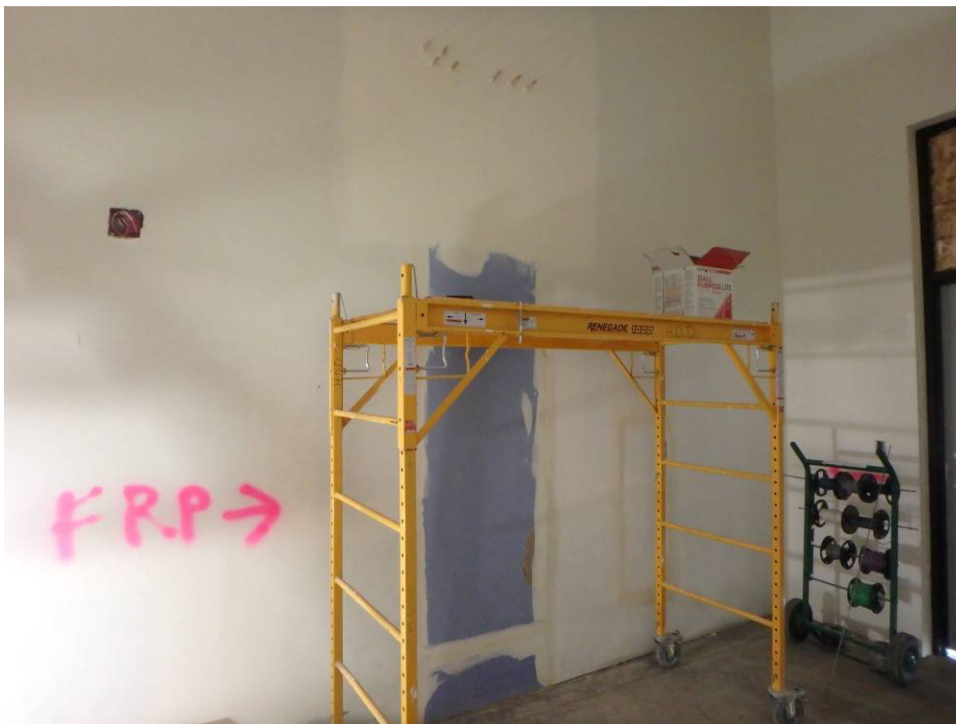
**Field Discussions:** Concrete curbs are completed. Windows installed except the bulletproof glazing and window treatment and painting complete except for the metal doors. The GWB has been replaced at the trap manifold in the kennel room, and is for paint. Fencing and gates installed. Autobody gate in operation. Tiling and ceiling grid are installed, most lights installed in the grid. The electrical panel guts are installed and the can here may 2<sup>nd</sup>. FRP work is complete and they have painted the interior doors. Low voltage work is on-going. The roof curb termination detail is complete and waiting for the DOAS. Building letters mounted to the building. Casework is installed about 75% with the lockers installed. TEM to install trim with vacuum remaining. Plumbers have started with the restroom installation. IT cabinet on site, reviewing fitment issues. Wiring the fire alarm system. Kennel room Janitor's sink is installed along with the vacuum.

Wallboard repair at the manifold to be relocated in the Kennel Room

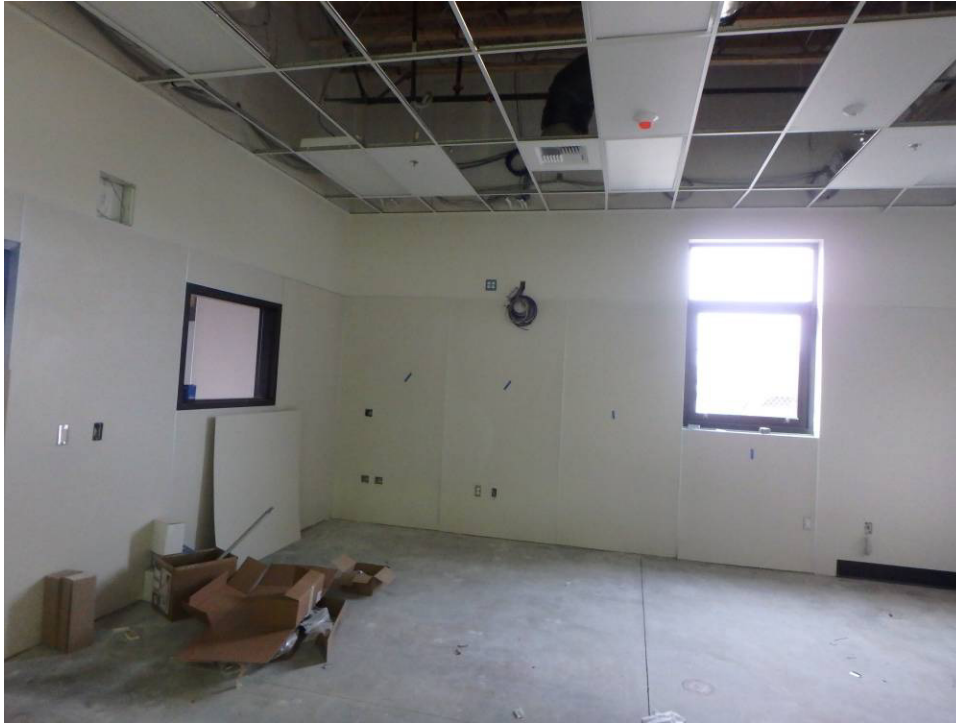
Lab – southeast corner

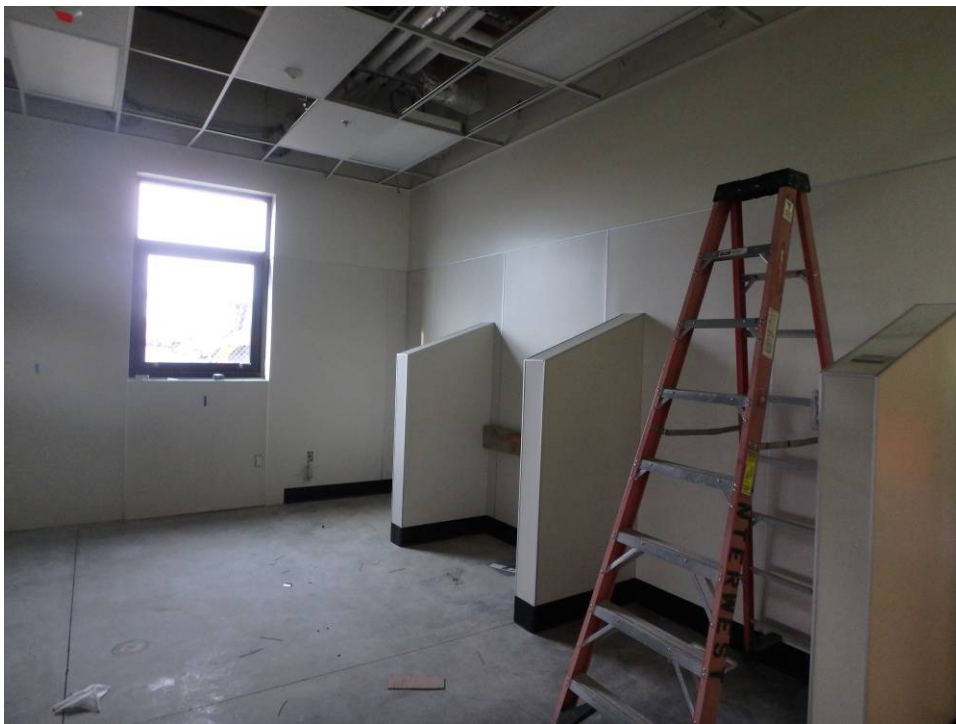
Dog wash dividers with FRP

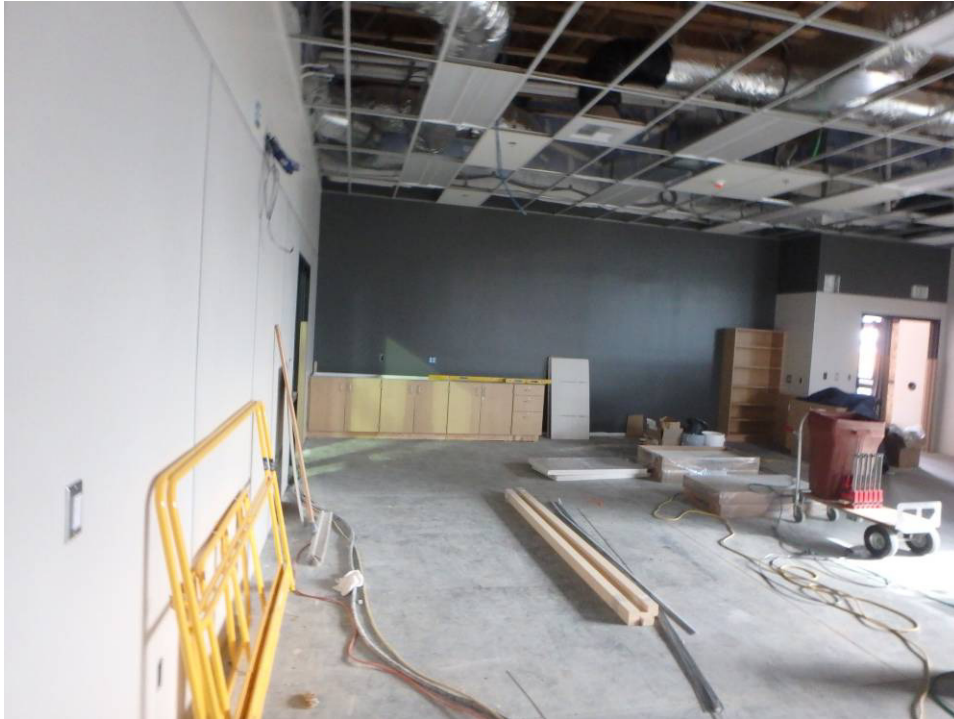
Casework and Ceiling grid in the South classroom – looking north

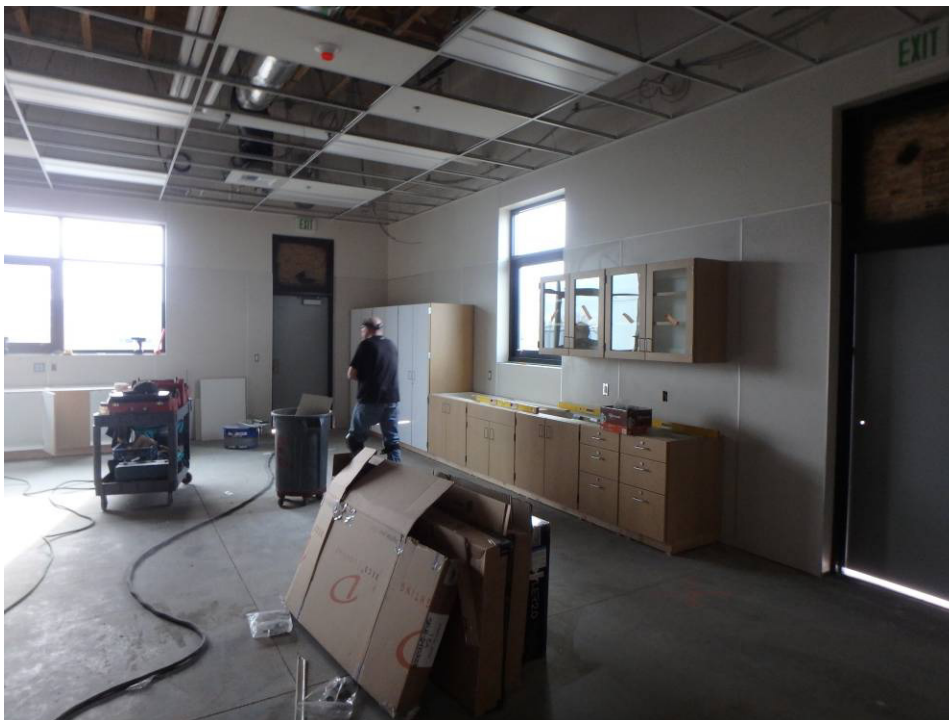
Looking at the South wall of the south classroom - Casework and Ceiling grid

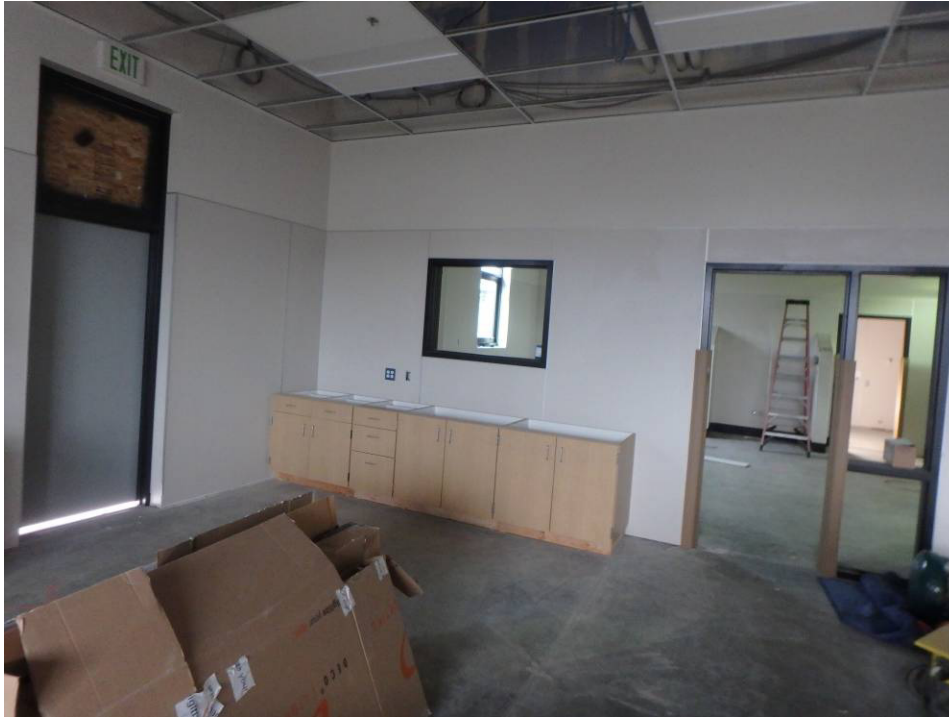
Looking at the southwest corner of the south classroom

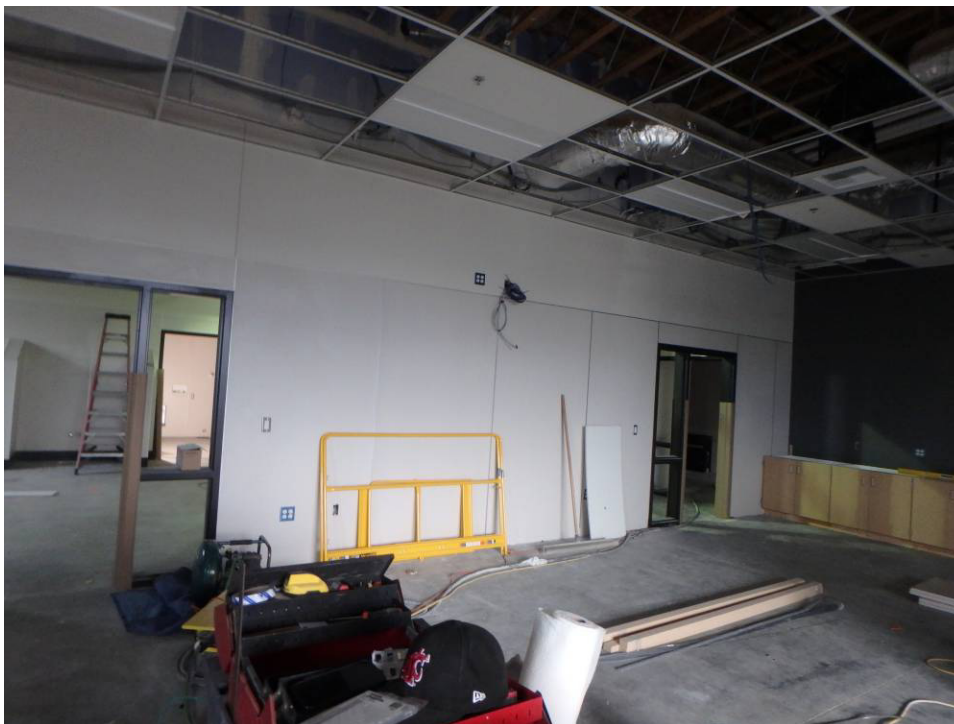
Looking at the northwest corner of the south classroom

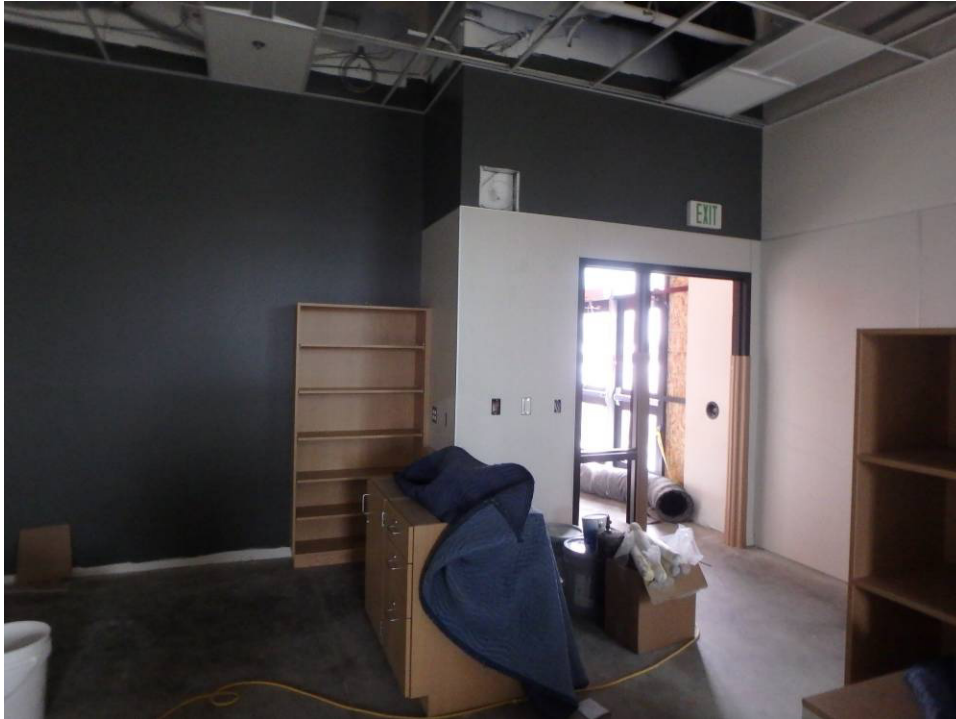
Looking at the northeast entry of the south classroom
