MARCH 2023

Unified School District of De Pere

District-Wide Facilities Condition &
Education Adequacy Assessment

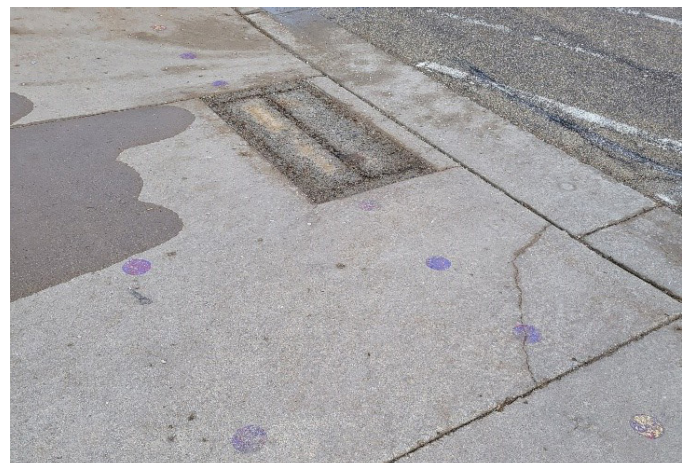
- 6 curb ramps on site do not meet the requirements for ADA Compliance. Slopes are too steep or there is a vertical deviation greater than a 1/4" where it meets the pavement.
- Multiple missing detectable warning fields.
- Many detectable warning fields have air and water under them between the concrete and warning field plate
- Some of the detectable warning fields have lots all paint and domes are starting to deteriorate

- Remove and replace non-compliant curb ramps
- Install detectable warning fields

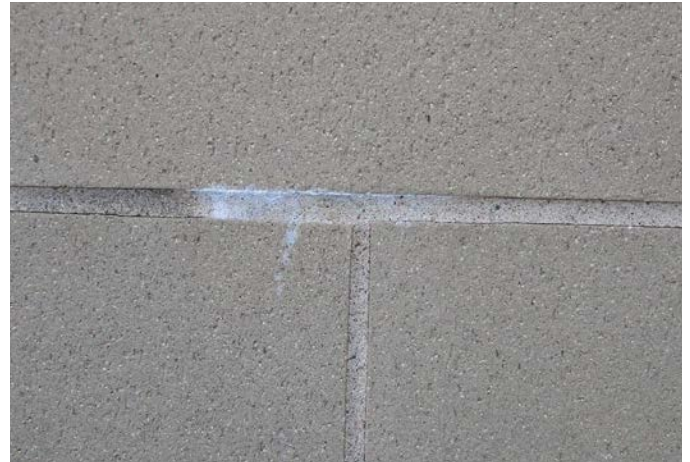
CLOSE UP OF EFFLORESCENCE

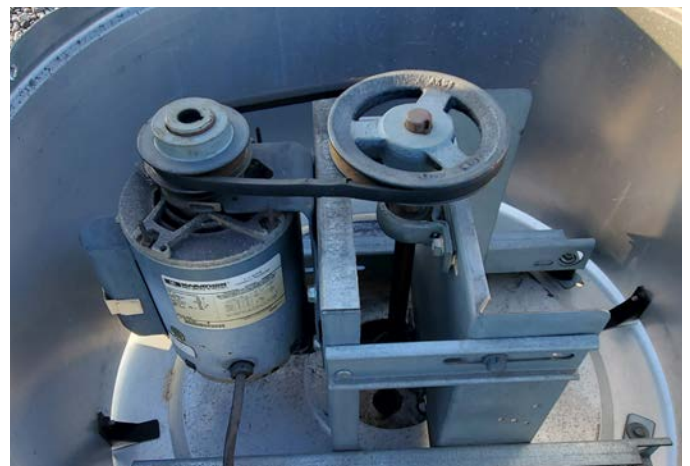
WORN BELT AT ROOF FAN

- Recommend testing and revision to control device installation and programming strategy to fix issues with existing AHU-3.
- Replace low return grilles where damage is present. In addition to the aesthetic benefit, this will provide additional return air where free area has been reduced by damage.
- Consider tune-up of roof mounted exhaust fans including replacement of belts.
- Clean dryer vent and associated ductwork. It is likely that lint has settled in the duct given the current condition.
- Recommend repair of fabric duct segment to prevent further damage and improve air distribution.

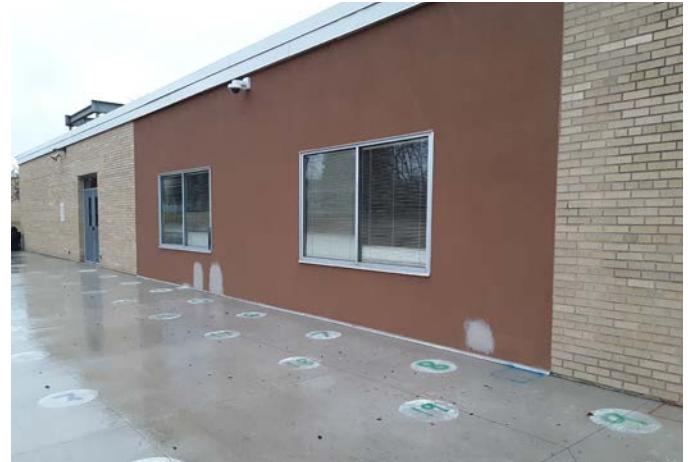
THE 1956 CLASSROOM WINDOW SYSTEM WAS REPLACED WITH NEW WALLS AND SMALLER WINDOWS

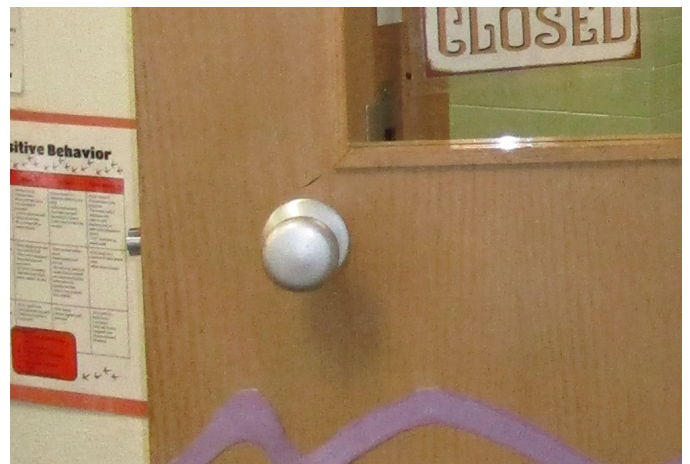
ROUND DOOR KNOBS NOT ADA COMPLIANT

- Infill the joint in the concrete subfloor and replace the vinyl floor tile where it is depressed.
- Replace wood doors and non-compliant round knob door hardware to meet ADA requirements.

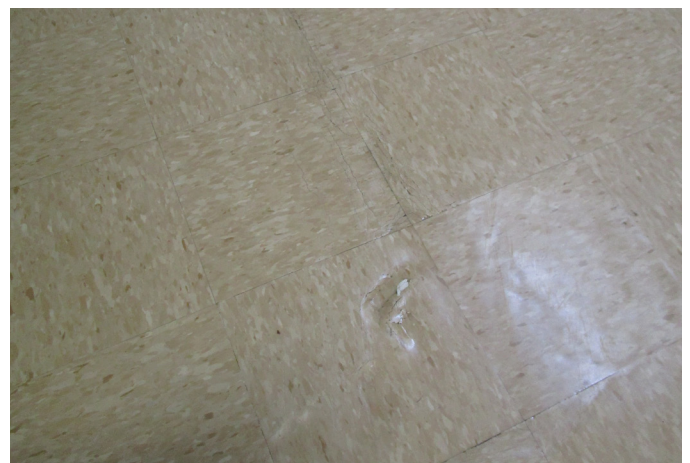
VCT DEPRESSED INTO FLOOR JOINT IN SLAB

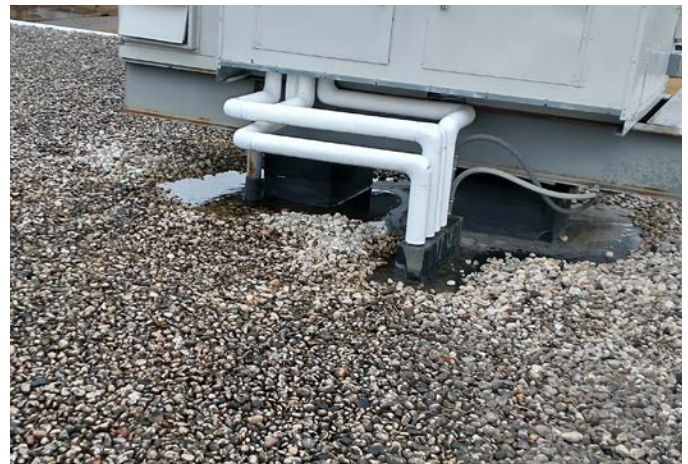
WATER PONDING NEAR ROOF DRAIN

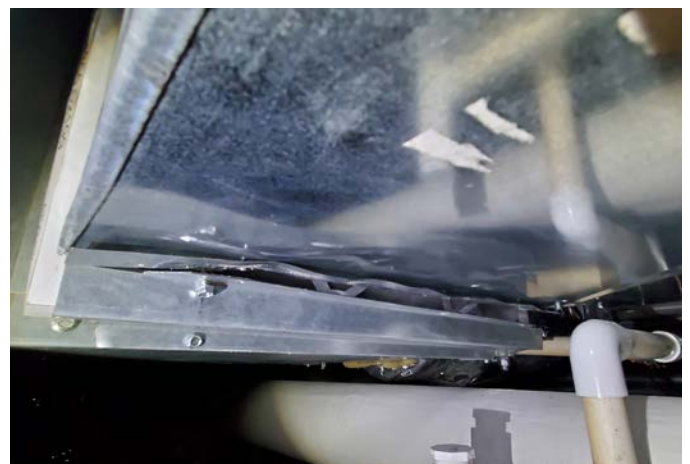
- Facility staff indicated several leaks are present through ductwork at air handling units. It was noted that outside air intakes for older rooftop units are very close to roof surface. It is likely that rain and snow is pulled in through intakes especially when windy conditions are present.
- DOAU-3 intake is adjacent to water heater flue. Recommend relocating flue to prevent contamination for ventilation air.

TYPICAL DUCT LEAKAGE AT SEAMS

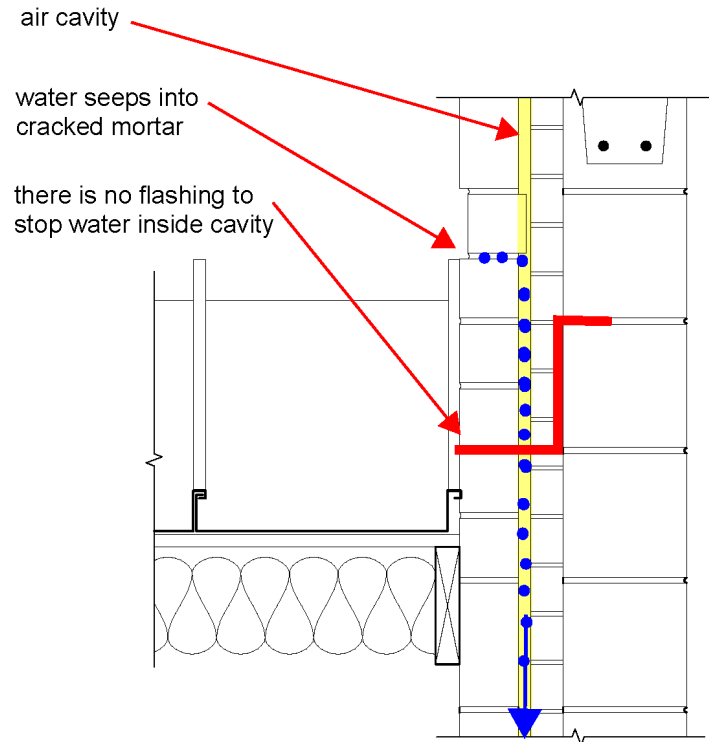
MISSING FLASHING ALLOWS WATER INSIDE THE BUILDING

- The proper solution is to open up the brick wall and properly flash the cavity between the brick and the CMU. Specialty Engineering Group estimates this could cost approximately \$162,000 – \$216,000 to repair all these conditions in the building.

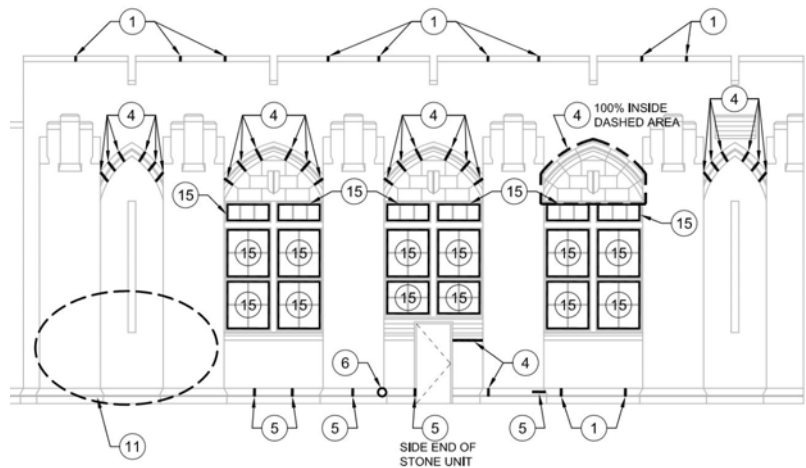
- As identified in the 2021 Specialty Engineering Group report, and noted by staff during our assessment, leaking is occurring at several ceiling locations where walls are adjacent to lower roof to upper roof transitions. As brick is a porous material, absorbing water, the leaking can be traced back to deficiencies in the brick masonry construction and lack of proper flashing and drainage channels within the walls. This is confirmed by staff comments that not all locations are leaking during all rain events and varies depending on the direction of wind driven rain.

EXTERIOR VIEW OF THE AUDITORIUM, AND A CONSTRUCTION DOCUMENT FROM SPECIALTY ENGINEERING GROUP NOTING WORK TO REPLACE SEALANT, TUCKPOINTING MORTAR JOINTS, REPLACING LIMESTONE TRIM, AND RE-GASKETING WINDOW SEALS.

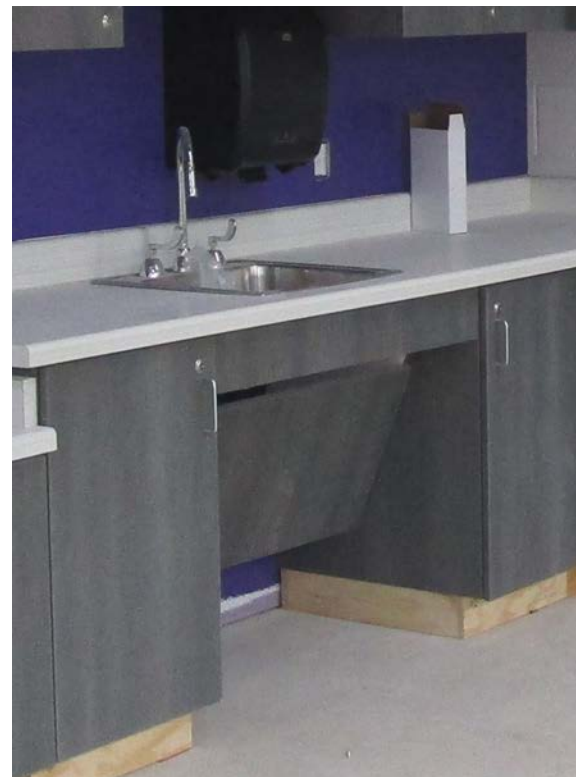
CRACKED PLASTIC LAMINATE COUNTERTOP

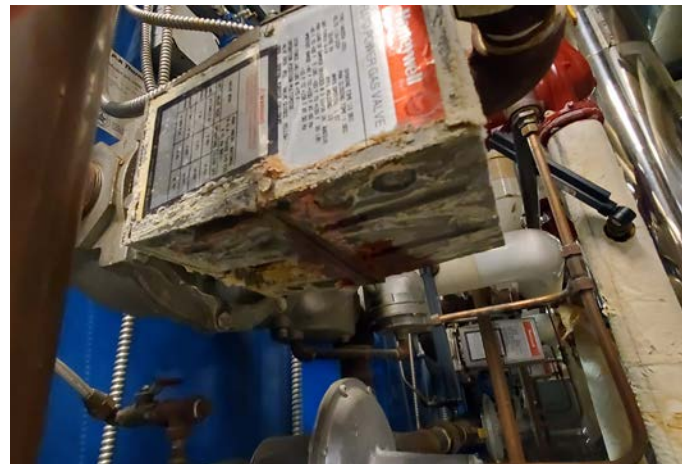
- General deferred maintenance items were noted, such as pipe leaks, missing insulation, missing sensors, etc. Repair of these items can improve reliability and limit risk of failure of the heating system.
- Secondary pumps are nearing their expected useful life and are likely losing efficiency and reliability due to age.
- (3) of the (7) total air handling unit heating coils were non-functional and have reported performance issues.
- Boilers are approaching the end of their expected service life.
- Reported difficulties by facilities staff regarding achieving suitable heating performance in classrooms is concerning.

BOILER COMPONENTS IN POOR CONDITION

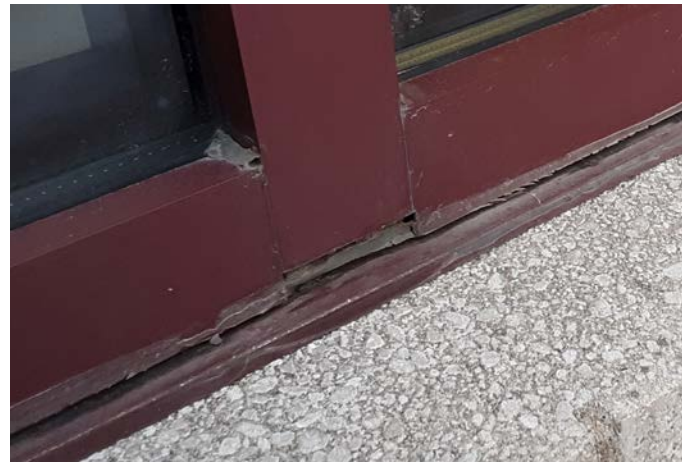
CRACKED MORTAR AT WINDOW SILL

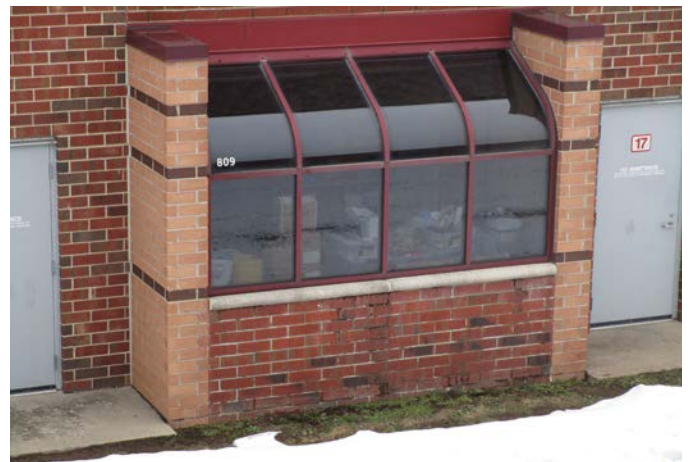
WATER LEAKING FROM GLAZING PANEL GASKETS

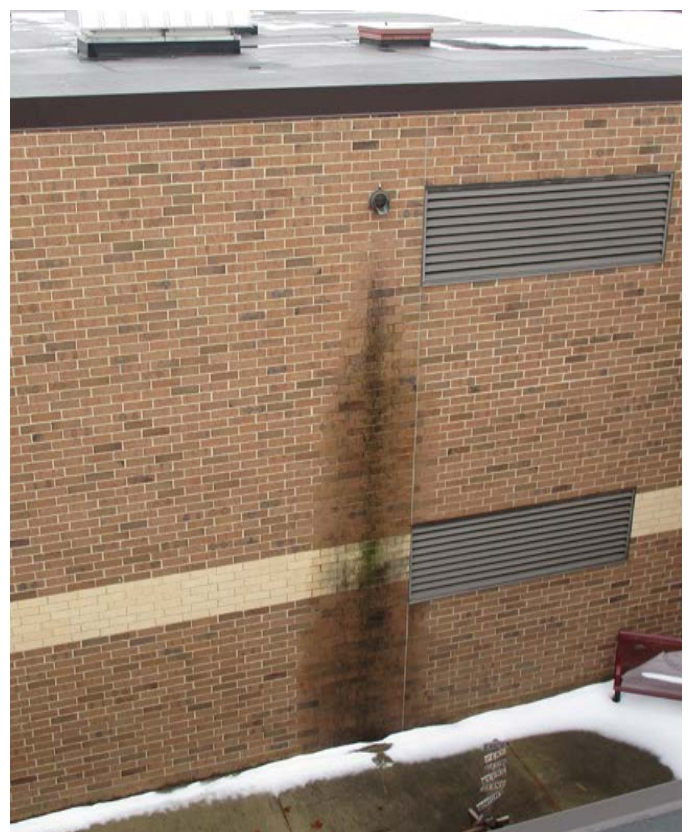
ACTIVE RELIEF ROOF DRAINS STAINING EXTERIOR WALLS

- Raise the height of the two existing relief drains noted above to allow water to flow to the primary drains first.
- Leaking at walls that penetrate between two roofs are hard to pinpoint due to the fact that the water infiltration might be coming through the wall and wall flashing and not the actual roof membrane. A building envelope specialist should be hired to investigate persistent roof water infiltration issues.

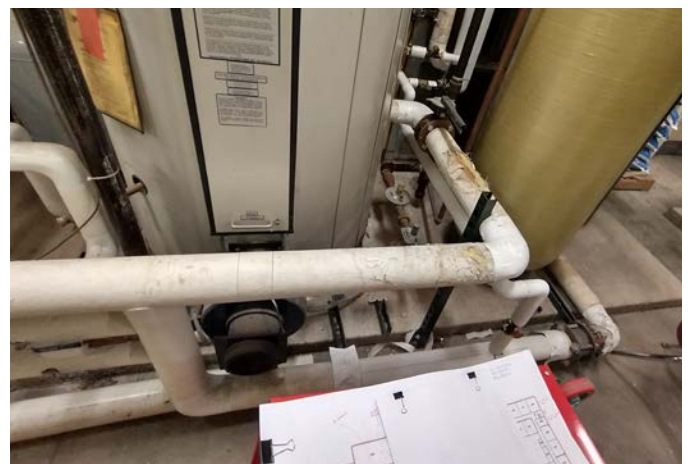
DAMAGED INSULATION
