**Project Observation Report**

Project Name:	Tri Tech East Building C 1.5	Project No.	2208
Report #:	28		
Observation Date:	4-19-23	Last Report:	4-12-23
Prepared By:	Steve Mallory, AIA	Contractor:	Banlin

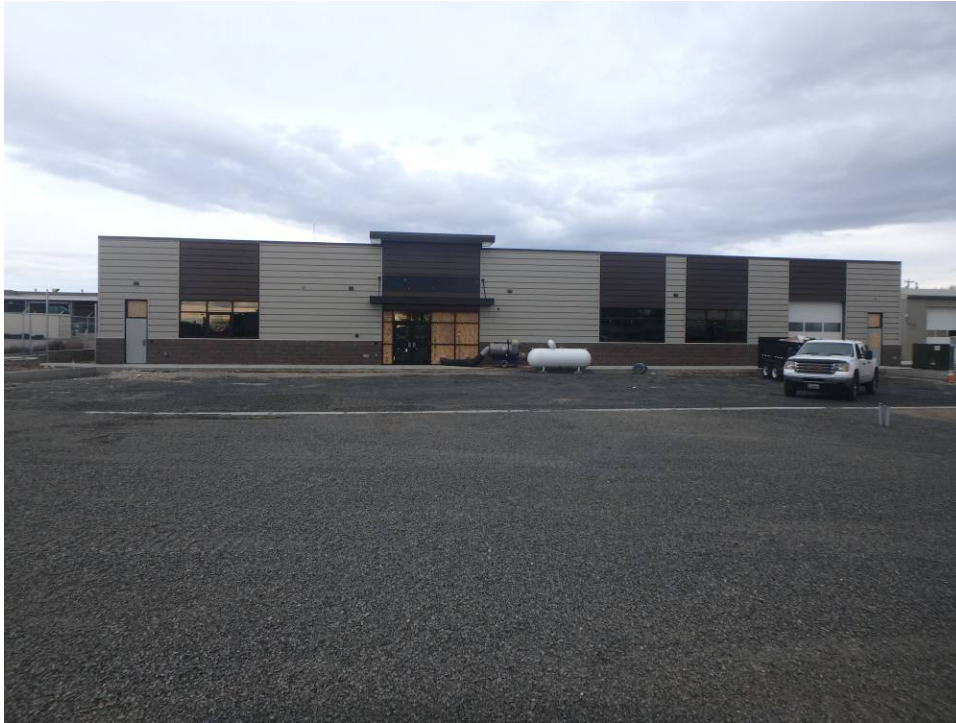
East Elevation

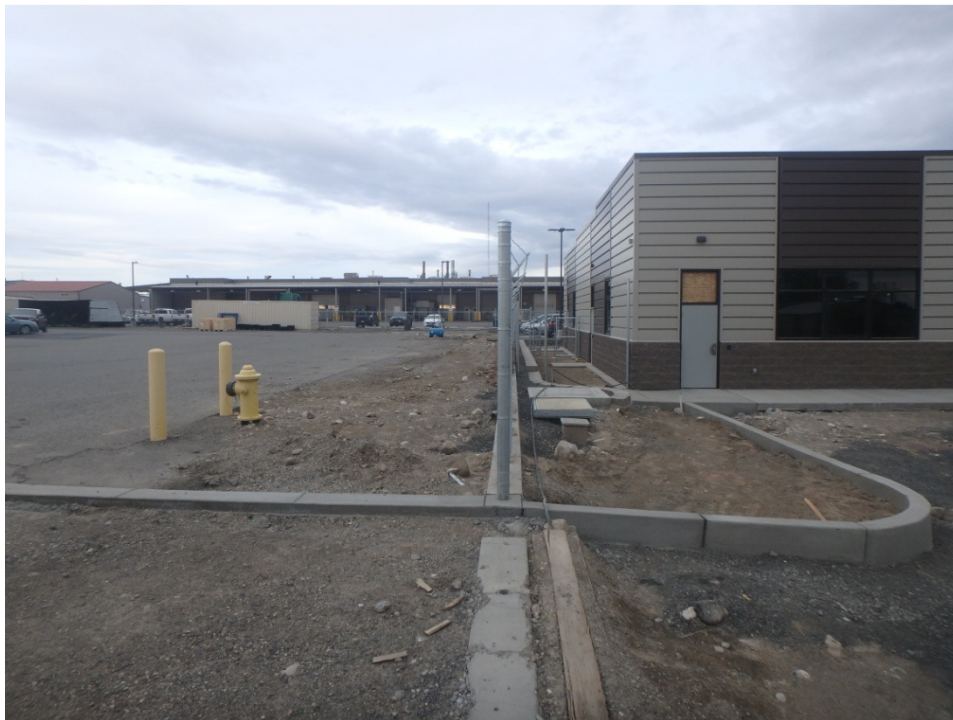
Southwest curb at site entry and Southwest peninsula and the southeast corner of the building and south property line fence

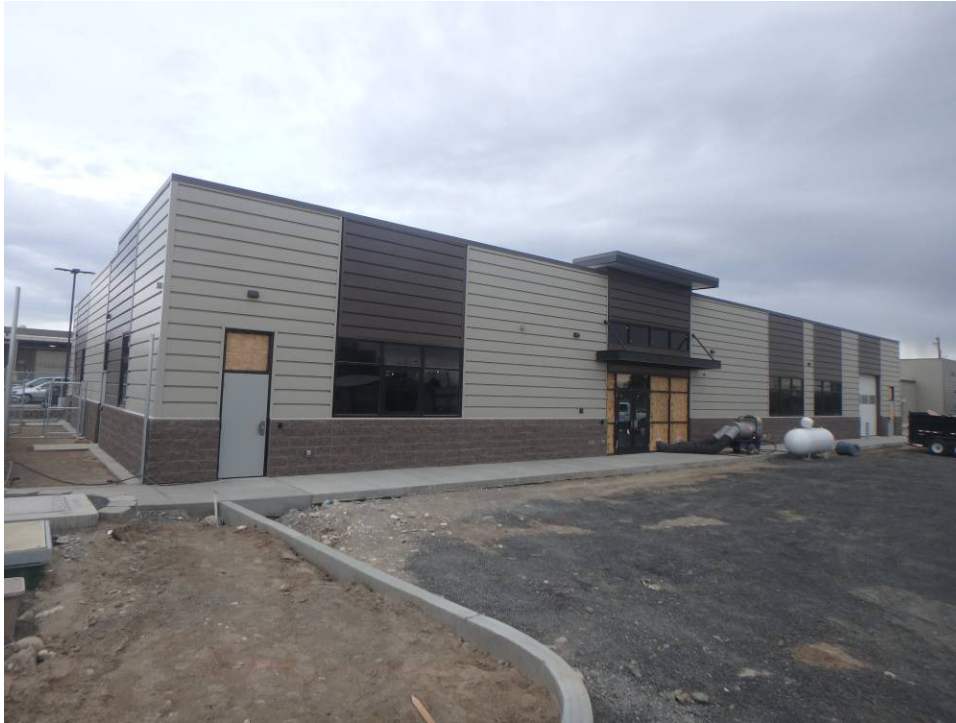
Southeast corner of the building

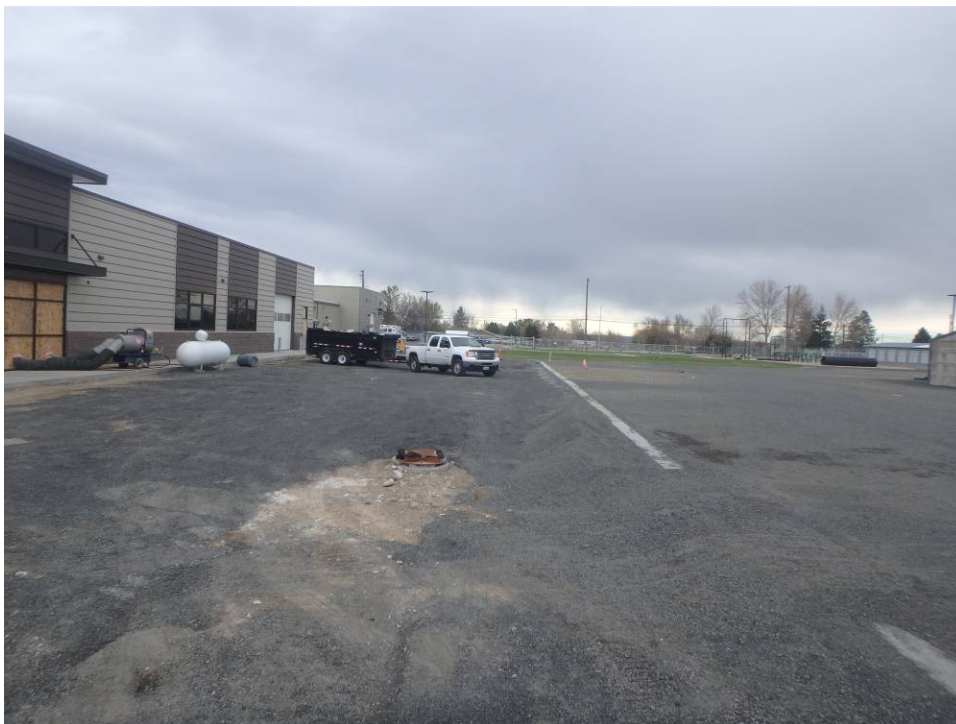
Looking north at the central curb and grading

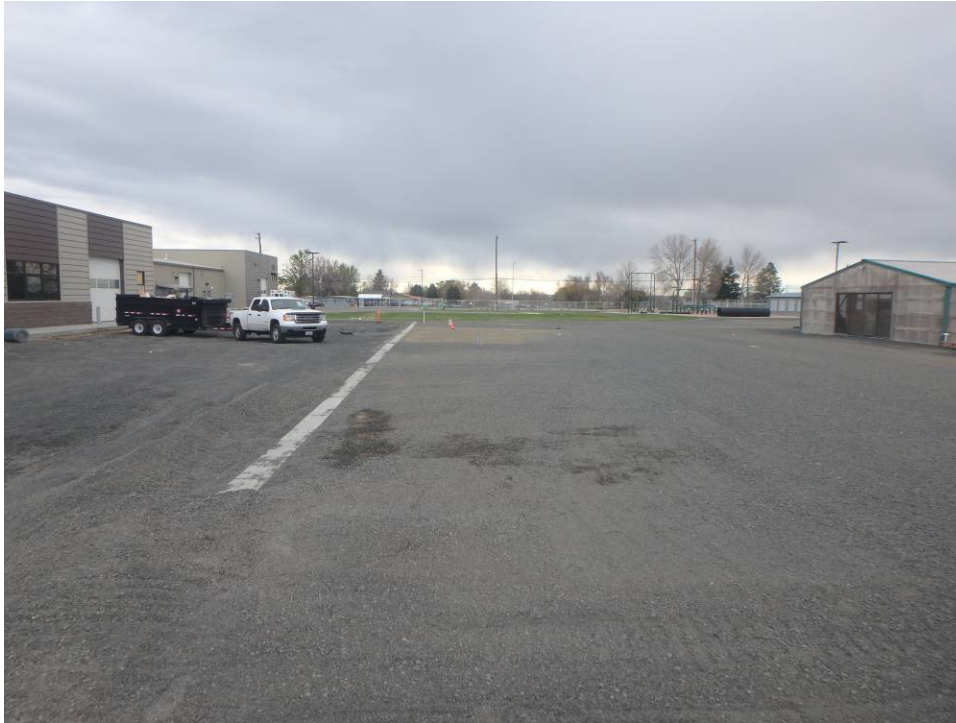
Looking north on the east side of the site

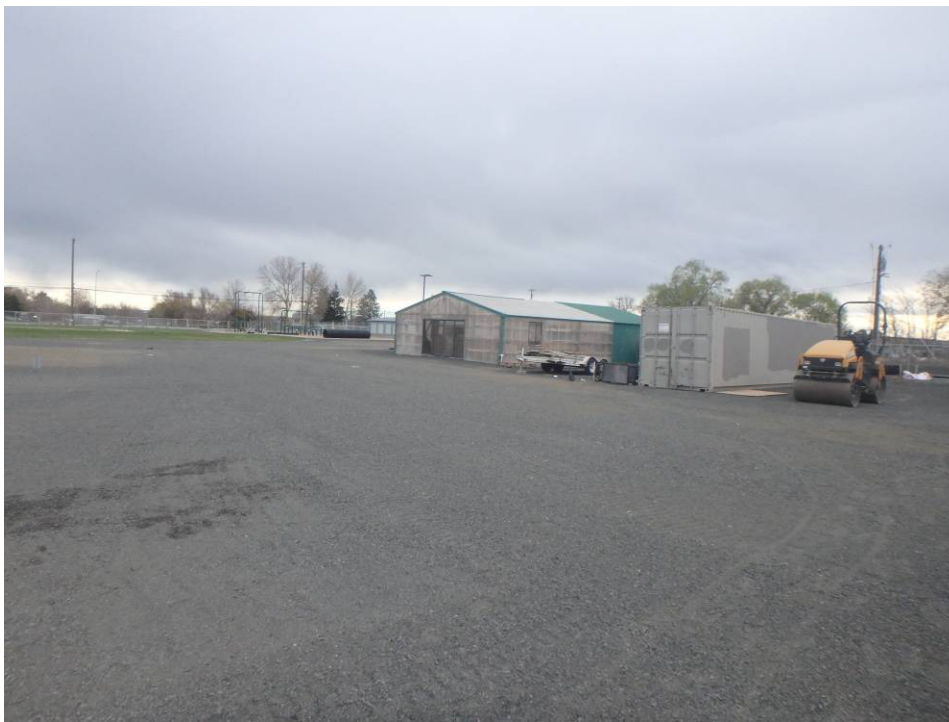
Greenhouse

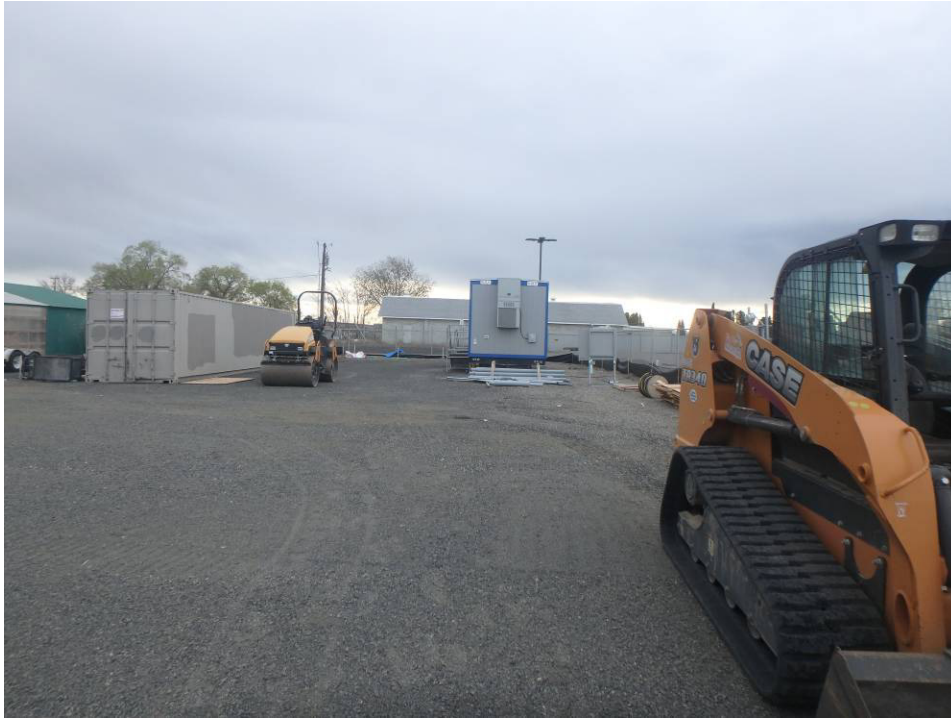
East site

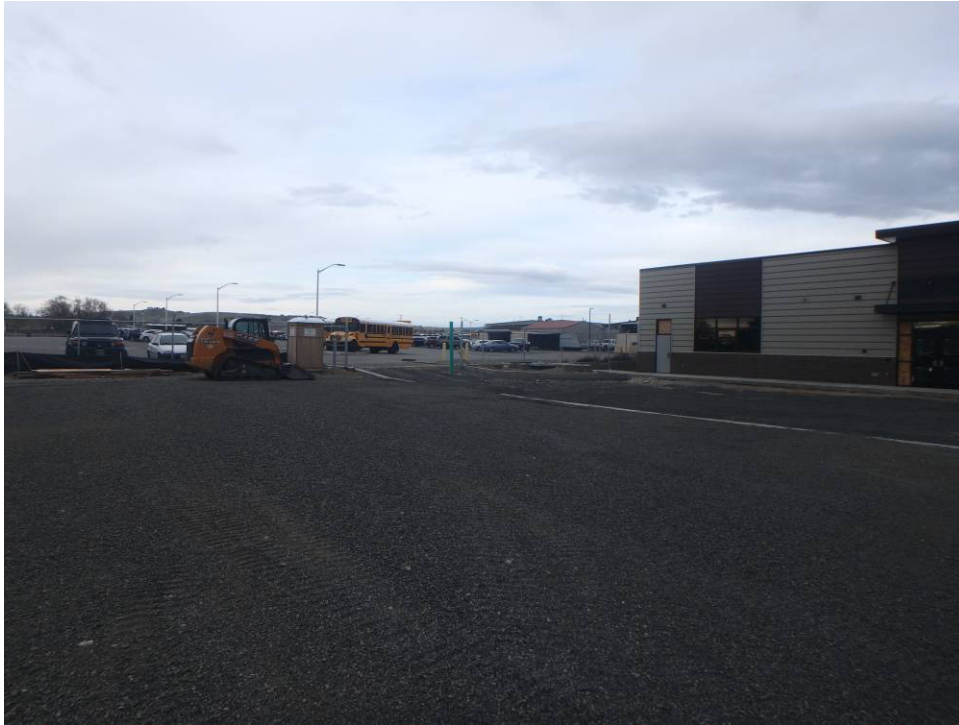
South site entrance east side

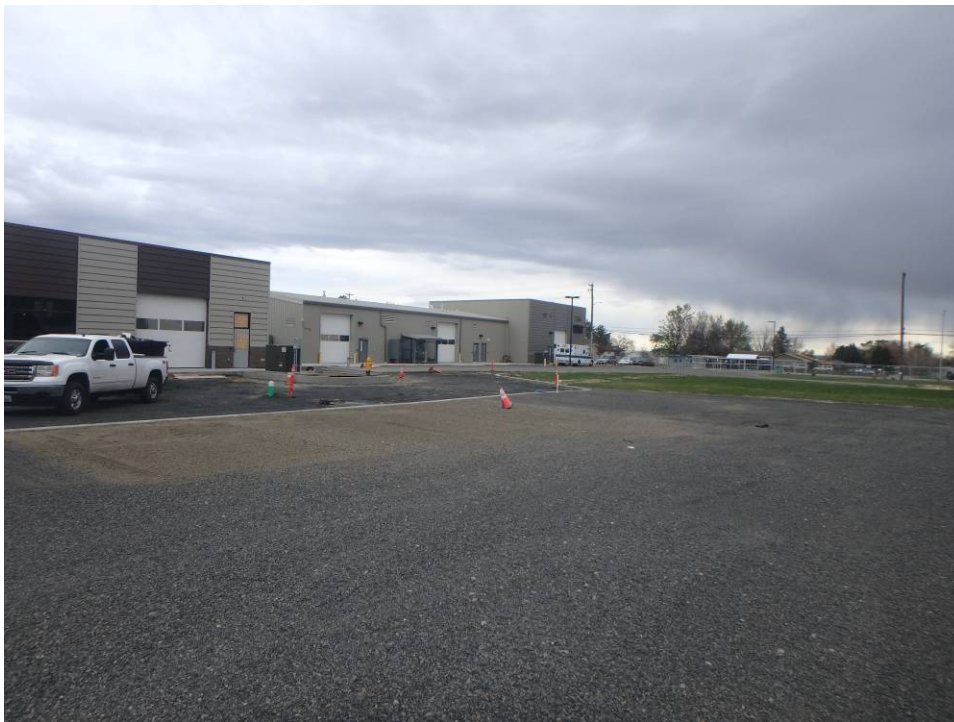
Looking northwest at the north site

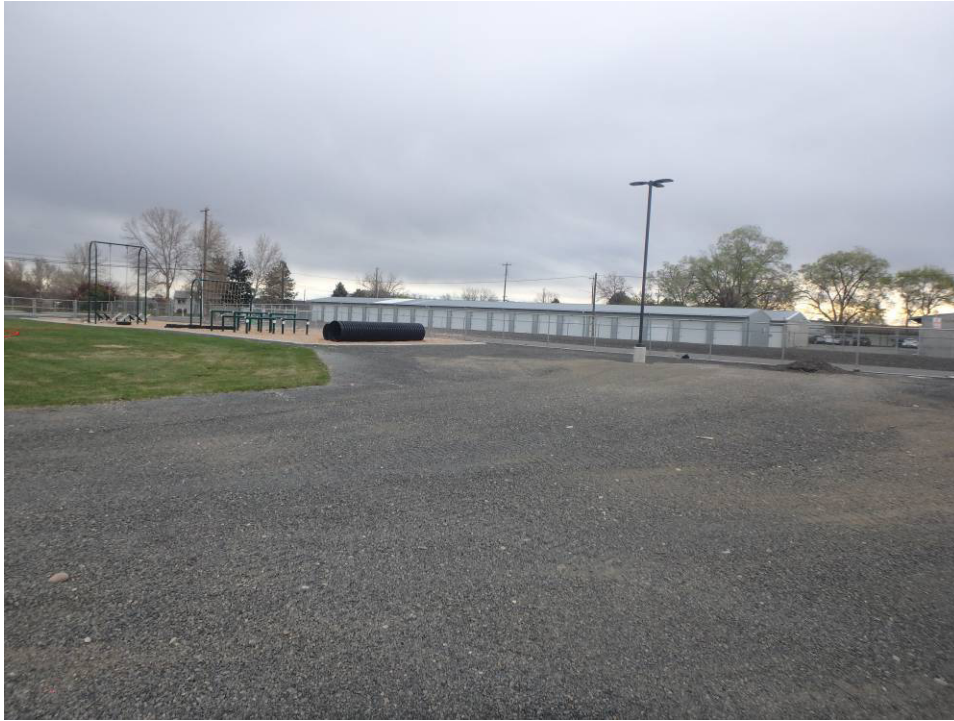
Northeast site

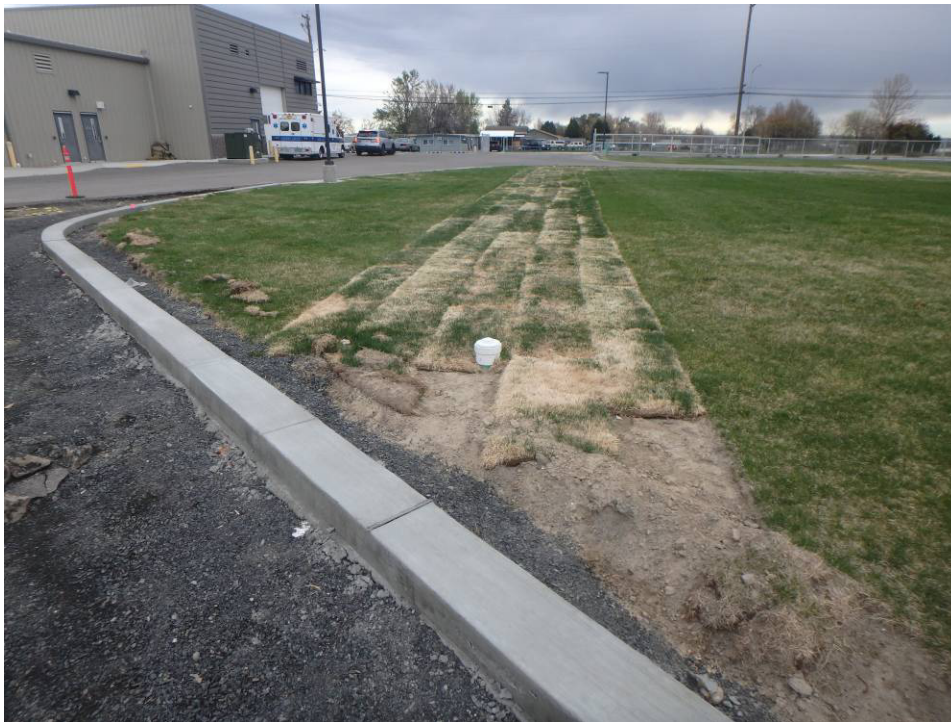
North site curb and sod

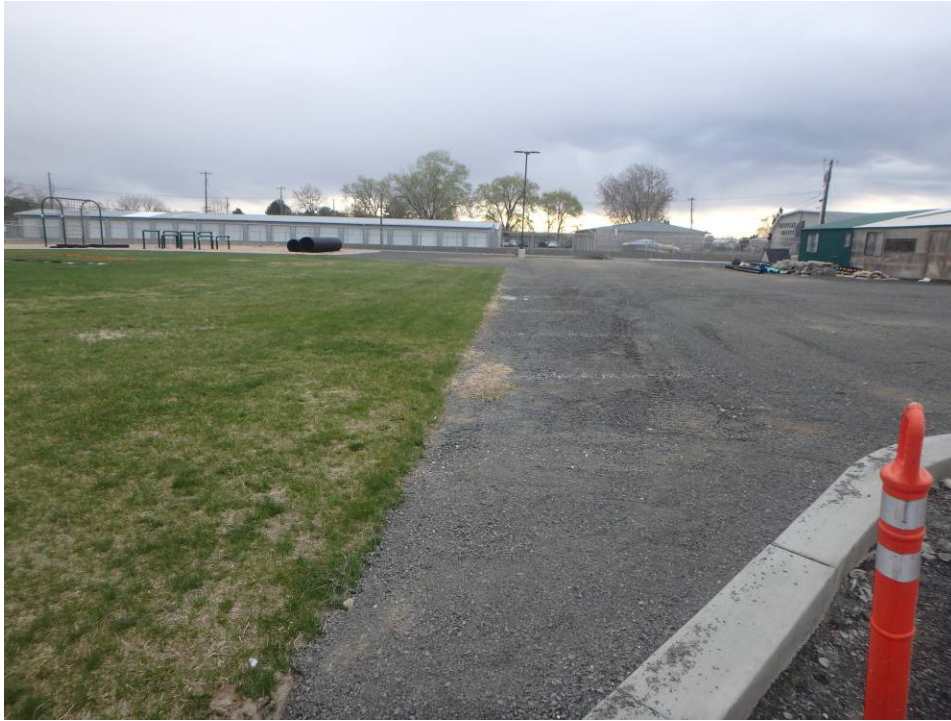
Looking east at the north property line

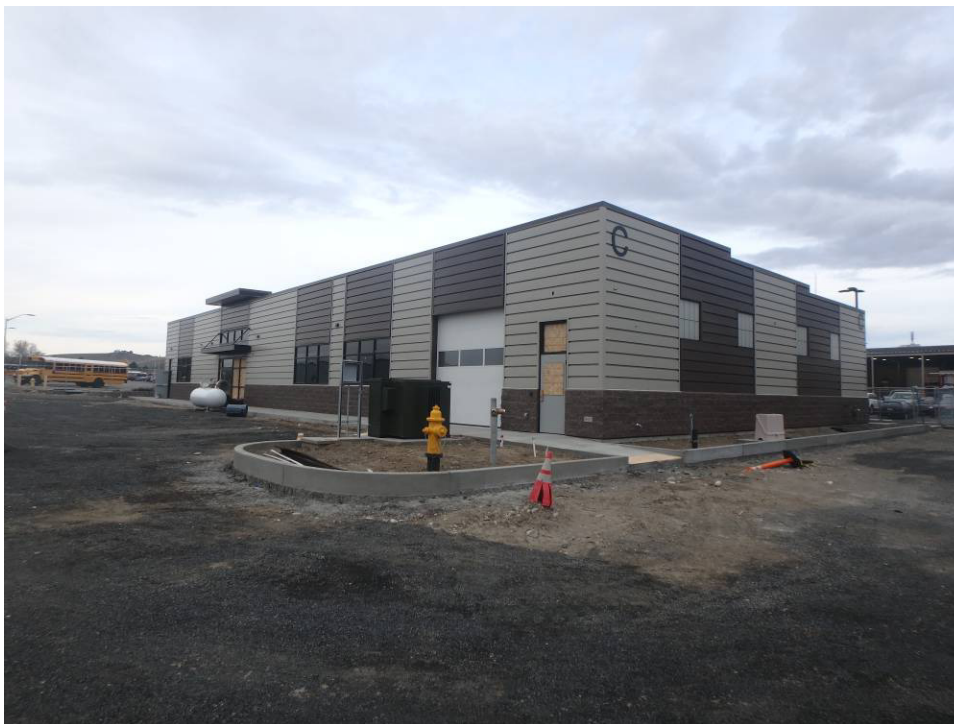
Northeast corner of the building

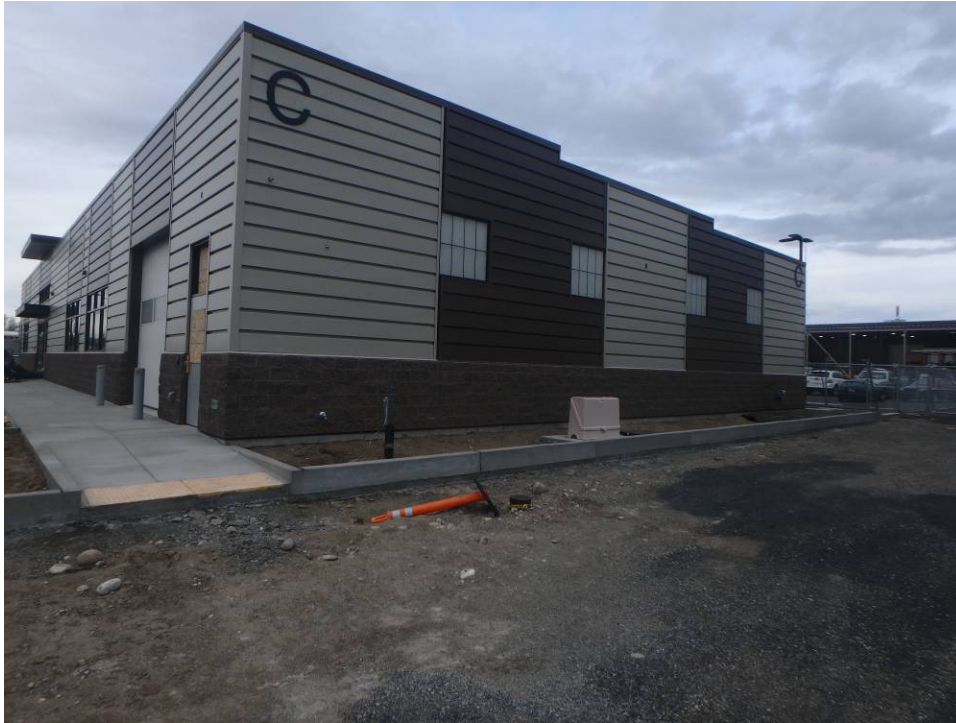
North elevation

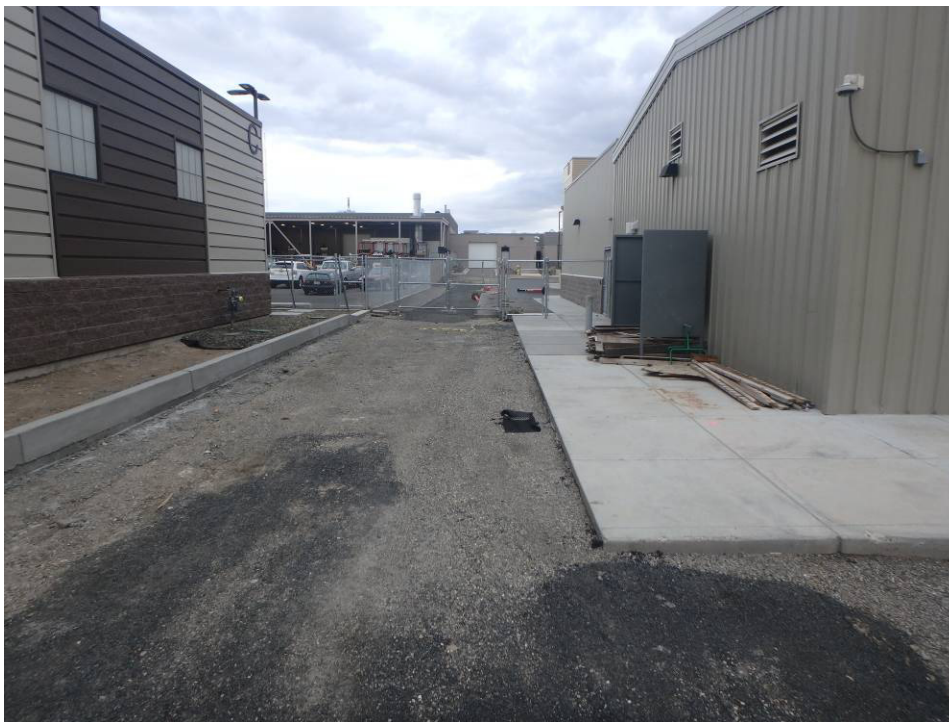
Alleyway – looking west

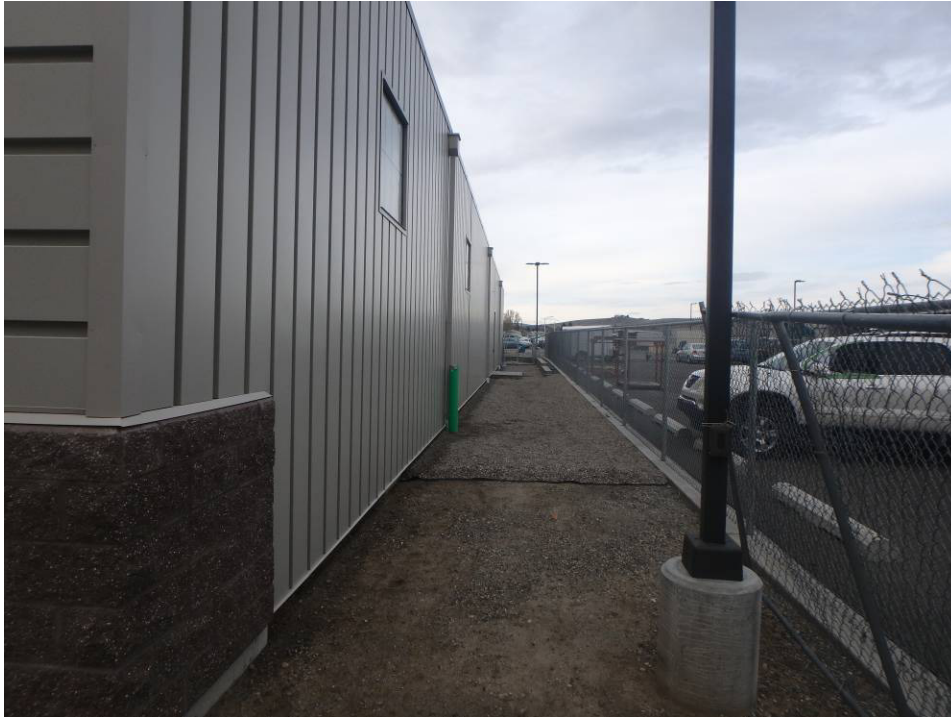
Looking south at the west property line and back of building

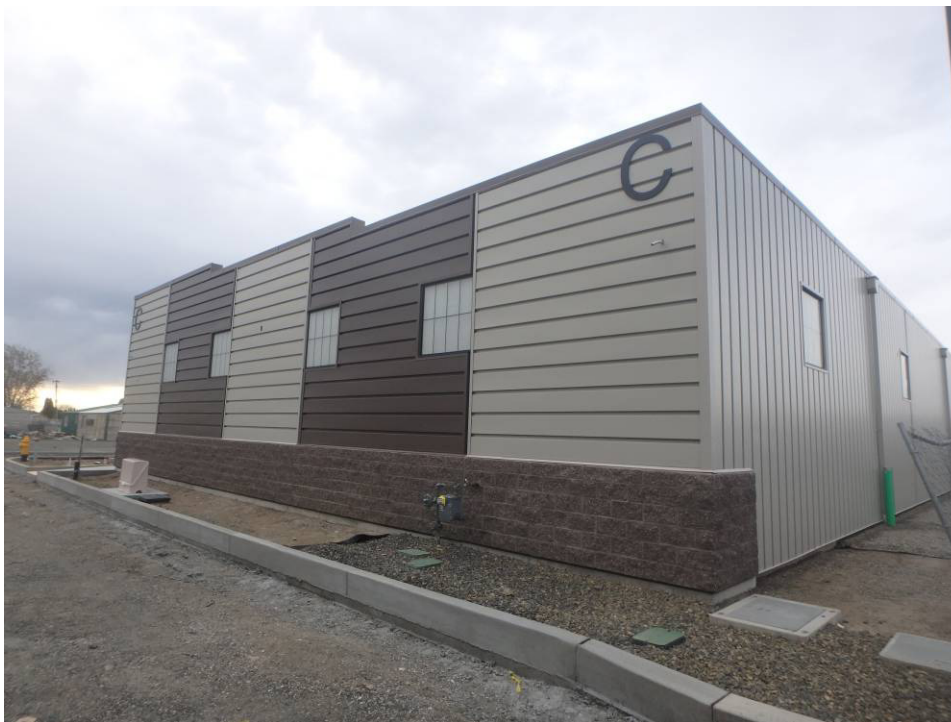
Looking east at the north curb and gas meter

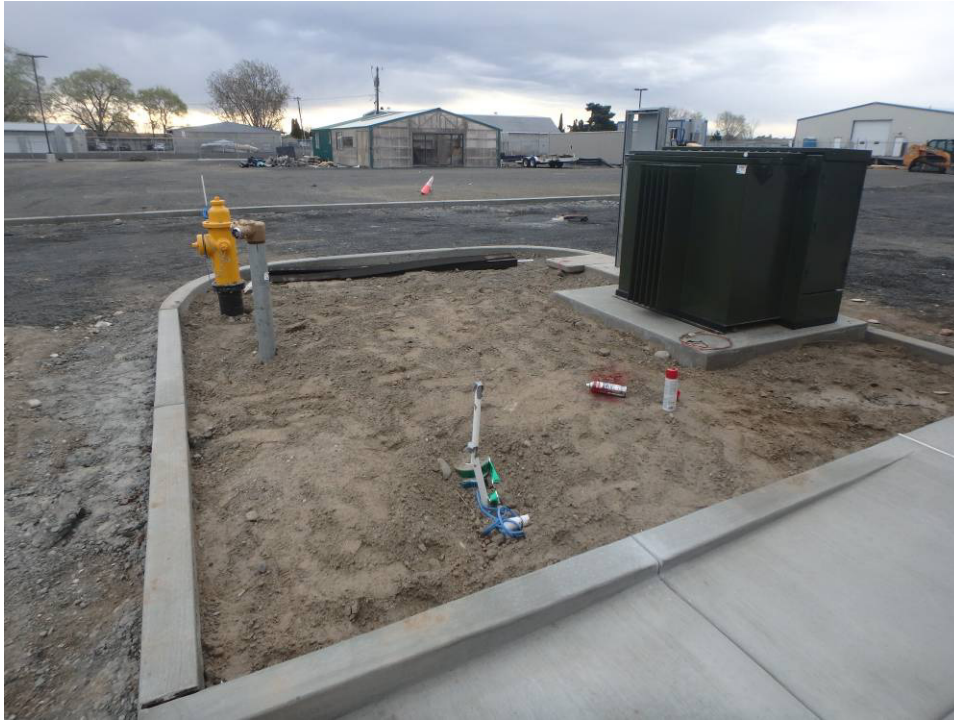
Curb at north end of building – looking east

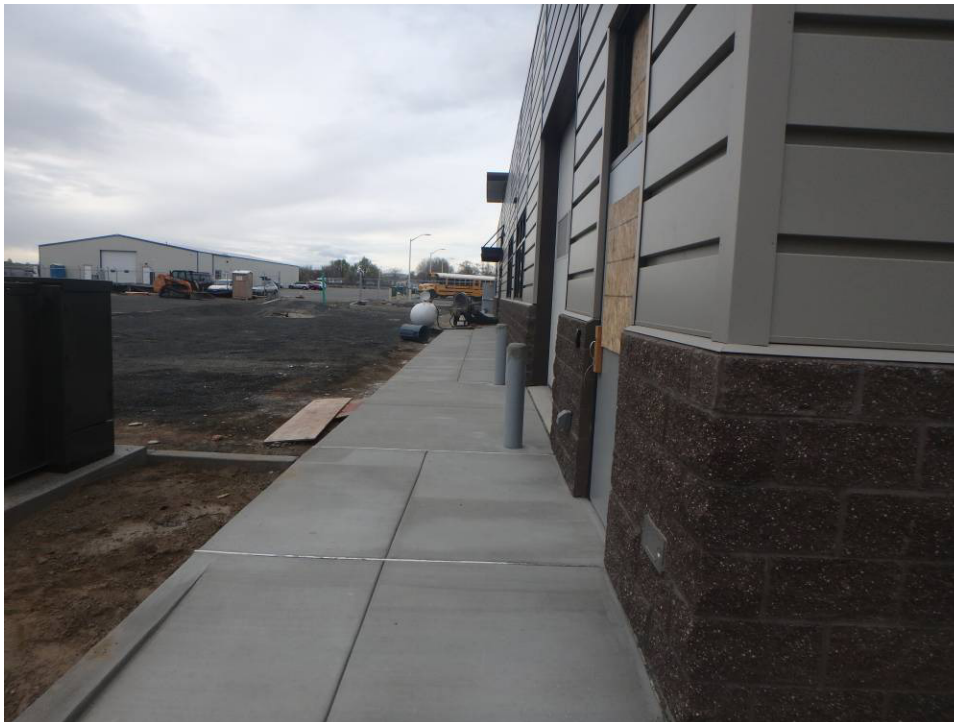
Looking south along the front sidewalk

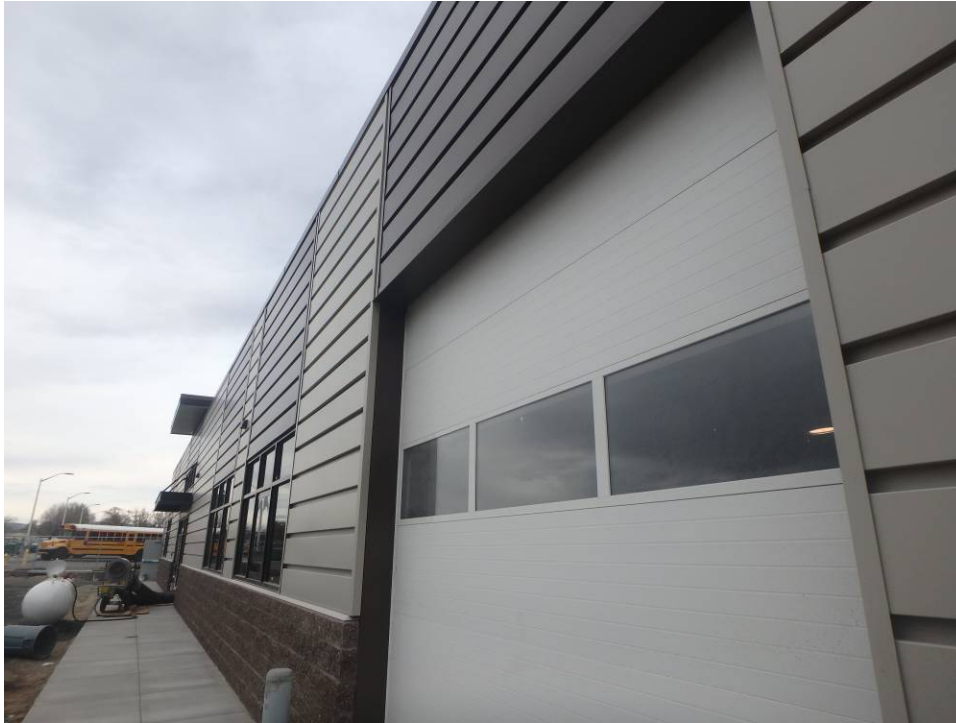
Overhead door

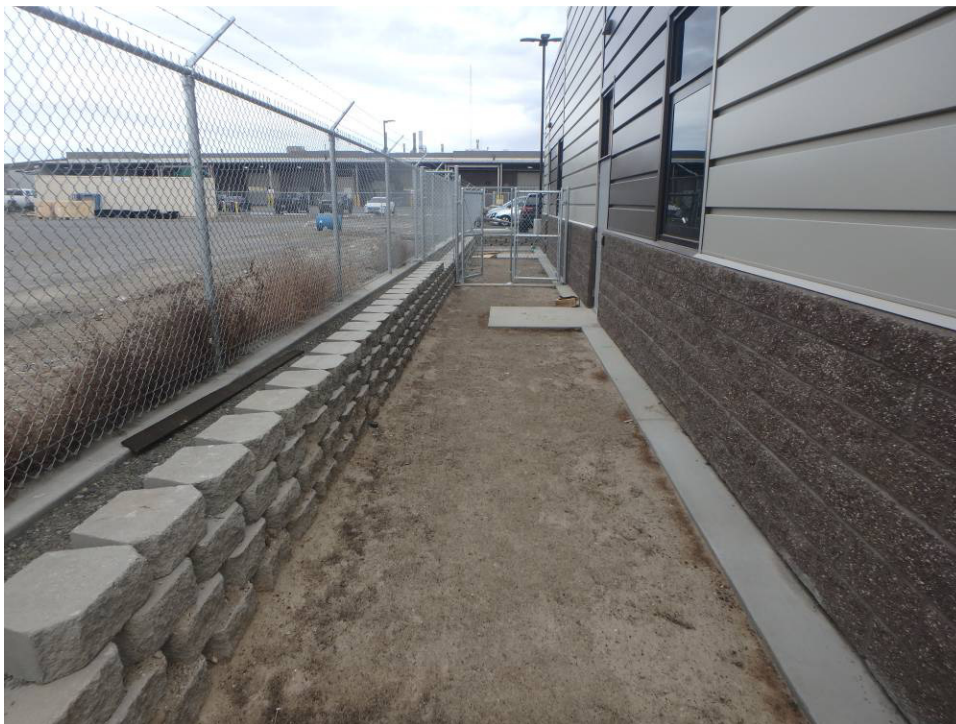
Looking west along the south side of the building  
Main entry

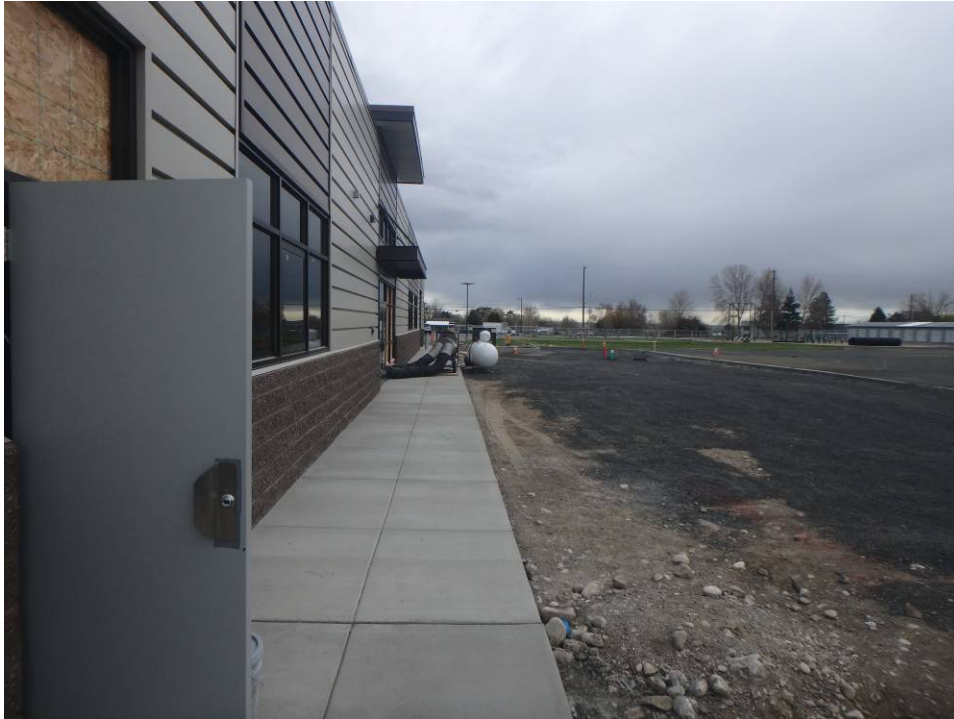
Looking north along the front sidewalk

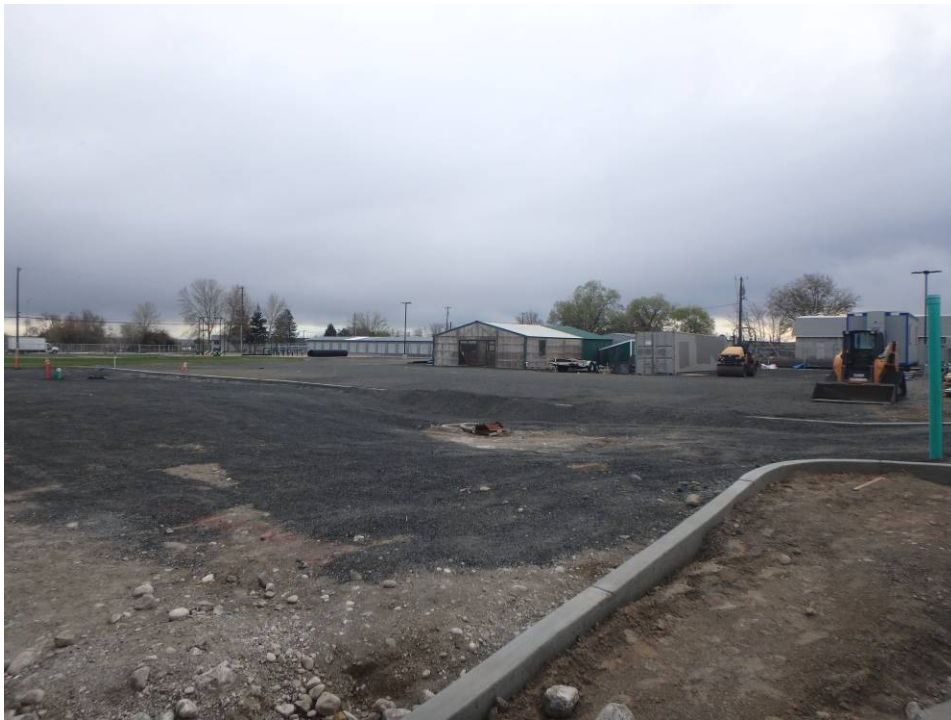
Looking northeast across the site

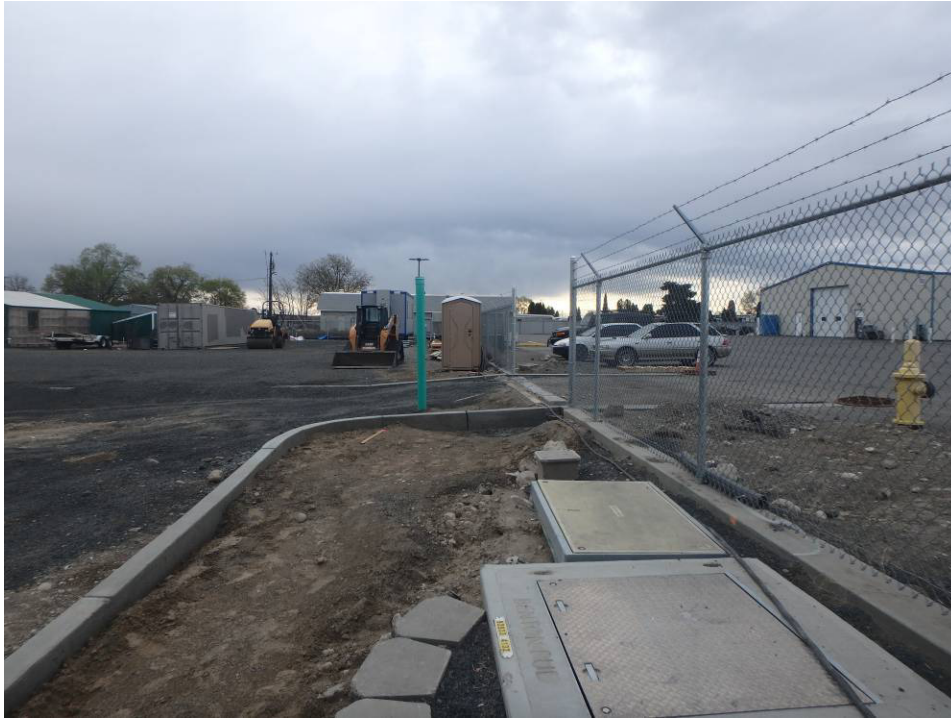
South site entry

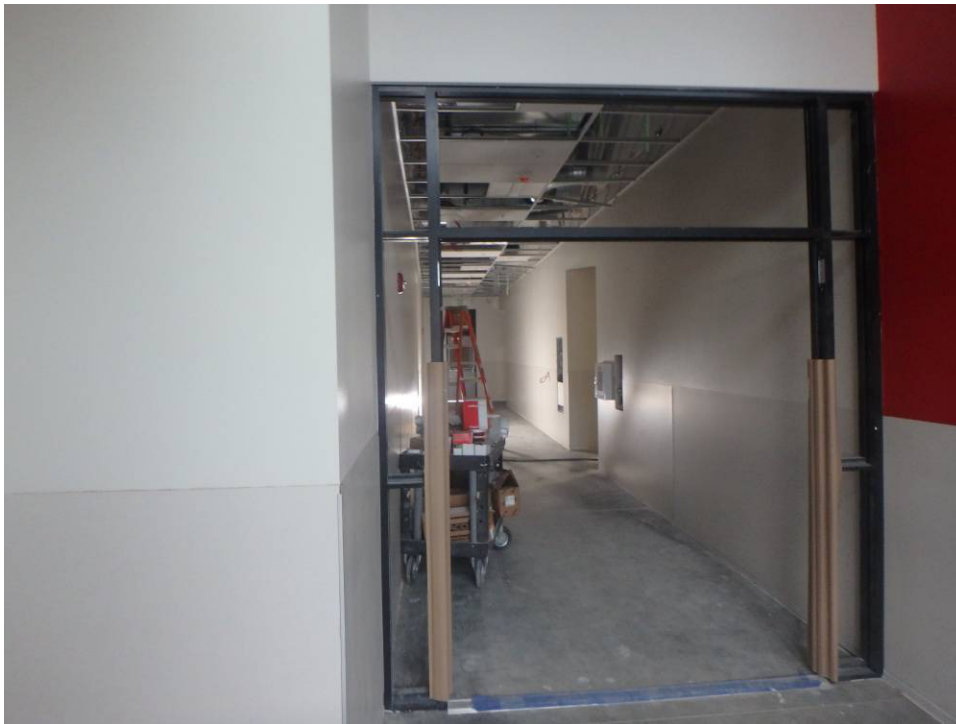
Main entry looking east into the east-west corridor

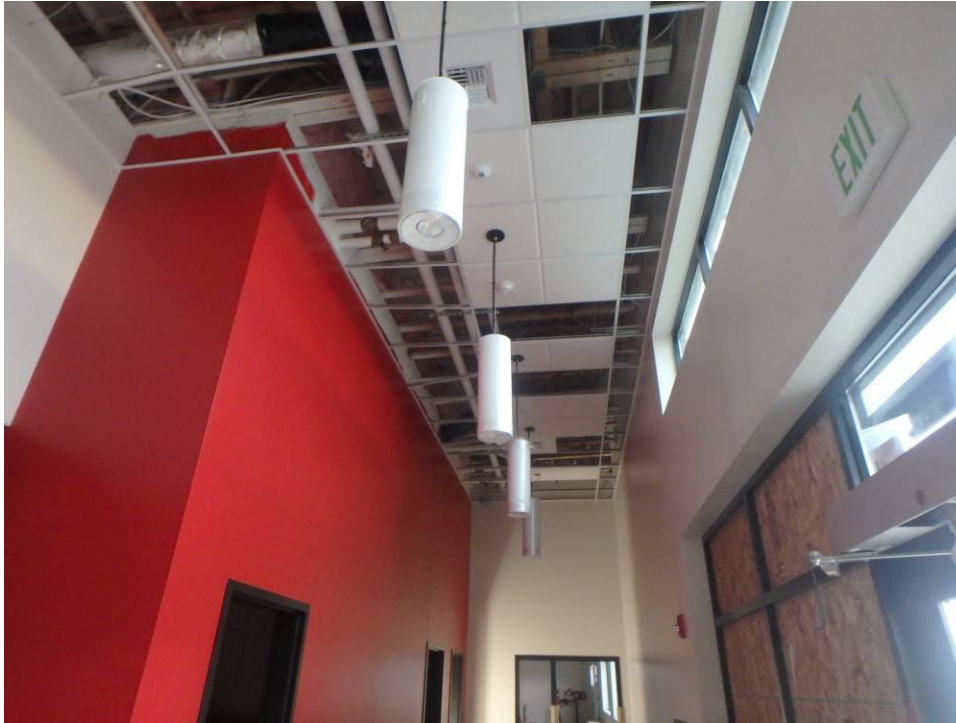
East corridor looking north at new pendant lighting and ceiling

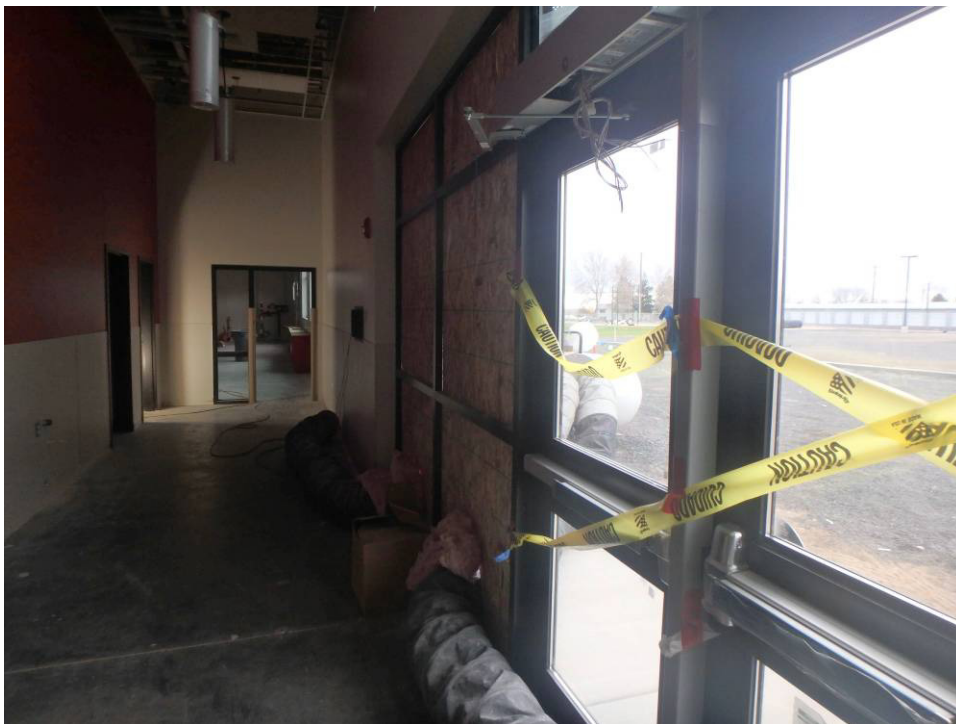
Main entry doors

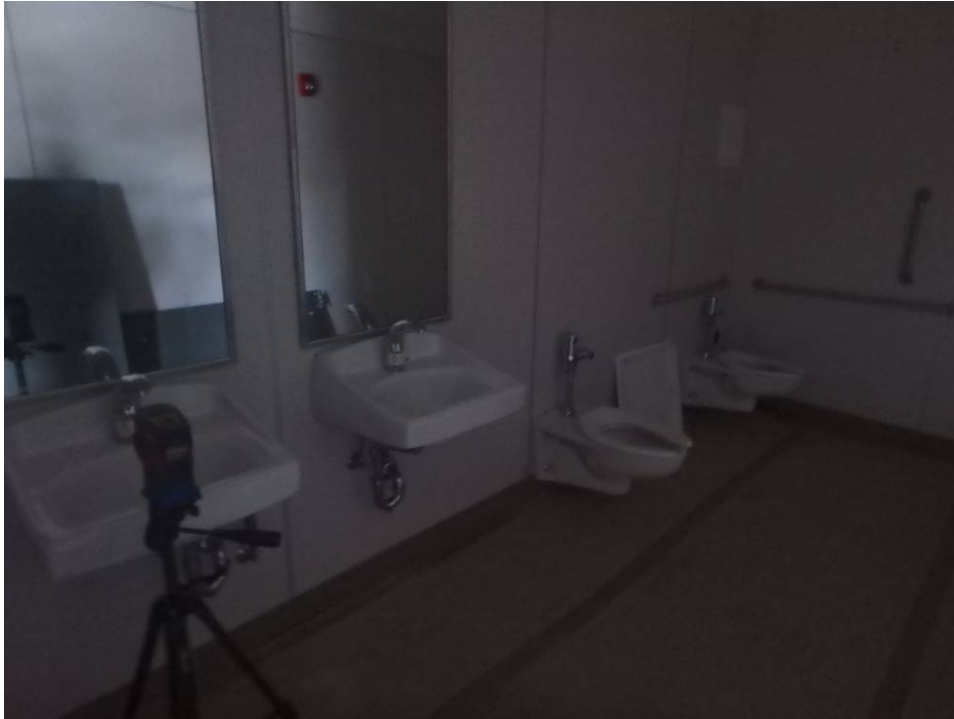
Typical restroom FRP walls and plumbing fixtures

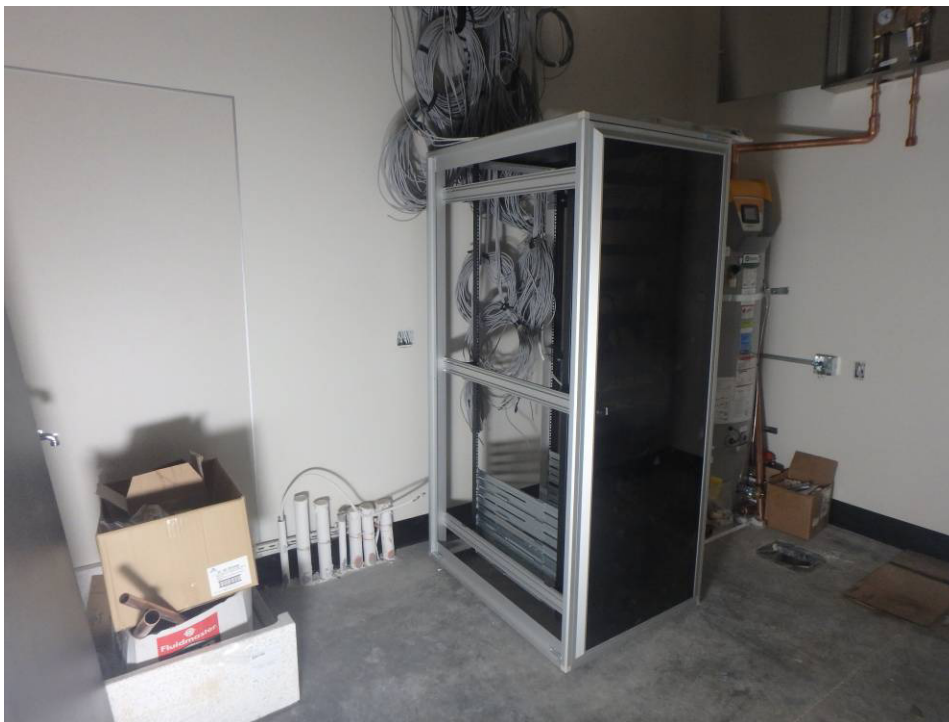
Server cabinet

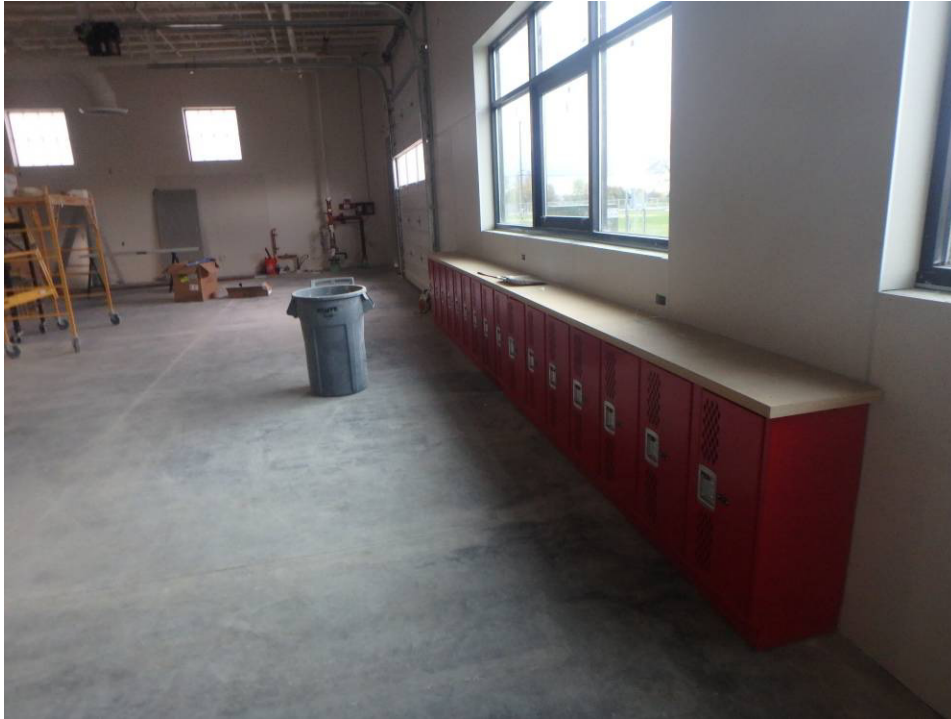
Looking north along the shop's east wall and lockers

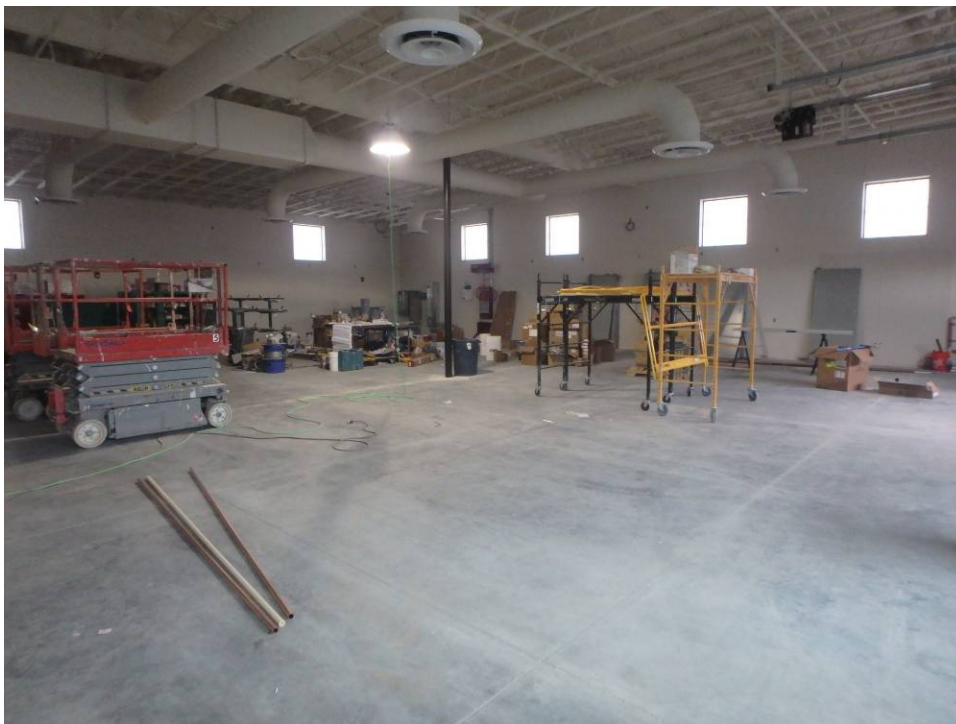
Looking northwest at the shop's north wall

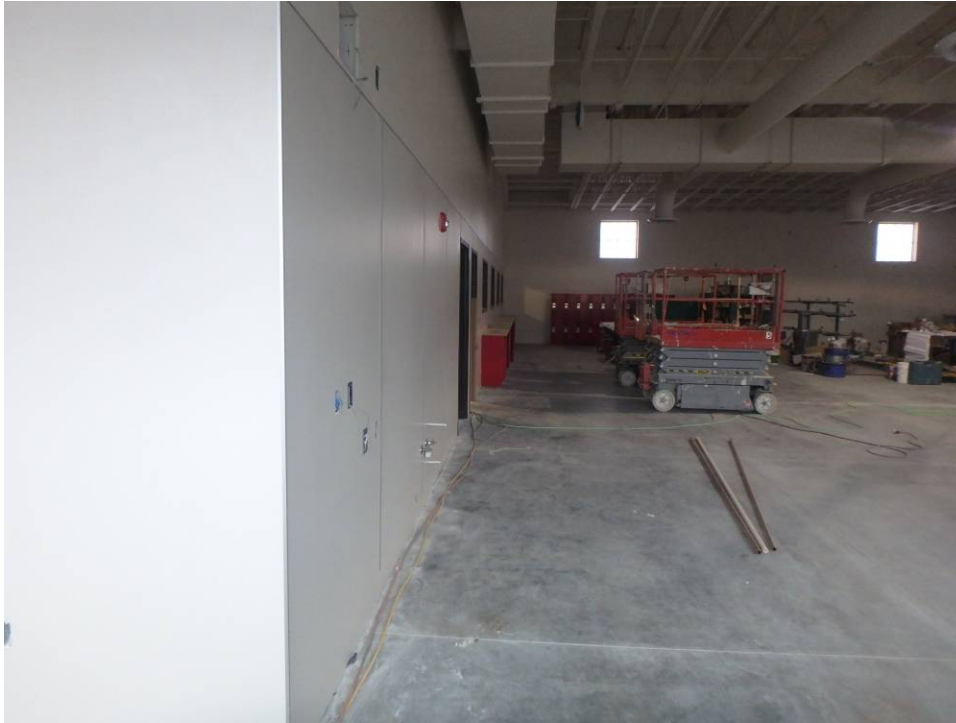
Looking west across the shop along the south wall and lockers

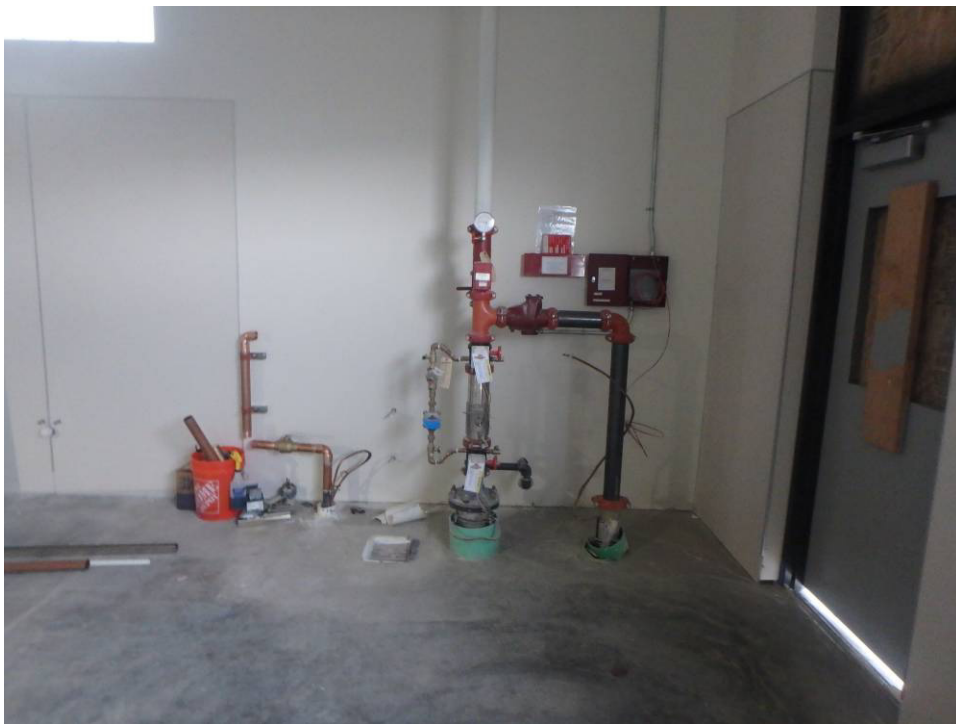
Standpipe
