**Project Observation Report**

Project Name:	Tri Tech East Building C 1.5	Project No.	2208
Report #:	28		
Observation Date:	4-19-23	Last Report:	4-12-23
Prepared By:	Steve Mallory, AIA	Contractor:	Banlin

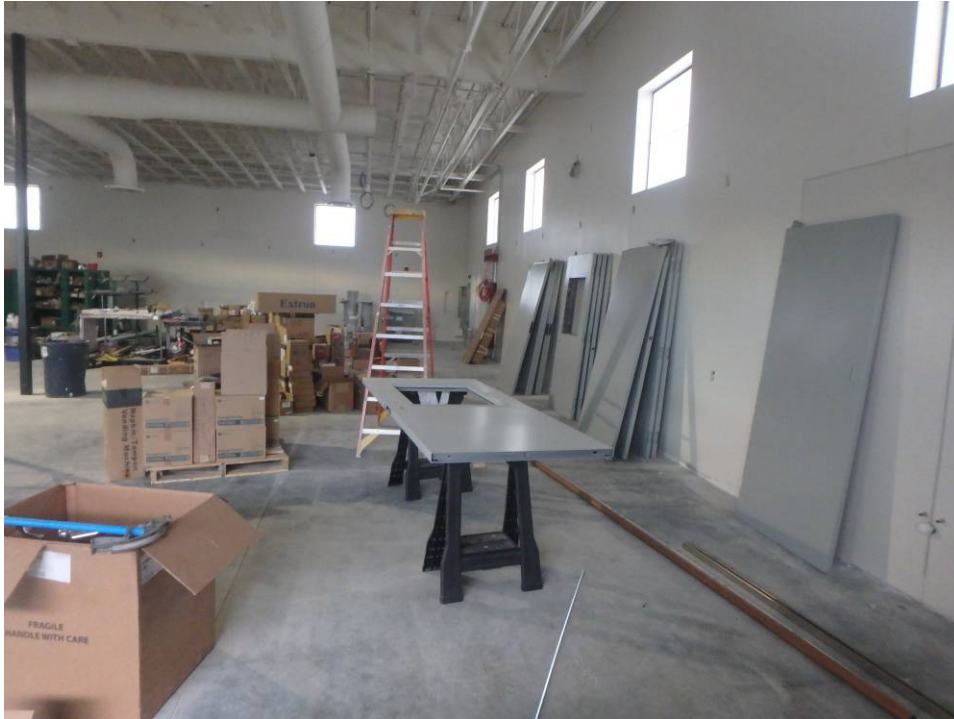
Looking west along the north wall of the shop

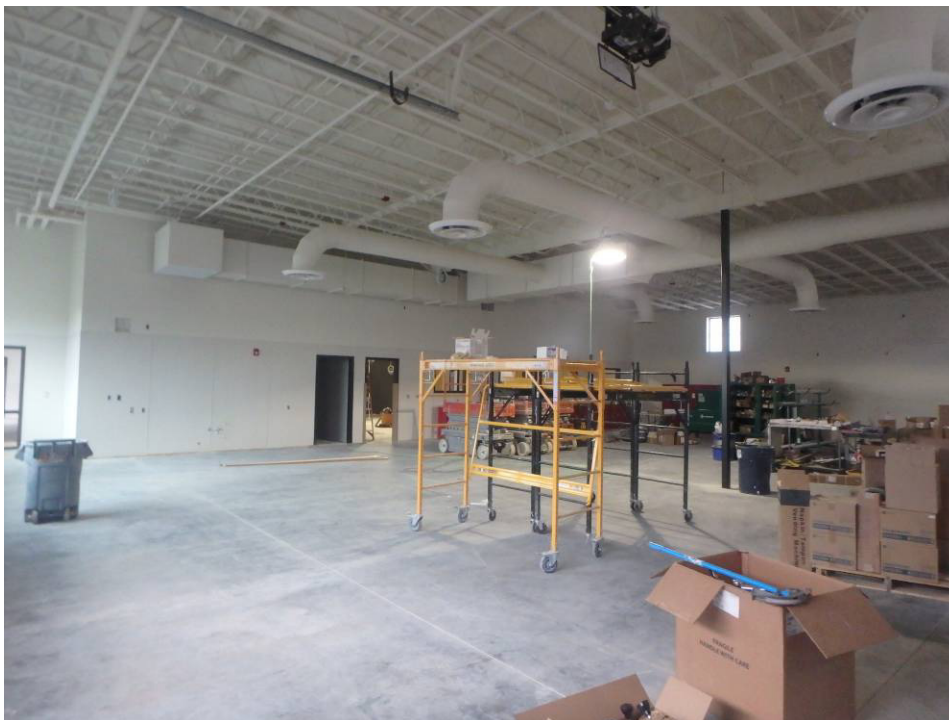
Looking southwest across the shop

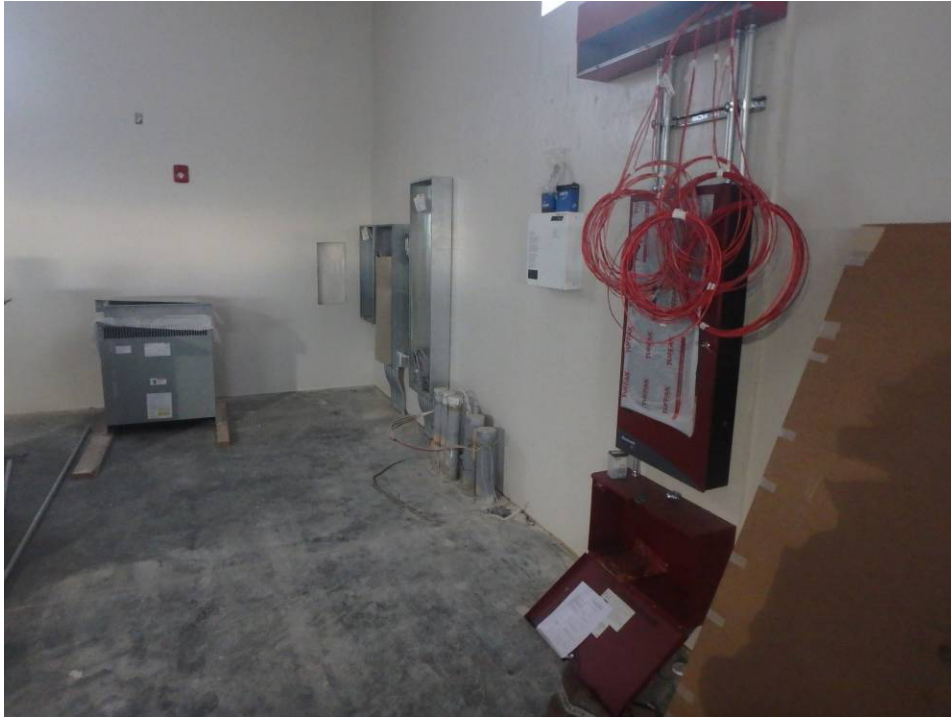
Wiring at the fire alarm panel, Electrical panels and transformer

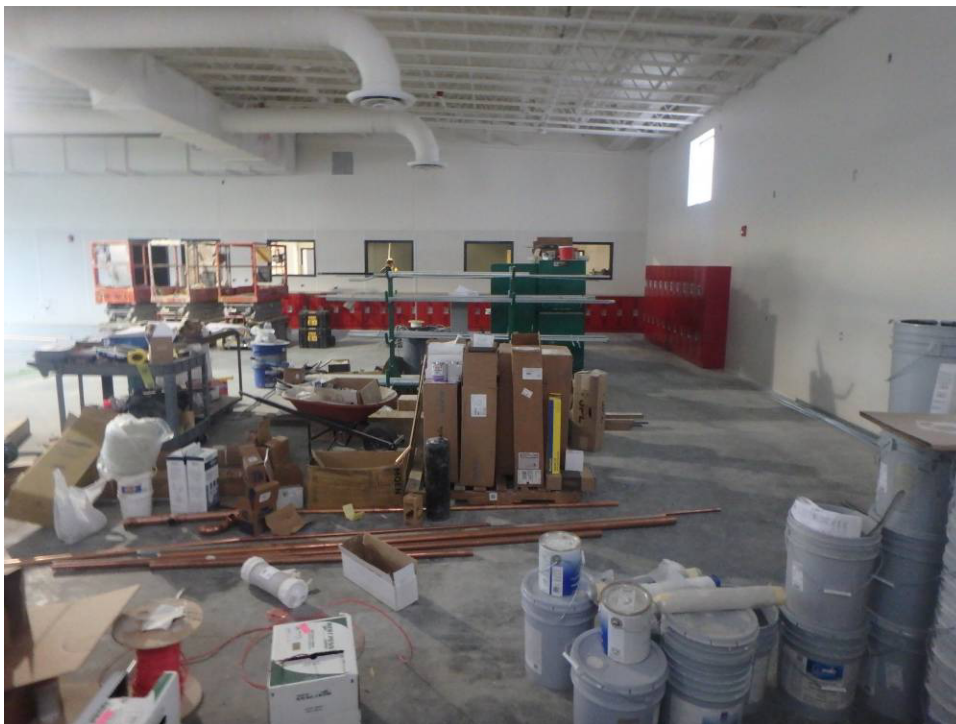
Looking south along the west wall of the shop

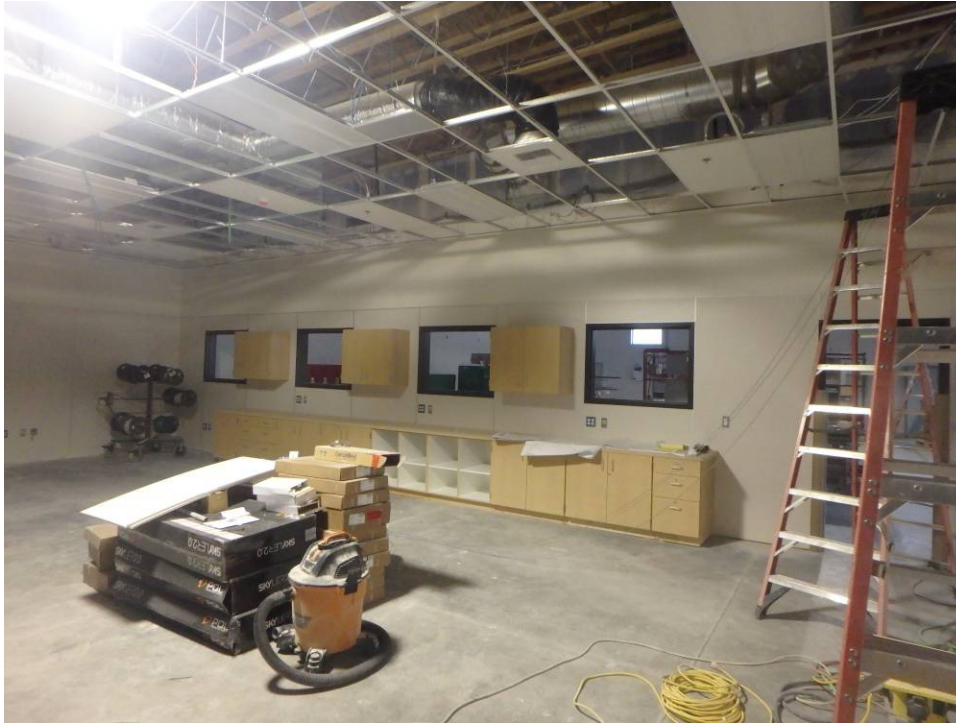
Looking at the north wall of the north classroom and casework and ceiling

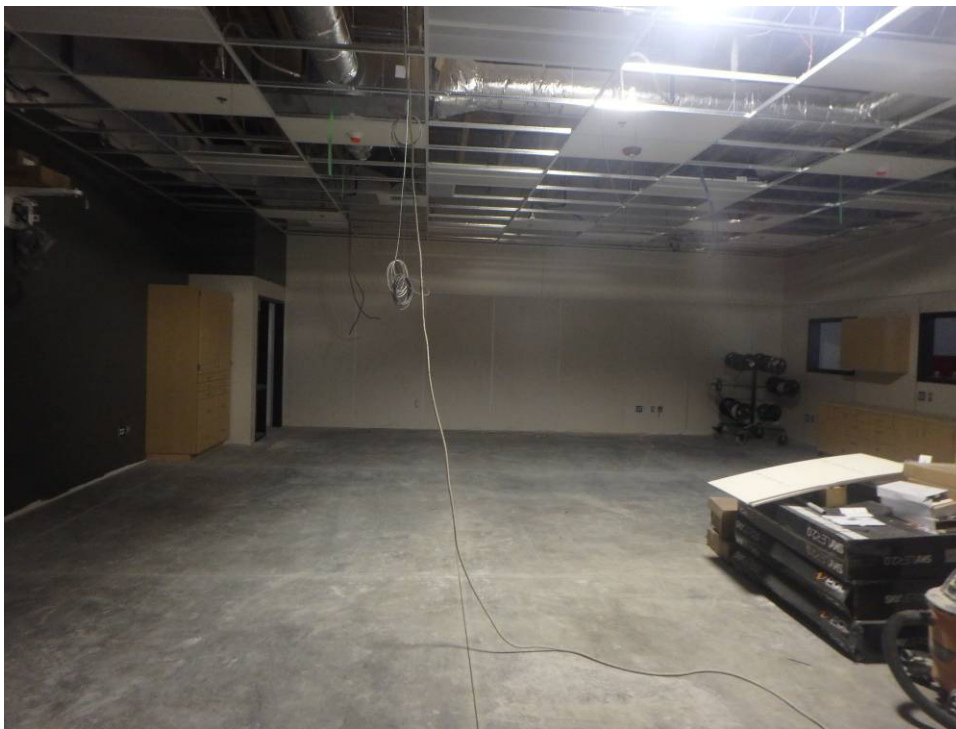
Looking west at the west wall of the north classroom and ceiling grid

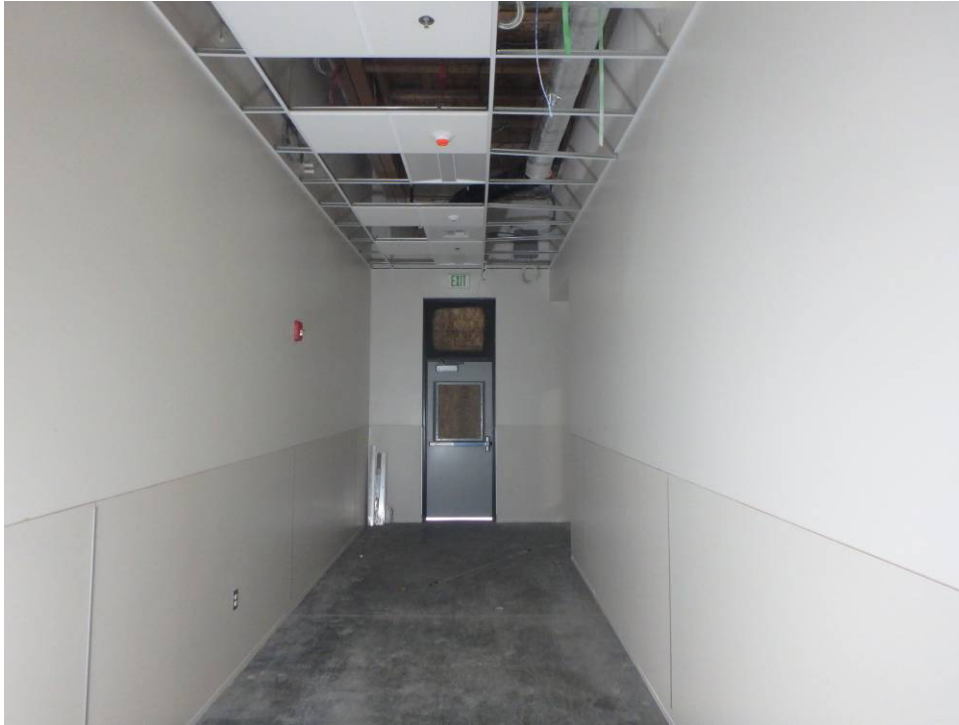
Looking west at the west end of the east-west (main) corridor

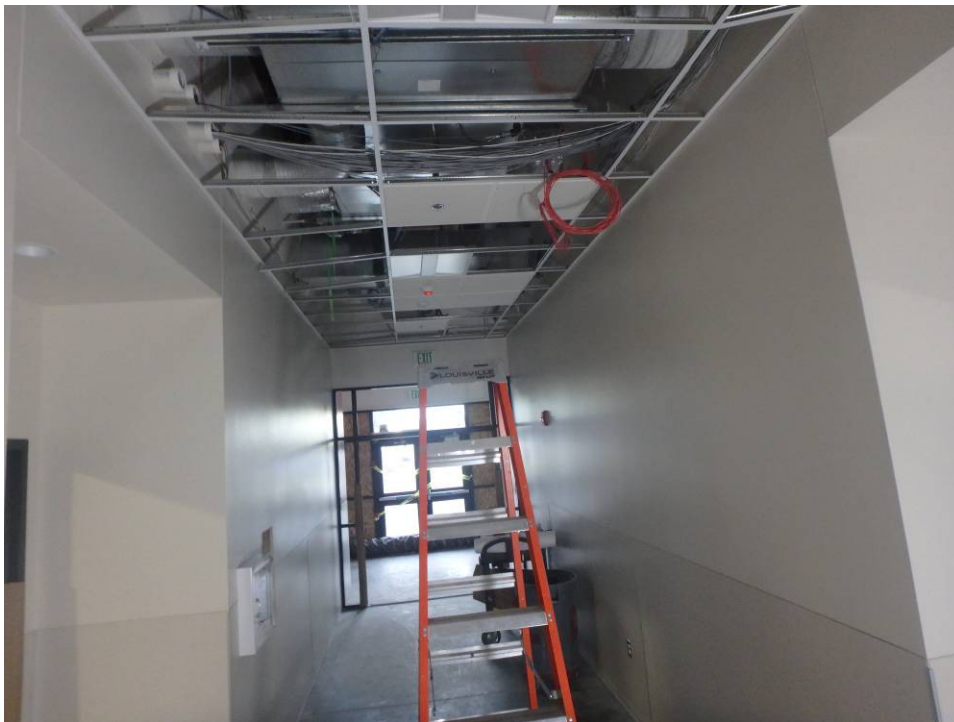
Looking east towards the entry from the west end of the main corridor

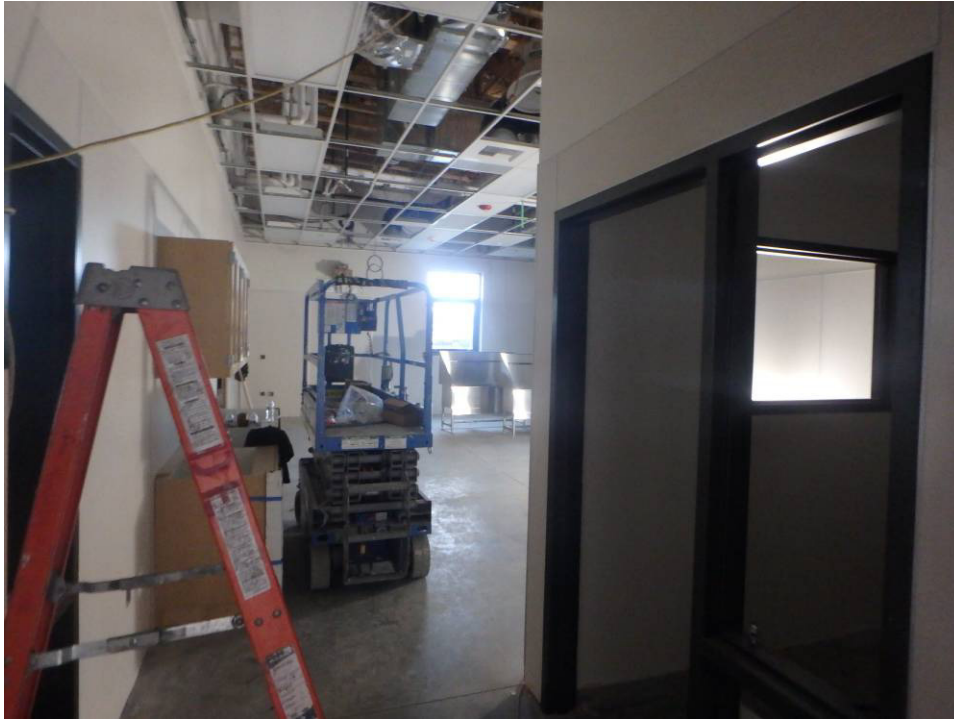
Looking south in the lab

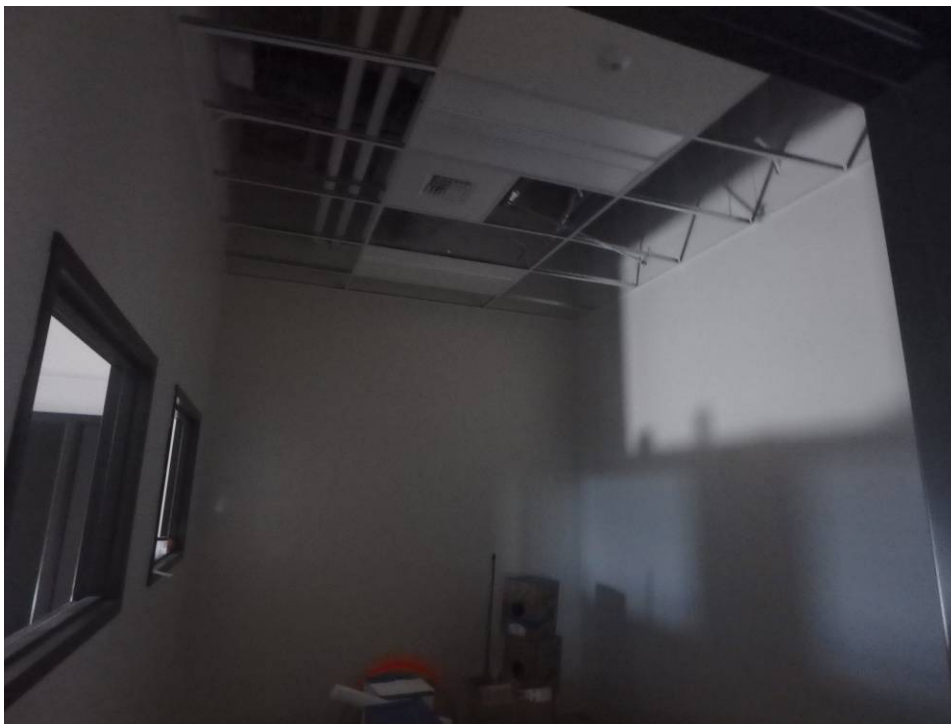
Office ceiling

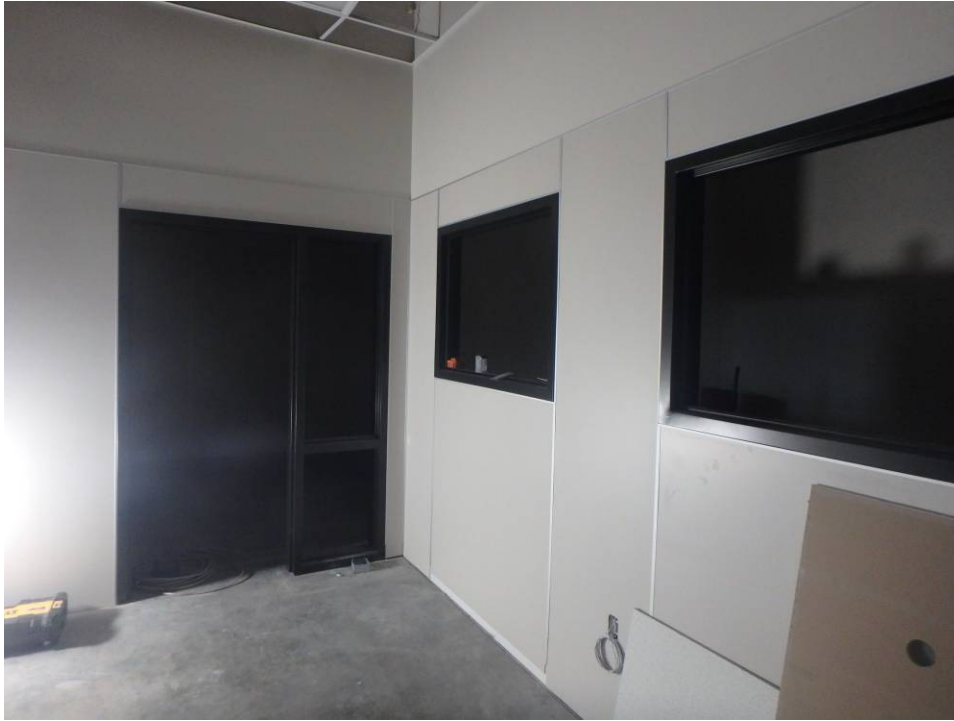
Looking northwest at the Lab's north wall and office wall

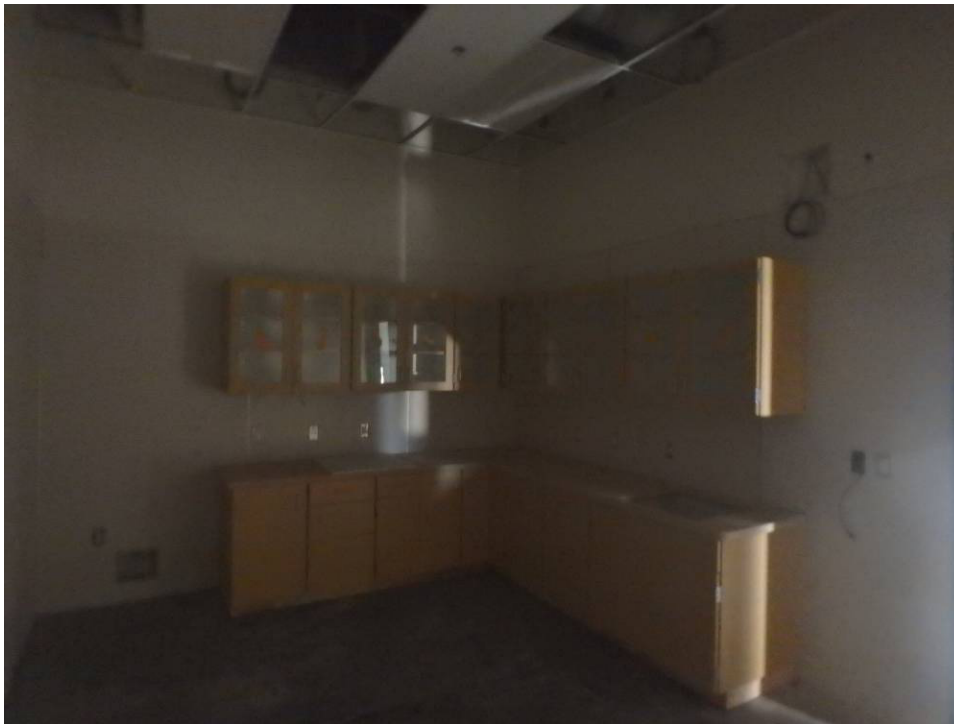
Casework in the Exam room

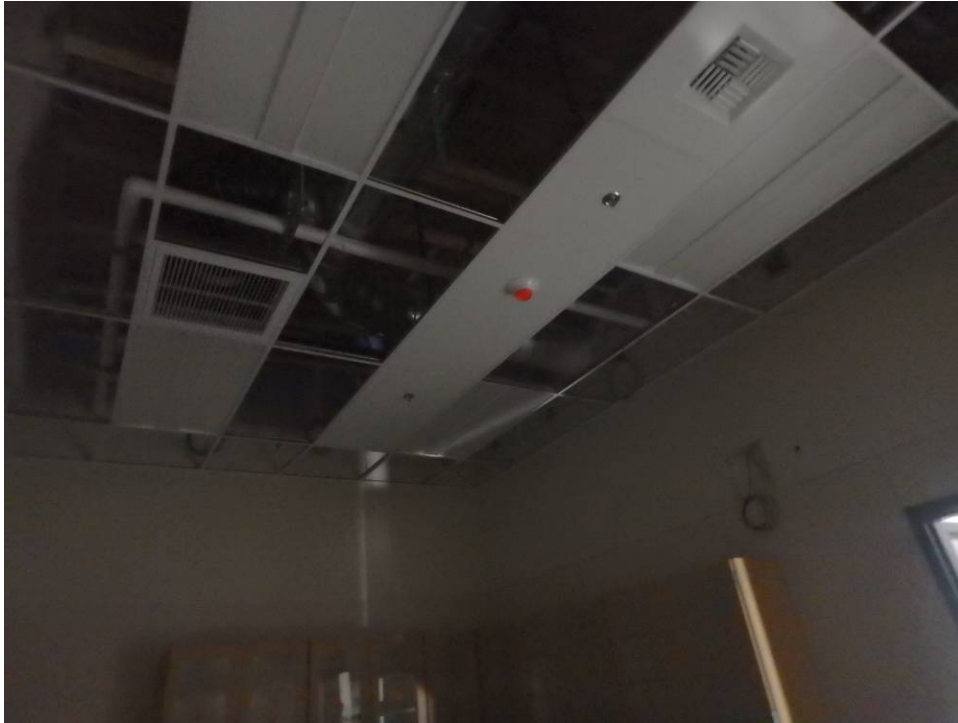
Exam room ceiling

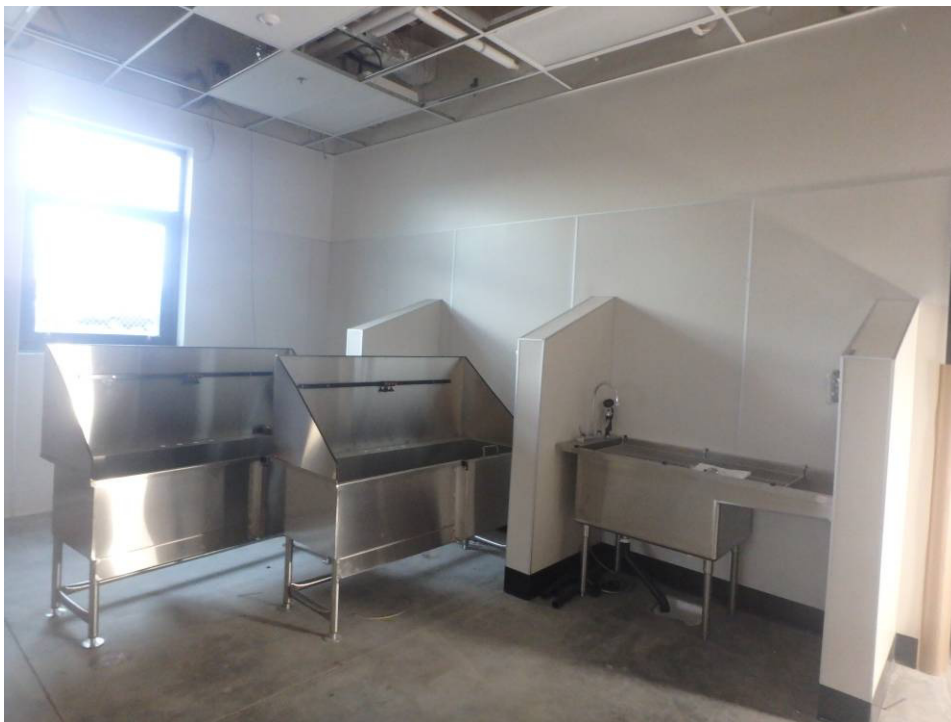
Dog wash dividers with FRP

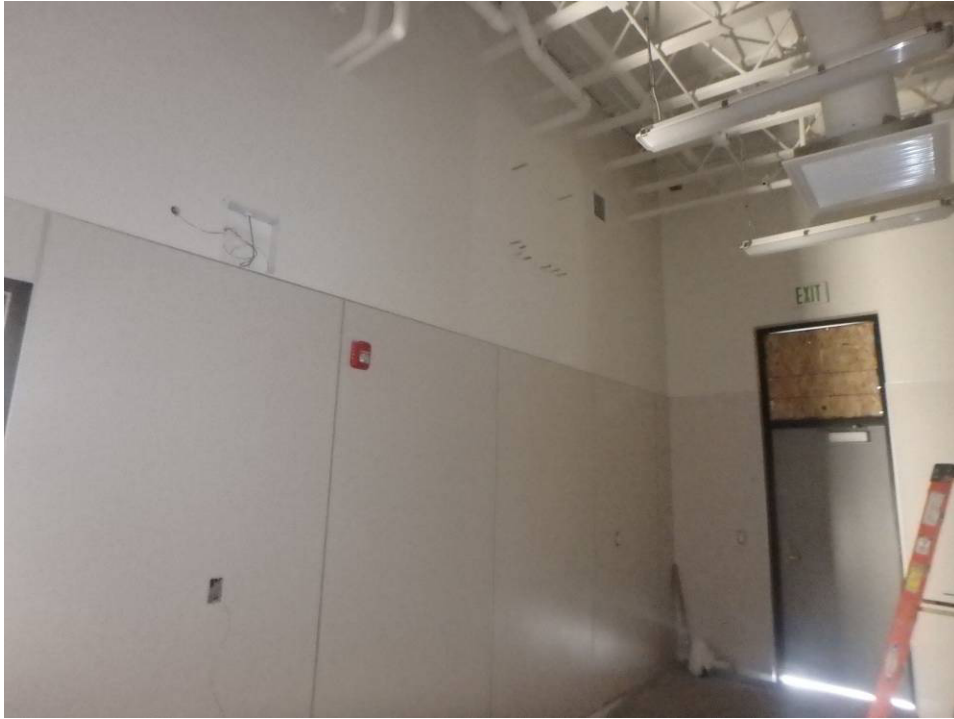
Wallboard repair at the manifold to be relocated in the Kennel Room and FRP

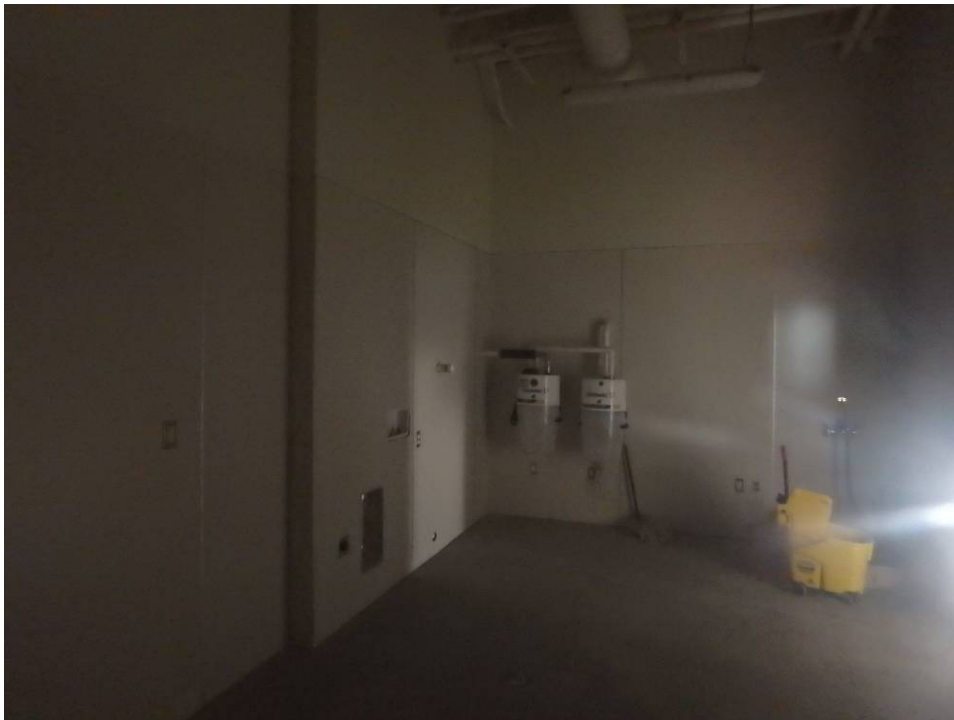
Kennel – vacuum and janitor's sink

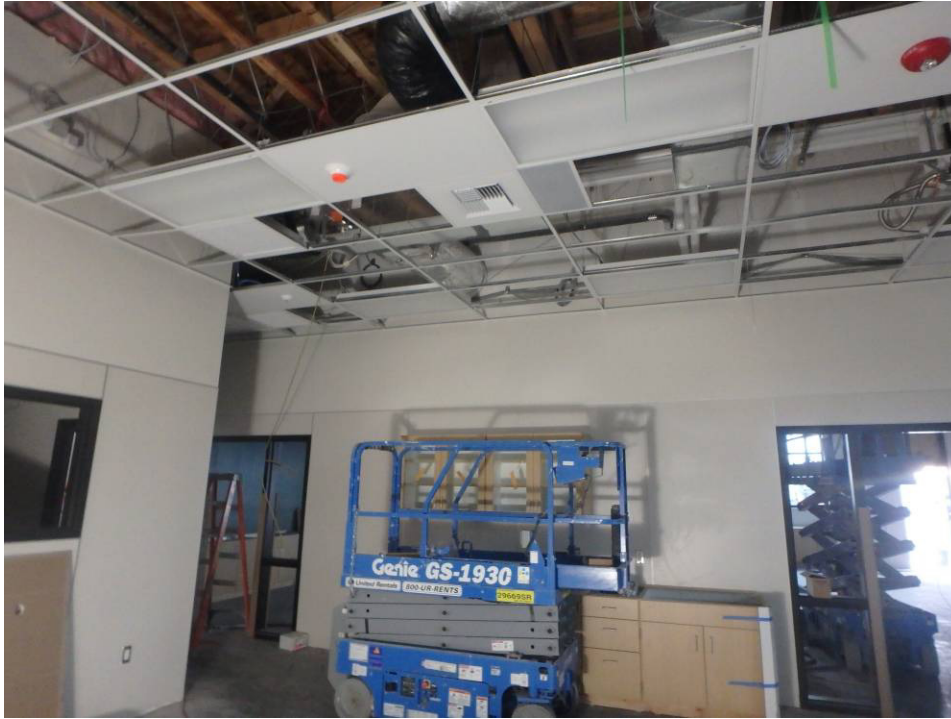
Lab – northeast corner

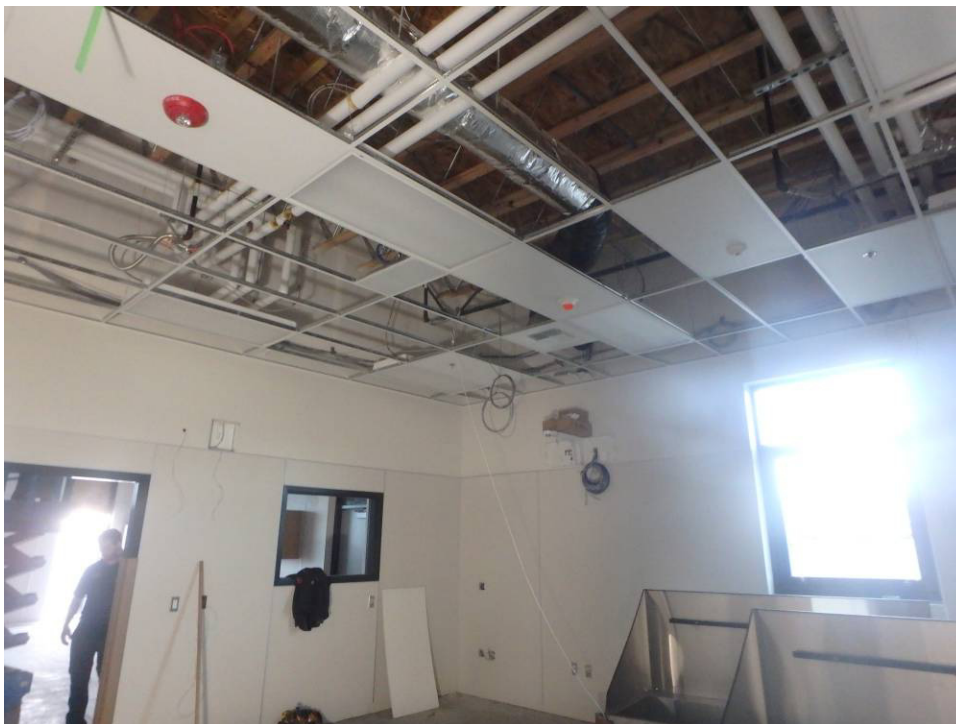
Lab – southeast corner

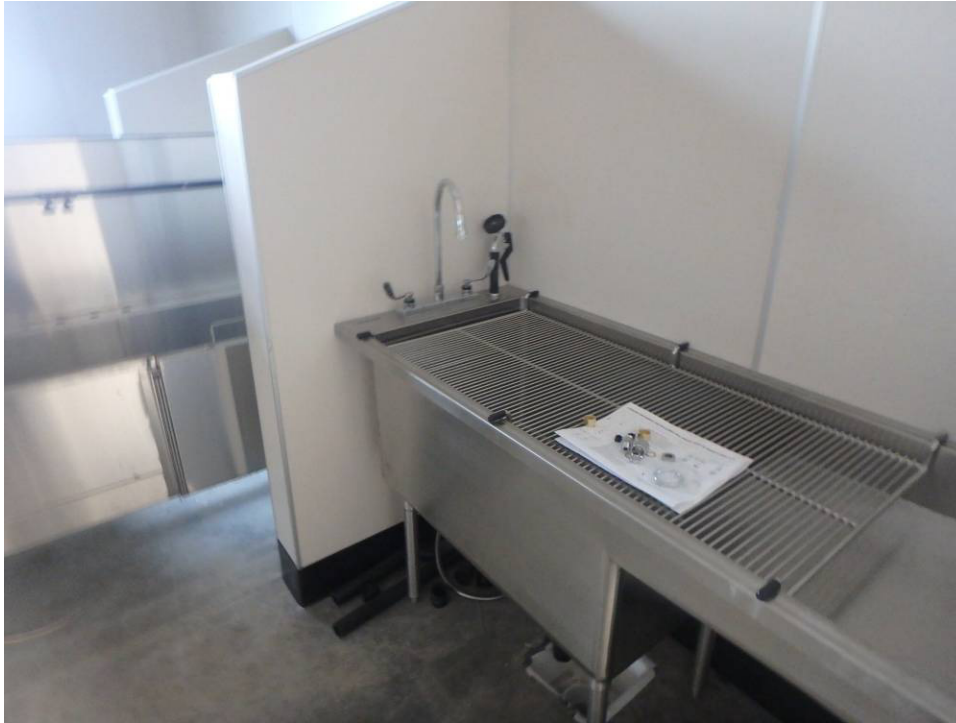
North dogwash station

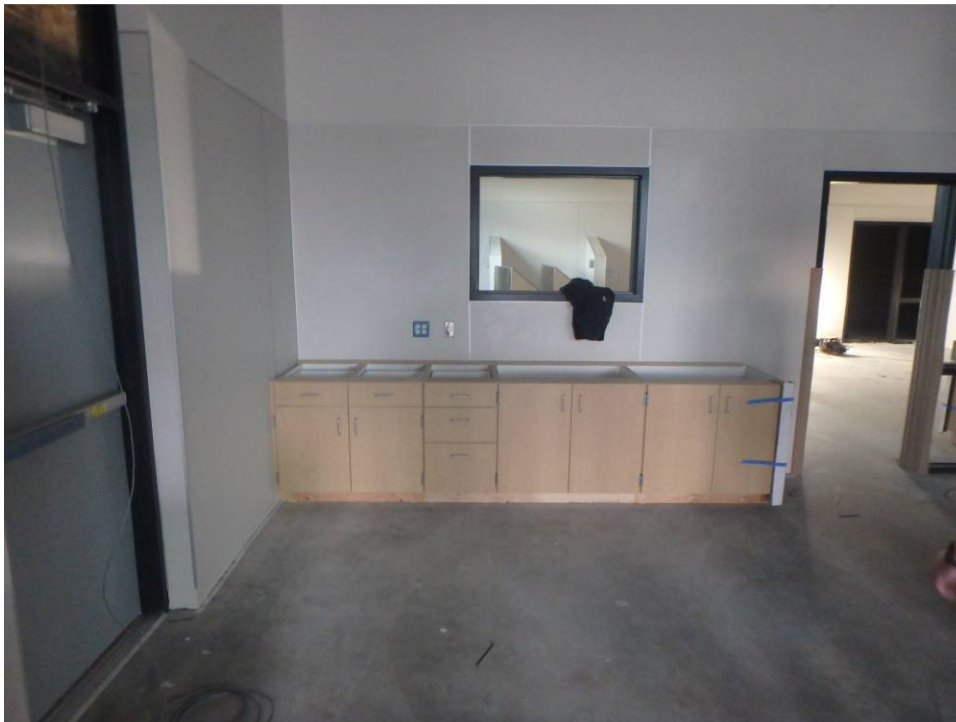
Casework in the South classroom – looking west

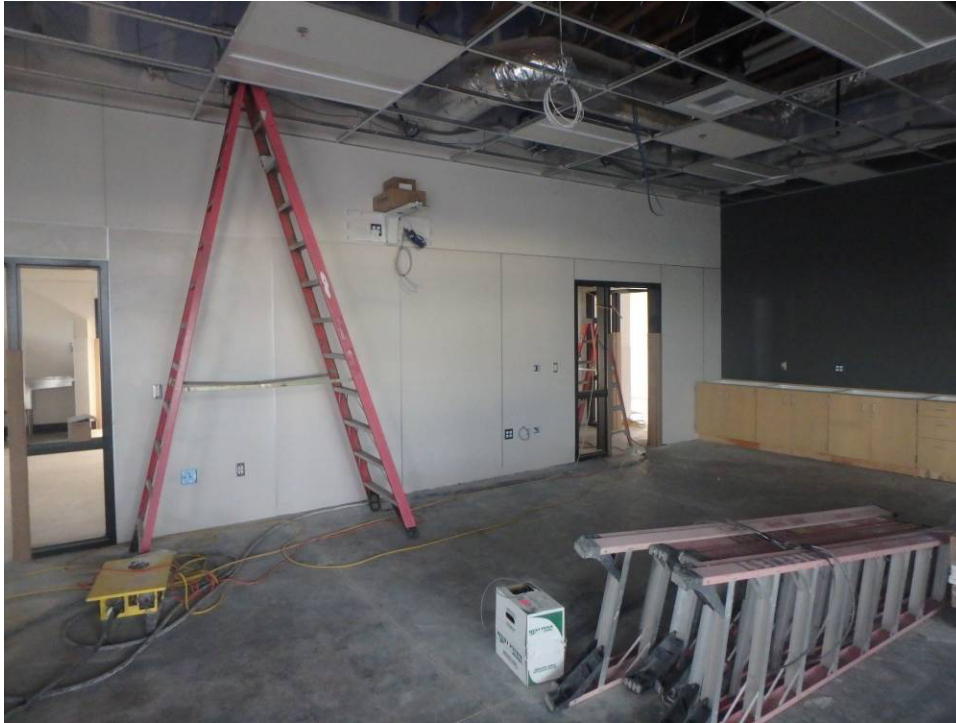
Looking at the northwest corner of the south classroom

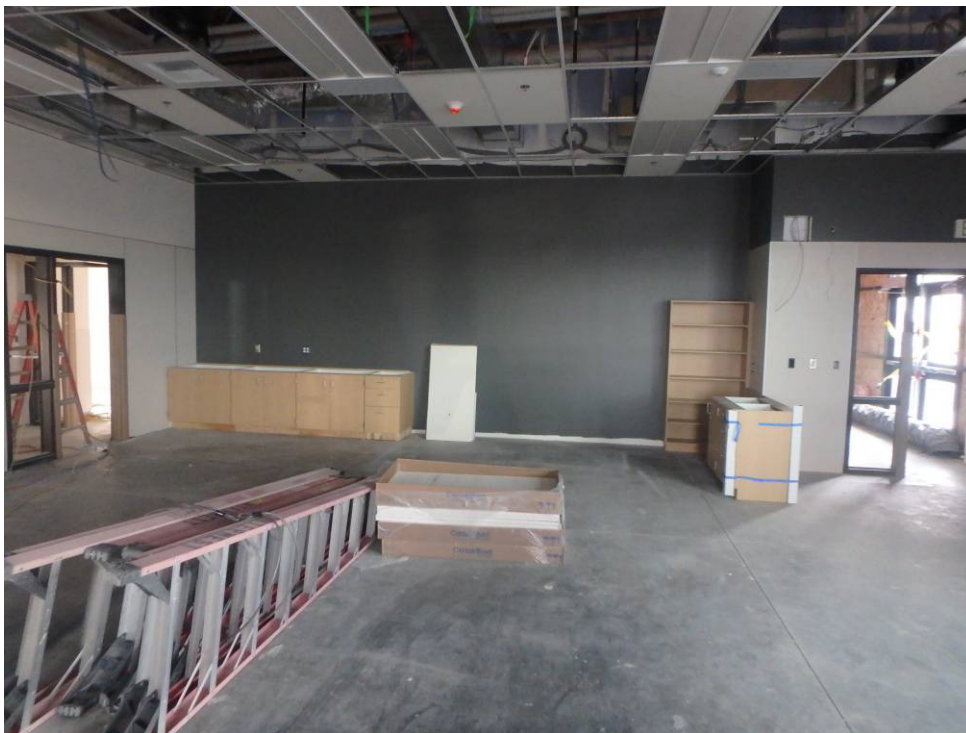
Looking at the north wall of the south classroom

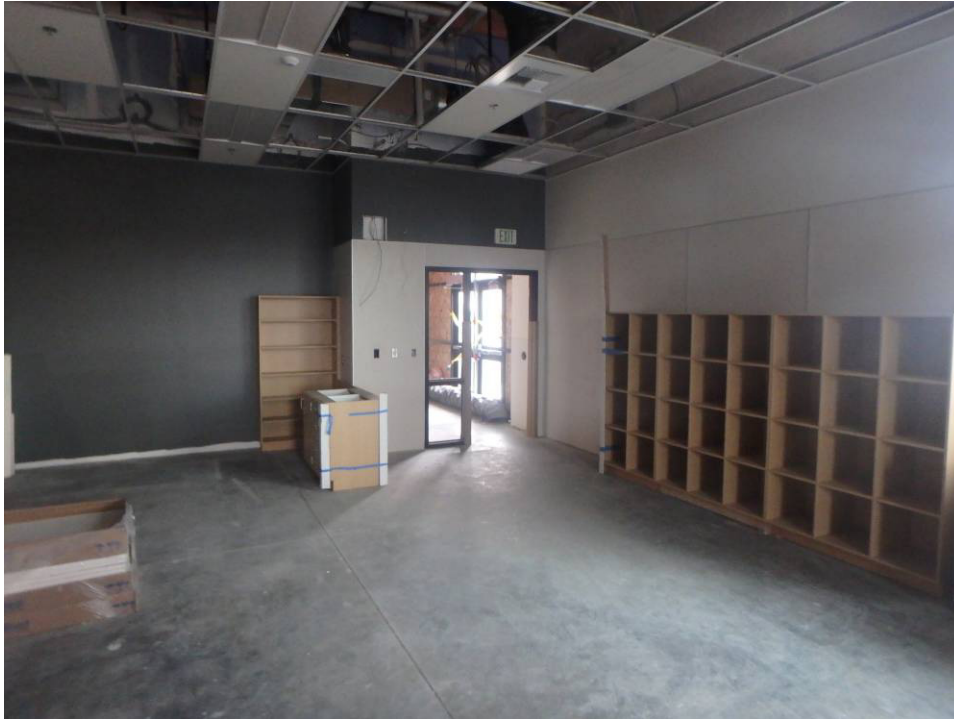
Looking at the northeast entry of the south classroom

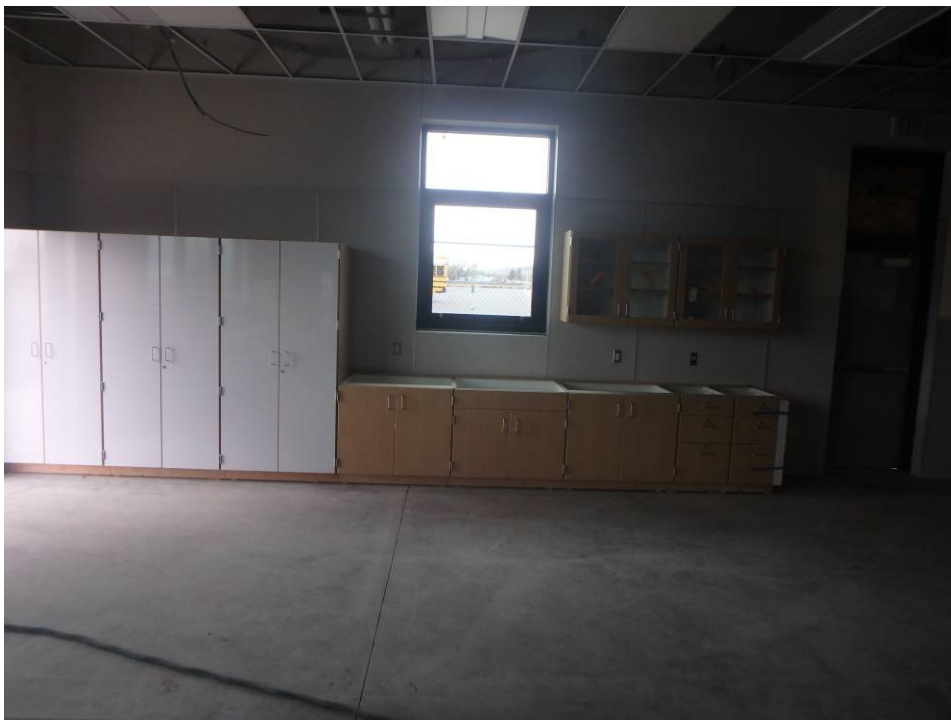
Looking at the South wall of the south classroom - Casework

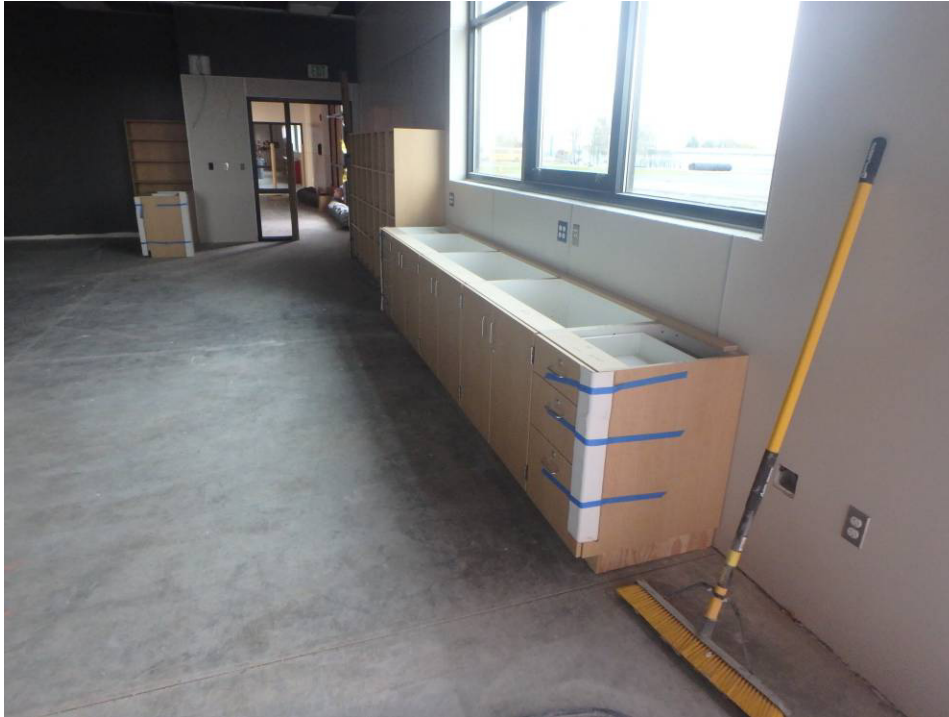
Looking at the east wall of the south classroom
