Darien School District #61

Facilities Condition Assessment

Eisenhower Junior High School

September 13, 2021

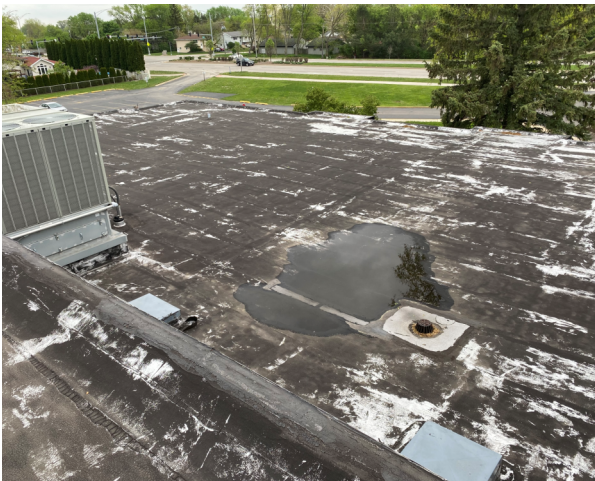
ROOF

Roofing at the older portions of the building is in poor condition. Roofing at these areas is a modified bituminous membrane. Multiple areas were indicated to have leaks, with at least one leak observed during the survey. The roofing at the older portions of the building is exhibiting fatigue, including on the membrane itself, as well as at seams / patches. Full replacement of these older portions of roofing is recommended within the next two years. The roofing at the 2000 Addition appears to be in fair condition. Roofing in this area includes a ballasted EPDM membrane, as well as an area of standing seam metal. The ballasted EPDM roofing is beginning to approach the end of its useful lifespan, and replacement should be planned for within the next five years.

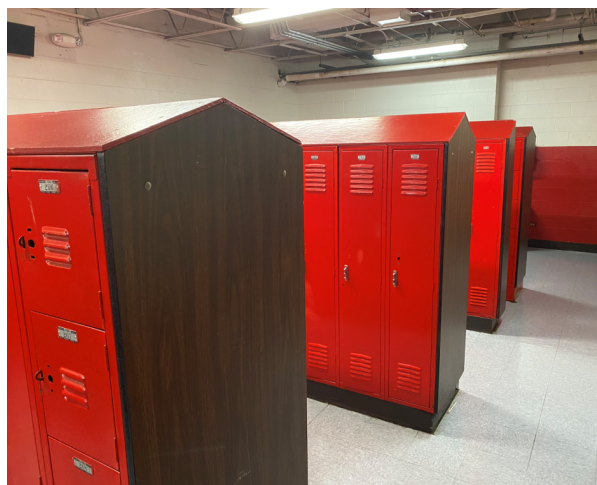
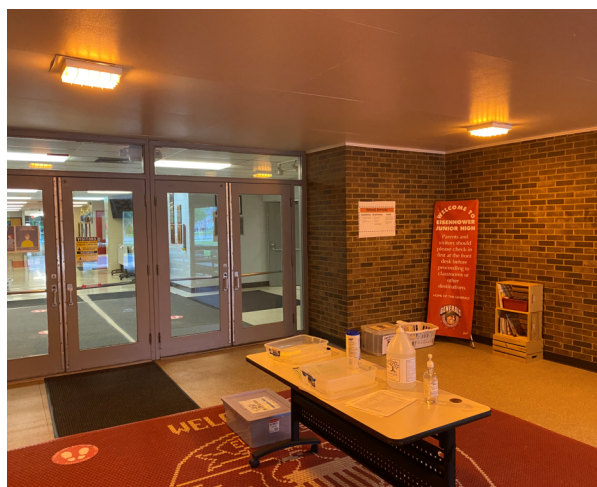
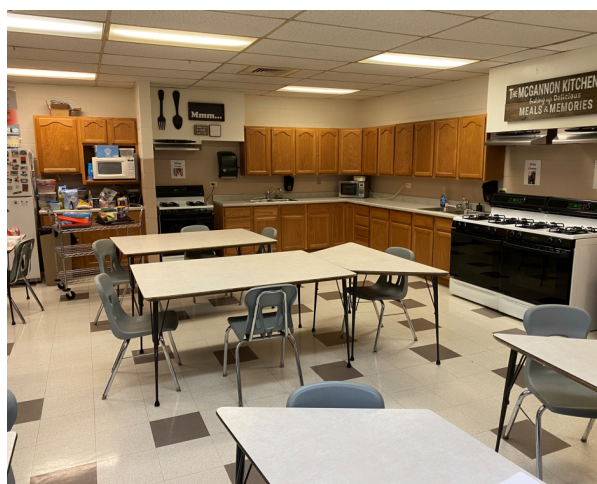
LOCKERS

Lockers in the older portions of the building appear to be in poor condition. Many of the lockers are not serviceable and as a result are unusable. Additional lockers in the 2000 Addition appear to be in fair condition. The remaining serviceable locker count appears to be sufficient for the current student population. It is recommended that the lockers be replaced to improve their general functionality.

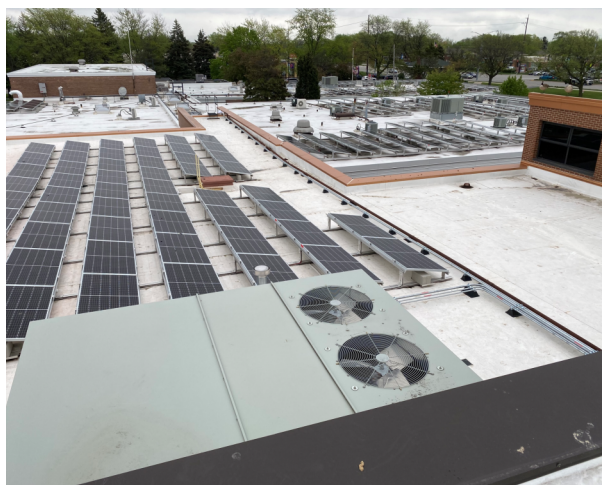
ROOF

Roofing at the older portions of the building has been replaced within the last decade and is in good condition. Roofing at these areas is a single-ply EPDM membrane. Replacement of these older portions of roofing is not anticipated within the next ten years. The roofing at the 2007 Addition appears to be in fair to good condition. Roofing in this area includes a single-ply EPDM membrane, as well as an area of standing seam metal and an area of vegetative roof covering. The single-ply EPDM roofing is past the midpoint of its useful lifespan, and replacement should be planned for within the next six to ten years.

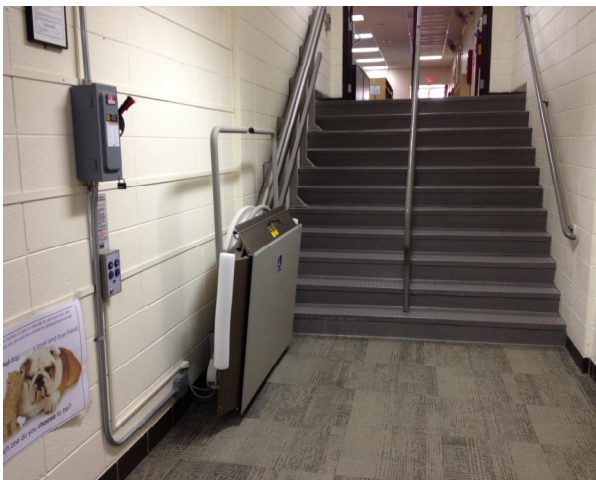
ELEVATOR

The building currently is a 'split-level' configuration with two sets of stairs. A lift has been provided to provide accessibility between the main and lower levels. It is recommended that a full elevator be considered to allow accessibility between all three levels of the building. The inclusion of an elevator would require a significant remodeling at the interior of the building, and would result in the loss of functional space within the building. As such an elevator is recommended only in conjunction with a larger renovation project that would allow additional elements to be modified in order to accommodate the elevator.
