Darien School District #61

Facilities Condition Assessment

Eisenhower Junior High School

September 13, 2021

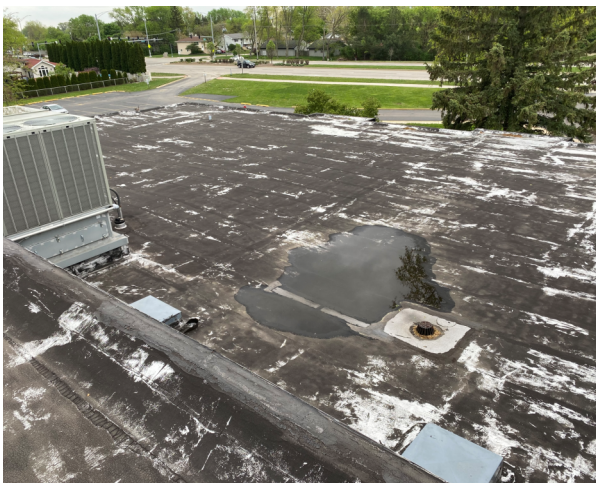
ROOF

Roofing at the older portions of the building is in poor condition. Roofing at these areas is a modified bituminous membrane. Multiple areas were indicated to have leaks, with at least one leak observed during the survey. The roofing at the older portions of the building is exhibiting fatigue, including on the membrane itself, as well as at seams / patches. Full replacement of these older portions of roofing is recommended within the next two years. The roofing at the 2000 Addition appears to be in fair condition. Roofing in this area includes a ballasted EPDM membrane, as well as an area of standing seam metal. The ballasted EPDM roofing is beginning to approach the end of its useful lifespan, and replacement should be planned for within the next five years.

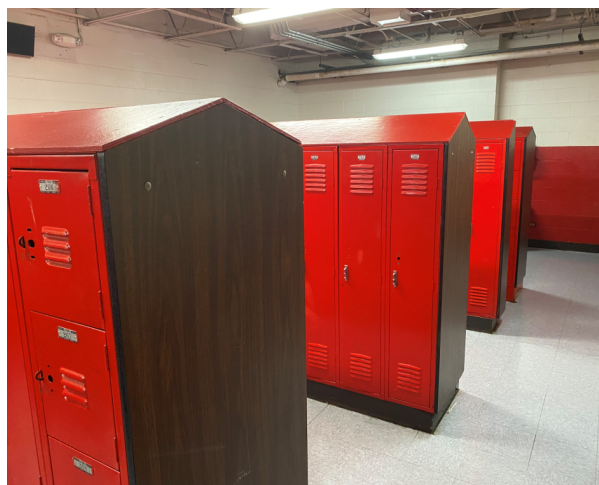
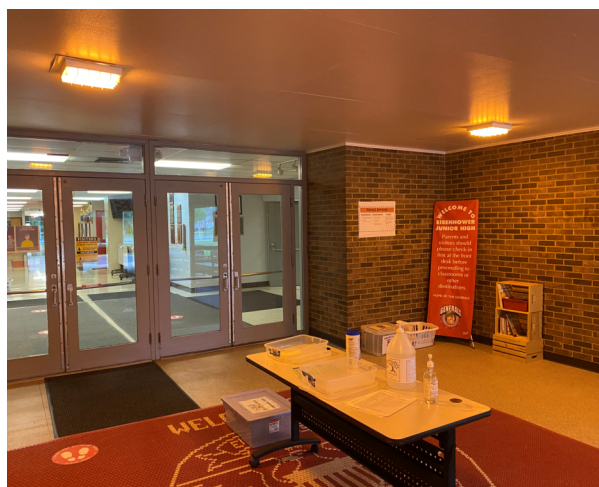
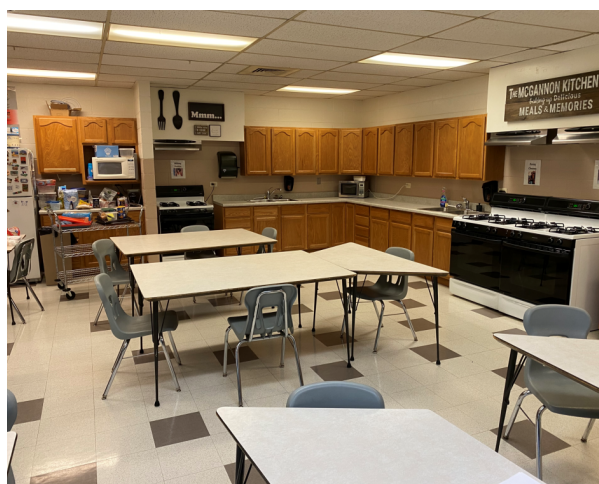
LOCKERS

Lockers in the older portions of the building appear to be in poor condition. Many of the lockers are not serviceable and as a result are unusable. Additional lockers in the 2000 Addition appear to be in fair condition. The remaining serviceable locker count appears to be sufficient for the current student population. It is recommended that the lockers be replaced to improve their general functionality.

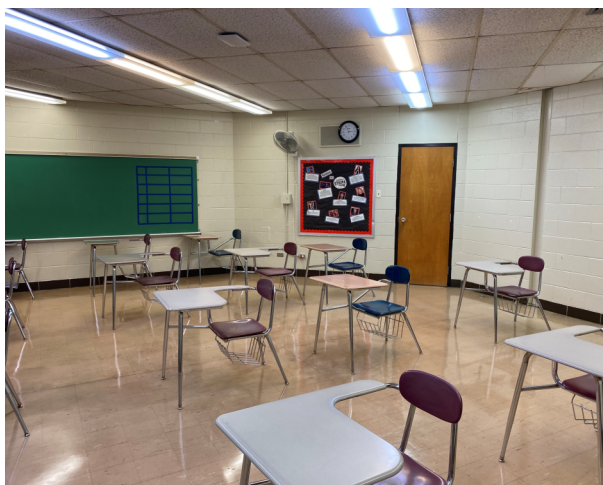
“LIGHT & BRIGHT”

In general little to no interior renovation has occurred in a majority of the classrooms and corridors since the original building and additions were constructed. It is recommended that a renovation be considered to replace the flooring, paint the walls, replace older ceilings, and replace lighting throughout all classroom and corridor spaces, or at least throughout all corridor spaces.

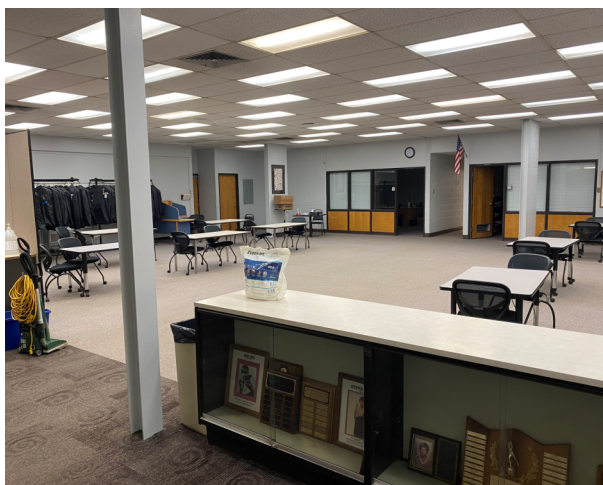
OLD TECH LAB

The old tech lab is currently underutilized. This is a rather large space that has the potential to be repurposed to a more effective function. It is recommended that the old tech lab be renovated into a modern STEM lab or other such function to allow for a more current curriculum use.

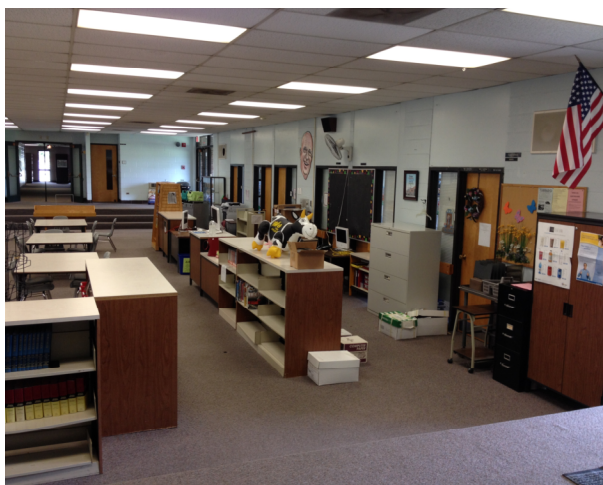
LIBRARY

The library is a large open space that includes a depressed floor area. A large portion of the space is allocated to stairs and ramps in order to access the depressed area. It is recommended that the library be renovated, with consideration given to the potential infill of the existing depressed floor area. Renovation would improve the usable size and quality of the space, and would allow incorporation of current educational amenities within the library.

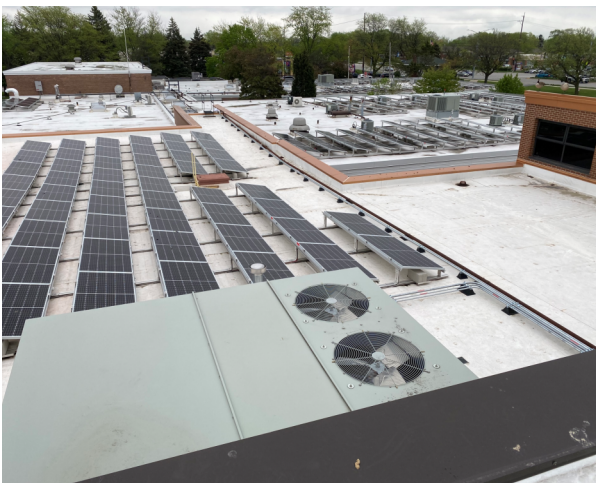
ROOF

Roofing at the older portions of the building has been replaced within the last decade and is in good condition. Roofing at these areas is a single-ply EPDM membrane. Replacement of these older portions of roofing is not anticipated within the next ten years. The roofing at the 2007 Addition appears to be in fair to good condition. Roofing in this area includes a single-ply EPDM membrane, as well as an area of standing seam metal and an area of vegetative roof covering. The single-ply EPDM roofing is past the midpoint of its useful lifespan, and replacement should be planned for within the next six to ten years.

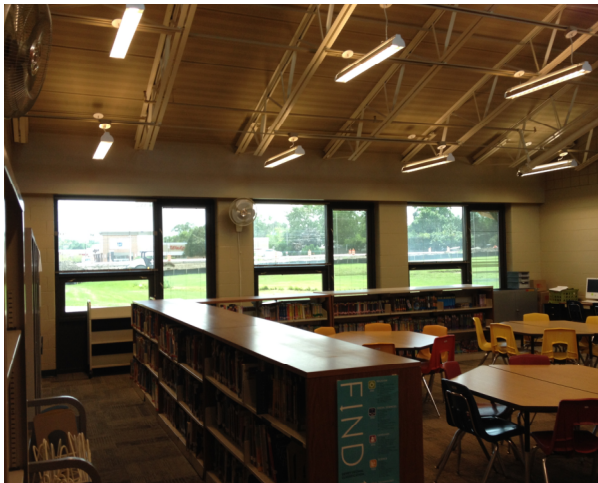
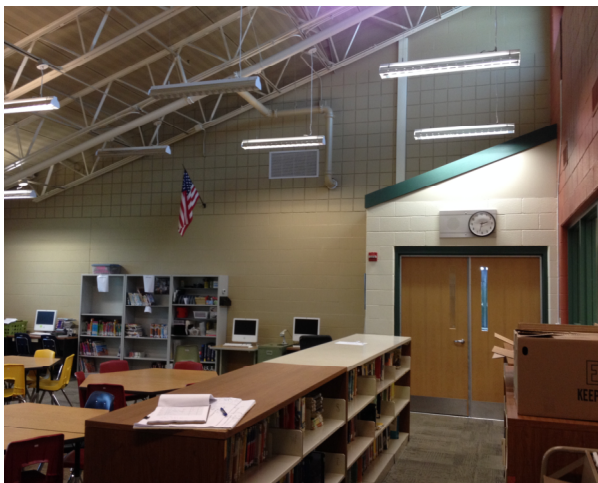
LIBRARY / STEM LAB

The STEM lab is currently located within a classroom sized space, and lacks the amenities that would be preferred for a STEM lab. Additionally, the library, which is adjacent to the STEM lab, is isolated from surrounding spaces. Consideration should be given to remodeling these spaces to better connect them to the surrounding spaces, and to incorporate current educational amenities.

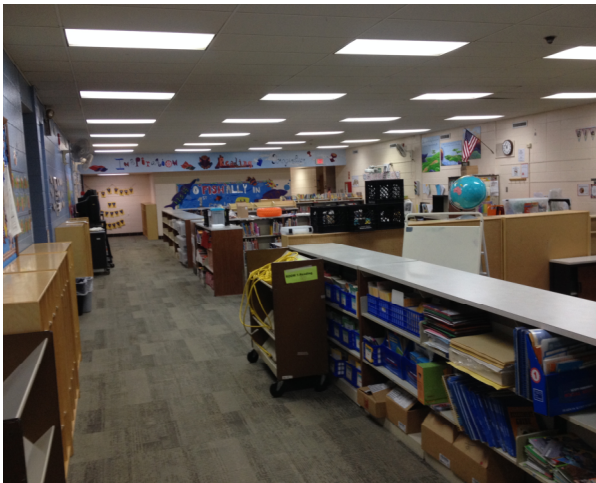
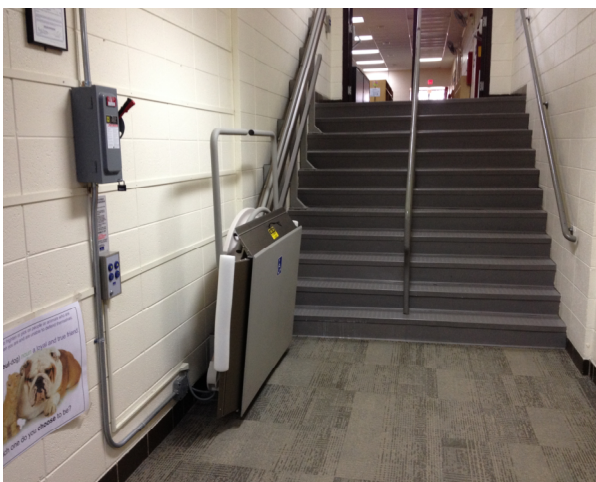
ELEVATOR

The building currently is a 'split-level' configuration with two sets of stairs. A lift has been provided to provide accessibility between the main and lower levels. It is recommended that a full elevator be considered to allow accessibility between all three levels of the building. The inclusion of an elevator would require a significant remodeling at the interior of the building, and would result in the loss of functional space within the building. As such an elevator is recommended only in conjunction with a larger renovation project that would allow additional elements to be modified in order to accommodate the elevator.
