**Project Observation Report**

Project Name:	Tri Tech East Building C 1.5	Project No.	2208
Report #:	29		
Observation Date:	4-27-23	Last Report:	4-12-23
Prepared By:	Steve Mallory, AIA	Contractor:	Banlin

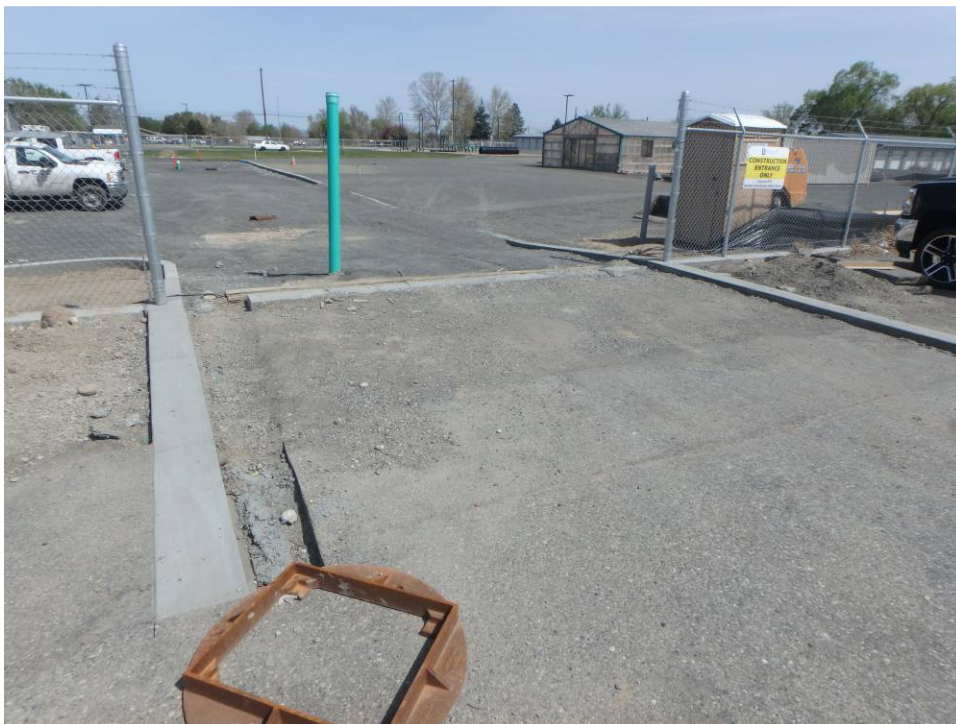
West curb at site entry

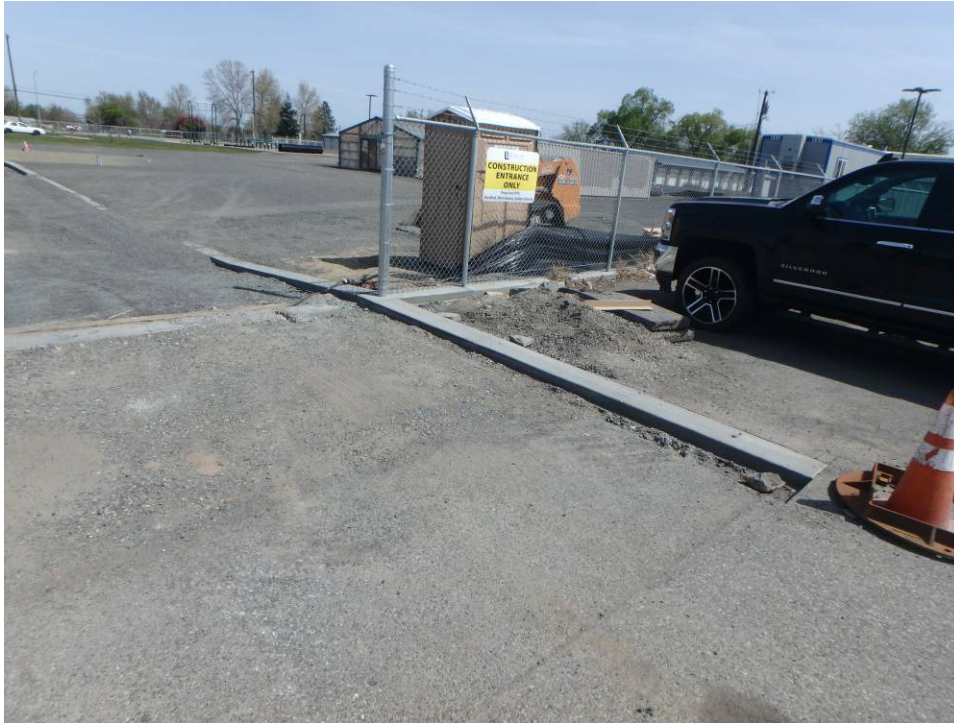
East curb at the site entry

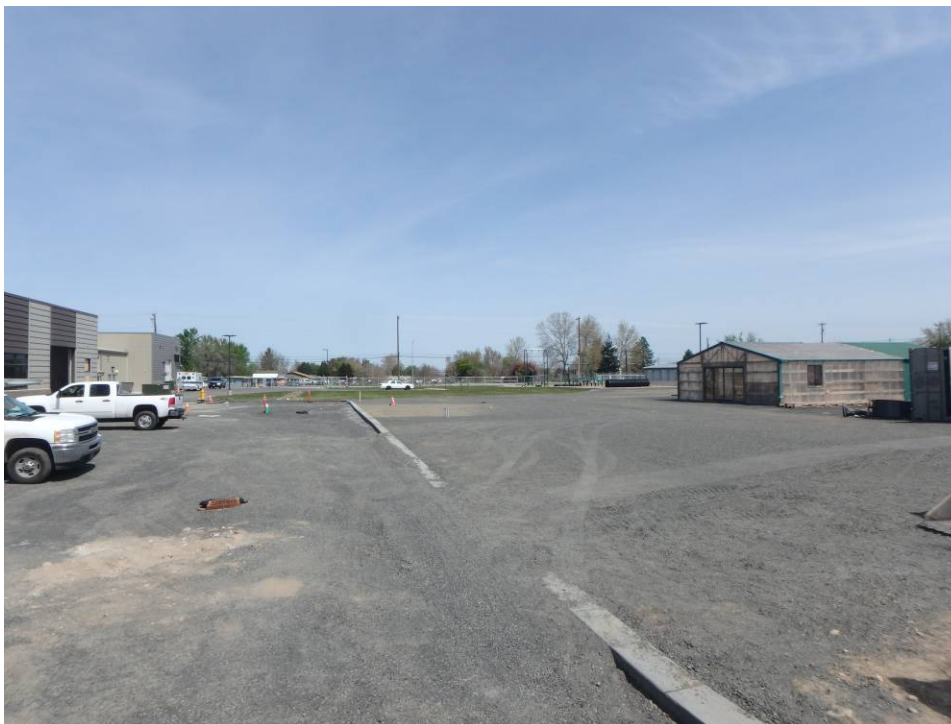
Looking north at the central curb and grading

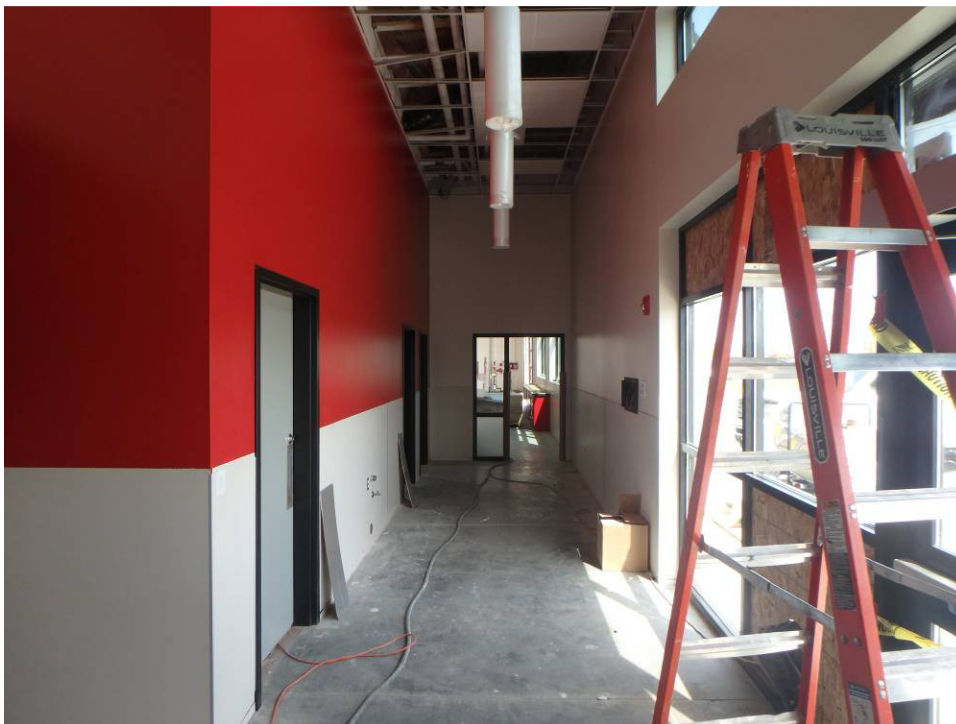
East corridor looking north at new pendant lighting and ceiling

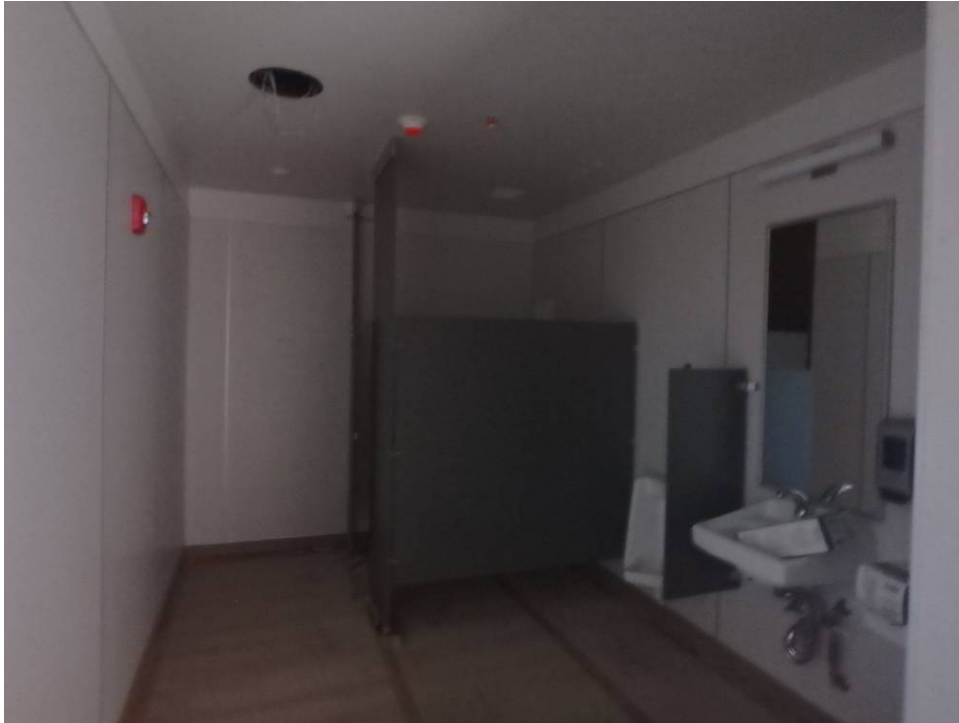
Restroom partitions and plumbing fixtures

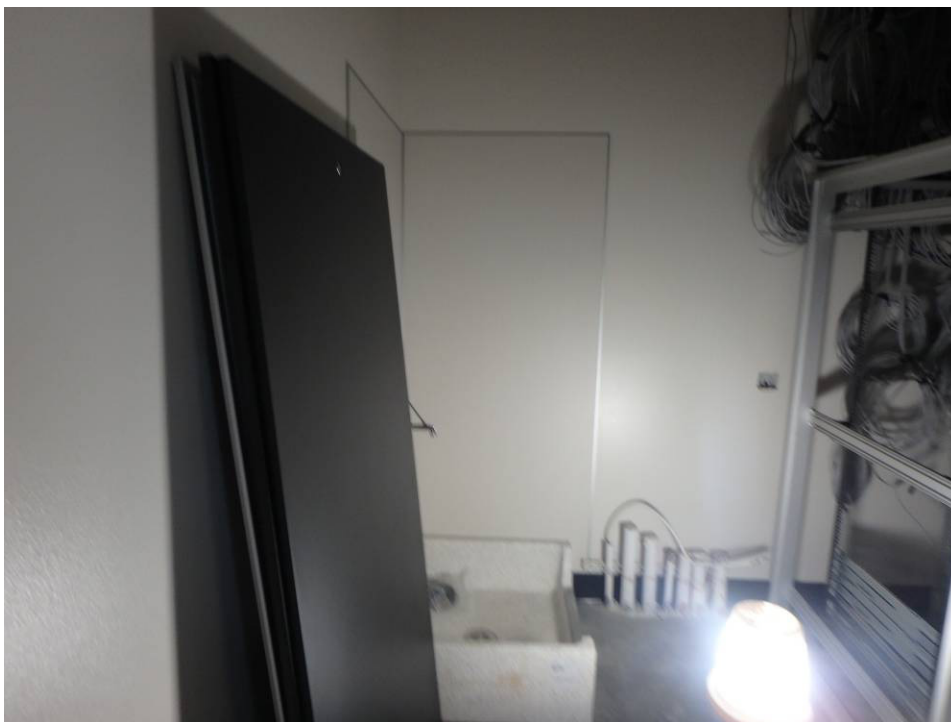
Janitor's sink in the mechanical room and FRP walls

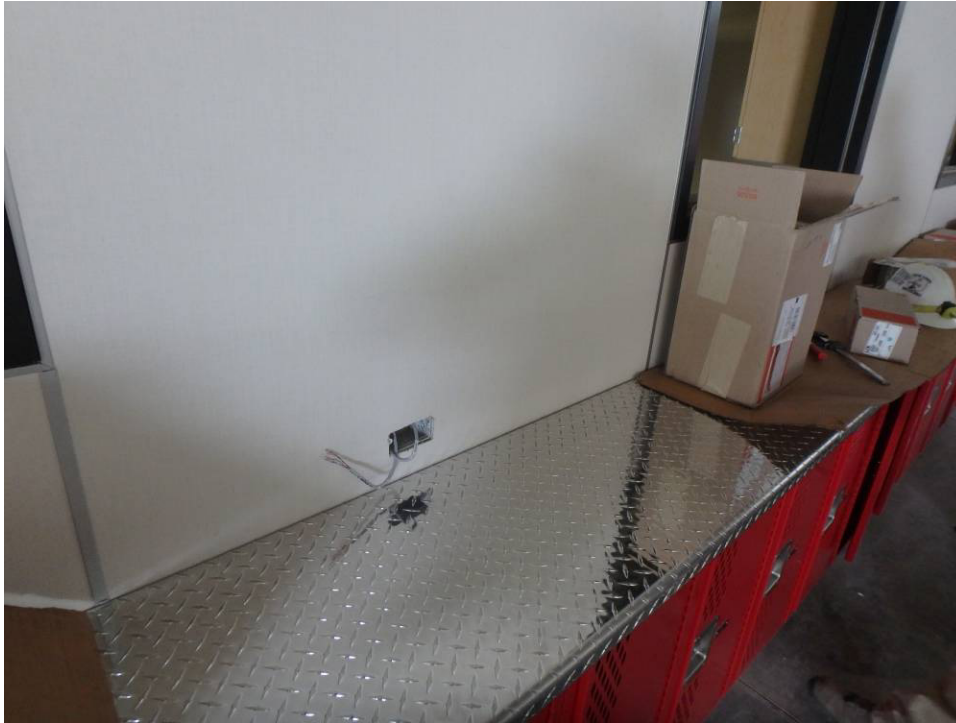
South lockers with placed diamond plate top (covered with cardboard above)

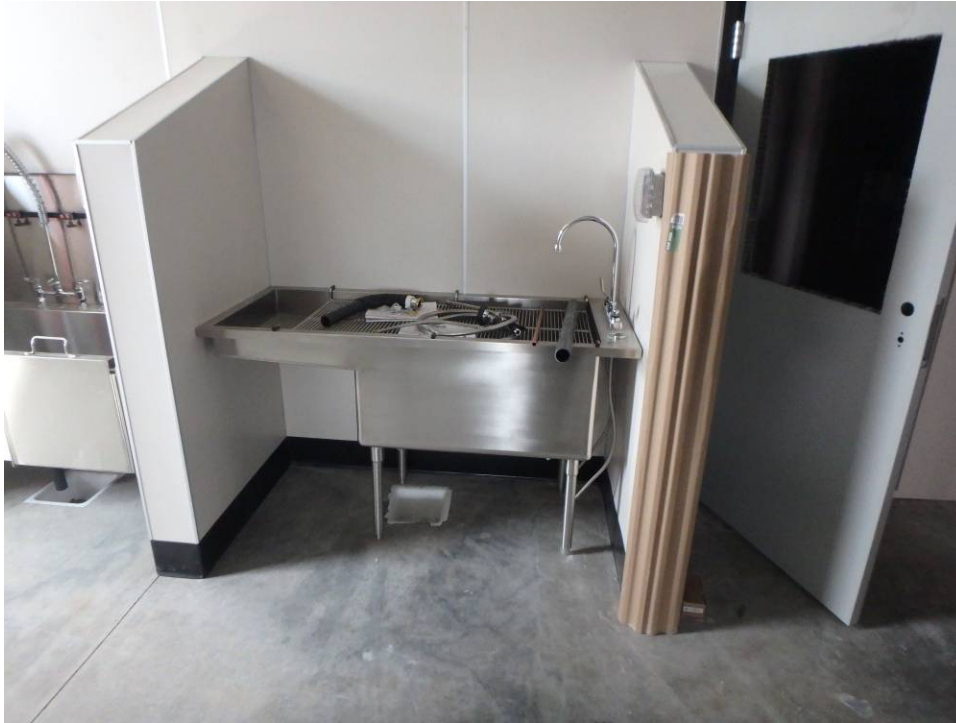
North dogwash station – reversed
