# **Asbestos Survey and Limited Lead Paint Inspection**

Five Structures

Grandview Lumber Property

**Project No.: 64583.003 Phase No.: 0001**

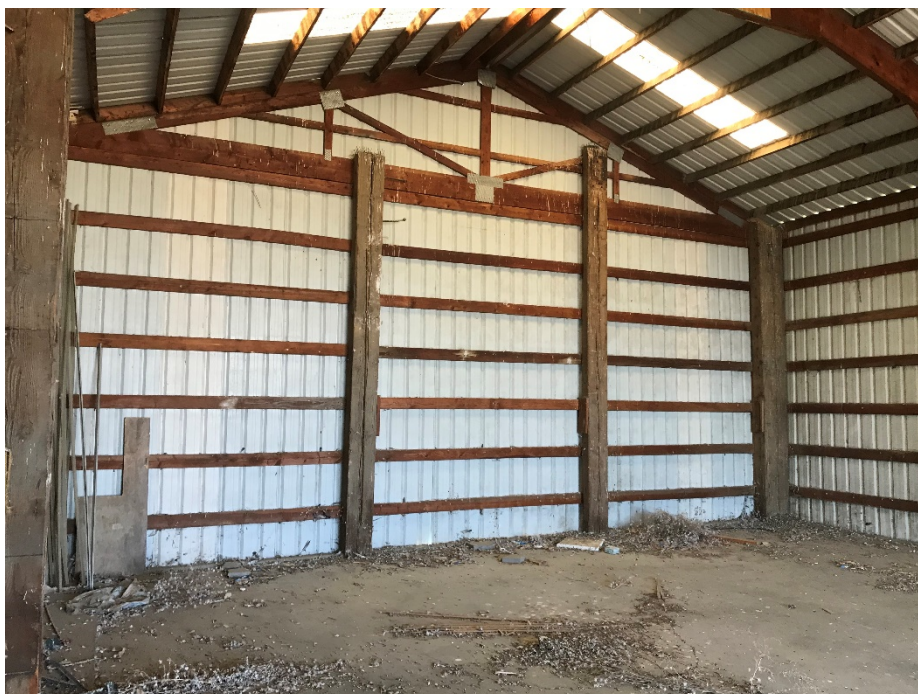
Photo 2. Building #1, view of interior west side of building.

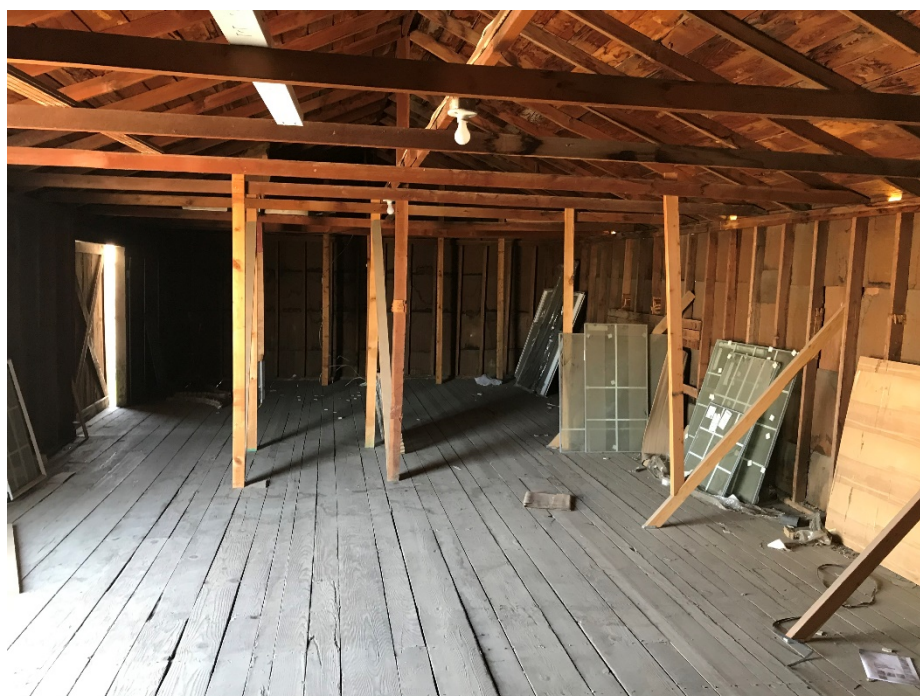
Photo 6. Building #3, view of west interior of building.

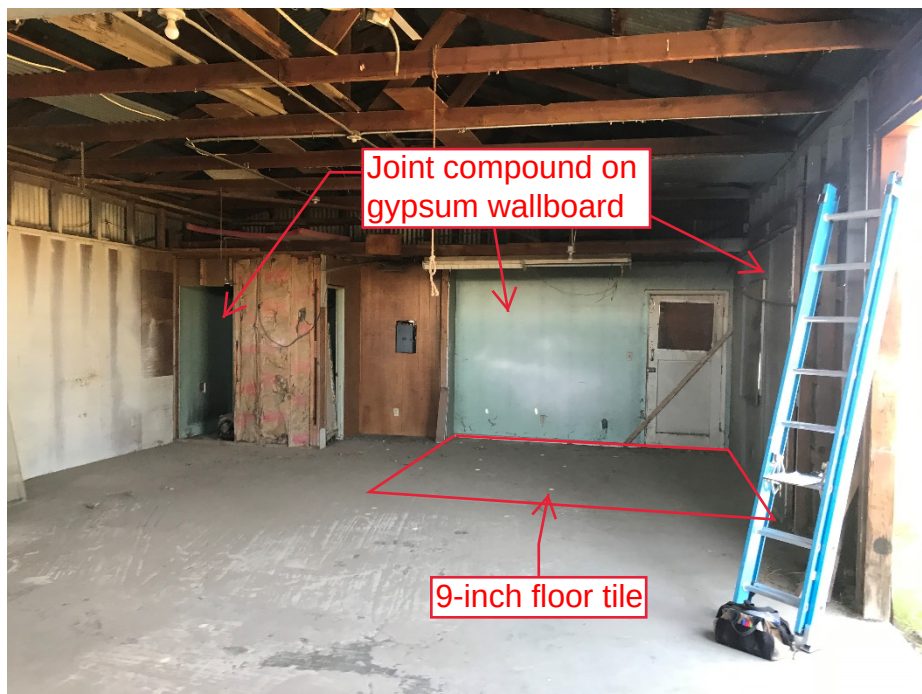
| <b><u>Result</u></b> | <b><u>Material (type)</u></b> | <b><u>Location</u></b> | <b><u>Approx. Quantity</u></b> |
|---|---|---|---|
| (+) | Gypsum Wallboard/Joint Compound | Building #5, north side of building, interior walls | 400 SF |
| (+) | Vinyl Floor Tile/Mastic - 9-inch beige | Building #5, NE area of building, floor | 160 SF |

- Joint compound on gypsum wallboard assemblies – 2% asbestos was identified in the joint compound layers on the remaining gypsum wallboard walls on the north side of Building #5. This material is damaged along edges where sections of the walls were previously removed. The joint compound would be considered friable during demolition and renovation work. Additional analysis may be performed which could result in the total asbestos concentration of the wallboard system in being less than one percent (<1%) asbestos. See the regulatory conversation below for additional information.
- Asbestos-containing vinyl floor tile was observed in the northeast area of the building. The black mastic under the floor tile contains <1% asbestos. The tile is significantly damaged along the edges of the section of flooring. It is possible that dust from the floor tile has been spread throughout the building.

Photo 12. Building #5, view of north interior showing gypsum wallboard with asbestos-containing joint compound and area of asbestos-containing 9-inch vinyl floor tile.

WAC 296-62-077 requires proper removal and handling of ACM by licensed and trained asbestos abatement contractors prior to building renovation or demolition.
