— GRIFFITH PUBLIC SCHOOLS

District Facility Assessment
June 11, 2020

Beiriger Elementary School

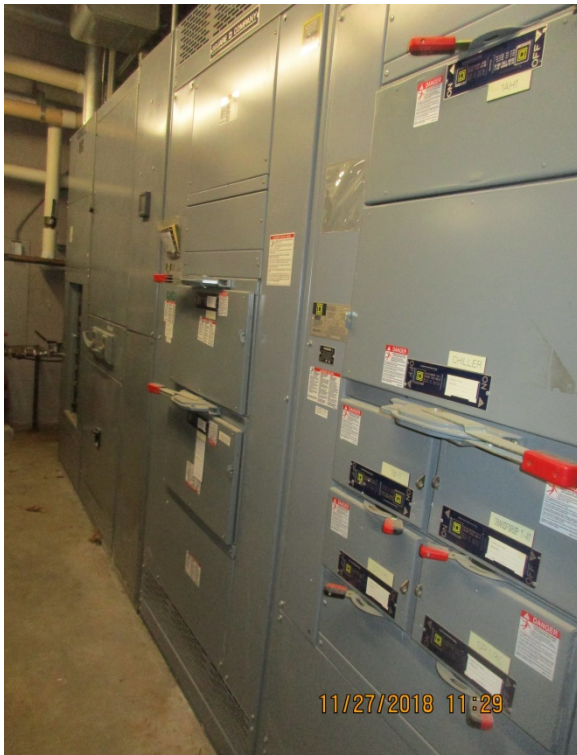
SOME OF THE SWITCHGEAR IS OLDER AND CAUSING OPERATIONAL ISSUES.

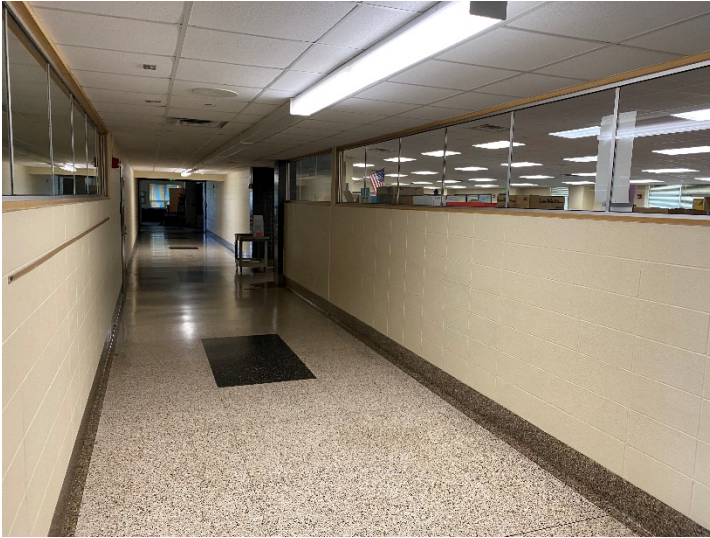
- ✓ Existing Terrazzo flooring in good condition.
- ✓ Existing ceiling appears to be in good condition.

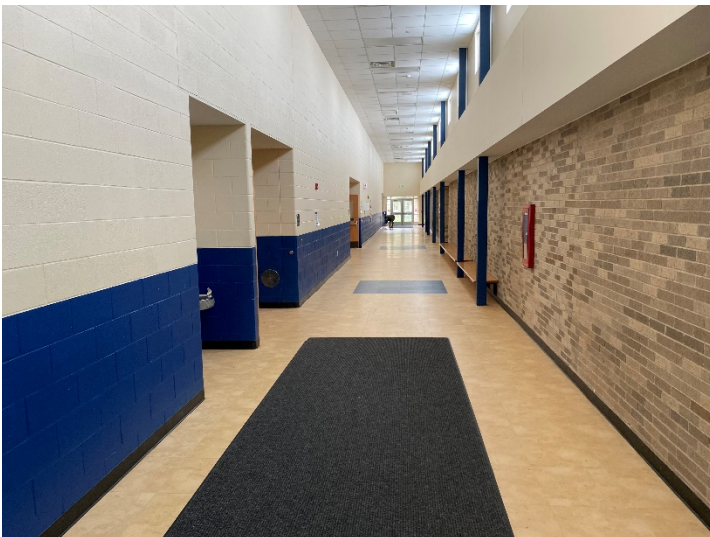
- ✓ Existing vinyl flooring in average to poor condition throughout the building.
- ✓ The aesthetics do not work well with the current building and may consider replacement

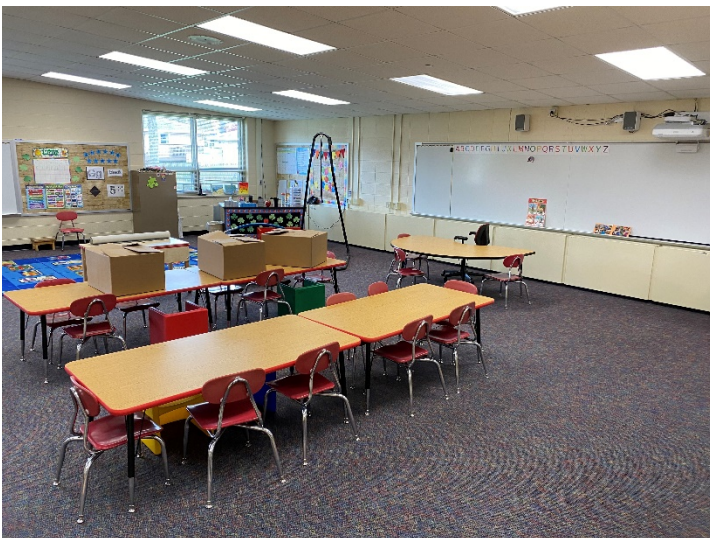
- ✓ Carpet in in average condition. While showing some wear, it does not appear to be damaged.
- ✓ Carpet is broad loom and not carpet tiles.

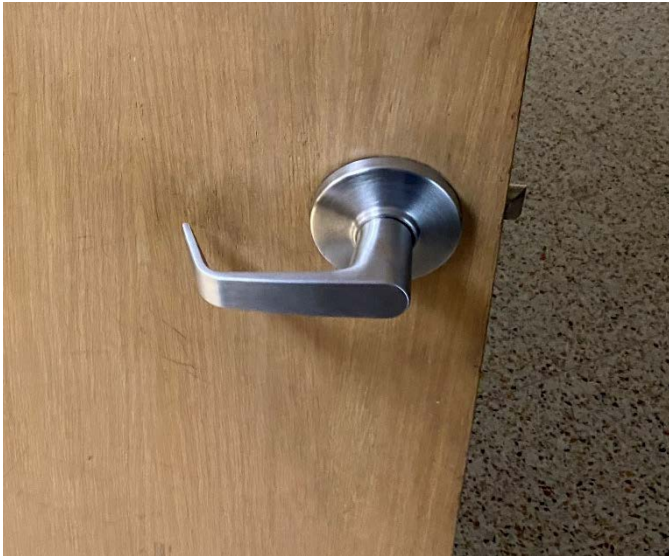
- ✓ Interior door hardware is not classroom secure. The staff member would be required to leave the room to lock the door in the event of an emergency.

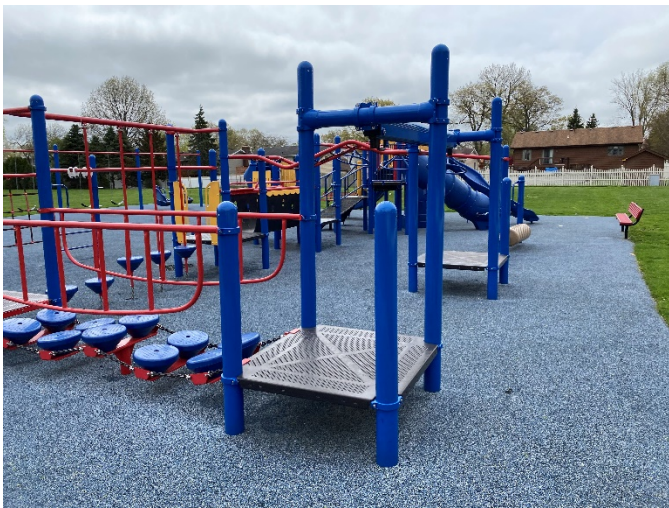
- ✓ The playground surface is worn in many locations and should be patched.

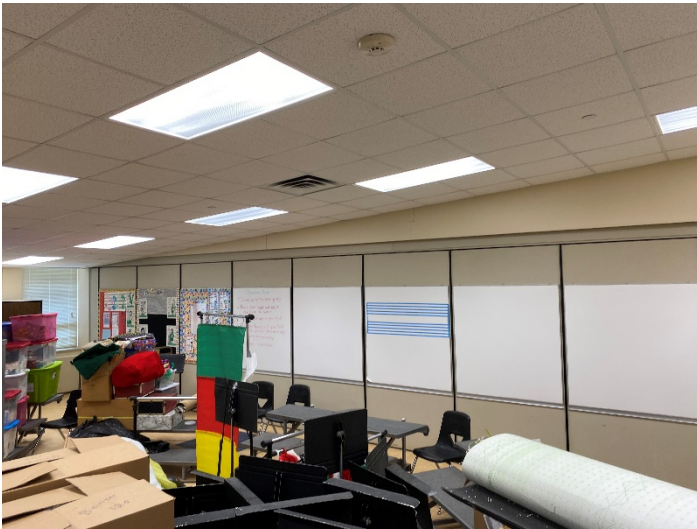
- ✓ Operable partition between art and music should be removed and installed with a permanent wall to improve the acoustical separation between the rooms.

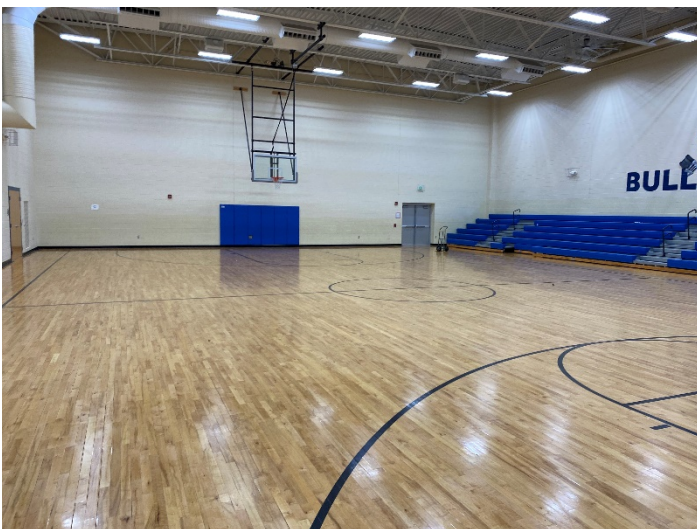
- ✓ Existing gym floor and equipment appears to be in good condition. There are no acoustical treatment in the gym which should be considered.

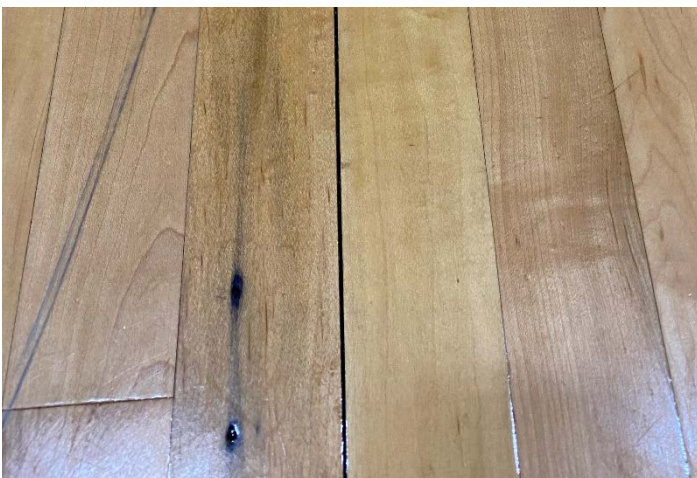
- ✓ Existing gym floor shows some separation. This is not critical to replace. This is typically caused by the wood drying and shrinking. However, additional coating of finish is recommended.

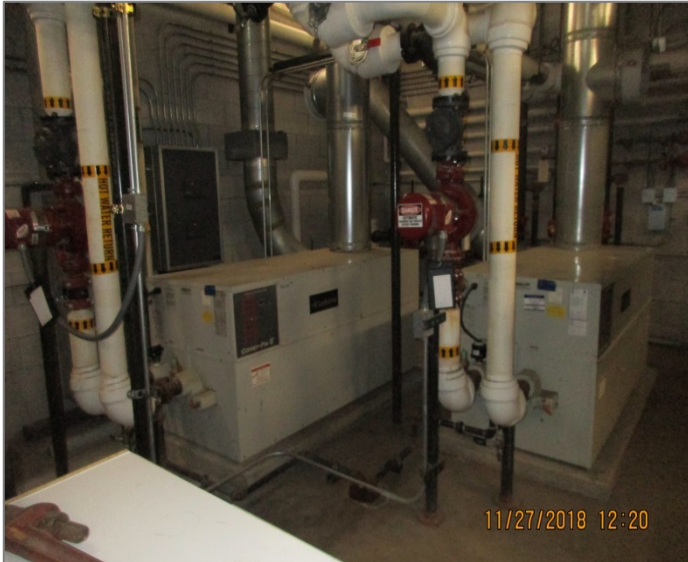
BOILER PLANT

- ✓ Two (2) atmospheric Lochinvar boilers are original to the 2001 renovation. Boilers are rated at 1.8 MBH each.
- ✓ Boilers are only 80% efficient.
- ✓ Boilers are in fair to poor condition due to their age and hours of operation.

- ✓ Recommend replacing boilers with two high efficiency condensing boilers.

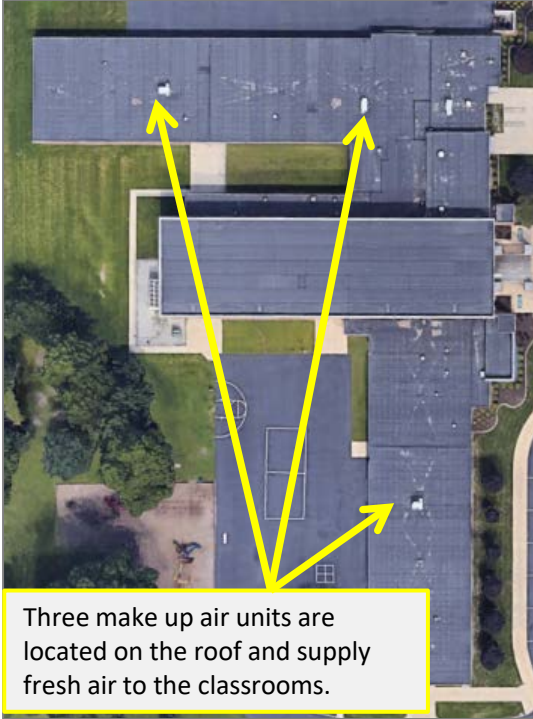
Fresh Air Units

- ✓ The fresh air in this building comes mostly from three Venmar energy recovery units are located on the roof supplying air to the building. Units installed in 2001.
- ✓ Fresh air is ducted to the fan coil units installed in the ceilings.
- ✓ Then, air is ducted to each classroom from the fan coil unit to diffusers in the ceiling.

- ✓ Recommend replacing the fresh air units at the end of their life with a system that is designed to better control humidity and temperatures including either a VAV system or vertical classroom units.

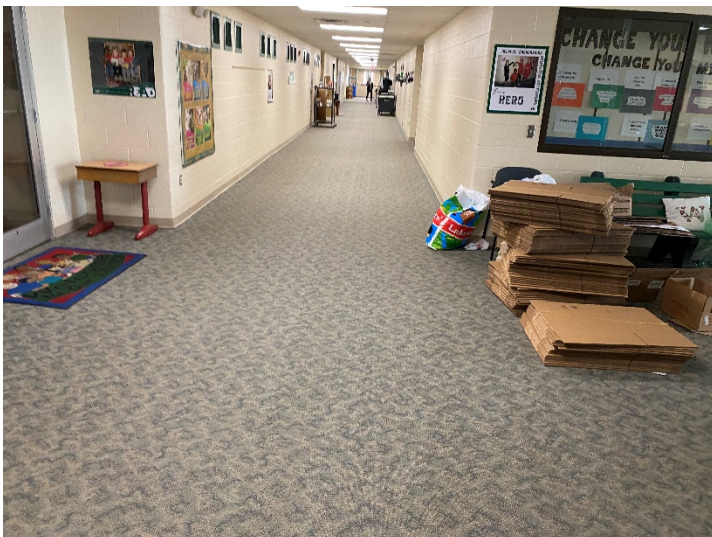
- ✓ Corridors are broad loom carpet and are worn and should be replaced.

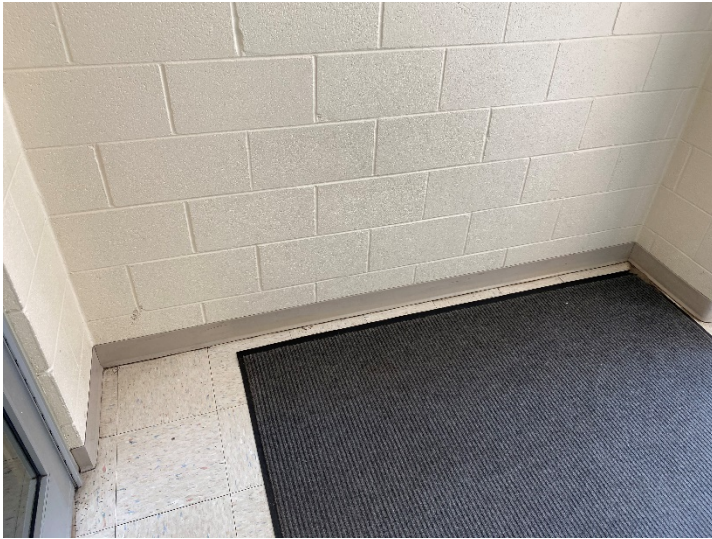
- ✓ VCT in vestibules in poor condition and should be replaced.

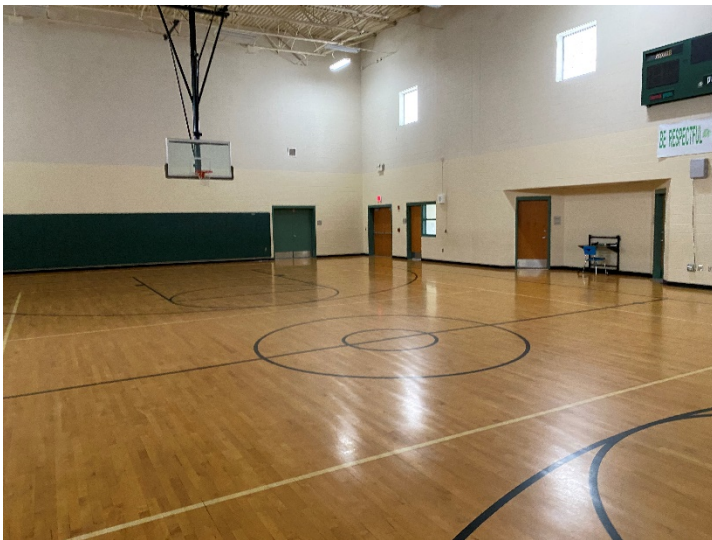
- ✓ Existing gym appears to be in good condition. There are no acoustical wall panels resulting in a loud and reverberant room.

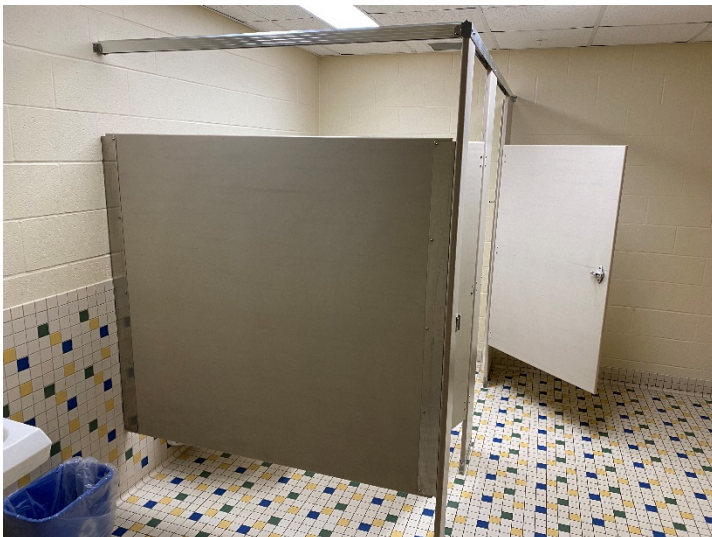
- ✓ Gym restroom in good condition. There is poor site line protection to the room (most of the restroom is visible from the gym). Due to current layouts, there is not a cost-effective solution to remedy the situation.

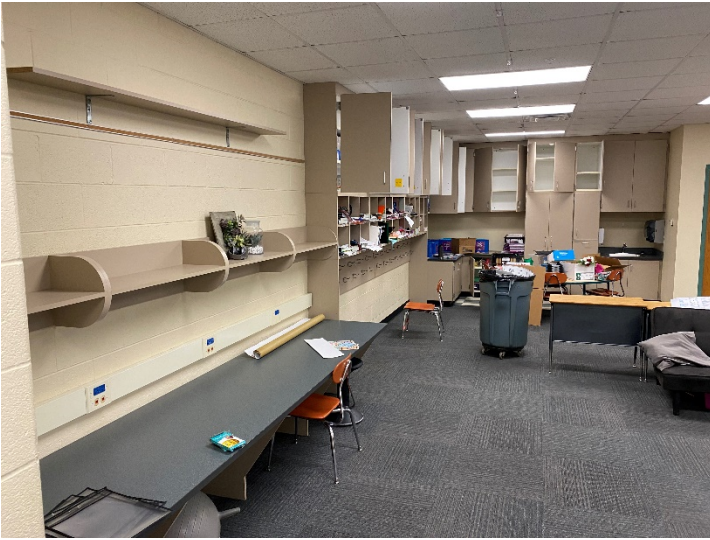
- ✓ Existing classroom casework is in good condition. The student coat storage is a series of wall hooks. As these hooks are not separated between student, this can allow the spread of lice. It is recommended that coat cubbies be utilized to provide separation between student's belongings.

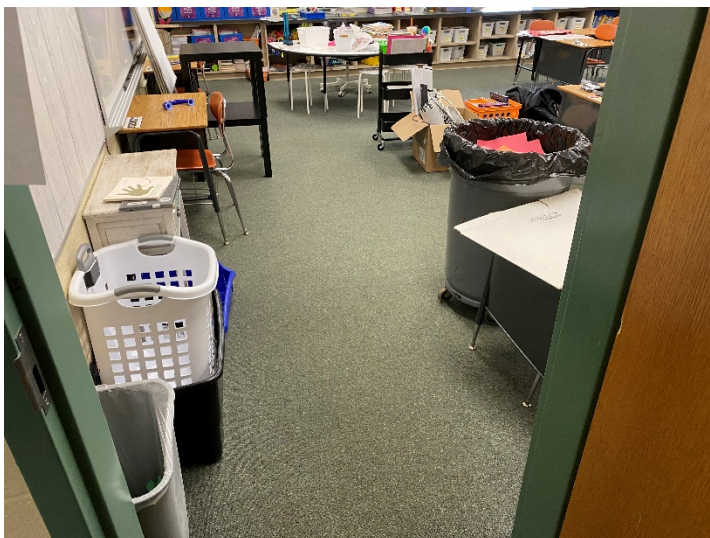
- ✓ Classroom carpet is worn and should consider replacement.

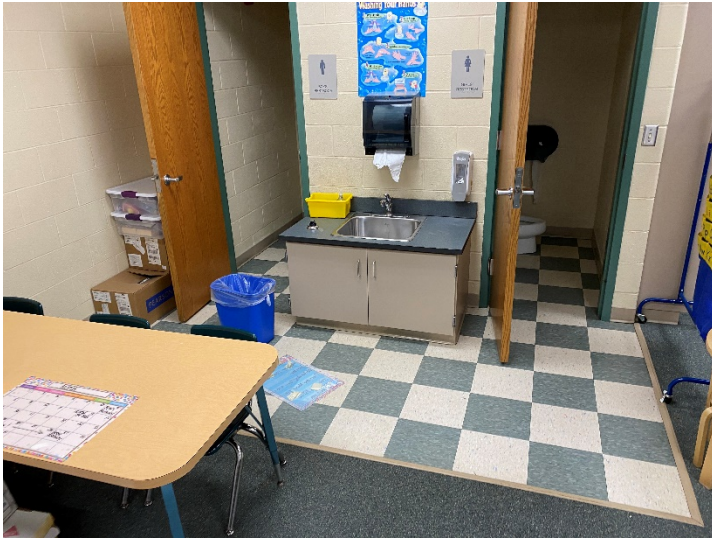
- ✓ Kindergarten restrooms do not appear to meet ADA requirements and are undersized for accessibility.

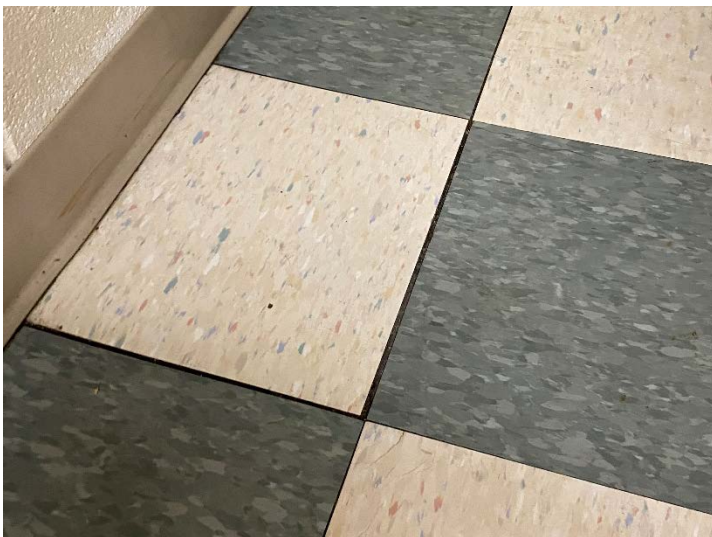
- ✓ The kindergarten restroom floors are VCT and is failing. As this will commonly be subject to water, it is recommended these be replaced with a resinous floor.

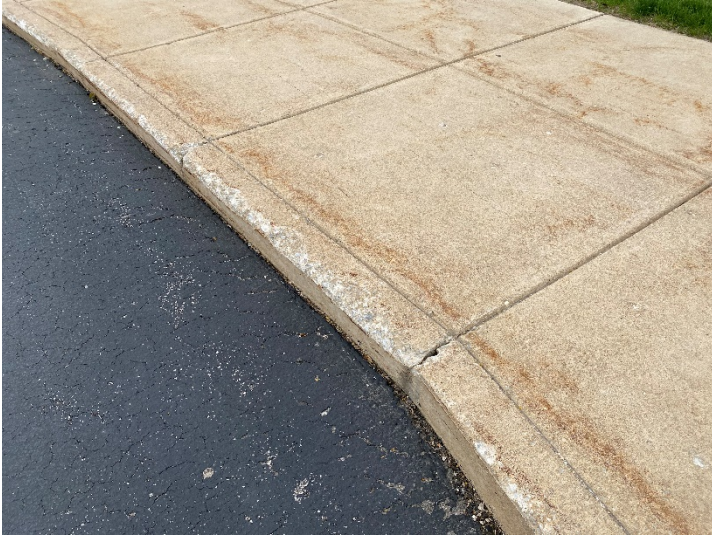
- ✓ The existing asphalt and curbs are in average conditions. There are some damaged curbs due to vehicle traffic and cracks should be infilled.

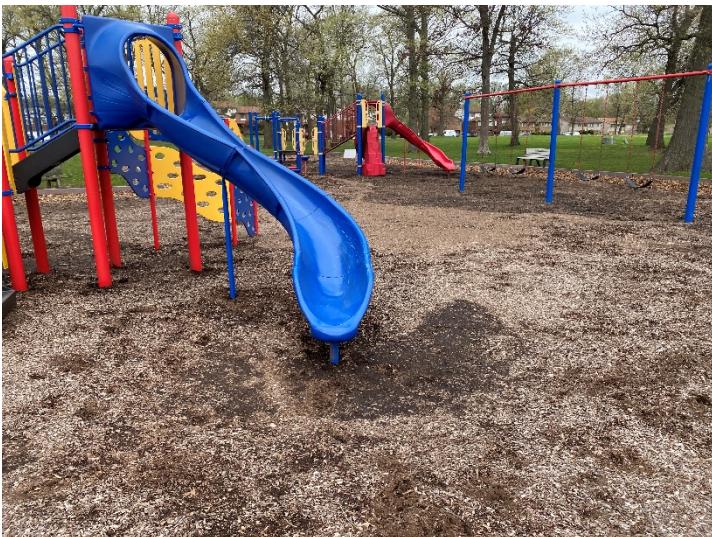
- ✓ The playground equipment appears to be in good condition. Additional mulch is recommended to infill low areas.

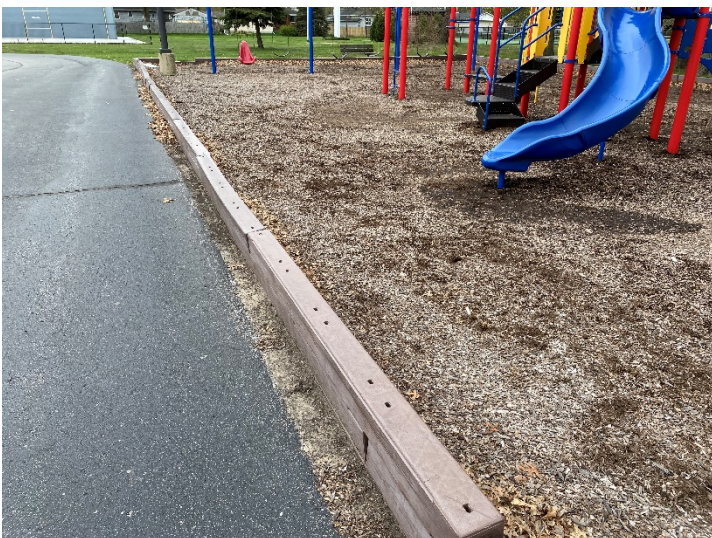
- ✓ The playground border should be re-secured.
- ✓ If the school uses the playground during car drop off/pick up, a fence should be considered to protect the playground from car traffic.

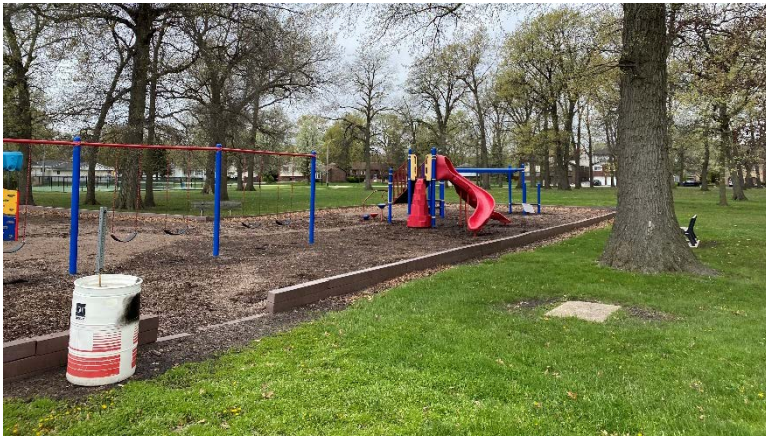
- ✓ A sidewalk is recommended between the hard surface play area to the entrance to the playground equipment for ADA access and reduce dirt / mud spreading.

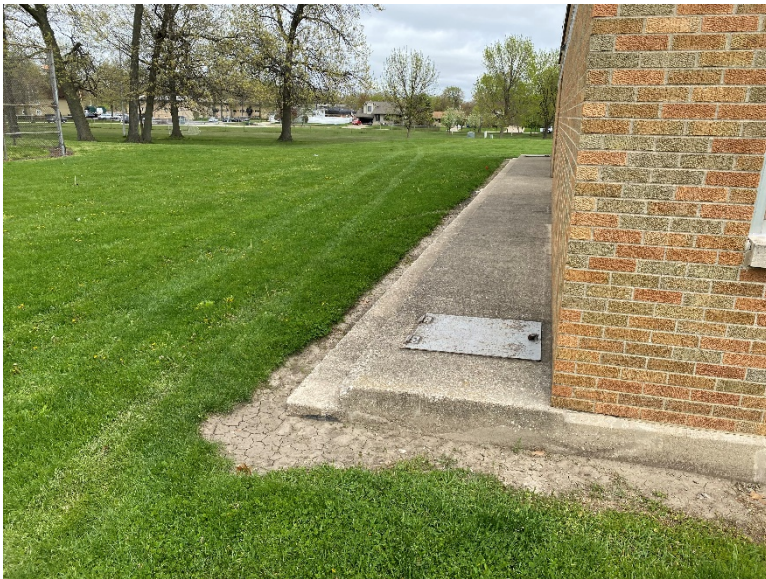
- ✓ The exist on the northwest wing does not have a sidewalk outside of the door bringing in dirt / mud when the door is used.

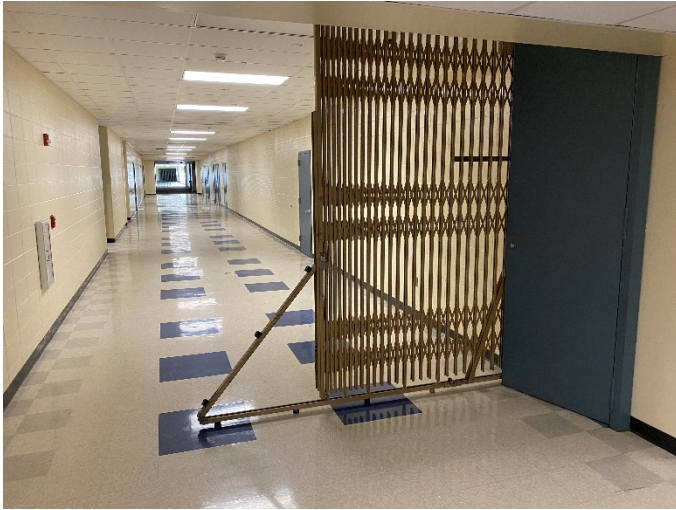
- ✓ Existing security gates create dead-end corridors creating life safety issues. Reference security door diagram for secured sections of the building. Additional security gates can be provided to secure sections of building. However, these doors must be located as to not create dead-end corridors.
- ✓ Additional doors are recommended to be installed at one staircase to secure the 2nd floor.

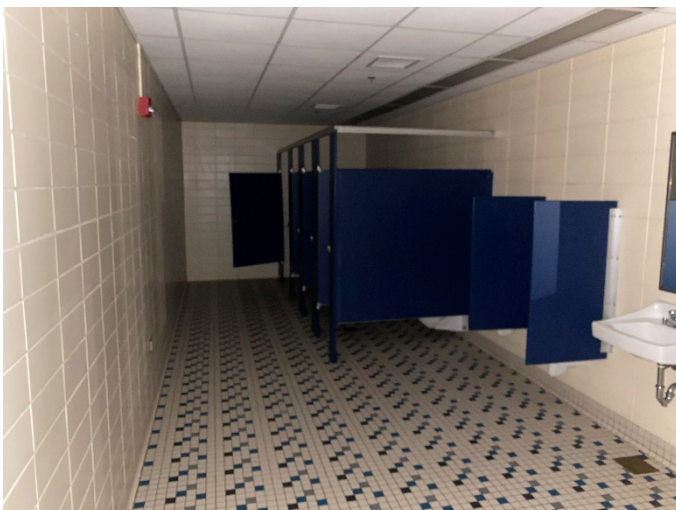
- ✓ Restrooms are in good condition. The appearance is dated. Restrooms can be upgraded with new paint and/or floor replacement. However, the finishes are in good condition for the age.

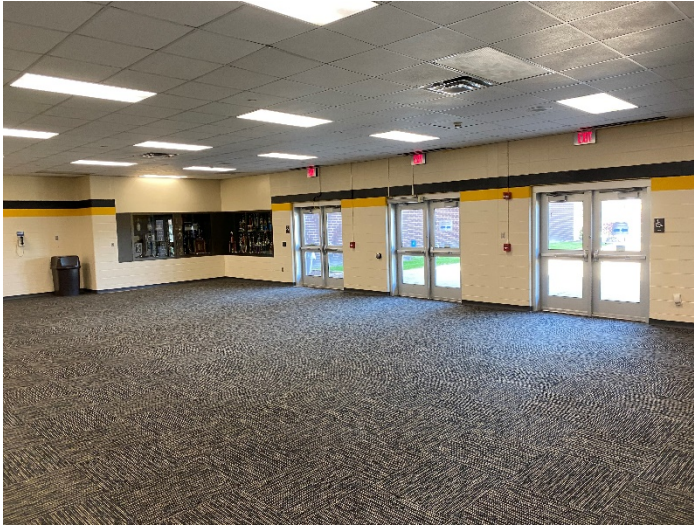
- ✓ The north entrance lobby does not have a vestibule to protect from the weather / cold, especially during evening events and activities.

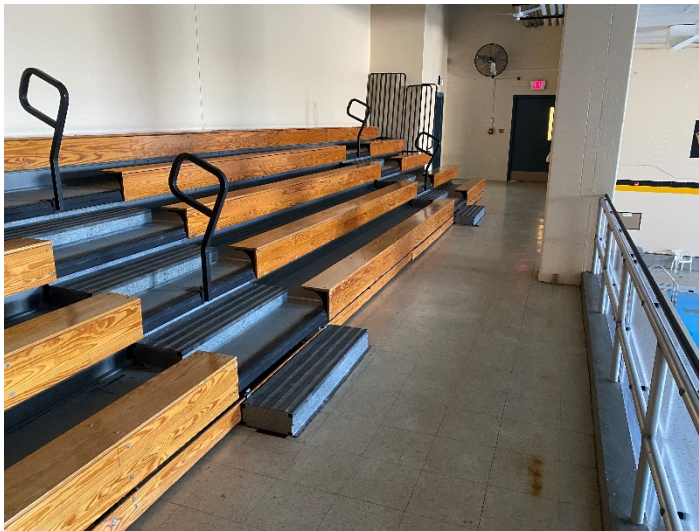
- ✓ Pool spectator seating area is not accessible. Accessible seating should be planned on the main pool deck.
- ✓ Flooring on the mezzanine is in poor condition and should be considered to be replaced.
- ✓ The existing railing is does not meet current safety requirements.

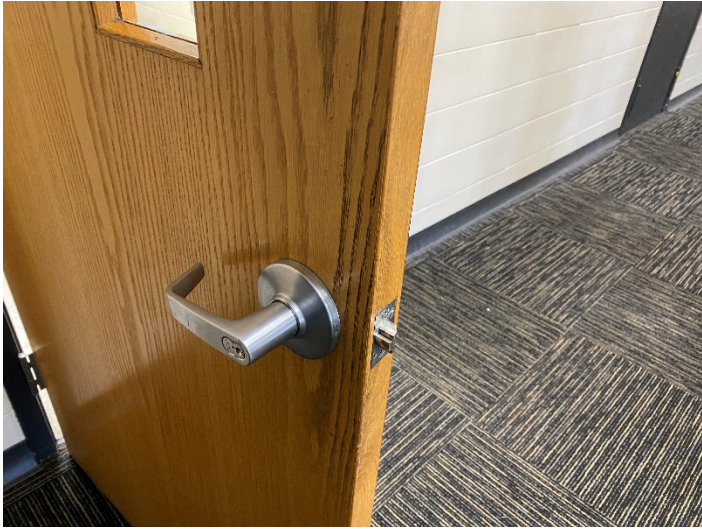
- ✓ Classroom door hardware is in good condition. However, the locks cannot be secured from the inside of the classroom in an emergency situation.

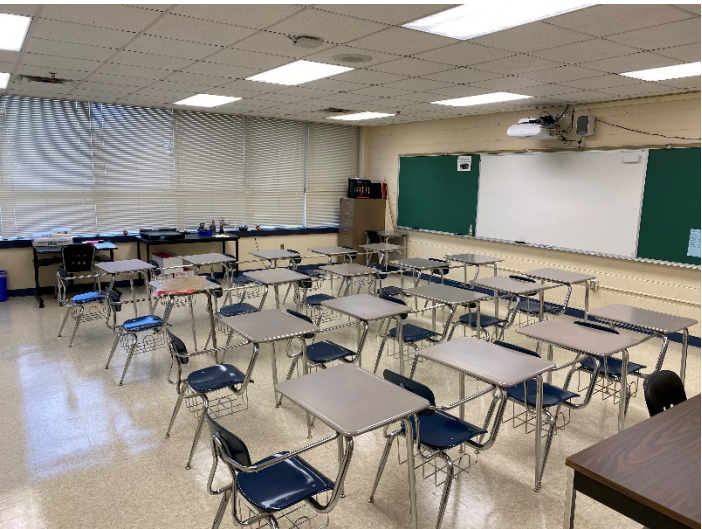
- ✓ Existing classrooms have chalk boards. These should be considered to be replaced with markerboard.

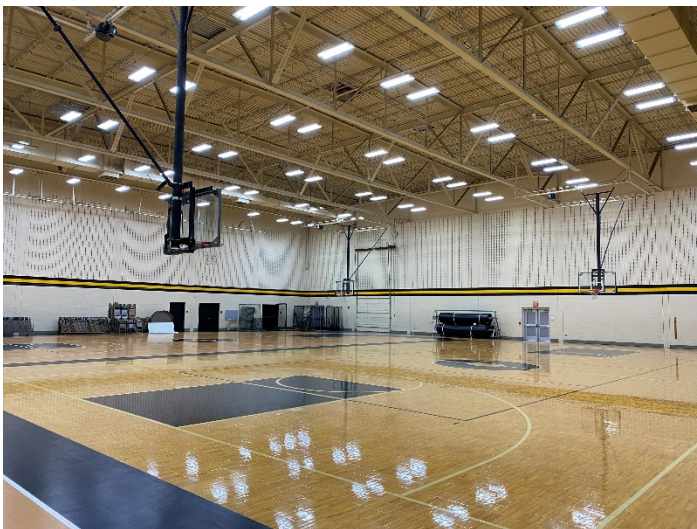
- ✓ Existing fieldhouse is in good condition. Floor markings on the wood floor and synthetic floor appearance is in average condition. The markings on the wood floor should be repainted when refinished. The synthetic flooring also shows signs of marking.

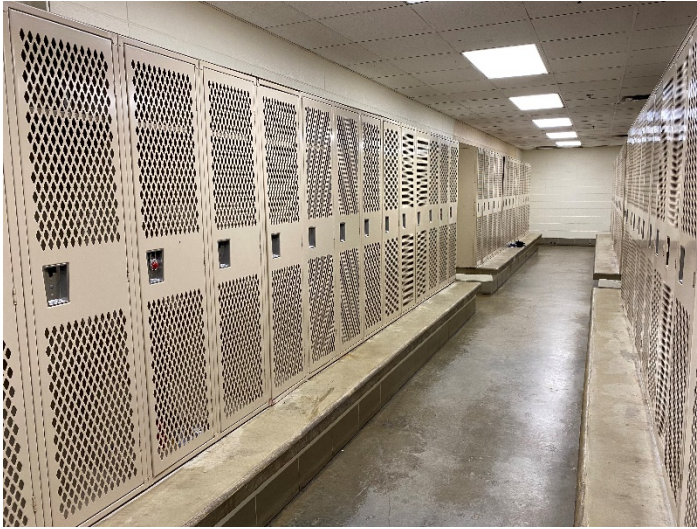
- ✓ Existing lockers are damaged in some locations. The lockers appear to be knock-down type lockers. As these are free-standing in many locations, these lockers should be fully welded type lockers for durability

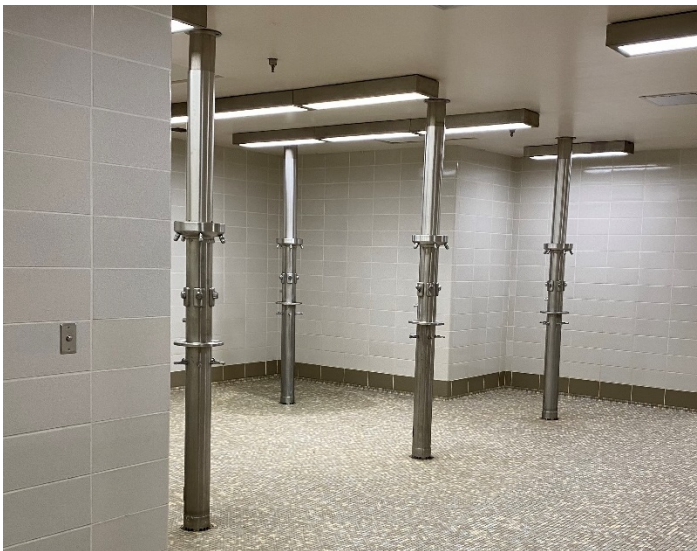
- ✓ Existing pole showers should not be used as this does not meet Indiana Board of Health Requirements and not an ideal layout. These should be reconfigured to individual showers.

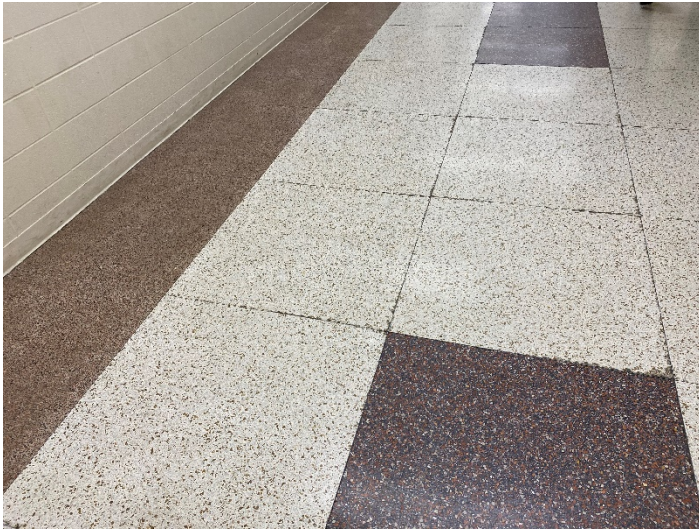
- ✓ Existing terrazzo by the field house is damaged and should be refinished and repaired.

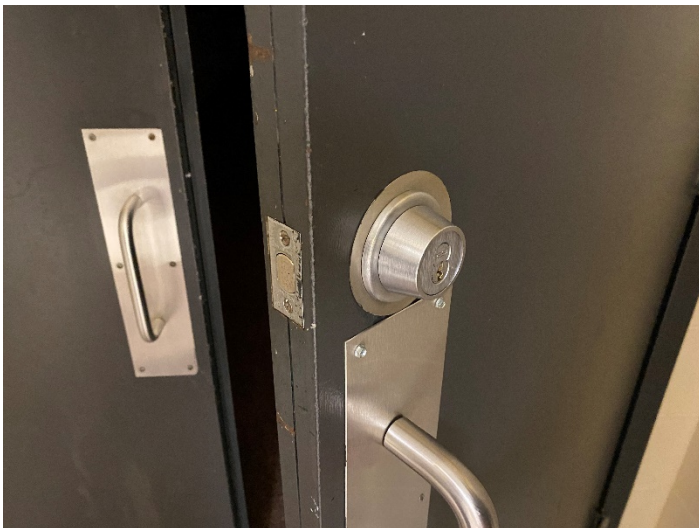
- ✓ Existing locker rooms have deadbolts which does not meet panic egress requirements. These should be replaced with standard hardware or panic hardware where required.

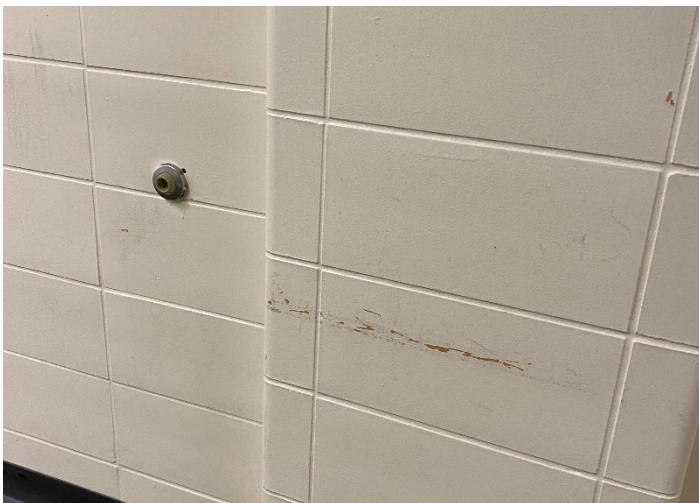
- ✓ Painting in areas are marked. A budget and plan should be developed to paint the building.

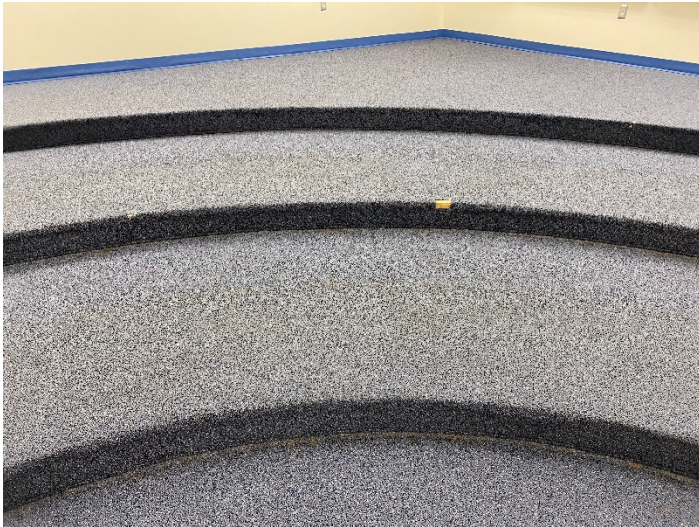
- ✓ The band and choir carpet steps have minor damage and should consider replacement. Flooring in the choir practice room has also been removed and should be replaced.

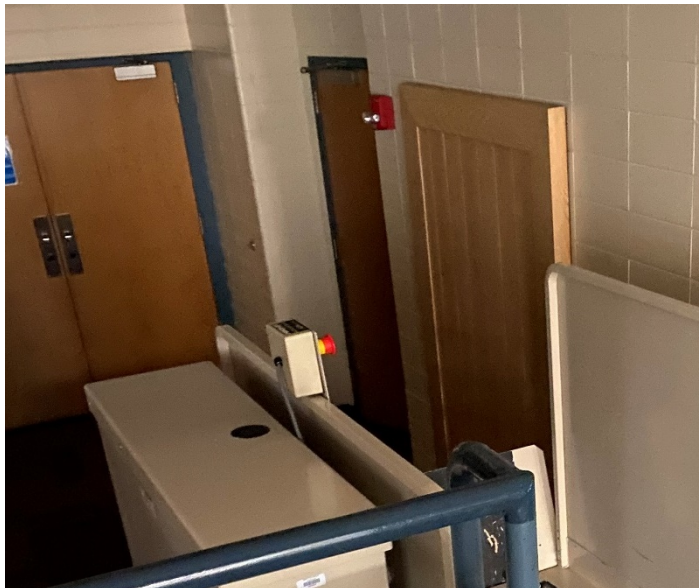
- ✓ The auditorium main entrance do not have a light-lock vestibule to protect from noise and light from the corridor / lobby.

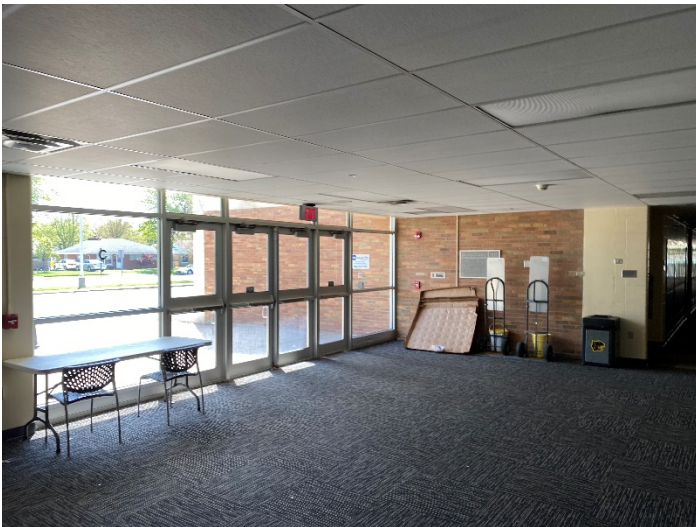
- ✓ Classroom entrance does not have a vestibule to protect from weather / wind. If this is used for regular use, a vestibule should be considered.

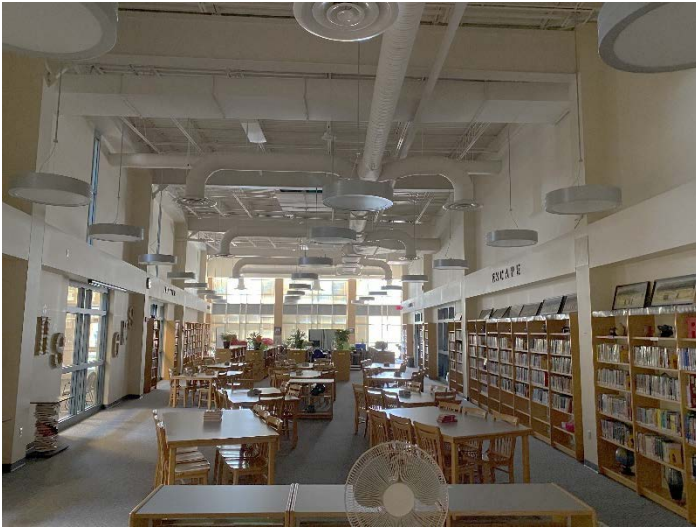
- ✓ The existing media center is in good condition. However, there is limited acoustical treatment causing high reverberation (echo) in the roof. Additional acoustical panels are recommended.

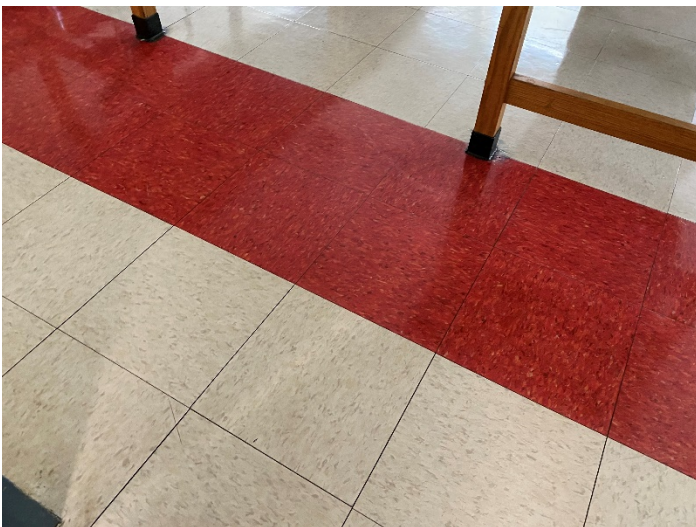
- ✓ The flooring on the upper floor is in poor condition.

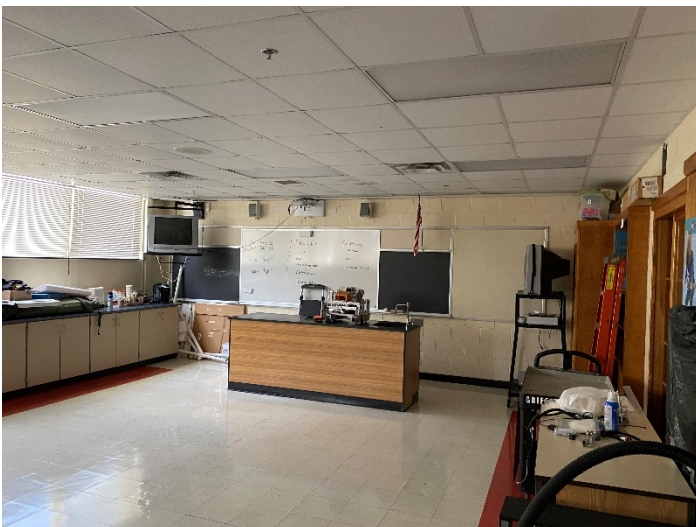
- ✓ The old science casework on the upper level should be removed and install new standard casework to match the remainder of other typical classrooms.

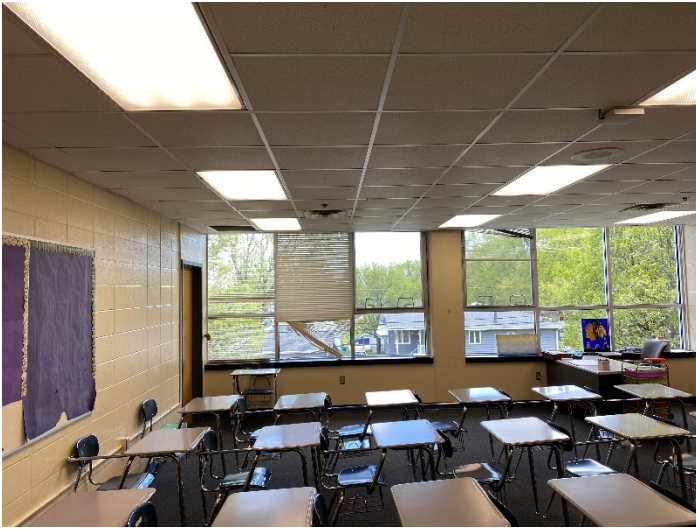
- ✓ The existing blinds are damaged in some rooms. These should be selectively replaced or replaced throughout the building with a different blinds system.

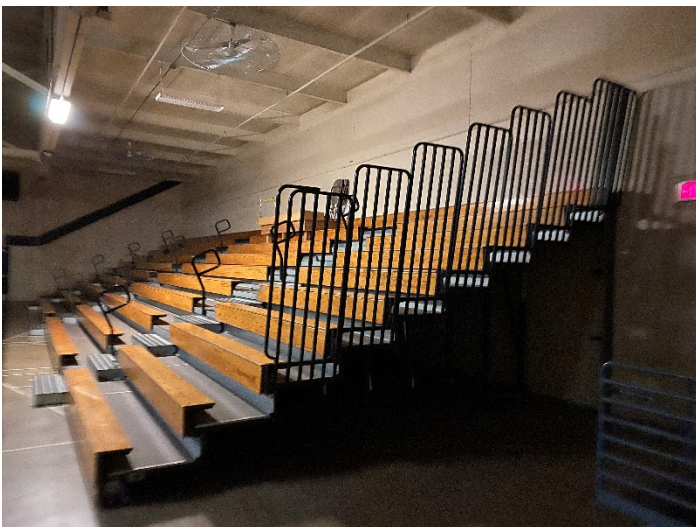
- ✓ The bleachers in the main gym appears to be in average condition but showing age, especially at the wood seats. The ends should have a vinyl cover installed to secure the under bleachers from the public.
- ✓ The upper bleacher section is not ADA accessible. Unfortunately, there is not a convenient method to provide an accessible route.

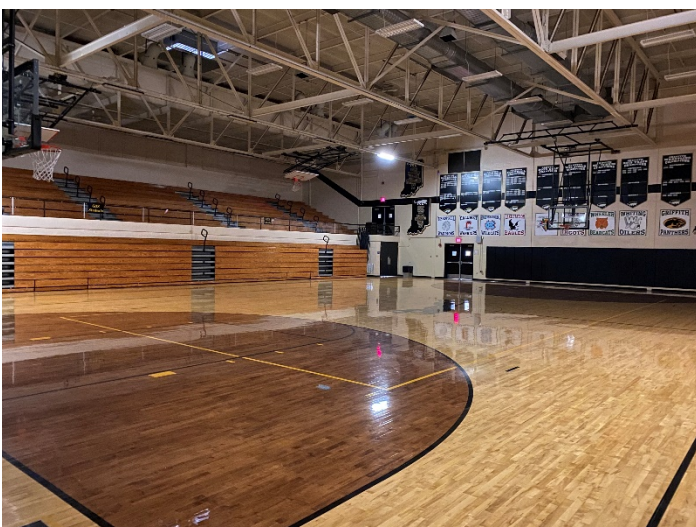
- ✓ The main gym appears to be in good condition. The bleachers are aged but appear to function.
- ✓ Railings at existing mezzanine do not meet current safety requirements.

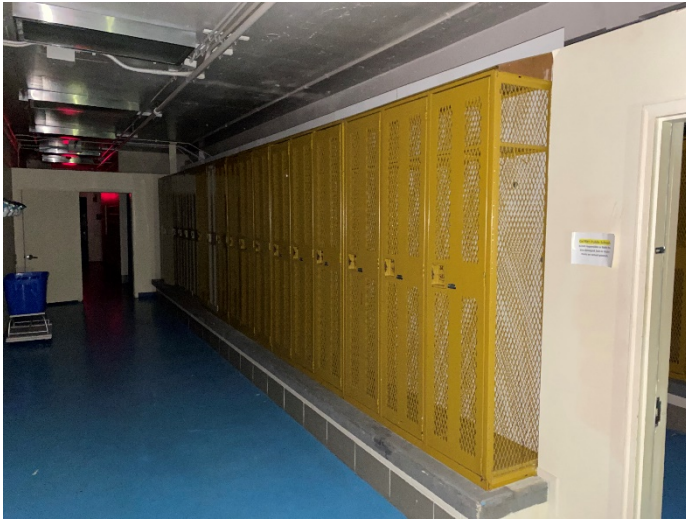
- ✓ The lockers under the existing gym is not accessible as there are stairs at each entrance. The locker rooms are sub divided into smaller locker spaces making supervision poor.

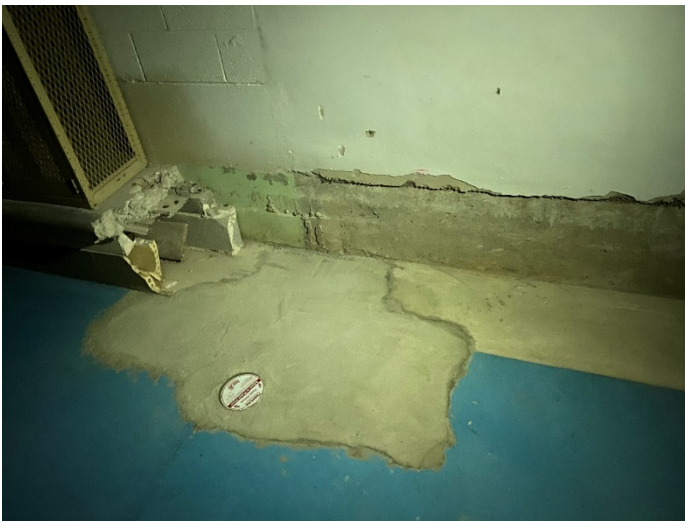
- ✓ The locker rooms have damaged sections and appearance is dated.

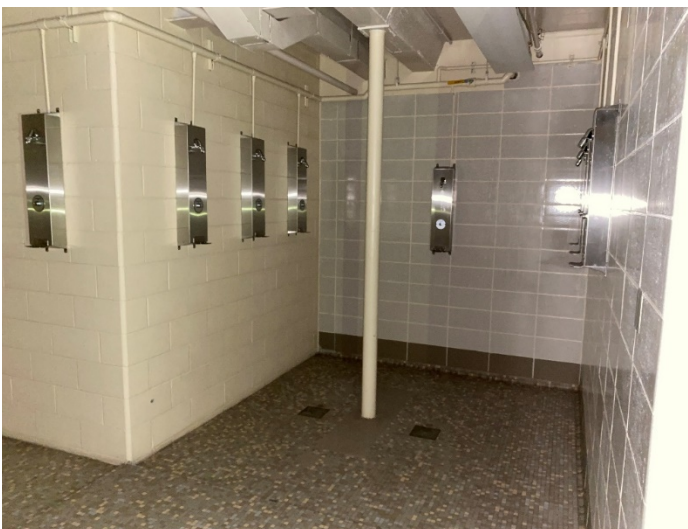
- ✓ The showers is a large open space and does not provide individual showers.
