TEXARKANA ISD

Facility Assessment Capacity Analysis Presentation

March 23, 2022

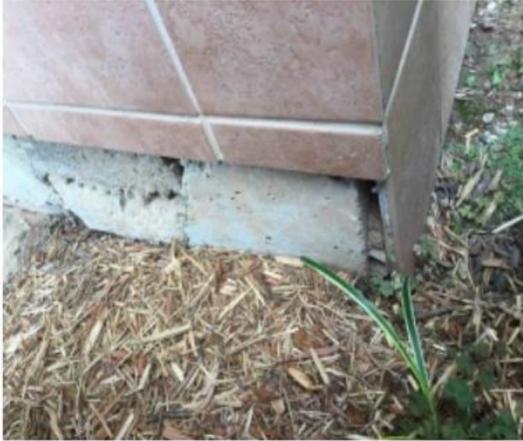
Grade beam cracking at entry. Occurs in various locations at building perimeter.

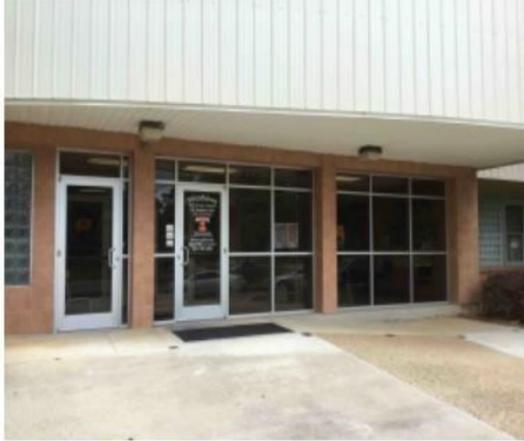
Tile cladding chipping at base. Metal soffit and fascia in fair condition. Soffit lighting is outdated. Storefront entry in good condition.

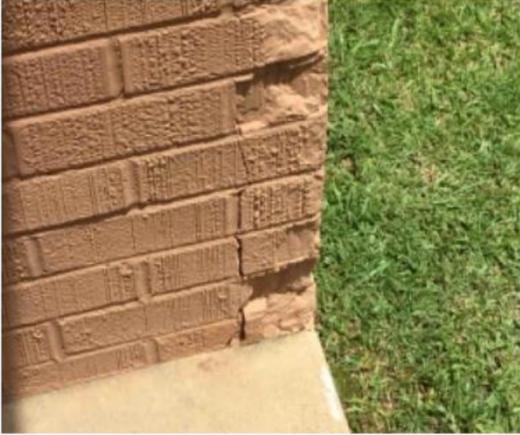
Brick cracking at various locations

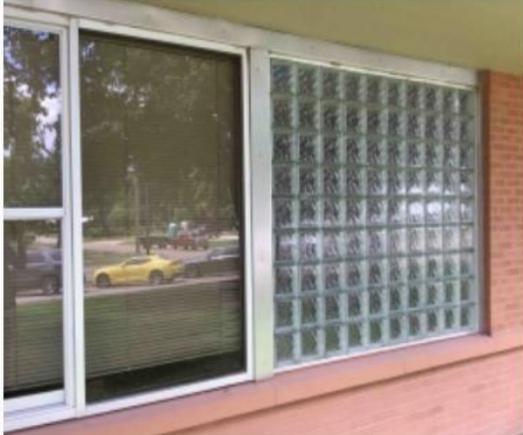
Typical window framing in poor condition

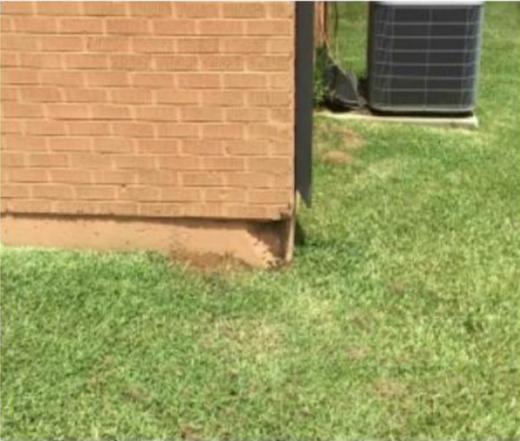
Grade beam cracking in various locations

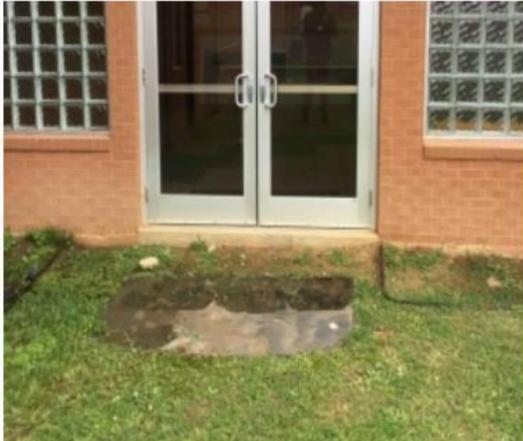
Paved landing not present at a portion of exit doors

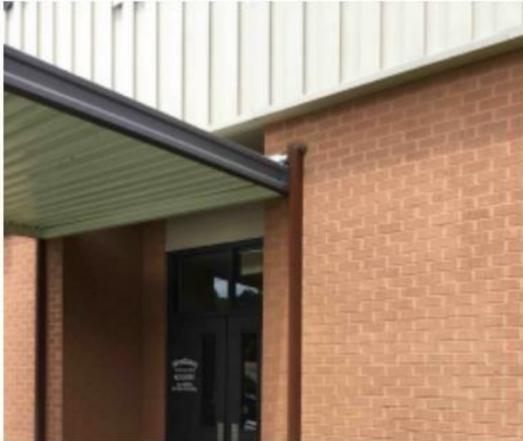
Walkway canopy superstructure is rusted

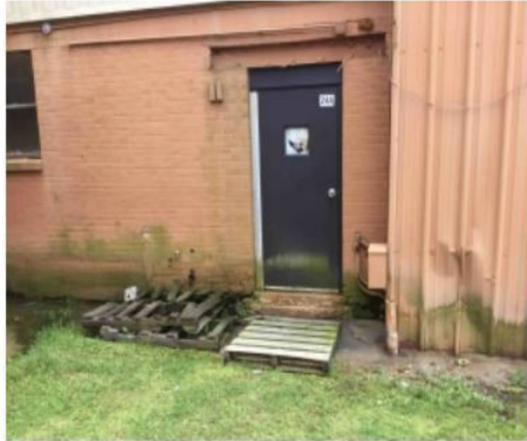
Draining is poor at between classroom wings. Metal panel bent in various locations. Door stoop missing.

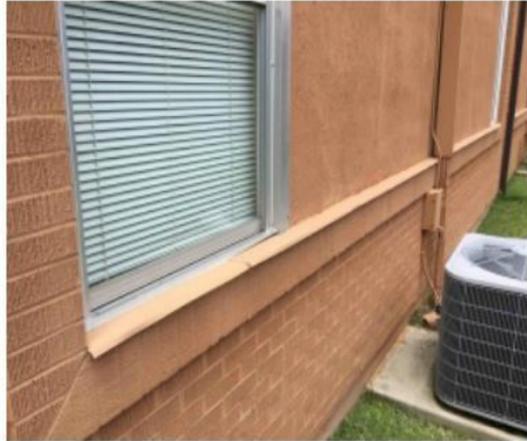
Metal window flashing along north façade is bent. Single pane windows and frames are in poor condition.

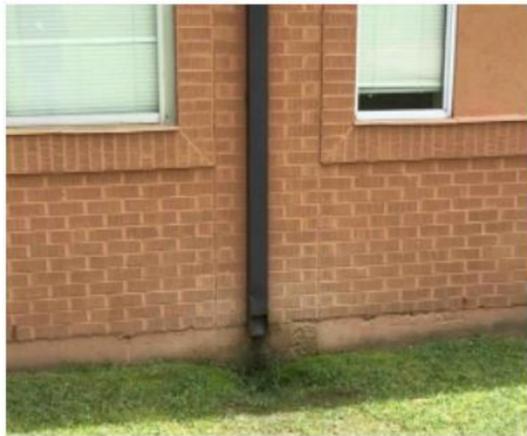
No splash blocks present at downspouts

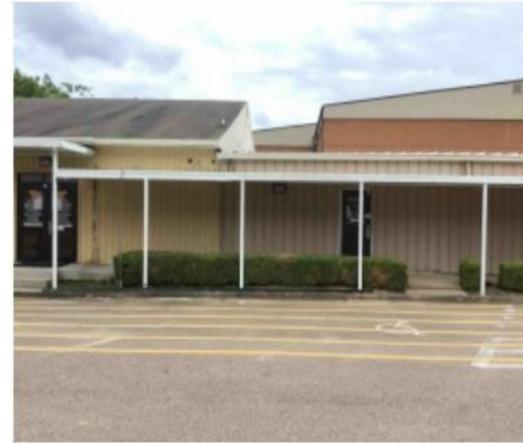
Portables in poor condition. East portable houses district-wide IT.

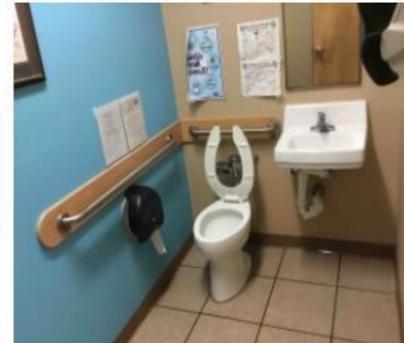
Restroom fixture clearances non-compliant, missing pipe insulation under sinks, door hardware non-compliant, door clearances non-compliant, typical throughout.

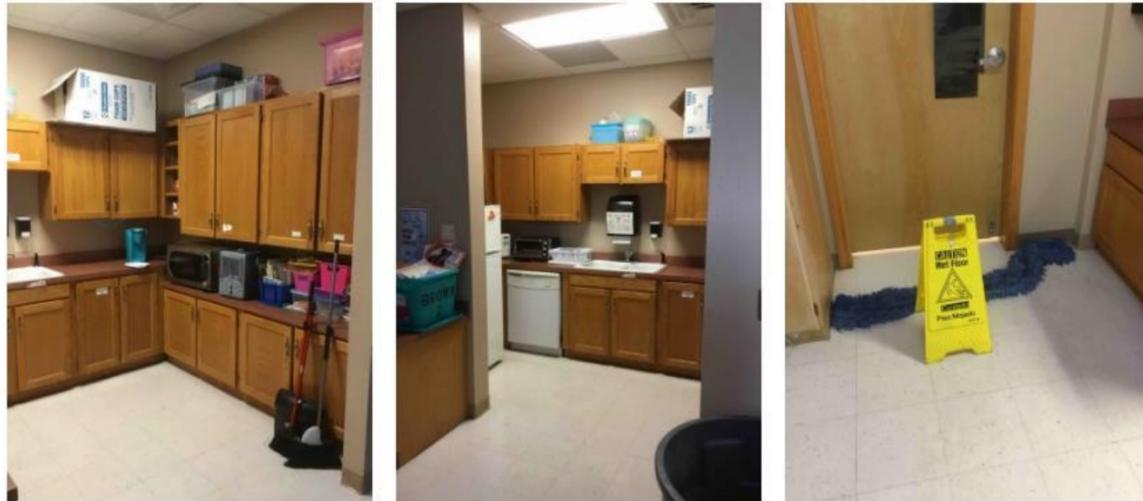
SPED Kitchen

Overall good condition, updated finishes. Staff noted significant leaks in this area. Visual evidence of leaks.

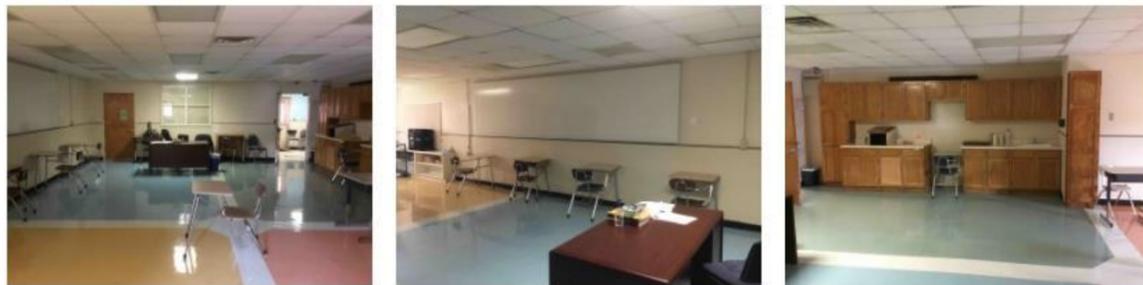
Typical Portable Classroom

Overall fair condition. Minor wear and tear throughout.

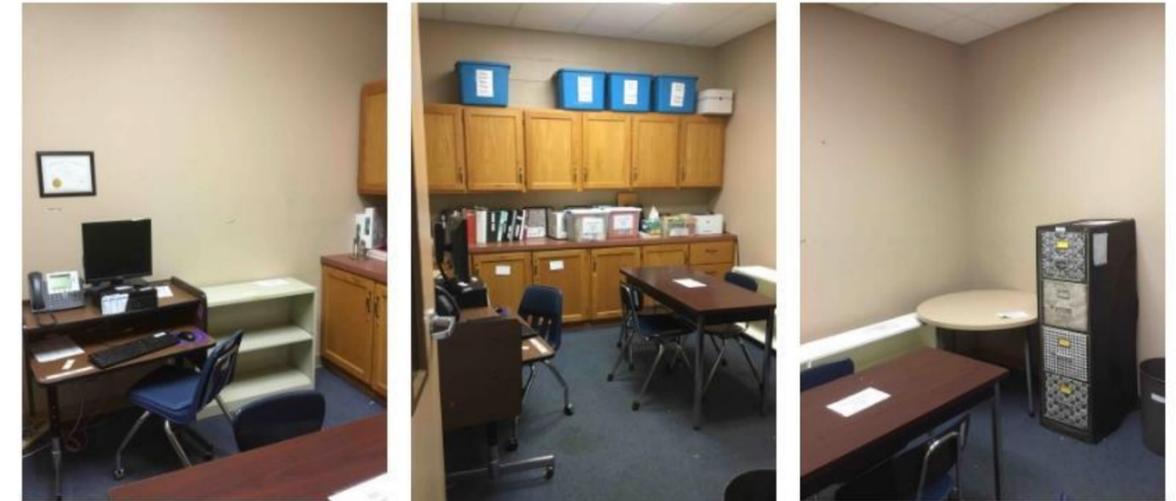
Specialty Classroom - Speech

Carpet in fair condition. Ceiling grid and tile updated. Carpeting stained with traffic marks.

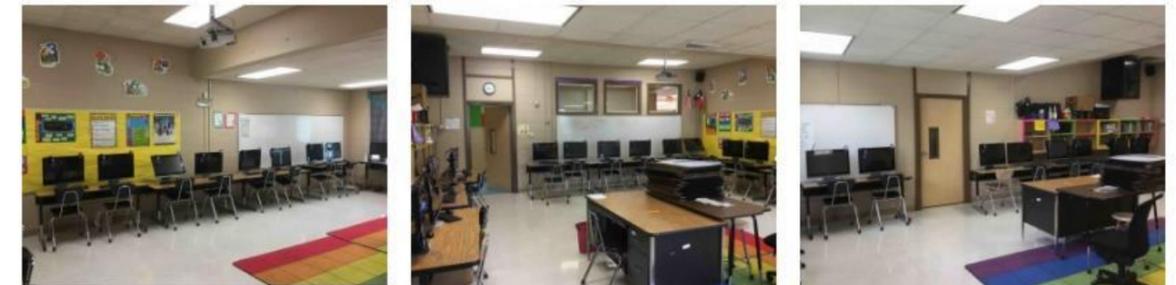
Computer Lab

Overall fair condition. Minor wear and tear throughout.

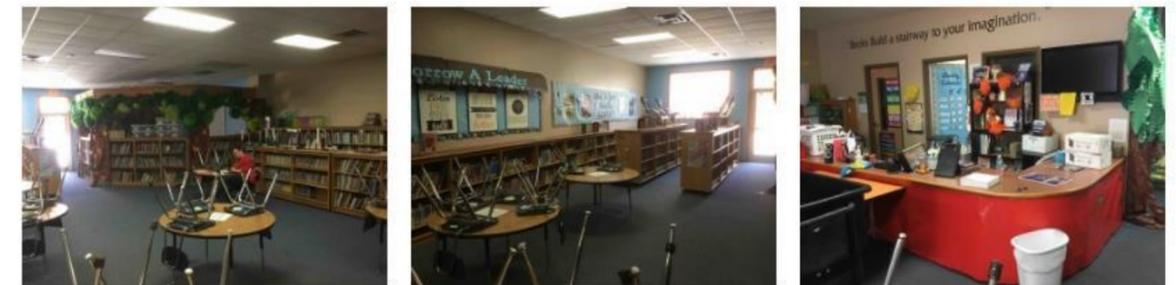
Library

Carpet in poor condition, visible traffic lanes and discoloration. Staff noted library is sized appropriately for current capacity but needs updating.

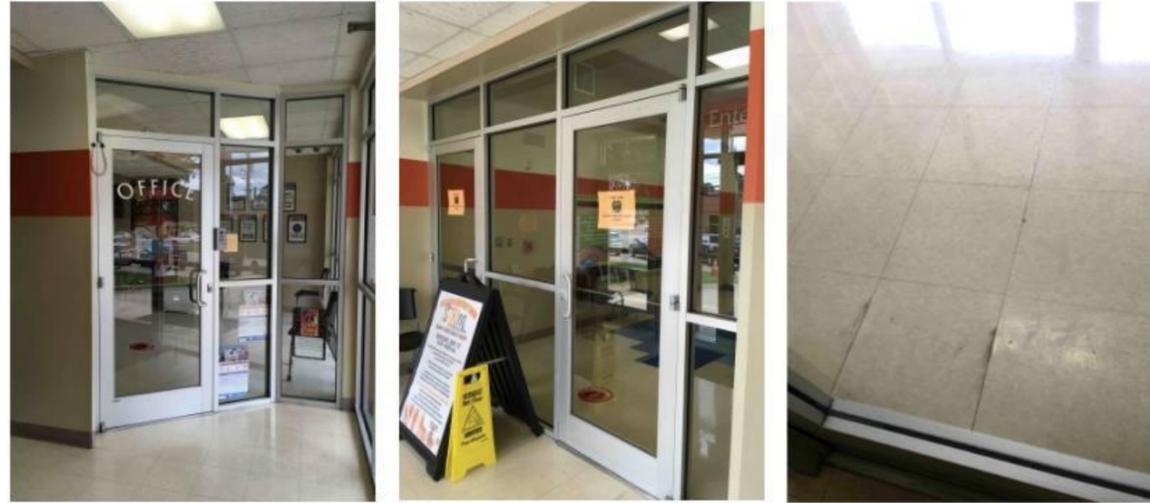
Entry Vestibule

Overall fair condition. Tile floor separating. Rubber base receding.

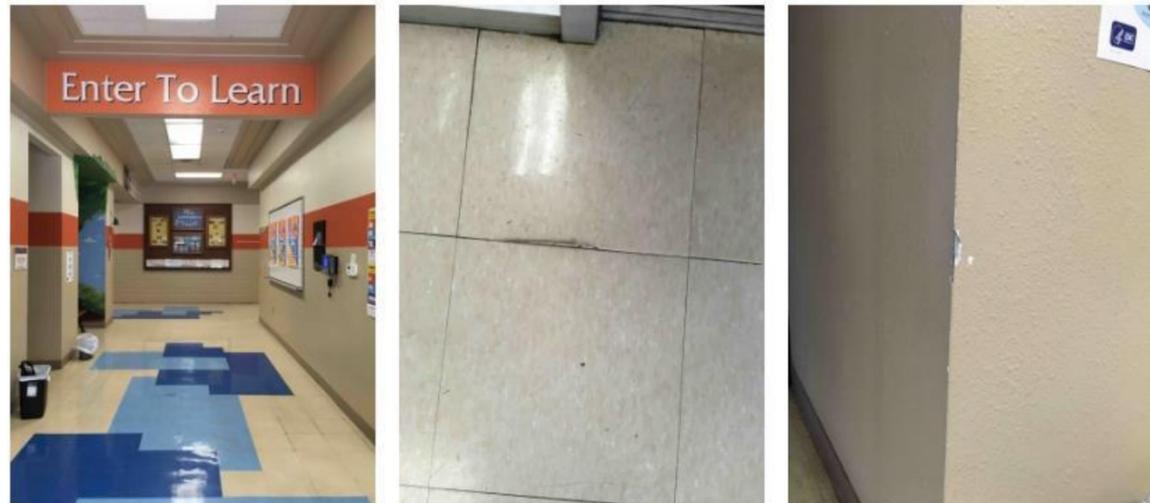
Entry Corridor

Overall fair condition. Tile floor damaged and separating, rubber base receding, damaged gyp bd.

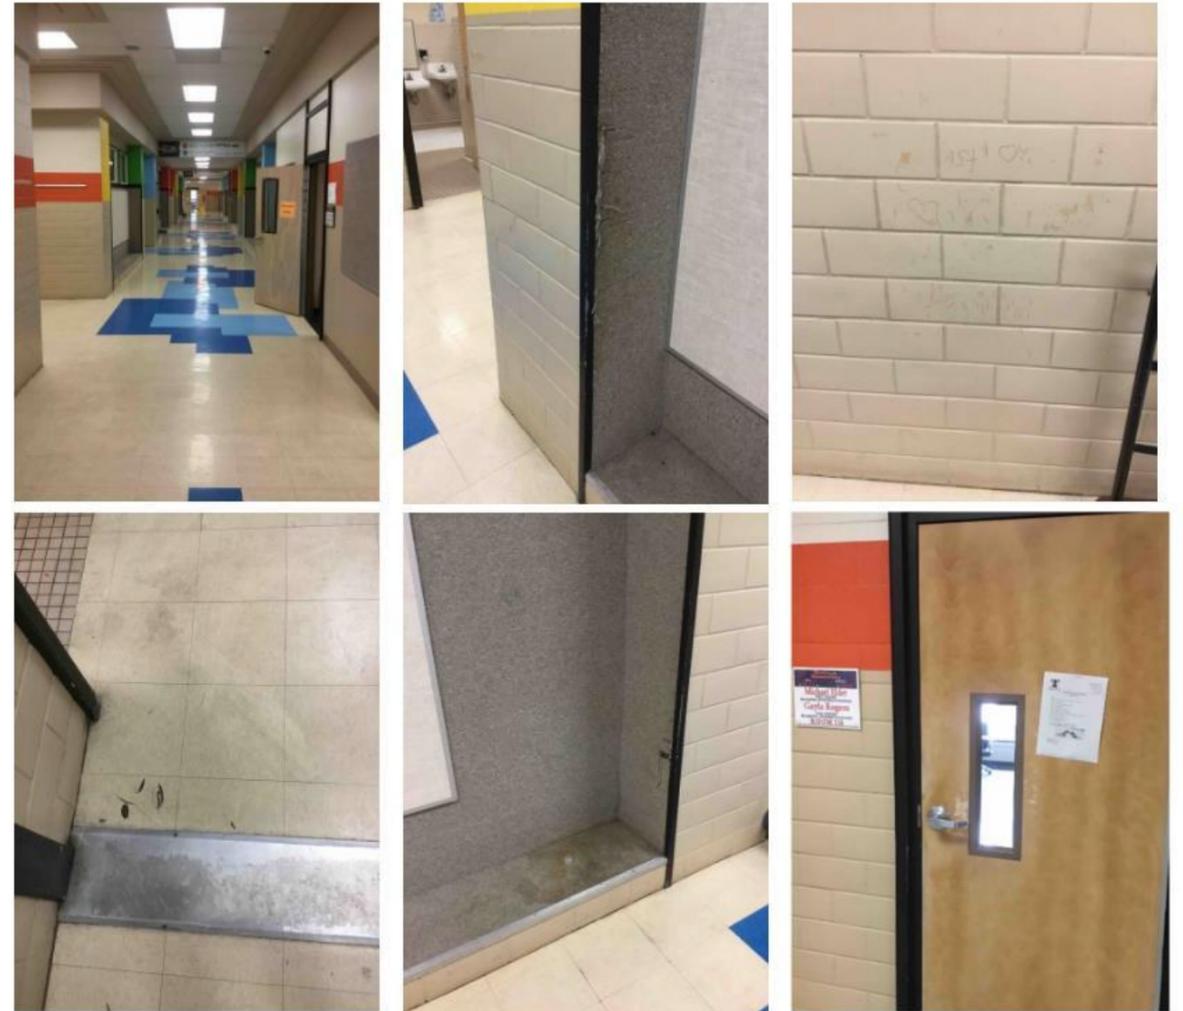
Main East-West Corridor

Rubber base missing at CMU walls. Damage to gyp bd. above cove base consistent. Tack board and carpet surround in poor condition. Paint on glazed block is scratched. Wood doors are worn.

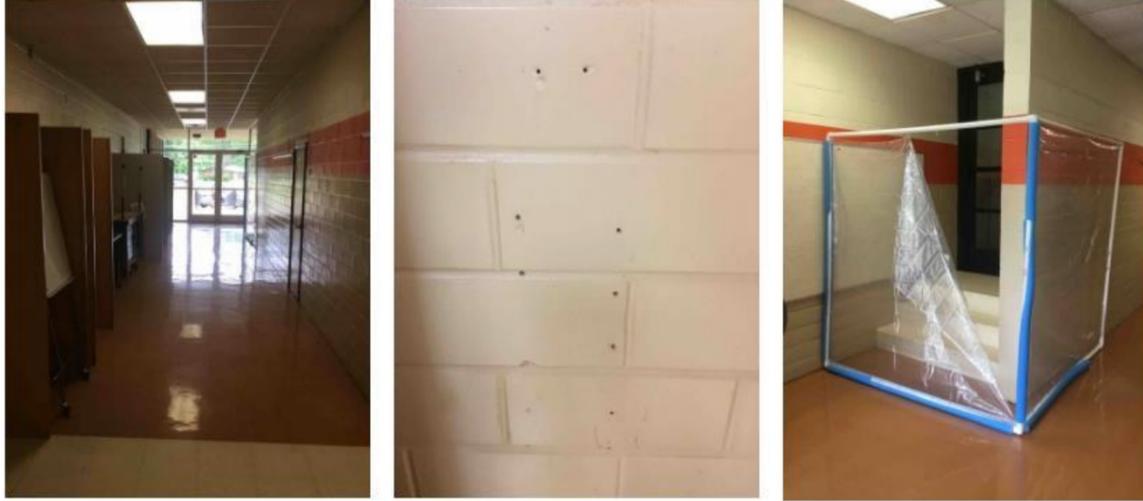
Exit Corridor

Rubber base missing at CMU walls. Exterior storefront in good condition. Stairs to second level blocked off by plastic curtain.

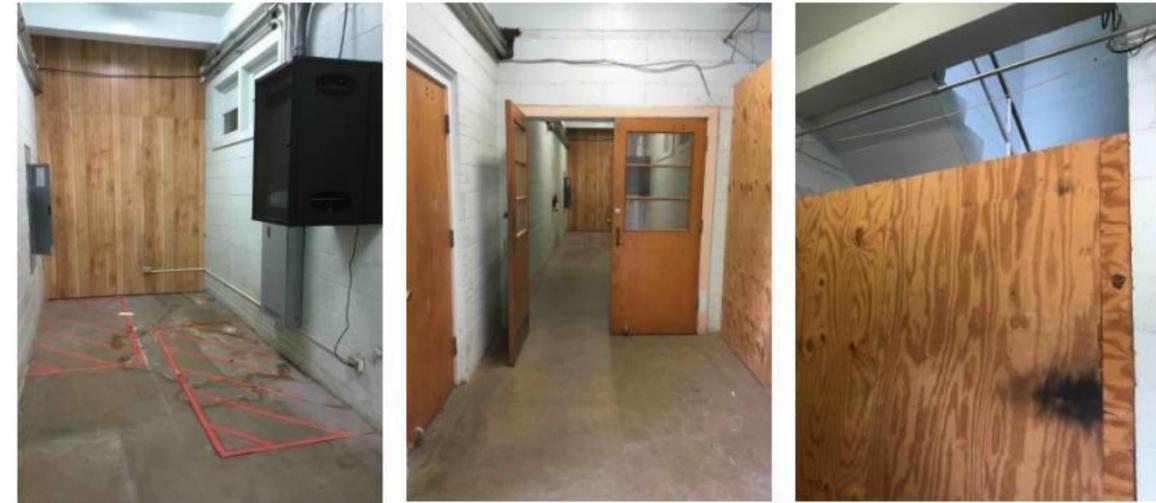
Corridor Behind Stage (not in use)

Corridor not in use. Hallway bisected with temporary wall. Plywood blocking stairs to level 2. Staff was unfamiliar with this area of the building.

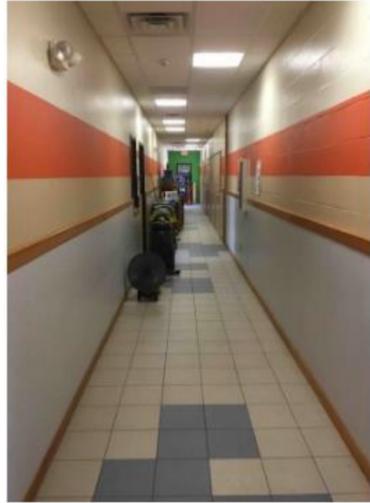
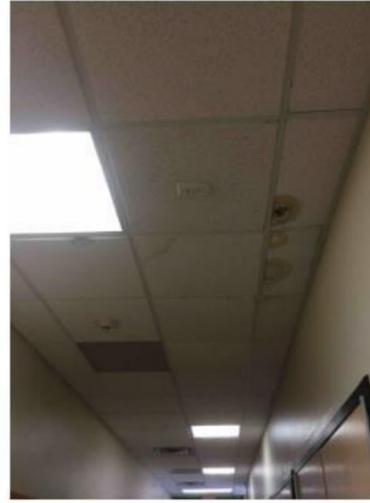
SPED Corridor

Updated finishes. Water damage at ceiling tiles.

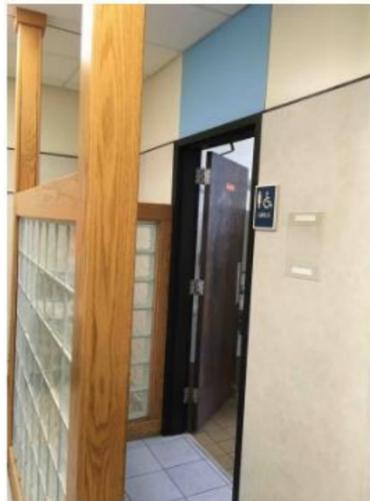
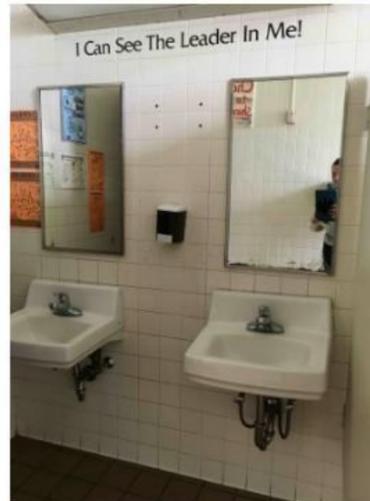
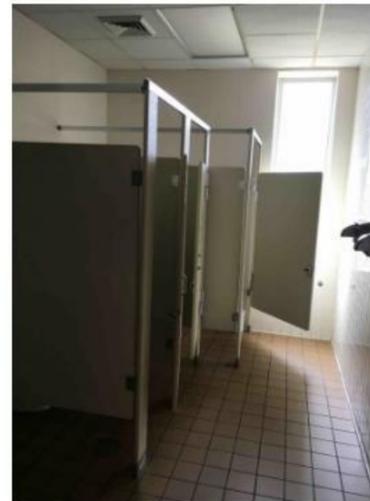
Group Restroom (north classroom wing)

Missing ADA-stall, pipe insulation under sinks. Toilet accessories in poor condition.

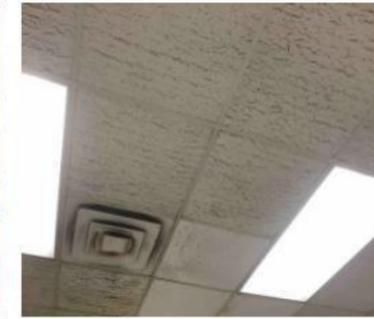
Group Restroom (near front entry)

Missing proper latch clearance on stall interior. Ceiling in poor condition.

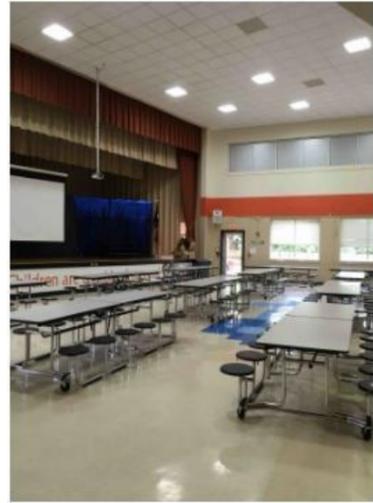
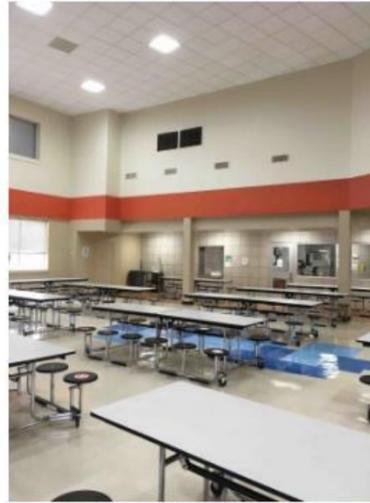
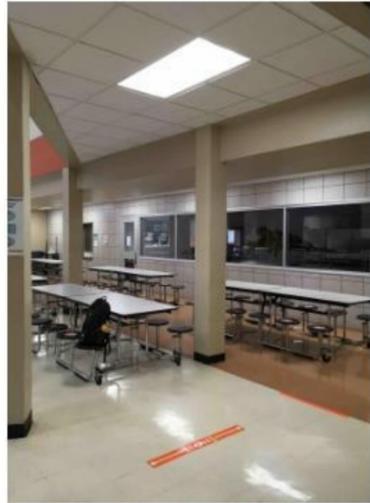
Cafeteria

Tile floor bubbling. Exposed corner bead. Clerestory windows covered from interior.

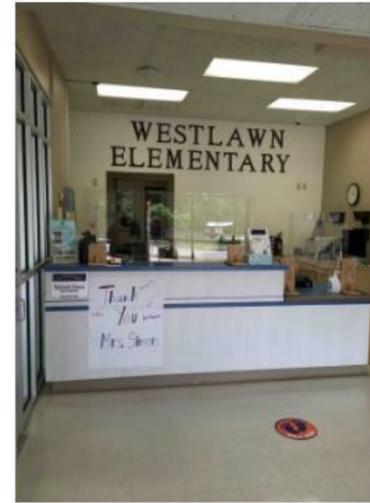
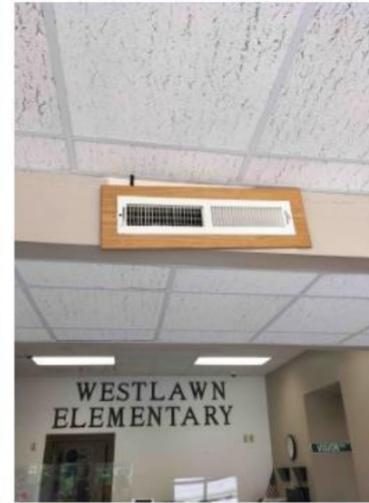
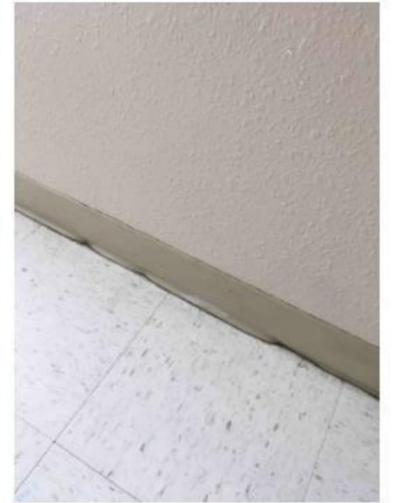
Reception

Overall poor condition. Rubber base receding. Plastic laminate chipping at reception desk.

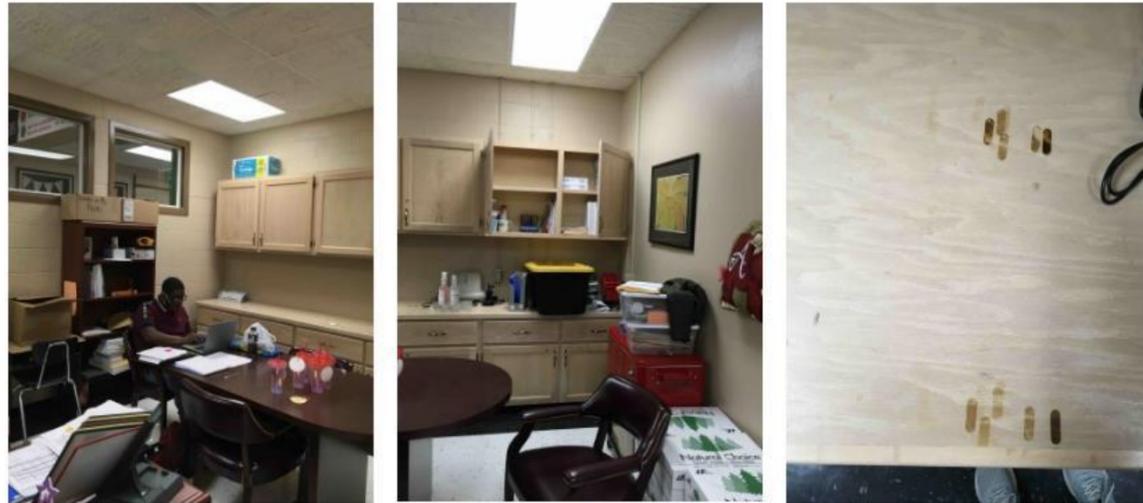
Conference Room

Overall fair condition. Functions as both conference room and an office for one staff member. Millwork in fair condition, staining on countertop surface.

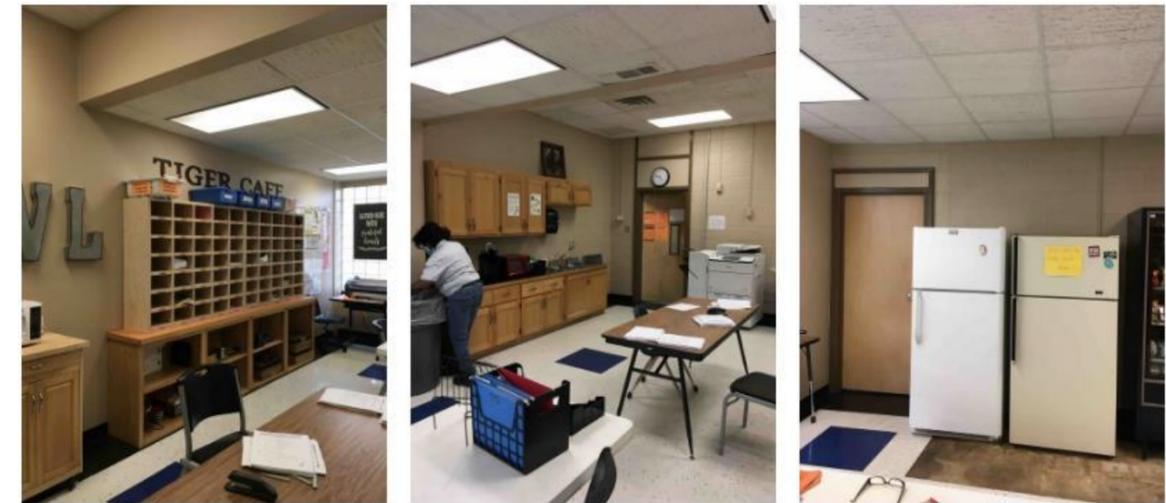
Teacher Workroom

Floor in poor condition, missing floor tiles in front of refrigerators and vending machine.

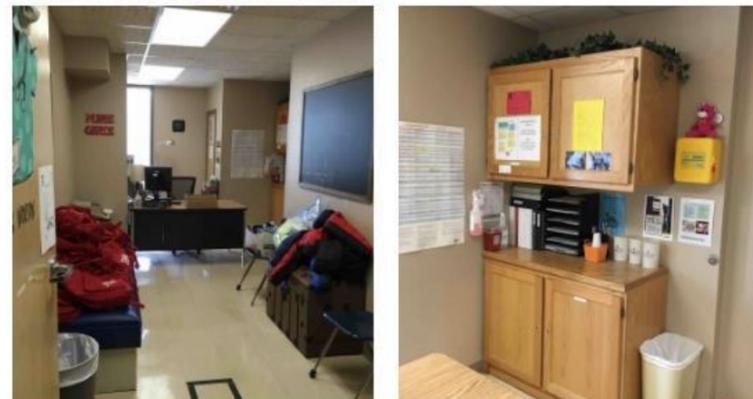
Clinic

Cracking floor tiles. Peeling rubber base. Unfinished, uninsulated storage closet. Accessible restroom in clinic.

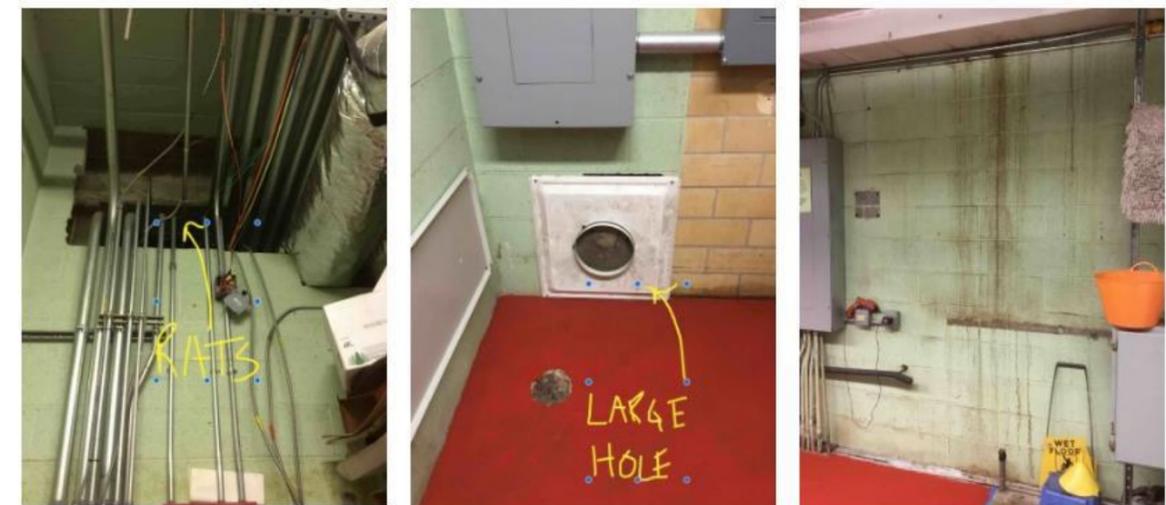
Custodial Closet (near front entry)

Overall poor condition. Staff noted numerous holes in building maintenance room where rodents access the building. Rats are noted in the ceiling. Threshold of exterior door rusting away, allowing water to enter the building.
