**Project Observation Report**

Project Name:	Tri Tech East Building C 1.5	Project No.	2208
Report #:	37		
Observation Date:	6-14-23	Last Report:	6-7-23
Prepared By:	Steve Mallory, AIA	Contractor:	Banlin

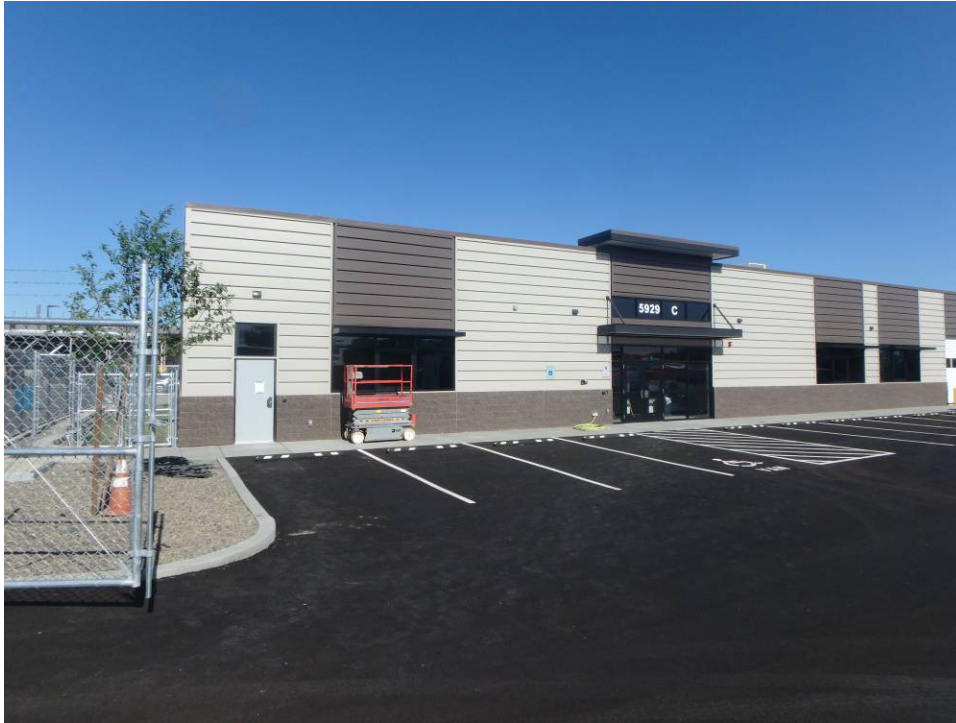
East elevation

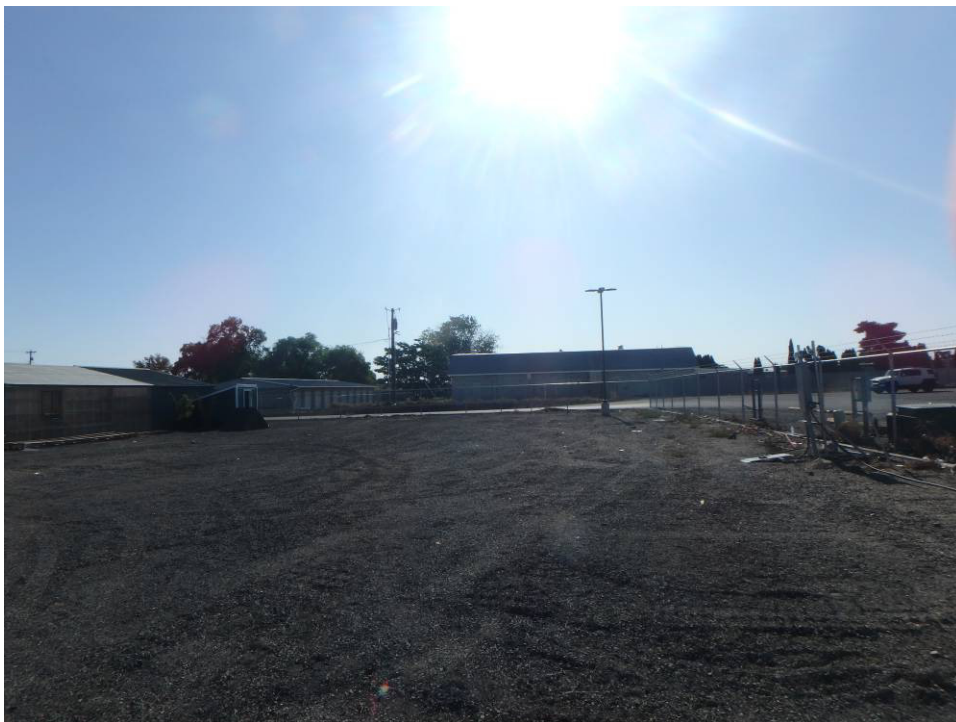
Southeast site

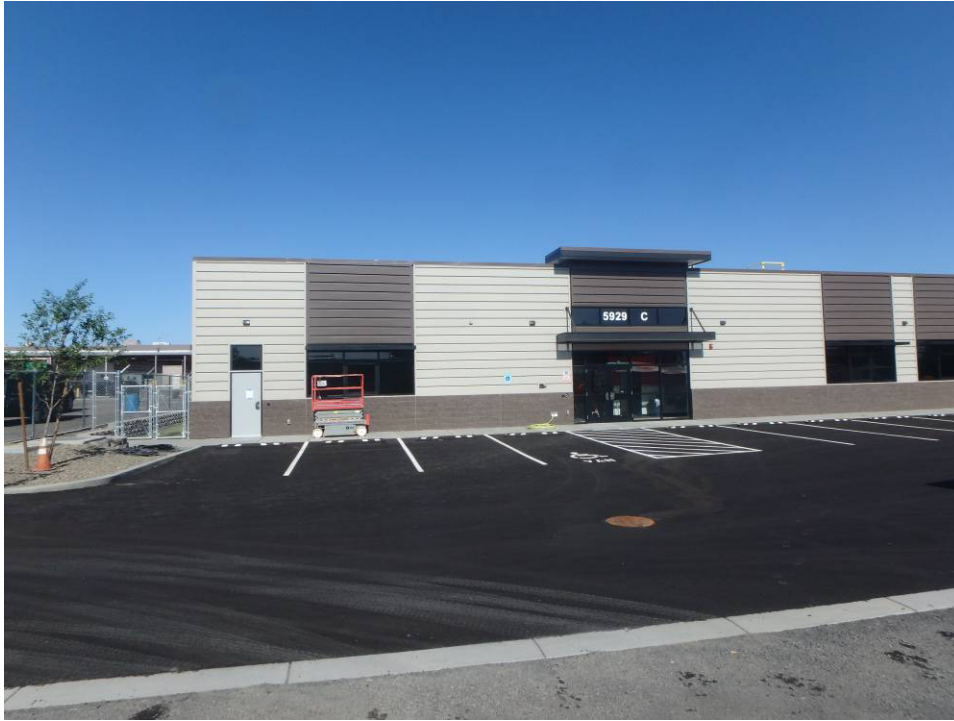
Looking at the south end of the East elevation

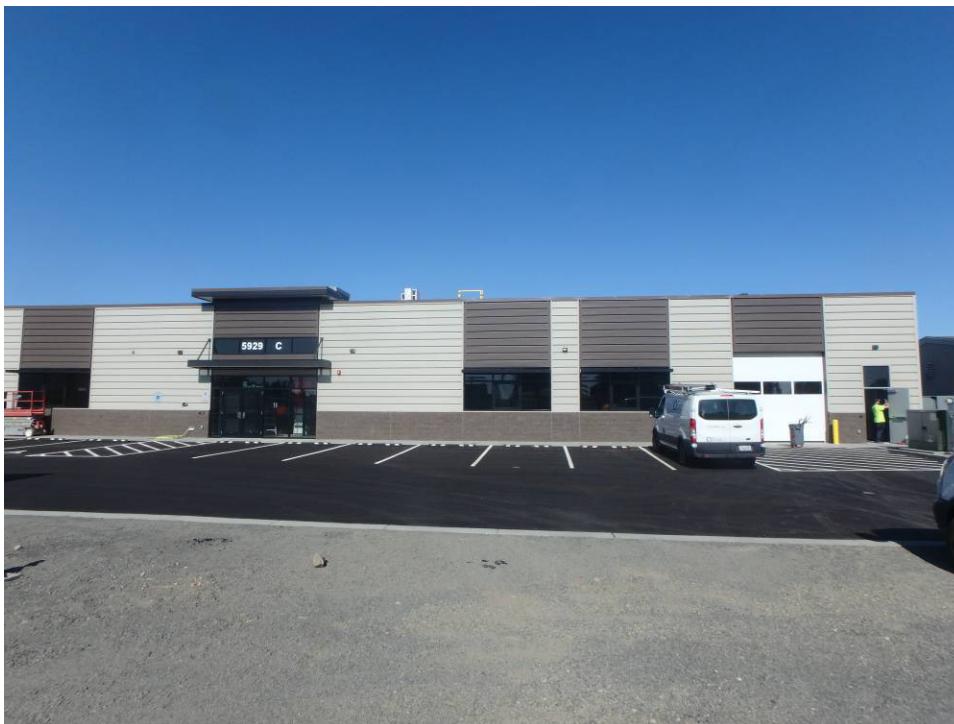
Looking at the north end of the East elevation

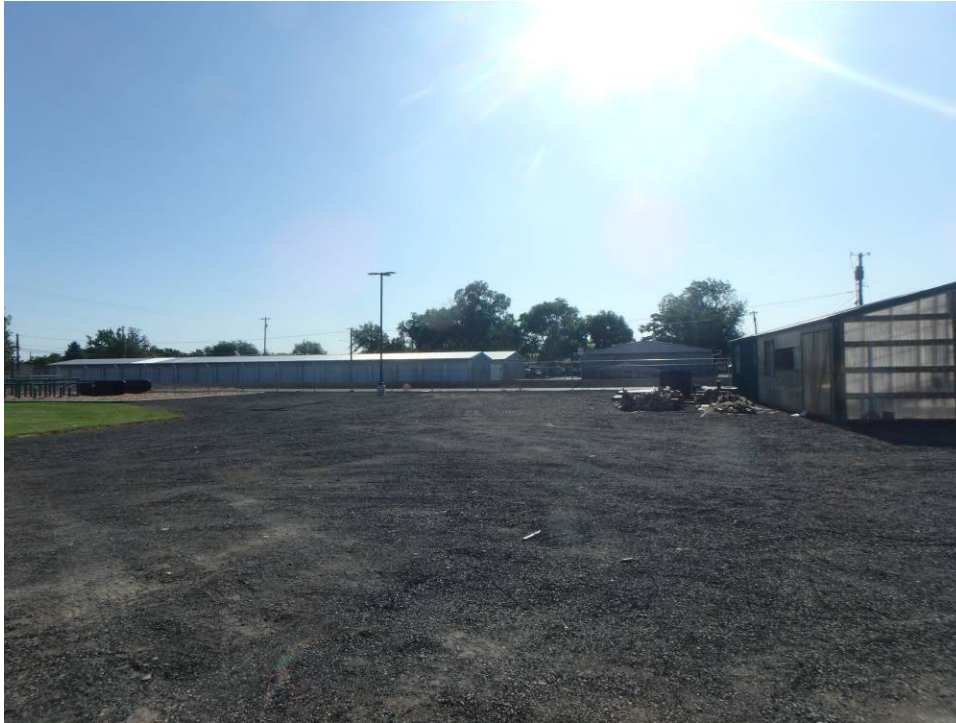
Looking northeast at the northeast corner of the site and the greenhouse

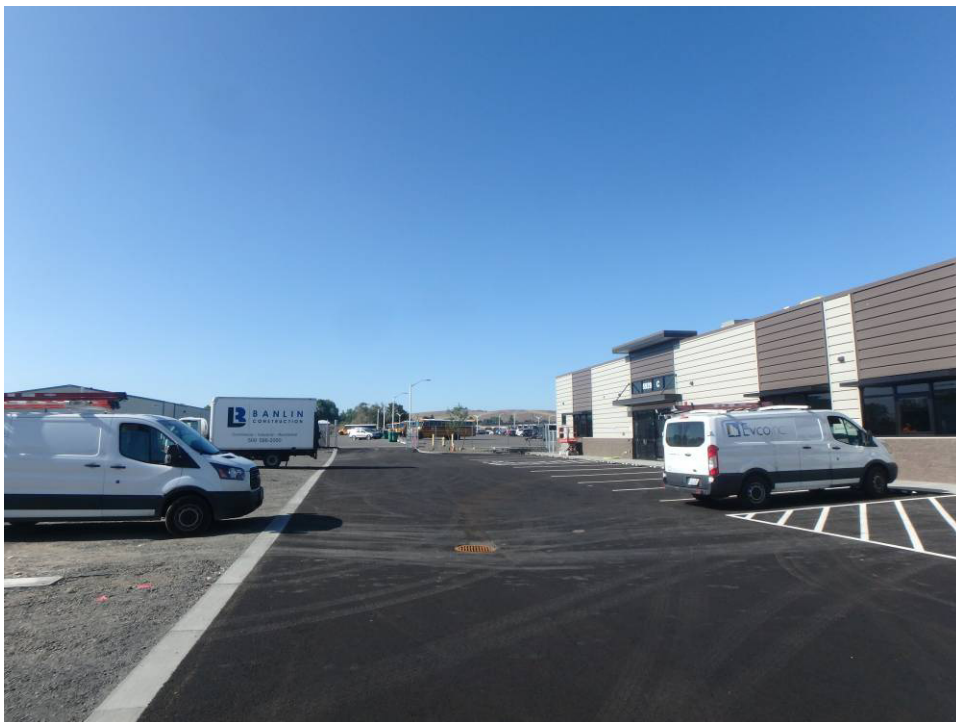
Looking south at the parking area

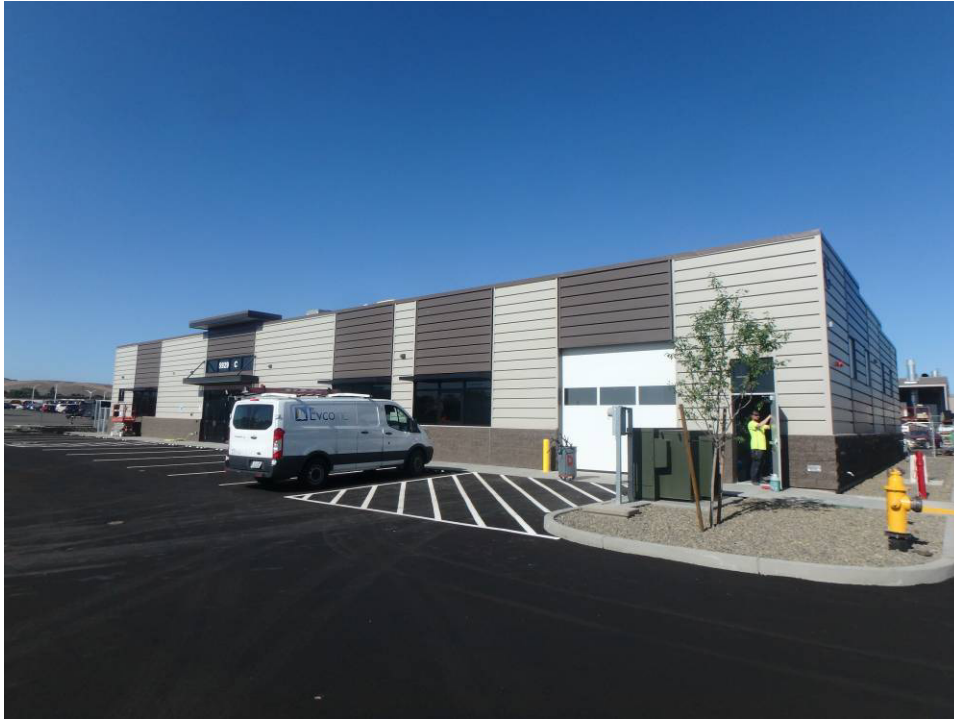
Looking at the northeast corner of the building

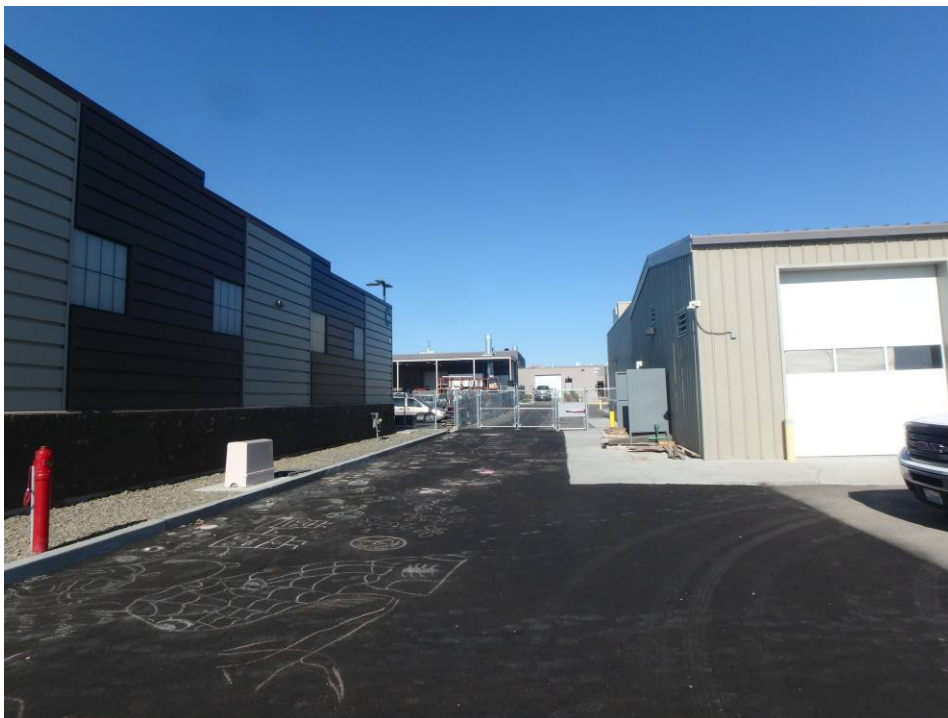
Alleyway – looking west and the North elevation

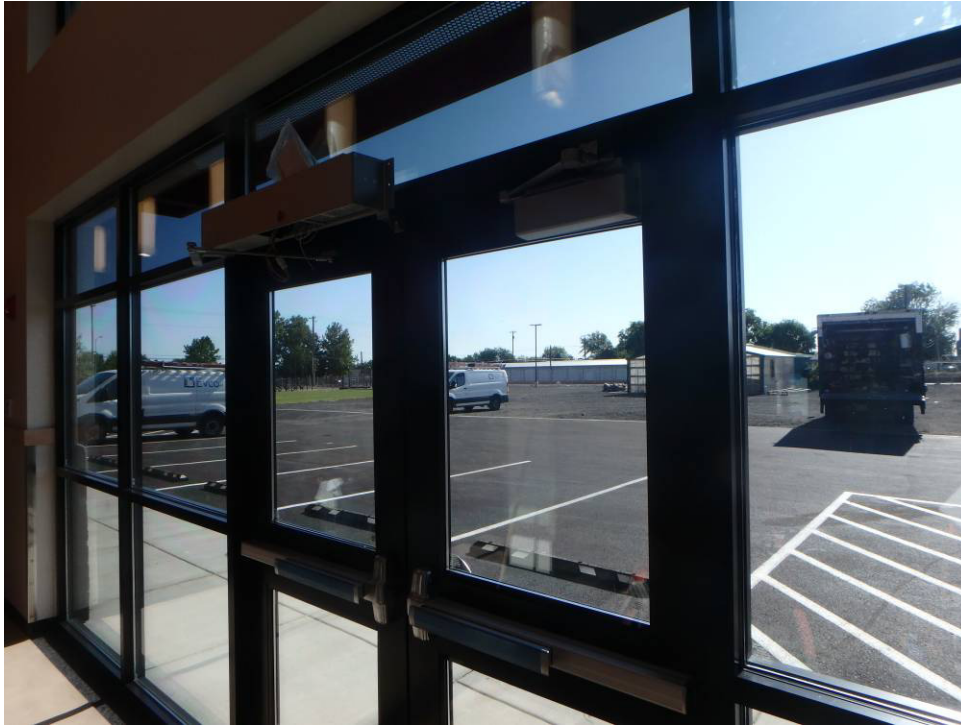
Main entry doors and sidelites

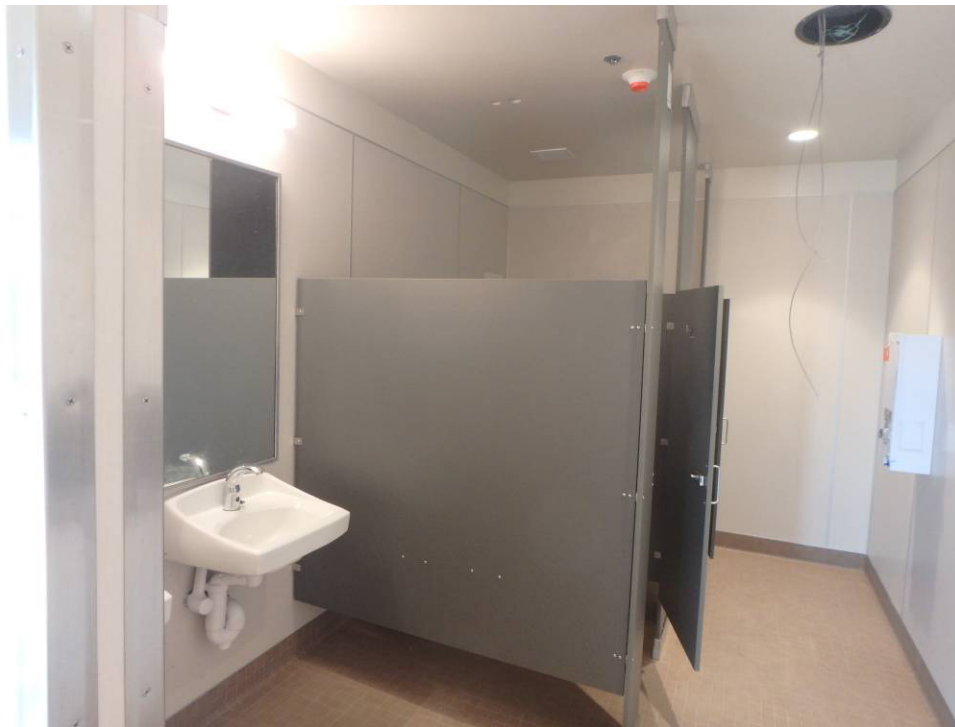
Restroom partitions and architectural accessories

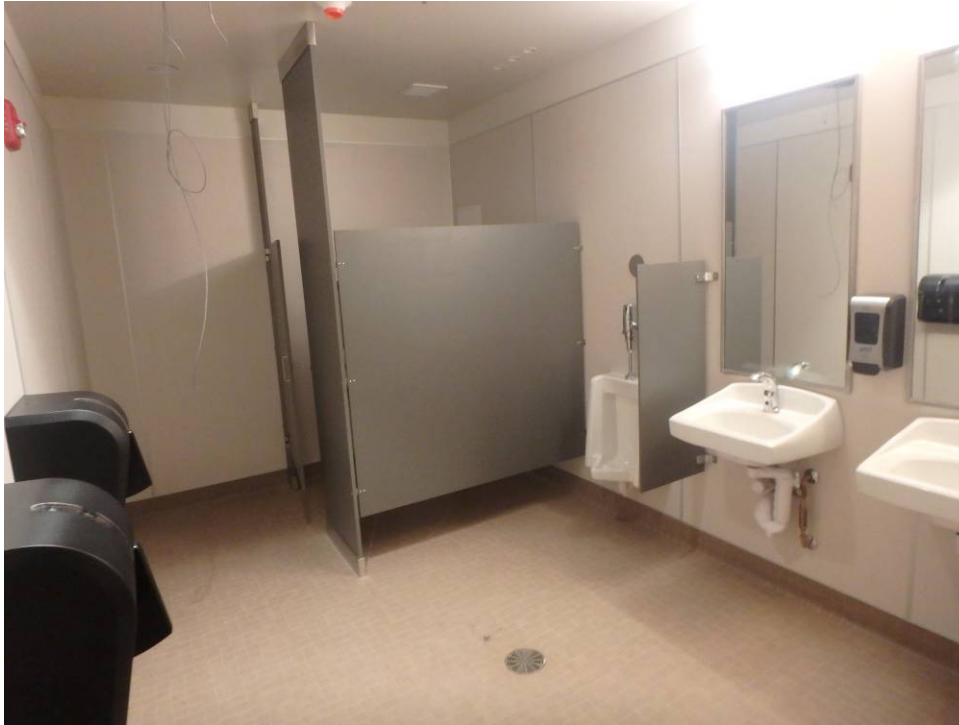
Men's Restroom partitions and architectural accessories

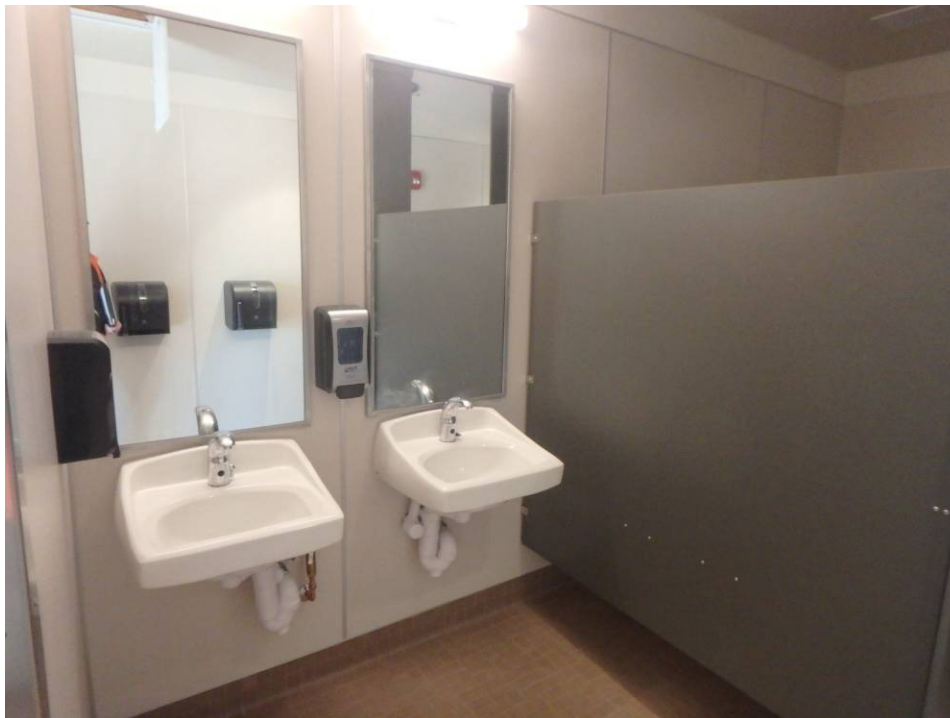
Sinks

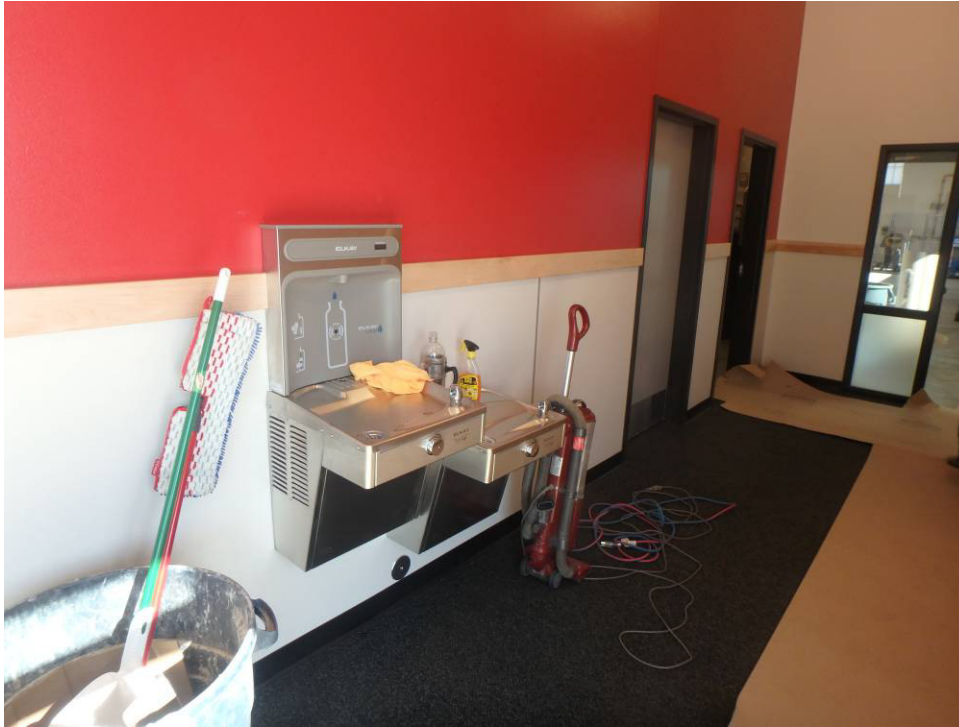
Drinking fountains

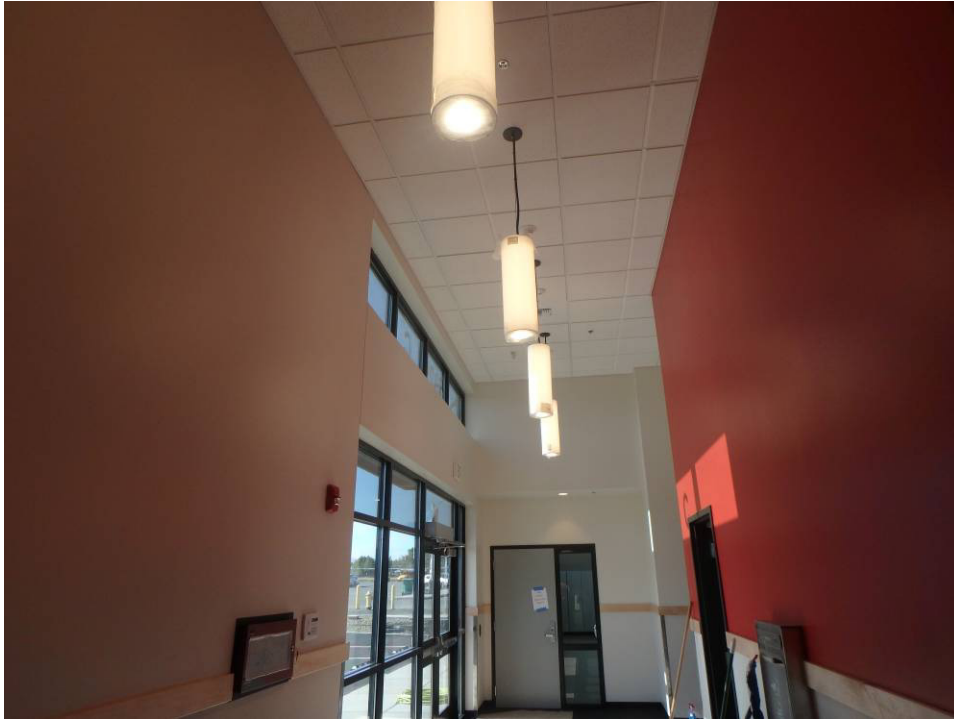
Looking south at the entry

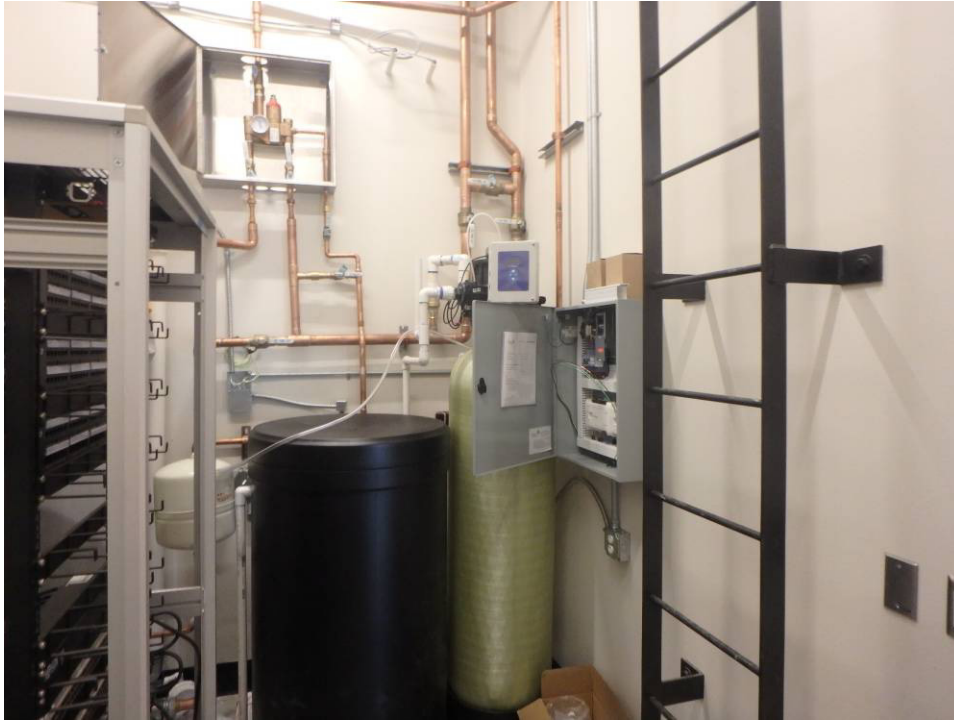
Mechanical room –preparing to sent water softener and brine tank

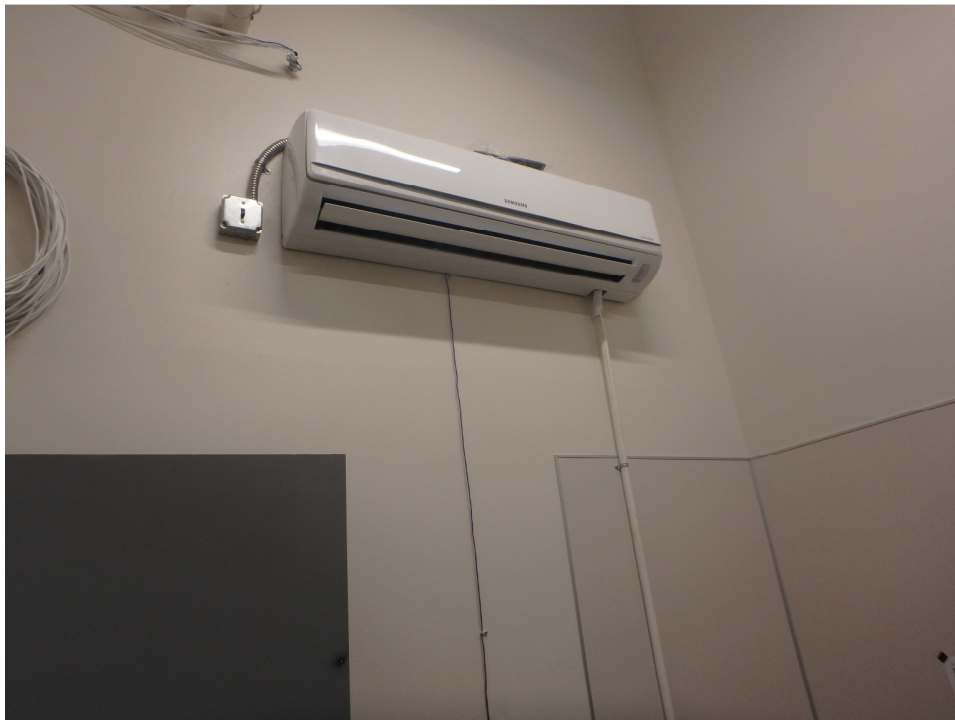
Mechanical room –minisplit unit

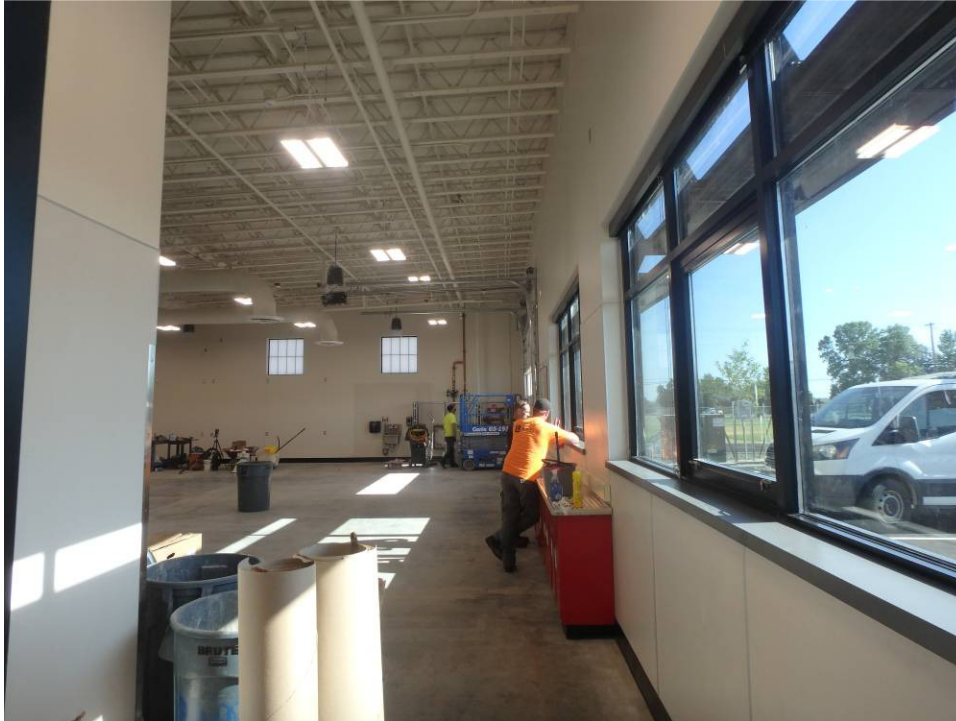
Looking north along the shop's east wall and lockers with diamond plate top

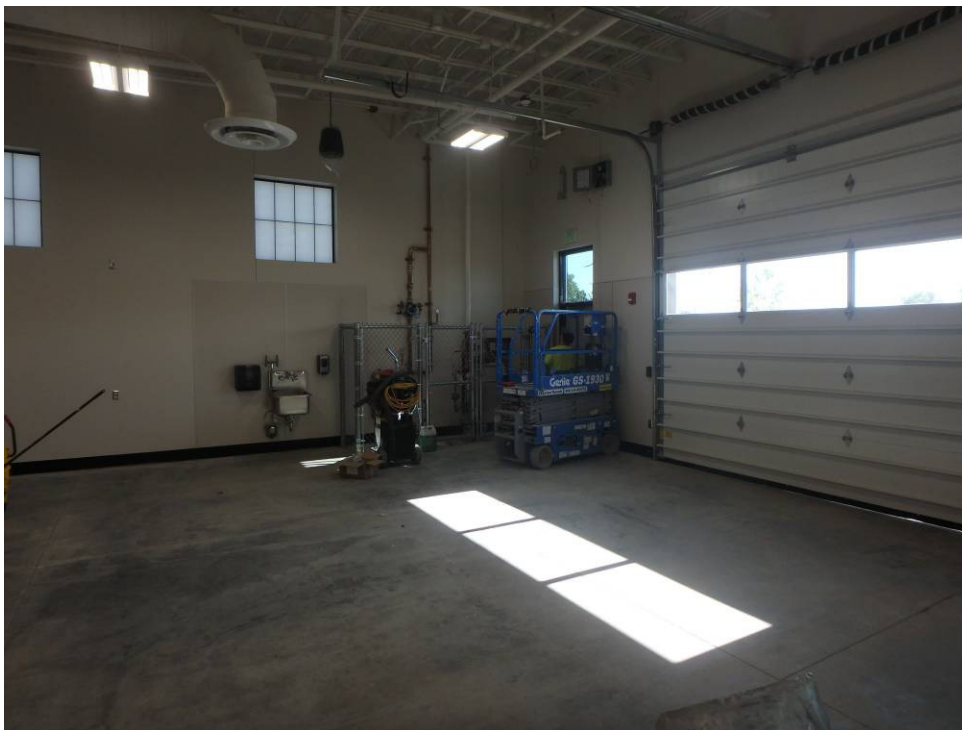
Looking northeast into the shops northeast corner

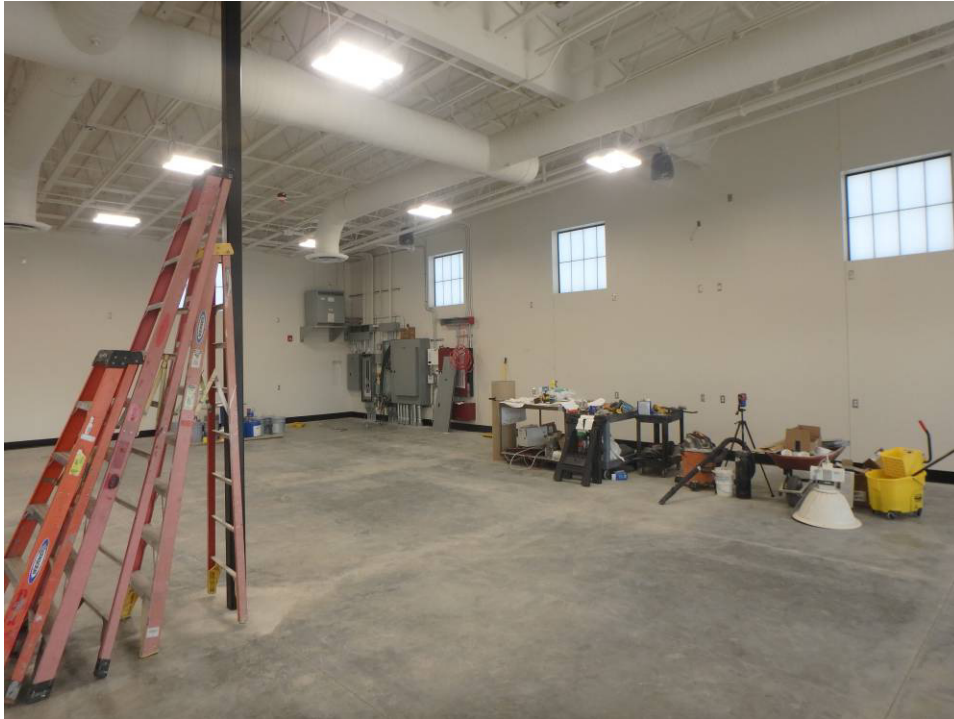
Looking northwest towards the shop's electrical panels and transformer mounted on the wall

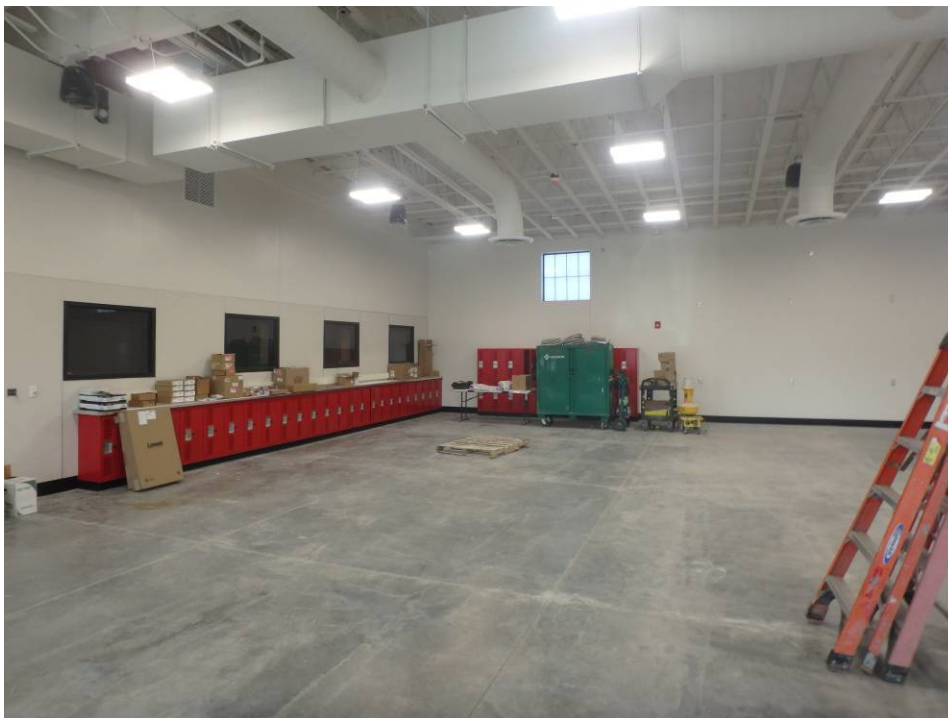
Looking west along the south wall of the shop

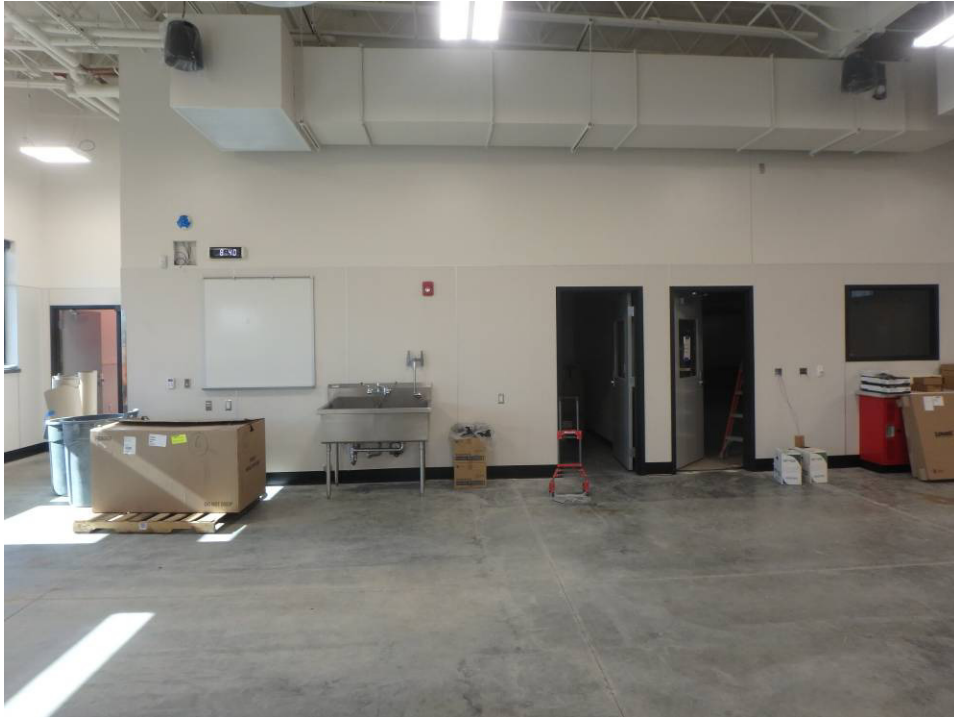
Looking south at the north classroom south wall

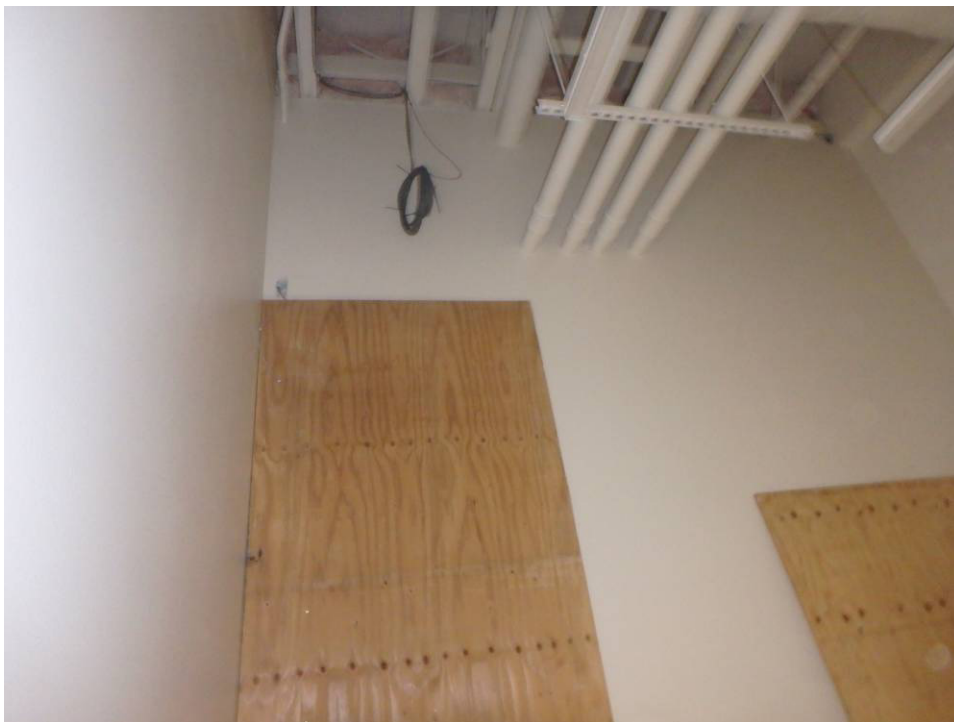
Storage room backboard

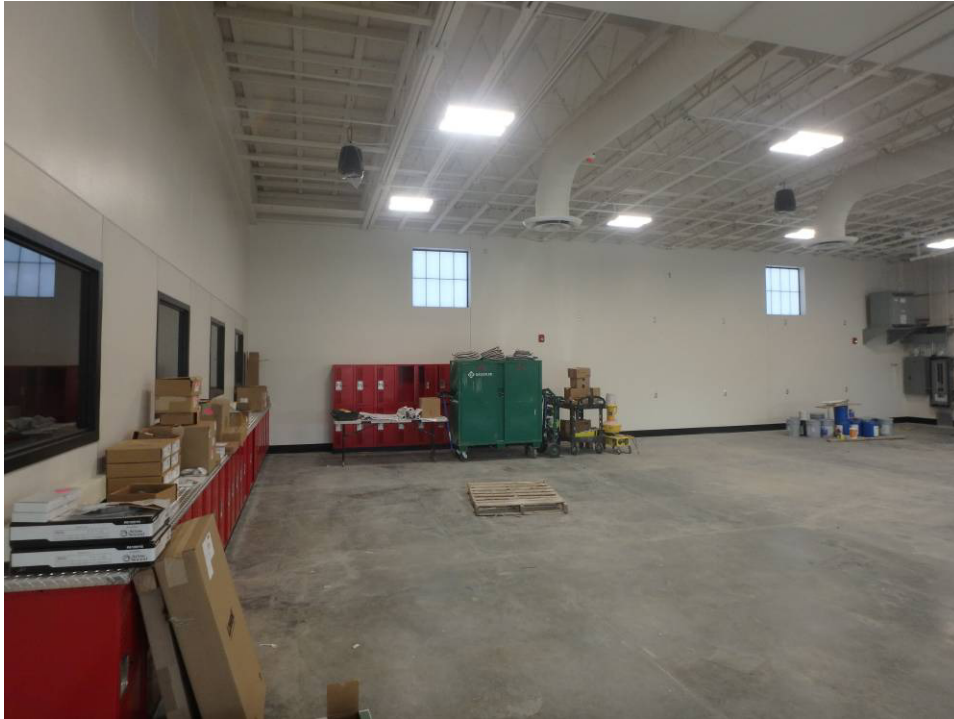
Looking west at the south wall of the shop

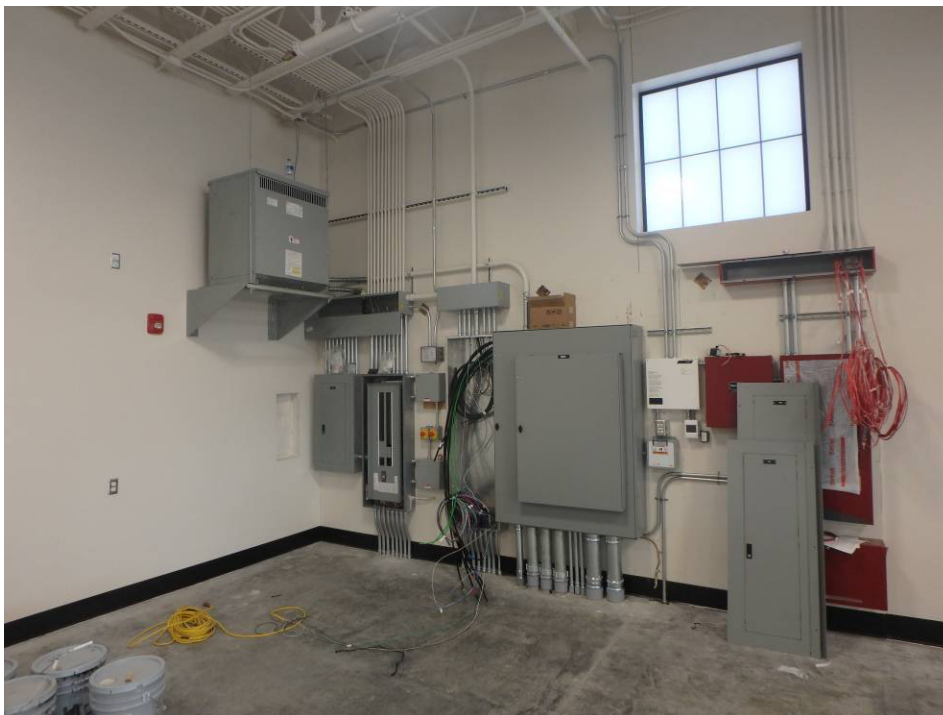
Electrical panels, and transformer

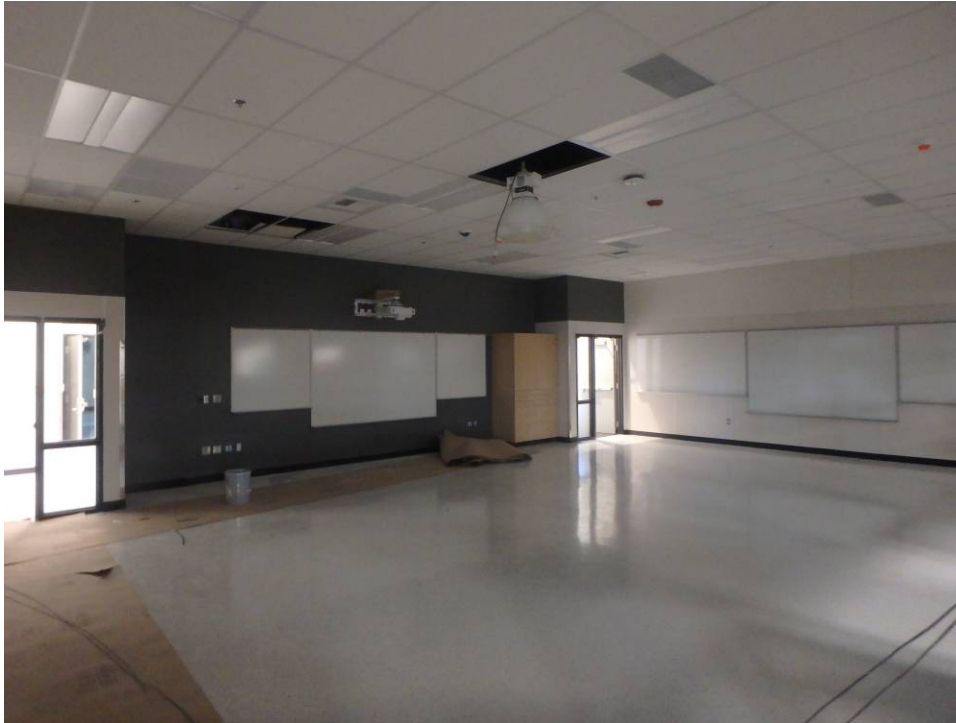
Looking southwest at the southwest corner of the north classroom

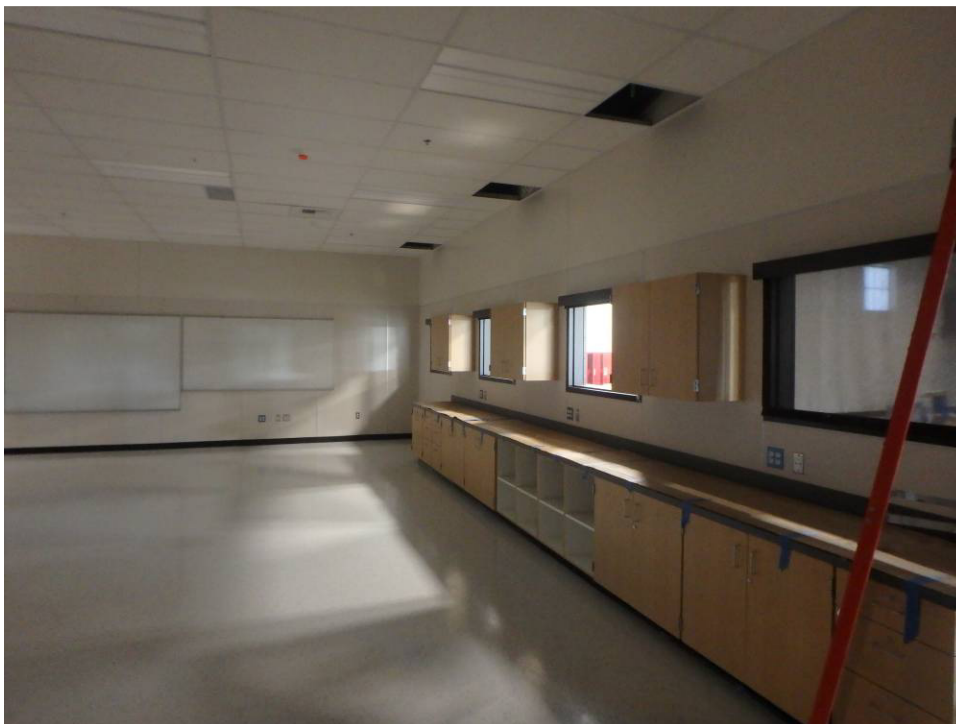
Looking west at the north wall of the north classroom

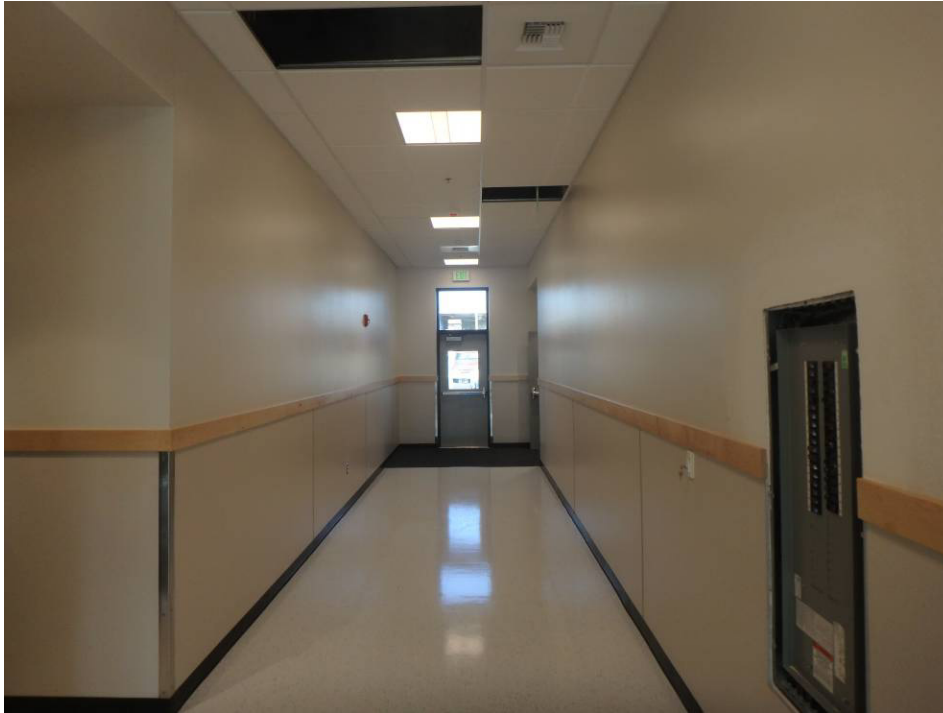
Looking west at the main east-west corridor

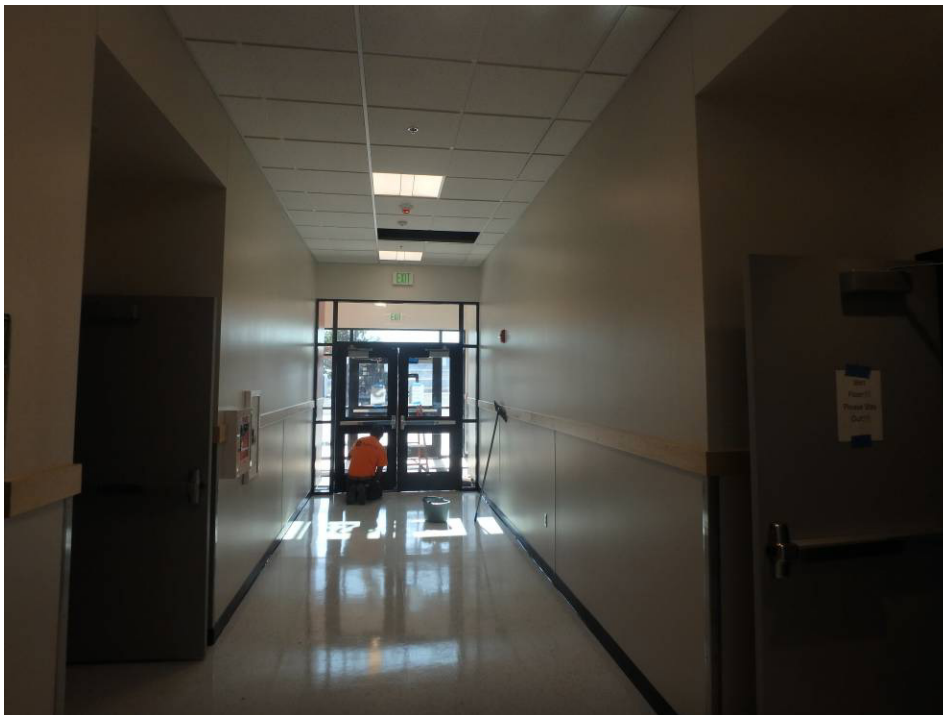
Looking east at the main east-west corridor

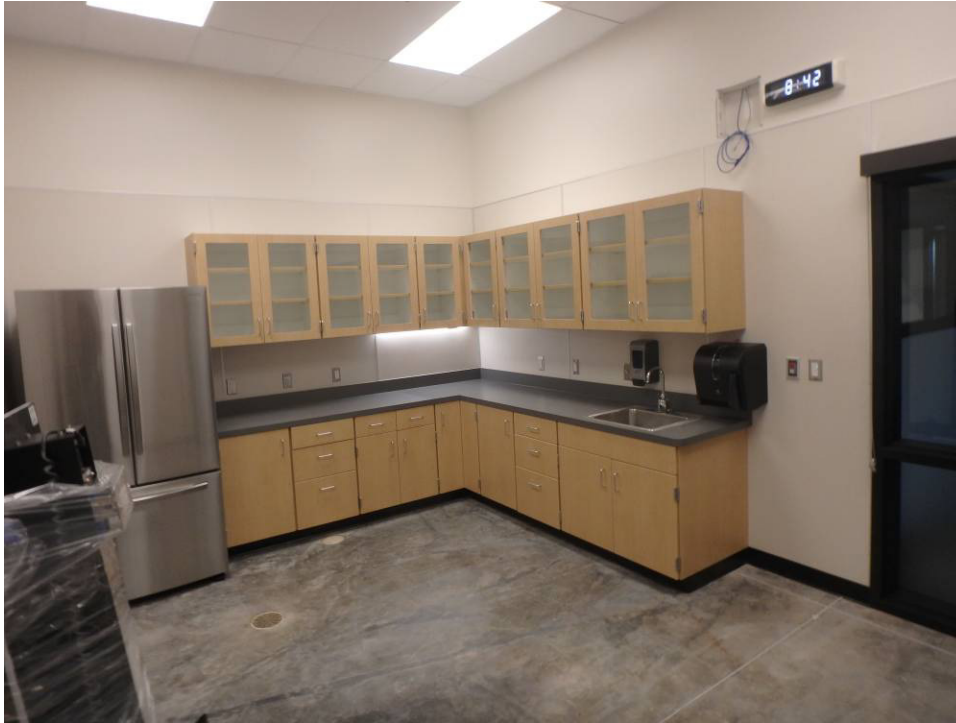
Exam room casework

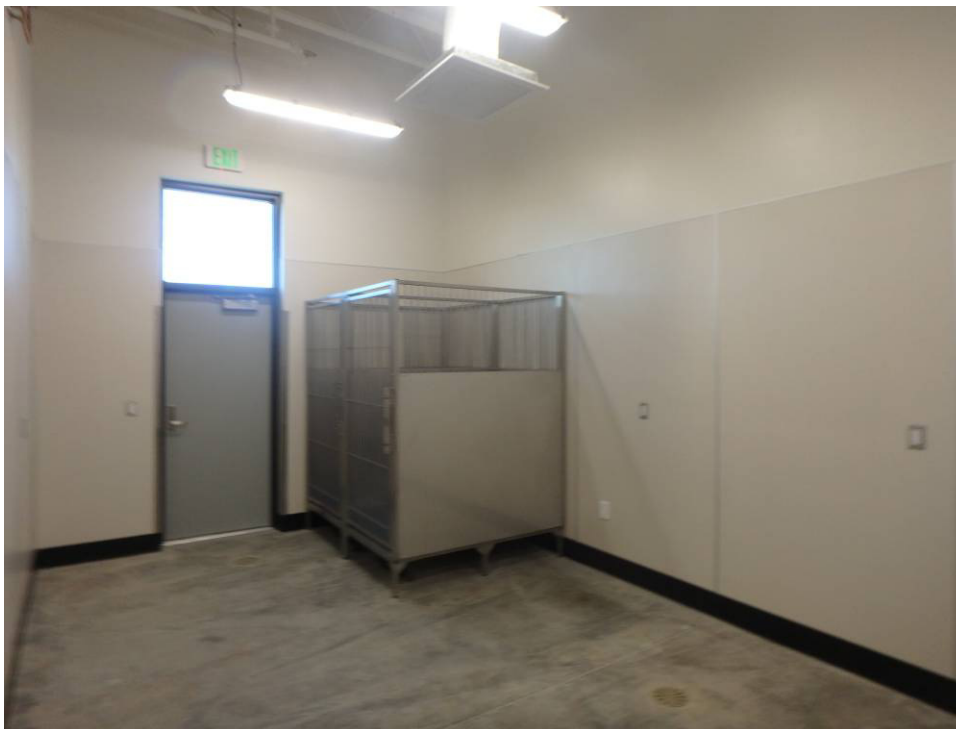
Kennels

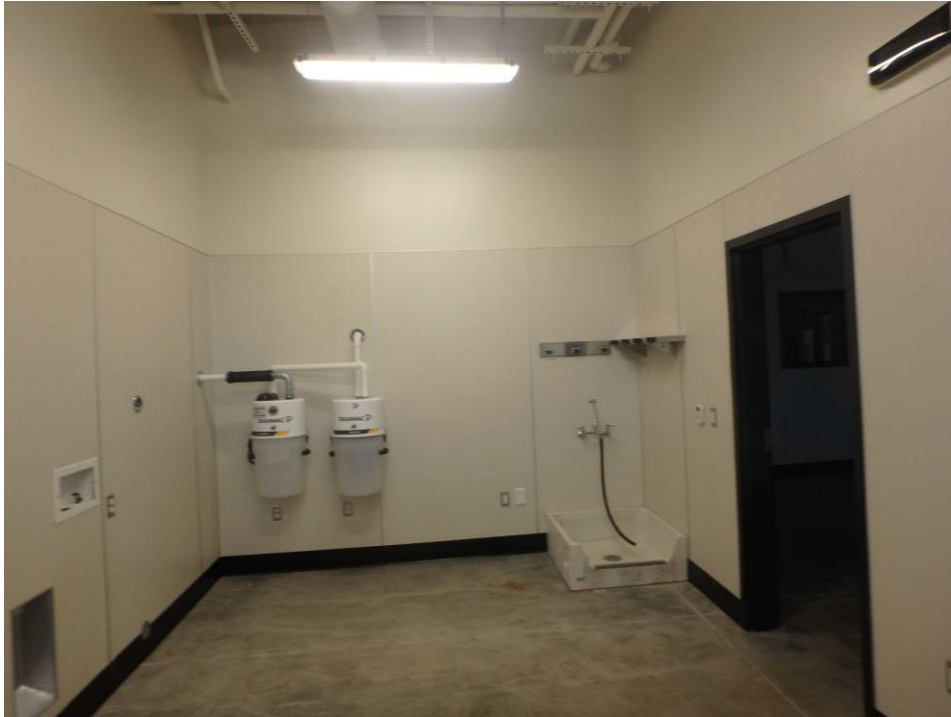
Kennel Room vacuum and sink on the north wall

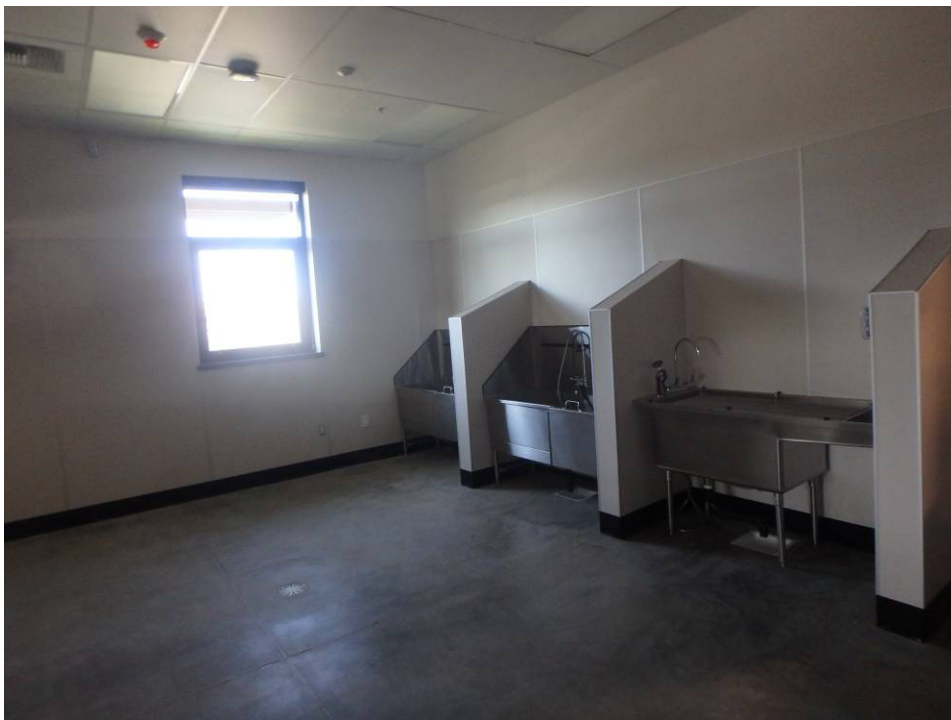
Dogwash stations

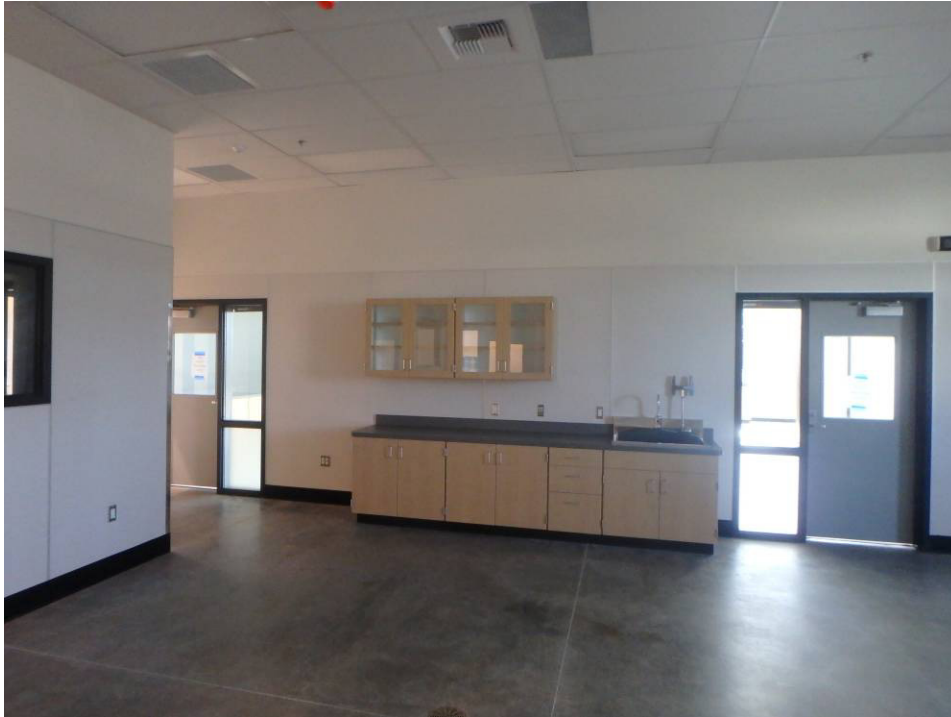
Lab – eyewash station and east wall
