**Project Observation Report**

Project Name:	Tri Tech East Building C 1.5	Project No.	2208
Report #:	37		
Observation Date:	6-14-23	Last Report:	6-7-23
Prepared By:	Steve Mallory, AIA	Contractor:	Banlin

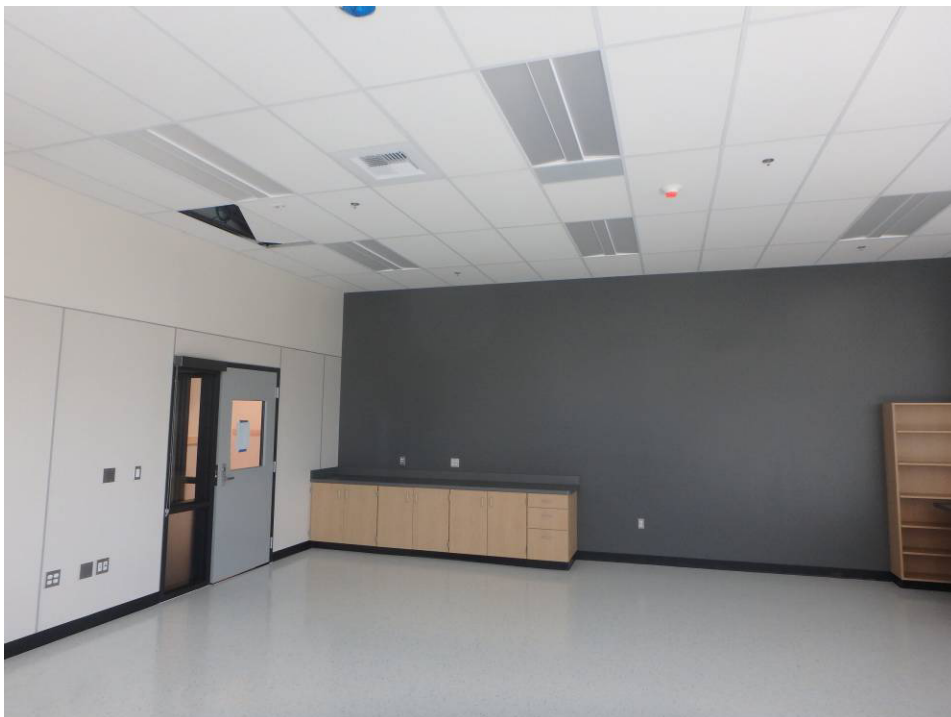
Looking at the casework in the northwest corner of the south classroom

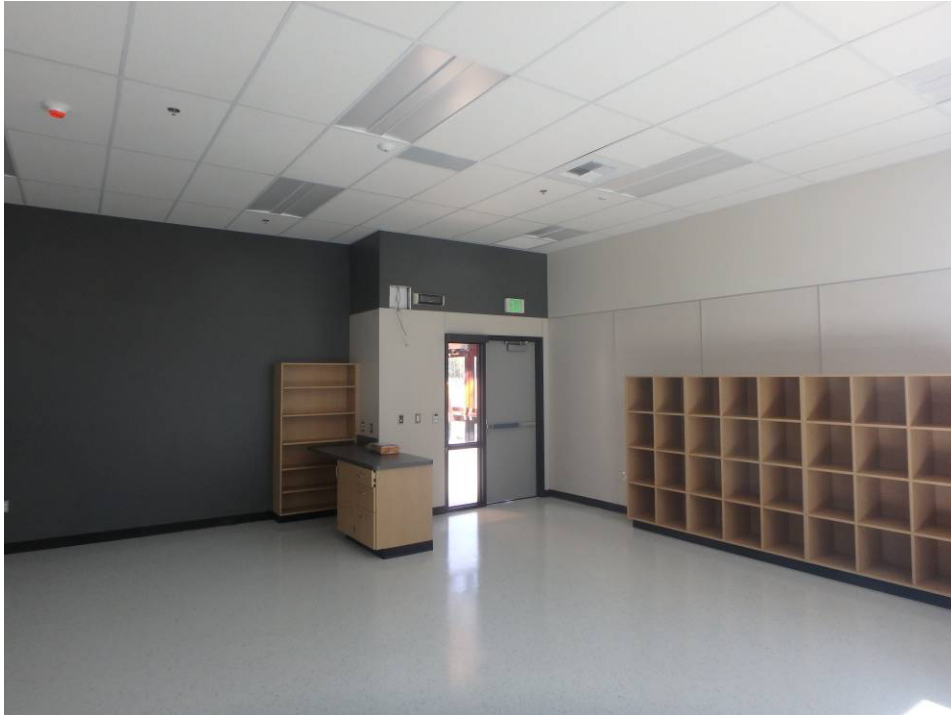
Looking at the casework in the northeast corner of the south classroom

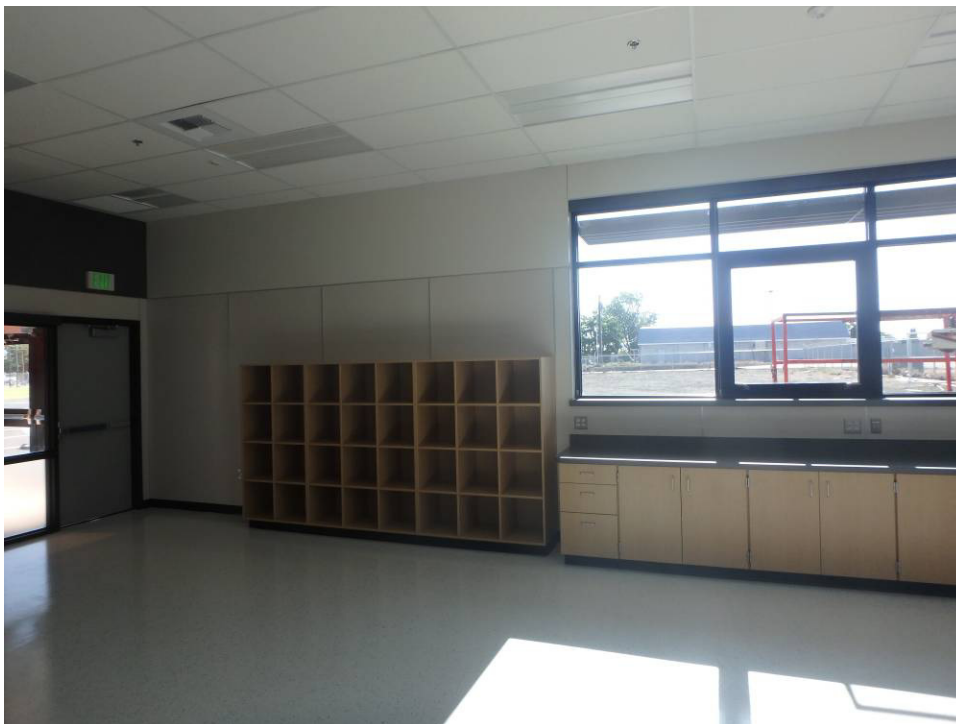
Looking at the casework on the east wall of the south classroom-north end

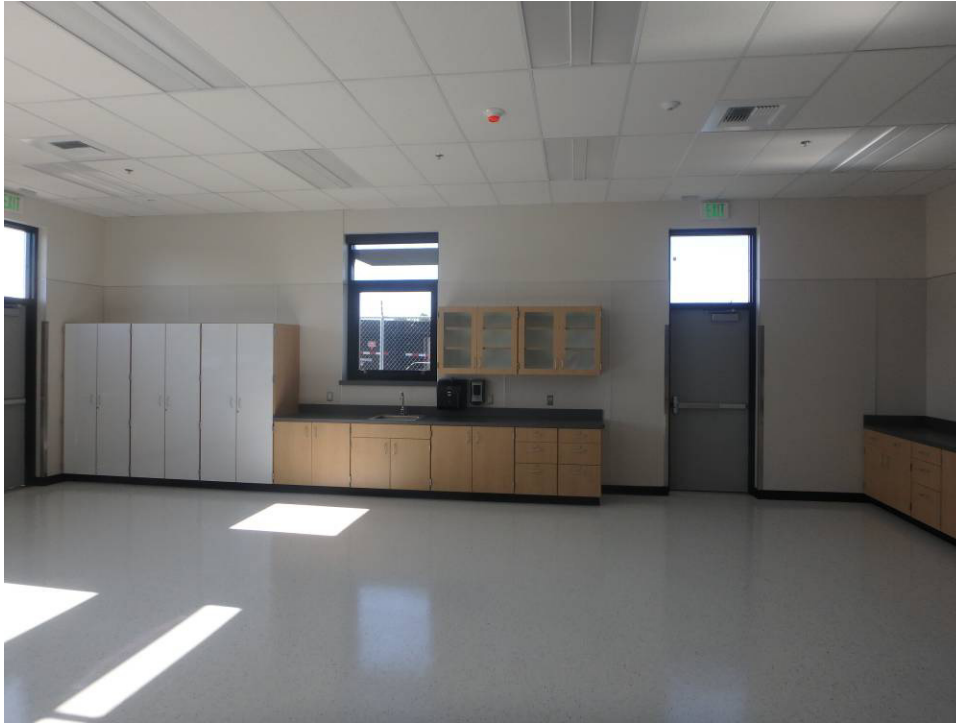
Looking south at the south wall of the south classroom

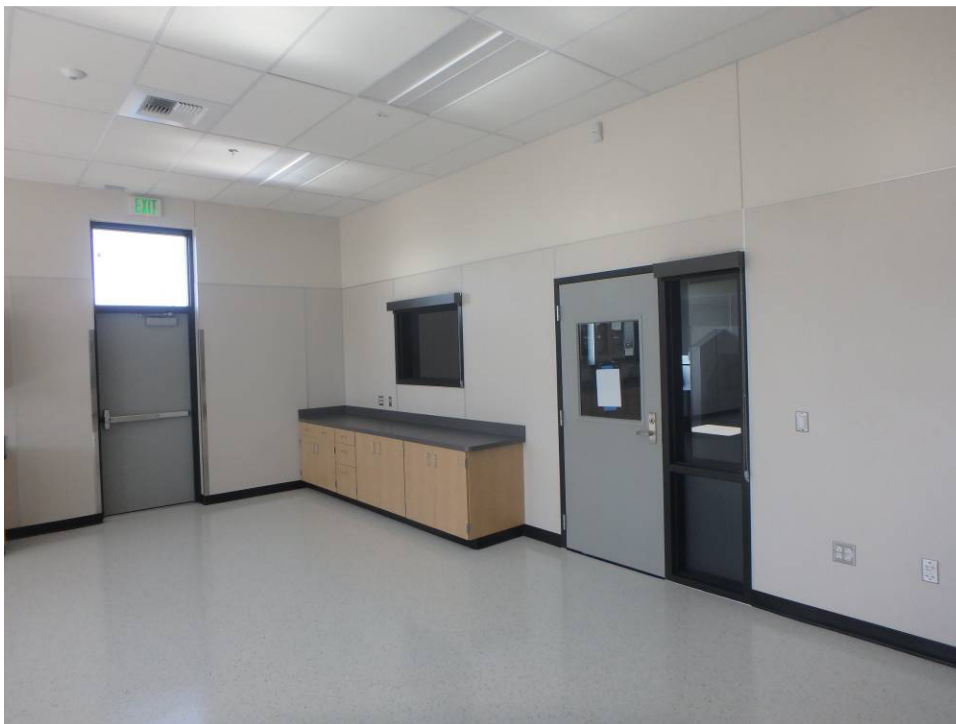
Looking southwest at the southwest corner of the south classroom
