2121.PR- B.2

Kofman Auditorium Dressing Rooms, ADA Observations

Project: Alameda High School – Kofman Auditorium
Systems Upgrades

Re: Theatre Assessment and Recommended Systems
Upgrade

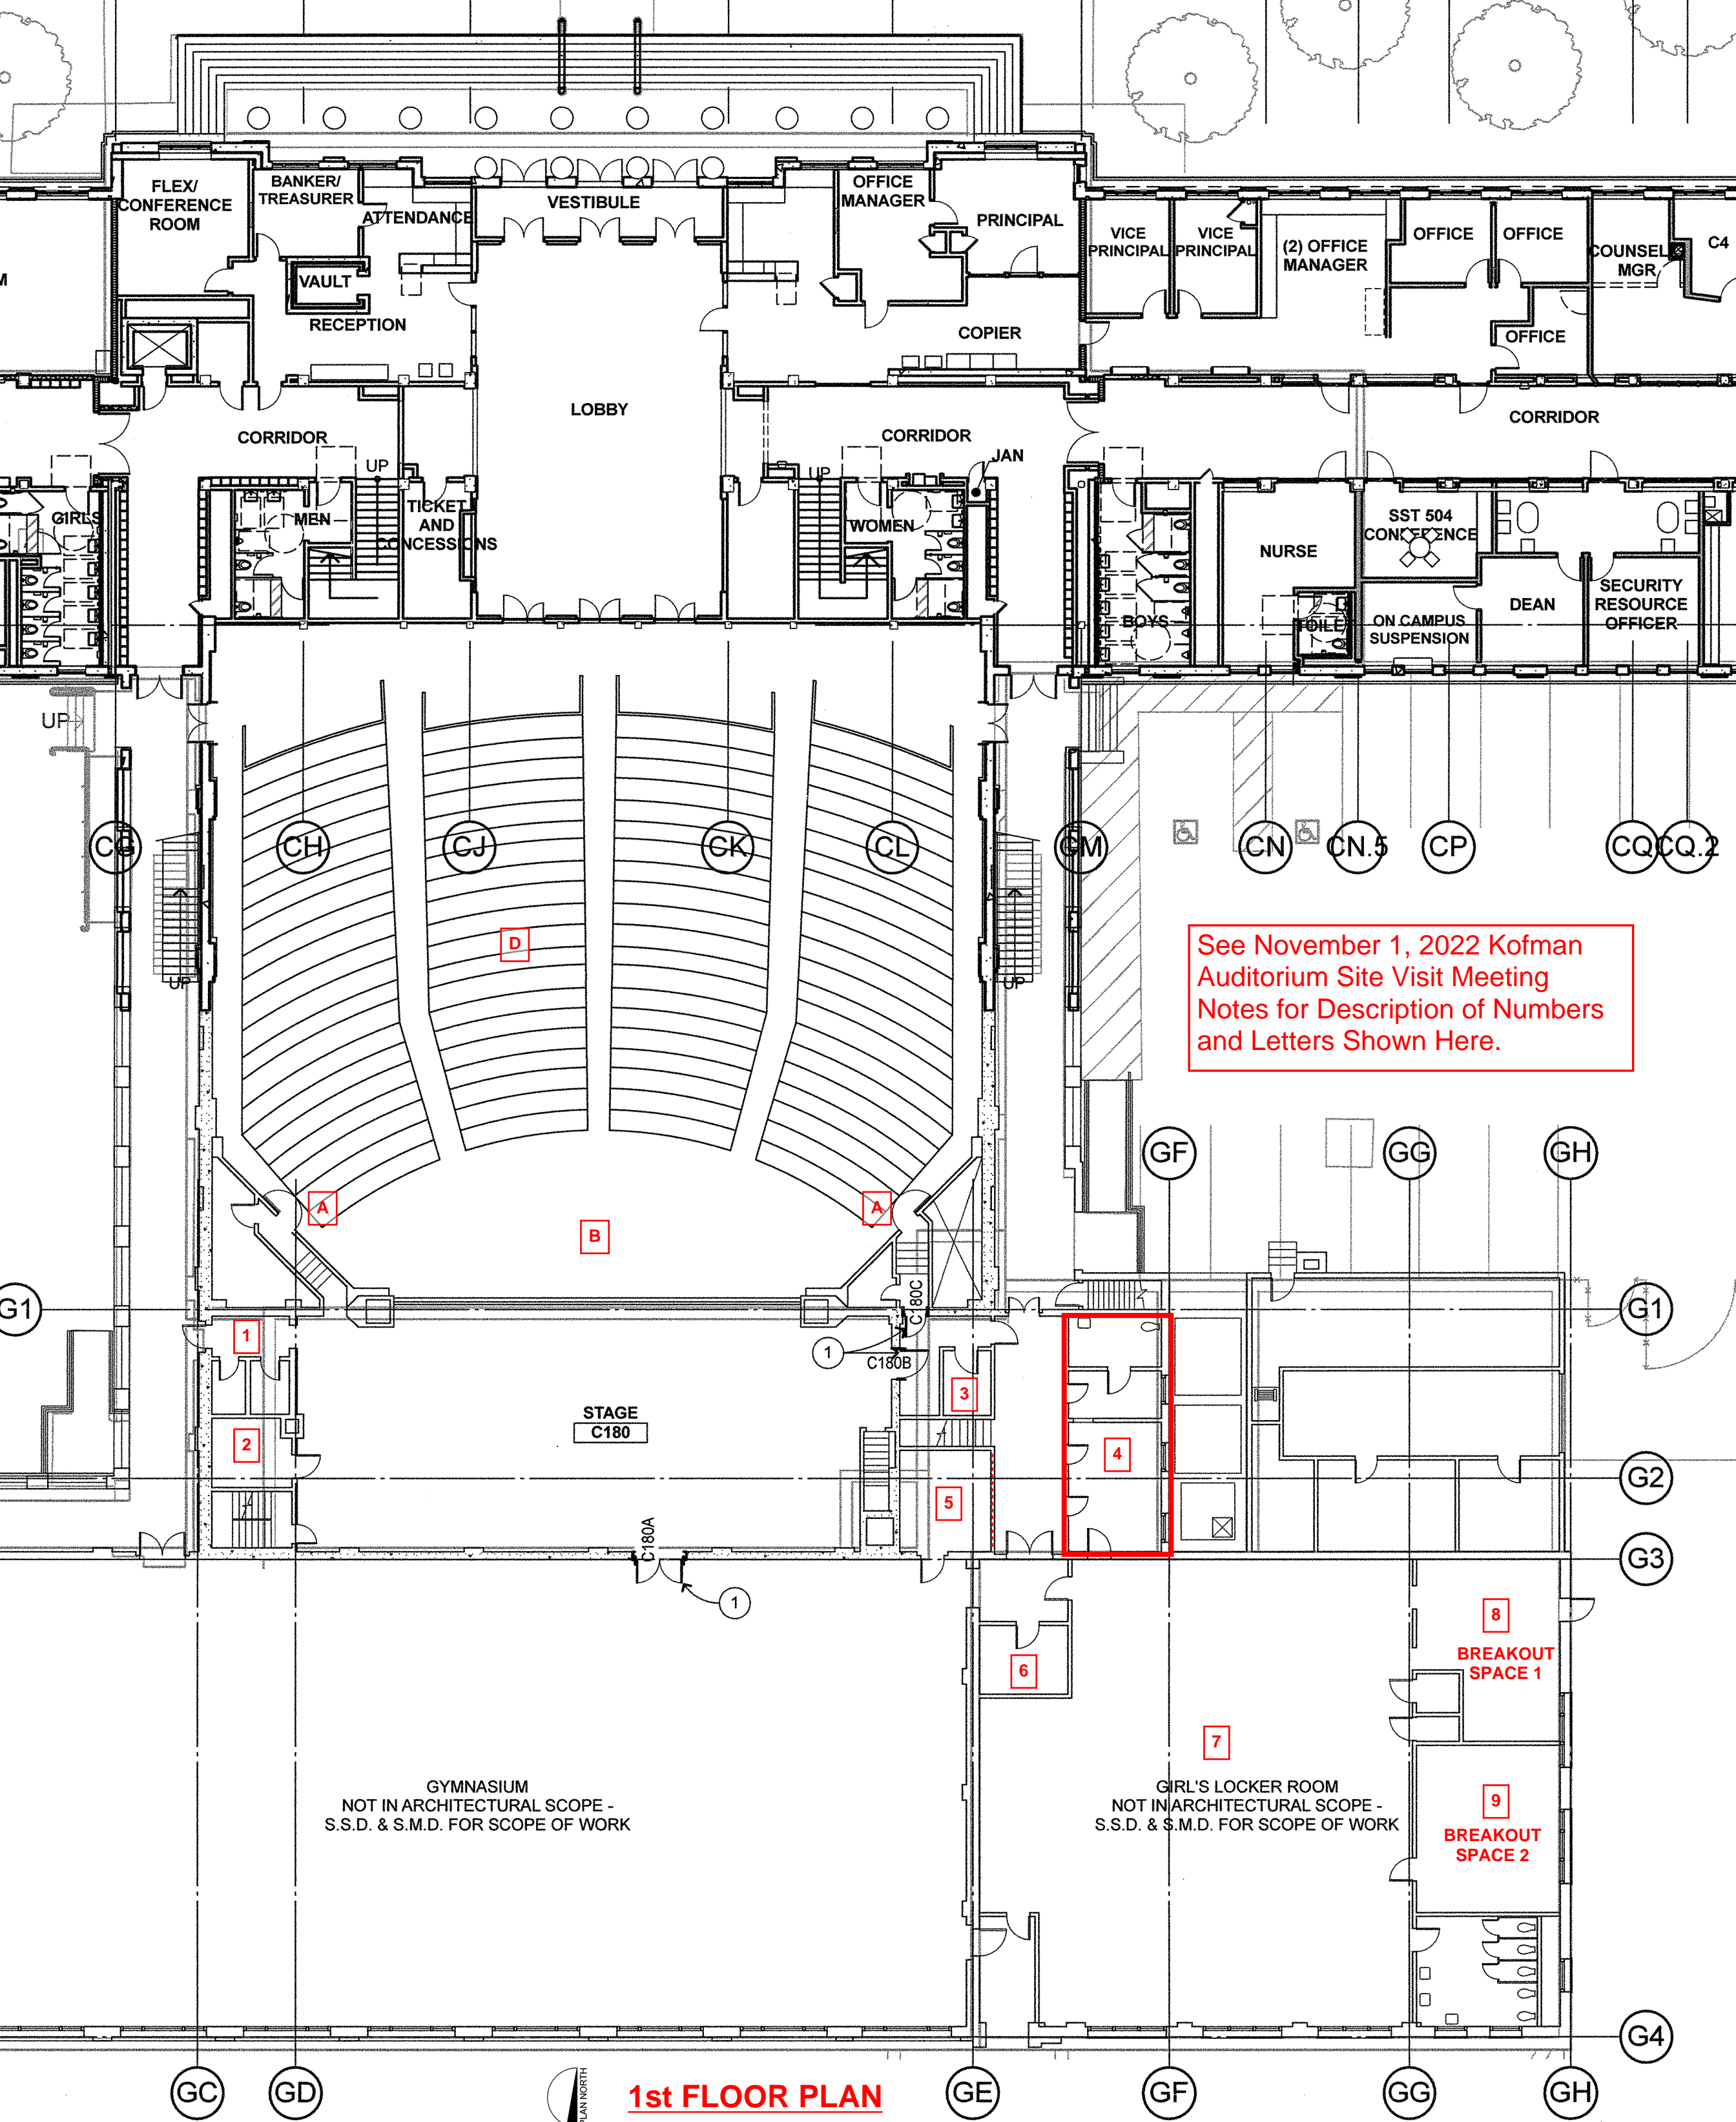
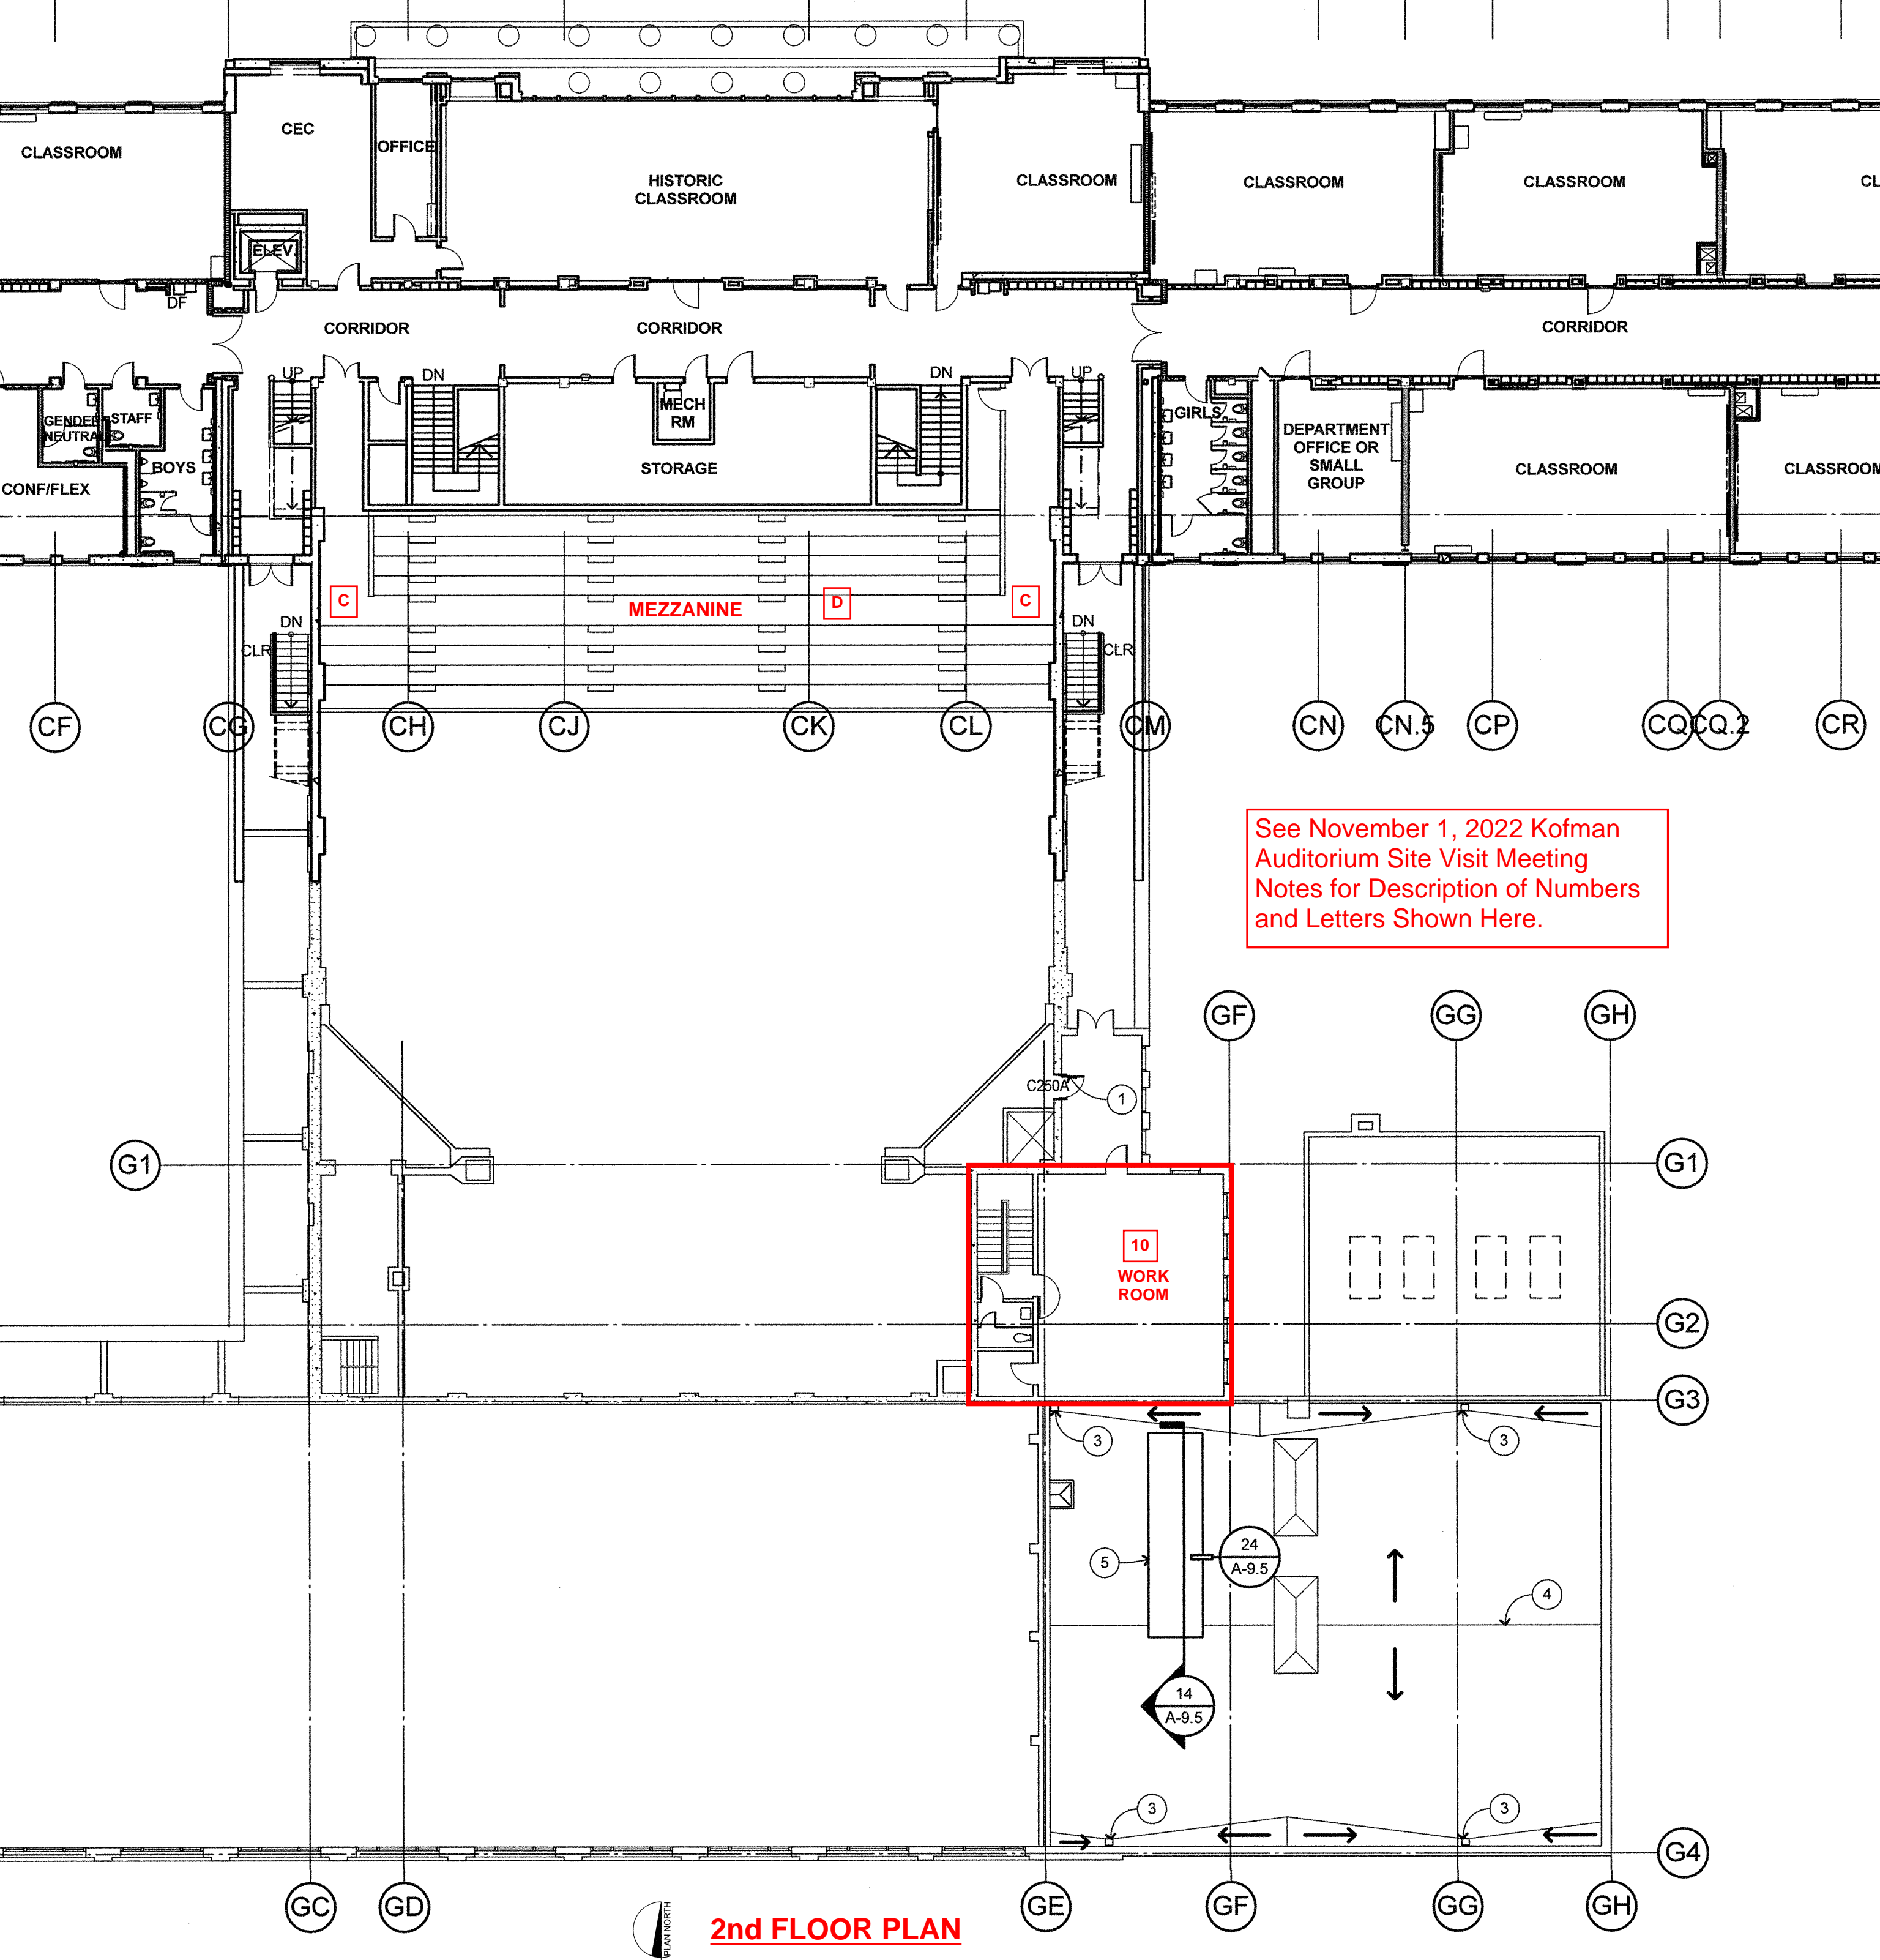
1. Existing dressing rooms w/ plumbing fixtures. Need replacement finishes & plumbing fixtures (if sinks in dressing rooms are desired).
2. Candidate for use as dressing room/s: Theater Manager's Office. SK stated that school is not planning to hire or keep on staff a theater manager. This space could be converted to dressing room/s to supplement keynote areas 1 & 3.

3. Like keynote area 1, this is an existing dressing room w/ a plumbing fixture. Similarly, would need replacement finishes & plumbing fixture (if needed).

4. Candidate for use as dressing rooms: Inspectors Rooms. These spaces are reserved for outside inspectors. SK suggested it may be possible to move them to another area/building/campus. These spaces have good proximity to the stage. One room appears to have plumbing as well (rooms were locked so was not able to access).

5. Candidate for use as dressing room/s: Storage Room. This space is being used for long term storage of Theater items that RI & SK agreed could be disposed of.

- a. There was a question as to whether the wall shown dashed used to have a door through it. Wall appears to be patched. Restoring that as an egress point to the hallway would benefit the space for dressing room use. Would need to study record drawings & code analysis.

6. Sports Equipment Storage. RI stated, the Gym needs to keep this space for storage, as they already have very limited space for storage.

7. Martial Arts/Tumbling space. This large open space is well finished out for its current use. RI stated that sports message tables at south end of room could be moved to Breakout Space 2 (Keynote 9), and tumbling mats moved south to create more space on north side of room.

- a. If this newly created space was divided up by addition of partition walls into dressing rooms, that would most certainly need DSA review.
8. Breakout Space 1: Candidate for use as dressing room/s. The space might be used as overflow dressing room/s, in addition to using spaces at keynotes 1-5.

9. Breakout Space 2: Candidate for use as dressing room/s. This could also be used as an overflow dressing room, but Breakout Space 1 would likely work better programmatically. That way there is less intrusiveness between sports & theater activities.

See November 1, 2022 Kofman Auditorium Site Visit Meeting Notes for Description of Numbers and Letters Shown Here.

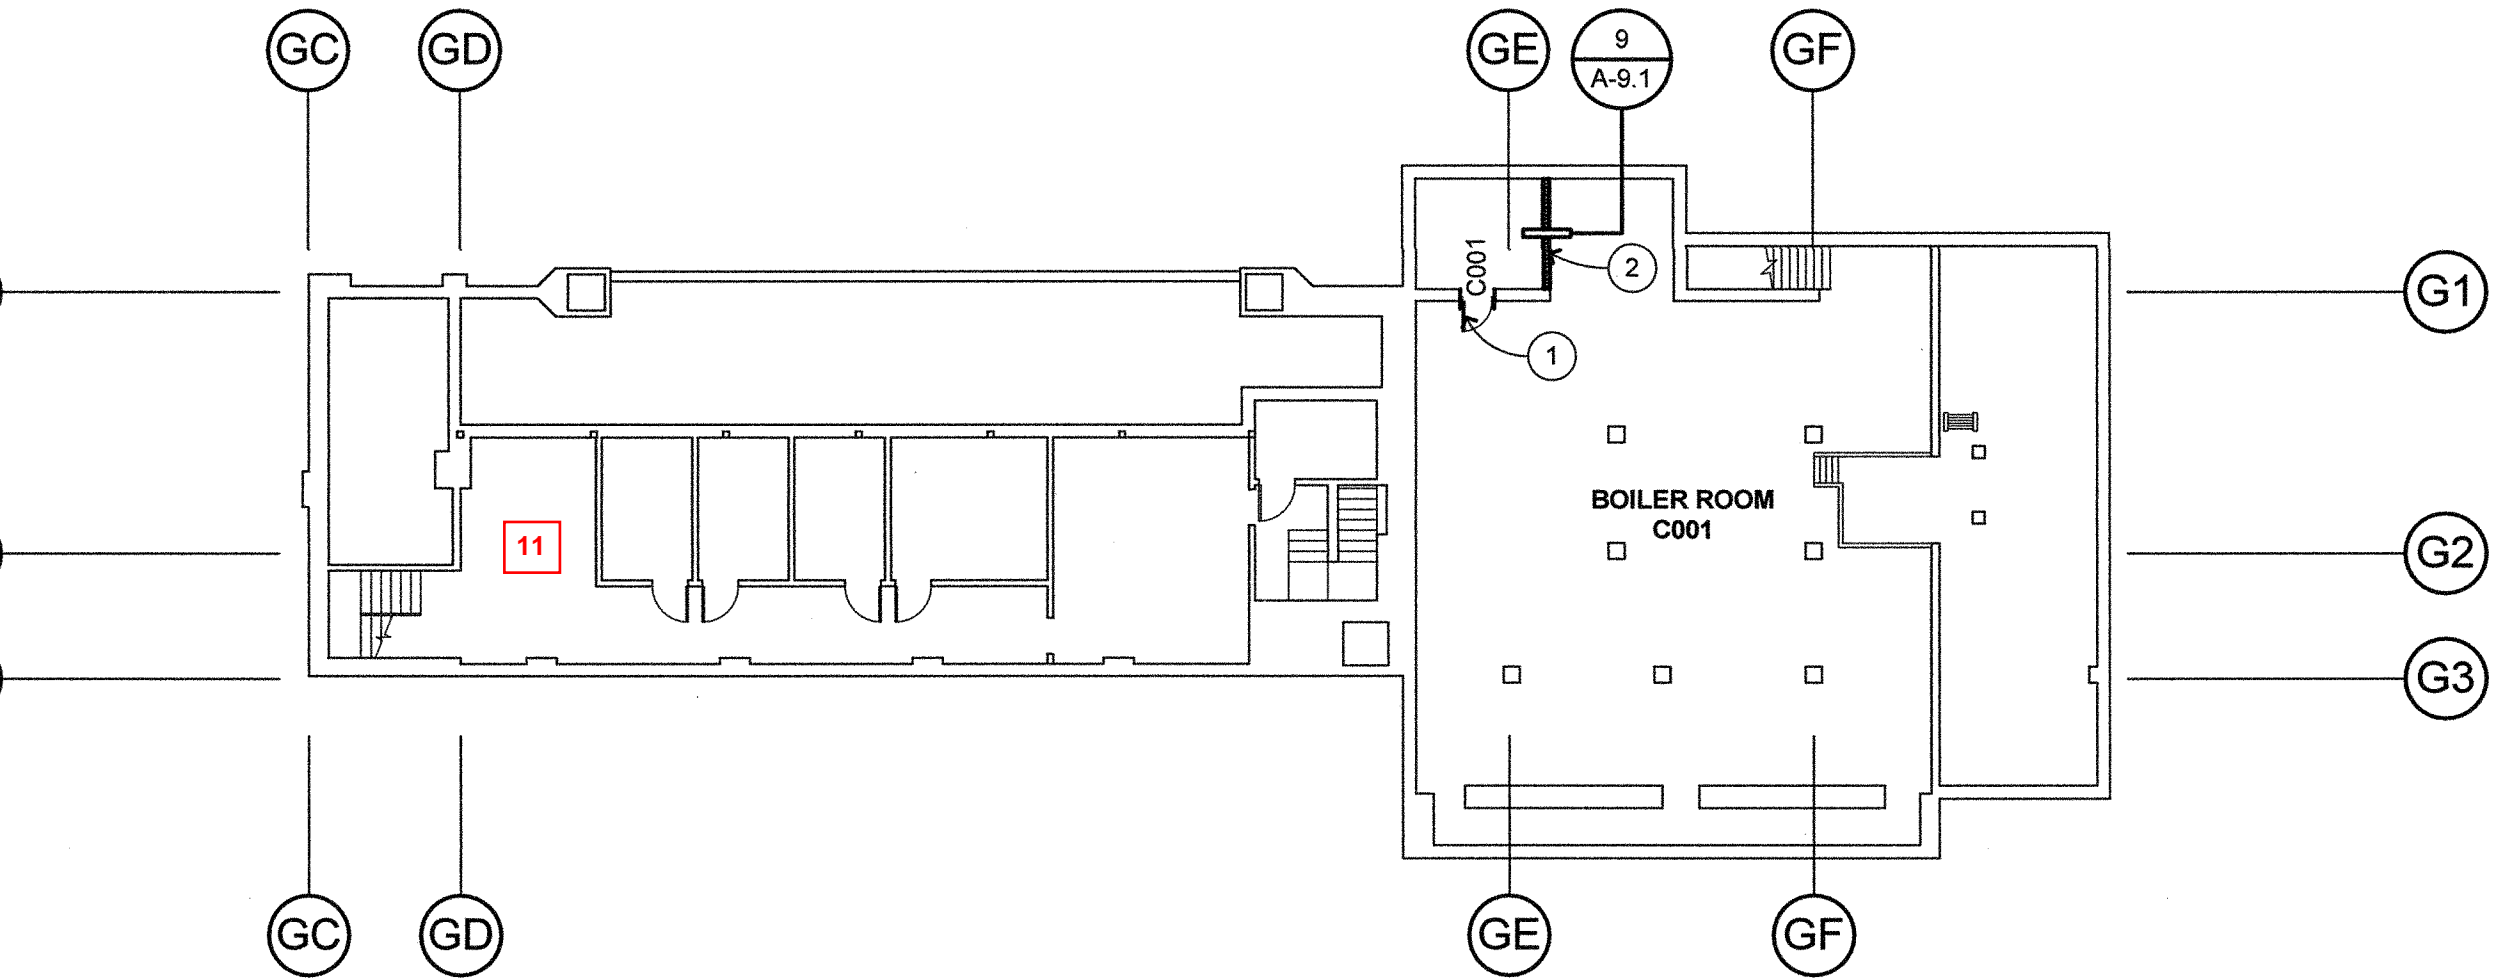
BASEMENT PLAN

11. Below stage space previously used for dressing rooms. A fair amount of space, but in addition to ADA compliance issues that space might require HVAC work. Seems damp and very musty.
