Proposed Southampton Greenway Trail Existing Conditions Review of Bridges and Culverts

TO: Michael Buehler, Chair of the Southampton Greenway Committee
FROM: Craig French, P.E. Structural Engineering Manager, Tighe & Bond
COPY: Elizabeth Baldwin, P.E., Vice President, Tighe & Bond
Margaret Freed, Structural Staff Engineer, Tighe & Bond
DATE: November 7, 2017

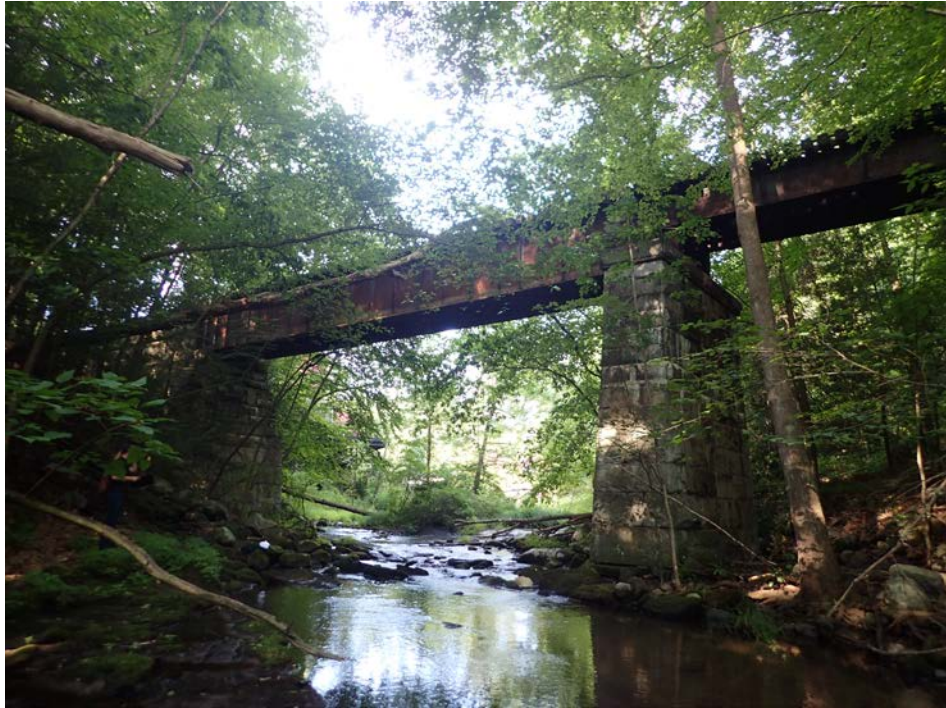
Adjacent to Sheldon's Ice Cream Shop is an unused railroad bridge that spans over the Manhan River (**Photo 1**). The bridge is oriented from North to South and the Manhan River flows from West to East. This bridge is a two span, built-up riveted steel stringer bridge with two girders. The southern span is the longer span and constructed with deeper girders compared to the northern span. The pier and abutments are constructed of dry-laid, granite blocks with parged mortar joints (**Photos 2-3**). At the north abutment, there are

Photo 1: East Elevation of the Manhan River Bridge

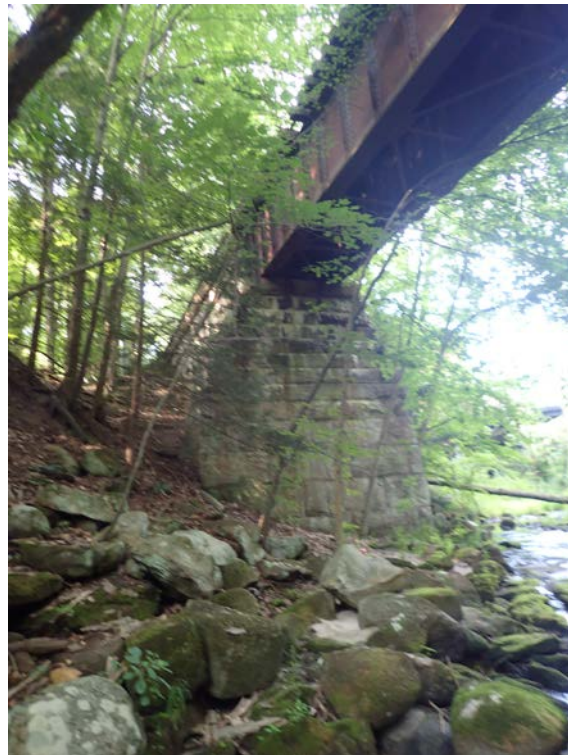
Photo 2: View of the South Abutment

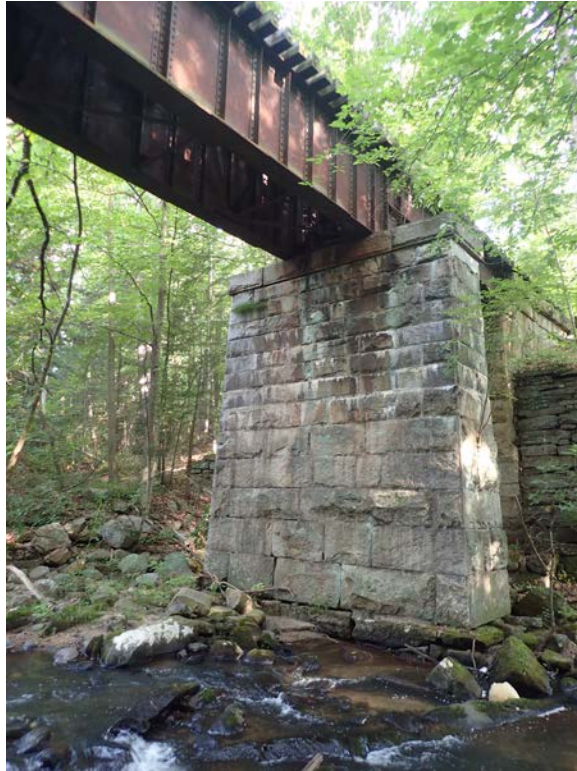
Photo 3: View of the Center Pier

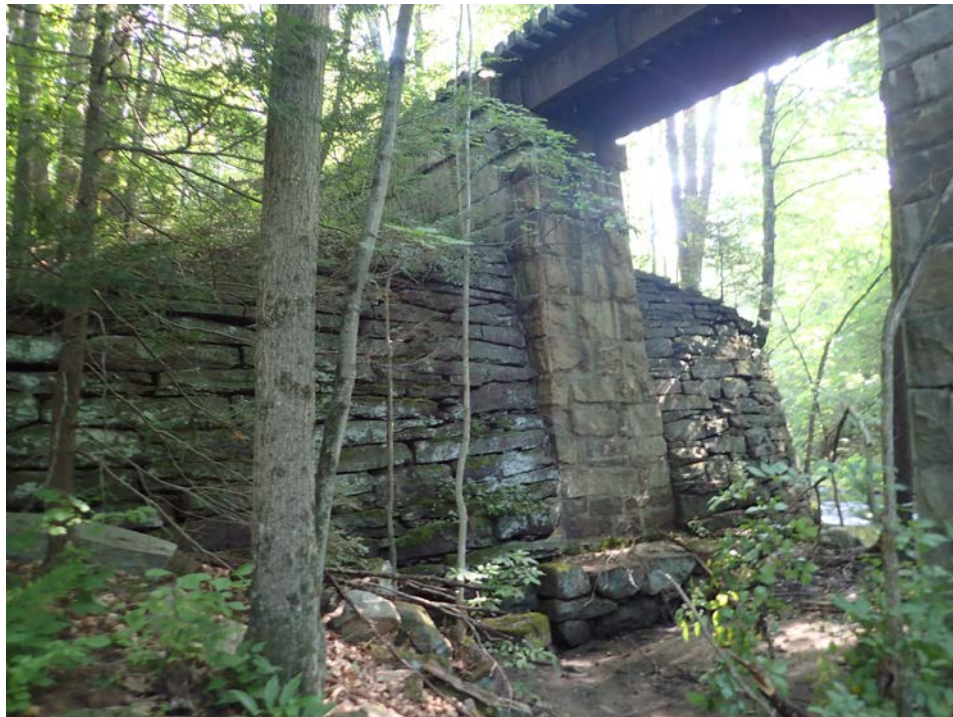
dry-laid stone masonry wingwalls on either side (**Photo 4**).

Photo 4: View of the North Abutment

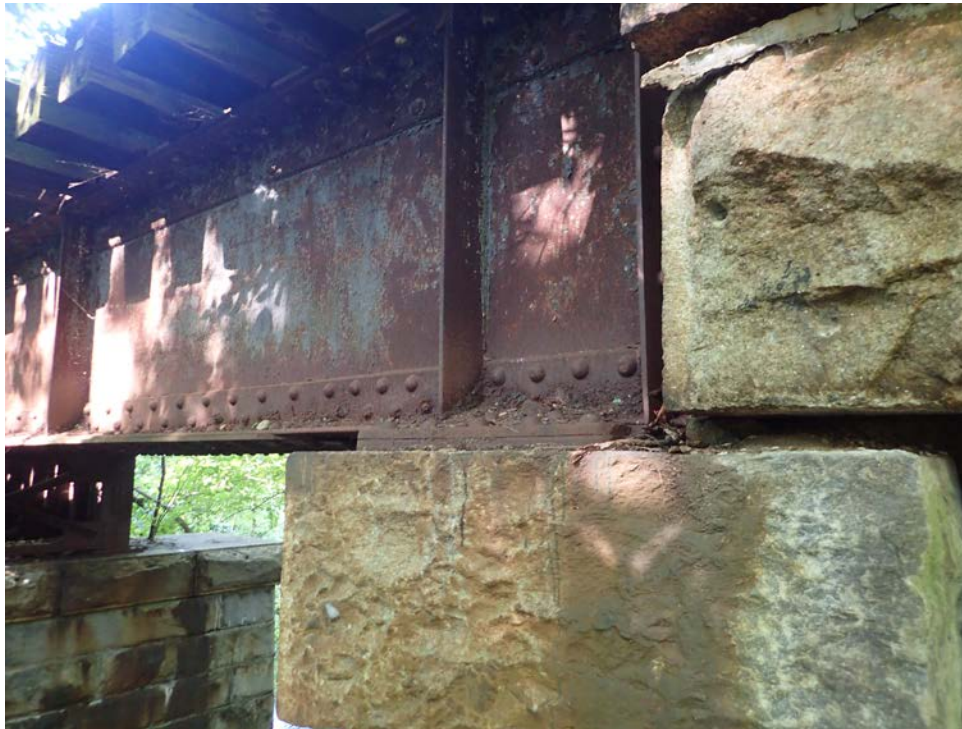
Superstructure: The built-up, riveted steel girders of the existing Manhan River Bridge exhibit moderate rusting throughout the webs and flanges. The most advanced areas of rusting are along the bottom flange of both girders. Rivets located closest to the bottom flanges have advanced deterioration and many rivet heads have complete section loss (**Photo 5**). In these locations, it is likely that the entire stem of the rivet has also deteriorated. The existing paint system is failed across the entire structure. Due to the age of the structure, there is a possibility that the coating system contains hazardous materials, such as lead paint.

Photo 5: North end of girders, complete section loss of rivet heads

Most of the rivets in the bridge girders are in fair condition; however, many rivets located along the bottom flange of the beams are severely deteriorated. We recommend that rivets with severe section loss be replaced. This can be accomplished by removing the deteriorated rivets, cleaning the hole of remaining rust and debris, and installing new high strength bolts in their place.

We recommend sandblasting the steel superstructure to remove any buildup of rust on the built-up riveted steel, and to remove the failing coating system. Once the rust and existing coating system has been removed, a new layer of protective coating should be applied. This coating will help extend the lifespan of the existing structure.

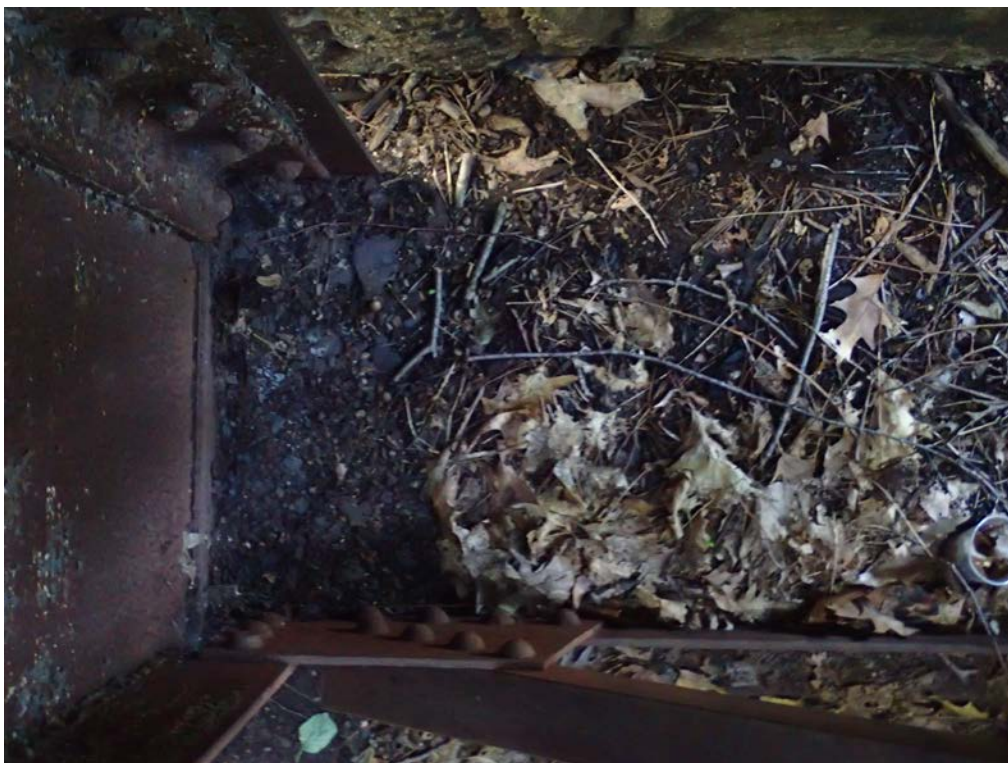
Due to a buildup of debris on the bearing, the condition of the bearing could not be readily determined (**Photo 6**). Based on the minor rusting on the adjacent steel superstructure, it is likely that the bearings are in similar condition.

Photo 6: Heavy debris on bearing

Many of the bearings were not fully visible during our inspection due to a significant amount of debris accumulation, and it is likely that the bridge bearings have some level of deterioration. In order to determine the exact amount of corrosion, an inspection utilizing ladders will be necessary to reach the upper bearings. For the purposes of this technical memorandum, replacement of the bearings is included in the repair cost estimate.

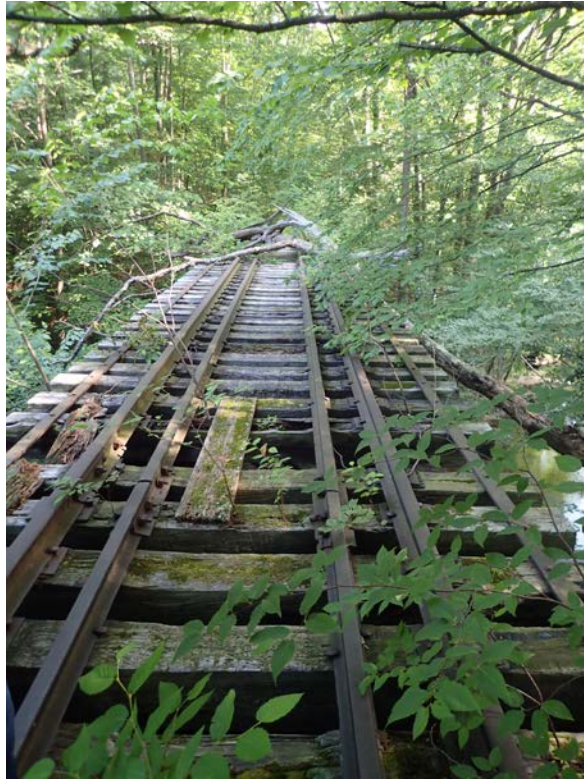
Deck: The deck of the existing bridge consists of deteriorated timber ties and a railroad track (**Photo 7**). Trees and brush are growing over the structure at the approaches. At the time of the site visit, a fallen tree was resting on the bridge deck. For the installation of a suitable deck for the proposed rail trail, it will be necessary to demolish the existing timber ties and railroad track.

Photo 7: Existing timber deck with railroad ties

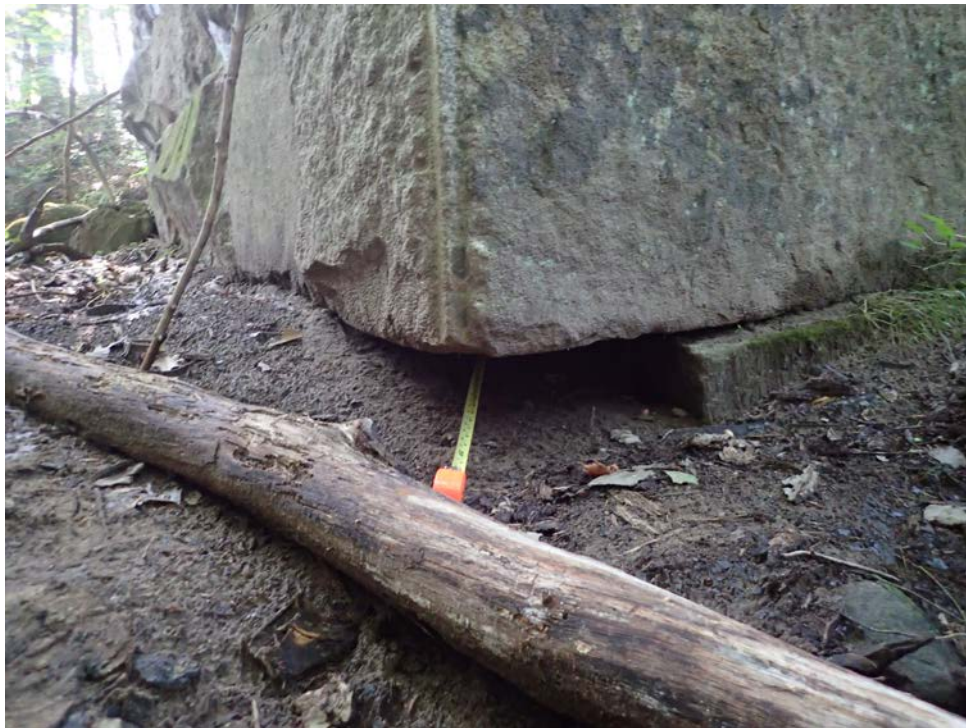
Substructure: The existing stone masonry abutments and the pier are generally in good condition. The parged mortared joints on the substructure elements have several areas of efflorescence. This likely means that water is migrating from the backfill through the parged mortar joints in the stone masonry abutments. However, none of the granite blocks in the masonry abutments and pier have visible cracks and there were no signs of sections shifting. This is a good indicator that the abutments are stable and not settling. On the northwest side of the pier, there is a 3-foot-deep section of undermining beneath the masonry blocks (**Photo 8**). In general, the base stones that support the center pier do not extend very far beyond the footprint of the stone masonry. This leaves the pier unprotected and at risk for further advancement of the current scour and undermining issue. There are already several foundation supports fully exposed.

Photo 8: Undermining of center pier

The base of the abutments and piers should be protected with additional riprap and scour protection. Since the northwest corner of the pier has a potential undermining issue, repairs to the scour vulnerable areas should be completed to maintain the integrity of the structure. Grouting beneath the center pier to fill the current void created by scour should be completed, and rip-rap added around the pier and both abutments to direct water flow and prevent future erosion issues.

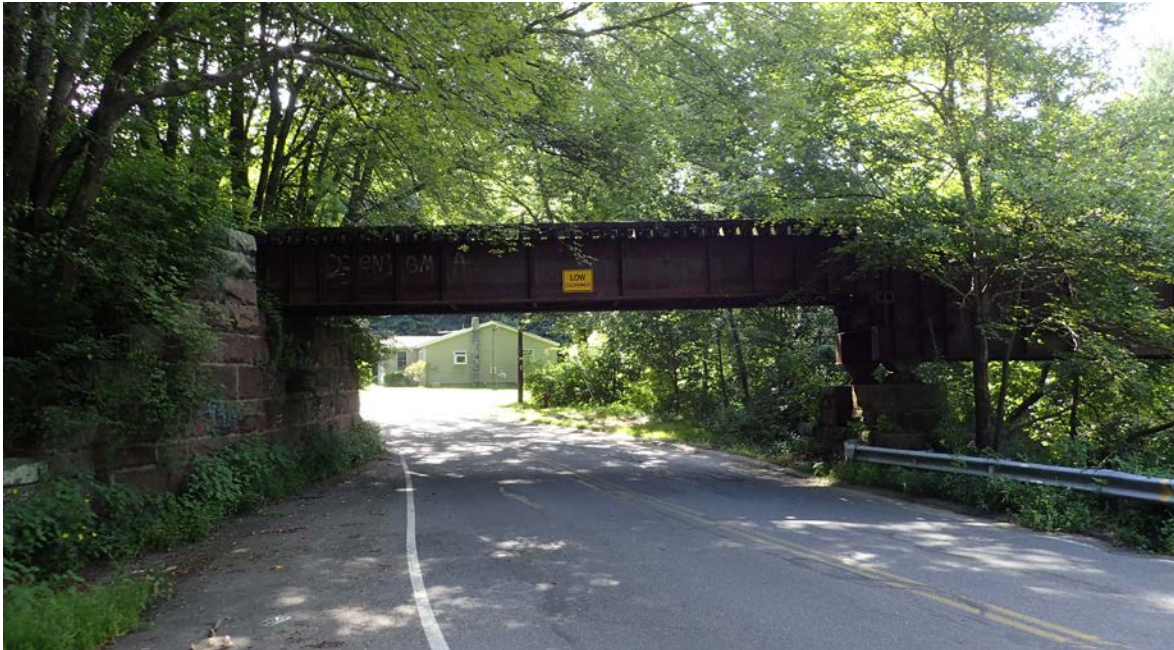
The second unused railroad bridge spans over Gunn Road and the Manhan River (**Photo 9**). The bridge is oriented from North to South and the Manhan River flows from East to West. Similar to the Manhan River Bridge, this structure is a built-up, riveted steel stringer bridge with two girders. The southern span, over the Manhan River, is the longer span and constructed with deeper girders compared to the northern span. The pier and abutments are constructed of dry-laid, granite blocks with parged mortar joints.

Photo 9: West Elevation of the bridge over Gunn Road

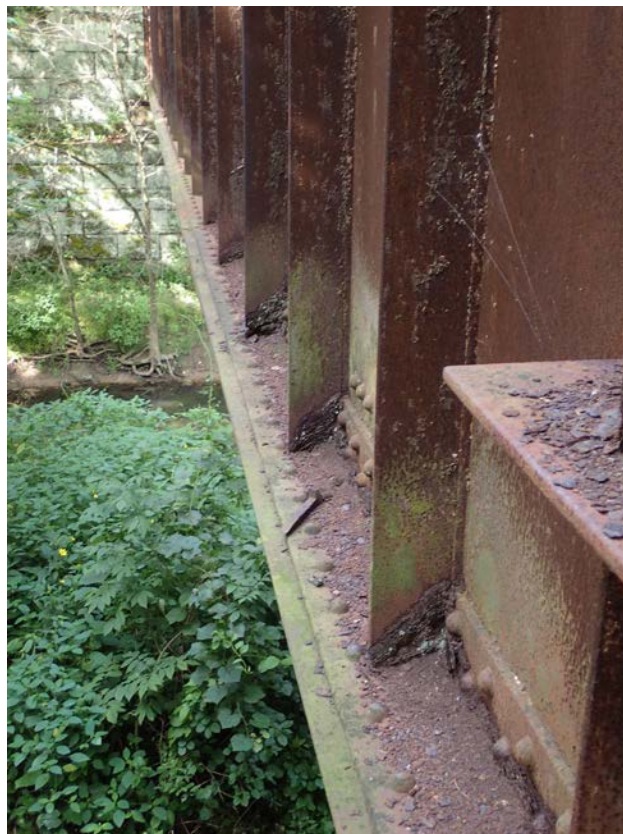
Superstructure: There is consistent surface rusting, and rust flaking throughout the built-up, riveted steel girders of Gunn Road Bridge. The most advanced deterioration is located on the bottom flanges of the girders and on the vertical steel stiffeners (**Photos 10-11**). Many of the steel stiffeners have complete section loss at the bottom of the member. Along the bottom flange, there is a heavy buildup of debris, and the condition of the hidden rivets could not be verified. Based on the corrosion of the adjacent stiffeners, it can be assumed

that some rivets along the bottom edge of the girders are severely deteriorated with advanced section loss.

Photo 10: Rusting and deterioration of the steel stiffeners

The majority of the riveted steel vertical stiffener plates have severe corrosion near the bottom flange and should be replaced. New stiffener plates can be fabricated to match the existing dimensions and connected to the structure using high strength bolts.

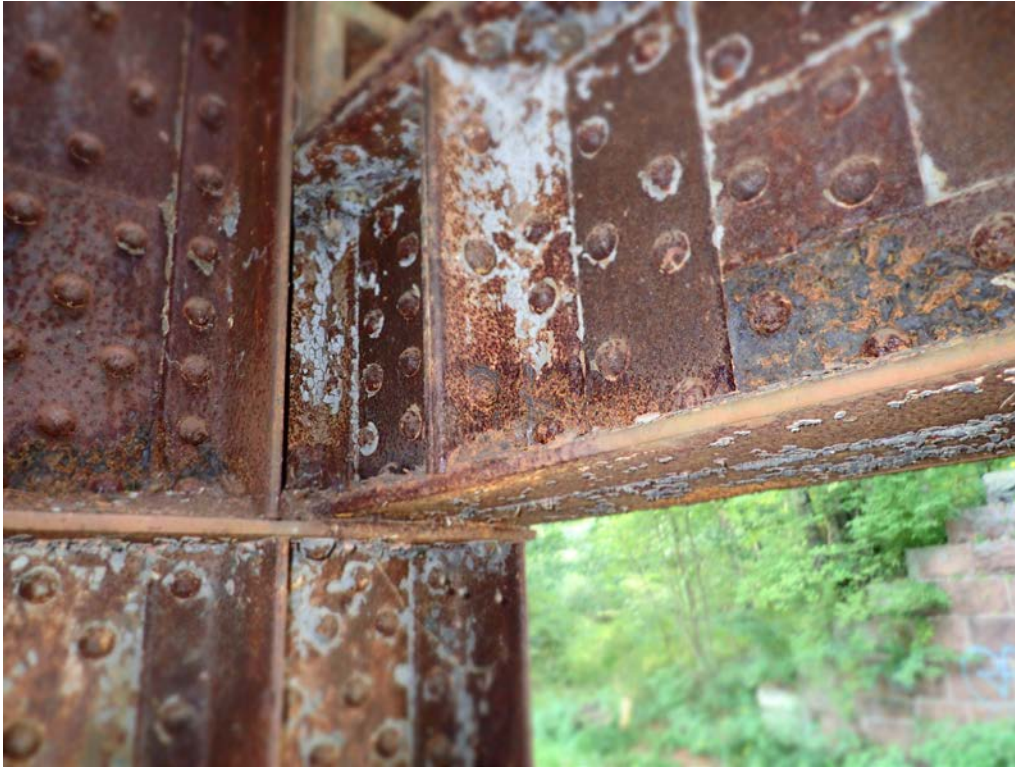
Photo 11: Rusting of riveted steel panels above the bridge pier

Some riveted panels, specifically around the center pier, have advanced deterioration and should be replaced. New panels can be fabricated to match the existing dimensions and installed using high strength bolts. On riveted panels with minor deterioration, we recommend sandblasting to remove any buildup of rust on the riveted steel and to remove the areas of the failing coating system. Once the rust and existing coating system has been removed a new layer of protective coating should be applied. This coating will help extend the lifespan of the existing structure.

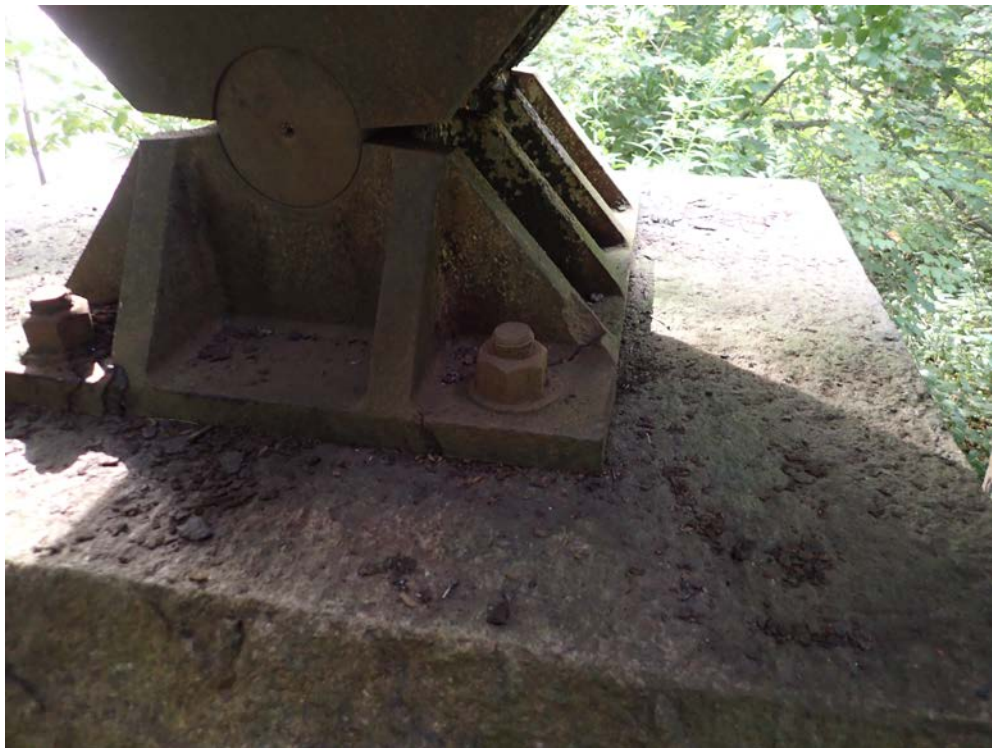
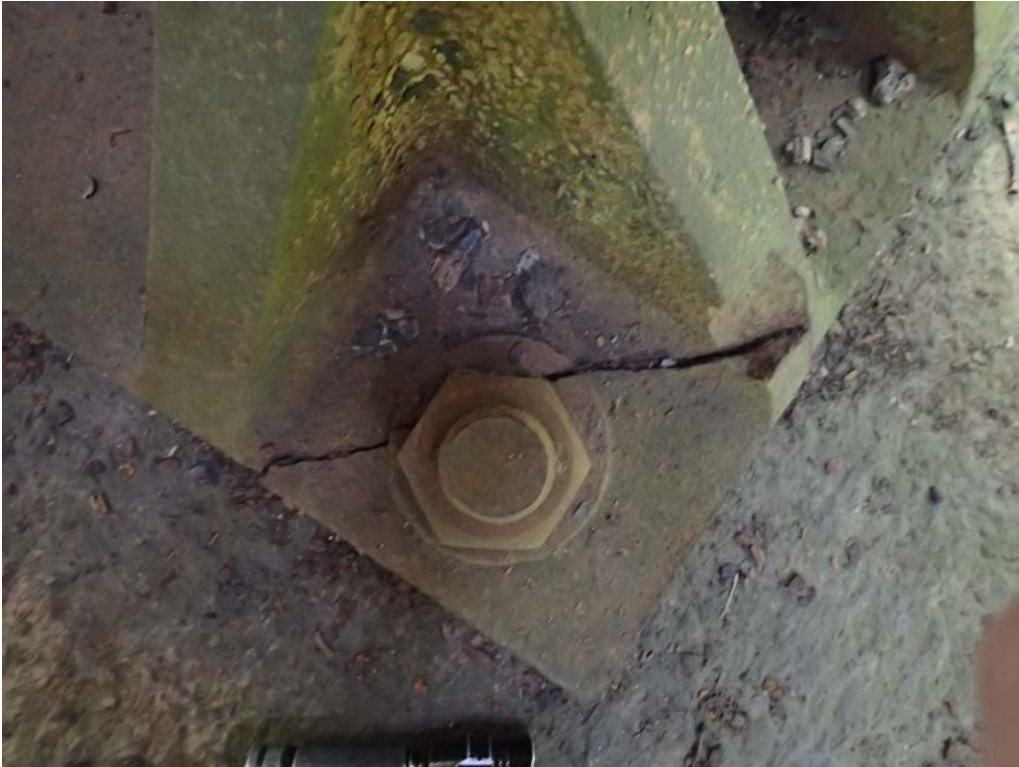
Several of the bearings are in poor condition. The bearing plates on the center pier have cracked diagonally across the corners at the anchor bolts (**Photos 12-13**). This indicates the fixed bearing is experiencing movement of the bridge superstructure from thermal expansion and contraction. A similar situation is occurring at the bearings on the north abutment. However, at the North location, the anchor bolts have tipped towards the north abutment, instead of the bearing plates cracking (**Photo 14**).

Photo 12: Cracked bearing on the bridge pier

Photo 13: Cracked bearing on the bridge pier

For the Gunn Road Bridge, we recommended that the bearings be replaced on the north abutment and the pier due to the cracked bearing plates and tipped anchor bolts. The cause of the bearing failure should be incorporated in the design of the new bearings to prevent a similar issue in the future repairs.

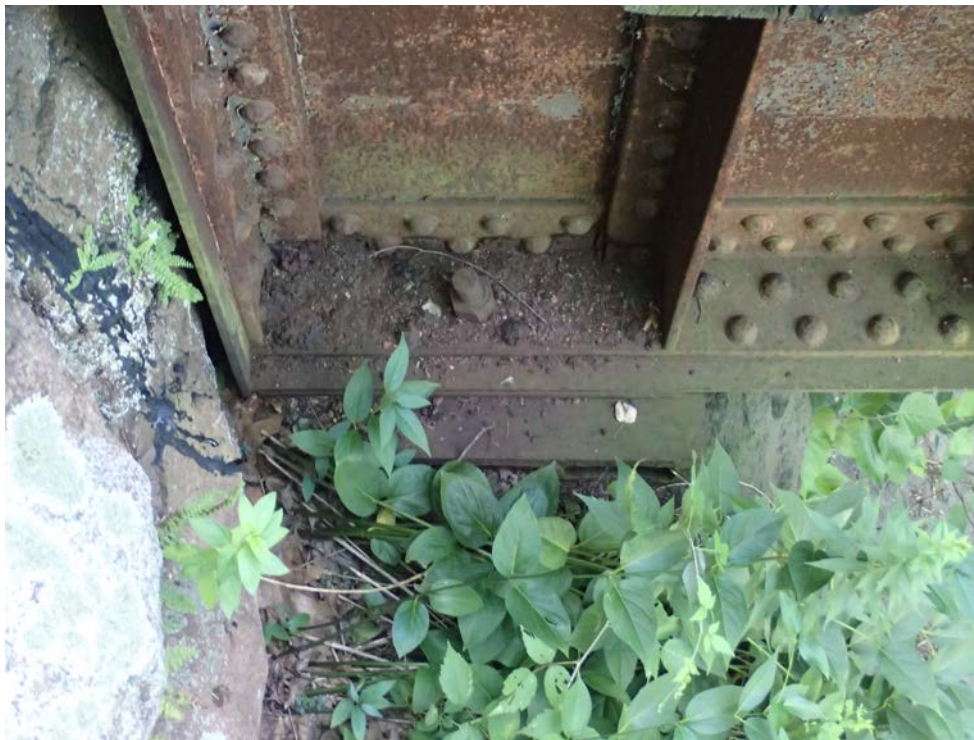
Photo 14: Tipped anchor bolt on the north abutment

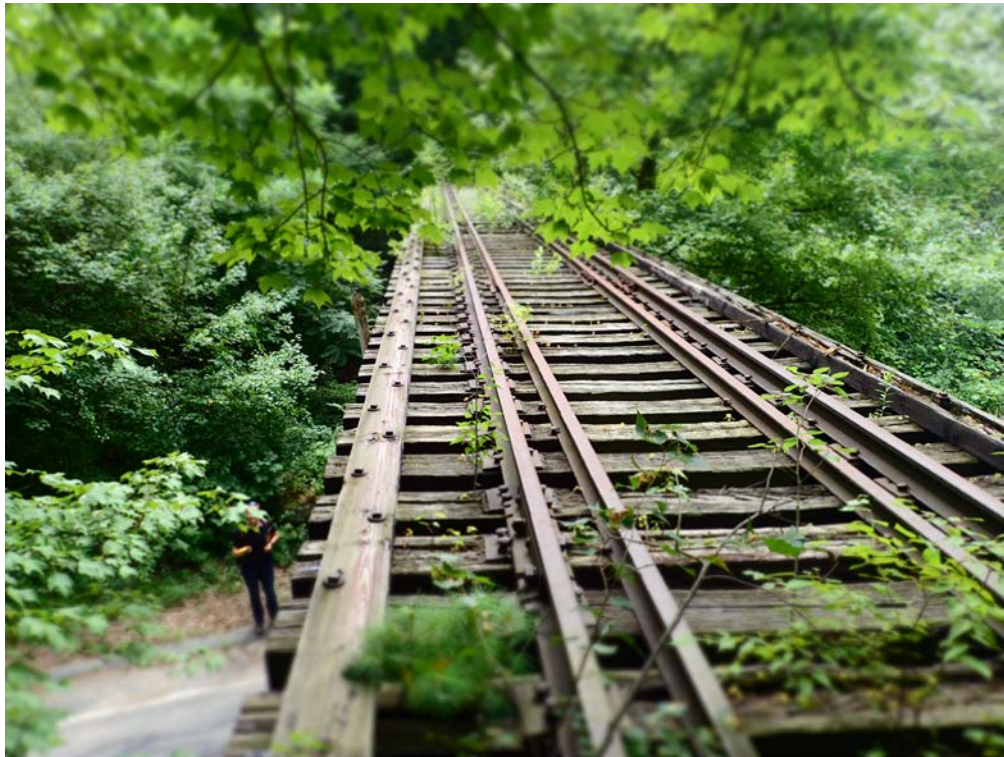
Deck: Similar to the Manhan River Bridge, the deck of the existing Gunn Road bridge consists of deteriorated timber ties and a single railroad track (**Photo 15**). Trees and brush are growing over the structure at the approaches. For the installation of a suitable deck for the proposed rail trail, it will be necessary to demolish the existing timber ties and railroad track.

Photo 15: Existing timber deck with railroad ties

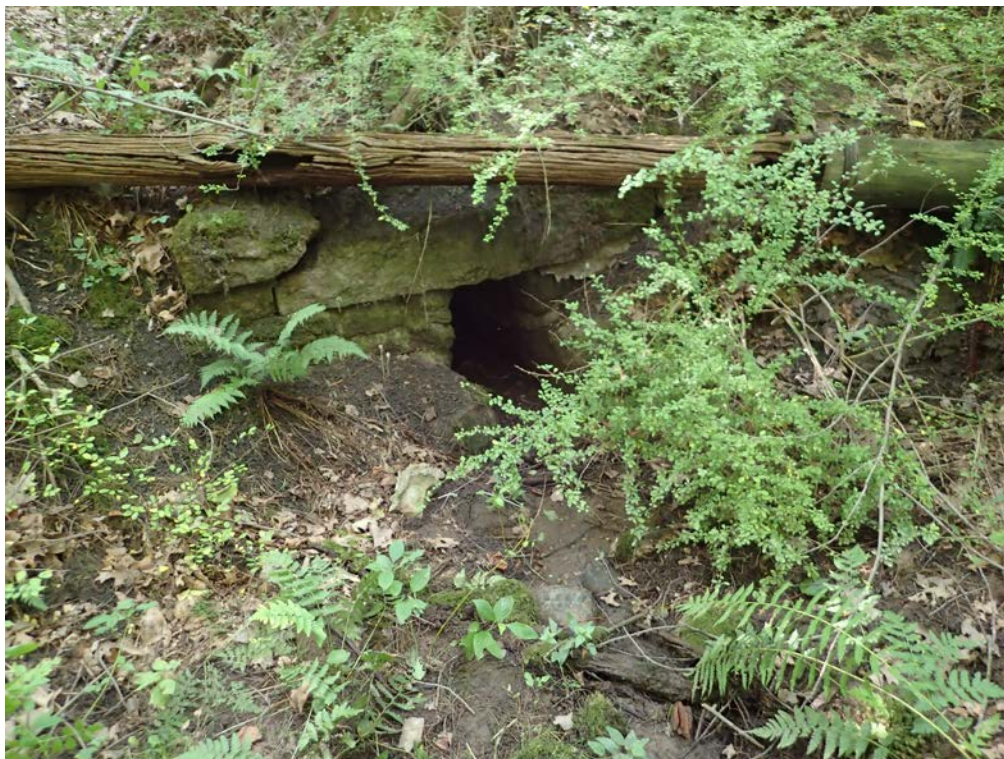
Culvert 1 is constructed of dry laid stone, with an opening of 16 inches wide by 27 inches high (**Photo 16**). Water flows from the west to the east side of the structure. The overall structural condition is rated as fair to poor. The east side of structure has completely collapsed; however, there are still signs of water traveling through the culvert (**Photo 17**). Besides the failed portion at the east side, the interior of the culvert is intact and overall in fair condition (**Photo 18**).

Photo 16: West Elevation

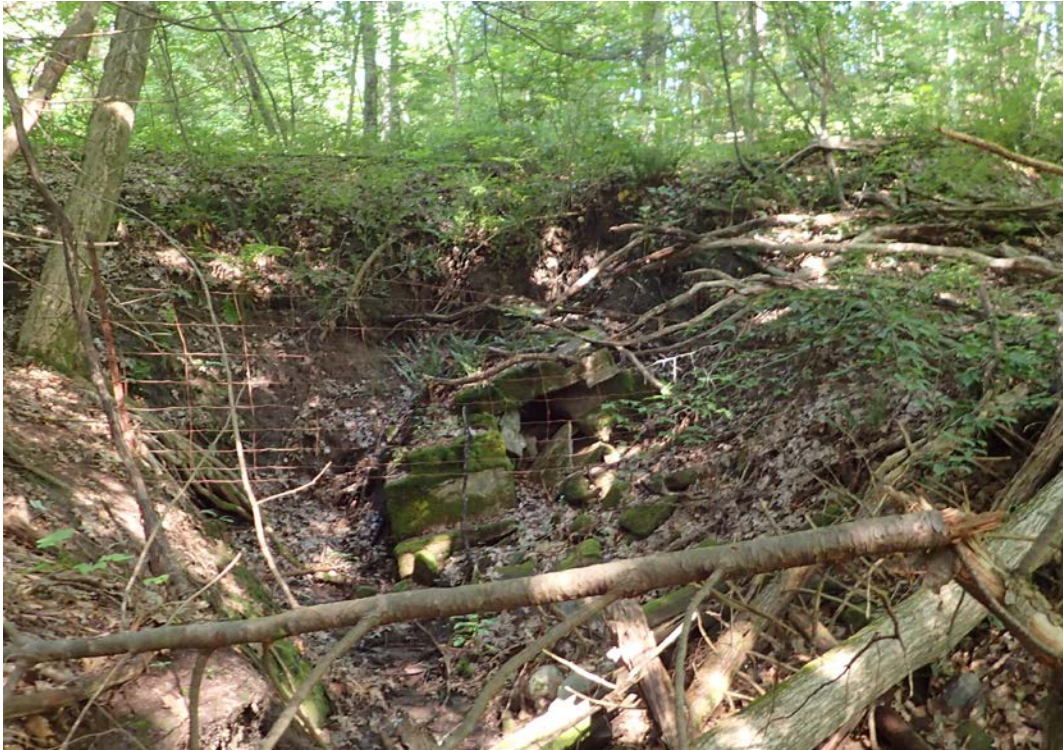
Photo 17: East Elevation showing Collapsed Section

Recommended Repair: Since the west side of the structure is in good condition, there are no necessary repairs to that portion of the culvert. However, the collapsed east side of the structure will need to be replaced. We recommended demolishing the entire deteriorated section of the culvert. This portion can then be replaced with a new concrete culvert connected to the remaining section of the existing structure.

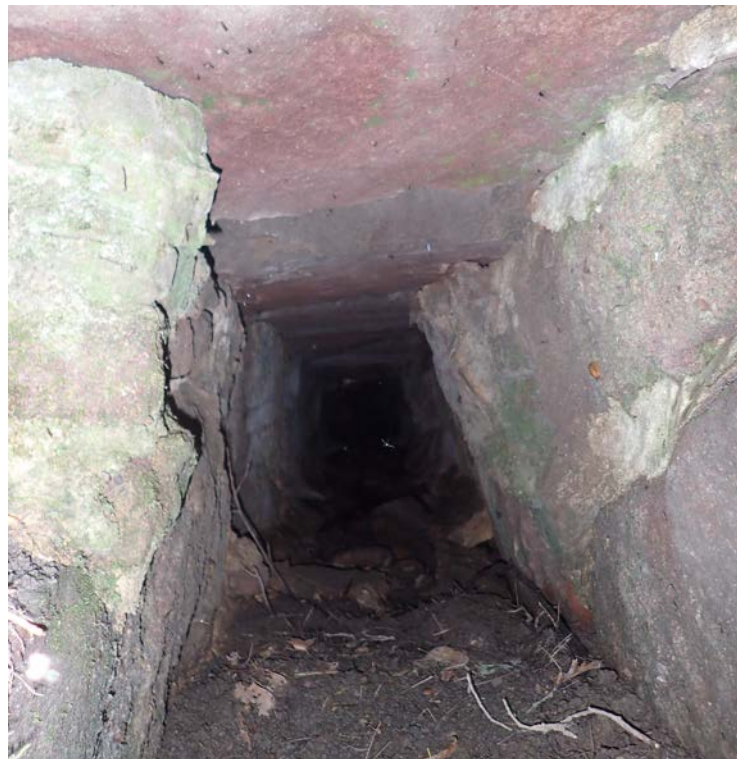
Photo 18: Interior of Culvert 1

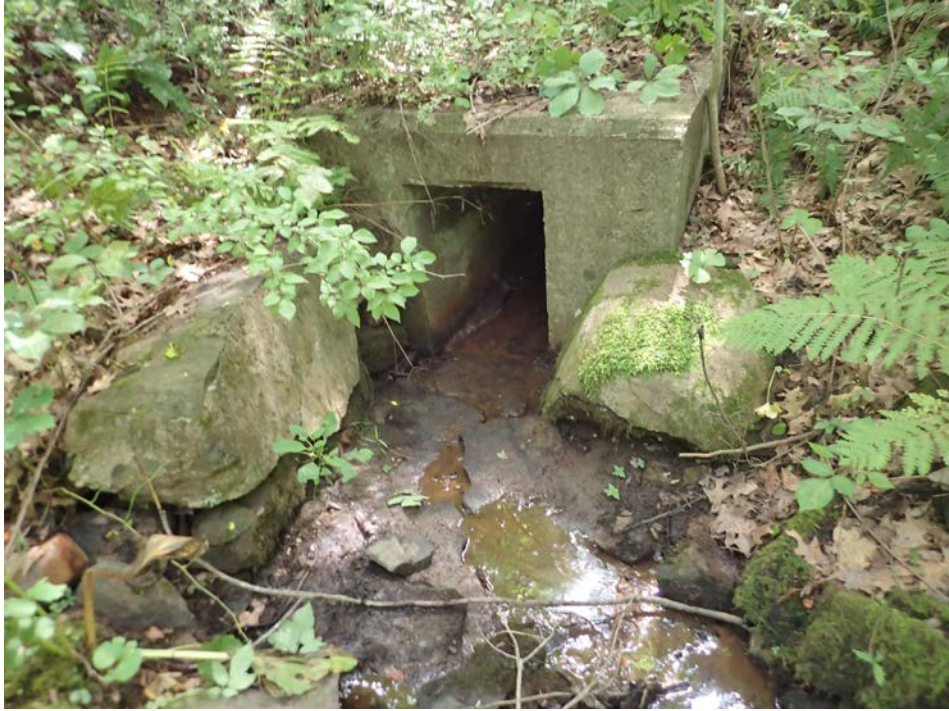
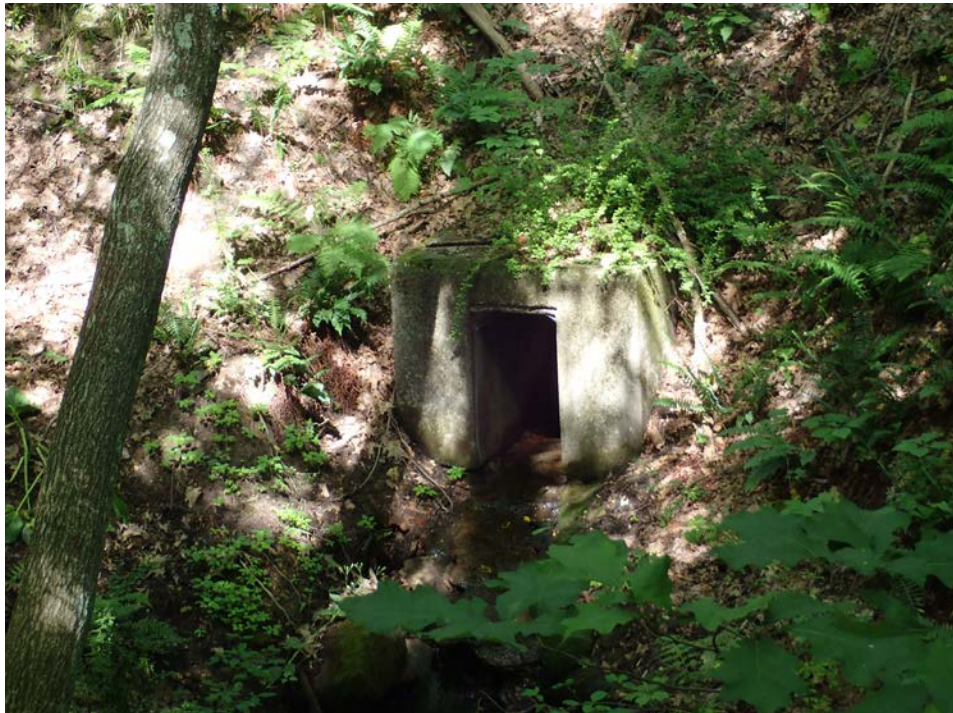
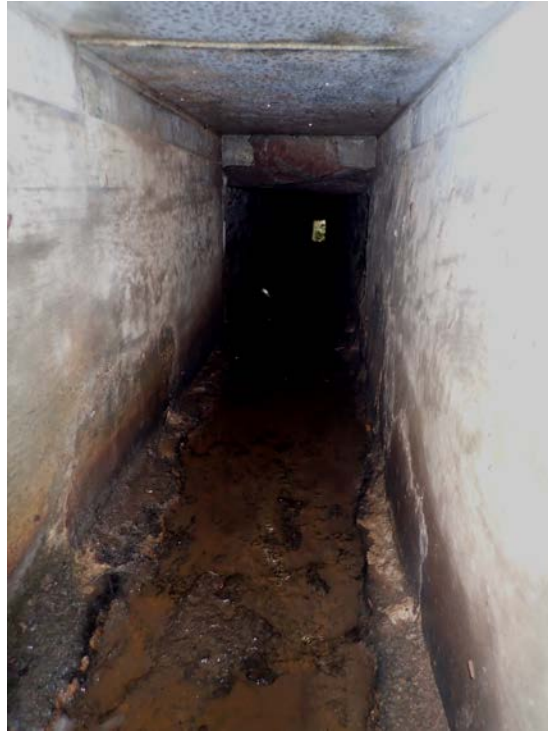
Culvert 2 has a middle section built from dry laid stone, and at some point, solid concrete inverts were constructed at either end of the structure (**Photos 19-21**). A joint is visible between the different construction types. The opening of the culvert is approximately 20 inches wide by 30 inches high at both the inlet and outlet. Water is actively flowing through the culvert from west to east. Overall the structure is in good condition.

Recommended Repair: No repairs necessary.

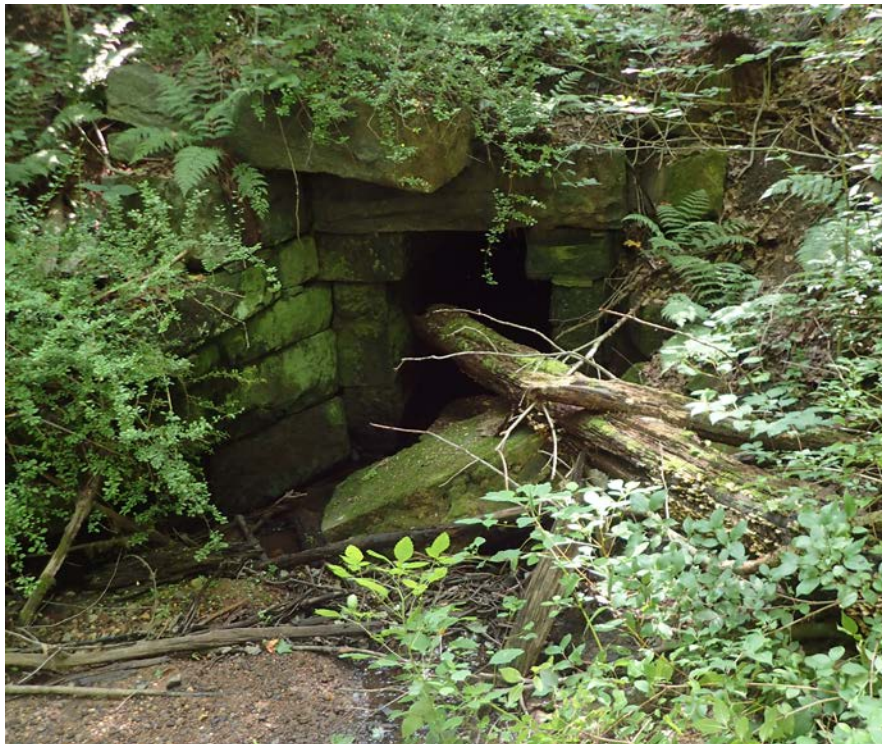
Culvert 3 is constructed with ashlar stone masonry with an opening size of 2 ft. wide by 4 ft. high. Overall the structure is in fair condition. The southwest wing wall has failed due to

Photo 22: West Elevation Showing Southwest Wingwall Failure

Recommended Repair: The southwest wingwall should be repaired using existing stone block. Localized excavation and clearing of vegetation is necessary to prepare the original area for resetting the wall stone. Patching and grouting the voids on the interior of the structure is also recommended. The dense overgrowth, upstream of the culvert should be cleared to maintain steady stream flow and to prevent debris from traveling through the structure.

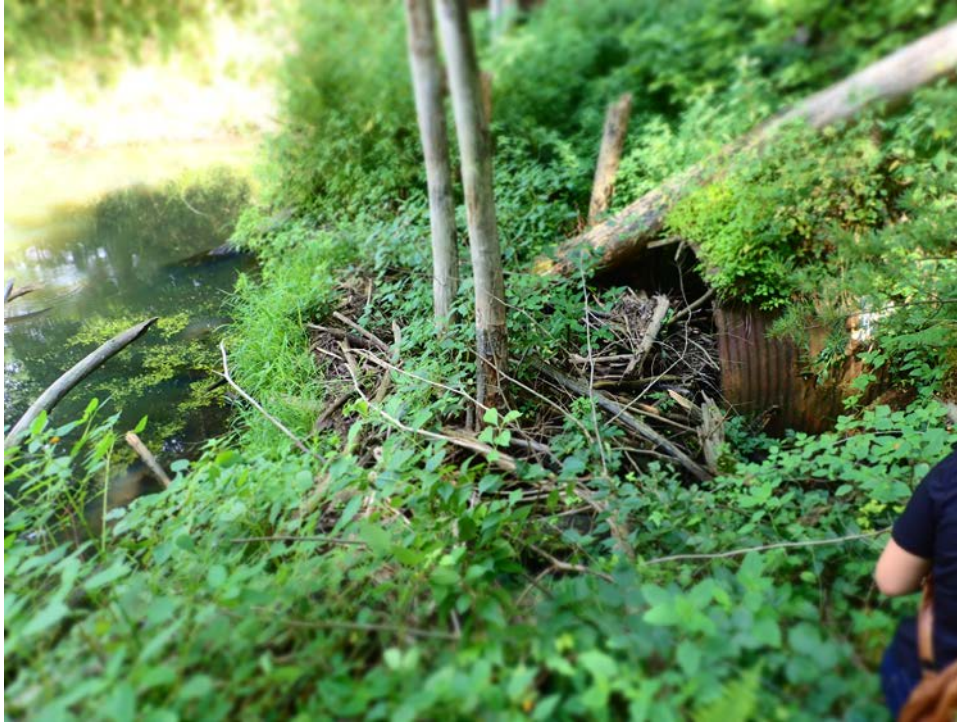
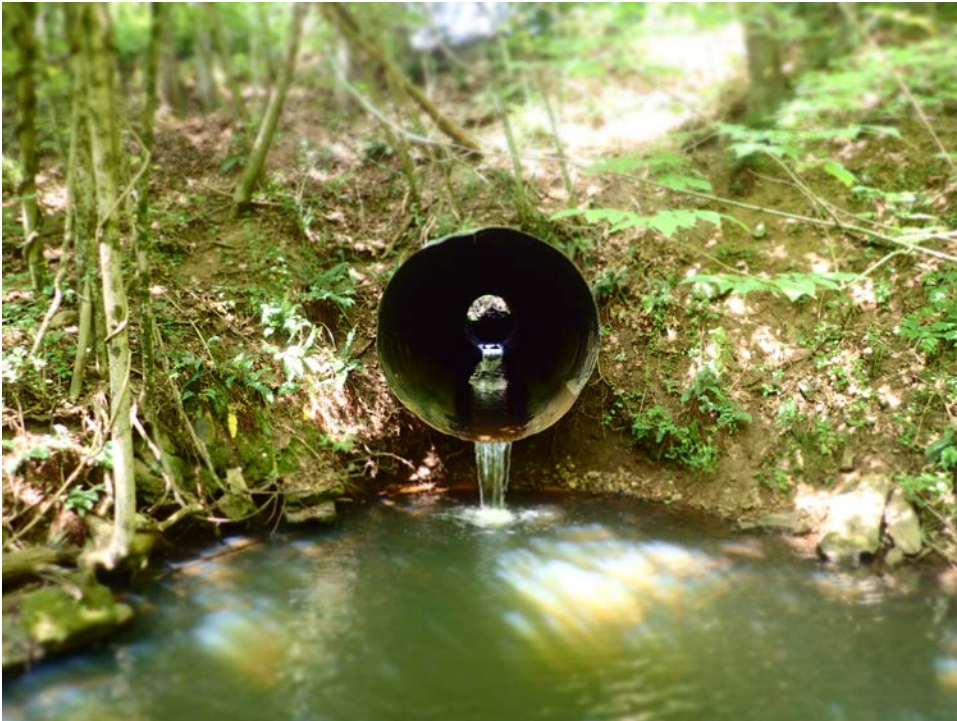
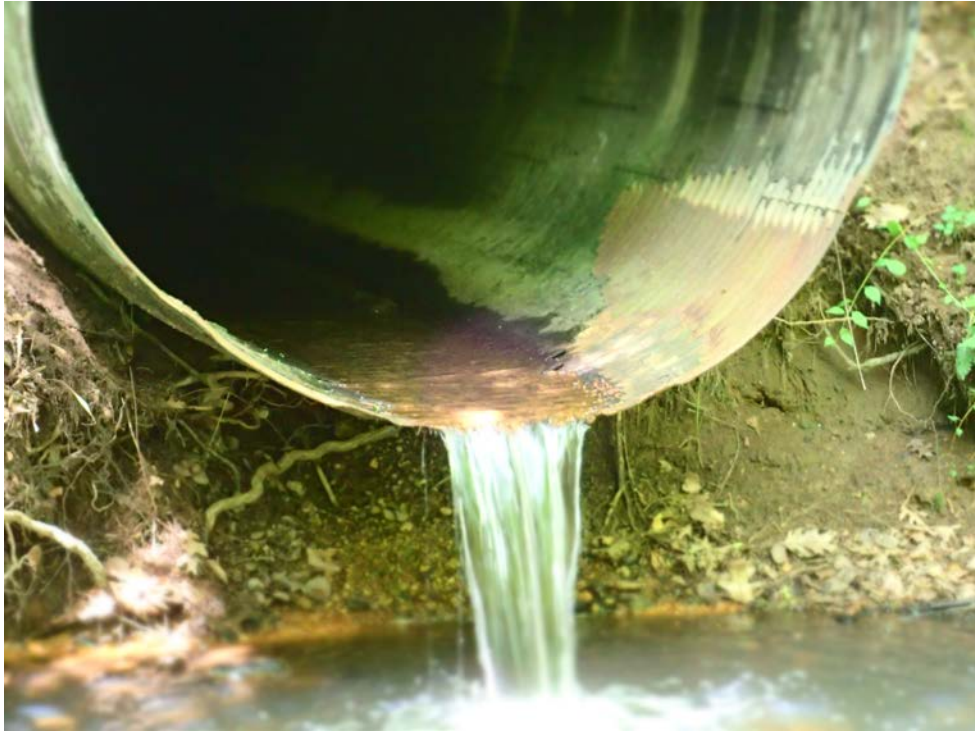
Culvert 4 consists of a corrugated steel pipe that is approximately 7 feet in diameter. The culvert spans over Potash Brook, which is an outlet from Lost Pond, and flows west to east. The overall condition of the structure is rated as fair. At the upstream side of the culvert, a large beaver dam has been constructed (**Photo 25**). Due to the retained water behind the beaver dam, there is a difference in water height of approximately 4 feet. The environmental impacts of the dam removal should be considered during the design of the proposed greenway rail trail. The outlet end of the culvert has moderate section loss and rust flaking (**Photos 26-27**). The existing coating system is flaking and has completely failed in most areas.

Recommended Repair: Due to the rusting and failing protective coating, we recommend sandblasting to remove any buildup or rust on the corrugated steel and to remove the areas of the failing coating system. Once the rust and existing coating system has been removed a new layer of protective coating should be applied. This coating will help extend the lifespan of the existing structure. Due to the large beaver dam on the upstream side of the culvert, the environmental impacts of dam removal should be analyzed before any changes are made. It does not appear that the beaver dam is currently adversely affecting the culvert, or its ability to control flow. However, the presence of the dam could be causing increased turbulence and flow velocities at the inlet of the pipe, increasing the risk for scour. In addition, should the dam fail, the debris could clog the pipe and cause flow restrictions.

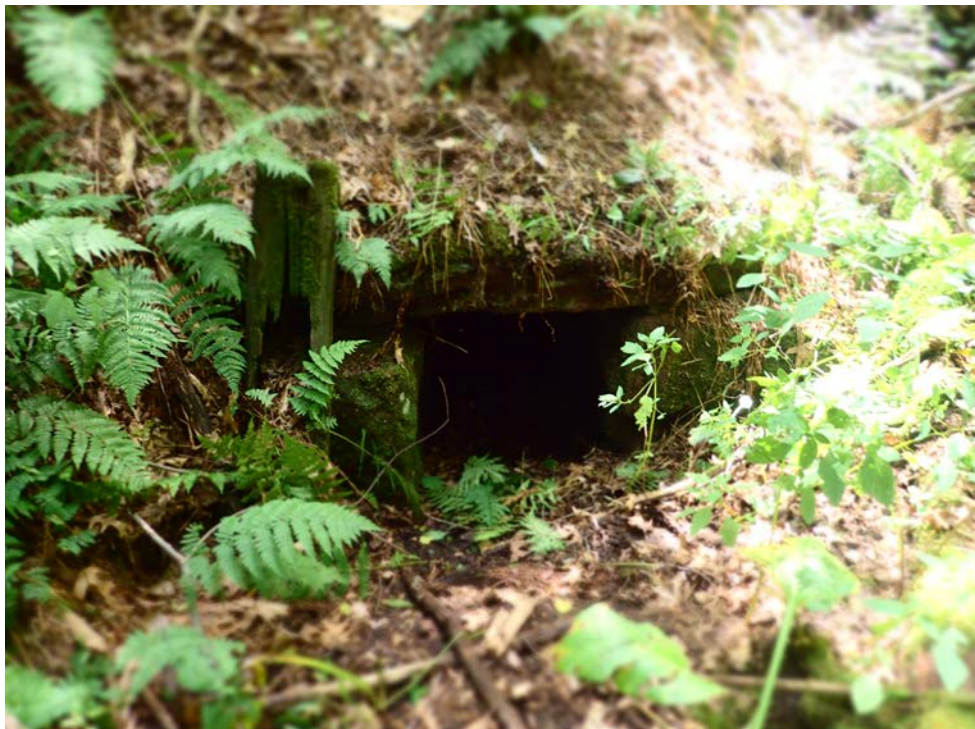
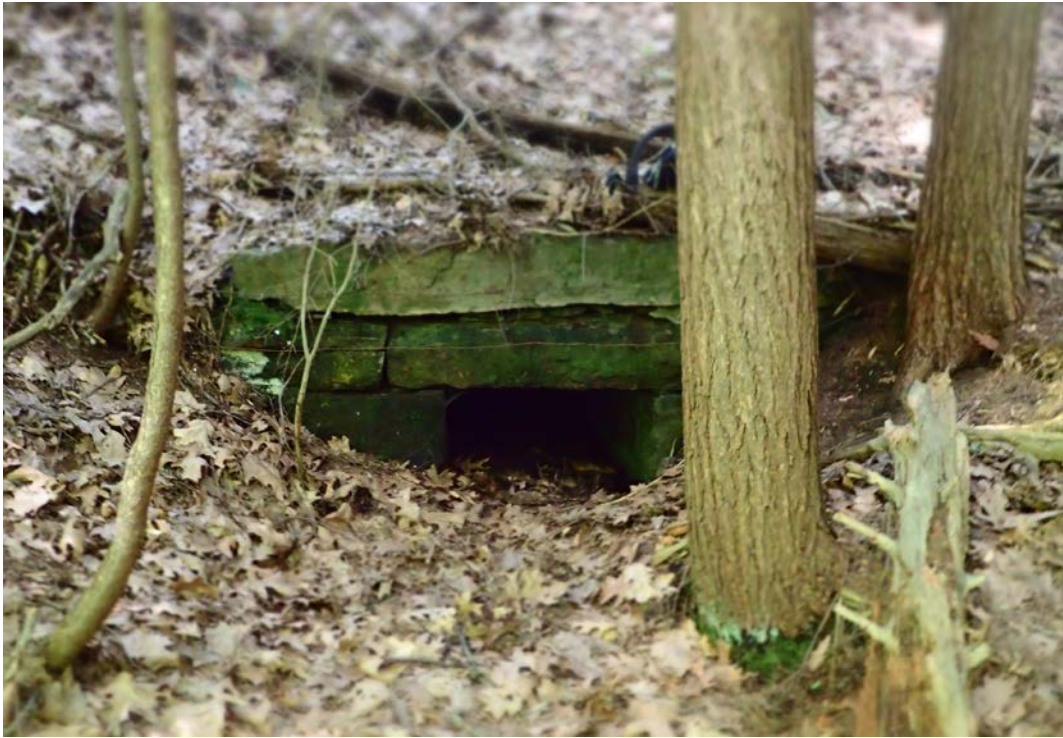
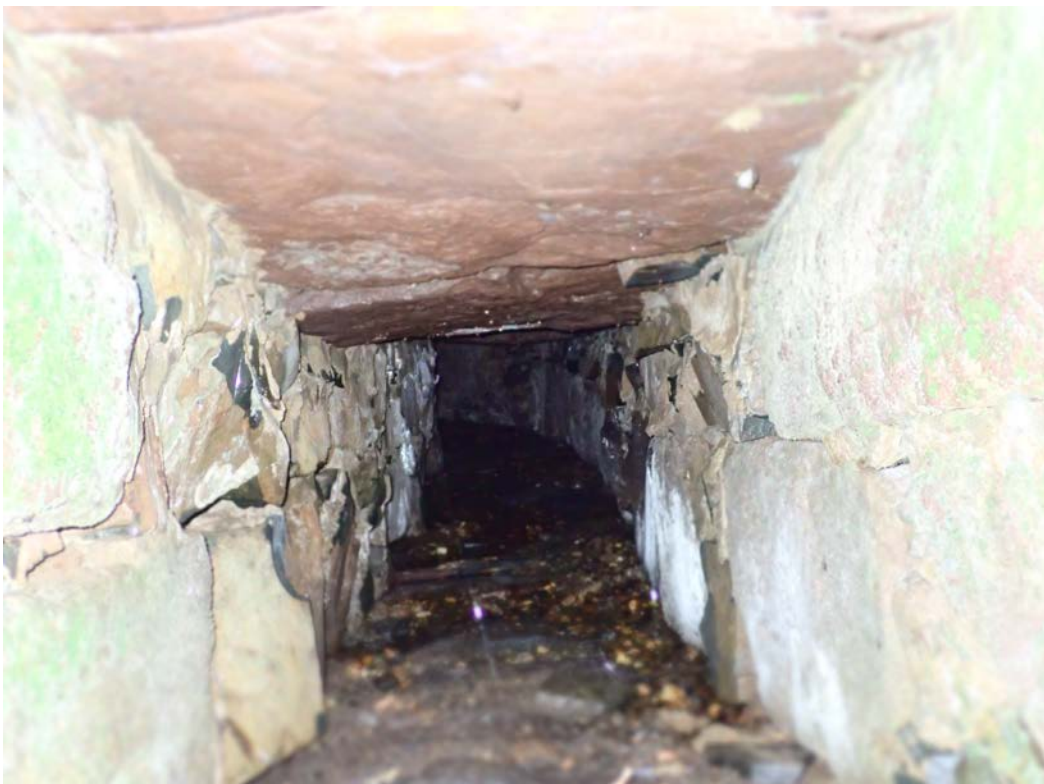
Culvert 5 is constructed of dry laid stone masonry with an opening of approximately 30 inches wide by 30 inches high (**Photos 28-30**). The structure is in overall good condition; however, the entire culvert is infilled with several inches of sediment. This infill is much heavier on the West side of the culvert, reaching approximately 8 inches. Due to the large amount of sediment, very little flow is visible through the culvert. There are also several small voids on the interior of the structure.

Recommended Repair: The structure of culvert 5 is generally in good condition; however, we recommend that the built-up sediment in the culvert be removed to maintain an open

passageway for steady flow. The larger trees adjacent to the East end of the culvert should also be removed before the roots interfere with the structure. The interior voids between the dry laid stone masonry should be patched and repaired to extend the life of the culvert.
