Proposed Southampton Greenway Trail Existing Conditions Review of Bridges and Culverts

TO: Michael Buehler, Chair of the Southampton Greenway Committee
FROM: Craig French, P.E. Structural Engineering Manager, Tighe & Bond
COPY: Elizabeth Baldwin, P.E., Vice President, Tighe & Bond
Margaret Freed, Structural Staff Engineer, Tighe & Bond
DATE: November 7, 2017

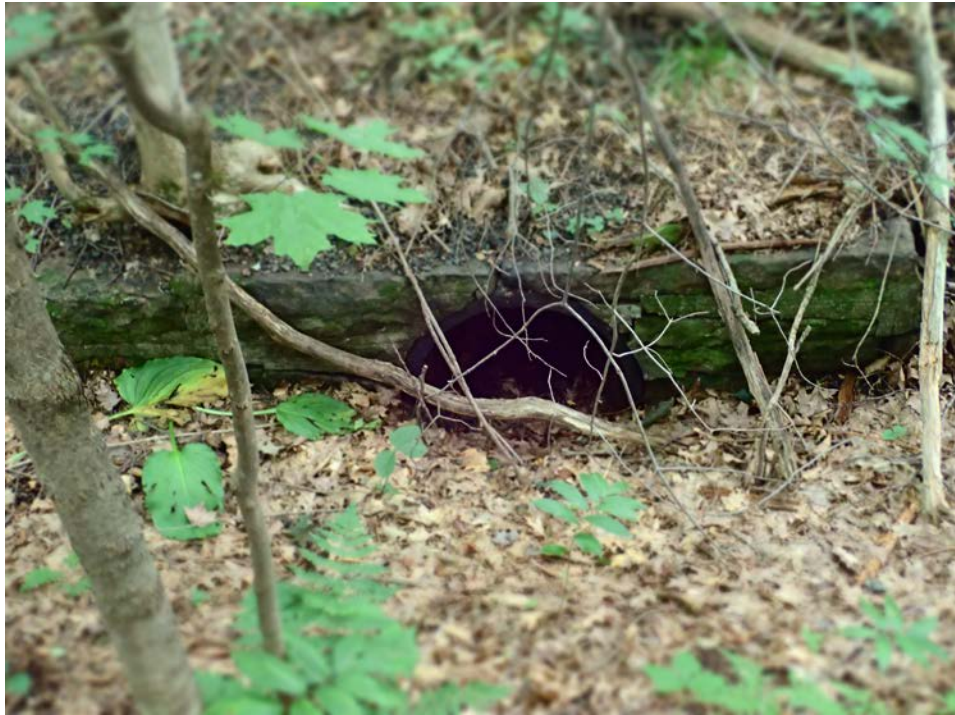
Culvert 6 consists of a 2-foot diameter cast iron pipe with a stone headwall on the upstream side (**Photo 31**). A small stream flows from West to East through the culvert. Based on water staining inside of the pipe, the stream level reaches approximately 2/3 up the culvert during high flow events (**Photo 32**). Overall, the structure is in good condition. The interior of the pipe has minor surface rusting and there is minimal section loss on the downstream pipe end. At the inlet of the pipe, there is a buildup of several inches of debris. At the pipe outlet, flowing water drips directly below the pipe end, forming a hole and slowly undermining the culvert (**Photo 33**).

Photo 31: West Elevation

Recommended Repairs: We recommend that the sediment build-up on the upstream end of culvert 6 be cleared to maintain an open passageway for steady flow through the structure. Since the downstream end is slowly eroding from water flowing out of the cast iron pipe, rip-rap should be installed below the pipe outlet to prevent further undermining of the structure.

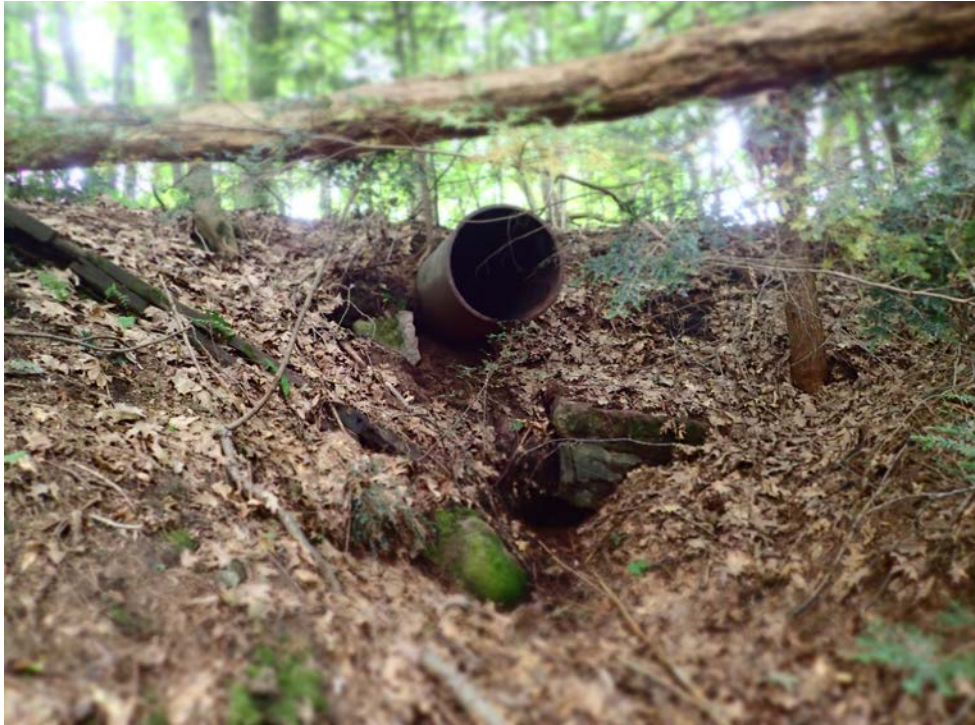
Photo 33: East Elevation

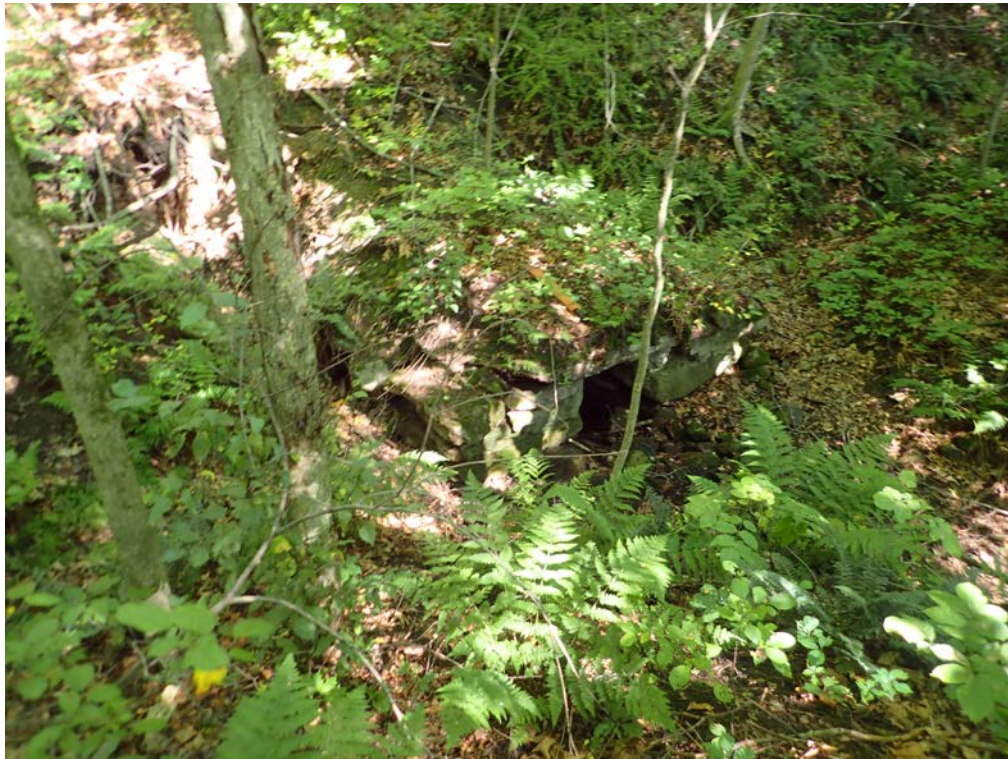
Culvert 7 is constructed from dry laid stone masonry with an opening of approximately 24 inches wide by 36 inches high at the culvert's east side. Water flows through the culvert from east to west. At the time of the site inspection, very little water was flowing through the structure. A large amount of embankment has eroded away around the inlet of the culvert; leaving the structure exposed (**Photos 34-35**). It appears that the erosion is caused by water flowing down the steep embankment above the culvert opening. The eroded sediment has been deposited throughout the culvert; reducing the opening on the downstream end to 24 inches high (**Photo 36**). Overall the structure is in fair condition, with several small voids in the structure's interior walls (**Photo 37**).

Photo 35: Erosion at East Side

Recommended Repair: Even though the dry laid stone masonry of culvert 7 is in good condition, we recommend that the embankment surrounding the upstream side of the structure be restored. Since water is also flowing down the embankment and causing erosion, it is recommended that measures be taken to stabilize the slope. Stabilizing the embankment will protect the culvert from further erosion and direct water to the inlet opening instead of through openings in the stone masonry. The voids on the interior of the culvert should be patched and repaired to extend the life of the culvert.

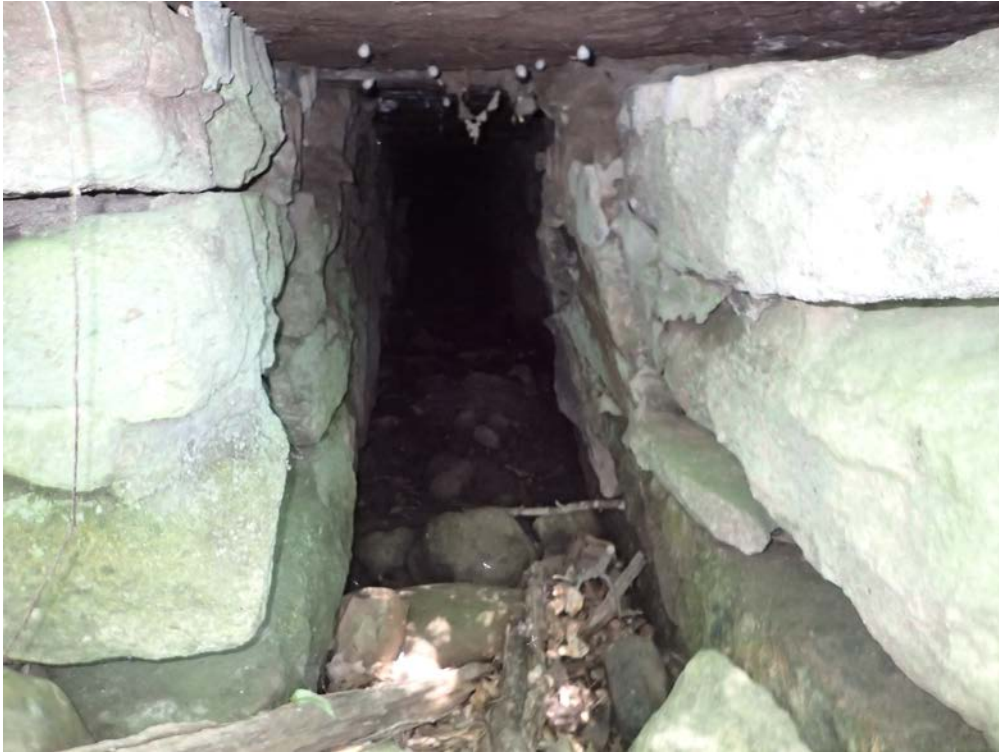
Photo 37: Interior of Culvert 7

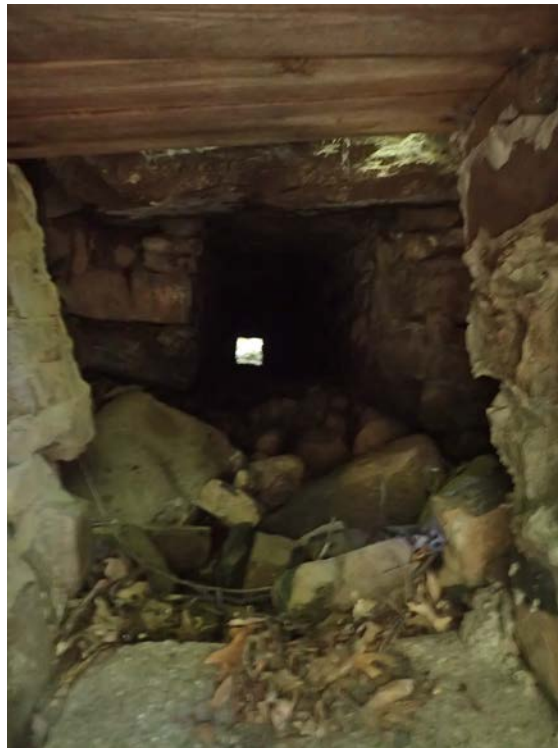
Culvert 9 is constructed of dry laid stone masonry, with an invert opening of 36 inches by 30 inches and an outlet opening of 30 inches by 40 inches. Water flows from west to east through the culvert. Overall, the structure is in poor condition. There is a partial collapse of an interior section at the downstream end of the culvert (**Photos 41-42**). This collapse is diverting water to flow beneath and around the structure, causing severe undermining. Even though there was no water flow observed at the time of this inspection, there is heavy erosion downstream of the culvert (**Photo 43**). Therefore, it can be assumed that the structure experiences high water levels with heavy flow velocities. The interior of the structure on the eastern side is in good condition (**Photos 44-45**).

Photo 42: Collapsed Interior

Recommended Repair: Since the west side of the structure has failed, it will need to be replaced. We recommended demolishing the entire deteriorated section of the culvert. This portion should then be replaced with a new concrete culvert connected to the remaining section of the existing structure. Since water is also flowing down the embankment and causing erosion, we recommend that measures be taken to stabilize the slope. Stabilizing the embankment will protect the culvert from further erosion and direct water to the inlet opening instead of through openings in the stone masonry.

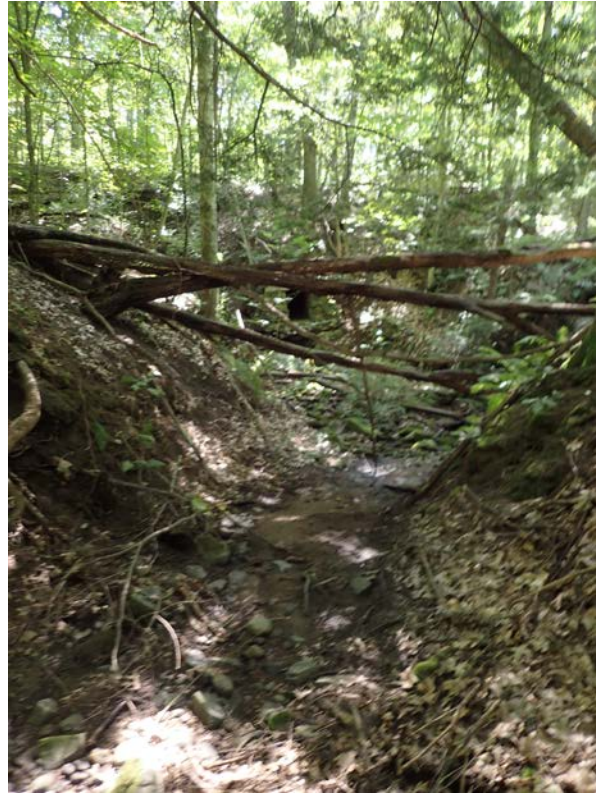
Photo 43: Signs of high water flow

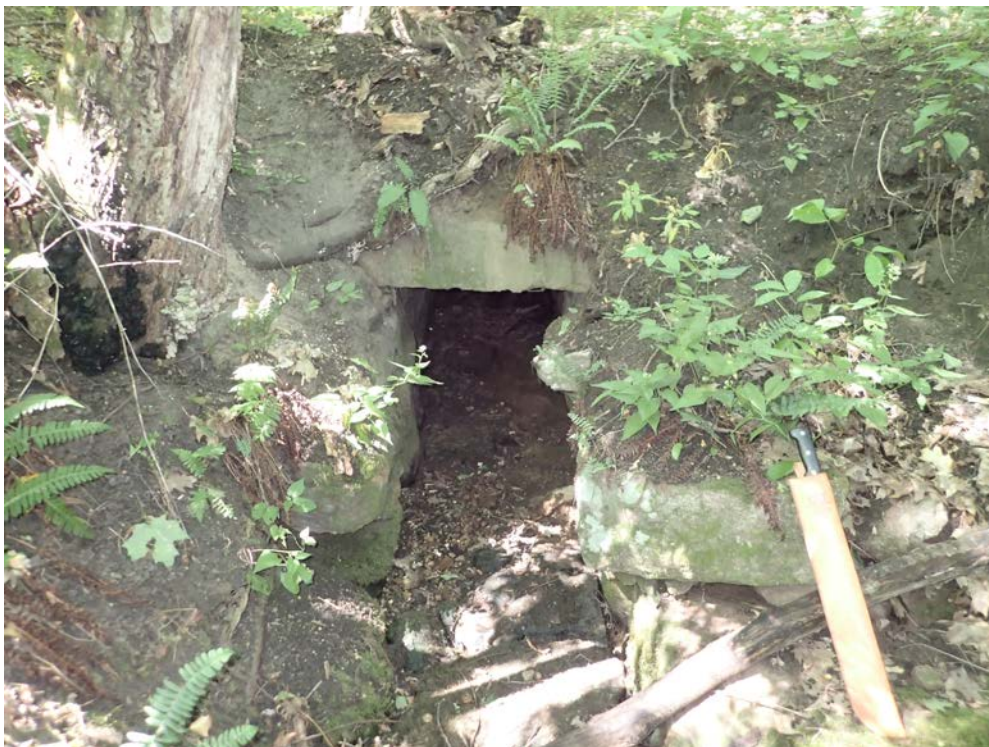
Culvert 10 is constructed of dry laid stone masonry with an upstream opening of 30 inches x 38 inches and a downstream opening of 20 inches x 16 inches (**Photo 46**). At this location, the water flows from east to west through the culvert. Overall the culvert is in fair condition. The southwest wingwall has failed due to the collapse of the stone masonry (**Photo 47**). Even with the collapsed wingwall, the culvert is still open for water to flow. At the upstream end, there is a void in the ceiling of the structure (**Photo 48**).

Photo 46: East elevation

Recommended Repair: The southwest wingwall should be repaired using existing stone block. Localized excavation and clearing of vegetation is necessary to prepare the original area for resetting the wall stone. The voids on the interior of the culvert should be patched and repaired to extend the life of the culvert.

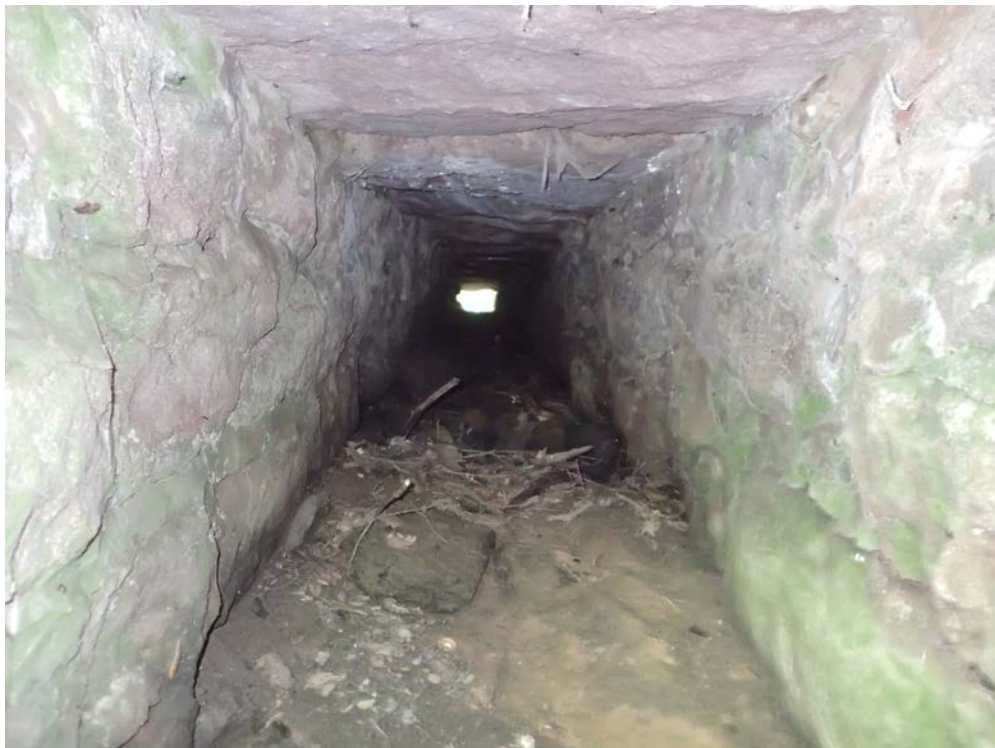
Photo 48: Interior of Culvert 10 with Void in Ceiling

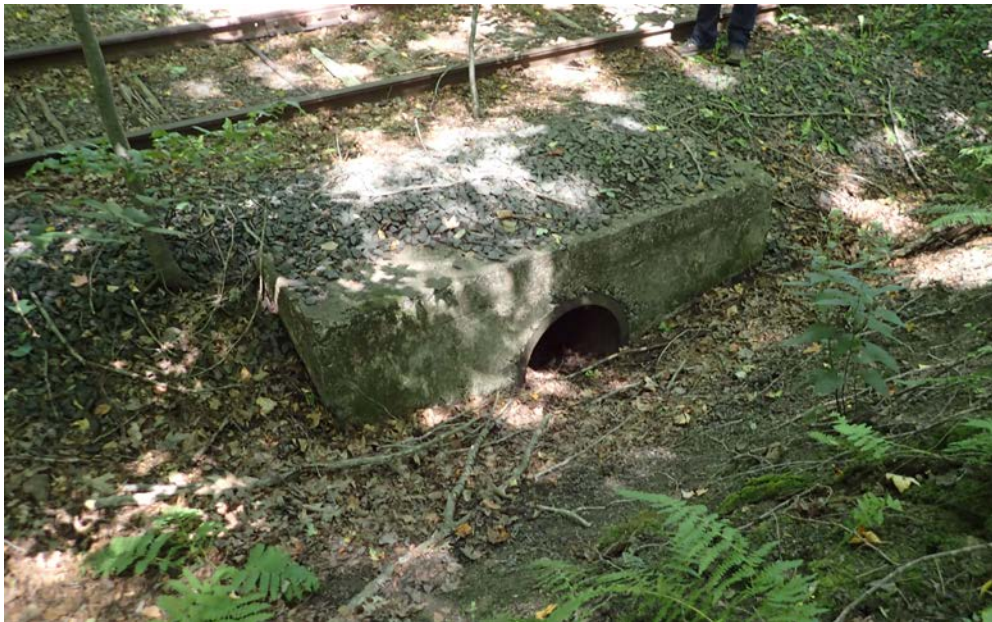
Culvert 11 consists of an 18-inch diameter cast iron pipe with concrete headwalls. Water flows from east to west through the structure, although at the time of this inspection there was no active water flow. Overall the structure is in good condition. The concrete headwalls have minor cracking throughout (**Photo 49**). At the upstream side, approximately 4 inches of sediment has filled the cast iron pipe (**Photo 50**). It should be

Photo 50: East elevation

Recommended Repair: We recommend that the sediment build-up on the upstream end of culvert 11 be cleared to maintain an open passageway for steady flow through the structure.
