ICON
ARCHITECTURAL GROUP

FACILITY ASSESSMENT FOR GRAND FORKS PUBLIC SCHOOLS

Grand Forks, ND

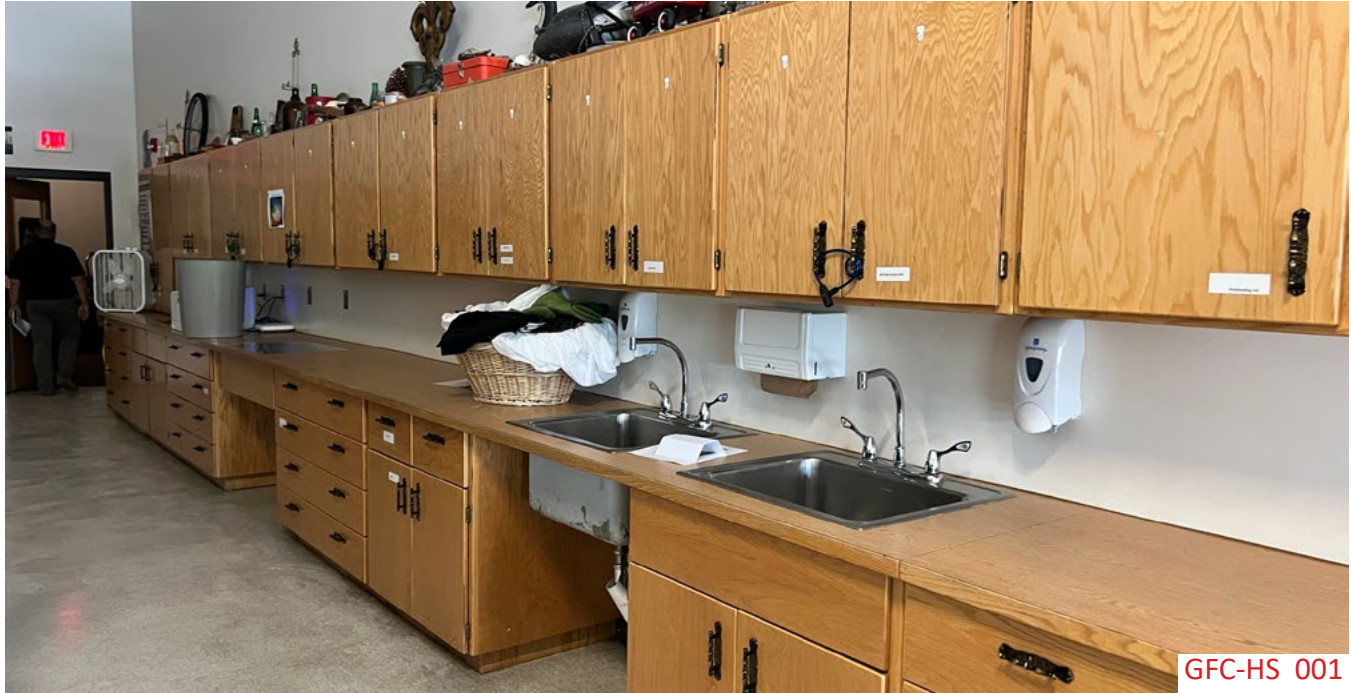
The casework is aged in some areas, but still in good condition.

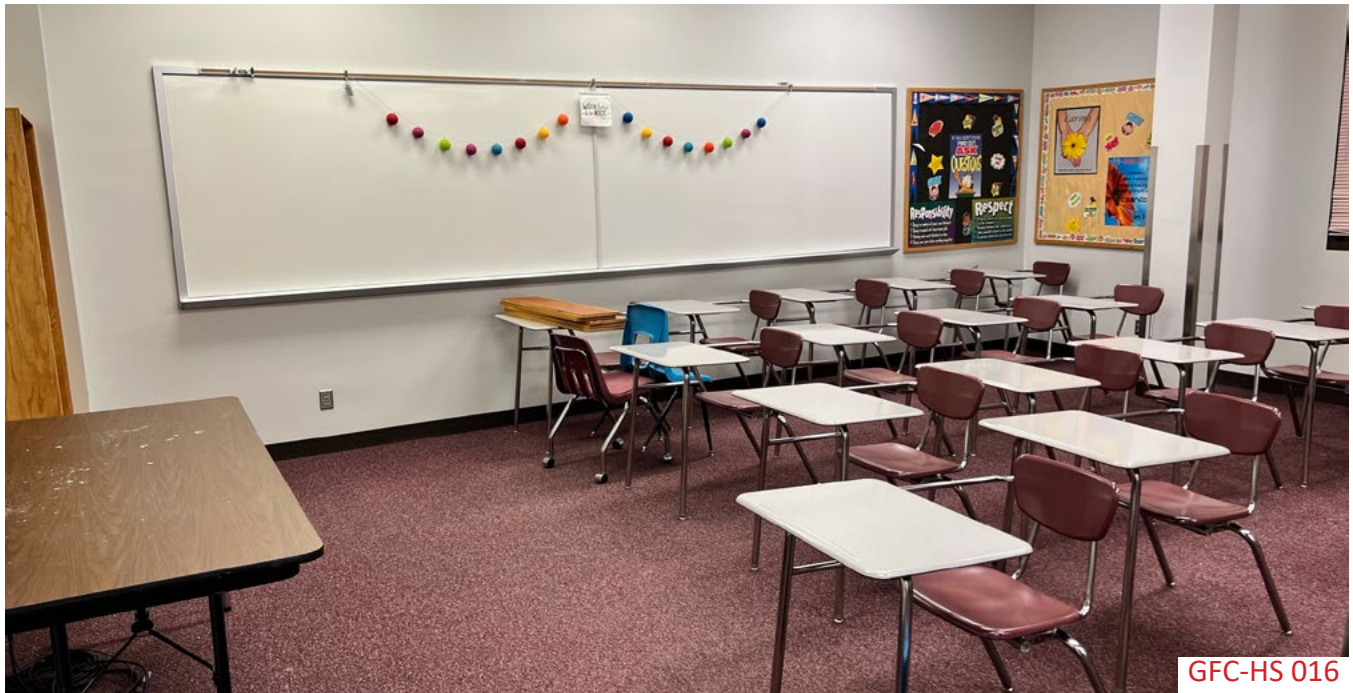
GFC-HS 016

Some of the carpet has been replaced, but there are still many areas where new carpet is needed.

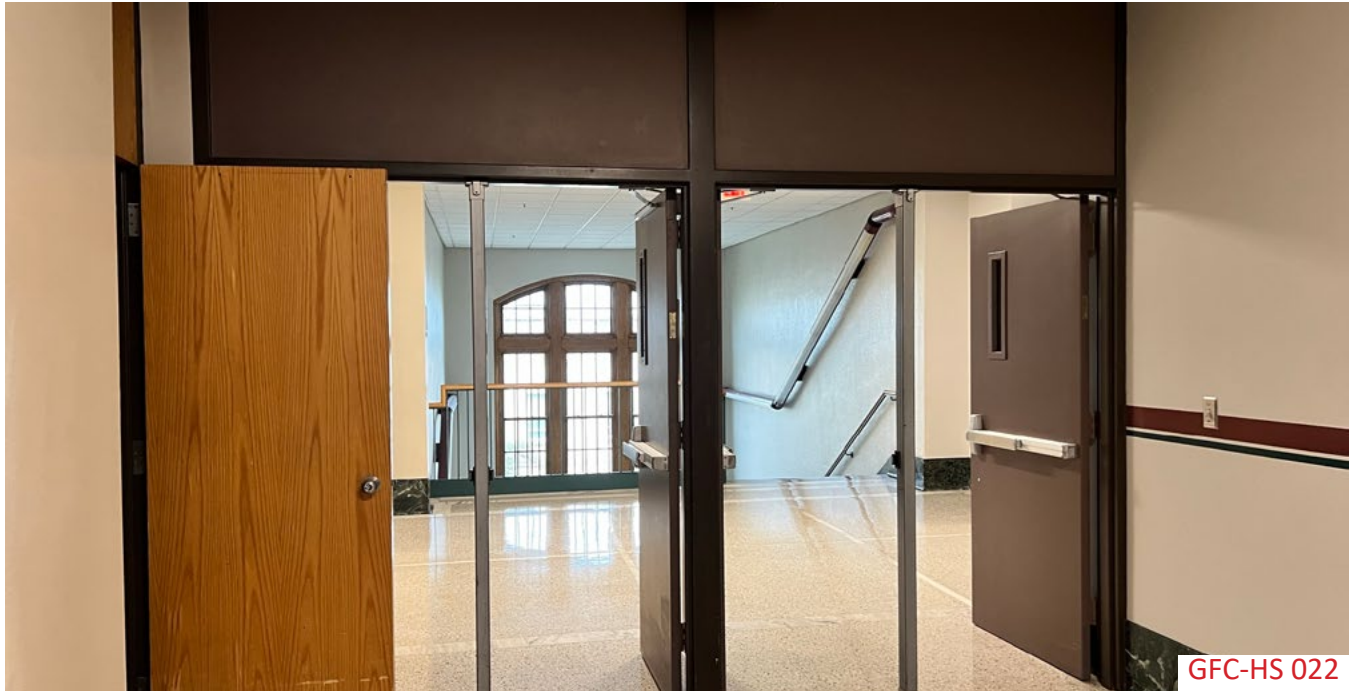
The corridor partition doors with a mullion do not allow sufficient clearance for wheelchairs.

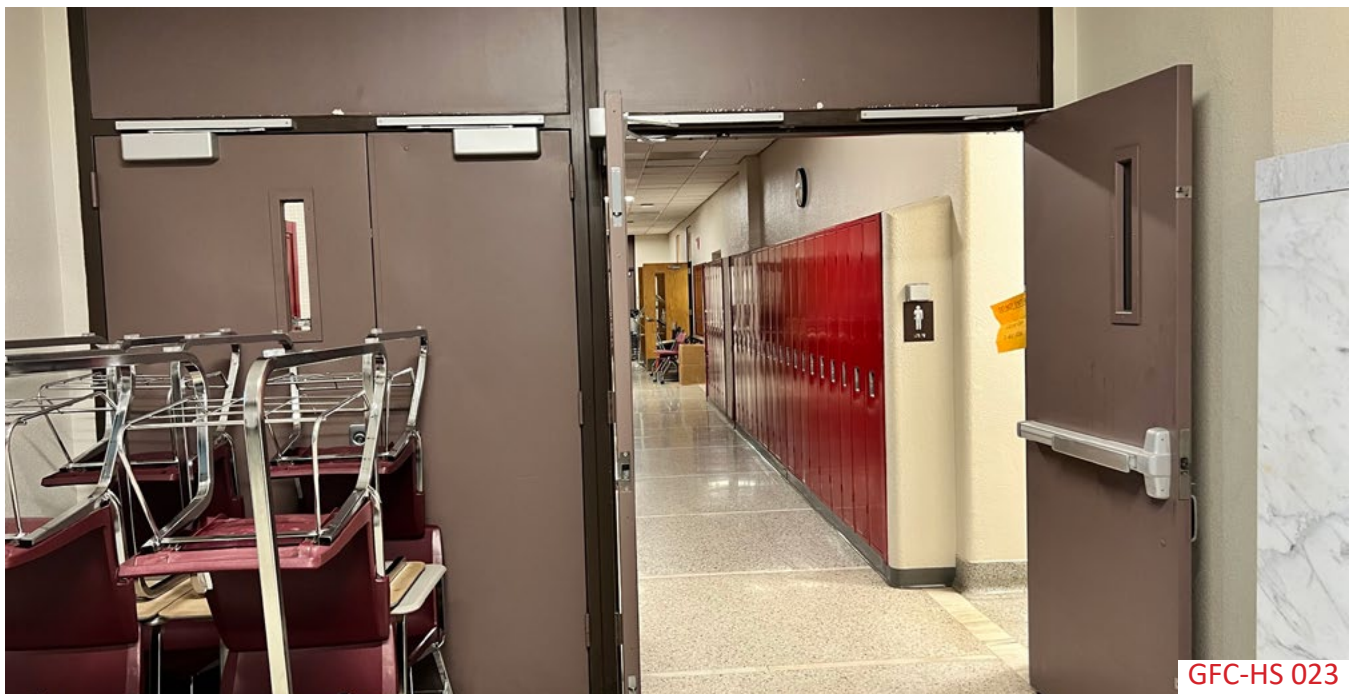
Many corridor partition doors are missing necessary panic hardware.

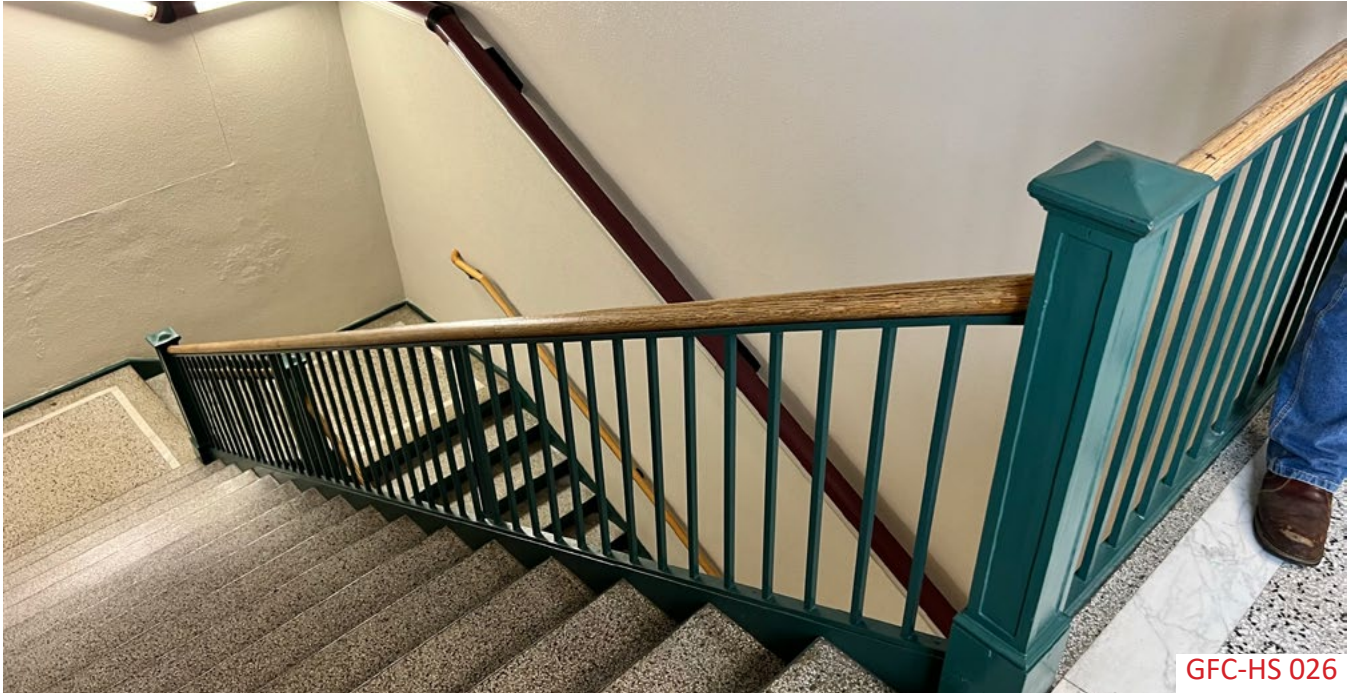
GFC-HS 026

Guardrails at all stairwells do not meet height requirements.

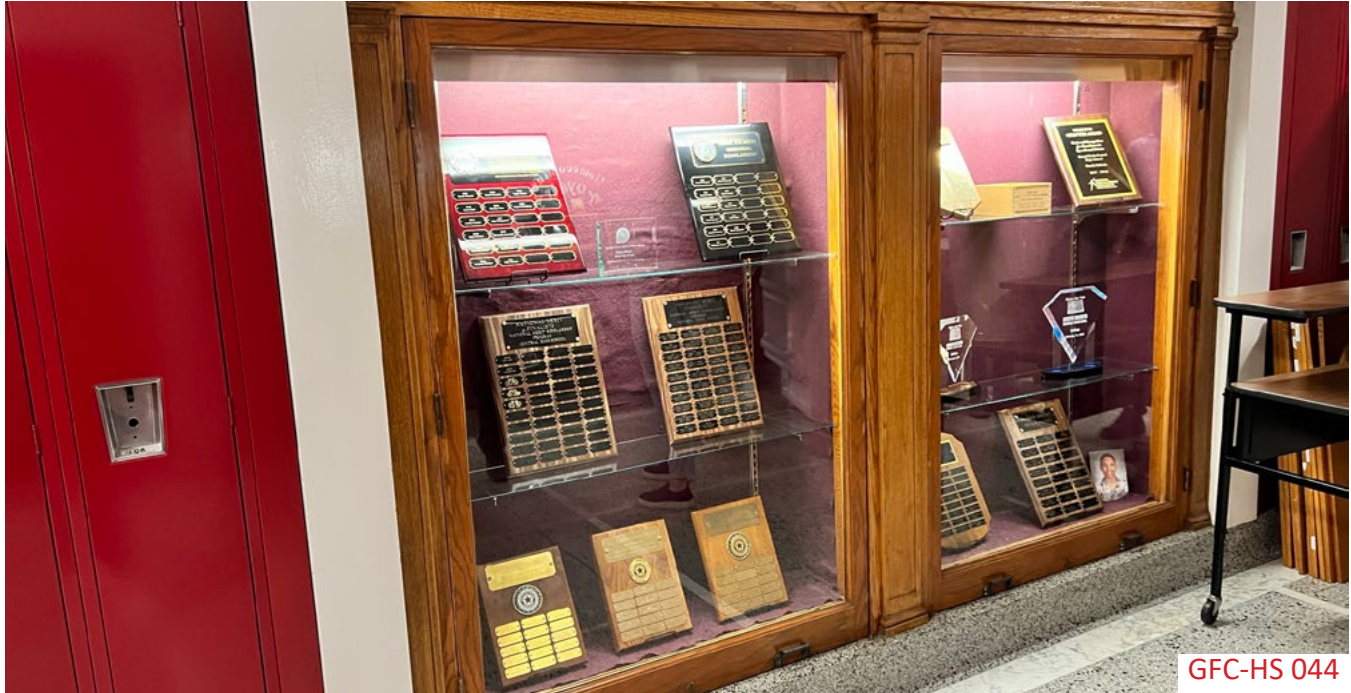
Display cases throughout the school do not have required safety glass.

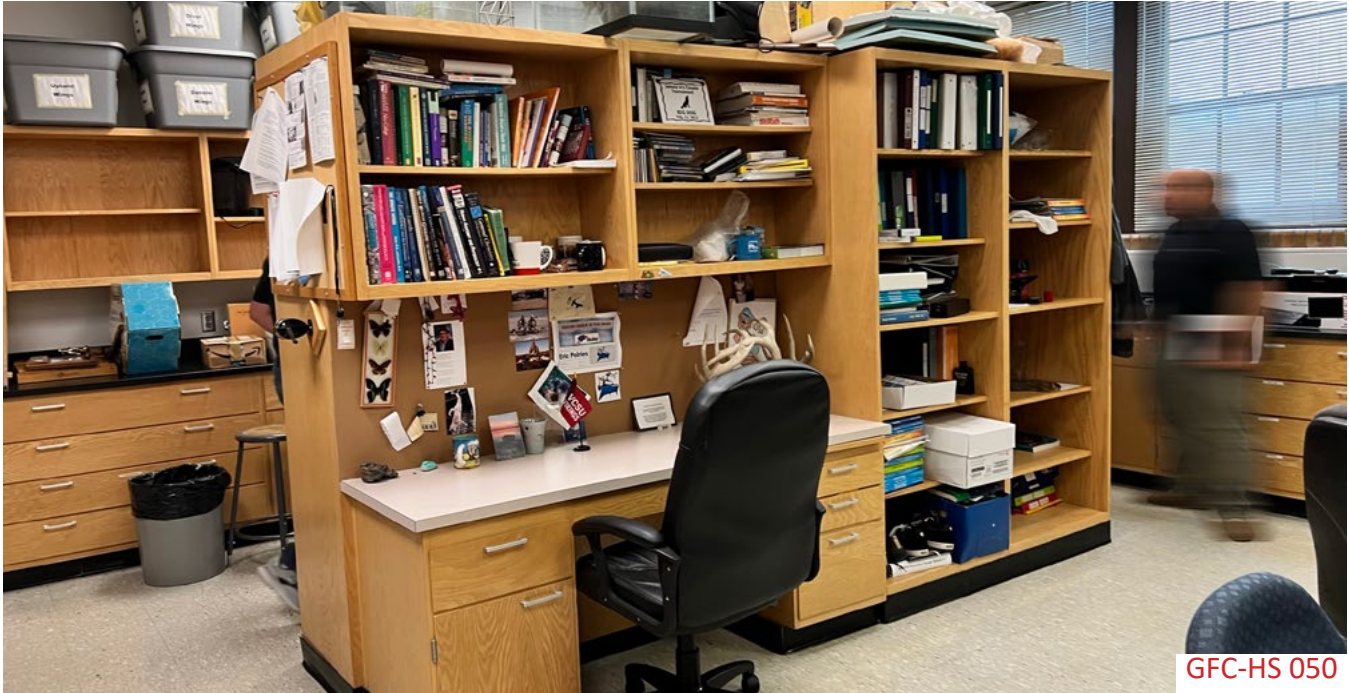
Casework within the biology office (Room 306) lacks sufficient clearances for accessibility.

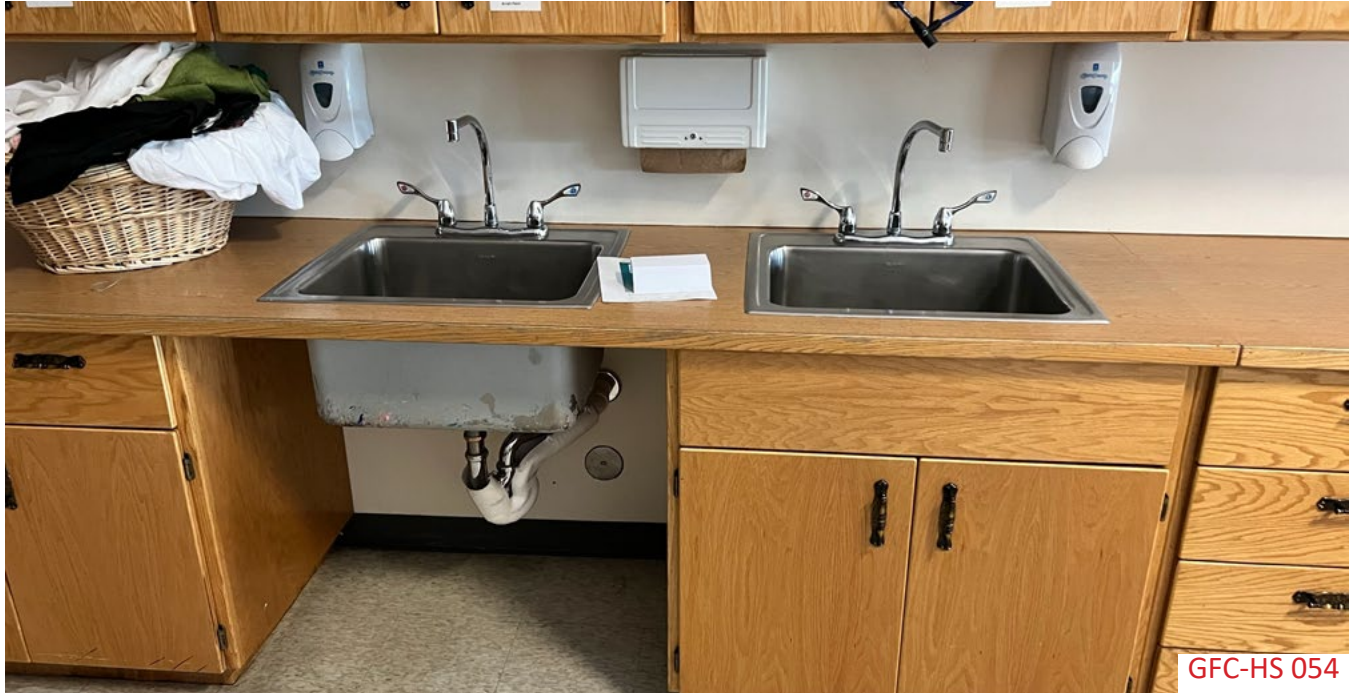
Art classrooms (Rooms 102 and 103) lack an accessible work area and the sinks do not have enough clearance underneath to comply with ADA standards.

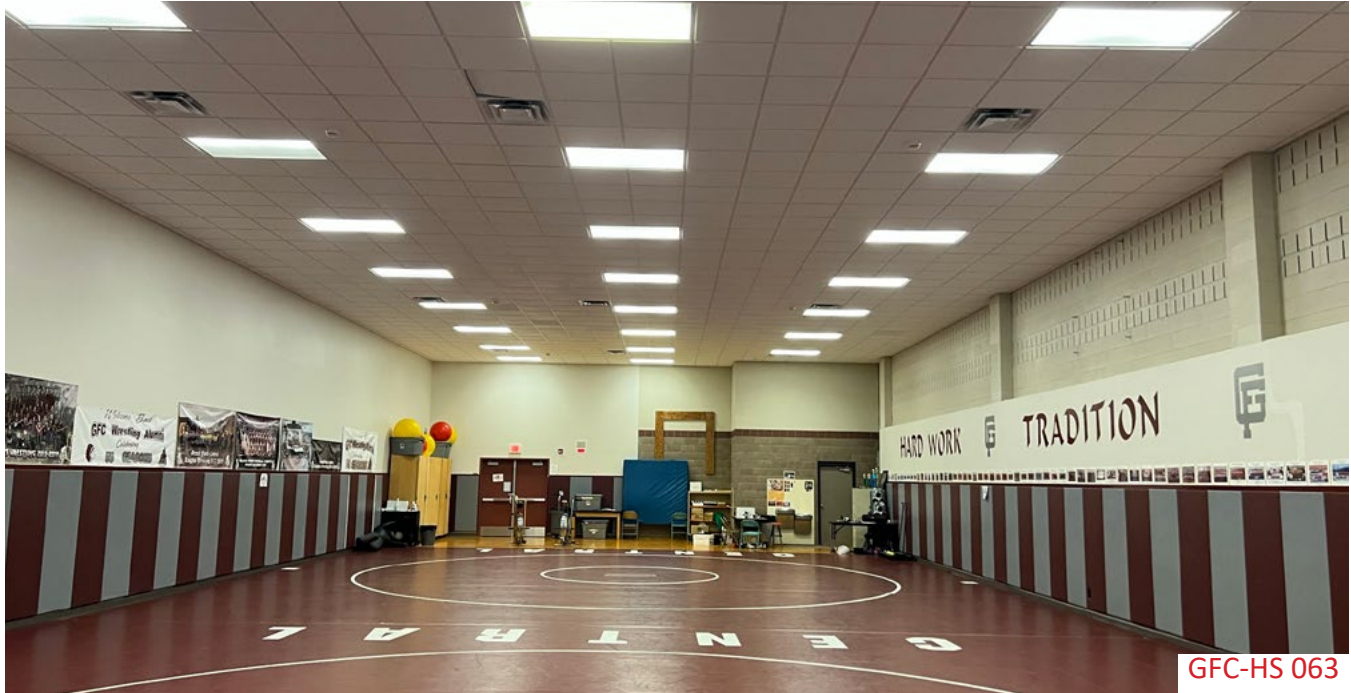
GFC-HS 063

Wrestling room and auxiliary gym are not sprinklered.

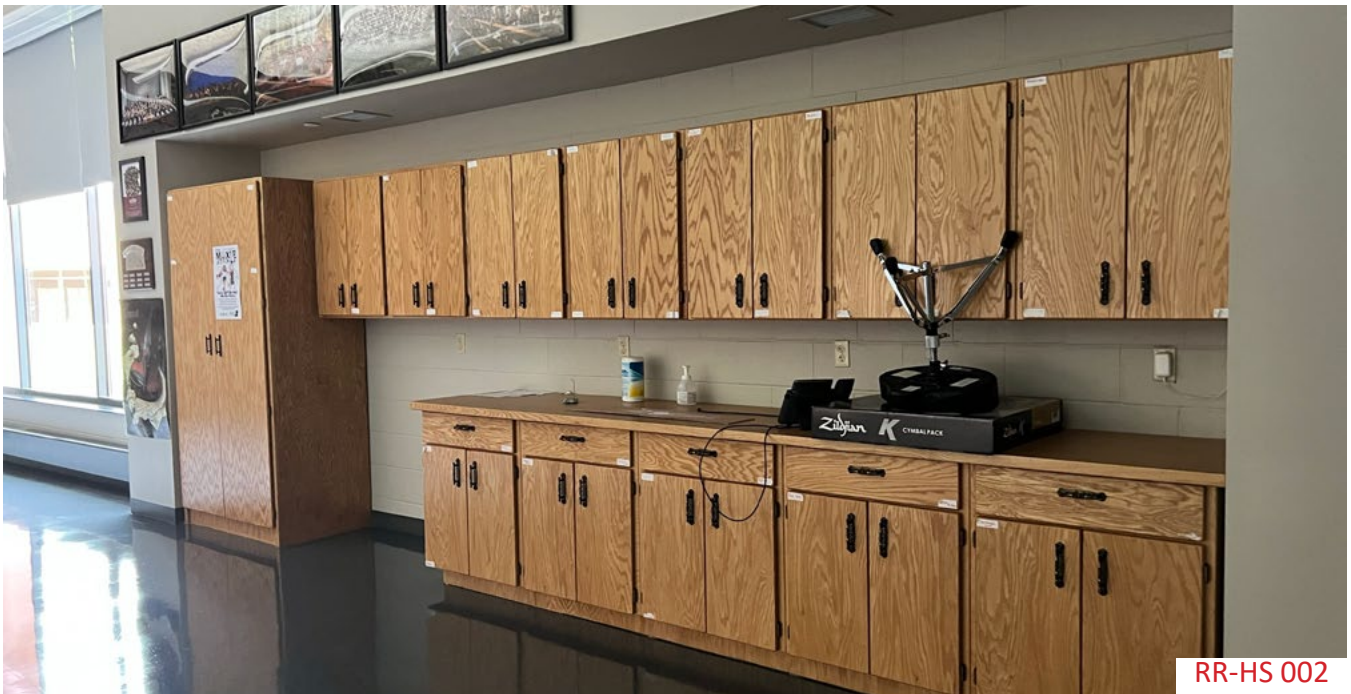
RR-HS 002

The original casework of the building and fixtures in the library are dated and replacement should be considered.

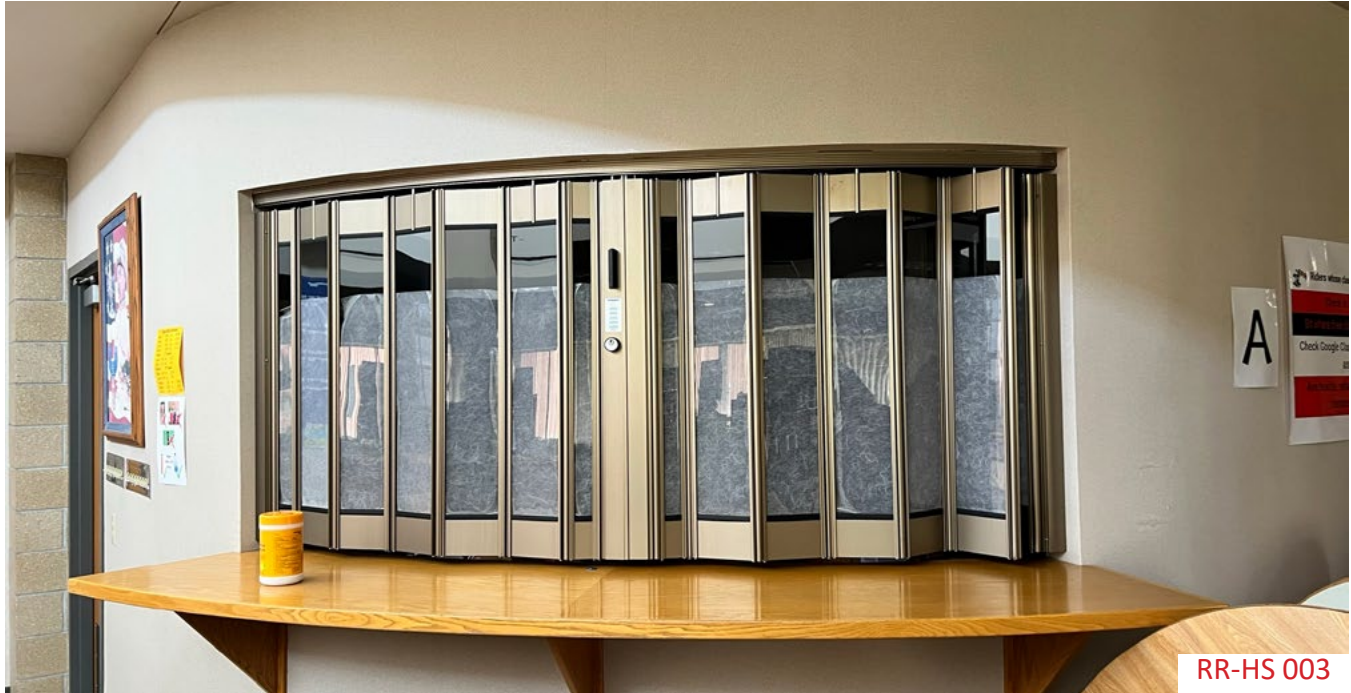
RR-HS 003

The original casework of the building and fixtures in the library are dated and replacement should be considered.

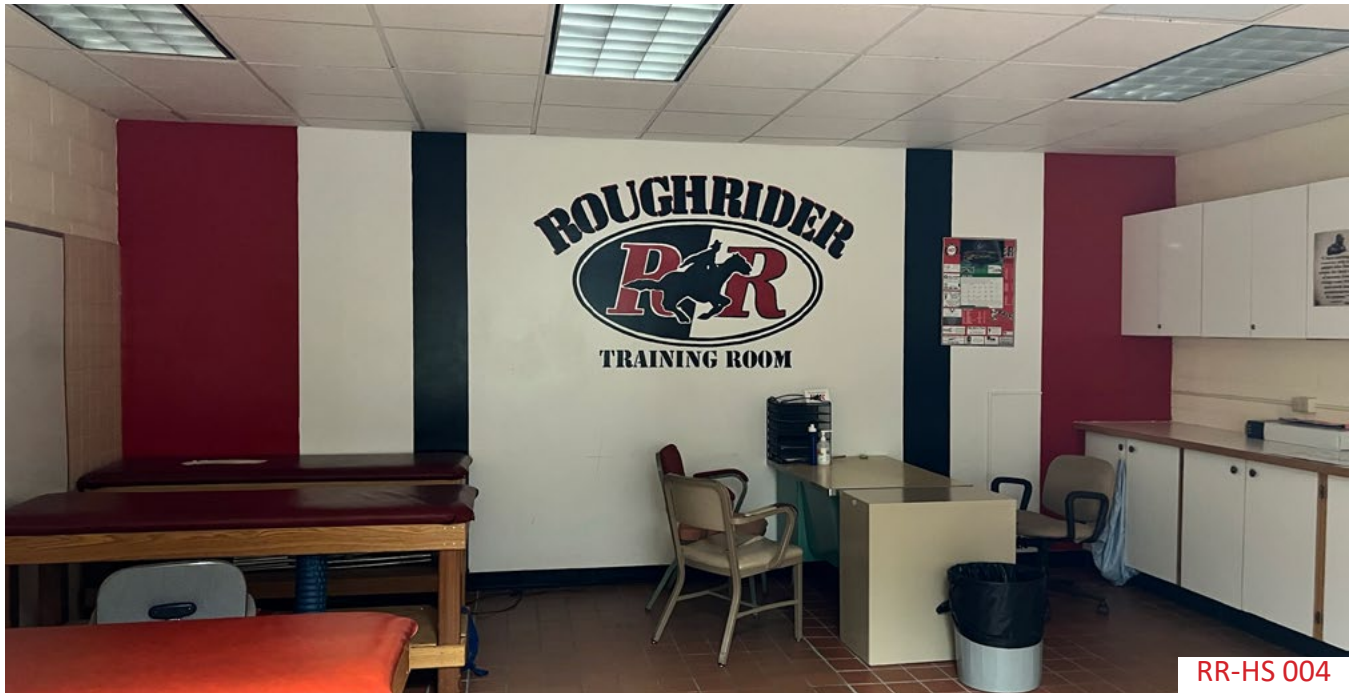
RR-HS 004

Renovation is recommended for the training room (Room 603) and the coaches office.

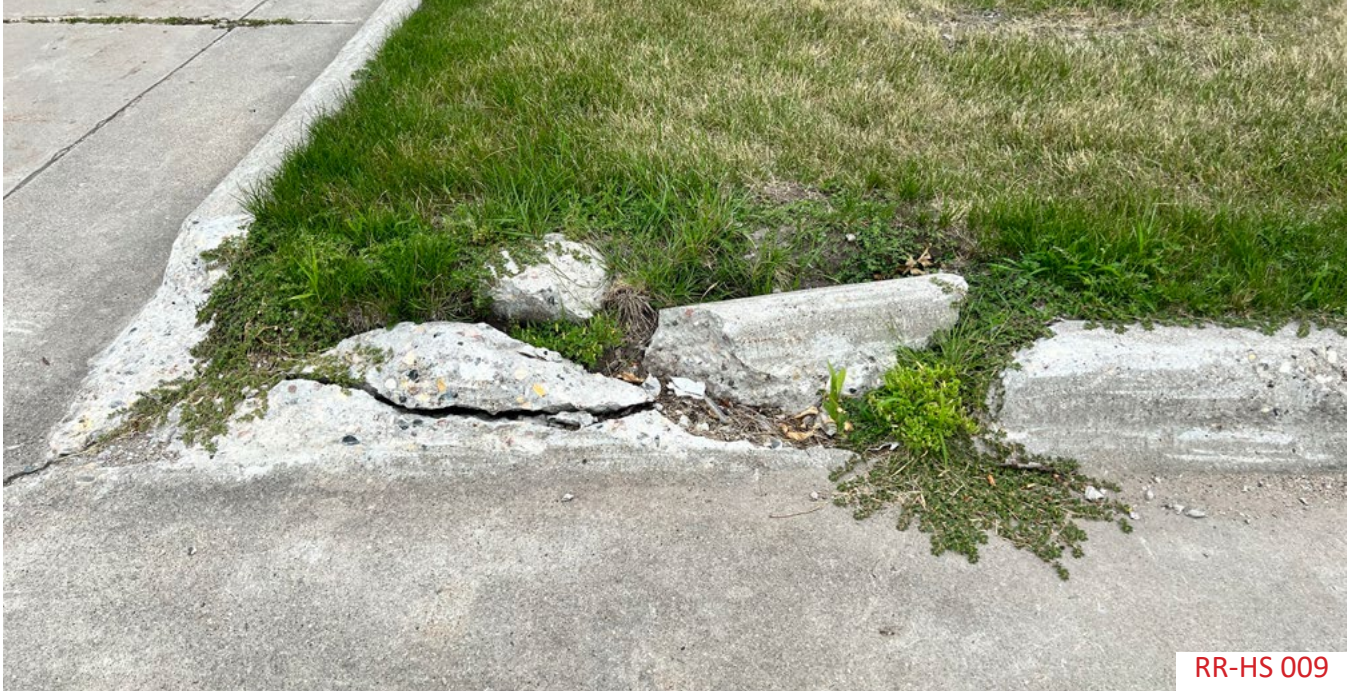
RR-HS 009

The concrete drives could use some attention, but the curb especially has been heavily damaged by snowplows and should be replaced or repaired.

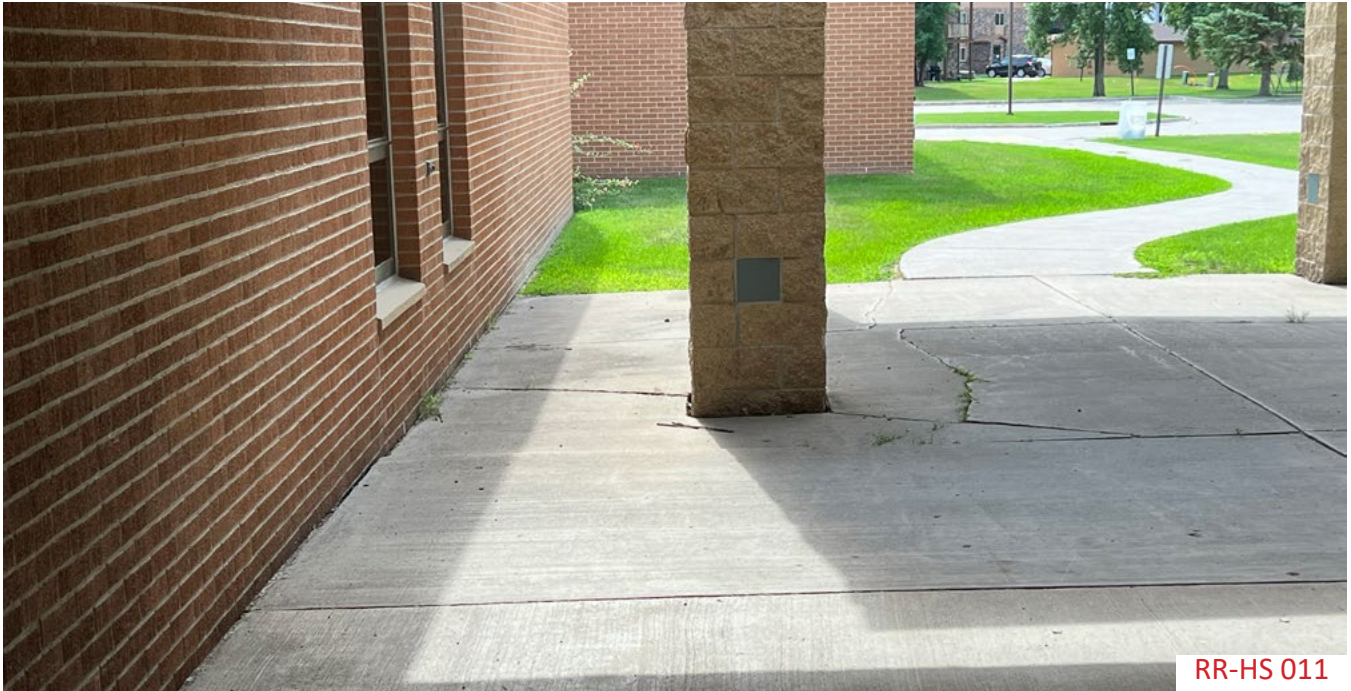
RR-HS 011

The concrete pads outside of doors 9, 10, and 16 are cracked and/or sinking, but all pads should be double checked to ensure adequate conditions (Door 9), (Door 16).

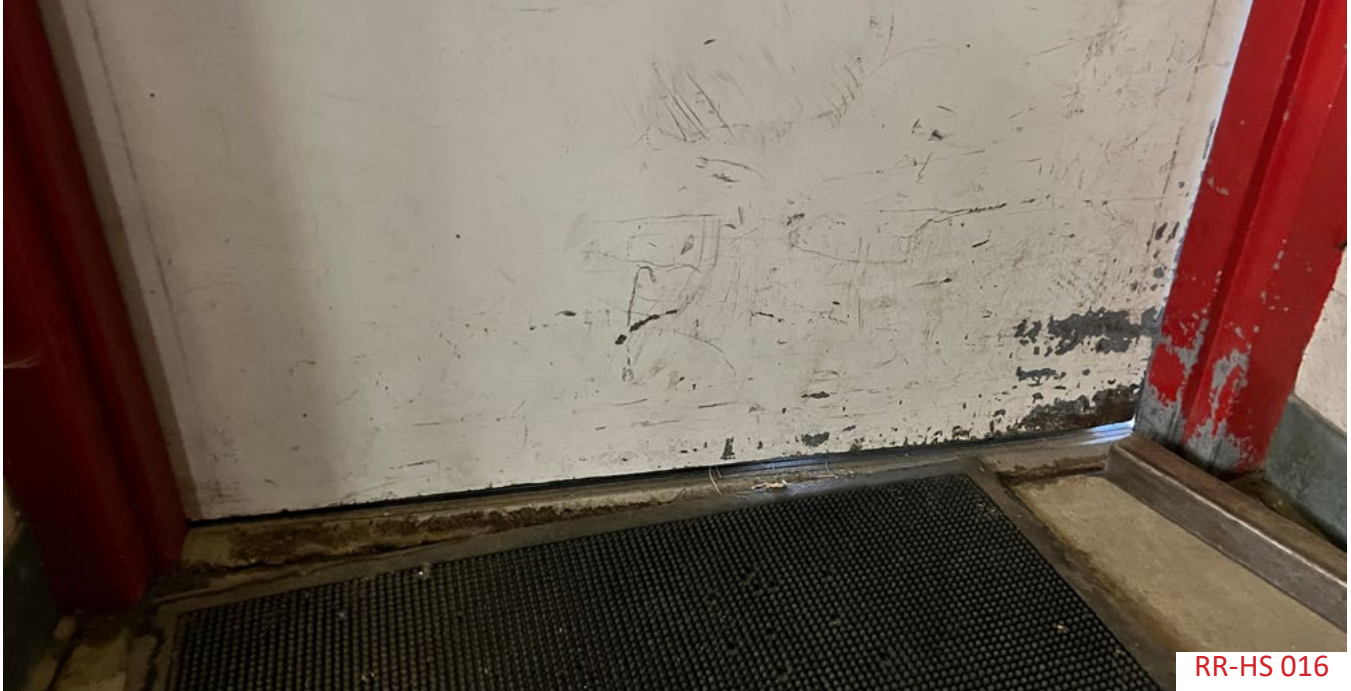
RR-HS 016

The weather stripping in the openings in the automotive and manufacturing/production classrooms are in poor condition and need to be redone.

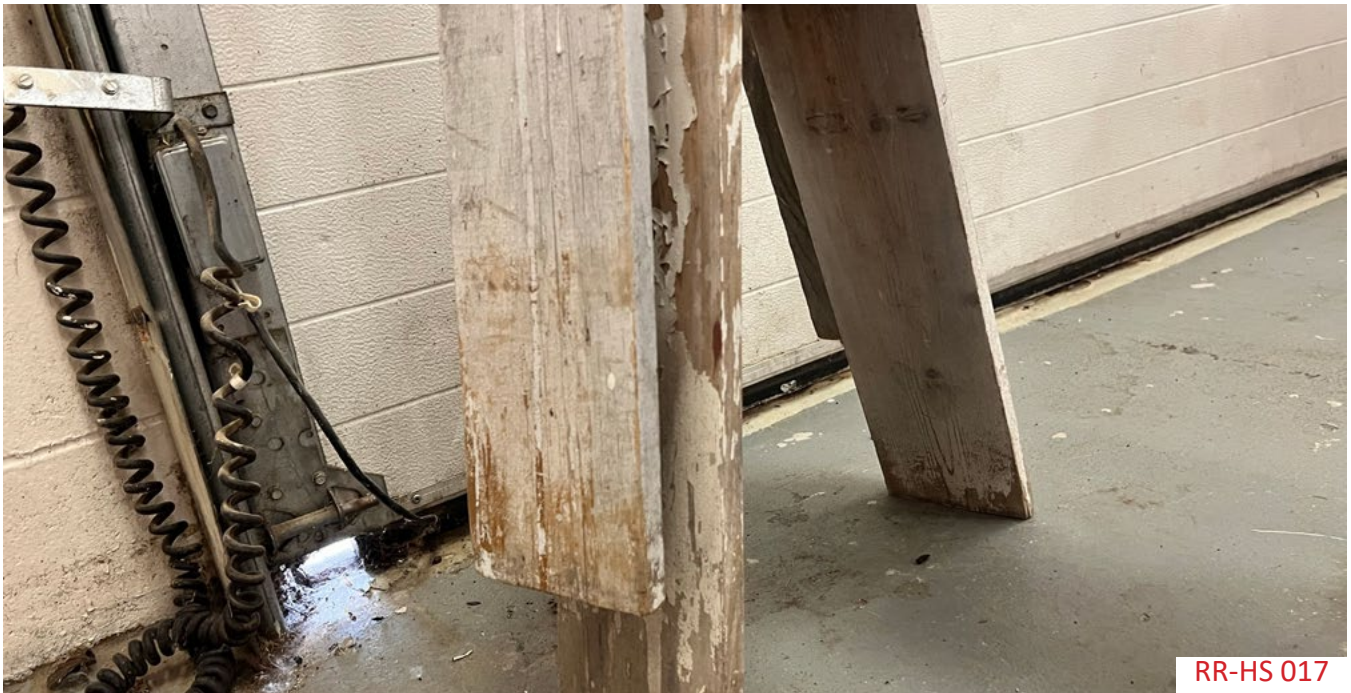
RR-HS 017

There is a large hole in the garage door in the automotive classroom as well.

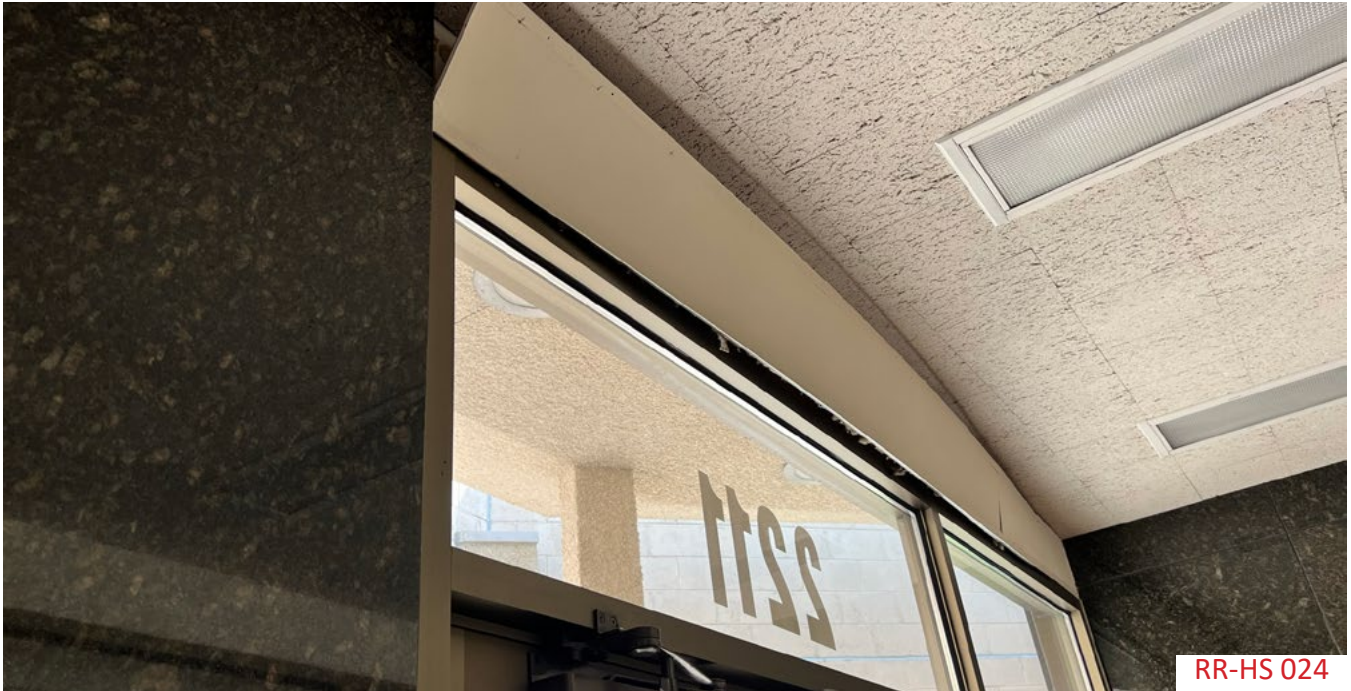
RR-HS 024

The soffits on the exterior portion of the main entrance are deteriorating and the gypsum board in the vestibule is also compromised.

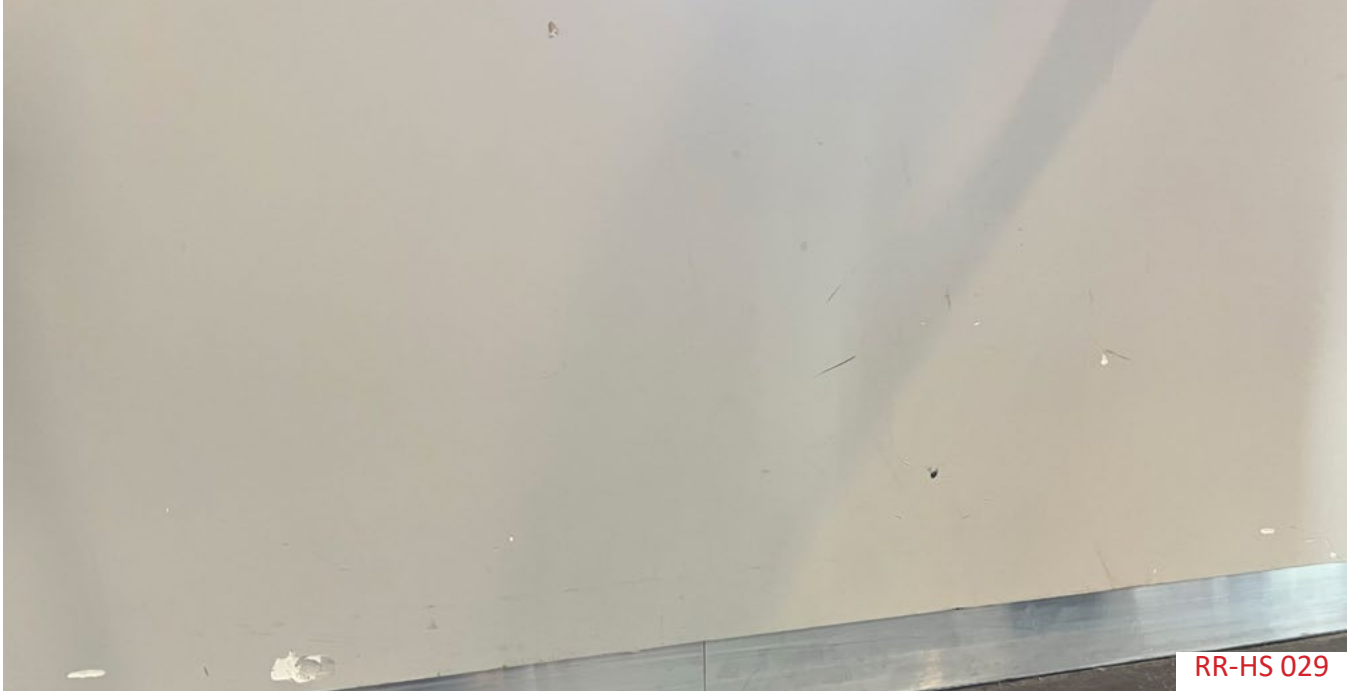
RR-HS 029

The painted gypsum board in the individual music practice rooms and outside the renovated auditorium need a general repair as they are damaged and chipping (Outside auditorium), (Practice room).

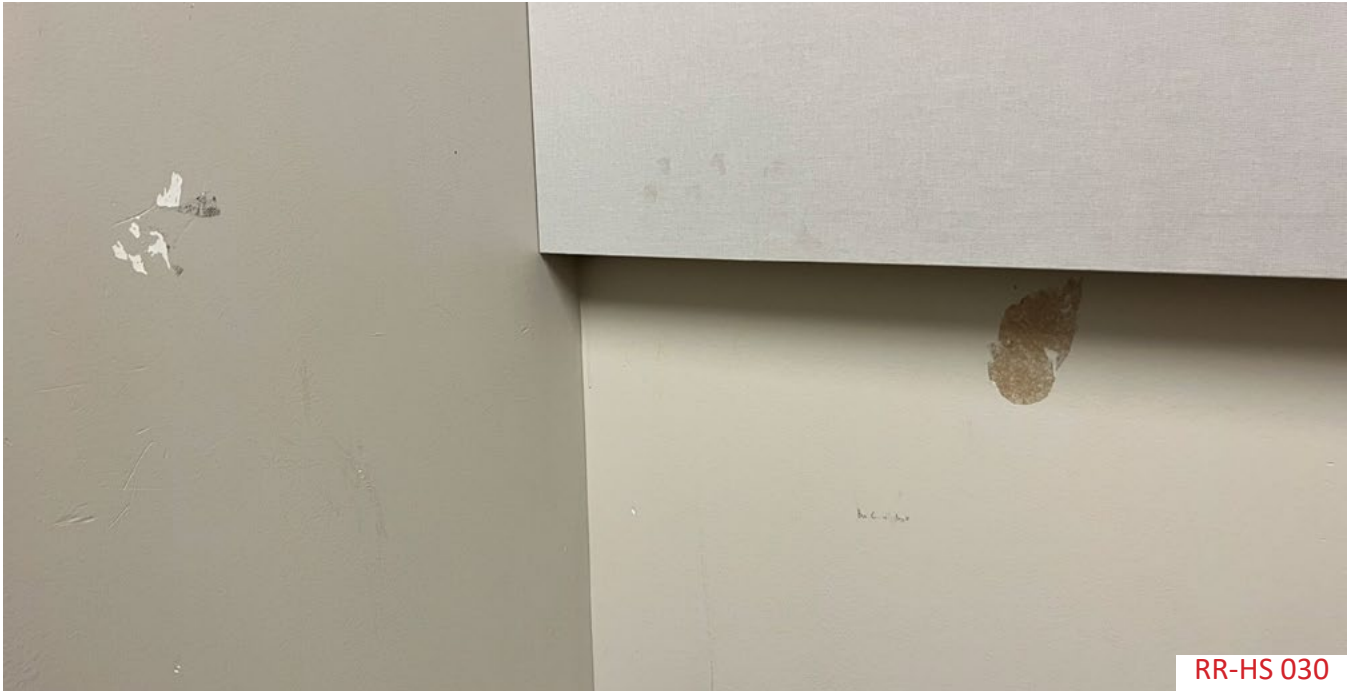
RR-HS 030

The painted gypsum board in the individual music practice rooms and outside the renovated auditorium need a general repair as they are damaged and chipping (Outside auditorium), (Practice room).

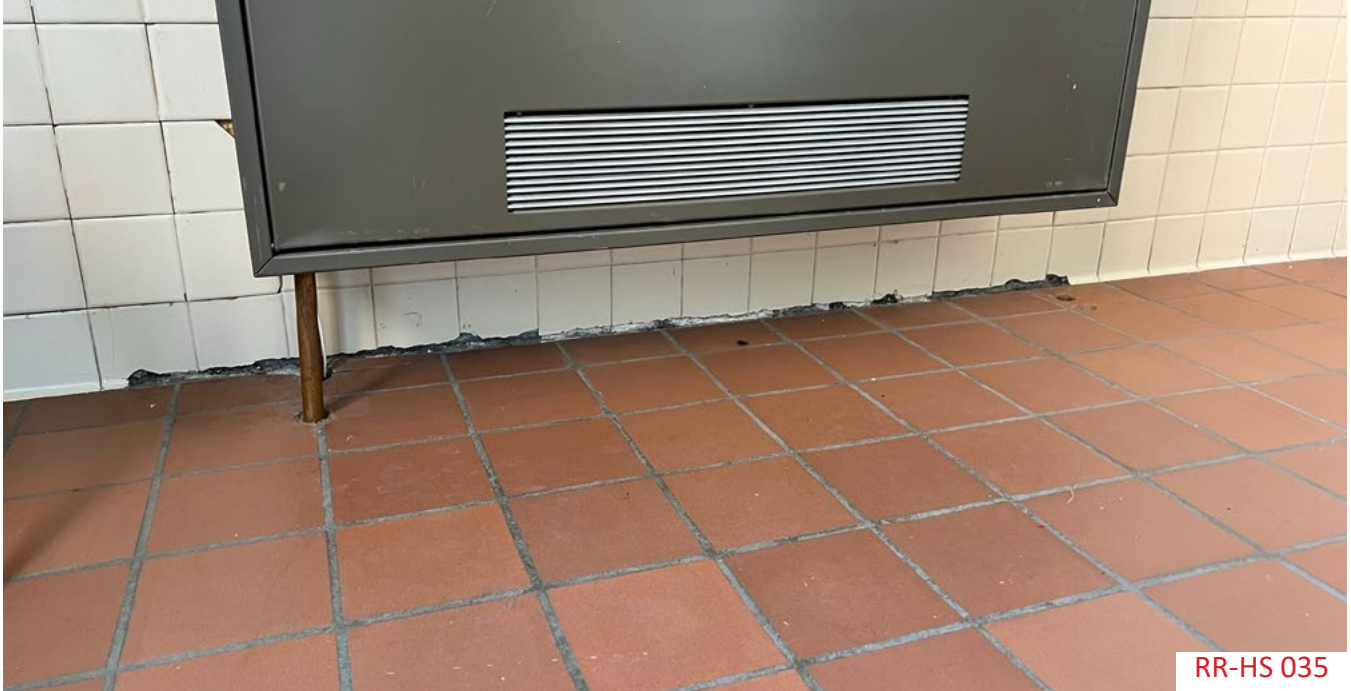
RR-HS 035

The vestibule tiles are especially in bad condition.

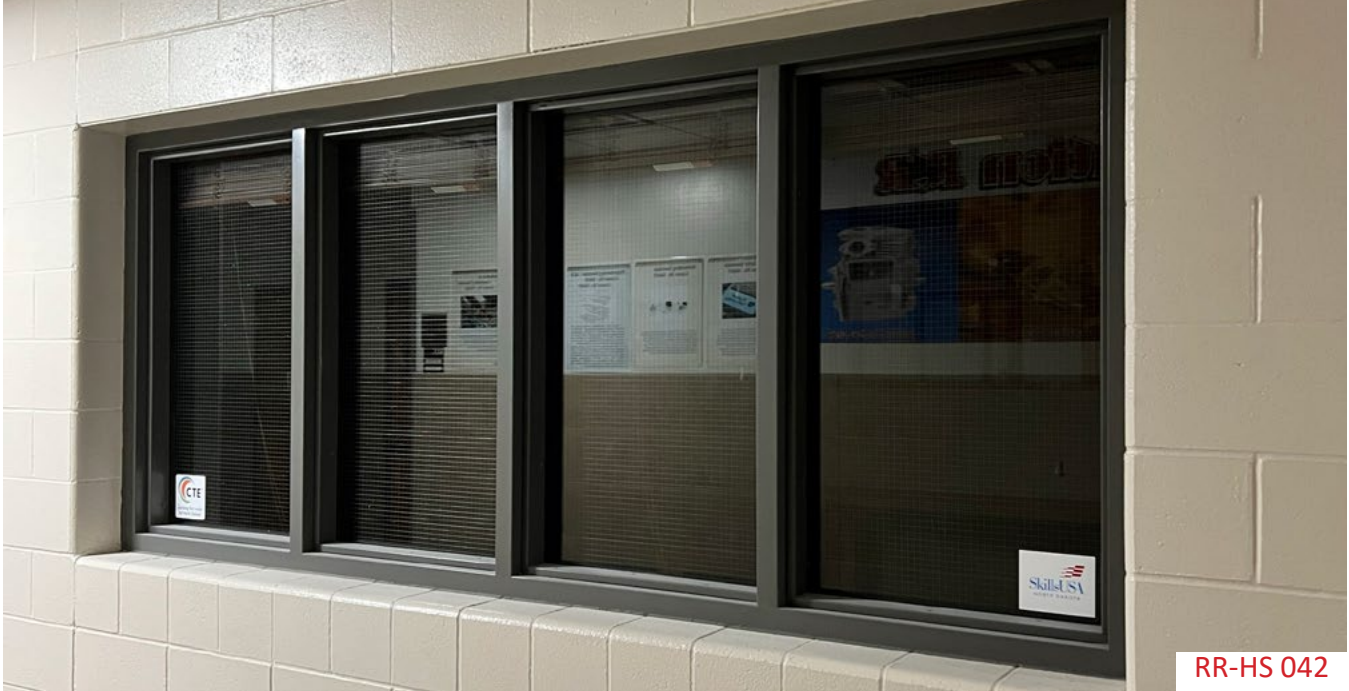
RR-HS 042

Traditional wire glass throughout the building is no longer to code as an acceptable type of safety glass.

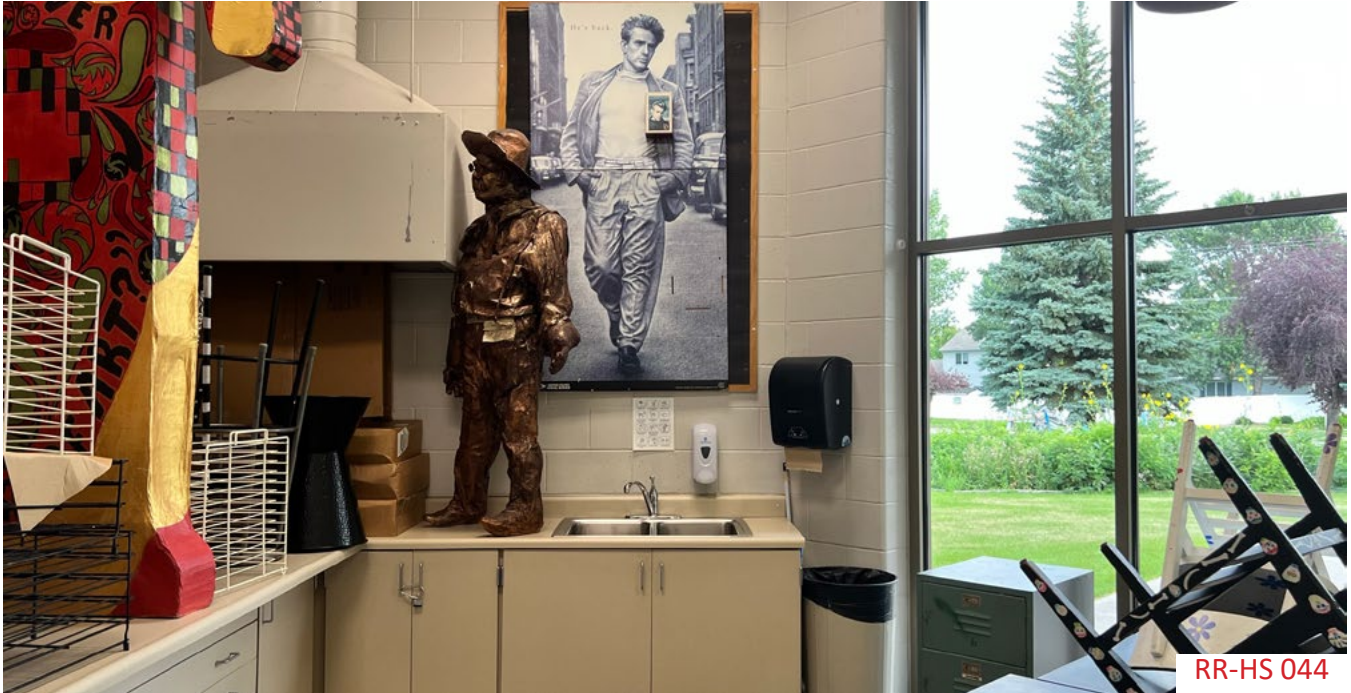
RR-HS 044

Sinks within classrooms and offices are not accessible.

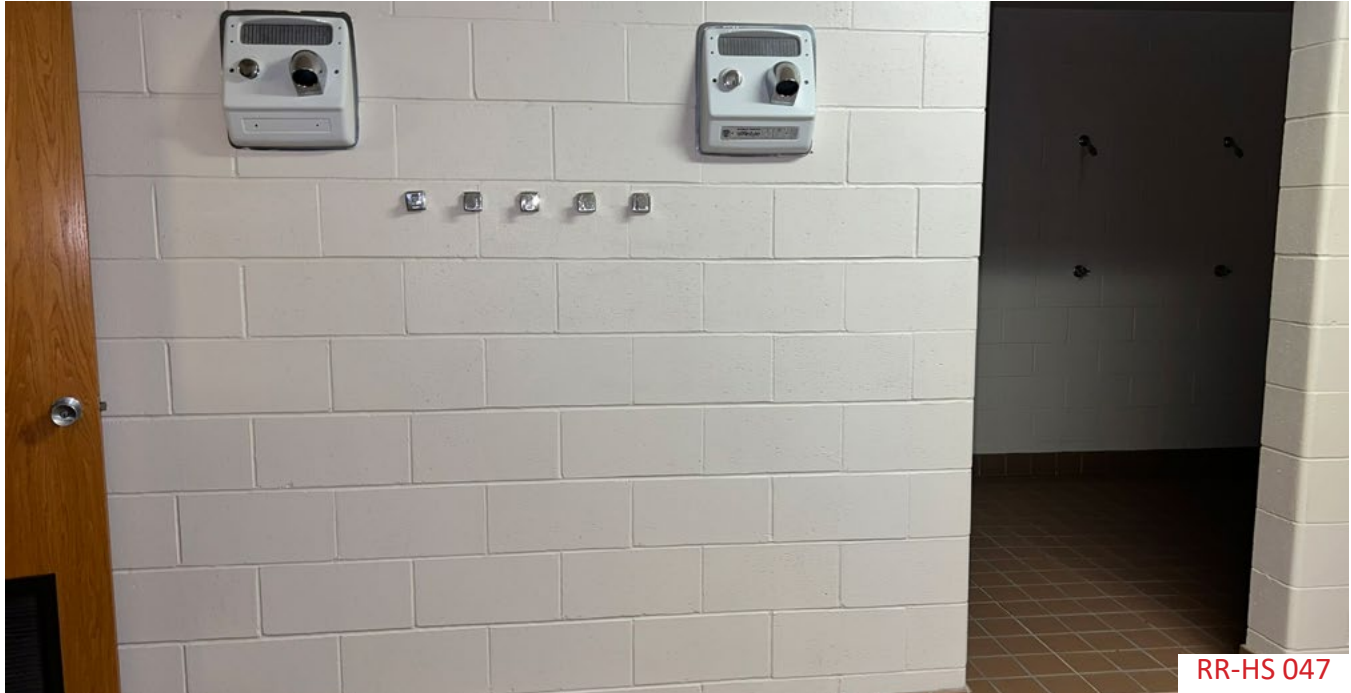
RR-HS 047

All men's and women's locker rooms have hand dryers that exceed height requirements.

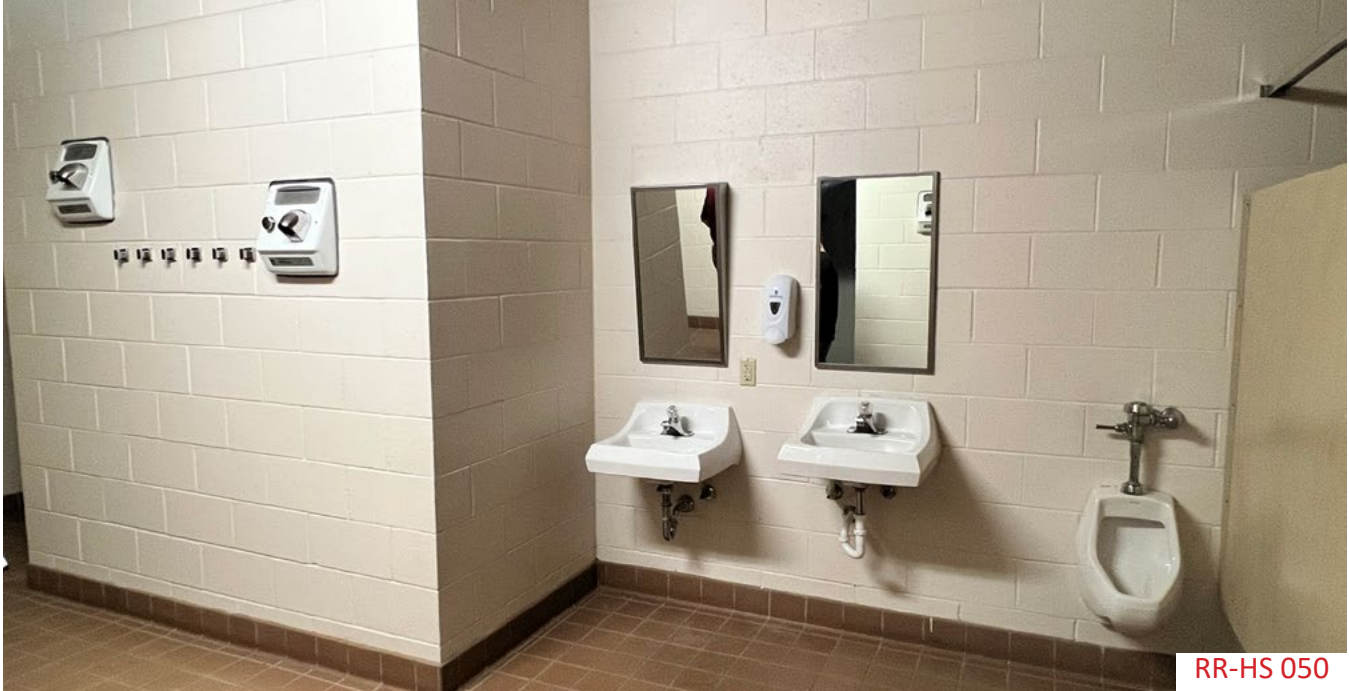
All three men's locker rooms are missing a lower urinal.
