ICON
ARCHITECTURAL GROUP

FACILITY ASSESSMENT FOR GRAND FORKS PUBLIC SCHOOLS

Grand Forks, ND

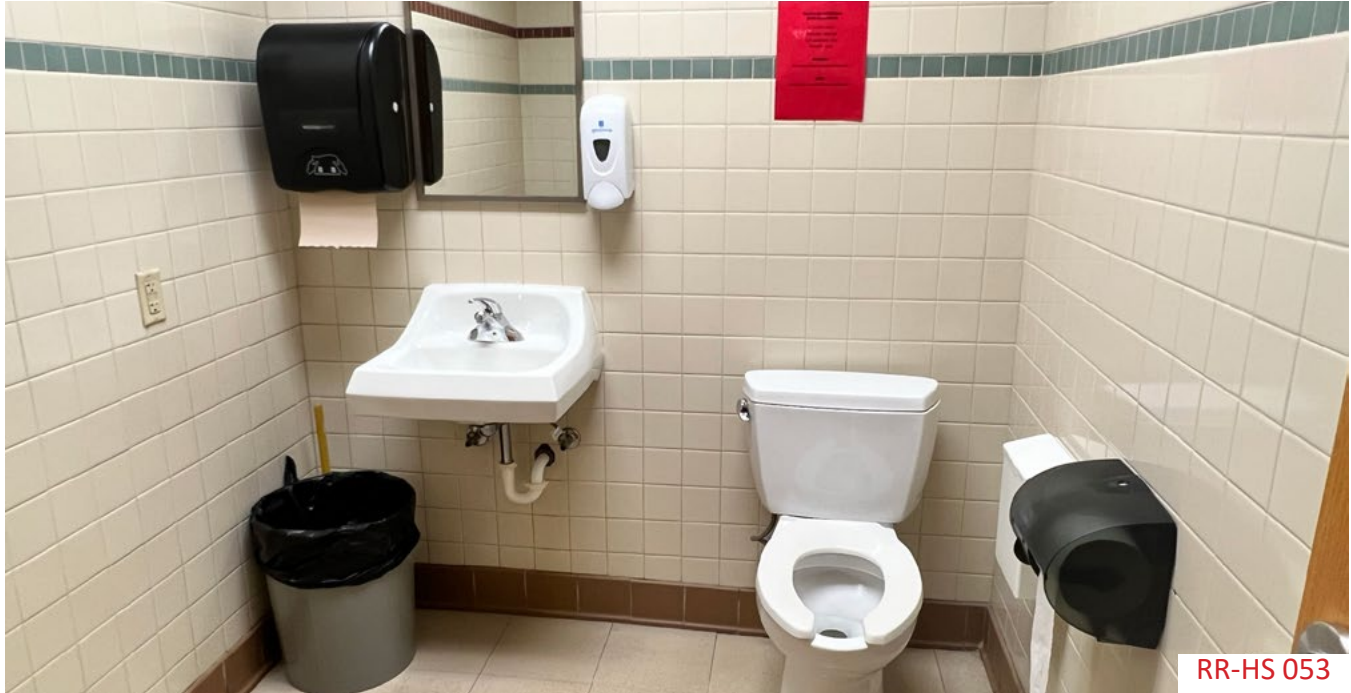
The restroom in the main office is not accessible.

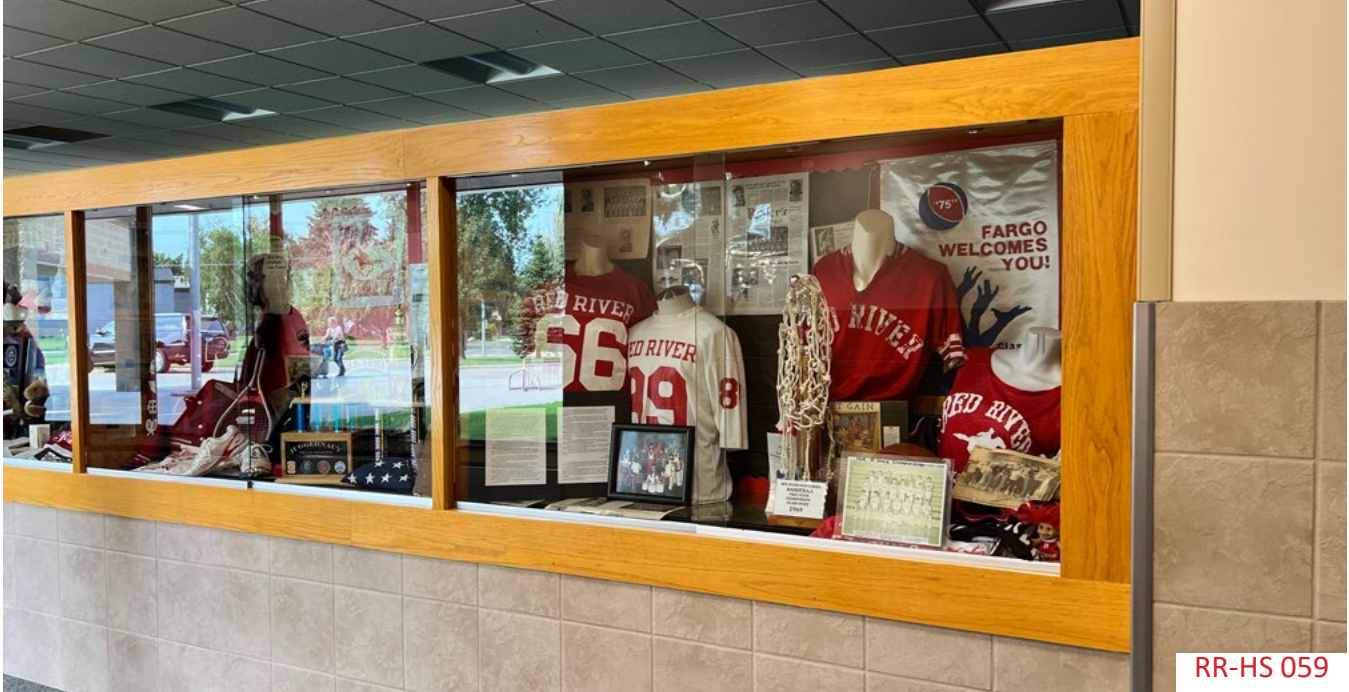
Display cases throughout do not have required safety glass.

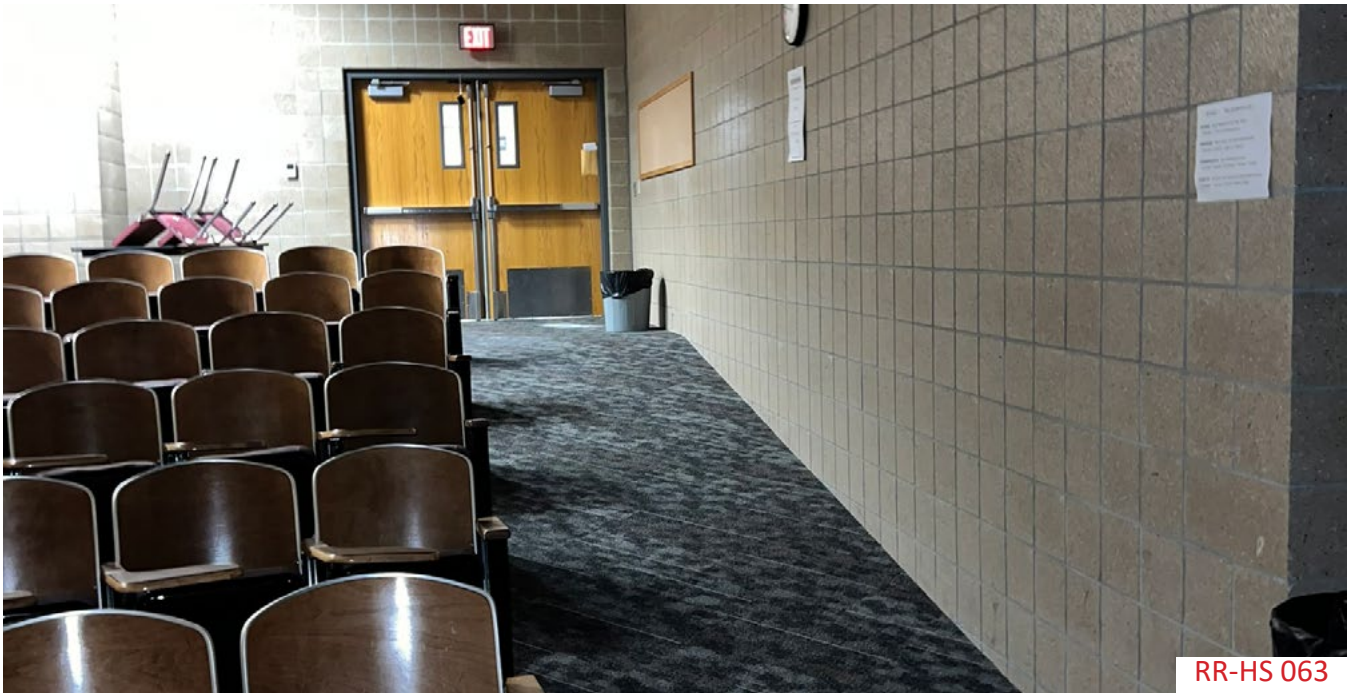
RR-HS 063

The Rider Room is missing handrails on the ramps.

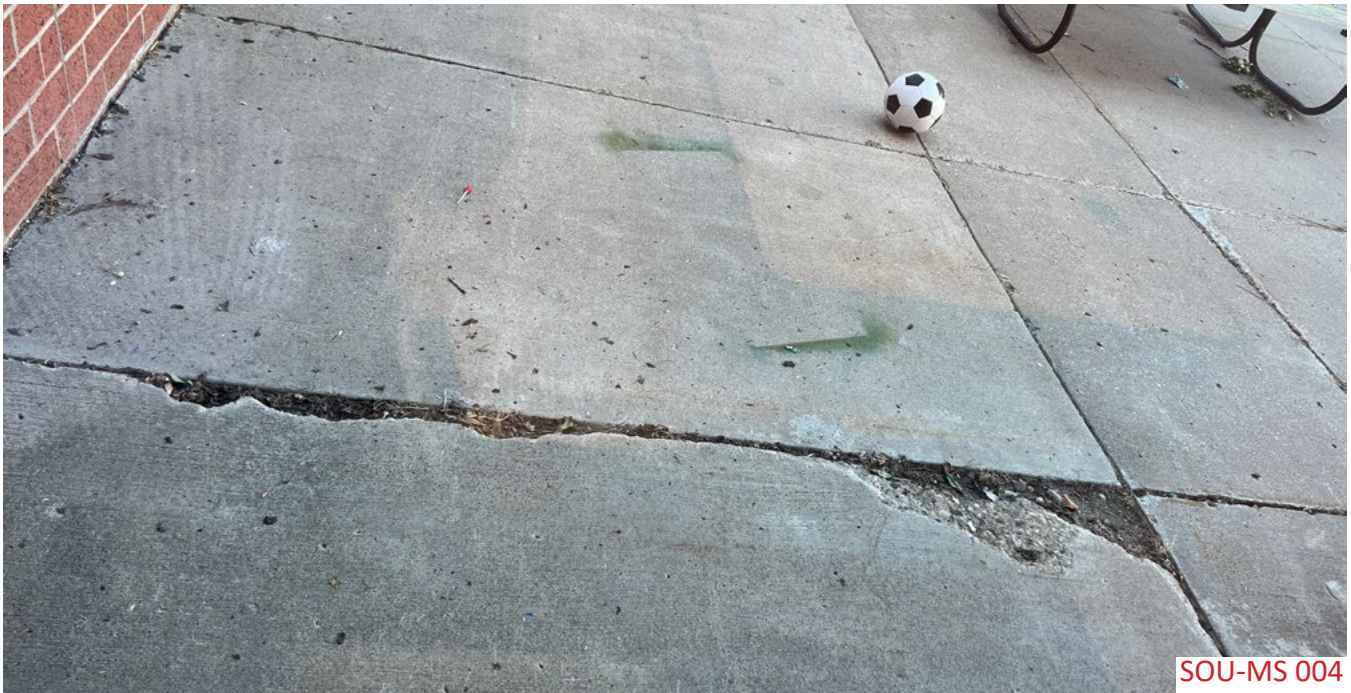
SOU-MS 004

A general patch and repair can be done for the sidewalk and asphalt on the site of the school.

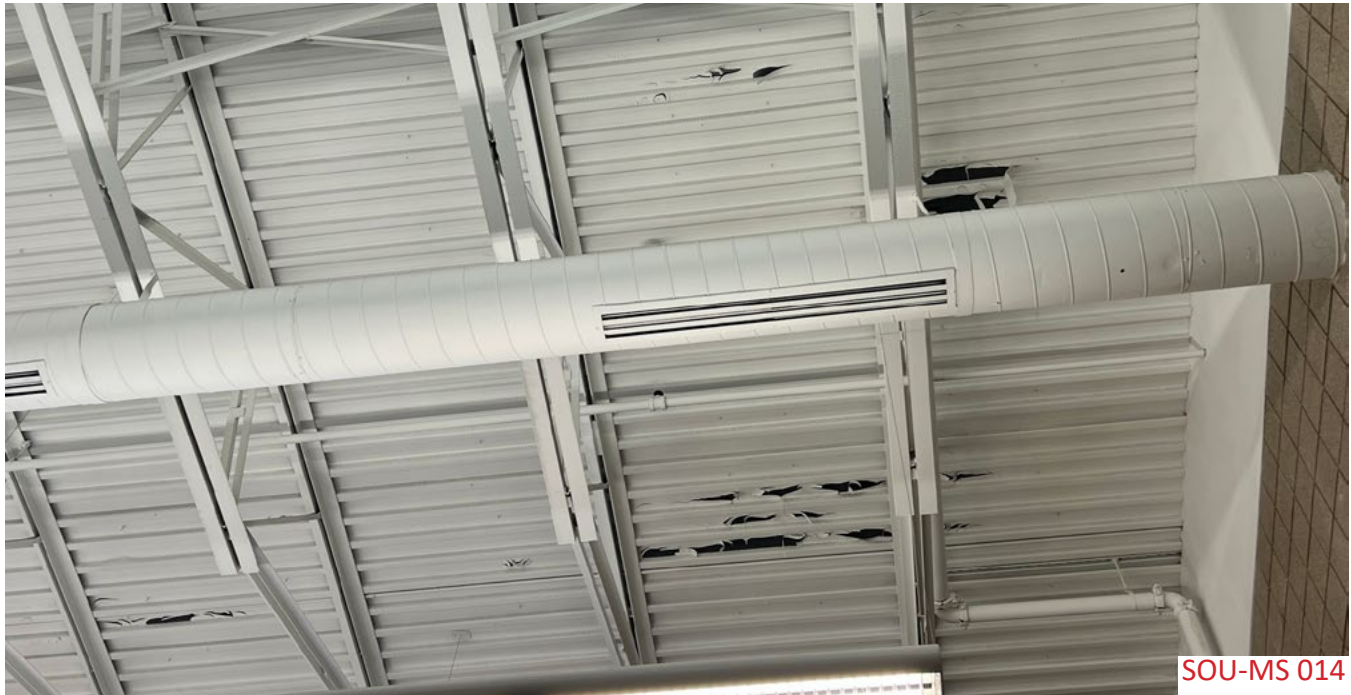
Another area of concern with ceiling is in the library where there is paint flaking from the steel deck paneling.

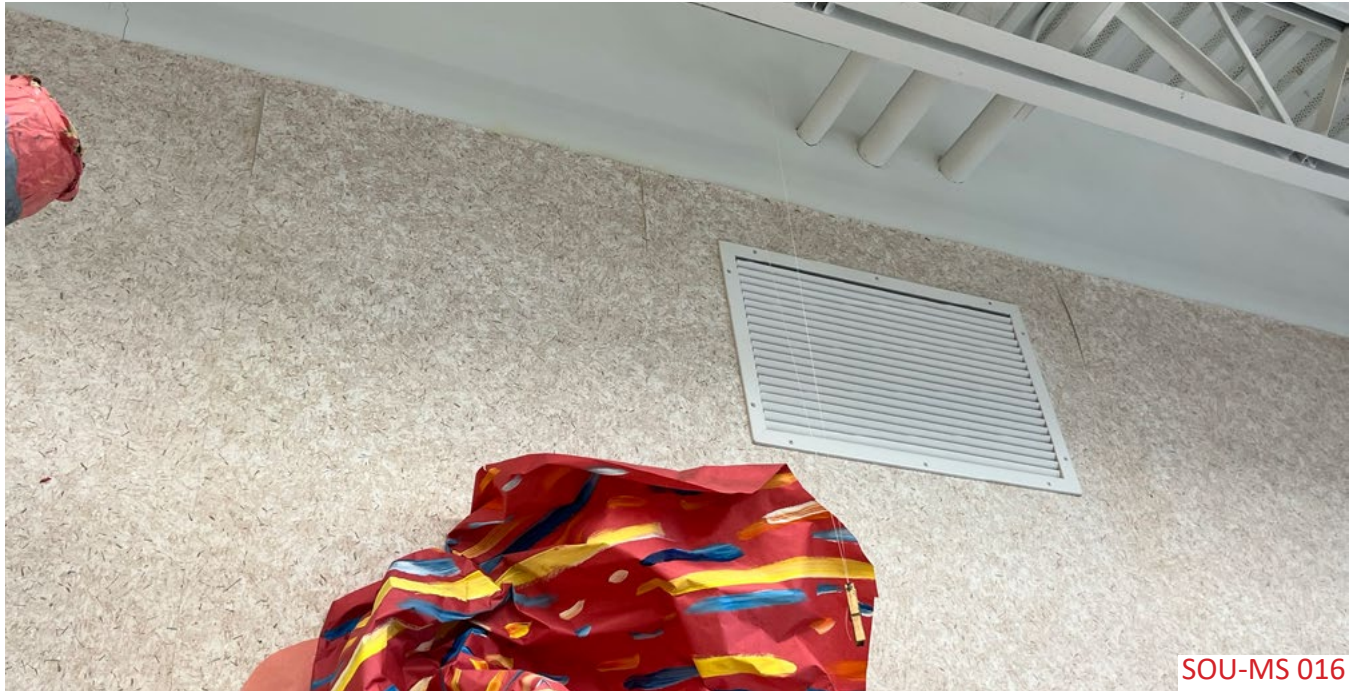
SOU-MS 016

There are several areas where the vinyl wall covering is releasing from the gypsum substrate.

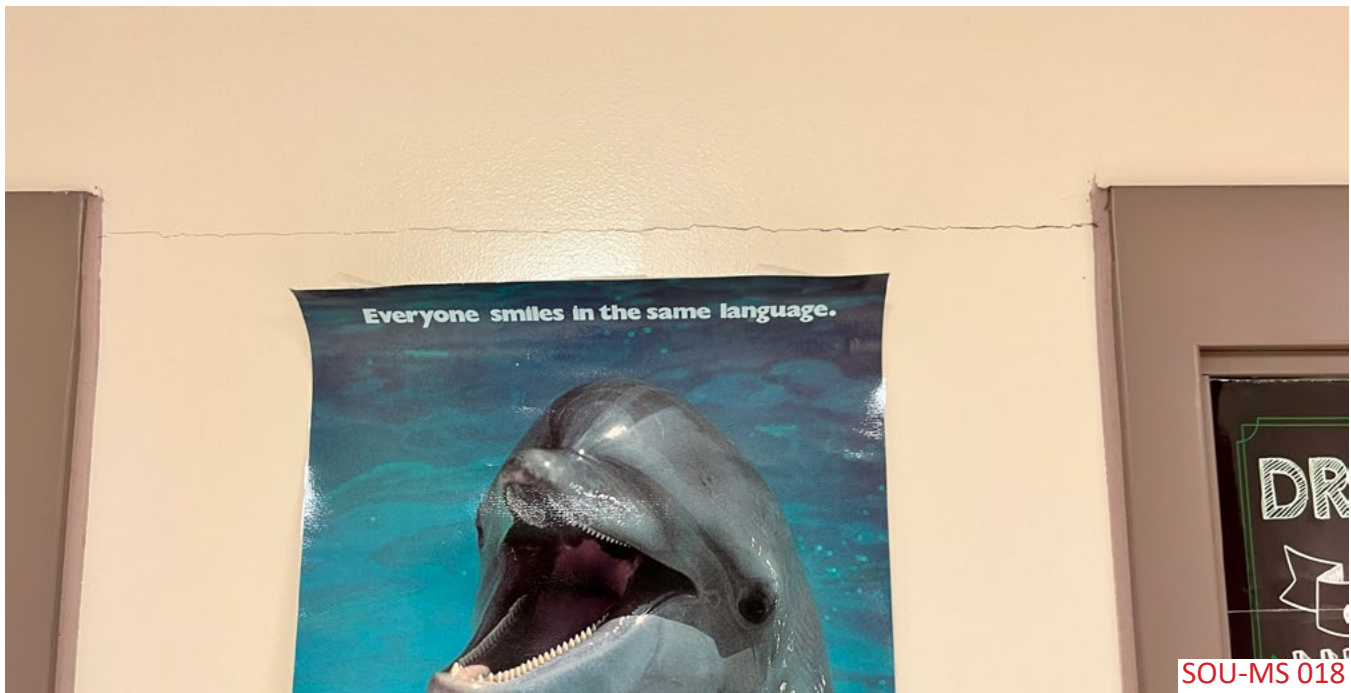
SOU-MS 018

There is horizontal cracking on the dry wall between many of the interior doors.

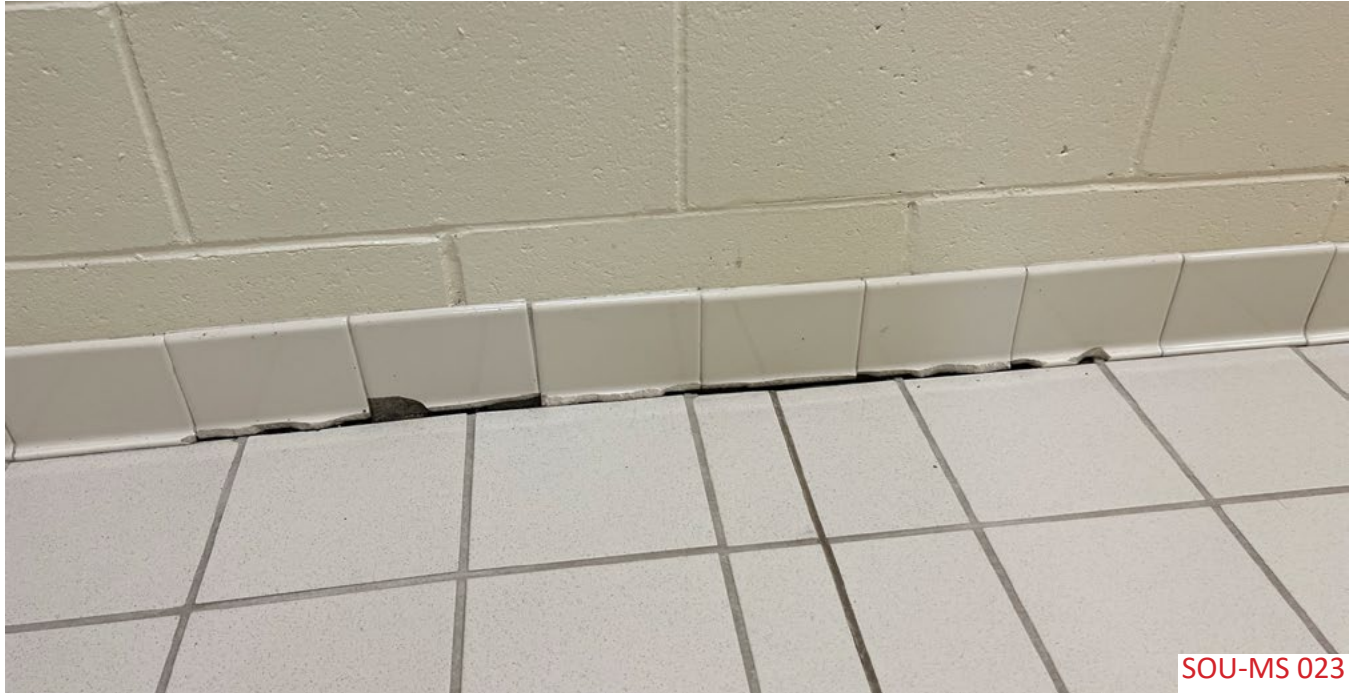
SOU-MS 023

The quarry and ceramic tiles in the kitchen and locker rooms could use general repair for problem spots, but do not have major issues.

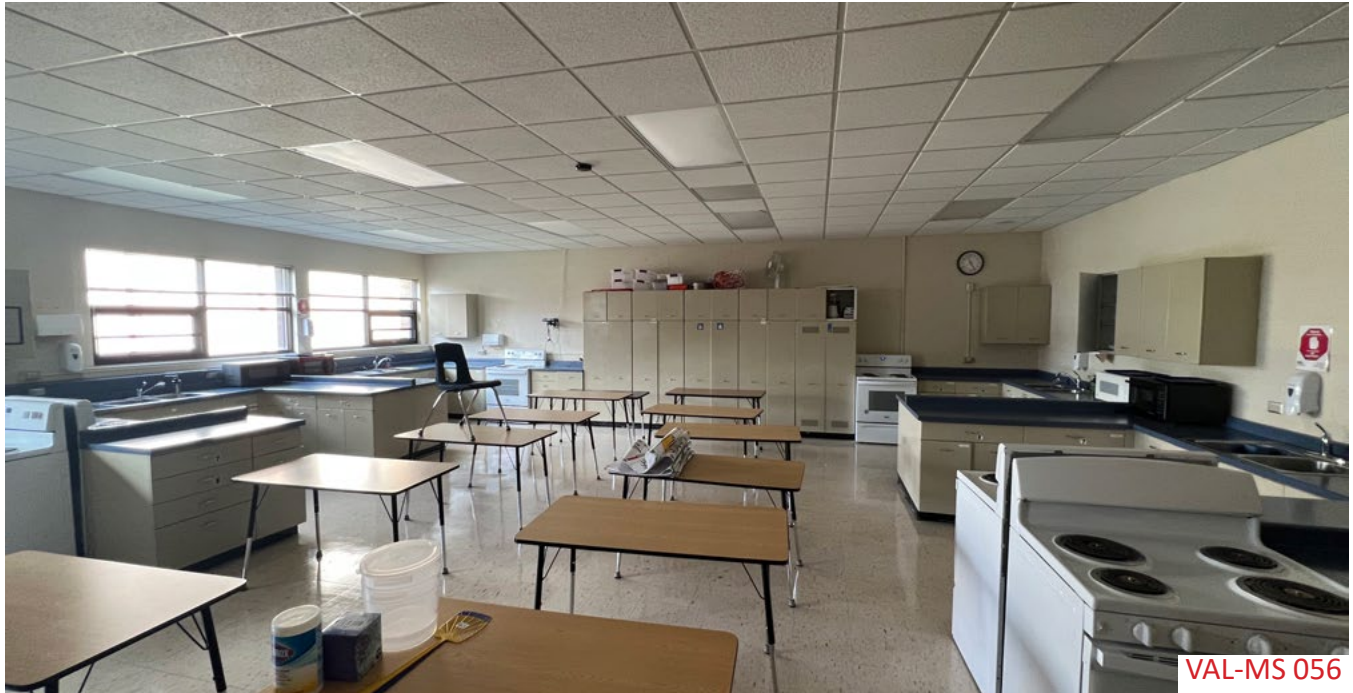
FACS classroom is not accessible.

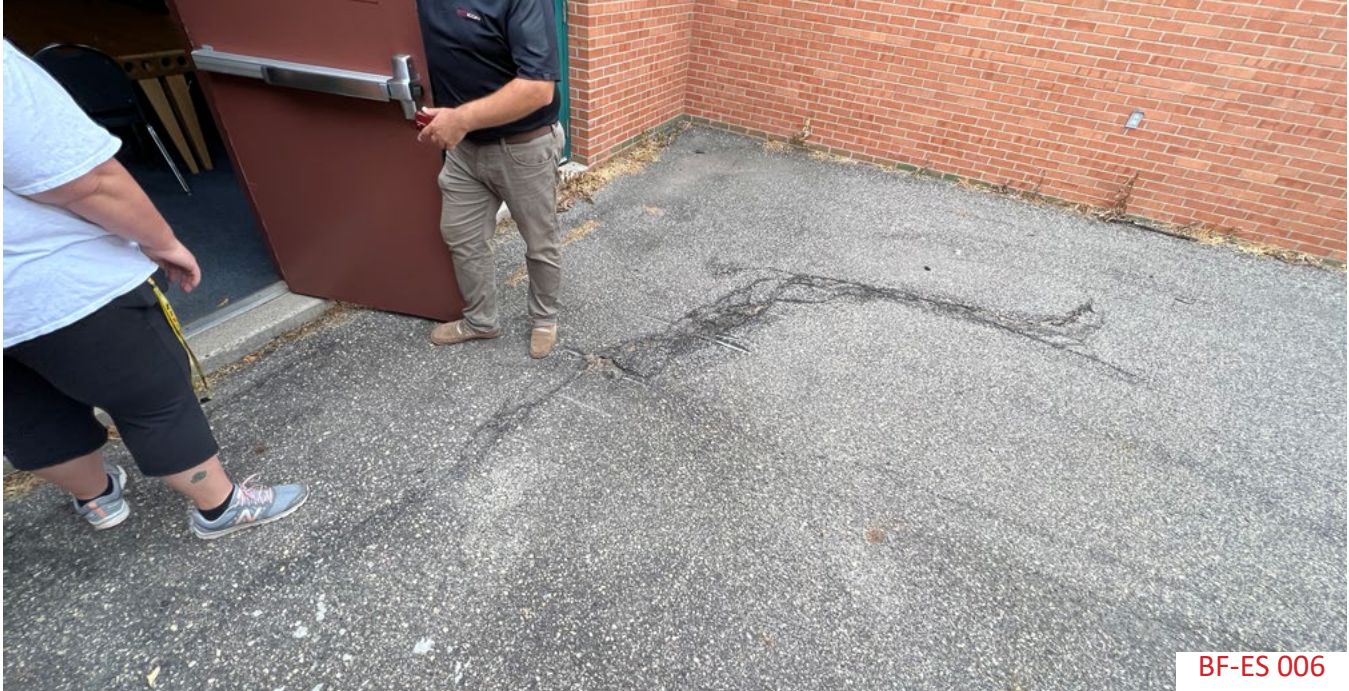
BF-ES 006

There is also a large new crack in the cement outside door 6.

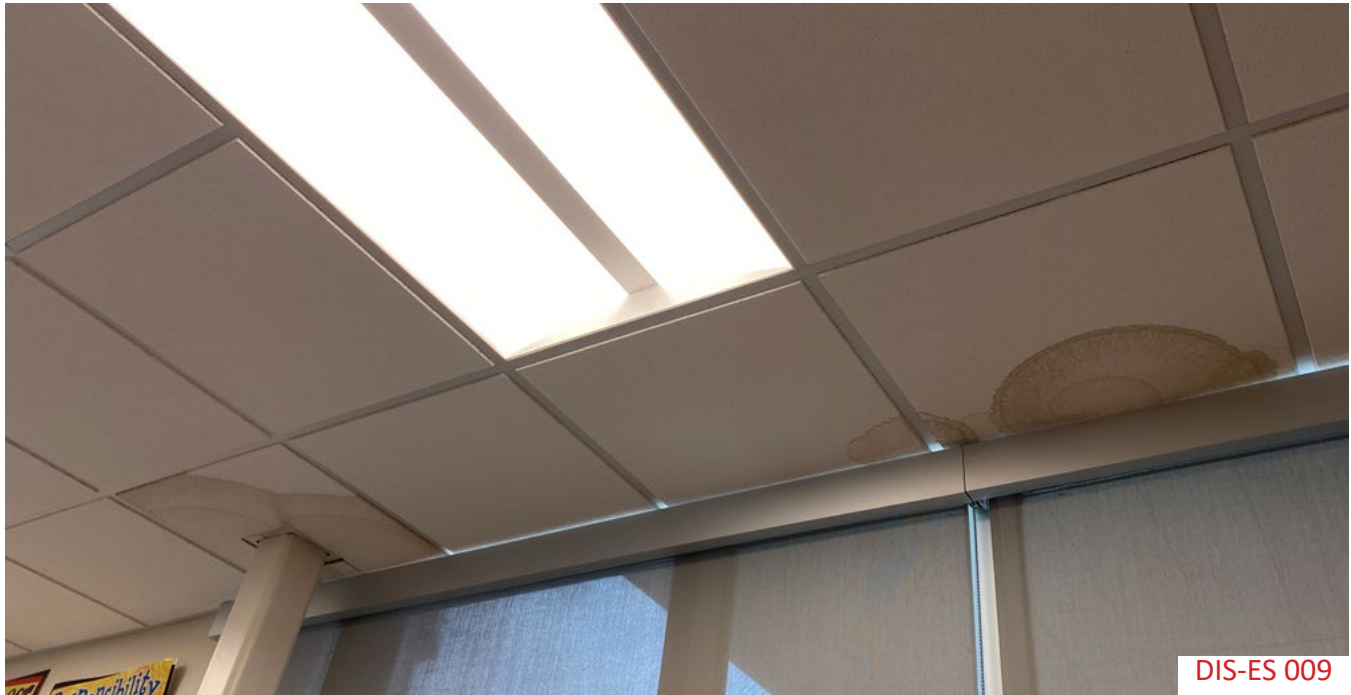
There are also several ceiling tiles throughout the school that have water damage.

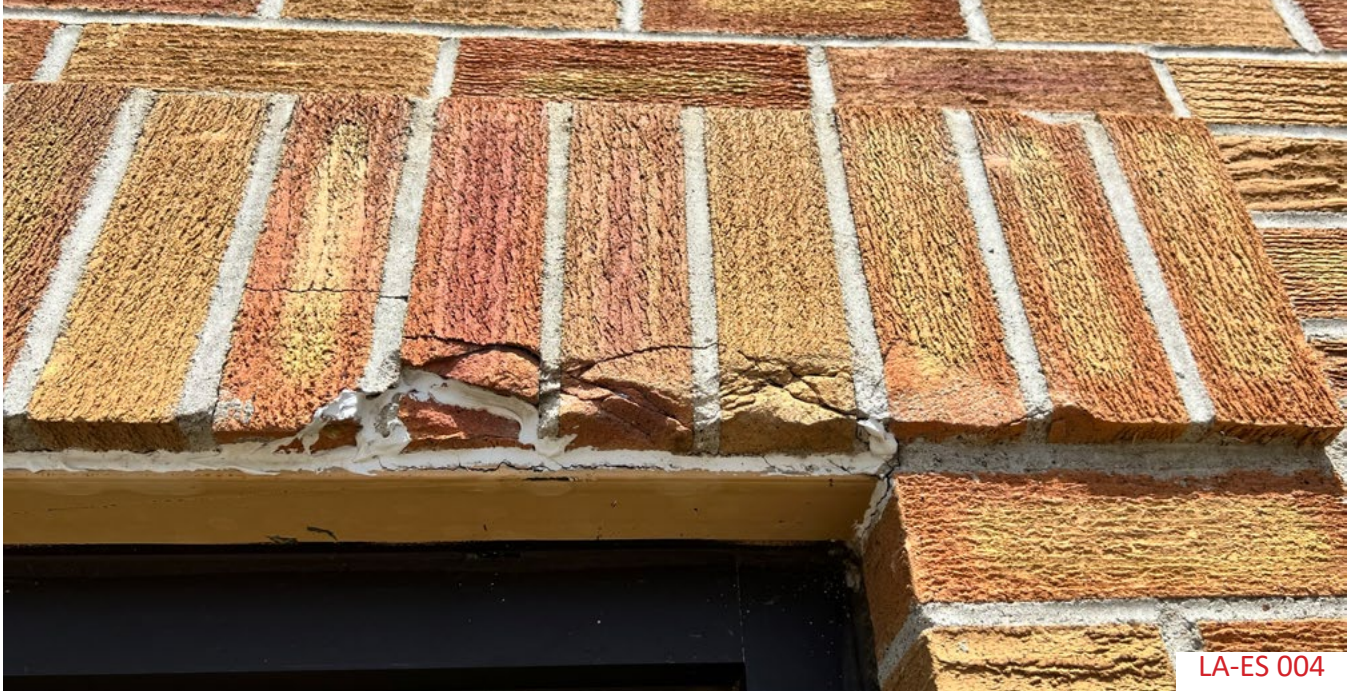
LA-ES 004

There are a few areas with damaged brick.

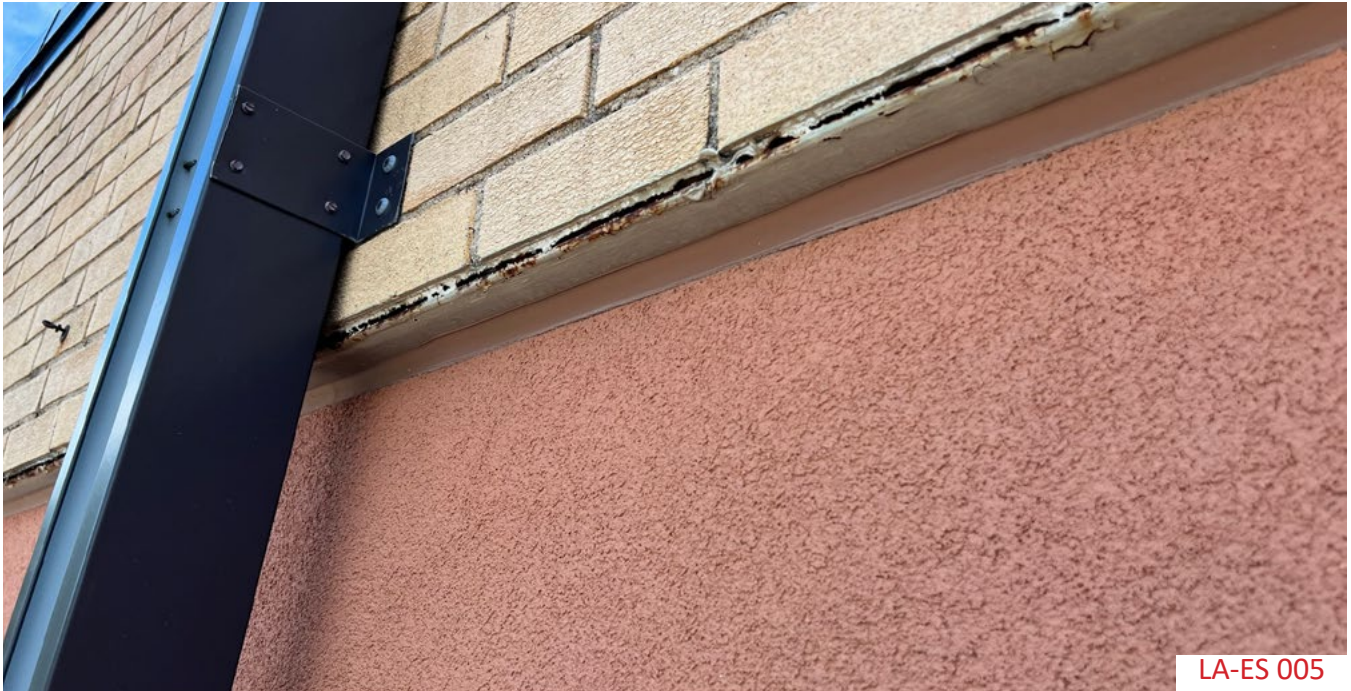
LA-ES 005

Flashing at the bottom of the brick portion of the wall was caulked over, preventing proper water drainage. Water pools on the lintel and it is causing it to rust and deteriorate.

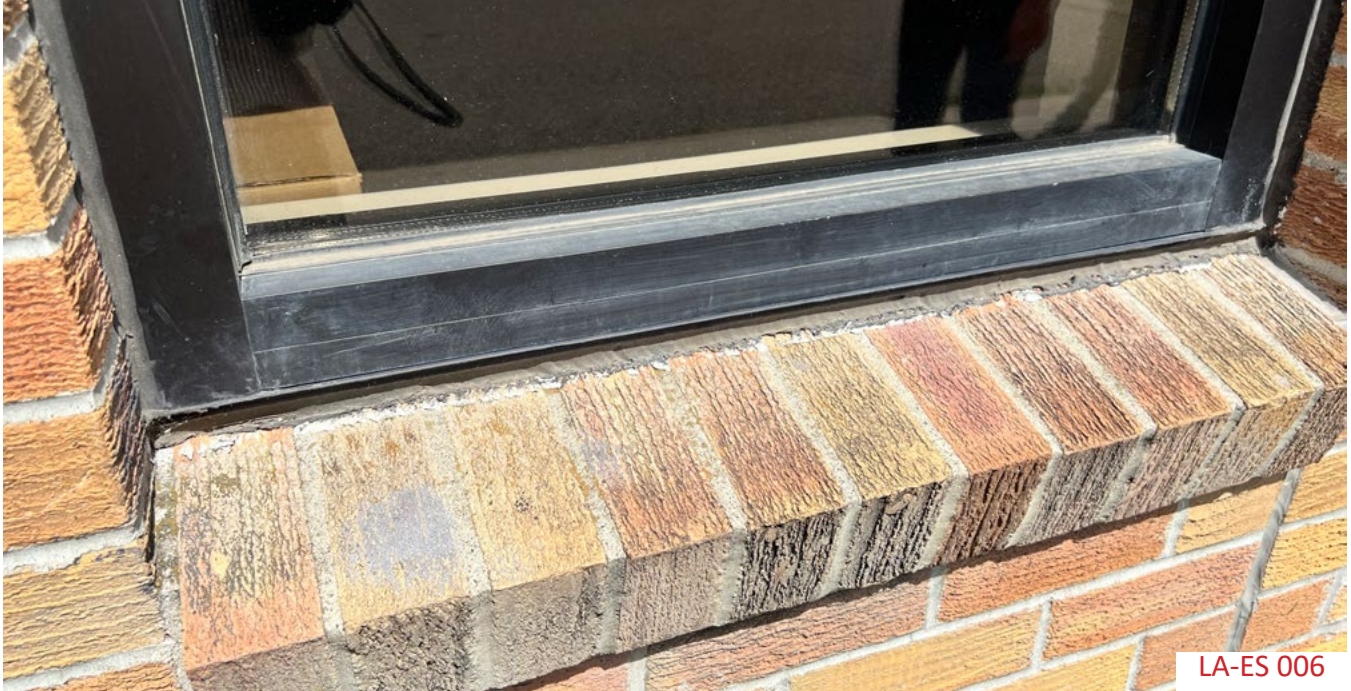
LA-ES 006

The original glazing compound on windows is coming off and needs to be redone.

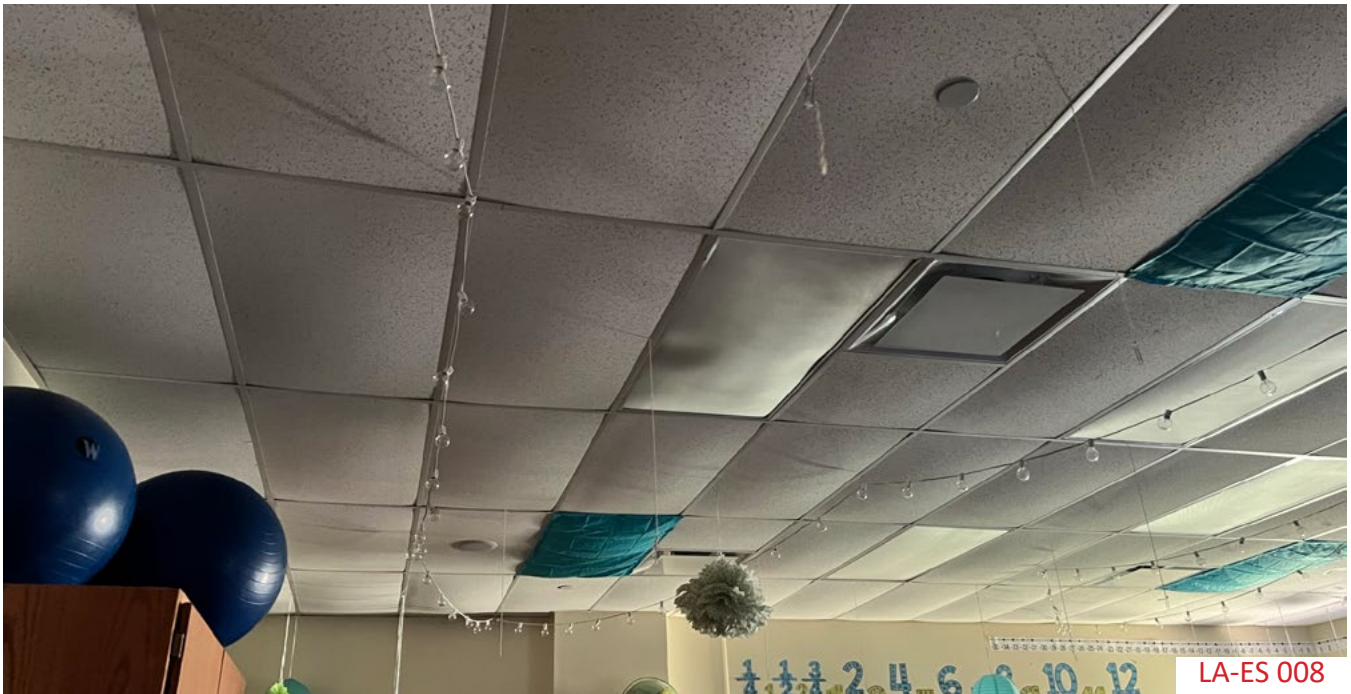
LA-ES 008

Some classrooms have sagging tile due to humidity.

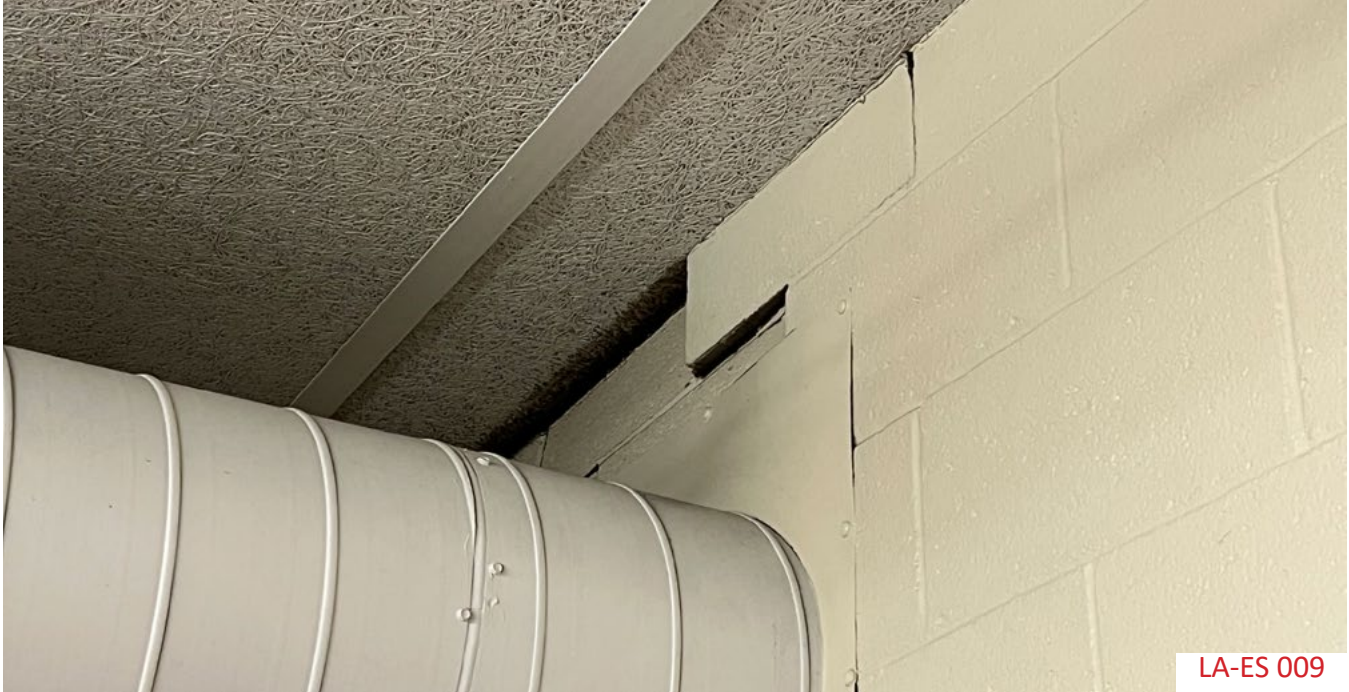
LA-ES 009

Some CMU brick is caving in from ducts.

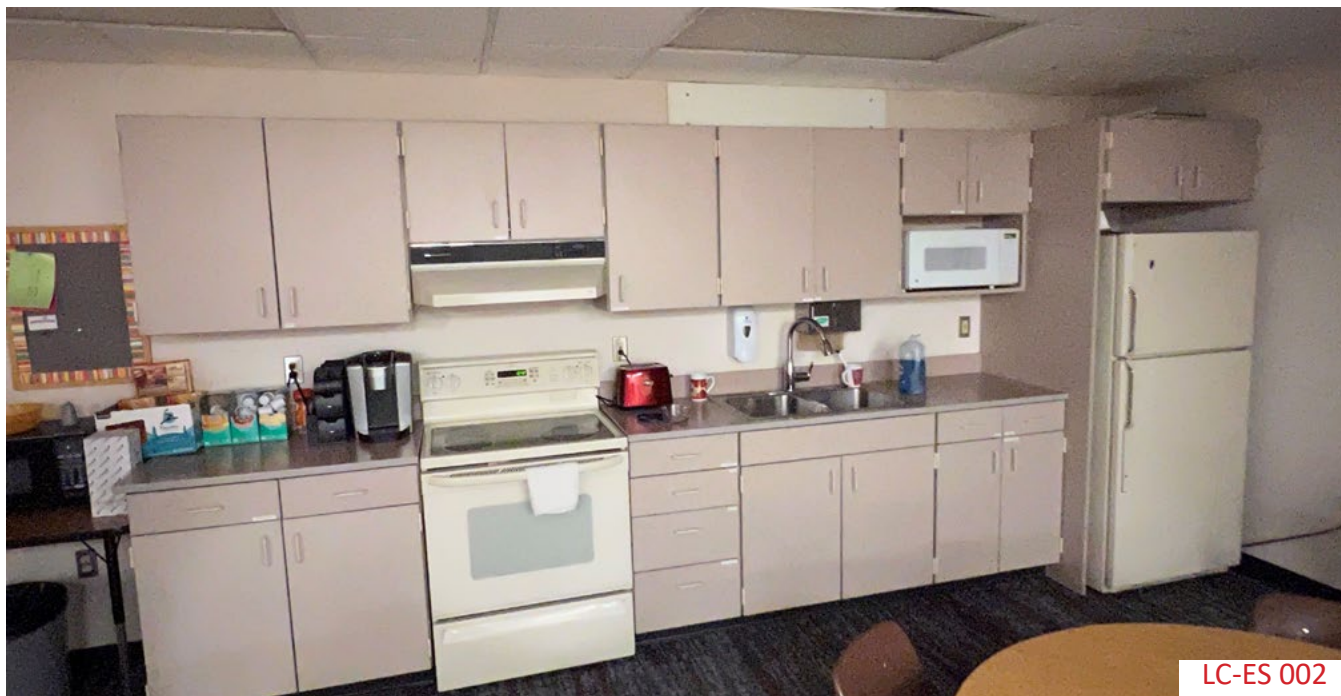
Casework and finishes throughout the school are dated and showing signs of wear.

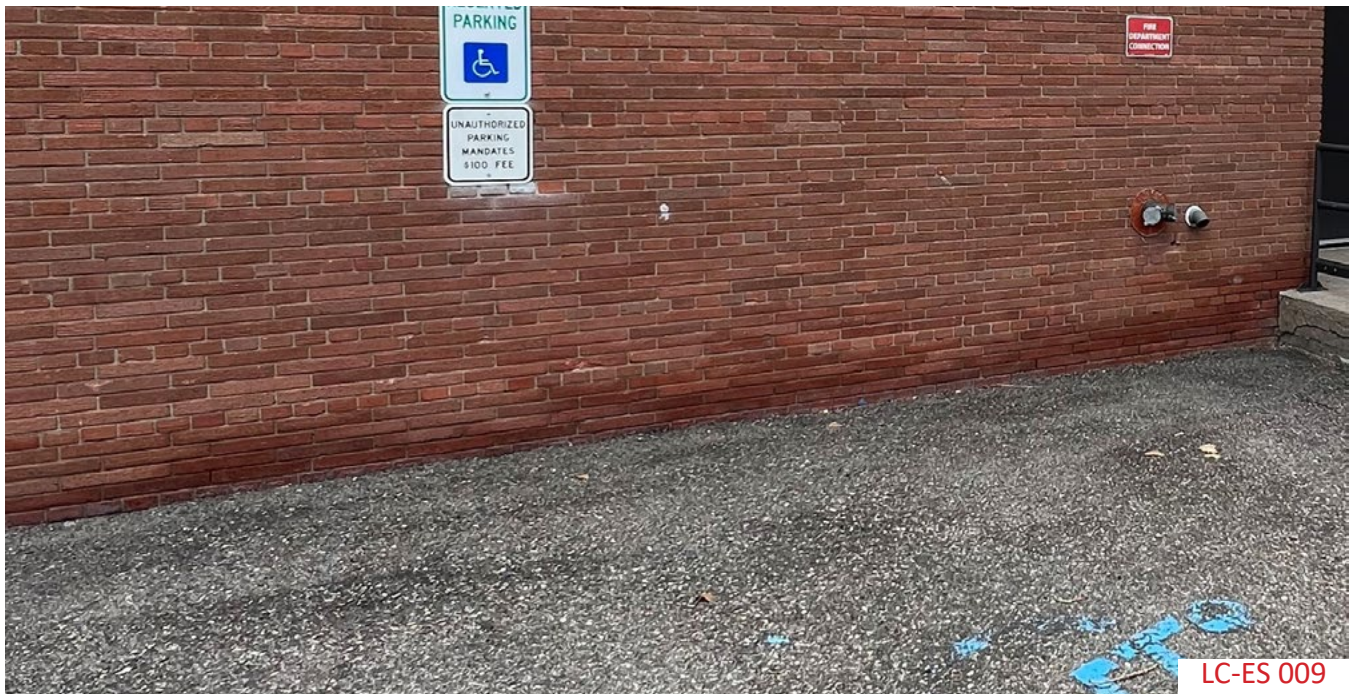
LC-ES 009

Tuckpointing is wearing and there are signs of moisture at the bottom of exterior brick walls

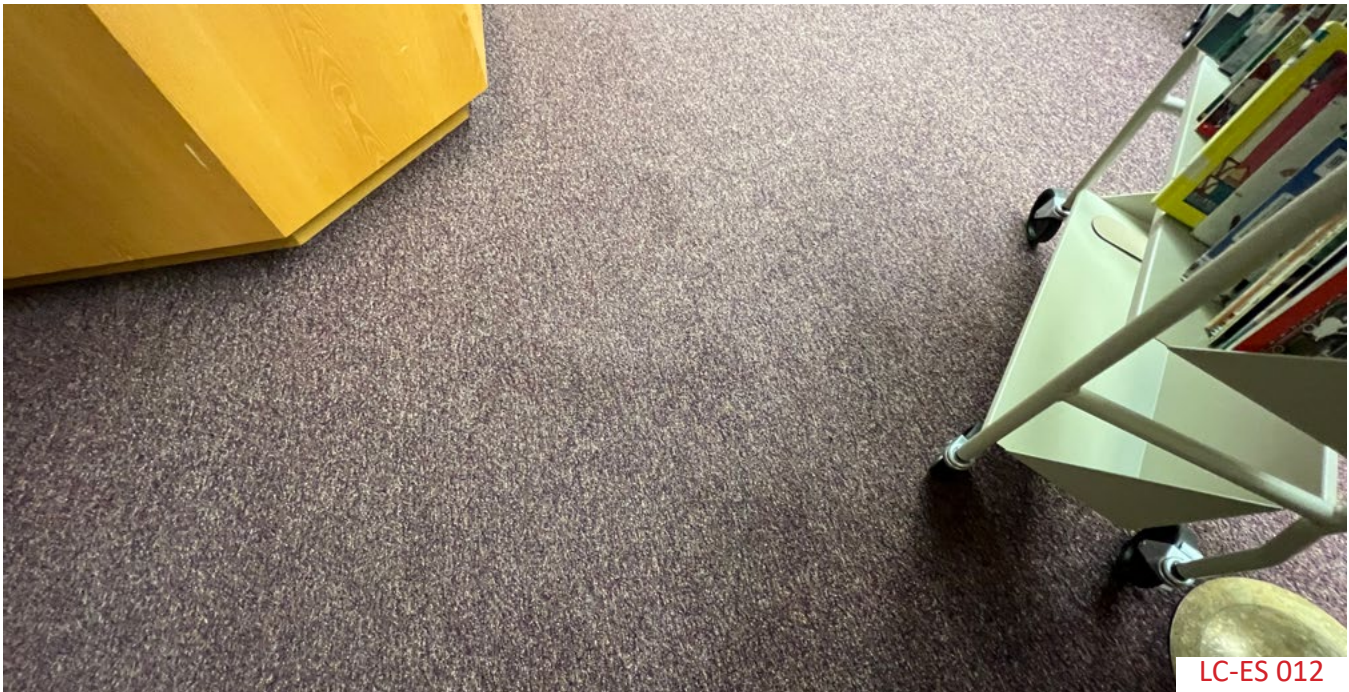
Carpet has been replaced in some spaces but overall, the flooring throughout the school is dated and showing signs of wear.

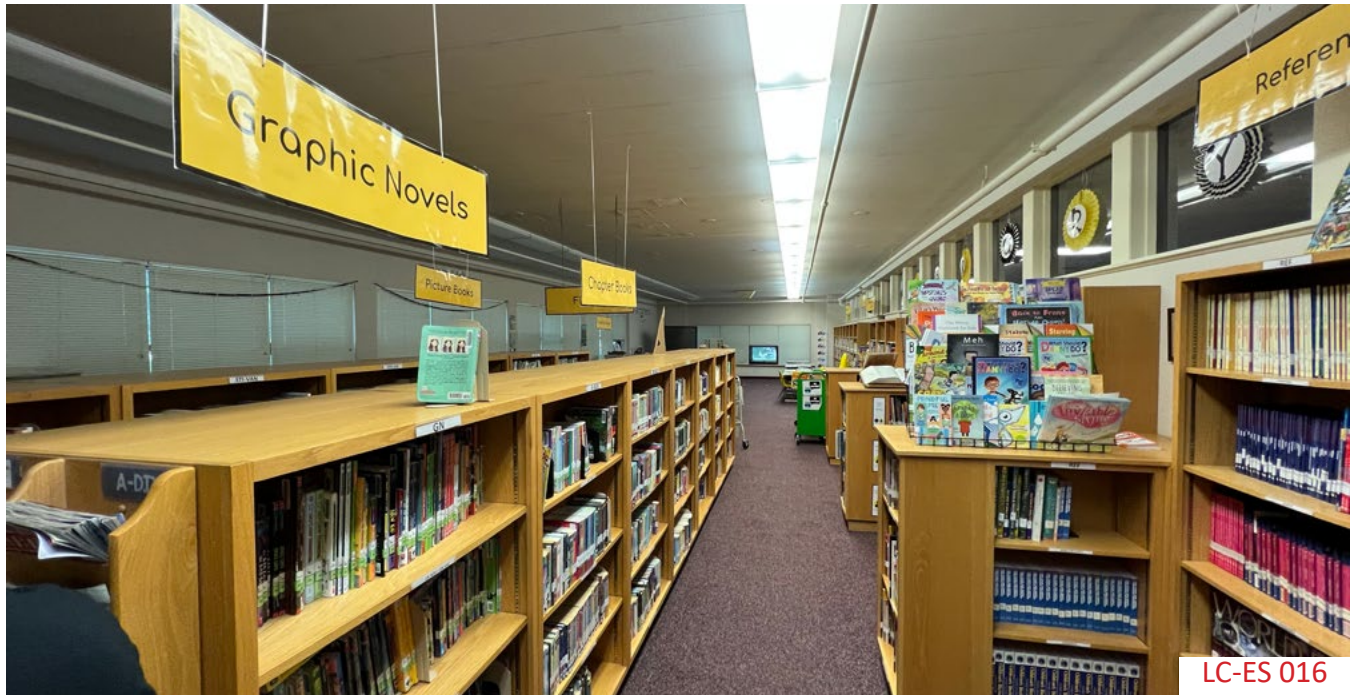
There is concern with the floor structure in the library due to the load the books place upon it.

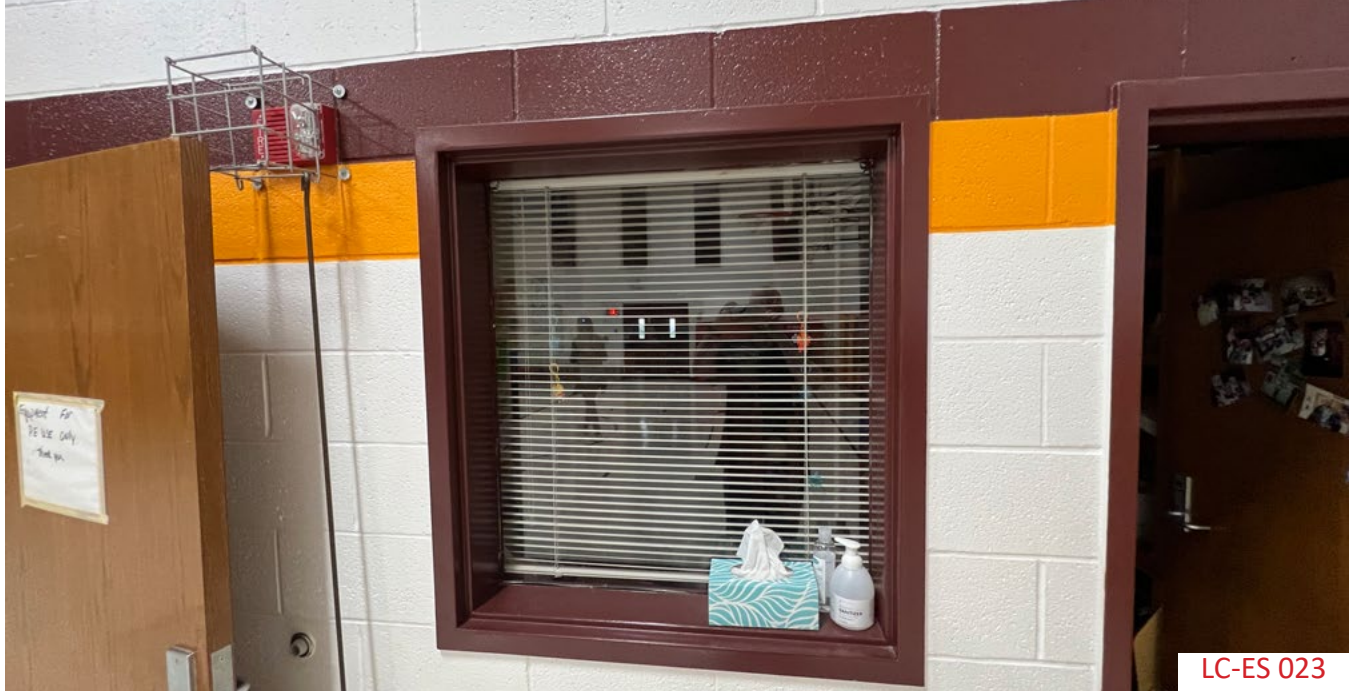
Window in the gym does not have the required safety glass

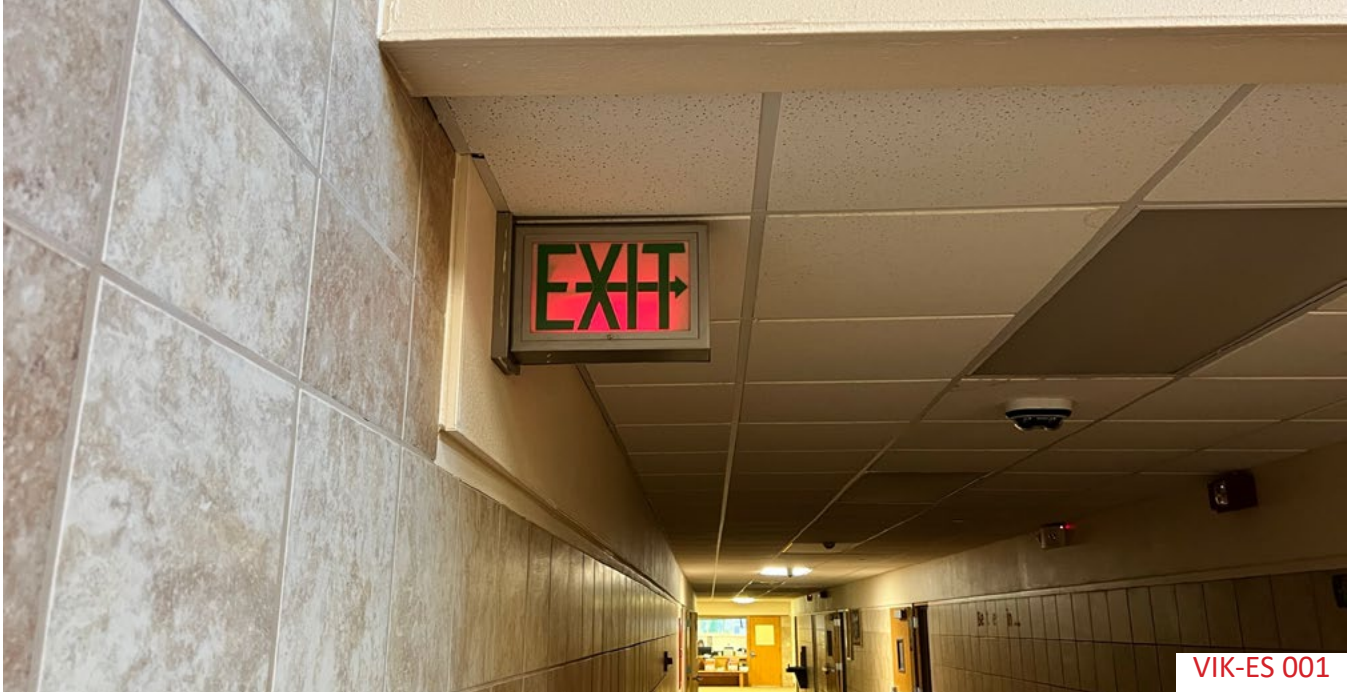
VIK-ES 001

Exit signs are dim and should be replaced.

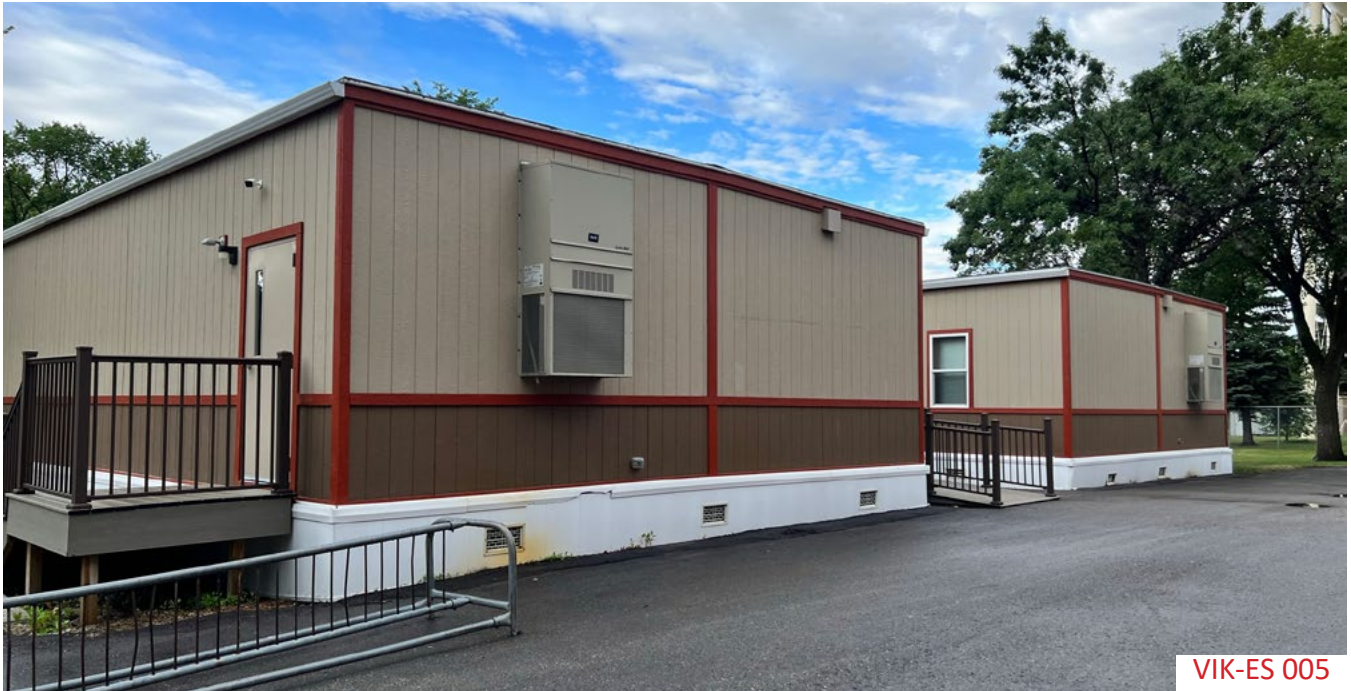
VIK-ES 005

Two portable classrooms are located on the south side of the building.

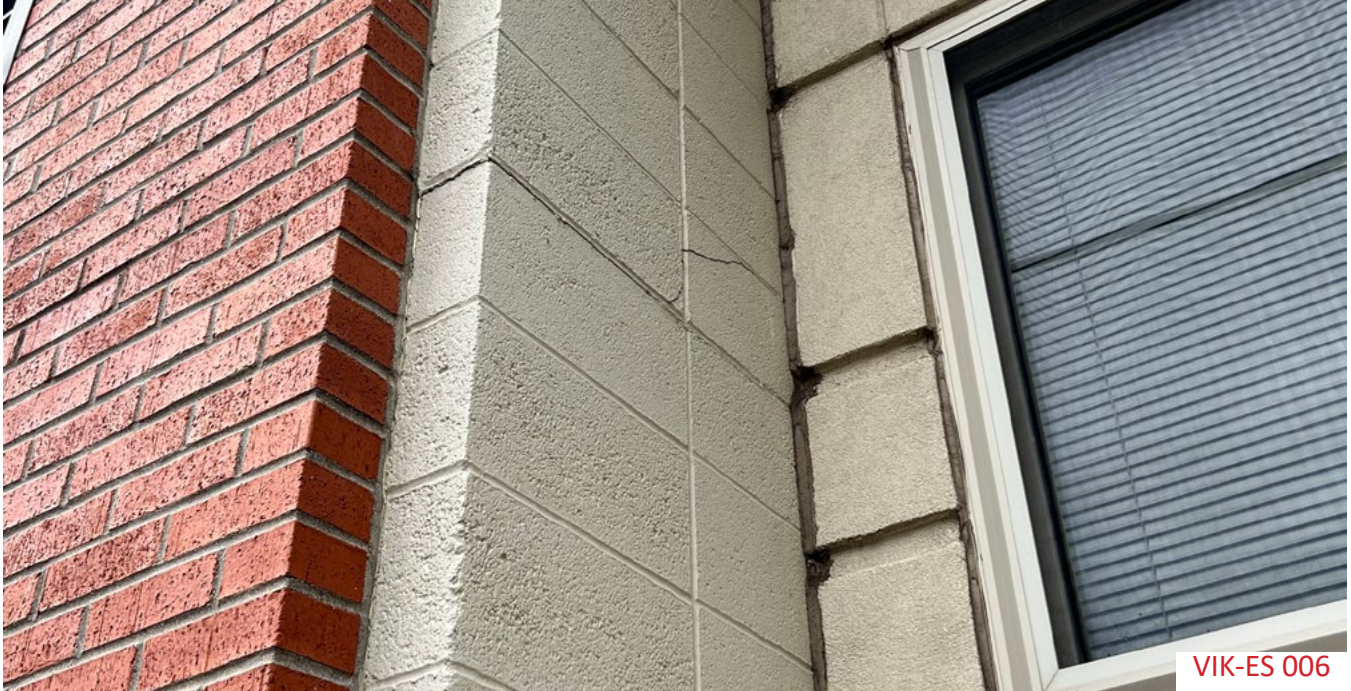
There is some cracking on exterior CMU brick.
