ICON
ARCHITECTURAL GROUP

FACILITY ASSESSMENT FOR GRAND FORKS PUBLIC SCHOOLS

Grand Forks, ND

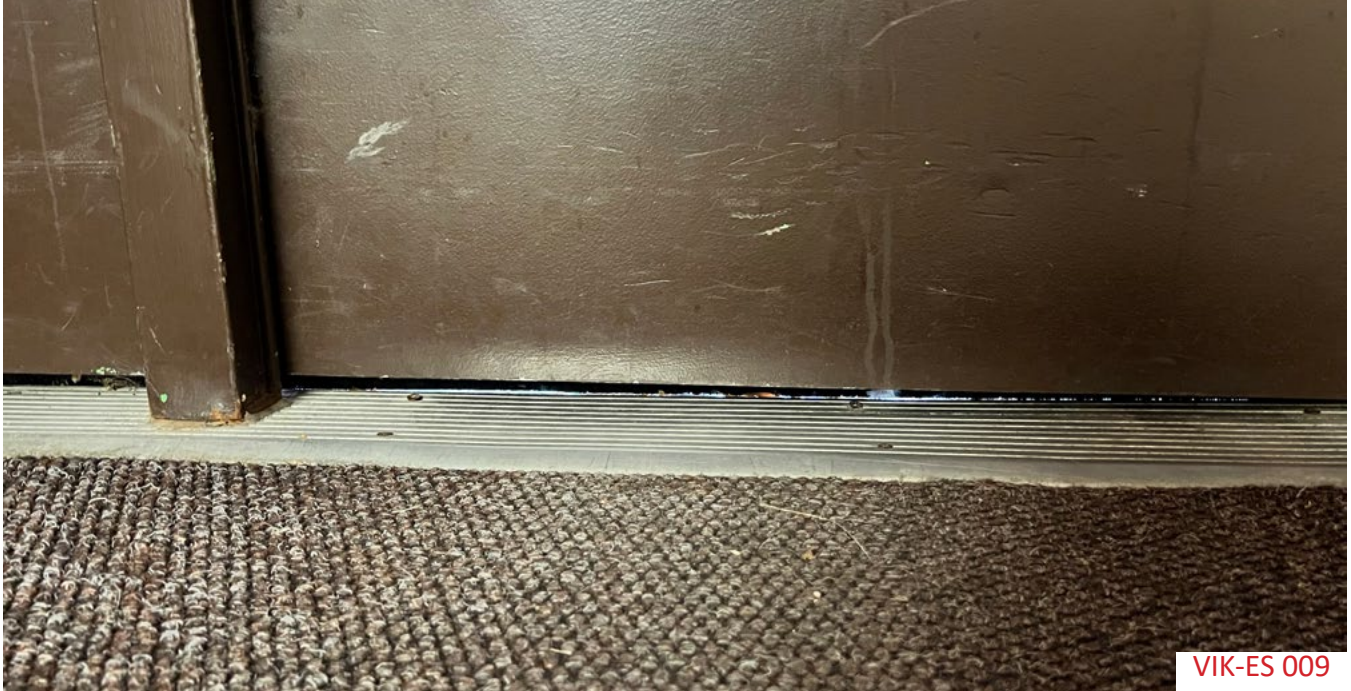
Weather stripping could be replaced.

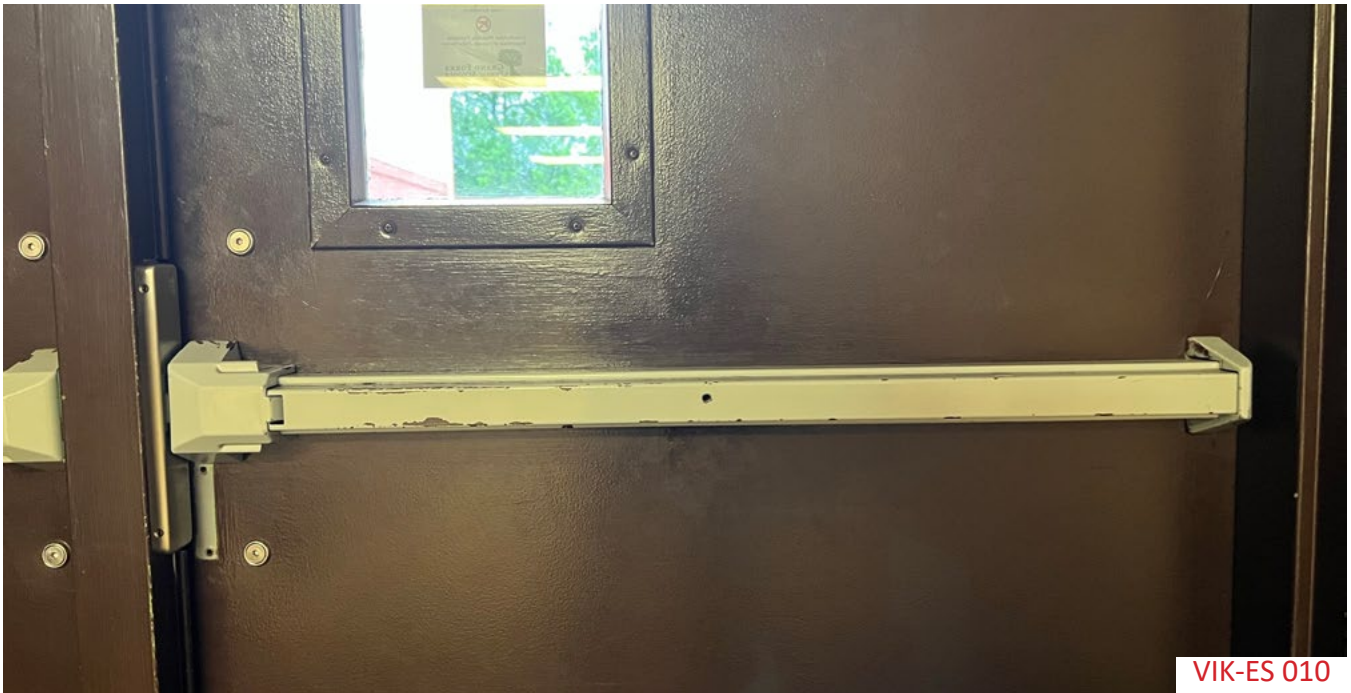
Weather stripping could be replaced and potentially door hardware.

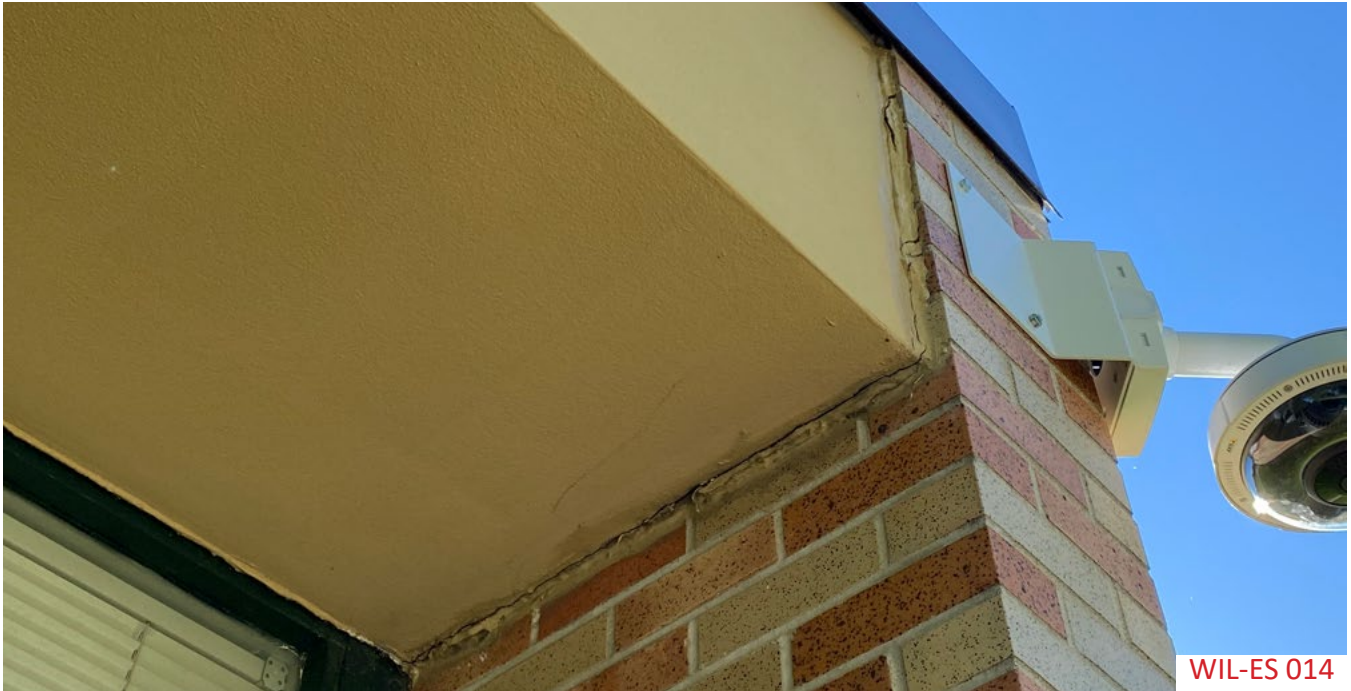
WIL-ES 014

Cracking was seen along the span of the EFIS along with the caulking needing to be redone.

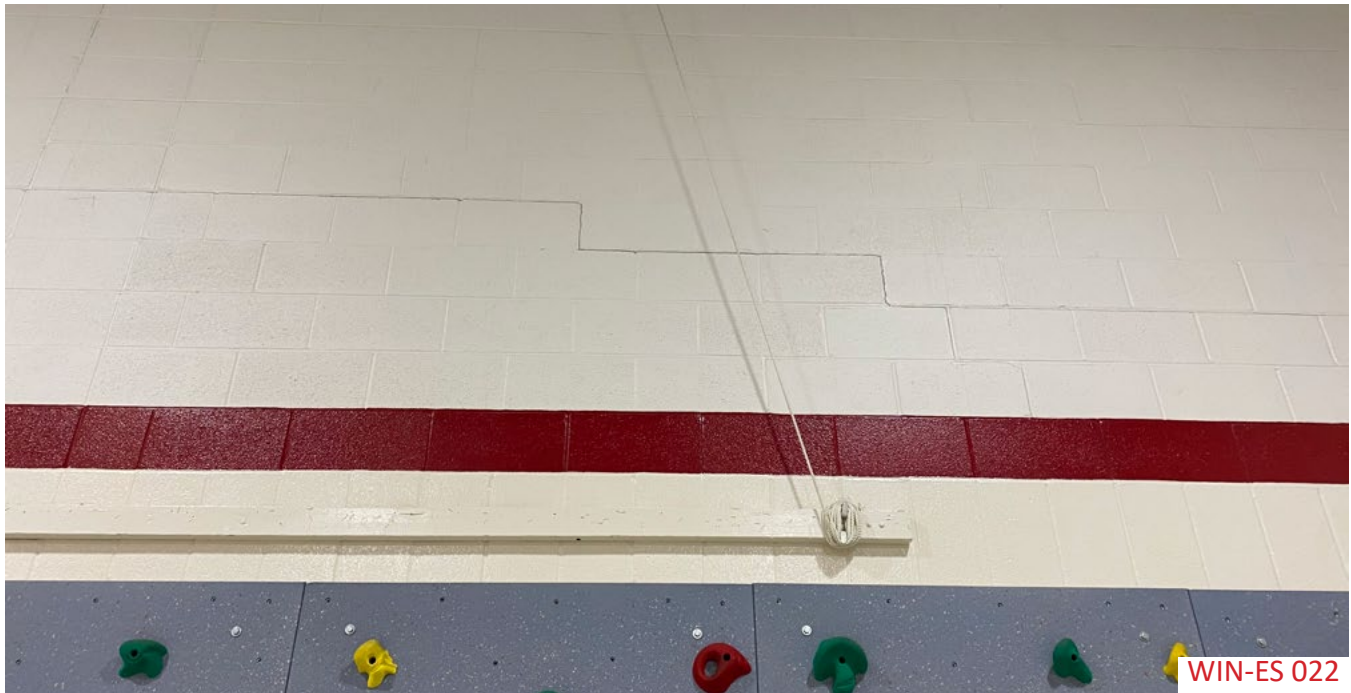
There was some cracking in the CMU seen within the gymnasium.

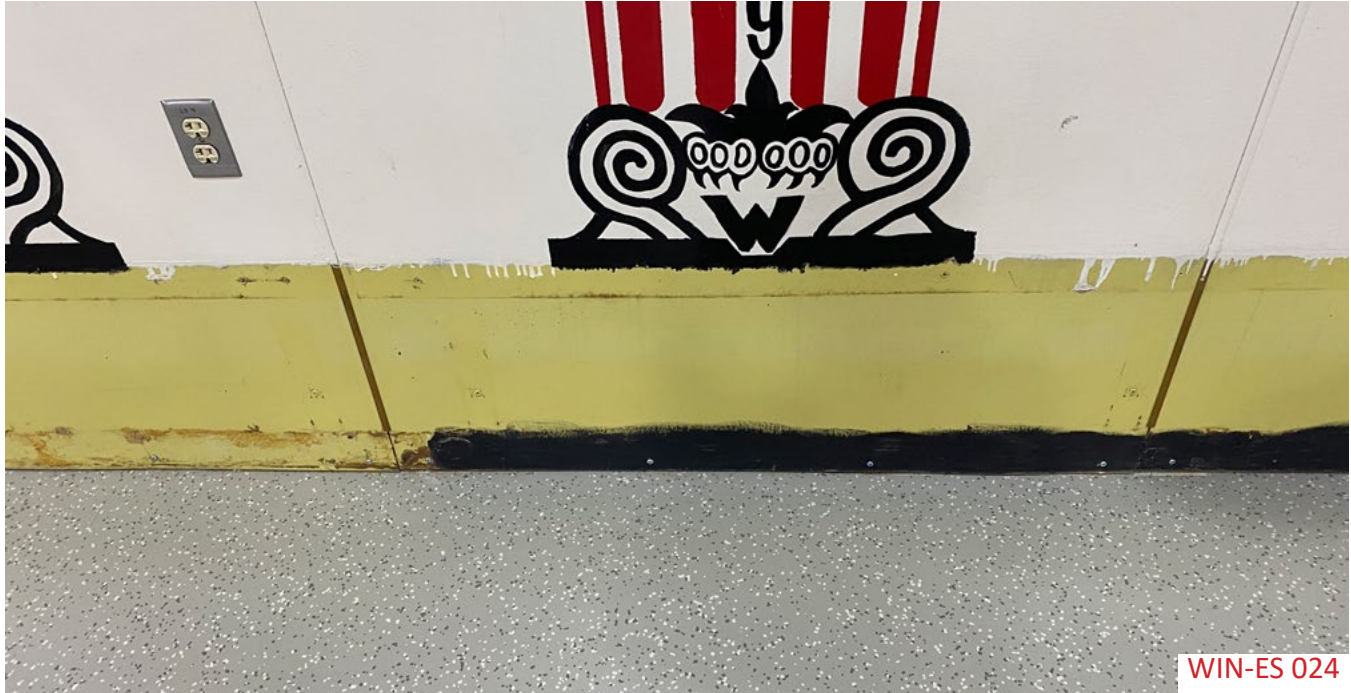
A gypsum board wall in the gymnasium needs painting after an attached bench was removed.
