BEN FRANKLIN ELEMENTARY SCHOOL

A. EXISTING BUILDING INVENTORY

INTERIOR AND EXTERIOR EXISTING DEFICIENCIES PHOTOS

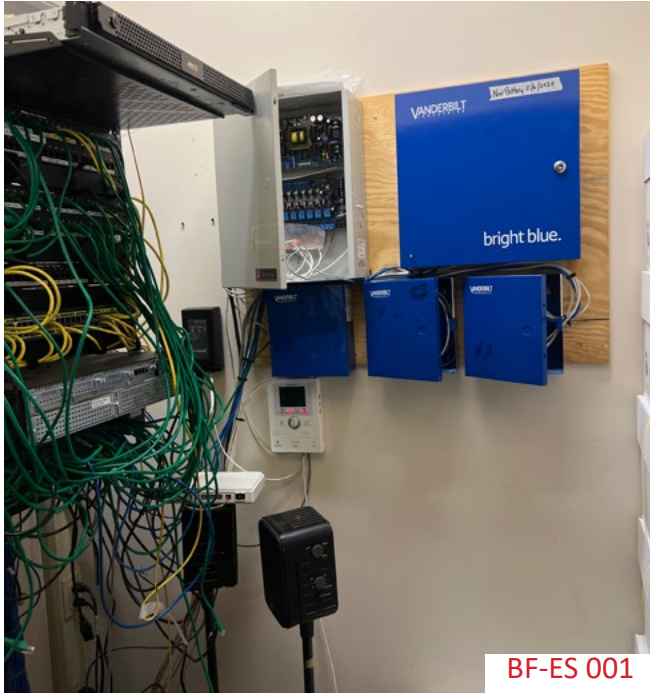
BF-ES 001

Another concern is the lack of an exhaust/relief in the server room.

Interior Upgrades									
Add an exhaust/relief in the server room	38	1 Ea.	\$17,369.43 / Ea.	\$17,369					\$17,369
Replace dated and damaged casework (100 lf of base, top, upper)	39	300 LF	\$389.57 / LF			\$116,872			\$116,872
Replace 66 blinds on windows and 50 on doors that are dated and damaged	40	116 Ea.	\$763.12 / Ea.		\$88,522				\$88,522
Replace ACT in the cafeteria	41	2,000 SF	\$11.54 / SF	\$23,080					\$23,080
Patch damaged ceiling in the girl's restroom next to room	42	50 SF	\$11.54 / SF	\$577					\$577
Paint some walls throughout the school that should be repainted and repair vinyl wall covering	43	52,311 SF	\$0.85 / SF		\$44,464				\$44,464
Caulk the several cracks in the CMU walls and repair caulking at the top of CMU walls that should be redone	44	52,311 SF	\$0.29 / SF	\$15,170					\$15,170
Replace dated carpet throughout the school (assuming 70% of building area)	45	36,618 SF	\$13.15 / SF		\$481,667				\$481,667

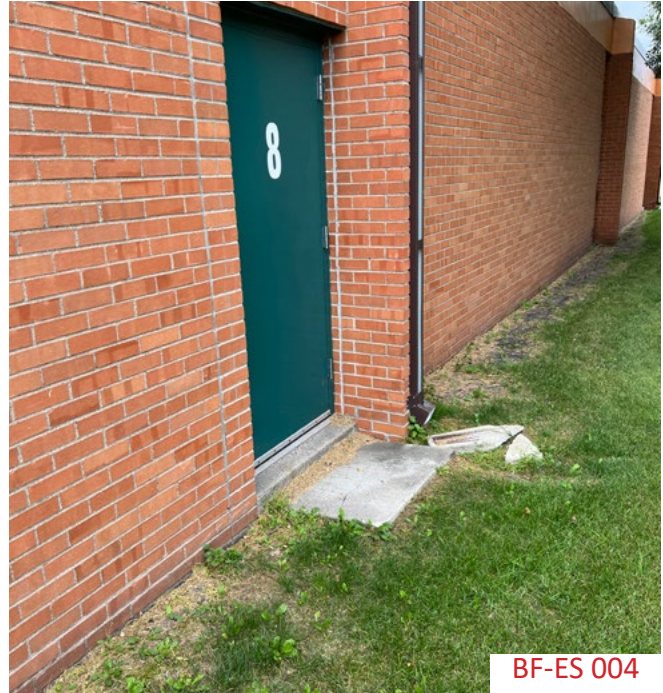
BF-ES 004

Several doors have floating slabs that have made noticeable movements from their original positions.

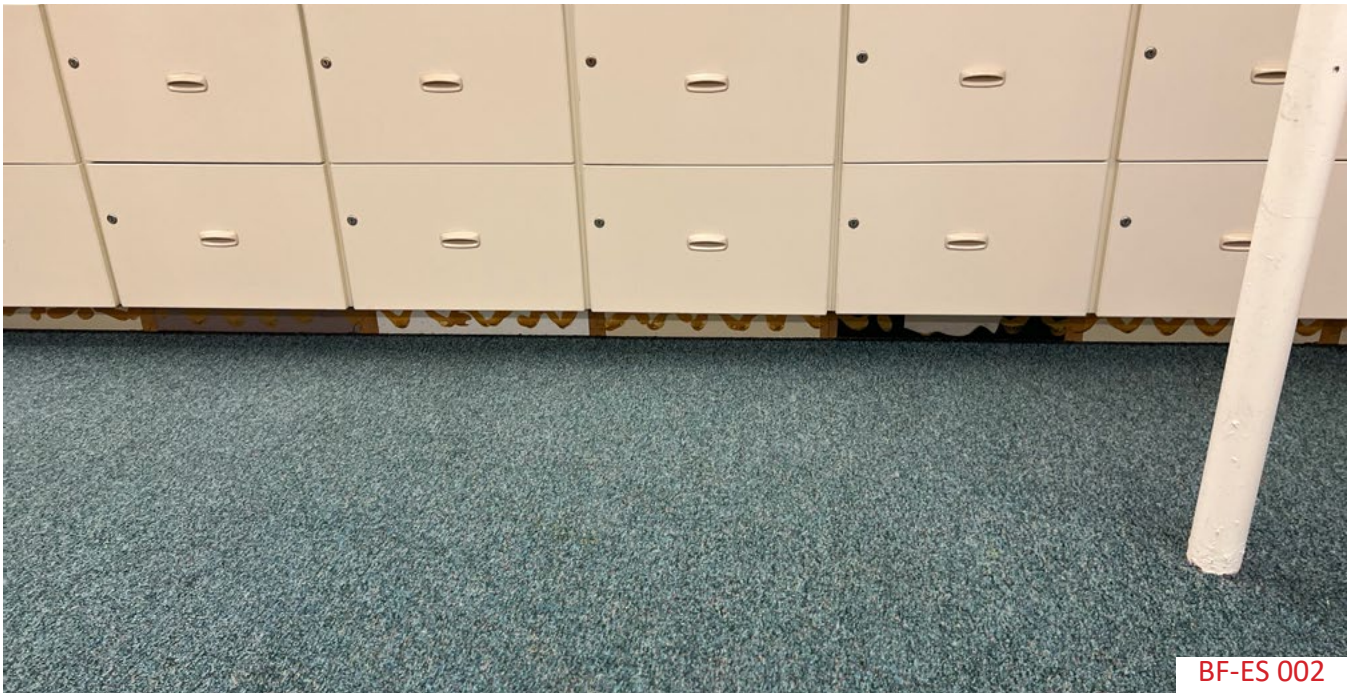
BF-ES 002

Casework is dated and damaged.

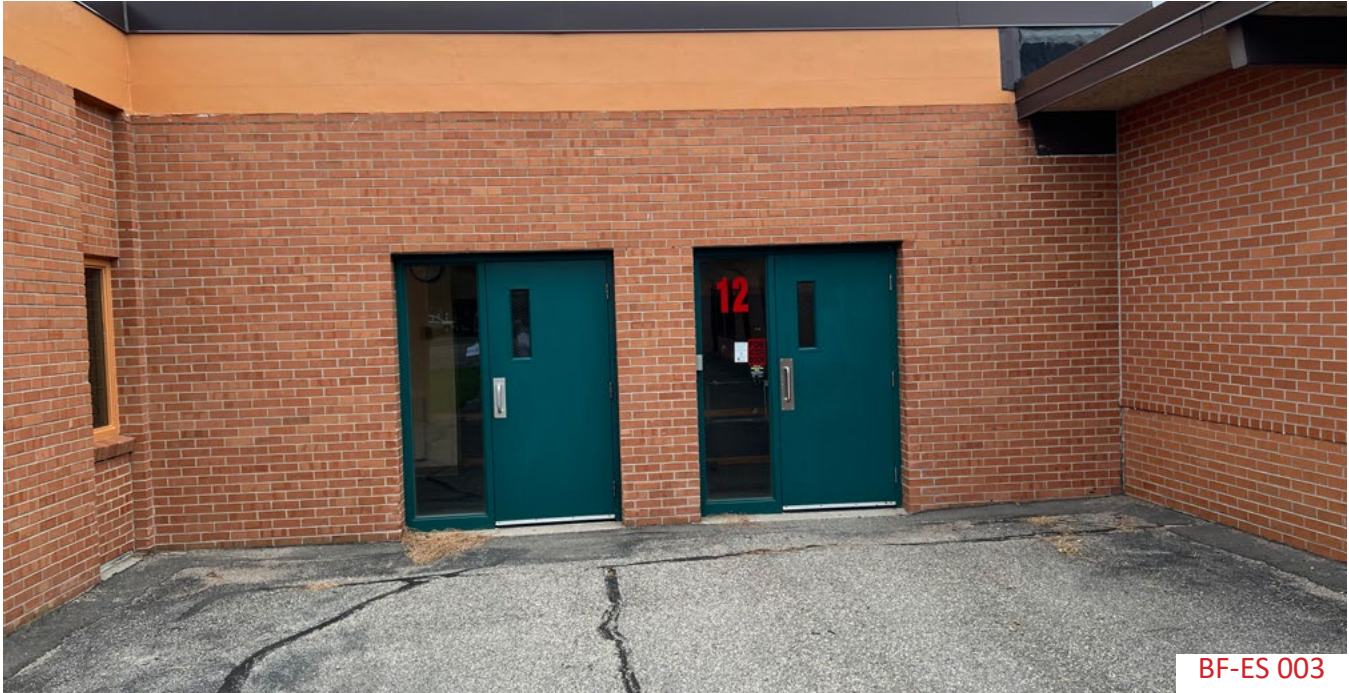
BF-ES 003

The lack of stoops at exterior doors is causing significant problems. The asphalt heaves when the ground is frozen in the winter, preventing Door 6 and 12 from opening (003). Several doors have floating slabs that have made noticeable movements from their original positions (004, 005). There is also a large crack in the cement outside Door 6 (006). Another noticeable site issue is the asphalt in the parking lot. It is in poor shape and could use replacement. Several emergency exits do not have a connection to a public way (007). There are water issues happening on the south side of the building outside the library/media center (008, 009). Water pools in these areas and has leaked into the building on multiple occasions. There are also issues with the courtyard ground. The pavers have shifted, making the ground very uneven (010).

The asphalt heaves when the ground is frozen in the winter, preventing doors 6 and 12 from opening.

Replace the wood flooring on the stage that is old and damaged	46	940 SF	\$19.69 / SF		\$18,509				\$18,509
Interior Upgrades Subtotal	52,311 SF		\$15.41 / SF						\$806,231
Exterior Upgrades									
Add stoops at exterior doors	47	6 Ea.	\$18,808.94 / Ea.	\$112,854					\$112,854
Add stoops to the exterior doors that have floating slabs	48	4 Ea.	\$18,808.94 / Ea.	\$75,236					\$75,236
Repair the large new crack in the cement outside door 6	49	200 SF	\$17.56 / SF		\$3,512				\$3,512
Mill and overlay N parking lot that is in rough shape	50	23,050 SF	\$5.08 / SF		\$117,168				\$117,168
Add sidewalks that connects the emergency exits to a public way	51	2,000 SF	\$17.56 / SF	\$35,115					\$35,115
Re grade the south side of the building outside the library/media center where there are water issues happening	52	1 Ea.	\$12,669.75 / Ea.	\$12,670					\$12,670
Re grade and landscape the areas where water pools to prevent water from being leaked into the building	53	1 Ea.	\$26,391.85 / Ea.	\$26,392					\$26,392

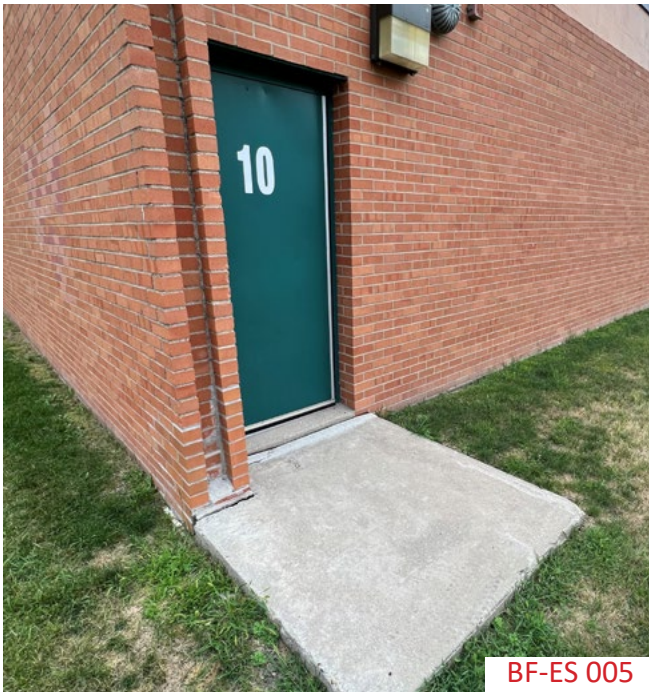
BF-ES 005

Several doors have floating slabs that have made noticeable movements from their original positions.

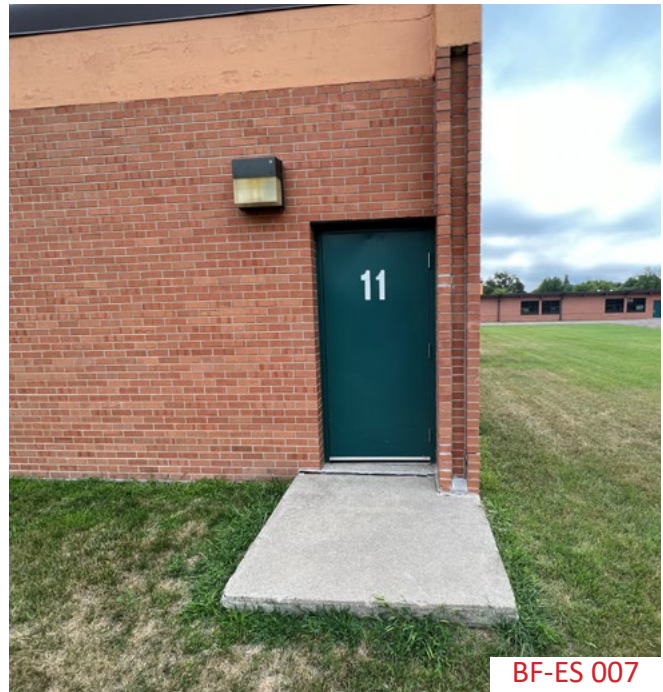
BF-ES 007

Several emergency exits do not have a connection to a public way.

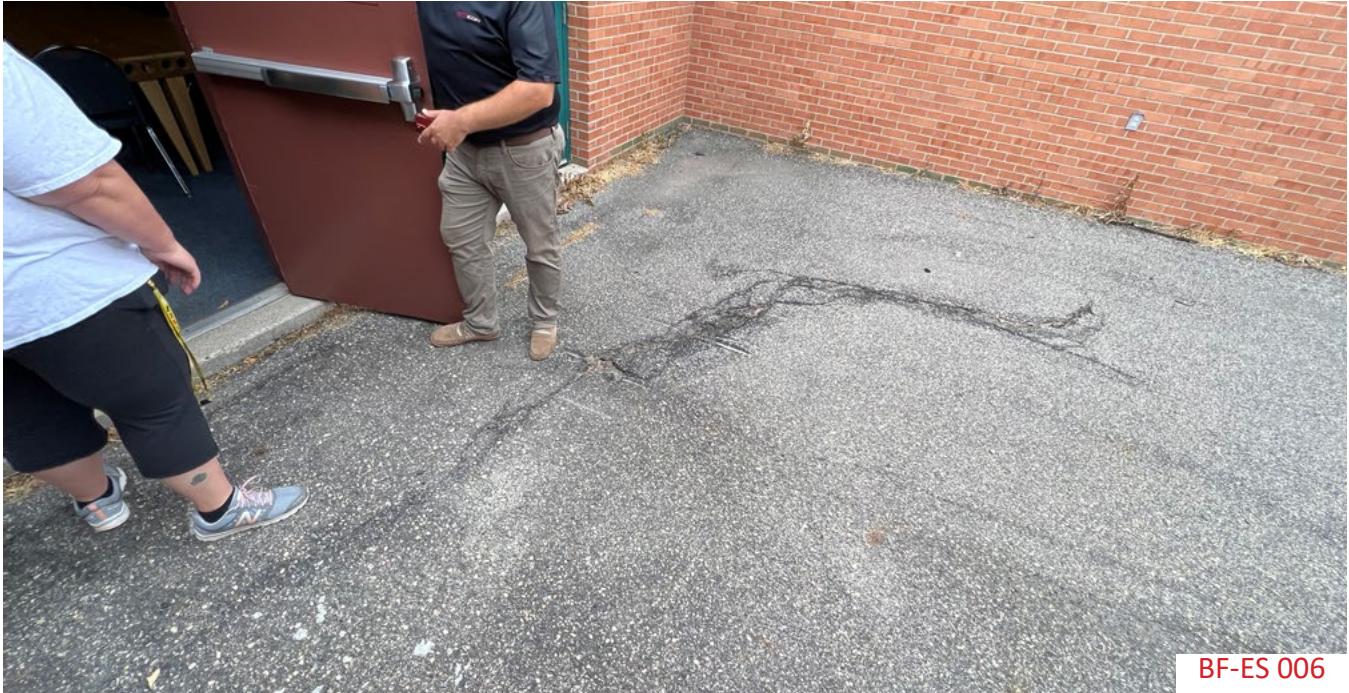
BF-ES 006

There is also a large new crack in the cement outside door 6.

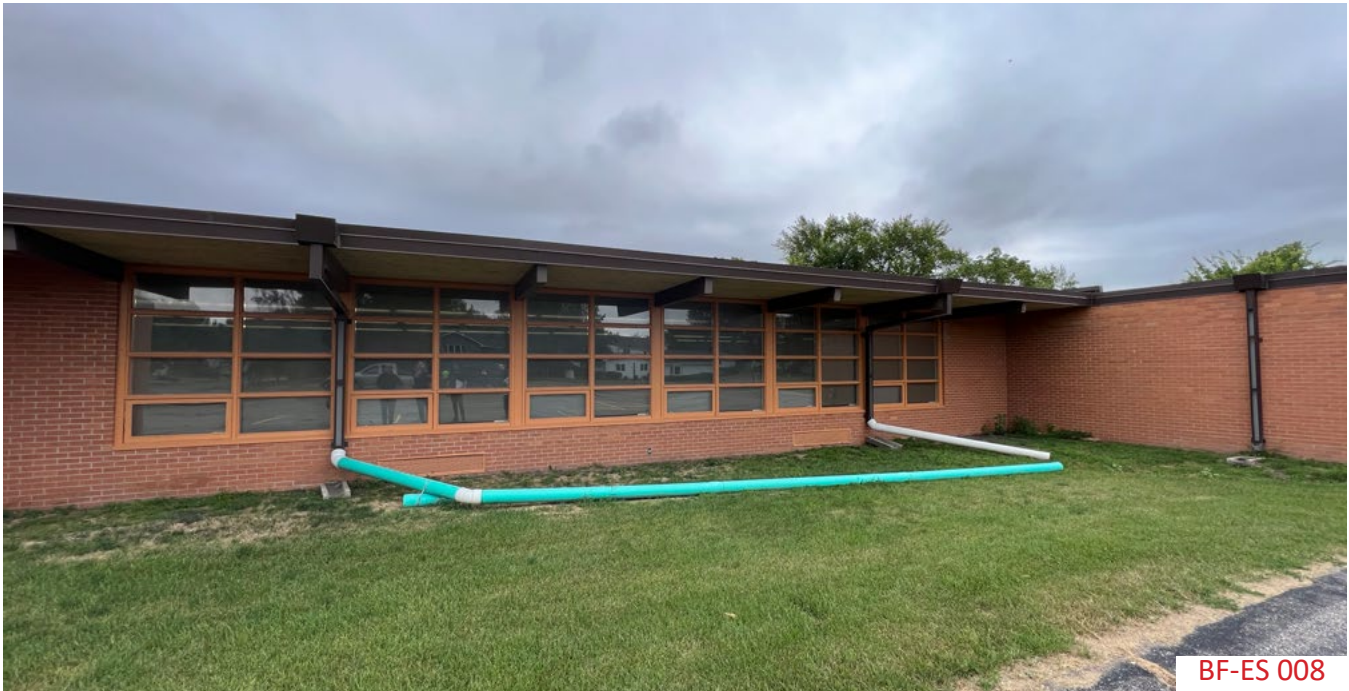
BF-ES 008

There are water issues happening on the south side of the building outside the library/media center.

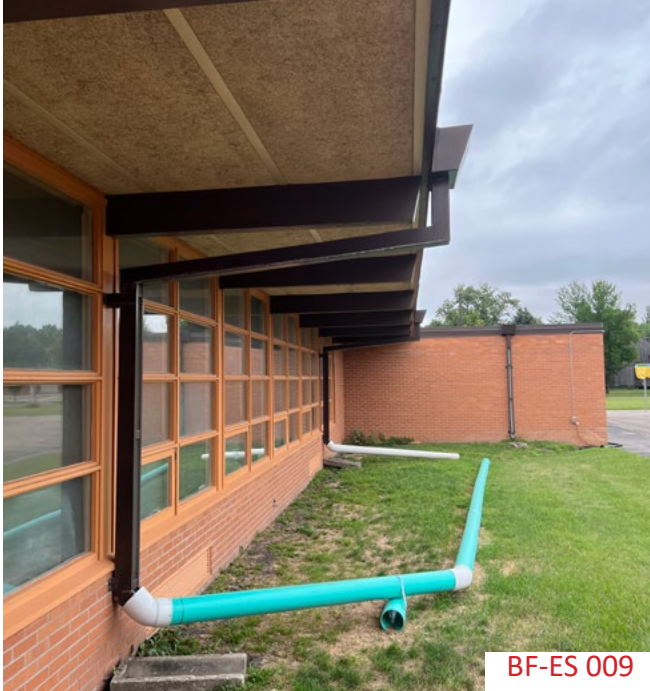
BF-ES 009

There are water issues happening on the south side of the building outside the library/media center.

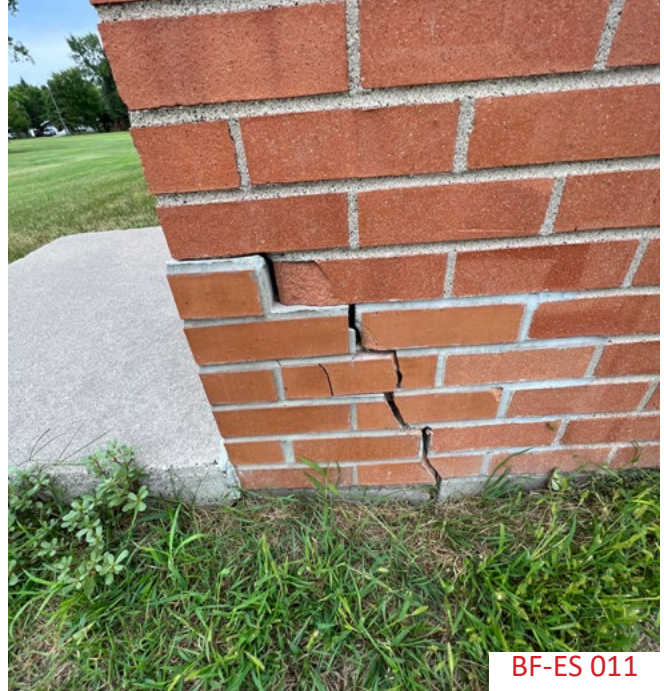
BF-ES 011

ICON could not recognize the presence of any weeps in most exterior brick walls. It is possible that they could be below grade (below the asphalt). The brick is cracked and pulling away at the corner near Door 11 (011). Tuckpointing is wearing at exterior corners (012).

The brick is cracked and pulling away at the corner near door 11.

Remove the pavers in the courtroom and replace it with concrete	54	1,440 SF	\$28.30 / SF		\$40,758				\$40,758
Repair the brick that is cracked and pulling away at corner near door 11	55	30 SF	\$216.83 / SF	\$6,505					\$6,505
Masonry tuckpointing at exterior of the building where the brick is wearing	56	5,000 SF	\$18.82 / SF		\$94,111				\$94,111

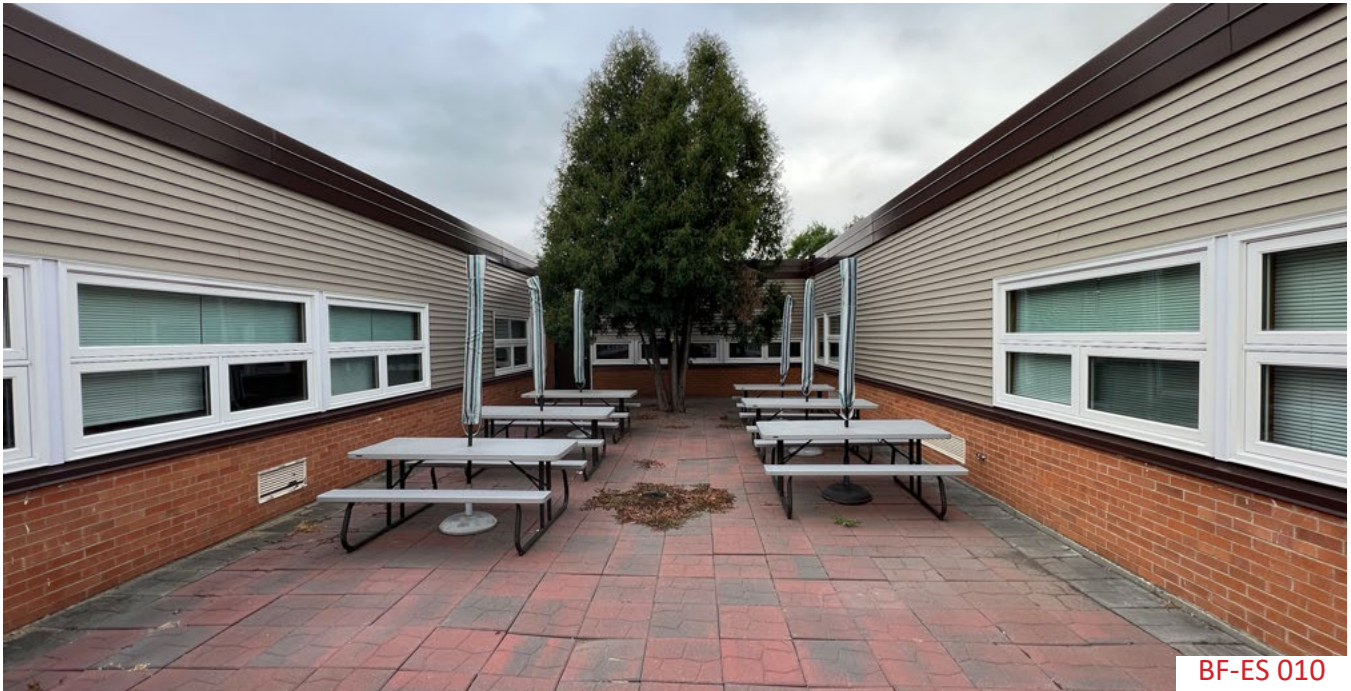
BF-ES 010

- The courtyard is not accessible due to the presence of a step at each door. (025)
- Residential siding in the courtyard is not to code. (010)
- The slanted corridors in the west wing of the building do not have an adequate turn radius and the doors fail to meet required maneuvering clearances for accessibility. (026, 027)

Residential siding in the courtyard is not to code.

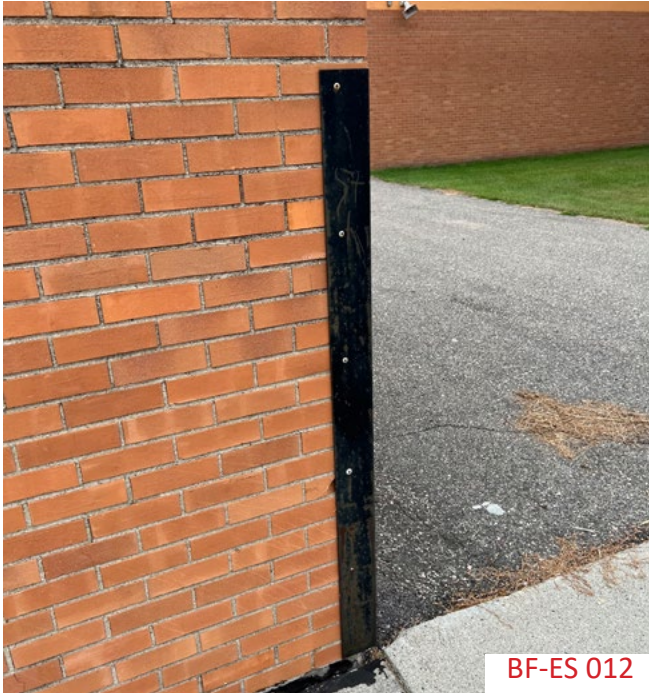
BF-ES 012

Tuckpointing is wearing at exterior corners.

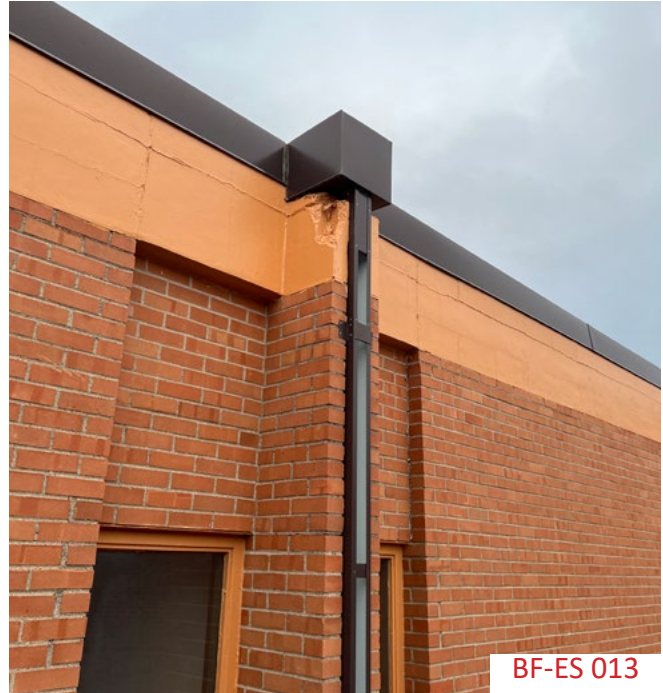
BF-ES 013

The exterior of the school consists primarily of brick. Some areas have CMU block around the top.

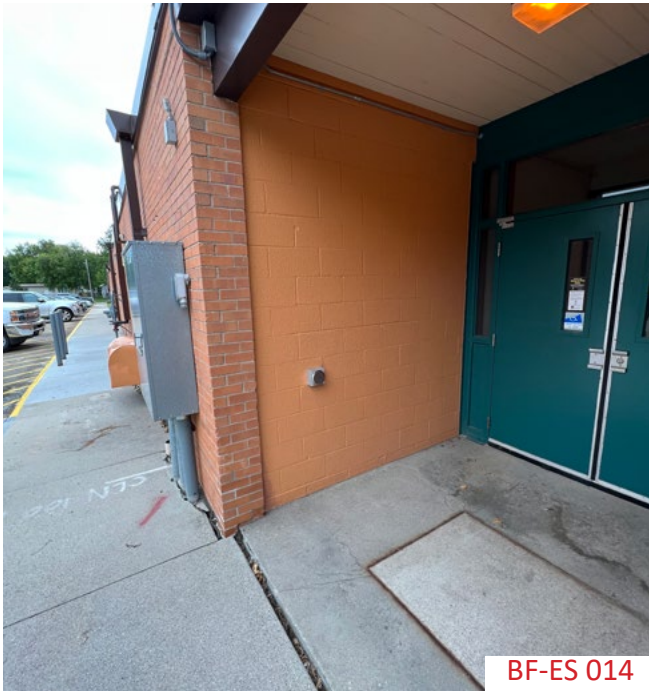
BF-ES 014

The exterior of the school consists primarily of brick. Some areas have CMU block around the top and near entry vestibules.

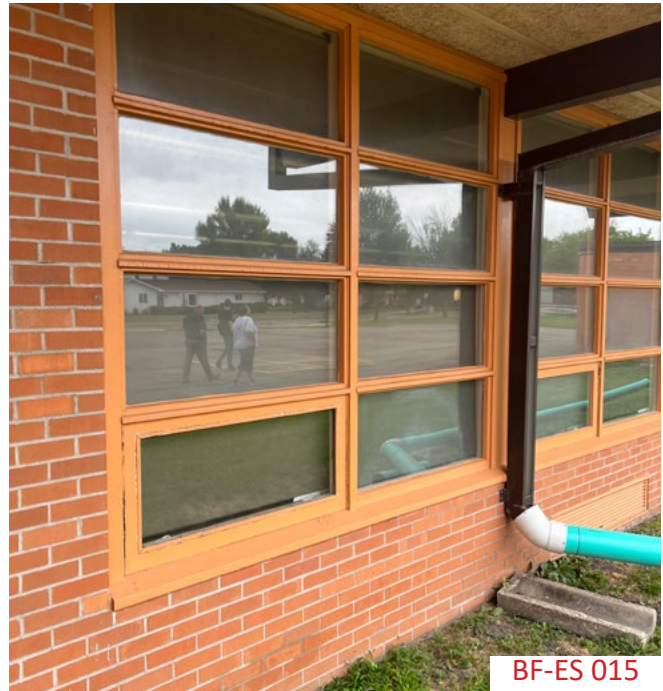
BF-ES 015

Windows in the media center are original to the building and are due for replacement (015). Several doors are damaged including exterior Door 5 and Classroom 22, and door frames should be repainted. The window in the boiler room is cracked.

Windows in the media center are original to the building and are due for replacement.

Description	Item Number	Takeoff Qty	Total Cost/Unit	Critical	5 yrs Deferred Maint	10 yrs Deferred Maint	Educational Adequacy	Synergistic with other needs	Total Cost
Replace windows in the media center that are original to the building and are due for replacement	57	6 Ea.	\$3,469.32 / Ea.	\$20,816					\$20,816
Replace the several doors that are damaged including exterior door 5 and classroom 22 door, and paint existing door frames	58	10 Ea.	\$2,368.31 / Ea.		\$23,683				\$23,683
Add 22 additional parking stalls to the parking lot since it is not large enough	59	5,500 SF	\$14.84 / SF				\$81,620		\$81,620
Replace the roof when it nears the end of its useable lifetime	60	52,311 SF	\$33.58 / SF		\$1,756,603				\$1,756,603
Replace the window in the boiler room that is cracked.	61	1 Ea.	\$3,469.32 / Ea.	\$3,469					\$3,469
Exterior Upgrades Subtotal		52,311 SF	\$46.08 / SF						\$2,410,511
Electrical Upgrades

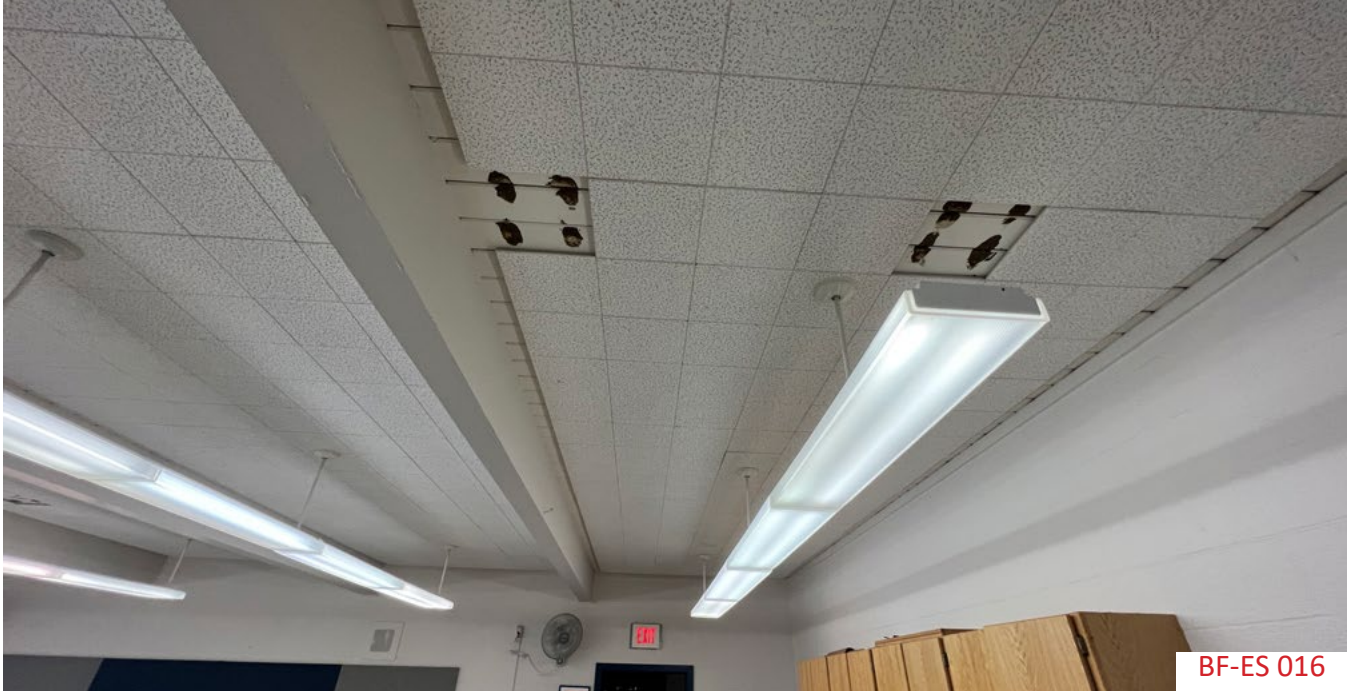
BF-ES 016

Ceiling tiles in the cafeteria continue to fall off and several are missing (016). The ceiling is damaged in the girls' restroom next to Room 25.

Ceiling tiles in the cafeteria continue to fall off and several are missing.

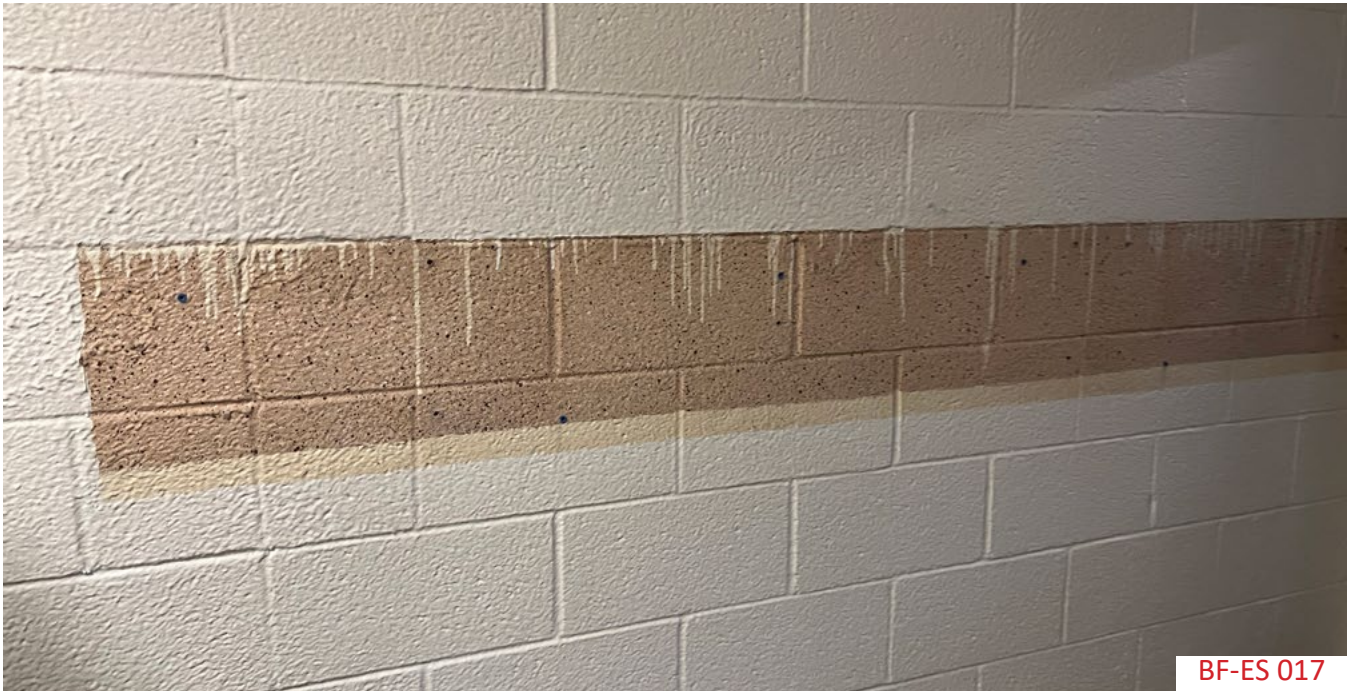
BF-ES 017

Various walls throughout the school should be repainted.

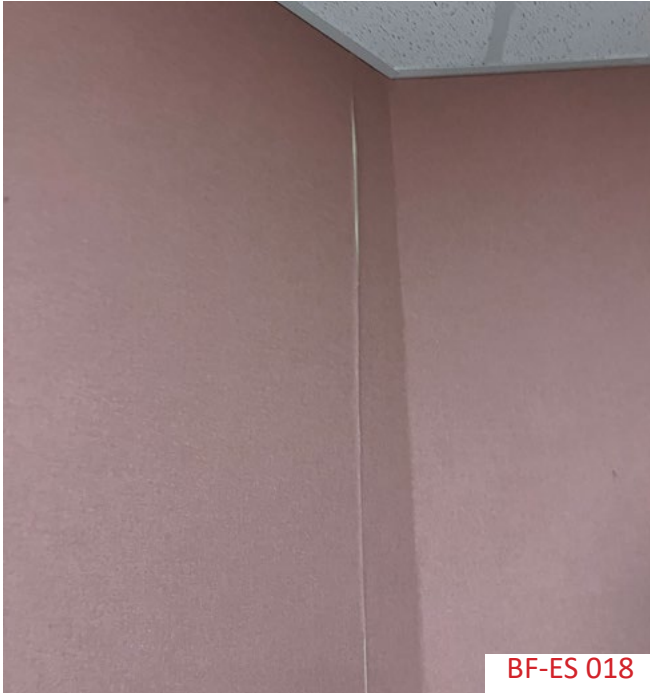
BF-ES 018

Various walls throughout the school should be repainted and vinyl wall covering repaired or replaced.

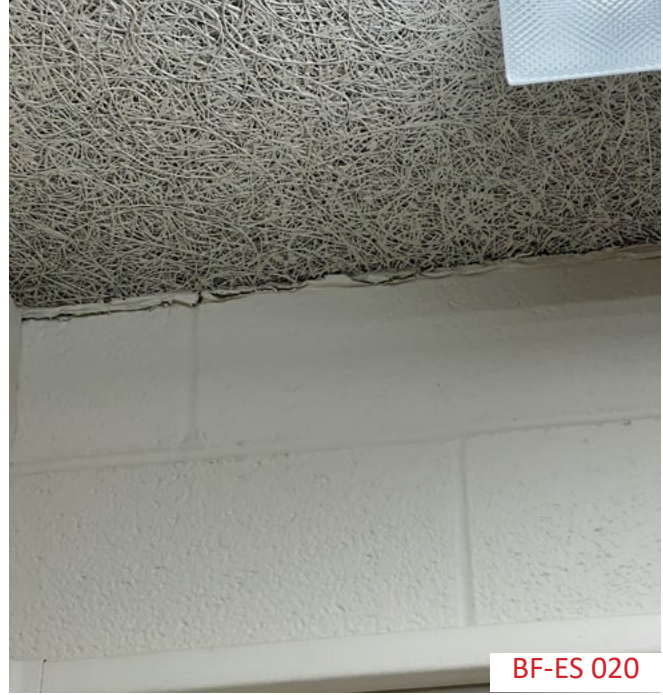
BF-ES 020

Caulking at the top of CMU walls should be redone.

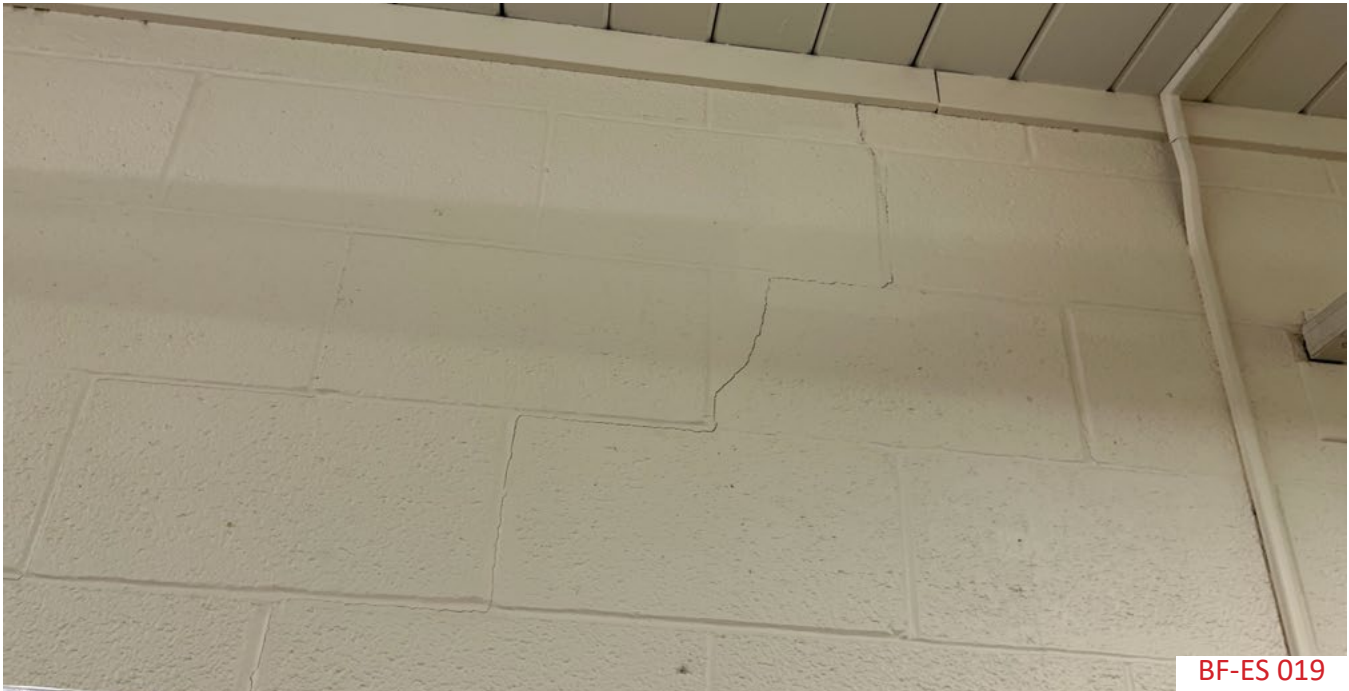
BF-ES 019

There are several areas where the CMU walls are cracking.

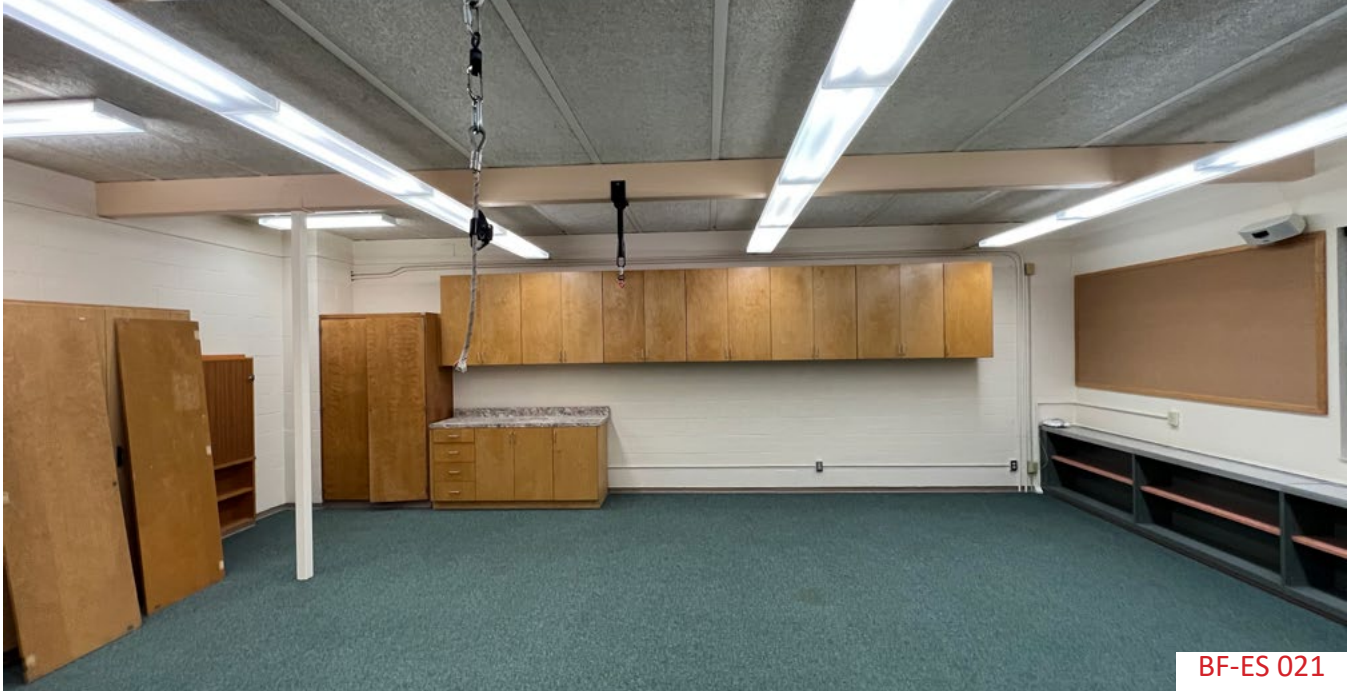
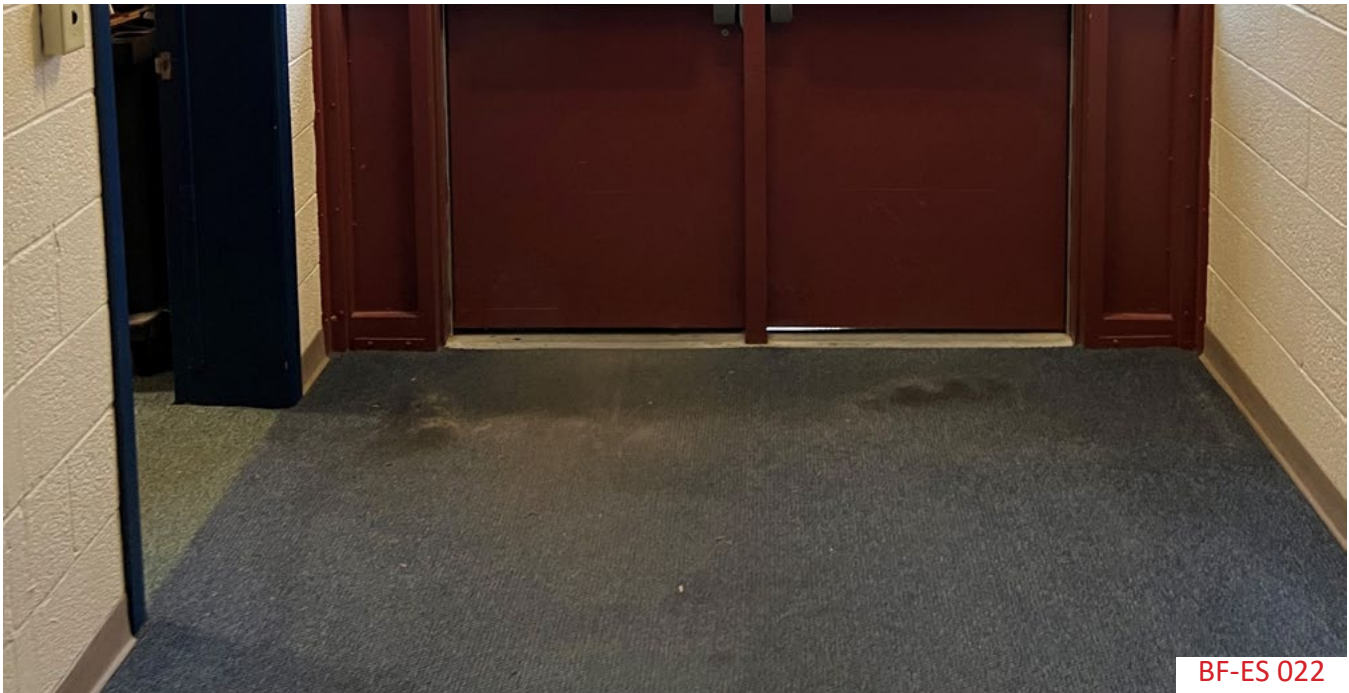
The common type of flooring at Ben Franklin Elementary School is either carpet or various types of tiles. The carpet throughout is old and could use replacing (021, 022). The wood flooring on the stage is old and damaged.

The carpet throughout is old and could use replacing.

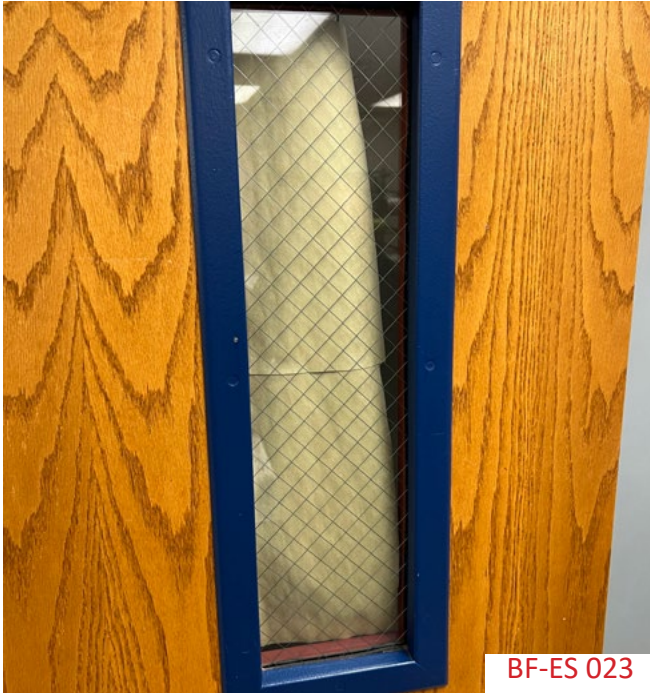
- Traditional wire glass throughout the building is no longer to code as an acceptable type of safety glass. (023)
- Glass in display cases and doors is not the required safety glass. (024)

Traditional wire glass throughout the building is no longer to code as an acceptable type of safety glass.

Description	Item Number	Takeoff Qty	Total Cost/Unit	Critical	5 yrs Deferred Maint	10 yrs Deferred Maint	Educational Adequacy	Synergistic with other needs	Total Cost
ADA and Building Code Compliance									
Replace wire glass throughout the building that is no longer up to code (frame to remain)	1	1,600 SF	\$33.65 / SF	\$53,840					\$53,840
Replace the glass in the display cases throughout the school with the required tempered glass	2	4 Ea.	\$4,515.86 / Ea.	\$18,063					\$18,063
Remove some pavers in the courtyard and add a concrete ramp to make the courtyard accessible	3	100 SF	\$34.54 / SF	\$3,454					\$3,454
Remove residential siding in the courtyard and replace it with metal wall panel	4	1,344 SF	\$32.25 / SF	\$43,344					\$43,344
Remodel the slanted corridors in the West wing of the building by moving the wall adjacent to the class room to all for required push/pull clearances and adequate turn radius	5	350 SF	\$329.70 / SF	\$115,395					\$115,395

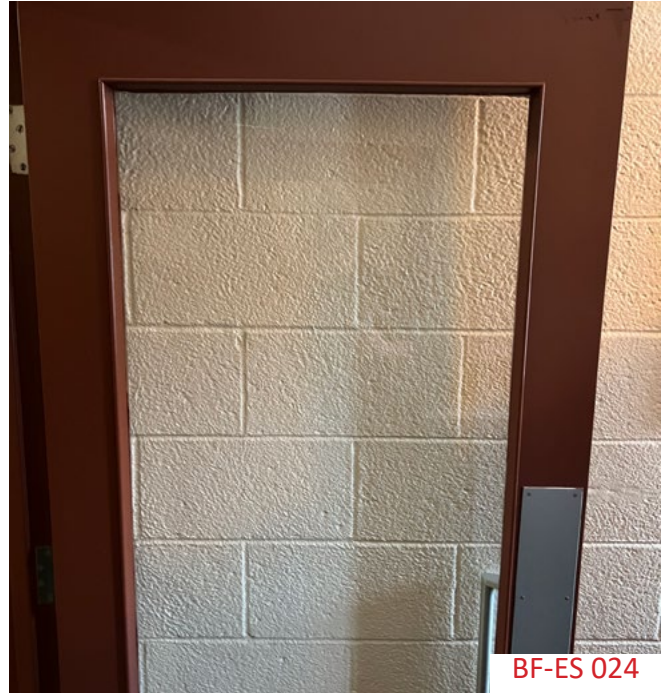
Glass in display cases and doors is not the required safety glass.

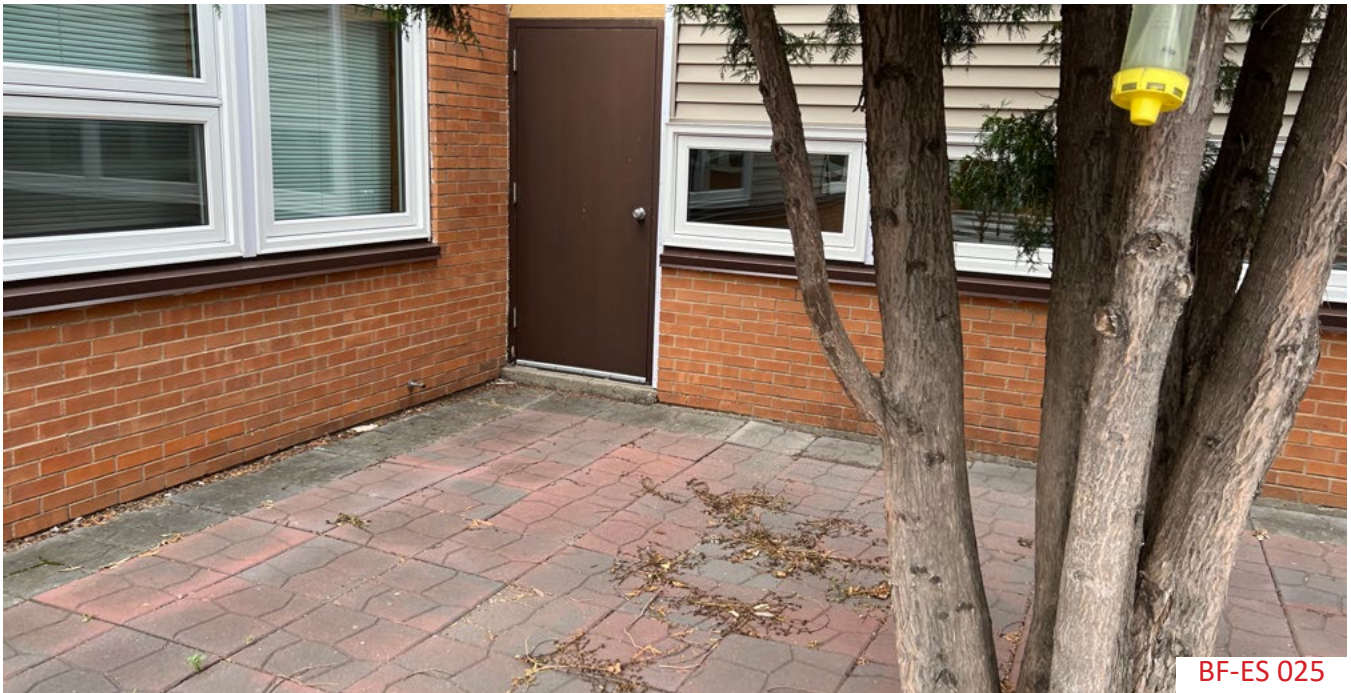
The courtyard is not accessible due to the presence of a step at each door.

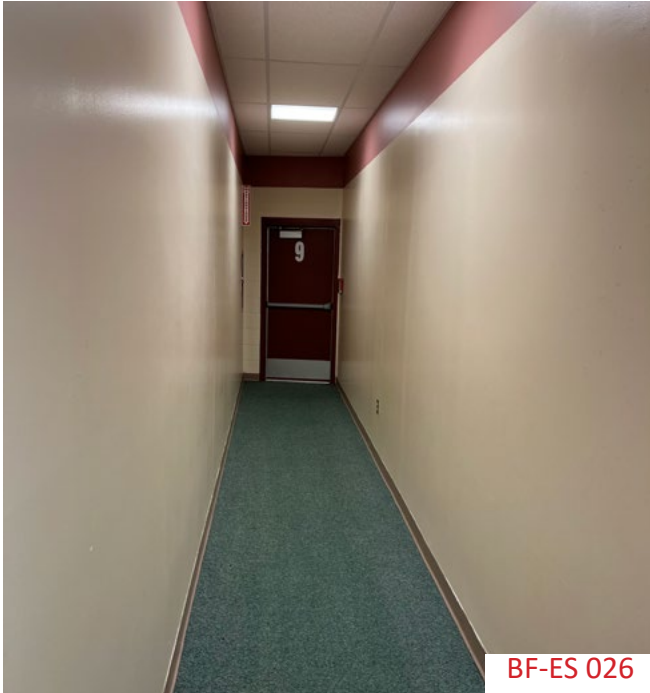
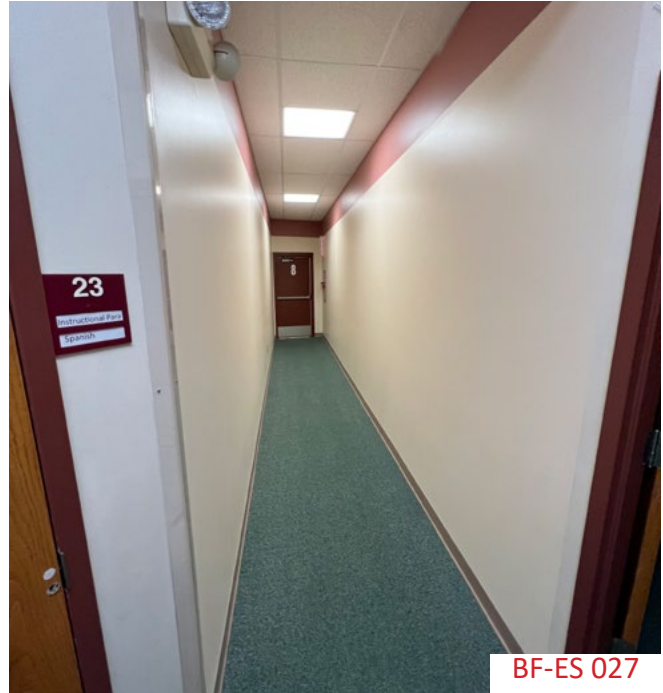
The slanted corridors in the west wing of the building do not have an adequate turn radius and the doors fail to meet required maneuvering clearances for accessibility.

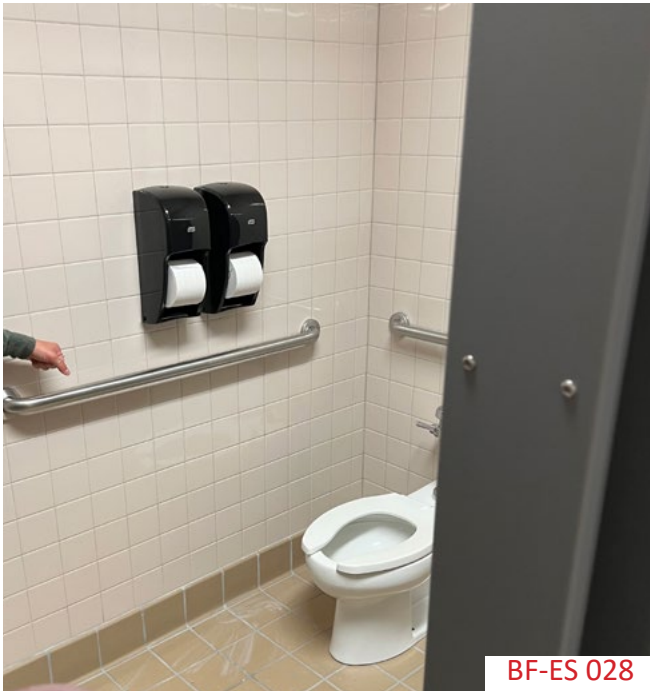
Boys' and girls' restrooms near the gym are not accessible. Grab bars and toilet paper dispensers exceed height limitations

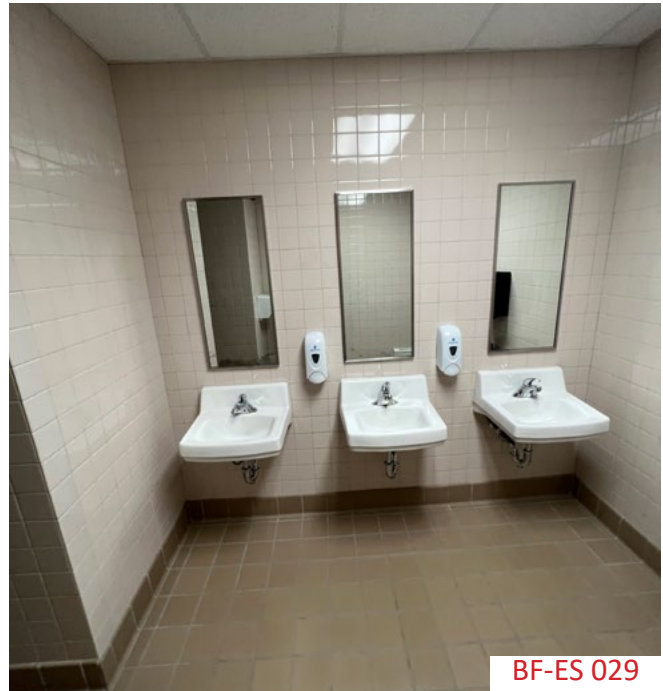
Pipes under the sinks are not protected (029), and the turning radius size is questionable.

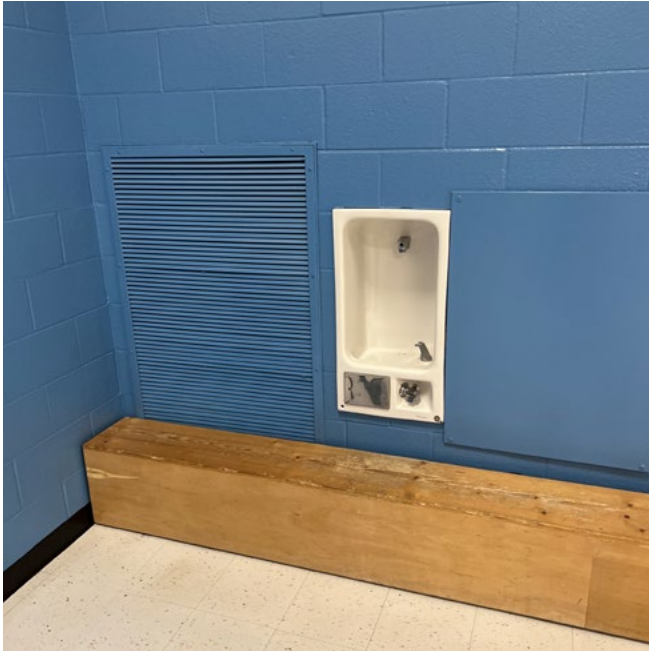
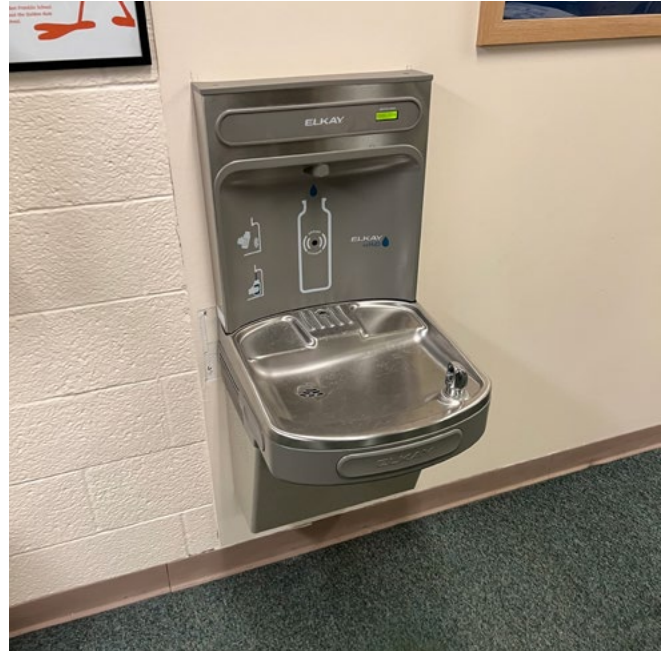
Drinking fountains throughout the building do not meet the required ratio of wheelchair accessible fountains to standing person accessible fountains.

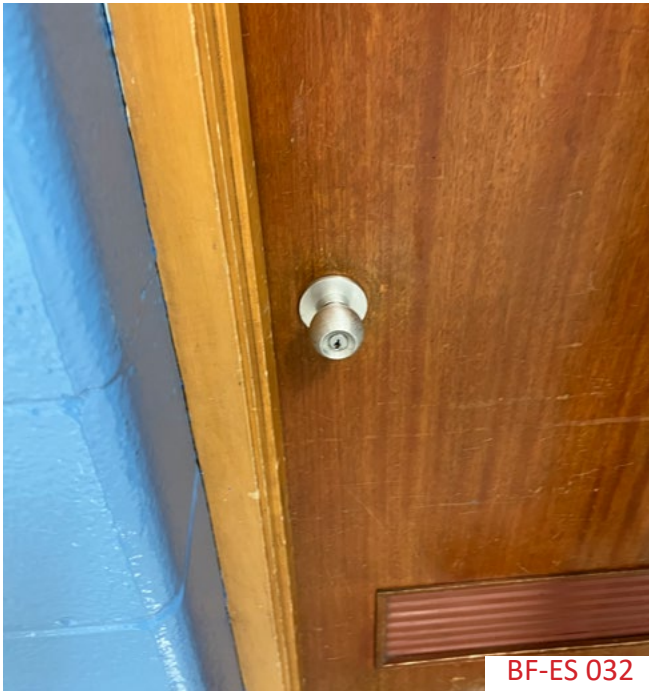
BF-ES 032

Several doors throughout the school have hardware that is not accessible.

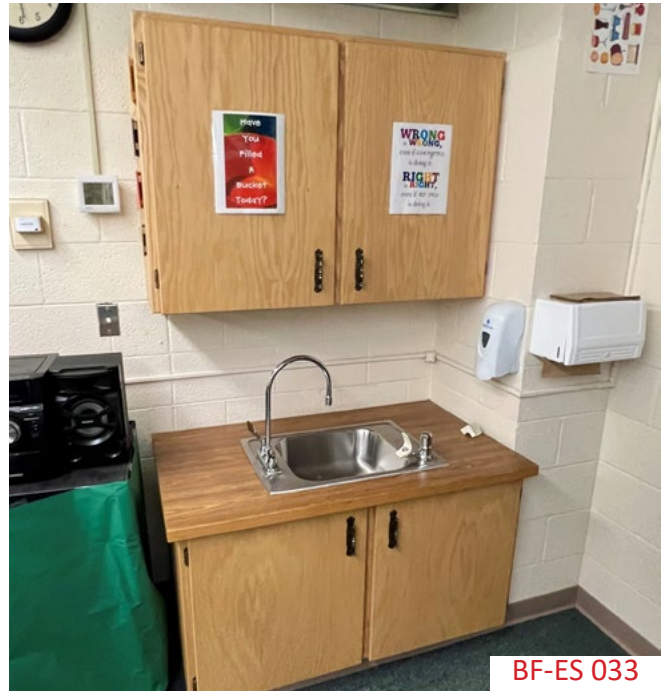
BF-ES 033

Classroom sinks are not accessible.
