BEN FRANKLIN ELEMENTARY SCHOOL

A. EXISTING BUILDING INVENTORY

INTERIOR AND EXTERIOR EXISTING DEFICIENCIES PHOTOS

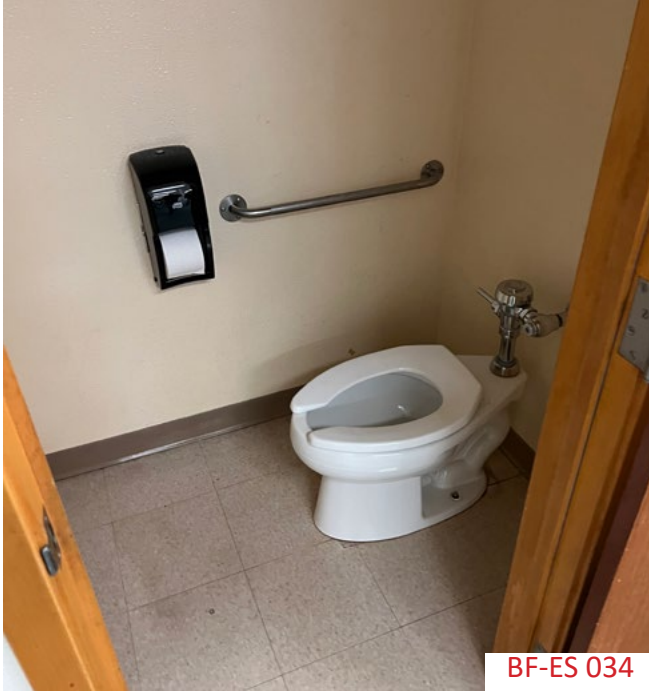
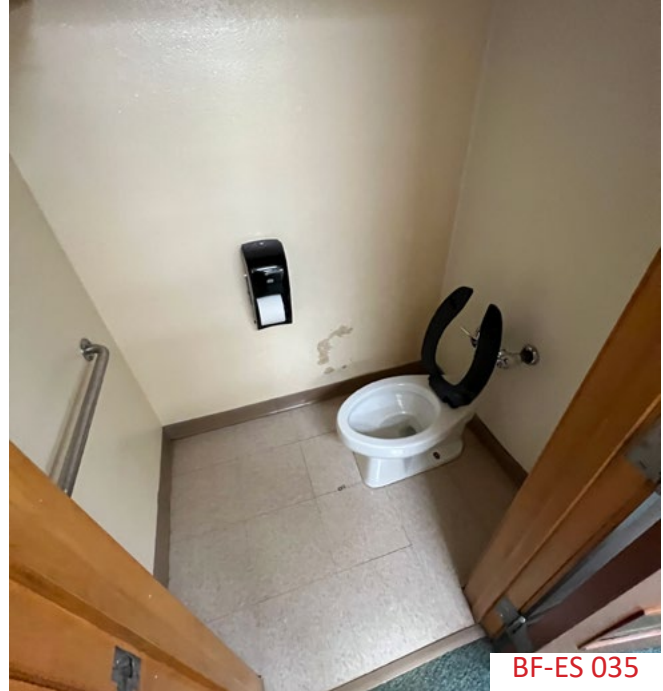
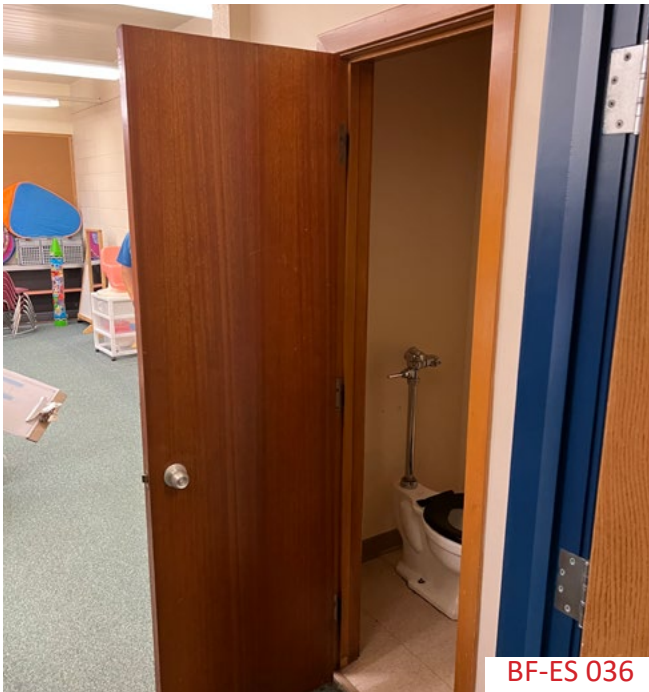
Classroom restrooms are not accessible.

Remodel classroom restrooms to make them accessible	13	6 Ea.	\$37,497.11 / Ea.	\$224,983				X	\$224,983
Change swing on doors where the door approaches fail to meet required push/pull clearances	14	10 Ea.	\$35,561.29 / Ea.	\$35,613					\$35,613
Add a lift to the stage to make it accessible	15	1 Ea.	\$100,329.00 / Ea.	\$100,329					\$100,329
Add an accessible sink in the old teacher's lounge, which is transitioning into a special ed room, by replacing the sink and 20 lf of lower, top, and upper cabinets	16	1 Ea.	\$26,939.88 / Ea.	\$26,940					\$26,940
Modify the cold air return that is causing the section of very low ceiling in the office	17	1 Ea.	\$16,248.16 / Ea.	\$16,248					\$16,248
Remove and replace the interior storefront at the door 13 vestibule so the interior width of doors match the exterior doors	18	1 Ea.	\$24,348.35 / Ea.	\$24,348					\$24,348
Total Code Compliance		52,311 SF	\$32.43 / SF	\$1,696,538	\$0	\$0	\$0		\$1,696,538

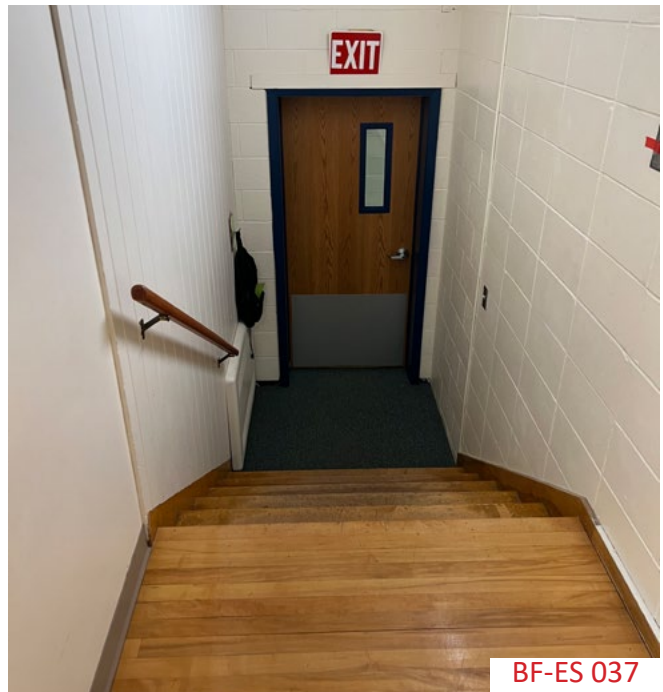
BF-ES 037

The stage is not accessible.

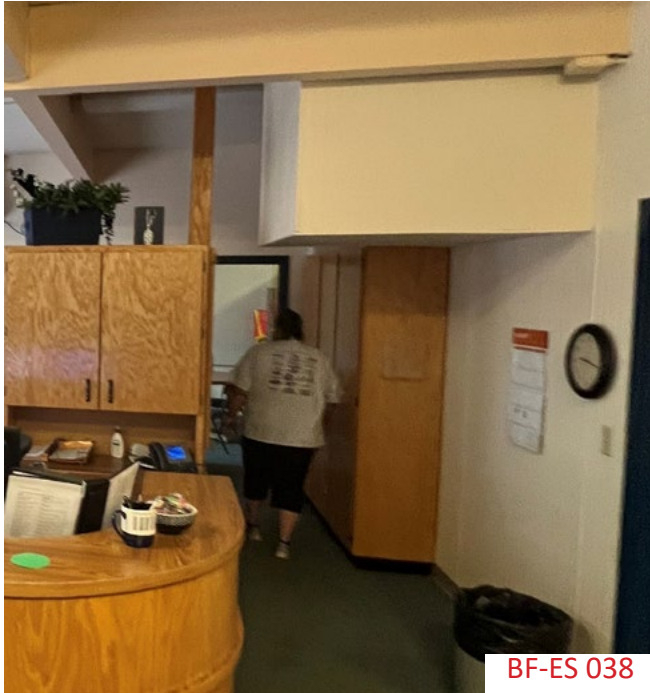
BF-ES 038

There is a section of very low ceiling in the office due to the location of the cold air return.

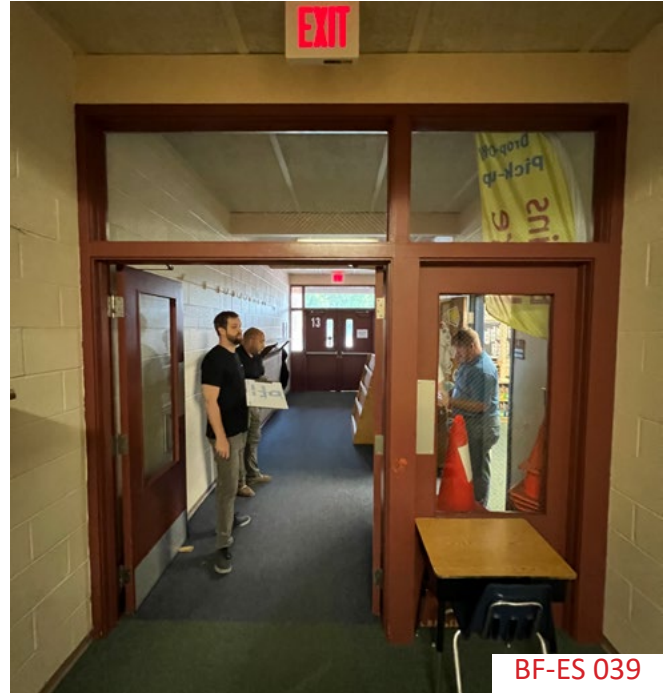
BF-ES 039

The vestibule at Door 13 does not meet code as the number of doors is reduced from 3 at the interior vestibule wall to 2 doors at the exterior wall.
